Pre-Plaster Report

Inspection Date: 30 Jul 2020

Property Address: Wollert Area

Report Type: New Home Construction

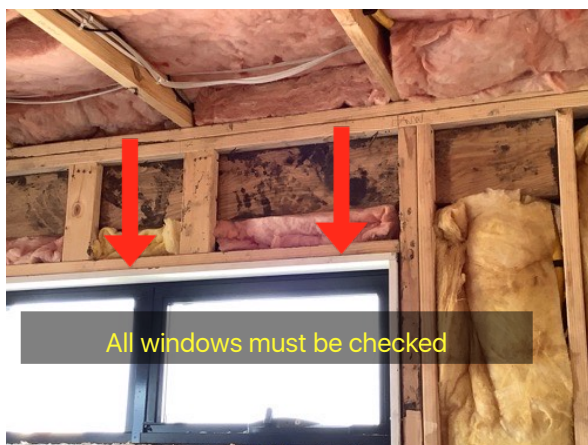
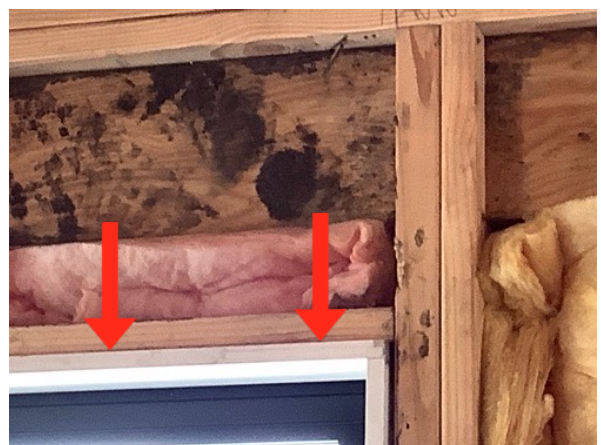
Non Compliant 2.01

Finding: Top Of Window - Undersized Gap.
There are areas where the top of the windows are currently tight or well under 15mm to the underside of the timber lintels.

It is a requirement of Australian Standard, A.S 1684 Residential Timber-Framed Construction, clause 6.2.3 Openings, that 'A minimum clearance of 15mm shall be provided between the underside of the lintel or lintel trimmer and the top of the window frame'.

This opening and/or ALL openings that are under 15mm must all be modified in compliance with the above.

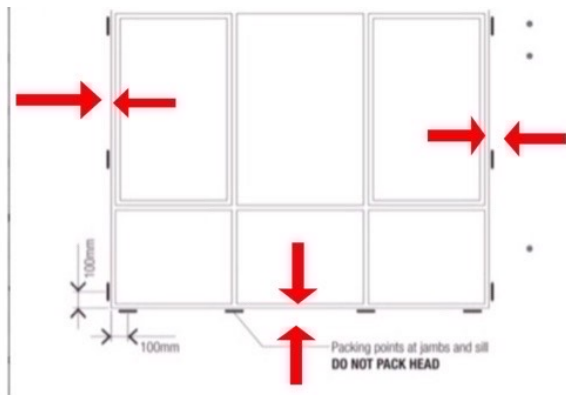
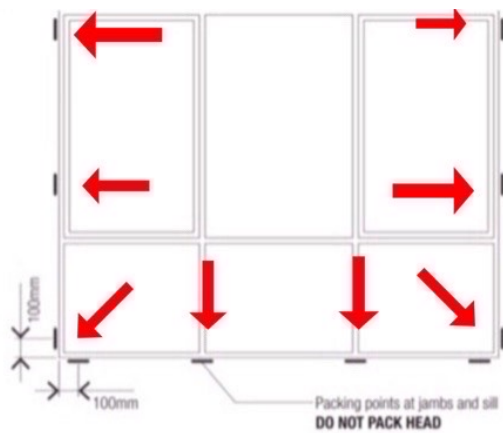
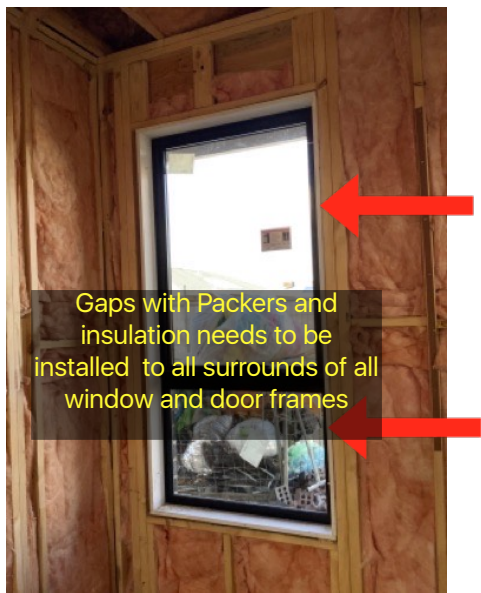
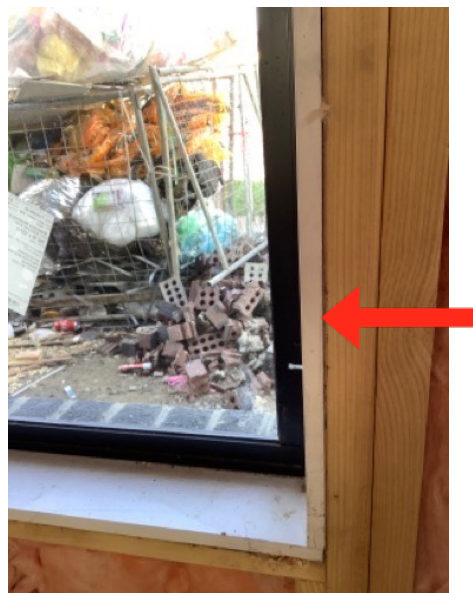
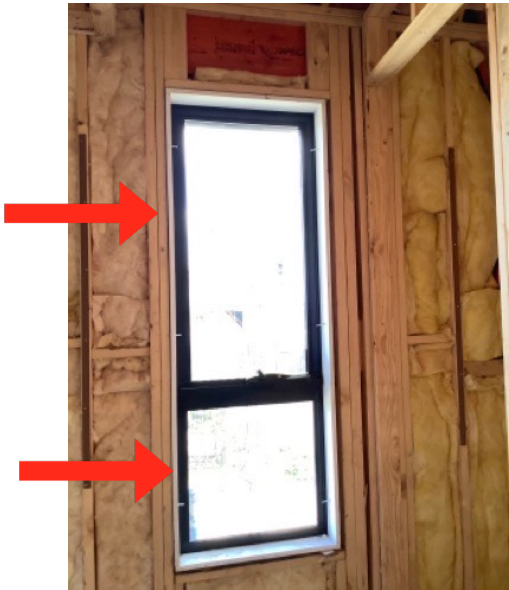
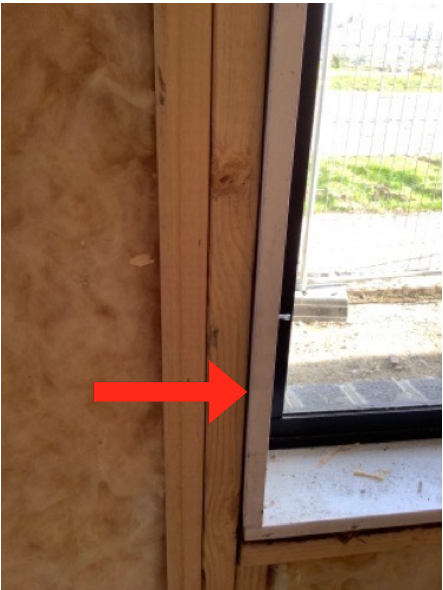
Non Compliant 2.02

Finding: Window Installation - Gaps To Perimeter Of Windows Defective.
As per AS-2047-1999 and the defect clause is below.
All windows must have sufficient gap around them with a minimum of 15mm at the top of the window to the underside of the timber frame.
In this case the defect in discussion is the sides of the window and the bottom of the window DO NOT have a sufficient gap if any to allow for movement and compression of the frame.

7.3.1 General A gap shall be provided between the window and the surrounding structure sufficient to prevent loads being imposed on the window, allowing for thermal expansion of the window and for structural movement as described in Clauses 7.3.2 and 7.3.3.

ALL WINDOWS with no or insufficient gaps, also as per manufacturers standards is packing to the sides and bottom of the windows as well, must be reworked to allow a recommended of at least 15mm to 20mm of packing.

The packers must be as the manufacturers specifications.

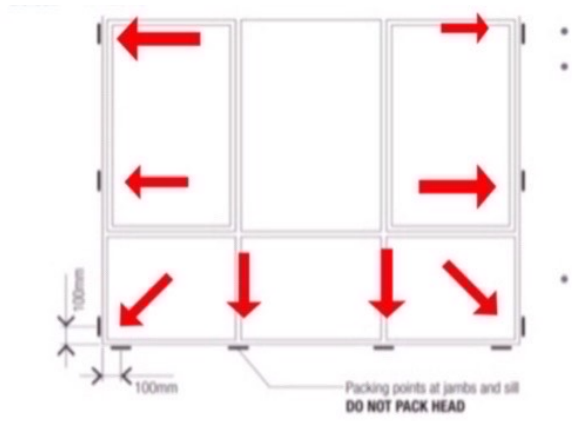
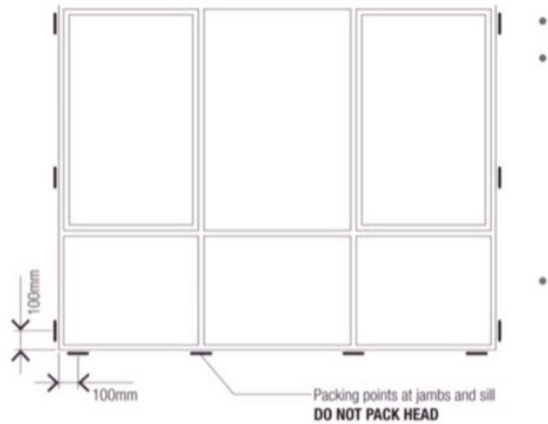
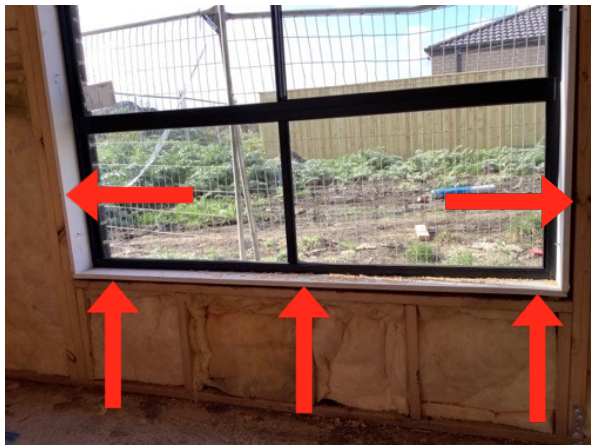
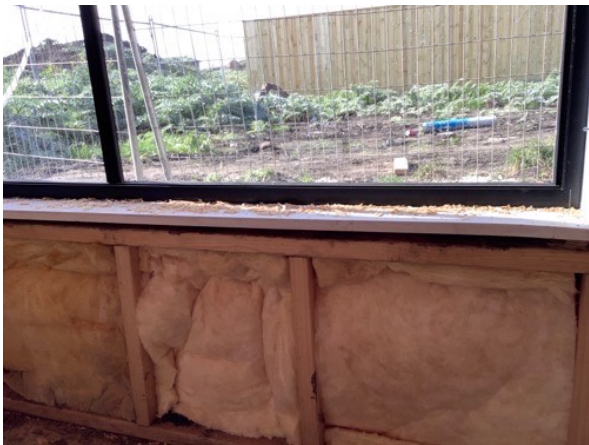
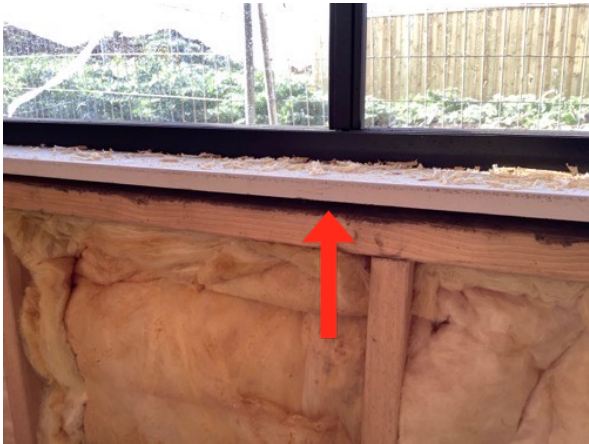
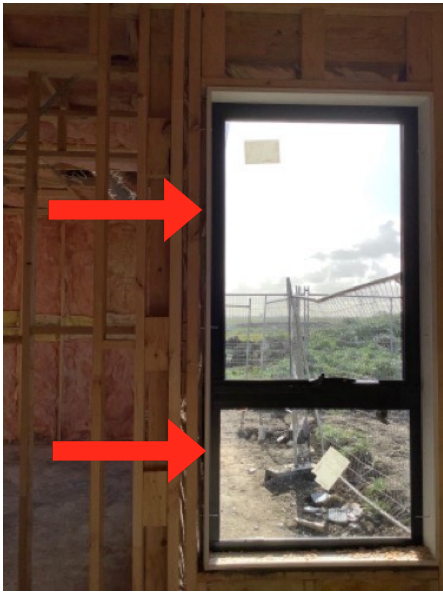
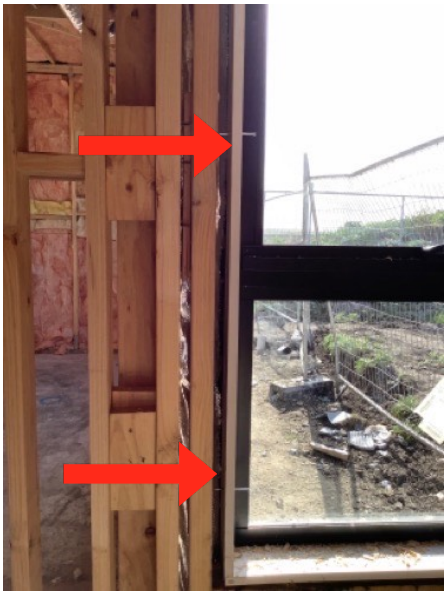
Non Compliant 2.03

Finding: Windows - No Packing, As Per The Manufactures Specifications. (Or Packing Not Satisfactory)

Windows must be packed at the mullions as specified by the window manufacturers specifications.

In this case the defect in discussion is the sides of the window and the bottom of the window DO NOT have a sufficient gap if any to allow for movement and compression of the frame.

ALL WINDOWS with no or insufficient gaps, also as per manufacturers standards is packing to the sides and bottom of the windows as well, must be reworked to allow a recommended of at least 15mm to 20mm of packing.

The packers must be as the manufacturers specifications.

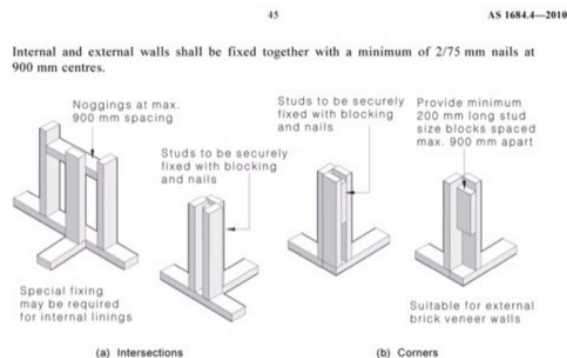
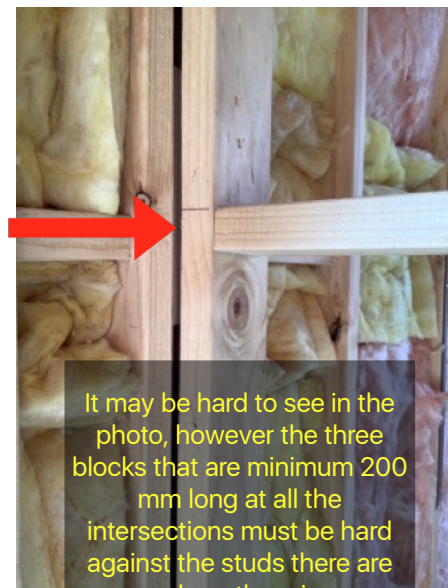
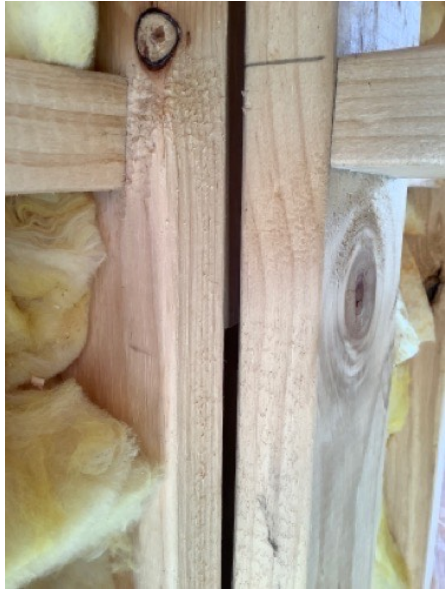
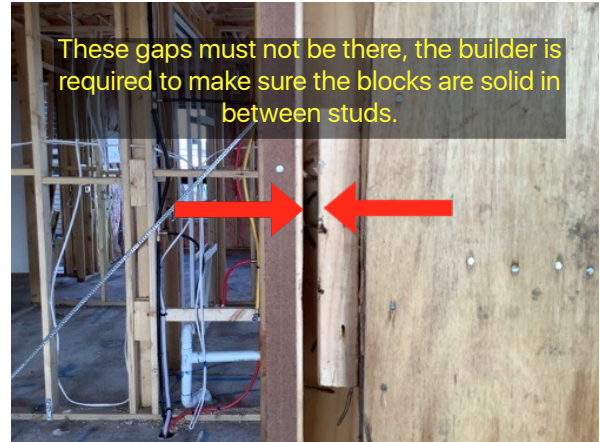
Non Compliant 2.04

Finding: Blocking at intersecting walls - insufficient / undersized
 It was observed that the blocking of intersecting walls are insufficient in the nominated locations throughout the Structure.
 The AS1684.2 indicates that three blocks are required at intersecting walls (minimum length 200mm)
 At spacings not exceeding 900mm and each stud must be fixed to the block with 2/75mm nails.
 Where wall junctions are within a deemed wet area, blocks must be installed at a maximum of 600mm centres .

In particular the standard notes that all walls must be installed with noggings at a spacing not exceeding 1350mm and wall intersections don't negate this requirement.

It may be hard to see in the photo, however the three blocks that are minimum 200 mm long at all the intersections must be hard against the studs there are areas where there is a gap between the blocks and the studs of about 15 mm

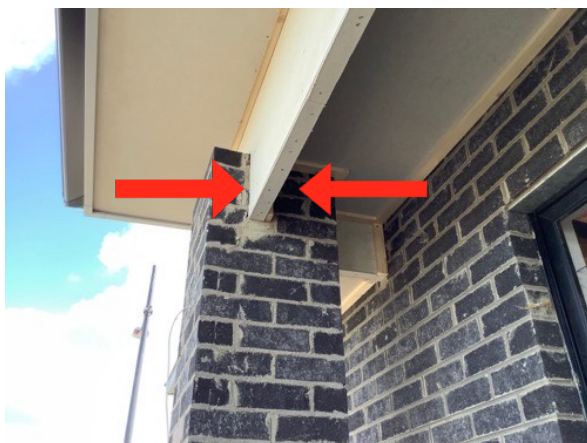
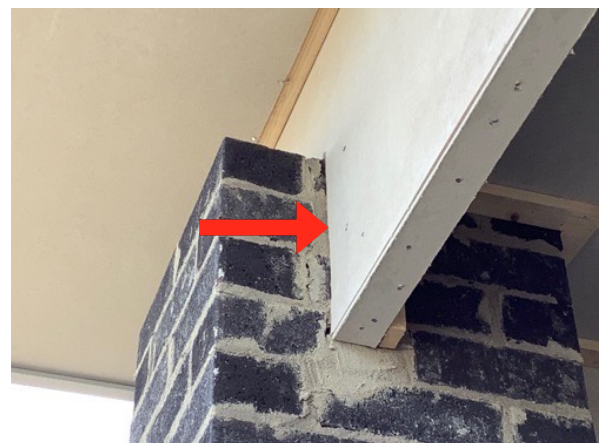
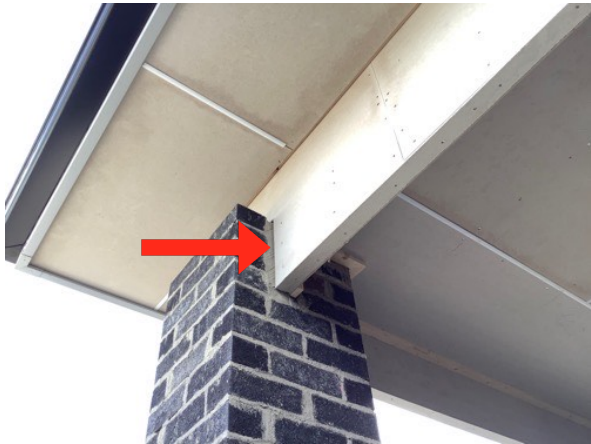
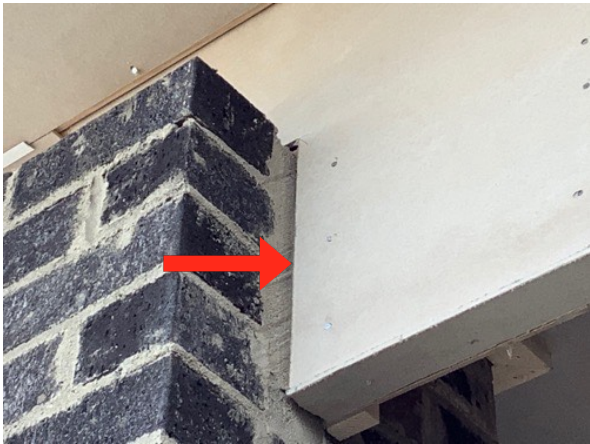
Non Compliant 2.05

Finding: No Space Between Beam And Brickwork
The brickwork had been installed hard up to the underside of the roof beams.

Part 3.3.1.10 Shrinkage Allowance for Timber Framing of the BCA requires that 'In masonry veneer walls a gap must be left between the timber frame and the top of the masonry wall, including window sills ect, to allow for settlement of the timber framing caused by timber shrinkage.

These clearances must be not less than 5mm at sills of lower and single storey windows; and 8mm at roof overhangs of single storey buildings'.

The brickwork below these beams will need to be lowered to achieve the required 8mm clearance.

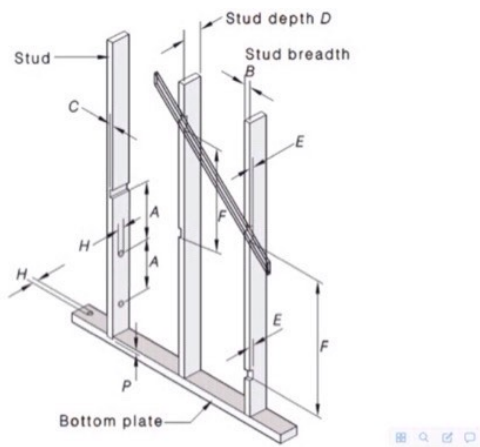
Non Compliant 2.07

Finding: Services holes and penetrations - over sized
It was observed during inspection that the diameter/size of holes and penetrations exceeded the maximum size allowable as defined in AS1684.
AS1684 states that service penetrations to studs and plates shall not exceed 25mm and shall be placed central to the breadth or width of the member.
Consultation with the building surveyor or certifier is recommended to establish the correct course of action to overcome the existing installation of services to comply with AS1684.

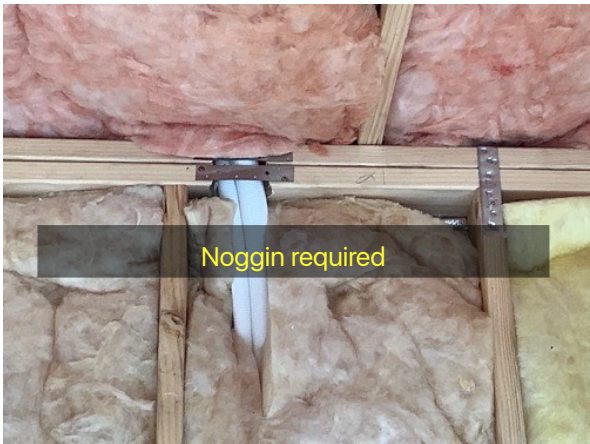
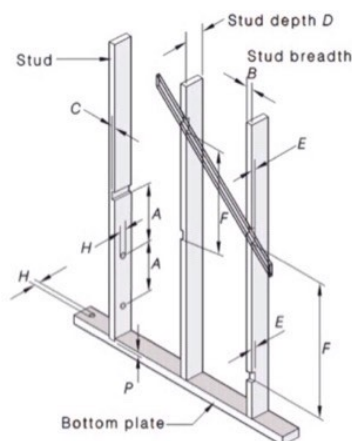
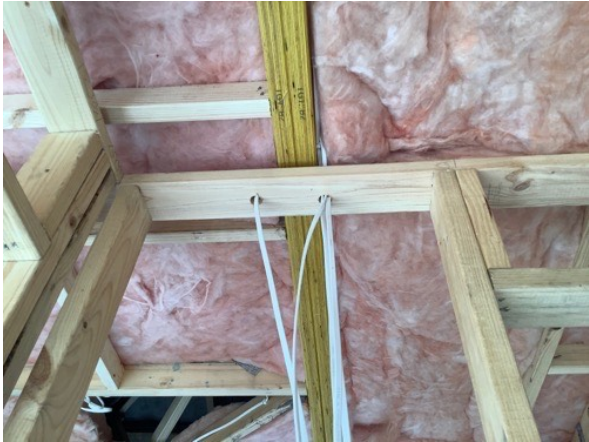
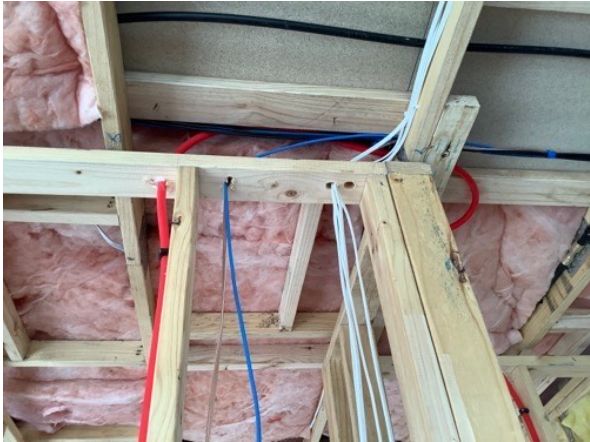
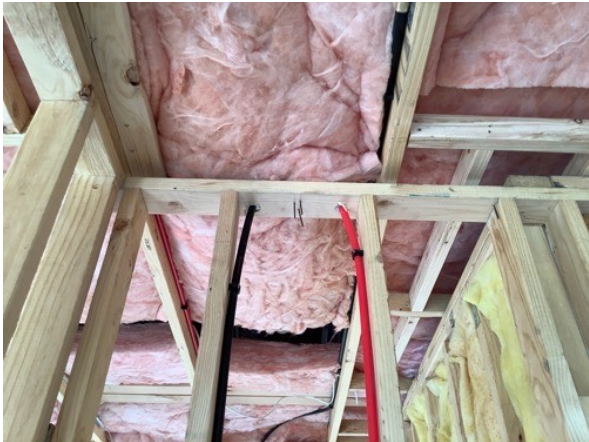
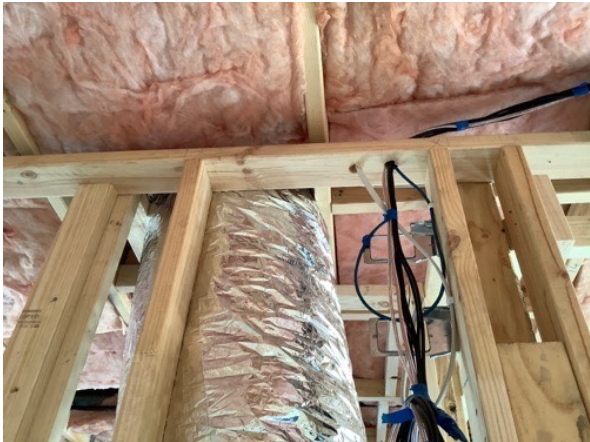
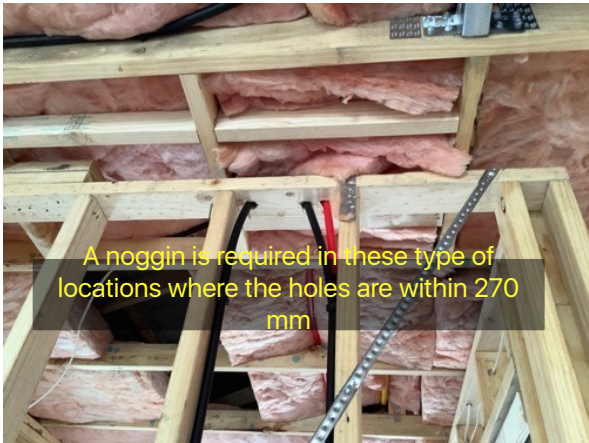
Non Compliant 2.08

Finding: Holes and notching - insufficient distance.
It was observed during inspection that the minimum distance between holes for services (electrical and / or plumbing) and notching has not been maintained. The AS1684.2 2010, Page 60 and 61 requires a minimum distance between holes and notching in a 90mm stud and top plates is 270mm apart.
The standard (table 6.1) states that the distance between holes and other holes or holes to notches in studs can be no closer than $3 \times D$. This is calculated as $3 \times$ the depth of the material used. In this case $3 \times D$ is $3 \times 90\text{mm}$ or 270mm minimum distance apart.

A noggin is required in these type of locations where the holes are within 270 mm

The timber must be replaced and the rough in reinstalled at 270mm separation or the area beside the rough in cleated to add additional support to the stud.

Consultation with the building surveyor or certifier is recommended to establish the correct course of action to overcome the existing installation of services to comply with AS1684.

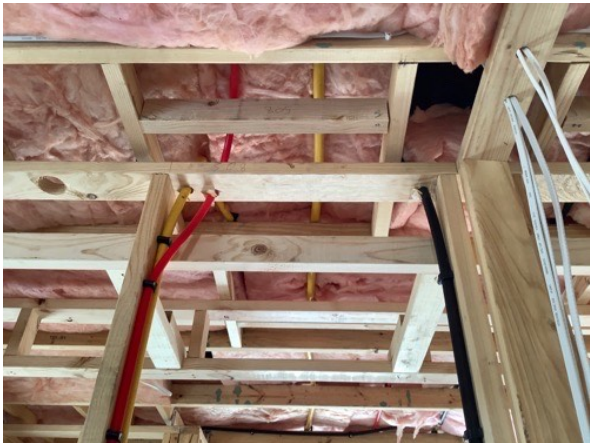
Non Compliant 2.09

(ii) Where uninsulated pipes are used, a collar of lagging material or a neutral cure silicone sealant shall be used to fill the annular space.

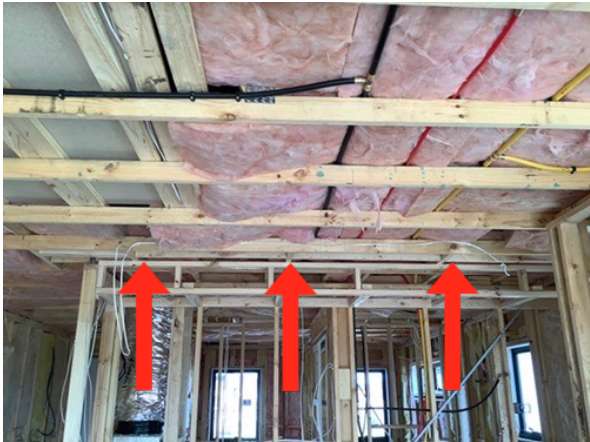
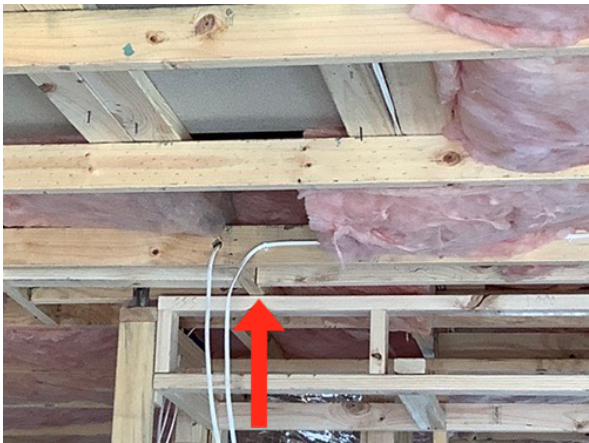
Non Compliant 2.10

Installation of Nail-plated Timber Roof Trusses, state in section 2.2.2 Non Walls, that ‘Non load-bearing walls, as designated, shall not carry any tru shall not be packed to touch the underside of trusses (see Figure 2.1)’.

Non-loadbearing walls shall be kept a minimum of 10 mm below the underside of the bottom chord, or ceiling battens when used. Trusses shall be fixed to internal non-loadbearing walls as shown in Figure 6.11, or as required for bracing (see Clause 8.3.6.9).

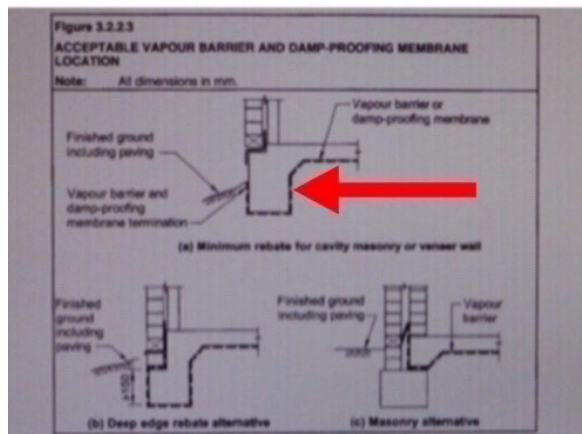
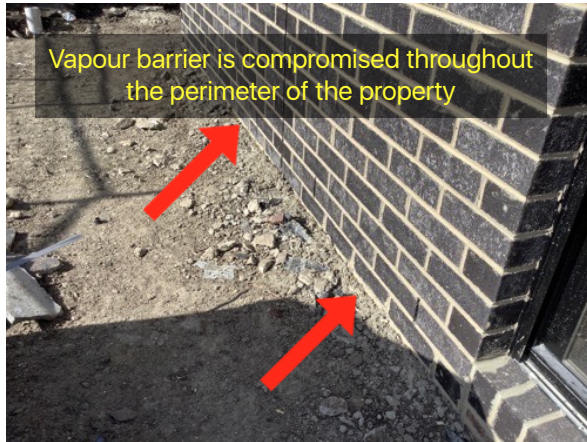
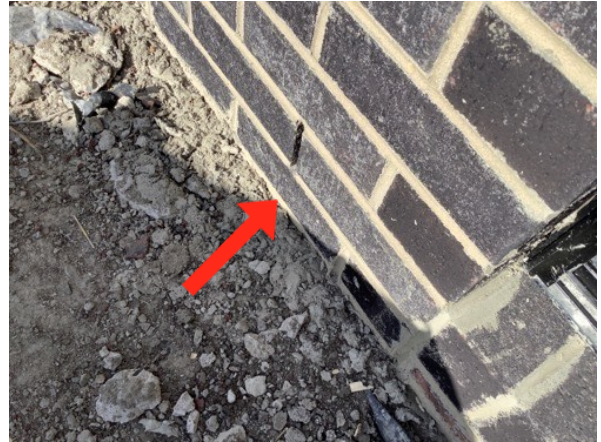
Non Compliant 2.11

Finding: Vapour barrier - Defective (AS2870- 2011)
 I HIGHLY RECOMMEND that the builders dig the entire perimeter carefully, without damaging the plastic and extends the vapour barrier plastic 600mm as it was in the slab inspection statement.
 The over lap must be a minimum of 200mm and the correct tape must be used and sealed both sides 100%.

It is a requirement of AS 2870-2011 5.3.3.4 that vapour barriers are turned up and terminated at ground level above pavement adjacent footing. The vapour barrier is defective if building materials and fill has been left on top of the membrane, as this prevents it from being pulled up against the slab when installing perimeter paving as it is intended to be.

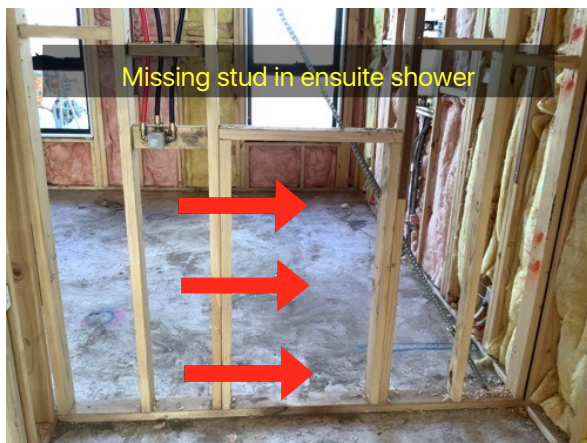
Non Compliant 2.12

Finding: Shower stud width NOT Acceptable.
The shower recess requires additional studs to be added to comply with the requirements of the BCA and the framing standard.
Although some building elements may seem irrelevant or unnecessary, all building elements play a key role in the operation and function of the overall structure and its performance. This wall or common studs need to be placed at centres no greater than 30cm and noggins must be spaced between at the same line as the rest of the dwelling no greater than 180mm off set.
Replacement of any missing building element should be conducted as soon as possible to ensure that no damage or functional issues occur to associated building materials.

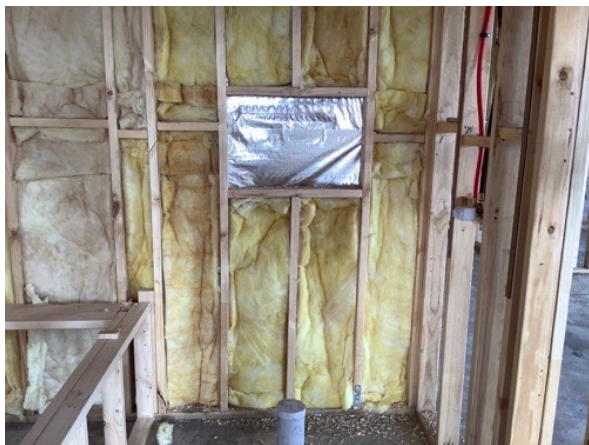
Finding: Shower Stud Width Acceptable In The Main Bathroom
Additional photos are provided for your general reference.

Upon inspection of the shower areas, it appears that the stud width installation is at 300mm centres which is suspected to be adequate for shower areas as per BCA and the framing standard.
