Specific Flooring Report-Warranty Dispute Due To Faulty & Incomplete Workmanship.

Inspection Date: 30 Jul 2020

Property Address: Western Area

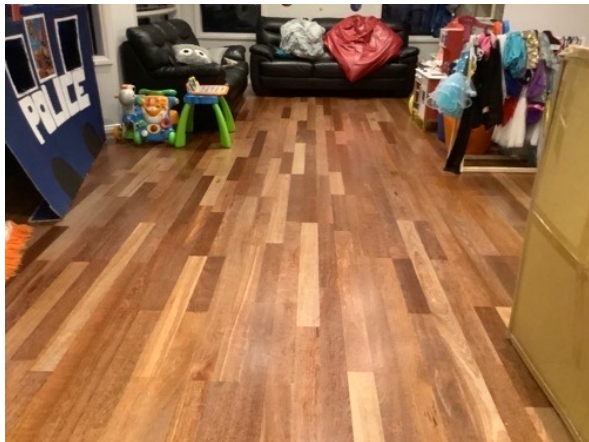
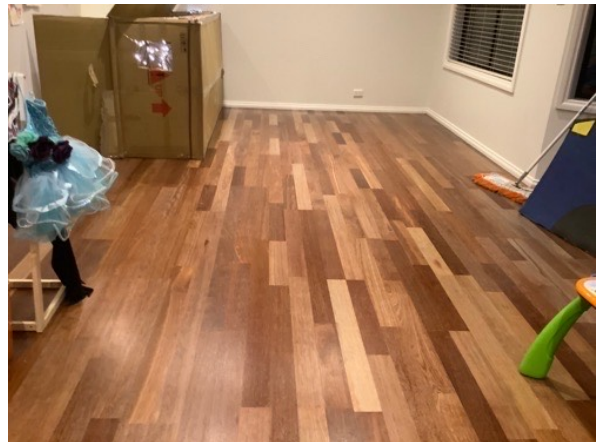
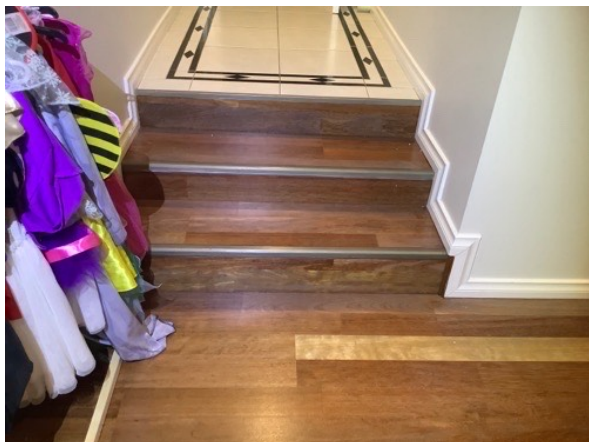
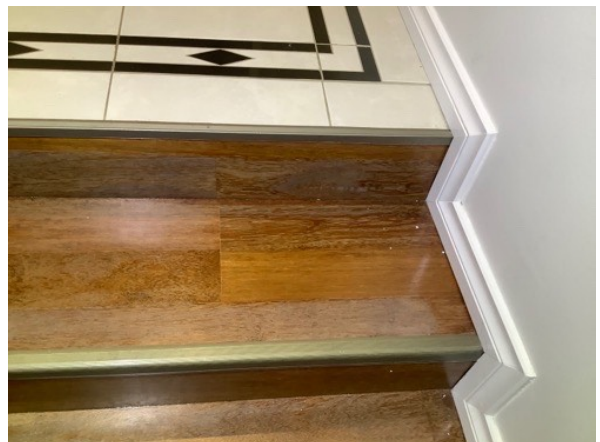
Observation 4.03

Finding: Rumpus Room
Site photos of rumpus room

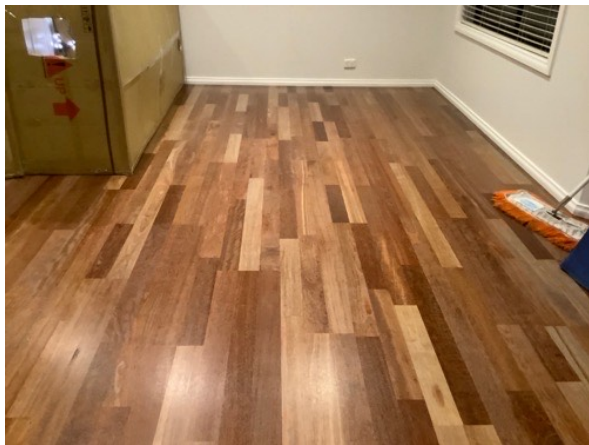
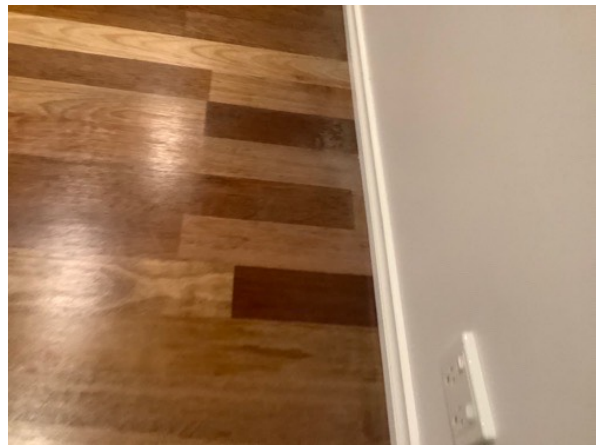
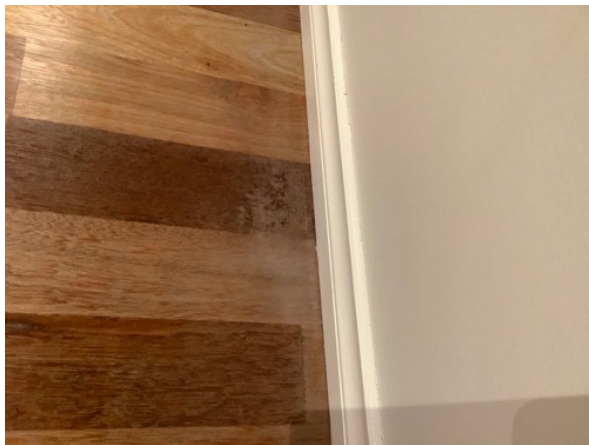
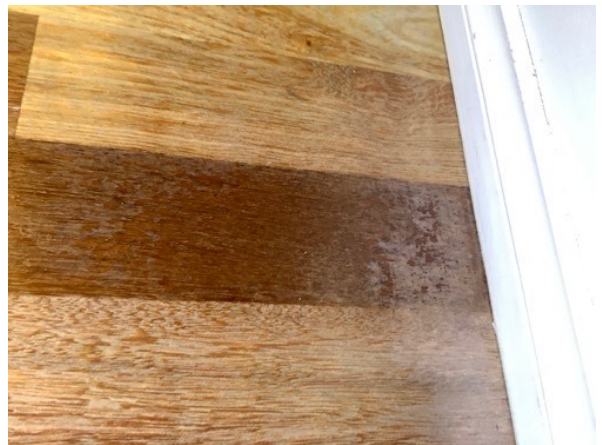
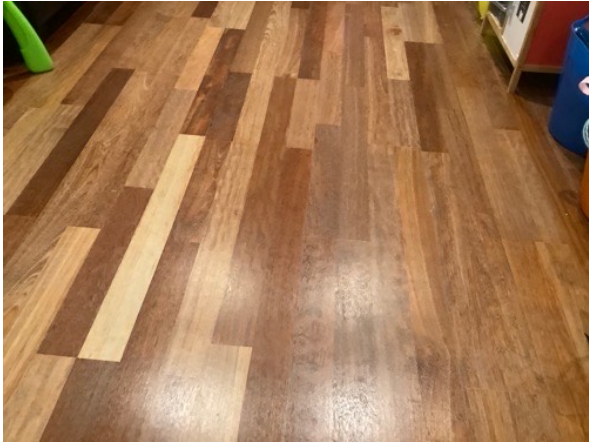
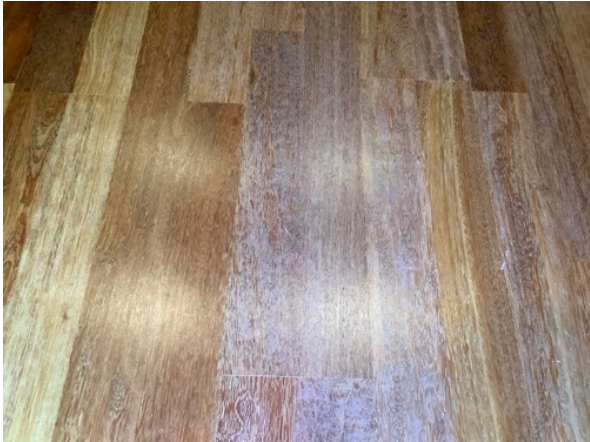
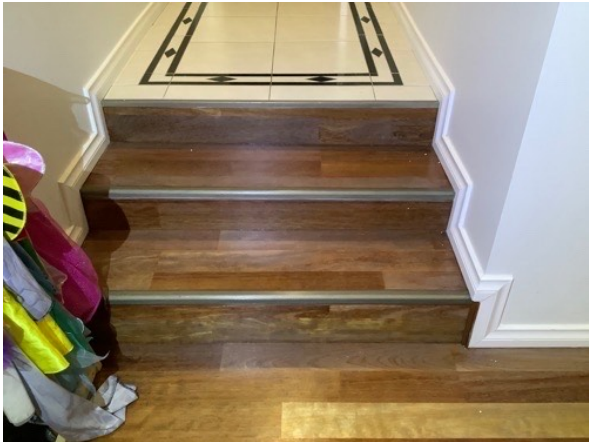
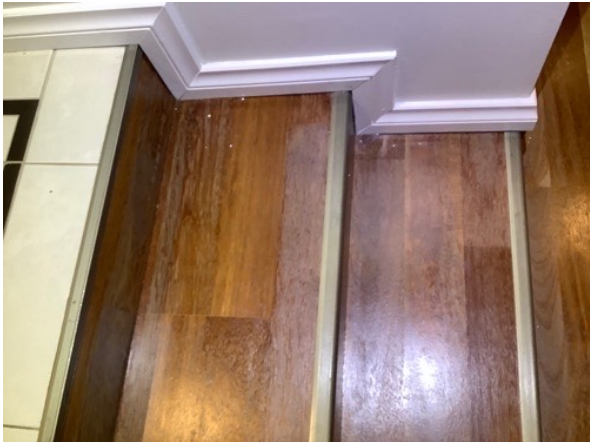
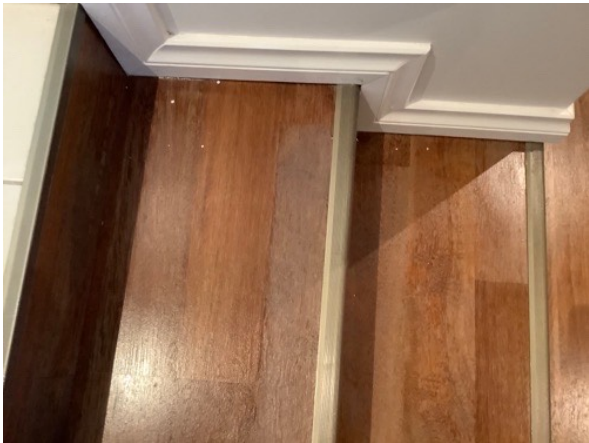
Observation 4.04

Finding: Defective workmanship to flooring.

The floating flooring or also known as engineered flooring has been sanded in the rumpus room, this product is not a product that is designed to be sanded.

The flooring once sanded has had coats of a clear lacquer product and it is now obvious that the product is compromised and damaged. The contractor should have contacted the manufacturer prior to attempting to sand this product.

This job clearly demonstrates this is not the case.

Unfortunately in relation to the rumpus room, the only method of repair I see is replacement.

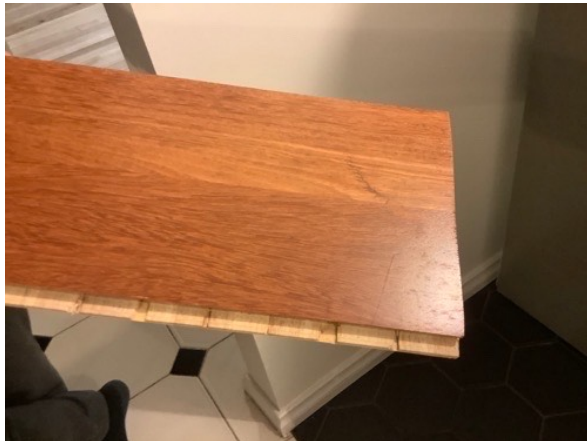
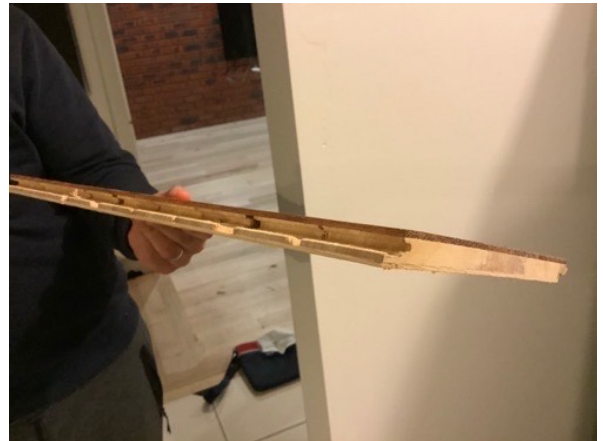
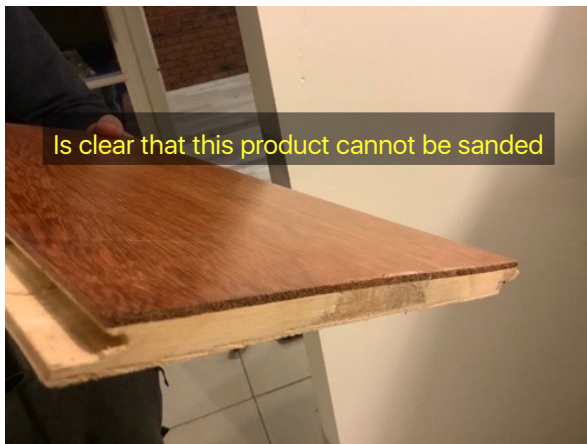
Observation 4.05

Finding: Evidence of original piece

The client happened to have an original piece of product that is in the rumpus room. This product is an older type product that is not designed to be re-sanded. It is manufactured by the company and is designed to be installed as it is and is not a product that can be sanded and re-lacquered at any later stage.

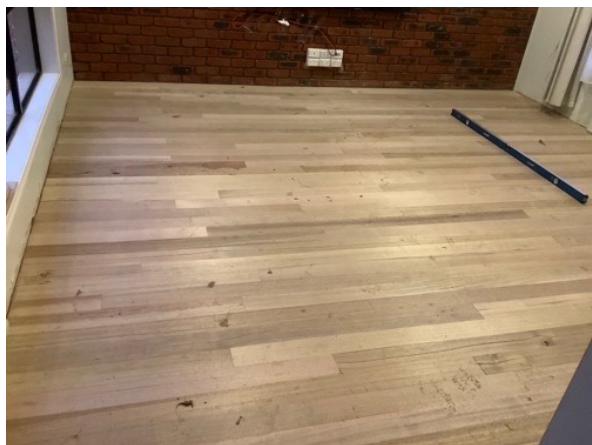
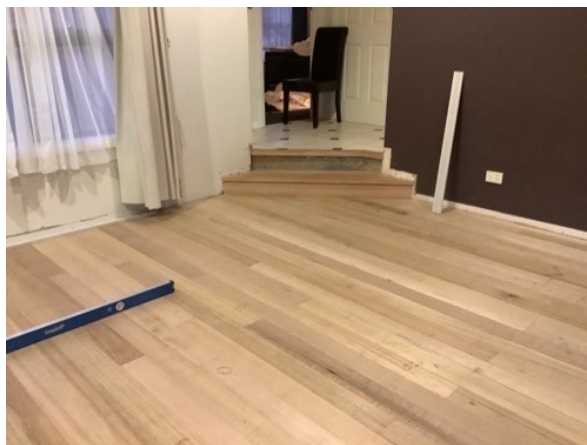
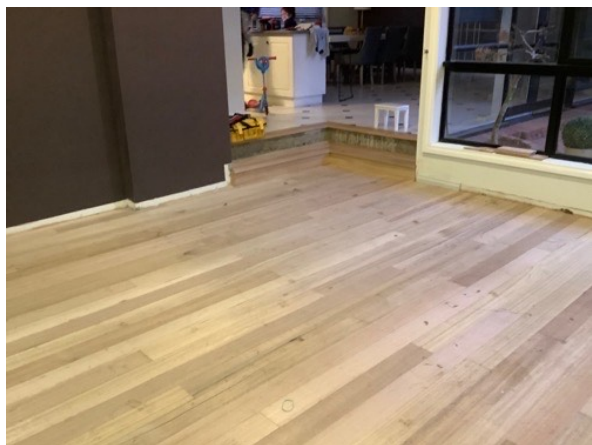
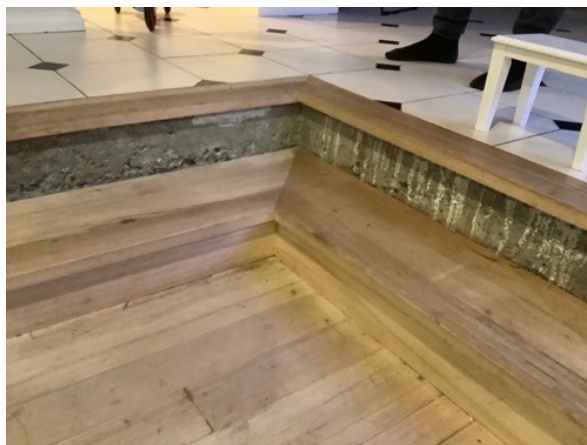
Observation 4.06

Finding: Lounge room

These photos are just to demonstrate the lounge room area in it's incomplete state.

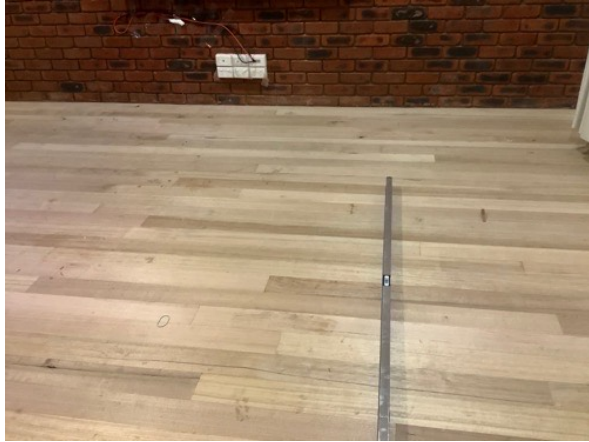
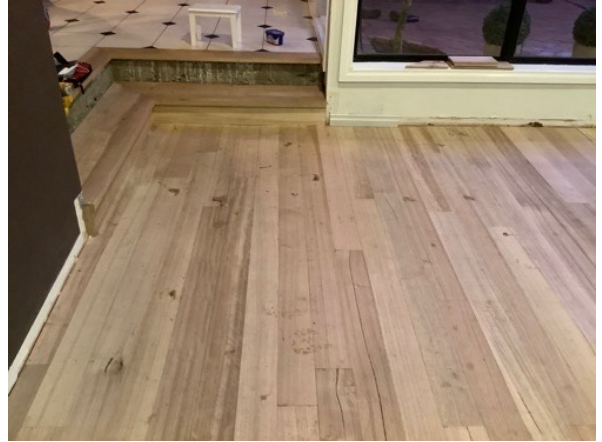
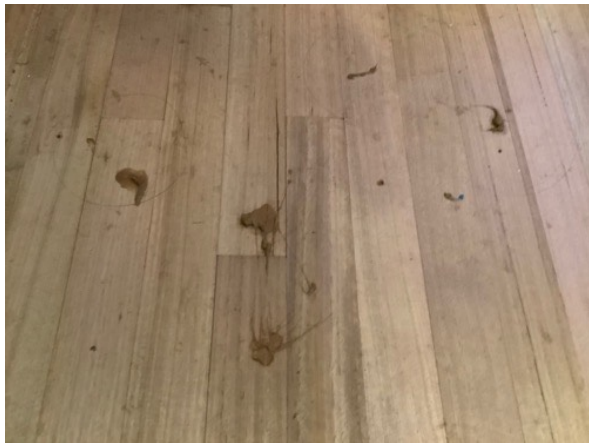
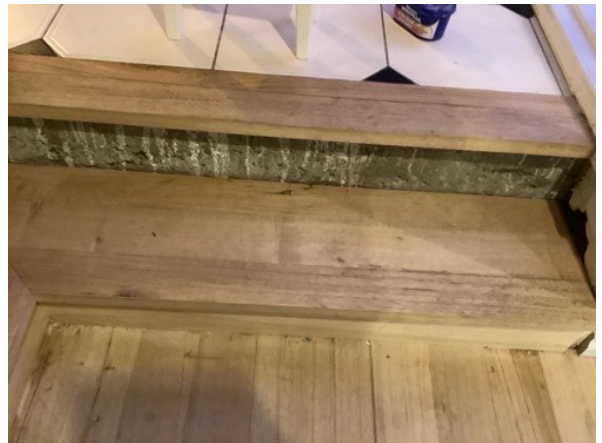
Observation 4.07

Finding: Floors not sanded

At the time of the inspection these photos are just to demonstrate that the flooring is not complete. It is clear that the flooring has not been sanded and lacquered.

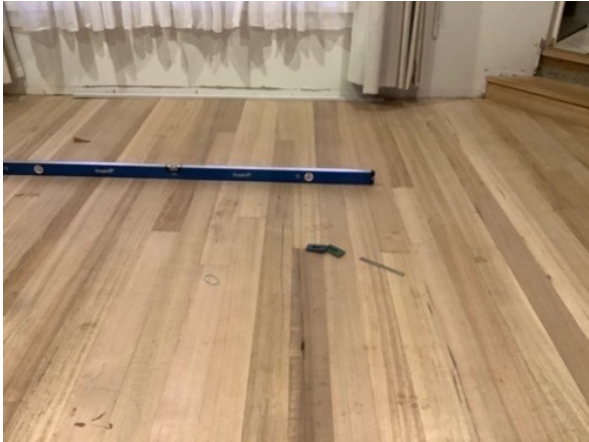
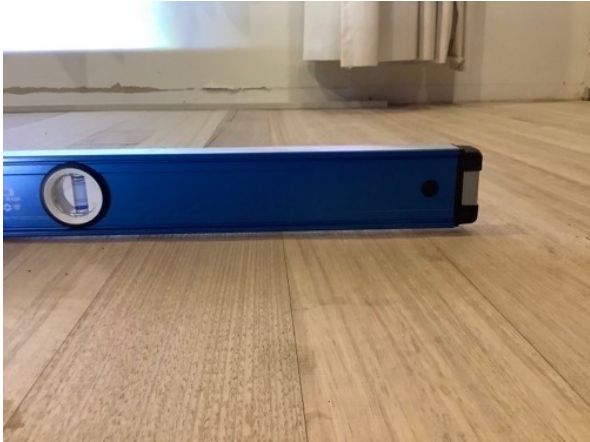
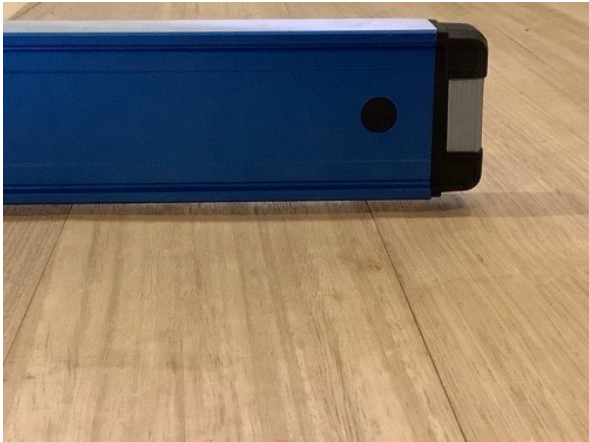
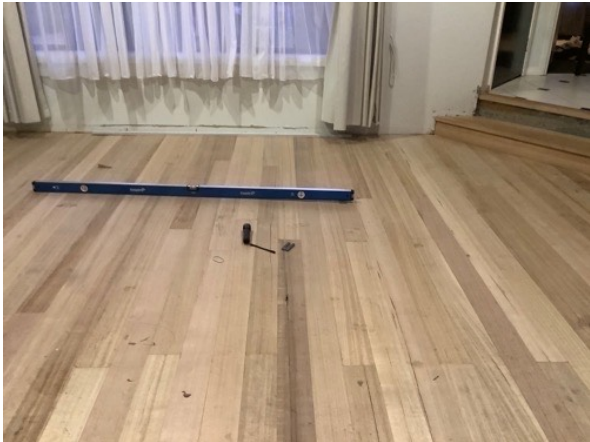
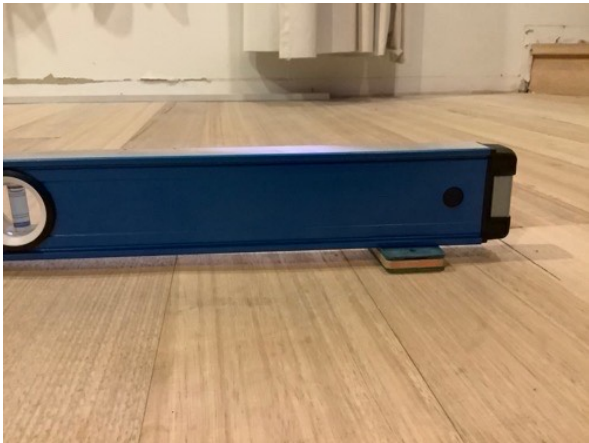
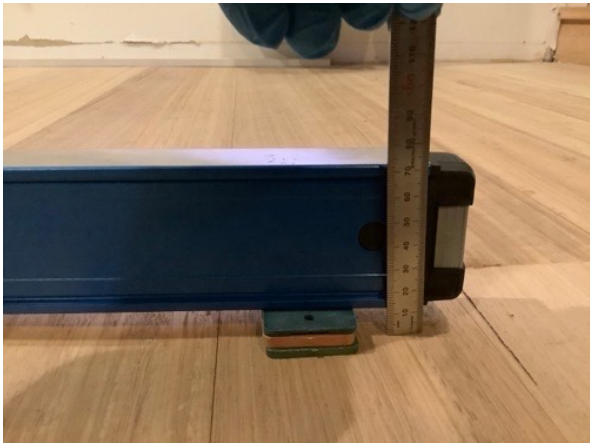
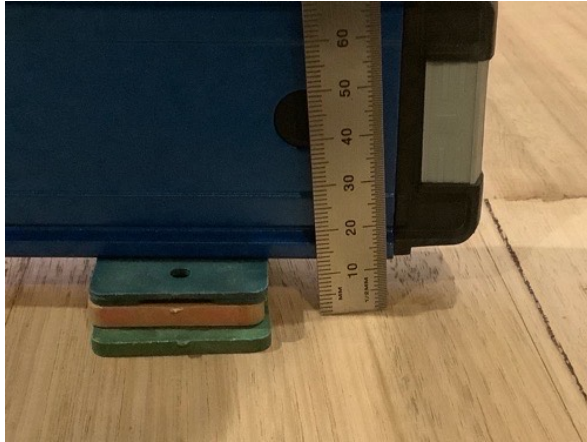
Observation 4.08

Finding: Flooring - Uneven

The photos clearly demonstrate that the flooring is out of level. Once a contractor takes ownership of a job, the job must be completed to the Australian standards.

The photos will demonstrate that the floor levels ARE NOT within Guide To Standards And Tolerances 2015, Footings, Slabs And Setting Out, 2.08 and Australian Standards (AS 1684)

When flooring begins out of level, the concrete flooring may create ongoing secondary problems and become visually unappealing.

The overall deviation of floor level (concrete slab) to the entire building footprint shall not exceed 20 mm or not more than 4 mm in any 2 metre length., as per the 'Guide to Standards and Tolerances' Section 2.08 and AS 1684.

Except where documented otherwise, new floors are defective if within the first 24 months of handover they differ in level by more than 10 mm in any room or area, or more than 4 mm in any 2 m length. The overall deviation of floor level to the entire building footprint shall not exceed 20 mm. Refer to Item I of this Guide where the new floor is to abut an existing floor.

This job clearly demonstrates this is not the case.

Prior to the flooring being installed, the professional process is to sand the high areas of concrete and fill the lower areas of concrete with a self levelling compound so that the flooring is level prior to the installation of the timber flooring.

The builder is required to check all levels on site to the concrete floor and commence all remedial works to the slab before the final floors such as tiles, engineered flooring, timber flooring, etc.

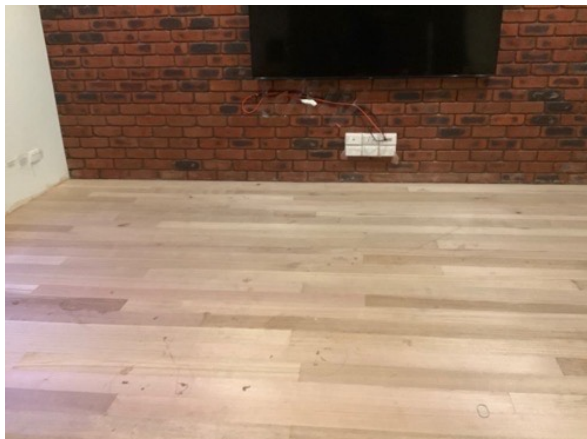
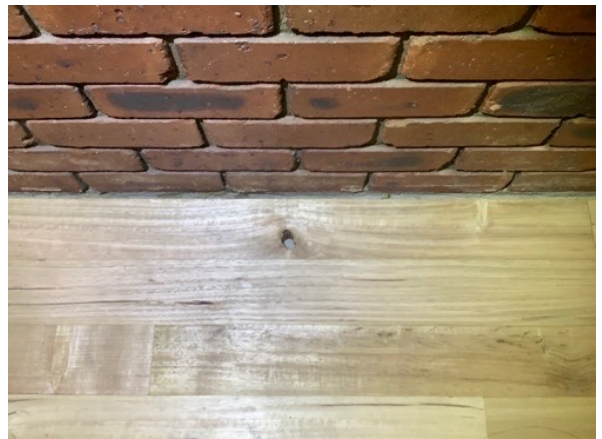
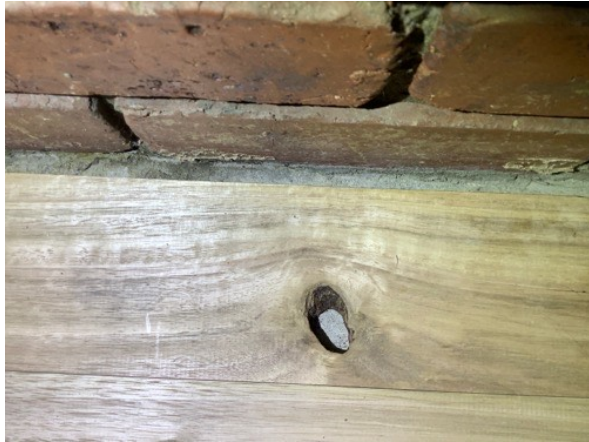
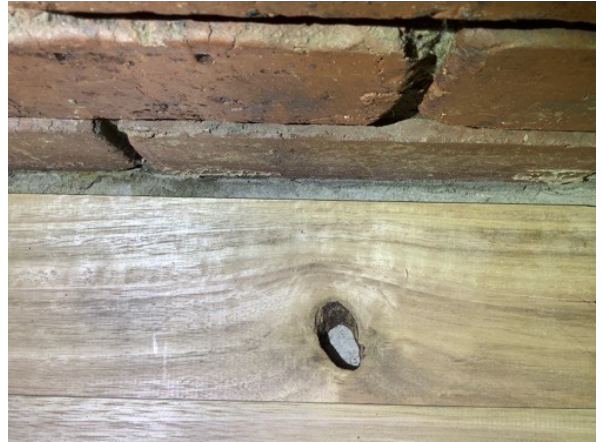
Observation 4.09

Finding: No waterproofing

It is clear that no waterproofing has been installed to this installation. This method of installation, meaning glueing timber straight to concrete is certainly extremely rare to see as there are so many superior installation methods of installing real timber flooring. However in saying this, if the contractor decides to use this method, it is imperative without compromise that the contractor installs the product as per the manufacturers specifications of the glue. Normally glue installations require the concrete flooring to be sealed to stop moisture. It is clear that this floor has not been sealed.

My client has asked the contractor for the glue product but has not been able to get an answer. If the flooring has not been installed by the manufacturers specifications the warranty is totally void and in my professional experience of over 30 years I have never seen a glue that glues timber direct to concrete, that does not require the concrete to be sealed.

This job clearly demonstrates this is not the case.

Unfortunately in relation to the lounge room being incomplete and the method of installation used I do not see any other way other than to completely take out the works to date by the other contractor and in saying this the likelihood of re-using the timber is very slim to impossible.

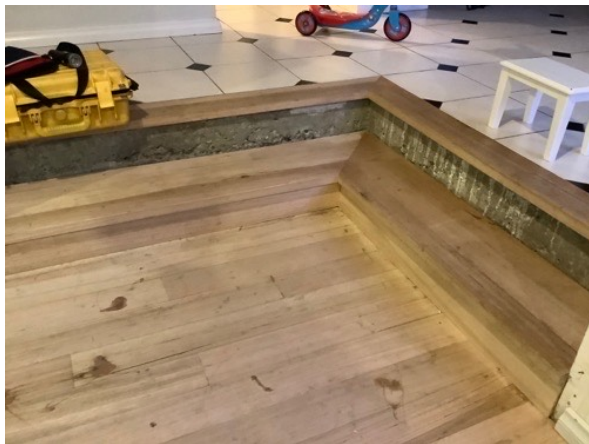
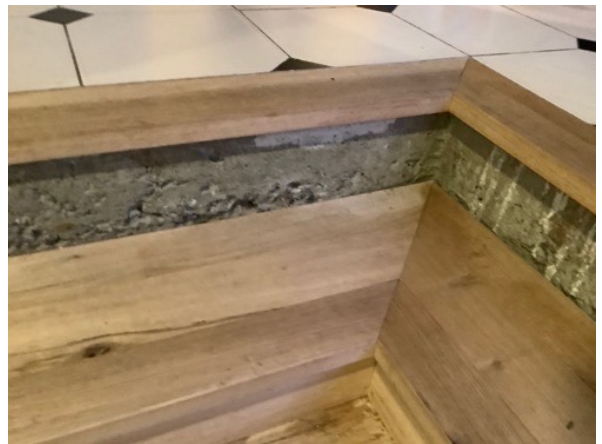
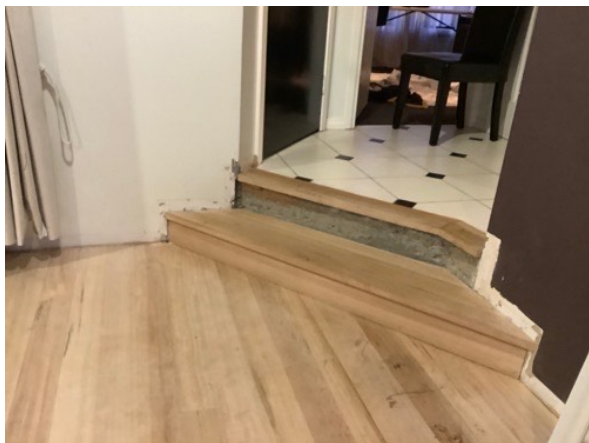
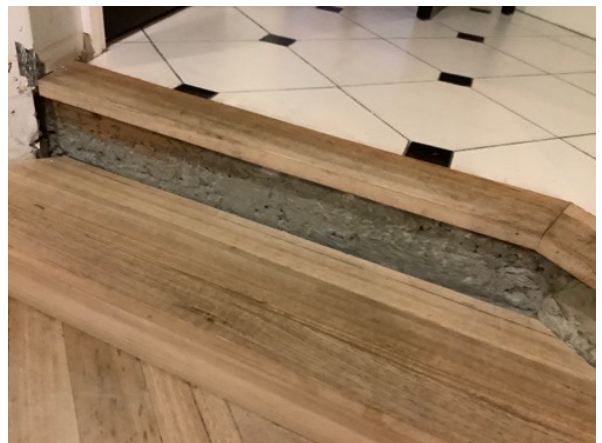
Observation 4.10

Finding: Incomplete works

These photos are just to demonstrate that the job is not complete. The timber has not all been installed and the floor has not been sanded and lacquered.

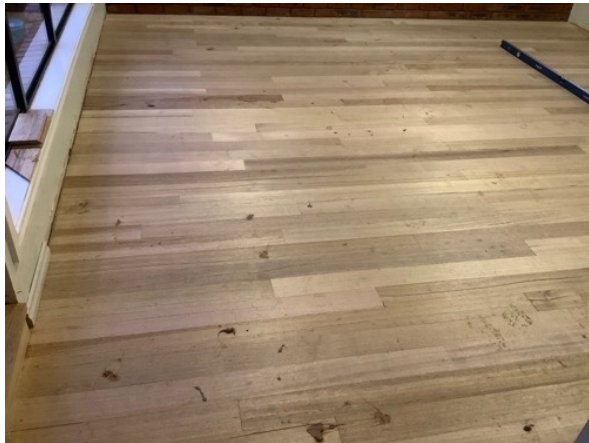
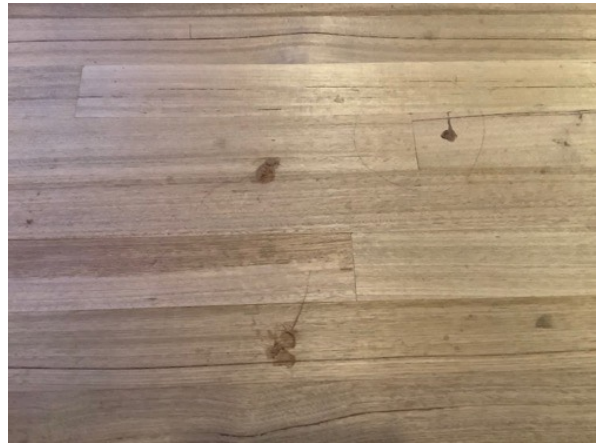
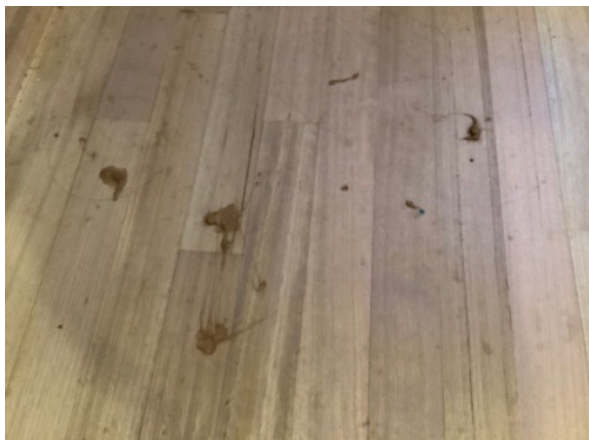
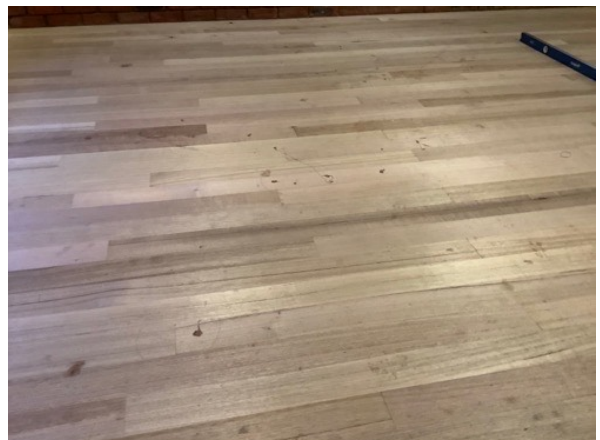
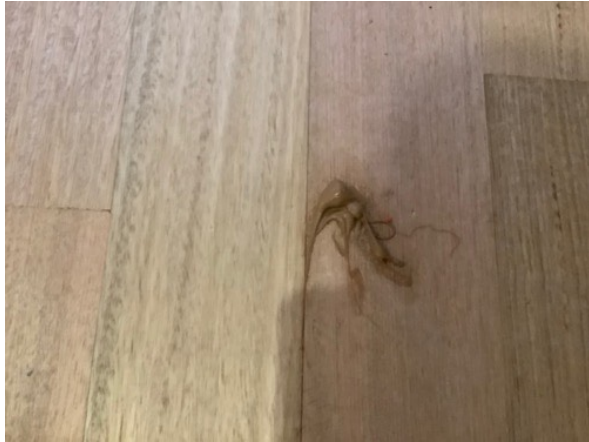
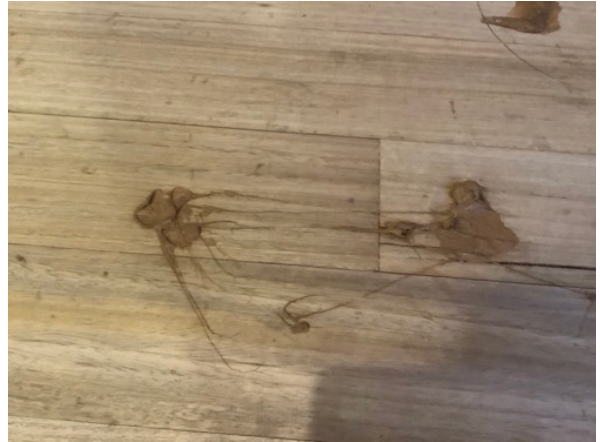
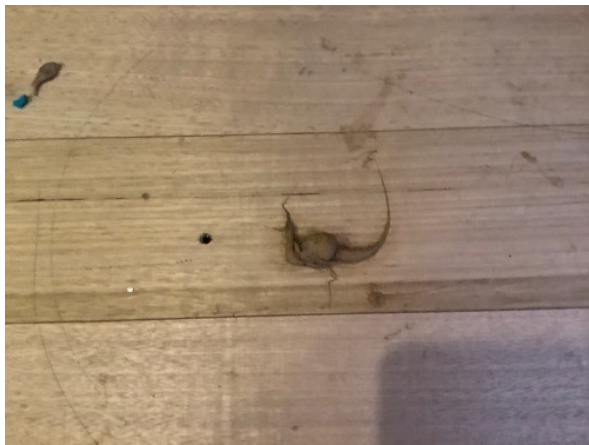
Observation 4.11

Finding: Timber has been drilled

The timber has been drilled and filled with glue to rectify the inconsistency in the floor levels. This method of works is absolutely not within the Australian standards. Also the timber flooring is a brand-new product and the contractor must install the product and complete the job with the end result showing that the product is brand-new. The contractor has taken it upon himself to drill holes in the timber which has clearly now damaged the face of the timber and the timber is now not installed as a product that is in as new condition.

Whilst the levels of the flooring is in another defect statement, I would like to note that if the flooring was level prior to installation of the timber the contractor would not have needed to drill any holes in the timber.

This job clearly demonstrates this is not the case.
