Year-1890 Old Mansion, Building & Termite, Timber Pest

Inspection Date: 27 Jul 2020

Property Address: Ascot Vale Area

Report Type: Property and Timber Pest Report

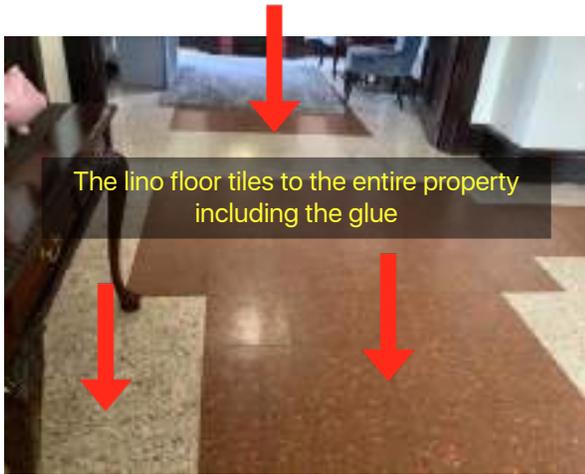
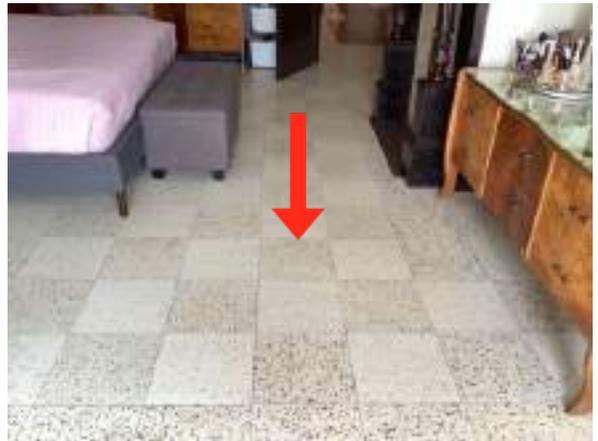
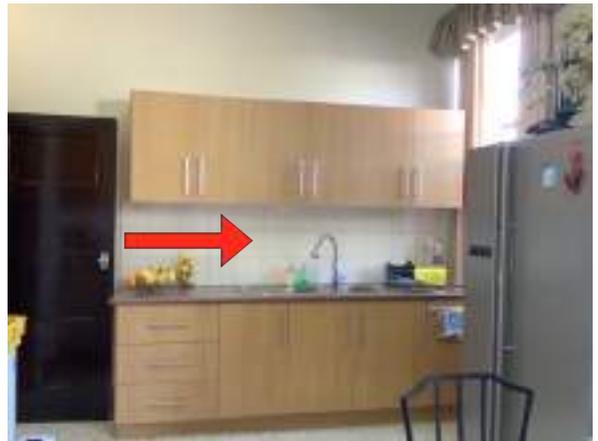
Serious Safety Hazard 1.02

Asbestos can be in the old wardrobes and cupboard areas, asbestos can be in the flu systems of the old hot water services or heater flu systems. Asbestos can be on the walls or ceilings. Asbestos can be in the eaves in the older homes and the exterior walls of the older homes. Asbestos can be found in the roof space areas in the floor space areas and in the old sheds.

Reporting on Asbestos is outside the Scope of this Report. This suspected defect is highlighted as a caution ONLY and is ONLY a guide as asbestos inspections are outside the scope of pre-purchase inspection and reports.

As Asbestos Reporting is outside the scope of this report, we advise that you consider a separate Asbestos Inspection and Condition Audit, which can include the taking of samples for definitive confirmation of the presence of Asbestos.

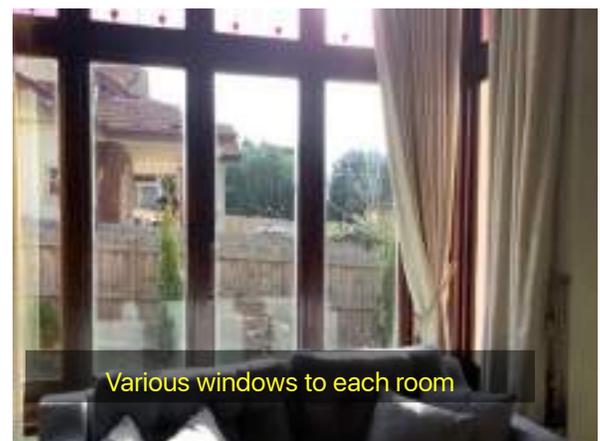
Serious Safety Hazard 1.06

Several windows throughout the property were jammed and difficult to operate at the time of the inspection. Windows provide ventilation to the adjoining area and should be at a fully operational level to ensure user comfort. Restricted function of the window may also pose as a potential safety hazard if required for emergency egress from the building.

Generally, factors such as general age of the building element and a lack of maintenance are the usual causes for this type of defect.

The windows may have several causes, ranging from minor defects as outlined above through to major structural issues, such as damage and/or subsidence (sinking) to subfloor structures.

For minor causes of repair, replacement where window hardware or frame may be required, as well as minor repairs and cleaning a carpenter, registered builder, window specialist/ company or general handy person will be required to repair the affected windows.

Windows MUST function as a safety requirement and we HIGHLY RECOMMEND that you engage an appropriate professional as soon as possible to check all windows to the property.

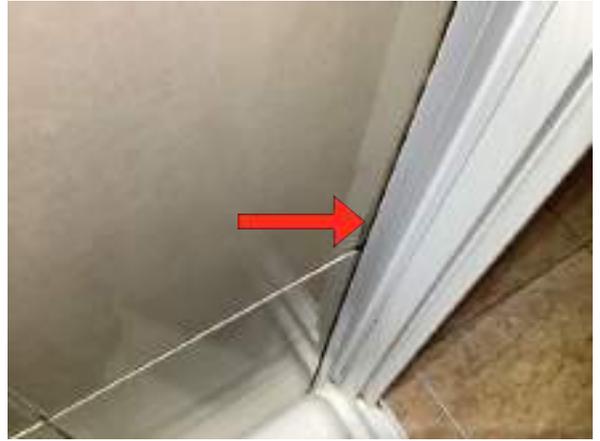
Serious Safety Hazard 1.07

Location: Bathroom

Mould in caulking or silicone is generally caused by faulty and/or damaged caulking or silicone as the moisture and water ingresses into the caulking or silicone.

The caulking or silicone must be replaced and the areas are cleaned and new caulking or silicone applied.

Generally, the client is advised to ensure that the general environment is free of moisture and humidity to aid in the prevention of mould formation and development. Any mould found during the inspection should be cleaned immediately and/or taken out, particularly where the mould is in the silicon / caulking.

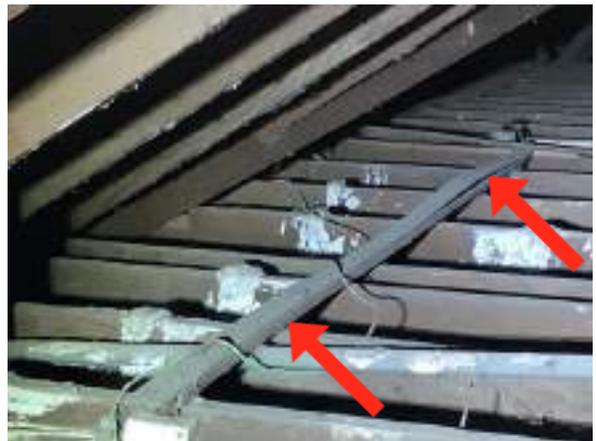
Serious Safety Hazard 1.08

Location: Roof Space

At the time of the inspection we noted that electrical installation items are not compliant with the electrical regulations AS3000-2007 and each picture attached is an electrical installation defect.

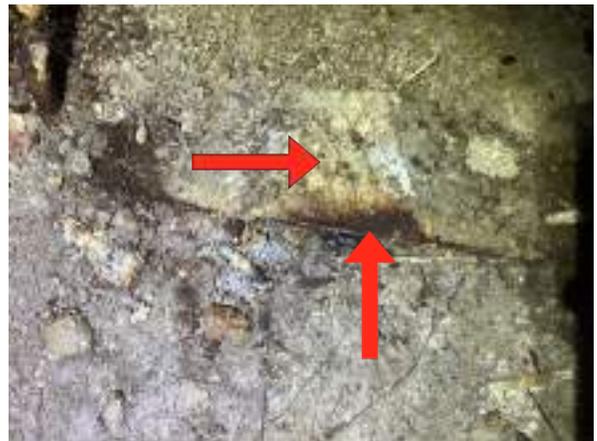
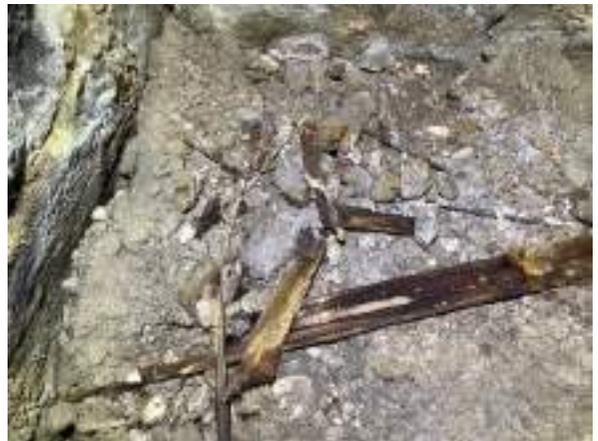
Serious Safety Hazard 1.12

Location: Subfloor

Finally the cause or source of the mould **MUST BE TAKEN CARE OF URGENTLY.**

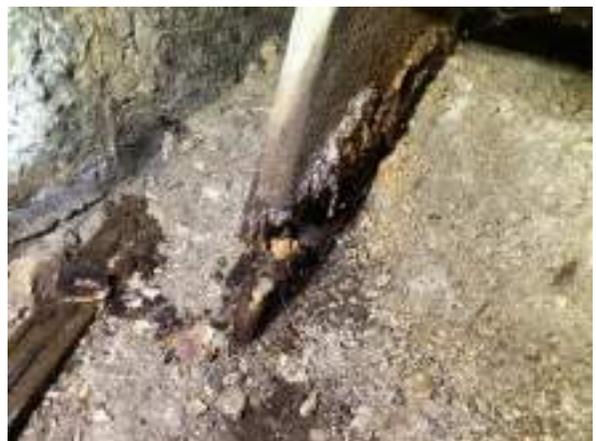
Serious Safety Hazard 1.13

Location: Subfloor

This building element shows evidence of wood rot. Wood rot, also known as Fungal Decay, occurs when timbers and other cellulose building materials are exposed to damp conditions on an ongoing basis. This could be the result of exposure to weathering over a prolonged period of time, or the attraction of excessive moisture from other abutting building materials. Contributing factors also include poor air ventilation in the area.

Wood rot is often associated with general damp problems and is evidenced by a `musty` smell or mould and mildew occurring on surfaces. If left unmanaged, damp conditions can lead to further health problems and the decay of timbers will continue.

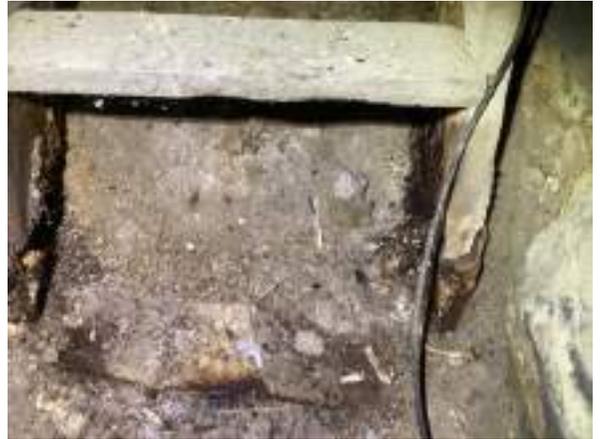
Major Defect 2.16

Location: Subfloor

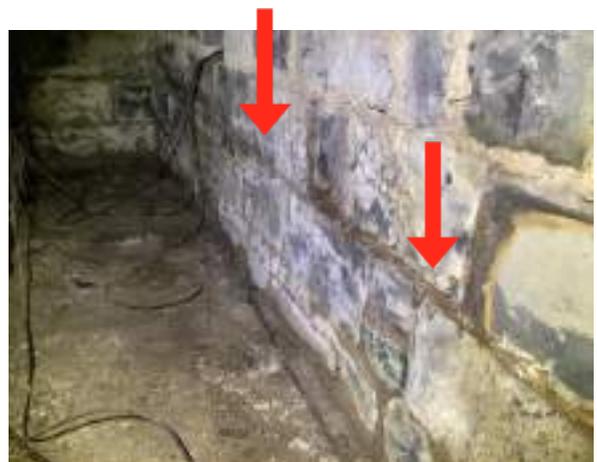
Major Defect 2.17

Location: Subfloor

Consultation with a PLUMBER, BUILDER AND OR STRUCTURAL ENGINEER AND SOMETIMES A GEOTECHNICAL ENGINEER, and also more then likely a structural engineer is advised immediately to identify the cause of the damp and perform remedial works as required.

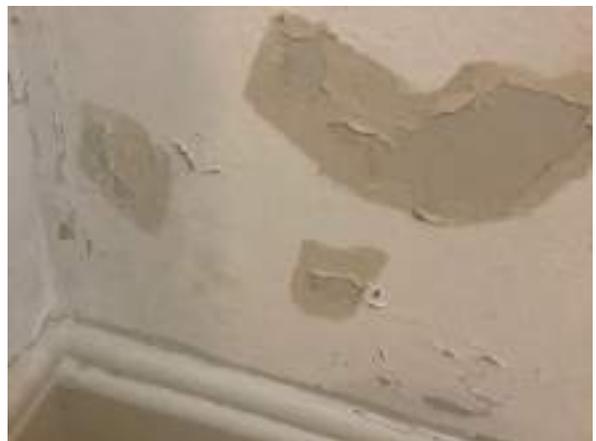
Minor Defect 3.23

The presence of excessive moisture can have major implications on associated building elements if left unattended. While only seemingly minor at this stage, the damage cannot be determined due to the paint obstructing any further inspection of the damage.

It is highly advised that the affected paint be cleaned to allow a further, more invasive inspection by a licensed plumber. Failure to act on this defect may necessitate major works in the future.

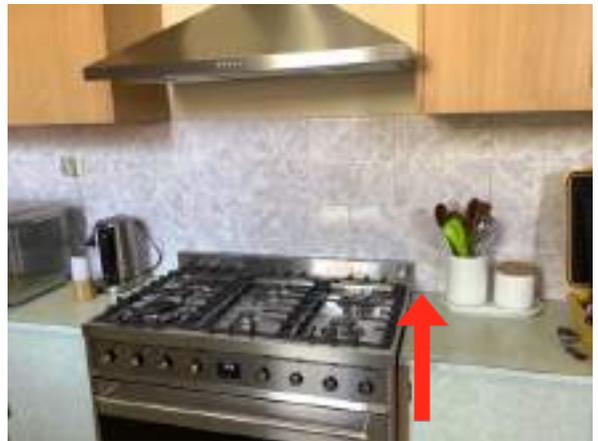
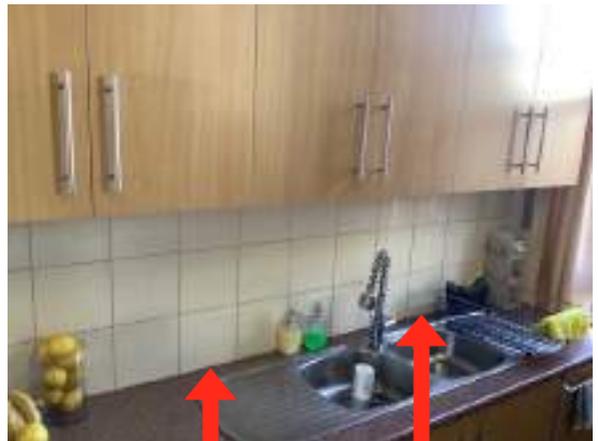
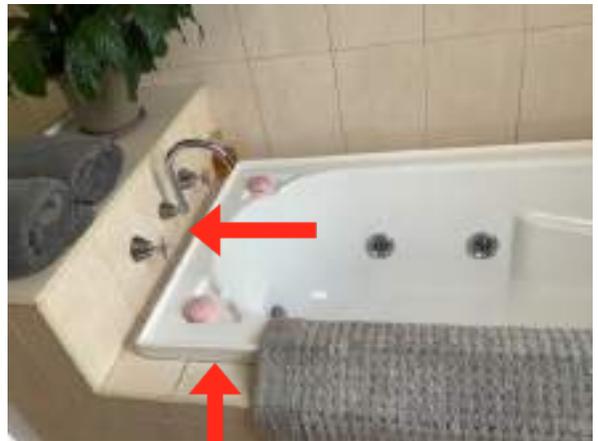
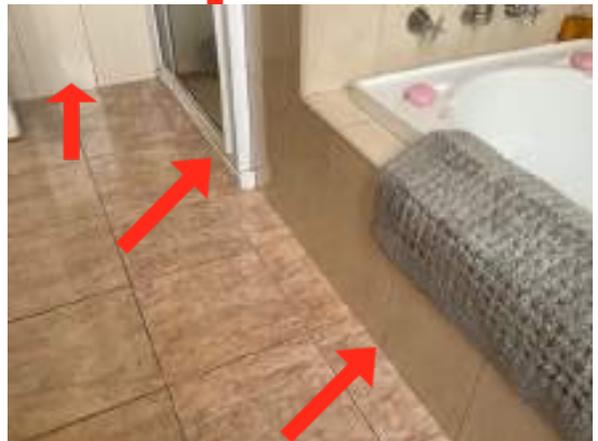
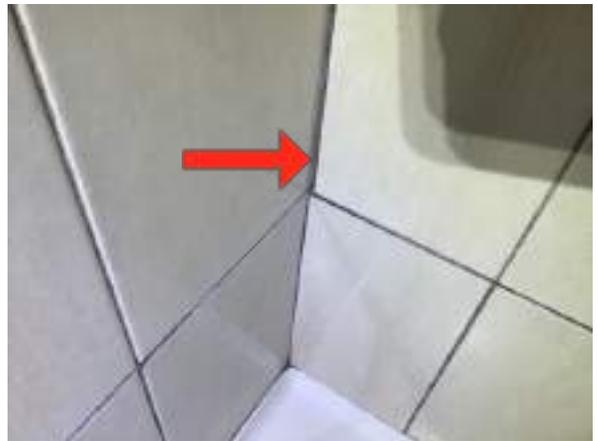
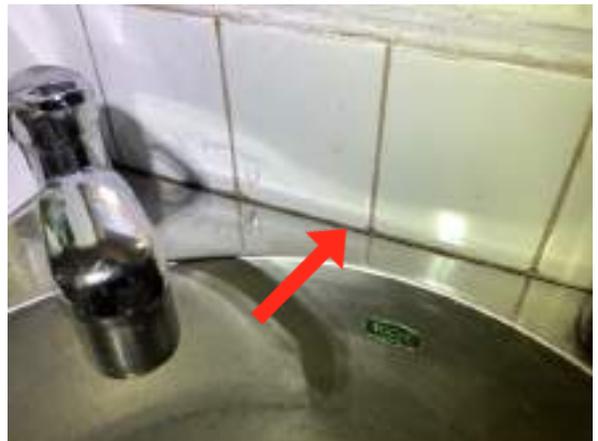
Minor Defect 3.25

Location: Caulking / Silicone-All Wet Areas

A sealant specialist, tiling contractor and/or registered builder should be appointed to assess any damage caused by water to the entire internal, sub-floor, walls etc of the building and clean, take off old sealant and tile mortar, then re-seal and re-mortar these works as soon as possible.

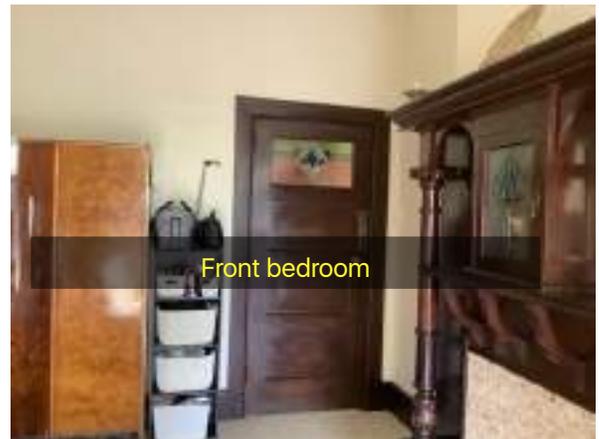
Minor Defect 3.26

Location: Cabinetry / Wardrobe Doors Internal Areas

For minor causes, a qualified carpenter or general handyperson should be appointed to perform minor rectification works at client discretion.

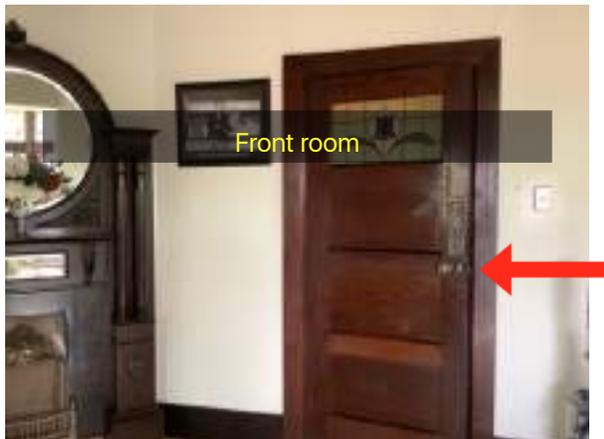
Minor Defect 3.28

If left unattended, further functional impairment is likely to occur.

A qualified carpenter or general handyperson may be appointed to perform rectification works as necessary, at client discretion.

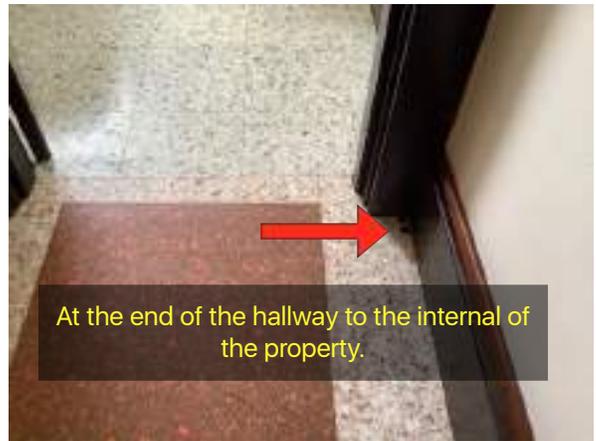
Minor Defect 3.34

Location: Perimeter Of Building - Exterior

An external hole was located at the time of inspection. This hole appears to be large enough to allow bird, rodent or other pest ingress creating the potential for nesting or infestation of live animals.

To ensure no such infestation occurs this hole should be adequately covered. Holes such as these are also likely to attract rain penetration which may lead to subsequent water damage to associated structures if left unmanaged.

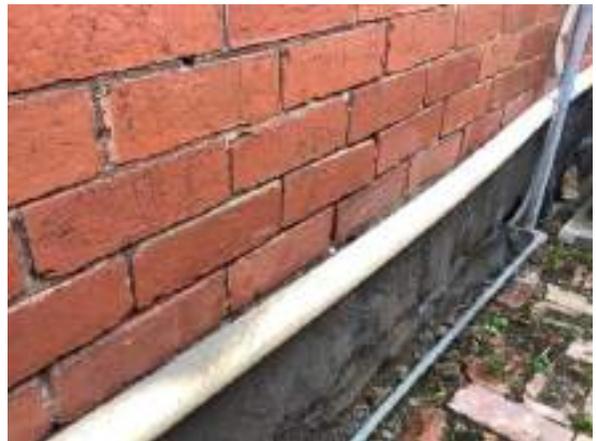
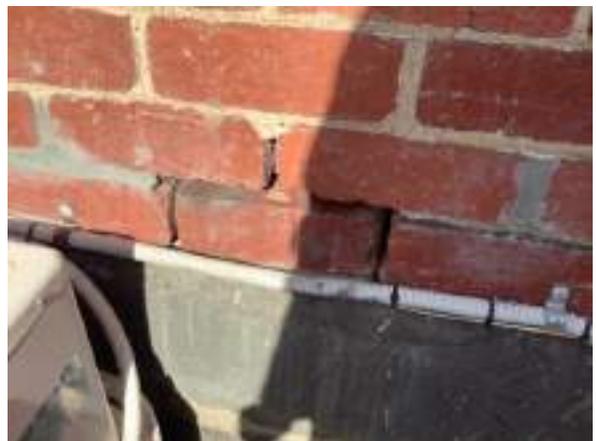
Minor Defect 3.35

Location: Brickwork

Where secondary structural defects have become evident, consultation with a structural engineer may be required.

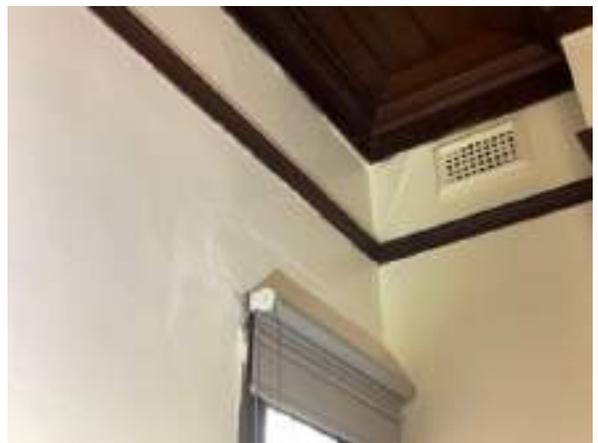
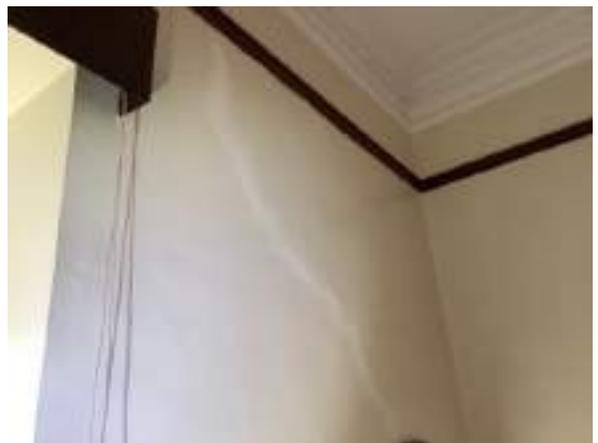
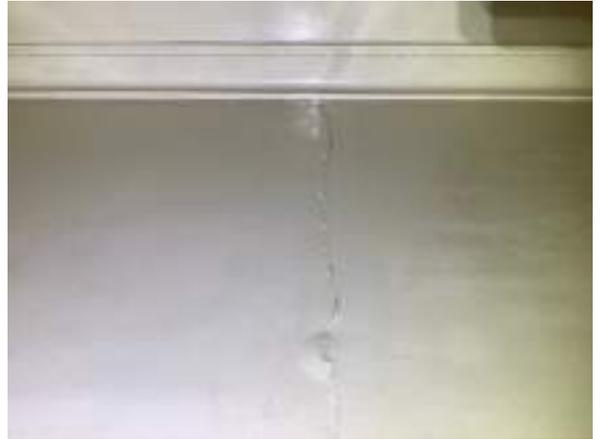
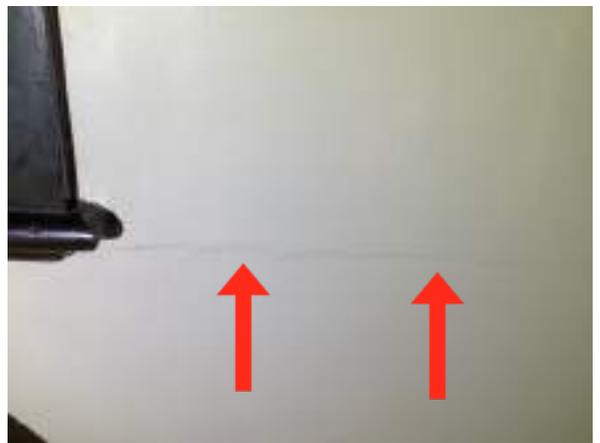
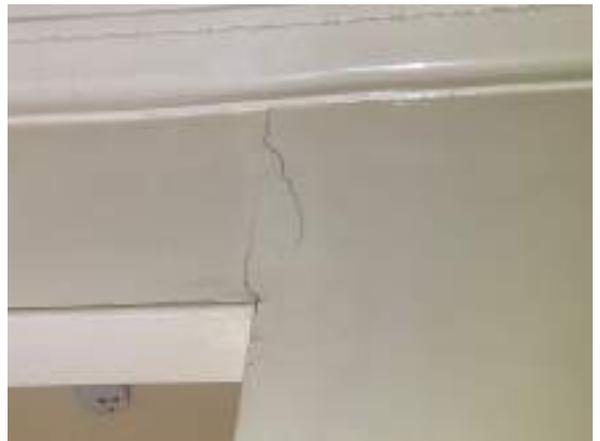
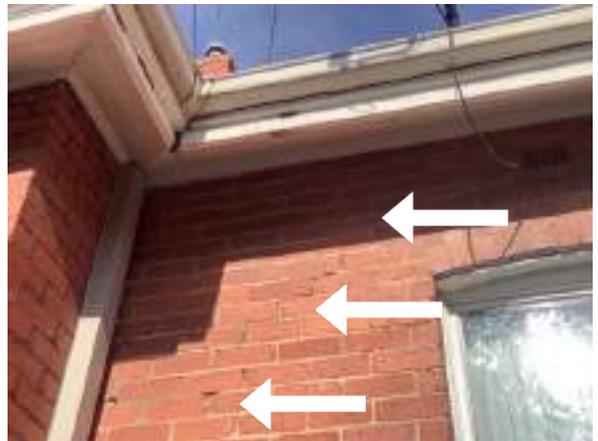
Minor Defect 3.36

Location: Brickwork

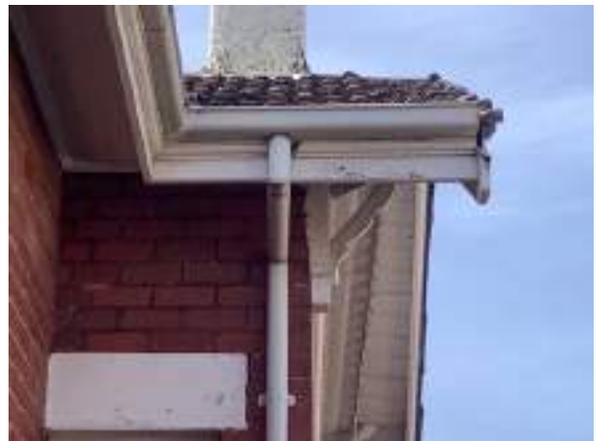
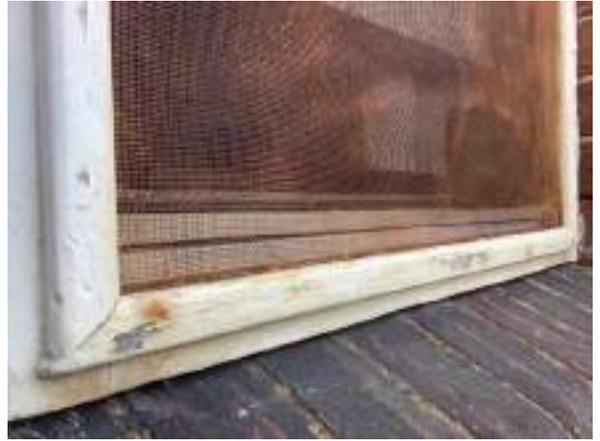
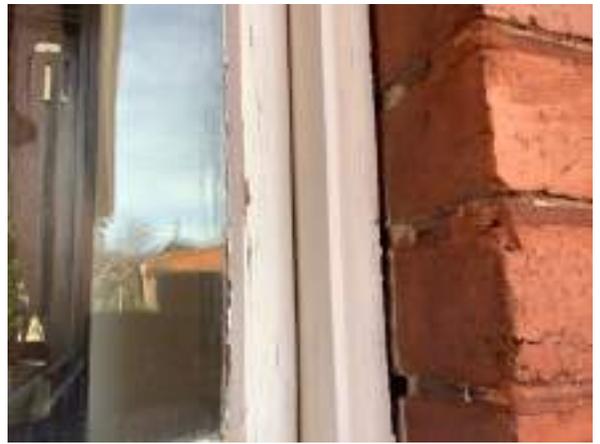
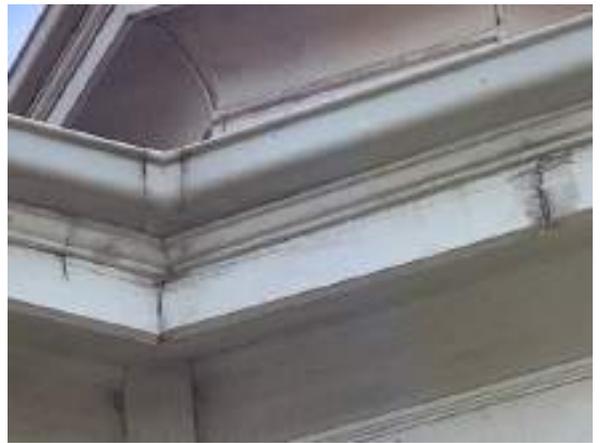
Minor Defect 3.37

Location: Timber Work - All External Areas

The property is a very high risk for termites as the environments to the property are very conducive with many susceptible areas.

Please read the report carefully and Maintenance to all susceptible and conducive areas is a MUST to minimise the risk of termite and timber pest existence and timber damage.
