Building & Termite Report (Termite Damage And Renovation Concerns Found)

Inspection Date: 6 Aug 2020

Property Address: Coburg Area

Report Type: Property and Timber Pest Report

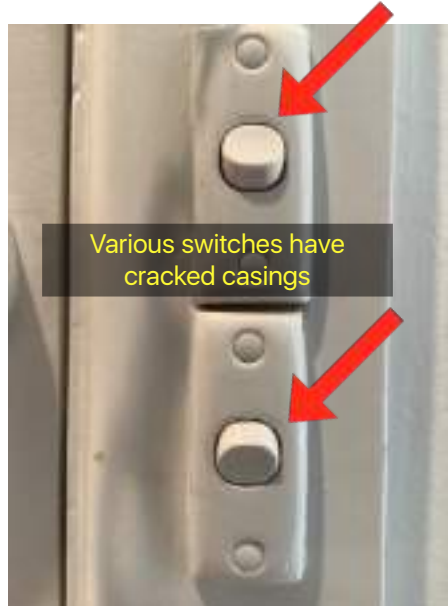
Serious Safety Hazard 1.01

Finding: Electrical - Switch - Damaged/Faulty

The switches in areas were found to be damaged or faulty at the time of inspection. This occurs generally when the building materials have either aged and decayed or as a result of impact damage (accidental or deliberate).

Repair and/or replacement of the switch is advised to ensure the fixture and it's associated structures are safe and fully operational. A licensed electrician should be appointed to repair/replace the light switch as soon as possible.

Please engage a licensed electrician to further inspect the property for the repairs and replacements as required.

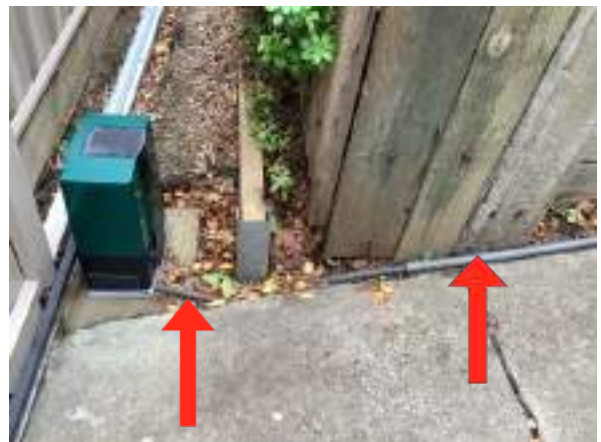
Serious Safety Hazard 1.02

Location: Electrical - All Areas

Finding: Electrical - Defective electrical wiring and/or installations.

At the time of the inspection we noted that the electrical installation appears to have items that may not be compliant with the electrical regulations AS3000-2007.

We recommend that the purchaser engages a licensed electrical contractor to check compliance and make good any defective wiring or unsafe items throughout the entire property including the outbuildings etc.

All the earthing to this property must be in accordance with AS3000 and we highly recommend further testing to the earthing system in its entirety.

We highly recommend that you engage a qualified electrician to further test the property's earthing system and that all the tests comply with AS3000 for all testing procedures of an electrical installation and its earthing components.

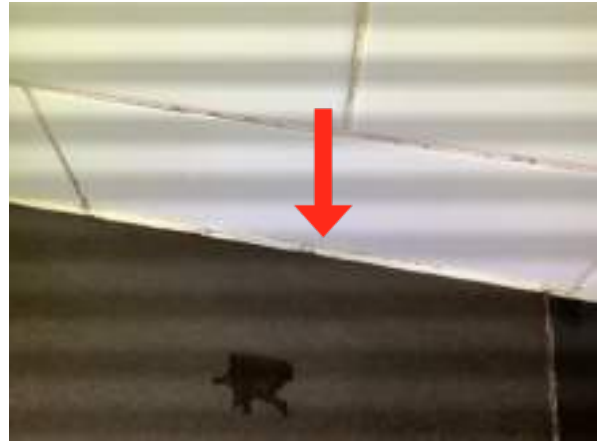
Serious Safety Hazard 1.03

Mould in caulking or silicone is generally caused by faulty and/or damaged caulking or silicone as the moisture and water ingresses into the caulking or silicone.

The caulking or silicone must be replaced and the areas are cleaned and new caulking or silicone applied.

Generally, the client is advised to ensure that the general environment is free of moisture and humidity to aid in the prevention of mould formation and development. Any mould found during the inspection should be cleaned immediately and/or taken out, particularly where the mould is in the silicon / caulking.

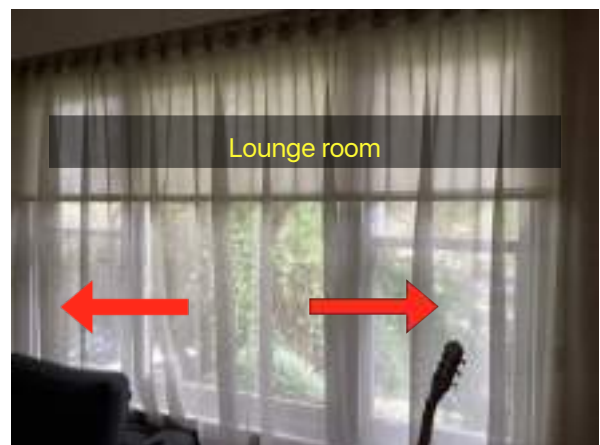
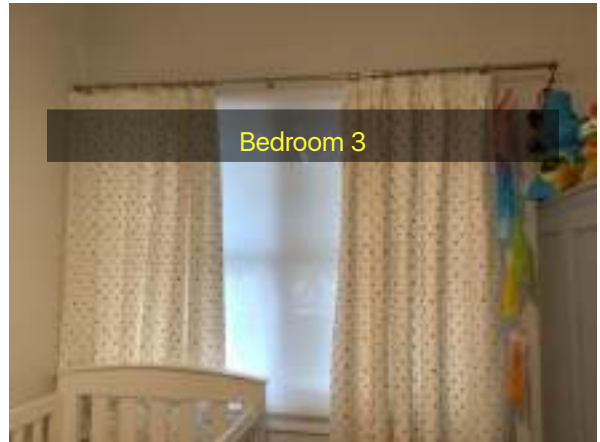
Serious Safety Hazard 1.04

Location: Windows - Internal Areas

Several windows throughout the property were jammed and difficult to operate at the time of the inspection. Windows provide ventilation to the adjoining area and should be at a fully operational level to ensure user comfort. Restricted function of the window may also pose as a potential safety hazard if required for emergency egress from the building.

Generally, factors such as general age of the building element and a lack of maintenance are the usual causes for this type of defect.

The windows may have several causes, ranging from minor defects as outlined above through to major structural issues, such as damage and/or subsidence (sinking) to subfloor structures.

For minor causes of repair, replacement where window hardware or frame may be required, as well as minor repairs and cleaning a carpenter, registered builder, window specialist/ company or general handy person will be required to repair the affected windows.

Windows MUST function as a safety requirement and we HIGHLY RECOMMEND that you engage an appropriate professional as soon as possible to check all windows to the property.

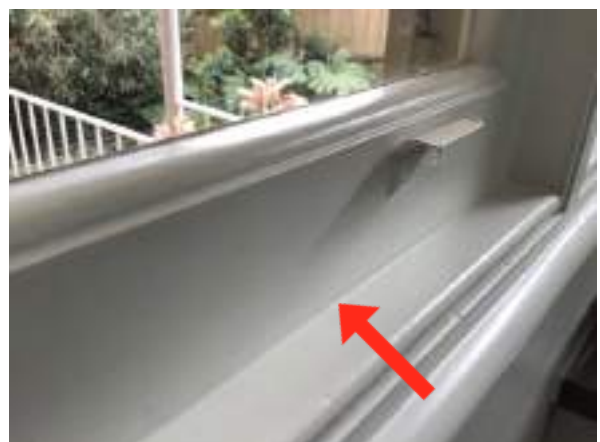
Serious Safety Hazard 1.05

Location: Windows - Internal Areas

Windows provide ventilation to the adjoining area and should be at a fully operational level to ensure user comfort. Restricted function of the window may also pose as a potential safety hazard if required for emergency egress from the building.

Where windows have been painted shut the seal of the paint needs to be broken. This is generally done by breaking the seal of the paint and then maintaining the sash tracks clearing and lubricating them with silicone. Remedial paint work will likely be required and can be completed along with the rest of the remedial works necessary by a general handyman.

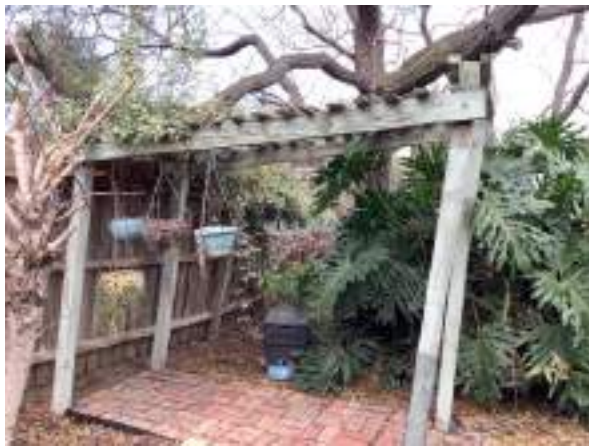
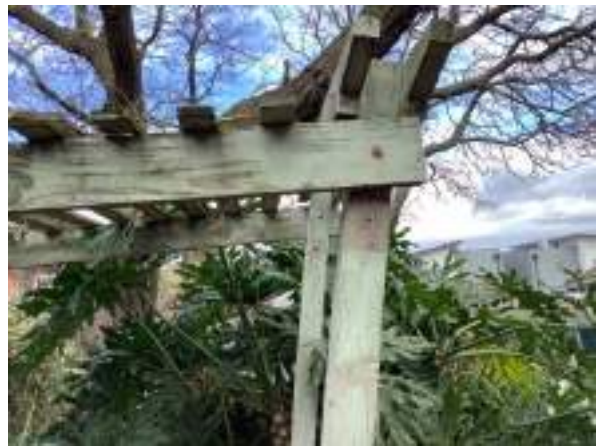
Serious Safety Hazard 1.07

The structure is in a dilapidated state, that requires urgent attention of repairs or demolition in a safe manner.

It is highly recommended that the repairs or demolition be performed by professional services or at a minimum a person that is handy.

Works are advised as soon as possible by the appropriate trades.

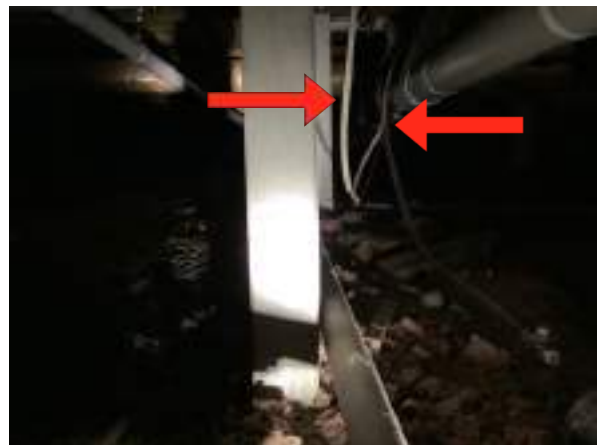
Serious Safety Hazard 1.08

Location: Subfloor

At the time of the inspection we noted that electrical installation items are not compliant with the electrical regulations AS3000-2007 and each picture attached is an electrical installation defect.

All wiring must be clipped to the timbers in accordance with AS3000 safe off the ground and/or subjected to damaged or people being in contact with them.

We recommend that the purchaser engages a licensed electrical contractor to check compliance and make good any defective wiring or unsafe items throughout the entire property including the outbuildings etc.

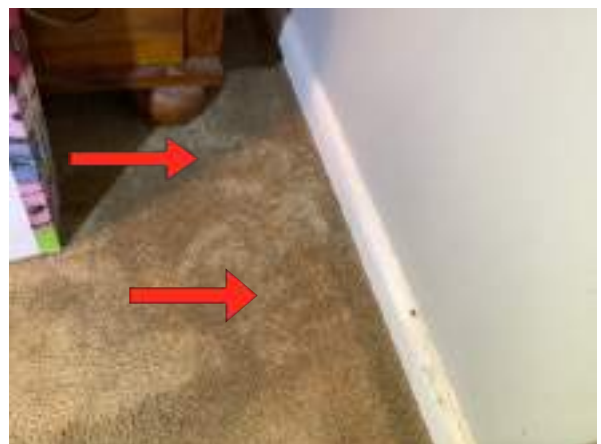
Serious Safety Hazard 1.09

It is important to determine the cause of mould not just to get rid of mould.

Finally the cause or source of the mould MUST BE TAKEN CARE OF URGENTLY.

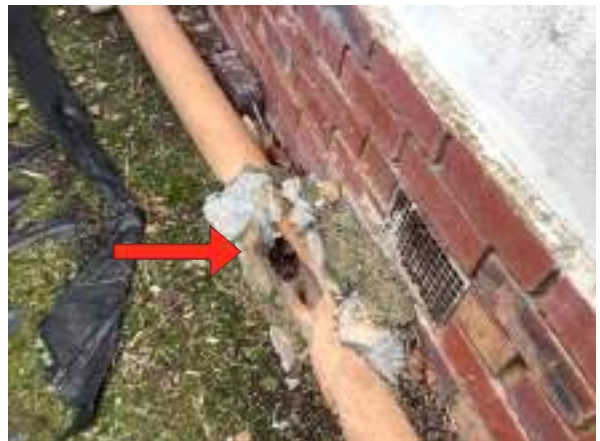
Major Defect 2.12

Location: Roof Areas & Stormwater

If secondary damages have accrued we highly recommend that you engage a structural engineer and/or a registered builder for remedial works.

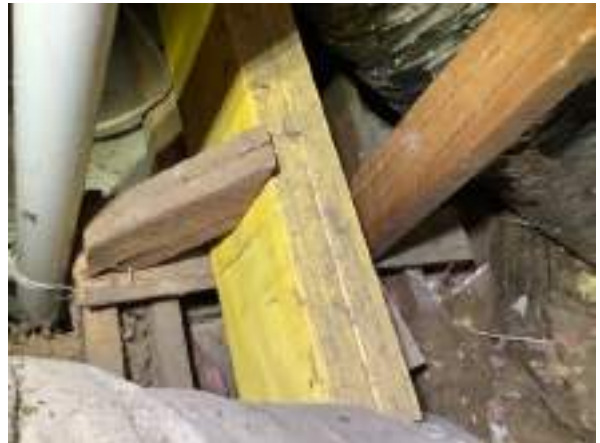
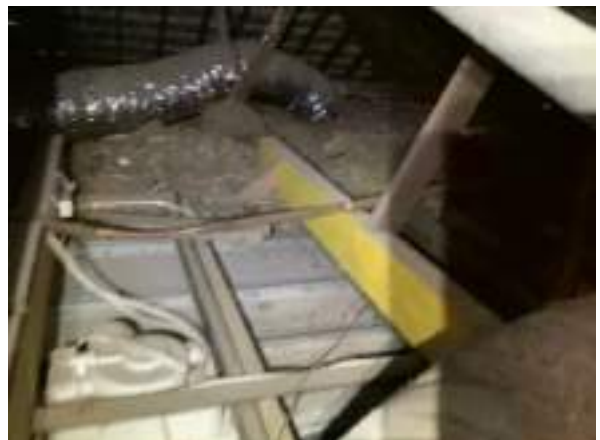
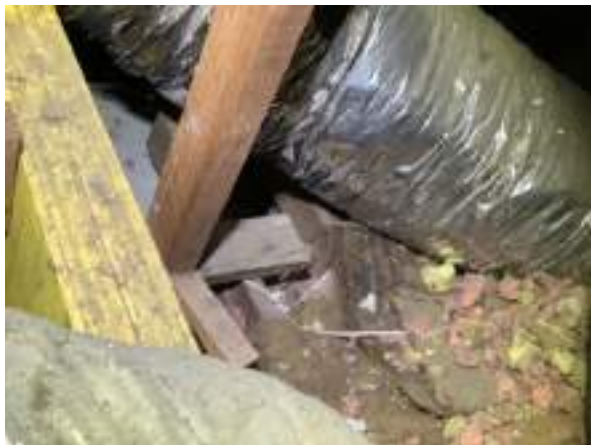
Major Defect 2.14

It does appear that the work would not comply with current building codes and standards and I highly recommend you engage a registered builder and possibly a structural engineer to determine the areas that may require further investigation and repairs.

I HIGHLY RECOMMEND that you only engage a registered builder and/or a qualified carpenter for all works in order to provide you all the necessary and correct contracts and warranties.

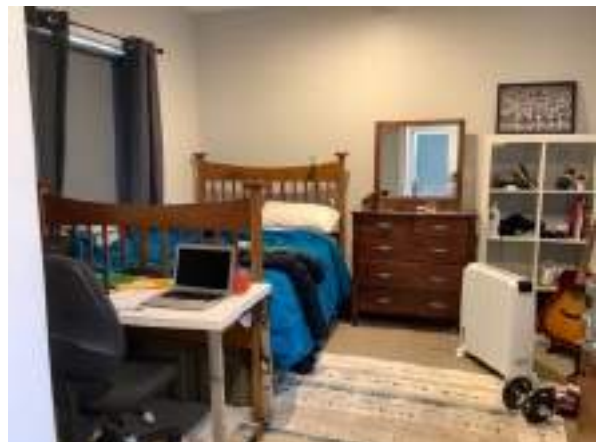
Major Defect 2.15

Location: Added Structures

It is highly advised to request that the current owner provide a Defect report (Owner Builder/ Section 137b) for this structure. This would involve a structural engineer or a licenced building surveyor conducting an inspection of the structure and advising of any defects and/ or areas of non-compliance in accordance with the current building codes. The current owner should then attend to any issues on this report prior to settlement.

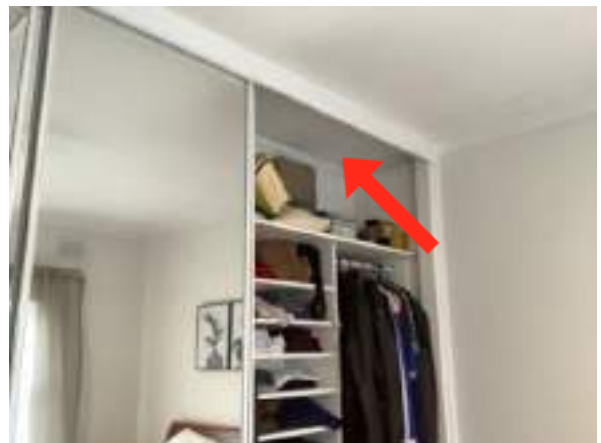
Minor Defect 3.18

Location: All Areas - Various

The appropriate tradesperson or specialist or handyman should be appointed to complete the various items for repair and organise the appropriate QUALIFIED trades (or not pending on job) to repair and complete the works to illiminate or reduce further deterioration / disfunction.

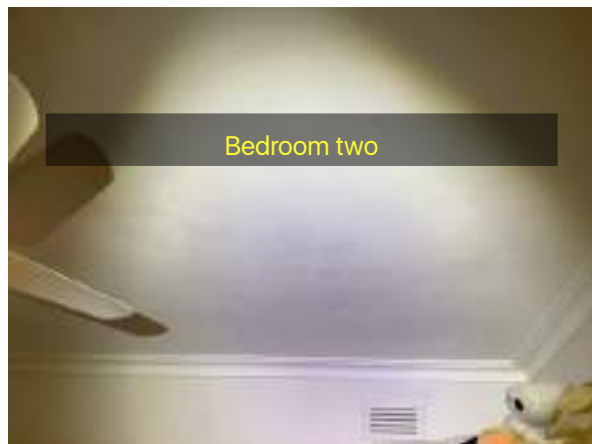
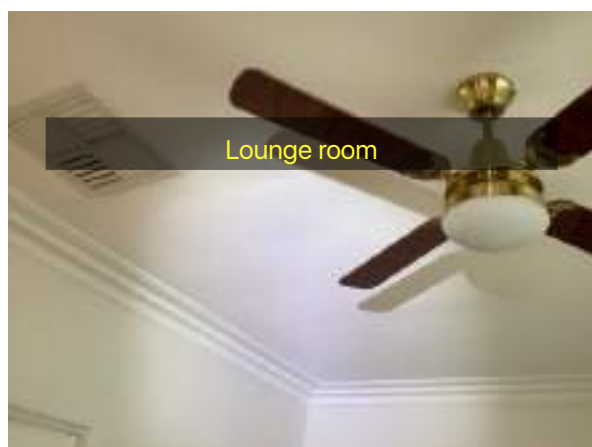
Minor Defect 3.24

Location: Plaster Internal Areas

Ensure that the general environment is free of moisture and humidity to aid in the prevention of drummy plaster and plaster damage. Appointment of a qualified plasterer and/or builder is advised in order to complete remedial works as necessary.

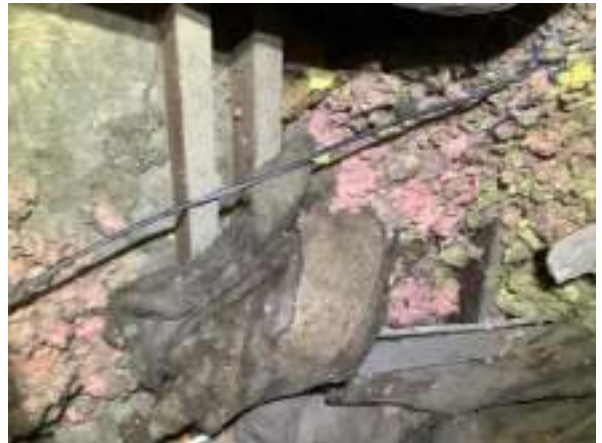
Minor Defect 3.27

Location: Laundry

Installation of adequate insulation is required according to Australian Standards and should be conducted as soon as possible.

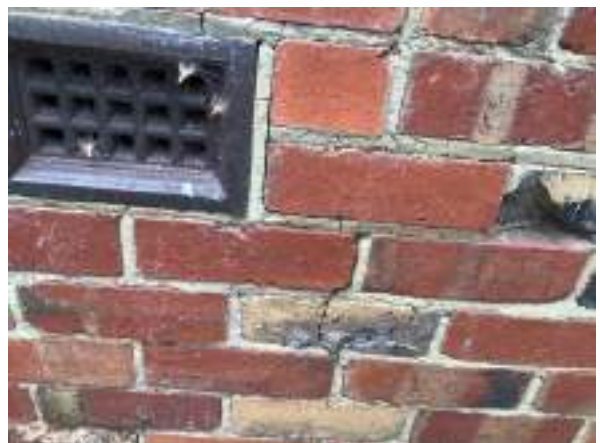
Minor Defect 3.30

Location: Perimeter Of Building - Exterior

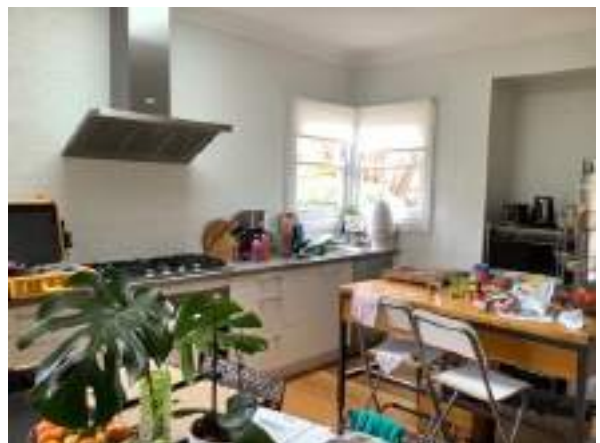
For your information 4.44

Location: The Site

A re-inspection is recommended once the areas are made accessible.

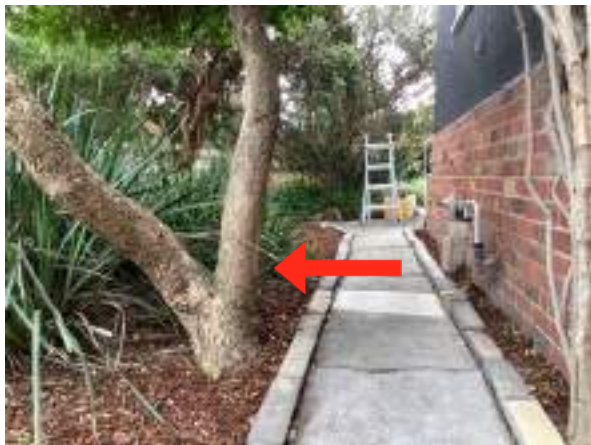
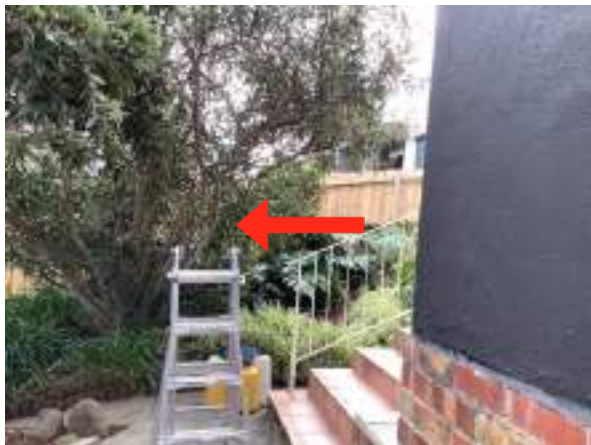
For your information 4.49

Location: Garden Areas - All Areas

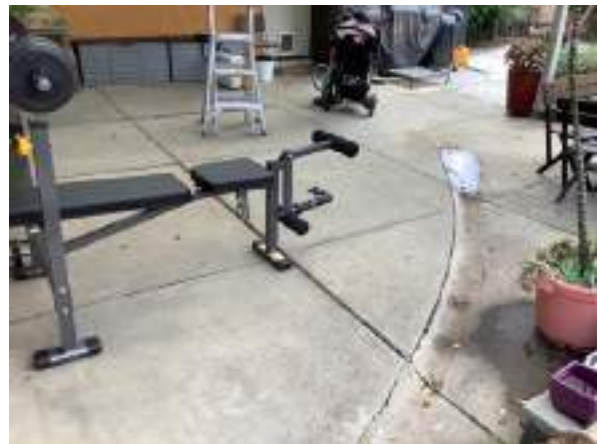
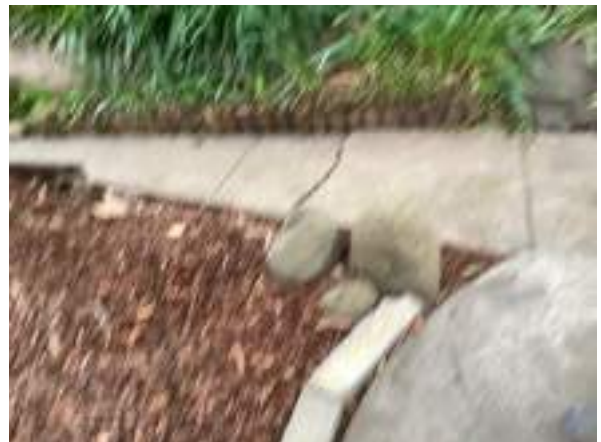
For your information 4.50

Location: Concrete - All Areas

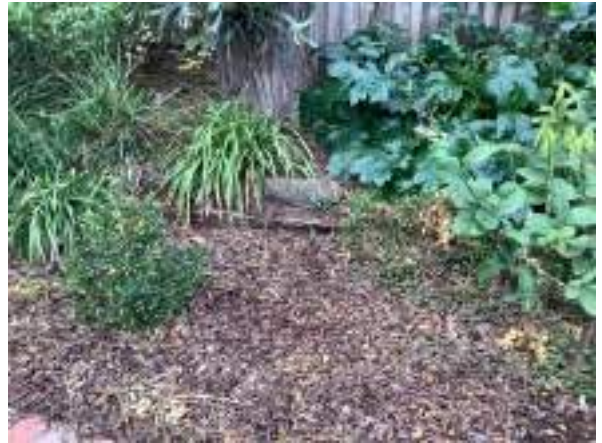
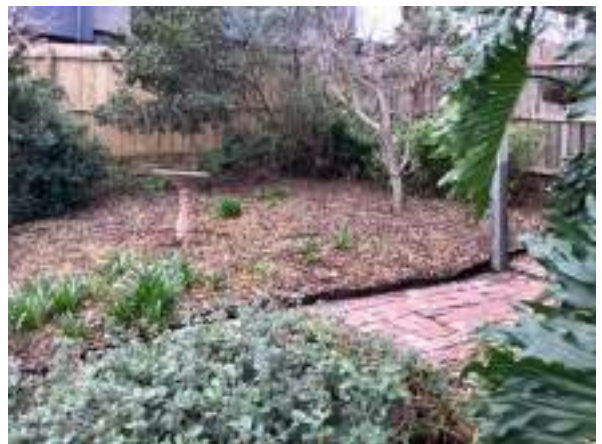
Item 2.04

Location: Perimeter Of Building - Exterior

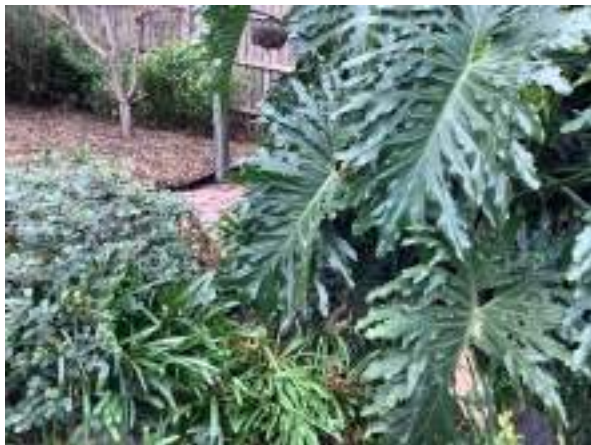
Item 2.06

Location: Garden Areas - All Areas

Please read the report carefully and Maintenance to all susceptible and conducive areas is a MUST to minimise the risk of termite and timber pest existence and timber damage.

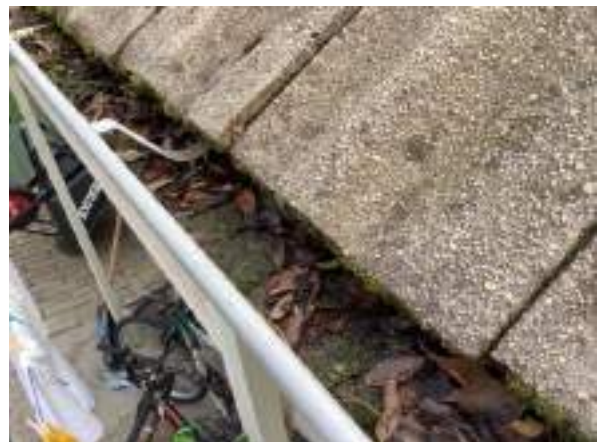
Item 2.07

Location: Roof Areas & Stormwater

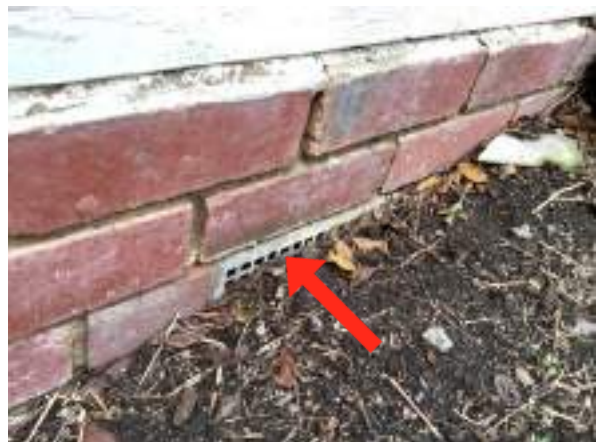
Item 2.08

BRIDGING OR BREACHING OF TERMITE MANAGEMENT SYSTEMS AND INSPECTION ZONES

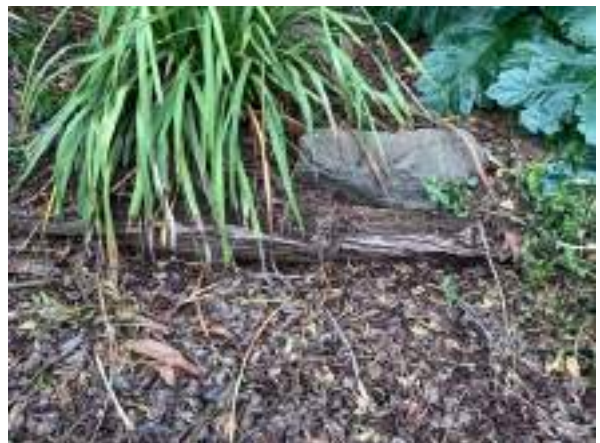
Item 2.09

UNTREATED OR NON-DURABLE TIMBER USED IN A HAZARDOUS ENVIRONMENT

Frequent pest inspections are advised to readily identify any termite activity in these areas.

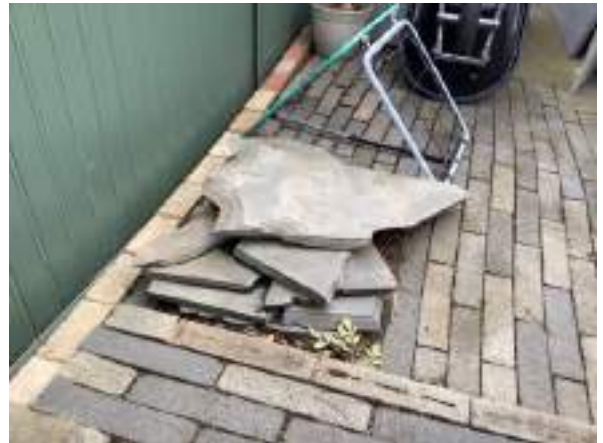
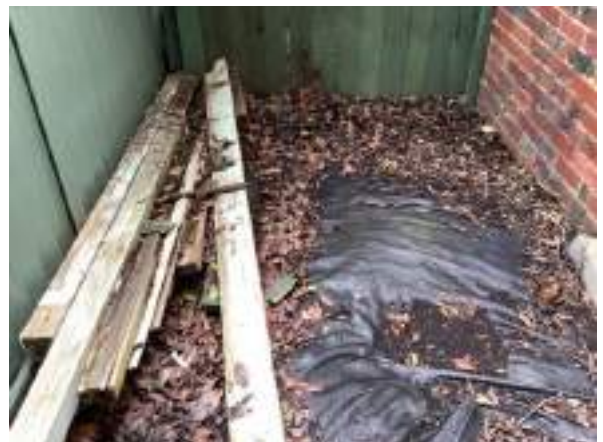
Item 2.10

OTHER CONDITIONS CONDUCIVE TO TIMBER PEST ATTACK

Minimisation of risk / prevention of termite attack is far more adequate than dealing with the presence of termite activity.
