New Construction-Specific Exterior Roof Report (Builder Warranty Claim, Whilst Construction Is In Progress)

Inspection Date: 2 Aug 2020

Property Address:	Country Area
Date:	2 Aug 2020
Report Type:	New Home Construction

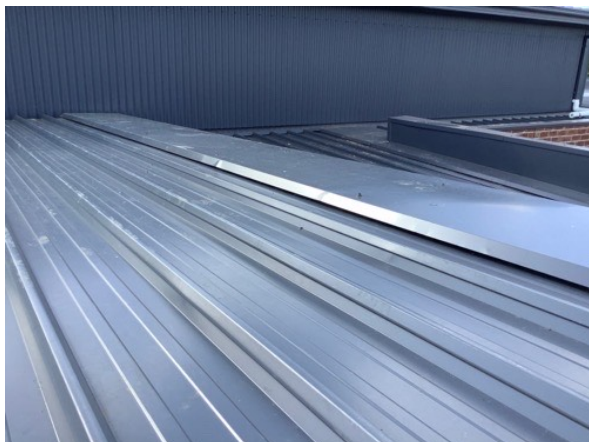
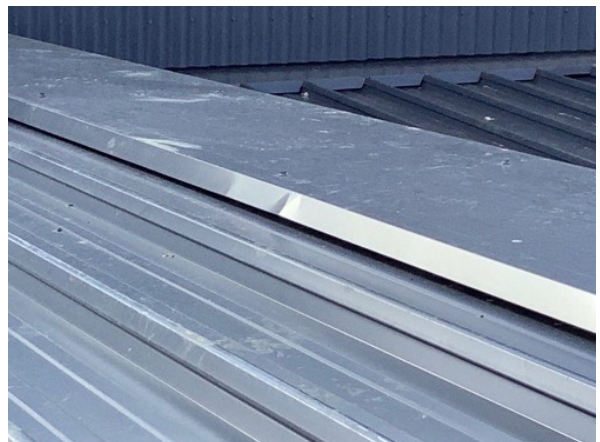
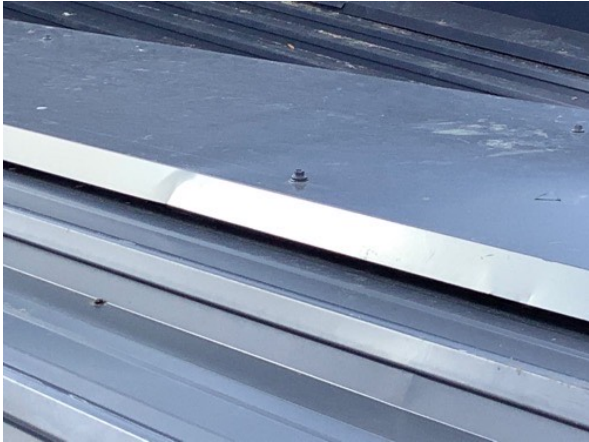
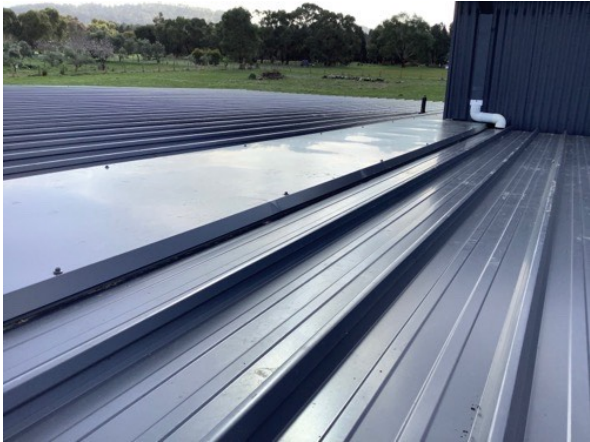
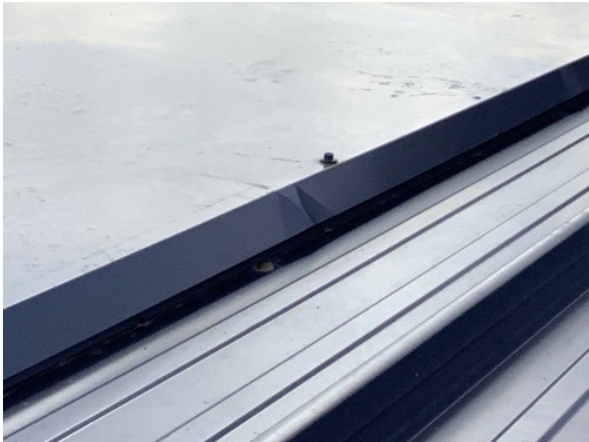
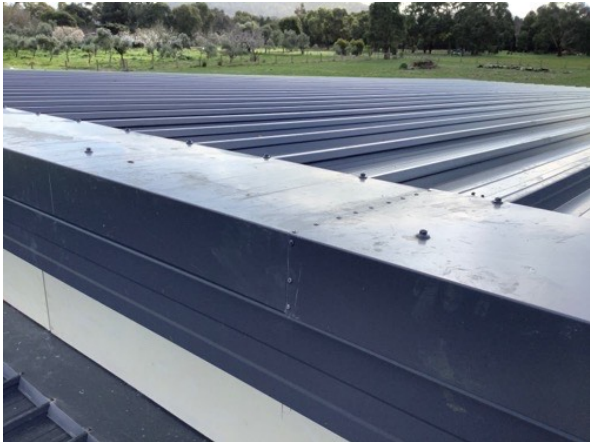
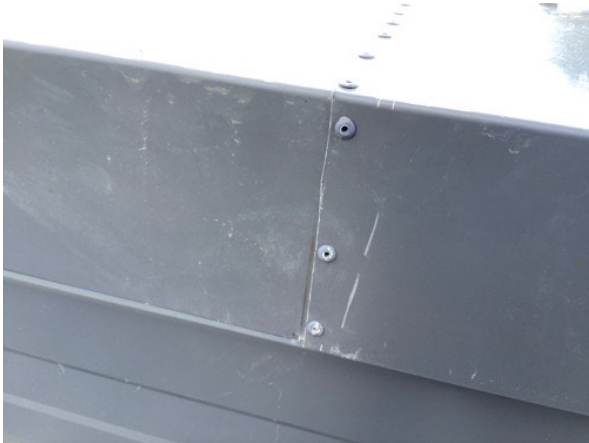
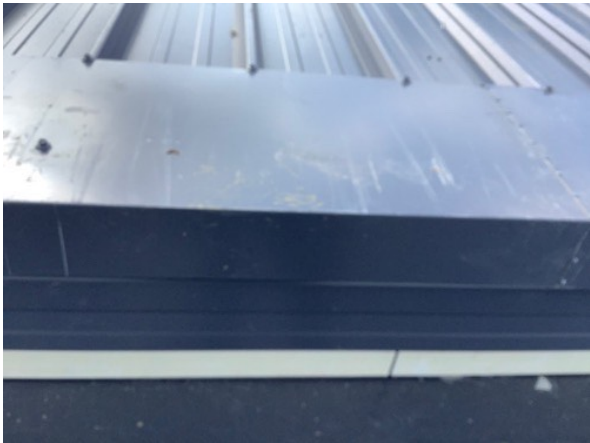
Non Compliant 2.01

Finding: Colourbond Coating & Powder coat finishes Scratched and Damaged
The entire roof area has Colourbond Coating & Powder coat finishes Scratches and Damages spread throughout the roof area

Where this is due to the builder's workmanship or damage occurring during construction it is considered a defect with respect to Standards and Tolerances - 18.02.

The colorbond / powder coat finish has had its prefinished painted coating scratched, exposing the base metal, which cannot be correctly repaired on site.

BlueScope Steel, the manufacturer of colorbond steel state on their web site that –'BlueScope steel does not recommend the use of touch up paints on Colorbond steel' and that 'Our recommendation is not to touch up. Minor scratching will not affect the life of the sheet and is rarely obvious to a casual observer. Should damage be substantial, replace the sheet.

The affected damaged sections will need to be replaced.

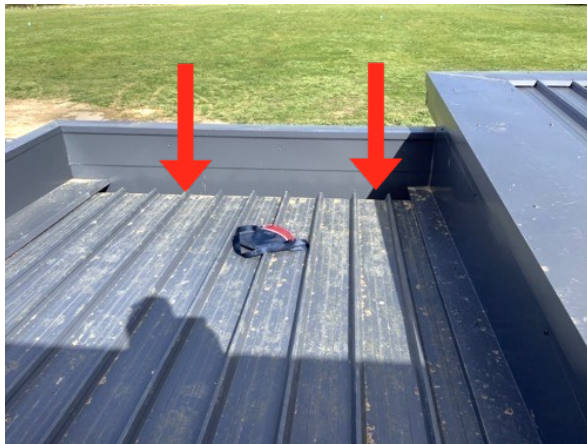
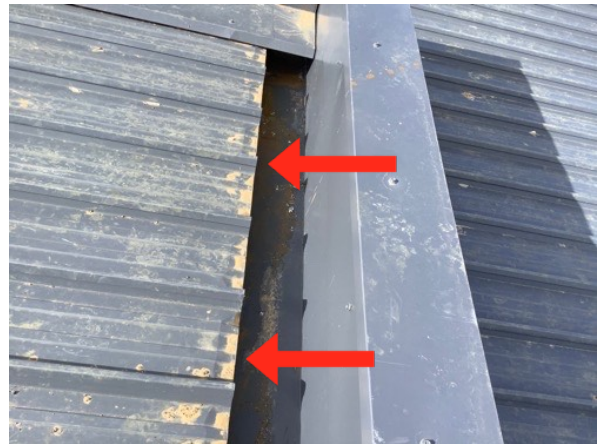
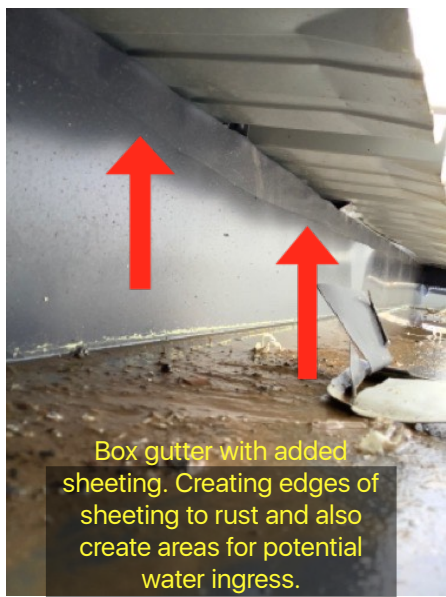
Non Compliant 2.02

Finding: Box gutter flashing - Defective

The box gutter vertical returns have been cut short and an additional piece has been installed to make up the shortfall in some areas and other areas are just short. By installing the box gutters to the incorrect height, this is leaving high potential for pest ingress, water ingress and energy star rating to be severely compromised.

No silicon no rivets

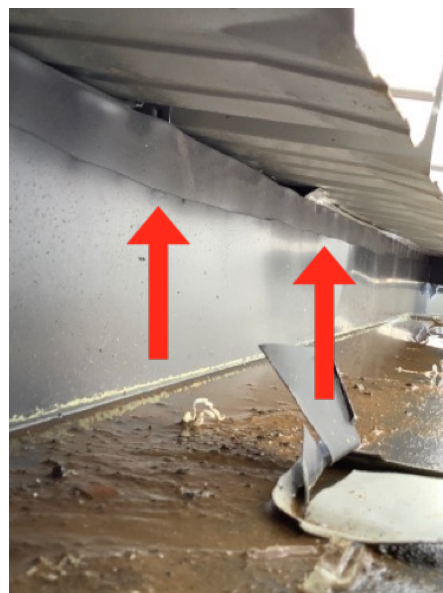
Box gutter with added sheeting. Creating edges of sheeting to rust and also create areas for potential water ingress.

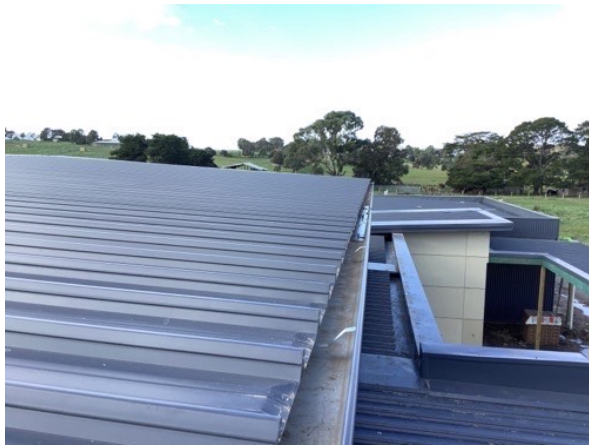
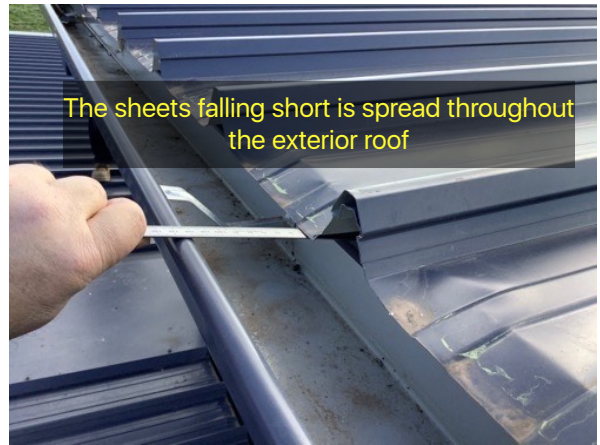
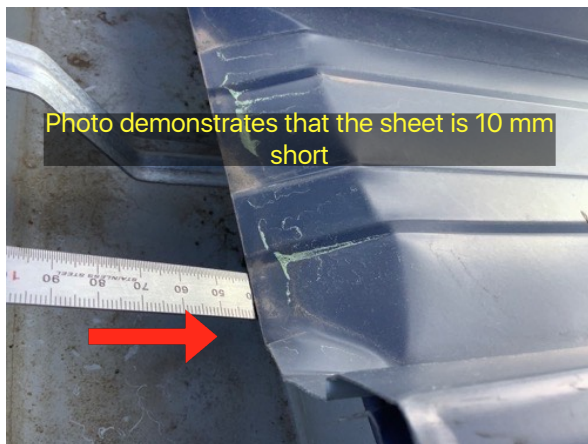
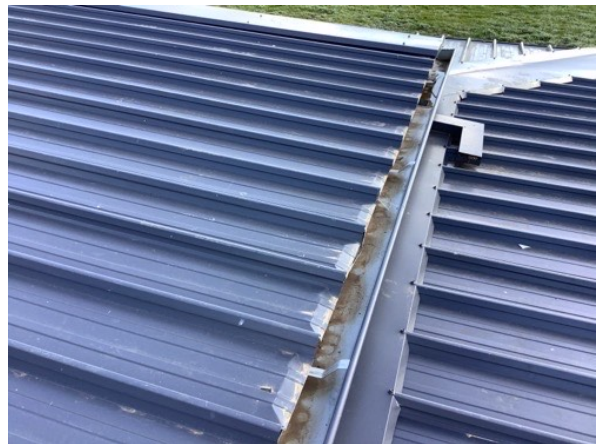
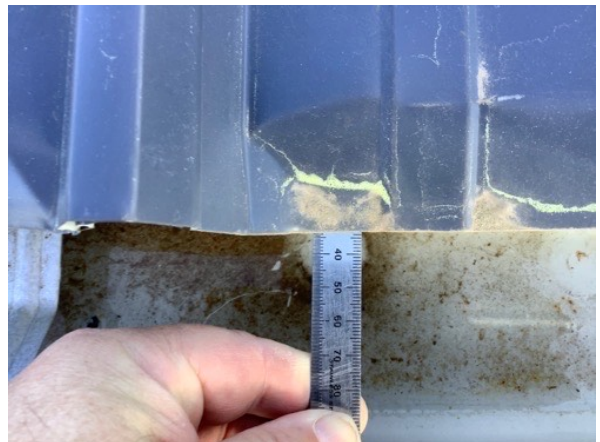
Non Compliant 2.03

Finding: Overhang of sheet roofing - less than allowed
It is observed that there is or are many instance/s of sheet roofing which is overhanging the inside face of the guttering by less than 50mm. This is considered a defect with reference to Standards and Tolerances.

Extension of roof sheeting is not an option.

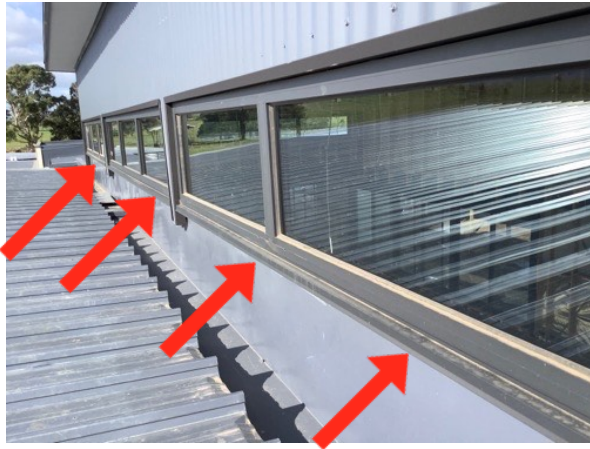
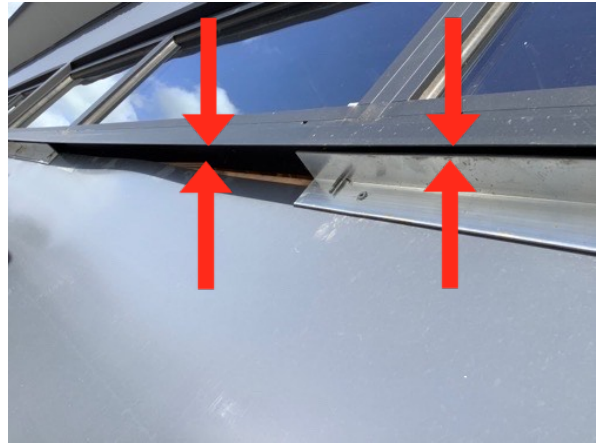
Non Compliant 2.04

Finding: Flashing fall short under windows

When the flashing falls short under the windows, various defects are created and are also stated in other defect statements in this report.

Pest ingress, Water Ingress and Water rot are the typical large problems that will occur over time creating secondary building defects to the property.

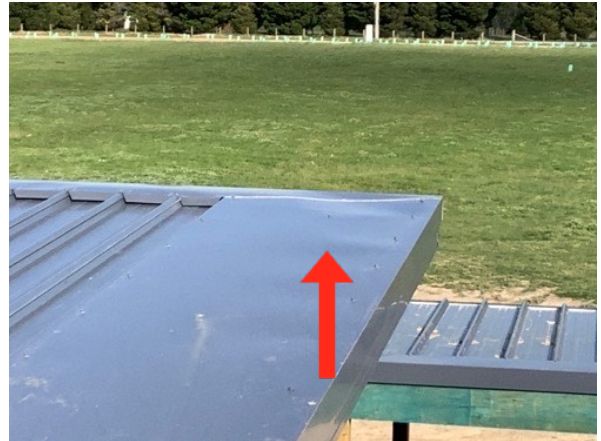
Non Compliant 2.05

Finding: Flashing will water pool
The flashings are not supported and secured accurately in all areas, leaving potential for water pooling, noisy flashings and secondary building defects.

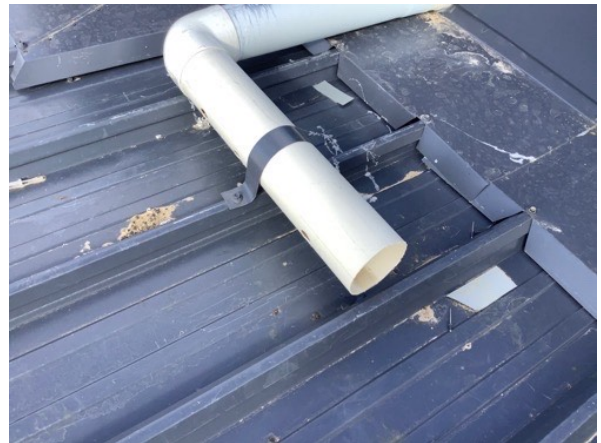
Non Compliant 2.06

Finding: Spreaders - Defective
The spreaders are incomplete and non compliant.

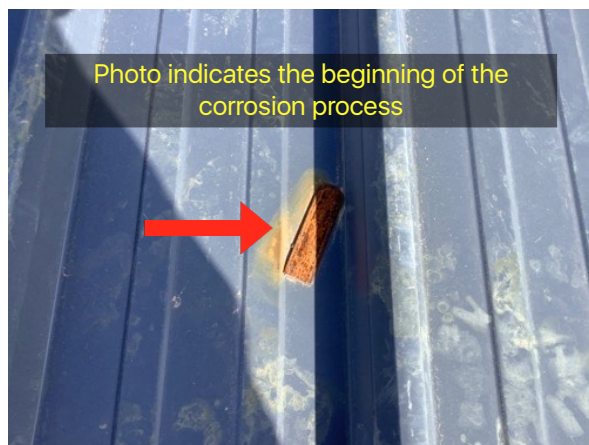
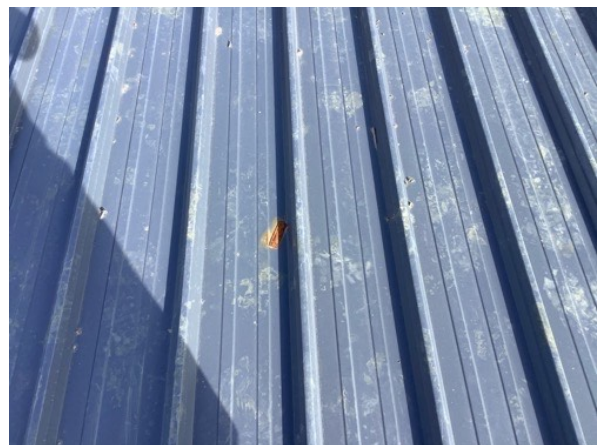
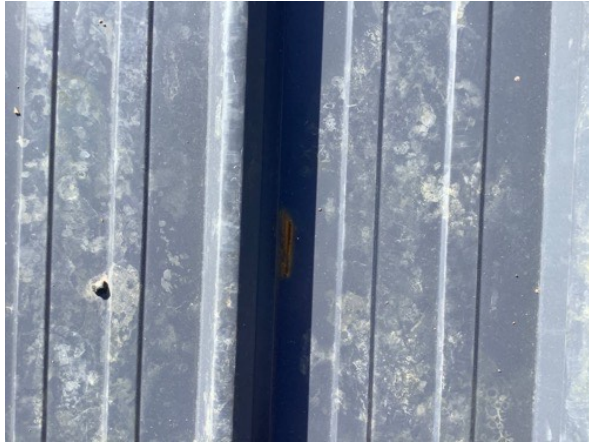
Non Compliant 2.07

Finding: Rust / Corrosion

Already at this very early stage of the build, meaning the home does not even have plaster as yet, rust is occurring due to the builders debris on the roof space.

Over time this will increase.

The builder is to hand the building to the client in as new condition.

Repairs to the roof is not acceptable.

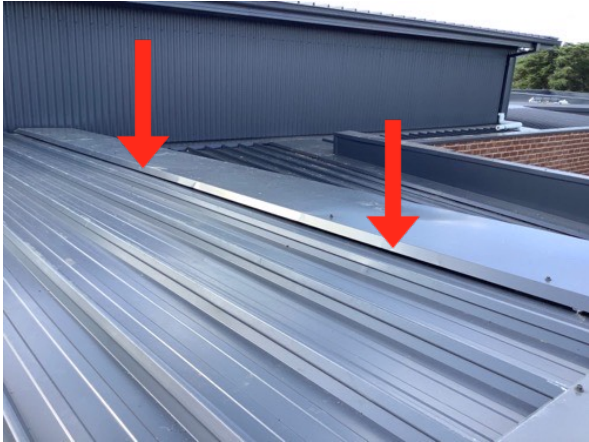
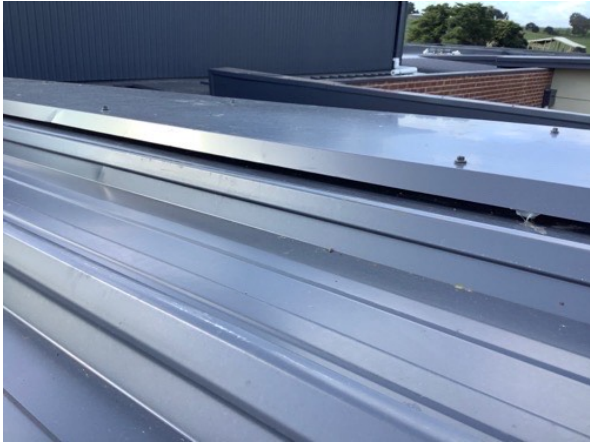
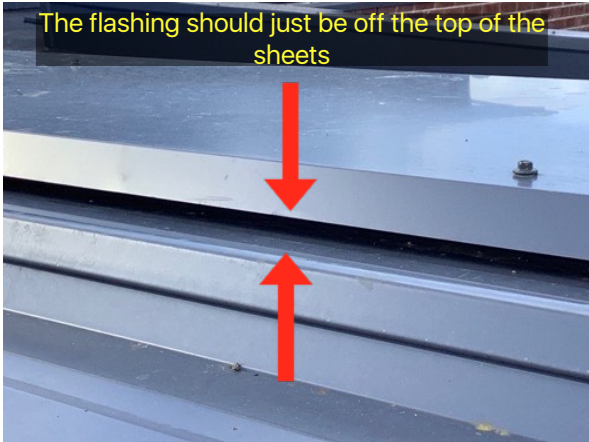
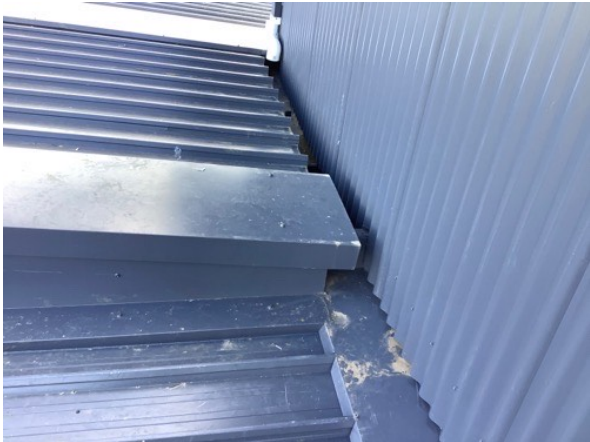
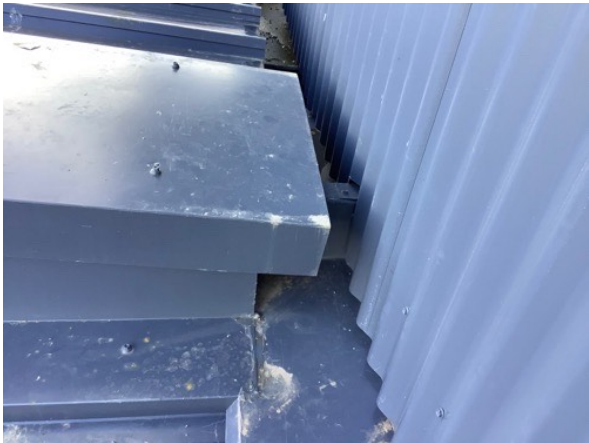
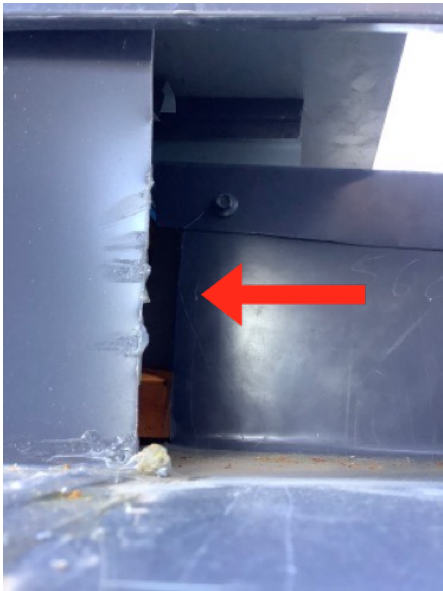
Non Compliant 2.08

Finding: Pest and vermin

It's very important to seal and block any areas where, rats, possums, cats, birds and any other type of animal or rodent can get into the roof space areas or wall spaces. Any holes large enough to allow bird, rodent or other pest ingress creating the potential for nesting or infestation of live animals.

The damage caused by the ingress of rats, possums, cats, birds and any other type of animal or rodent has the potential to cost the home owners large amounts of money, to plaster, heating and cooling ducts, electrical, plumbing, etc damages.

Particularly as this homes design is a flat roof, access to initiate repairs may entail invasive repairs that may require damage to plaster and/or more expensive ceilings.

Also whilst animal ingress is of a great concern, water ingress to this property is another major concern due to the level of unfinished areas, such as where the metal sheeting falls short as detailed in other defect statements in this report. The client has stated that the roof is leaking in many areas when it rains.

In order for the repairs of excess holes, metal sheeting falling short all the repairs must be completed to a tradesmens like finish and not patches and silicon in various areas as the client has engaged the builder to install the roof and complete the roof to a professional standard.

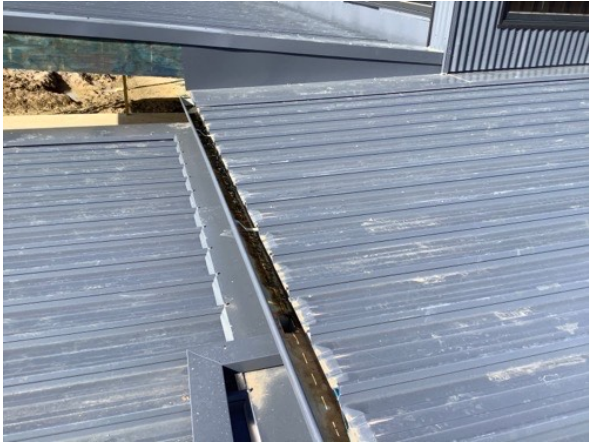
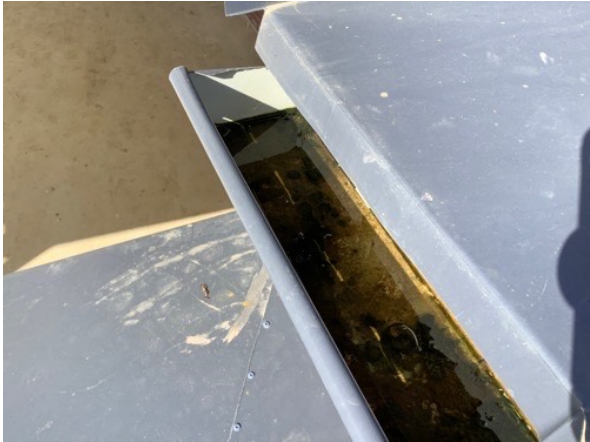
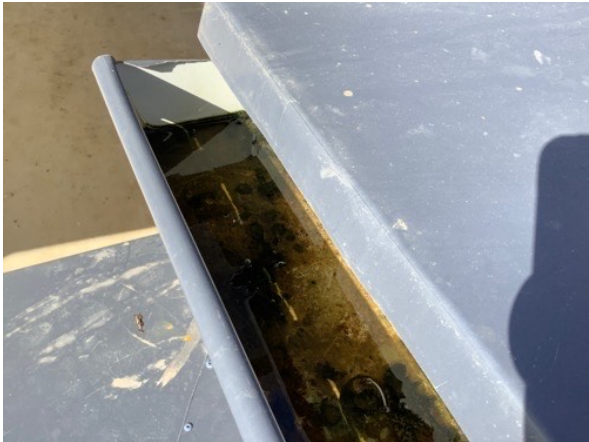
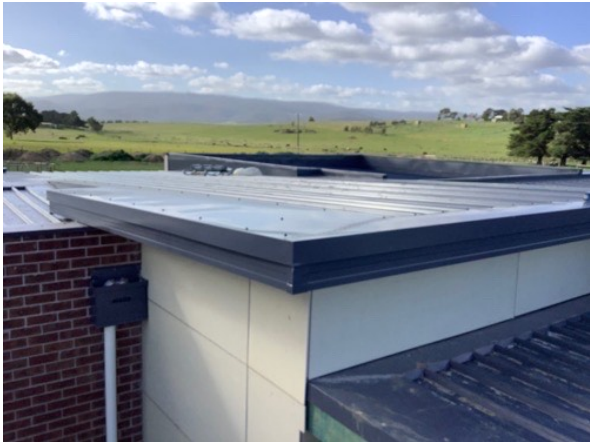
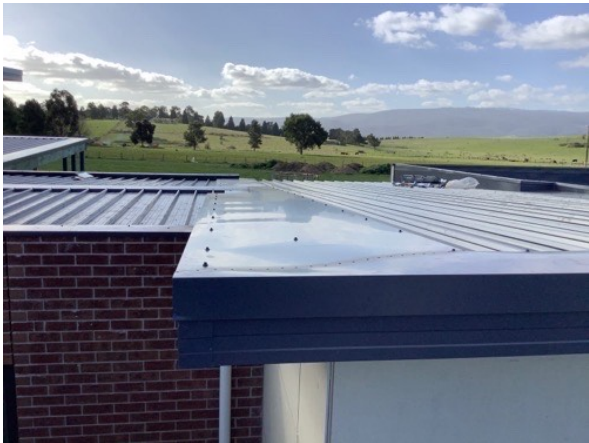
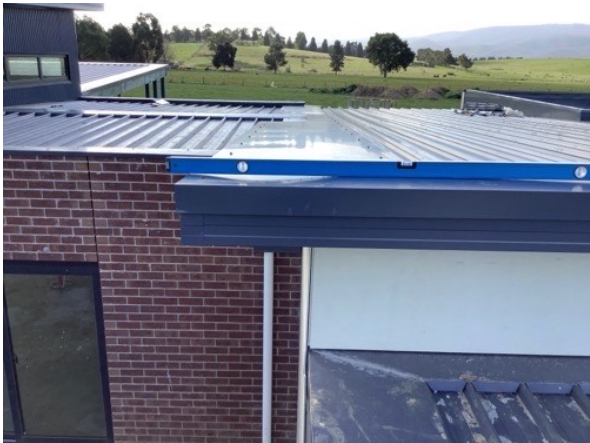
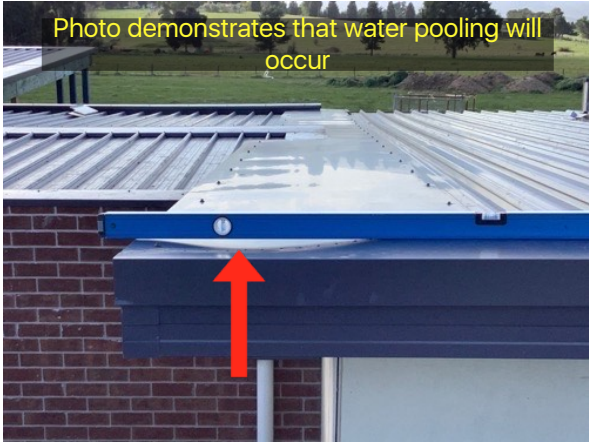
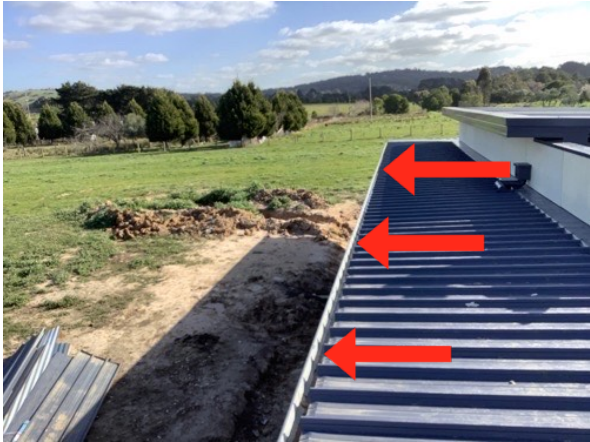
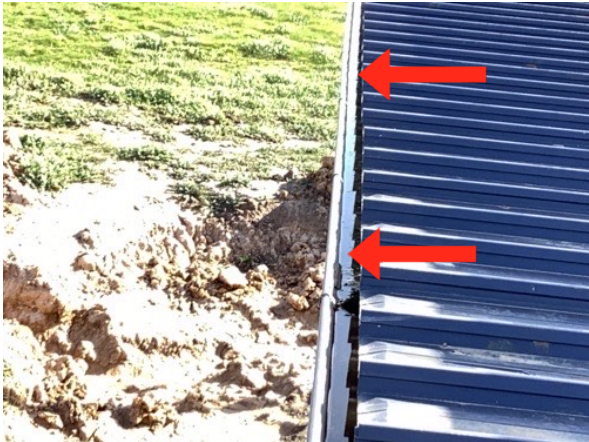
Non Compliant 2.10

Finding: Water pooling in areas of gutters

Water was found to be pooling in sections of the roof guttering. This is generally a secondary defect caused by blocked or partially blocked gutters or defective falls in the gutters, however in this case I would be confident to say that the water pooling is due to defective or inefficient falls in the gutters.

Such water pooling is likely to lead to rust and water damage to associated structures if not repaired.

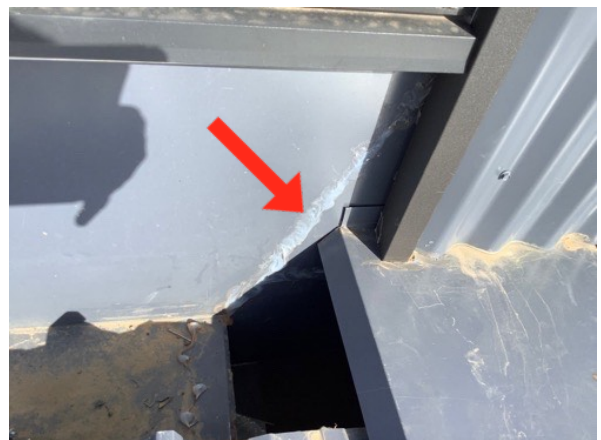
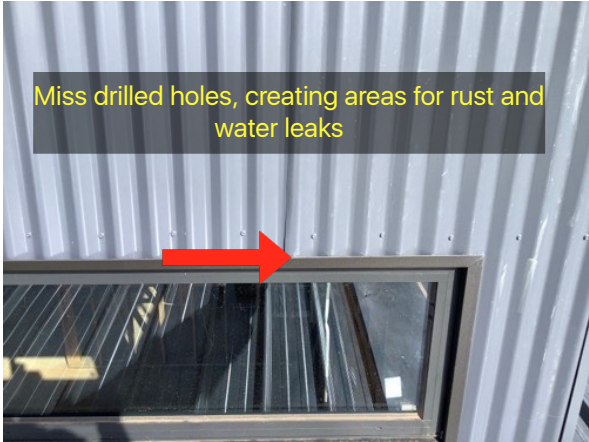
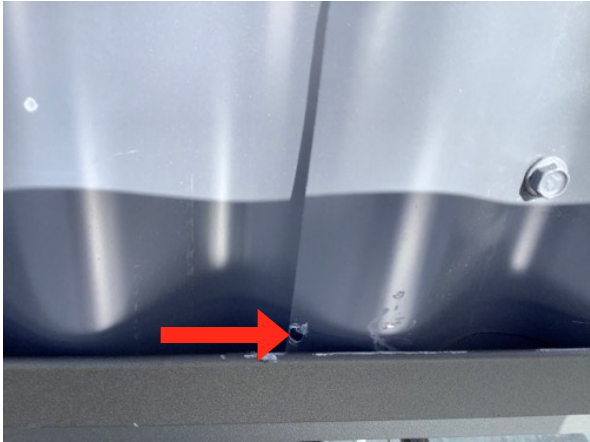
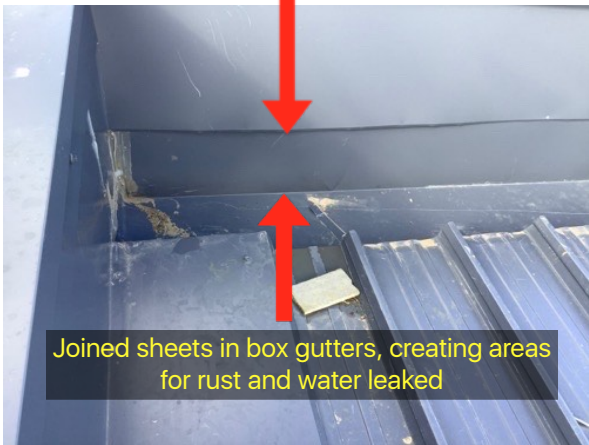
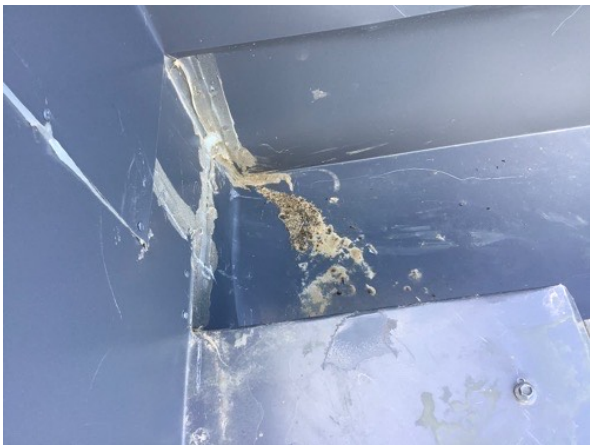
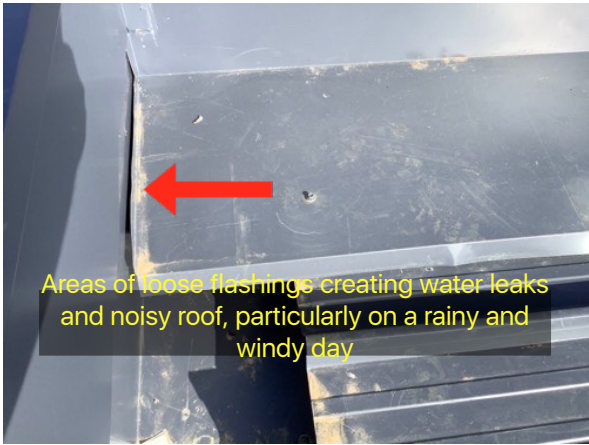
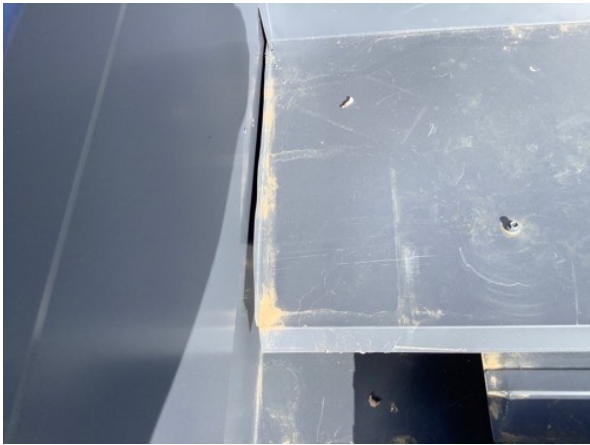
Non Compliant 2.11

Finding: Not complete to a tradesman is like level
The following items will need to be completed or repaired in accordance with the Domestic Building Contracts Act 1995.
We refer the builder to the implied warranties where the builder agreed to build the dwelling in a proper and workmanlike manner and with reasonable care and skill.

All these photos are added in to demonstrate DEFECTIVE / SUB STANDARD and/or INCOMPLETE WORKS and they are all required to be rectified as they are ALL not satisfactory for Handover as per the DOMESTIC BUILDING CONTRACT ACT 1995 as stated above.

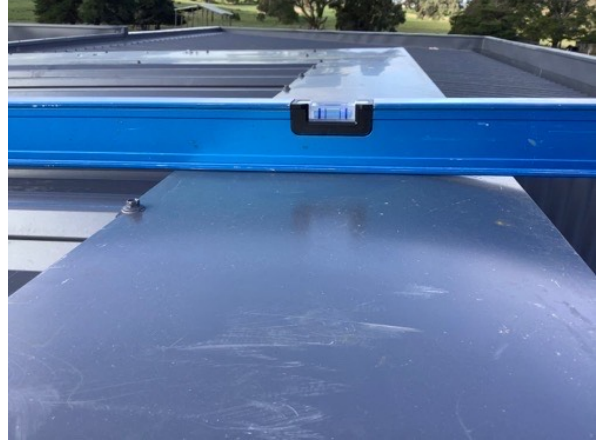
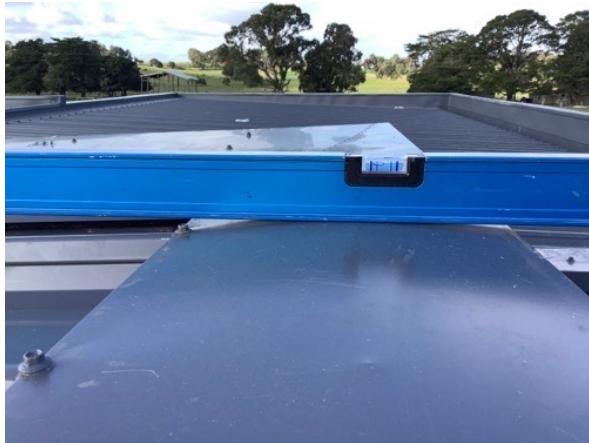
Non Compliant 2.12

Finding: Inconsistency in flashing levels
The flashings have inconsistent levels , this may be due to defective timber framing and/or defective flashing installation.poor installation such as this may also have effect on the appearance of the home.

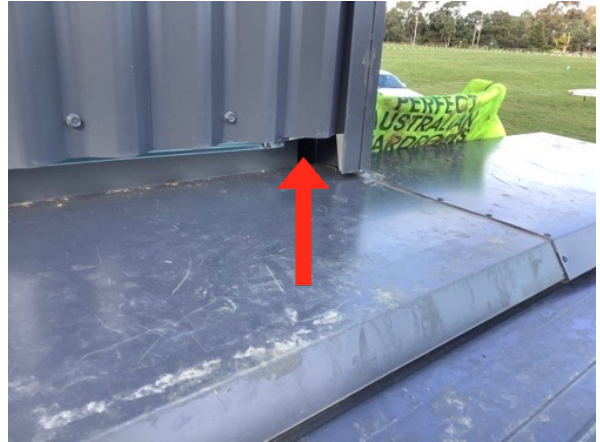
Non Compliant 2.13

Finding: Pest and water ingress

The corrugated sheeting falls short and as many areas to the roof, this area and areas like this create, pest ingress, water ingress creating wood rot and further secondary building defects.

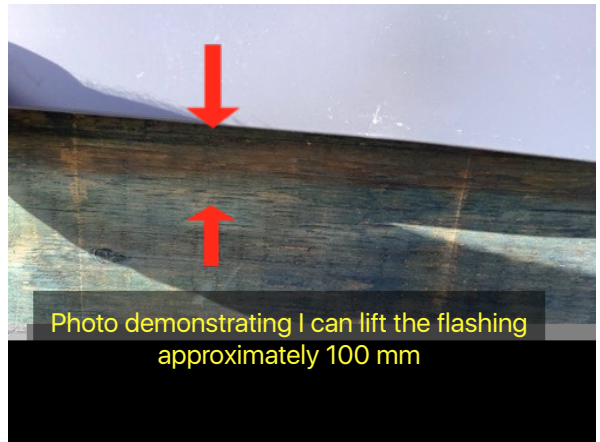
Non Compliant 2.14

Finding: Flashings not secured / loose in various areas spread throughout the roof exterior
Flashing not completed and secured down. This may be due to not enough fixings and/or not enough framing built for the fixings to securely hold the flashings

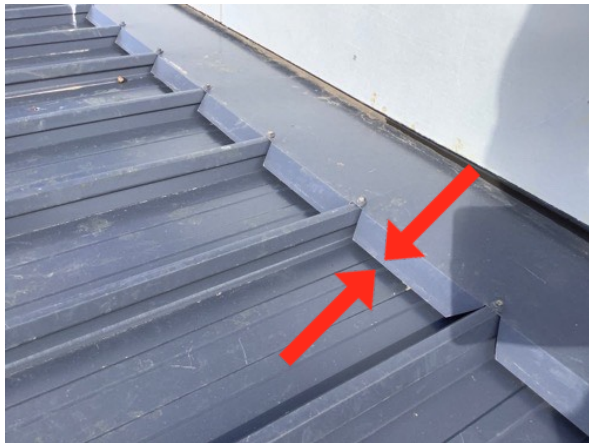
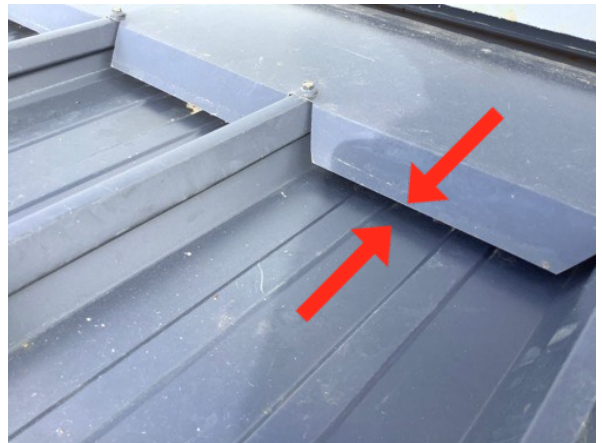
Substandard Workmanship 3.15

Finding: Flashing falls short
The flashings are falling very short to many areas, creating pest ingress, water ingress and secondary building damages such as wood rot

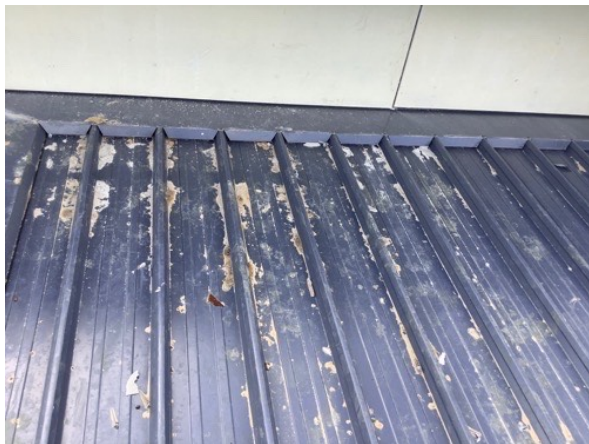
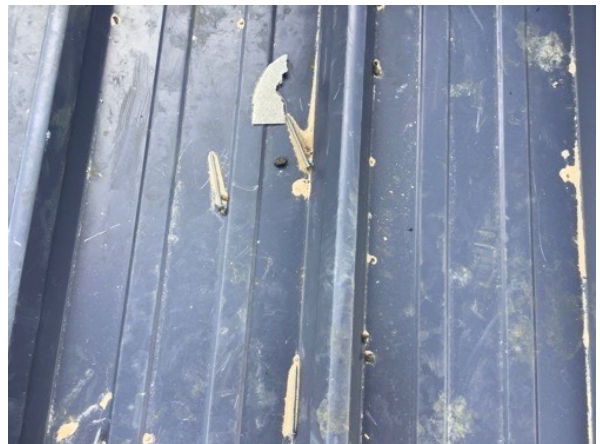
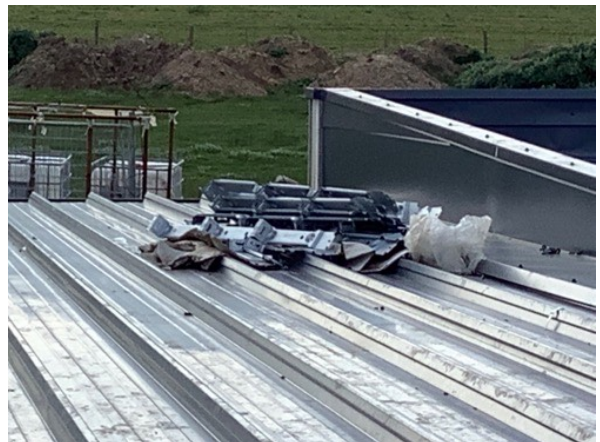
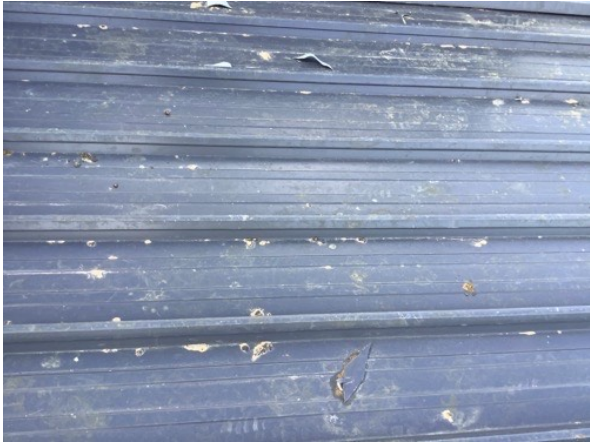
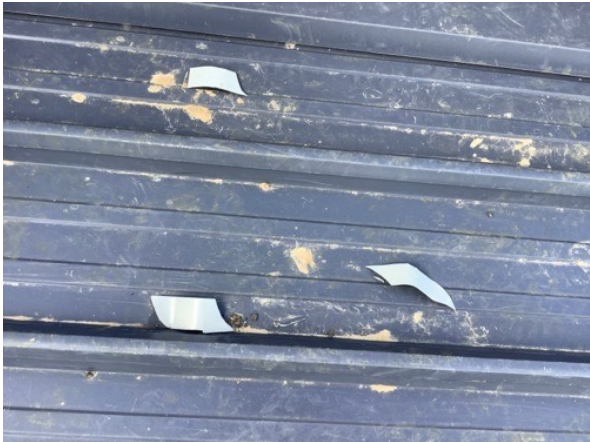
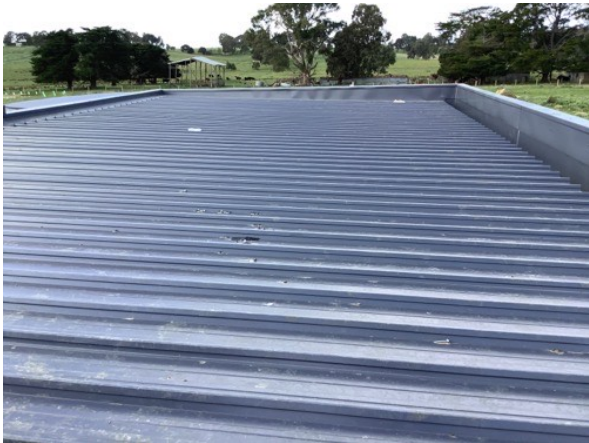
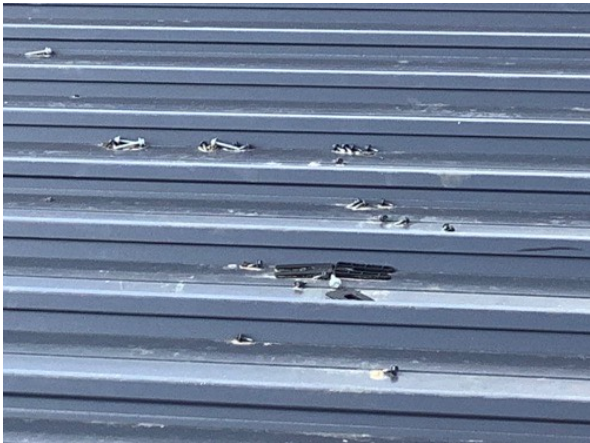
Substandard Workmanship 3.16

Finding: Builders debris spread throughout the entire roof area & gutters.
It was identified that the exterior roof is left in a very disrespectful state.

There is metal off cuts, pop rivots and various other builders debri spread through out the entire metal roofing, gutters and box gutters. Builders debri adds to further damage to the colour bond products, however the colour bond to entire metal roofing, gutters and box gutters is already damaged and scratched.

Roof plumbing structures, such as guttering and downpipes, should be free of all debris to prevent blockages. Blockages of the guttering and downpipes will lead to pooling and accumulated water overflows, which is likely to subsequently flood eaves and exterior walls.

Blocked gutters are likely to lead to high levels of moisture in the affected areas. Such moisture will cause rust and decay of the associated building materials.

There must not be any of the builders debri and associated building materials left on the roof after each day of work, to reduce or stop damages occurring as this roof has experienced.

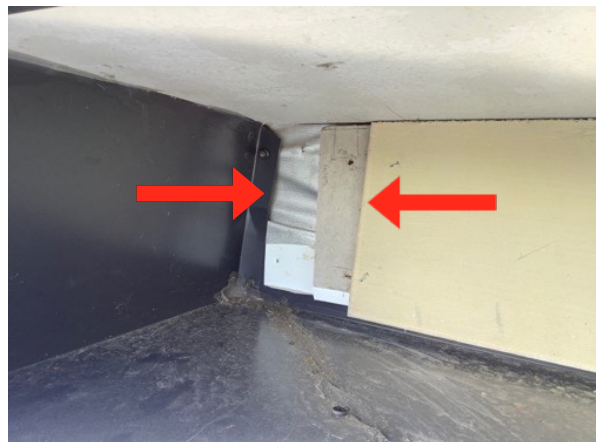
Incomplete 4.19

Finding: Matrix Sheeting falls short
The Matrix Sheeting falls short and as many areas to the roof, this area and areas like this create, pest ingress, water ingress creating wood rot and further secondary building defects.

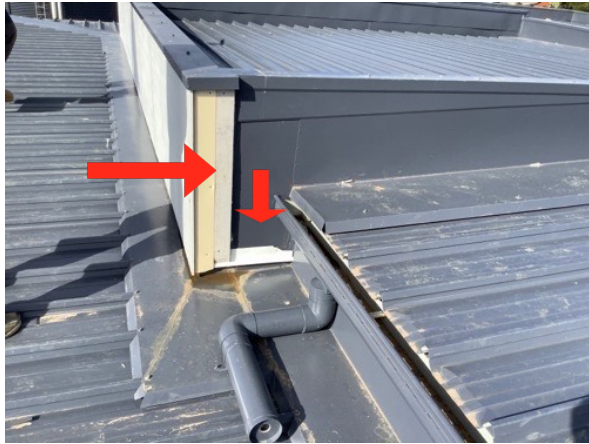
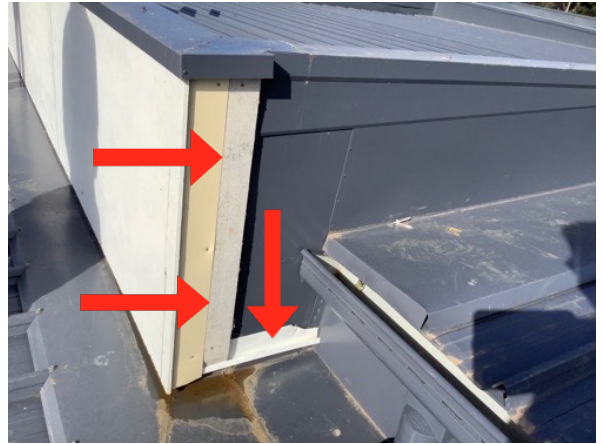
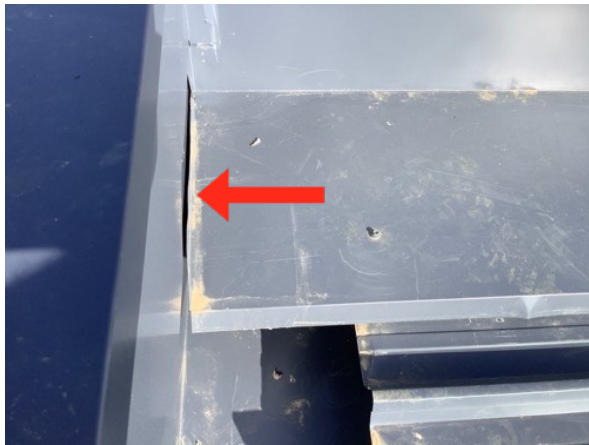
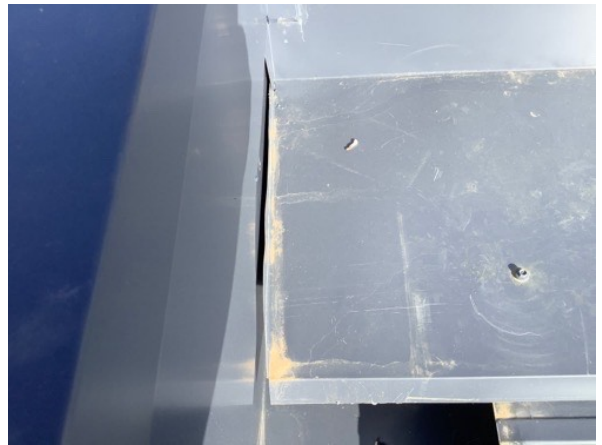
Incomplete 4.20

Finding: Incomplete works
Further incomplete works exposed to the weather creating further secondary building damages.
