# Post-Concrete Pour Slab Report - After Frame & Bricks Installed.

Inspection Date: 25 Aug 2020

Property Address: Craigieburn Area

Report Type: New Home Construction

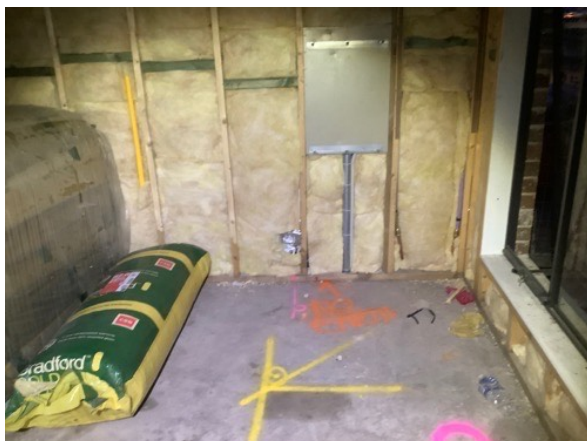
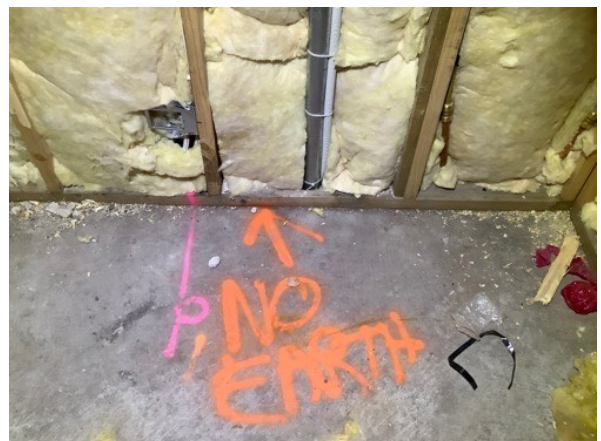
### Safety Hazard 1.01

Finding: Safety hazard - Earth Rod Connection To Steel Mesh Appears Missing.  
The earthing facility installed to the dwellings slab steel as required in AS 3000 has not been connected and/or installed.  
I refer the builder to AS 3000, clause 5.6.2.5 that states "Any conductive reinforcing within a concrete floor or wall forming part of a shower or bathroom shall be bonded to the earthing system".

Any slabs with wet areas MUST Have an earth bar connected to the steel mesh before the concrete is installed as per AS3000.

The electrician is responsible for these works and he connects an earth wire as per the standards AS3000 to this steel bar connected to the steel mesh before the concrete.

Now this bar is not in the slab and is a major safety concern and again does not comply with AS3000.

I can not stress enough that this project does not continue over this defect item until I completed and approved paperwork from the structural engineer and electrical inspections Victoria inspect and provide paperwork.

I highly recommend that the builder and electrician determine the method of repairs, but now since the slab will be structurally compromised, the electrical inspector and the structural engineer will need to be involved and I MUST request documentation as to the repair methods from the electrical inspector and the design and repair method from the structural engineer for the concrete.

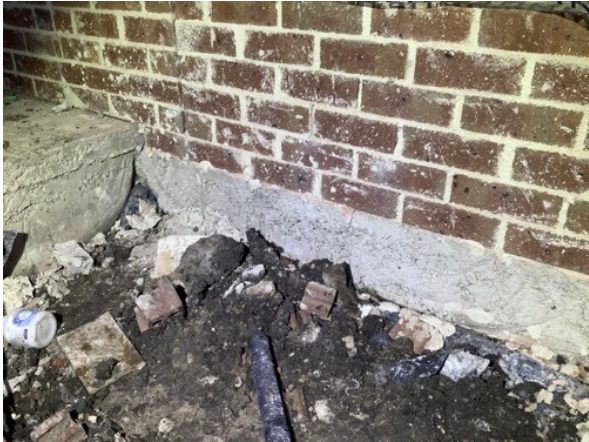
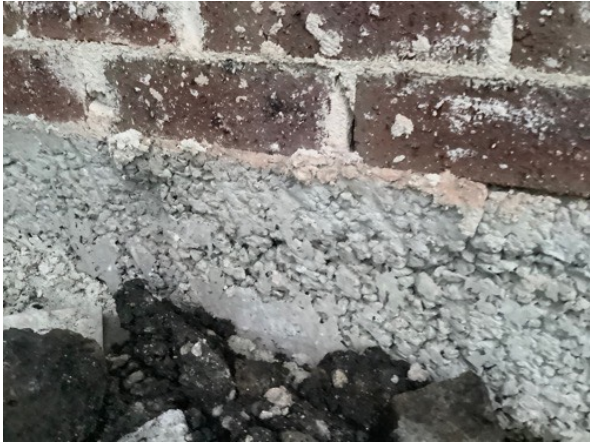
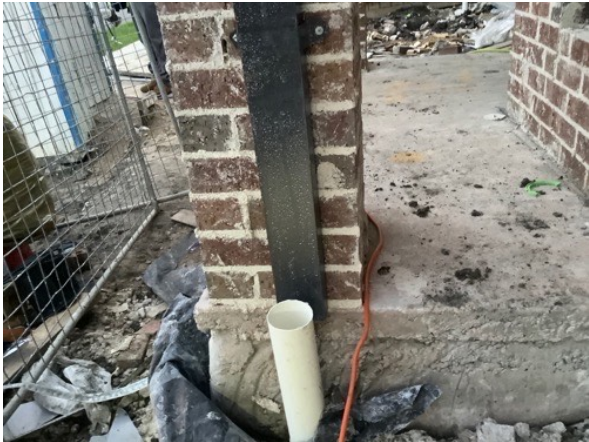
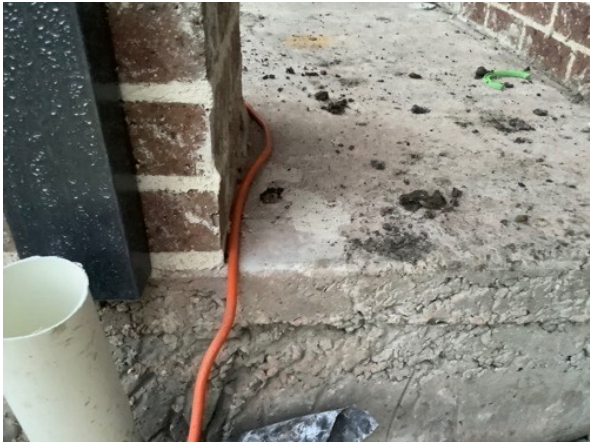
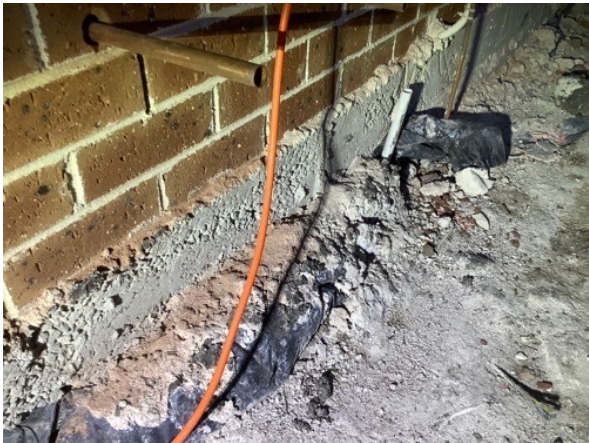
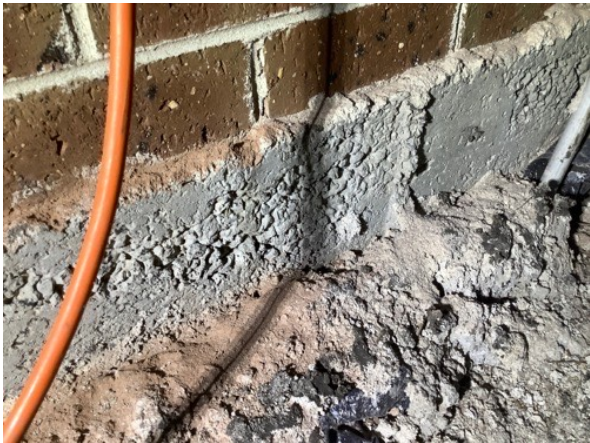
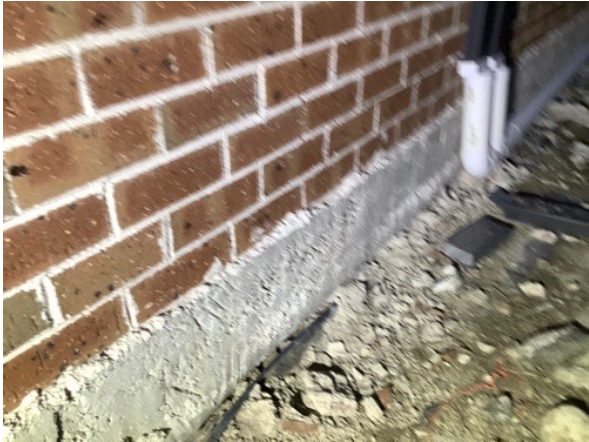
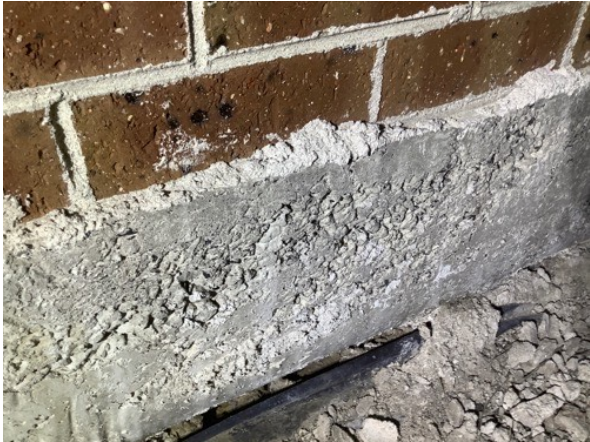
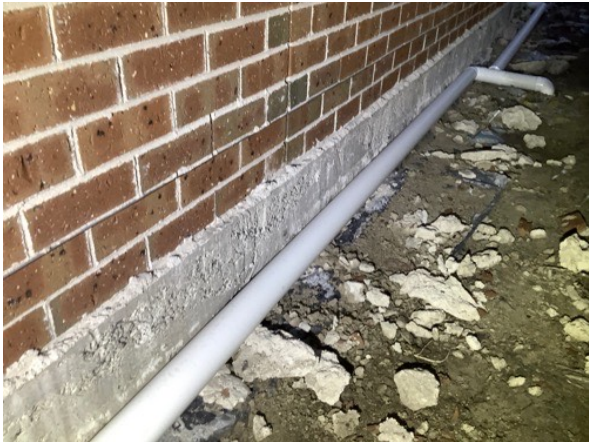
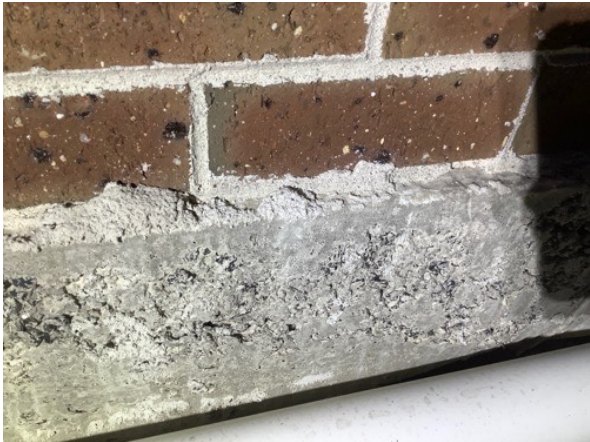
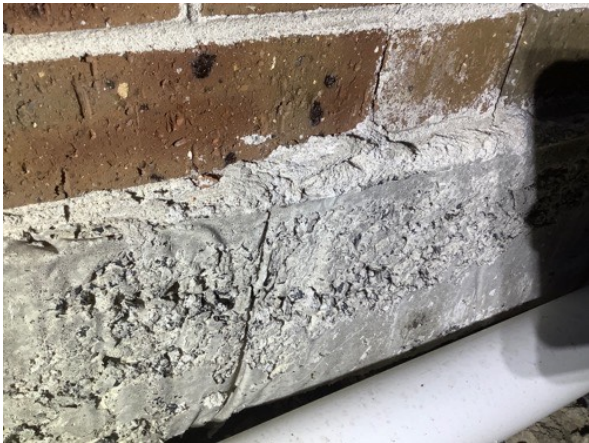
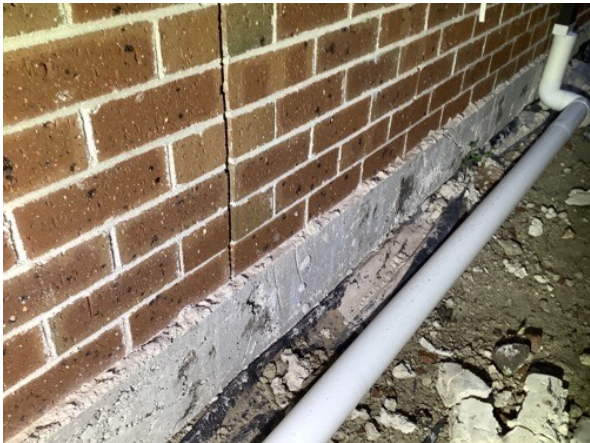
## Non Compliant 2.02

Finding: Compaction Of The Slab.( Honeycomb Evident )  
At the time of the inspection it appears that the slab has not been mechanically compacted as per the requirements of AS 2870. I refer the builder to:

Looking at the side of the slab, it appears evident that the slab has not been vibrated to all parts. The honeycomb effect that is made up of hundreds of air pockets is what should not be present.

Had this slab been vibrated to all parts, then this honeycomb effect would not be present and the concrete would have a smooth like finish.

The defect is that if it has not been done to the outer skin of the exposed areas, then the likely

hood is that the internal of the slab has the same honeycomb effects as well and if this is the case then the density of the concrete will be compromised.

It is highly recommended that you :

-/ Seek engineering advice.

-/ Seek a Compressive Strength Test to check the MPA strength after a certain period of cure time.

-/ Sample the slab via a core hole or several core holes that are taken by a NATA accredited testing agency. Note the NATA testing agency must take the samples to ensure a reliable chain of evidence.

-/ Share the results with my client and the engineer.

-/ Upon all the results a conclusion that meets the AS 2870.

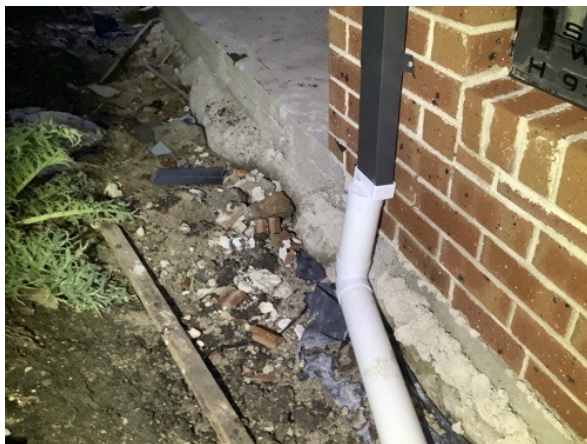
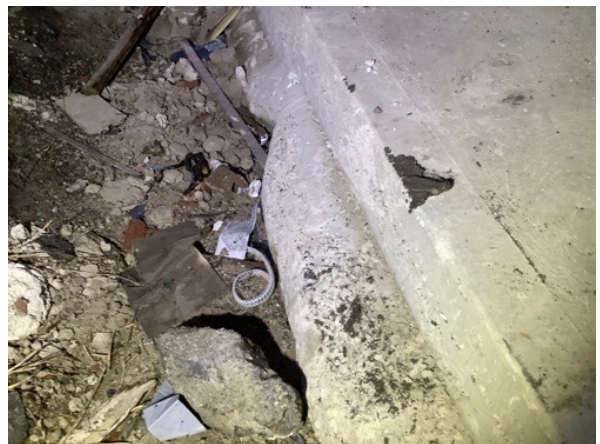
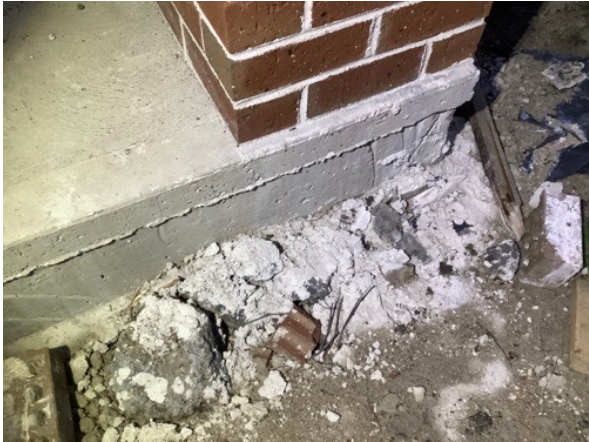
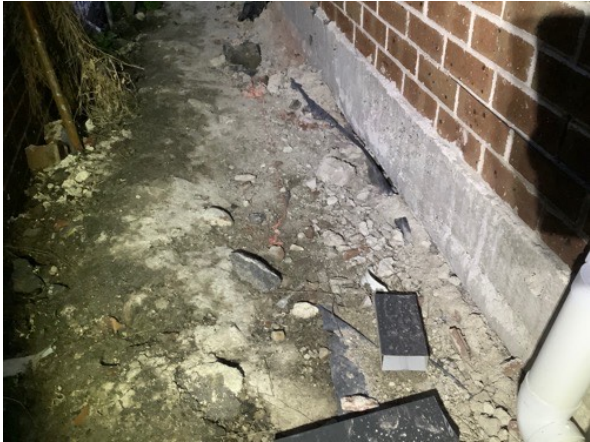
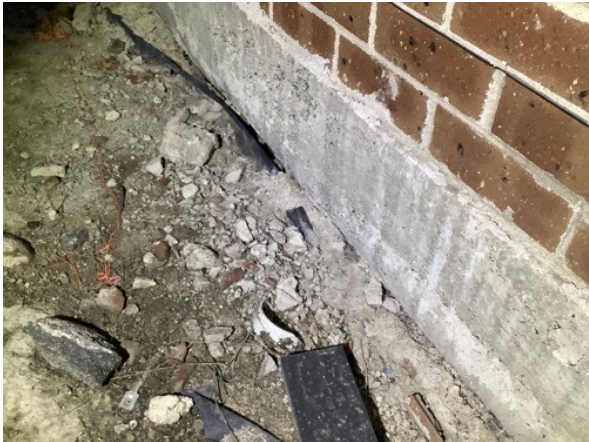
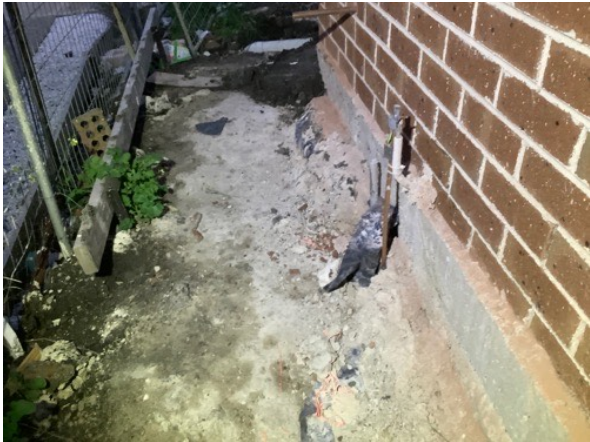
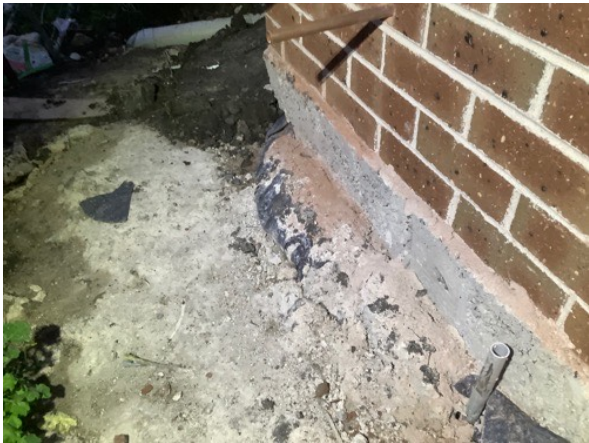
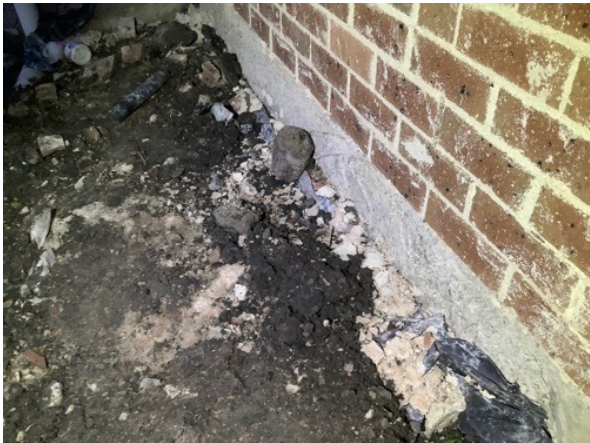
## Non Compliant 2.03

Finding: Slab Over Pour - Not Acceptable.  
The slab has been installed with what is known as over pour.  
The over pour will affect the home owner's ability to install paving and other landscaping.

THIS WILL EFFECT THE VAPOUR BARRIER SYSTEM, WHICH IS EXTREMELY IMPORTANT AND MAY ALSO EFFECT THE APPEARANCE OF THE HOME, ONCE THE CONCRETE PAVING AND/OR GARDEN IS COMPLETE.

The over pour will need to be removed. This will require:

- / Seek engineering process and design for rectification of this defect.
- / Document same.
- / Send the engineering to the site surveyor for approval.
- / Have the site surveyor witness the repair of the slab to ensure that the builder has carried out the works in accordance with the process's and rectification statements in the engineering documentation.
- / Supply a copy of all to my client as per section 26 of the Domestic building contracts Act 1995.
- / Satisfy the defect has not been hidden by placing soil over the edge beam of the over poured slab.

I HIGHLY RECOMMEND WITHOUT ANY COMPROMISE, THAT THE BUILDER RECTIFY THE DEFECTIVE CONCRETE SLAB PERIMETER WITHOUT COVERING WITH SOIL , CRUSH ROCK, BRICK LAYERS MORTAR DEBRI OR ANYTHING ELSE.

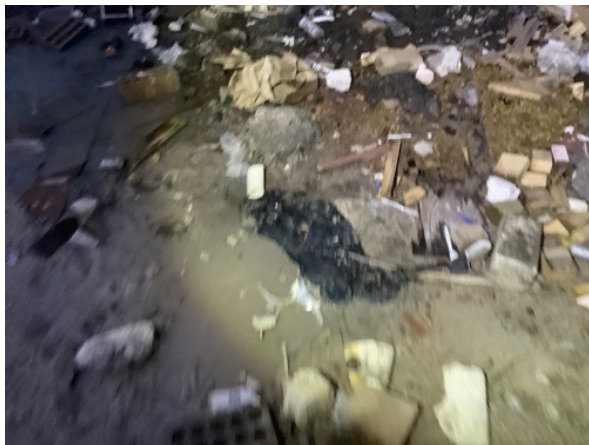
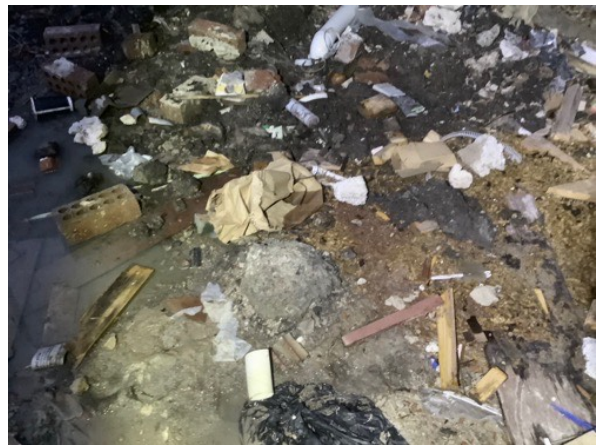
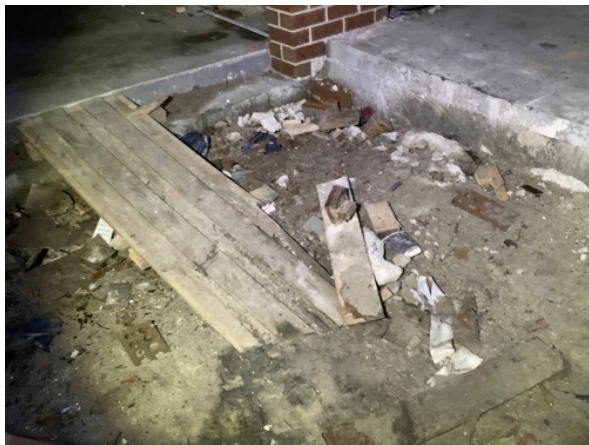
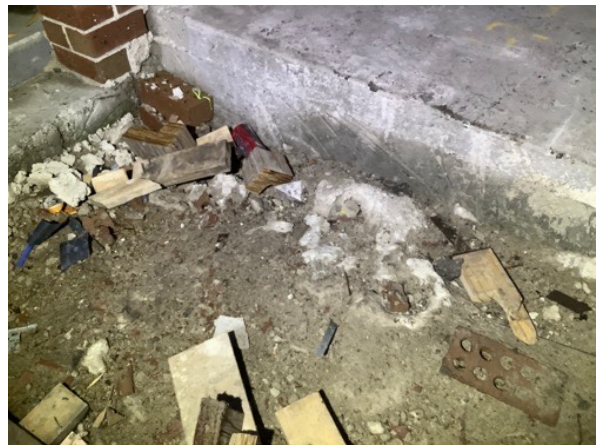
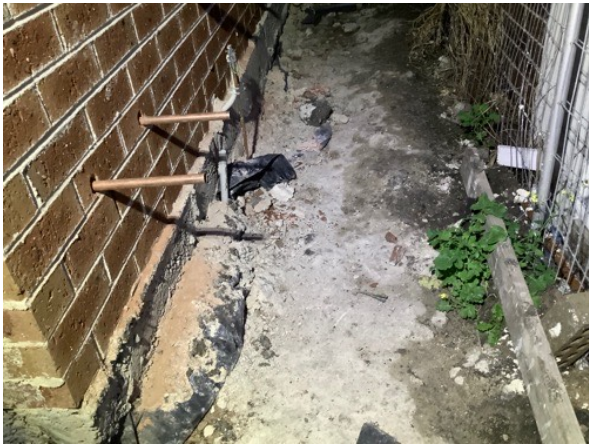
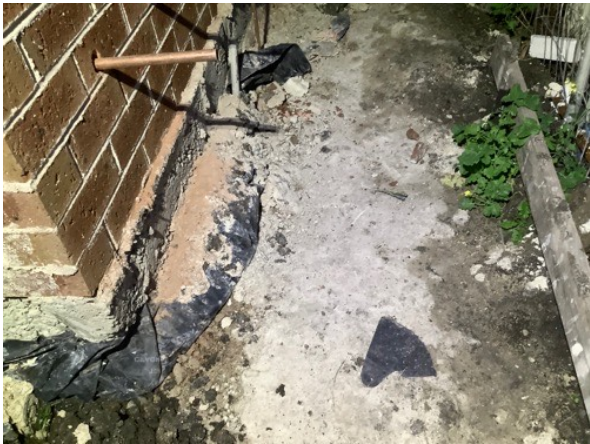
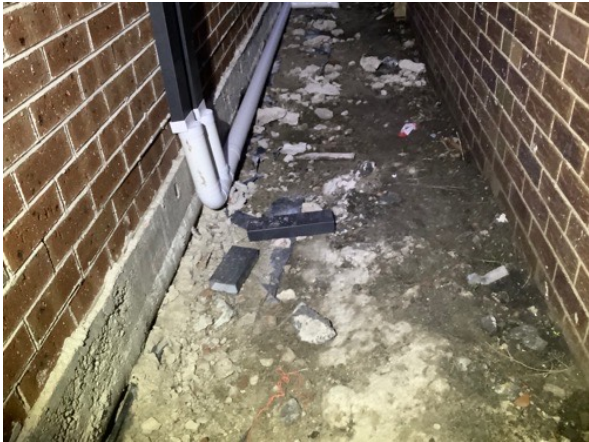
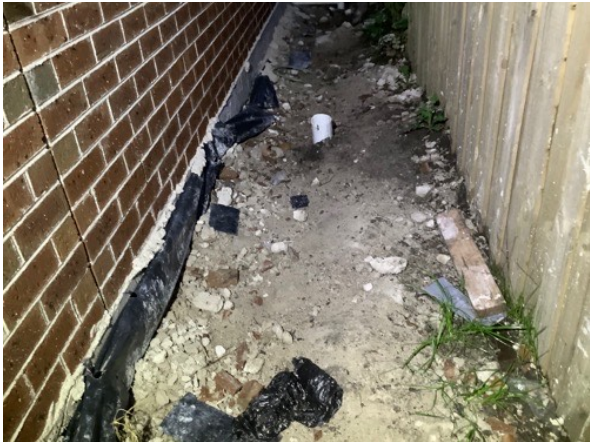
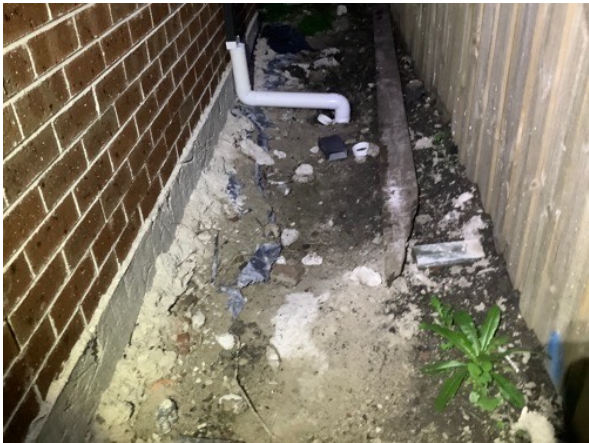
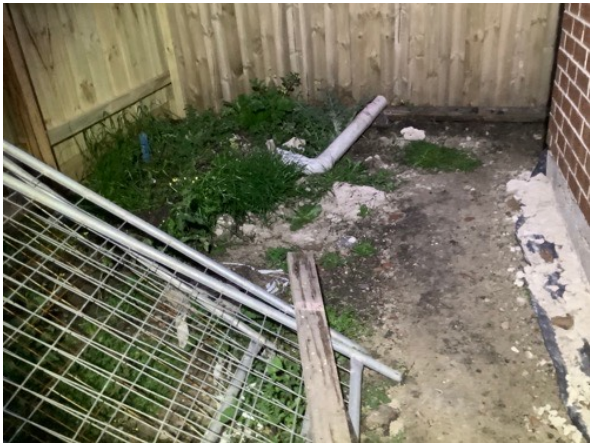
## Non Compliant 2.04

Finding: Builder Concrete Waste - Remaining

It was noted that there is excessive amount of concrete ( builder waste ) on the site in various areas. All builders waste must be removed as per the contract.

The builder must use all endeavours to ensure that the site is safe and left clean whilst in construction and a clean, builders waste free site prior to final handover as per the building act and contractual agreements.

I HIGHLY RECOMMEND WITHOUT ANY COMPROMISE, THAT THE BUILDER RECTIFY THE DEFECTIVE CONCRETE SLAB PERIMETER WITHOUT COVERING WITH SOIL , CRUSH ROCK, BRICK LAYERS MORTAR DEBRI OR ANYTHING ELSE.

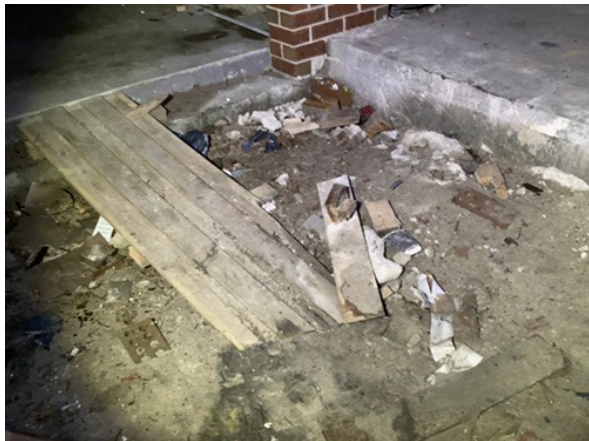
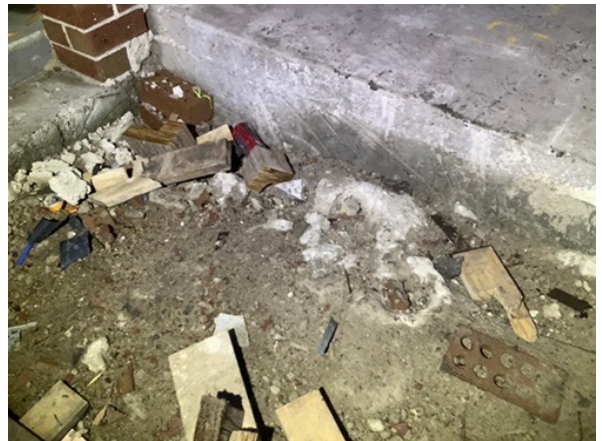
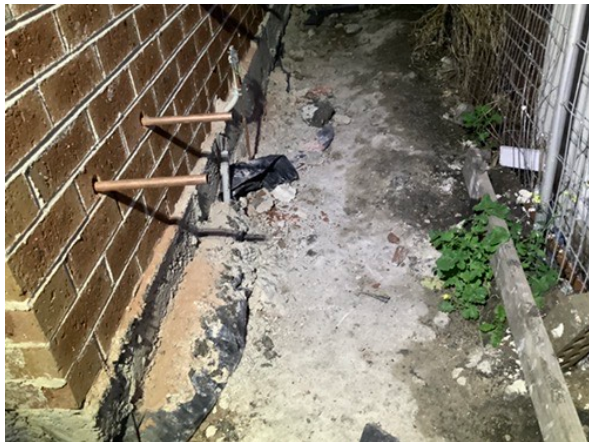
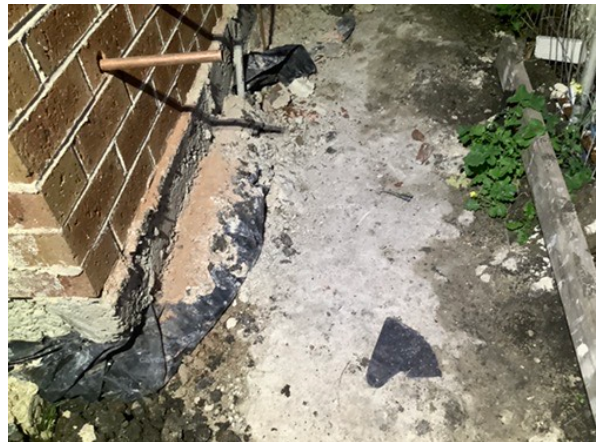
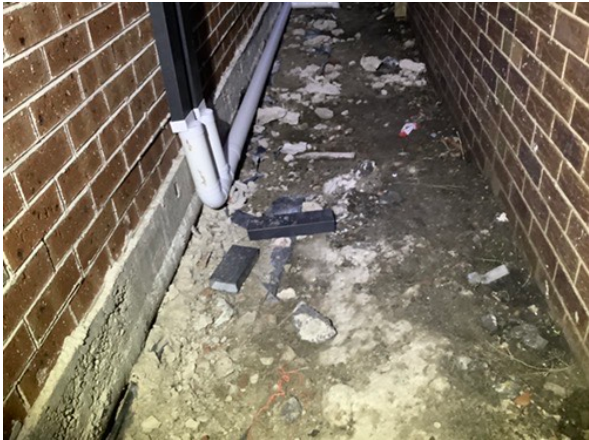
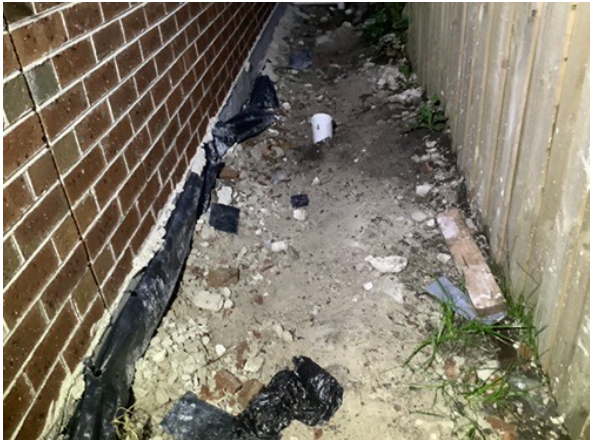
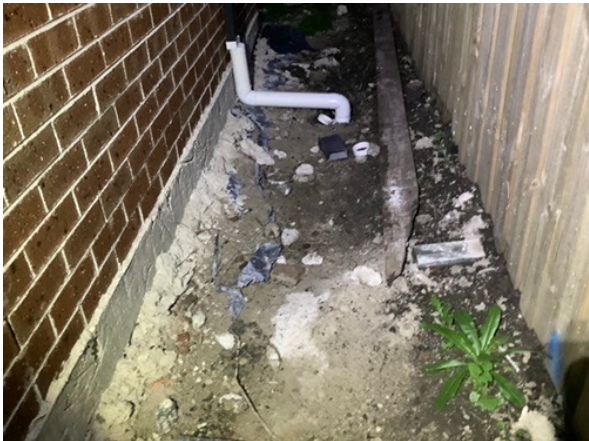
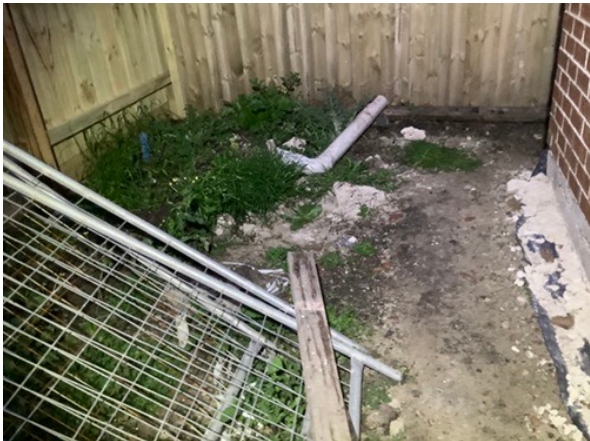
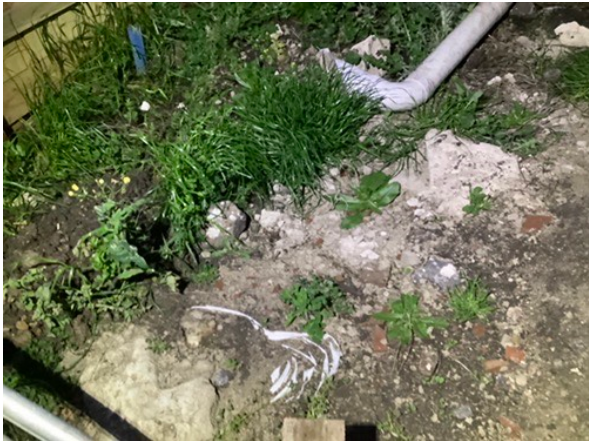
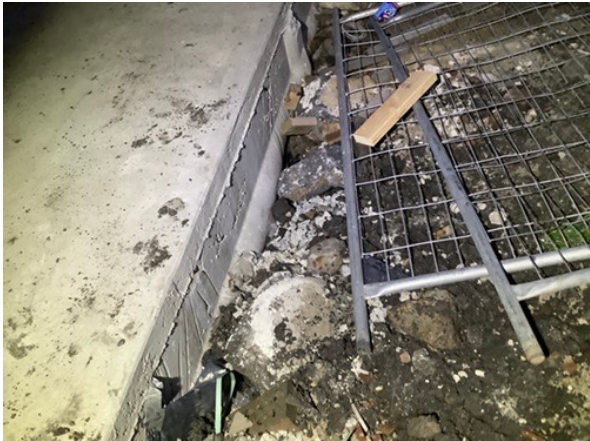
## Non Compliant 2.05

Finding: Excessive Concrete (Builders Waste/Debris)-Slab over pour or excessive builders concrete waste

Due to the excessive builders concrete waste/debris, it is unclear if some of it is builders concrete waste or if it is slab over pour and it is very important to rectify this before any covering up is performed around the perimeter of the concrete slab. THE POSSIBILITY OF ALL 3 DEFECTS IS ALSO VERY POSSIBLE.

This excessive concrete has also severely compromised the vapour barrier system as well.

I HIGHLY RECOMMEND WITHOUT ANY COMPROMISE, THAT THE BUILDER RECTIFY THE DEFECTIVE CONCRETE SLAB PERIMETER WITHOUT COVERING WITH SOIL, CRUSH ROCK, BRICK LAYERS MORTAR DEBRIS OR ANYTHING ELSE.

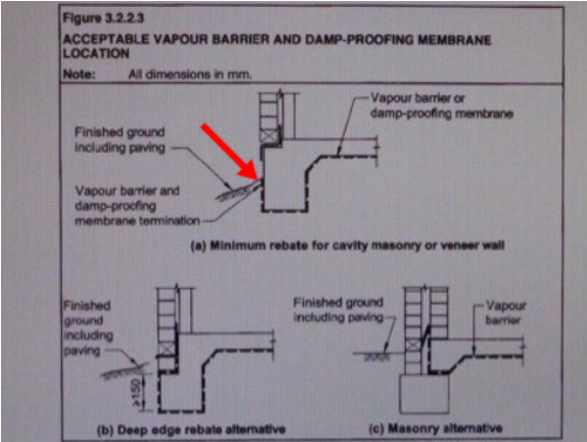
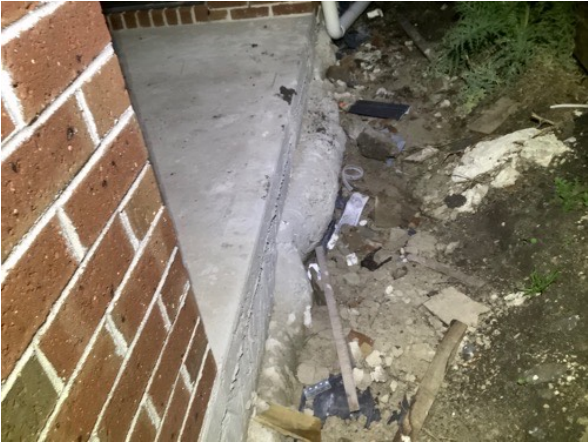
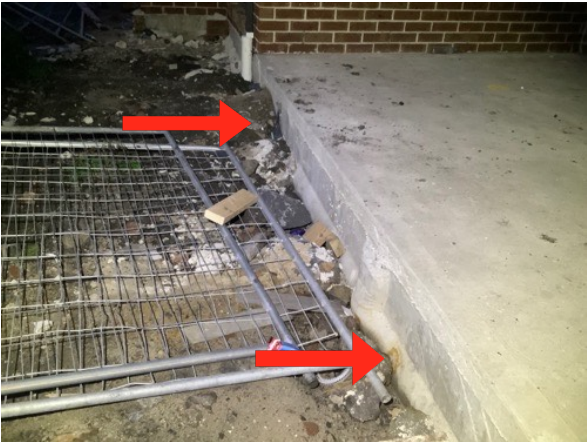
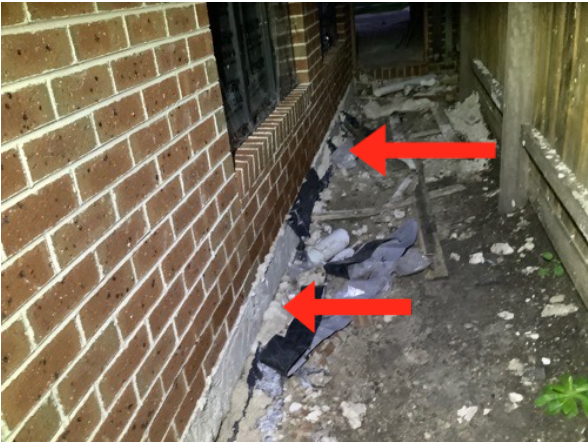
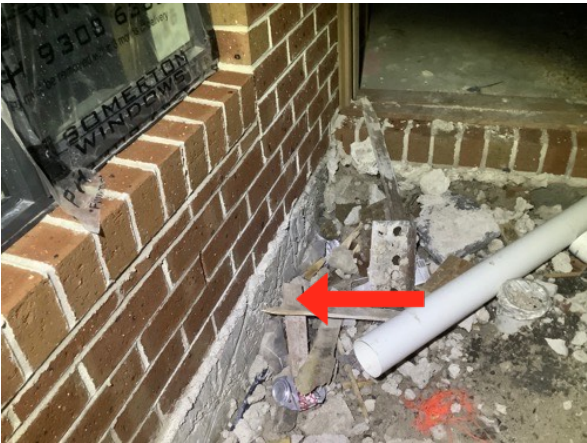
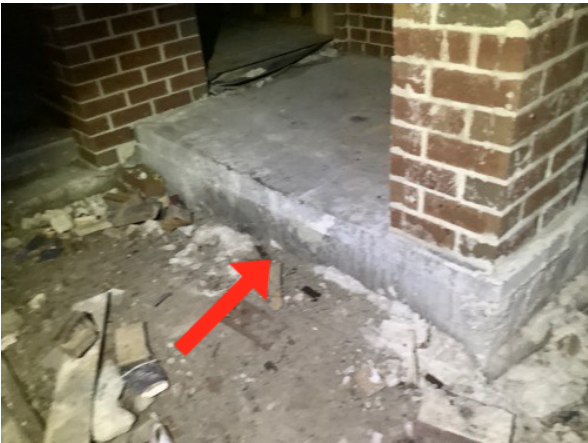
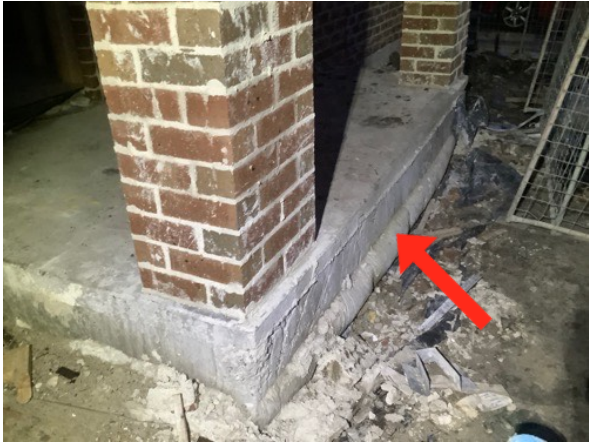
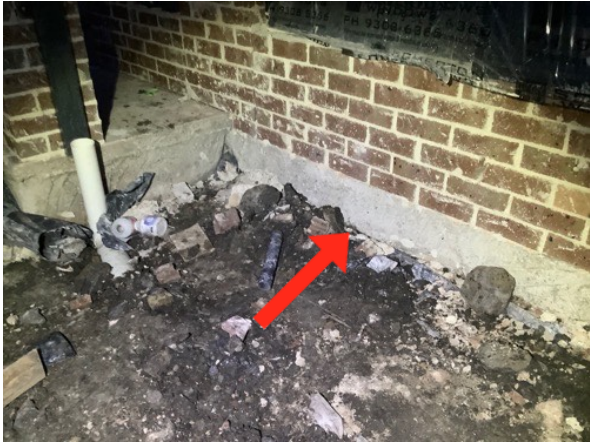
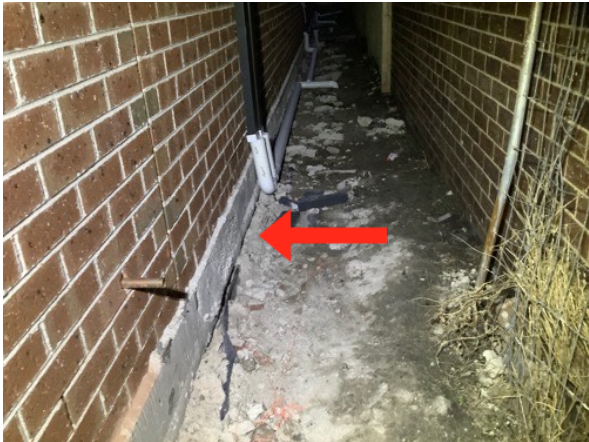
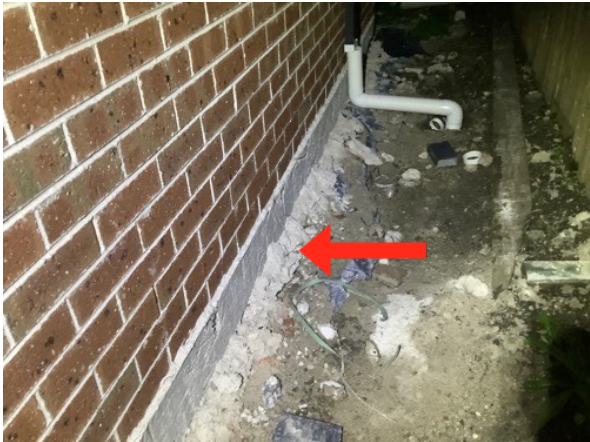
## Non Compliant 2.06

Finding: Polyethylene vapour barrier not installed as per BCA - Part 3.2.2.6  
The vapour barrier system has NOT been completed and installed in accordance with AS2870 and BCA Part 3.2.2.6. ALL areas of non compliance are required to be repaired.

The builder has not completed the vapour barrier system to the porch area and the alfresco area concrete perimeter. These areas require the exact same requirements for a vapour barrier system without compromise as the slab of the main building area.  
Some builders argue that these areas of porches, alfresco's and the like do not require the same vapour barrier system, however this is not an accurate statement and under Australian Standards the entire slab area including porches, Alfresco's and any other added areas to the main building must have the vapour barrier as well.  
There is no distinction in any supporting evidence of building code or Australian standards to state otherwise.

It is obvious that the concrete contractors have added additional plastic on the day of the concrete pour, however this added plastic is just sitting there.  
The photos are very clear examples of the plastic doing nothing or minimal as the plastic MUST BE TAPED AT ALL PLASTIC JOINS at a minimum of 200mm overlap and taped with an appropriate tape and it clearly isn't the case on this job.

The polyethylene vapour barrier from beneath the concrete floor slab must be turned up the external side faces of its edge beams. Failing to install the vapour barrier correctly will allow moisture ingress via slab edge dampness into the internal timber wall skins and/or the floor coverings if not done.

Without a vapour barrier installed, these areas are non-compliant with Australian Standards and are susceptible to excessive moisture, which may create major secondary defects as the building ages. Rectification works are necessary as soon as possible to ensure all standards are met.

### Repair Method :

To entirely dig the external perimeter of the building at least 300mm below the vapour barrier system (black plastic) damaged areas, which will vary in areas and then overlap the existing plastic with the new plastic by a minimum of 200mm and taped.

The overall height of the plastic must be above the top of the slab rebate surface for now at construction stage.

The plastic must be hard against the concrete with no soil, rocks and/or builders debris in between the slab and the plastic.

Any over pour of concrete must be cut flush and include engineers report for alteration works and if steel is visually seen must now also be notified to the structural engineer to determine the remedial works.

- 2/ All the ripps and/or damaged area needs to be taped.
- 3/ ALL areas are not up to future ground and/or finished paving or concrete heights and must be extended with 200mm overlay and taped.
- 4/ Some areas whilst listed above are Damaged / Ripped / Not Consistent And Sealed with 200mm Overlay And Taped / Not High Enough / Non Existent must ALL be repaired.

The polyethylene vapour barrier must properly extended up the external side faces of the edge beams to at least 600mm above the height of the slab for now and then at future finished ground level of the solid, concrete , etc.

I HIGHLY RECOMMEND WITHOUT ANY COMPROMISE, THAT THE BUILDER RECTIFY THE DEFECTIVE CONCRETE SLAB PERIMETER WITHOUT COVERING WITH SOIL , CRUSH ROCK, BRICK LAYERS MORTAR DEBRI OR ANYTHING ELSE, PRIOR TO A RE-INSPECTION BY Master Property Inspections.

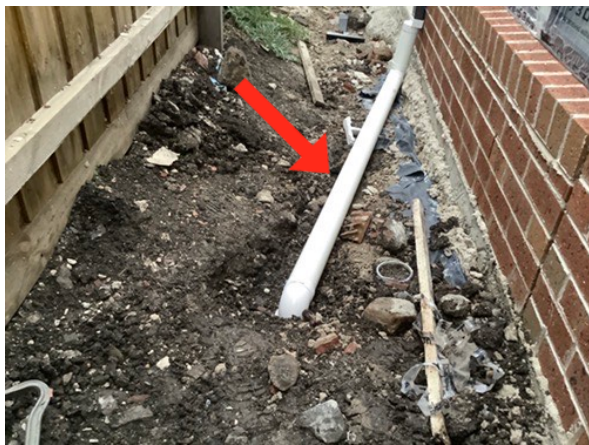
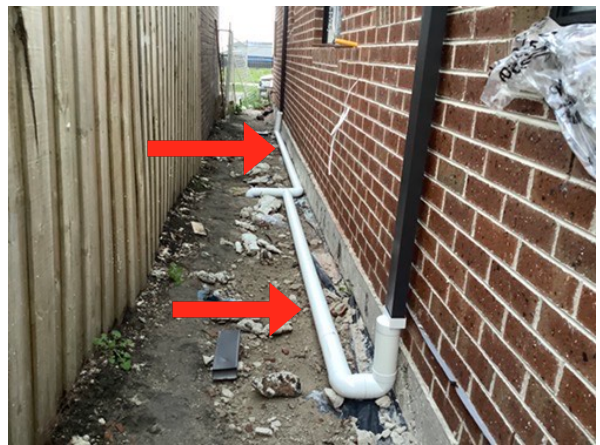
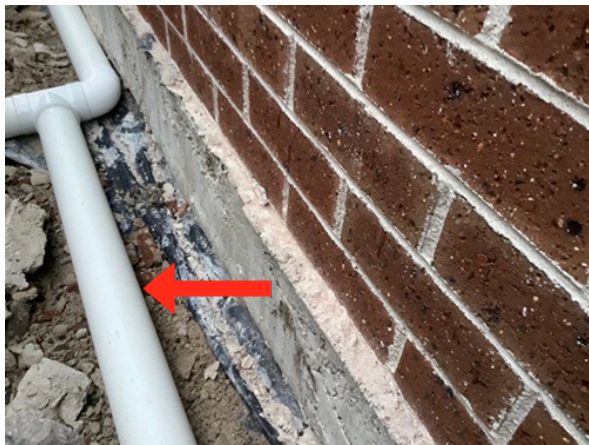
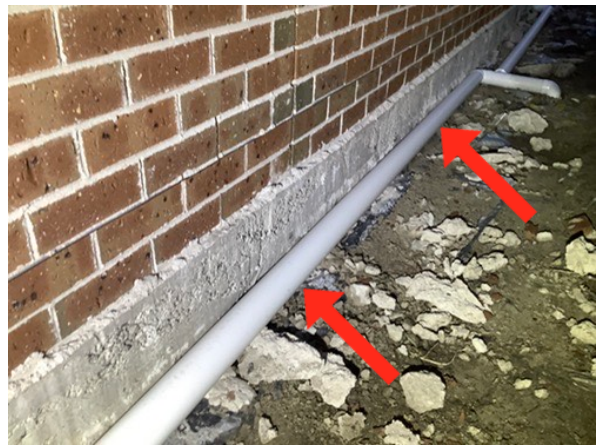
## Non Compliant 2.07

Finding: Stormwater Min depth in Soil  
(c) Cover to stormwater drains:  
the cover to 90 mm Class 6 UPVC stormwater drains installed underground must be not less than—  
(i) under soil — 100 mm; or  
(ii) under paved or concrete areas — 50 mm; or  
(iii) under areas subject to light vehicle traffic—  
(A) reinforced concrete — 75 mm; or  
(B) paved — 100 mm.

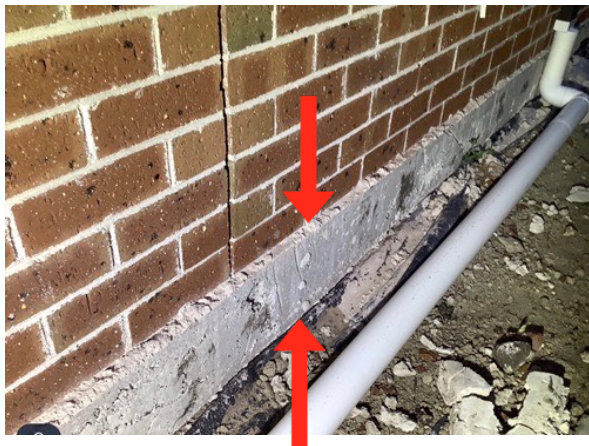
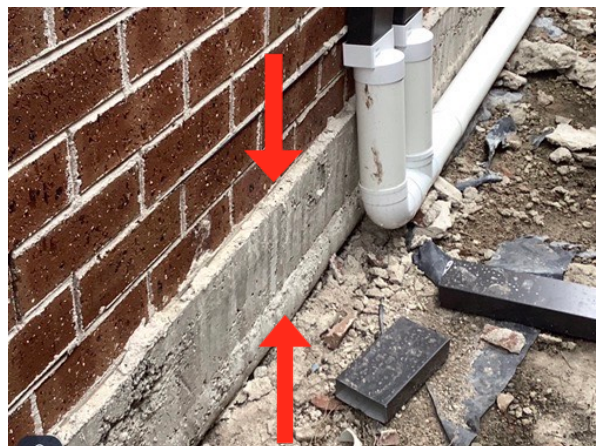
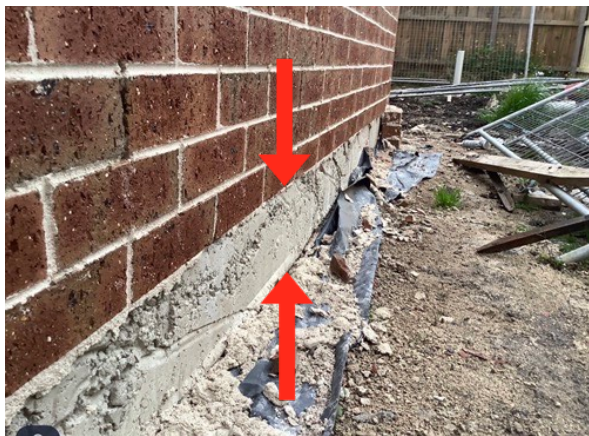
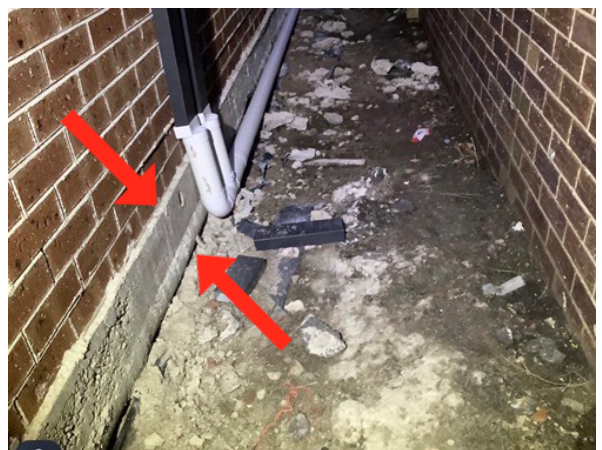
## Non Compliant 2.08

Finding: Concrete slab – rebate height, appears to high.  
The rebate for the brickwork to sit on to the concrete slab perimeter appears too high. This will not be covered and visually will be very displeasing to the eye. This is not normal practice to have a brick rebate so high.

The rebate for the brickwork to sit on to the concrete slab perimeter appears excessively too high. This will not be covered and visually will be very displeasing to the eye. This is not normal practice to have a brick rebate so high, with such a large amount of the concrete slab exposed.

I highly recommend that the plans get reassessed by the engineer to determine the correct brick rebate height.

I highly recommend that the plans get reassessed by the engineer and the surveyor to determine the correct brick rebate height and how this can be rectified.
