Vendors Report - Building/Termite/ Asbestos/Electrical/Digital Floor Level Assessment

Inspection Date: 5 Aug 2020

Property Address: Sunshine Area

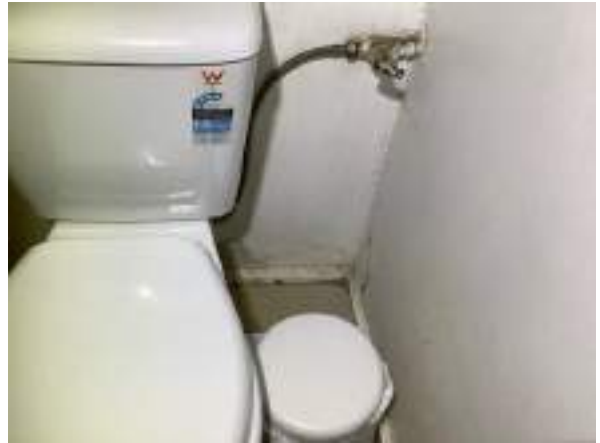
Serious Safety Hazard 1.02

Sections of paint in this area was found to have bubbled and deteriorated. Paint bubbling is generally an indication of excessive moisture in the area, that is currently hidden by the painted surface.

The presence of excessive moisture can have major implications on associated building elements if left unattended. While only seemingly minor at this stage, the damage cannot be determined due to the paint obstructing any further inspection of the damage.

It is highly advised that the affected paint be cleaned to allow a further, more invasive inspection by a licensed plumber. Failure to act on this defect may necessitate major works in the future.

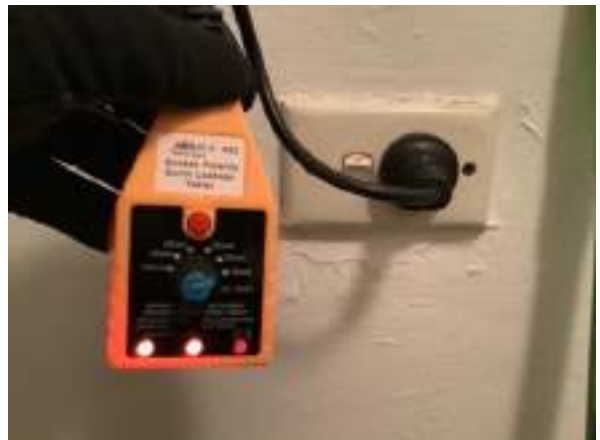
Serious Safety Hazard 1.05

This can place the person in a very dangerous situation in the event of a faulty appliance and may cause electrocution.

These tests DID NOT pass the AS 3000 requirement and exceptance level as noted above there is NO Safety Switch installed.

It is HIGHLY RECOMMENDED that you engage in a qualified electrician to install a new switchboard with a safety switch or at a minimum install a safety switch.

A Certificate of Electrical Safety is required for all electrical works and a electrical safety inspection is highly recommended upon completion of all electrical repairs.

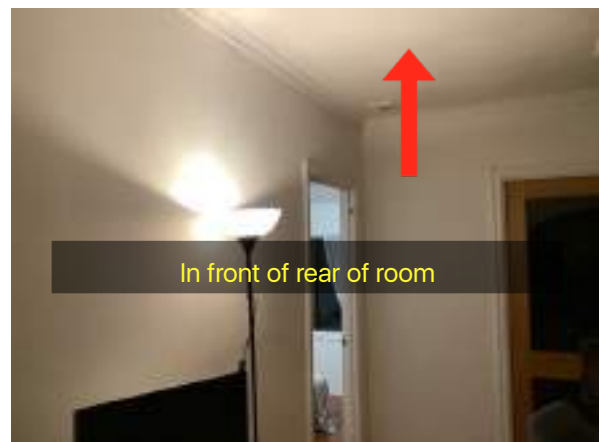
Serious Safety Hazard 1.06

Please note that this defect is highlighted as a caution only. We suspect, based on our experience in the building industry, that the absence of smoke detectors should be addressed as a matter of urgency to improve occupant safety.

Upon completion a safety certificate is required to be supplied to the owner of the building.

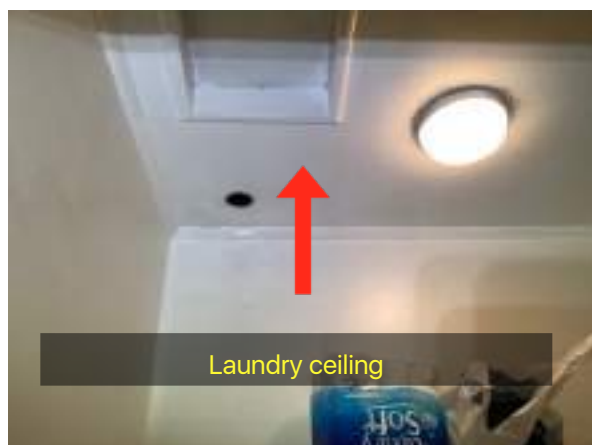
Serious Safety Hazard 1.07

Asbestos can be in the old wardrobes and cupboard areas, asbestos can be in the flu systems of the old hot water services or heater flu systems. Asbestos can be on the walls or ceilings. Asbestos can be in the eaves in the older homes and the exterior walls of the older homes. Asbestos can be found in the roof space areas in the floor space areas and in the old sheds.

Reporting on Asbestos is outside the Scope of this Report. This suspected defect is highlighted as a caution ONLY and is ONLY a guide as asbestos inspections are outside the scope of pre-purchase inspection and reports.

As Asbestos Reporting is outside the scope of this report, we advise that you consider a separate Asbestos Inspection and Condition Audit, which can include the taking of samples for definitive confirmation of the presence of Asbestos.

In the interim, the client is advised to act with caution, especially when considering any damage to building materials general wear and tear renovations extensions demolition and general maintenance activities due to the suspected presence of Asbestos.

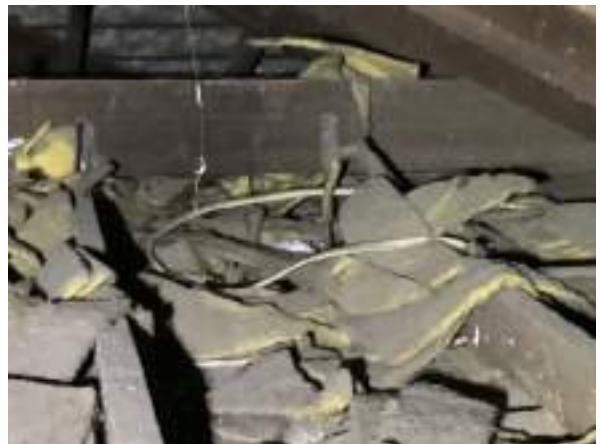
Serious Safety Hazard 1.08

At the time of the inspection we noted that electrical installation items are not compliant with the electrical regulations AS3000-2007 and each picture attached is an electrical installation defect.

All wiring must not go over timbers as any person is at risk of stepping or kneeling on the cables and may damage the cables or worse put them selves at risk of damaging or being exposed to damaged cables that have 240 volts in them.

We recommend that the purchaser engages a licensed electrical contractor to check compliance and make good any defective wiring or unsafe items throughout the entire property including the outbuildings etc.

A Certificate of Electrical Safety is required for all electrical works and repairs performed to this property.

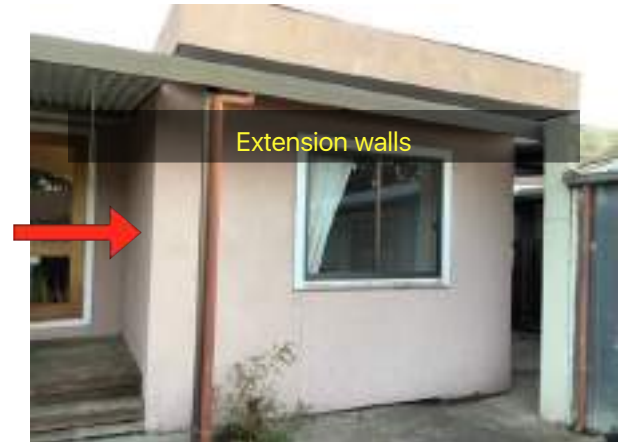
Serious Safety Hazard 1.10

Reporting on Asbestos is outside the Scope of this Report. This suspected defect is highlighted as a caution ONLY and is ONLY a guide as asbestos inspections are outside the scope of pre-purchase inspection and reports.

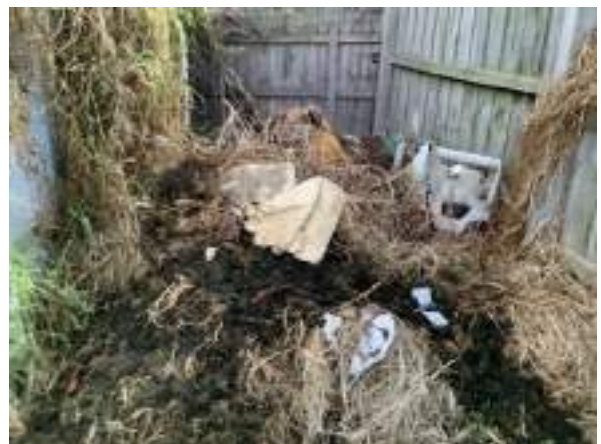
Serious Safety Hazard 1.11

This type of environment also creates a very conducive environment for termites as well.

I highly recommend as a matter of urgency the entire area be cleaned up by a handyman, gardener or competent similar persons and in addition the possibility of Vermin/Rodents/Snakes/Etc maybe of high risk as these conditions would be perfect.

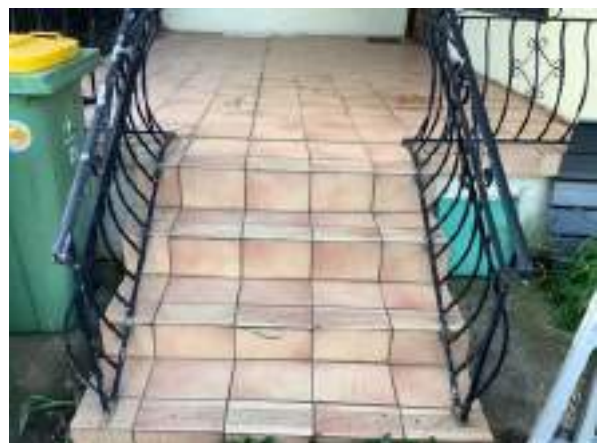
Major Defect 2.15

If left unmanaged, water penetration to these areas may lead to subsequent water damage, which is likely necessitate repair work to affected building elements.

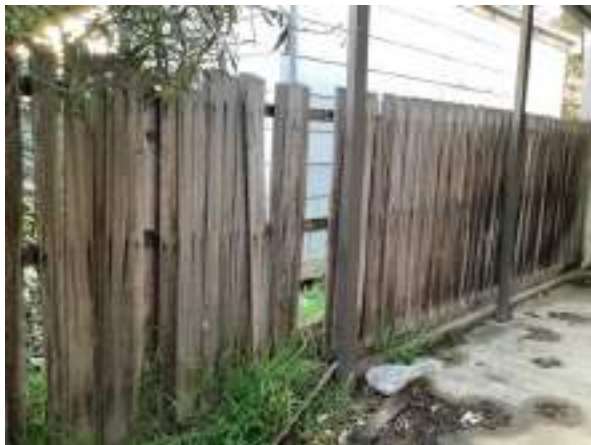
Minor Defect 3.39

It was noted at the time of inspection that sections of the fencing throughout the property have deteriorated. Typically fencing deteriorates due to age or rot which is generally expected for a structure of this age, due to prolonged exposure to weather conditions. A licensed fencing contractor should be appointed to provide further advice and perform rectification works as necessary.
