# Final - Handover Report

Inspection Date: 7 Aug 2020

Property Address: Melbourne

Report Type: New Home Construction

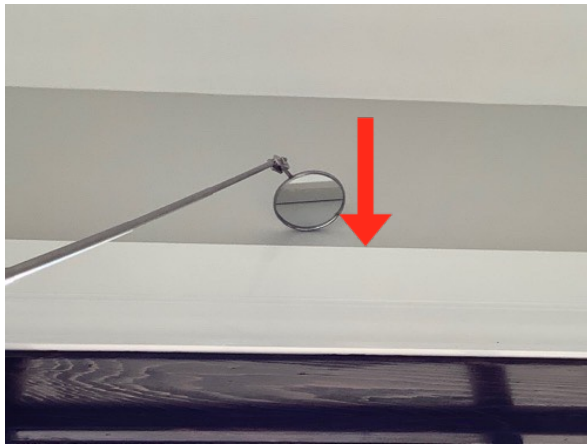
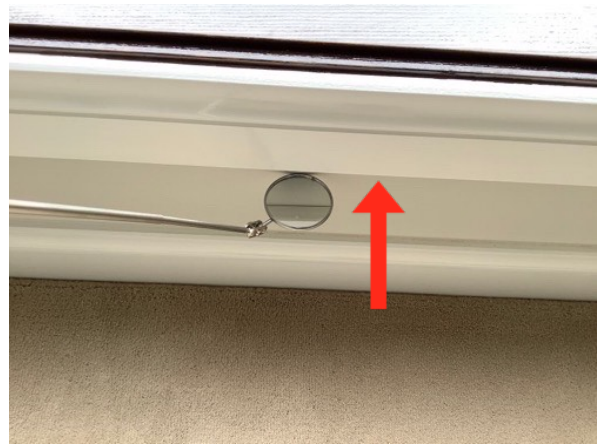
### Non Compliant 2.02

I have ONLY taken LIMITED photos of this defect and attached are LIMITED photos of this defect in SOME AREAS ONLY.

All AREAS to the entire property should be checked CAREFULLY to identify any further defects that are the same, as this defect is in other areas of the property.

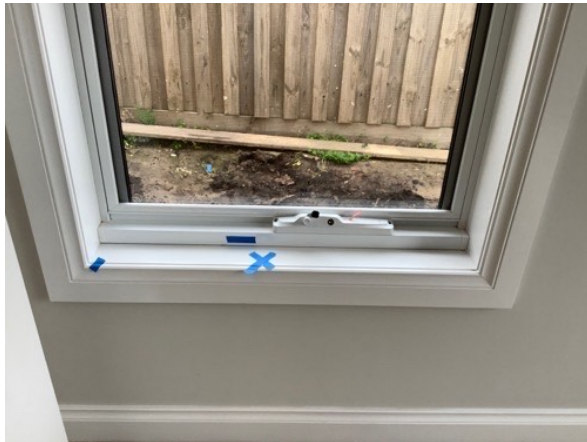
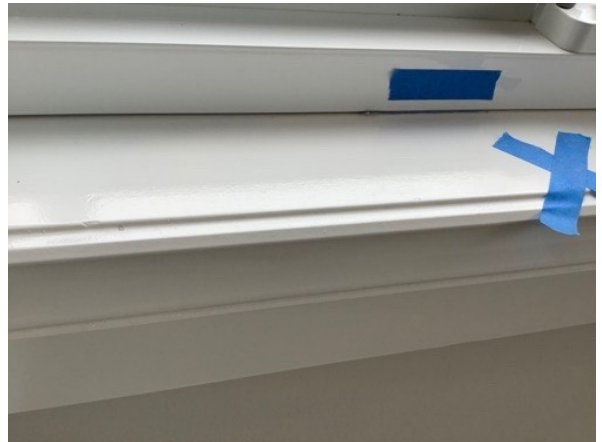
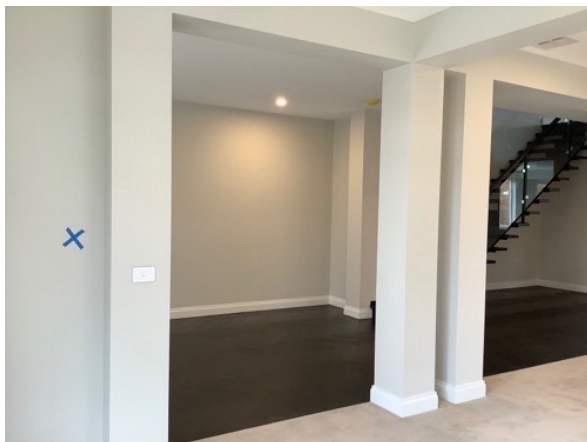
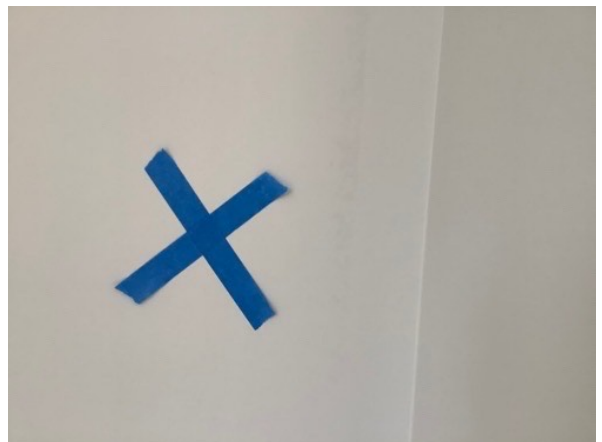
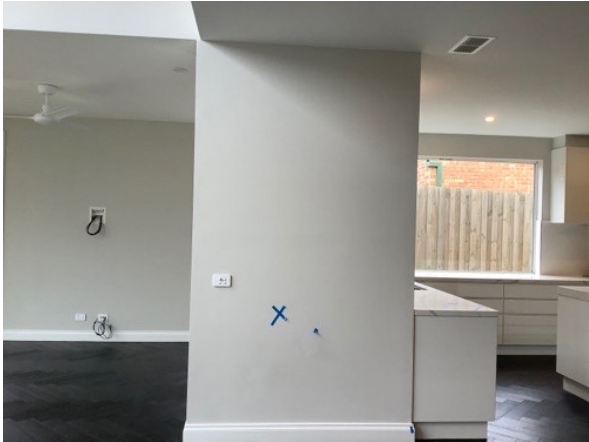
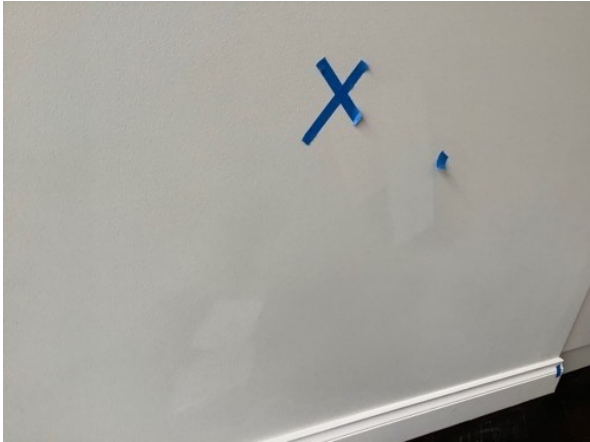
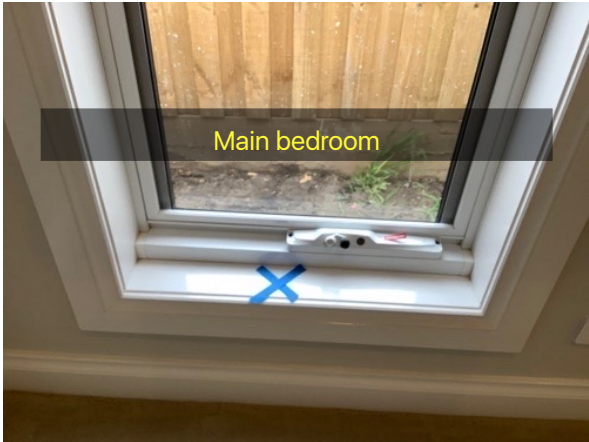
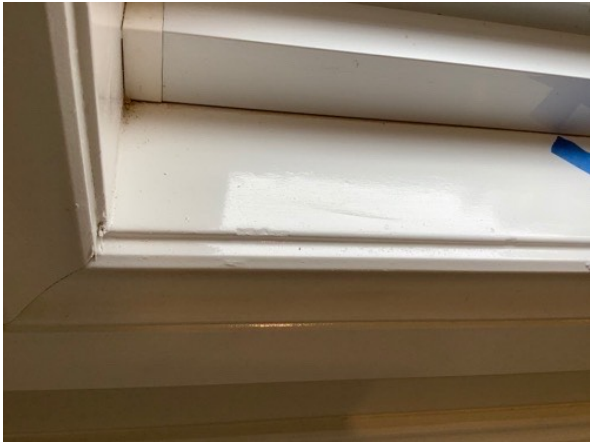
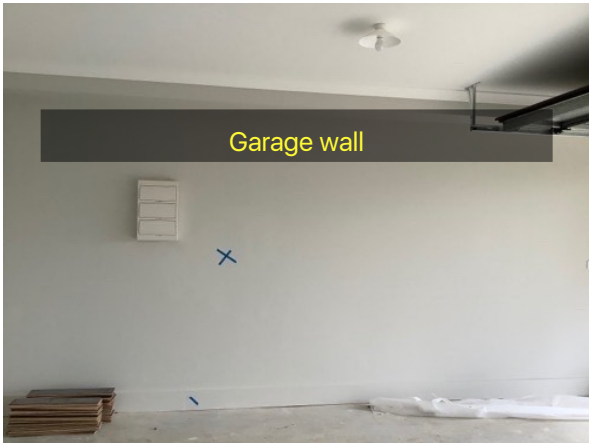
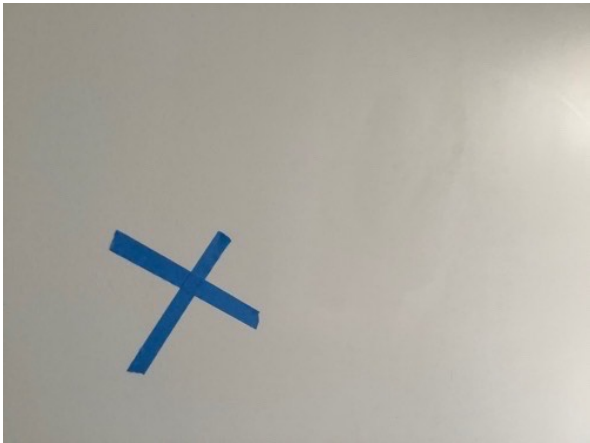
Finding: Paint Surface Finish - Incomplete/Starved/Defective.  
X = entire sand, repair and paint edges to edges

The paint finish in these areas was identified as being incomplete/starved/defective.

Whilst incomplete or missing paint finish is generally an appearance defect, it can also lead to the development of secondary building defects over time. Incomplete areas of paint finish exposes the area to moisture, potentially accelerating the deterioration of underlying building materials.

Incomplete paint finishes should be sanded back, filled, levelled and painted as applicable. Where inadequate or missing paint protection has led to the deterioration of the associated building element, repair and/or replacement of this building element may be required.

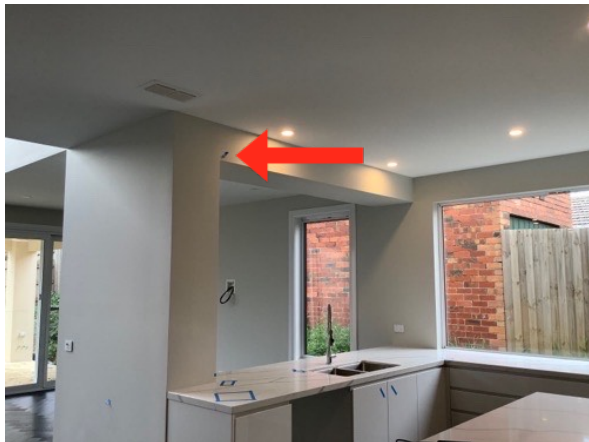
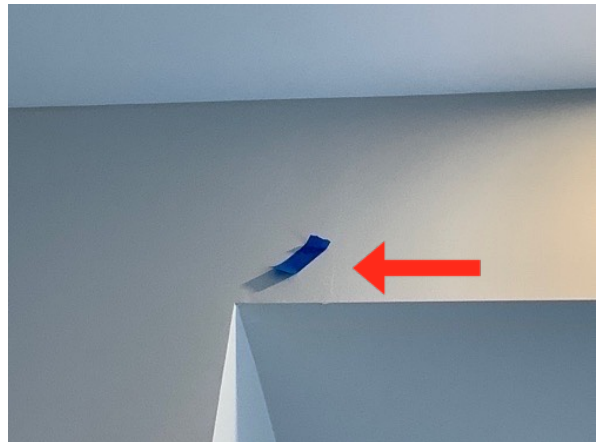
It was noted the plaster joins in the ceiling and walls in these areas as per the photos attached are clearly visible. AS 2589 calls for a level 4 finish to all plaster joins, unless otherwise documented.

The Building Commissions, Guide to Standards and Tolerances clause 9.14 Level of Finish for Plasterboard, states- 'All joint compound will be finished smooth and be free of tool marks and ridges. Additionally, clause 9.19 Peaking or Jointing in Plasterboard states- 'Plaster peaking or jointing is a defect if it is visible from a normal viewing position.'

I highly recommend that the client and builder understand the condition of the plaster to the walls and ceilings as I HIGHLY RECOMMEND that the builder / plasterer inspect ALL rooms and ALL areas of the building carefully to all the walls and ceilings as the plaster does not meet the Australian Standards and Standards and Tolerances.

All plaster work and plaster patching along with all the sanding and preparation to all the areas for repair to the plaster will require to be completed first and then the paint work.

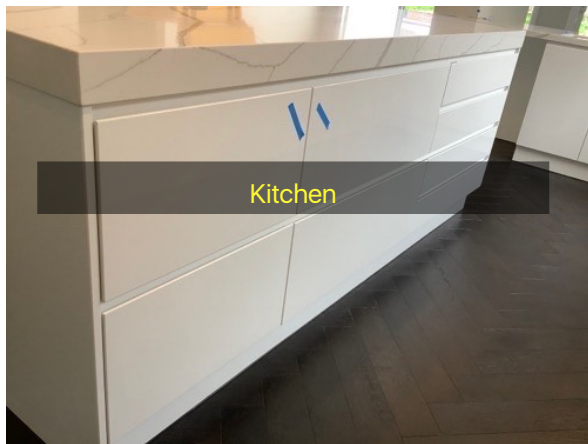
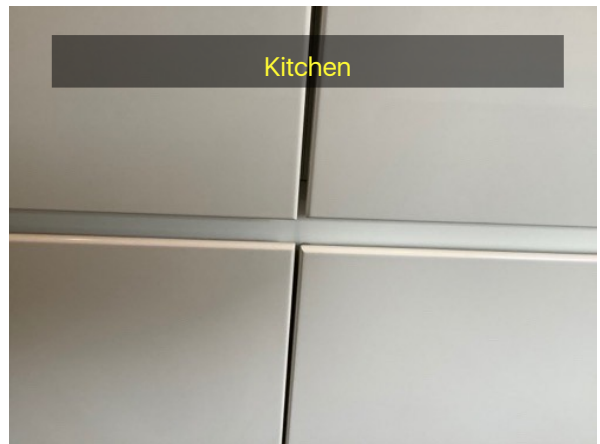
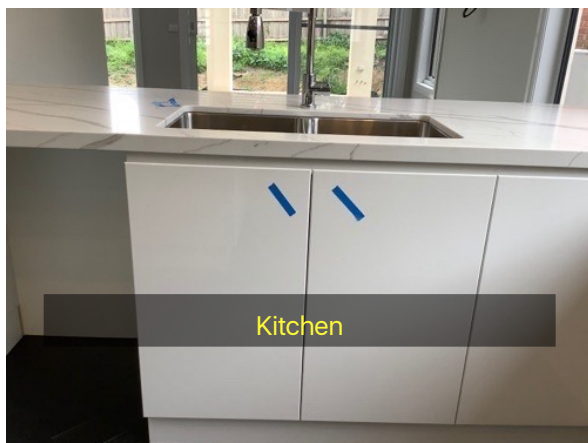
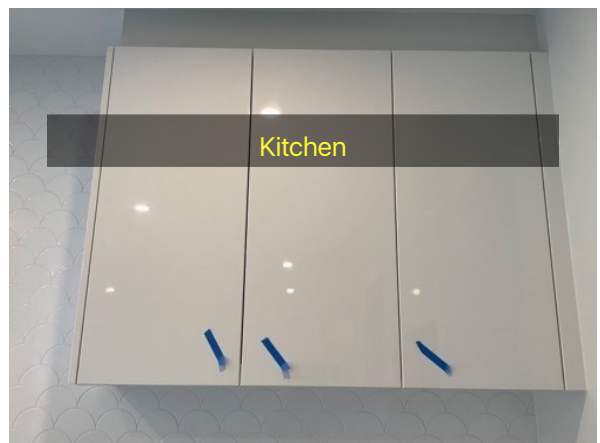
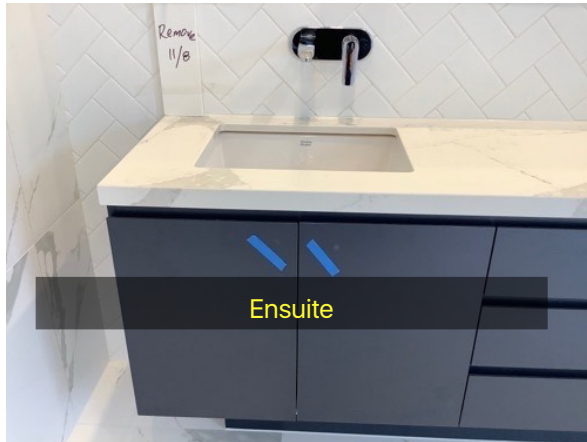
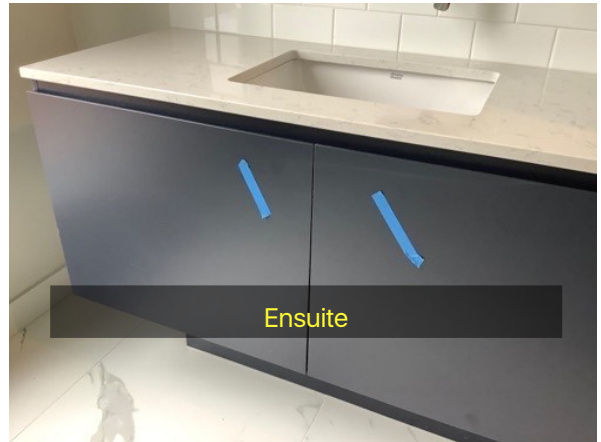
## Non Compliant 2.08

Finding: Cabinet doors - misaligned //. Cabinet drawers - misaligned.  
The photos attached are just a guide to the type of repairs required and are NOT all the defects related to this topic on the property.  
All areas to the entire property should be checked carefully to identify any further defects of the same type.

It is observed that some of the cabinet doors are not aligned and / or have inconsistent gaps between the doors.

It is observed that some of the cabinet drawers are not aligned and / or have inconsistent gaps between the drawers.

The Building Commissions, Guide to Standards and Tolerances clause 8.04 Internal Door Clearances, states- 'The installation of doors is defective if within three months of completion, clearances between door leaves and frames and between adjacent door leaves are not uniform and within 1mm. A clearance between door leaves or between a door leaf and the frame is defective if it is less than 2mm or greater than 5mm in width'

The gaps around these doors must be adjusted to comply with this tolerance.

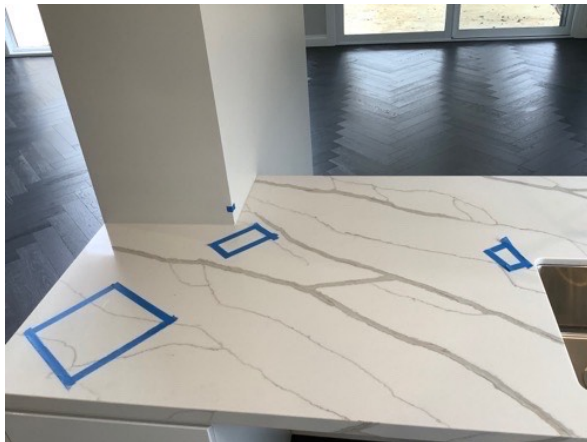
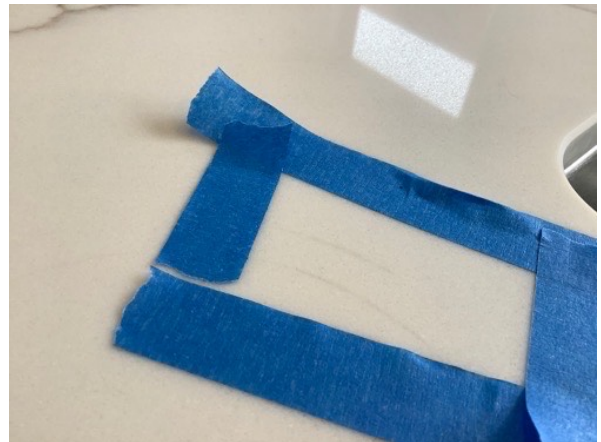
## Non Compliant 2.09

Finding: Damages/ Faults - Appliances / Fittings / Tiles, Etc  
All areas to the entire property should be checked carefully to identify any further defects of the same type.

It is identified that damage or faults affecting tiles, appliances and / or fittings supplied as part of the building contract have occurred. Where this is due to the builder's workmanship or damage occurring during construction it is considered a defect with respect to Standards and Tolerances - 18.02.

All items must be AS NEW WITHOUT COMPROMISE, prior to Handover.

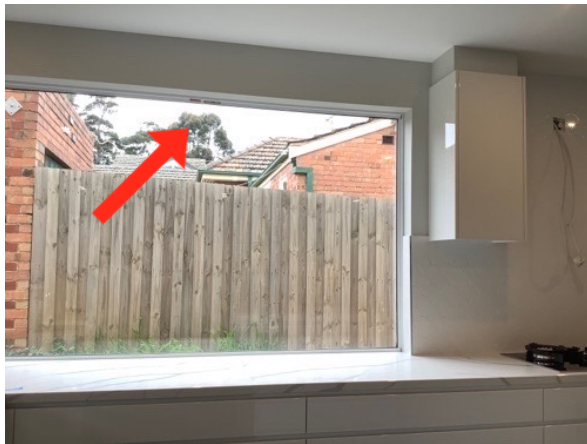
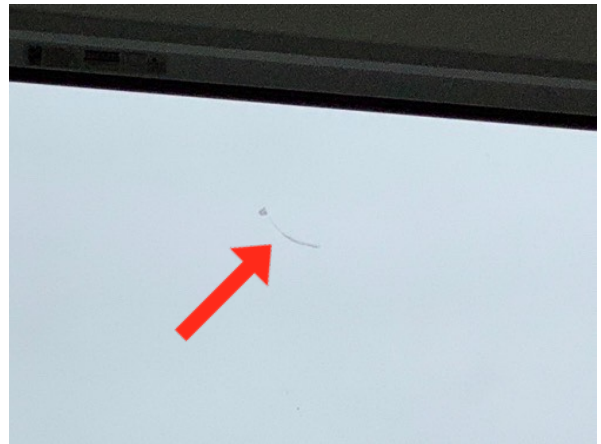
The Building Commission's, Guide to Standards and Tolerances clause 18.04 Glazing, states- 'Scratches, fractures, chips or blemishes on glazing and mirrors are defects if they are caused by the builder and can be seen from a normal viewing position. Minor scratches, fractures, chips or other blemishes that are not more than 10mm long and where there are not more than three blemishes per pane, are not defects'.

Windows are required to be presented in an `as new` condition during the final handover. Therefore, where minor rectification works are not adequate, affected windows must be replaced.

This pane of glass will have to be replaced with a new one.

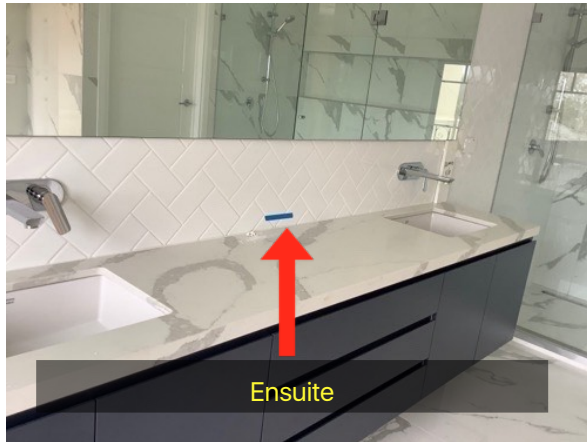
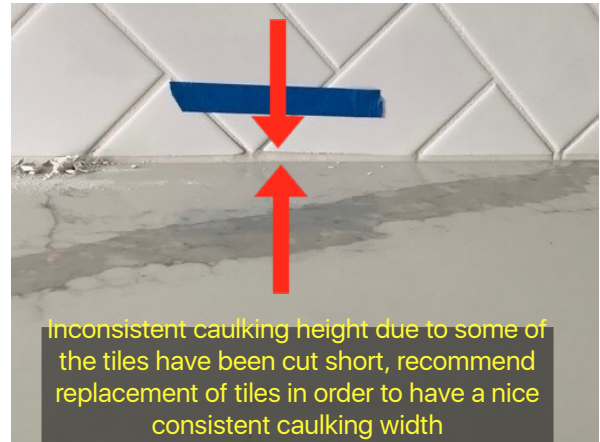
## Non Compliant 2.12

This defect has come about due to misjudgement on the tile set up. Normally the tiler would calculate the tiles and the tile grout widths to determine the first tile installed on the wall or floor, meaning it to be a full tile or 3/4 tile or 1/2 tile in order not to allow this defect to happen.

Areas of grouting which are inconsistent in their width were identified. It is considered a defect with reference to AS3958.1 if grout lines are as far as practicable not consistent widths.

The relevant Australian Standard A.S. 3958.1 – 2007 Ceramic Tiles – Guide to the Installation of Ceramic Tiles, clause 5.4.6 Tile Finish and Joints also states that 'Joint widths should be consistent throughout the installation unless otherwise specified. The recommended joint widths for floors with dust-pressed tiles are 3mm, measured at the tile face' and clause 5.4.3 – Fitting, states that 'Keep all joint lines, including mitres, straight and of even width'. These tiles and the grout joint widths must be properly rectified or replaced.

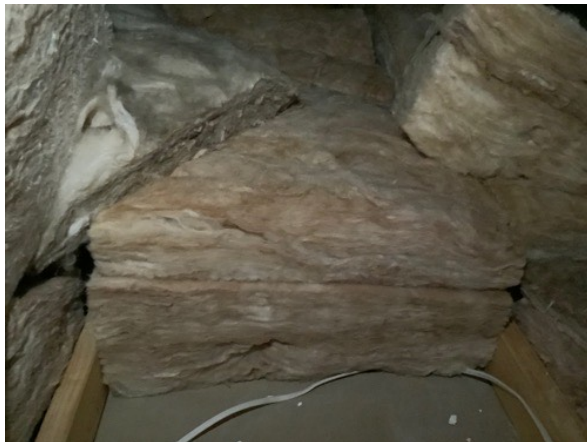
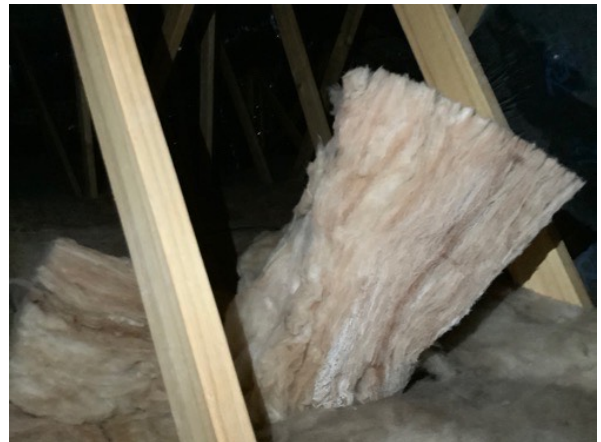
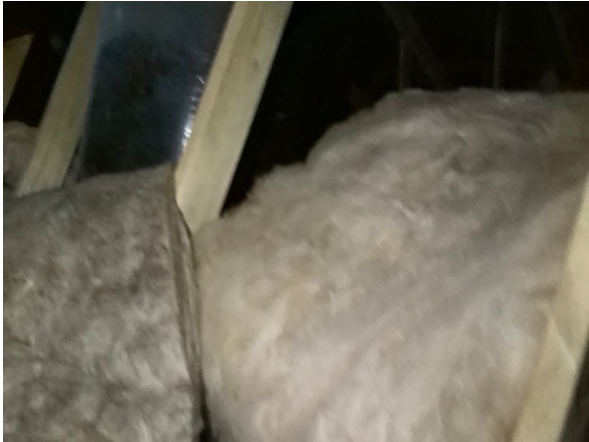
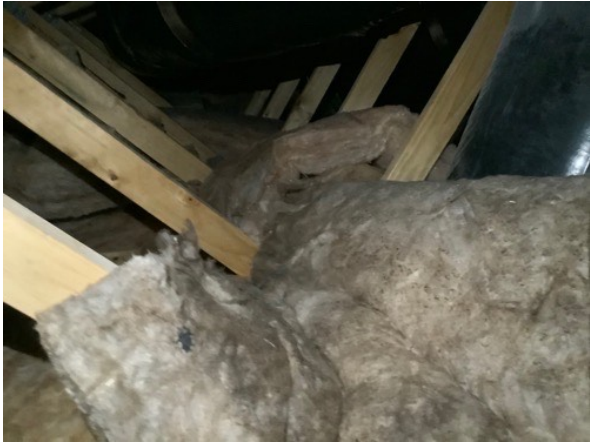
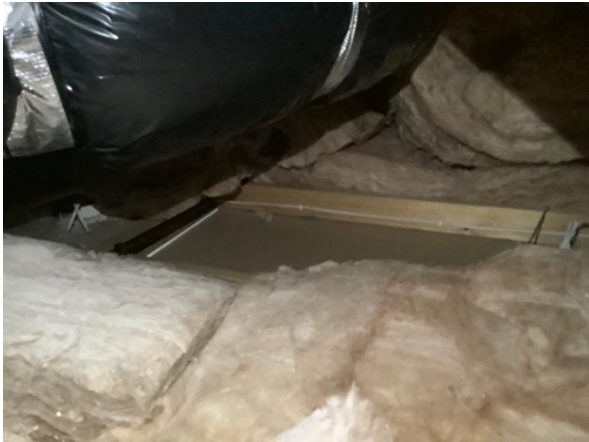
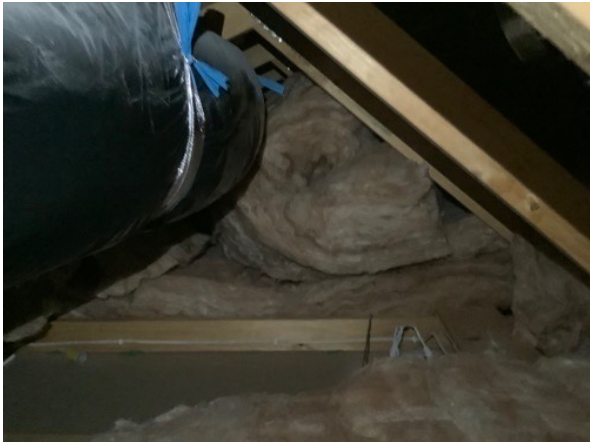
## Non Compliant 2.13

Finding: Insulation - Moved & Missing (AS4859)

Although the insulation batts appear to have been installed correctly, it appears as though several of the batts have been moved by other tradespeople and replaced incorrectly post-works.

All insulation batts should be reinstated prior to final handover to comply with standards and to ensure maximal energy efficiency within the property. Failure to do so results in non-compliance with AS4859.1 Materials for Thermal Insulation of Buildings.

I highly recommend that the builder check the entire roof and fix up all the areas of insulation and only have a minimum of 200 mm around each down light

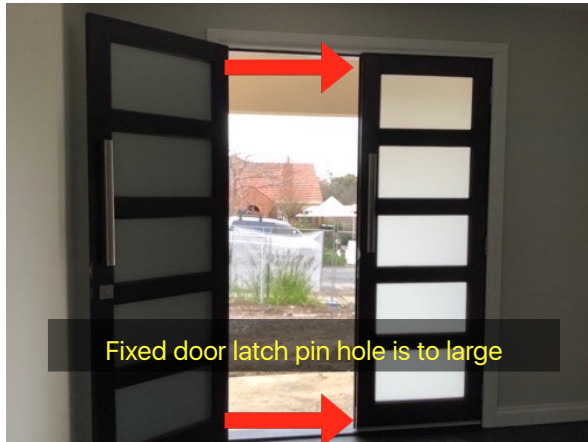
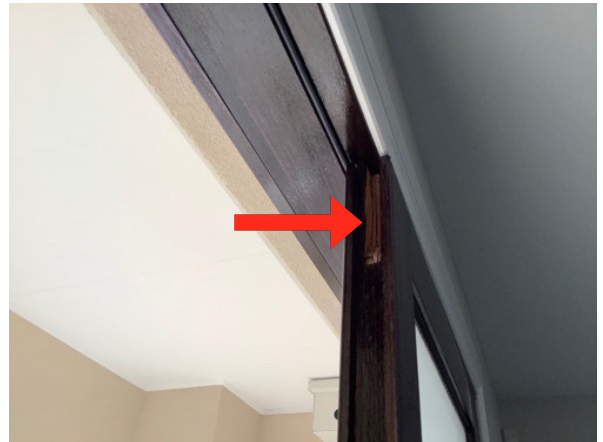
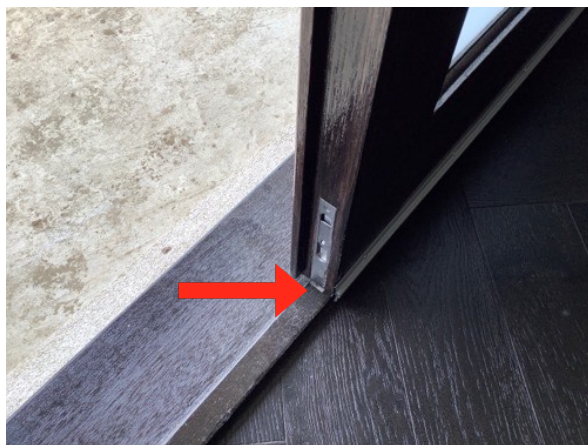
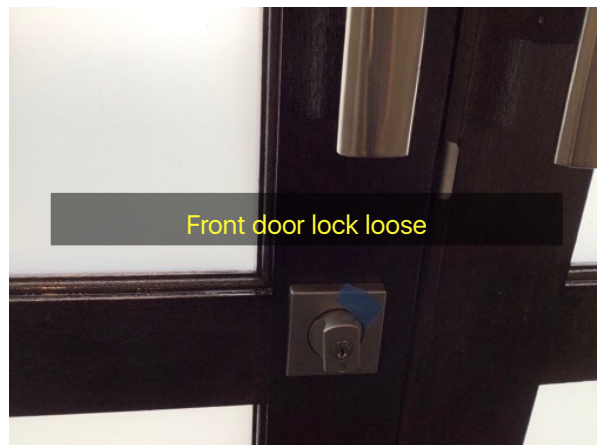
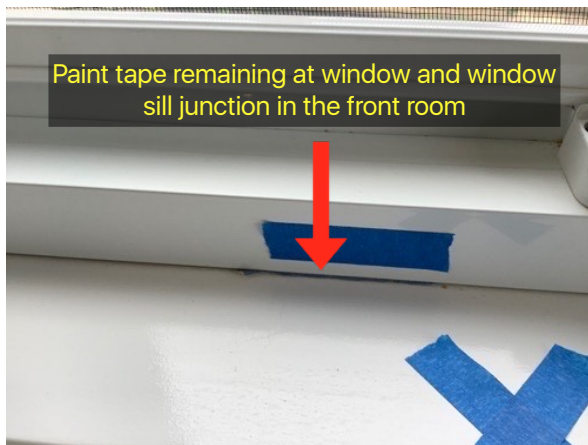
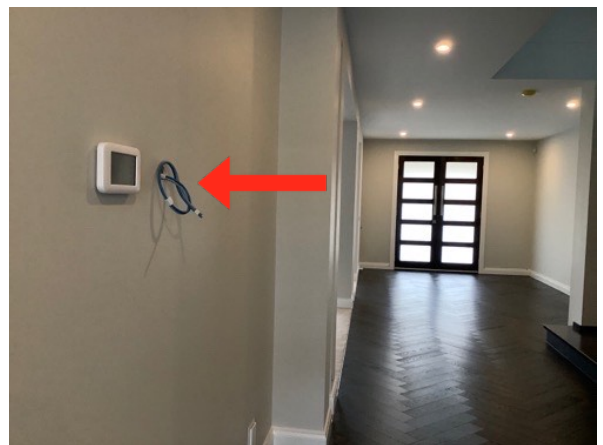
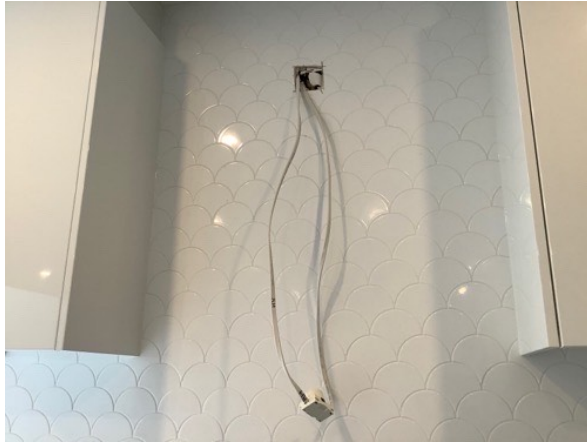
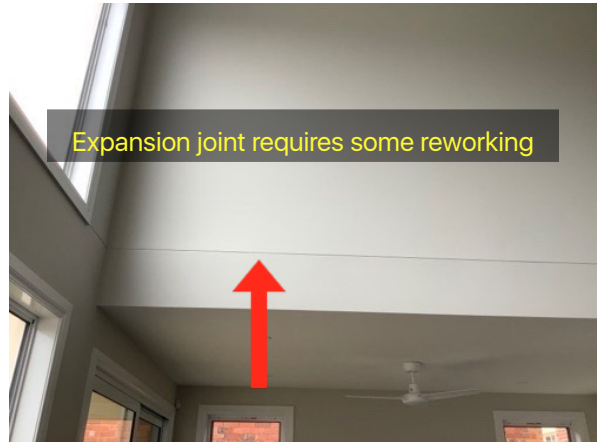
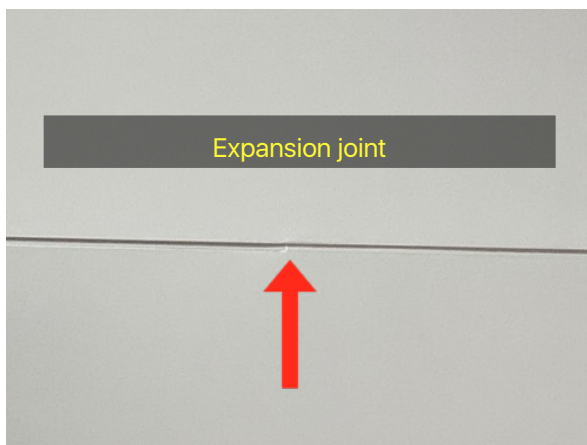
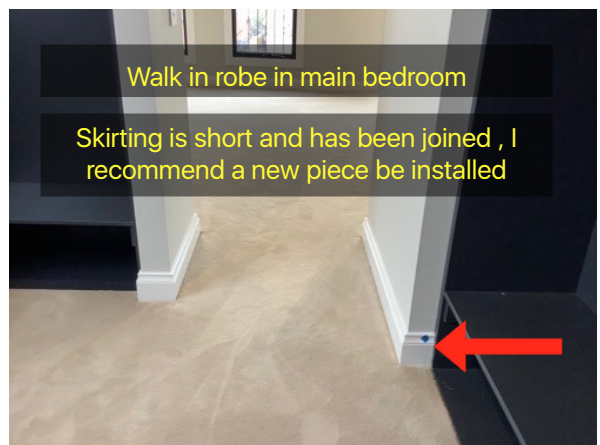
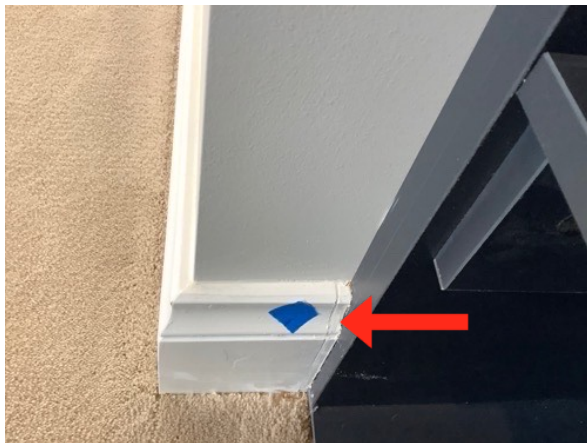
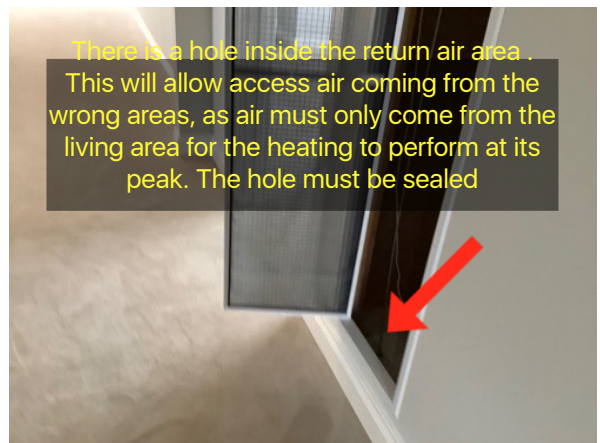
## Non Compliant 2.14

Location:	Internal-Unfinished/Defective Works
Finding:	<p>Internal - Unfinished/Defective Works - Additional Photos</p> <p>The following items will need to be completed or repaired in accordance with the Domestic Building Contracts Act 1995.</p> <p>We refer the builder to the implied warranties where the builder agreed to build the dwelling in a proper and workmanlike manner and with reasonable care and skill.</p> <p>DOMESTIC BUILDING CONTRACTS ACT 1995, Act No. 91/1995, Part 2 - Provisions that apply to all Domestic Building Contracts.</p> <p>Part 2 - Provisions That Apply To All Domestic Building Contracts.</p> <p>Division 1 - General warranties.</p> <p>8. Implied warranties concerning all domestic building work.</p> <p>The following warranties about the work to be carried out under a domestic building contract are part of every domestic building contract -</p> <p>(A) the builder warrants that the work will be carried out in a proper and workman like manner and in accordance with the plans and specifications set out in the contract.</p> <p>(D) the builder warrants that the work will be carried out with reasonable care and skill and will be completed by the date (or within the period) specified by the contract.</p> <p>ALSO</p> <p>Additional photos are provided for your general reference.</p> <p>Arrows have been included to highlight areas of importance.</p> <p>All these photos are added in to demonstrate DEFECTIVE / SUB STANDARD and/or INCOMPLETE WORKS and they are all required to be rectified as they are ALL not satisfactory for Handover as per the DOMESTIC BUILDING CONTRACT ACT 1995 as stated above.</p>

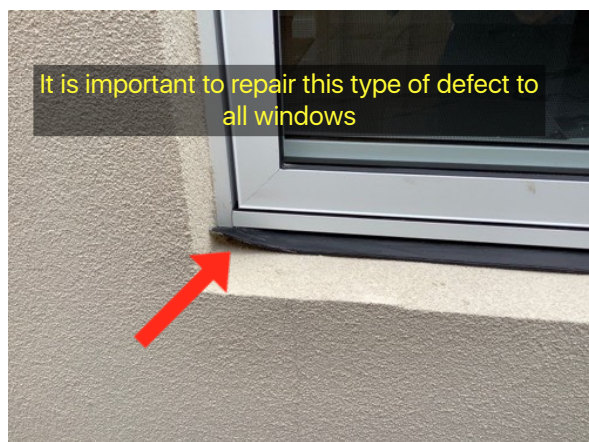
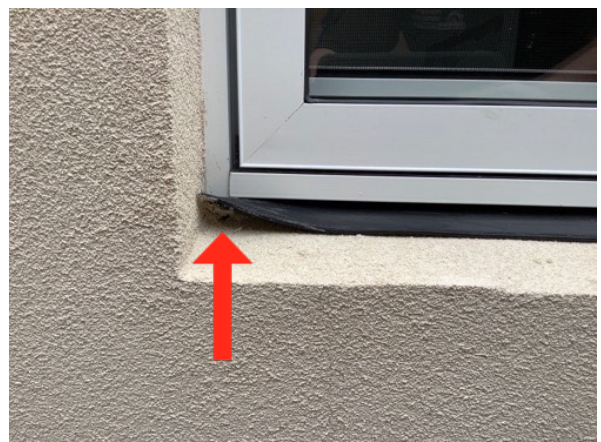
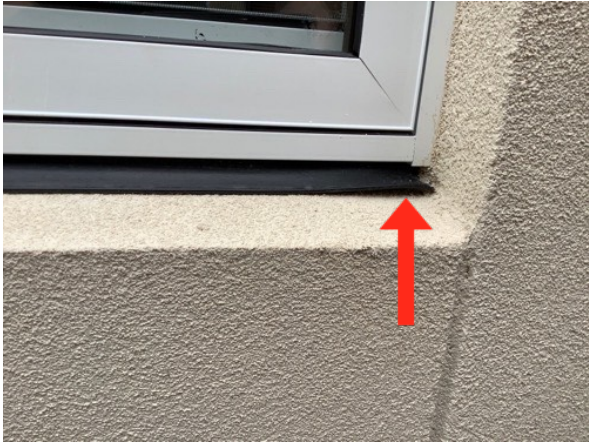
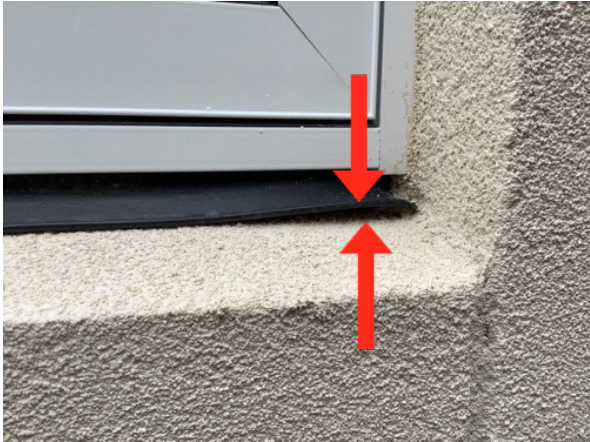
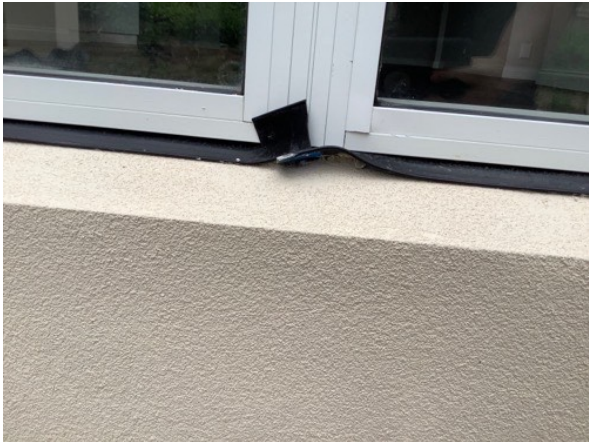
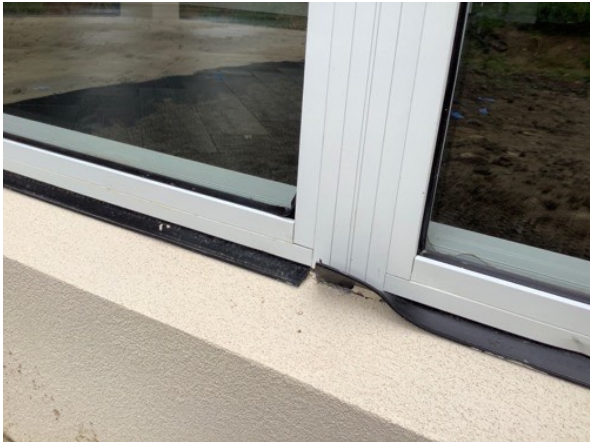
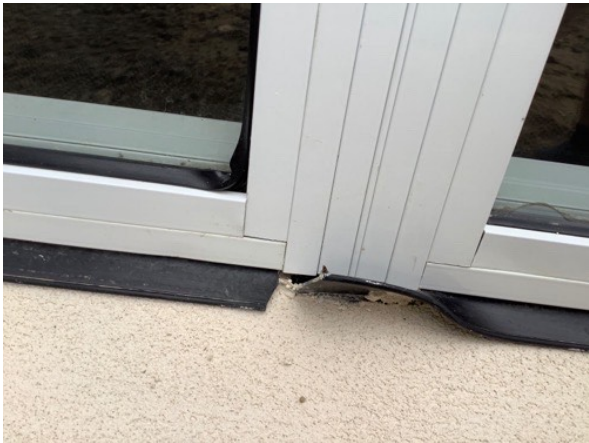
Finding: Window rubbers - Inadequate (AS2047)

It is recommended that some reworking will need to take place. If the builder intends on using a silicone to bridge small gaps, the silicone must be neatly applied and be UV rated.

The mortar may fall short of the rubber so just extending the mortar all the way up past the rubber may also be the alternative repair option.

The bricks in places may require to be replaced if the gaps are to large. It is important that the mortar is colour matched correctly.

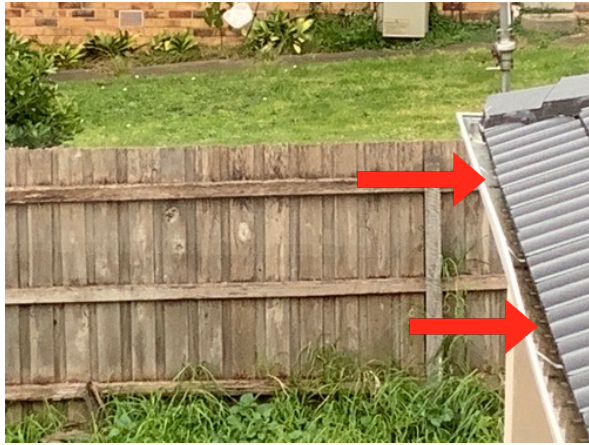
Water was found to be pooling in sections of the roof guttering. Such blockages or defective gutter falls and subsequent water pooling are likely to lead to rust and water damage to associated structures if left unattended.

Any areas of guttering that shows evidence of water pooling should be checked for partial or full blockages / defective gutter levels and any secondary damage that may have occurred as a result. Depending on the extent of the damage, building elements may require repair and/or replacement to ensure adequate roof drainage and function of exterior plumbing system.

All gutters should be checked and repaired prior to handover.

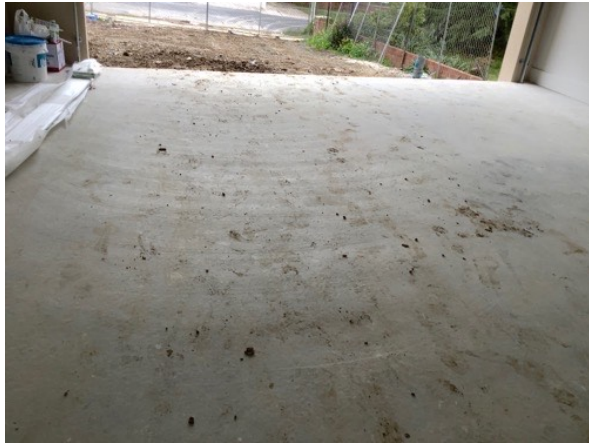
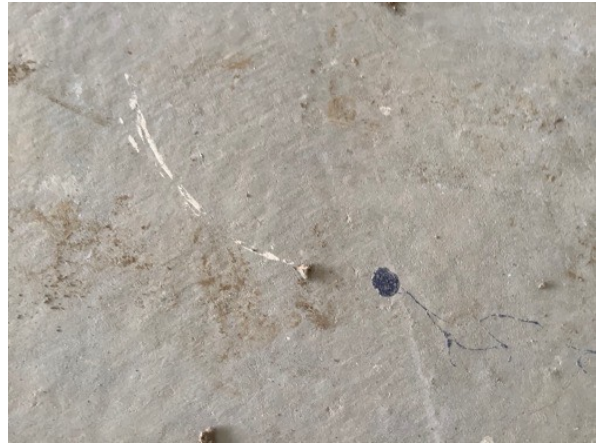
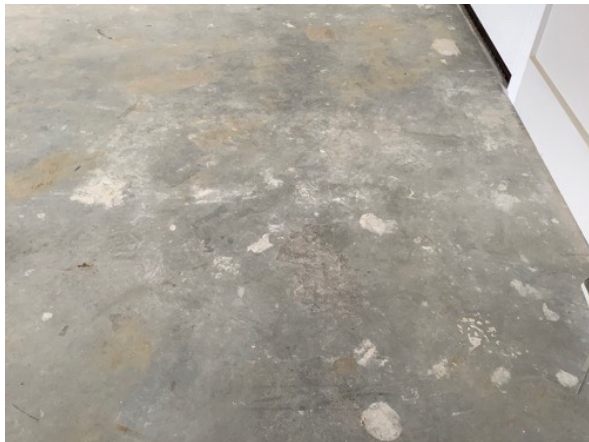
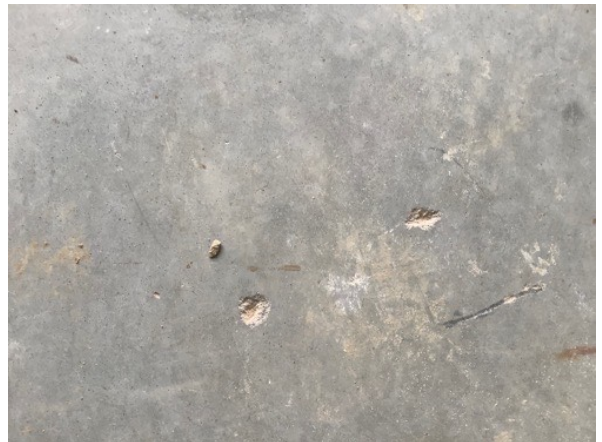
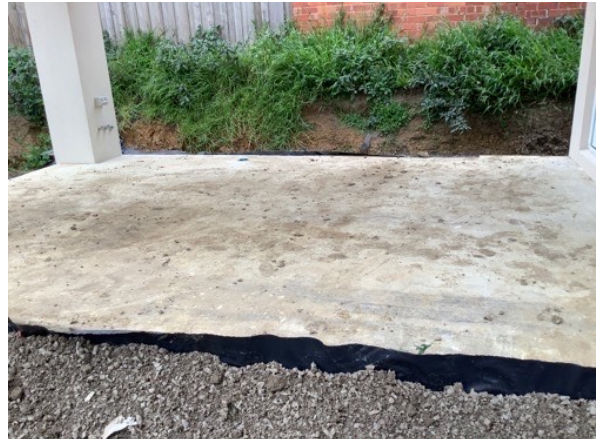
Location: Concrete Floors – Garage And Alfresco

Finding: Concrete Floor Damaged / Chipped / Marked / Paint, Etc - Non Compliant  
Areas where the concrete floor has been damaged were identified. The damage consists of deep gouges chips and scrape and associated marks.  
An acceptable finish consistent with AS 2870 Residential Slabs and Footing Construction requires the surface to be even and consistent in appearance.  
The concrete floors must be presented as new prior to handover.

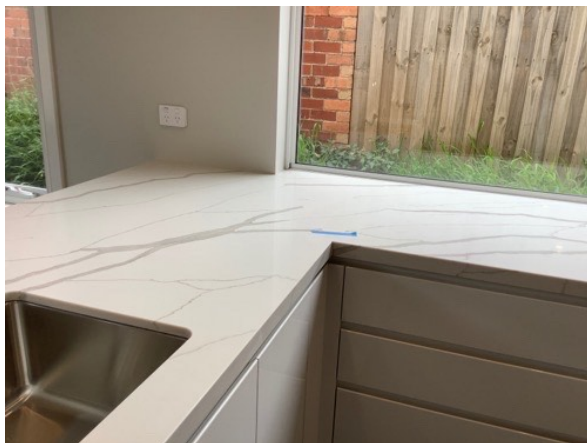
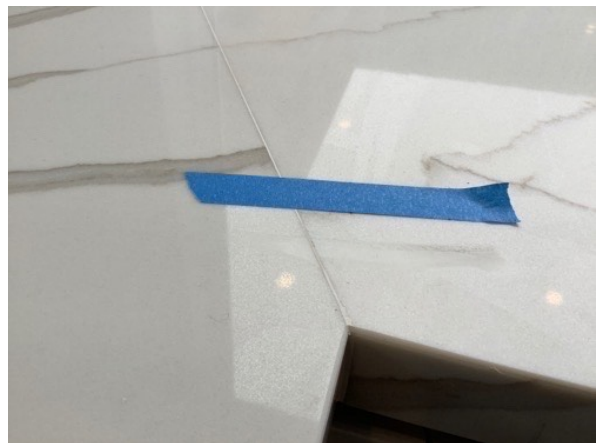
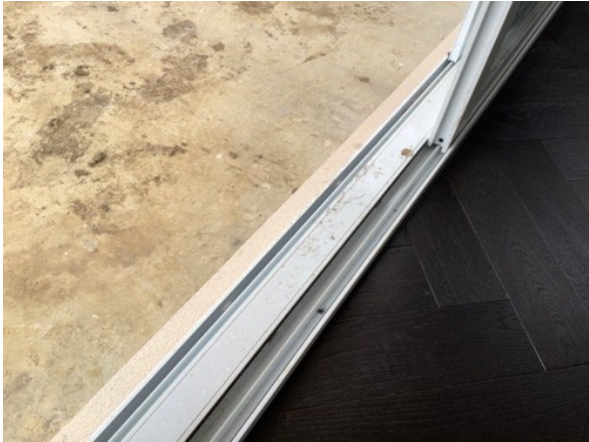
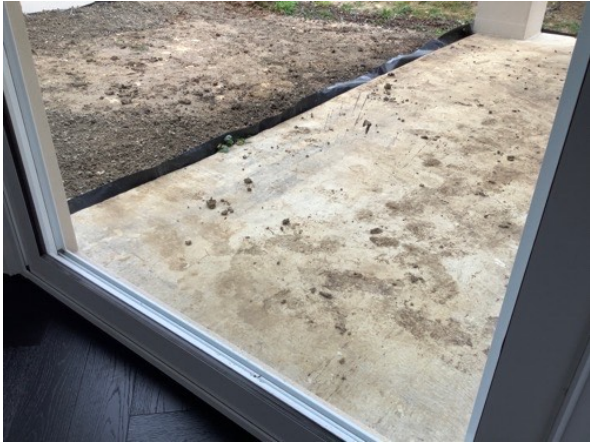
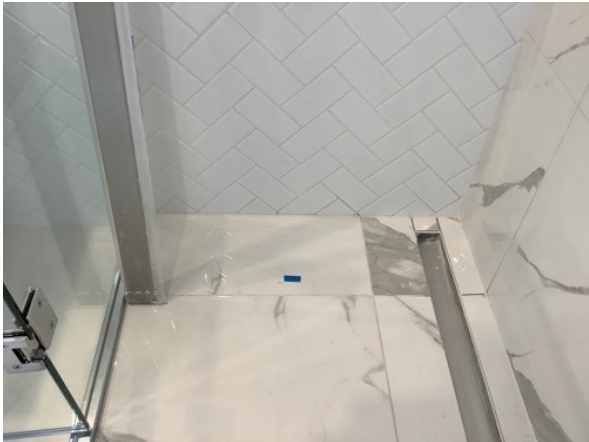
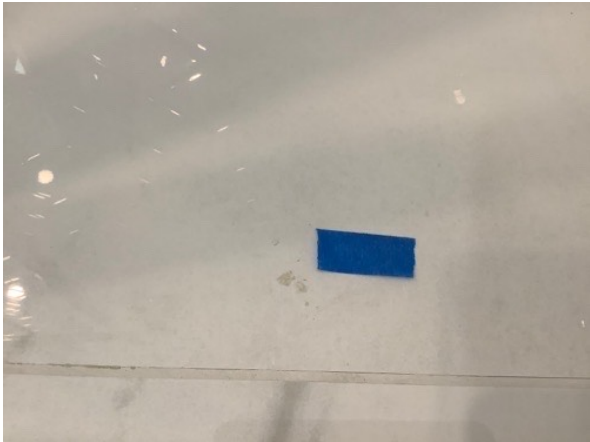
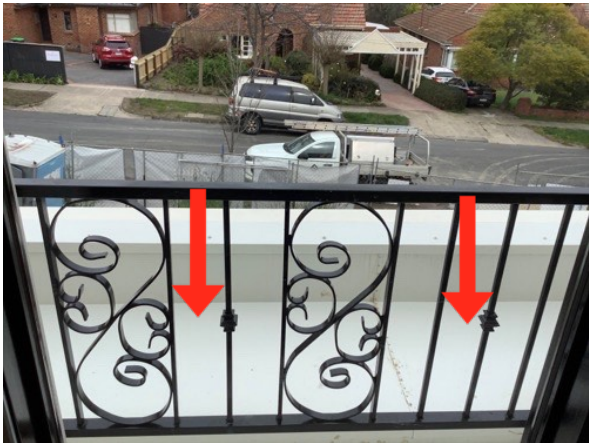
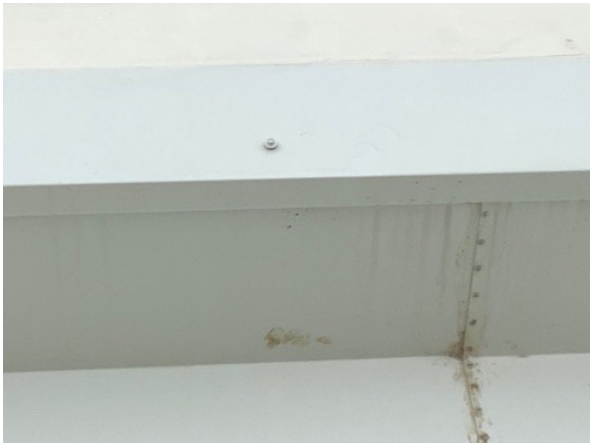
Finding: Cleaning Defective - Floors, Tiles, Glass, Bathroom fittings and fixtures, Etc  
I have ONLY taken LIMITED photos of this defect and attached are LIMITED photos of this defect in SOME AREAS ONLY.  
All AREAS to the entire property should be checked CAREFULLY to identify any further defects that are the same, as this defect is in other areas of the property.

It was identified that the cleanliness and degree of finish for fixtures and fittings is substandard. Fittings and fixtures including sinks and bathtubs are required to be as new prior to handover. Evidence of damage marks scuffs and dirt need to be removed where present.

The Building Commission's, Guide to Standards and Tolerances clause 18.09 Cleaning, states- 'Owners are entitled to expect that the building site and works are clean and tidy on completion. Building works are defective where windows are not clean, floors are not swept, mopped or vacuumed as appropriate, tiles, sinks, basins, troughs, baths, etc. are not cleaned and shelving, drawers and cupboards ready for use.'

Once the cleaners have properly completed all of this work, all of the glazing, mirrors, cupboards, baths, shower bases, shower screens, floor coverings, walls, stairs, garage floor, fixtures and fitting etc, should all be thoroughly checked again for any scratches and damage which may have occurred, prior to handover proceeding.

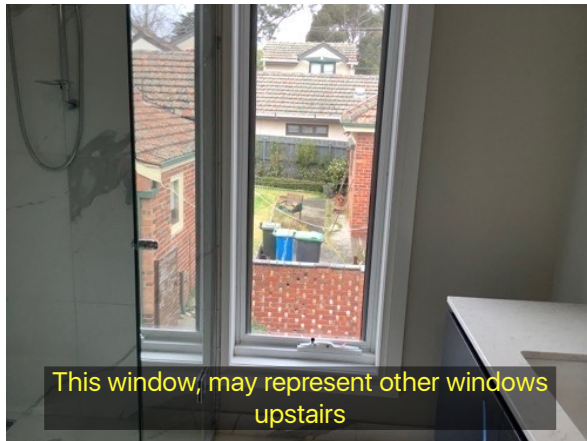
Finding: Frosted glass – recommended  
Please note, This report does not cover councils requirements and or building codes.  
However I would like to mention that normally upstairs windows that look into neighbours yard normally require frosted glass or limited view of some type.

I highly recommend you further investigate this matter with your builder.

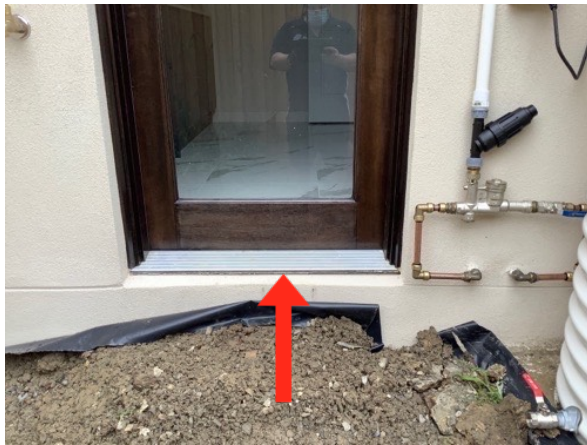
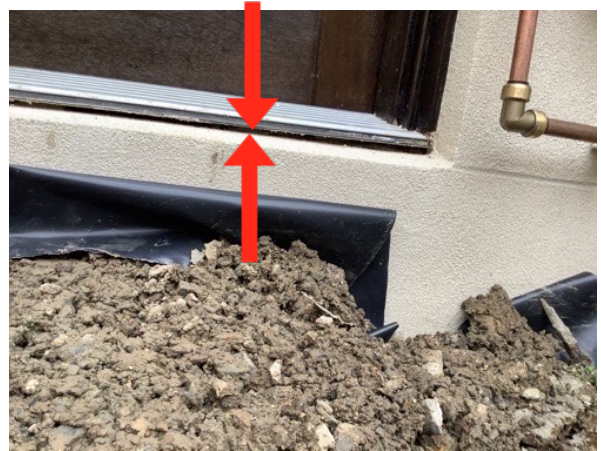
## For Your Information 5.27

Finding: Window / Doors installation - not weather tight  
It was observed that the Window / Doors installation is defective because it was allowing water to penetrate rooms under normal weather conditions.  
It is important to colour match the silicon to the window frame, but normally if there is silicon required to the bottom window and/or window rubber then black silicon is normally used.
