## Building Specific Inspection Report

Inspection Date: 25 Aug 2020

Property Address: 3 Sample street Melbourne

Report Type: Building Inspection

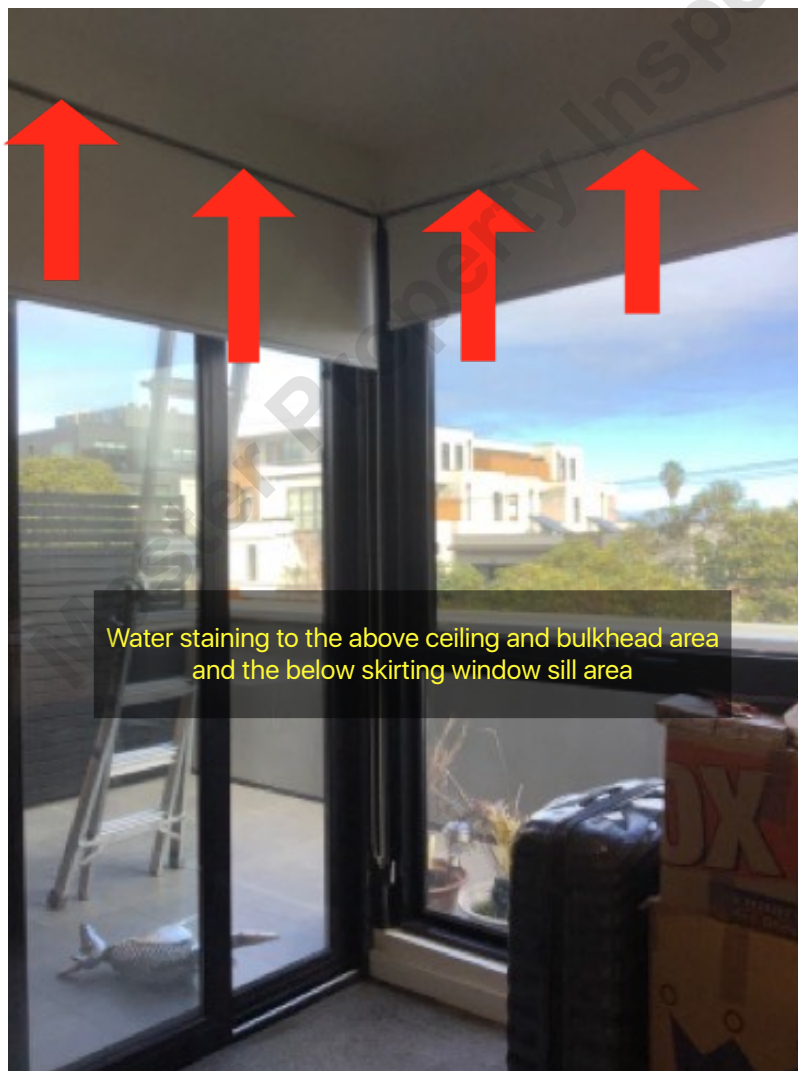
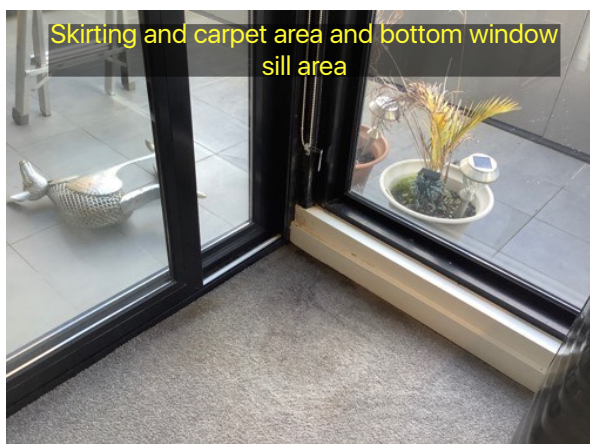
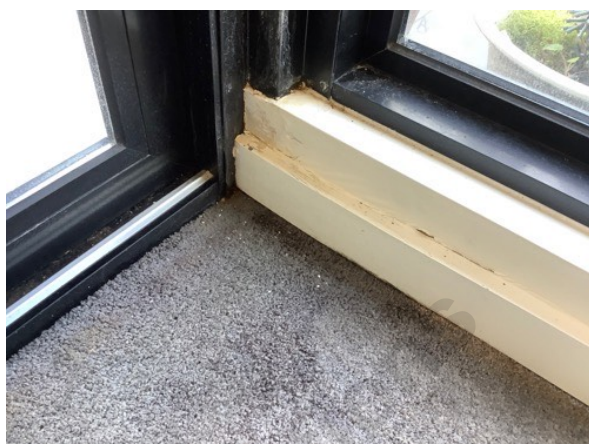
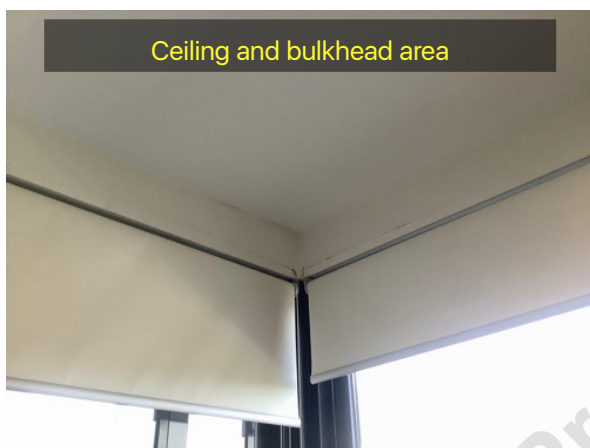
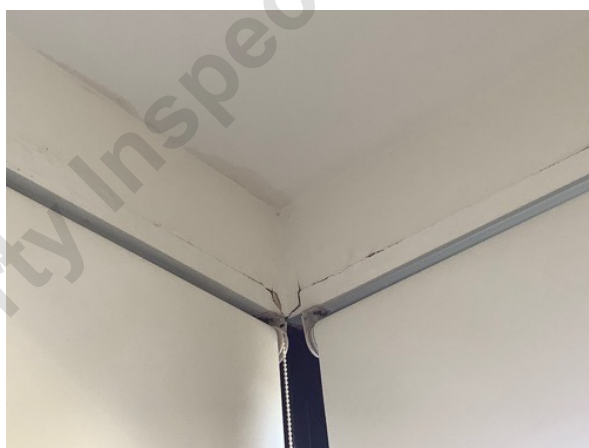
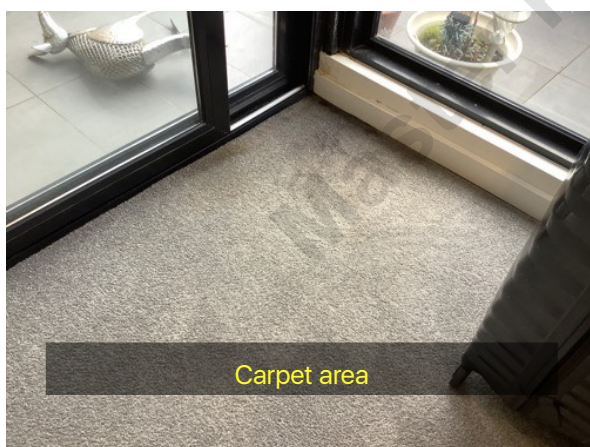
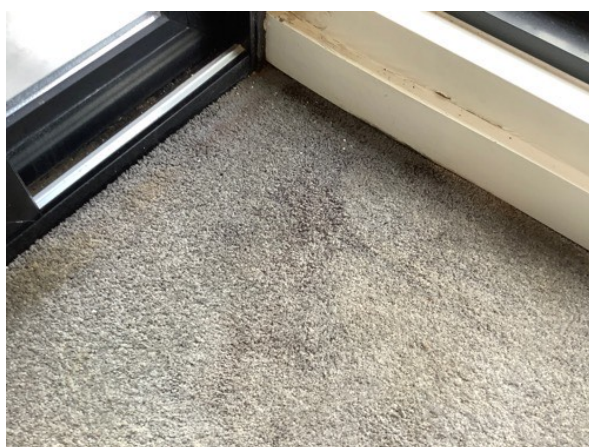
### Defect 1.01

Finding: Addendum 'B' - DEFECT - 1 - Damp Wetness Location  
Water is staining the ceiling, bulkhead, timber skirting and window sill areas

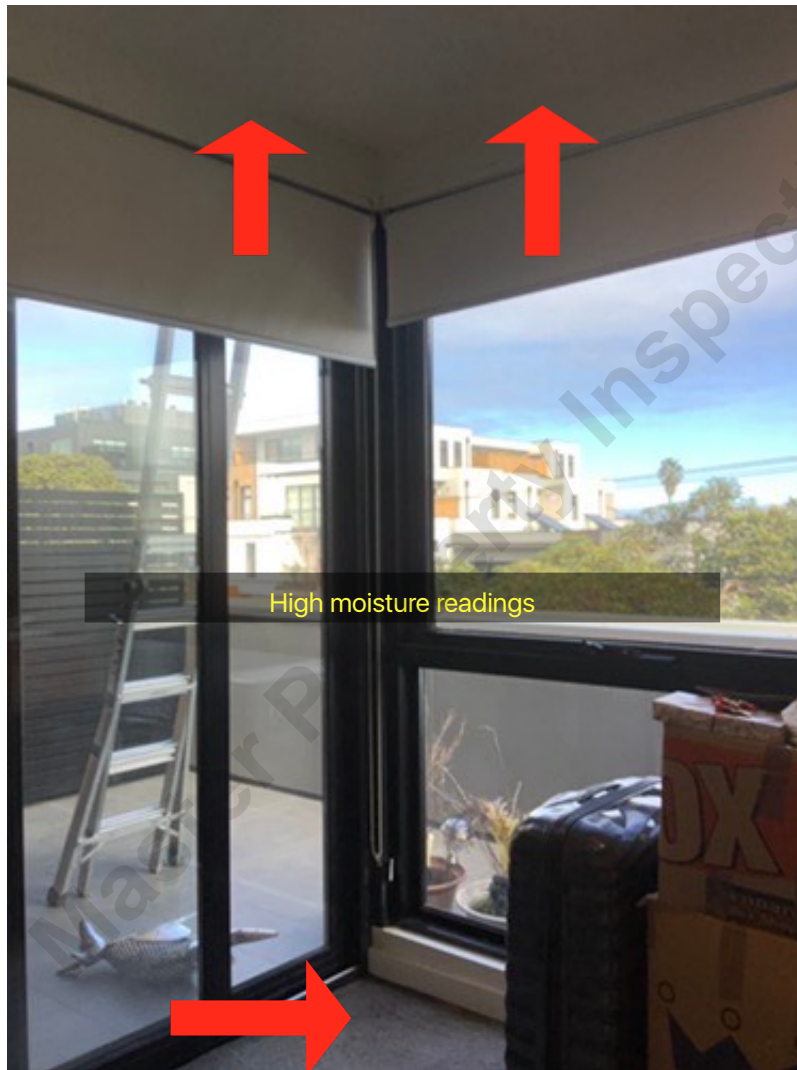
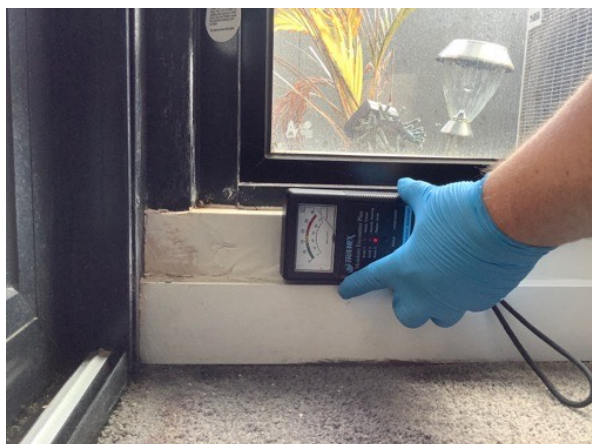
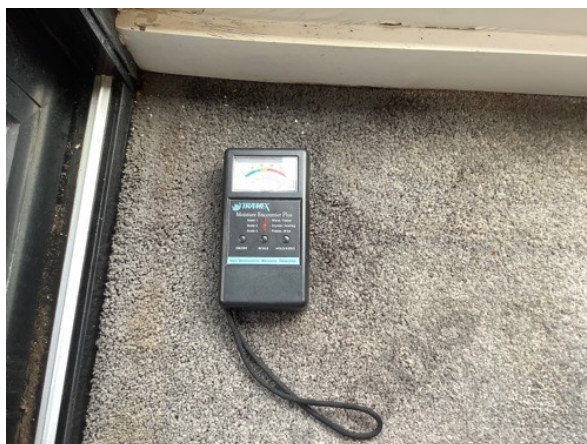
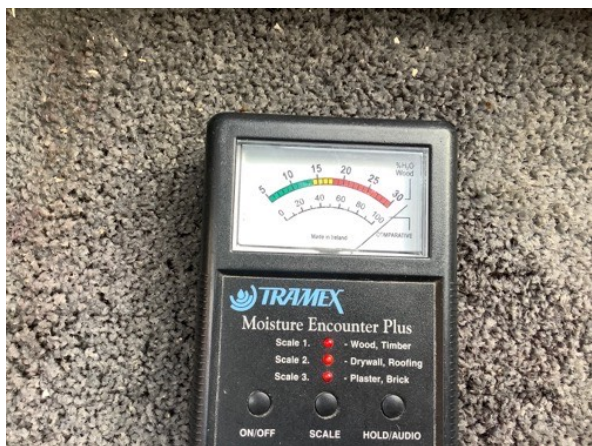
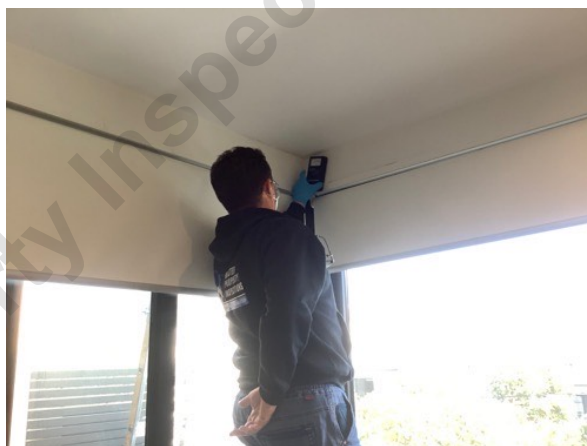
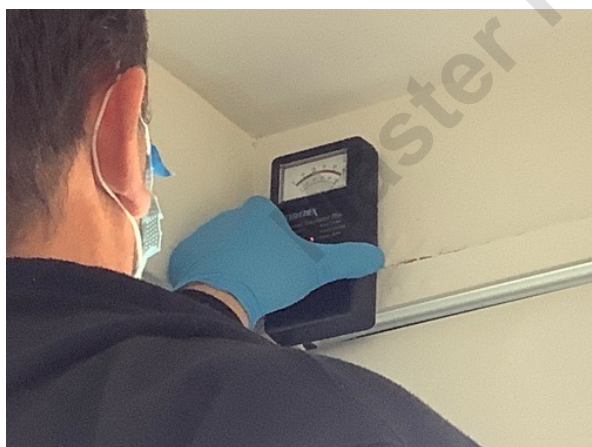
## Defect 1.02

Finding: Addendum 'B' - DEFECT - 2 - High Moisture Levels  
As per the photo's in this defect statement, we show and indicate high readings of moisture.

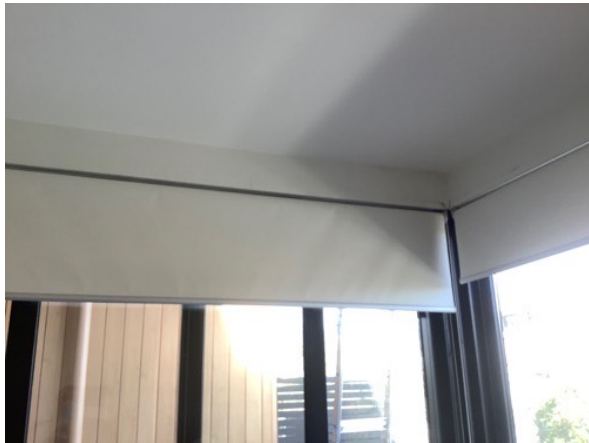
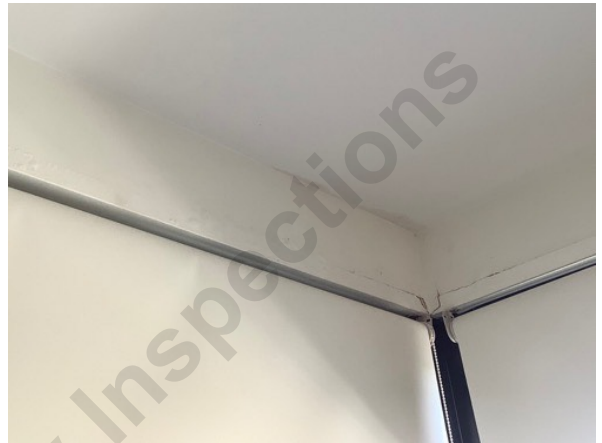
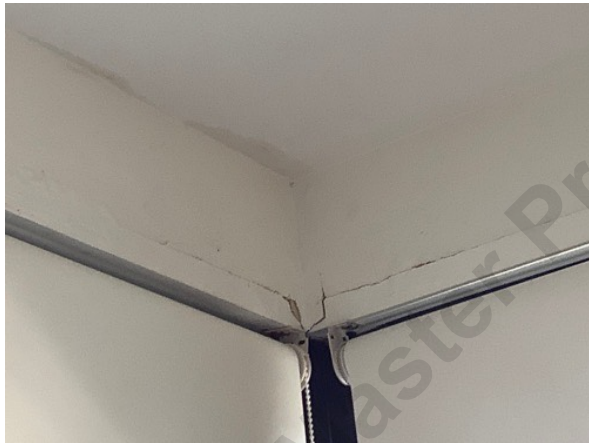
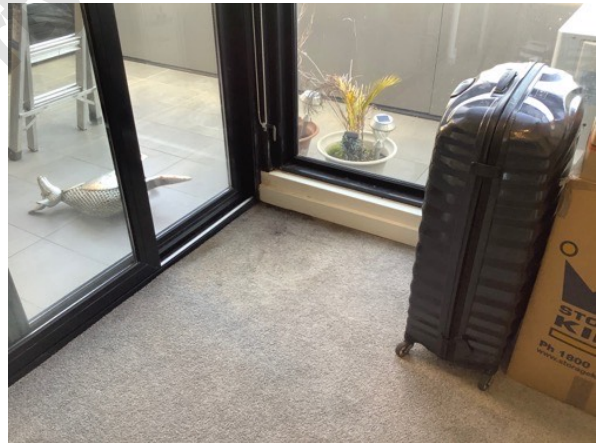
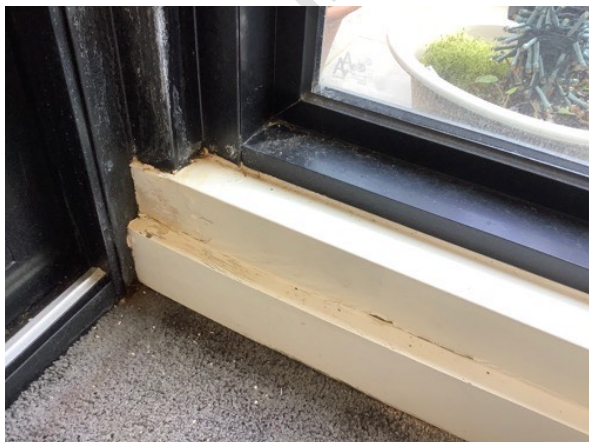
## Defect 1.03

Finding: Addendum 'B' - DEFECT - 3 - Plaster & Timber Work  
These photos show the plaster and timber work, water staining damage.

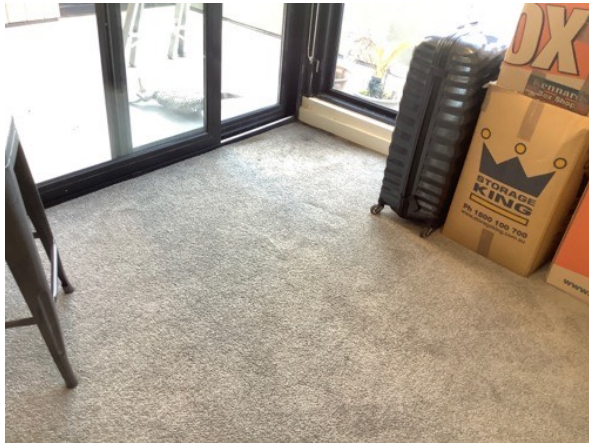
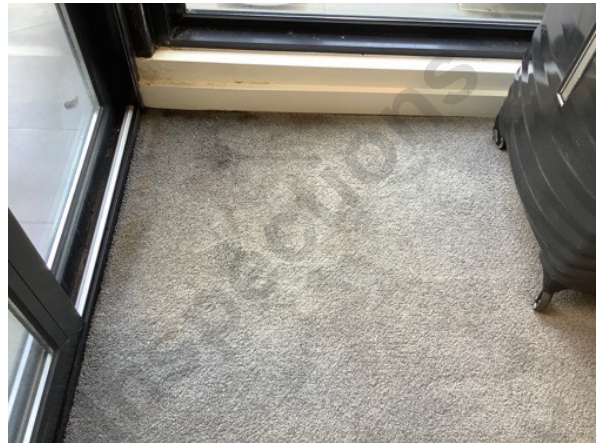
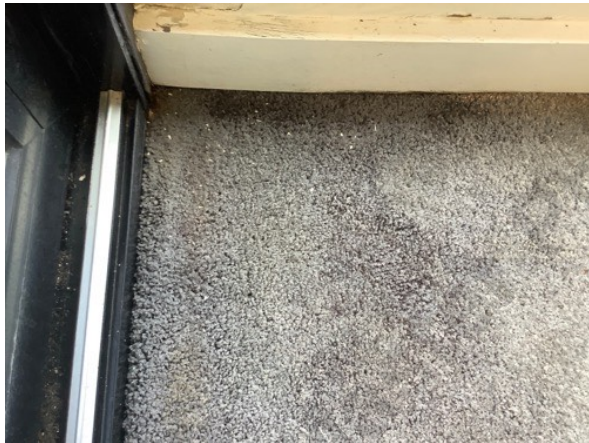
## Defect 1.04

Location: Addendum 'B' - Defects List  
Finding: Addendum 'B' - DEFECT - 4 - Wet Carpet  
Wet carpet area.

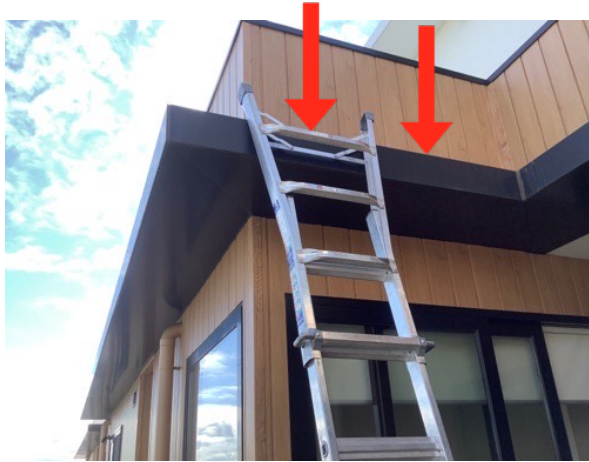
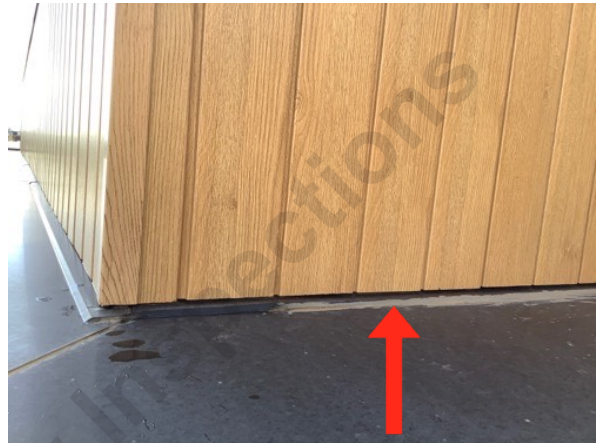
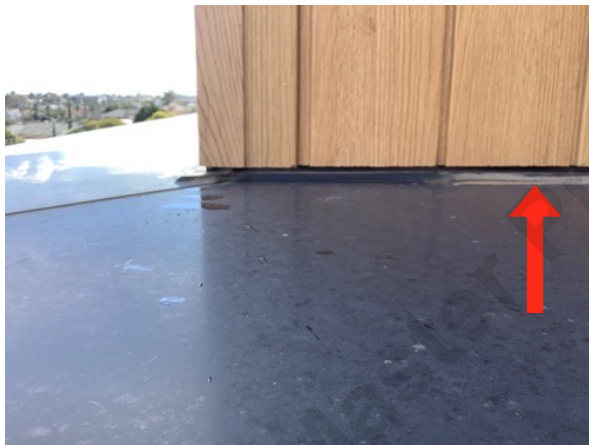
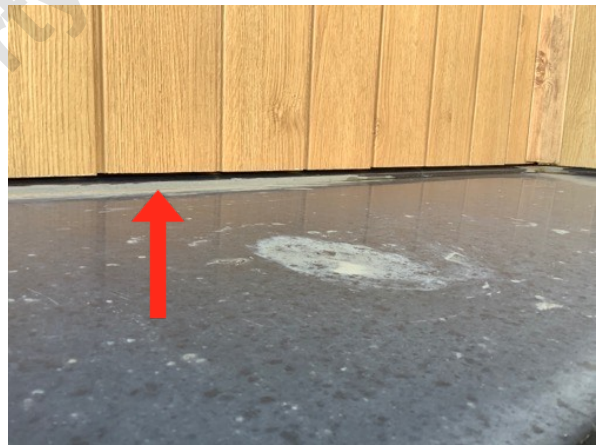
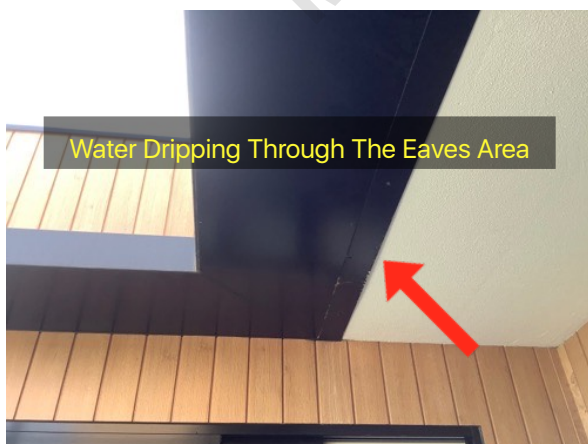
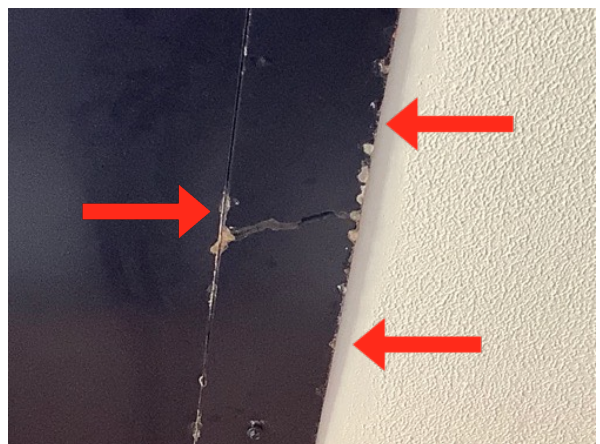
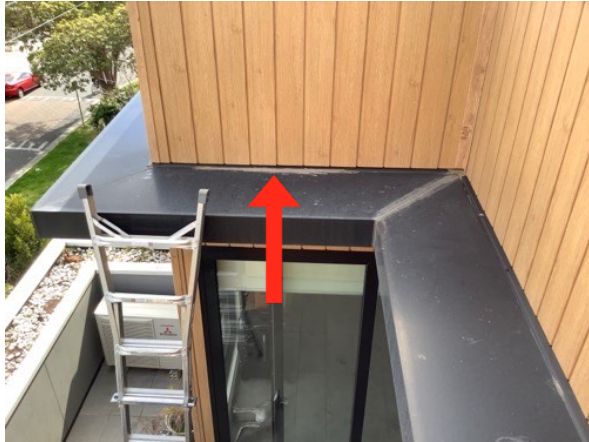
## Defect 1.05

that there was some sealant installed along one of the metal flashings that would not have been installed at the time of the construction build as the area that had the sealant was not an area that normally requires sealant and it was clear that only this particular area has this added type sealant, this to me suggested that some person has attempted to stop the water ingress into the apartment.

Finding: Addendum 'B' - DEFECT - 5  
Photo's indicate the minor repair attempt of sealant to the flashing area.

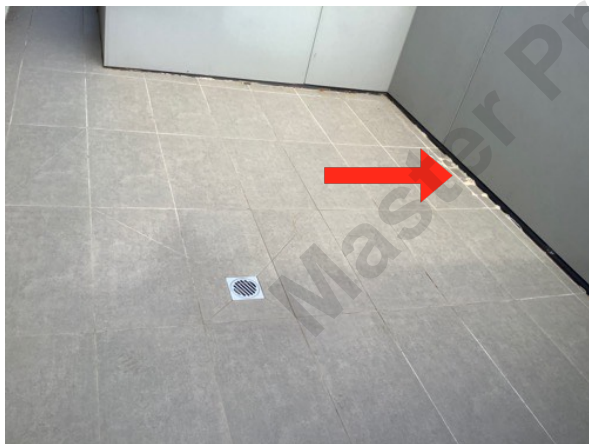
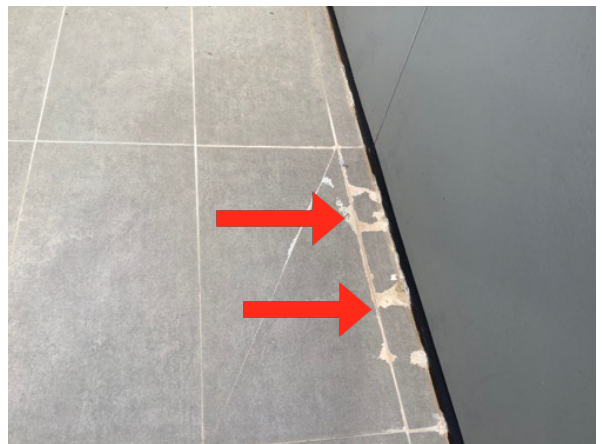
## Defect 1.06

Finding: Addendum 'B' - DEFECT - 6, Upper Apartment 306 - Tile Efflorescence  
There is evidence of calcification or efflorescence to Upper Apartment 306, affecting the tiled balcony area.  
Where calcification or efflorescence is caused by water coming from the deck or balcony .  
This is considered a defect.

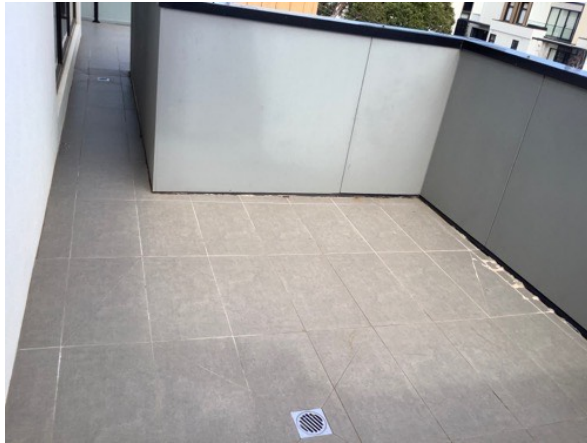
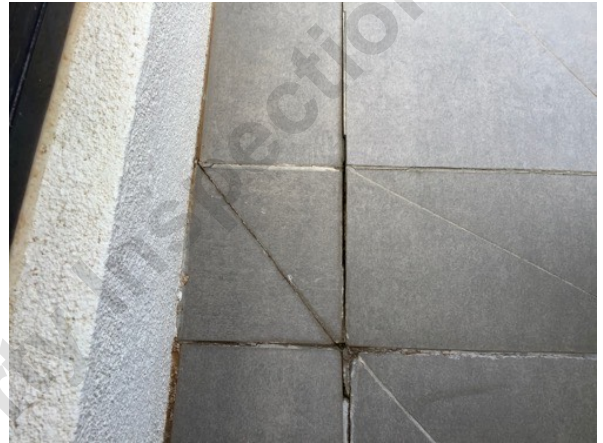
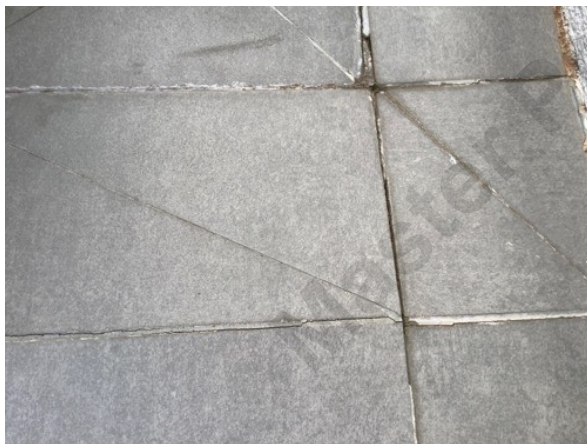
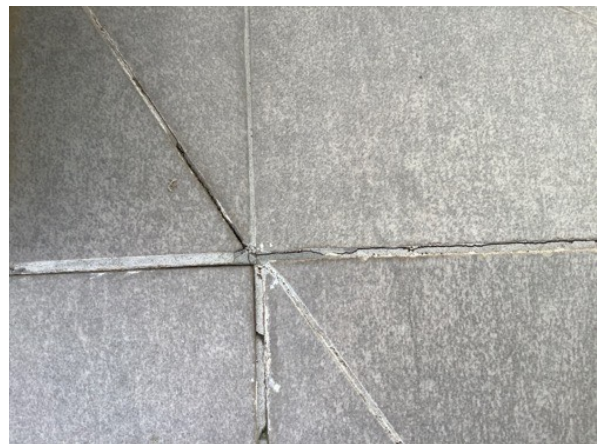
## Defect 1.07

Finding: Addendum 'B' - DEFECT - 7, Upper Apartment 306 - Drummy Tiles  
Drummy tiled areas were identified in Upper Apartment 306 at the time of inspection. The term 'drummy' refers to tiles that have become detached from their fixing.

Such defects are generally caused by physical or moisture damage to the area. Drummy tiled areas may also be a direct result of poor workmanship during the construction process.

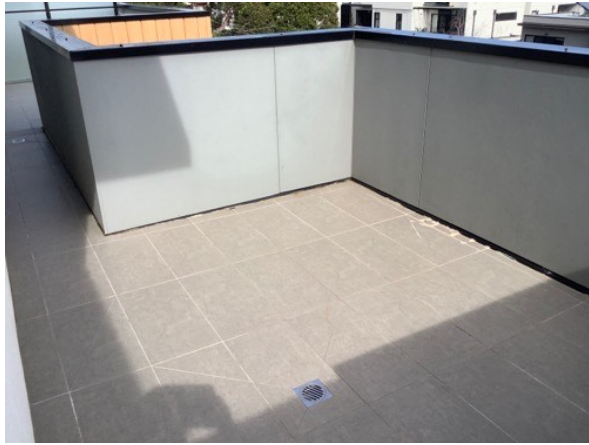
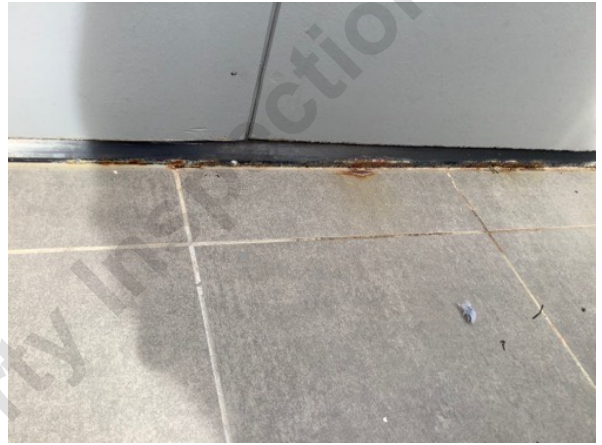
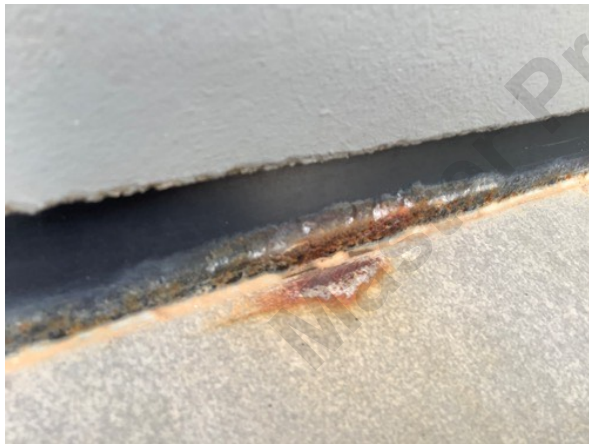
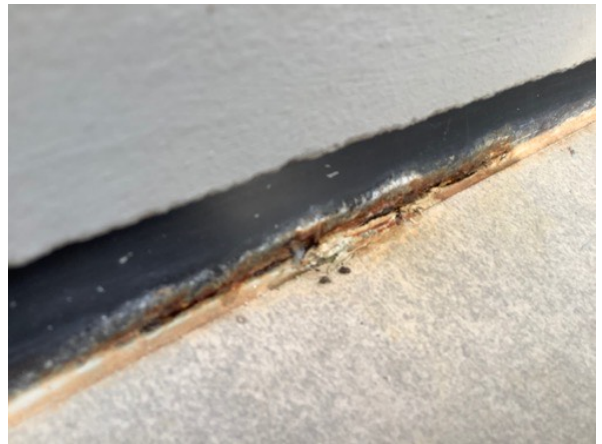
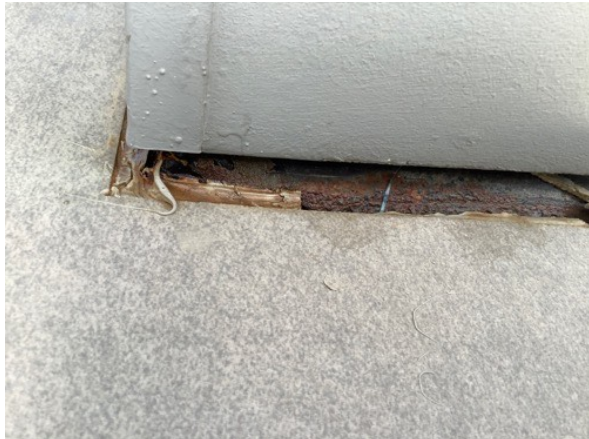
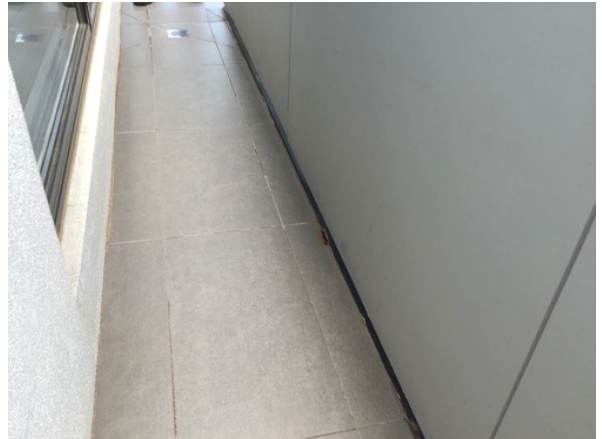
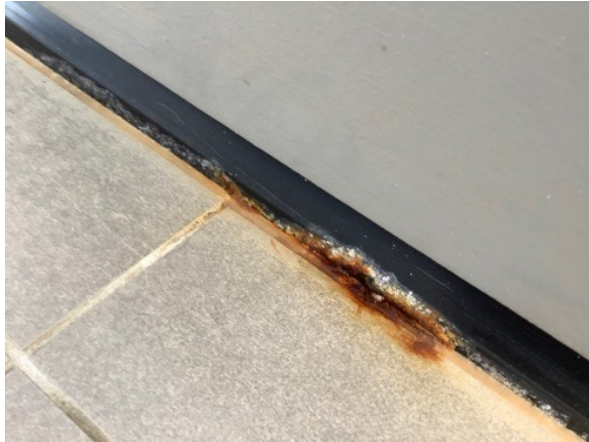
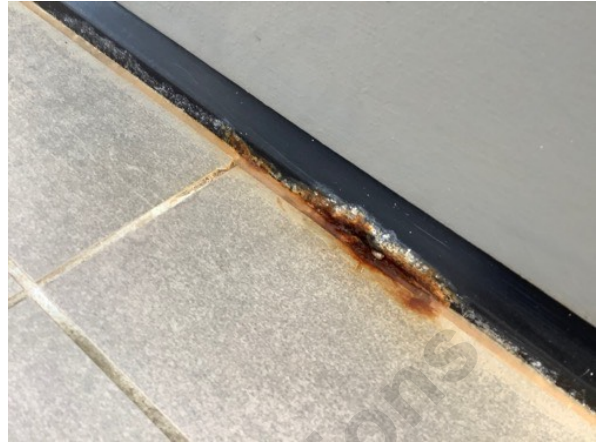
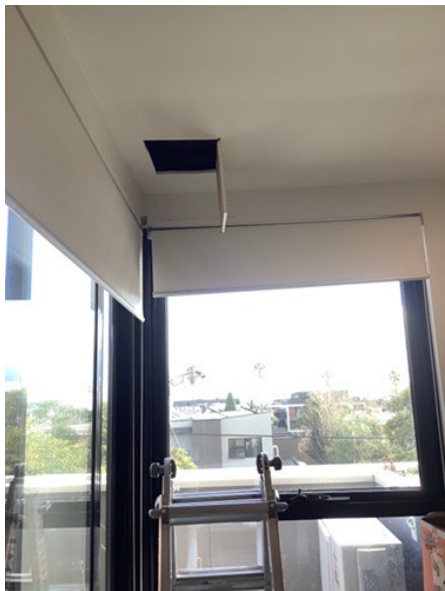
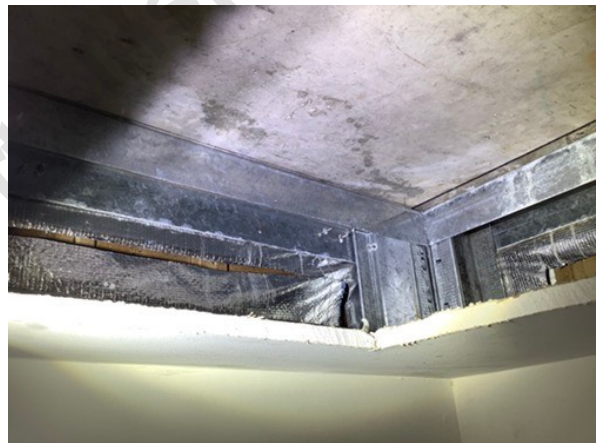
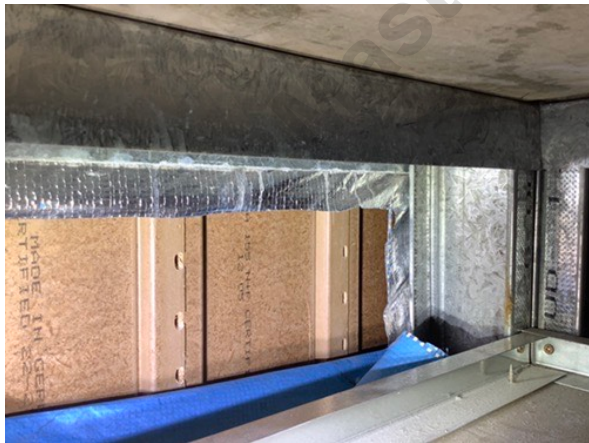
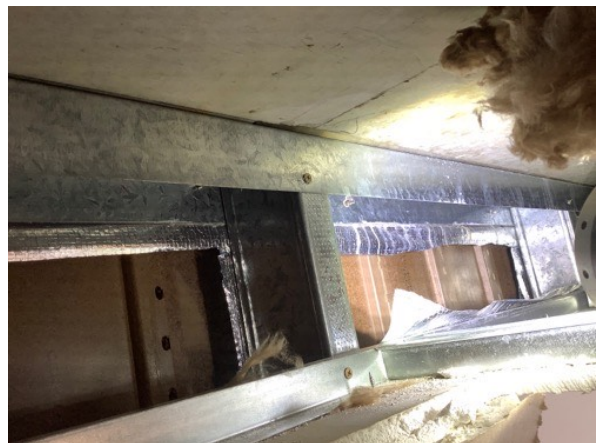
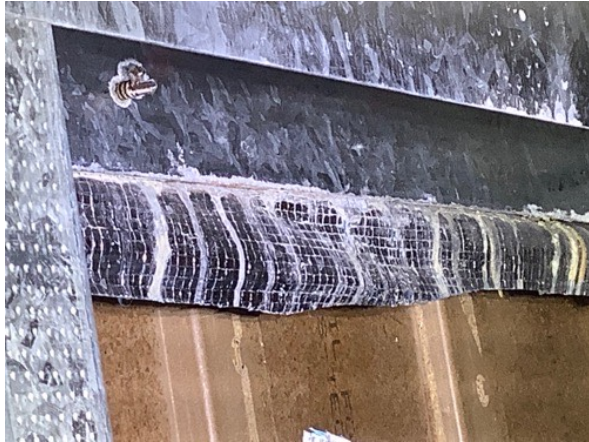
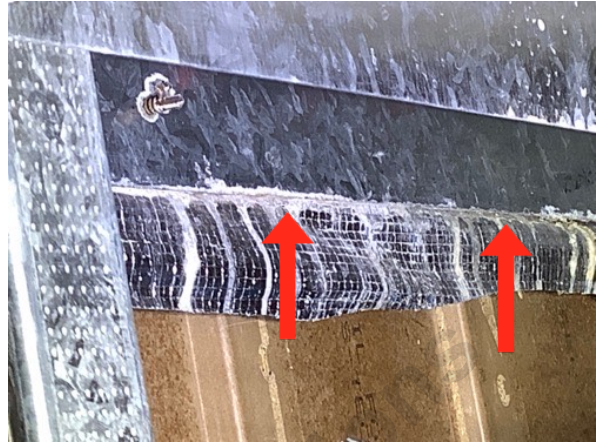
## Defect 1.08

Finding: Addendum 'B' - DEFECT - 8, Upper Apartment 306 Material Corrosion / Rusting  
There is severe corrosion and rusting in Upper Apartment 306 to the balcony perimeter. This indicates that the materials used are not as the manufacturer has intended the material to be used for.  
This damage also will not allow the very important sealant to adhere to the rusting metal areas.

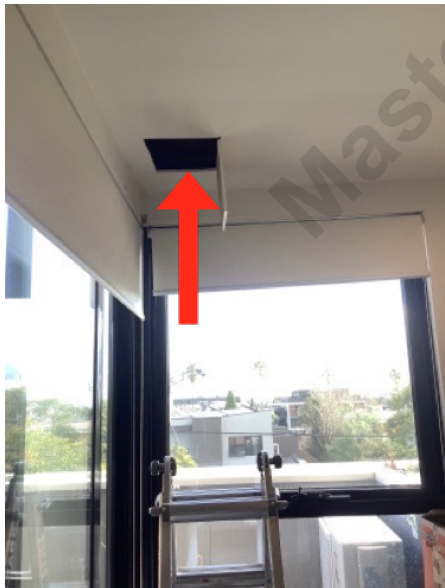
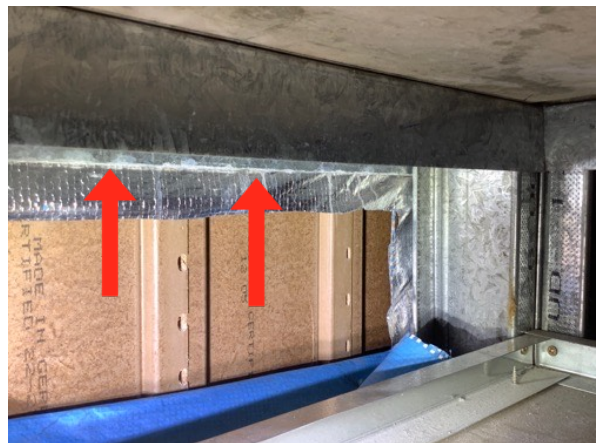
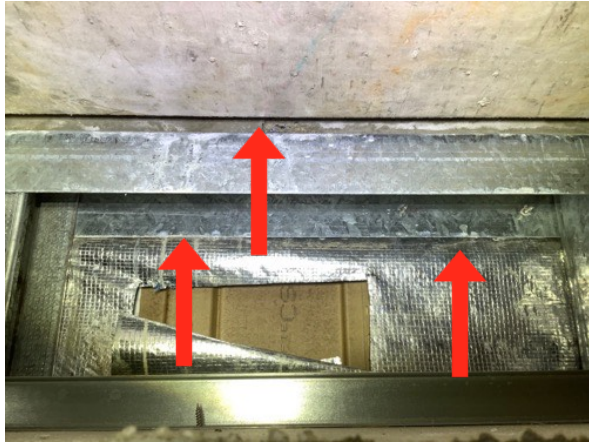
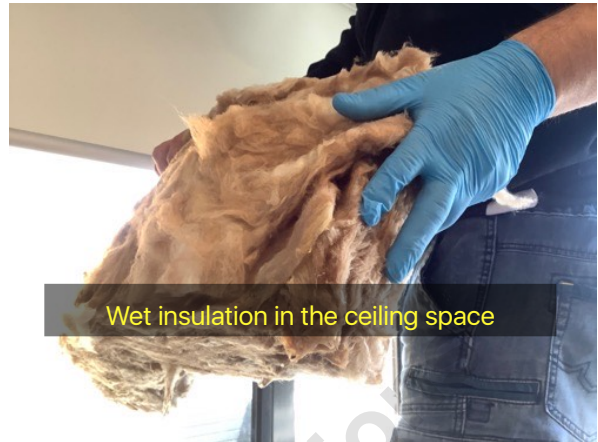
## Defect 1.09

Due to our limited inspection in the ceiling space we have determined that water is ingressing from upstairs, via the front of the sisalation wrapping, which highly suggests that the water is coming from the defective and damaged upstairs balcony installation as water appears to be ingressing the balcony upstairs and running along the concrete floor in between the two buildings, then running in front of the sisalation wrapping to the exterior perimeter wall and at this point now in the ceiling space of our client which then is finding various ways to spread in the ceiling and down the walls, window and door frames, finally ending up on the carpet floor.

Finding: Addendum 'B' - DEFECT - 9, Ceiling Space Water Traveling  
 We have cut 2 squares in the plaster ceiling at approximately 330mm x 330mm to identify the water ingress and also the water travel.  
 At the time of the inspection we did identify that the water appears to be coming from the front of the sisalation wrapping. This would appear to indicate that the water would be travelling from the upstairs balcony area as the exterior cladding is on the other side of the sisalation wrapping, so if the water ingress was coming from the exterior roofing or cladding the other side of the sisalation wrapping area should be wet.

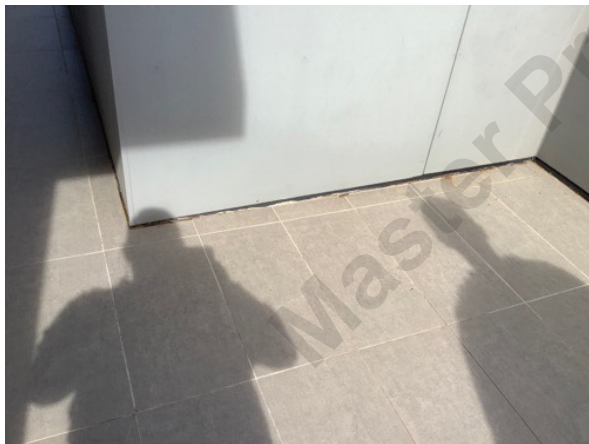
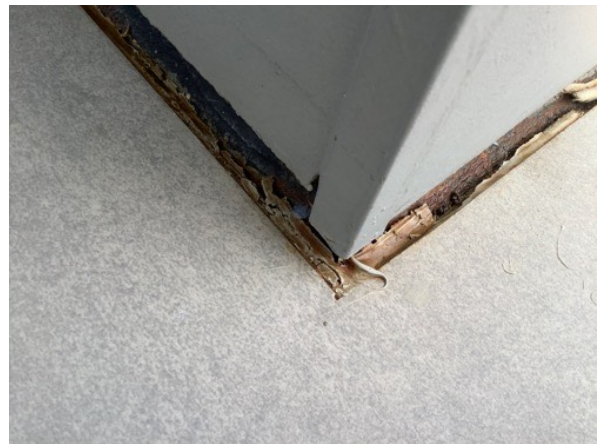
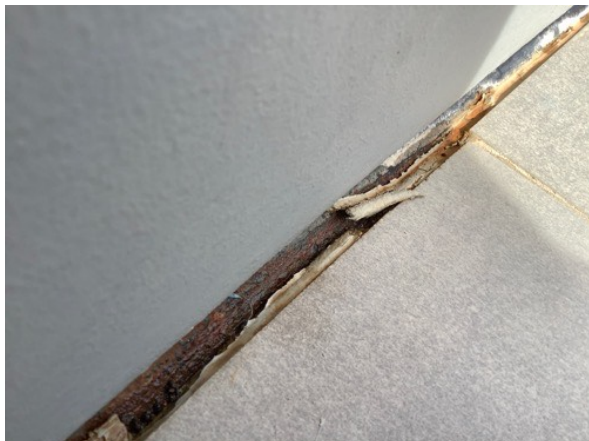
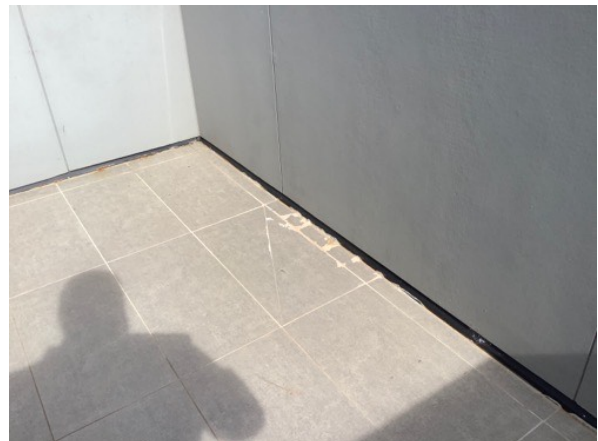
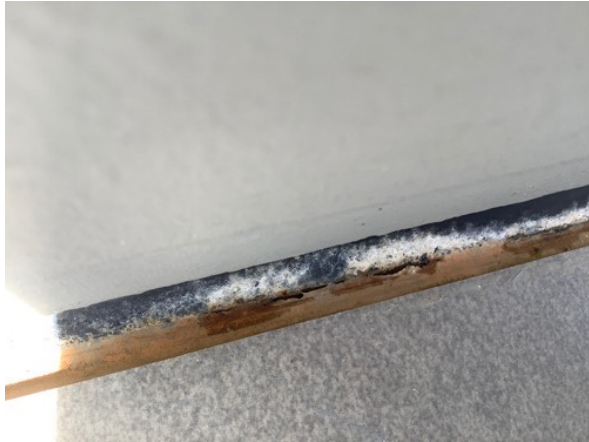
## Defect 1.10

Finding: Addendum 'B' - DEFECT - 10, Upper Apartment 306 - Defective Caulking & Materials  
The sealant is non-existent and severely compromised to the balcony in Upper Apartment 306. The sealant is an extremely important and integral part of a balcony area. Due to the corrosive and damaged metal surround, it is impossible for a sealant to adhere to the metal.
