Dilapadation Report

Inspection Date: 4 Oct 2020

Property Address: Ascot vale area.

Report Type: Dilapidation Inspection Report

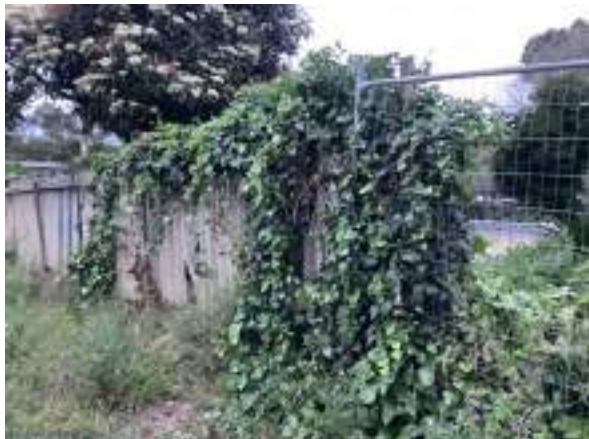
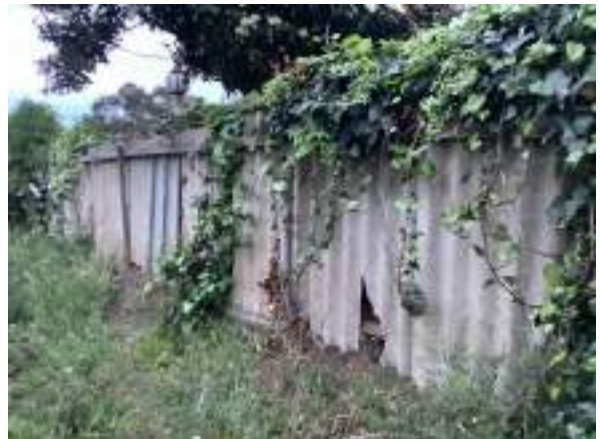
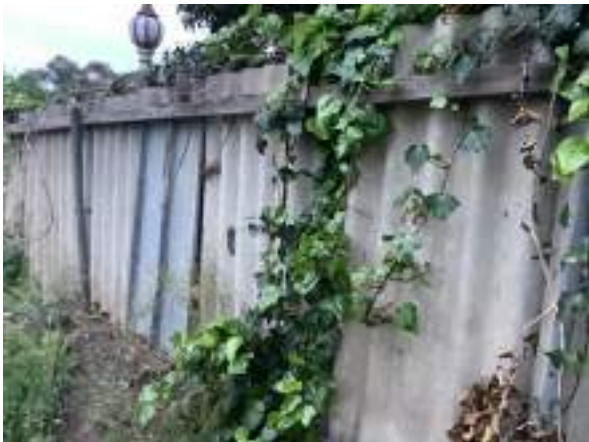
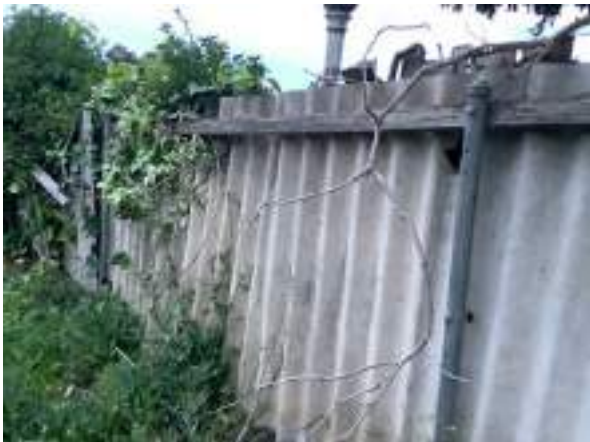
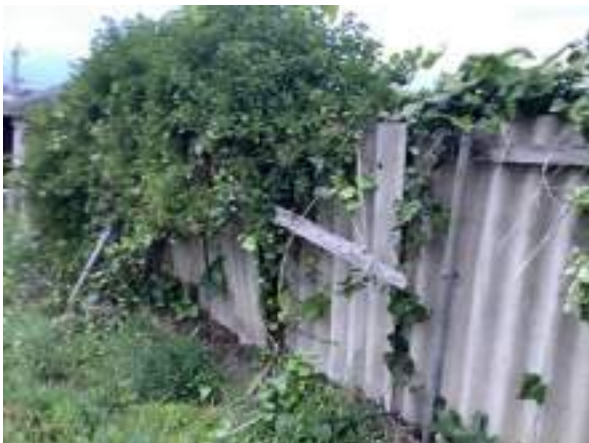
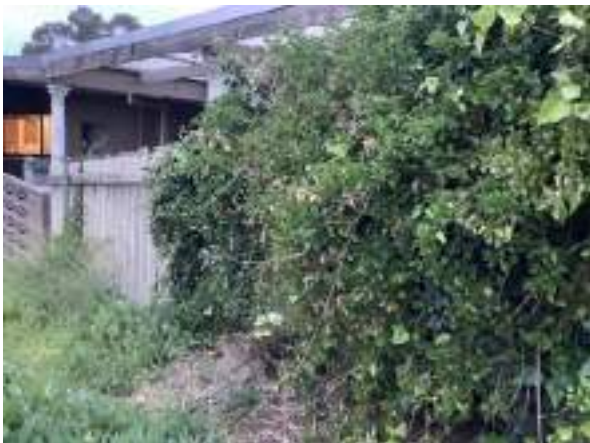
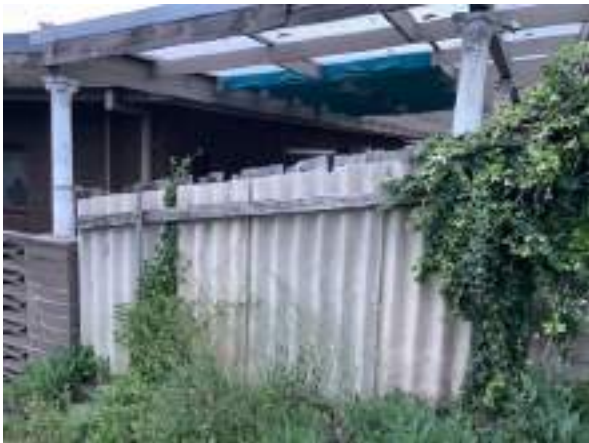
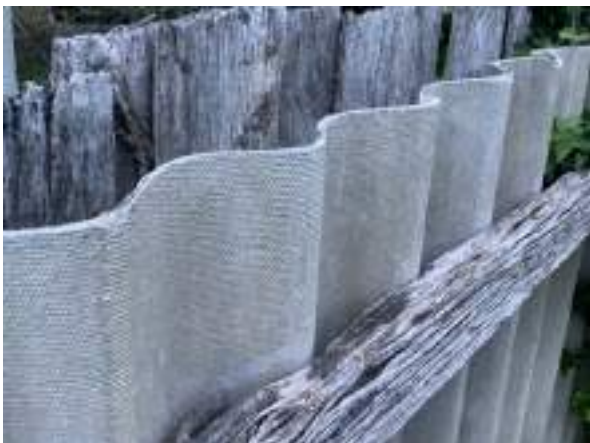
Safety Hazard 1.01

Location: Fence From Proposed Site
Finding: Fence - Suspected Asbestos-Suspected ACM Identified on Site.

Asbestos-Suspected ACM Identified on Site.

Reporting on Asbestos is outside the Scope of this Report. This suspected defect is highlighted as a caution only. We suspect, based on our experience in the building industry, that there is a higher risk of the identified building element containing asbestos (ACM).

As Asbestos Reporting is outside the scope of this report, we advise that you consider a separate Asbestos Inspection and Condition Audit, which can include the taking of samples for definitive confirmation of the presence of Asbestos.

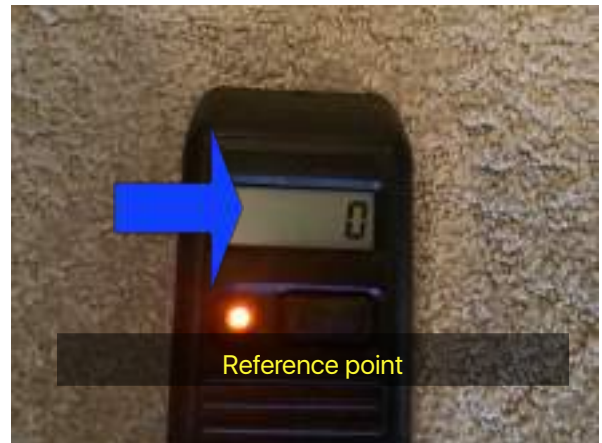
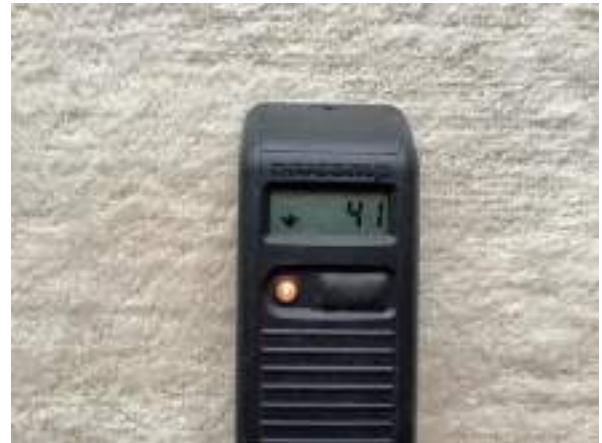
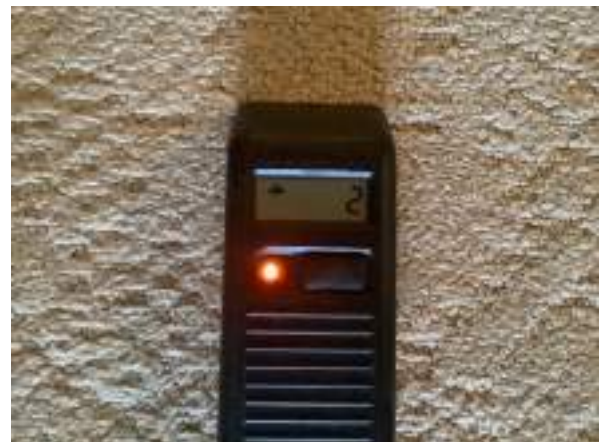
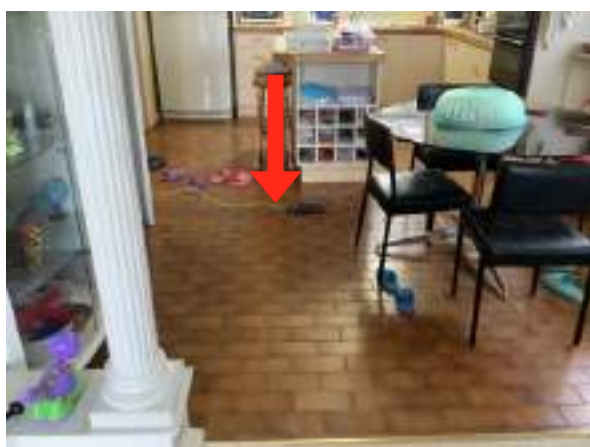
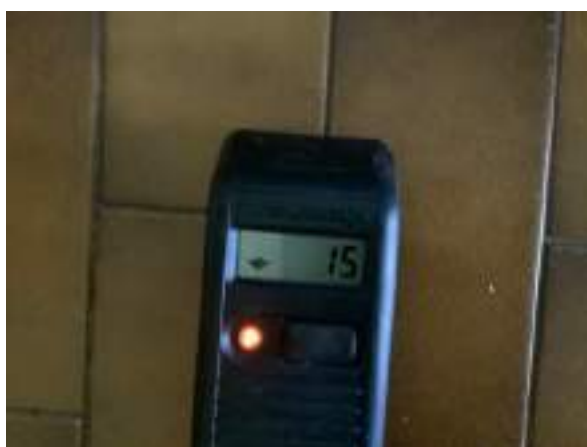
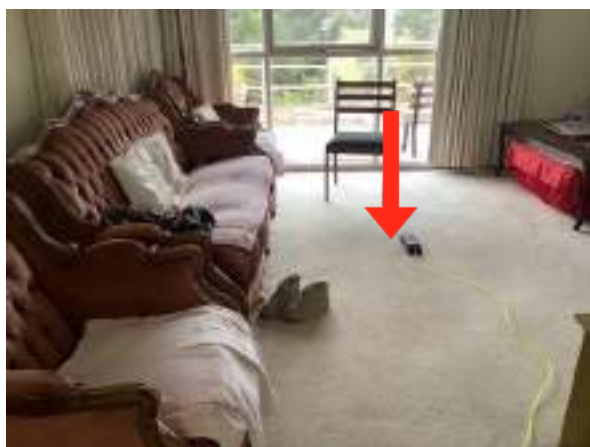
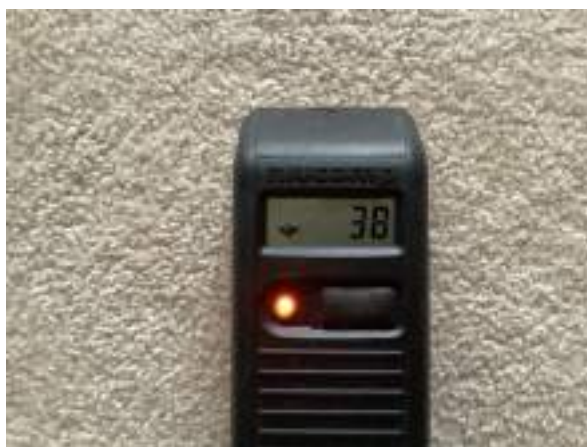
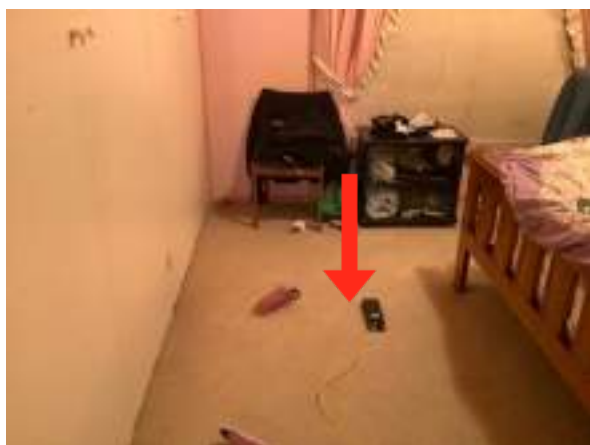
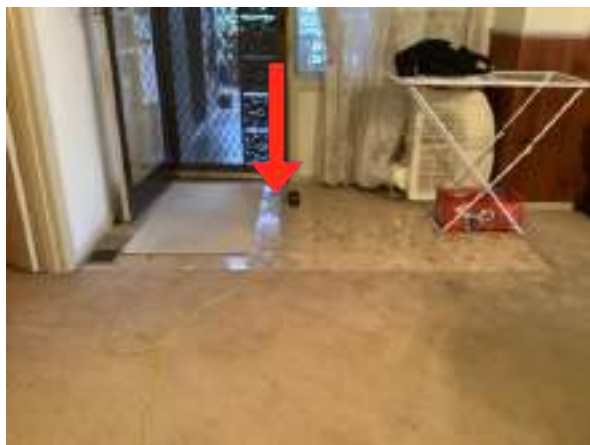
For your information 4.03

Location: Internal Floor Levels

Finding: Floor Levels - Upper Level
Attached are the floor levels in relation to a reference point to the upper level.

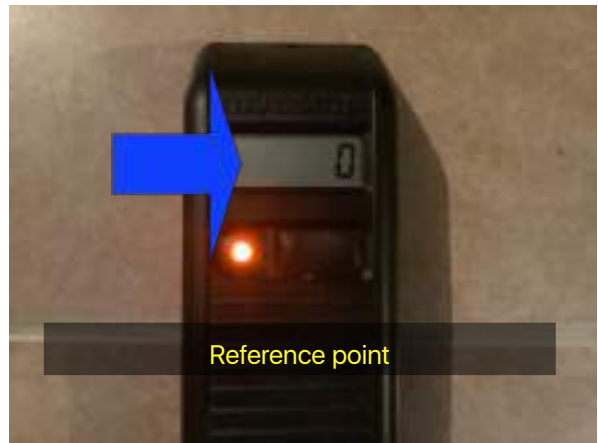
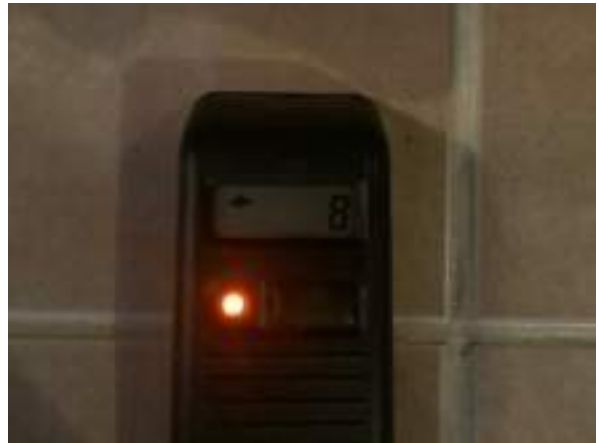
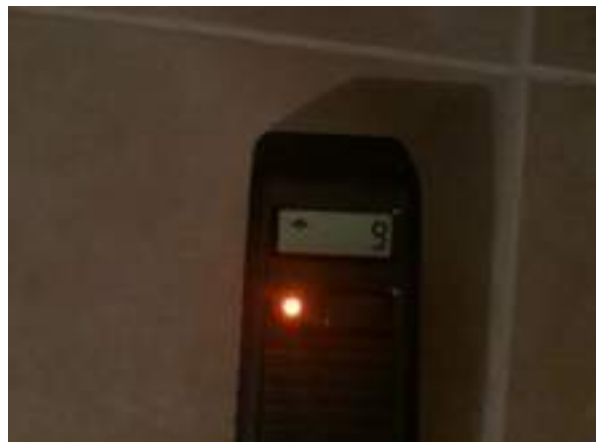
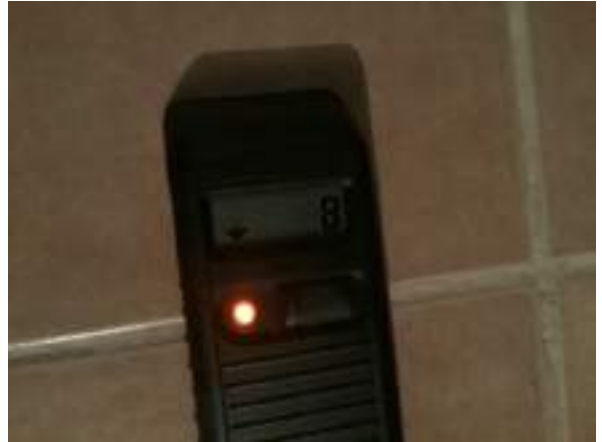
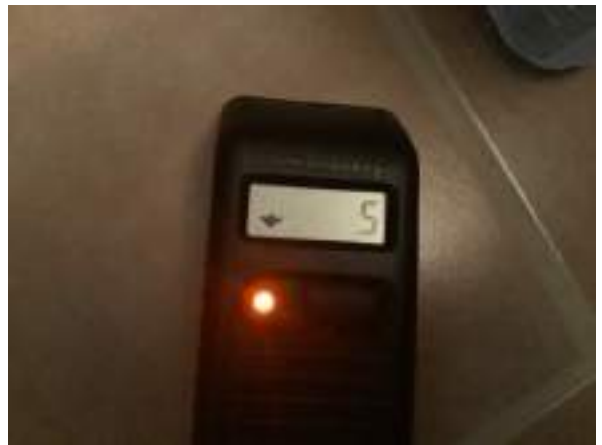
For your information 4.04

Location: Internal Floor Levels

Finding: Floor Levels - Below Storage
Attached are the floor levels in relation to a reference point to the lower level.

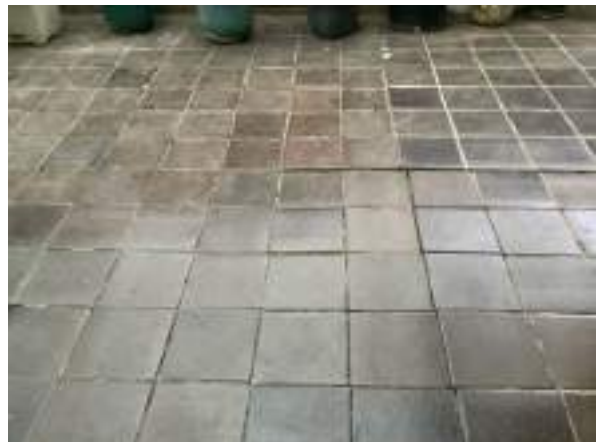
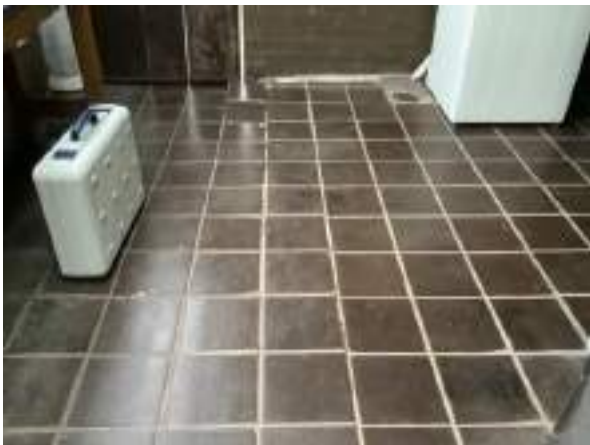
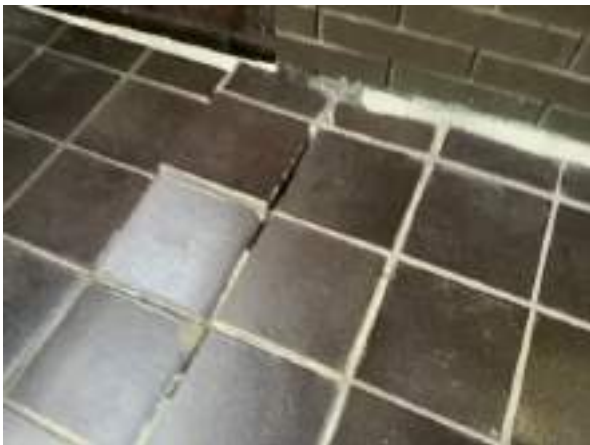
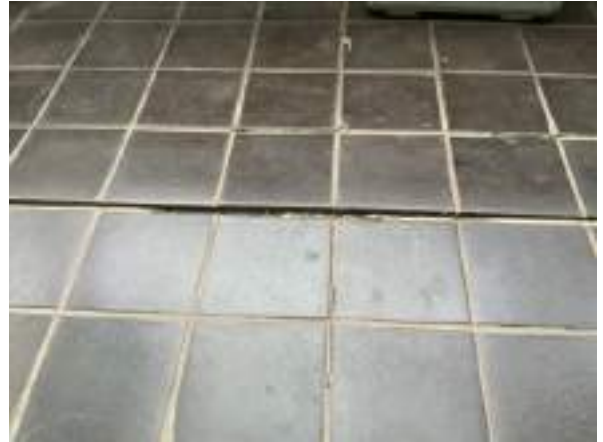
For your information 4.06

Location: Exterior North Side

Finding: Tile Paving
The tile paving is considerably compromised and drummy at the time of the inspection.

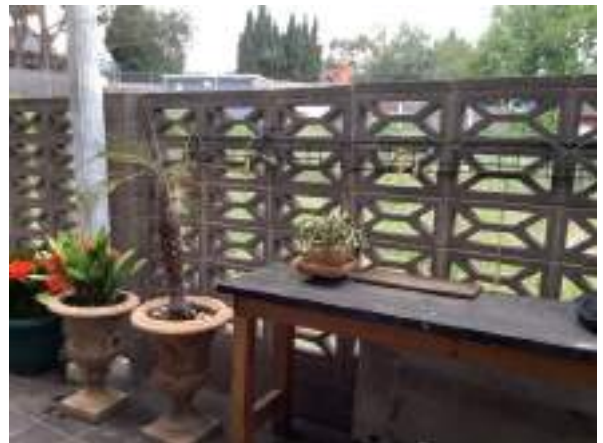
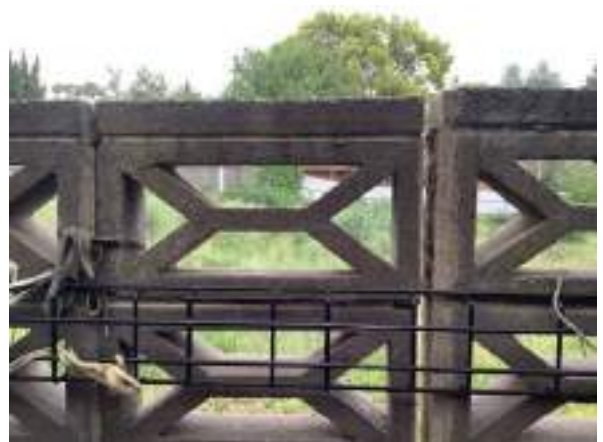
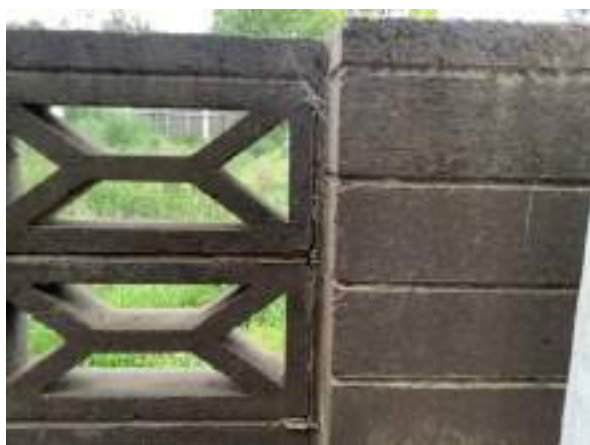
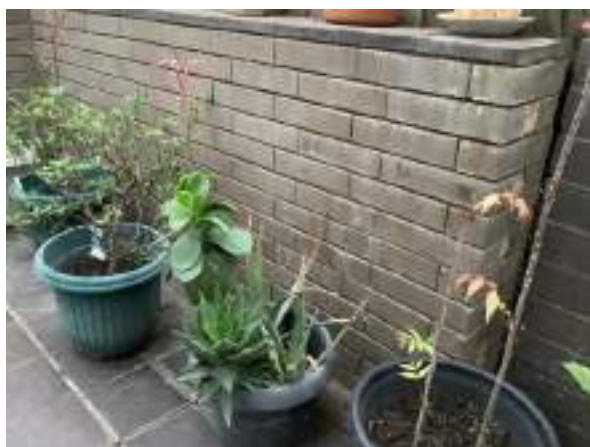
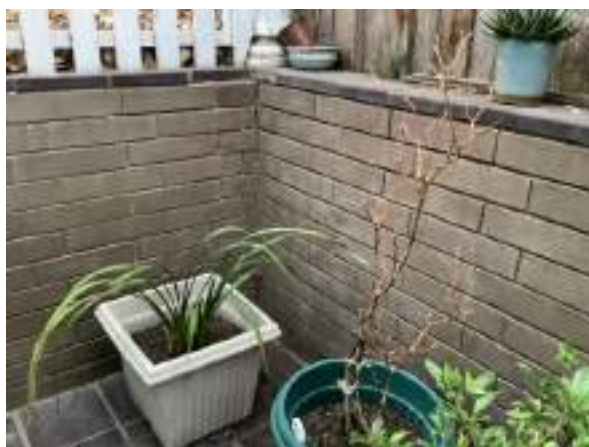
For your information 4.07

Location: Exterior North Side

Finding: Block Fencing
At the time of the inspection the block fencing has considerable movement.

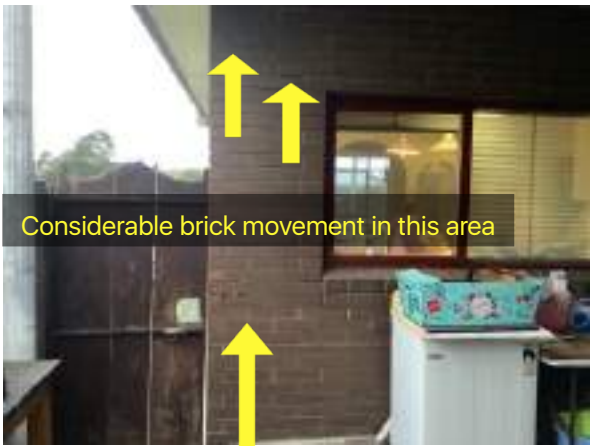
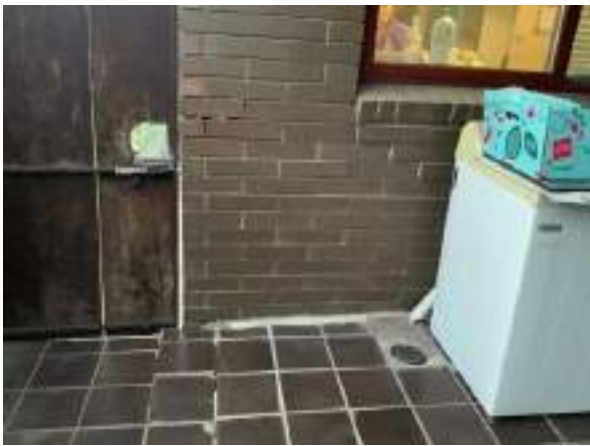
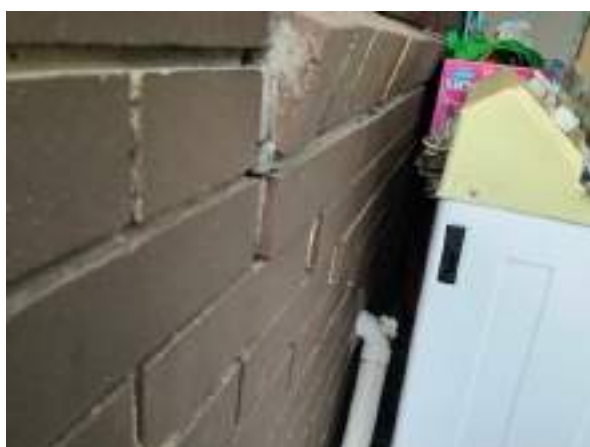
For your information 4.09

Location: Exterior North Side

Finding: Brickwork - Backyard (Behind Gate)
The photos will demonstrate that the area has movement in relation to the brickwork.

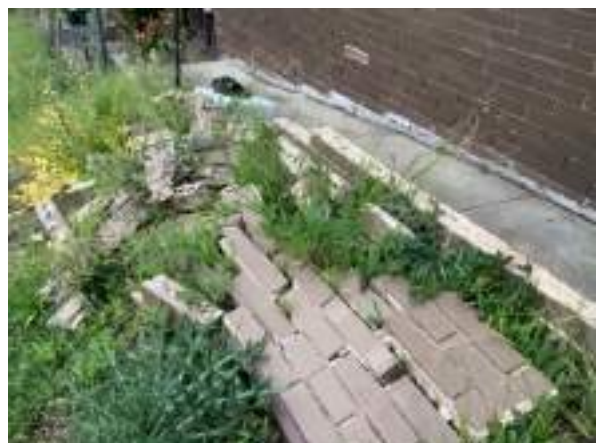
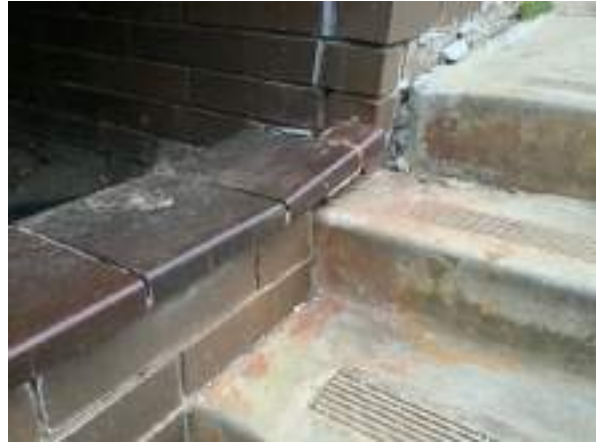
For your information 4.11

Location: Exterior North Side

Finding: Brick - Movement & Dilapidated (In Front Of Gate)
The photos will demonstrate that the brick fence is severely compromised and in a state of dilapidated which requires removal.

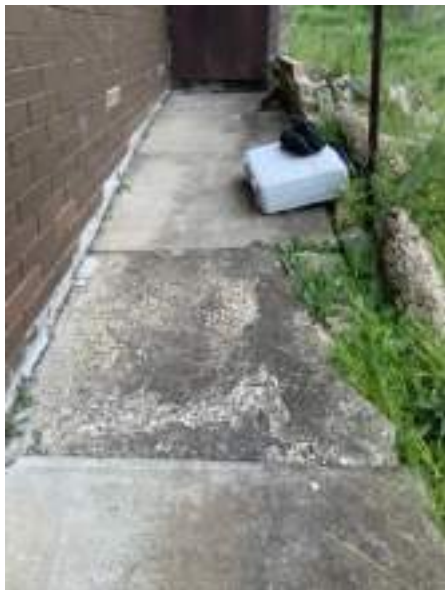
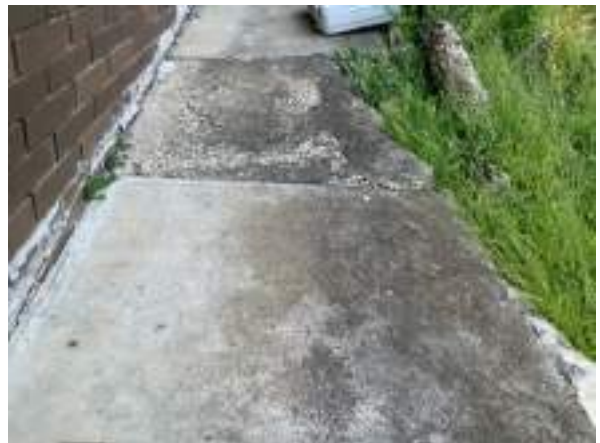
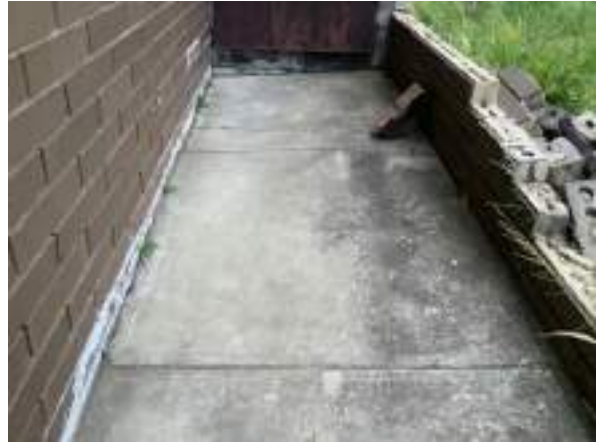
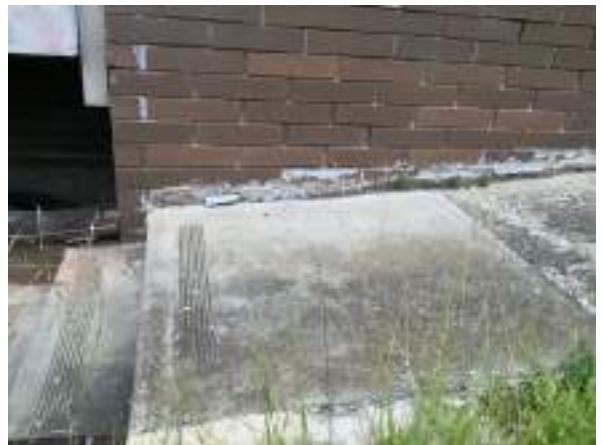
For your information 4.12

Location: Exterior North Side

Finding: Concrete Path
The photos will demonstrate that the concrete path is severely compromised and in a state of dilapidated.

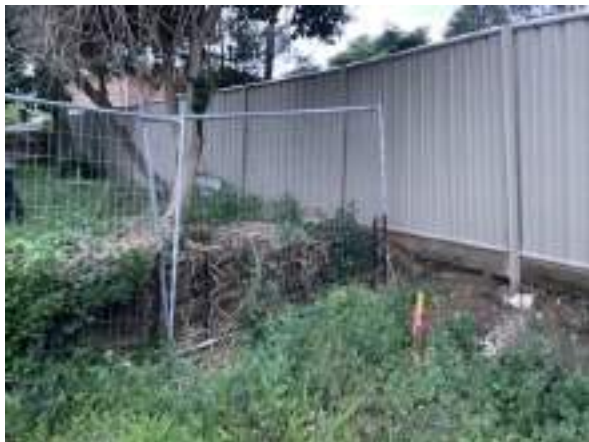
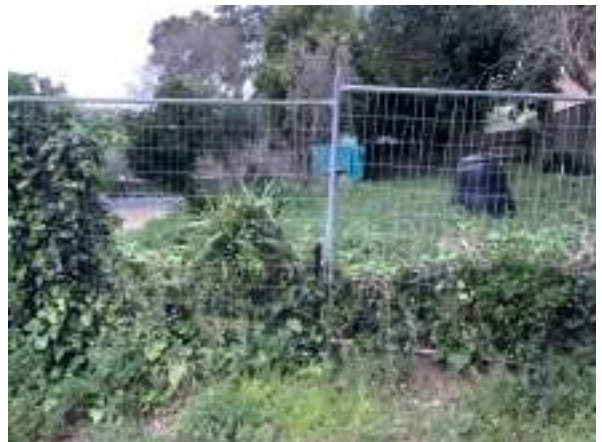
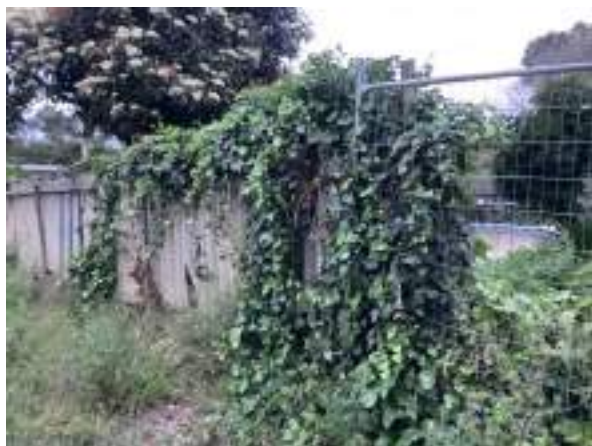
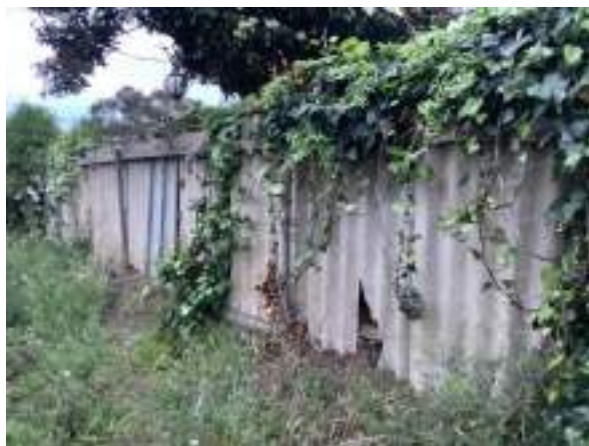
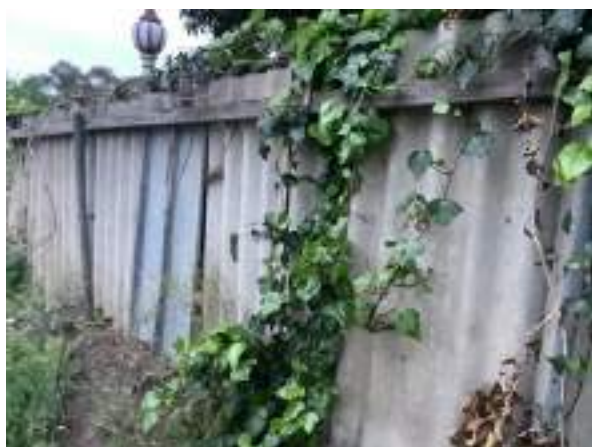
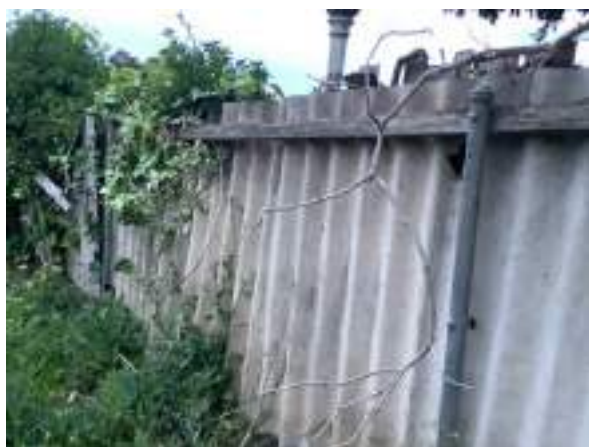
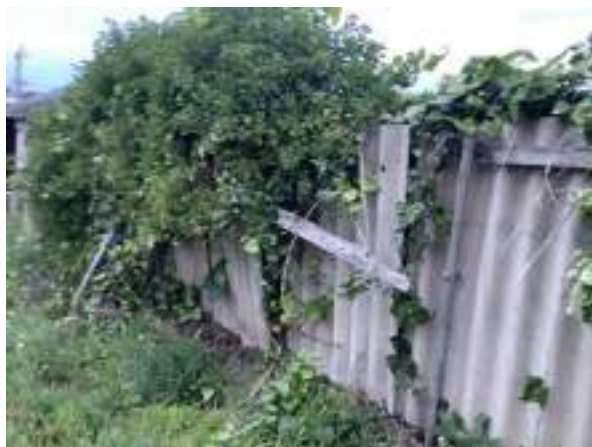
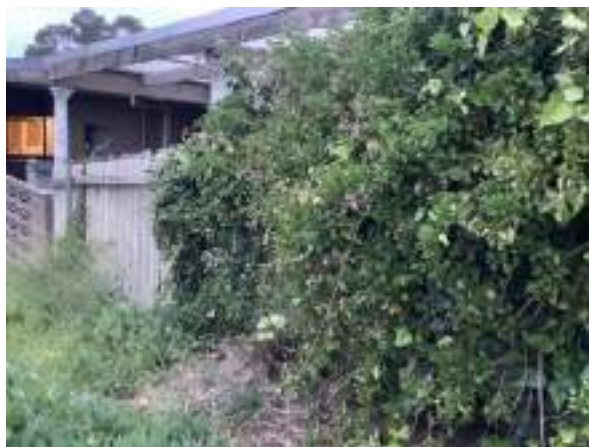
For your information 4.13

Location: Fence From Proposed Site

Finding: Fencing from the proposed working site
Photos of the fencing, various areas of damage and no fencing.
