Lock Up Report

Inspection Date: 2 Oct 2020

Property Address: Dandenong Victoria

Report Type: New Home Construction

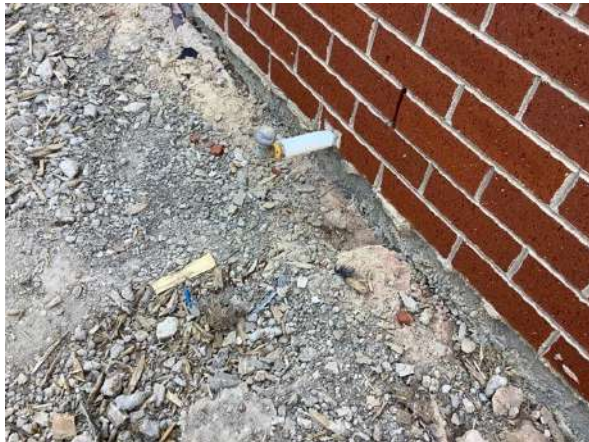
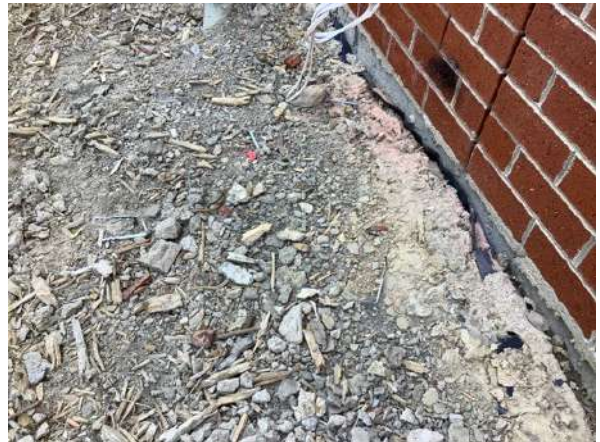
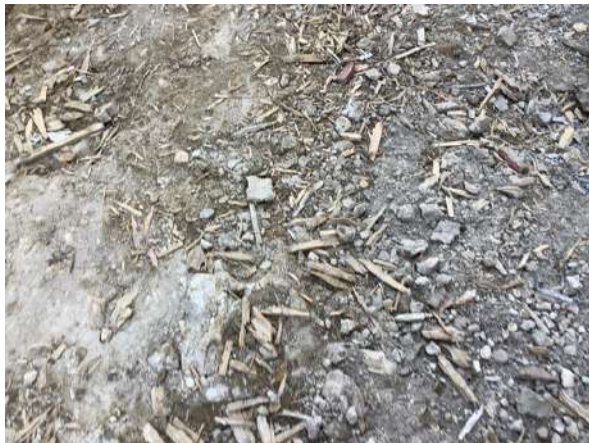
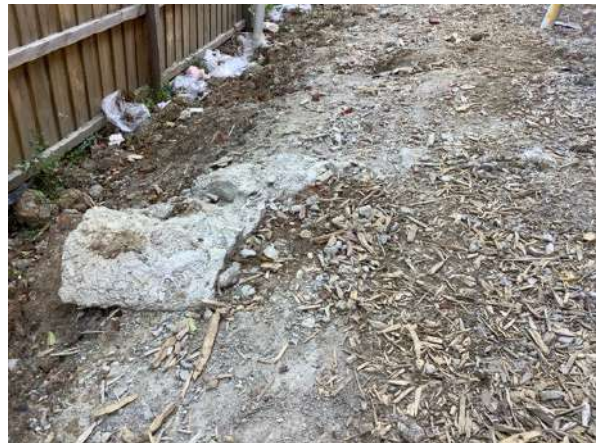
Non Compliant 2.01

Location: Cleaning - All Areas

Finding: Cleaning - debris on site at handover.
It was observed that builder's debris was present on site at handover. This is a defect with reference to Standards and Tolerances.

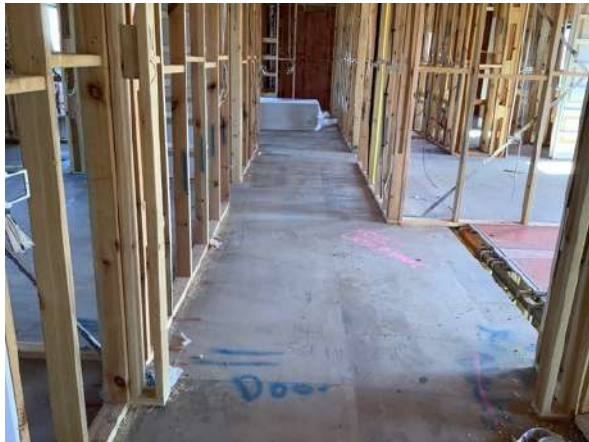
Non Compliant 2.02

Location: Flooring Upstairs

Finding: Floors - Bouncy / Squeaking (AS1684)

The flooring in this upstairs area was deemed to be noticeably bouncy / squeaky and unreasonably noisy when walked across.

Floors that squeak in trafficable areas in the first 24 months post-handover are considered defective

Floors that bounce in a way that can be detected by a person walking normally across the area are defective unless the substructure has been constructed in accordance with AS.1684 - Residential timber-framed construction.

Bouncy flooring may also be the result of gaps between flooring or joist structures, which require packing and/or addition adhesive.

Where required, the flooring should be repaired prior to final handover.

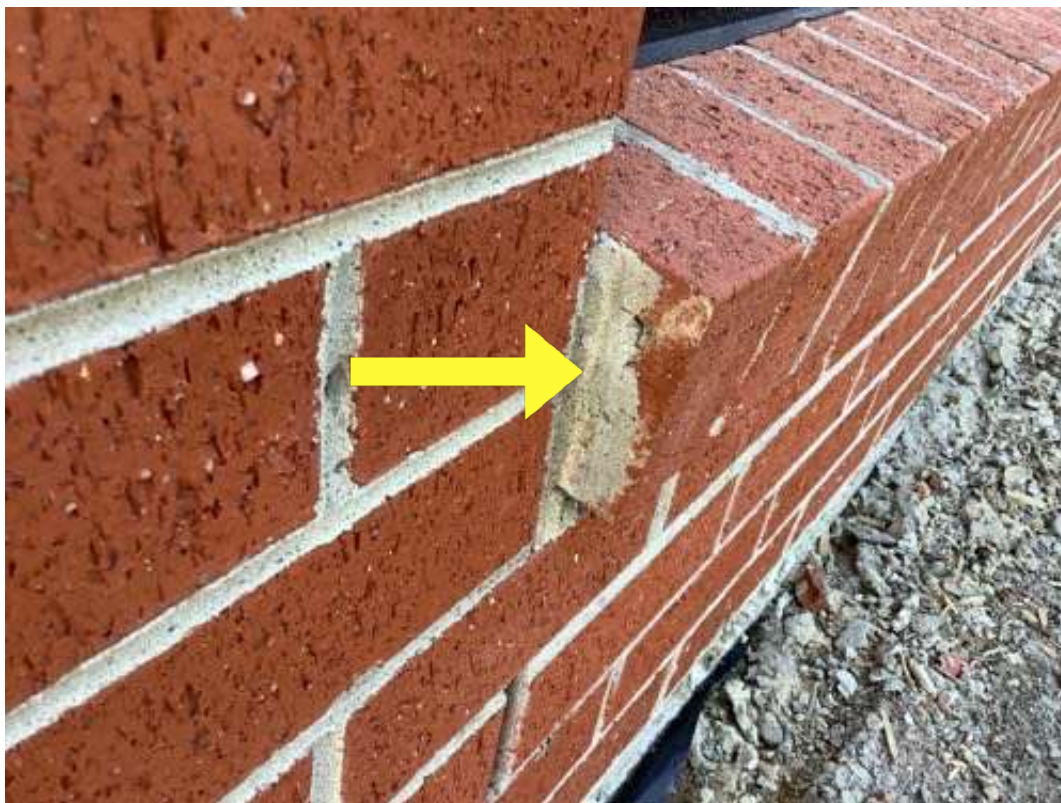
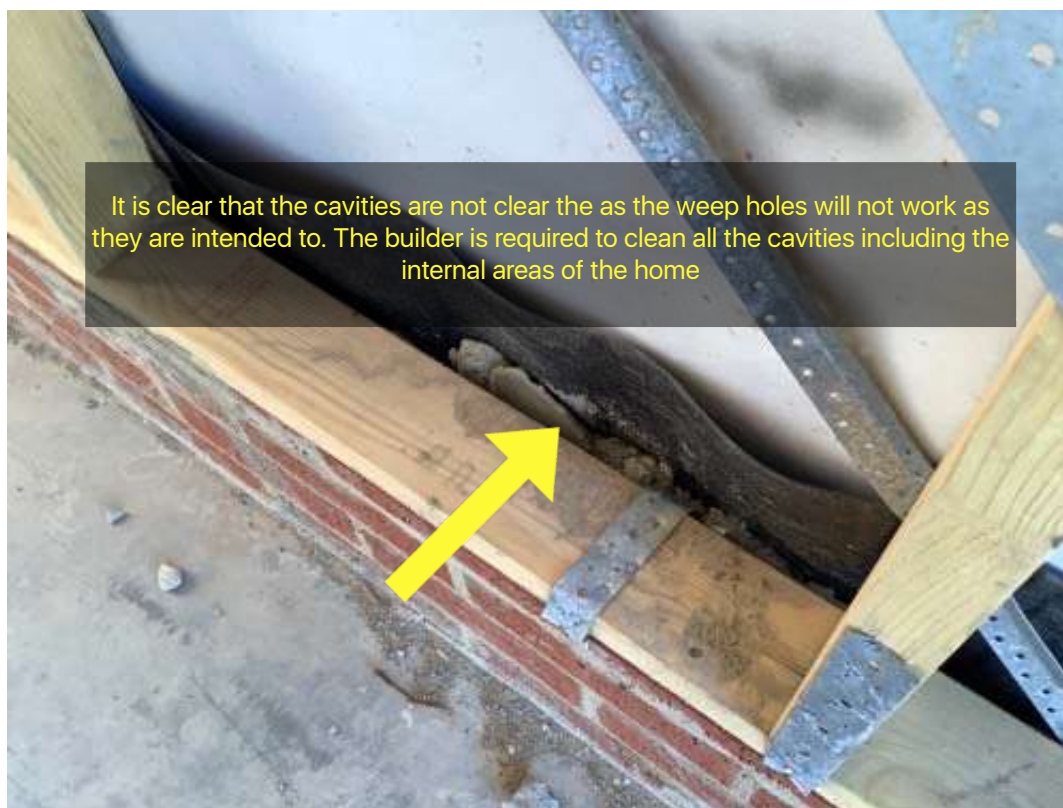
Non Compliant 2.03

Location: External-Unfinished/Defective Works

Finding: External - Unfinished/Defective Works

All these photos are added in to demonstrate DEFECTIVE / SUB STANDARD and/or INCOMPLETE WORKS and they are all required to be rectified as they are ALL not satisfactory for Handover as per the DOMESTIC BUILDING CONTRACT ACT 1995 as stated above.

The following items will need to be completed or repaired in accordance with the Domestic Building Contracts Act 1995.

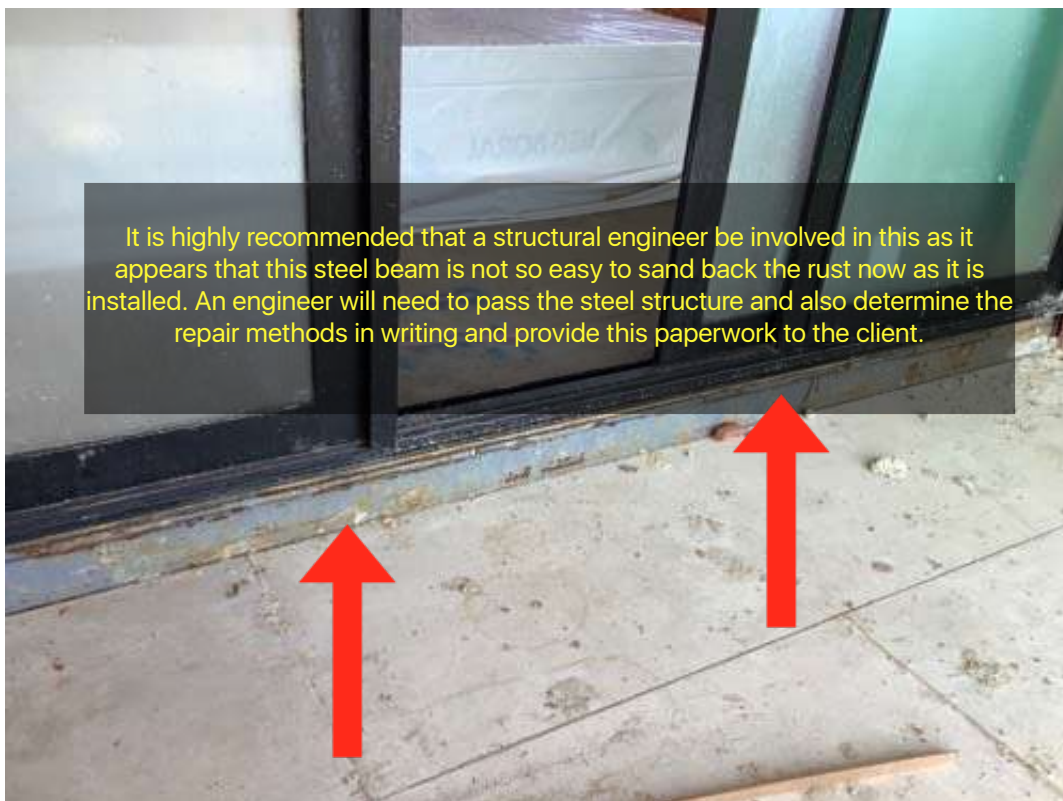
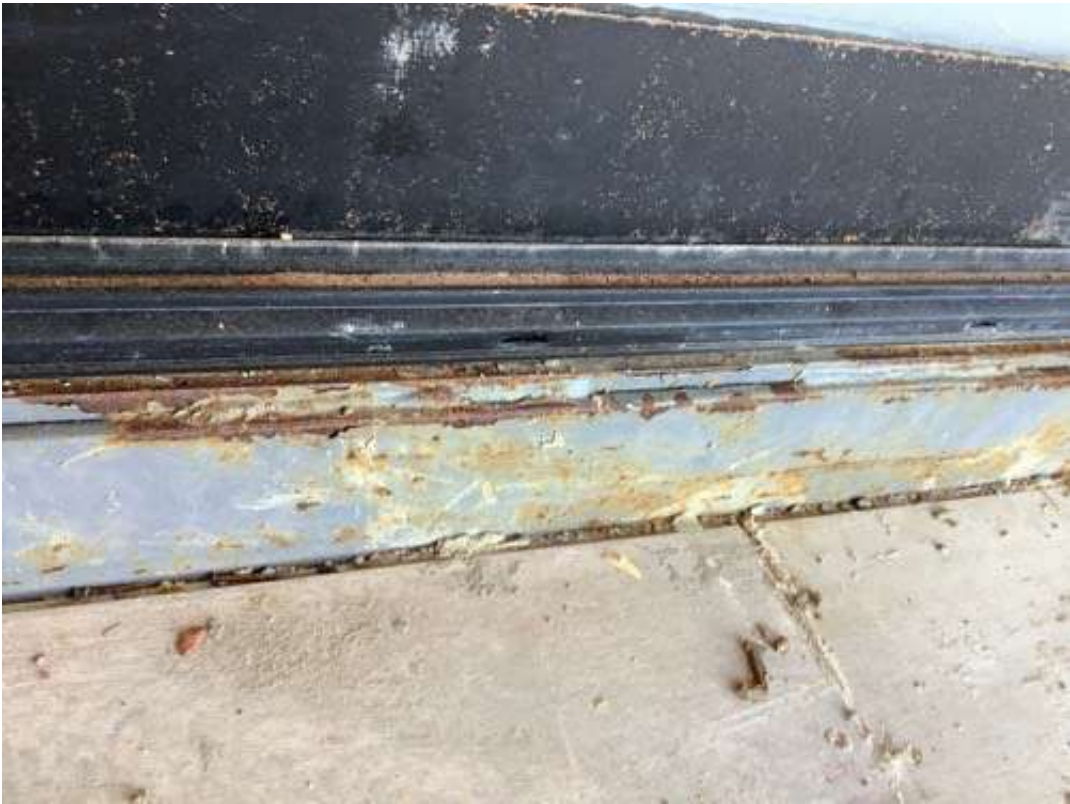
Non Compliant 2.04

Location: Perimeter Of The Building - Exterior

Finding: Corrosion Building Element - Rusted or corroded

This building element shows evidence of rusting and corrosion, which is likely to have developed as a result of excessive exposure to moisture and or inadequate coatings.. As surface rust provides no protection to the underlying iron, the deteriorating condition is likely to worsen if not addressed in the short-term future.

Rusting and corrosion should be managed by ideally removing or limiting the affected surface from exposure to moisture.

The builder should replace or repair any building elements that have been severely affected by rust or water damage.

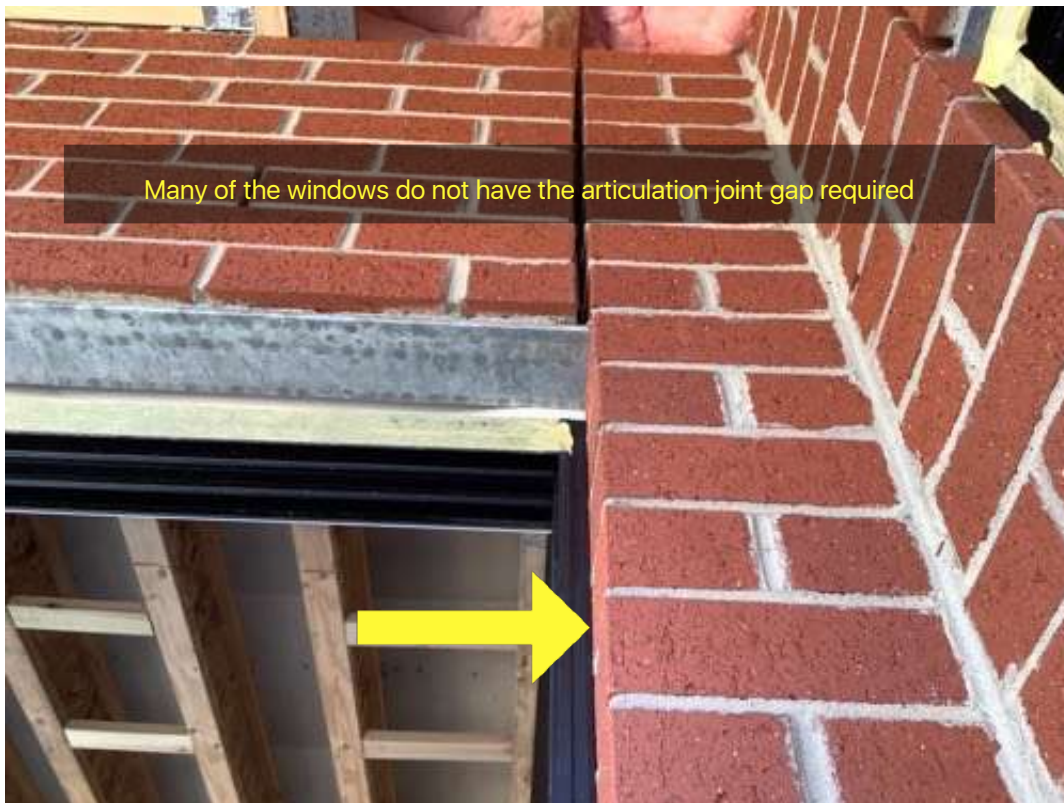
Non Compliant 2.05

Location: Articulation Joints - Exterior Perimeter Of Building

Finding: Articulation joints - Width defective .(AS3700)
To comply with AS3700 all articulation joints must be a minimum gap of 10mm wide and a max gap of 15mm.

The Masonry Structures Code AS3700 limits the amount of movement to be accommodated at a vertical joint to 15mm, and requires that a gap of at least 5mm should remain after the movement has taken place. It limits the amount of movement to be accommodated at a horizontal joint to 10mm.

The joints also must be sealed to maintain the integrity of weatherproofness, acoustic and fire isolation.

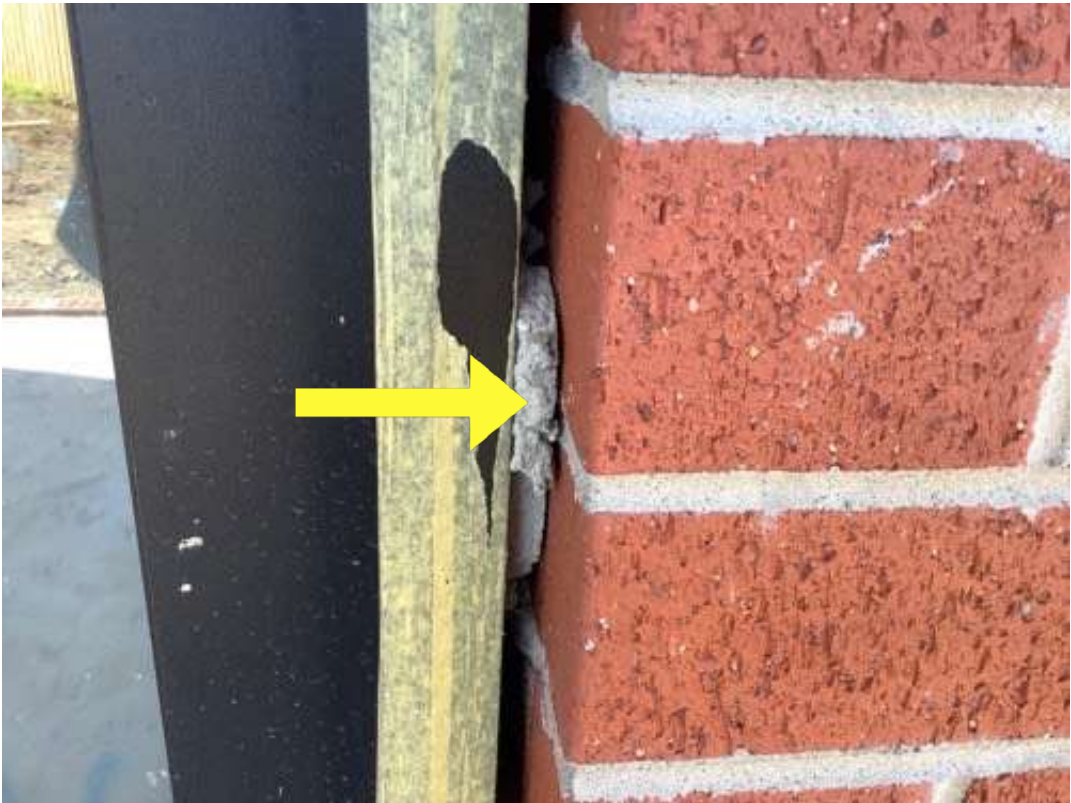
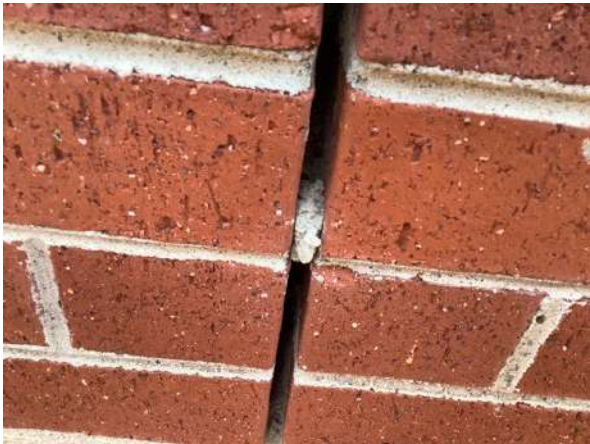
Non Compliant 2.06

Location:	Articulation Joints - Exterior Perimeter Of Building
Finding:	<p>ARTICULATION JOINTS - Not Free Of Mortar</p> <p>I have ONLY taken LIMITED photos of this defect and attached are LIMITED photos of this defect in SOME AREAS ONLY.</p> <p>All AREAS to the entire property should be checked CAREFULLY to identify any further defects that are the same, as this defect is in other areas of the property.</p> <p>-----</p> <p>----- 7.2 ARTICULATION JOINTS</p> <p>Where appropriate, articulation joints shall be used in masonry walls to limit the potential cracking or distress that may be caused by footing movement.</p> <p>Articulation joints shall be provided in unreinforced masonry walls longer than 5 m long.</p> <p>Articulation joints are not required for Class A and Class S sites or for reinforced masonry designed in accordance with Section 12.</p> <p>Articulation joints shall be vertical (not toothed), full-height of the masonry, and free of mortar.</p> <p>It was observed at the time of inspection that many of the articulation joints (AJ's) were obstructed by incompressible material (mortar)</p> <p>At the time of inspection, this area does not meet the requirements of Australian Standards AS 4455 masonry for small structures or the BCA contractual requirements regarding acceptable finishes.</p> <p>All AJ's need to be cleaned out and continuous for the full length of the wall.</p> <p>The responsible contractor should be appointed to complete these works in order to comply with standards and regulations. Such works should be completed prior to final handover.</p>

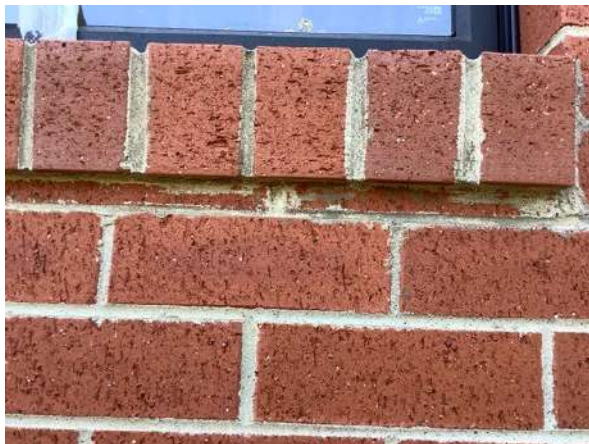
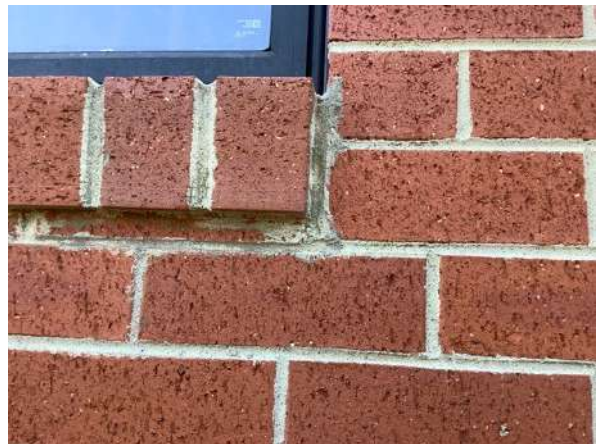
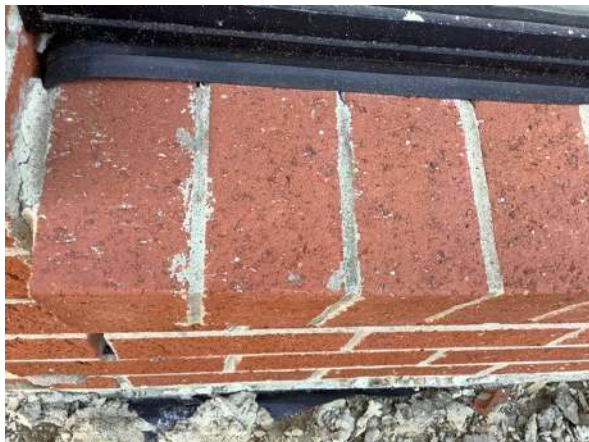
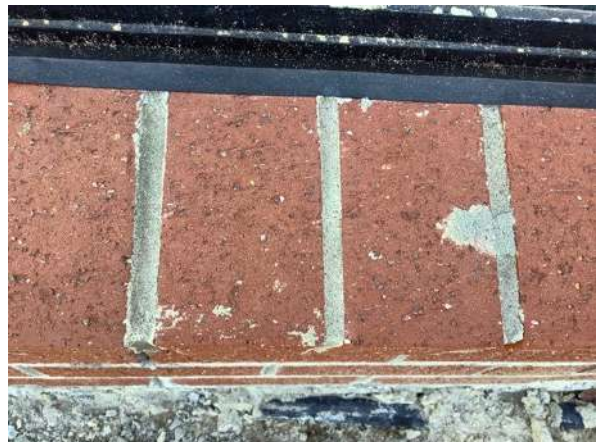
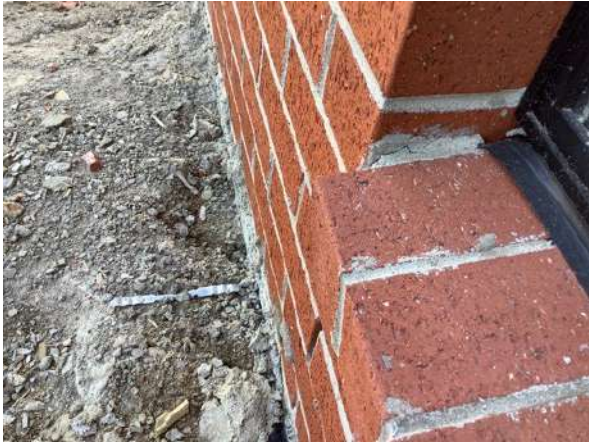
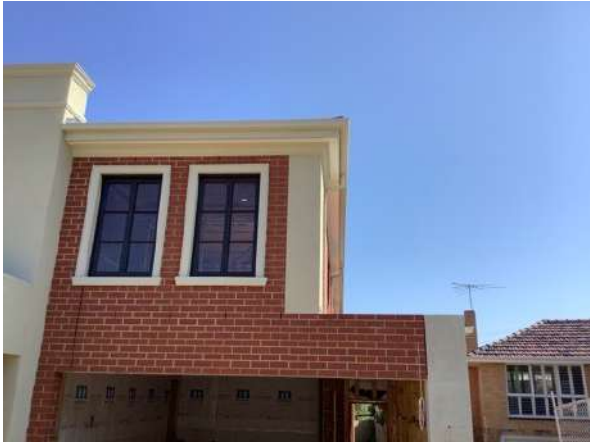
Non Compliant 2.07

Location: Brick Work - Exterior Perimeter Of Building

Finding: Brickwork - Excessive mortar (AS4455)
IMPORTANT 🖱️ ONLY SAMPLE PHOTO'S of the Brick Excessive mortar defects. All AREAS to the entire property MUST be checked and repaired.

It was observed at the time of inspection that several bricks in this area of brickwork require cleaning to remove excessive mortar. While not likely to cause secondary defects, excessive mortar detracts from the overall appearance of the area and should therefore be removed.

The Building Commission's Guide to Standards and Tolerances clause 3.07, Masonry Facing states that:- 'Masonry faces are defective if they are not cleaned and free of excess mortar' and clause 3.11, Cleaning, Mortar Smears & Stains states that:- 'Stains, mortar smears and damage caused by cleaning are defects if they are visible from a normal viewing positioning.' The faces and edges of the bricks within the wall around this home will have to be properly re-cleaned to remove all traces of the mortar residue from across them.

At the time of inspection, this area does not meet contractual requirements regarding acceptable finishes. The responsible contractor should be appointed to complete these works in order to comply with standards and regulations. Such works should be completed prior to final handover.

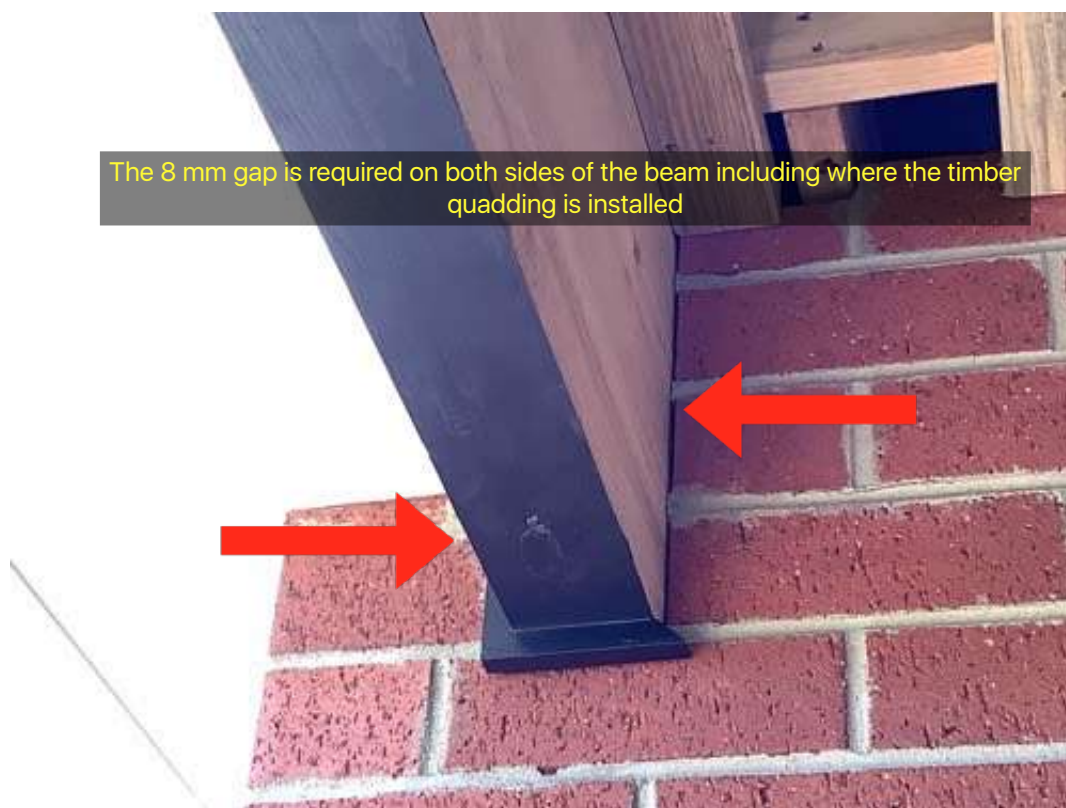
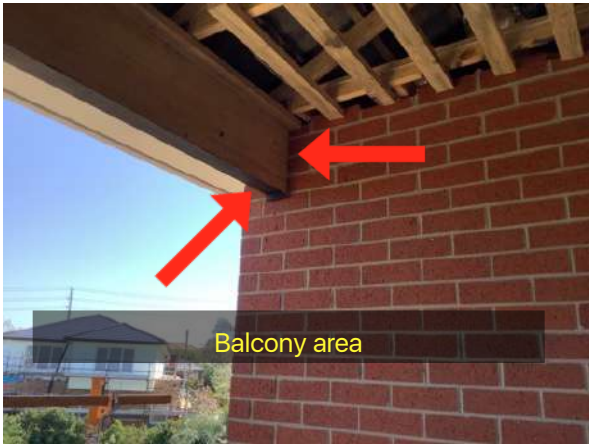
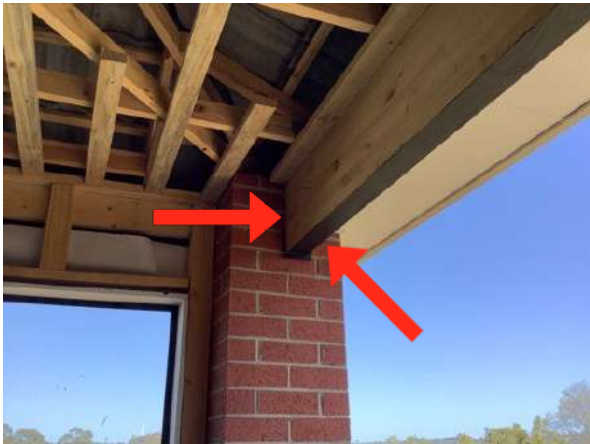
Non Compliant 2.08

Part 3.3.1.10 Shrinkage Allowance for Timber Framing of the BCA requires that 'In masonry veneer walls a gap must be left between the timber frame and the top of the masonry wall, including window sills ect, to allow for settlement of the timber framing caused by timber shrinkage.

The Australian Standard AS 1684.2 Timber Framed Construction and Masonry standard call for a clear gap of 8-10mm to be left to allow for expansion and contraction of timber beams due to varying moisture content.

The bricklayer needs to rework these junctions to achieve the 8mm minimum gap.

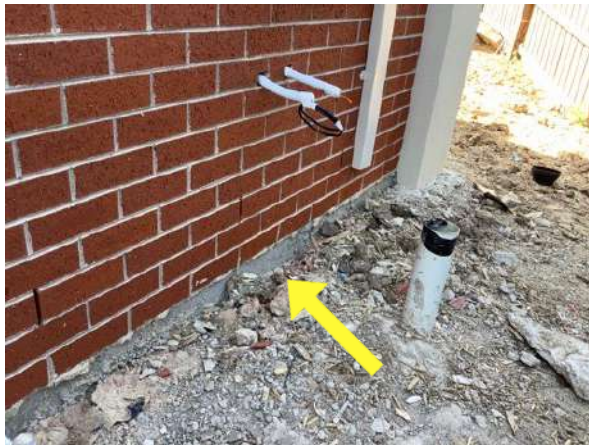
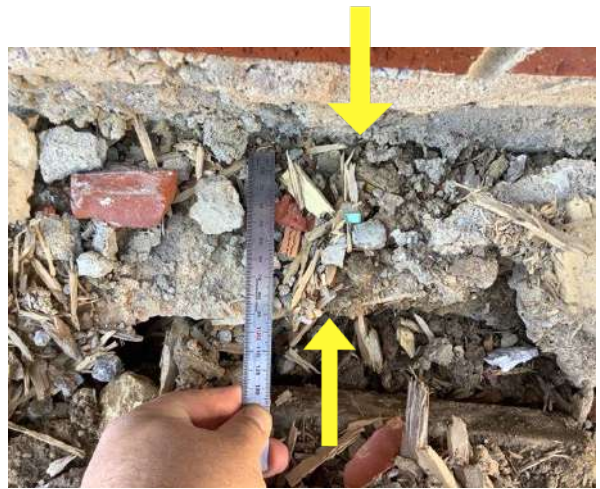
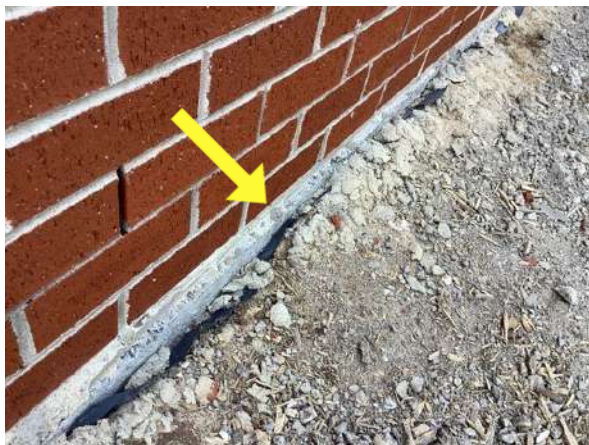
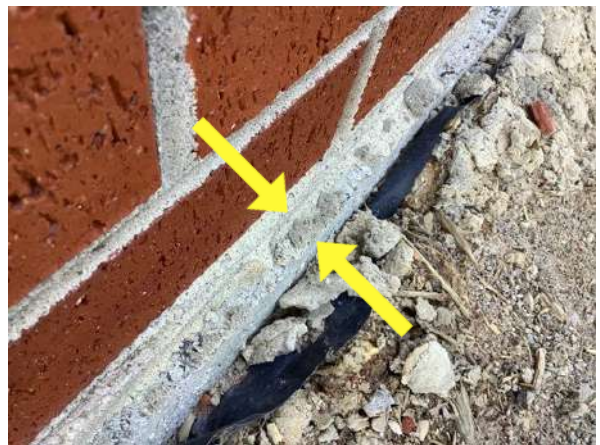
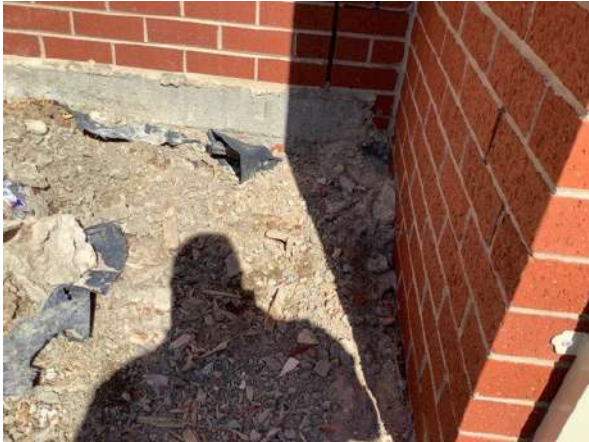
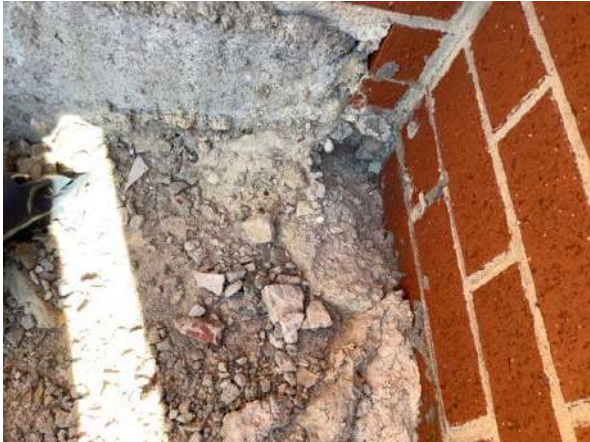
Non Compliant 2.09

Location: Brick Work - Exterior Perimeter Of Building

It was observed that there are areas where the edge of the slab protrudes past the document finished dimension of the slab.

It appears the boxing on the slab may have bulged out which occurs when insufficient pegging and bracing is provided prior to the concrete pour.

The current overhang will affect any concrete pavement or hard material landscaping such as pavers and as such the overhang needs to be cut back.

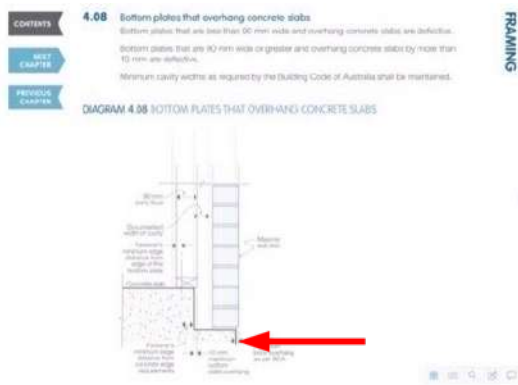
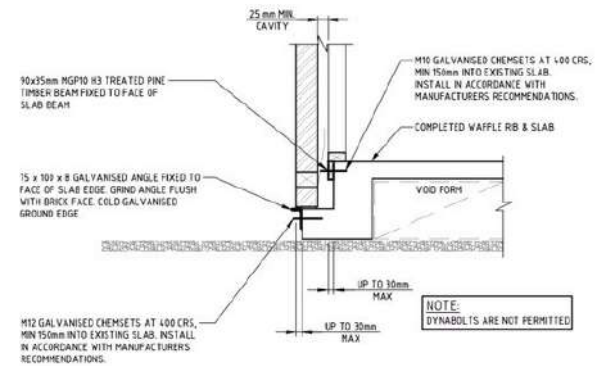
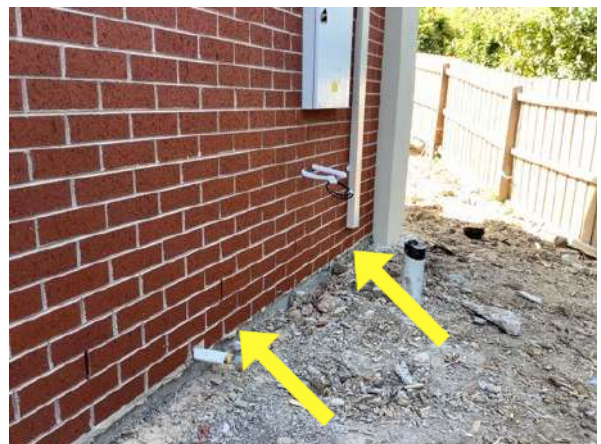
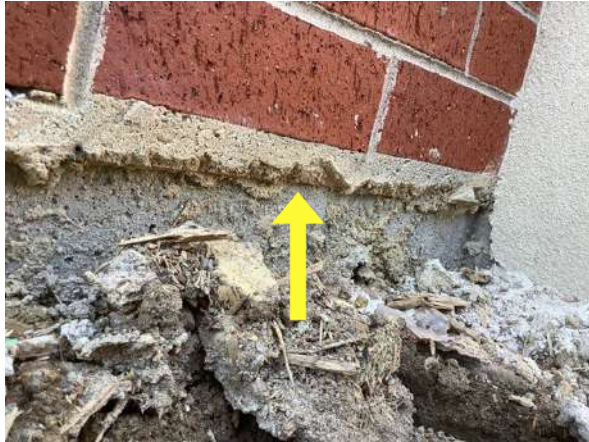
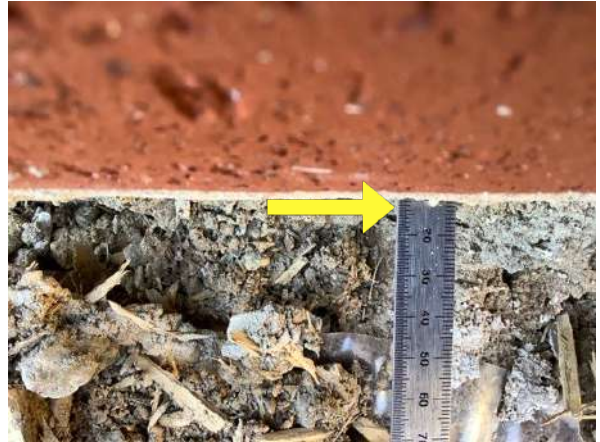
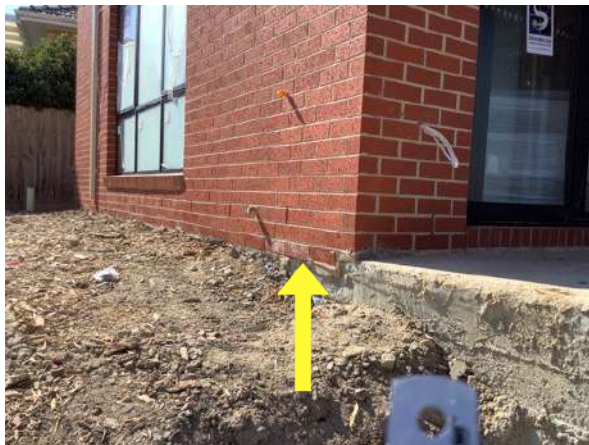
Non Compliant 2.10

Location: Brick Work - Exterior Perimeter Of Building

Finding: Brick/Wall Overhang On Slab.
I have ONLY taken LIMITED photos of this defect and attached are LIMITED photos of this defect in SOME AREAS ONLY.
All AREAS to the entire property should be checked CAREFULLY to identify any further defects that are the same, as this defect is in other areas of the property.

At the time of the inspection it was found that the brickwork is overhanging the slab by more than 15 mm.

Standards and Tolerances 2015 - Diagram 4.08 states that the maximum overhang of the brick work is 15 mm.

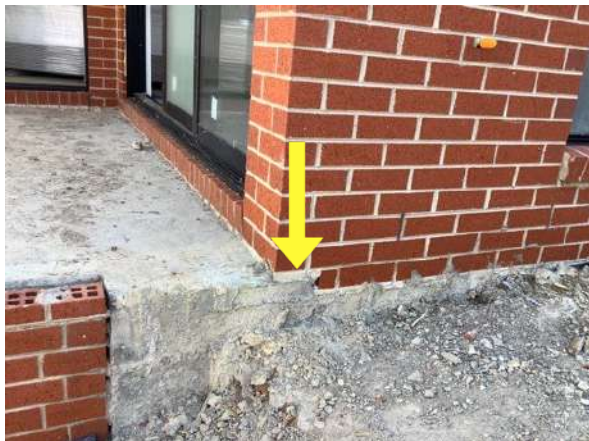
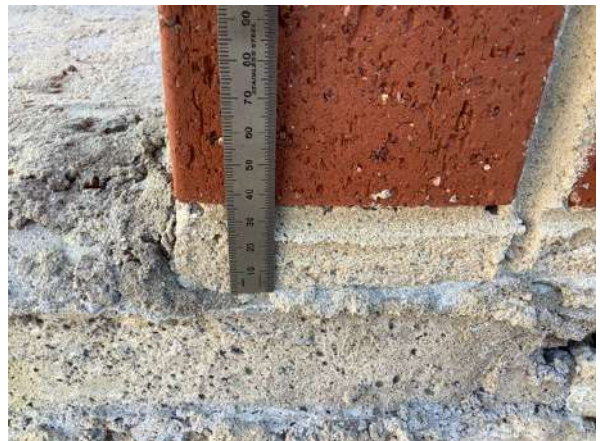
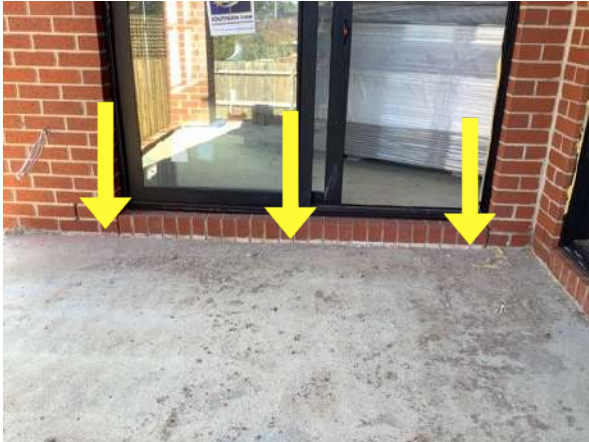
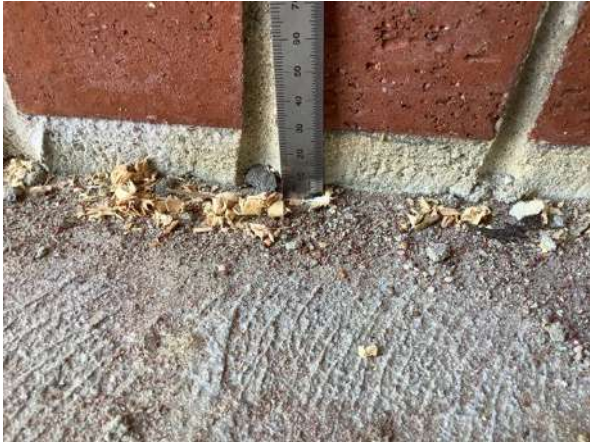
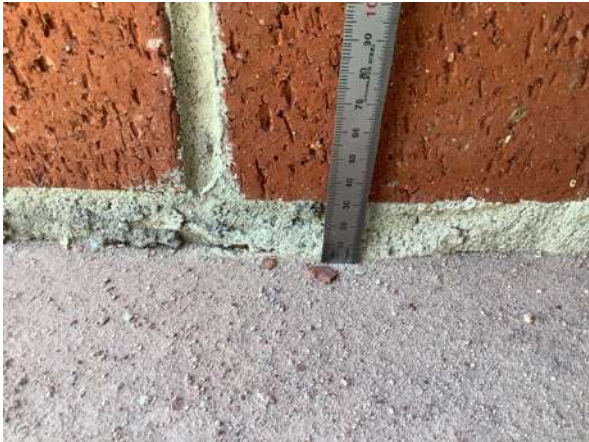
Non Compliant 2.11

Location: Brick Work - Exterior Perimeter Of Building

Finding: Brick Base bed joints (exposed)- defective
It was observed that the exposed base bed joint is defective. Exposed base bed joints in masonry walls which are above the finished ground level are considered to be defective if they exceed 20mm in thickness which is the allowable Standards and Tolerances.

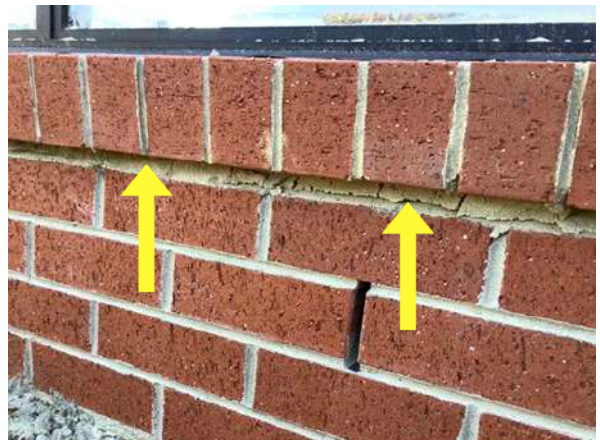
Non Compliant 2.12

Location: Brick Work - Exterior Perimeter Of Building

Finding: Brick Mortar joints inconsistent depth - raking defective
IMPORTANT 📌 ONLY SAMPLE PHOTO'S of the Brick Mortar joint defects. All AREAS to the entire property MUST be checked and repaired.

Areas of defective mortar joints were identified as they are raked to inconsistent depths which may also exceed 10mm in some areas. Raked joints should be consistent in depth and not exceed 10mm.

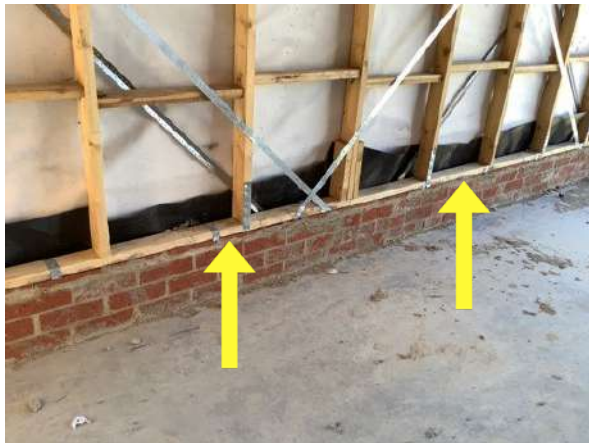
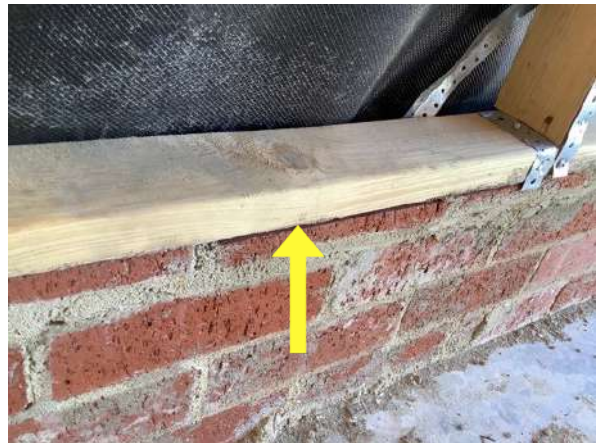
Non Compliant 2.13

Location: Brick Work - Exterior Perimeter Of Building

Finding: Brick- NO Damp proof course not compliant with AS requirements
It was observed that the wall which is a single skinned brick veneer wall with a timber frame to be lined with Gypsum Plaster.
The builder has failed to install the required damp proof course material leaving the wall incapable of draining any accumulated moisture.
The BCA and Australian Standards are very descriptive when it comes to the need to install the Damp Proof Course.
There is no simple way to install the DPC material safely other than to dismantle the wall and start again with the DPC attached to the frame.
The actual DPC position depends on the location and the requirements for this are: 150mm above the adjacent finished ground level or 100mm above sandy well drained areas or 75mm above finished paved or concrete areas or 50mm above finished paved or concrete areas

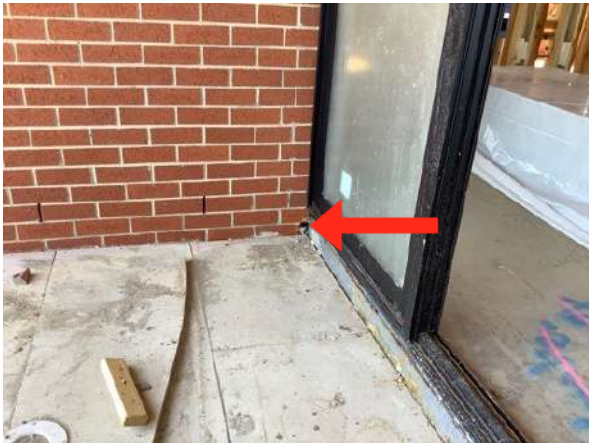
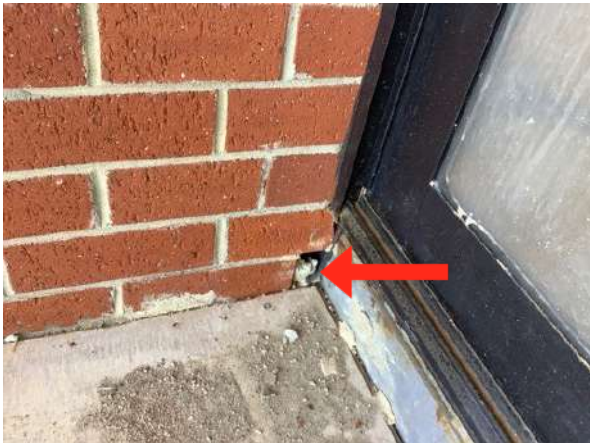
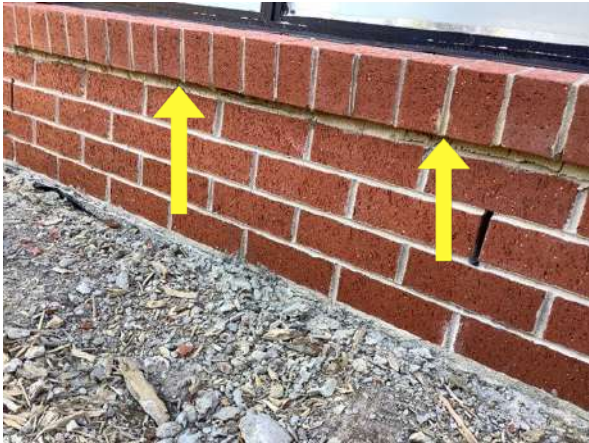
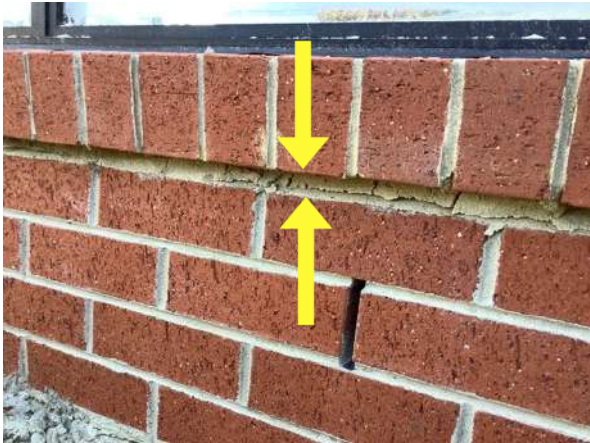
Non Compliant 2.14

Location: Brick Work - Exterior Perimeter Of Building

Finding: Brick Perp Ends & Bed Joints - Variations Excessive
 IMPORTANT 🖱️ ONLY SAMPLE PHOTO'S of the Brick Perp Ends & Bed Joint defects. All AREAS to the entire property MUST be checked and repaired.

It is observed that there is an excessive deviation from the documented thickness of the brick per ends.

There are variations in excess of 10mm which is excessively high then the acceptable levels of workmanship regardless if it is the bricklayers defective workmanship and/or defective sizing or seconds brick supplied by the builder.

The maximum non-structural framework tolerance is 3mm. This identified defect exceeds the maximum allowable tolerance and is therefore considered a defect.

The relevant Australian Standard, A.S.3700-2001 Masonry Structures, states that 'the maximum deviation from a specified thickness of a perpend joints for non-structural face brickwork is +/- 5mm on average' as well as that 'the maximum difference in perpend thickness in any non-structural face brick wall is 8mm' and also that 'the minimum perpend thickness for non-structural face brick wall is 5mm'.

Generally the remedial works are demolition of brick work and/or at the clients consent render.

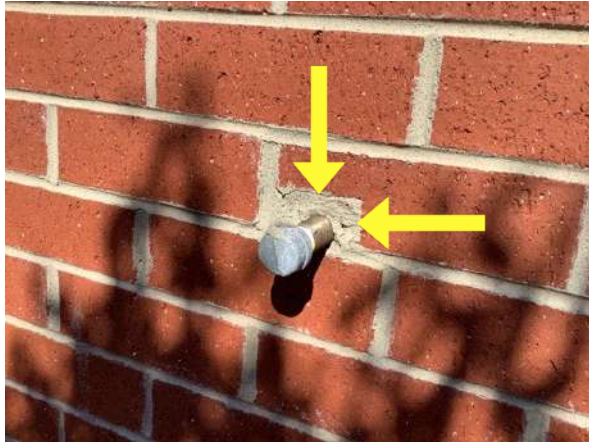
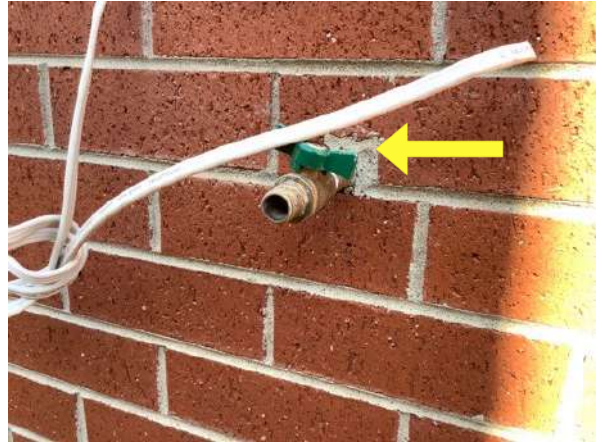
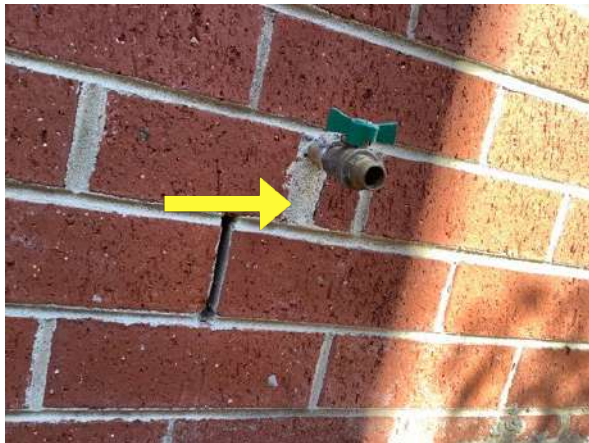
Non Compliant 2.15

Location: Brick Work - Exterior Perimeter Of Building

Finding: Brick Pipe penetrations (walls) - defective
Examples of pipe penetrations or plumbing holes which are penetrating external walls being defective were identified. Generally this means that the penetrations have not been finished neatly grouted as appropriate or kept to the smallest practicable size.

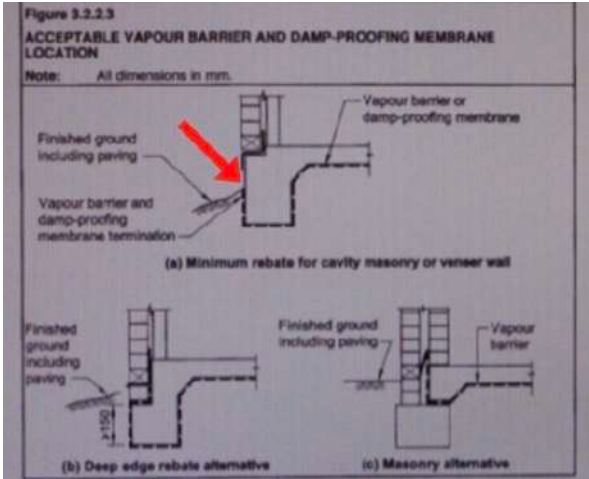
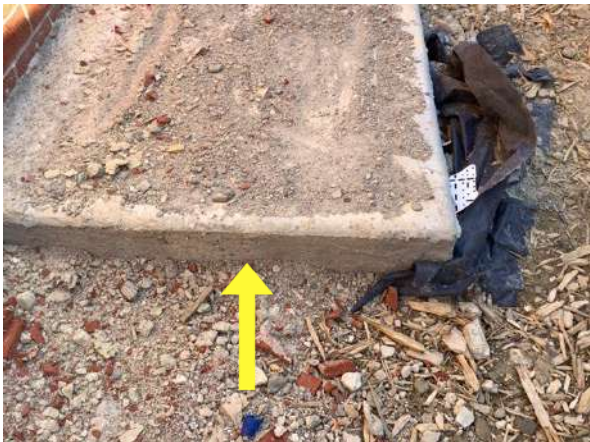
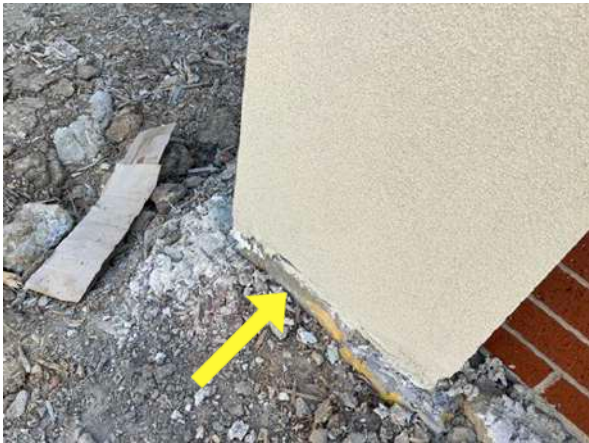
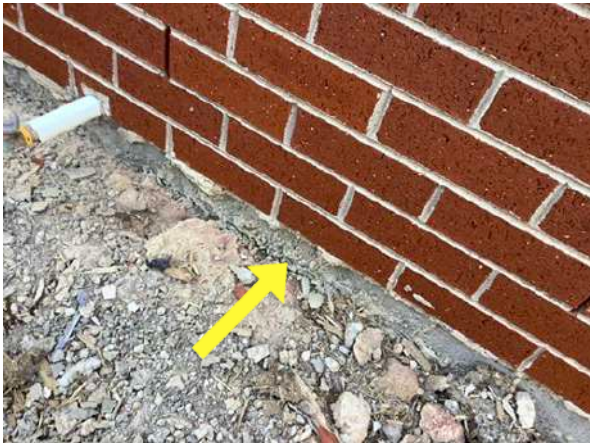
Non Compliant 2.16

Location: Concrete Slab - Perimeter To All Areas

Finding: Vapour barrier - Defective (AS2870- 2011)
 IMPORTANT 🖱️ ONLY SAMPLE PHOTO'S of the vapour barrier defects. All AREAS to the entire property MUST be checked and repaired.

Defective Vapour Barrier Installation - Damaged/Punctured and/or overlapping Defective.

It was noted at the time of inspection that a vapour barrier had not be installed in accordance with AS2870 and BCA Part 3.2.2.6.

- 1/ All over laps are not taped as described below.
- 2/ All the ripples and/or damaged area needs to be taped.
- 3/ Some areas are not up to future ground and/or finished paving or concrete heights and must be extended with 200mm overlay and taped.
- 4/ Some areas whilst listed above are Damaged / Ripped / Not Consistent And Sealed with 200mm Overlay And Taped / Not High Enough / Non Existent must ALL be repaired.

The polyethylene vapour barrier from beneath the concrete floor slab must be turned up the external side faces of its edge beams. Failing to install the vapour barrier correctly will allow moisture ingress via slab edge dampness into the internal timber wall skins and/or the floor coverings if not done.

Without a vapour barrier installed, these areas are non-compliant with Australian Standards and are susceptible to excessive moisture, which may create major secondary defects as the building ages. Rectification works are necessary as soon as possible to ensure all standards are met.

I HIGHLY RECOMMEND that the builders dig the perimeter carefully,, sometimes the entire perimeter, pending of the severity of the vapour barrier (plastic) damage, pending on slab over pour, pending on excessive builders concrete (debris).
