Lock Up Report

Inspection Date: 2 Oct 2020

Property Address: Dandenong Victoria

Report Type: New Home Construction

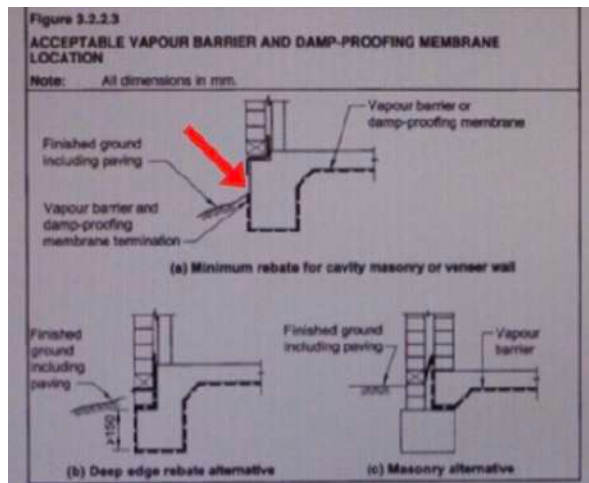
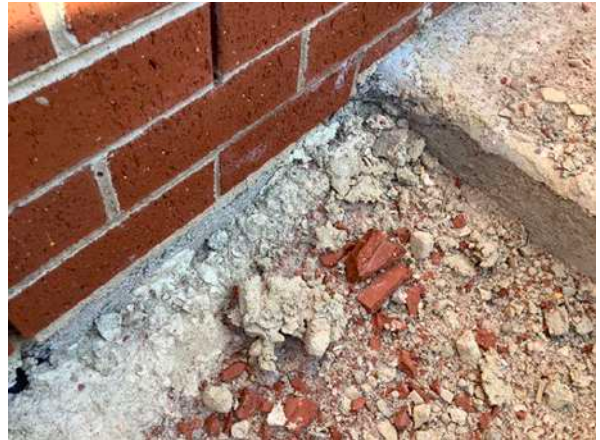
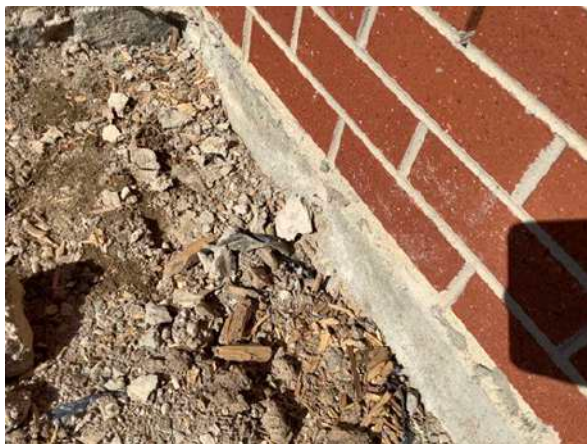
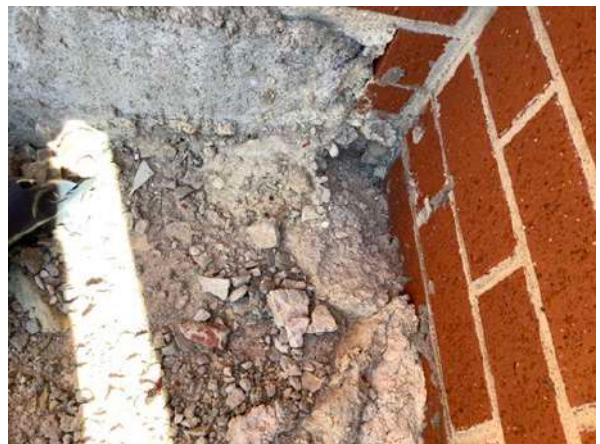
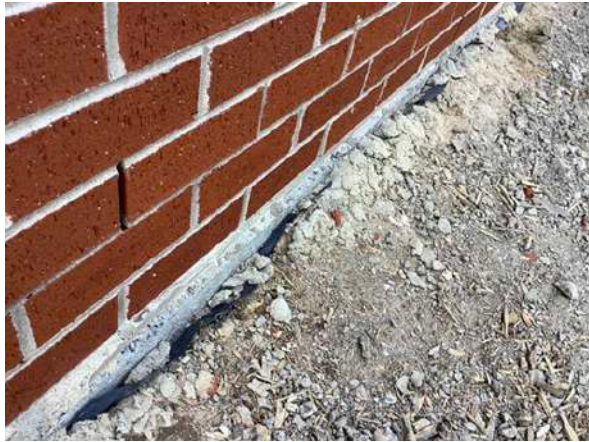
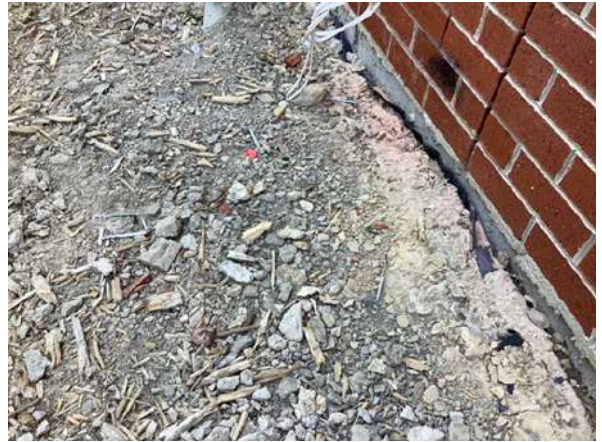
Non Compliant 2.17

Location: Concrete Slab - Perimeter To All Areas

Finding: Vapour Barrier - Cleaning Perimeter - Builders Excessive Debris.
It is very hard to determine the vapour barrier system and the Brick/Wall Overhang & the Concrete Slab Overhang On Slab with so much excessive brick mortar, render on the ground and other builders debris of excessive rock, small rocks, concrete overpour, but not limited to. The exterior perimeter to the property should be carefully all cleaned up to determine the EXACT defects that require rectification works prior to handover and without all the above performed, the repairs in particular the vapour barrier system can not be determined and repaired.

IMPORTANT 📌 ONLY SAMPLE PHOTO'S of the vapour barrier Excessive Debris defects. All AREAS to the entire property MUST be checked and repaired.

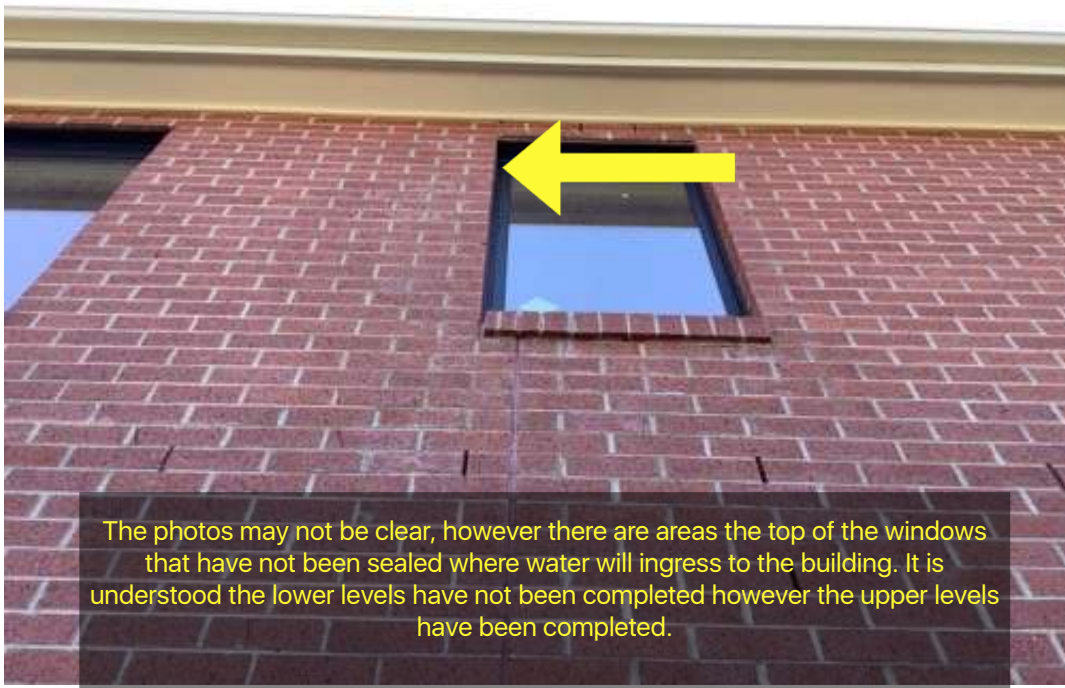
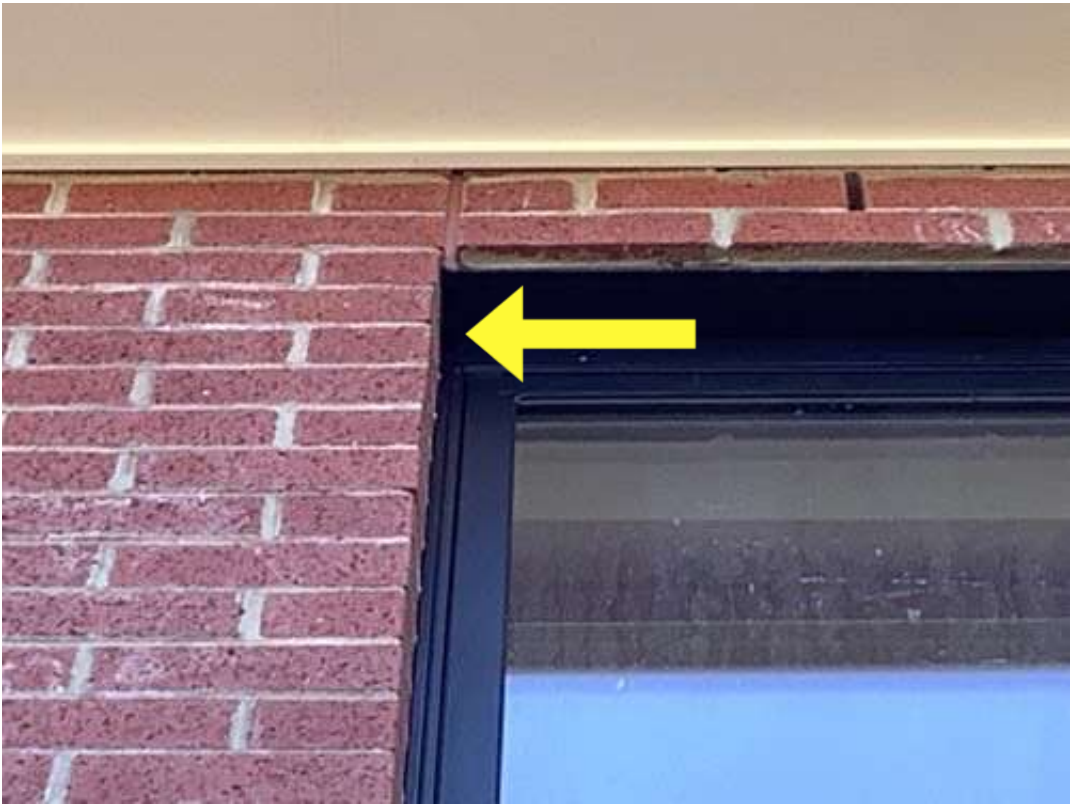
Finding: Window installation not weather tight
It was observed that the window and / or window frame installation is defective because it was allowing water to penetrate rooms under normal weather conditions.
It is important to colour match the silicon to the window frame, but normally if there is silicon required to the bottom window and/or window rubber then black silicon is normally used.

IMPORTANT 🖐️ ONLY SAMPLE PHOTO'S of the Window installation not weather tight defects. All AREAS to the entire property MUST be checked and repaired.
