Post Concrete Pour Slab Report. (Serious Defective Works Found)

Inspection Date: 15 Oct 2020

Property Address: Taylors Lakes area

Report Type: New Home Construction

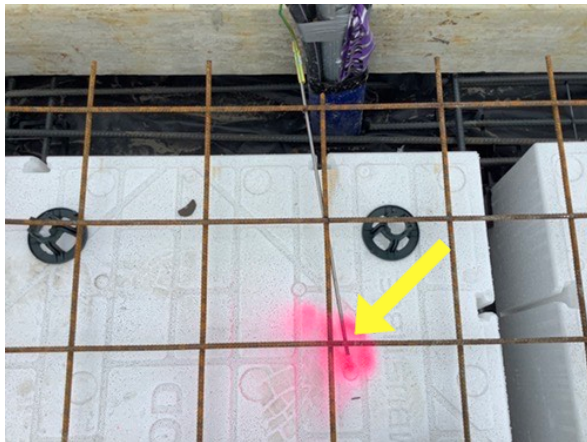
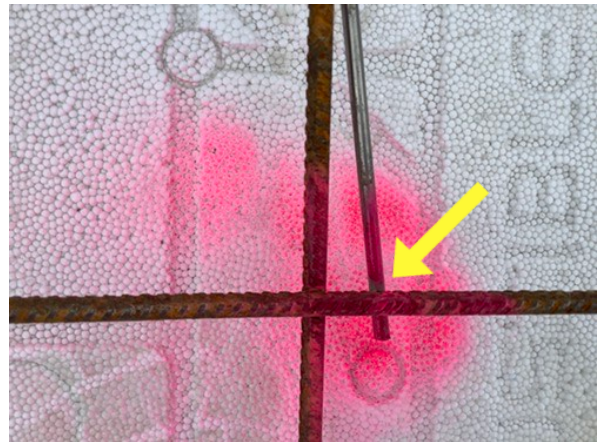
Safety Hazard 1.01

Location: Meter Box Area

Finding: Earthing To Steel Mesh-NOT SECURED TIGHT / LIMITED TIES
The earthing facility installed to the dwellings slab steel as required in AS 3000 has not been SECURED TIGHT / LIMITED TIES.

If the earth bar does not have enough wire ties and/or is not across atleast 2 steel mesh bars then the contacts may be defective and not meet the AS3000 guidelines.

I refer the builder to AS 3000, clause 5.6.2.5 that states "Any conductive reinforcing within a concrete floor or wall forming part of a shower or bathroom shall be bonded to the earthing system".

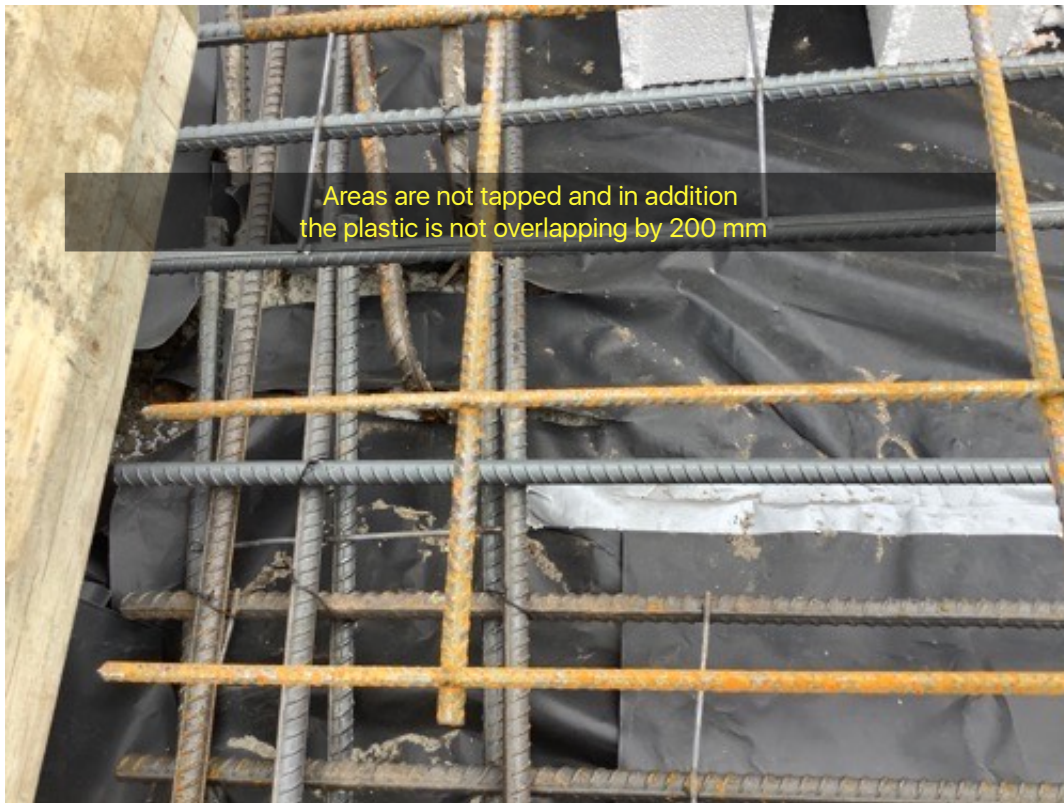
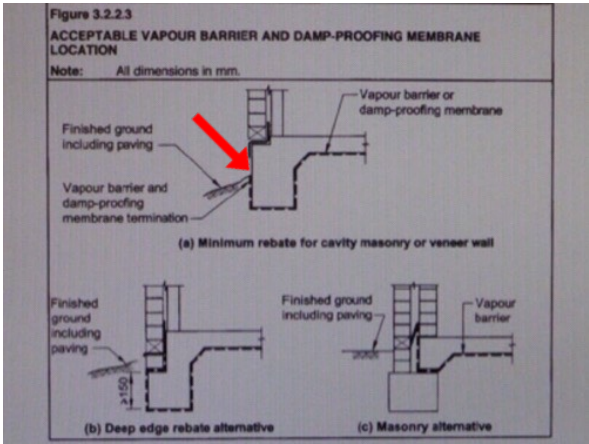
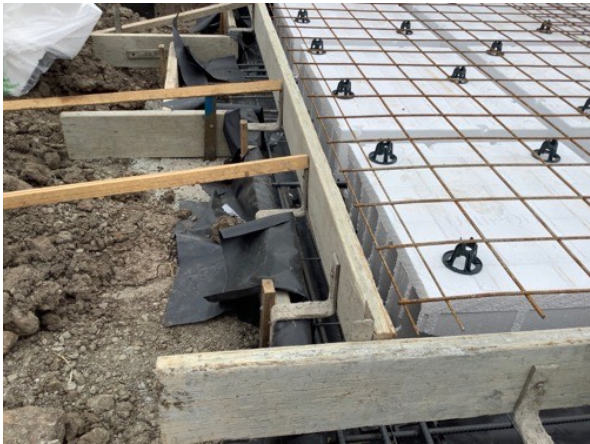
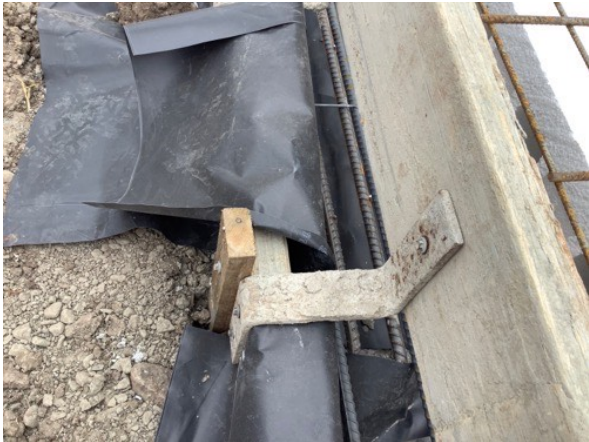
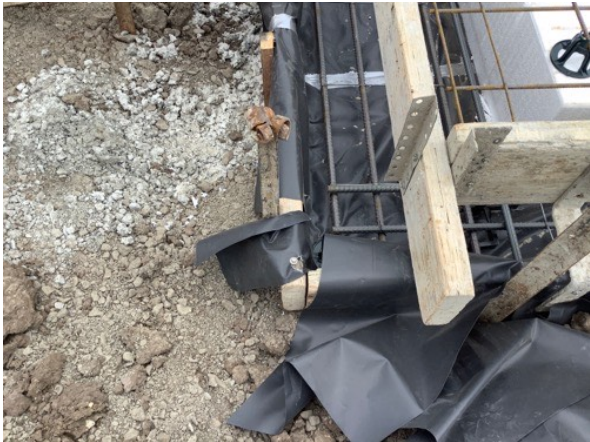
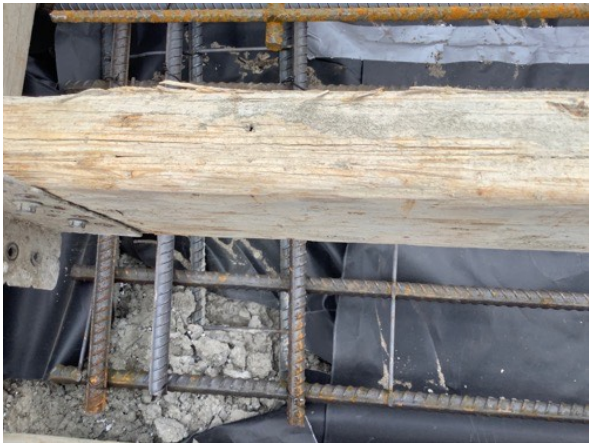
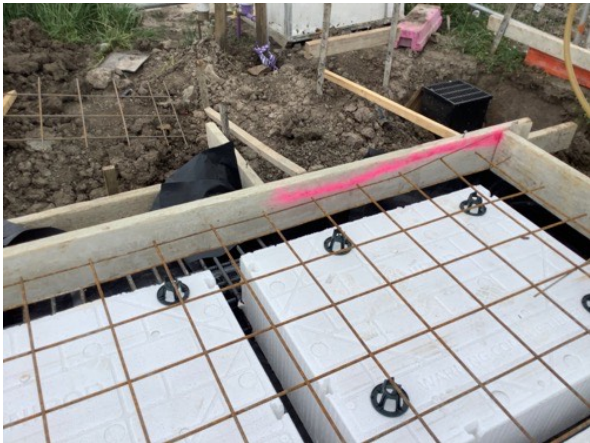
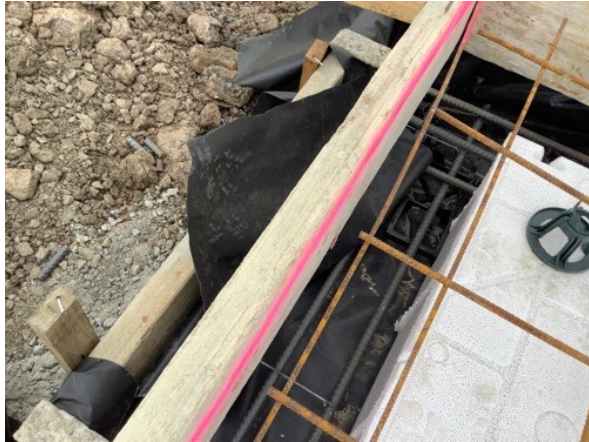
Non Compliant 2.02

Location: All Areas
 Finding: Polyethylene (plastic) vapour barrier not installed as per BCA - Part 3.2.2.6

Defective Vapour Barrier Installation - Damaged/Punctured and/or overlapping Defective.

It was noted at the time of inspection that a vapour barrier had not be installed in accordance with AS2870 and BCA Part 3.2.2.6.

The polyethylene vapour barrier from beneath the concrete floor slab must be turned up the external side faces of its edge beams. Failing to install the vapour barrier correctly will allow moisture ingress via slab edge dampness into the internal timber wall skins and/or the floor coverings if not done.

Without a vapour barrier installed, these areas are non-compliant with Australian Standards and are susceptible to excessive moisture, which may create major secondary defects as the building ages. Rectification works are necessary as soon as possible to ensure all standards are met.

- 1/ All over laps are not taped as described below.
- 2/ All the rips and/or damaged area needs to be taped.
- 3/ Some areas are not up to future ground and/or finished paving or concrete heights and must be extended with 200mm overlay and taped.
- 4/ Some areas whilst listed above are Damaged / Ripped / Not Consistent And Sealed with 200mm Overlay And Taped / Not High Enough / Non Existent must ALL be repaired.

The polyethylene vapour barrier must properly extended up the external side faces of the edge beams to at least the height of future finished ground level or paving i.e. 75mm below the damp-proof course and bottoms of the weepholes, after which any termite barriers that are in place, if required, will also need to be properly installed.

All AREAS to the ENTIRE slab should be checked CAREFULLY to identify any further defects that are the same as this defect.

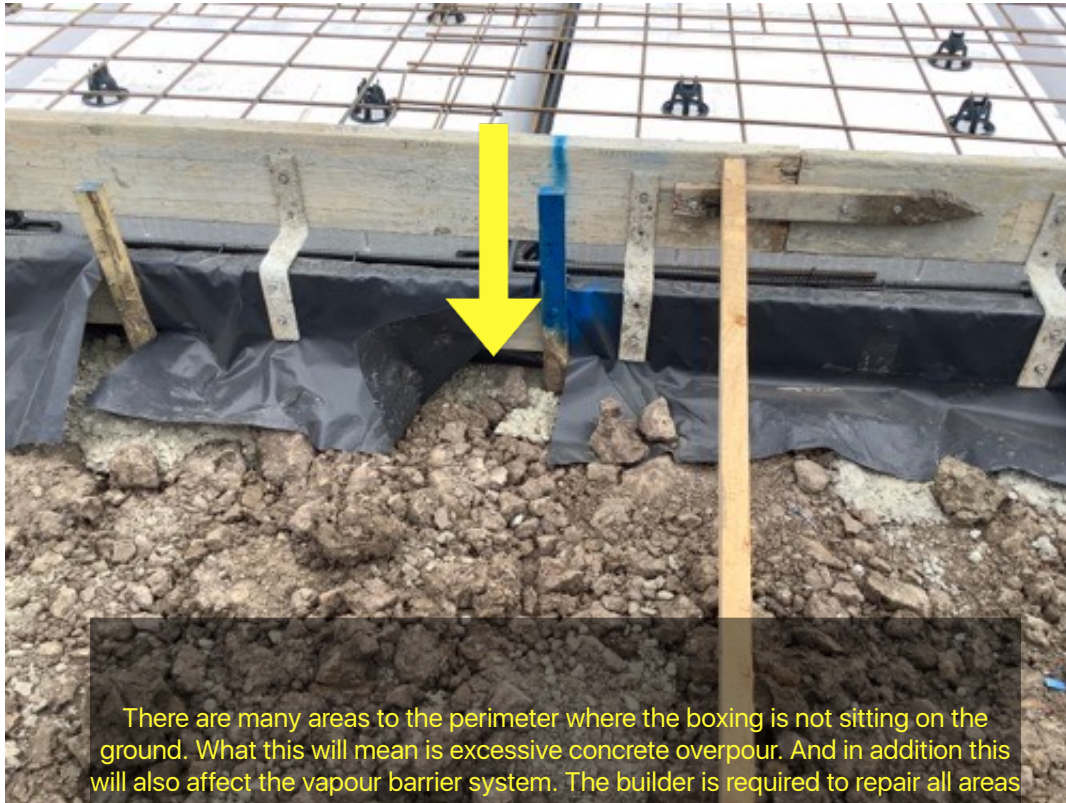
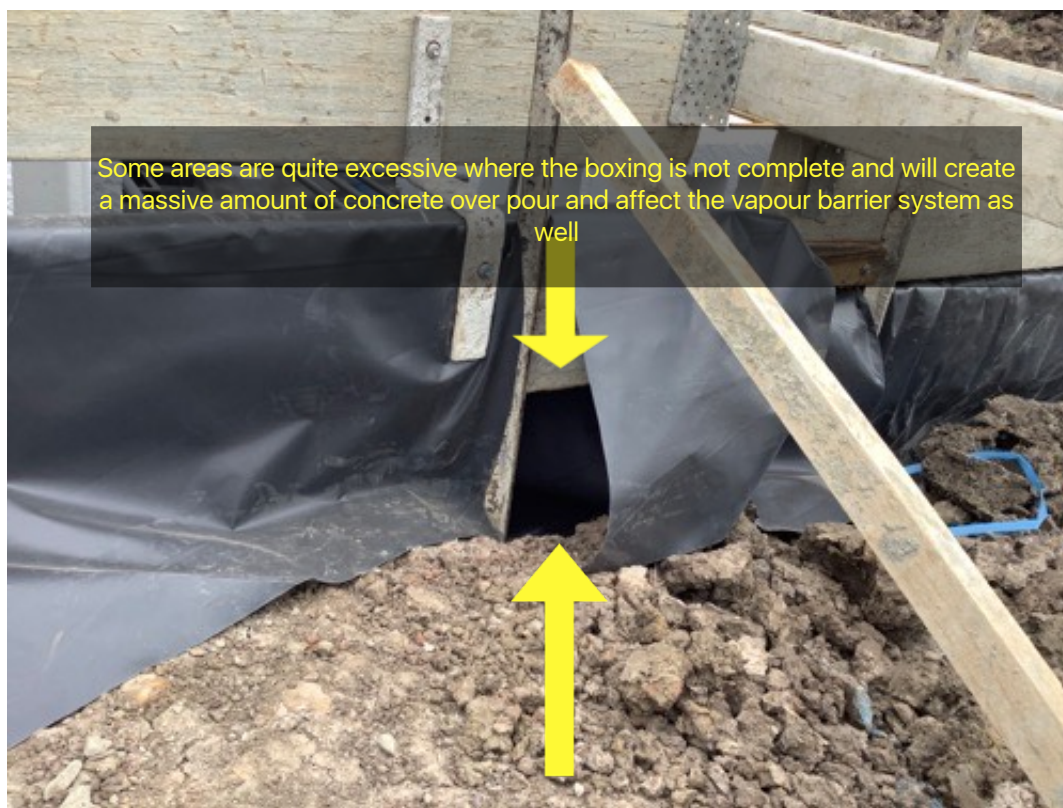
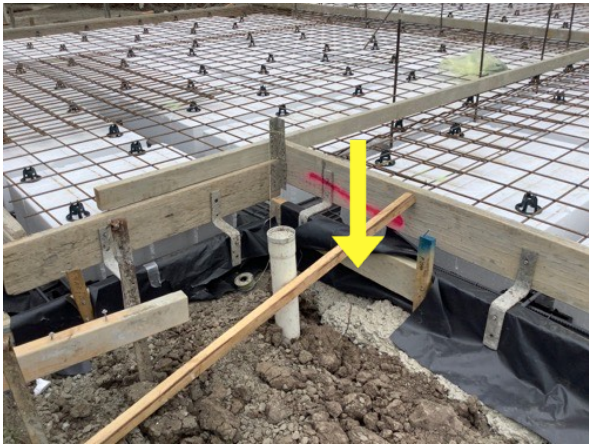
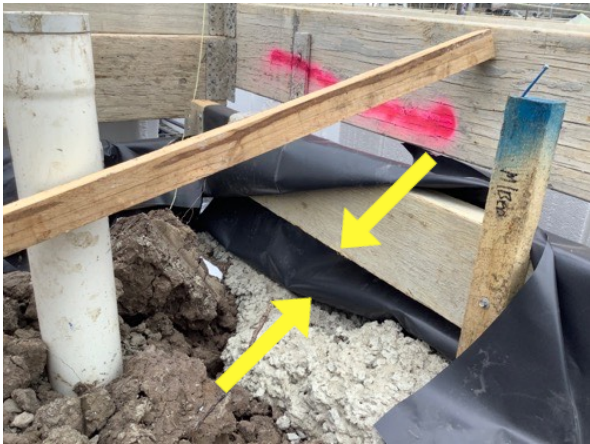
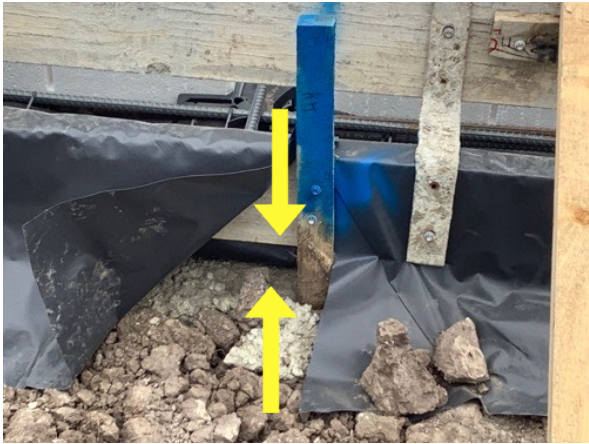
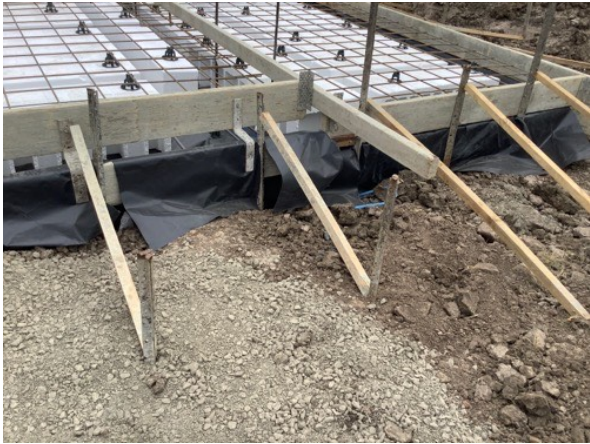
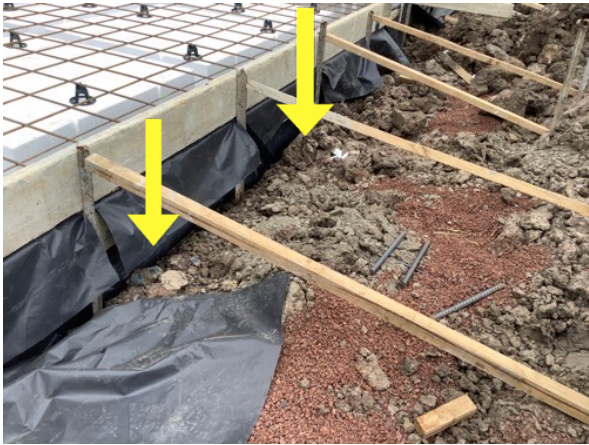
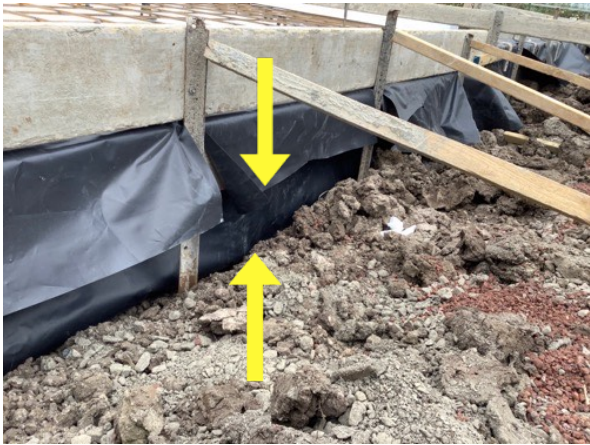
Non Compliant 2.03

Location: All Areas

Finding: Timber Boxing - Missing / Inadequate
The timber boxing is missing in many areas to the property and should all be repaired prior to concrete pour

At the time of the inspection there are areas of timber boxing that is missing and inadequate where there will definitely be slab over pour.

Additional timbers are required to secure the concrete in place and allow the vapour barrier not to become compromised and to allow the vapour barrier to come up the side of the concrete, vertically straight at 90 degrees in order to comply with the Australian standards

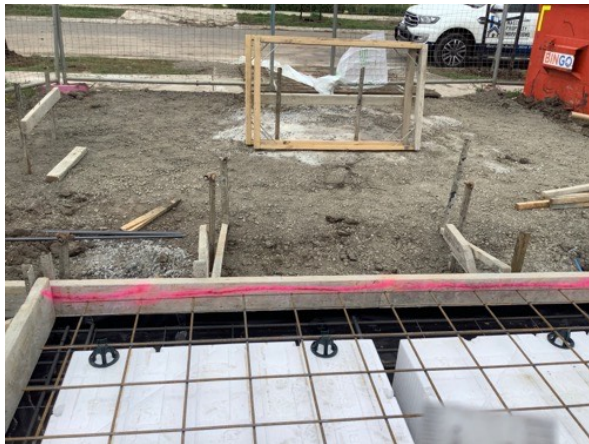
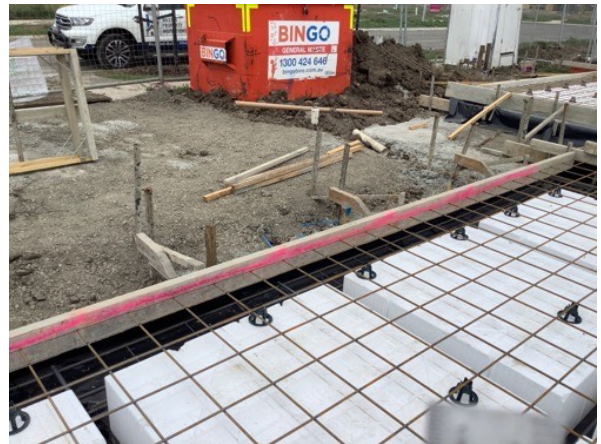
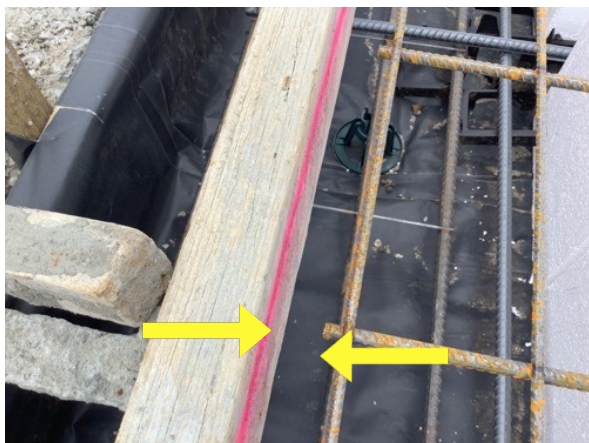
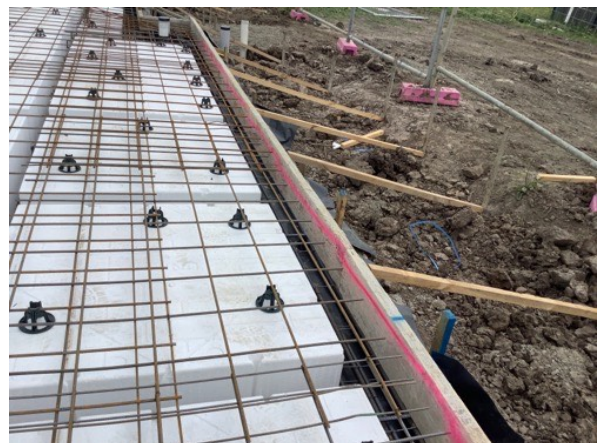
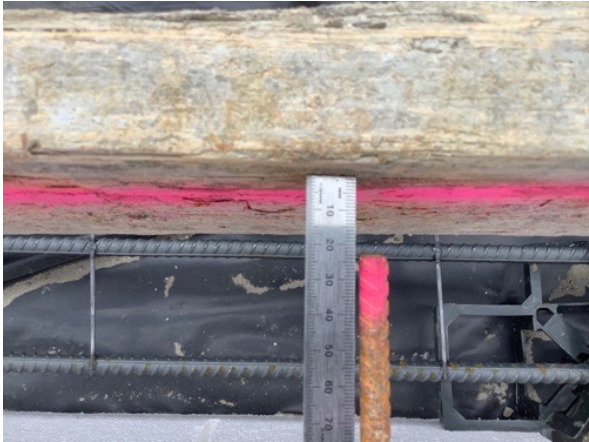
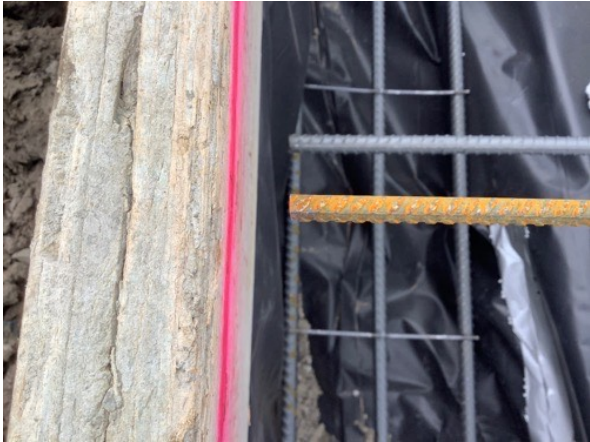
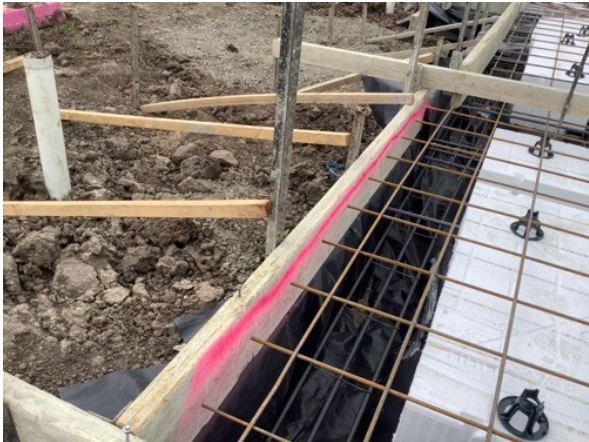
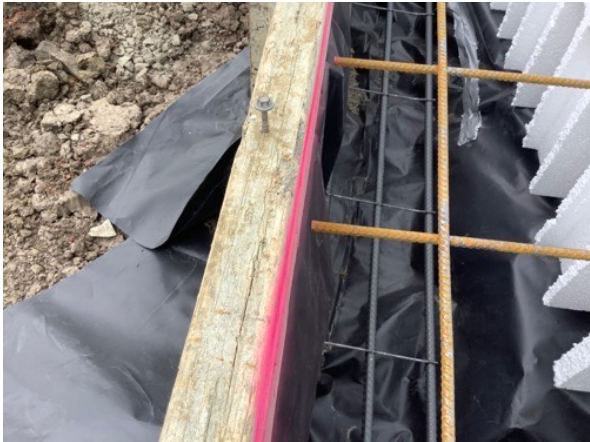
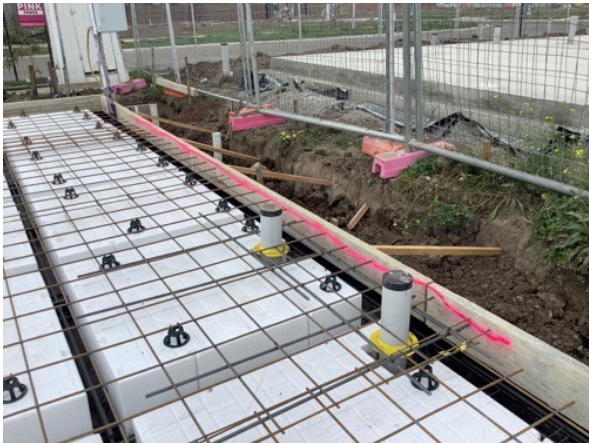
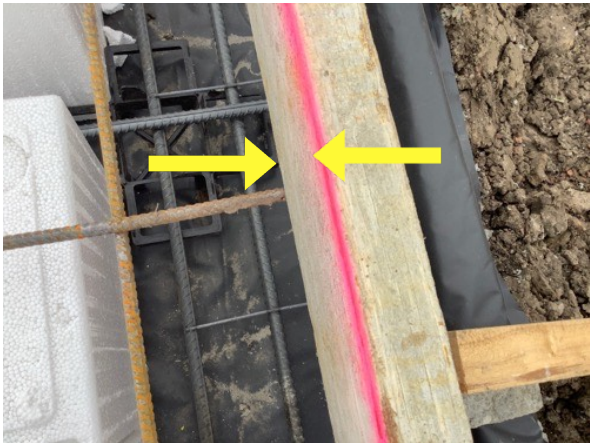
Non Compliant 2.04

Location: All Areas

Finding: Mesh Too Close To The Perimeter.

1The reinforcement mesh is sitting too close to the perimeter boxing to sections of the dwelling. 40mm to external exposure, to the entire perimeter boxing is required.

This mesh will need to be cut back or repositioned before the slab is poured to provide sufficient concrete cover to the reinforced steel.

All AREAS to the ENTIRE slab should be checked CAREFULLY to identify any further defects that are the same as this defect.

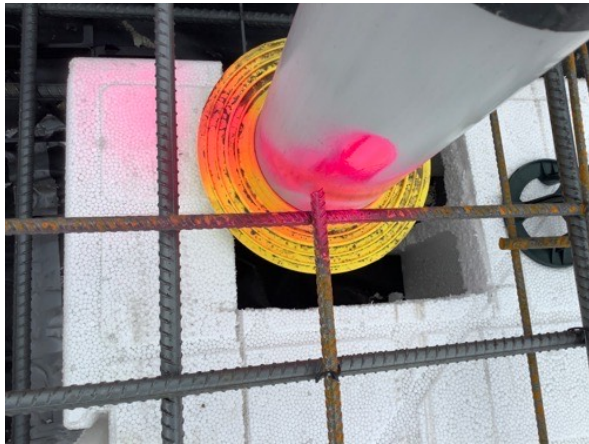
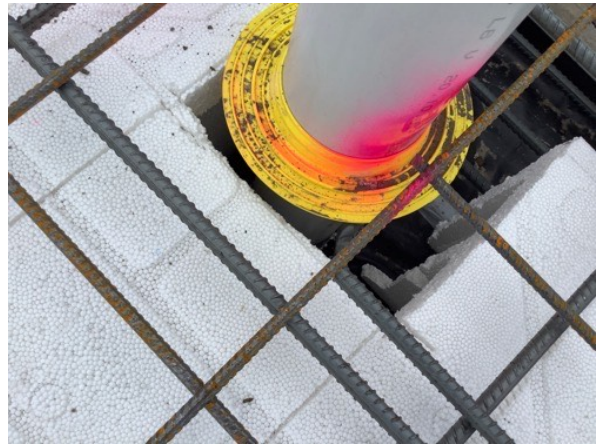
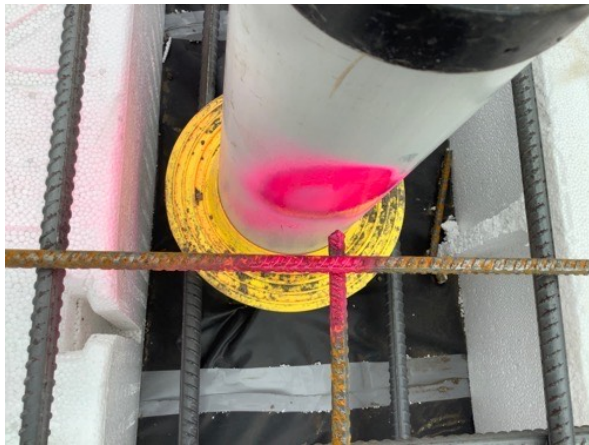
Non Compliant 2.05

Location: All Areas

Finding: Plumbing Pipe Clearance.

At the time of inspection it was found that distance between the plumbing pipes and the Mesh/Reo is NOT at a minimum clearance of 20mm.

It is advised that all the Mesh/Reo that is not 20mm clearance to any plumbing be rectified before the concrete is poured.

Note all repairs required are sprayed with pink paint.

All AREAS to the ENTIRE slab should be checked CAREFULLY to identify any further defects that are the same as this defect.

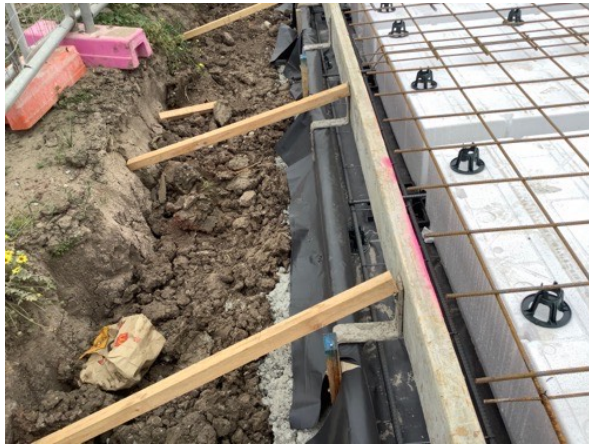
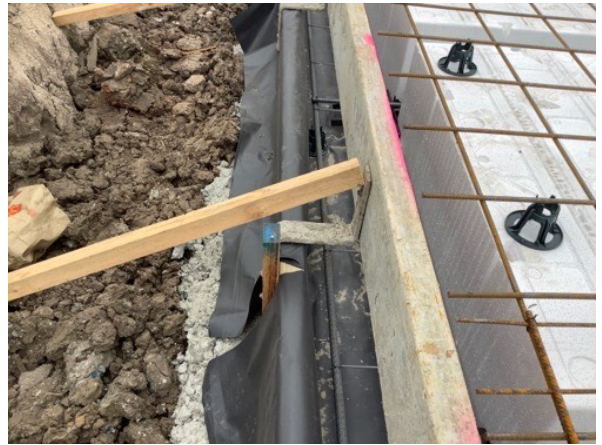
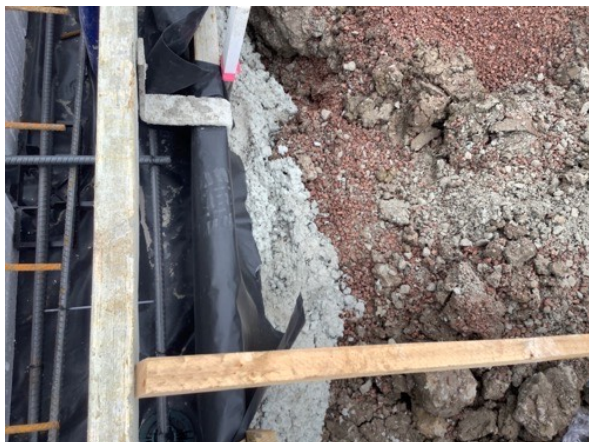
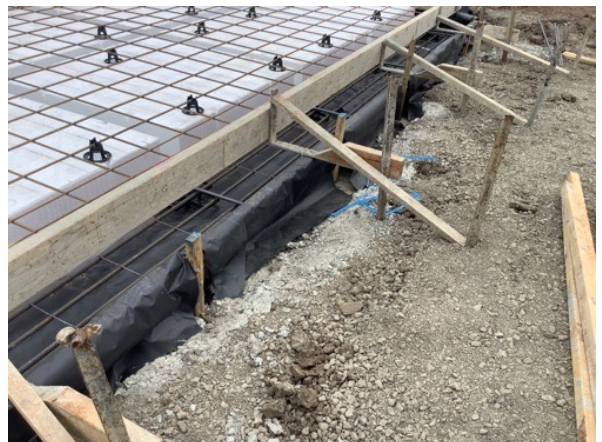
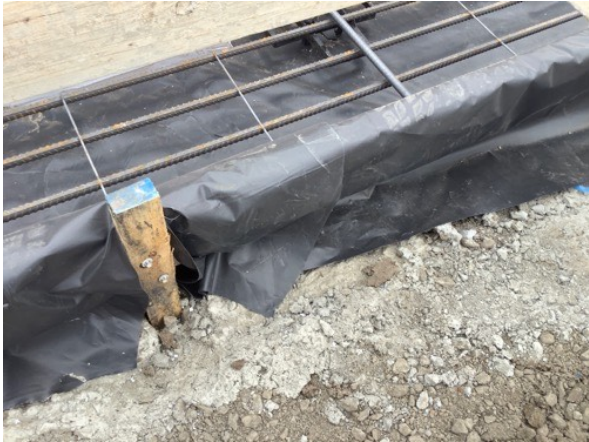
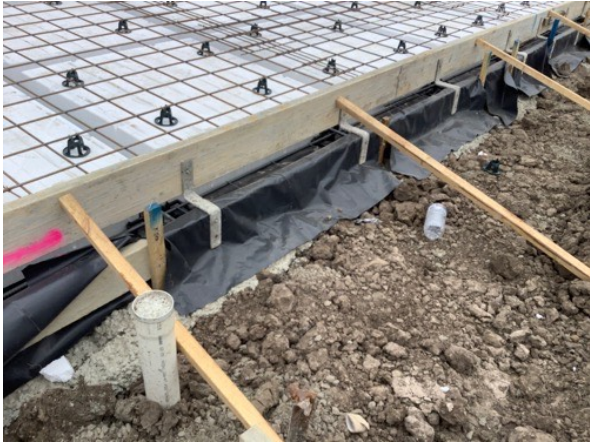
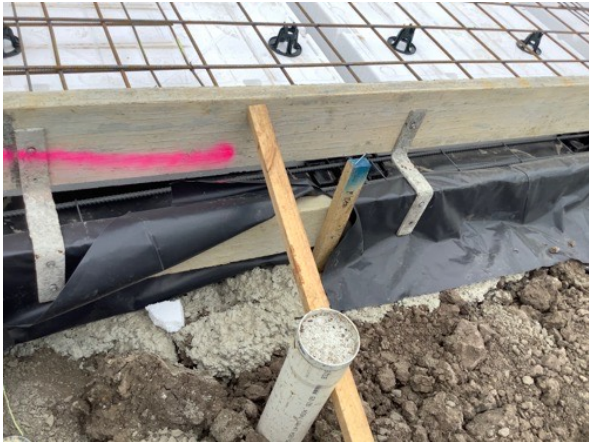
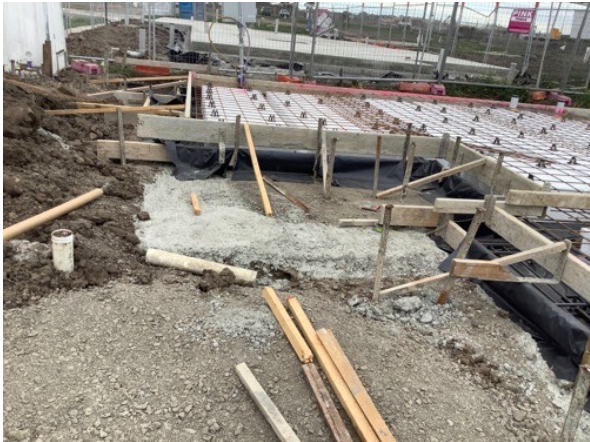
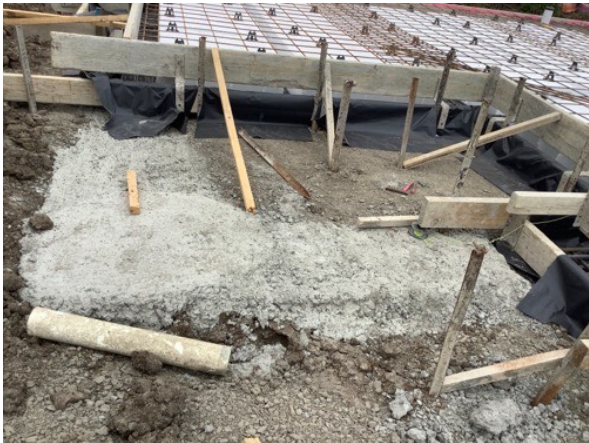
Non Compliant 2.06

Location: All Areas

Finding: Concrete footings poured and concrete poured to perimeter of slab in various areas
The front porch concrete footings have been poured. This normally gets done at the exact same time as the concrete pour of the slab so that all the concrete ties in together and all the steel ties in together.

I am not a structural engineer however my experience does tell me to separate concrete pour creates a cold joint and in addition the steel does not all work together and the structural integrity of the concrete slab is now compromised.

In addition there has been concrete poured in the footings at the front porch area and concrete poured around the perimeter of the slab. It is unknown as to why this has happened and the builder has suggested that the engineer has given them approval for this. I have asked for this approval and I also ask my clients to further challenge this matter as it is not typical for the footings to have a separate concrete pour as they are generally designed for the concrete pour to be all done as one.

I highly recommend that the concrete pour tomorrow does not Happen until the builder provides very accurate documentation as to why the concrete has been poured and I request my client seek further professional opinion on this matter as it appears to be a very serious situation.

Also in addition the concrete has been poured to the perimeter areas in my opinion must all be taken out as well and the timber boxing be completed. Again I request the engineer get involved in relation to this matter as well.

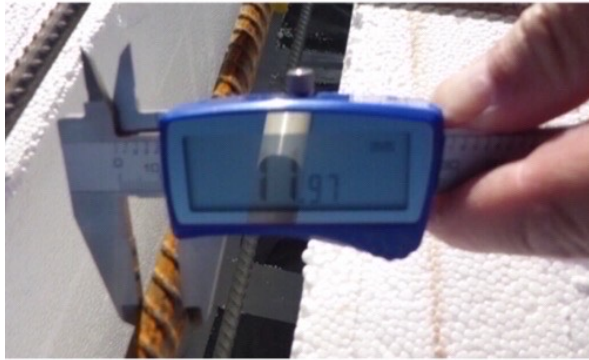
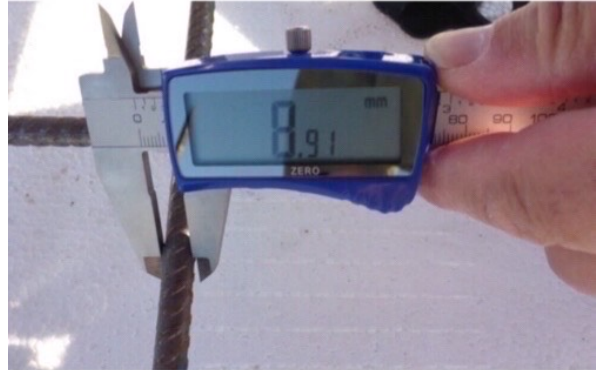
For Your Information 5.12

Finding: Thickness Of Steel Mesh
Steel thickness checks completed at the time of the inspection and are provided for your general reference.
