Vendors Report (Building & Termite/ Timber Pest)

Inspection Date: 1 Oct 2020

Property Address: Bundoora

Report Type: Property and Timber Pest Report

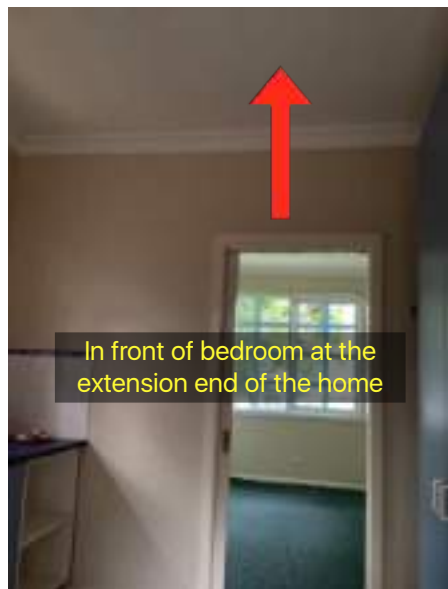
Serious Safety Hazard 1.01

Please note that this defect is highlighted as a caution only. We suspect, based on our experience in the building industry, that the absence of smoke detectors should be addressed as a matter of urgency to improve occupant safety.

A qualified electrician is required do these works for hard wiring.

Upon completion a safety certificate is required to be supplied to the owner of the building.

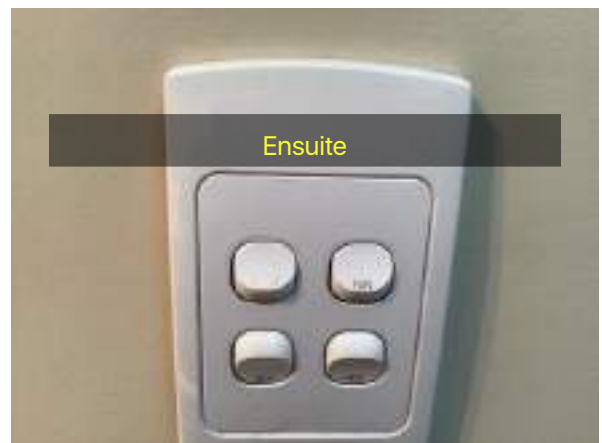
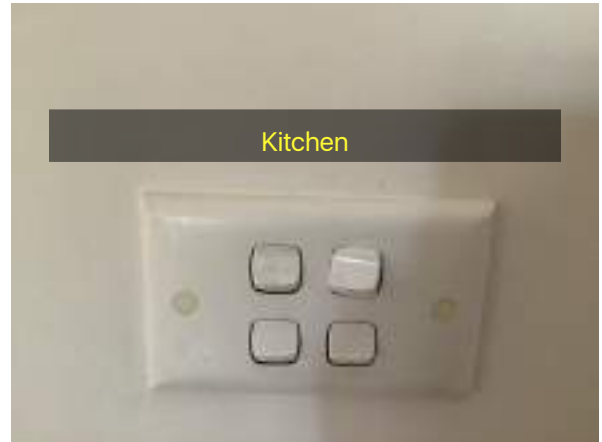
Serious Safety Hazard 1.03

Finding: Electrical - Switch - Damaged/Faulty

The switches in areas were found to be damaged or faulty at the time of inspection. This occurs generally when the building materials have either aged and decayed or as a result of impact damage (accidental or deliberate).

Repair and/or replacement of the switch is advised to ensure the fixture and it's associated structures are safe and fully operational. A licensed electrician should be appointed to repair/replace the light switch as soon as possible.

Please engage a licensed electrician to further inspect the property for the repairs and replacements as required.

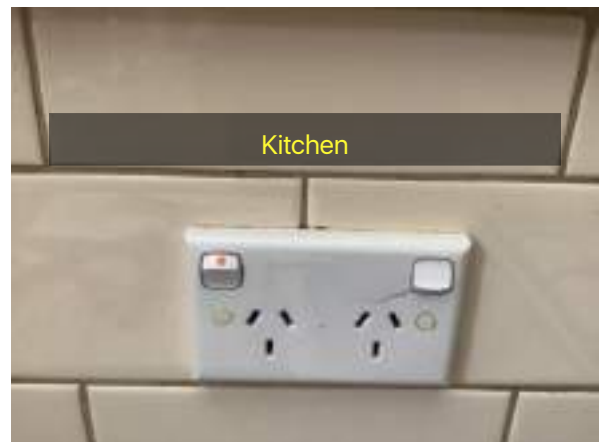
Serious Safety Hazard 1.04

Finding: Electrical - Power Points - Damaged/Faulty

The power points in areas were found to be damaged or faulty at the time of inspection. This occurs generally when the building materials have either aged and decayed or as a result of impact damage (accidental or deliberate).

Repair and/or replacement of the power points is advised to ensure the fixture and it's associated structures are safe and fully operational. A licensed electrician should be appointed to repair/replace the power points as soon as possible.

Please engage a licensed electrician to further inspect the property for the repairs and replacements as required.

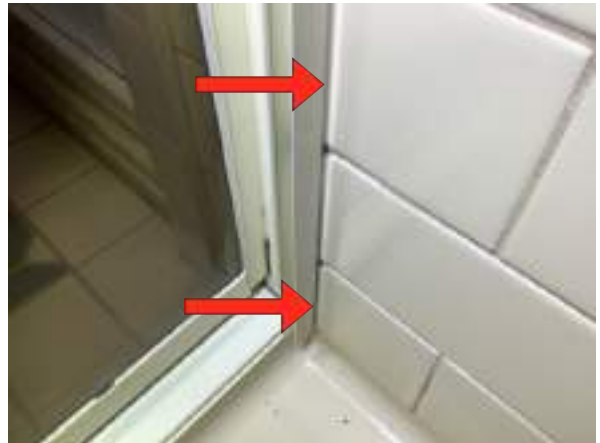
Serious Safety Hazard 1.05

Location: Mould In Caulking / Silicone-All Wet Areas

Mould in caulking or silicone is generally caused by faulty and/or damaged caulking or silicone as the moisture and water ingresses into the caulking or silicone.

The caulking or silicone must be replaced and the areas are cleaned and new caulking or silicone applied.

Generally, the client is advised to ensure that the general environment is free of moisture and humidity to aid in the prevention of mould formation and development. Any mould found during the inspection should be cleaned immediately and/or taken out, particularly where the mould is in the silicon / caulking.

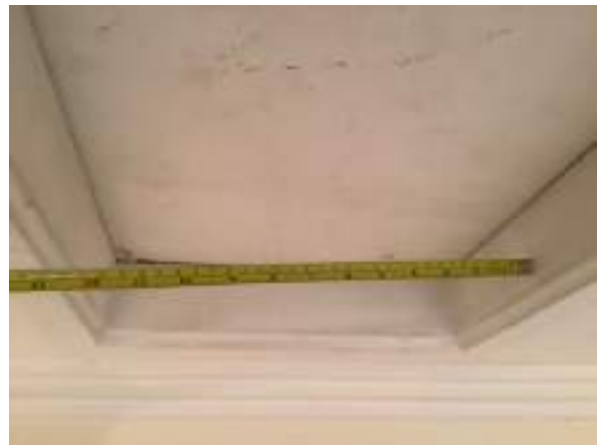
Serious Safety Hazard 1.09

By not inspecting the roof space area there can hide an array of defects, without inspection to the roof void area it is impossible to rule out termite activity and/or termite damage and other undetectable issues .

I would treat this manhole area alteration as a matter of urgency, a carpenter or competent handyman can install a new manhole that complies.

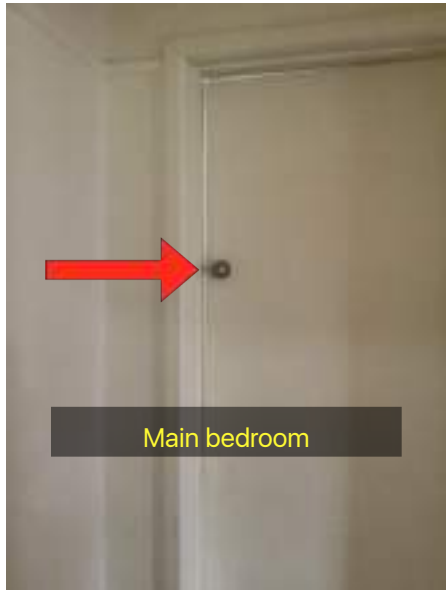
Minor Defect 3.20

If left unattended, further functional impairment is likely to occur.

A qualified carpenter or general handyperson may be appointed to perform rectification works as necessary, at client discretion.

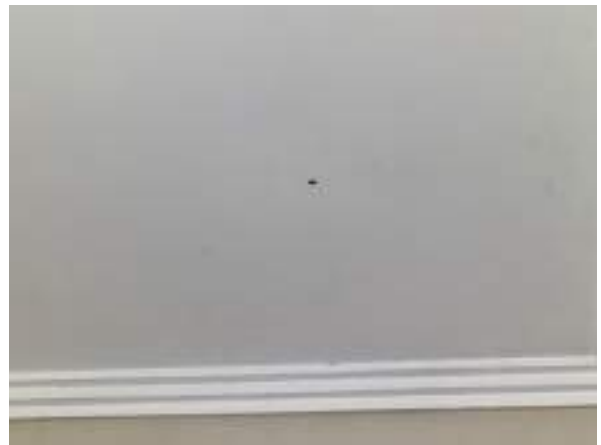
If left unmanaged, the ceiling sheets may become loose and unstable, increasing the rate of deterioration of the internal ceiling and creating potential for the development of secondary defects.

Re-fastening of popped nails will help to maintain the stability of the internal ceiling and associated building elements. Such minor works will also help to improve the appearance of the affected area and secure the ceiling sheets, so as to prevent the onset of ceiling sagging. These works should be performed by a qualified carpenter or plasterer at client discretion.

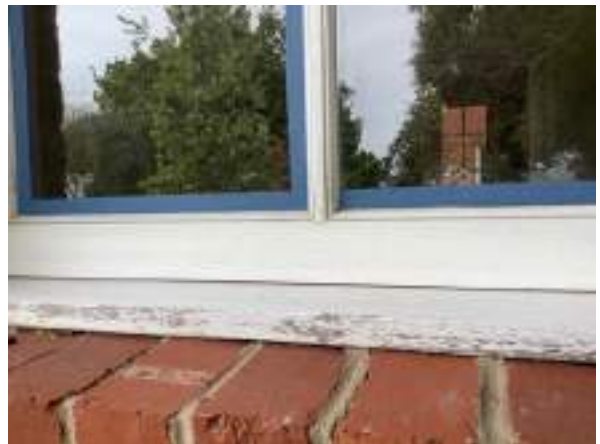
Minor Defect 3.30

The property is a very high risk for termites as the environments to the property are very conducive with many susceptible areas.

Please read the report carefully and Maintenance to all susceptible and conducive areas is a MUST to minimise the risk of termite and timber pest existence and timber damage.

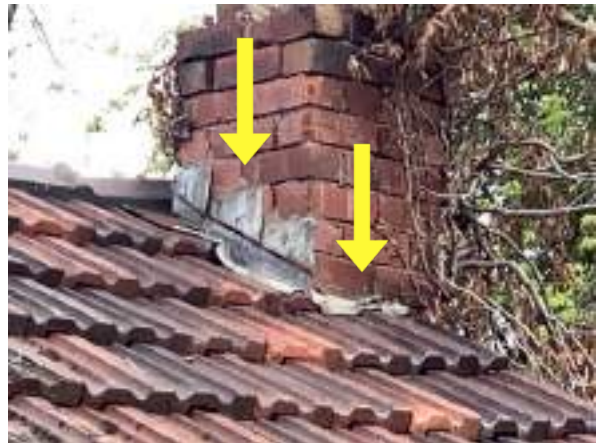
Minor Defect 3.35

Premature ageing and secondary building defects are imminent where roof plumbing is missing or inadequately installed. Additionally, water pooling also creates an environment that is susceptible to termite and pest infestation.

A roofing plumber should be appointed as soon as possible to install relevant roof plumbing materials, ensuring that no further damage is sustained.

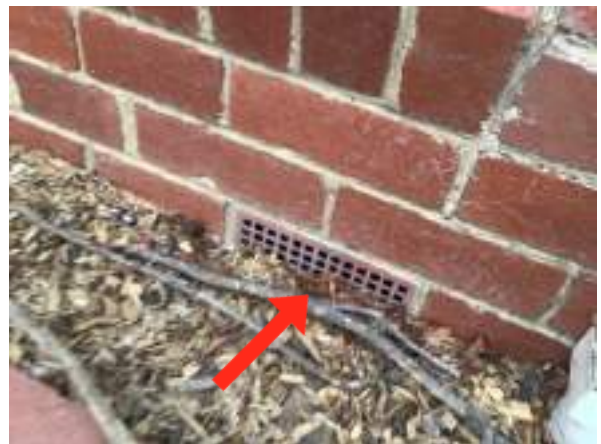
Item 2.07

BRIDGING OR BREACHING OF TERMITE MANAGEMENT SYSTEMS AND INSPECTION ZONES

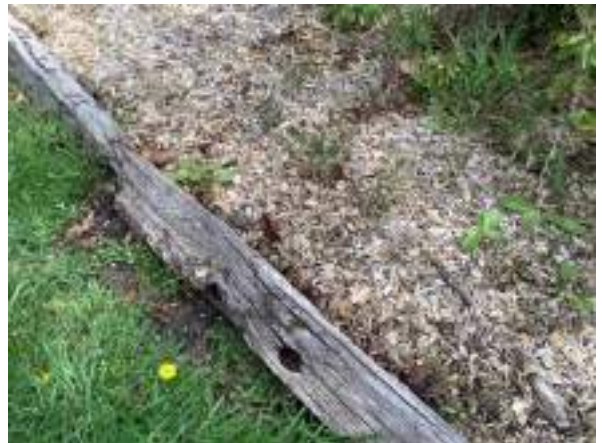
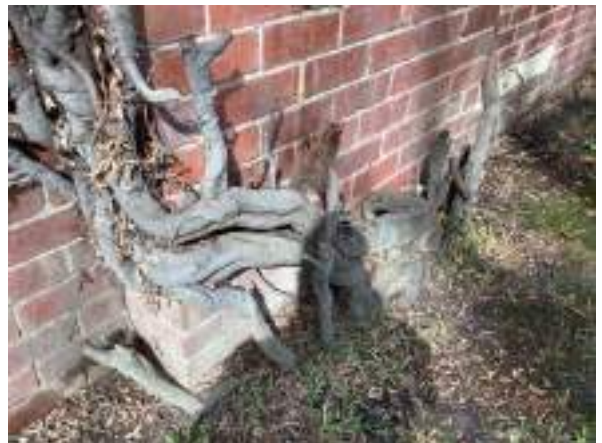
Item 2.08

UNTREATED OR NON-DURABLE TIMBER USED IN A HAZARDOUS ENVIRONMENT

Frequent pest inspections are advised to readily identify any termite activity in these areas.
