(Vendors Report)- Building & Termite/ Timber Pest Report

Inspection Date: 5 Feb 2021

Property Address: Yarraville Area

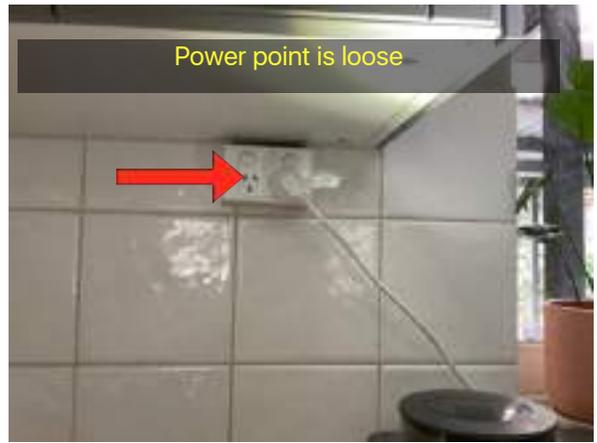
Serious Safety Hazard 1.02

Finding: Isolating switch for the fan fire place / Kitchen power point / Gym room conduit work / Exterior Power Point / Wiring in old meter box - Defective / Unsafe / Exterior Front Light - Non Compliant - Electrical Wiring Installation

It appears that the electrical wiring to the Isolating switch for the fan fire place / Kitchen power point / Gym room conduit work / Exterior Power Point / Wiring in old meter box - Defective / Unsafe / Exterior Front Light, does not comply with today's electrical safety standards and electrical regulation codes of AS3000-2007.

We HIGHLY RECOMMEND that the purchaser engage a licensed electrical contractor to check compliance and make good any defective wiring or unsafe items throughout the entire property including the outbuildings, garden, etc, where applicable.

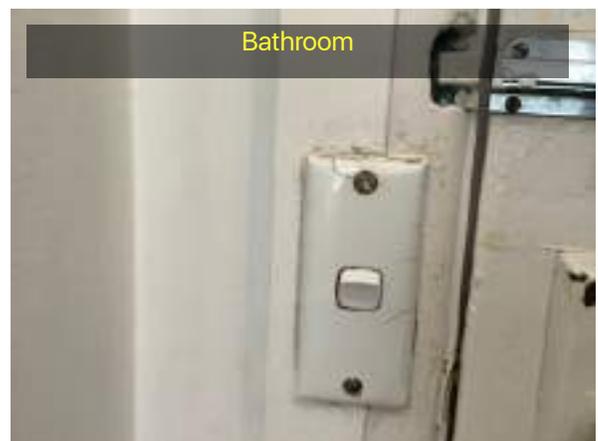
Serious Safety Hazard 1.03

Finding: Electrical Switch - Damaged/Faulty

The switches in areas were found to be damaged or faulty at the time of inspection.

This occurs generally when the switch plate or the switch itself have either worn, decayed or burnt out as a result of electrical arching.

Repair and/or replacement of the switch is advised to ensure the fixture and it's associated structures are safe and fully operational.

A licensed electrician should be appointed to repair/replace the light switch or switches as soon as possible.

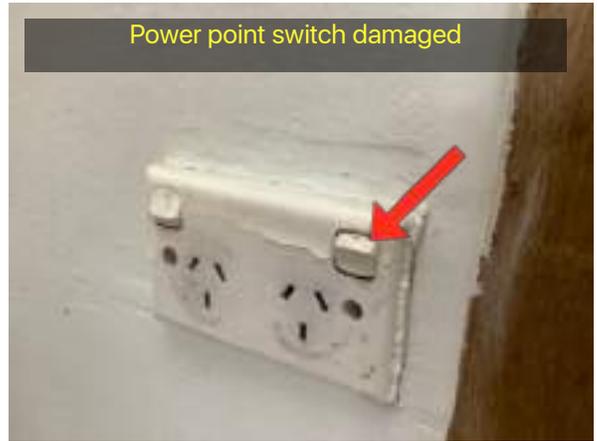
Serious Safety Hazard 1.04

Location: Electrical - All Areas

Finding: Electrical Power Points - Damaged/Faulty

The power points in areas were found to be damaged or faulty at the time of inspection. This occurs generally when the power point plate or the switch mechanisms have either worn, decayed or burnt out as a result of electrical arching.

Repair and/or replacement of the power points is advised to ensure the fixture and it's associated structures are safe and fully operational.

A licensed electrician should be appointed to repair/replace the power points as soon as possible.

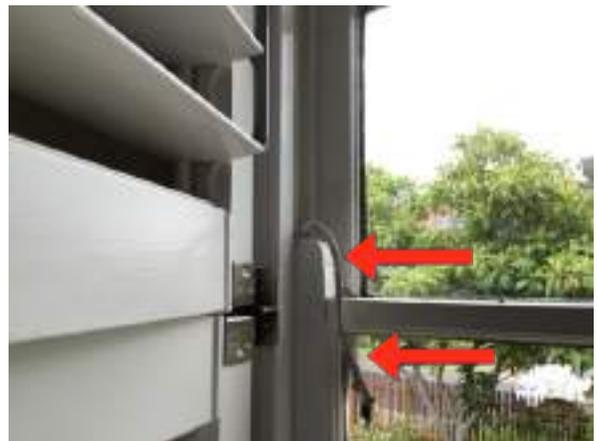
Serious Safety Hazard 1.06

Location: Windows - Internal Areas
Finding: Window - Handles / Locks / Accessories- Broken

The handle / lock to certain windows was missing / broken at the time of the inspection to many areas of windows.
Absence of the handle / locks limits the operation of the window and may pose as a safety risk as windows do not lock, also window locks not functioning smoothly also poses a safety concern.

Replacement of the handle /locks should be conducted as soon as possible. A general handy person, window manufacturer and/or service technician should be appointed to perform these works to improve the operational state of the affected window and improve the safety of the internal area.

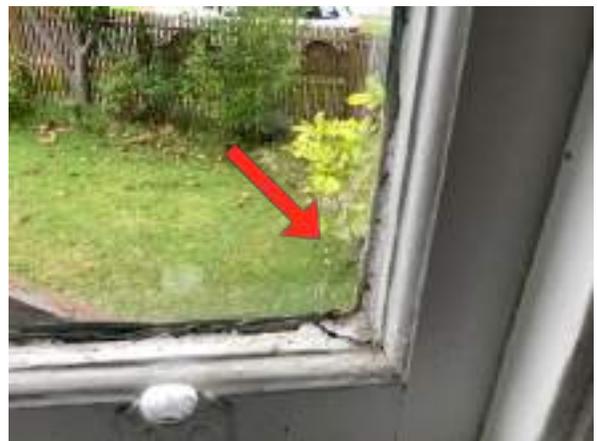
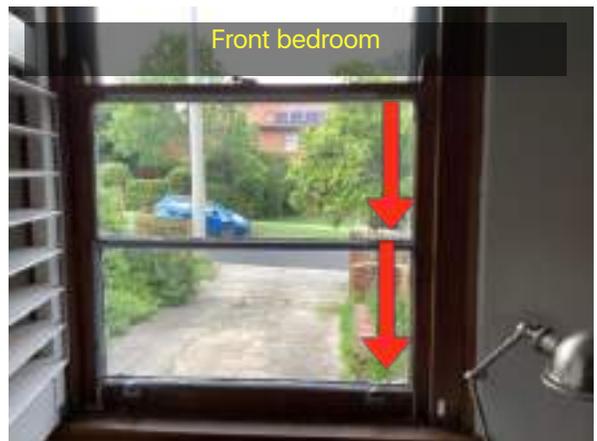
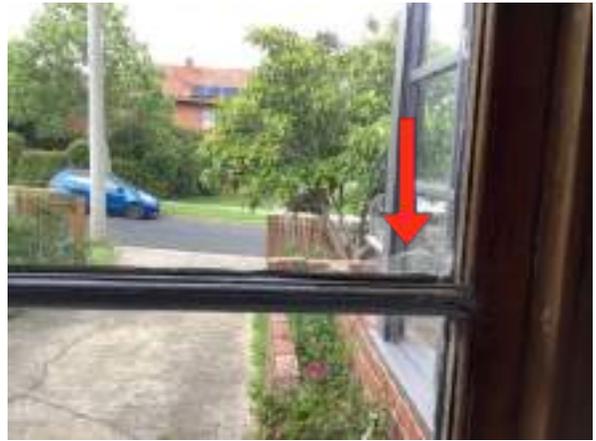
Serious Safety Hazard 1.07

Location: Windows - Internal Areas

Finding: Window - Cracked

Cracks were identified in the windows. Cracking in windows is generally the result of impact damage, windows not operating smoothly and/or building movement and is likely to develop further when left unmanaged.

The likelihood of this window pane further cracking and shattering is increased exponentially, providing a safety hazard in the area. The cracked window also impairs the weather tightness of the building, creating potential for minor water leaks.

A qualified glazier is required to repair the window as soon as possible. Depending on the extent of the cracking, replacement of the window may be required.

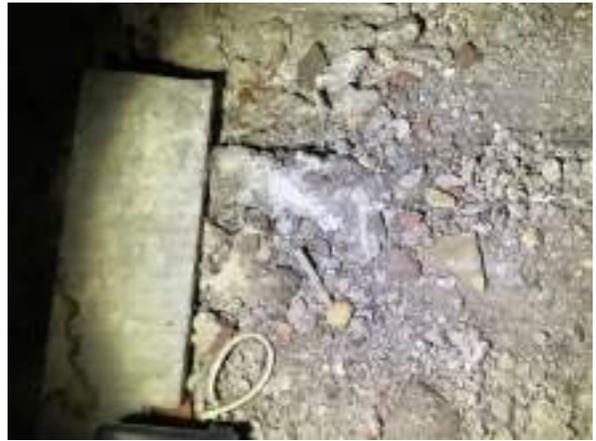
Serious Safety Hazard 1.09

Location: Subfloor

Where evidence of mould growth was noted, there may be environmental, biological or health issues associated with the report. A specialist inspection by a suitably qualified environmental health inspector may be warranted where mould is extensive or where any queries regarding air quality spores or other related issues apply.

Generally, the client is advised to ensure that the general environment is free of moisture and humidity to aid in the prevention of mould formation and development. Any mould found during the inspection should be cleaned immediately and/or taken out, particularly where the mould is in the silicon / caulking.

Heavy mould on walls, ceilings and under homes, generally will require professionals in this field, like hazardous material company's.

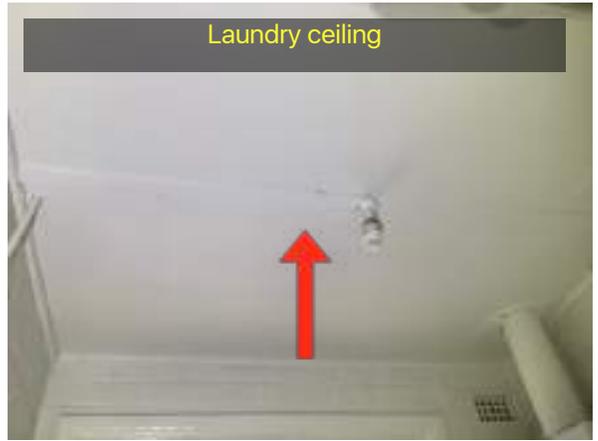
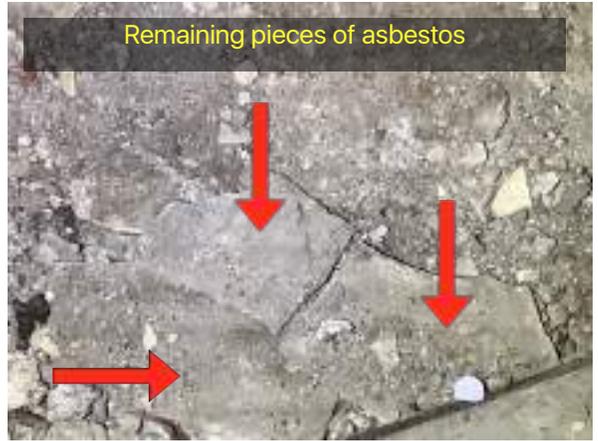
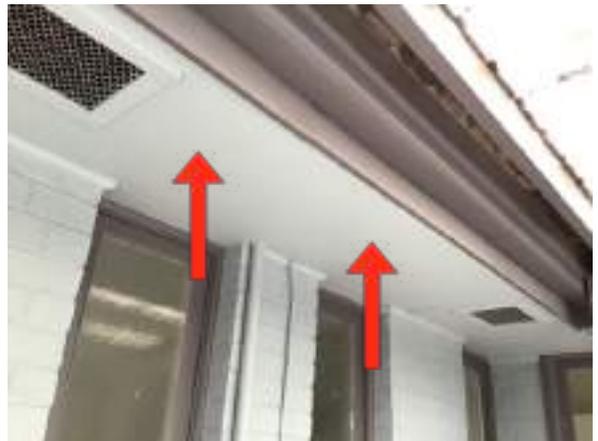
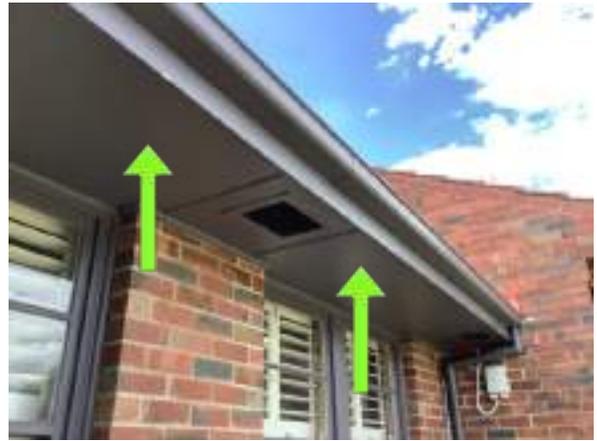
Serious Safety Hazard 1.10

Location: Asbestos - Various Areas

Asbestos can be in the old wardrobes and cupboard areas, asbestos can be in the flu systems of the old hot water services or heater flu systems. Asbestos can be on the walls or ceilings. Asbestos can be in the eaves in the older homes and the exterior walls of the older homes. Asbestos can be found in the roof space areas in the floor space areas and in the old sheds. This is only the typical type scenarios in the homes up to 1990 in particular.

In the interim, the client is advised to act with caution, especially when considering any damage to building materials general wear and tear renovations extensions demolition and general maintenance activities due to the suspected presence of Asbestos.

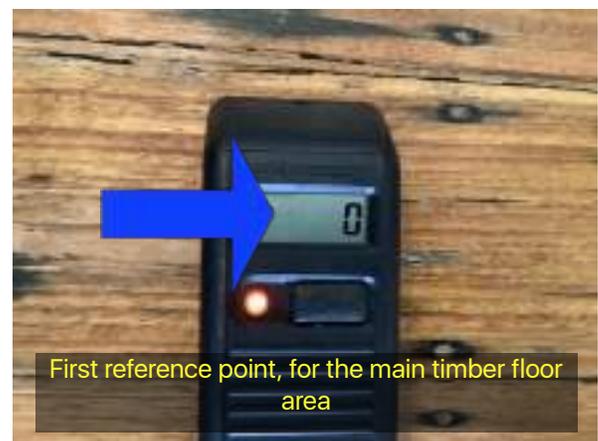
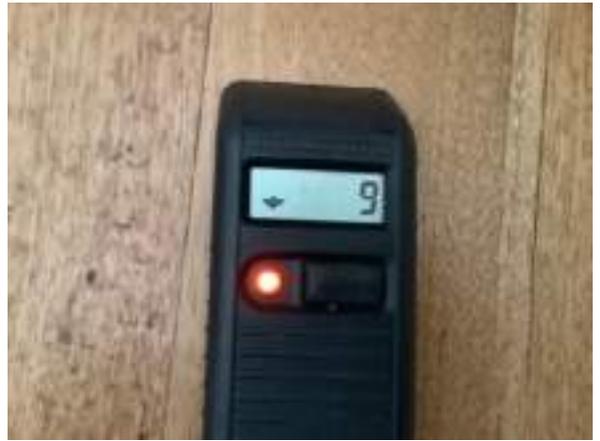
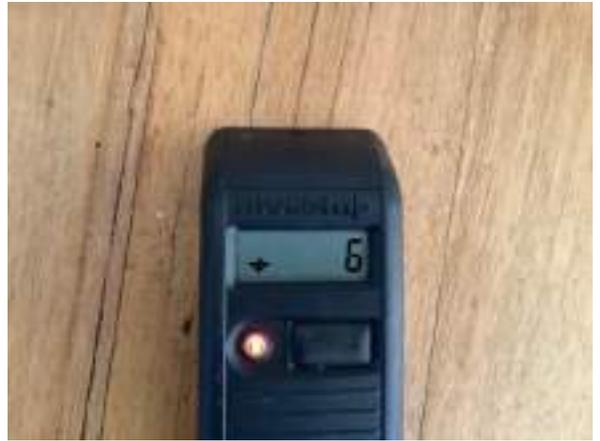
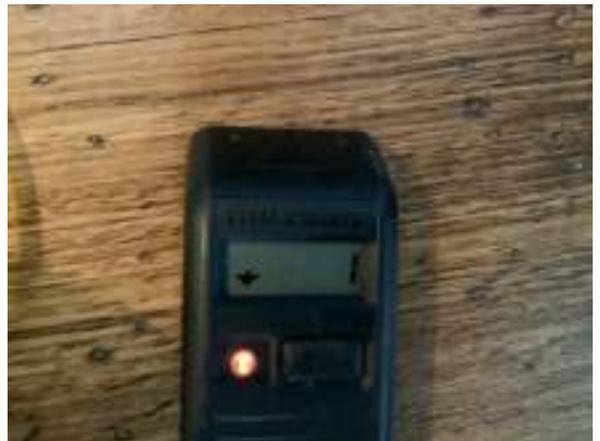
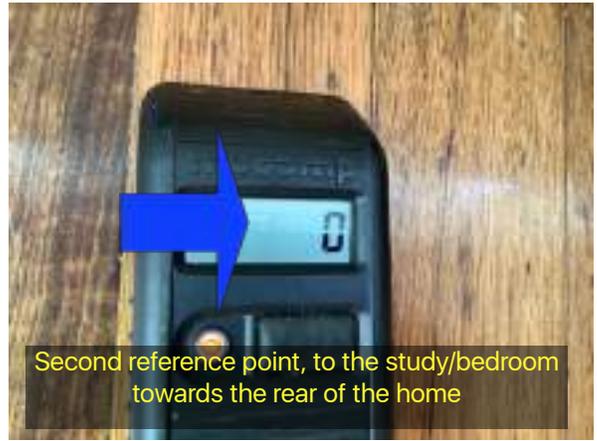
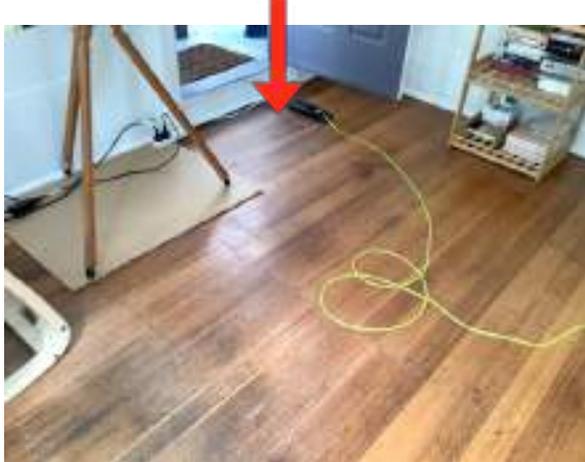
Major Defect 2.01

IMPORTANT TO NOTE : It will be important to note that the likelihood of cracking and movement to plaster, floor and wall tiles, doors requiring re-working, windows requiring re-working, kitchen cupboards, etc will be high once the home is jacked up and re-leveled to the correct height, the amount of repairs can be nothing to many areas. There will more then likely be the repairs of plaster, paint and the other repair concerns mentioned.

A Registered Builder who is experienced in flooring, stumps and re-stumping would then generally carry out works or be associated with re-stumpers as advised by a Structural Engineer and/or a geotechnical engineer, if required.

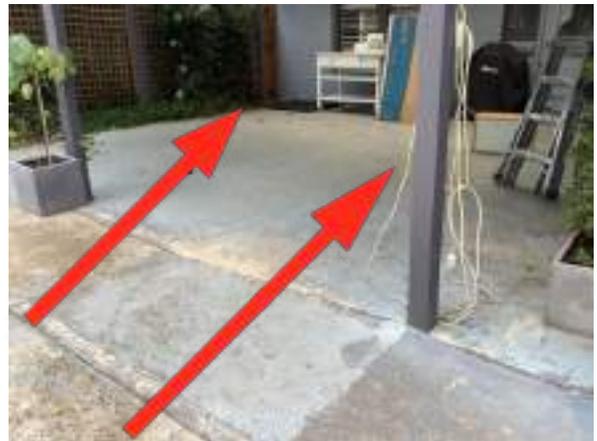
Major Defect 2.02

Location: Perimeter Of Building - Exterior

In relation to termites, Defective drainage and falls create high water and moisture which creates a very high risk for termites as the environments to the property are very conducive with many susceptible areas.

Please read the report carefully and Maintenance to all susceptible and conducive areas is a MUST to minimise the risk of termite and timber pest existence and timber damage.

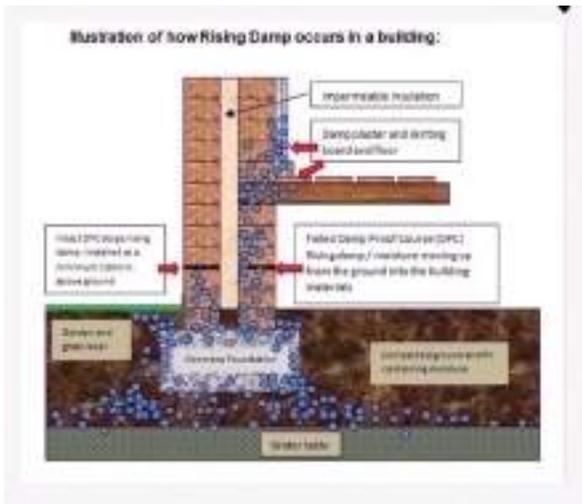
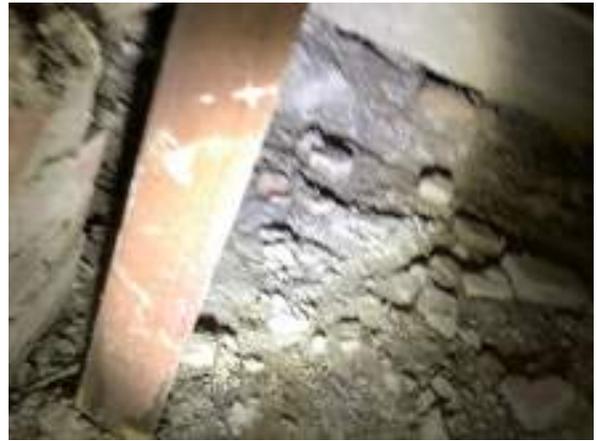
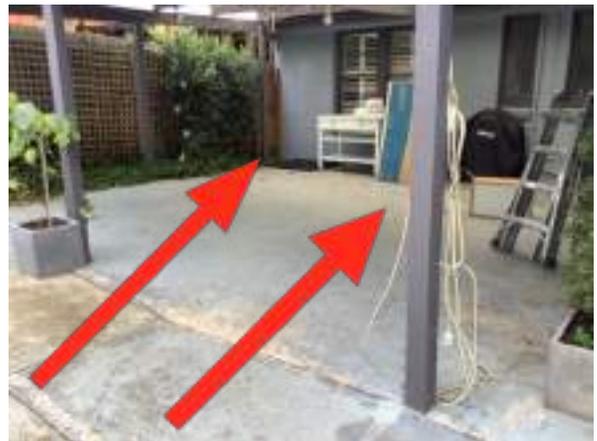
Major Defect 2.03

Location: Subfloor
Finding: DAMP & WET LEAK

Once the cause is rectified further determinations may be required by a BUILDER AND OR STRUCTURAL ENGINEER AND SOMETIMES A GEOTECHNICAL ENGINEER.

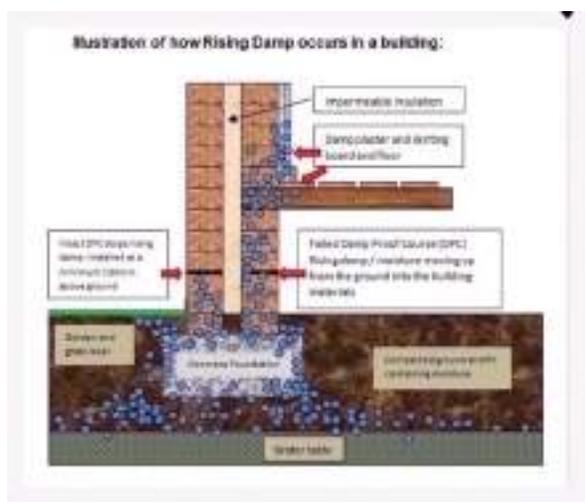
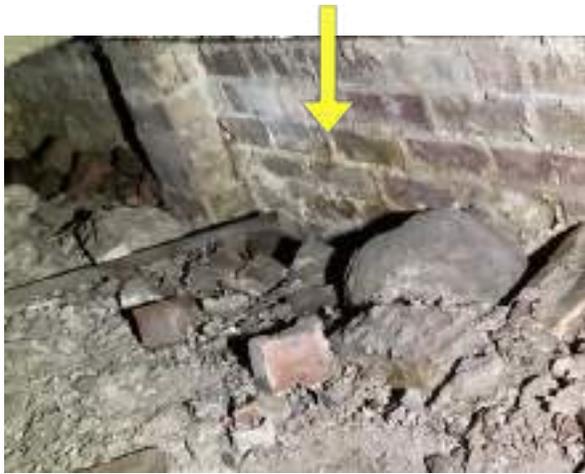
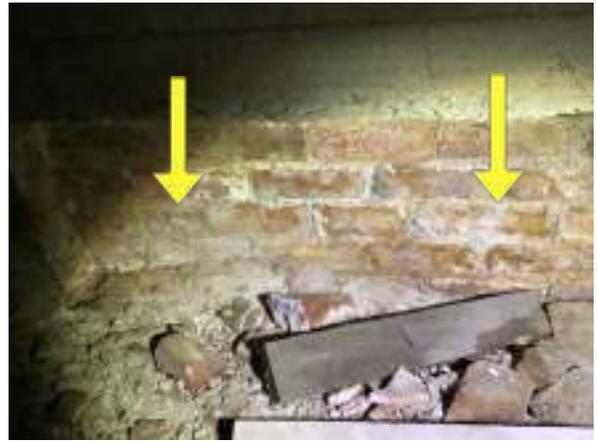
Major Defect 2.04

Location: Subfloor
 Finding: Damp - Rising

Consultation with a PLUMBER, BUILDER AND OR STRUCTURAL ENGINEER AND SOMETIMES A GEOTECHNICAL ENGINEER, and also more then likely a structural engineer is advised immediately to identify the cause of the damp and perform remedial works as required.

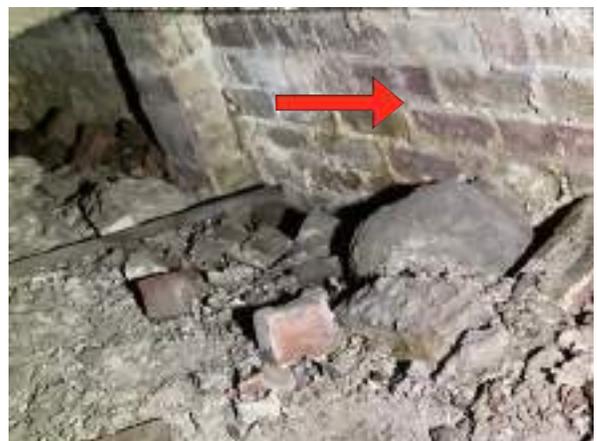
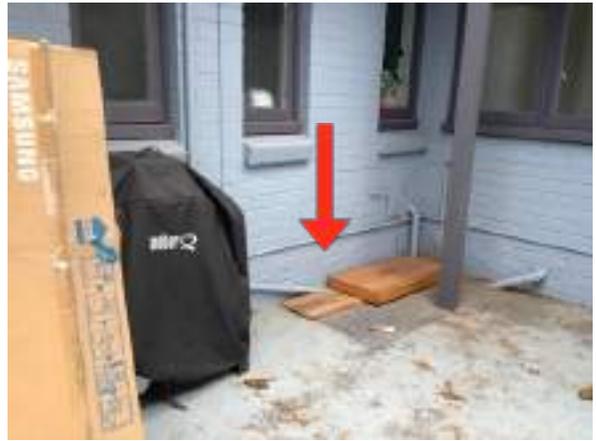
Major Defect 2.05

Location: Subfloor
Finding: Subfloor - Lack of ventilation

The initial step in improving ventilation is to ensure that the subfloor area is free of any debris or stored items. Where ventilation is still inadequate, it is advised to ensure that all vents are clear of blockages, and additional vents may be installed.

The client may also consider adding additional ventilation to the perimeter of the subfloor area and/or mechanical ventilation (powered fans) to improve subfloor airflow. This can be a complicated problem that may require various solutions and remedial works should be conducted as a matter of urgency to protect against the development of potentially harmful subfloor conditions and/or further damage the subfloor area.

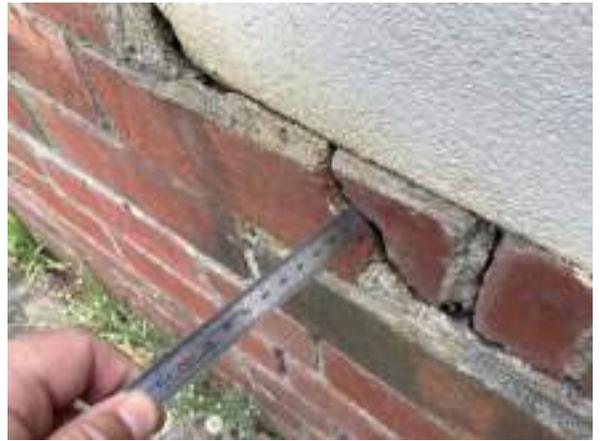
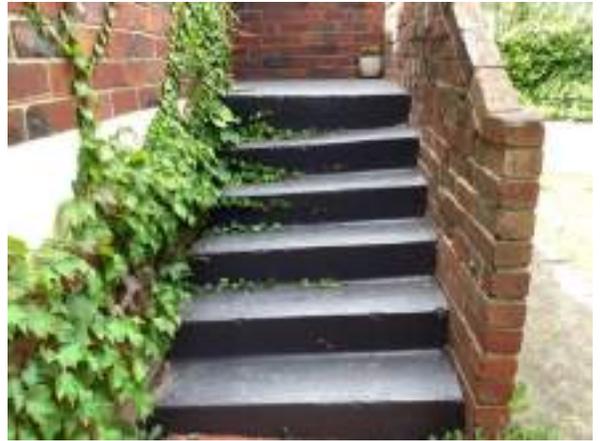
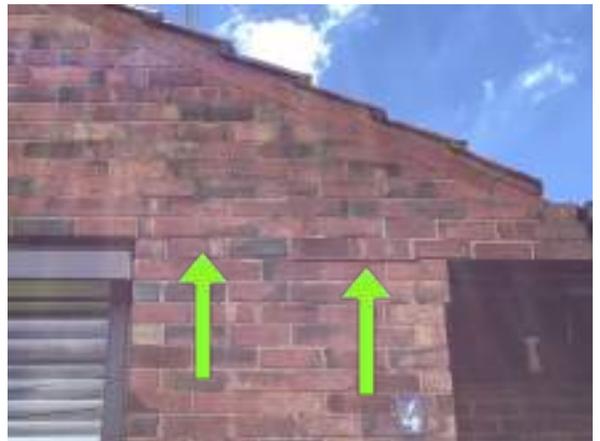
Major Defect 2.06

Location: Brickwork

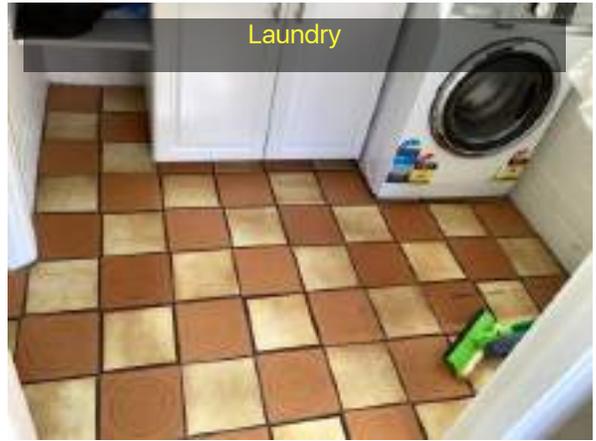
Minor Defect 3.01

If left unmanaged, water penetration to these areas may lead to subsequent water damage, which is likely necessitate repair work to affected building elements.

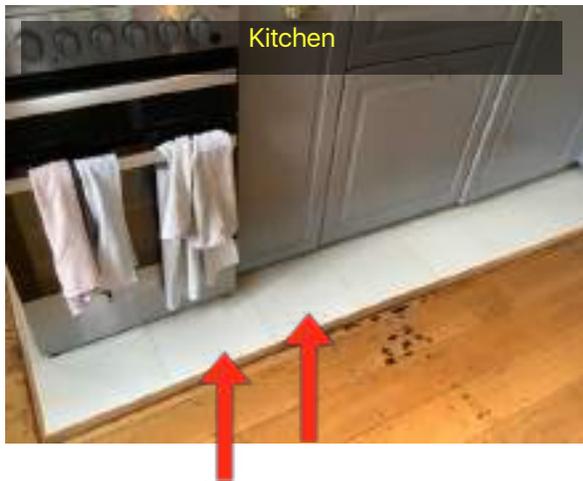
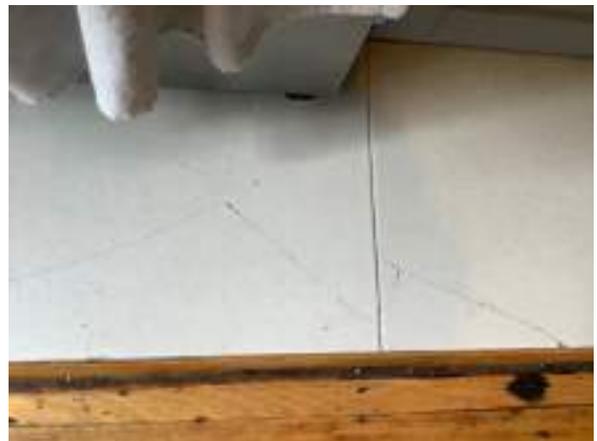
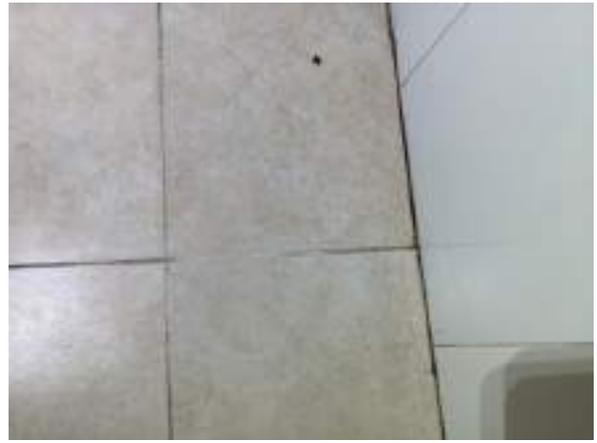
Minor Defect 3.02

Location: Tiled Areas

Where water penetration has led to water damage, appointment of a relevant tradesperson may be required to repair damaged building elements.

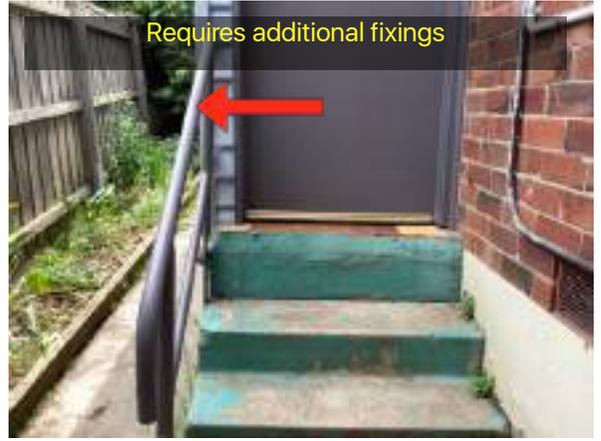
Minor Defect 3.05

Location: Sub Standard Workmanship or Incomplete-All Areas

The appropriate tradesperson, specialist or handyman should be appointed to complete the various items for repair and organise the appropriate QUALIFIED trades (or not pending on job) to repair and complete the works to illiminate or reduce further deterioration / disfunction.

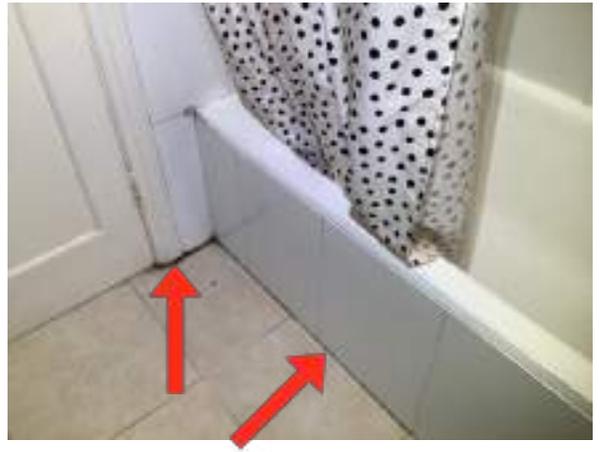
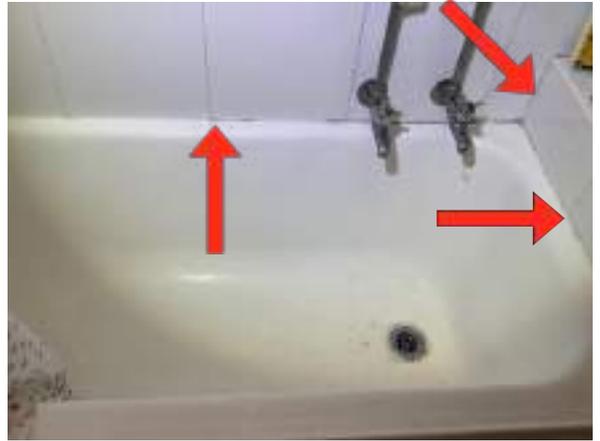
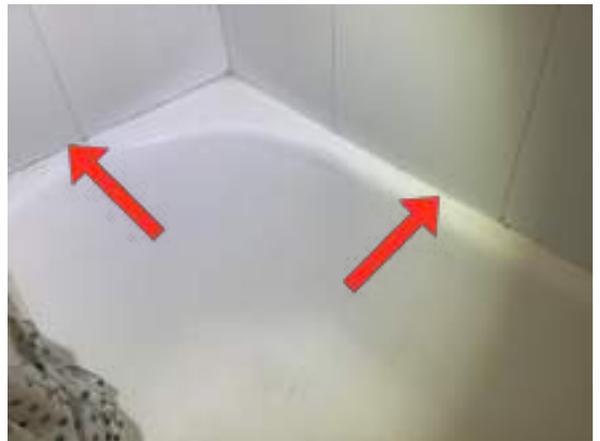
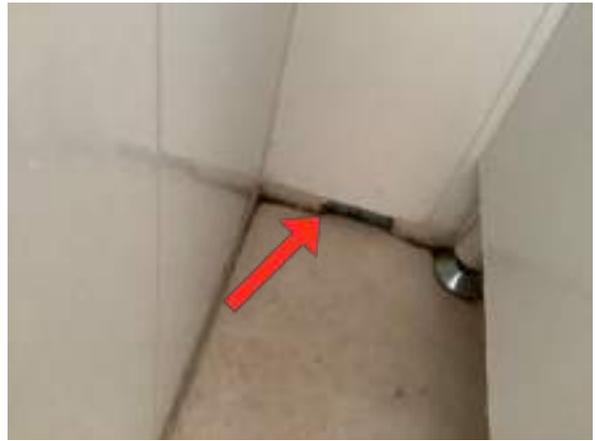
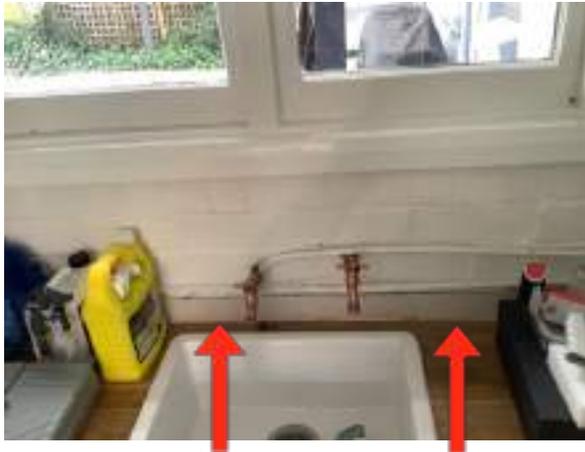
Minor Defect 3.06

Location: Caulking / Silicone / Tile Grout-All Wet Areas

◆ ALL AREAS should be checked carefully, for the Silicone / Caulking To All Wet Area Junctions and Tile Grouting, that is Missing/Damaged or just installed poorly.

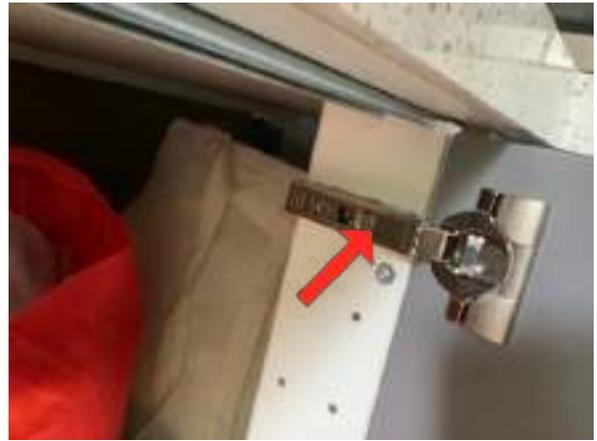
Minor Defect 3.07

Location: Cabinetry / Wardrobe Doors Internal Areas

To improve operation of the affected doors, a general handyman / cabinetmaker/ carpenter may be appointed to replace the faulty hinges and/or adjust .

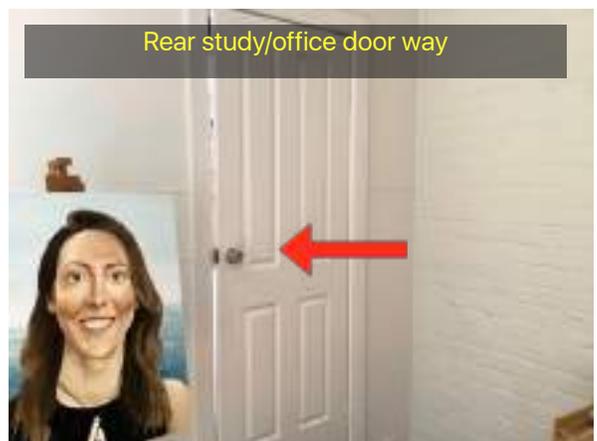
Minor Defect 3.08

Location: Doors - All Areas

For minor causes, a qualified carpenter or general handyperson should be appointed to perform minor rectification works at the clients discretion.

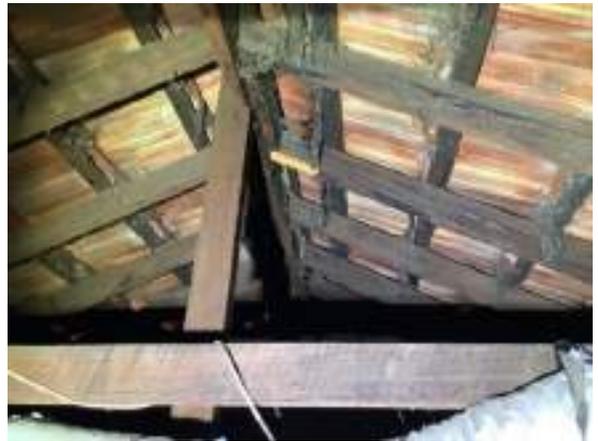
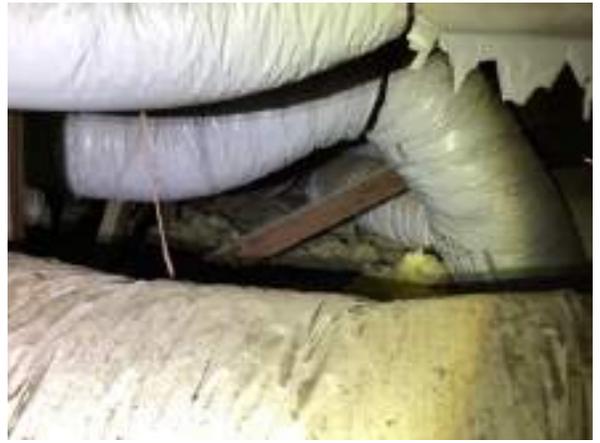
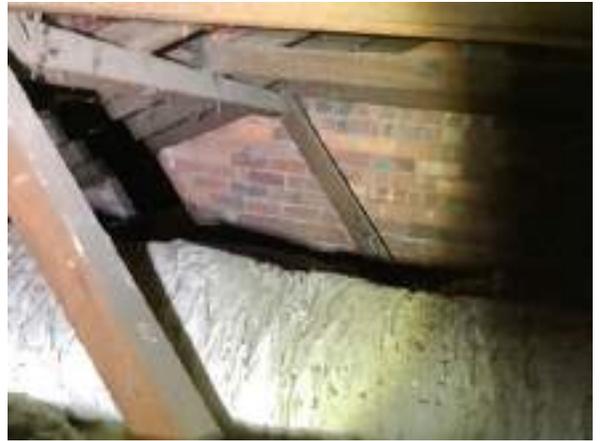
For your information 4.08

The property is a very high risk for termites as the environments to the property are very conducive with many susceptible areas.

Please read the report carefully and Maintenance to all susceptible and conducive areas is a MUST to minimise the risk of termite and timber pest existence and timber damage.

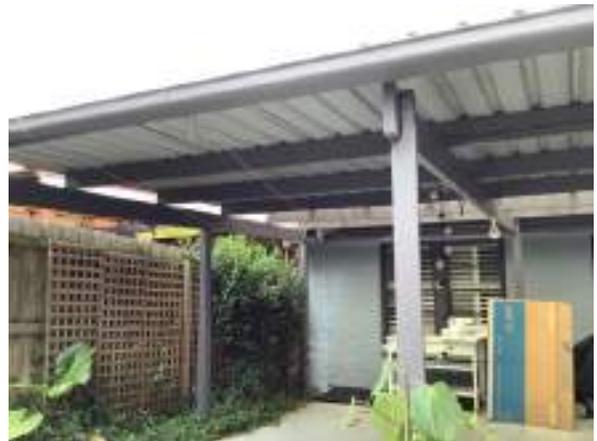
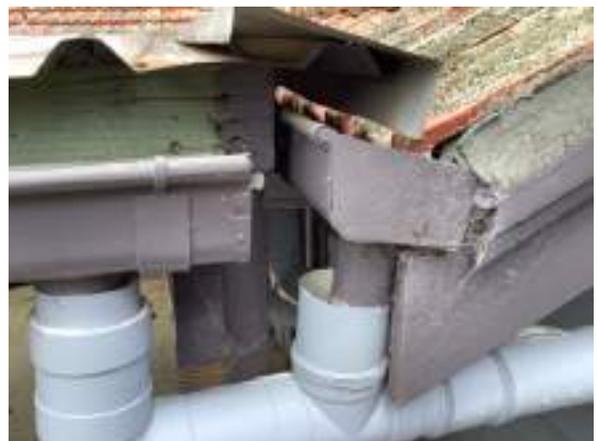
For your information 4.09

Location: Garden Areas - All Areas

It is highly advised to request that the current owner provide a Defect report (Owner Builder/ Section 137b) for this structure. This would involve a structural engineer or a licenced building surveyor conducting an inspection of the structure and advising of any defects and/or areas of non-compliance in accordance with the current building codes. The current owner should then attend to any issues on this report prior to settlement.

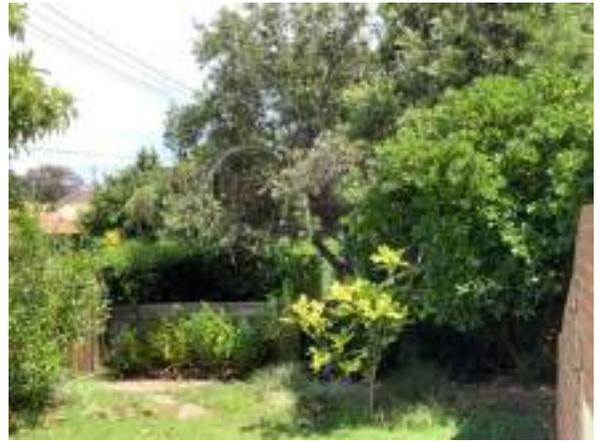
Conditions conducive to timber pest attack 4.14

Location: Garden Areas - All Areas

Please read the report carefully and Maintenance to all susceptible and conducive areas is a MUST to minimise the risk of termite and timber pest existence and timber damage.
