Structural report related to concrete slab movement.

Inspection Date: 10 Mar 2021

Property Address: Werribee Area, Victoria.

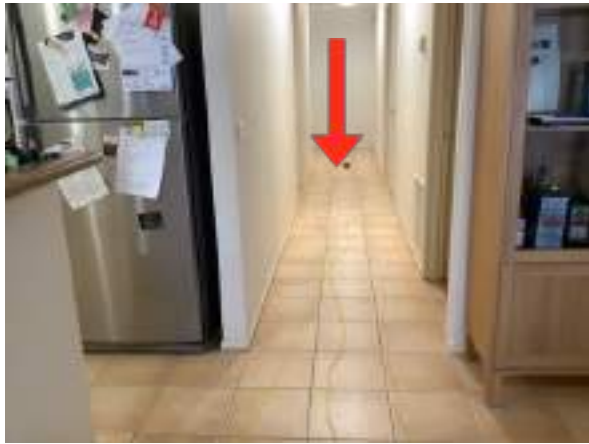
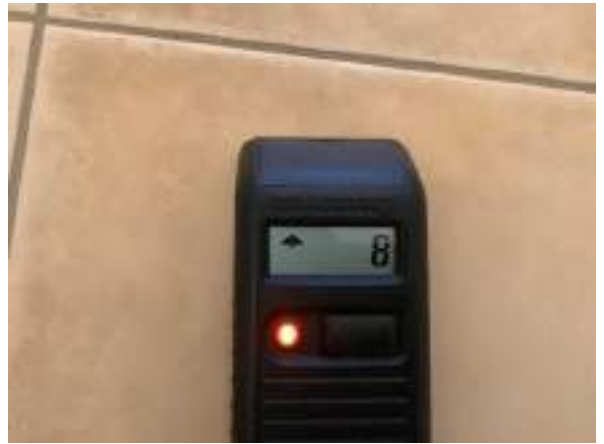
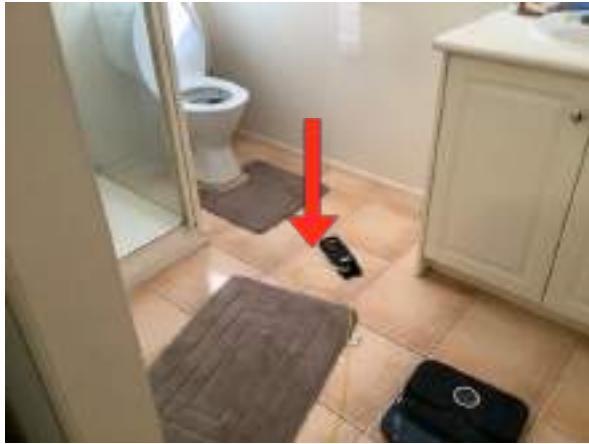
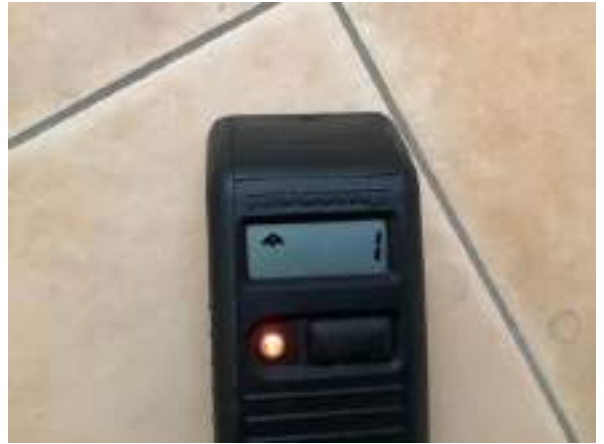
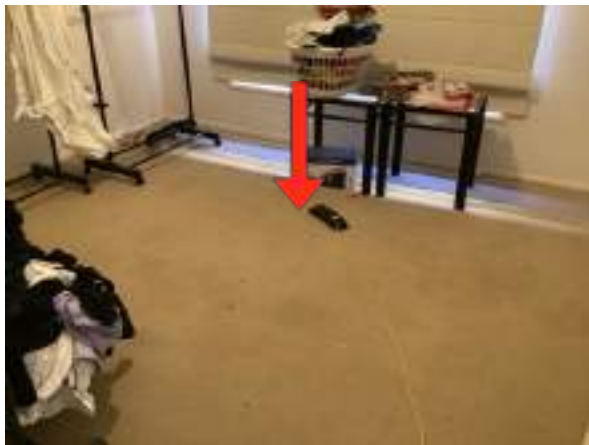
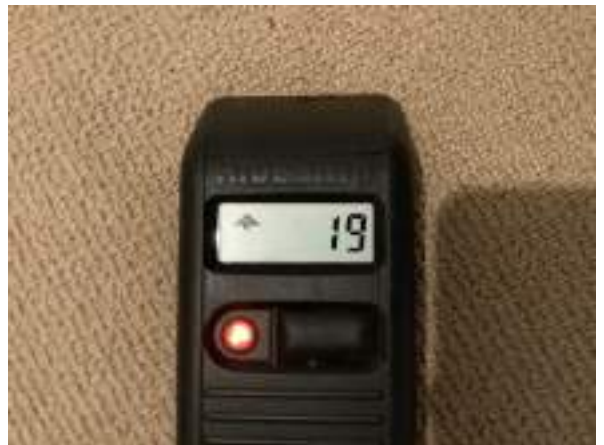
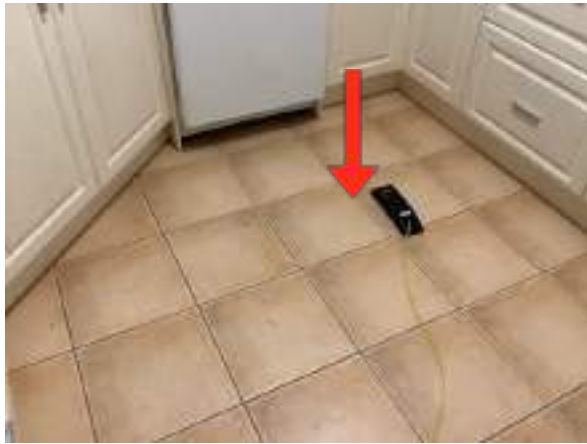
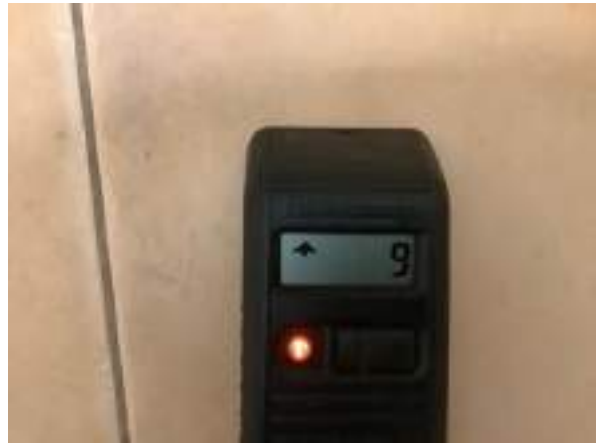
Major Defect 2.01

Concrete - Slab Heave & Foundation Subsidence

It appears that the subfloor structure (concrete slab) has been affected by movement of the foundations, often referred to as sinking or subsidence, now a degree of movement is expected in subfloors over time, but generally not with concrete slabs of a home and not to this degree, where the brickwork in areas, the floors and the walls are all consistent with signs of serious movement.

General subsidence is usually initiated by changes in soil moisture content clauses by various reasons. The most critical factor is identifying the specific causes, and identifying if this is a recurring or ongoing problem, or one that has been resolved by previous works in the past.

This significant type of movement in a concrete slab that shifts the floors, walls and brickwork may be caused by an under engineered concrete slab, soil moisture changes, broken water pipes and others forms of causes.

It is unknown if the ground has stabilised and slab heave and/or foundation subsidence has stopped, slowed down and/or is continuing as an ongoing concern.

Subsidence can have complex and varying causes, which will influence the required remedial works. It is advised to begin by consulting a structural engineer , geotechnical engineer to determine the required scope of works. This generally includes some form of underpinning, in part or full, that is if the concrete slab can be repaired and/or even saved ??

I HIGHLY RECOMMEND URGENT ATTENTION to this matter and engaging a structural and geotechnical engineer would be the first step to the process. In addition engaging a qualified plumber and a registered builder to assist in determining the cause and/or the source is imperative

We highly recommend engaging, perhaps a plumber, or other professional type companies who inspect underground plumbing/drains, who have the camera/video systems to inspect all the underground stormwater/sewage/drain pipes.

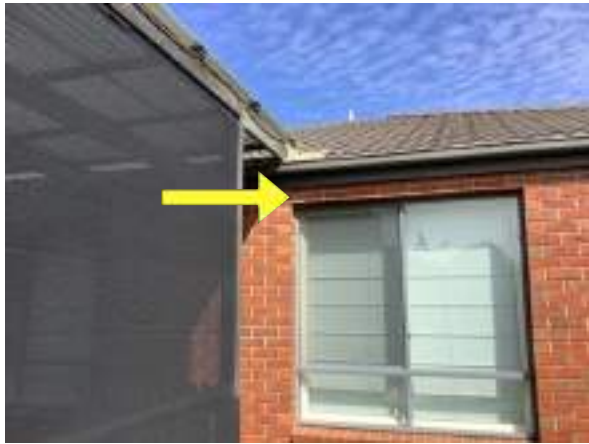
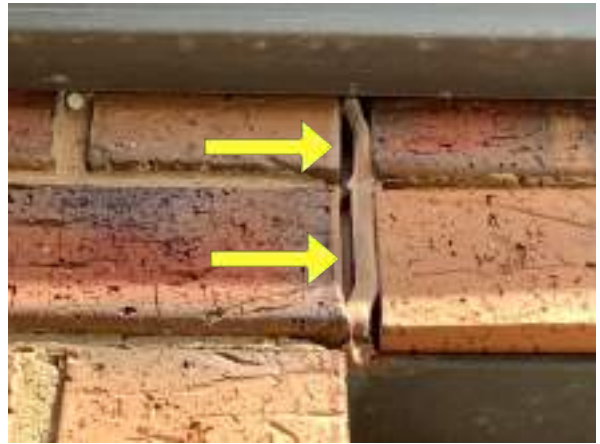
Major Defect 2.02

Location: Brickwork
 Finding: Brickwork - Major / Structural Movement.

There are areas of noticeable major cracks to the property. These cracks usually coincide with openings (windows and doors) however they can present in other areas also. Cracks of this type are likely to have been caused by minor expected movement of building elements, but may also have a structural cause that is more significant.

Structural issues are generally the underlying cause of such cracking. It is suspected that this damage has been created due to movement of key structural elements or general subsidence of associated footings.

Major cracking is evident to the brickwork in this area. When managing this degree of cracking, major extensive repair work is generally required. Such work is likely to involve replacement of sections of affected brickwork.

A structural engineer and bricklayer should be appointed immediately to inspect the structural integrity of the affected brickwork and to assess the safety of the associated structures. The engineer can also nominate a scope of works required for rectification. I believe that the building warrants a structural engineer to determine the structural integrity of the foundations.

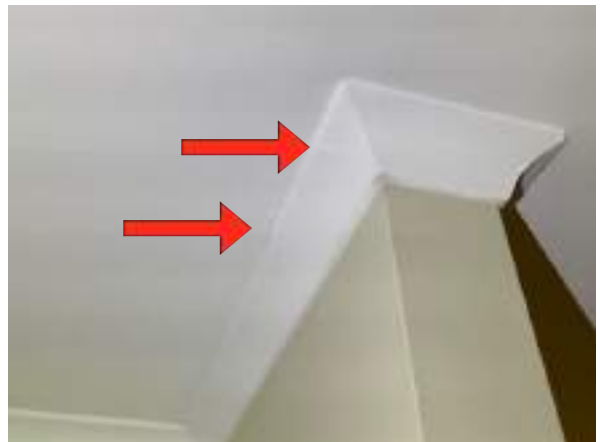
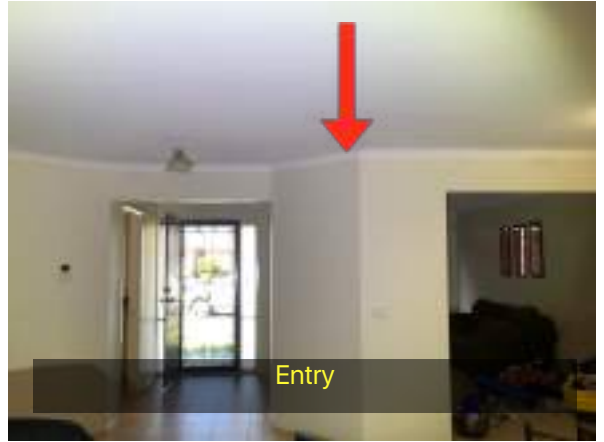
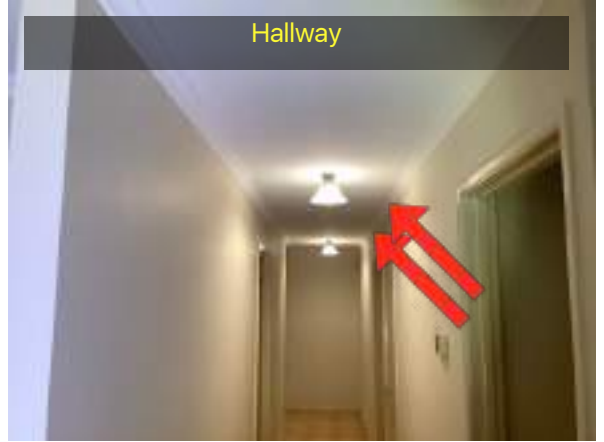
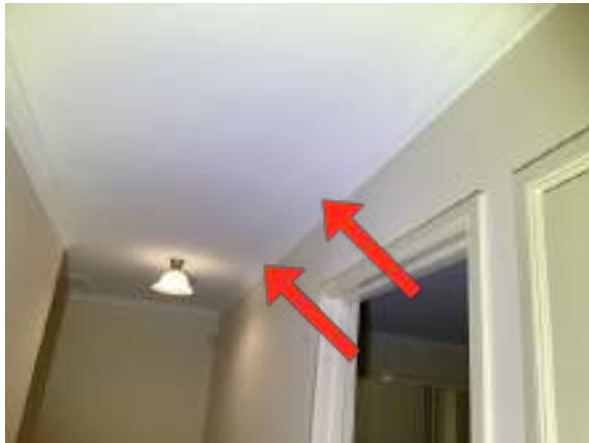
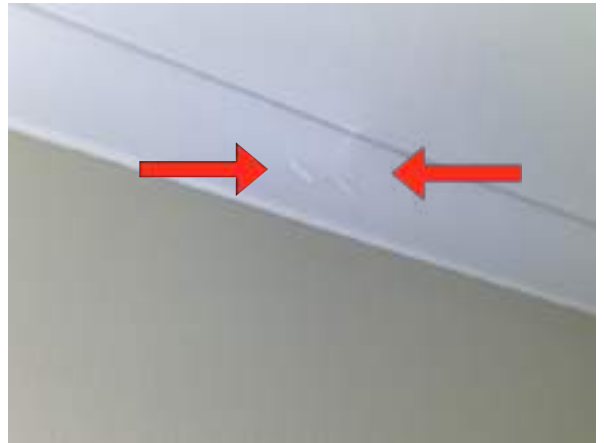
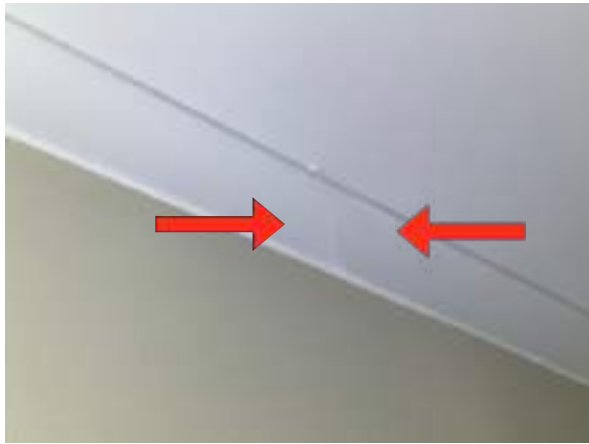
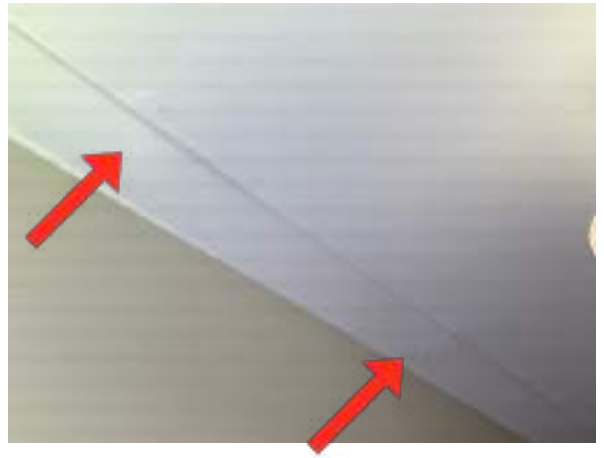
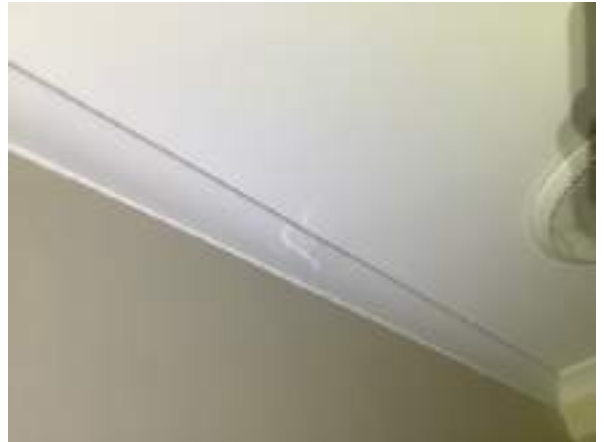
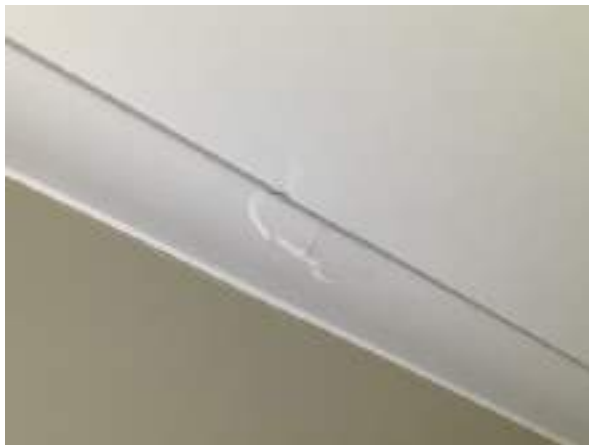
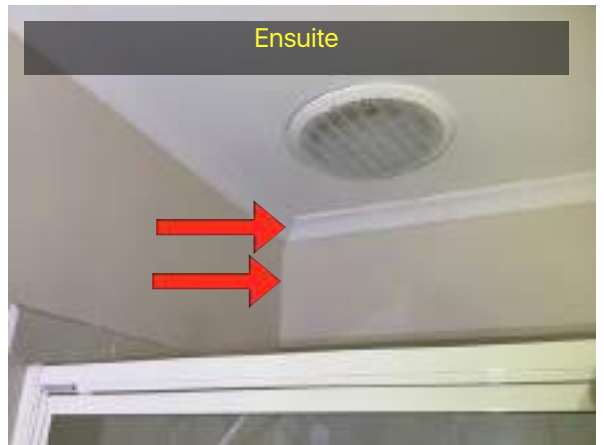
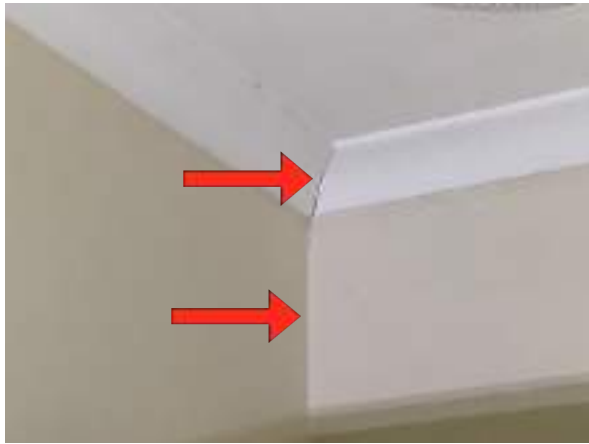
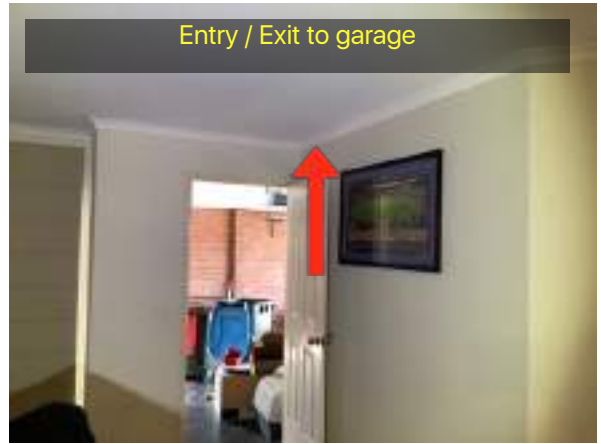
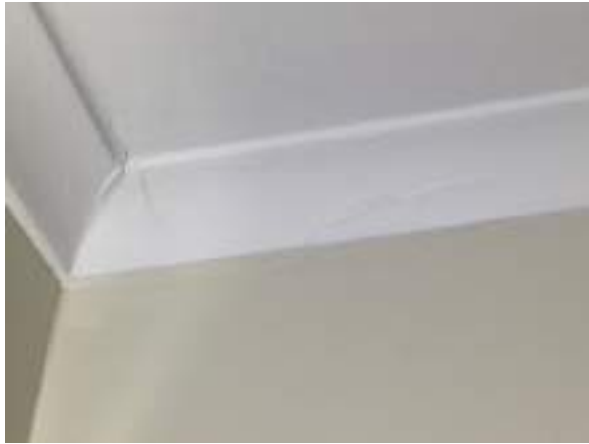
Major Defect 2.03

Location: Various Plaster Cracking

Finding: Various Plaster Cracking - Related To Concrete Slab Movement

The cause and effect of cracking of this degree is almost always structural and related to movement of key structural elements and in this particular case, as per the concrete slab levels, it has been proven that there is severe slab movement as detailed in this report

Extensive repair work is generally required when managing cracking of this degree. This may involve breaking out and replacing wall sections, especially over doors and windows. Doorframes and window frames are often distorted, causing windows and doors to jam and stick. The property may already be affected by leaning or bulging walls, and loss of some load bearing in the beams. This may also result if the source of the cracking is unmanaged. Service pipes may already be disrupted or could become disrupted in the future.

The engineer can also nominate a scope of works required for rectification.

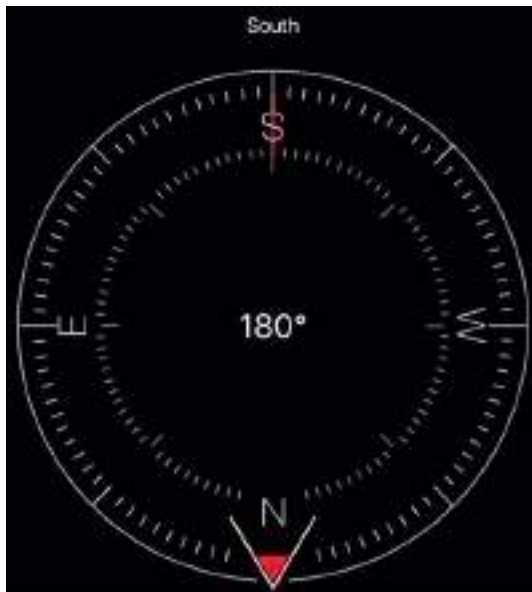
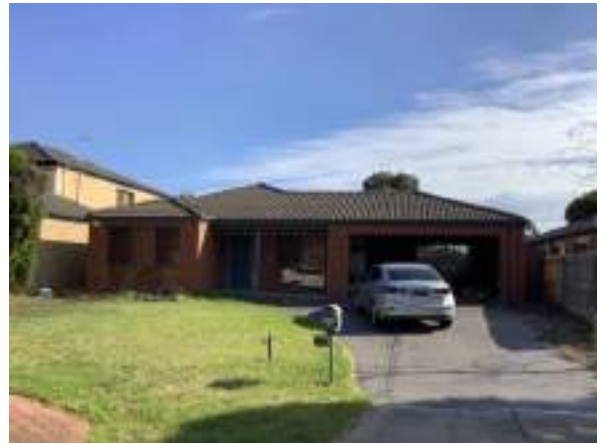
Finding: General Site Photos

General site photos and other areas of interest are provided for your general reference.

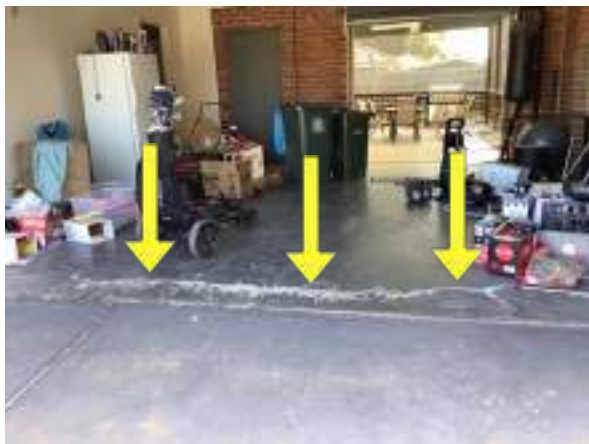
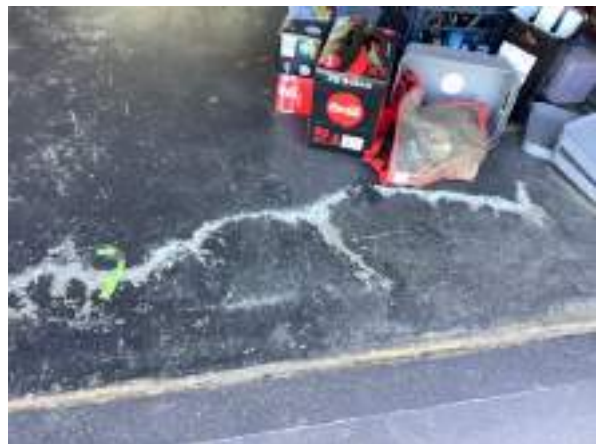
Efflorescence appears to be affecting the in this area. Efflorescence typically occurs when excess salts within the concrete is leached to the surface due to water transfer. It is typically seen as white salt deposits on the surfaces of concrete pavement. While detracting from the overall appearance of the affected area, efflorescence is not likely to develop into secondary damage if left unmanaged. Generally, soluble salt deposits can be removed by dry brushing with a stiff-bristled brush. Repeated dry brushing is an ideal treatment for eliminating this forming of efflorescence.

A cleaning contractor or general handy person may be appointed to perform these works at the discretion of the client.

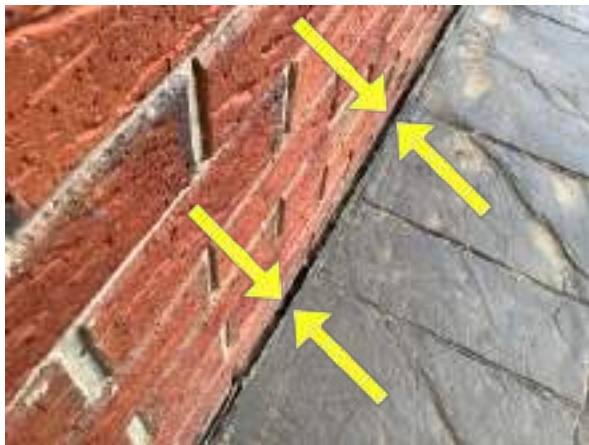
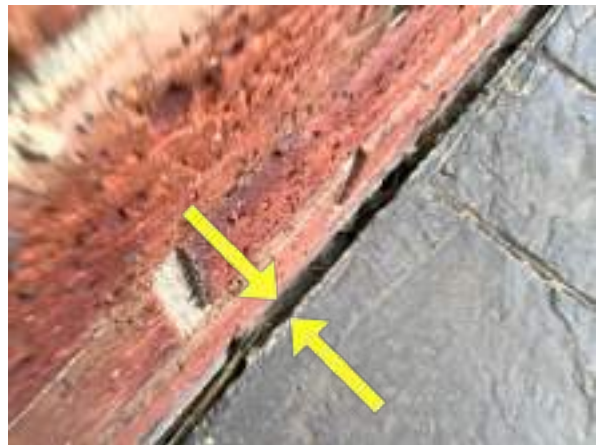
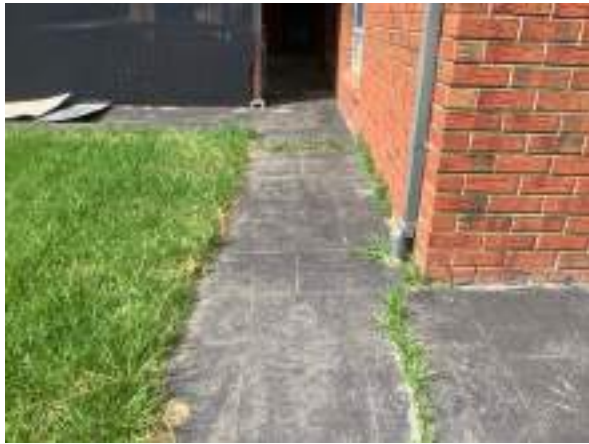
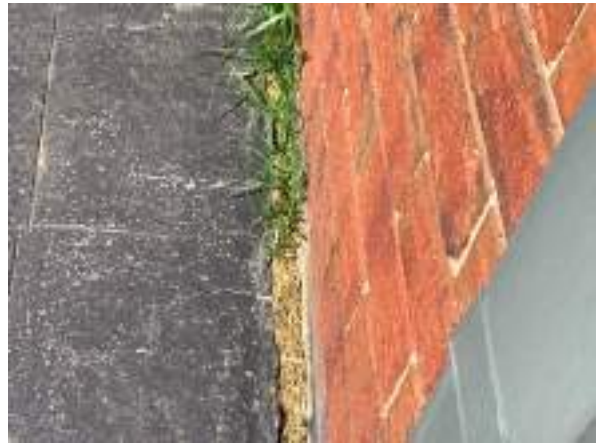
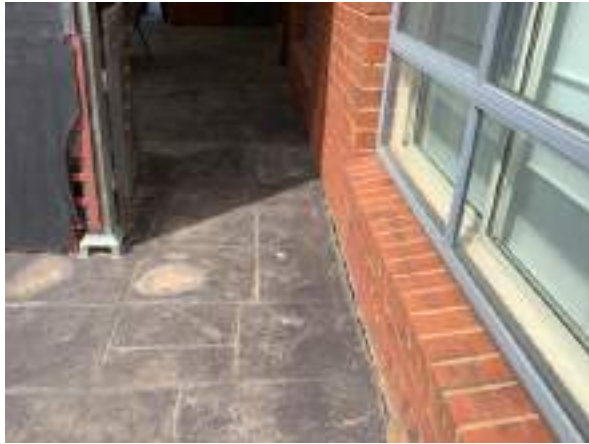
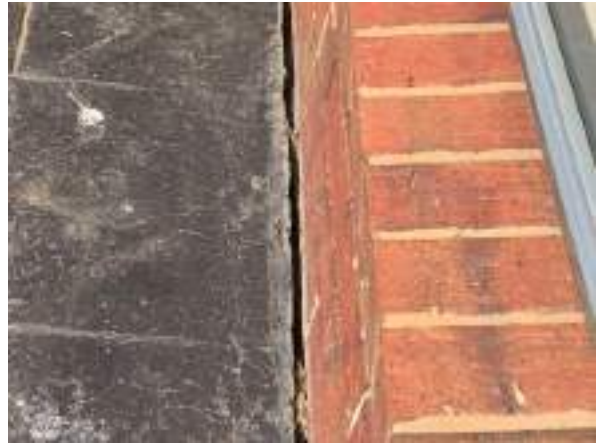
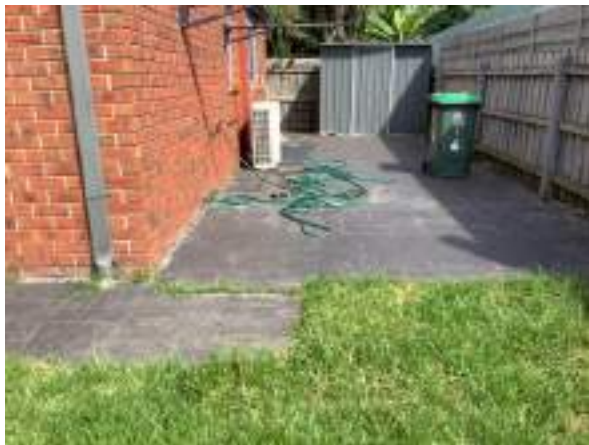
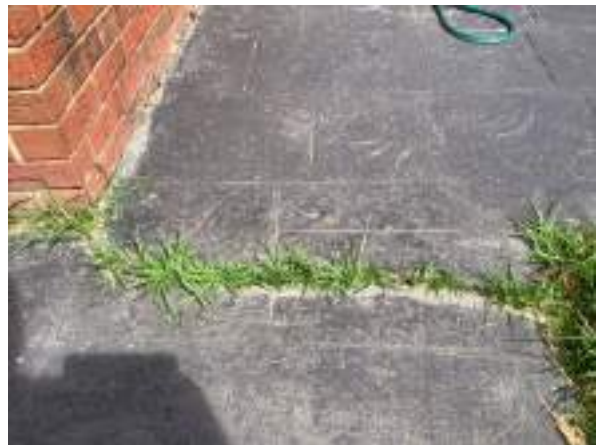
Observation 4.04

It has been found that the concrete around the perimeter of the building has separated from the brickwork approximately 20 to 40 mm in various areas.

It just appears that the concrete has moved over time due to subsidence and /or shrinkage of the soil from the dry periods and perhaps even excessive moisture in the ground.

It is not recommended to fill the gap with a solid type material such as concrete or another product of the same type of nature, it is important to allow the concrete to expand and contract when it needs to so the right type of filler would be an expansion type foam and a suitable type UV rated sealant.

It is highly recommended that you engage in a professional contractor that understands this process such as a professional caulker or a registered builder.

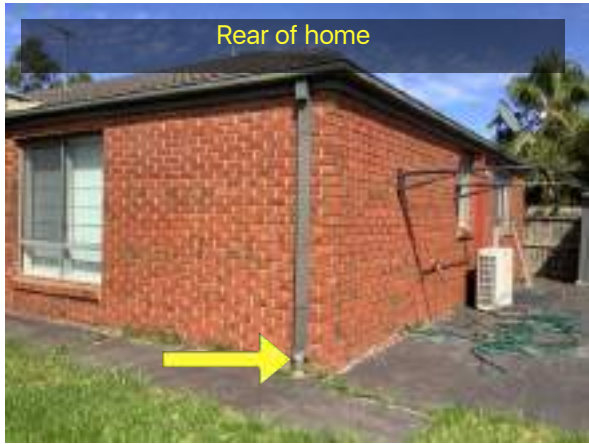
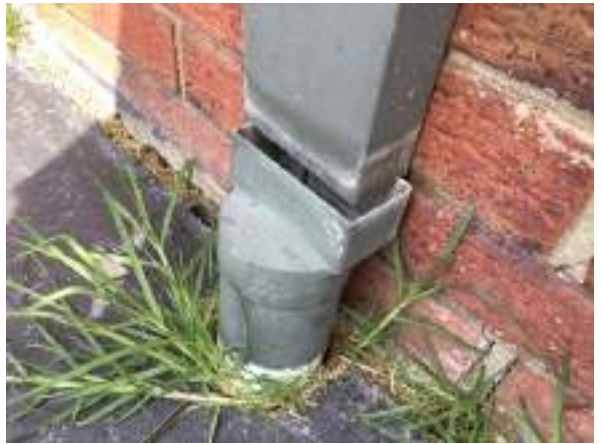
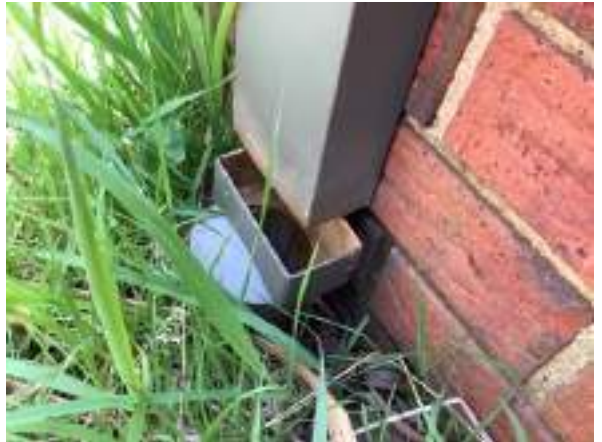
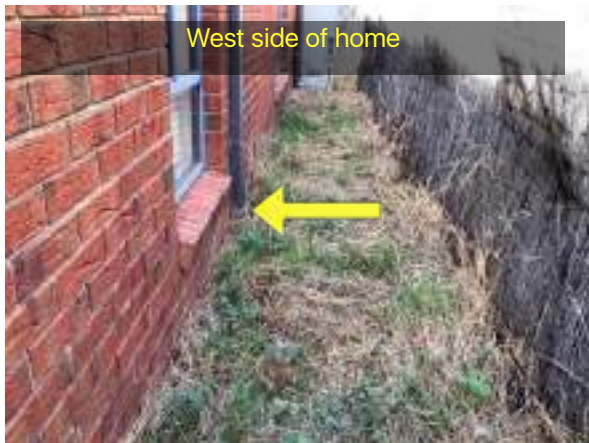
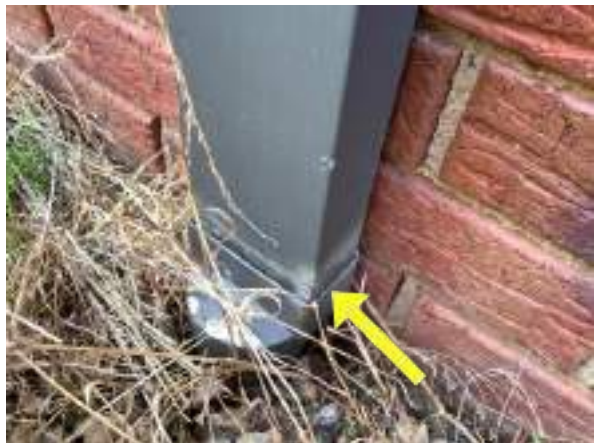
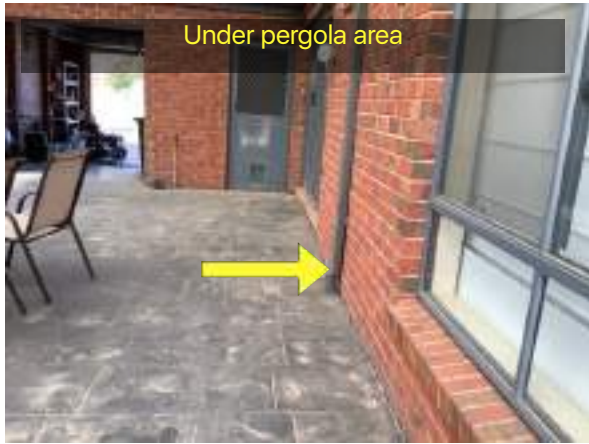
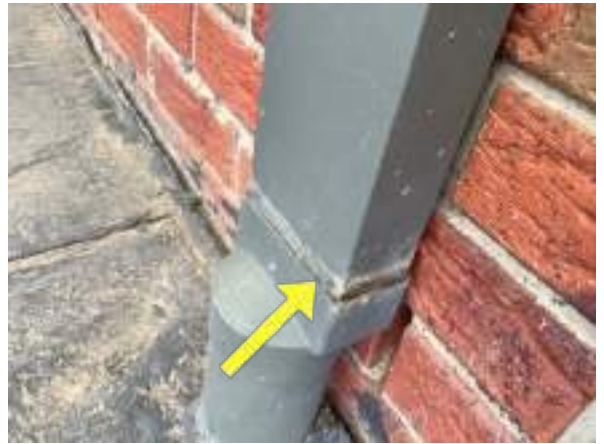
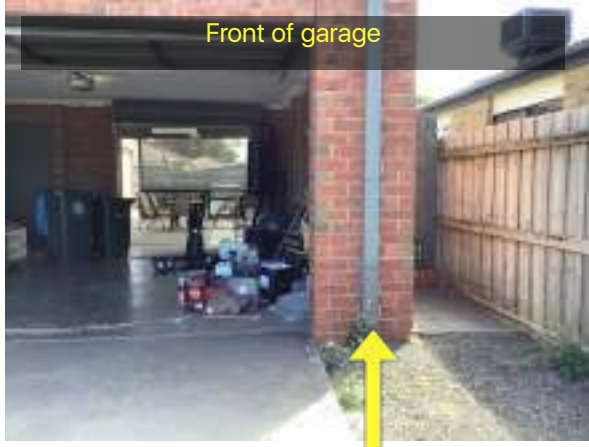
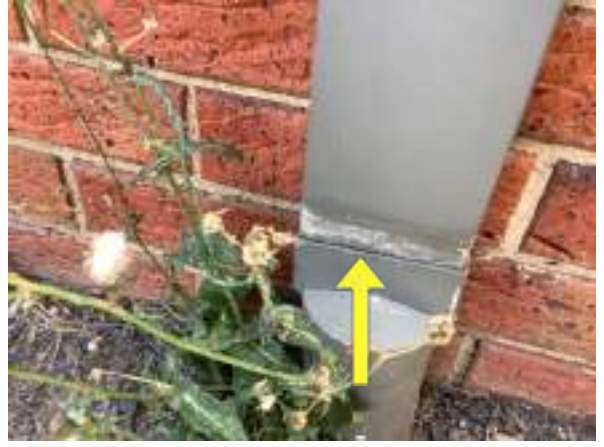
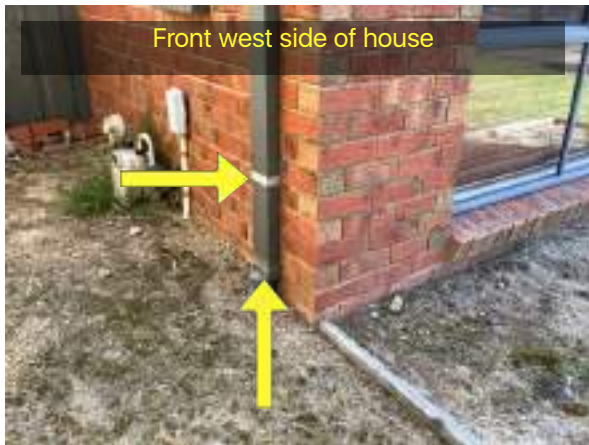
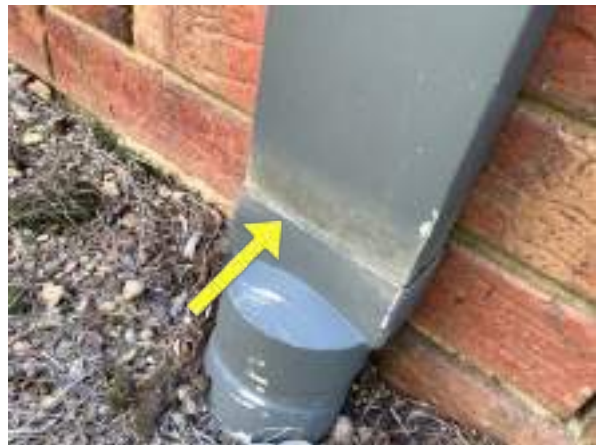
Observation 4.05

Finding: Stormwater drain - Not connected , Partially connected and/or Damaged.

It would appear that this is further evidence of the building and soil movement of the property as the underground storm water has pulled away from the downpipes and this intern is creating or has the potential to create further damage

Where roof plumbing doesn't drain adequately, the area at the base perimeter can become excessively damp, potentially creating an environment that is susceptible to rust and corrosion of surrounding building elements, as well as attracting termites and other pests.

This has the potential for foundation subsidence and/or secondary damages such as structural defects such as brick movement / cracking.

It is highly recommended that a plumber be appointed to further inspect the area and to install / repair adequate drainage equipment where necessary.

If secondary damages have accrued we highly recommend that you engage a structural engineer and/or a registered builder for remedial works.

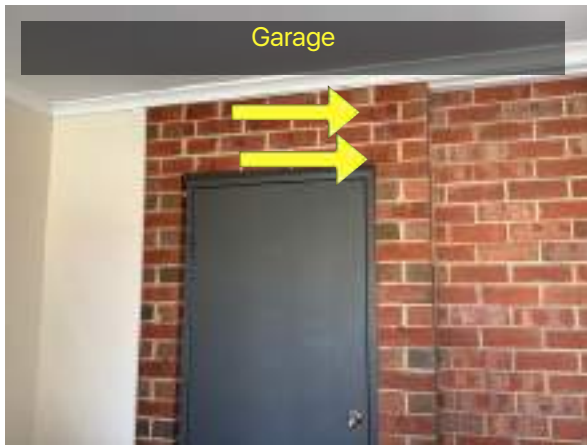
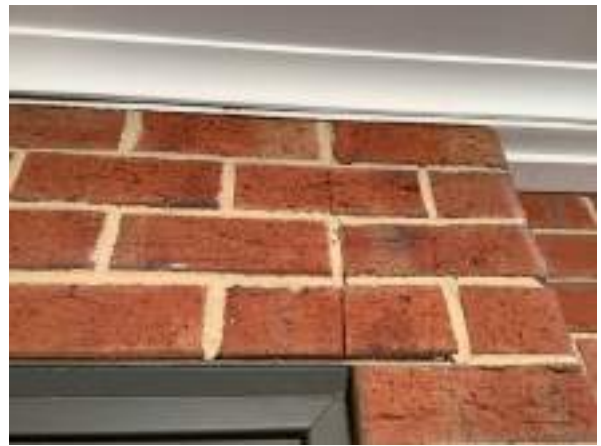
Observation 4.06

Finding: Brickwork / Masonary - Step cracking and minor cracking

There are several cracks and/or step cracking evident throughout the exterior of the property . These cracks are commonly less than 5mm in width.

Although fine cracks are quite noticeable, they are often only considered to be an appearance defect and usually do not indicate any structural damage most of the time.

Generally, the cause of a fine crack is indicative of a separation between brickwork and mortar throughout the structure, but single bricks may also show cracks of this nature.

Step cracking, which is similar to other forms of cracking, has a variety of possible causes. However, the most common is the subsidence of adjacent footings.

Cracking of this nature can generally be repaired with minor filling and should be conducted by a qualified bricklayer and/or registered builder.

Where step cracking is extensive or severe, the client is advised to consult a structural engineer. Minor step cracking can be used as a warning sign to address factors causing stress to the wall, which can include the effect of surrounding trees, water leaks, soil erosion, or even the presence of reactive soils in the surrounding area.

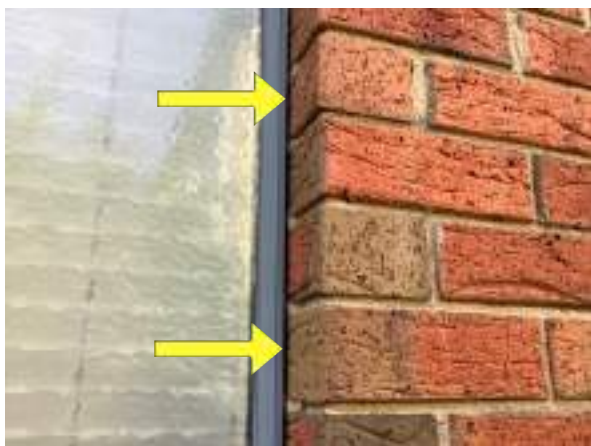
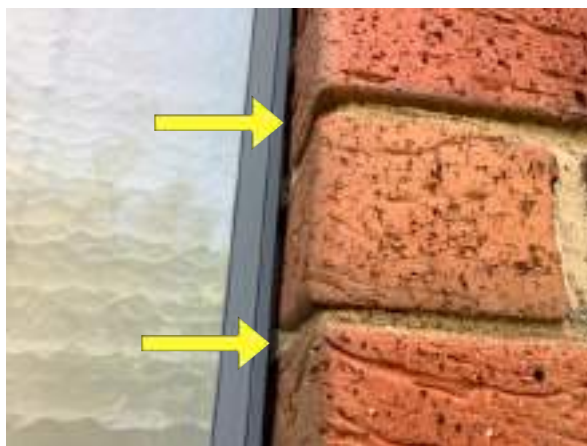
Finding: Water Leaking & Water Ingress - External Areas

Water leaks were found to be present to the exterior sides, tops and or bottoms of the windows and/or doors and other areas as per the photos attached, such as brick expansion joints and timber and cement sheet junctions above windows , eaves and other areas.

Leaks are generally caused by deterioration of silicon or rubber seals or sometimes just defective workmanship when no caulking as ever been used .

It is highly advised that a licensed plumber, handyman, builder be appointed to rectify any water leaks that may be present.

It is important to note once caulking these areas if water damage is noticeable to windows, timbers, etc, such as wood rott, it is imperative to engage the appropriate trades for replacement or repairs.

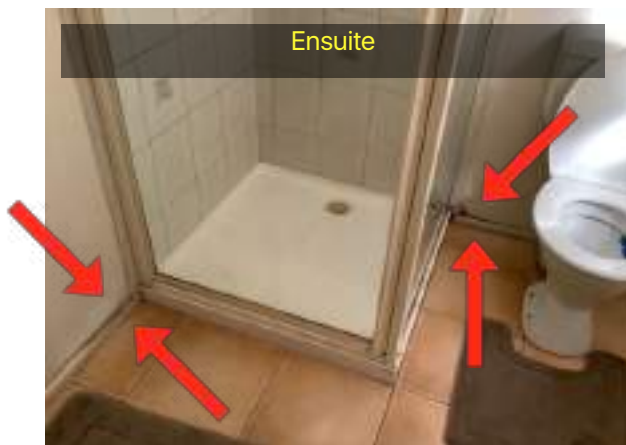
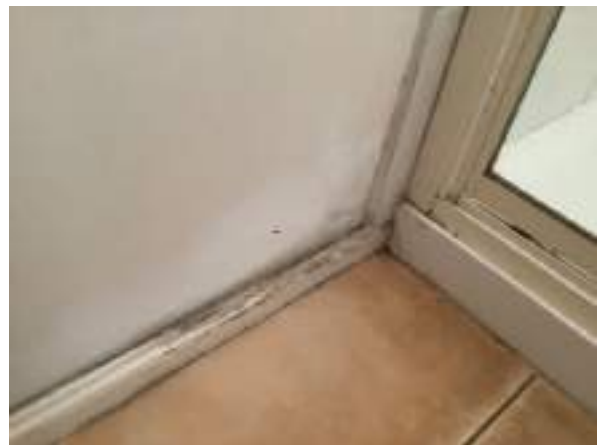
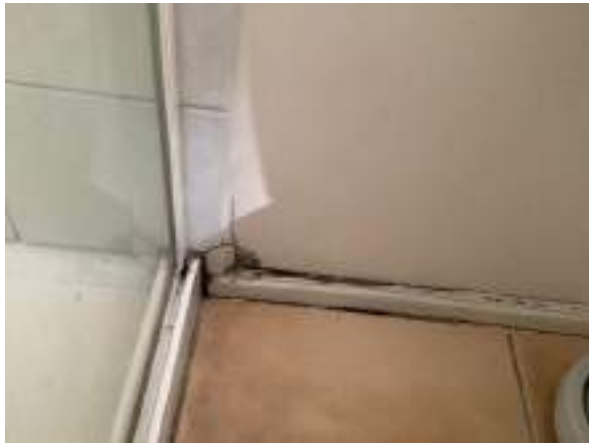
Observation 4.09

Location: Ensuite

Finding: Water Rott / Water Staining - Timber Skirting & Door Frames

Water Rott / Water Staining was evident in this area or areas at the time of inspection.

Water staining indicates that surfaces have been exposed to excessive moisture / water over time. The minerals and other elements in the water lead to staining, which may graduate to corrosion and deterioration if left unmanaged.

It is important to identify the cause of water staining and STOP FURTHER DETERIORATION by the appropriate tradesperson.

Replacement of any broken or damaged structures is advised in particular if the damage has caused secondary defects that have compromised the building structure.

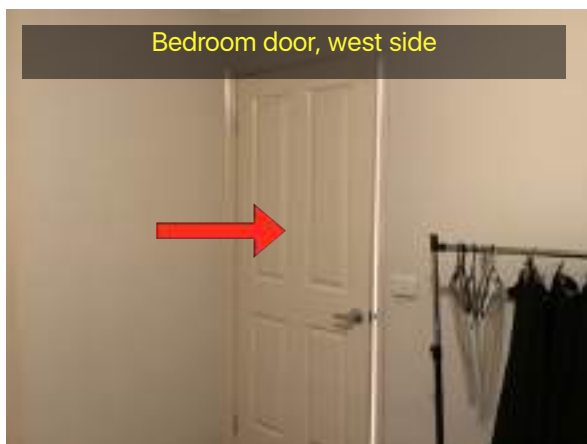
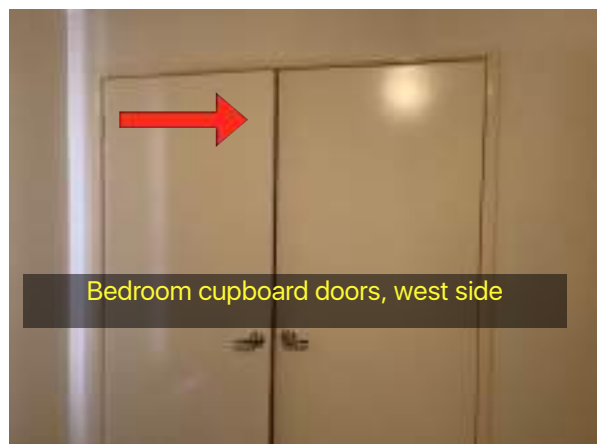
Observation 4.10

Location: Doors - All Areas

Where door binding/jamming/out of level appears to indicate major structural issues, a registered builder specialising in re-stumping, a re-stumping company or concrete slab subsidence expert should be appointed to provide an estimate on the cost of rectification. In extreme cases a structural engineer or geotechnical engineer will need to be engaged as well.

For minor causes, a qualified carpenter or general handyperson should be appointed to perform minor rectification works at the clients discretion.

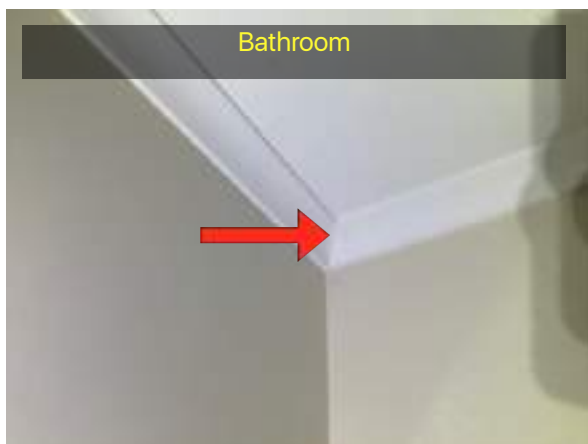
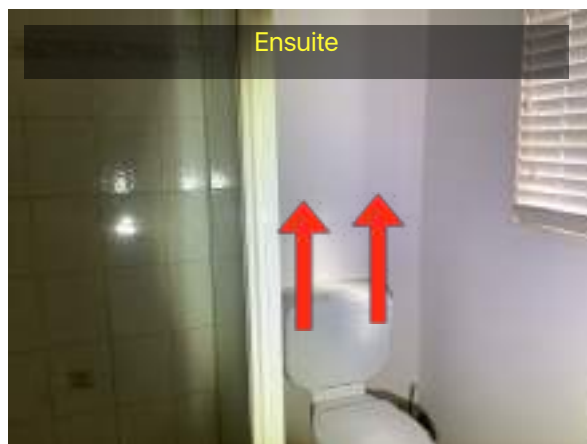
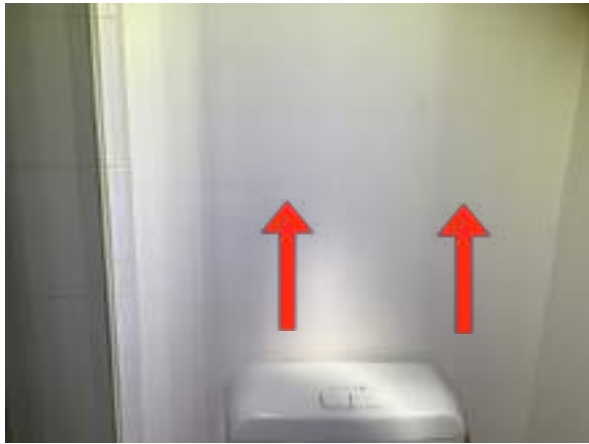
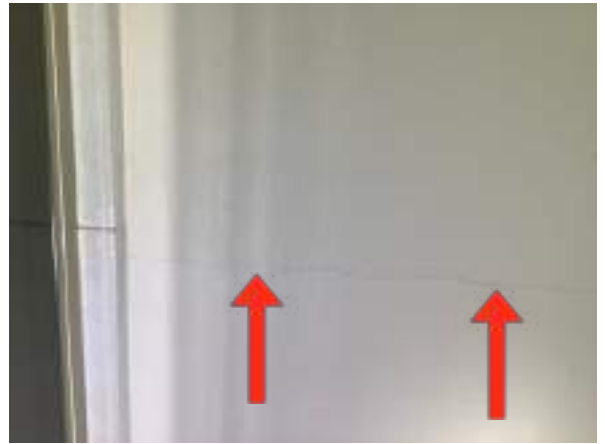
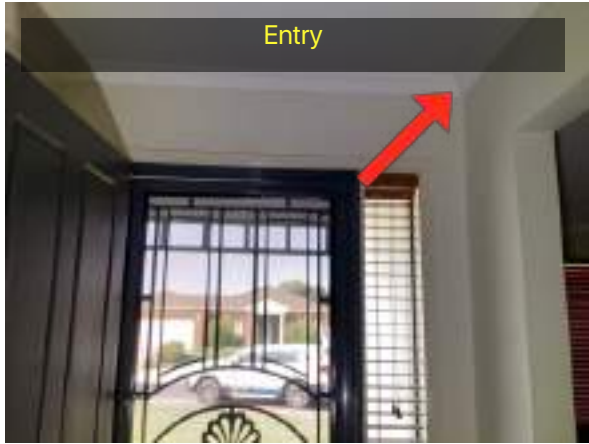
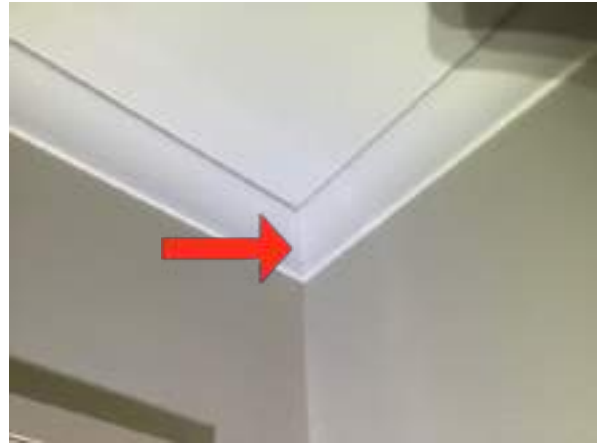
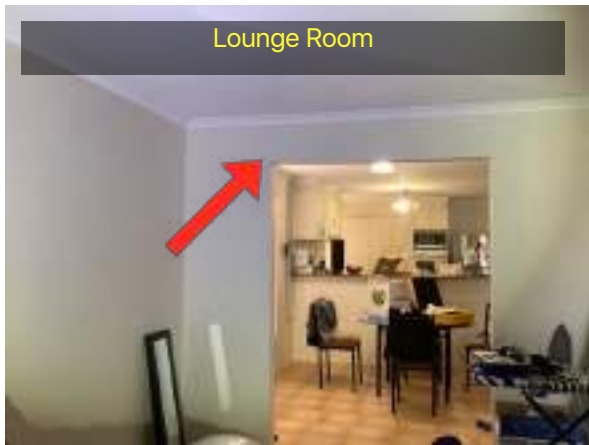
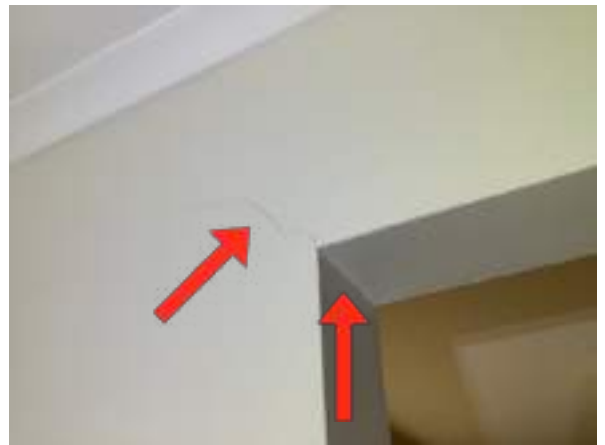
Observation 4.11

Location: Plaster-Various Area's
Finding: Plaster & Timber Cracking - Damage Category 2 - Noticeable (up to 5mm)

Relevant tradespeople, such as carpenters, painters and plasterers, should be appointed to perform remedial works, as deemed necessary.
