Building & Termite/Timber Pest Report (report In June/2021)

Inspection Date: 16 Jun 2021

Property Address: Glen Iris Area, Vic

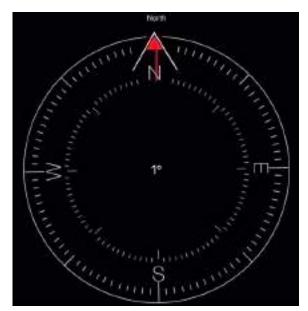
Finding: General Site Photos

General site photos and other areas of interest are provided for your general reference.
