# Building & Termite/Timber Pest Report ( 4 Star )

Inspection Date: 9 Jul 2021

Property Address: Sunshine Area

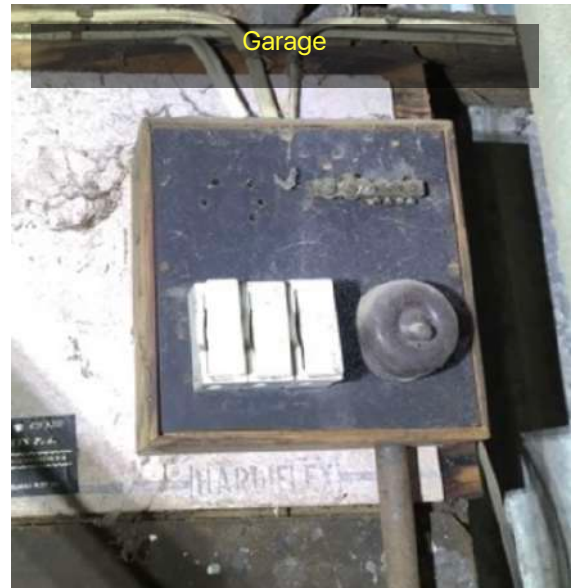
### Serious Safety Hazard 1.01

At the time of inspection it was noted that the switchboard protective devices are old fuse wire type.

Generally, the switchboard is out-dated and should be replaced with circuit breaker protective devices and fitted with a safety switch as soon as possible as a minimum to improve the safety of the property. It is advised that a qualified electrician be contacted immediately to install a new switchboard complete with a safety switch and provide any further advice on additional works that may be required in this State.

A switchboard upgrade with modern circuit breakers and safety switches is highly recommended in accordance with AS 3000.

Upon completion of electrical works a Safety Certificate ( Prescribed ) is required to be given to the owner of the property.

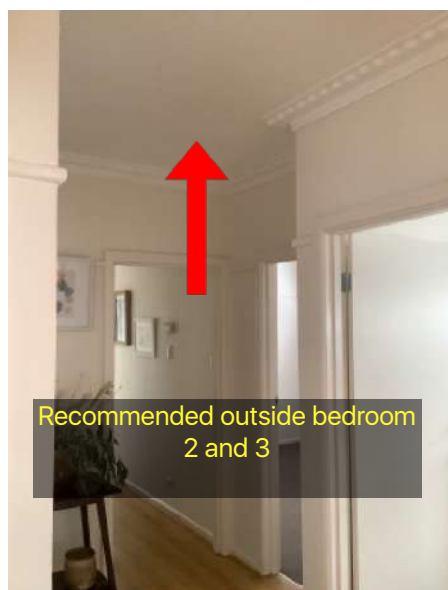
## Serious Safety Hazard 1.02

◆ EXISTING SMOKE DETECTOR, IS A LITTLE TO FAR FROM THE BEDROOM DOORS. Recommend to add Smoke Detector to be Installed closer to the bedroom door or doors. Whilst there is a smoke detector, between the bedroom and/or bedrooms, the smoke detector does appear to be a little too far away from bedroom and/or bedrooms doors and we would highly recommend a new smoke detector to be installed closer to the bedroom door or doors in the event of a fire or excessive smoke. This would allow the smoke detector to alarm at an earlier time frame and in an emergency situation as every second counts, in the event of a fire.

Please note that this defect is highlighted as a caution only. We suspect, based on our experience in the building industry, that the absence of smoke detectors should be addressed as a matter of urgency to improve occupant safety.

A qualified electrician is required do these works for hard wiring.

Upon completion a safety certificate is required to be supplied to the owner of the building.

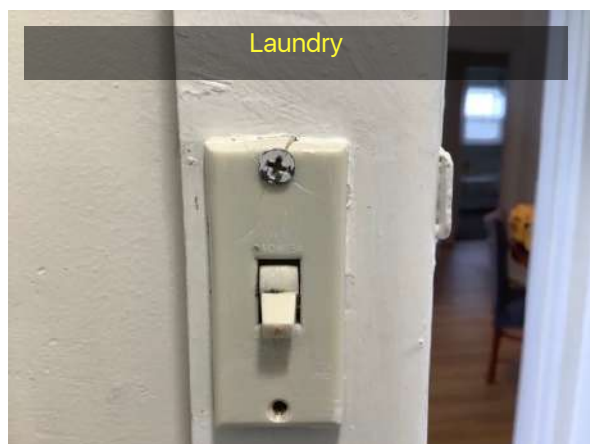
## Serious Safety Hazard 1.03

Finding: Electrical Switch - Damaged/Faulty

The switches in areas were found to be damaged or faulty at the time of inspection.

This occurs generally when the switch plate or the switch itself have either worn, decayed or burnt out as a result of electrical arching.

Repair and/or replacement of the switch is advised to ensure the fixture and it's associated structures are safe and fully operational.

A licensed electrician should be appointed to repair/replace the light switch or switches as soon as possible.

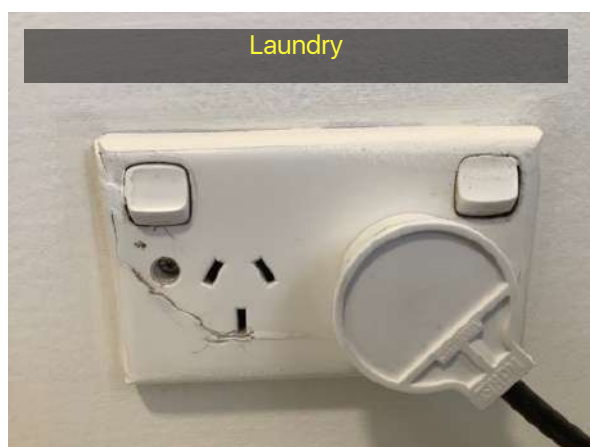
## Serious Safety Hazard 1.04

Finding: Electrical Power Points - Damaged/Faulty

The power points in areas were found to be damaged or faulty at the time of inspection. This occurs generally when the power point plate or the switch mechanisms have either worn, decayed or burnt out as a result of electrical arching.

Repair and/or replacement of the power points is advised to ensure the fixture and it's associated structures are safe and fully operational.

A licensed electrician should be appointed to repair/replace the power points as soon as possible.

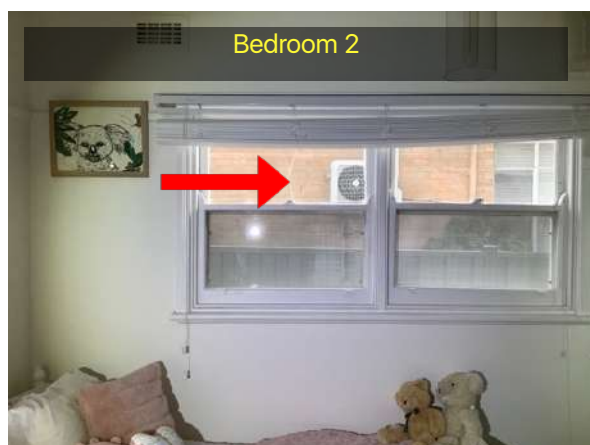
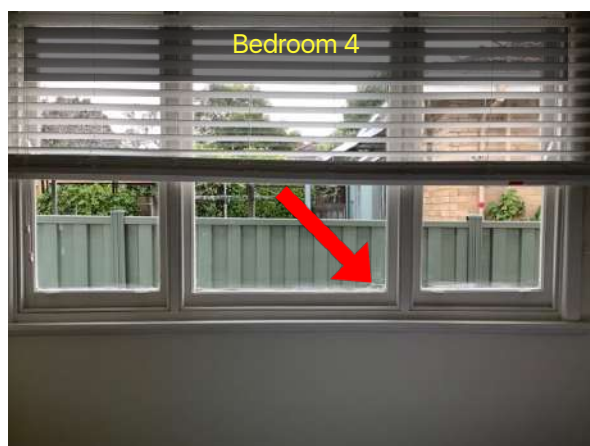
## Serious Safety Hazard 1.06

Finding: Window - Cracked

Cracks were identified in the windows. Cracking in windows is generally the result of impact damage, windows not operating smoothly and/or building movement and is likely to develop further when left unmanaged.

The likelihood of this window pane further cracking and shattering is increased exponentially, providing a safety hazard in the area. The cracked window also impairs the weather tightness of the building, creating potential for minor water leaks.

A qualified glazier is required to repair the window as soon as possible. Depending on the extent of the cracking, replacement of the window may be required.

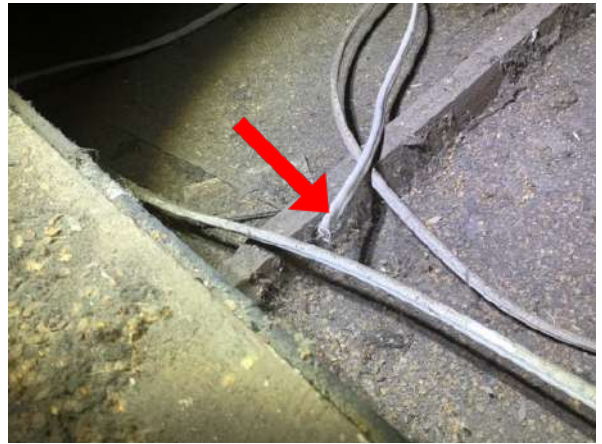
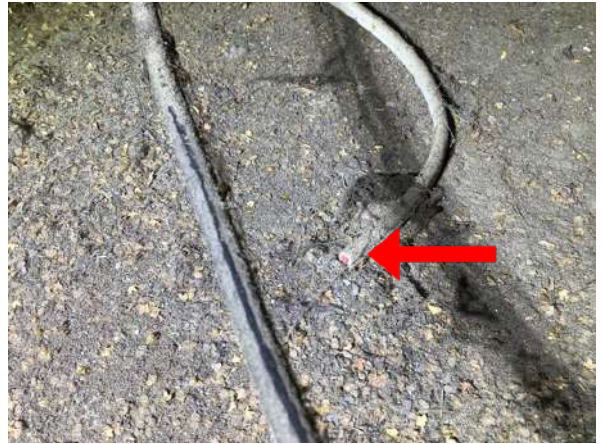
## Serious Safety Hazard 1.08

At the time of the inspection we noted that electrical installation items are not compliant with the electrical regulations AS3000-2007 and each picture attached is an electrical installation defect.

Exposed electrical wiring was identified. Exposed electrical wiring represents a potential safety hazard including for fire and personal contact. Contact a licensed electrician urgently for further inspection investigation and rectification.

We recommend that the purchaser engages a licensed electrical contractor to check compliance and make good any defective wiring or unsafe items throughout the entire property including the outbuildings etc.

A Certificate of Electrical Safety is required for all electrical works and repairs performed to this property.

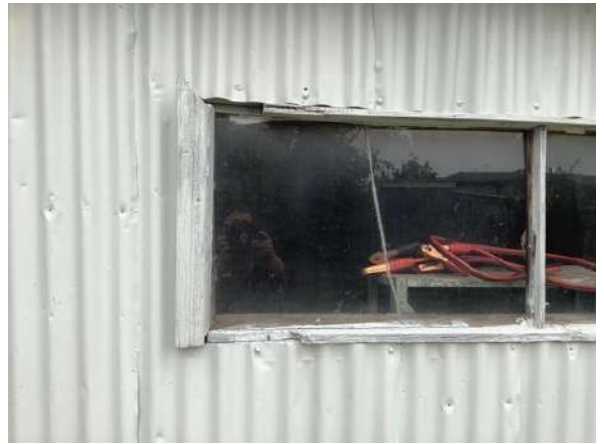
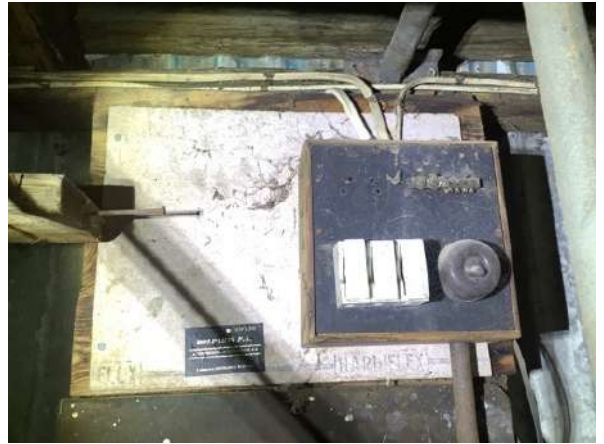
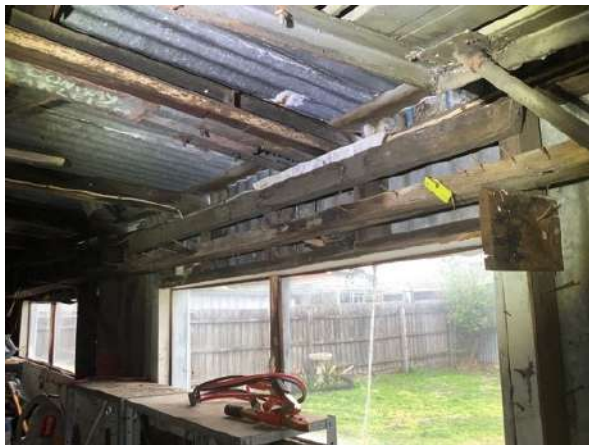
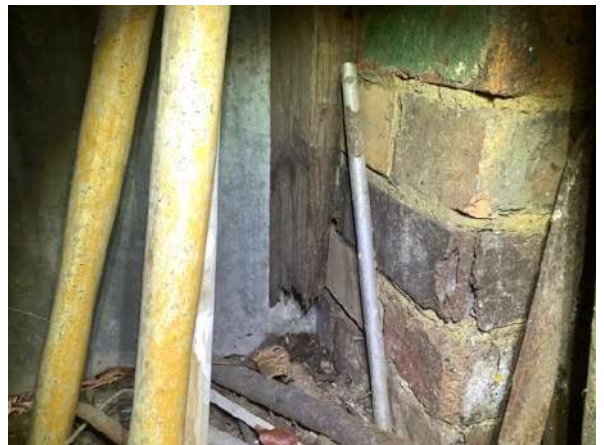
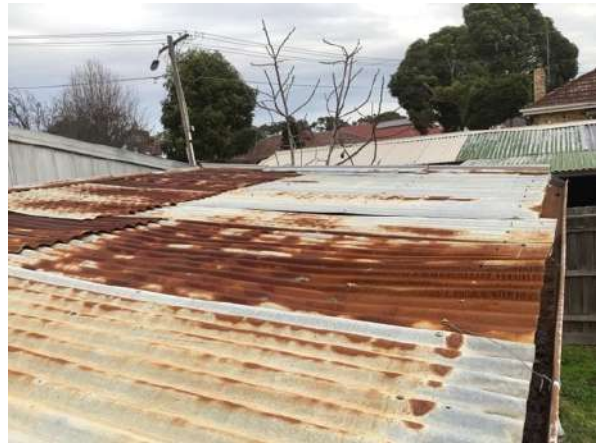
## Serious Safety Hazard 1.09

The structure is in a dilapidated state, that requires urgent attention of repairs or demolition in a safe manner.  
It is highly recommended that the repairs or demolition be performed by professional services or at a minimum a person that is handy.

The client should exercise care when coming into the immediate vicinity of the area.  
Works are advised as soon as possible by the appropriate trades.

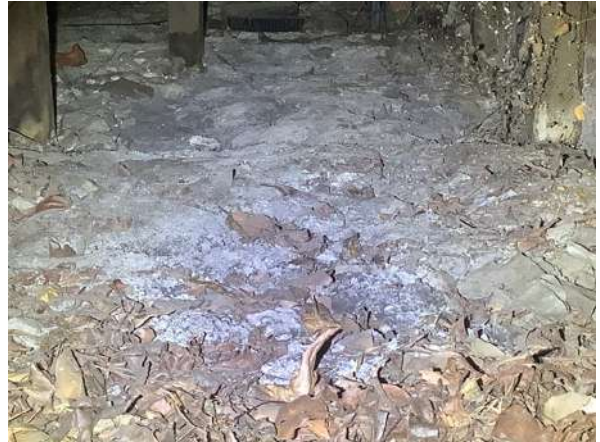
## Serious Safety Hazard 1.10

It is important to determine the cause of mould not just to get rid of mould.

Heavy mould on walls, ceilings and under homes, generally will require professionals in this field, like hazardous material company's.

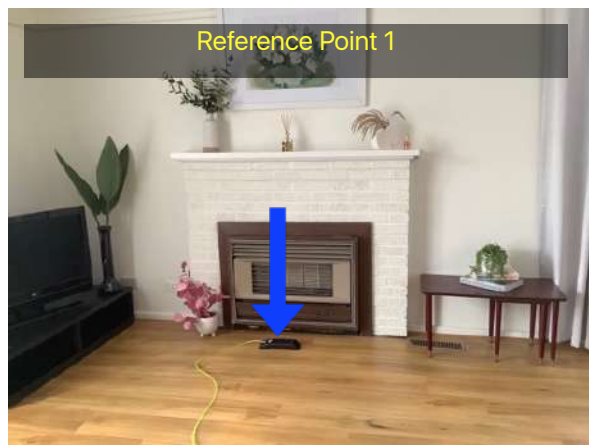
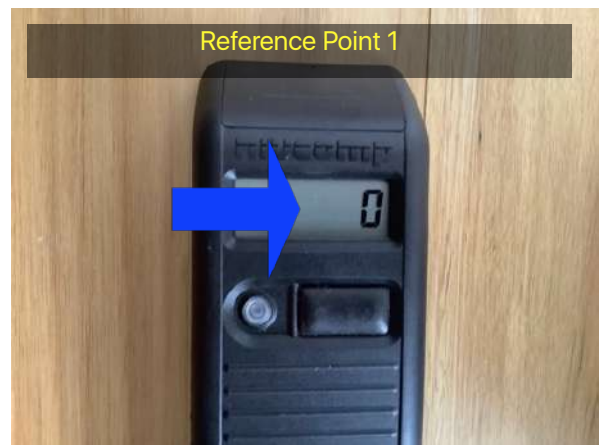
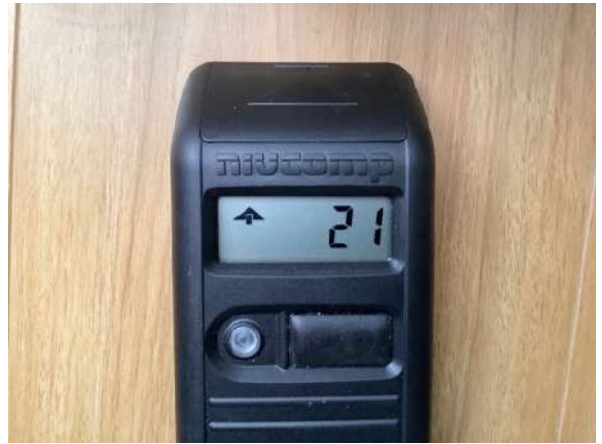
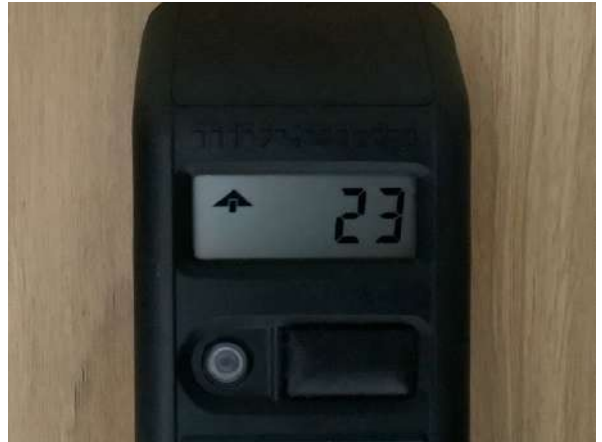
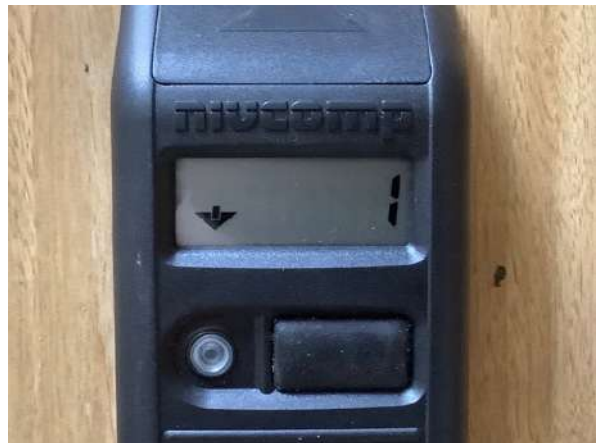
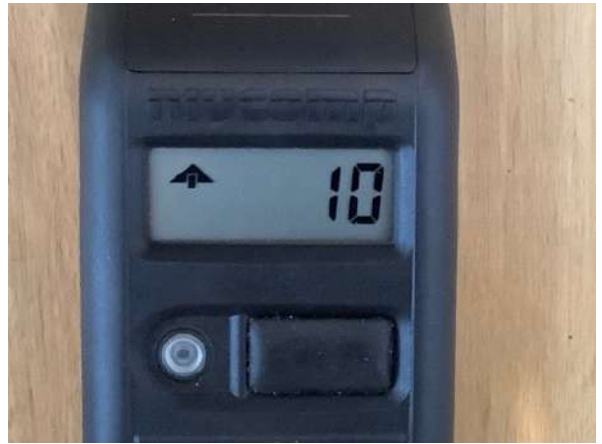
IMPORTANT TO NOTE : It will be important to note that the likelihood of cracking and movement to plaster, floor and wall tiles, doors requiring re-working, windows requiring re-working, kitchen cupboards, etc will be high once the home is jacked up and re-leveled to the correct height, the amount of repairs can be nothing to many areas. There will more then likely be the repairs of plaster, paint and the other repair concerns mentioned.

A Registered Builder who is experienced in flooring, stumps and re-stumping would then generally carry out works or be associated with re-stumpers as advised by a Structural Engineer and/or a geotechnical engineer, if required.

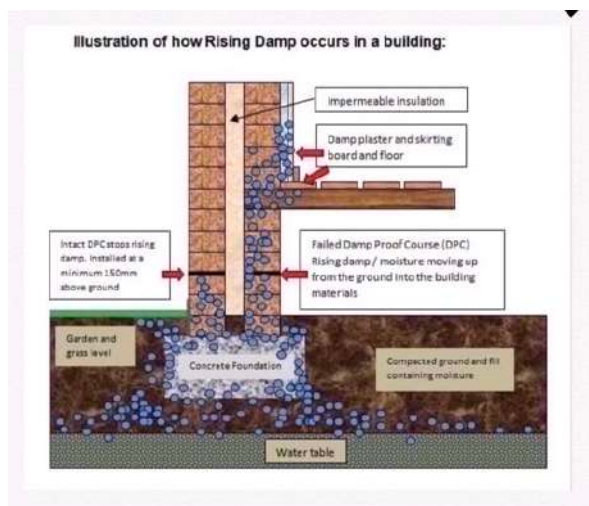
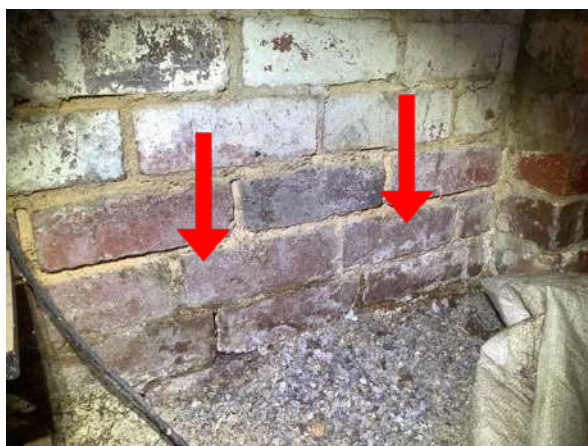
## Major Defect 2.02

Location: Garage  
Finding: Damp - Rising

Consultation with a PLUMBER, BUILDER AND OR STRUCTURAL ENGINEER AND SOMETIMES A GEOTECHNICAL ENGINEER, and also more then likely a structural engineer is advised immediately to identify the cause of the damp and perform remedial works as required.

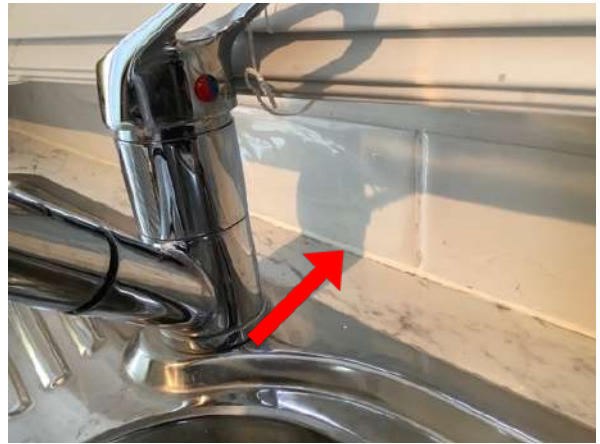
## Minor Defect 3.02

Location: Caulking / Silicone / Tile Grout-All Wet Areas

A sealant specialist, tiling contractor and/or registered builder in some serious cases, should be appointed to assess any damage caused by water to the entire internal, sub-floor where applicable, walls, etc of the building and clean, take off old sealant and tile mortar, then re-seal and re-mortar these areas as soon as possible.

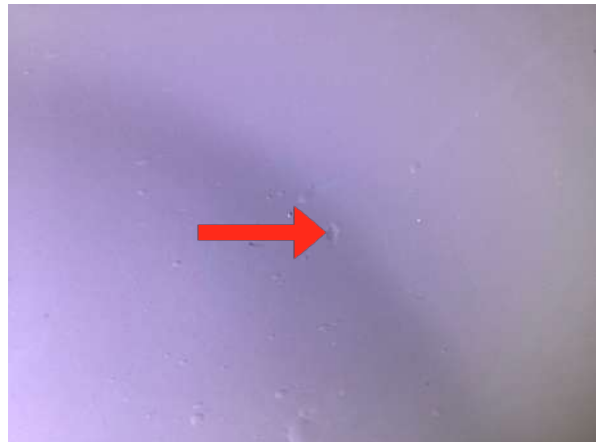
## Minor Defect 3.04

Location: Bathroom  
Finding: Bath tub installation – damaged

I highly recommended you engage a builder to replace the bath tub installation and provide all certificates required such as the plumbers certificate for installation and the waterproofing certificate for waterproofing or at your discretion you may just decide to monitor the bath tub over time, to see if you identify any cracks in the bath tub, to then take action.

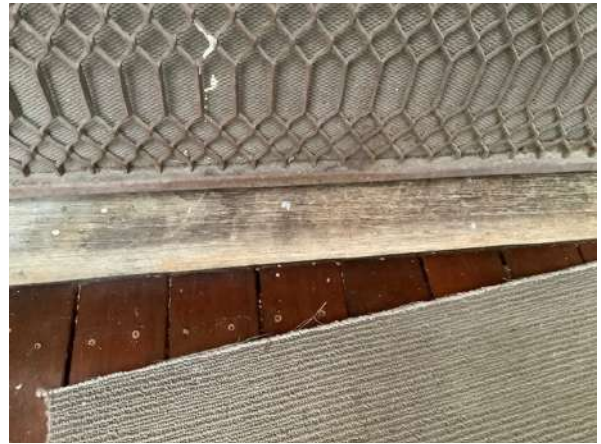
## Minor Defect 3.07

If left unattended, replacement of these timbers is likely to be necessary in the short-term future. Adequate treatment of these timbers is required as soon as possible by a painting contractor should be appointed as soon as possible to perform necessary works to aid the appearance of the affected area and to ensure the area is protected against further deterioration. Alternatively, the homeowner following manufacturer instructions may perform these works.

Please read the report carefully and Maintenance to all susceptible and conducive timber areas is a MUST to minimise the risk of termite and timber pest existence and timber damage.

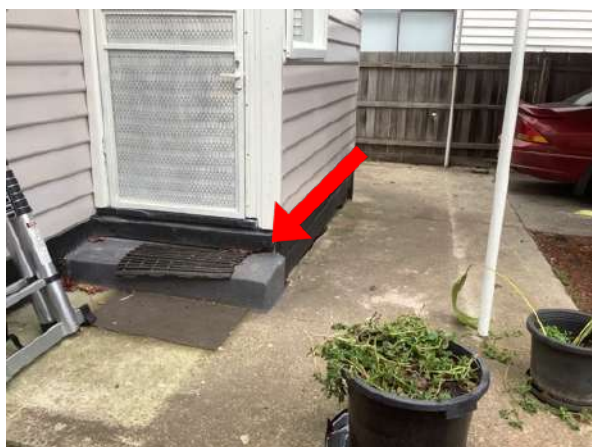
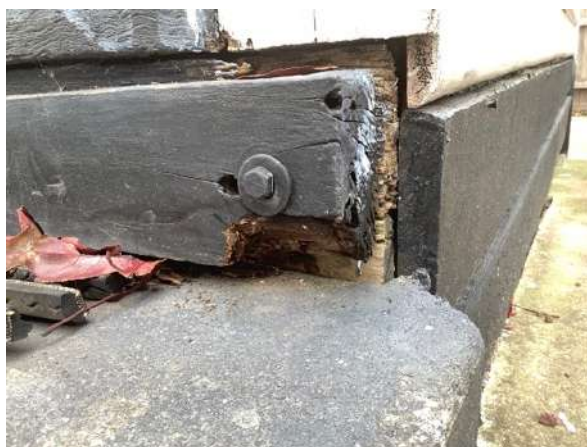
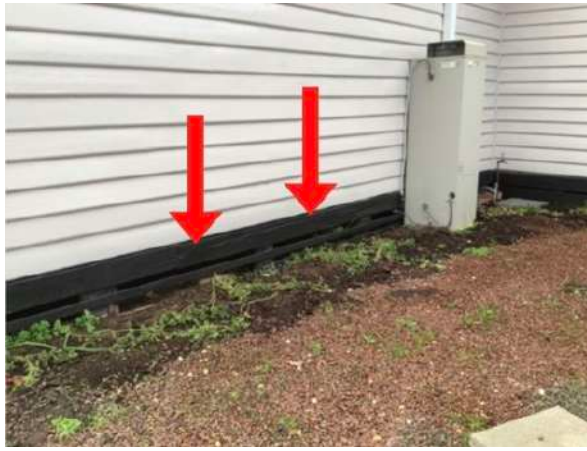
## Minor Defect 3.09

The property is a very high risk for termites as the environments to the property are very conducive with many susceptible areas.

Please read the report carefully and Maintenance to all susceptible and conducive areas is a MUST to minimise the risk of termite and timber pest existence and timber damage.

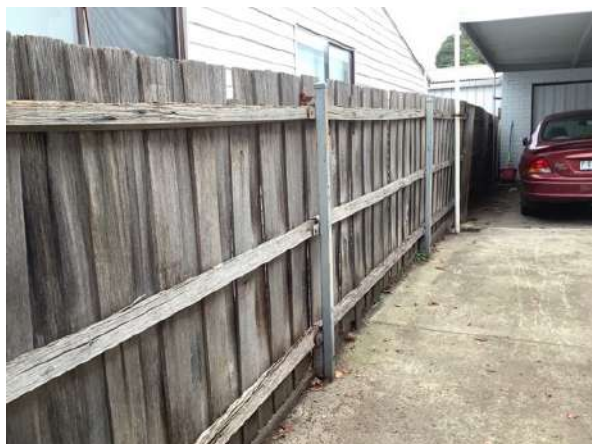
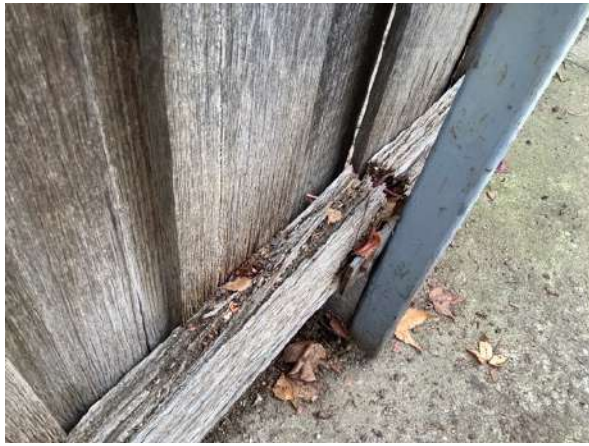
### Minor Defect 3.13

Finding: Timber Fencing - Deteriorated

It was noted at the time of inspection that sections of the fencing throughout the property have deteriorated. Typically fencing deteriorates due to age or rot which is generally expected for a structure of this age, due to prolonged exposure to weather conditions. A licensed fencing contractor should be appointed to provide further advice and perform rectification works as necessary.

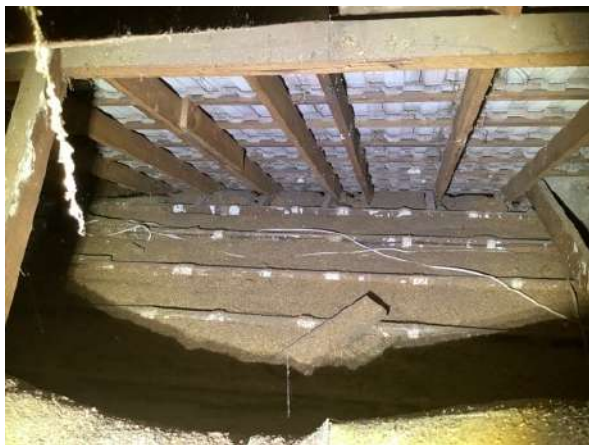
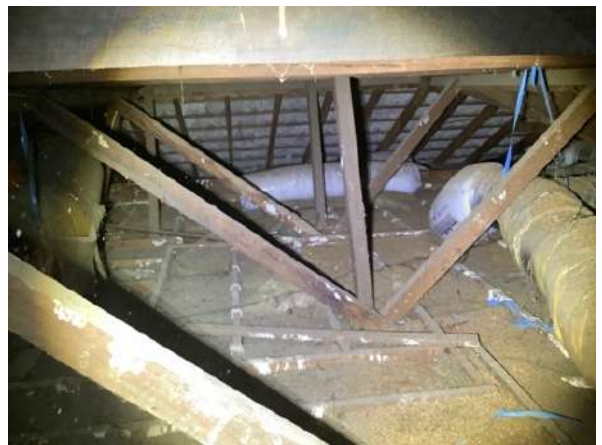
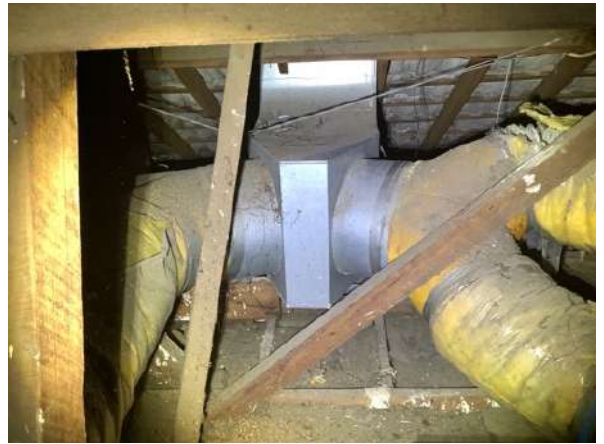
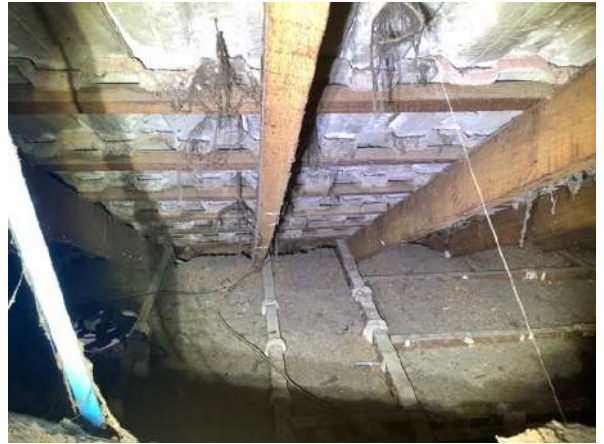
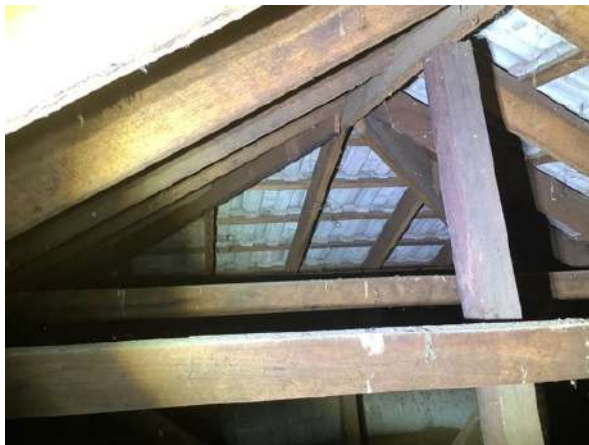
## For your information 4.07

The property is a very high risk for termites as the environments to the property are very conducive with many susceptible areas.

Please read the report carefully and Maintenance to all susceptible and conducive areas is a MUST to minimise the risk of termite and timber pest existence and timber damage.

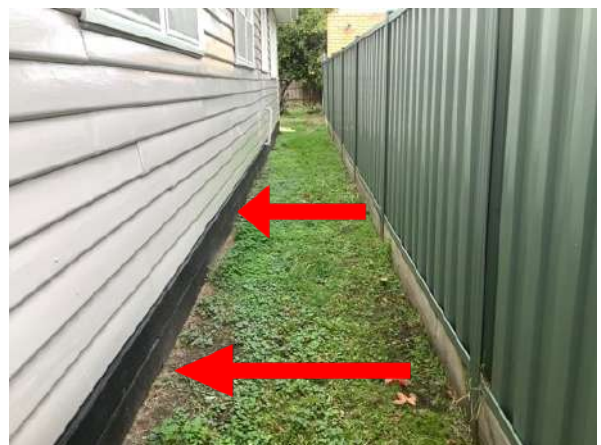
## For your information 4.08

In relation to termites, Defective drainage and falls create high water and moisture which creates a very high risk for termites as the environments to the property are very conducive with many susceptible areas.

Please read the report carefully and Maintenance to all susceptible and conducive areas is a MUST to minimise the risk of ptermite and timber pest existence and timber damage.
