Asbestos Sampling Report

Inspection Date: 30 Apr 2020

Property Address: Nothern Country Area

Report Type: Asbestos Inspection and Condition Report

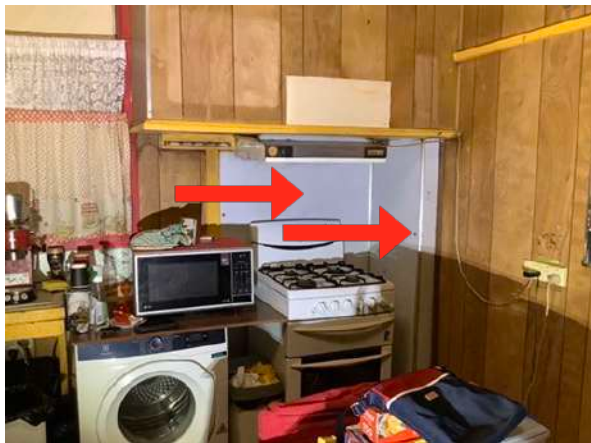
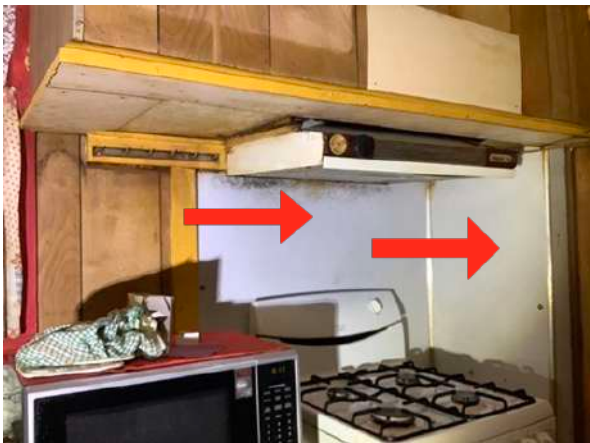
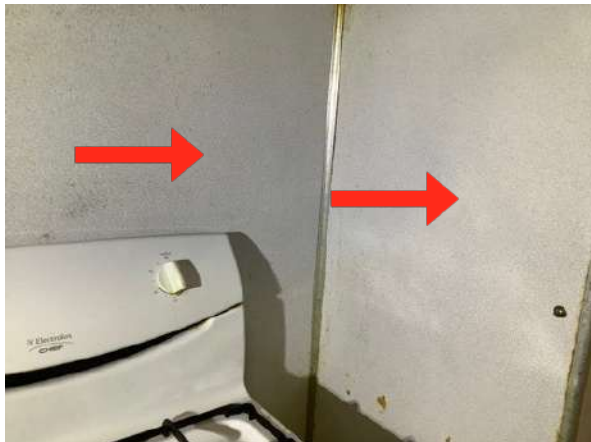
ACM Confirmed in Samples 4.01

Finding: Asbestos - ACM Confirmed - Sample 1.
A sample of the kitchen splash back was taken and sent to the Lab.

Item Confirmed With Asbestos (ACM)

Samples of suspected Asbestos Containing Material (ACM) were removed from the building for analysis by a NATA accredited laboratory. The sample results confirmed that the material/s tested do contain Asbestos. The results indicated that the type of Asbestos is (White Chrysotile or Brown Amosite or Other).

Consequently, the client is advised to consider relevant risk reduction strategies, including removal by a licensed Asbestos Removal firm.

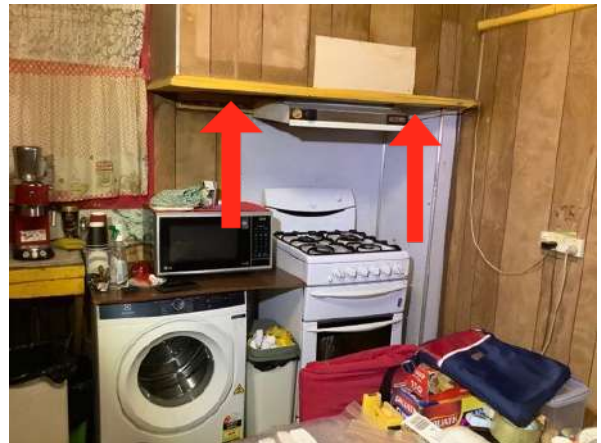
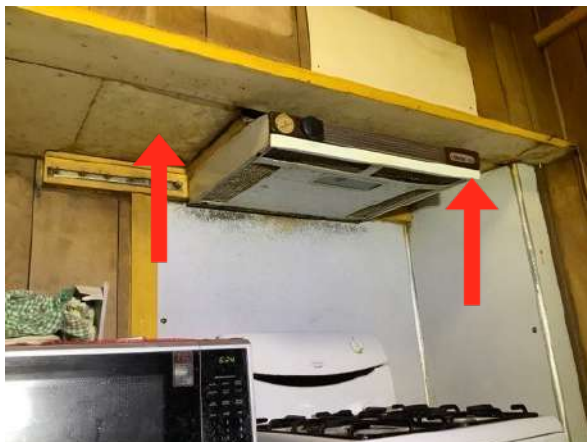
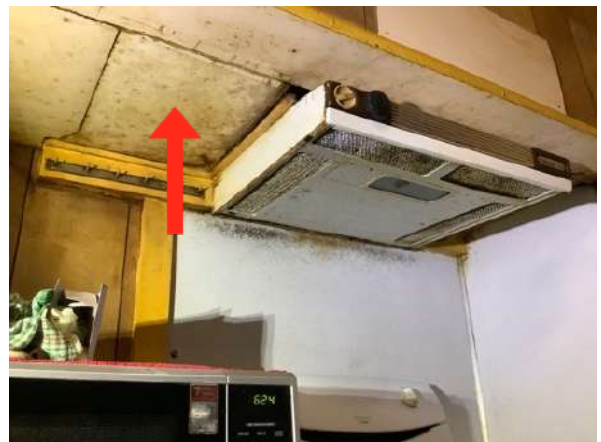
ACM Confirmed in Samples 4.02

Finding: Asbestos - ACM Confirmed - Sample 2
A sample under the cooking area canopy in the kitchen was taken and sent to the Lab.

Item Confirmed With Asbestos (ACM)

Samples of suspected Asbestos Containing Material (ACM) were removed from the building for analysis by a NATA accredited laboratory. The sample results confirmed that the material/s tested do contain Asbestos. The results indicated that the type of Asbestos is (White Chrysotile or Brown Amosite or Other).

Consequently, the client is advised to consider relevant risk reduction strategies, including removal by a licensed Asbestos Removal firm.

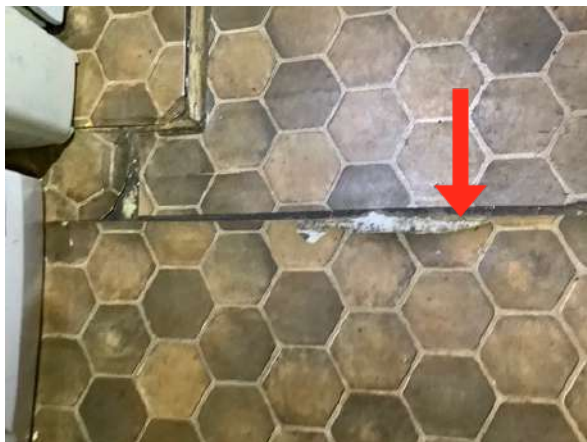
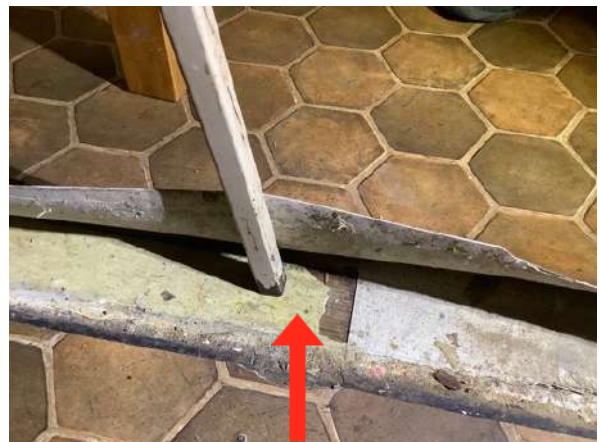
ACM Confirmed in Samples 4.03

Finding: Asbestos - ACM Confirmed - Sample 4
A sample of the underlay of the lino in the kitchen was taken and sent to the Lab.

Item Confirmed With Asbestos (ACM)

Samples of suspected Asbestos Containing Material (ACM) were removed from the building for analysis by a NATA accredited laboratory. The sample results confirmed that the material/s tested do contain Asbestos. The results indicated that the type of Asbestos is (White Chrysotile or Brown Amosite or Other).

Consequently, the client is advised to consider relevant risk reduction strategies, including removal by a licensed Asbestos Removal firm.

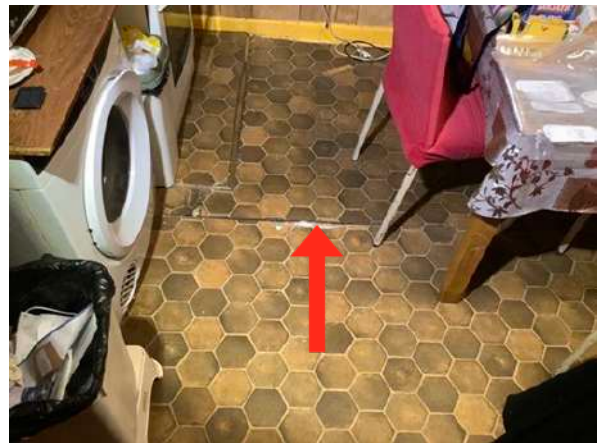
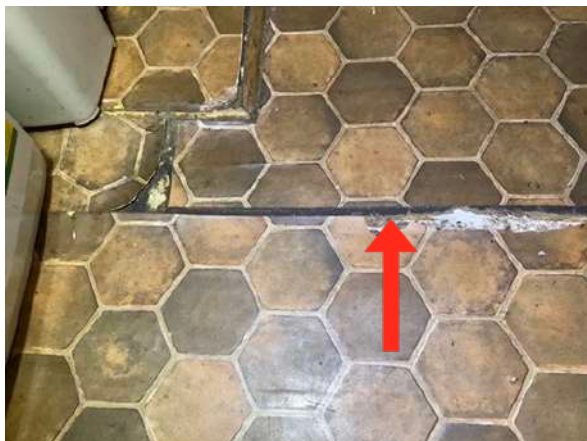
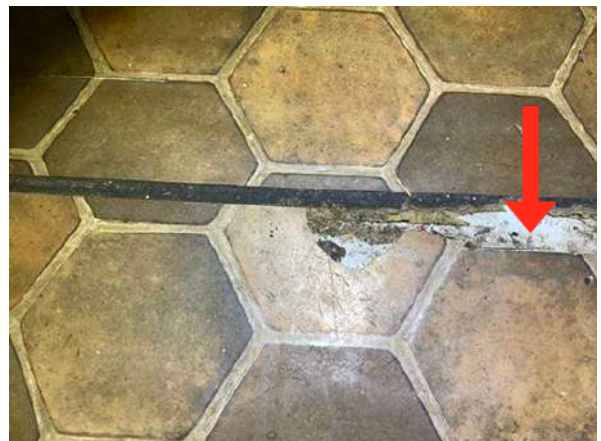
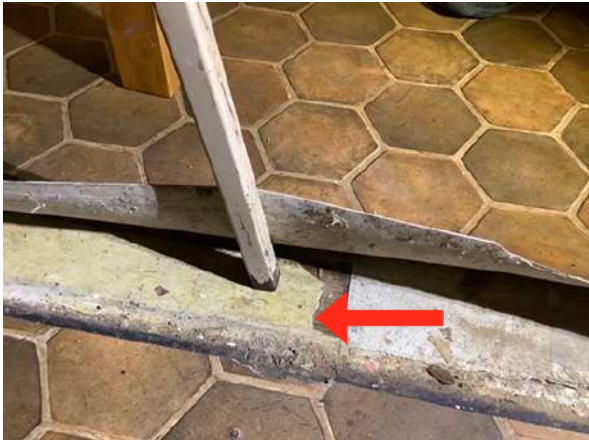
ACM Confirmed in Samples 4.04

Finding: Asbestos - ACM Confirmed - Sample 5
A sample of the glue from the lino was taken and sent to the Lab.

Item Confirmed With Asbestos (ACM)

Samples of suspected Asbestos Containing Material (ACM) were removed from the building for analysis by a NATA accredited laboratory. The sample results confirmed that the material/s tested do contain Asbestos. The results indicated that the type of Asbestos is (White Chrysotile or Brown Amosite or Other).

Consequently, the client is advised to consider relevant risk reduction strategies, including removal by a licensed Asbestos Removal firm.

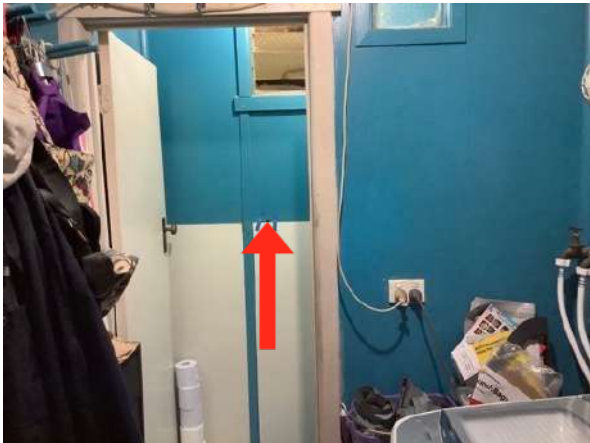
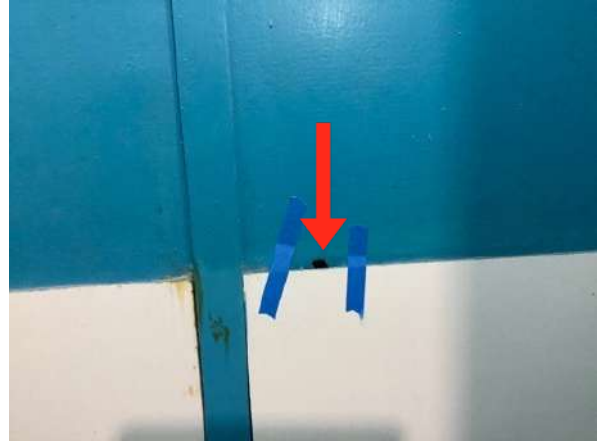
ACM Confirmed in Samples 4.05

Finding: Asbestos - ACM Confirmed - Sample 6
A sample of the toilet wall was taken and sent to the Lab.

Item Confirmed With Asbestos (ACM)

Samples of suspected Asbestos Containing Material (ACM) were removed from the building for analysis by a NATA accredited laboratory. The sample results confirmed that the material/ s tested do contain Asbestos. The results indicated that the type of Asbestos is (White Chrysotile or Brown Amosite or Other).

Consequently, the client is advised to consider relevant risk reduction strategies, including removal by a licensed Asbestos Removal firm.

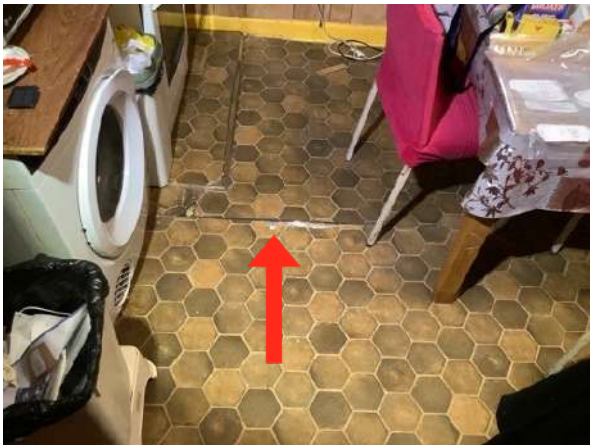
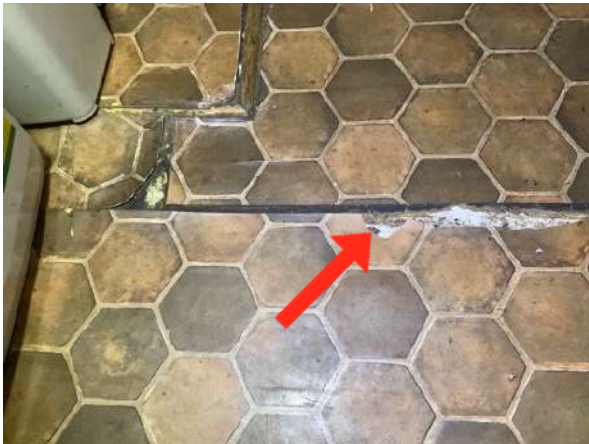
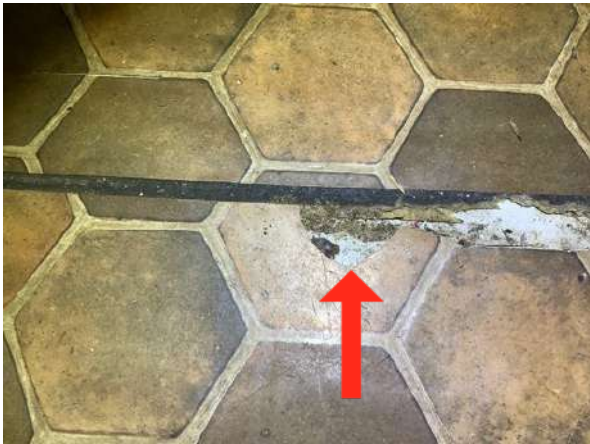
ACM Samples Negative 5.06

Finding: Asbestos - ACM Confirmed - Sample 3
A sample of the lino in the kitchen area was taken and sent to the Lab.

The samples analysed was free of Asbestos fibres.

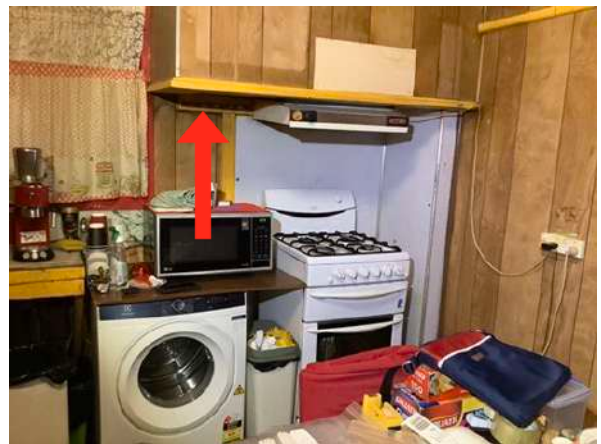
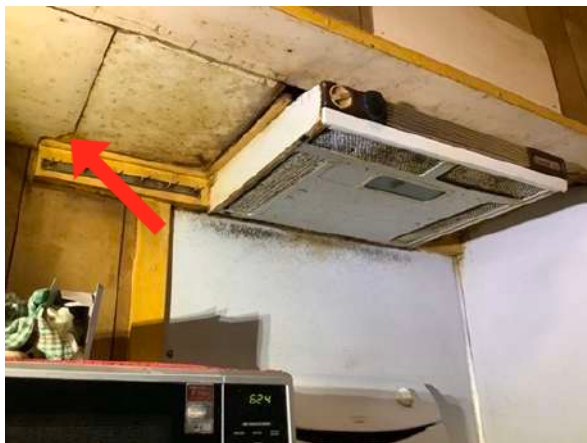
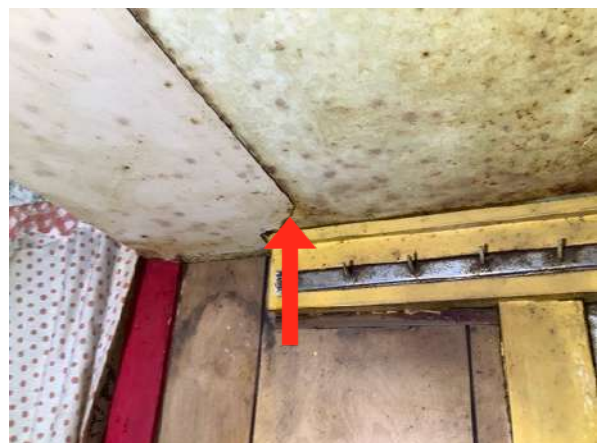
ACM Samples Negative 5.07

Finding: Asbestos - ACM Confirmed - Sample 7
A sample of the under sheet glue, under the canopy in the kitchen area was taken and sent to the Lab.

The samples analysed was free of Asbestos fibres.

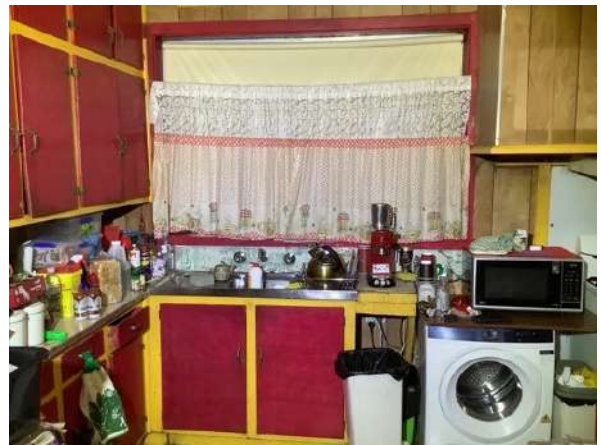
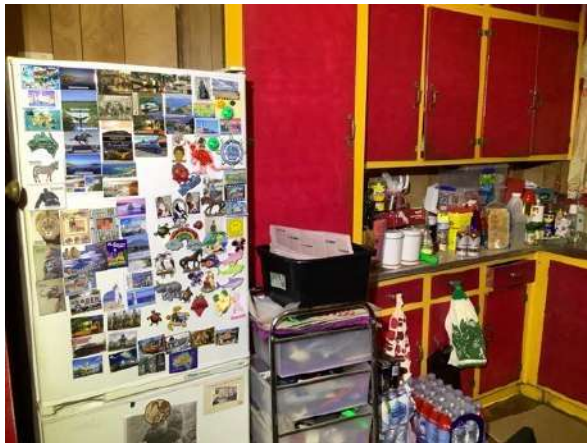
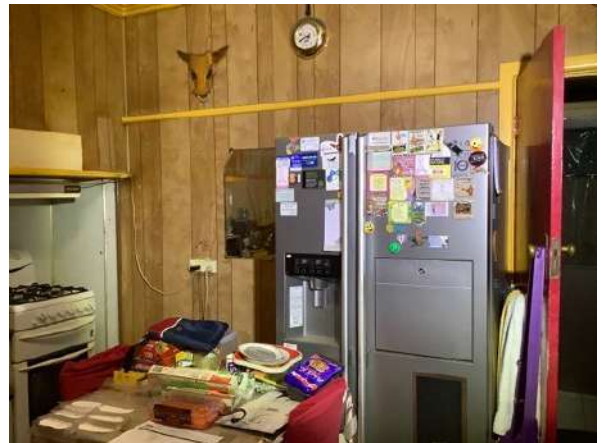
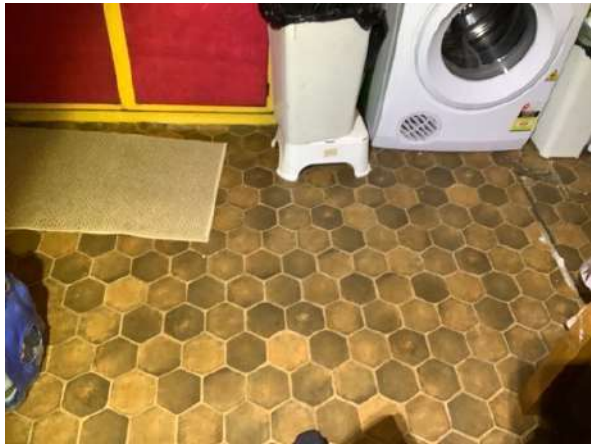
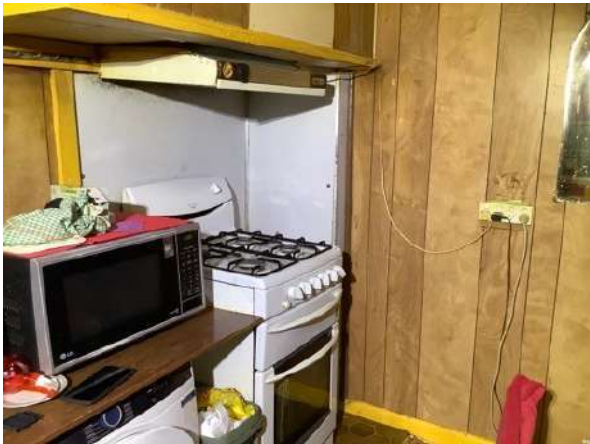
For your information 5.08

Finding: Additional Photos - Obstructions and Limitations

These photographs are an indication of the obstructions and limitations which impeded full inspection of the property at the time of inspection. These obstructions can hide an array of defects and should be removed to allow full inspection to be carried out.

A re-inspection is recommended once the areas are made accessible, if you require a further detailed inspection and report, which we do recommend.

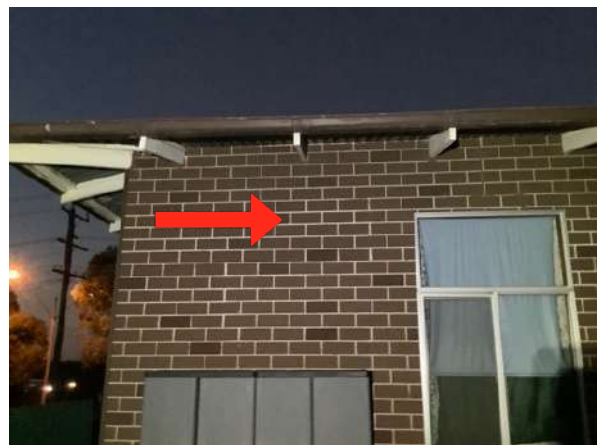
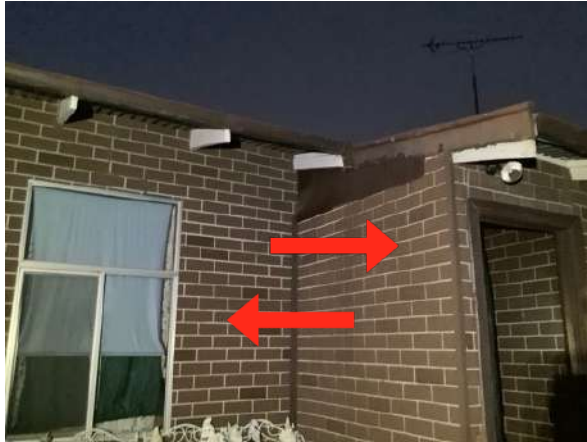
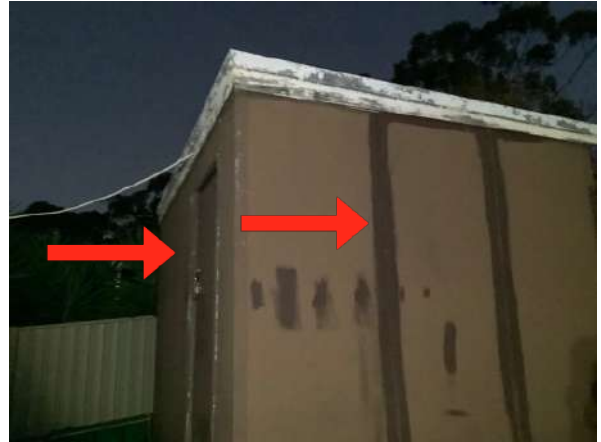
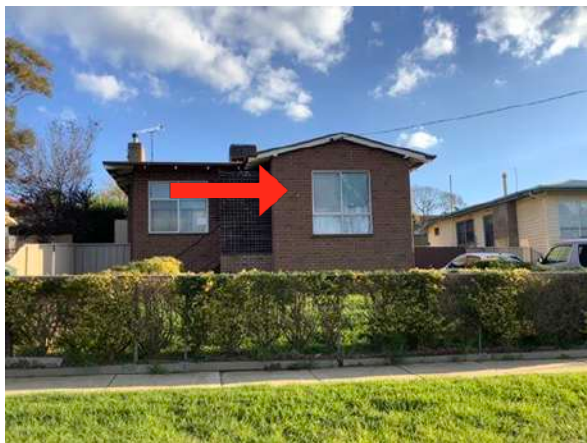
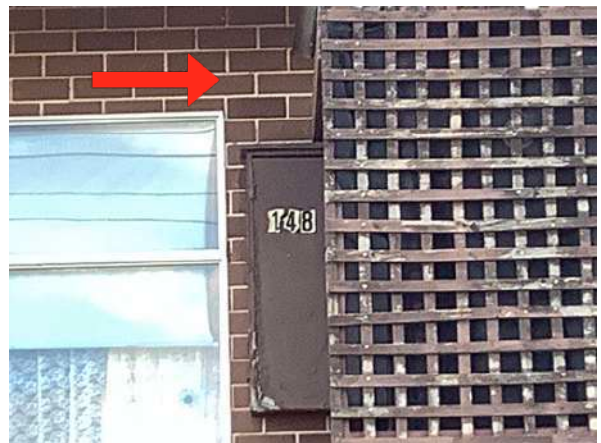
For your information 5.13

Finding: Asbestos - Suspected ACM Identified on Site (Visual Assessment Only)
This statement and photos attached to this statement are areas that we believe may be asbestos and/or contain asbestos and this is just a visual observation as requested and is a guide only.
We strongly believe we should take samples of these areas that appear to contain asbestos to the laboratory as a visual inspection of asbestos is only a guide and not accurate.

This suspected defect is highlighted as a caution only. We suspect, based on our experience in the building industry, that there is a higher risk of the identified building element containing asbestos.

As noted above we advise that you consider a separate Asbestos Inspection and Condition Audit of these areas as well, which can include the taking of samples for definitive confirmation of the presence of Asbestos.
