Commercial Report

Inspection Date: 2 Jul 2021

Property Address: Outer Suburbs Area

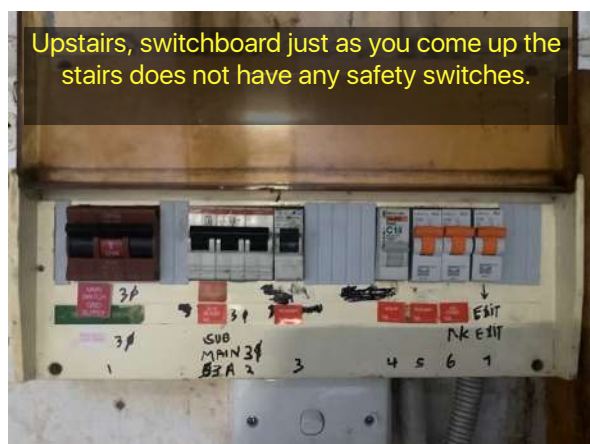
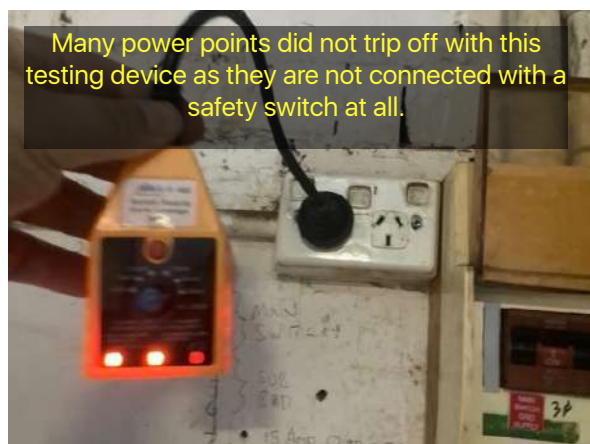
Safety Hazard 1.01

This can place the person in a very dangerous situation in the event of a faulty appliance and may cause electrocution.

These tests DID NOT pass the AS 3000 requirement and exceptance level as noted above there is NO Safety Switch installed.

It is HIGHLY RECOMMENDED that you engage in a qualified electrician to install a new switchboard with a safety switch or at a minimum install a safety switch.

A Certificate of Electrical Safety is required for all electrical works and a electrical safety inspection is highly recommended upon completion of all electrical repairs.

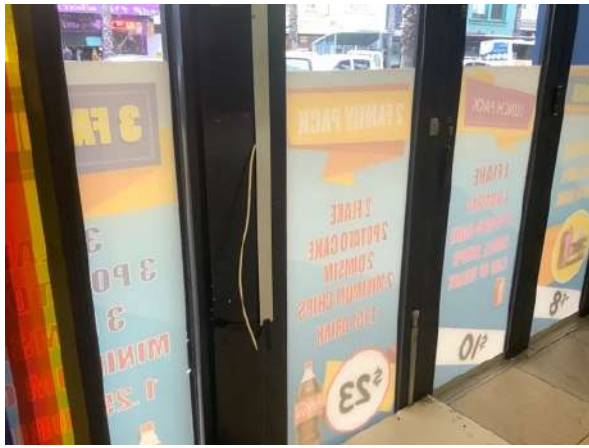
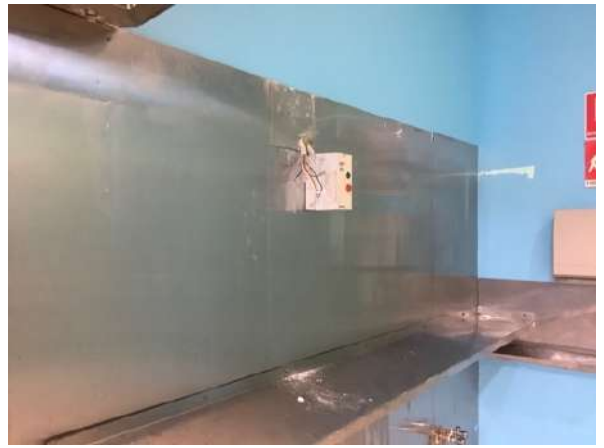
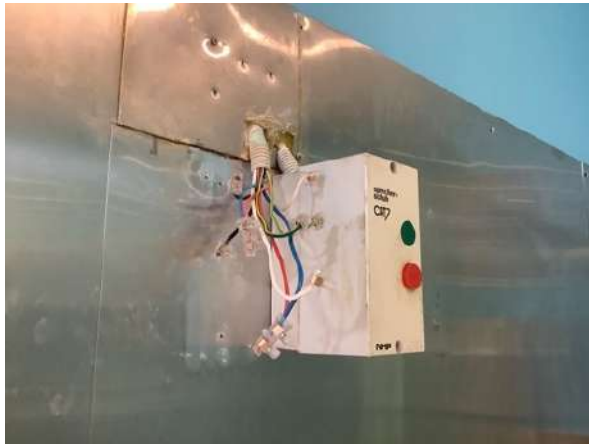
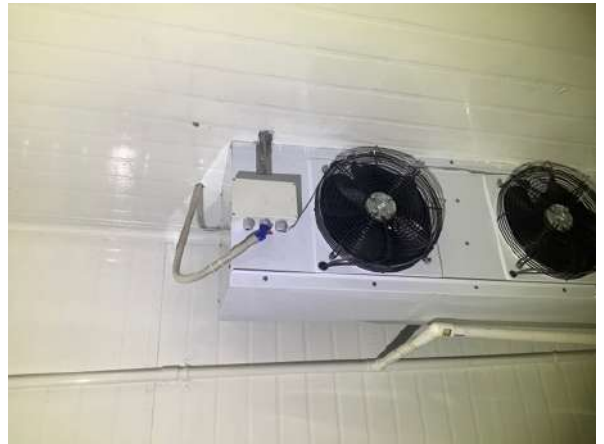
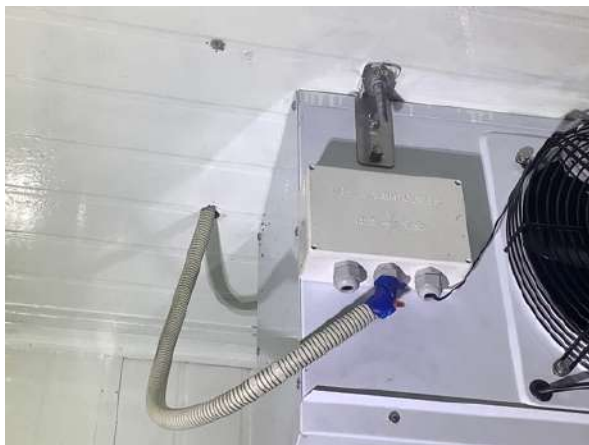
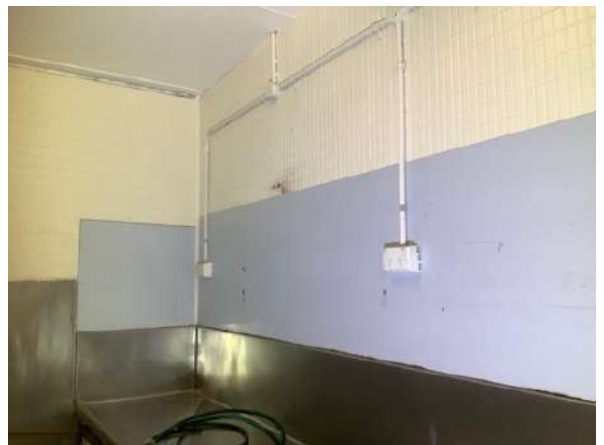
Safety Hazard 1.02

Location: Electrical - All Areas
 Finding: Electrical - Defective / Unsafe / Non Compliant.

It appears that the electrical installation does not comply with today's electrical safety standards and electrical regulation codes of AS3000-2018 in all areas, and/or has faulty unsafe electrical items on the property.

We HIGHLY RECOMMEND that the purchaser engage a licensed electrical contractor to check compliance and make good any defective wiring or unsafe items throughout the entire property.

A Certificate of Electrical Safety is ALWAYS required for all electrical works and repairs performed by the electrician on completion of there works, without compromise.

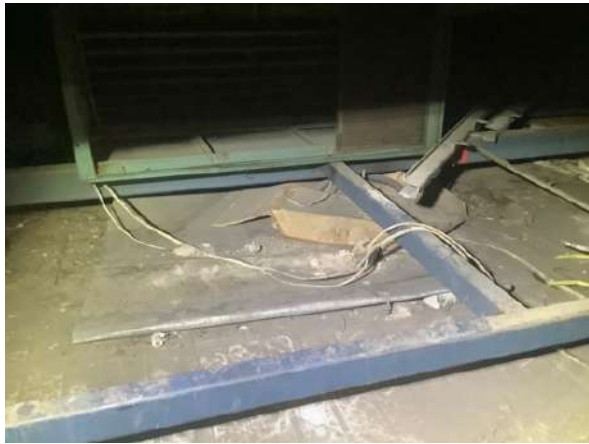
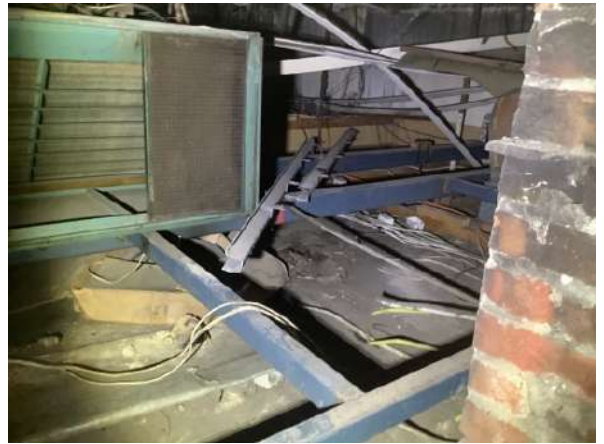
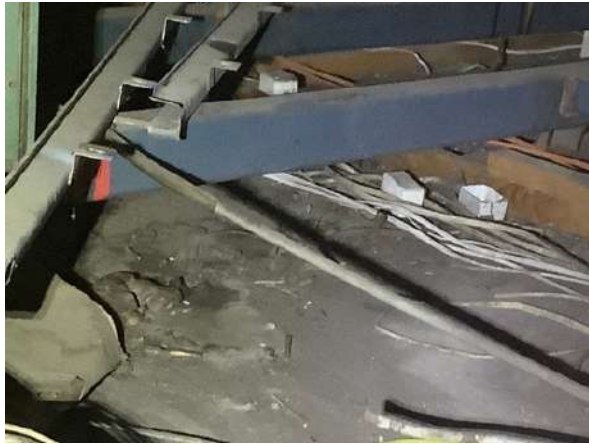
Safety Hazard 1.03

Location: Roof Space
Finding: Electrical - Wiring Not Clipped or Protected

At the time of the inspection we noted that electrical installation items are not compliant with the electrical regulations AS3000-2007 and each picture attached is an electrical installation defect.

The wiring in the roof void area has various electrical works that DO NOT comply with AS3000. All wiring must not go over timbers as any person is at risk of stepping or kneeling on the cables and may damage the cables or worse put them selves at risk of damaging or being exposed to damaged cables that have 240 volts in them.

All cables in roof void areas must be clipped to the sides of timbers in compliance with AS3000 and protected from all mechanical protection situations.

We recommend that the purchaser engages a licensed electrical contractor to check compliance and make good any defective wiring or unsafe items throughout the entire property including the outbuildings etc.

A Certificate of Electrical Safety is required for all electrical works and repairs performed to this property.

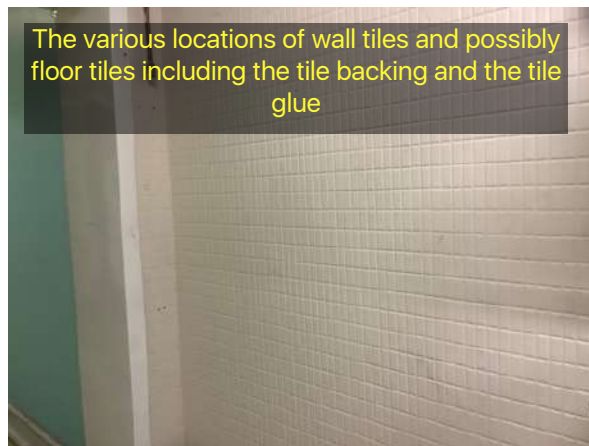
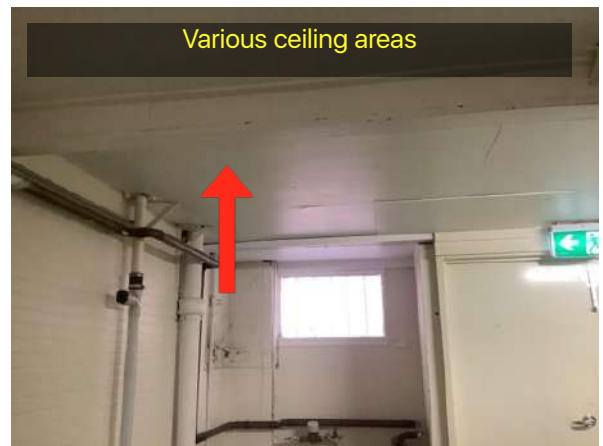
Safety Hazard 1.04

Location: Asbestos - Various Areas

As Asbestos Reporting is outside the scope of this report, we advise that you consider a separate Asbestos Inspection and Condition Audit, which can include the taking of samples for definitive confirmation of the presence of Asbestos.

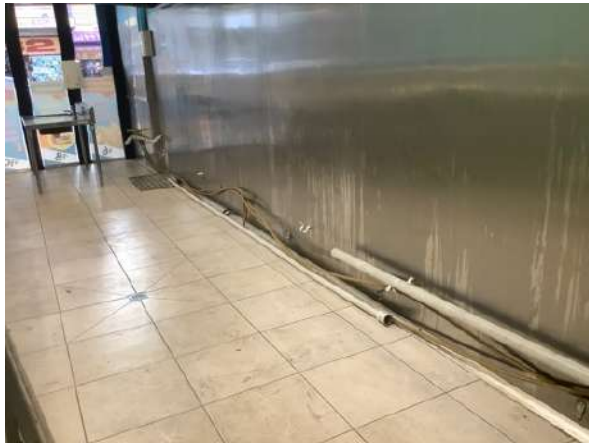
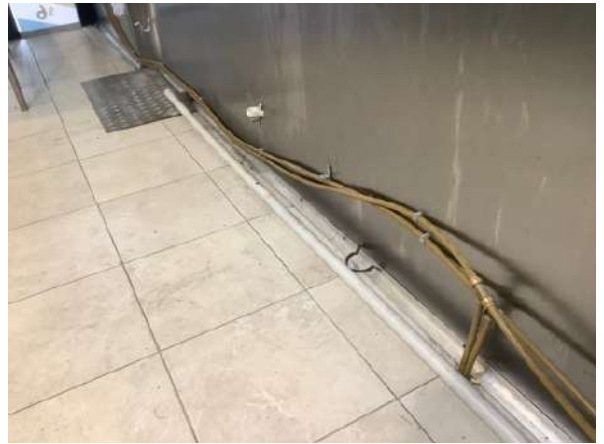
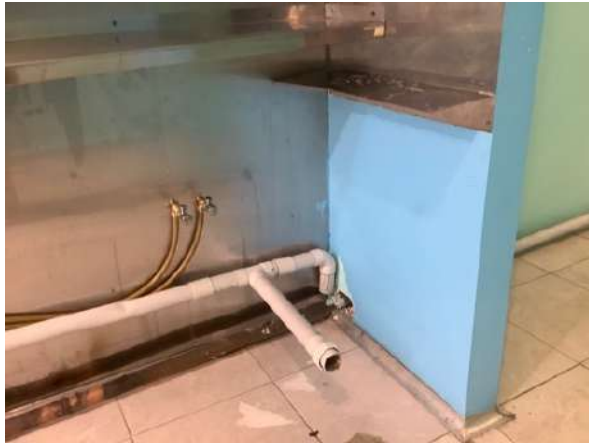
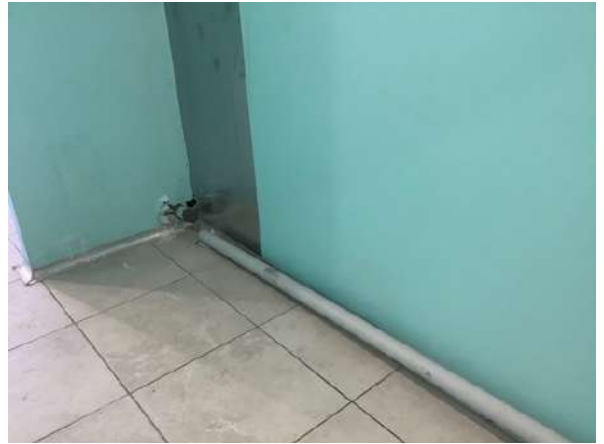
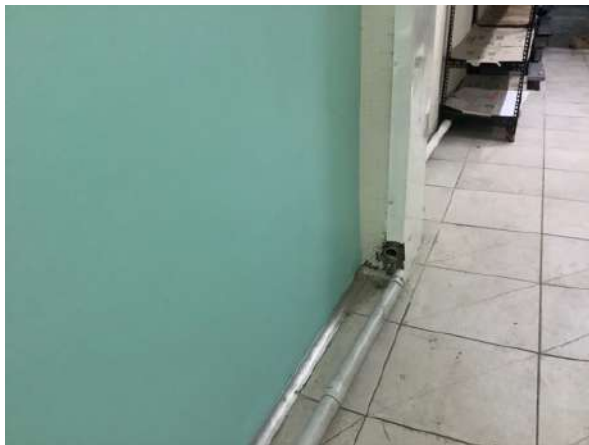
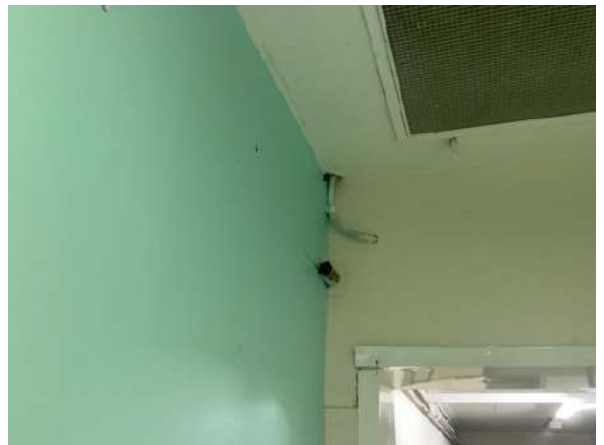
Safety Hazard 1.05

Location: Plumbing - Various Locations

Finding: Plumbing work - appears defective

An instance of potentially defective plumbing work was identified.

The plumber is required to provide a Certificate of Compliance when required by the relevant regulations or if the home is out of warranty and/or aged a qualified plumber should be engaged to do any repairs that are creating secondary defects or are unsafe or not up to code as we suspect.

A plumber is required to give you a compliance certificate for all works they have performed to this property.

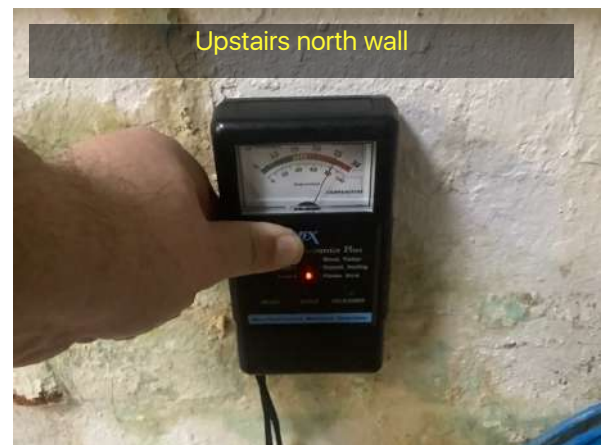
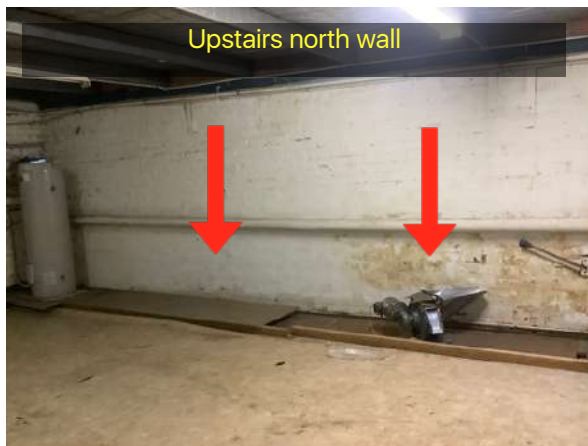
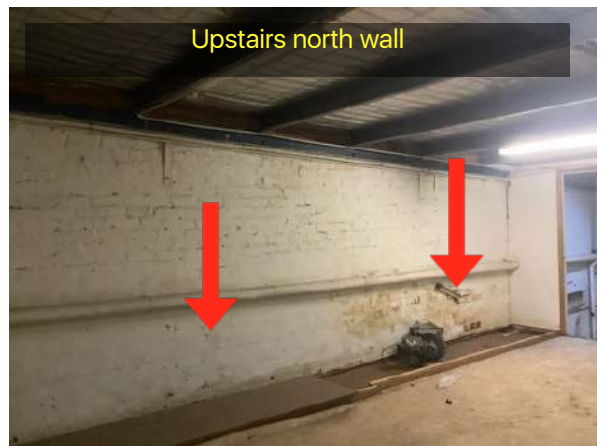
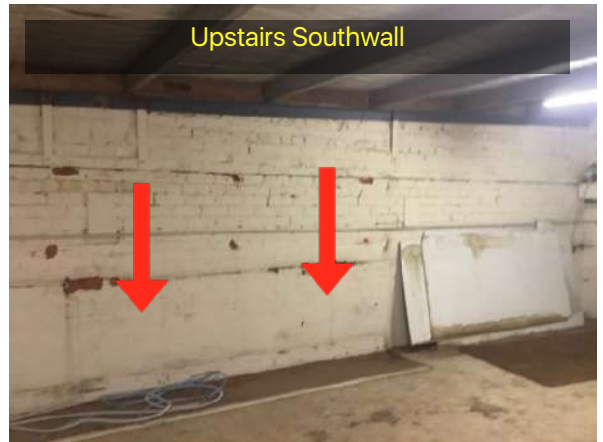
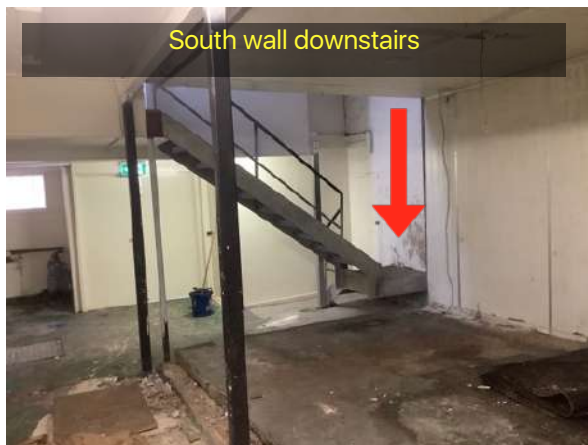
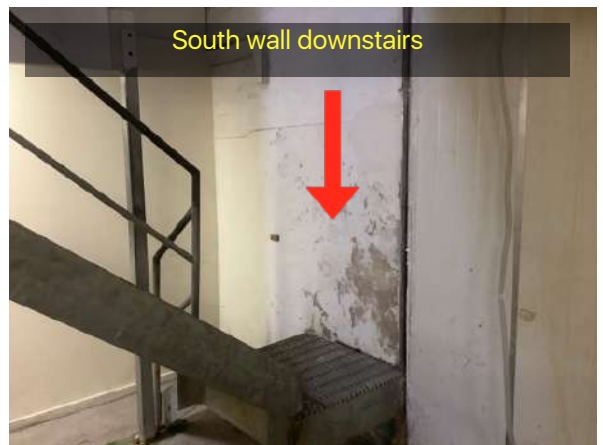
Major Defect 2.01

◆ HIGH MOISTURE READINGS FOUND ◆

The moisture content variation was HIGH and NOT within the acceptable range of 5% to 20% in all areas.(Areas with high moisture levels, should be attended to by the appropriate professionals as a matter of urgency to determine the cause, in order to stop further deterioration to associated building materials generally caused by water damage.

◆ TIMBER FLOORING - Areas of the timber flooring were found to have a higher moisture content that is acceptable. This may suggest that there is excessive moisture and dampness to the subfloor area.

High moisture readings can be caused by various reasons, however high moisture readings are normally caused by excessive moisture or dampness, so this could mean that the subfloor is damp and wet and/or there is bad ventilation to the subfloor area, there may also be wood rot which may make the property structurally unsound/compromised.

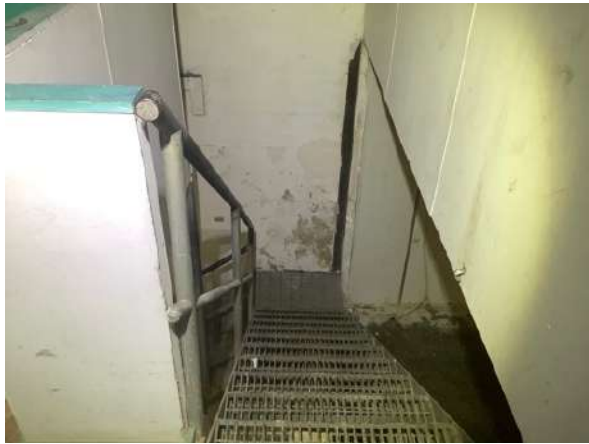
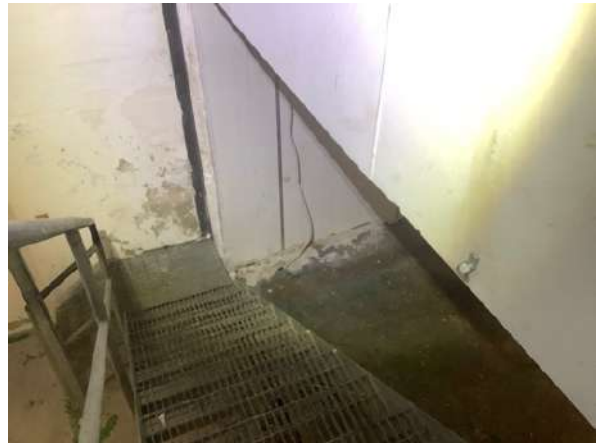
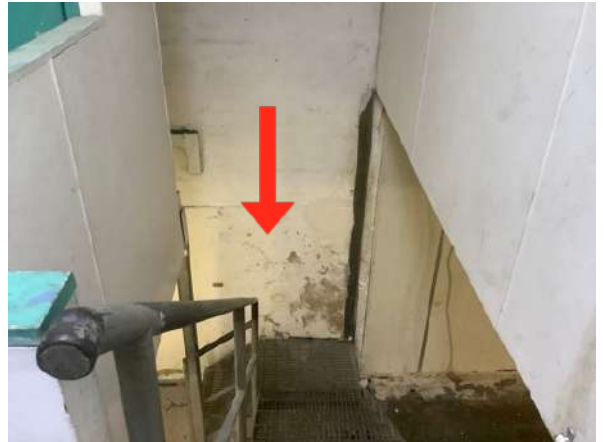
Major Defect 2.02

Location: Added Structures
 Finding: Non Compliant & Additional Structures Suspected To Be Built Without A Permit

I highly recommend that you further investigate this home as the Stair Case & Upstairs Platform Areas may or may not have the correct permits / paperwork through the council, architects, engineers, etc regardless if the works have been done to a quality tradesmens like manner or not.

It is highly recommended that any planned repair, remodelling or demolition works be carried out by a registered builder.

I HIGHLY RECOMMEND that you engage the professionals as stated above. I also highly recommend that persons keep clear of the areas until further investigations are made , repaired and cleared by the appropriate people.

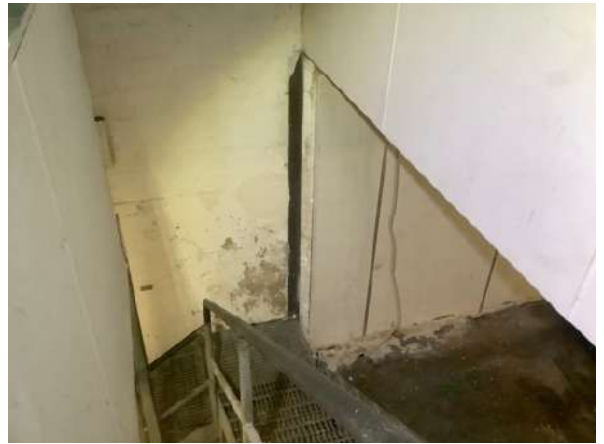
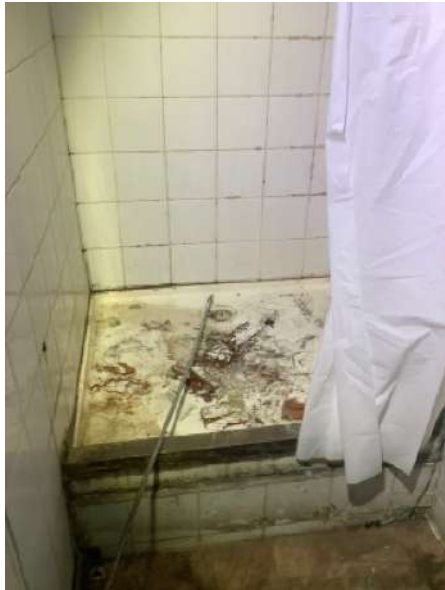
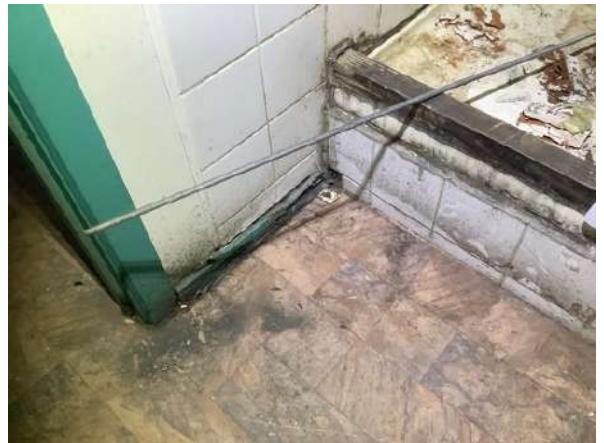
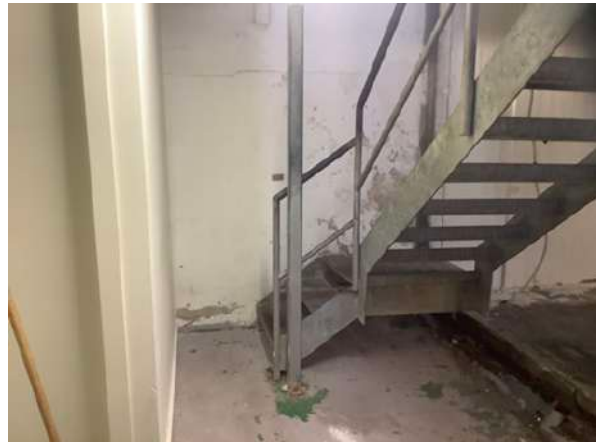
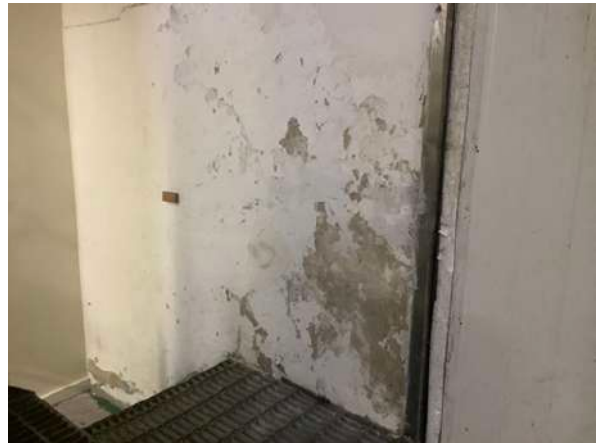
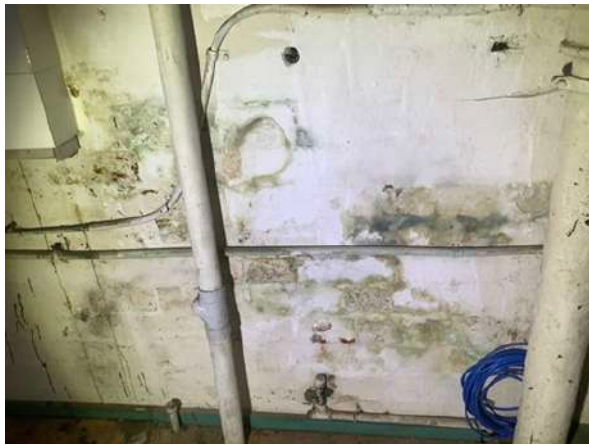
Major Defect 2.04

Finding: Property Condition - Overall Assessment - Dilapidated / Poor & Run Down
Overall Poor Conditions - To the internal and external of the entire property.

The overall condition of the internal and external of the building would be classed as POOR to FAIR at best .

It is very obvious that the Internal area of the shop needs to be completely reworked. However the rear of the property downstairs and upstairs is in a dilapidated state. The shower is completely damaged and needs to be completely re-done by a professional, the flooring is damaged upstairs and the last tenant has left a complete mess, so a registered builder will need to go right through the internal of the property to make it structurally sound and safe.

In addition the damp rising is a very big problem and the repair costs could be quite large.

The plaster work is severe cracking and impossible to repair as it is the old lathen plaster and hair type plaster.

There are URGENT repairs required just to get the building to a point so that the building stops deteriorating and the safety hazards such as the electrical etc are in a safe using condition.

On closing this statement as mentioned above it is IMPERATIVE that you engage registered and qualified trades and at the end of there works they must supply certificates, such as an electrical safety certificate, plumbing and gas certificate, waterproofing certificate and the builder must use an appropriate contract, such as a HIA contract or a Master Builders contract.

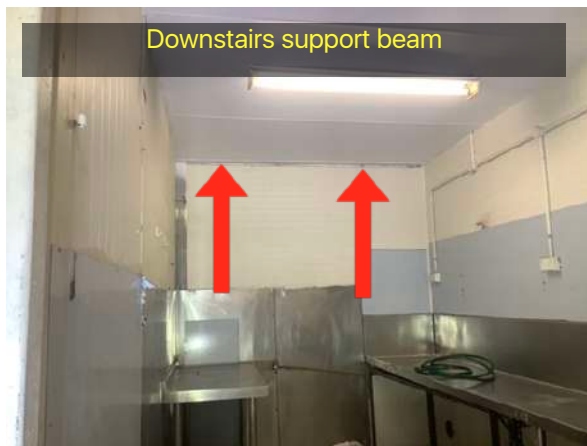
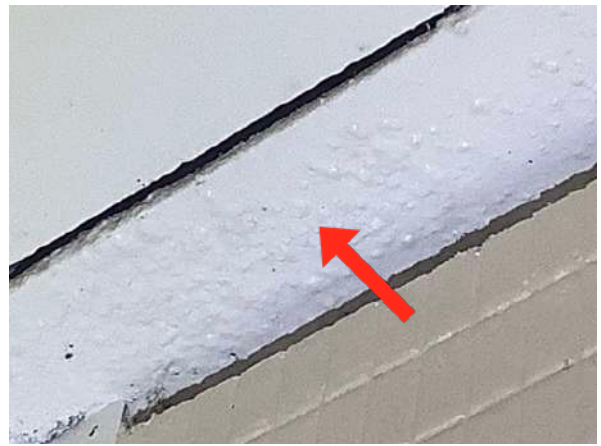
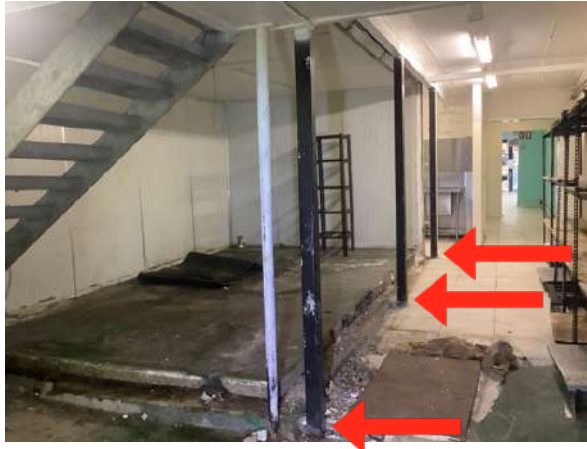
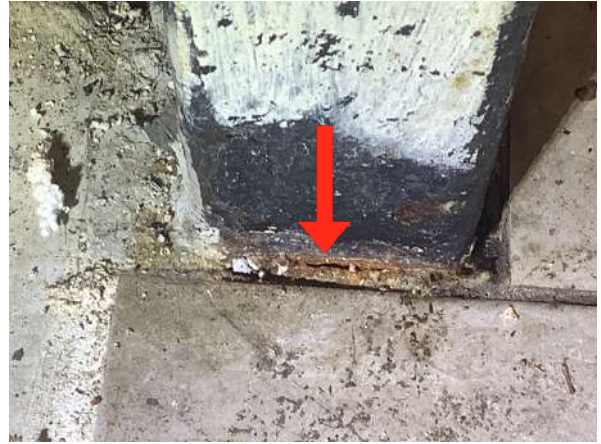
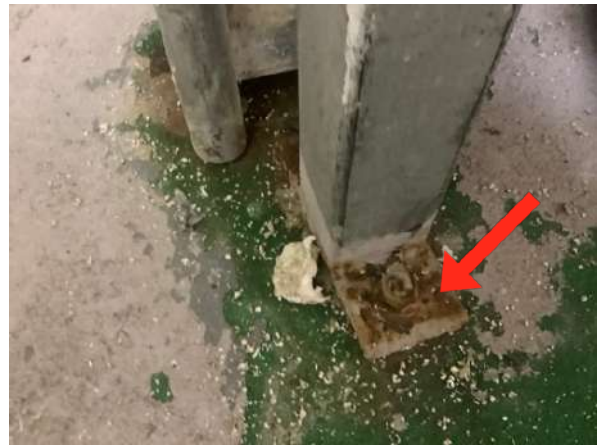
Major Defect 2.05

Finding: Rusted / Corroded - Building Materials - Major Items

This building element shows evidence of rusting and corrosion, which is likely to have developed as a result of excessive exposure to moisture.

As surface rust provides no protection to the underlying iron, the deteriorating condition is likely to worsen if not addressed in the short-term future.

Rusting and corrosion should be managed by ideally removing or limiting the affected surface from exposure to moisture.

Depending on repair, A registered builder, competent person or handyman may be appointed to replace any building elements that have been severely affected by rust or water damage.

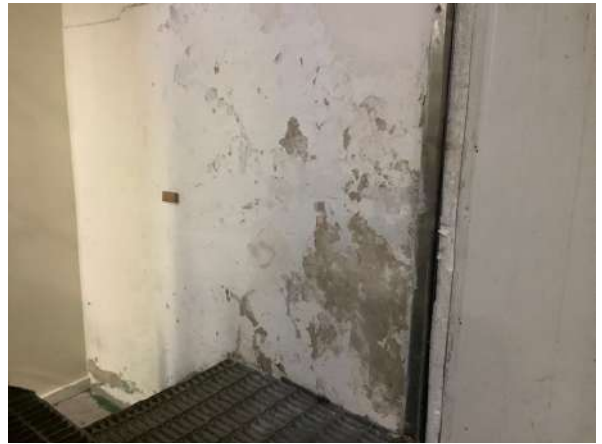
Upstairs perimeter wall

Location: Perimeter & Separating Walls

Consultation with a PLUMBER, BUILDER AND OR STRUCTURAL ENGINEER AND SOMETIMES A GEOTECHNICAL ENGINEER, and also more then likely a structural engineer is advised immediately to identify the cause of the damp and perform remedial works as required.

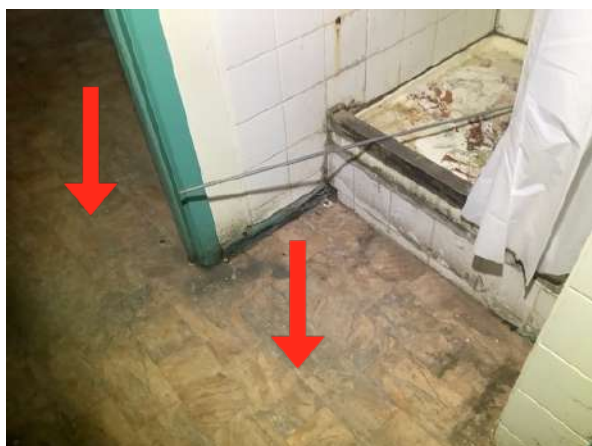
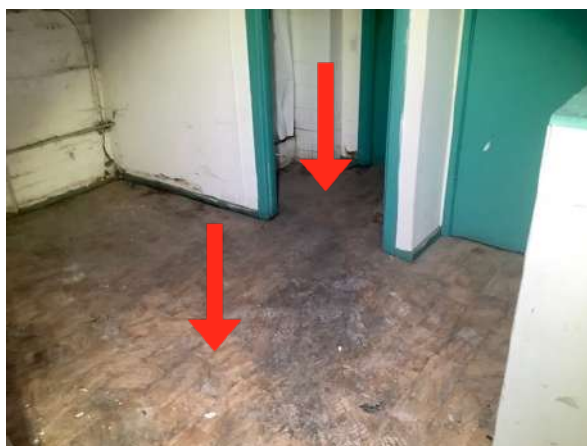
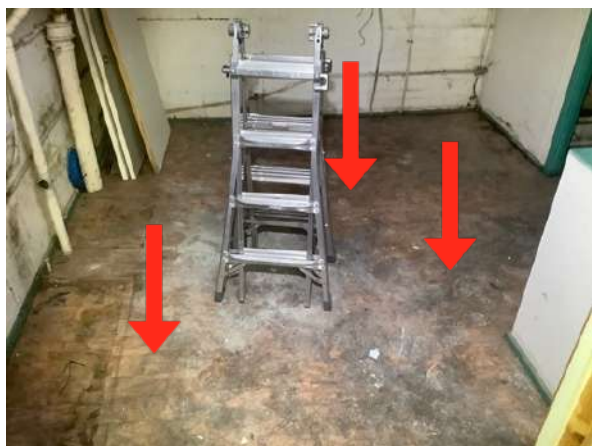
Major Defect 2.07

Location: Upstairs Flooring

There are areas of soft timber flooring found.

Generally when the timber floor softness is upstairs, it possibly can be related to water damage generally from wet area room such as showers, water basins, etc.

We highly recommend that you engage a qualified carpenter or in some cases a registered builder to perform invasive inspections which may include lifting up some flooring or cutting plaster to determine the extent of the damage. Once the extent of the damage has been found, at that point a structural engineer may also be required.

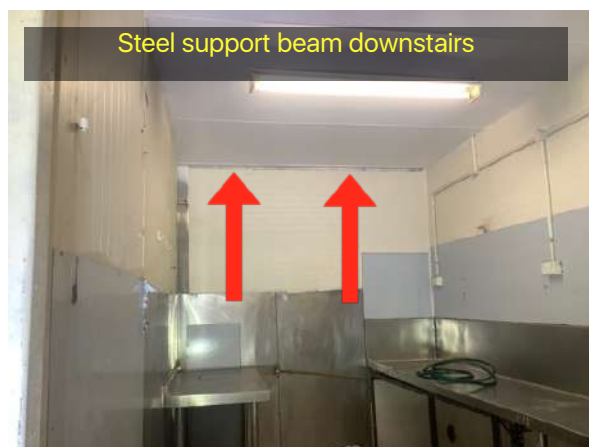
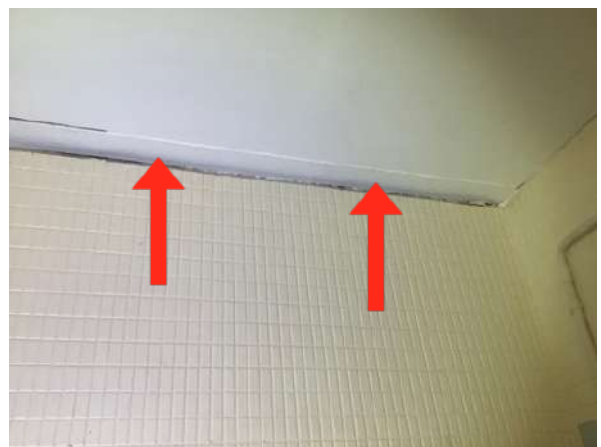
Major Defect 2.08

Location: Steel Beam

The presence of excessive moisture can have major implications on associated building elements if left unattended. While only seemingly minor at this stage, the damage cannot be determined due to the paint obstructing any further inspection of the damage.

It is highly advised that the affected paint be cleaned to allow a further, more invasive inspection by a licensed plumber. Failure to act on this defect may necessitate major works in the future.

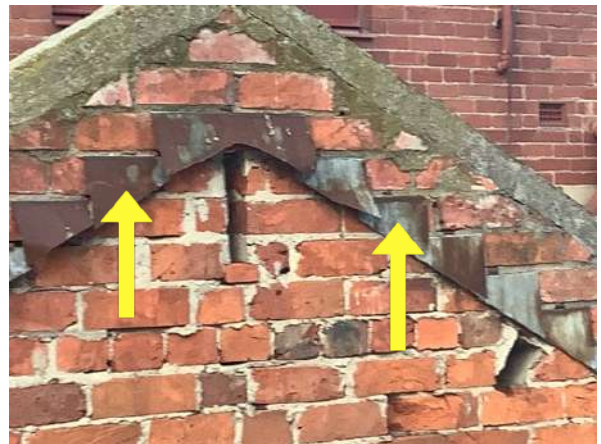
Minor Defect 3.02

Location: Roof & Stormwater Areas

A licensed plumber or specialist roof restoration company should be appointed to undertake these works. It is advised that such works be completed as soon as possible to prevent any further damage and deterioration.
