# Digital Floor Level Assessment Report (( PARTIAL REPORT ))

Inspection Date: 8 Jul 2021

Property Address: Fairfield Area

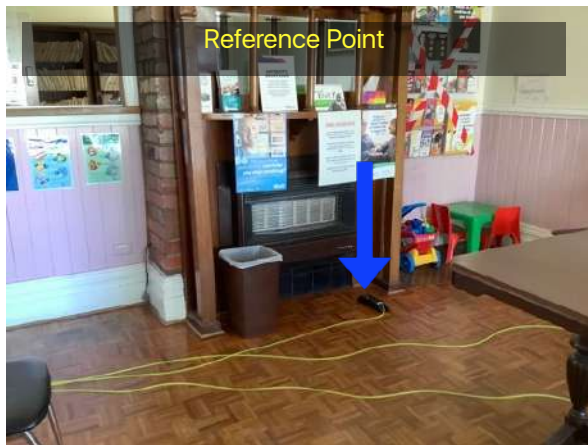
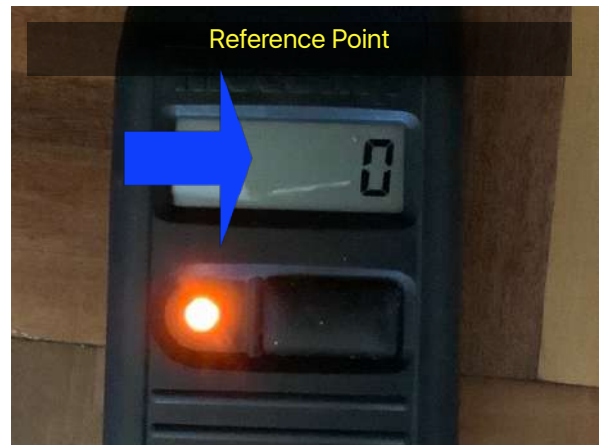
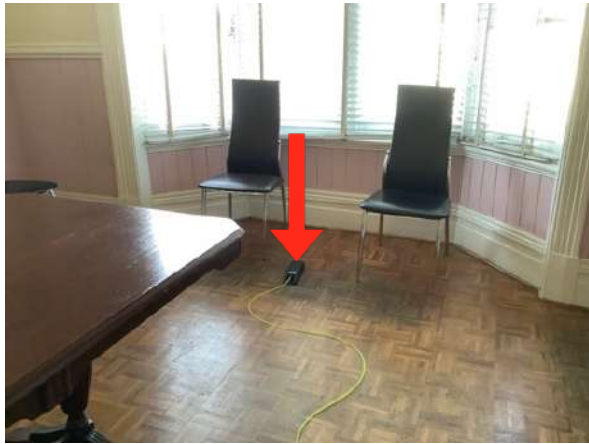
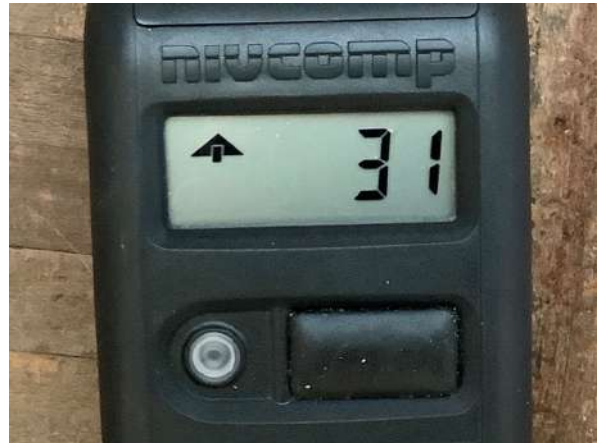
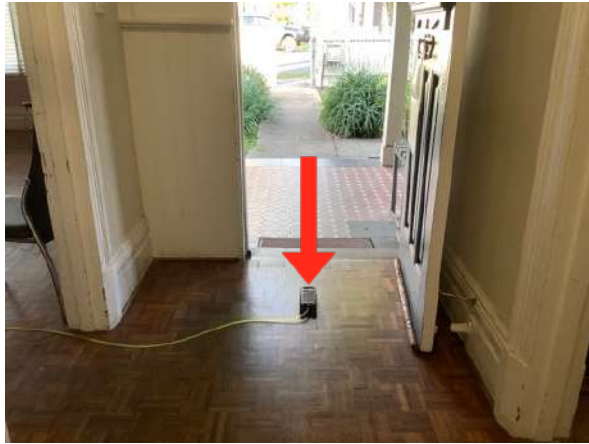
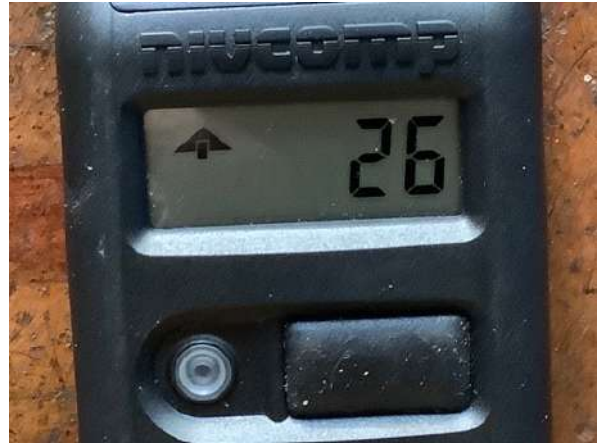
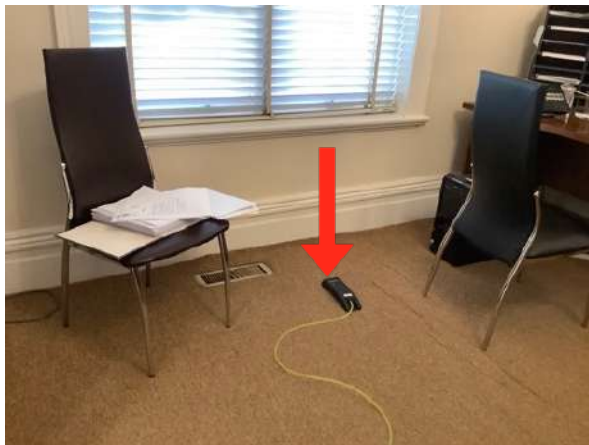
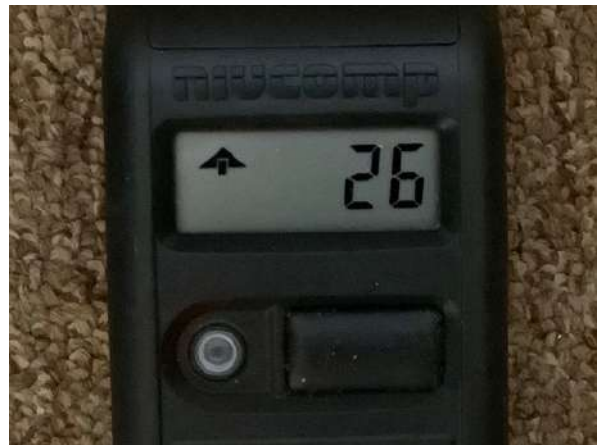
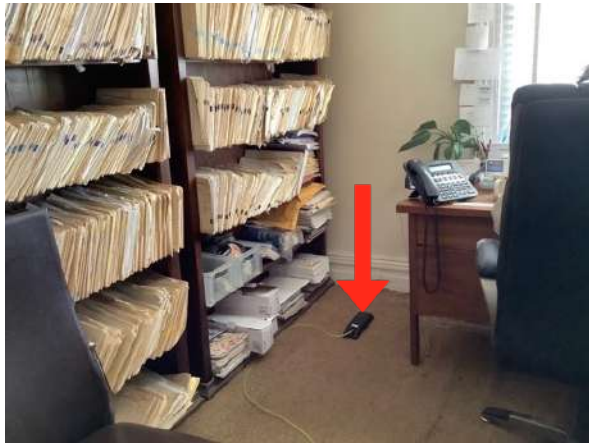
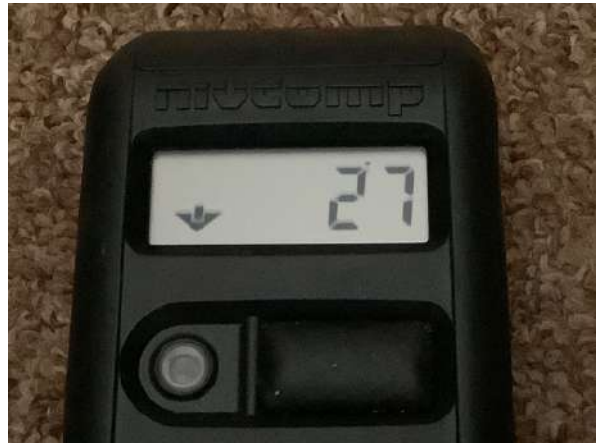
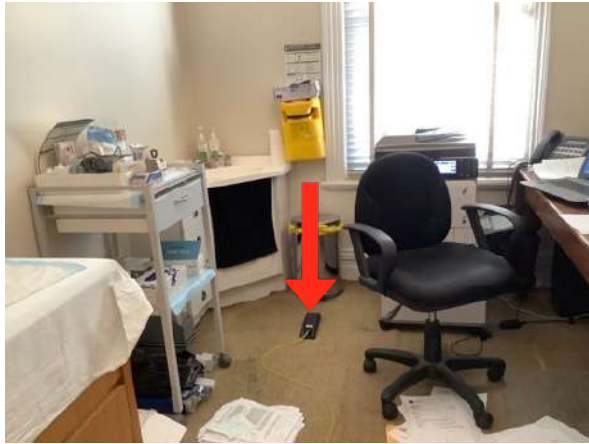
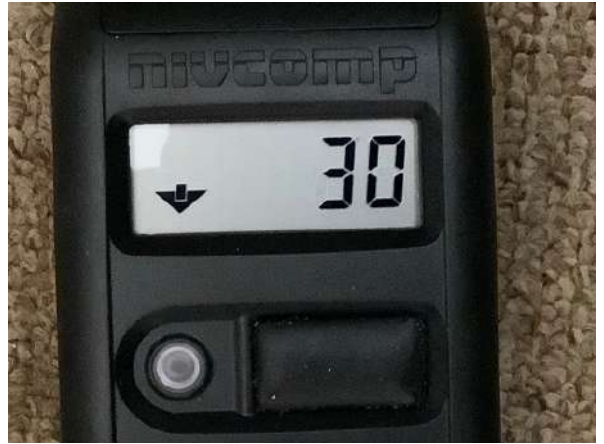
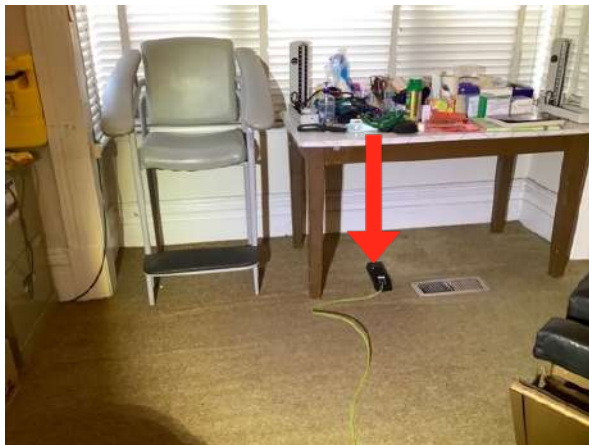
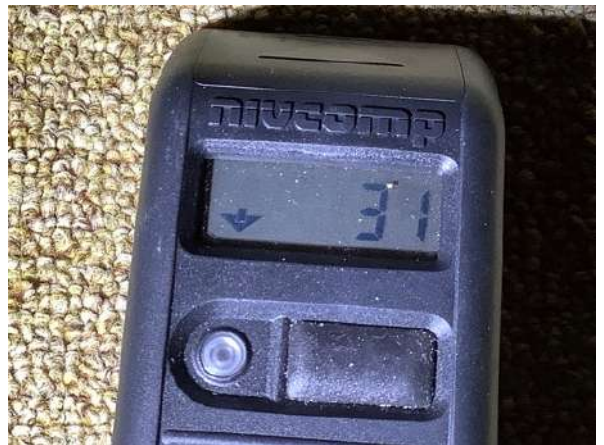
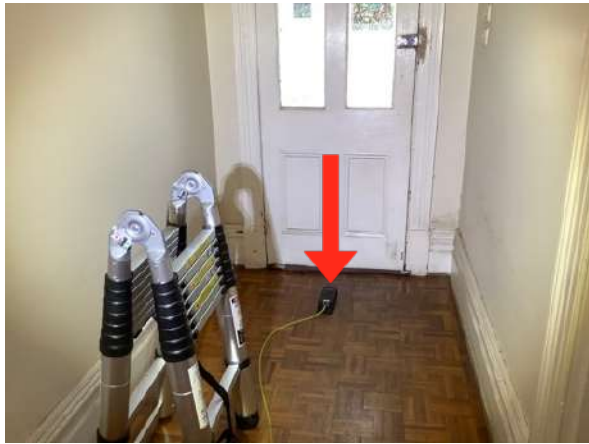
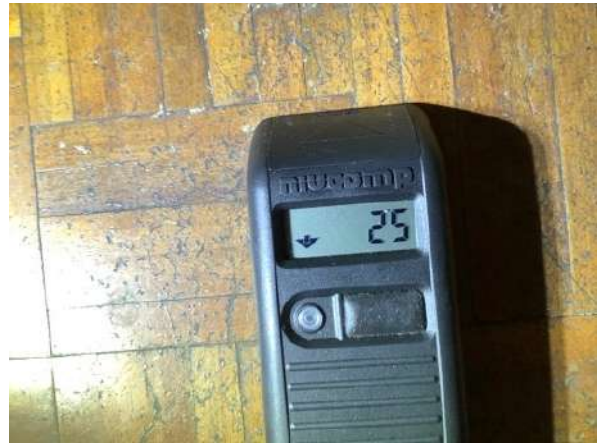
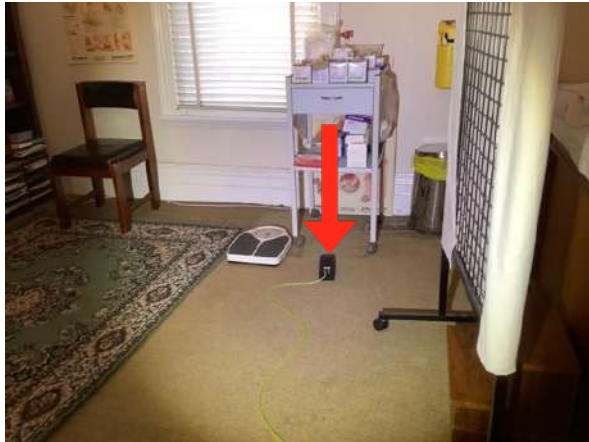
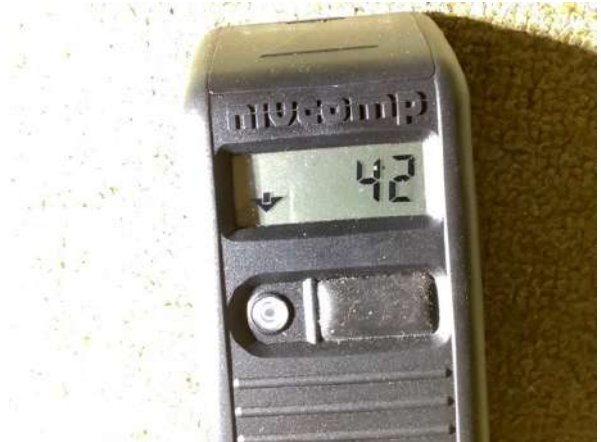
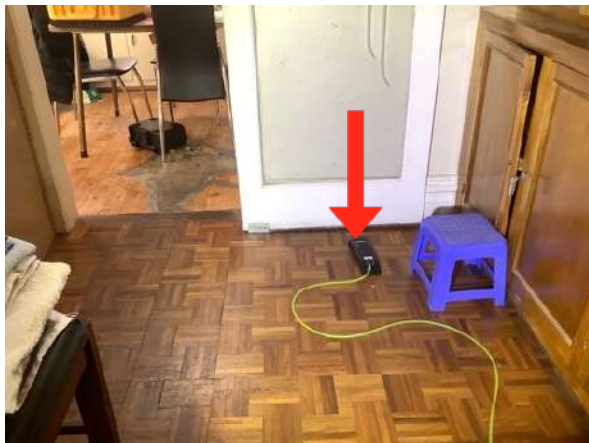
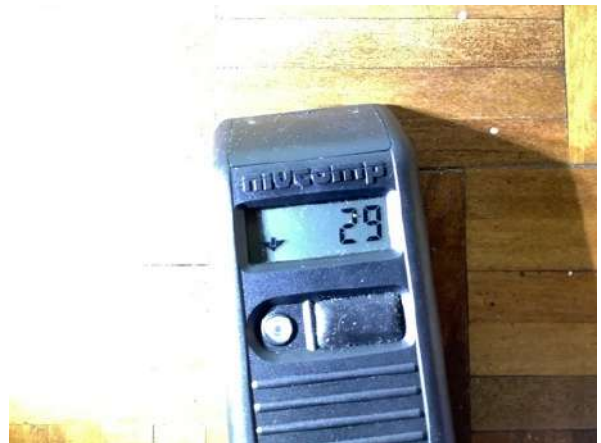
## Major Defect 2.01

Finding: Floor Levels—NOT Acceptable, Uneven / Defective

◆ THIS PROPERTY INDICATES THAT THE FLOORING IS Considerably OUT OF LEVEL as the Australian Standard® Inspection of buildings, Part 1: Pre-purchase inspections— Residential buildings AS4349.1-2007, Appendix C, BUILDING ELEMENTS AND SERVICES TO BE INSPECTED, Table C1 states that “OUT OF LEVEL FLOORING “ is DEFECTIVE.

It appears that the subfloor structure has been affected by movement of the foundations, often referred to as sinking or subsidence. a degree of movement is expected in subfloors over time, especially as environmental conditions change and buildings `settle` after construction, this degree of subfloor movement requires attention.

The internal flooring in areas is out of level and uneven. Uneven flooring is likely to indicate minor defects such as expected movement of the foundations of the property, but may also indicate subsidence of the associated subfloor stumps.

Any repairs, re-stumping and/or packing MUST be performed by qualified trades, whom take there own levels during the remedial works process.

Subsidence can have complex and varying causes, which will influence the required remedial works. It is advised to begin by consulting a Registered builder and/or a structural engineer to determine the required scope of works, which will then lead to a re-stumping company. This generally includes some form of underpinning, Re-Stumping in part or full or at best packing up to a maximum of 20mm with a non compressible product as well as addressing the underlying cause.

It is advised that the flooring be closely monitored by a building consultant, registered builder or similar professional to identify any further movement. Where flooring remains relatively unchanged for an extended period of time (i.e. several months or seasons ) it is likely that this defect has been caused by expected movement of the foundations of the property.

Where flooring has become uneven further, potentially invasive inspection of the subfloor structures and stumps in this area is required. In this case, works to repair are likely to be required, and would be carried out by a registered builder specialising or understanding the sub floor structure and the requirements of re-stumping.
