Final / Practical Completion Inspection (PCI) Report

Inspection Date: 9 Jun 2021

Property Address: Wallan Area

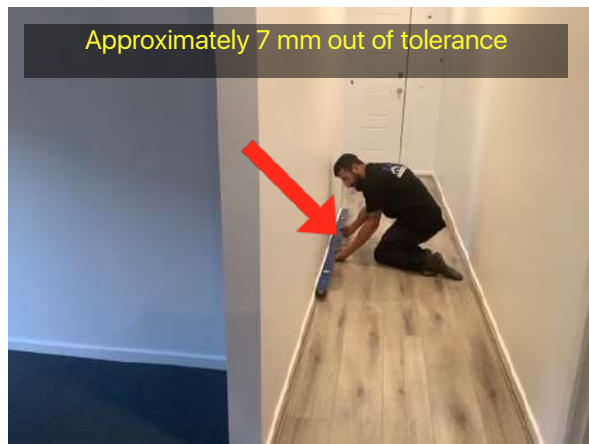
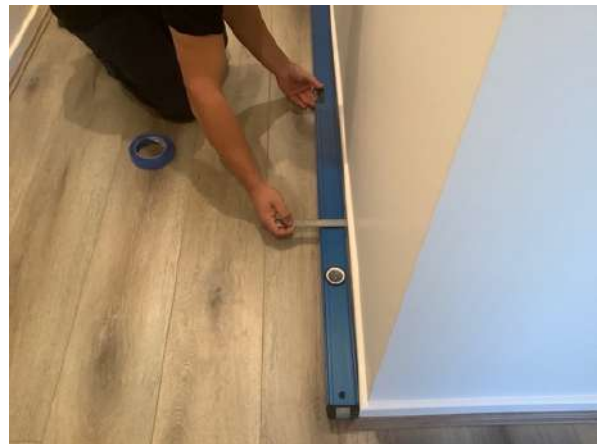
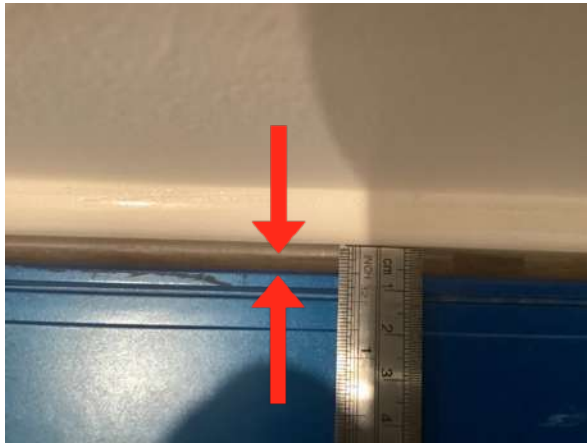
Finding: Walls / Frame / Posts- Vertical / Horizontal Defective (max variation is 4mm over 2 mtrs).
IMPORTANT 🖱️ ONLY SAMPLE PHOTO'S of the Vertical/Horizontal Defective Areas. All AREAS to the entire property MUST be checked and repaired.

It is observed that the wall frame is defective as there is a deviation from a vertical or straight plumb line which exceeds 4mm within any 2m of height / length.

This is commonly referred to as a bow in the frame material and/or defective workman.
 Any bow in excess of 4mm as identified exceeds the allowable Standards and Tolerances and is considered defective.

Any deviation in excess of 4mm exceeds the allowable Standards and Tolerances and is considered a defect.

A registered builder should be appointed to assess the defect and perform rectification works as necessary.

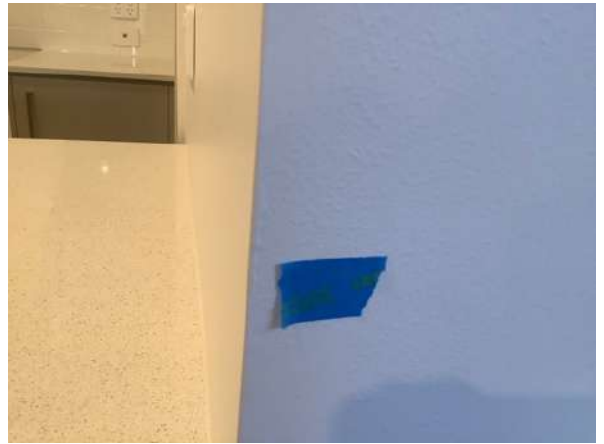
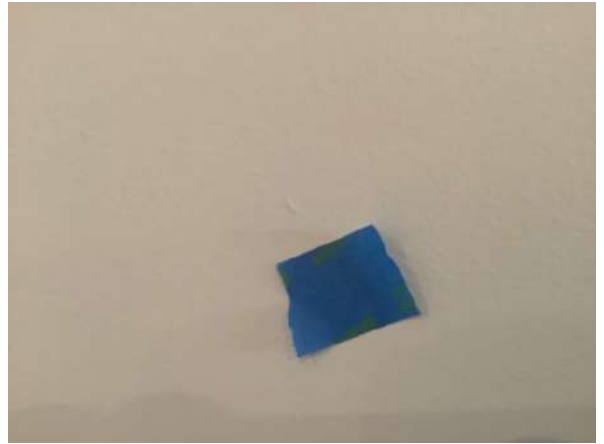
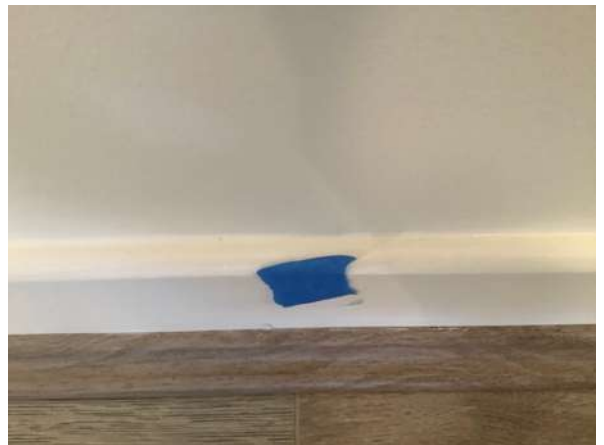
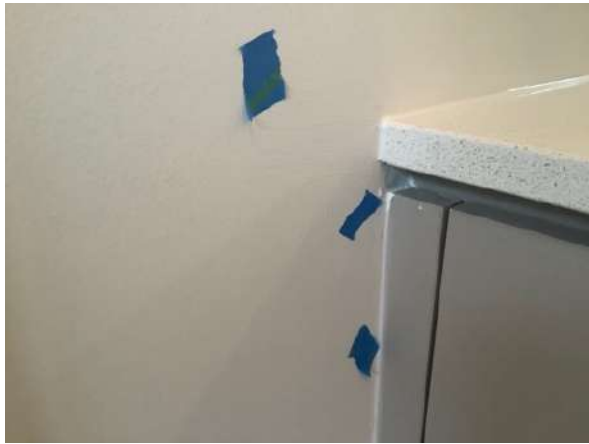
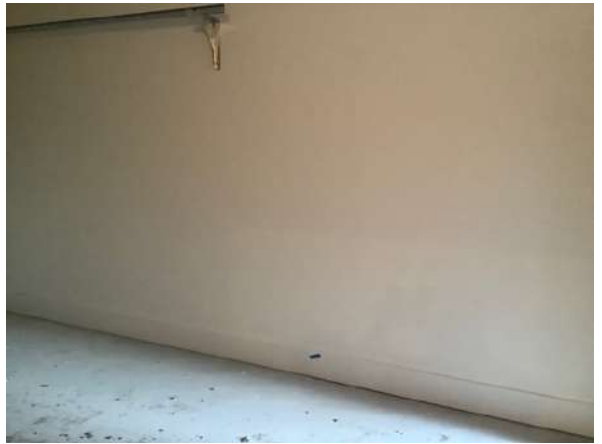
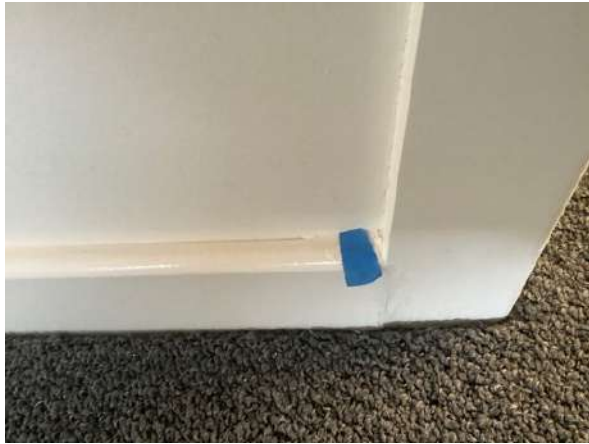
Finding: Painting - Defective (AS2311)

Areas were identified where the surface finish of the painting was found to be defective. This includes areas of minor blemishes, missing painting, over-painting, paint runs, sags , paint chips, scratches and general paint imperfections.

Paintwork is defective if the application has blemishes such as paint runs, paint sags, wrinkling, dust, bare or starved painted areas, colour variations, surface cracks, irregular and coarse brush marks, sanding marks, blistering, non-uniformity of gloss level and other irregularities in the surface that are visible from a normal viewing position.

Paintwork is defective if the application results in excessive over-painting of fittings, trims, skirtings, architraves, glazing and other finished edges.

It is up to the builder and painter to inspect and repair the paint work to ALL AREAS, TO ALL ROOMS methodically and carefully, to the plaster, timber doors, timber skirting and architraves, but limited to, so that the finishes are consistent throughout.

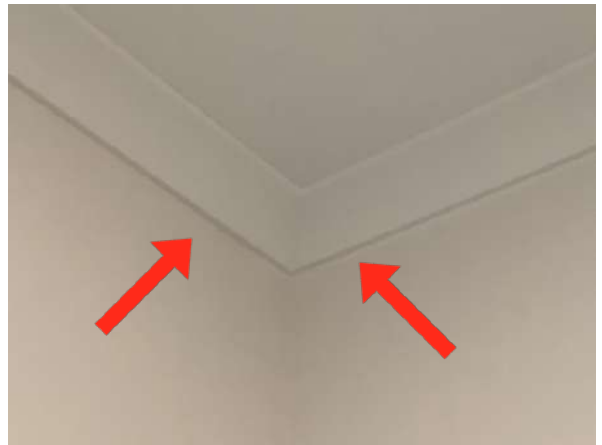
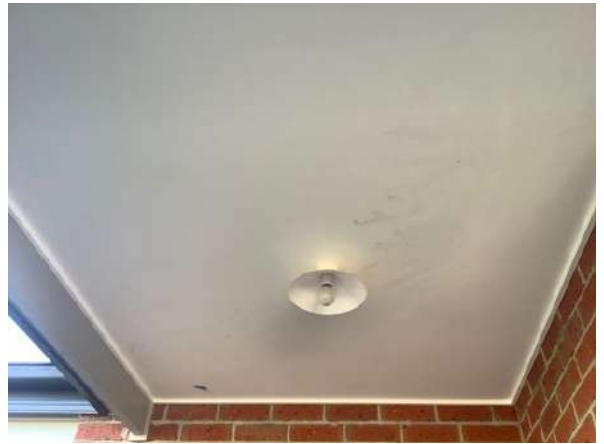
Location: Painting-Under Painted / Defective-All Areas
 Finding: Paint Surface Finishes - Incomplete / Under Painted / Defective.

X in relation to the tape markings = entire sand, repair and paint edges to edges, where the X of the tape areas are.

Whilst incomplete or missing paint finish is generally an appearance defect, it can also lead to the development of secondary building defects over time. Incomplete areas of paint finish exposes the area to moisture, potentially accelerating the deterioration of underlying building materials.

Incomplete paint finishes should be sanded back, filled, levelled and painted as applicable. Where inadequate or missing paint protection has led to the deterioration of the associated building element, repair and/or replacement of this building element may be required.

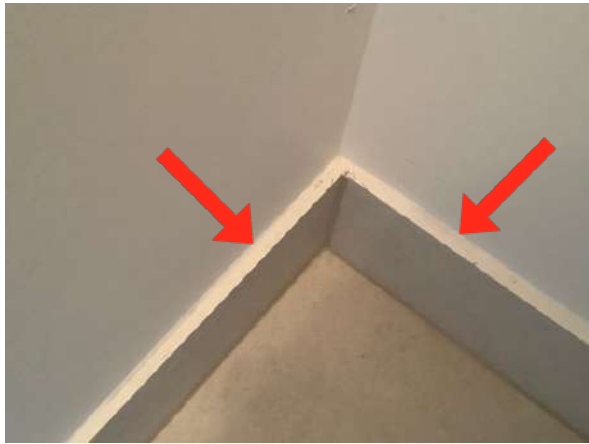
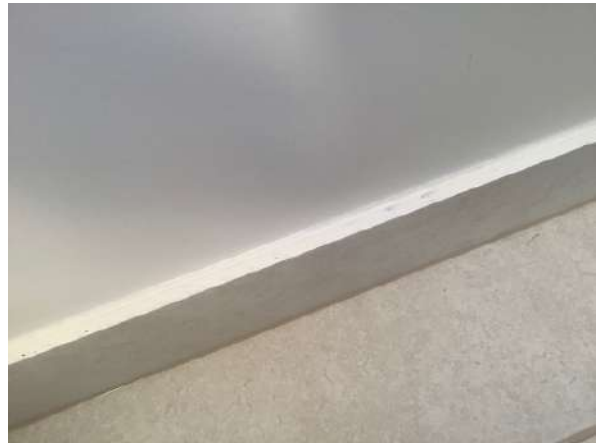
IMPORTANT 🖱️ ONLY SAMPLE PHOTO'S of the paint defects. All AREAS to the entire property MUST be checked and repaired.

Paintwork is defective if the application has blemishes such as paint runs, paint sags, wrinkling, dust, bare or starved painted areas, colour variations, surface cracks, irregular and coarse brush marks, sanding marks, blistering, non-uniformity of gloss level and other irregularities in the surface that are visible from a normal viewing position.

Paintwork is defective if the application results in excessive over-painting of fittings, trims, skirtings, architraves, glazing and other finished edges.

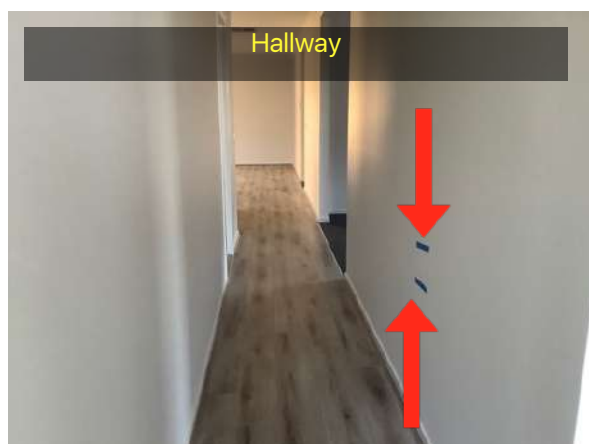
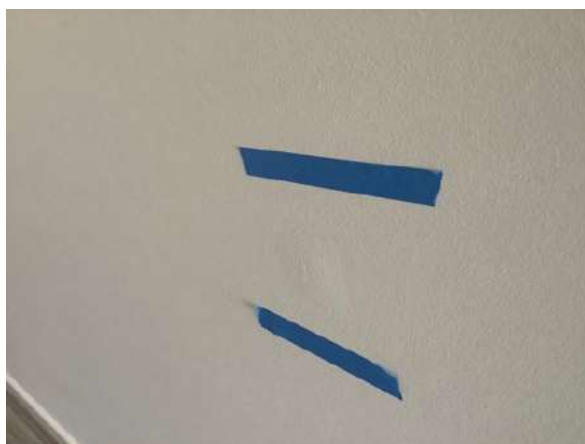
Location: Plaster Work
Finding: Plaster joins - Visible (AS2589)

The Building Commissions, Guide to Standards and Tolerances clause 9.14 Level of Finish for Plasterboard, states- 'All joint compound will be finished smooth and be free of tool marks and ridges. Additionally, clause 9.19 Peaking or Jointing in Plasterboard states- 'Plaster peaking or jointing is a defect if it is visible from a normal viewing position.'

These joints will have to be properly rectified and repainted.

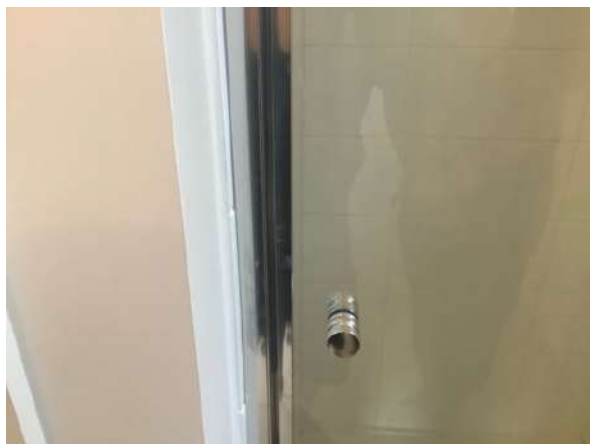
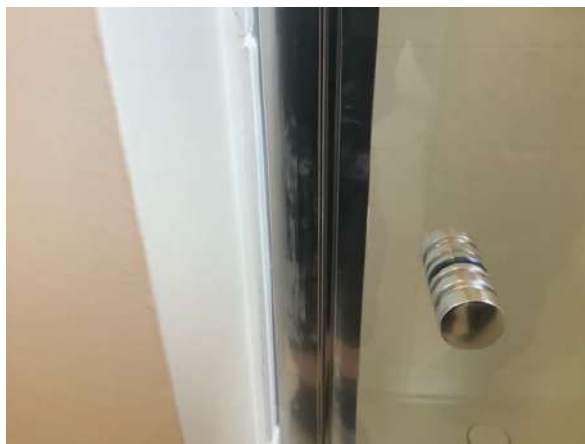
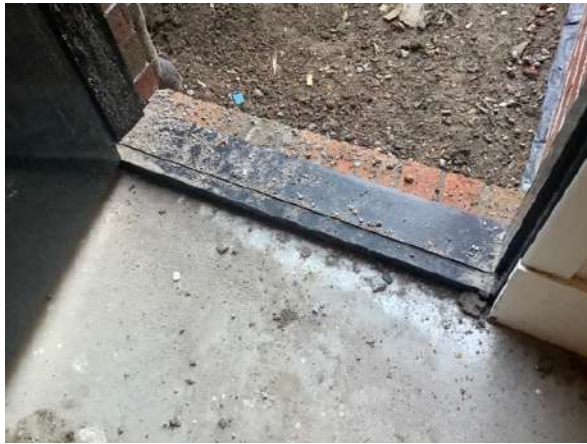
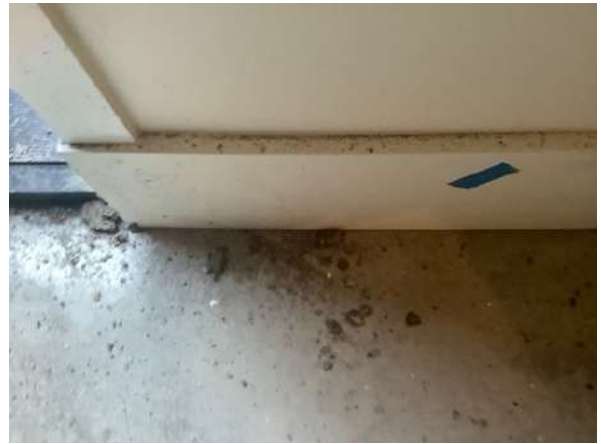
Location: Cleaning - All Areas

Finding: Cleaning Defective - Floors, Tiles, Glass, Paint, Concrete, Bench Tops, Bathroom fittings and fixtures, Etc.

Fittings and fixtures including sinks and bathtubs are required to be as new prior to handover. Evidence of damage marks scuffs and dirt need to be removed where present.

The Building Commission's, Guide to Standards and Tolerances clause 18.09 Cleaning, states- 'Owners are entitled to expect that the building site and works are clean and tidy on completion. Building works are defective where windows are not clean, floors are not swept, mopped or vacuumed as appropriate, tiles, sinks, basins, troughs, baths, etc. are not cleaned and shelving, drawers and cupboards ready for use.'

Once the cleaners have properly completed all of this work, all of the glazing, mirrors, cupboards, baths, shower bases, shower screens, floor coverings, walls, stairs, garage floor, fixtures and fitting etc, should all be thoroughly checked again for any scratches and damage which may have occurred, prior to handover proceeding.

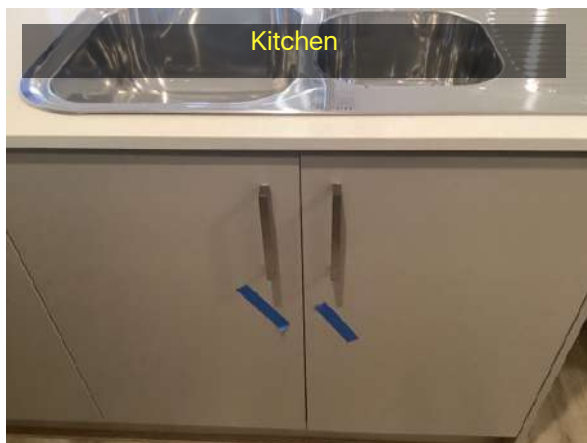
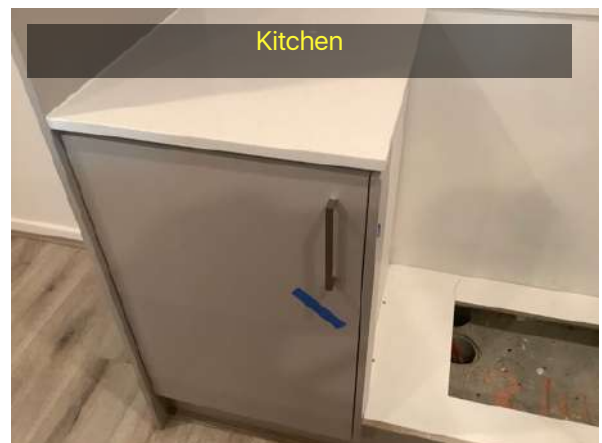
Location: Cabinet Doors - All Areas

♦ It is observed that some of the cabinet doors are not aligned and / or have inconsistent gaps between the doors.

♦ It is observed that some of the cabinet drawers are not aligned and / or have inconsistent gaps between the drawers.

The Building Commissions, Guide to Standards and Tolerances clause 8.04 Internal Door Clearances, states- 'The installation of doors is defective if within three months of completion, clearances between door leaves and frames and between adjacent door leaves are not uniform and within 1mm. A clearance between door leaves or between a door leaf and the frame is defective if it is less than 2mm or greater than 5mm in width'

The gaps around these doors must be adjusted to comply with this tolerance.

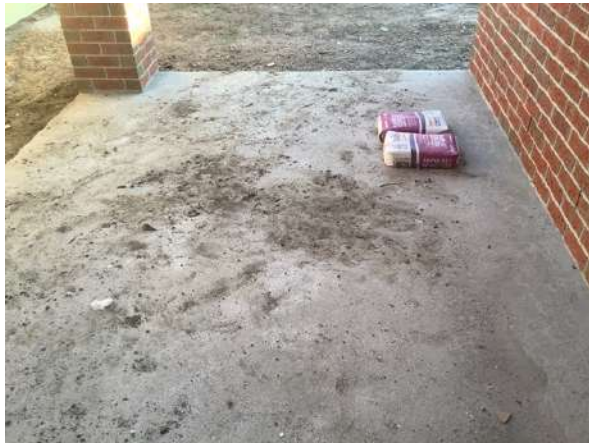
Finding: Garage, Porch & Alfresco - Concrete Floor Damaged / Chipped / Marked / Paint, Etc - Non Compliant

Areas where the concrete floor has been damaged were identified. The damage consists of deep gouges, chips, excessive concrete, paint, scrapes and associated marks.

The concrete is well compromised and must be in as new condition. It would appear that there are two options.

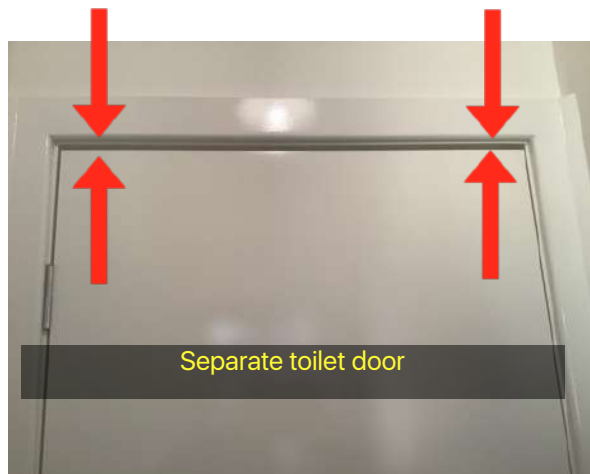
Location: Door Defects - All Areas

Finding: Door Clearances Defective.

Unless additional clearance is required for removable toilet doors or air ventilation, a clearance between the door and the floor finish is defective if it is greater than 20 mm after installation of the floor covering.

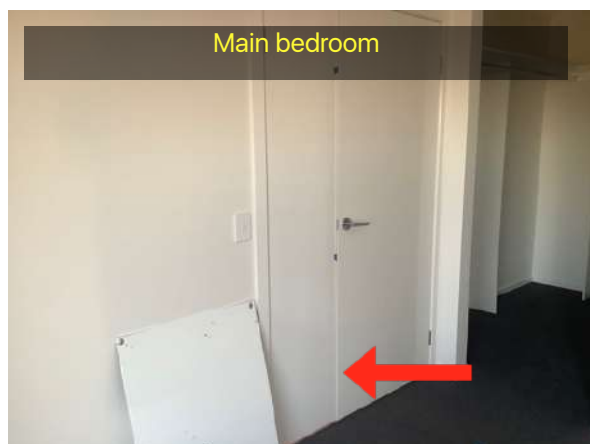
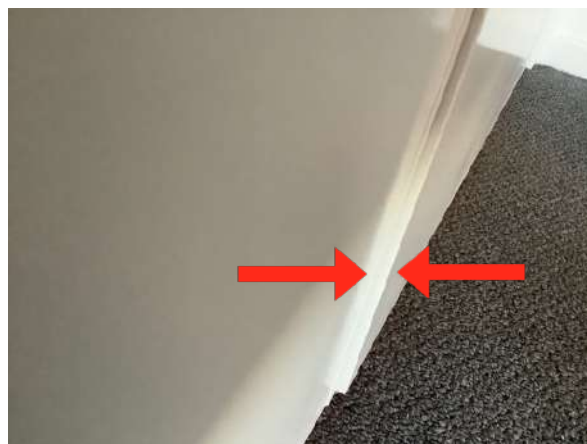
Location: Door Defects - All Areas

Finding: Doors - Double doors misalignment on closing

It was observed that the surface or face of the doors are misaligned which means that the at the meeting edges of double swing or French doors there is a variation when doors are fully closed.

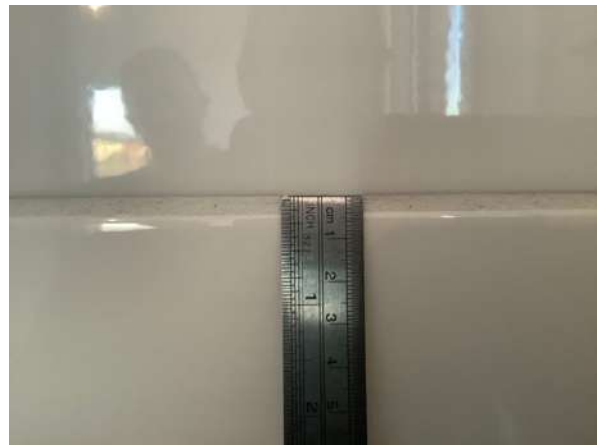
Except where tiles have distortions inherent in the manufacture, tiling is defective if it has joints that are not uniform, of even width, aligned or in the same plane.

Floor tiles have 5 mm spacings, maximum is 3 mm

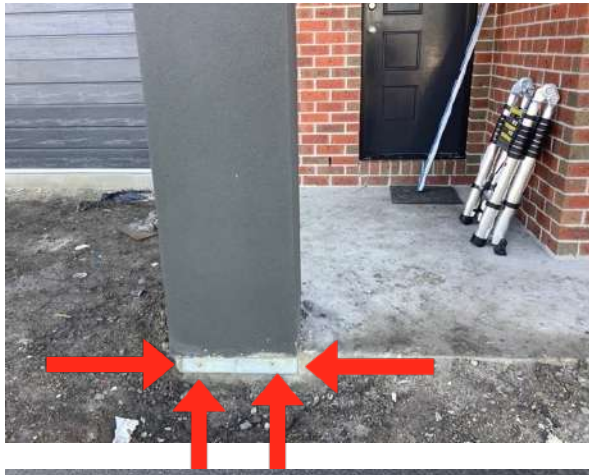
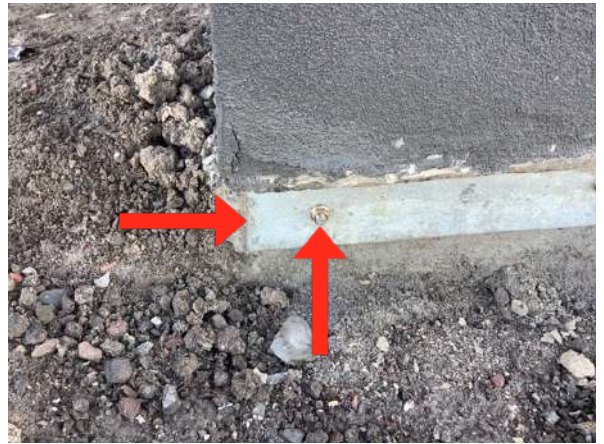
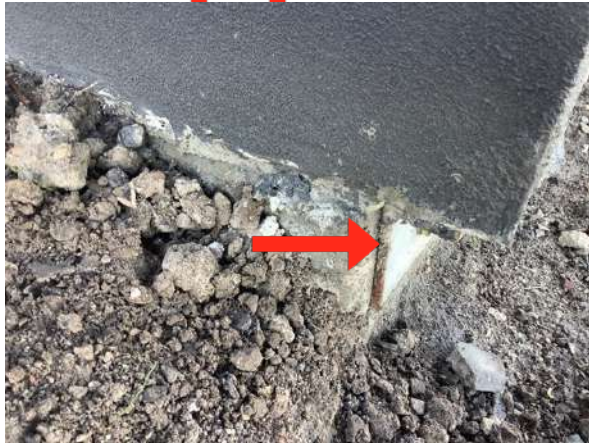
Location: Perimeter Of The Building - Exterior
 Finding: Corrosion Building Element - Rusted or corroded

I have ONLY taken LIMITED photos of this defect and attached are LIMITED photos of this defect in SOME AREAS ONLY.

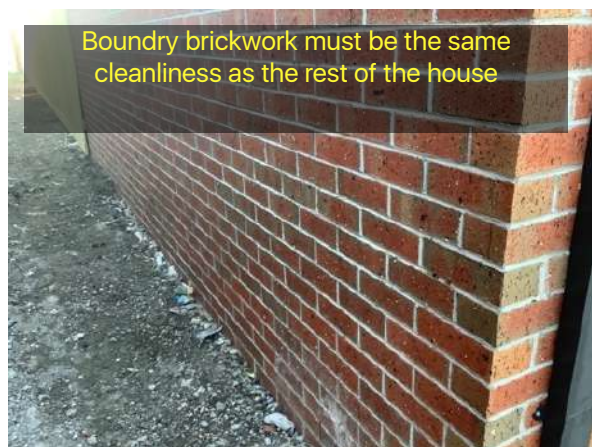
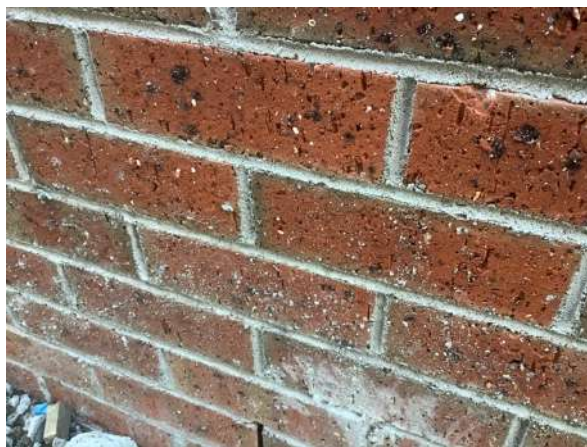
Location: Brick Work - Exterior Perimeter Of Building

At the time of inspection, this area does not meet contractual requirements regarding acceptable finishes. The responsible contractor should be appointed to complete these works in order to comply with standards and regulations. Such works should be completed prior to final handover.

The Building Commission's Guide to Standards and Tolerances clause 3.07, Masonry Facing states that:- 'Masonry faces are defective if they are not cleaned and free of excess mortar' and clause 3.11, Cleaning, Mortar Smears & Stains states that:- 'Stains, mortar smears and damage caused by cleaning are defects if they are visible from a normal viewing positioning.' The faces and edges of the bricks within the wall around this home will have to be properly re-cleaned to remove all traces of the mortar residue from across them.

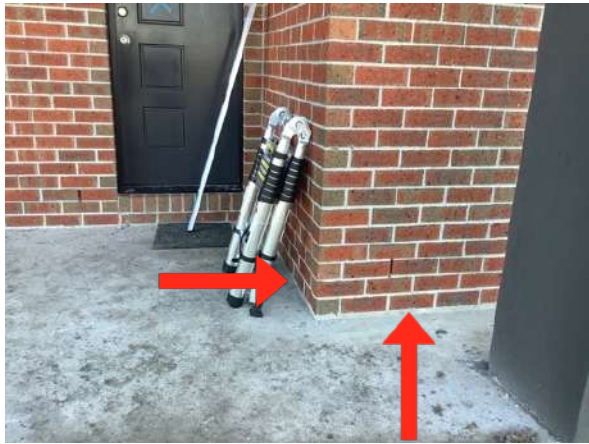
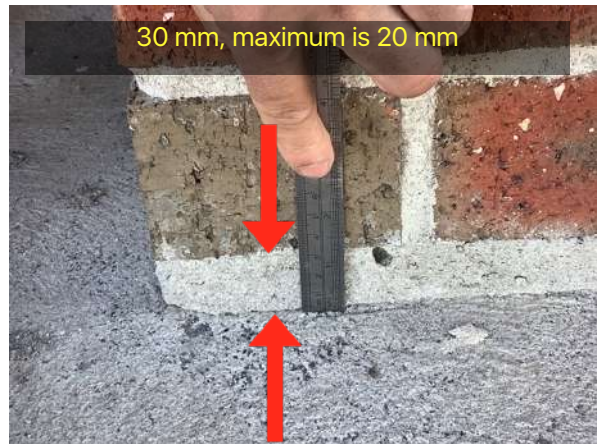
Location: Brick Work - Exterior Perimeter Of Building

Finding: Brick Base bed joints (exposed)- defective

It was observed that the exposed base bed joints is defective. Exposed base bed joints in masonry walls which are above the finished ground level or exposed are considered to be defective if they exceed 20mm in thickness which is the allowable Standards and Tolerances.

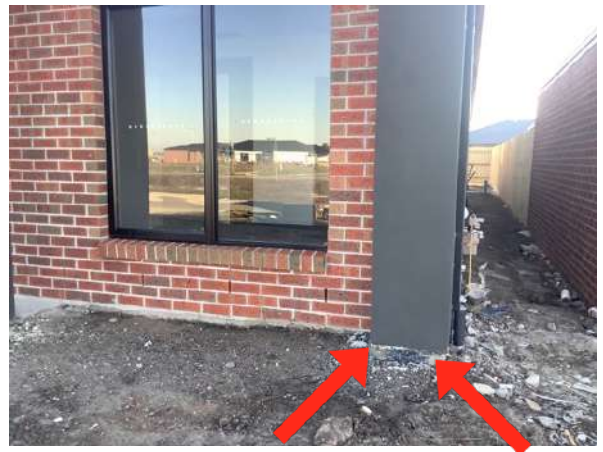
At the time of the inspection it was found that the brickwork is overhanging the slab by more than 15 mm.

Standards and Tolerances 2015 - Diagram 4.08 states that the maximum overhang of the brick work is 15 mm.

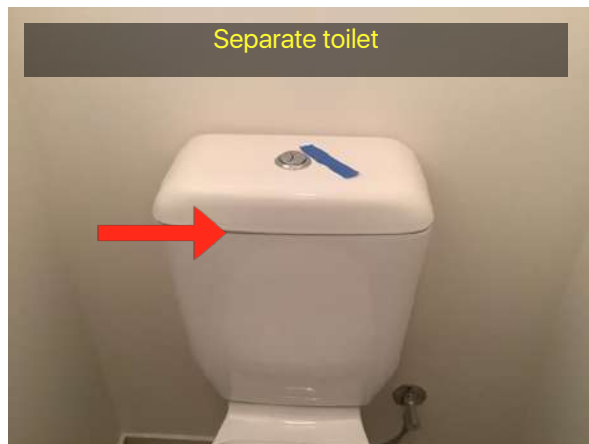
Location: Toilet Or Toilets

If left unmanaged, the toilet cistern could deteriorate further and cause leaks and/or secondary damages.

It is recommended that the cistern be secured to the wall and if this is not possible we recommend just a couple of dabs of silicon behind the cistern and this will stabilise the cistern.
