## Lock Up Report

Inspection Date: 29 Jun 2021

Property Address: Niddrie Area

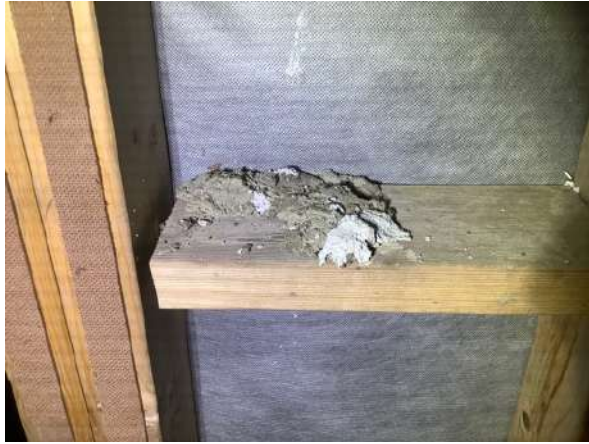
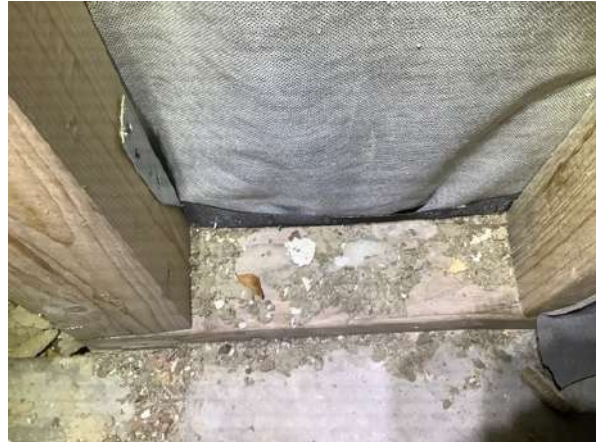
## Non Compliant 2.02

Location: Perimeter Of The Building - Exterior  
Finding: Cavity's Require Cleaning - Defective

I highly recommend the builder spends the time required to clean all the cavities particularly to the lower bottom plates and/or top plates of the walls to both floors.

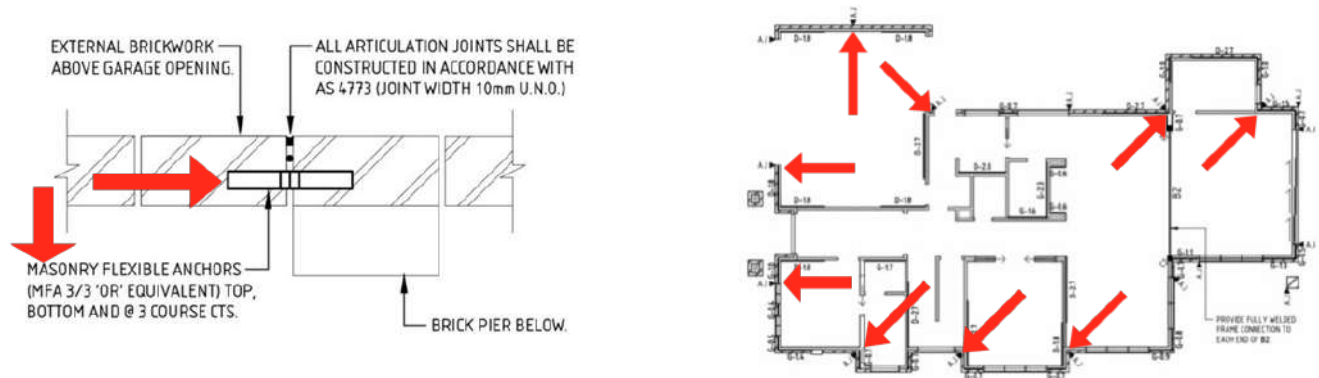
## Non Compliant 2.03

Finding: ARTICULATION JOINTS - Missing

Not all the articulation joints are installed as per the plans supplied, In fact in this particular case the articulation joints are missing in most areas including junctions of walls and I cannot stress enough how important it is the builder identify how he's going to fix this problem and that my client is made well aware prior to these works beginning due to the severity of the defect.

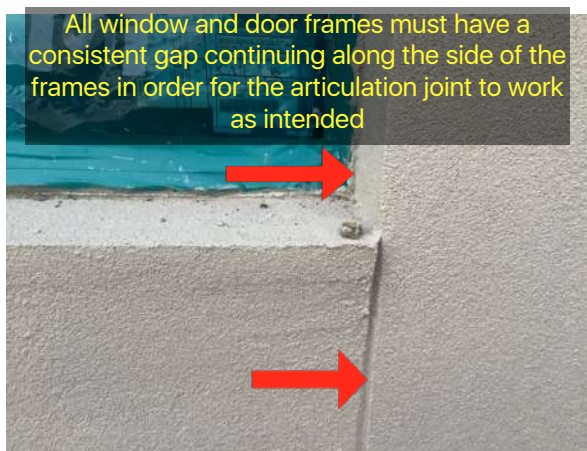
## Non Compliant 2.04

Finding: Articulation joints - Width defective .(AS3700)

The Masonry Structures Code AS3700 limits the amount of movement to be accommodated at a vertical joint to 15mm, and requires that a gap of at least 5mm should remain after the movement has taken place. It limits the amount of movement to be accommodated at a horizontal joint to 10mm.

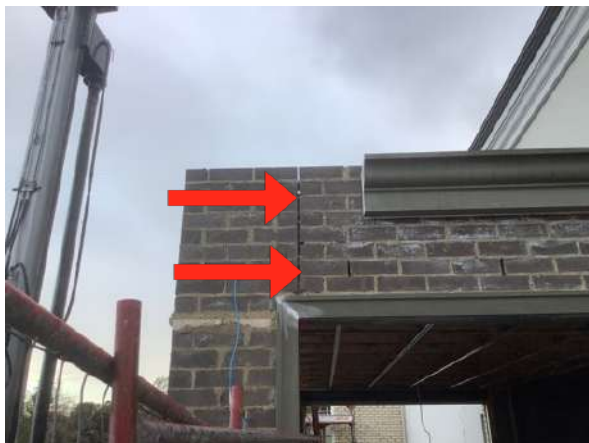
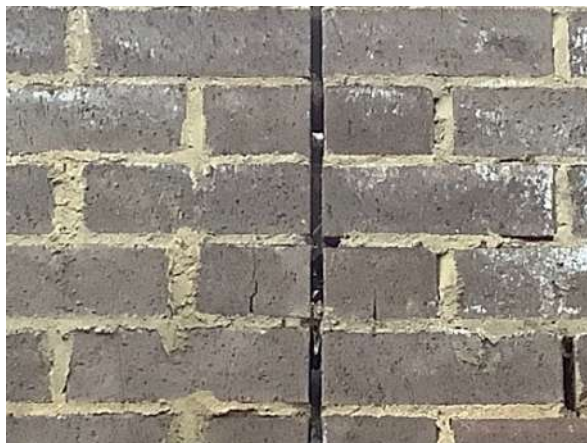
## Non Compliant 2.05

It was observed at the time of inspection that many of the articulation joints (AJ's) were obstructed by incompressible material (mortar)

All AJ's need to be cleaned out and continuous for the full length of the wall.

The responsible contractor should be appointed to complete these works in order to comply with standards and regulations. Such works should be completed prior to final handover.

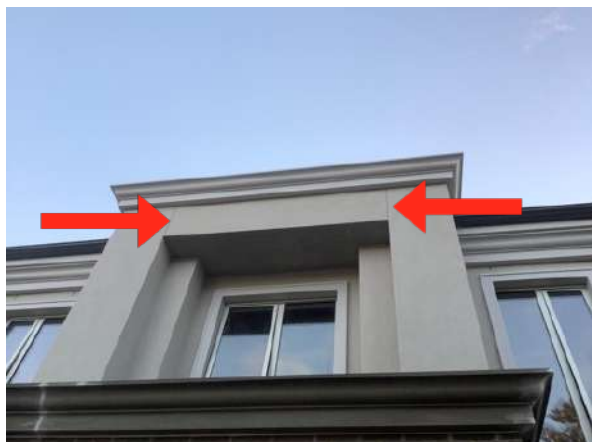
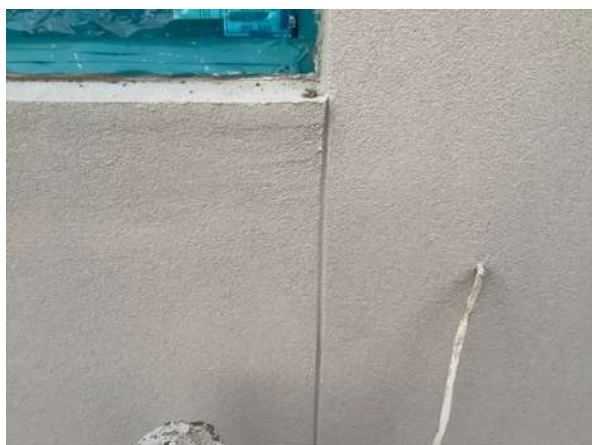
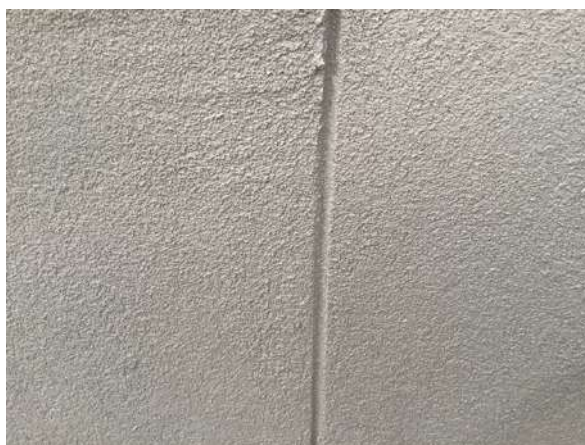
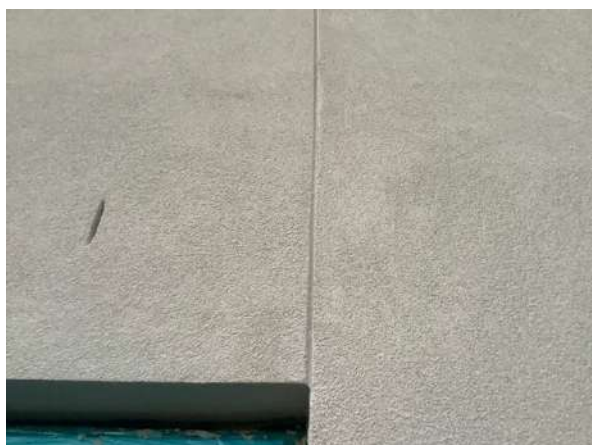
## Non Compliant 2.06

Finding: Articulation Joint - Render Covering Joint - Defective

-----  
-----  
It was observed that render or other similar applied finishes are covering articulation and control joints this is considered a defect with reference to Standards and Tolerances.

NO paint or render is to go over the sealant to the articulation joints.

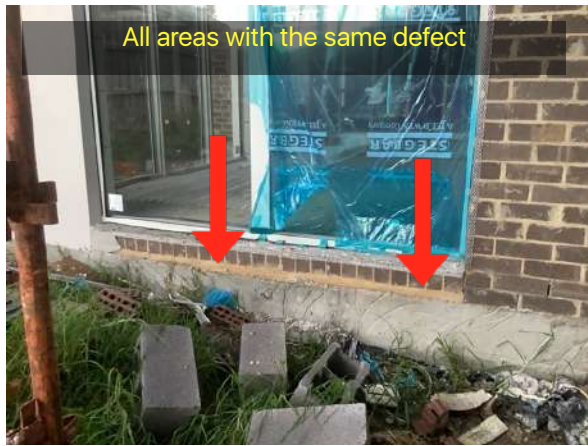
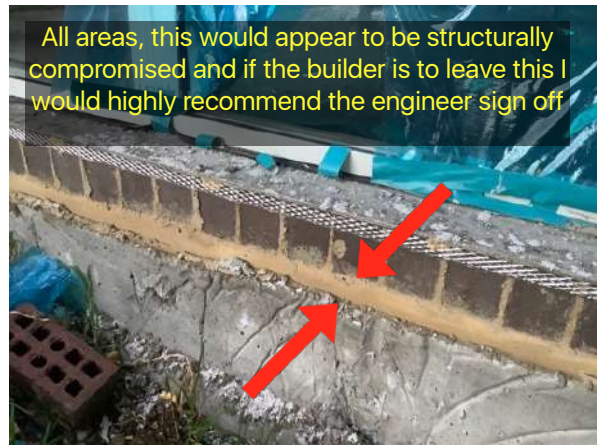
## Non Compliant 2.07

Finding: Brick Base bed joints (concealed) - defective

It was observed that the concealed base bed joint is defective. Concealed base bed joints in masonry walls are considered to be defective if they exceed 40mm in thickness which is the allowable Standards and Tolerances.

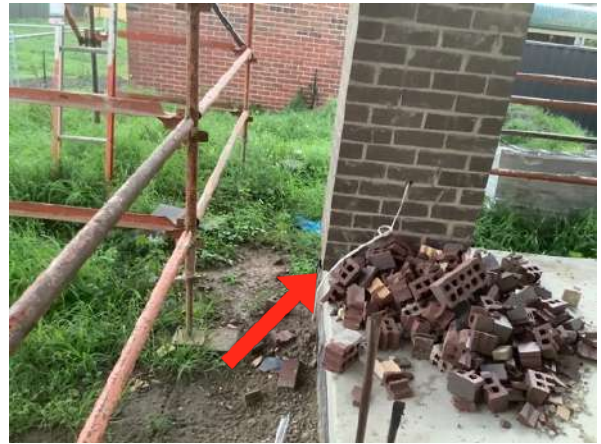
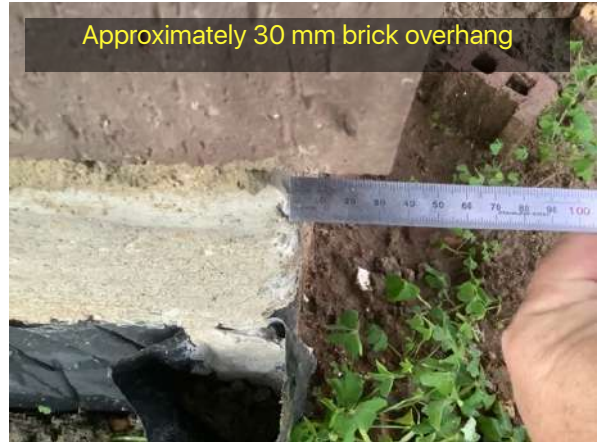
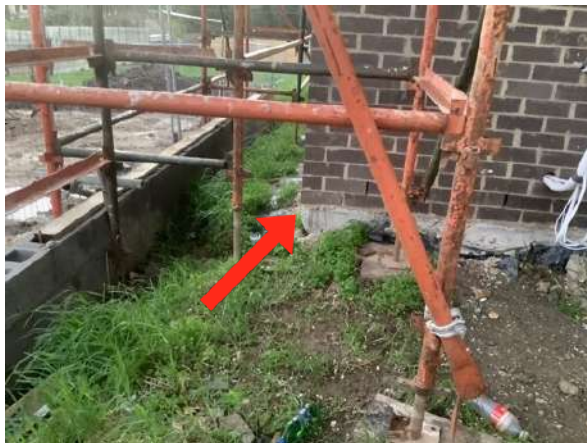
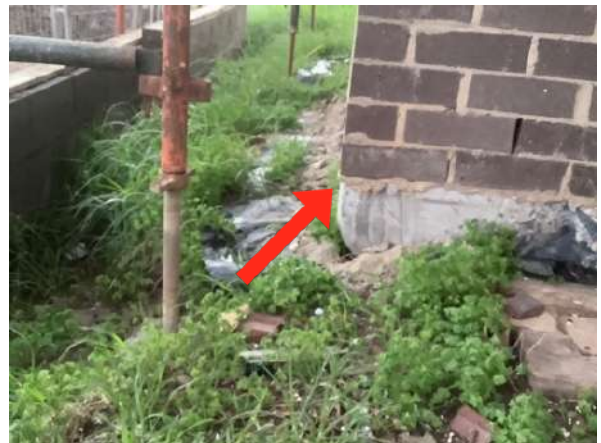
## Non Compliant 2.08

Location: Brick Work - Exterior Perimeter Of Building  
 Finding: Brick/Wall Overhang On Slab.

At the time of the inspection it was found that the brickwork is overhanging the slab by more than 15 mm.

Standards and Tolerances 2015 - Diagram 4.08 states that the maximum overhang of the brick work is 15 mm.

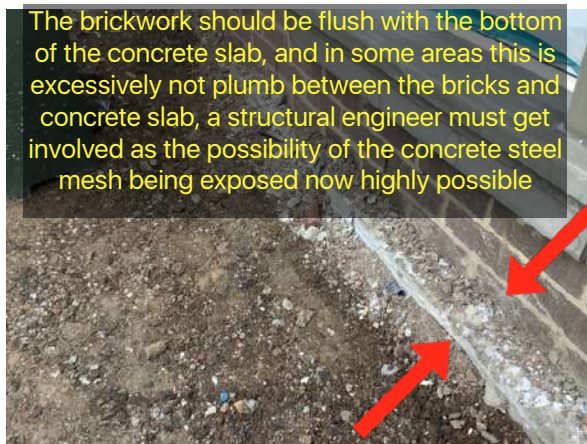
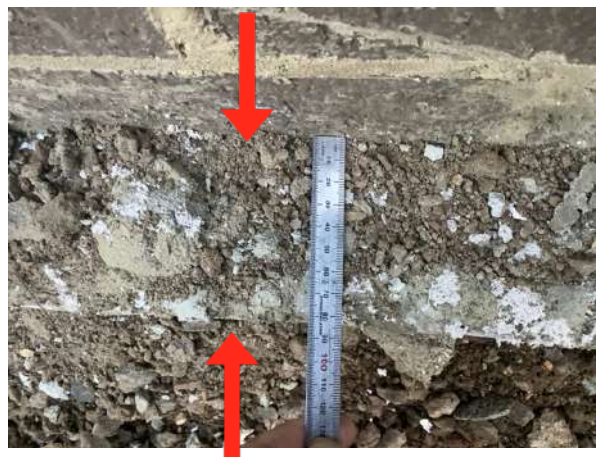
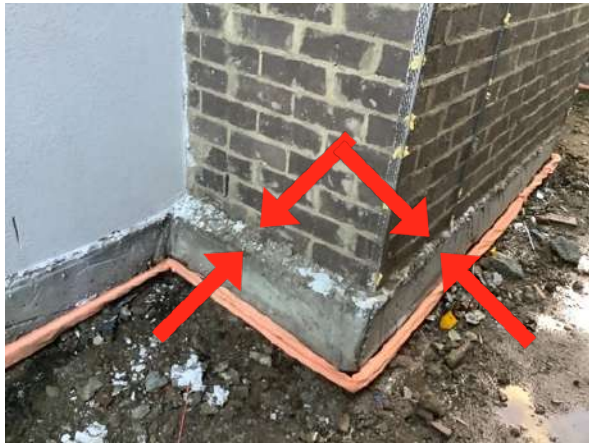
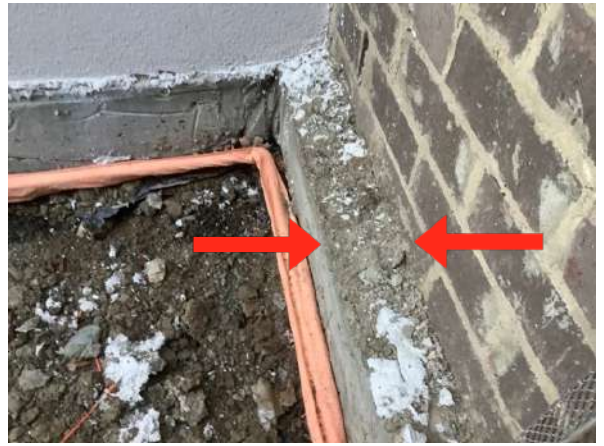
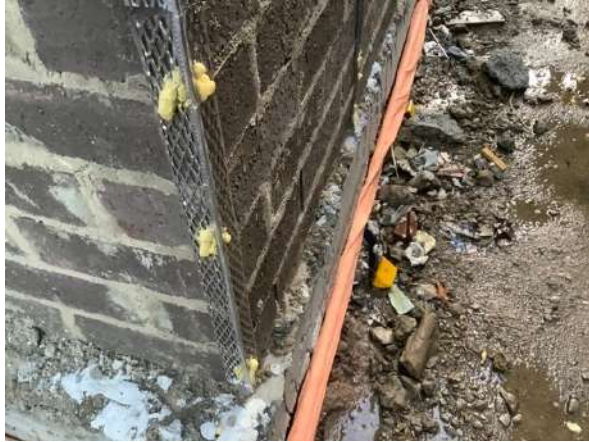
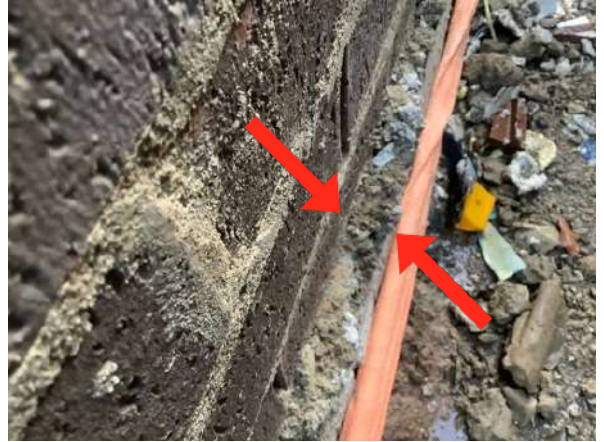
## Non Compliant 2.09

It was observed that there are MANY areas where the edge of the slab protrudes past the document finished dimension of the slab.

It is very important that if cutting the concrete slab back, which appears to be the method that will have to be taken, the vapour barrier will more than likely be damaged and compromised . The builder must repair all the vapour barrier if it gets compromised in any way. Once the builder cuts all the excessive slab around the perimeter of the building , The vapour barrier more than likely will get damaged. So in order for the vapour barrier to comply and provide the job that it is intended to do, I HIGHLY RECOMMEND that the builders dig the perimeter carefully,, sometimes the entire perimeter, pending of the severity of the vapour barrier (plastic) damage, pending on slab over pour, pending on excessive builders concrete (debris). It is important to dig along the slab perimeter without damaging the plastic and to extend the vapour barrier plastic higher than the slab rebate as would have been in the post slab report if we performed one.

- 1/ All over laps are to be taped as described below.
- 2/ All the rips and/or damaged area needs to be taped.
- 3/ All areas of vapour barrier are to be up to the future ground and/or finished paving or concrete heights and must be extended with 200mm overlay and taped.

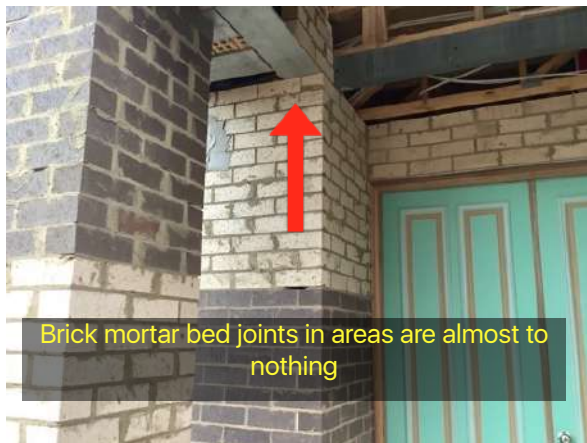
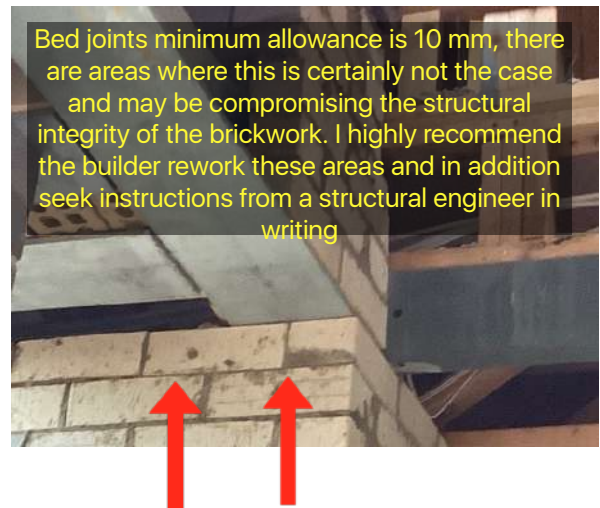
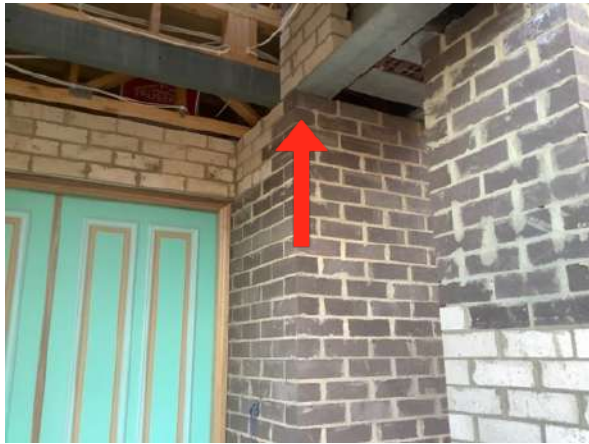
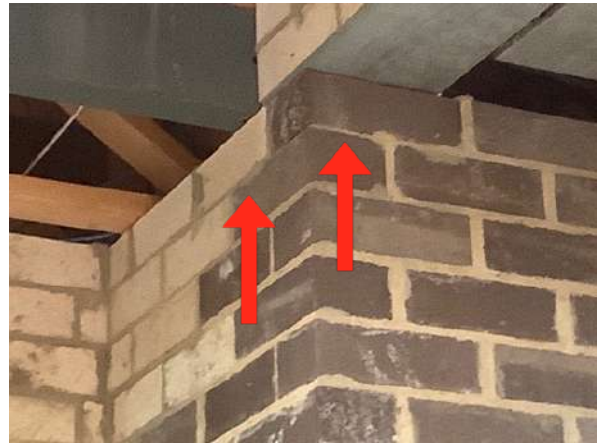
## Non Compliant 2.10

It is observed that there is an excessive deviation from the documented thickness of the bed joint.

There are variations in excess of 10mm which is excessively highly then the acceptable levels of workmanship regardless if it is the bricklayers defective workmanship and/or defective sizing or seconds brick supplied by the builder.

The maximum non-structural framework tolerance is 3mm. This identified defect exceeds the maximum allowable tolerance and is therefore considered a defect.

Generally the remedial works are demolition of brick work and/or at the clients consent render.

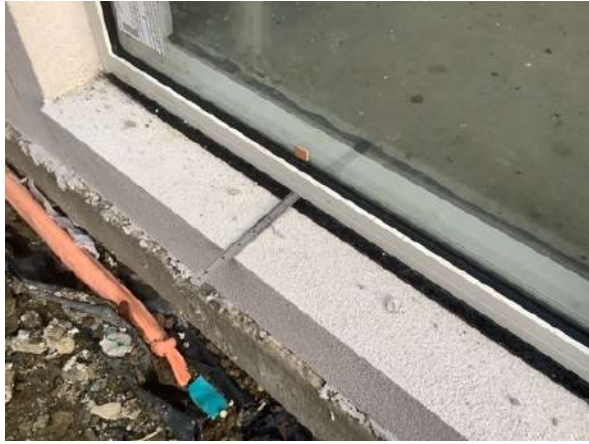
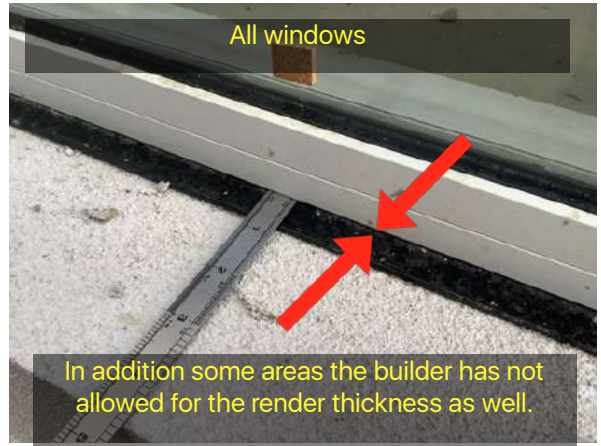
## Non Compliant 2.11

No minimum gap under the windows. Description of this is in the Defect statement below.

This defect is of great importance and repair and re-working of the brick work, brick sills and/or window installation may be required.

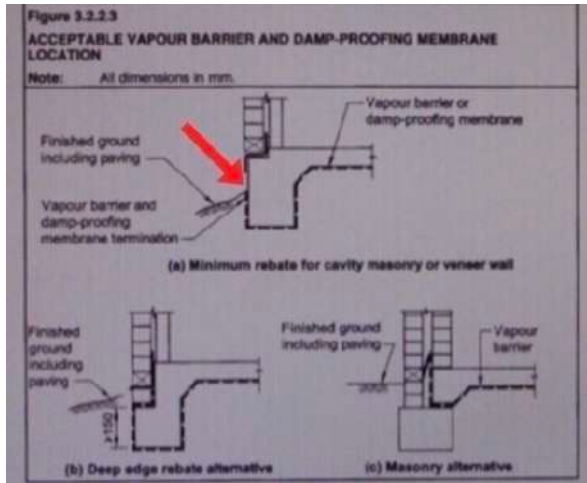
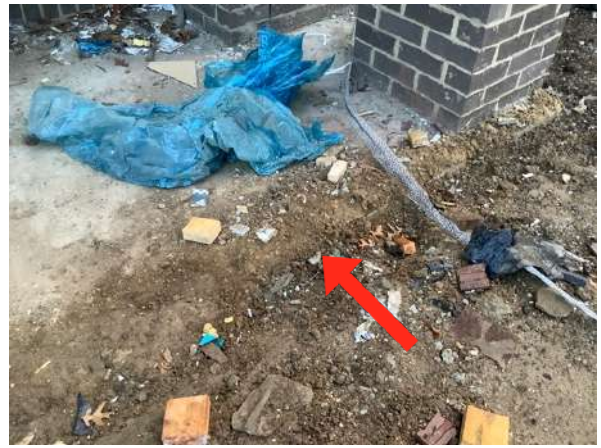
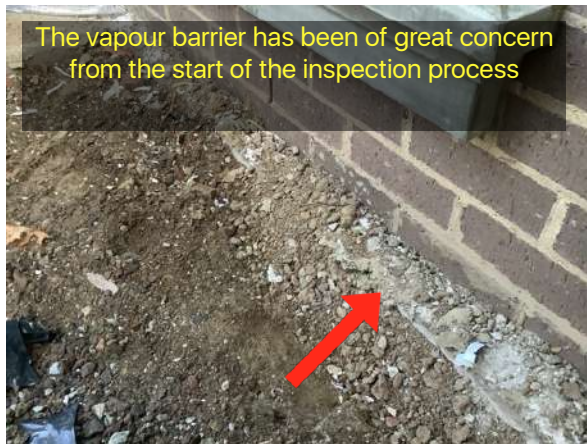
## Non Compliant 2.12

Finding: Vapour barrier - Defective (AS2870- 2011)

It was noted at the time of inspection that a vapour barrier had not been installed in accordance with AS2870 and BCA Part 3.2.2.6.

The polyethylene vapour barrier from beneath the concrete floor slab must be turned up the external side faces of its edge beams. Failing to install the vapour barrier correctly will allow moisture ingress via slab edge dampness into the internal timber wall skins and/or the floor coverings if not done.

I HIGHLY RECOMMEND that the builders dig the perimeter carefully,, sometimes the entire perimeter, pending of the severity of the vapour barrier (plastic) damage, pending on slab over pour, pending on excessive builders concrete (debris).

To entirely dig the external perimeter of the building at least 300mm below the vapour barrier system (black plastic) damaged areas, which will vary in areas and then overlap the existing plastic with the new plastic by a minimum of 200mm and taped.

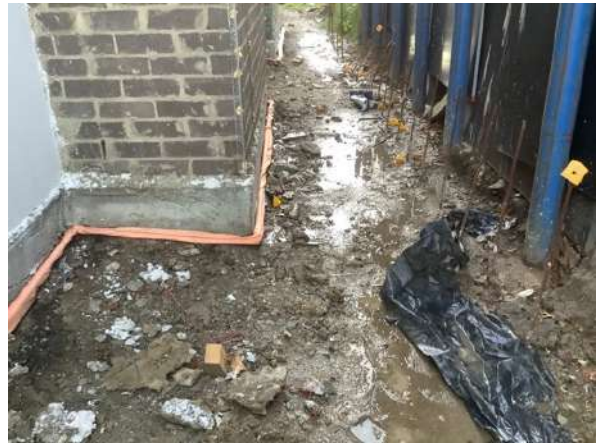
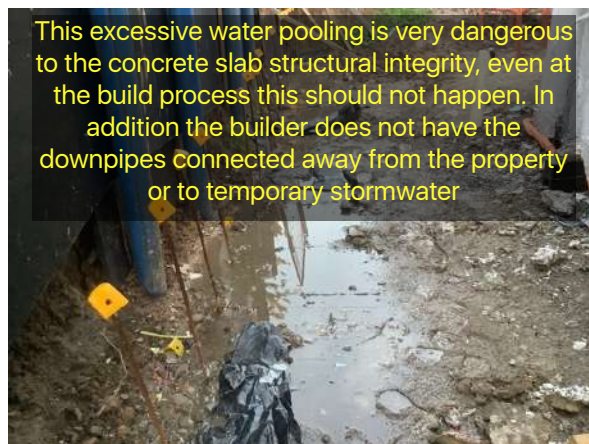
## Non Compliant 2.13

Finding: Drainage - Fall Ground Perimeter Building - Inadequate Fall (AS2870)

At the time of inspection, it was noted that drainage in these areas is poor, and likely to result in the pooling of water around footings and foundations. Slab and footing movement is often caused by a failure to design and construct in accordance with Australian Standards. Such movement is likely to cause major secondary defects in the long-term.

The soil levels around several footings need to be adjusted to ensure that footings and foundations are protected from excessive moisture.

To be compliant, finished ground levels (FGLs) must fall away from slab and footing construction by a minimum 50mm over the first 1 metre. This fall is designed to promote site drainage away from foundations to minimise susceptibility to erosion.

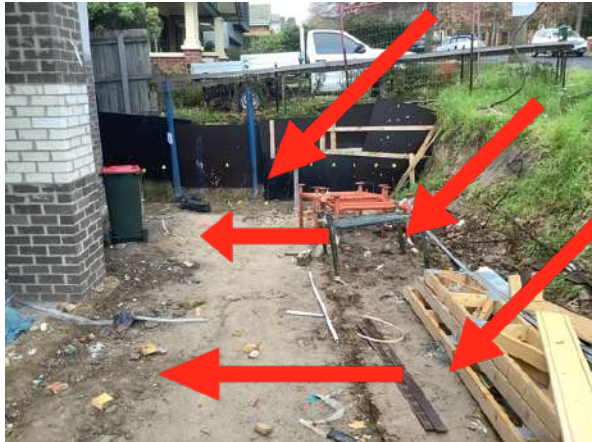
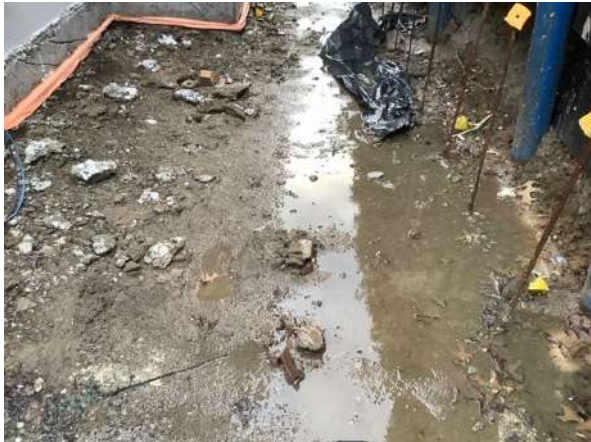
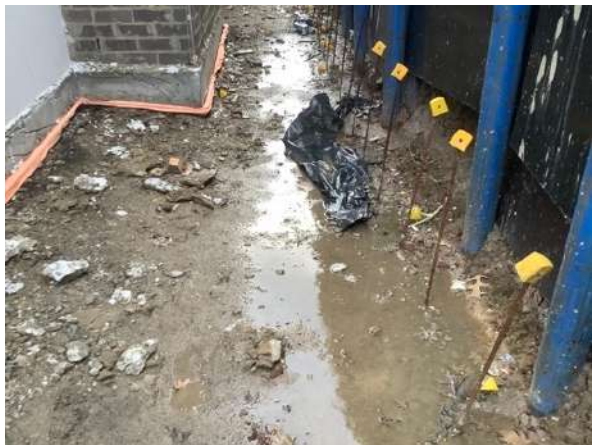
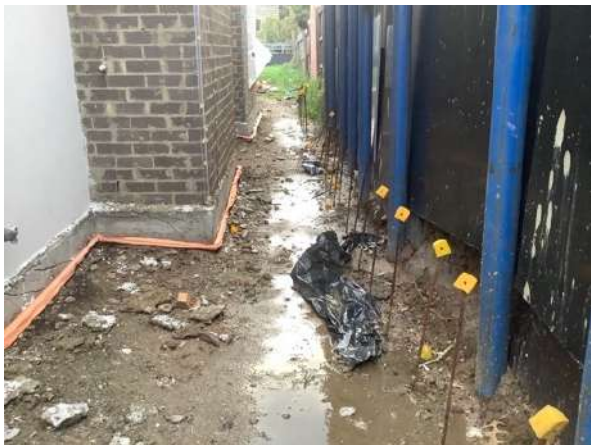
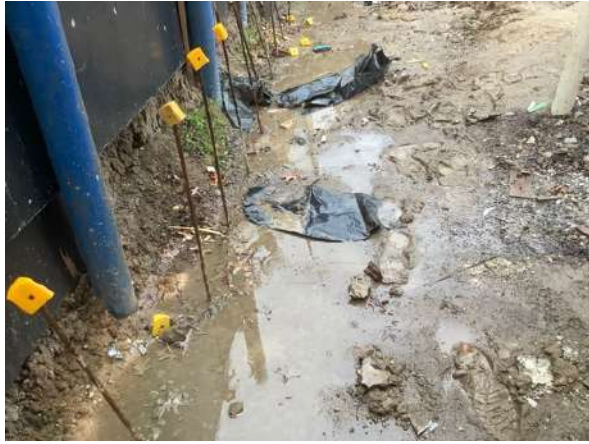
## Non Compliant 2.14

The drainage has been of great concern from the very start pre-slab inspection on this job and I have made it very clear from day one. It does appear that there is excessive water pooling around the property and this is of great concern, because with excessive water over a long period of time, creates the soil to contract which can very much compromise the structural integrity of the concrete slab and brickwork. Drainage should've been determined by now. Regardless of who is going to be handling the drainage, it is the builders responsibility through the build process to not allow such excessive water pooling.

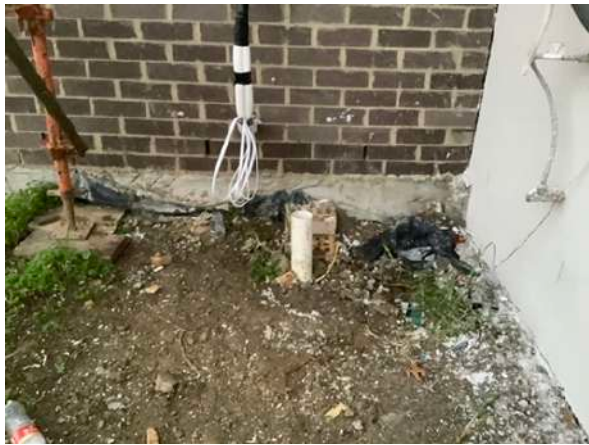
## Non Compliant 2.15

Finding: Plumbing work - Appears Defective.

There appears to be concern of the stormwater pipes not being 100 mm as intended. I request the builder look into this matter and possibly with an independent camera detecting agency , To determine how severe the underside stormwater pipes are.

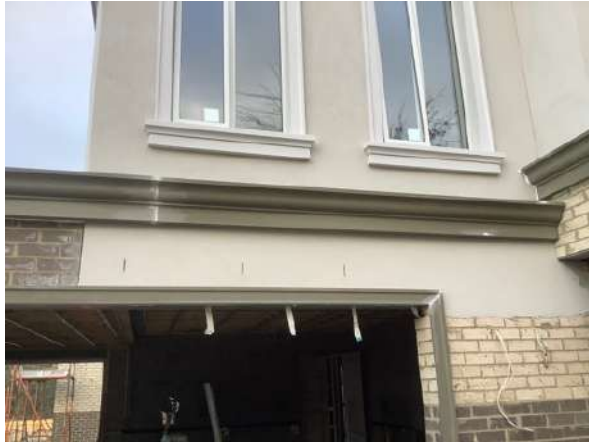
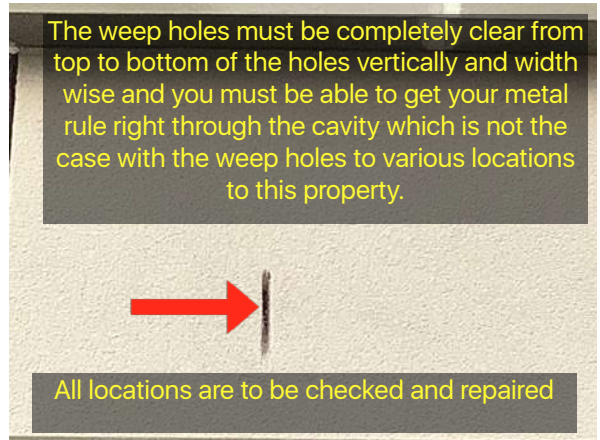
## Non Compliant 2.16

The weep holes to the brickwork are particularly blocked. Weep holes are designed to allow water to escape the cavity from leaks or seepages in brickwork before the water enters in or damages the wall cavity and in particular to windows and doorways. Weep holes should be kept clean and free of debris or blockages.

The weep holes must be completely clear from top to bottom of the holes vertically and width wise and you must be able to get your metal rule right through the cavity which is not the case with the weep holes to various locations to this property.

All locations are to be checked and repaired

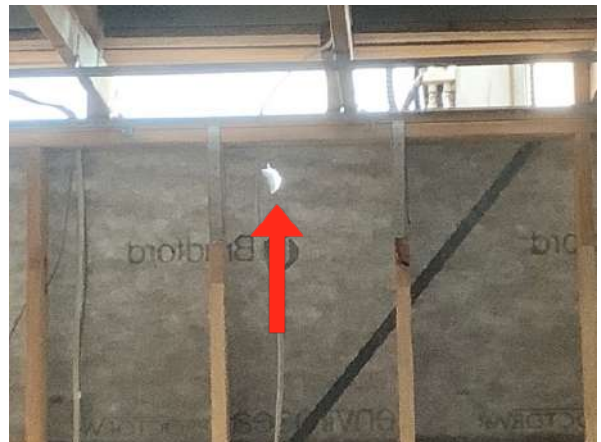
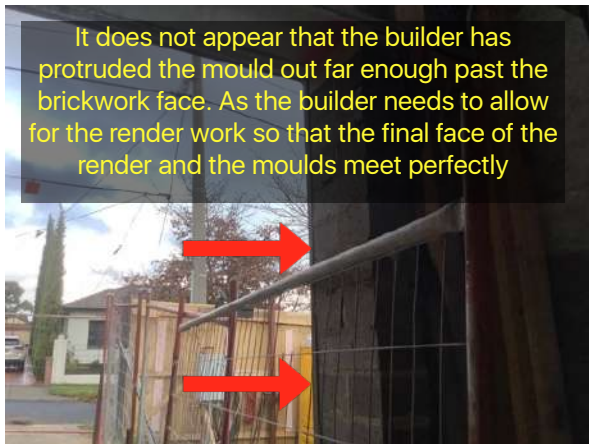
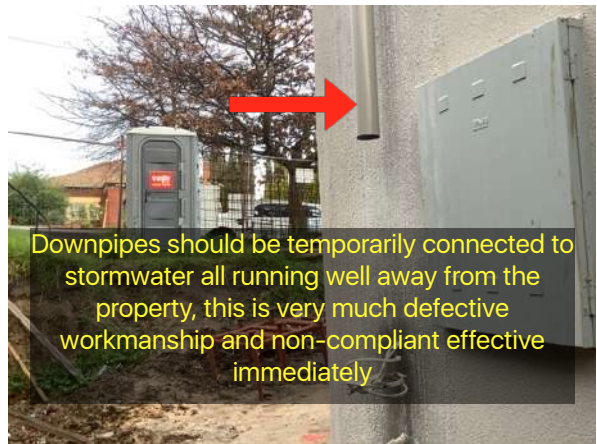
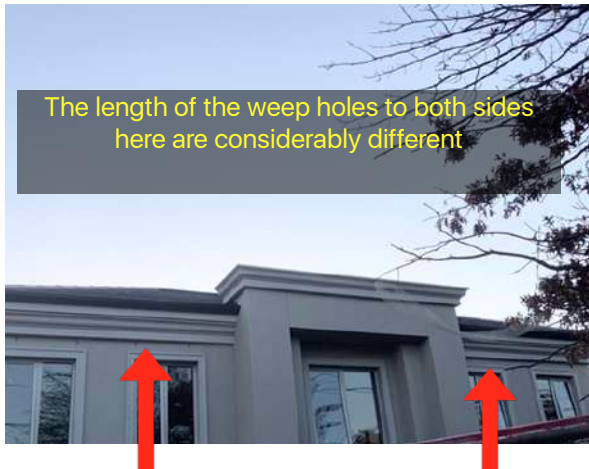
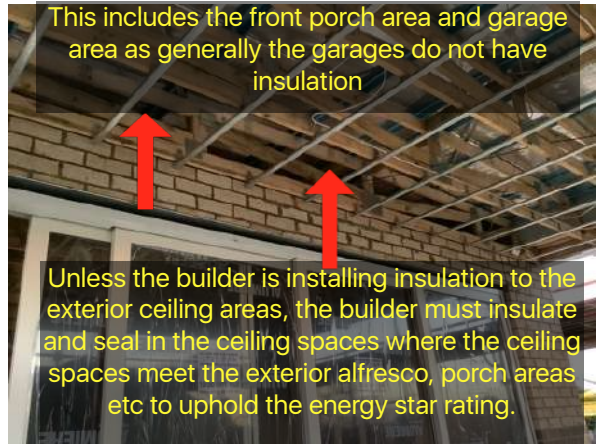
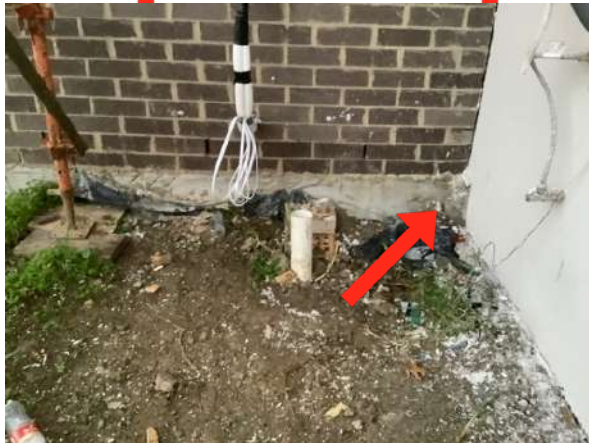
Location: Unfinished/Defective Works

Finding: Unfinished/Defective Works

All these photos are added, to demonstrate DEFECTIVE / SUB STANDARD and/or INCOMPLETE WORKS and they are all required to be rectified as they are ALL not satisfactory for New construction specifications of finish required as per the DOMESTIC BUILDING CONTRACT ACT 1995 as stated in the contract :

The following items will need to be completed or repaired in accordance with the Domestic Building Contracts Act 1995.

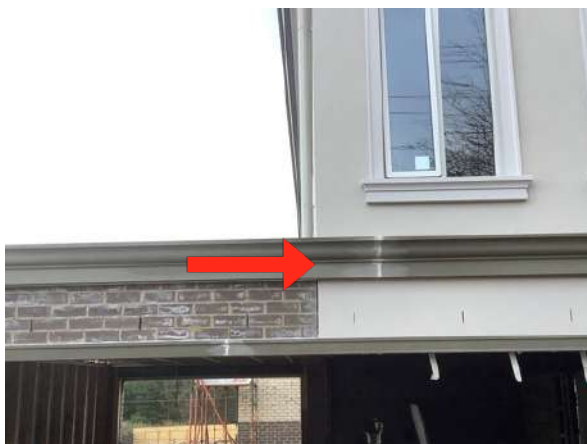
### Substandard Workmanship 3.02

Finding: Articulation joints & Mouldings Defective (AS3700)

Mouldings and inflexible covering strips are defective if they are installed across articulation or control joints and are fixed or restrained on both sides.

Where required, articulation/control joints are defective if they are not sealed in accordance with AS 3700.

Replacement of these mouldings may be required to meet associated standards.
