Post-Concrete Pour Slab Report

Inspection Date: 9 Jul 2021

Property Address: Niddrie area

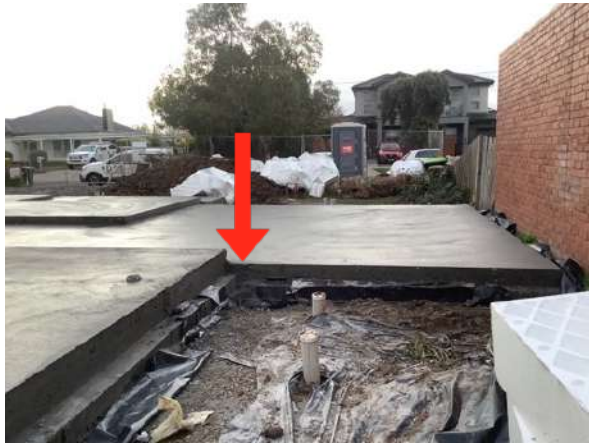
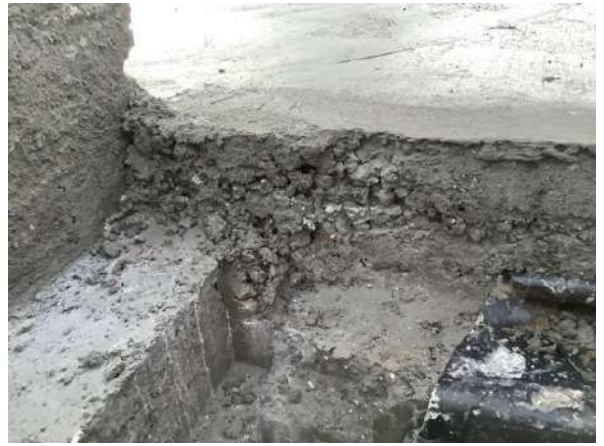
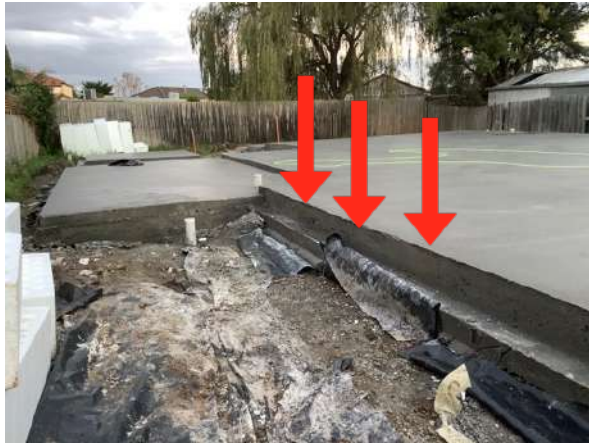
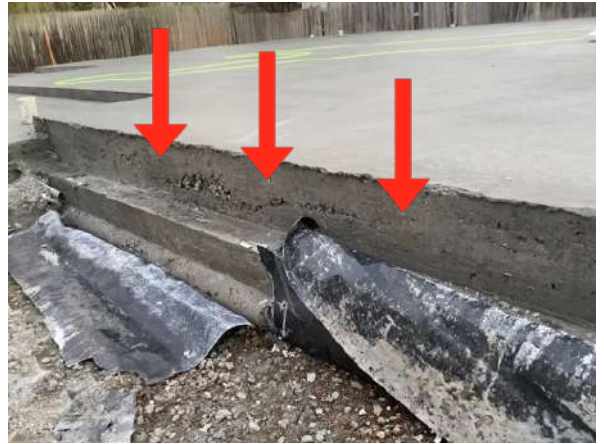
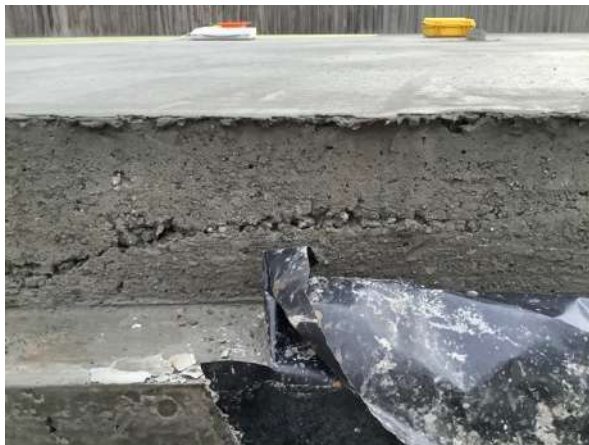
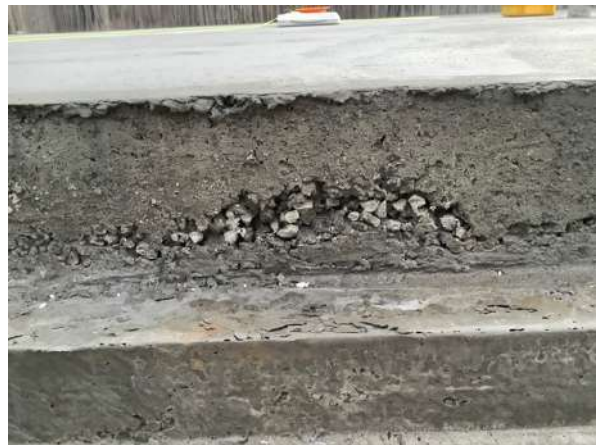
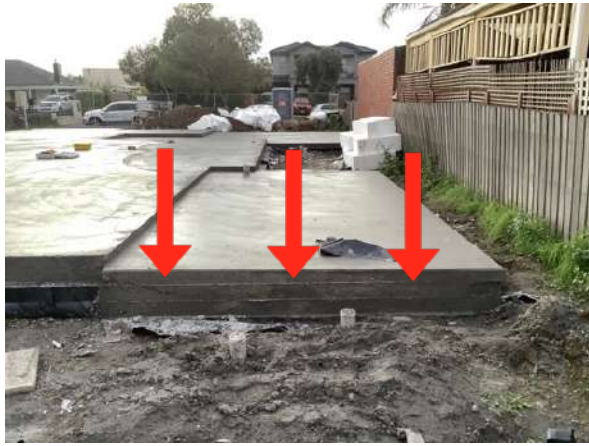
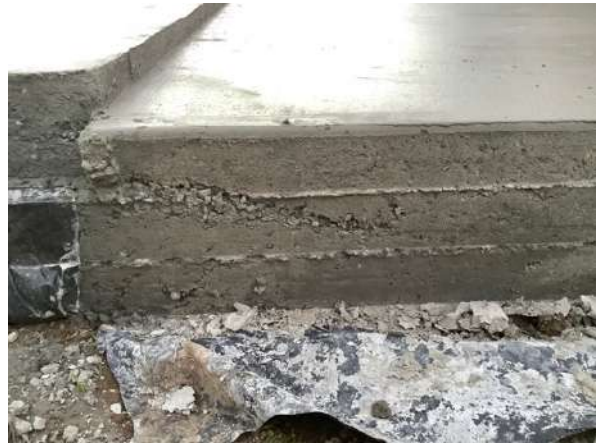
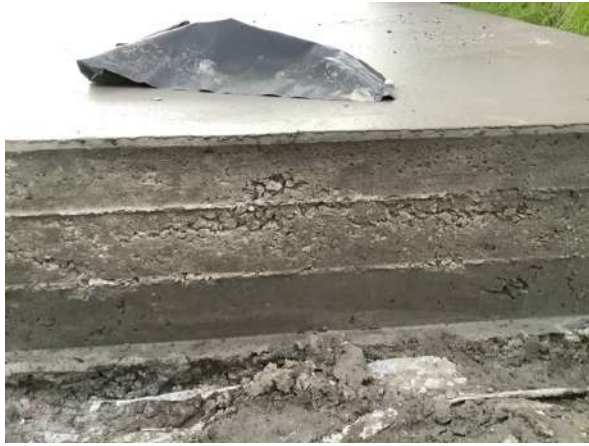
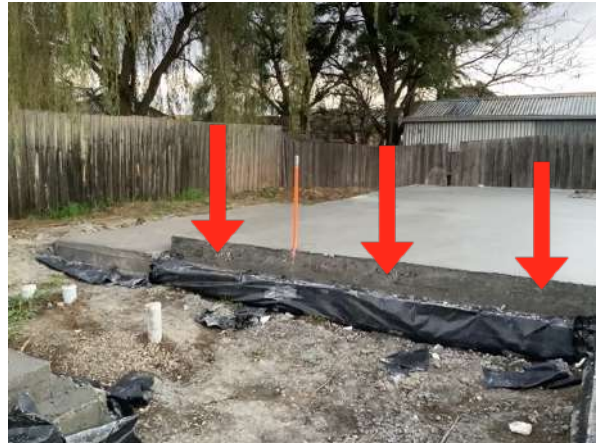
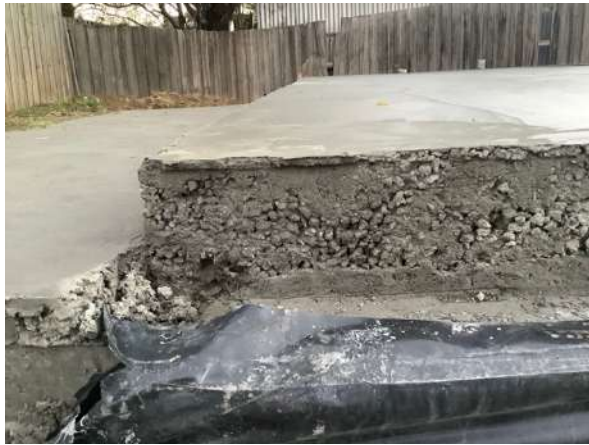
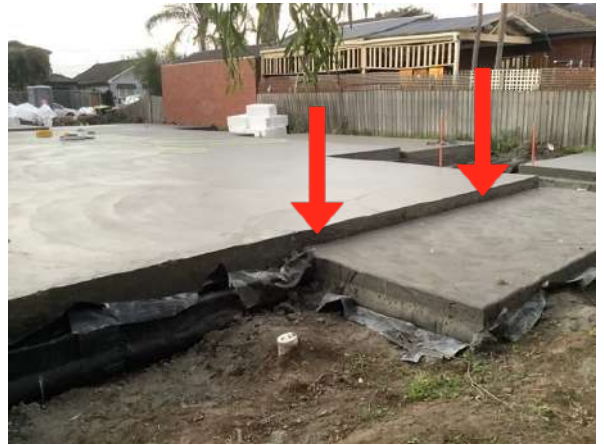
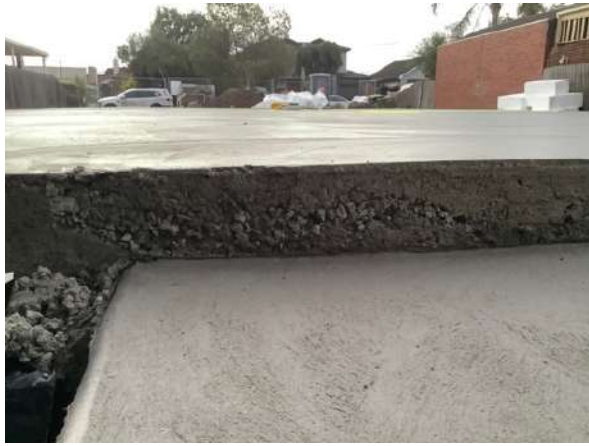
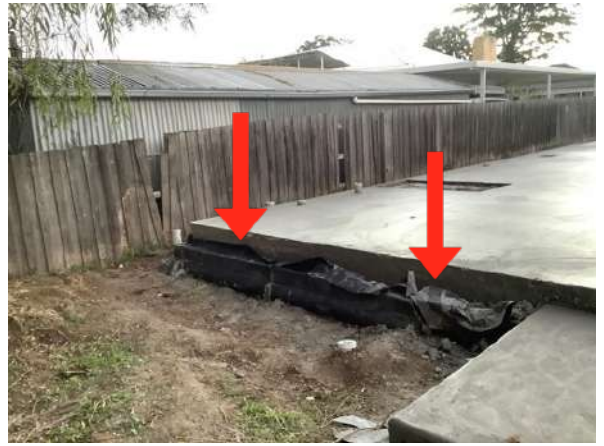
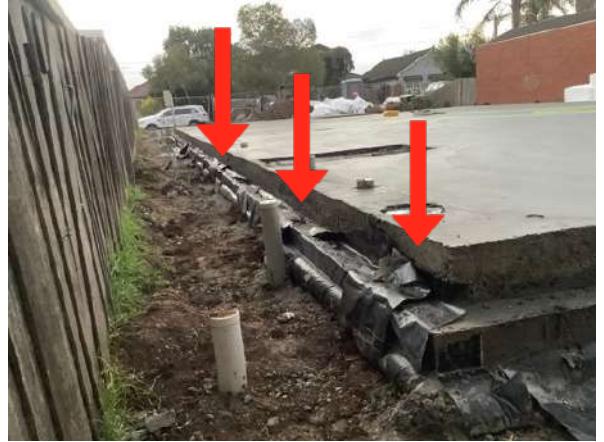
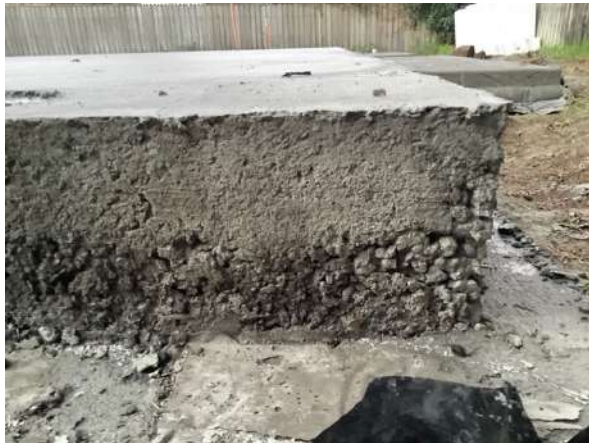
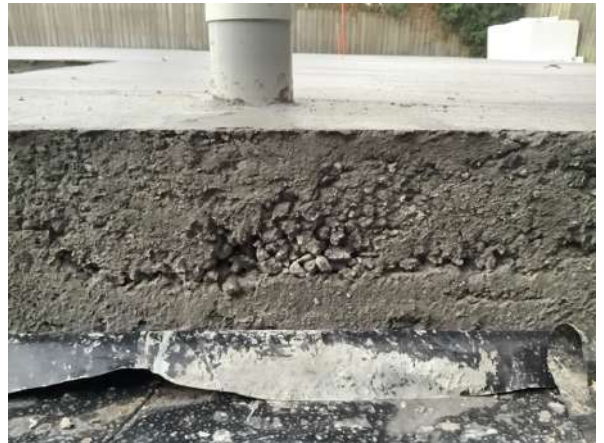
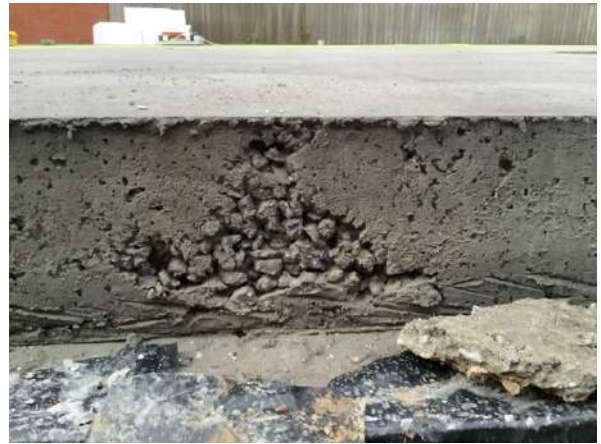
Non Compliant 2.01

Finding: Compaction Of The Slab.(Honeycomb Evident)

Looking at the side of the slab, it appears evident that the slab has not been vibrated to all parts. The honeycomb effect that is made up of hundreds of air pockets is what should not be present.

Had this slab been vibrated to all parts, then this honeycomb effect would not be present and the concrete would have a smooth like finish.

The defect is that if it has not been done to the outer skin of the exposed areas, then the likely hood is that the internal of the slab has the same honeycomb effects as well and if this is the case then the density of the concrete will be compromised.

-/ Seek engineering advice.

-/ Seek a Compressive Strength Test to check the MPA strength after a certain period of cure time.

-/ Sample the slab via a core hole or several core holes that are taken by a NATA accredited testing agency. Note the NATA testing agency must take the samples to ensure a reliable chain of evidence.

-/ Share the results with my client and the engineer.

-/ Upon all the results a conclusion that meets the AS 2870.

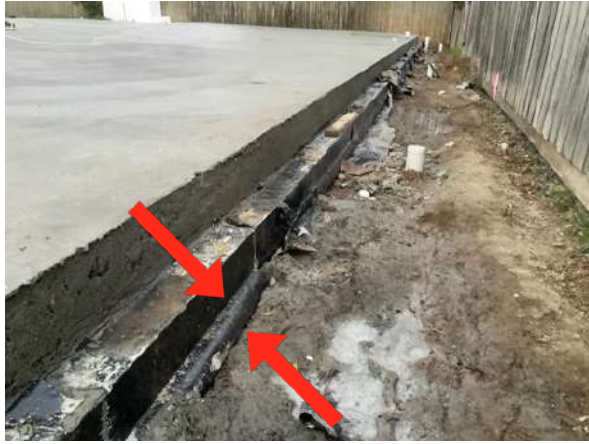
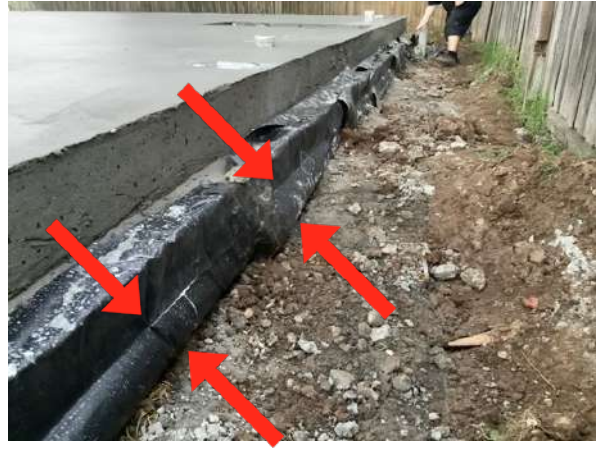
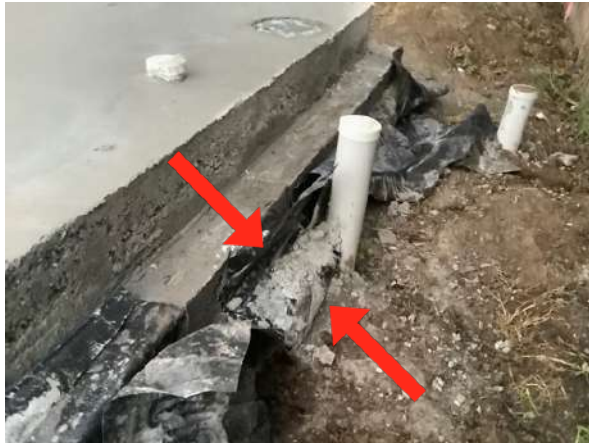
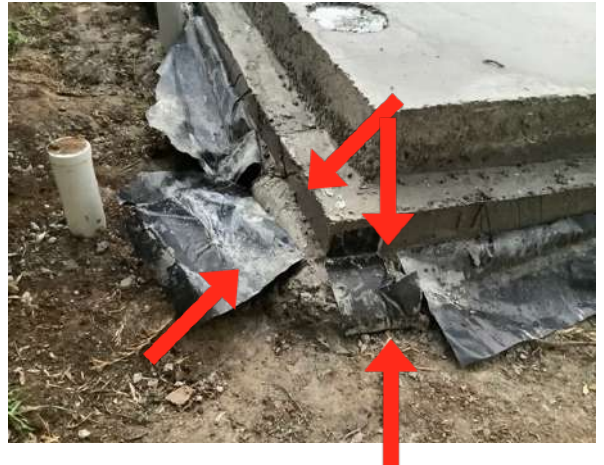
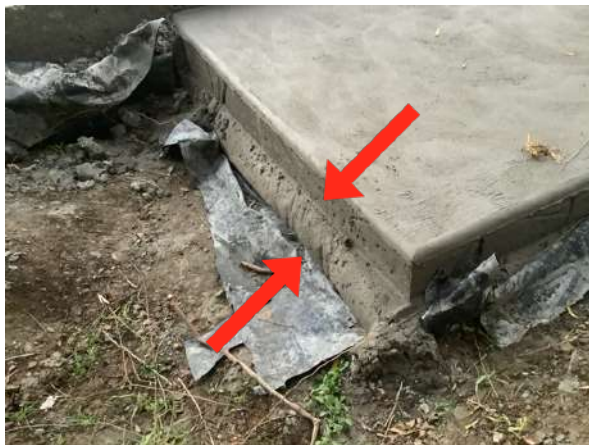
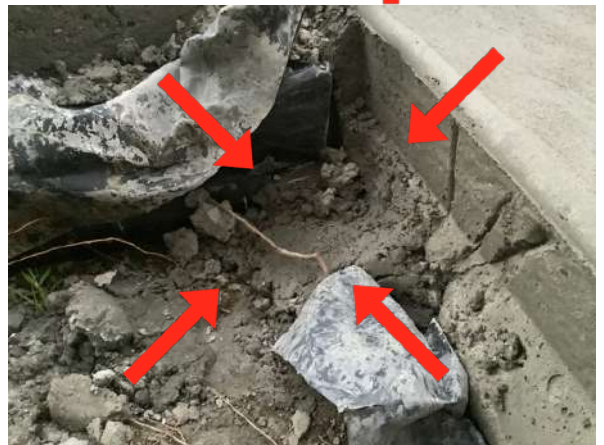
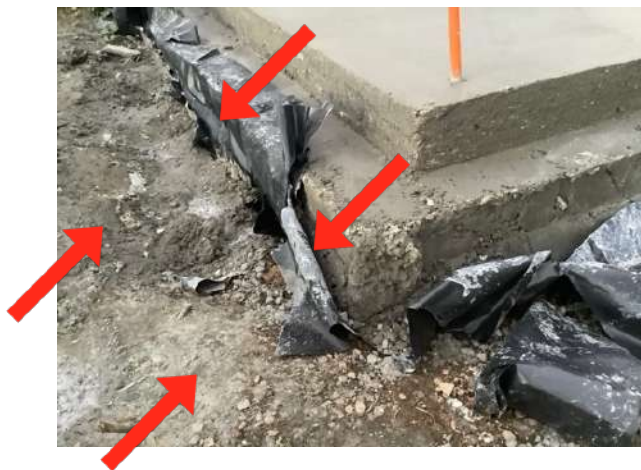
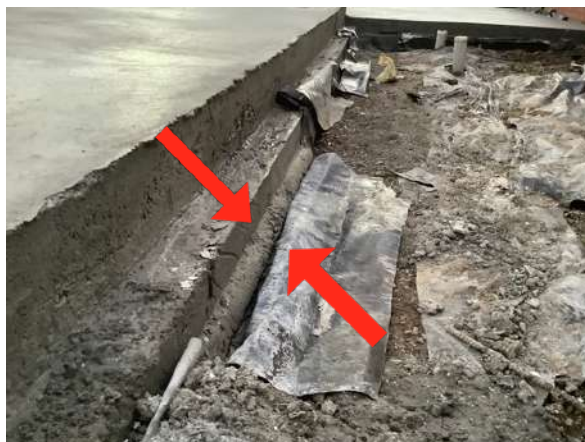
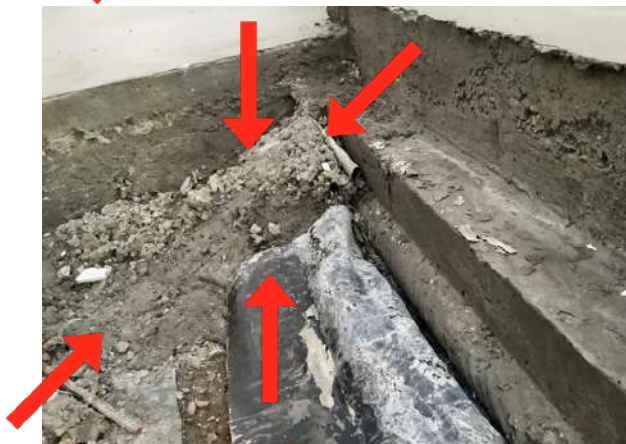
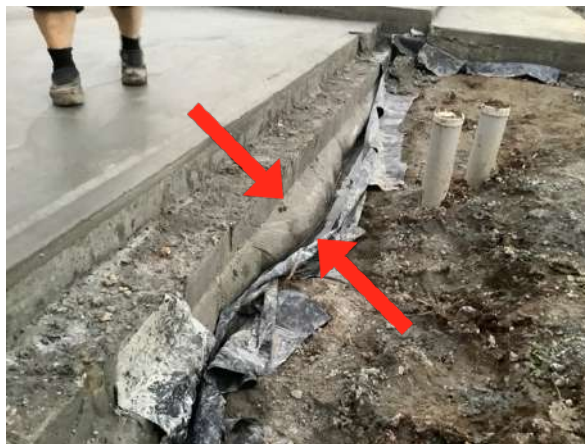
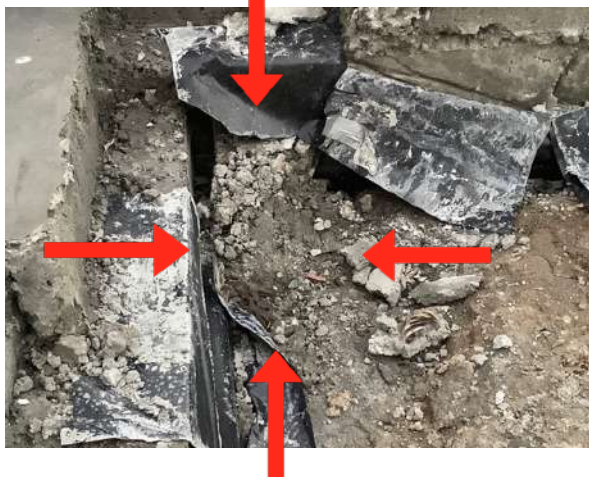
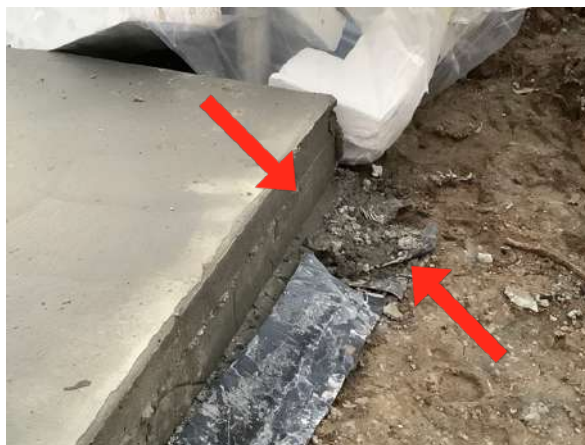
Non Compliant 2.02

Finding: Slab Over Pour - Not Acceptable.

The slab has been installed with what is known as over pour.

The over pour will affect the home owner's ability to install paving and other landscaping.

THIS WILL EFFECT THE VAPOUR BARRIER SYSTEM, WHICH IS EXTREMELY IMPORTANT AND MAY ALSO EFFECT THE APPEARANCE OF THE HOME, ONCE THE CONCRETE PAVING AND/OR GARDEN IS COMPLETE.

The over pour will need to be removed. This will require:

-/ Seek engineering process and design for rectification of this defect.

-/ Document same.

-/ Send the engineering to the site surveyor for approval.

-/ Have the site surveyor witness the repair of the slab to ensure that the builder has carried out the works in accordance with the process's and rectification statements in the engineering documentation.

-/ Supply a copy of all to my client as per section 26 of the Domestic building contracts Act 1995.

-/ Satisfy the defect has not been hidden by placing soil over the edge beam of the over poured slab.

I HIGHLY RECOMMEND WITHOUT ANY COMPROMISE, THAT THE BUILDER RECTIFY THE DEFECTIVE CONCRETE SLAB PERIMETER WITHOUT COVERING WITH SOIL , CRUSH ROCK, BRICK LAYERS MORTAR DEBRI OR ANYTHING ELSE.

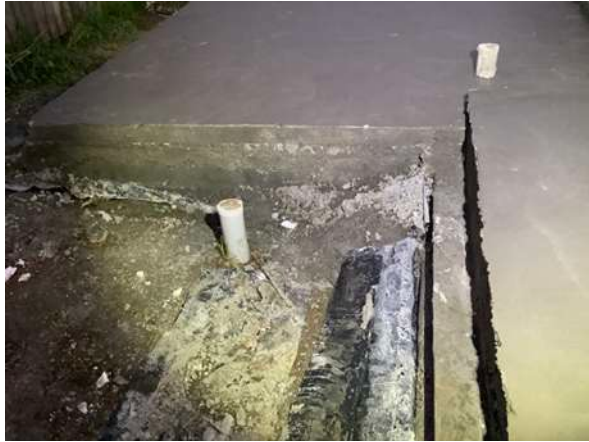
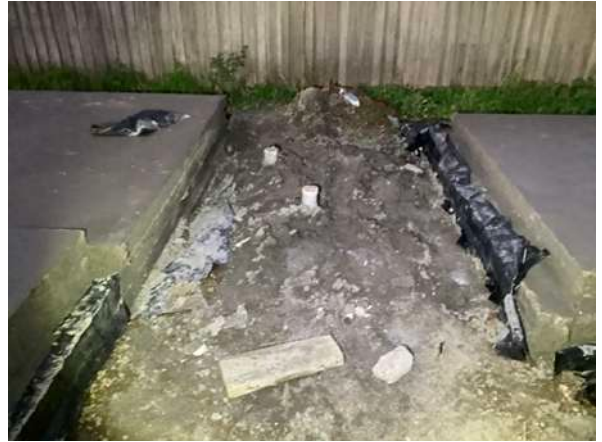
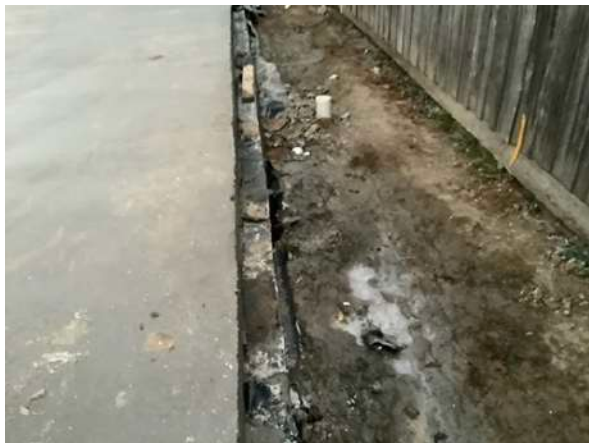
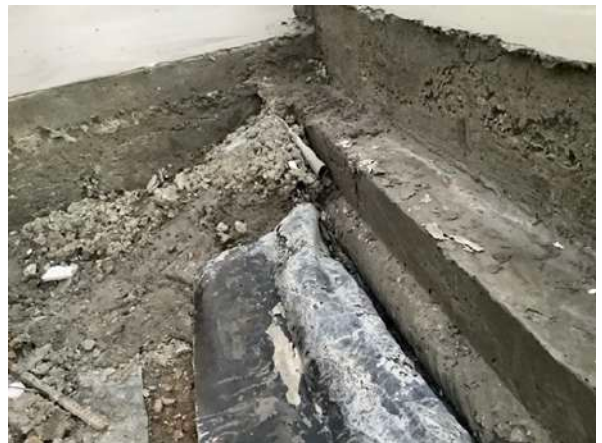
Non Compliant 2.03

Excessive Concrete (Builders Waste/Debris)-Slab over pour and/or excessive builders concrete waste

It appears that there is excessive builders concrete waste/debris around the perimeter of the concrete slab.

This excessive concrete has also severely compromised the vapour barrier system as well.

It is very important to rectify this before any covering up is performed around the perimeter of the concrete slab with soil or crush rock.

◆ I HIGHLY RECOMMEND WITHOUT ANY COMPROMISE, THAT THE BUILDER RECTIFY THE DEFECTIVE CONCRETE SLAB PERIMETER WITHOUT COVERING WITH SOIL , CRUSH

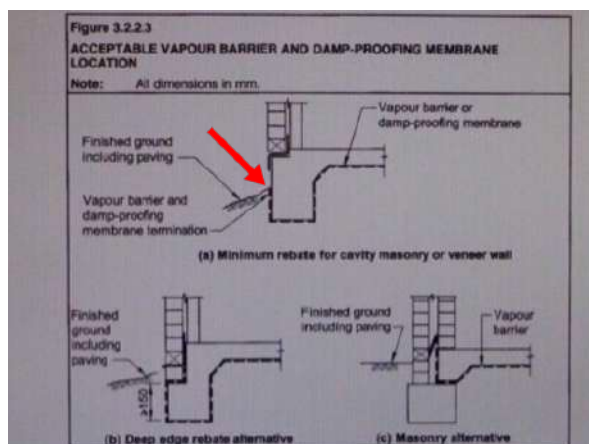
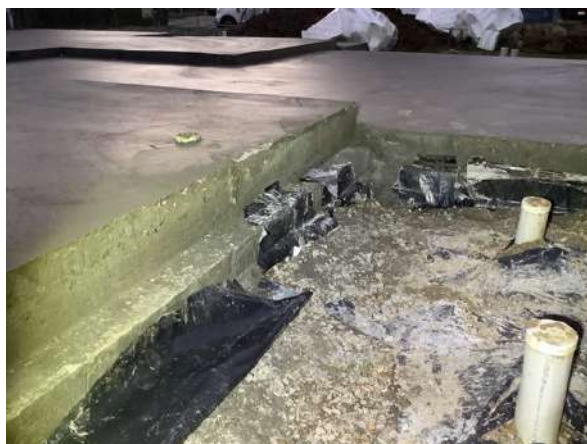
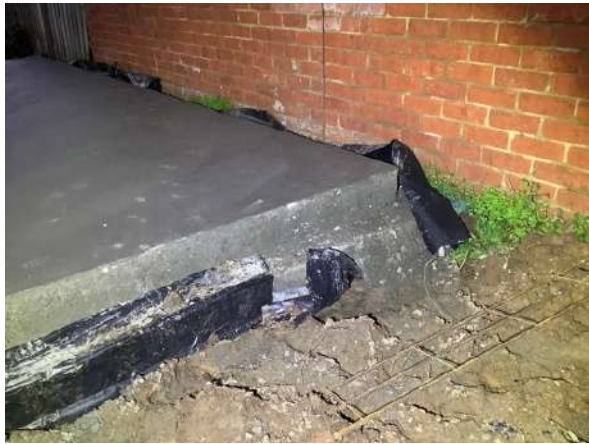
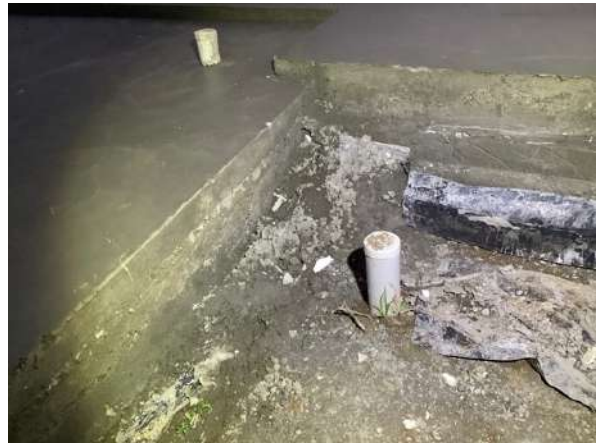
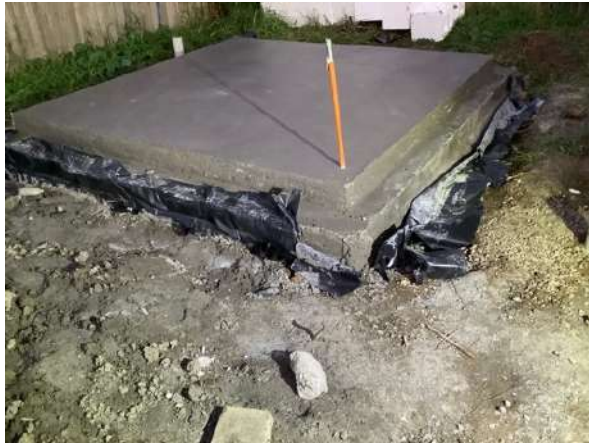
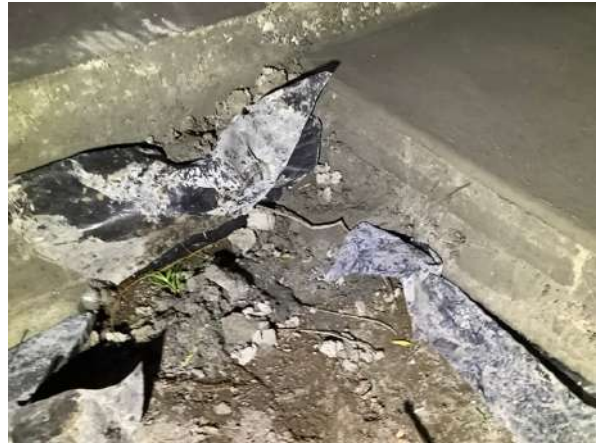
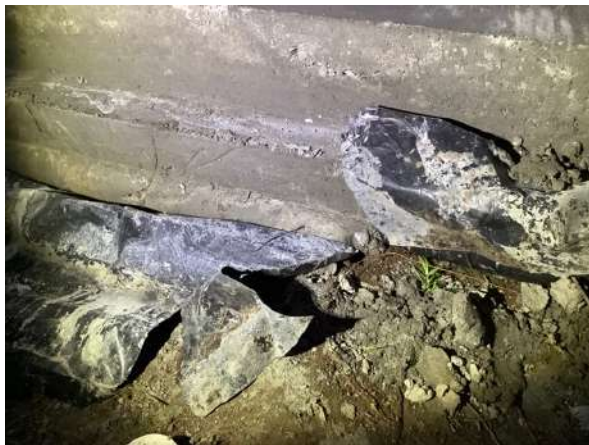
Non Compliant 2.04

Finding: Polyethylene vapour barrier not installed as per BCA - Part 3.2.2.6

The vapour barrier system has NOT been completed and installed in accordance with AS2870 and BCA Part 3.2.2.6. ALL areas of non compliance are required to be repaired.

It is obvious that the concrete contractors have added additional plastic on the day of the concrete pour, however this added plastic is just sitting there.

The photos are very clear examples of the plastic doing nothing or minimal as the plastic MUST BE TAPED AT ALL PLASTIC JOINS at a minimum of 200mm overlap and taped with an appropriate tape and it clearly isn't the case on this job.

To entirely dig the external perimeter of the building at least 300mm below the vapour barrier system (black plastic) damaged areas, which will vary in areas and then overlap the existing plastic with the new plastic by a minimum of 200mm and taped.

The overall height of the plastic must be above the top of the slab rebate surface for now at construction stage.

The plastic must be hard against the concrete with no soil, rocks and/or builders debris in between the slab and the plastic.

Any over pour of concrete must be cut flush and include engineers report for alteration works and if steel is visually seen must now also be notified to the structural engineer to determine the remedial works.

The builder must supply the vapour barrier system clean, visible and tight against the concrete perimeter slabs at handover, without compromise.

I HIGHLY RECOMMEND WITHOUT ANY COMPROMISE, THAT THE BUILDER RECTIFY THE DEFECTIVE CONCRETE SLAB PERIMETER WITHOUT COVERING WITH ANY ADDITIONAL
 ♦ SOIL , ANY ADDITIONAL ♦ CRUSH ROCK, ♦ BRICK LAYERS MORTAR DEBRI OR ANYTHING ELSE, PRIOR TO A RE-INSPECTION BY Master Property Inspections.

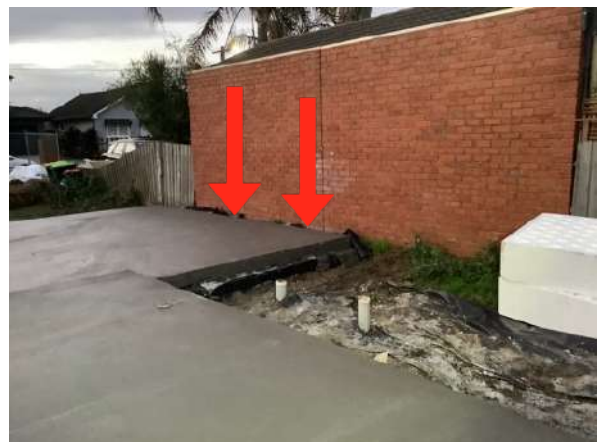
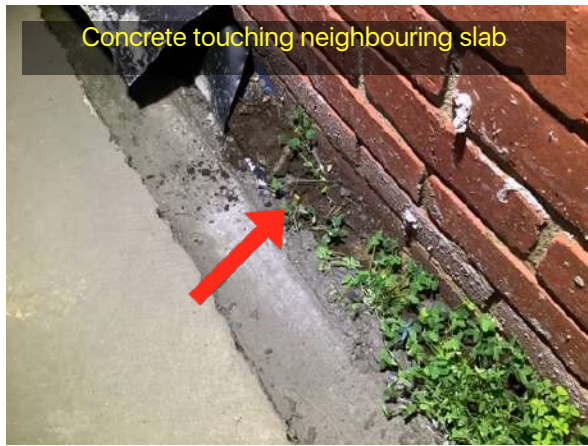
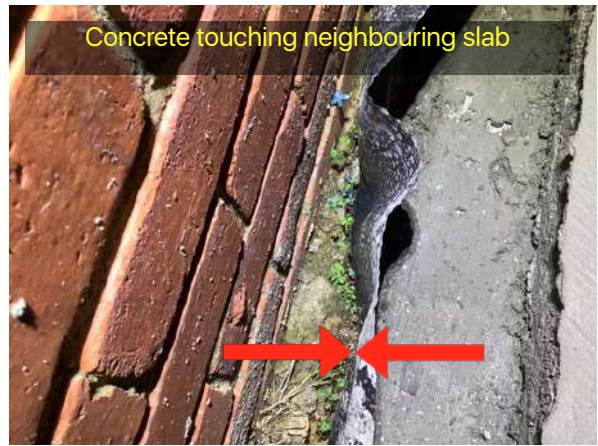
Non Compliant 2.05

Finding: Gap BETWEEN BUILDINGS Required - NO bond breaking flexible product
 Gap Between Buildings Required - NO bond breaking flexible product (Between Buildings)
 Concrete will be Butting / Touching the next doors concrete slab .

The slab abutment to the neighbouring slab edge has not been set up with a bond breaking flexible product such as ableflex. (Minimum Of 10mm gap required)

I noted that the connection between the adjoining property and my clients has no provisions for isolation and it appears that other than the vapour barrier plastic, this part of the BCA has not been complied with.

The performance requirements of the BCA mandate that this isolation is in place. It is more than likely that any movement on either site will impact on the other. This creates a multitude of legal questions should one or the other of the dwellings suffers cracking or movement.

A 10MM GAP MUST BE BETWEEN THE NEIGHBOURS PROPERTY AND THIS PROPERTY.
 It is important that the builder create this gap from the very top of all areas to the very bottom of all areas. If any areas of either the neighbors side or this side are touching then the concerns of touching properties are of great concern and hydraulic forces may potentially create building damages such as concrete cracking, brick cracking and many other secondary building problems to either properties.

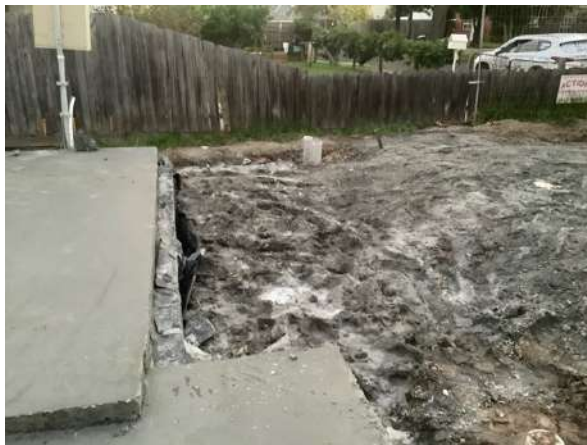
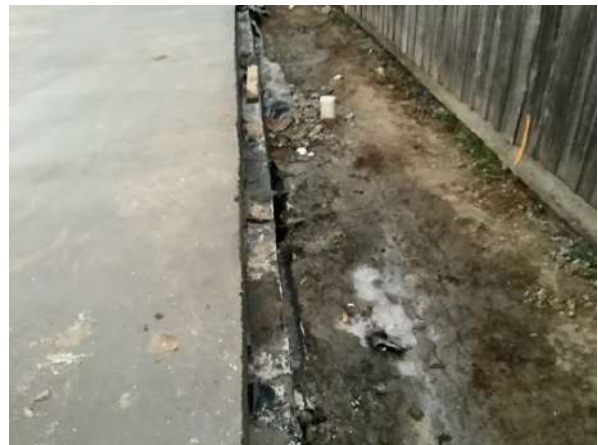
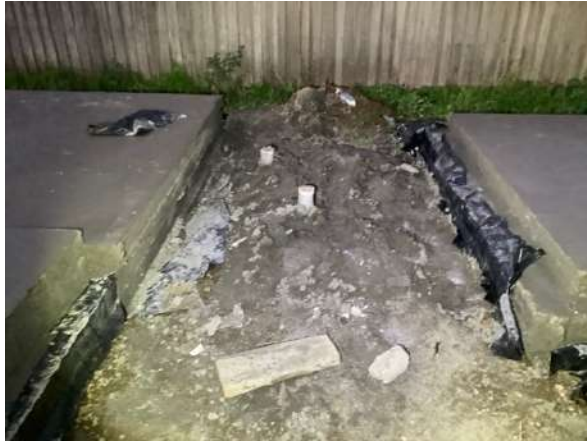
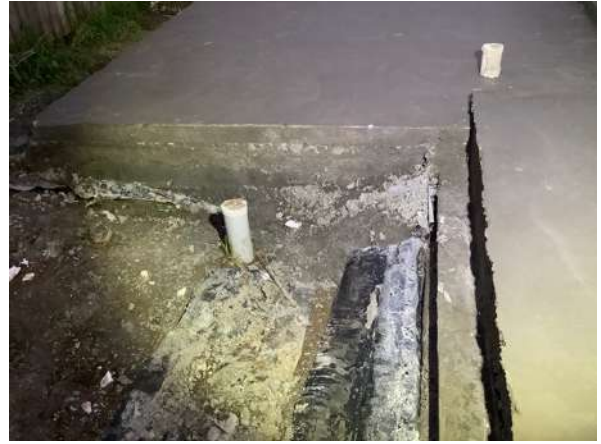
Substandard Workmanship 3.01

It was noted that there is excessive amount of concrete (builder waste) on the site in various areas. All builders waste must be removed as per the contract.

I HIGHLY RECOMMEND WITHOUT ANY COMPROMISE, THAT THE BUILDER RECTIFY THE DEFECTIVE CONCRETE SLAB PERIMETER WITHOUT COVERING WITH SOIL , CRUSH ROCK, BRICK LAYERS MORTAR DEBRI OR ANYTHING ELSE.

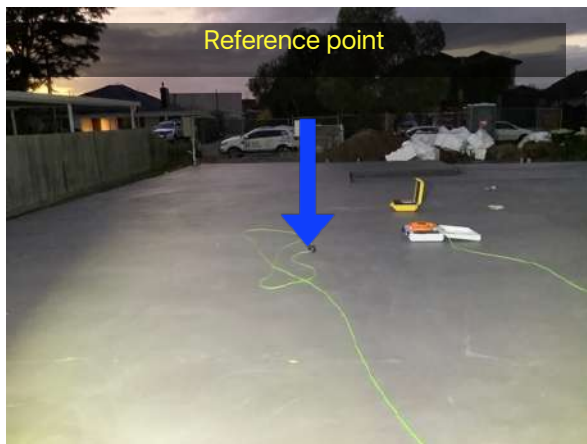
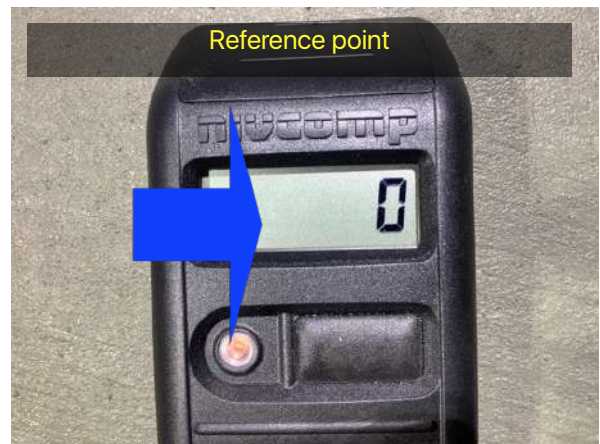
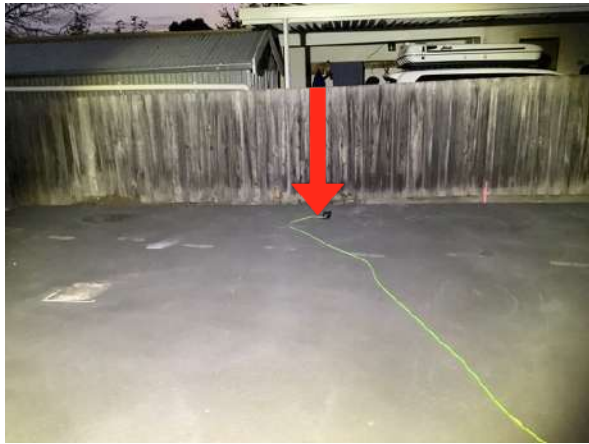
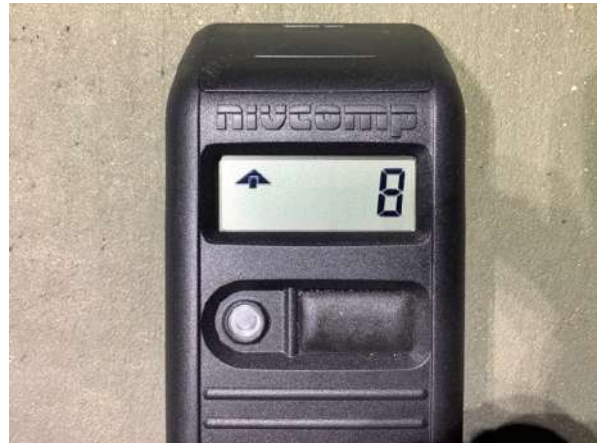
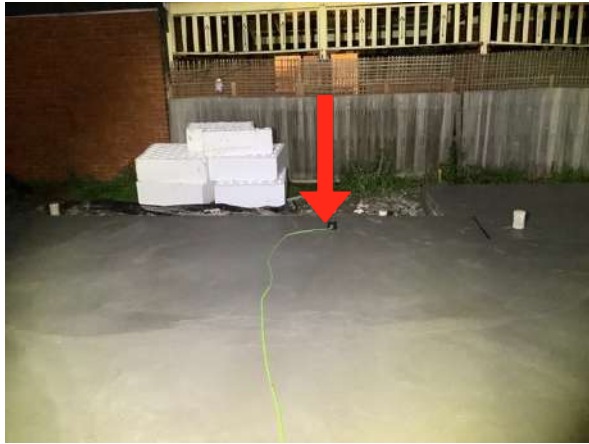
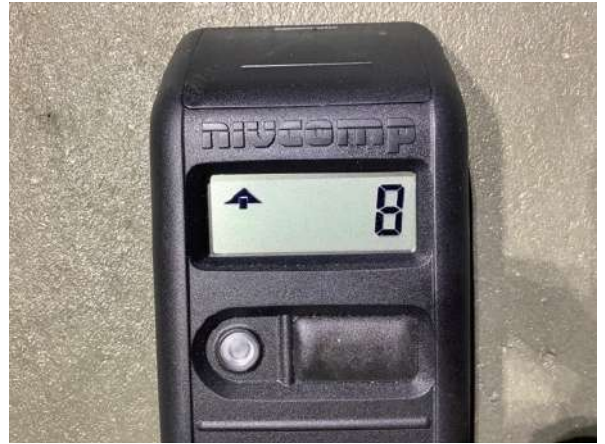
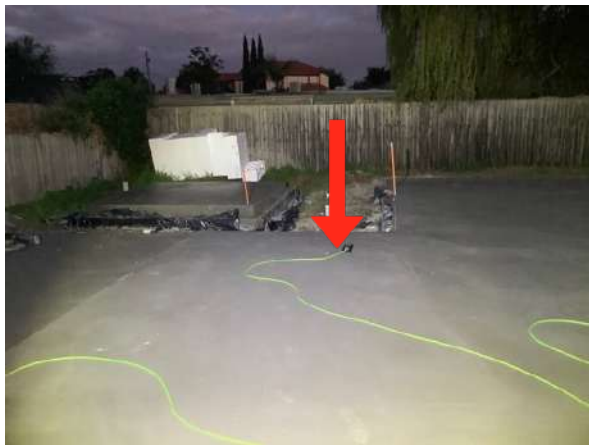
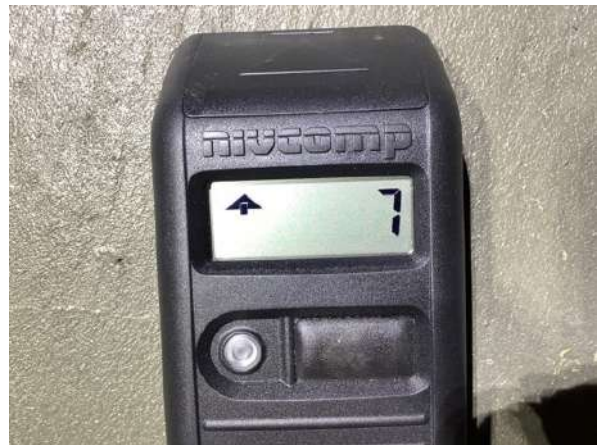
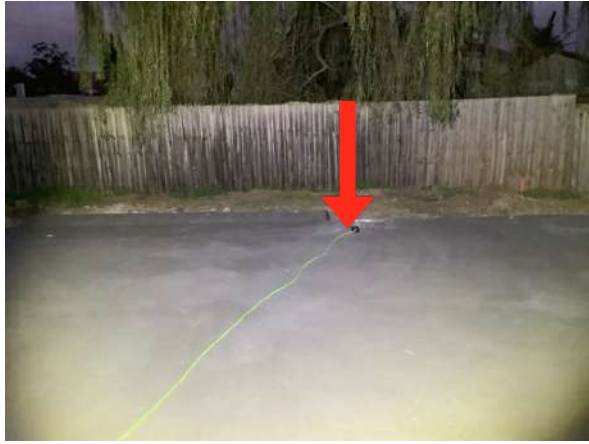
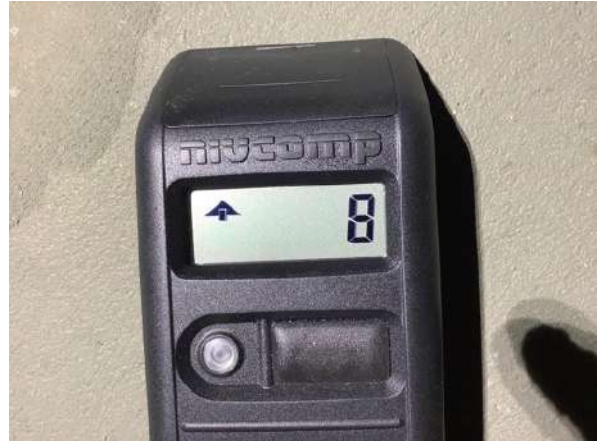
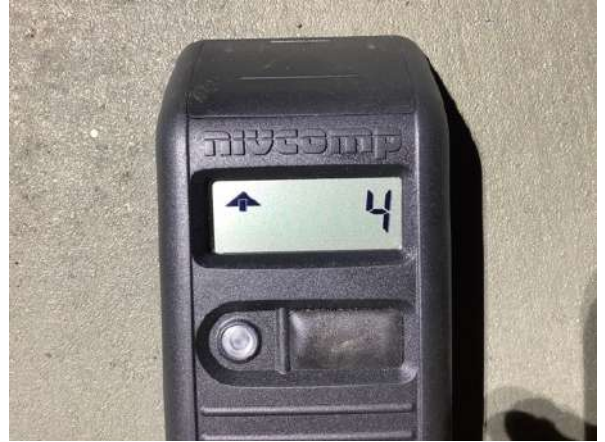
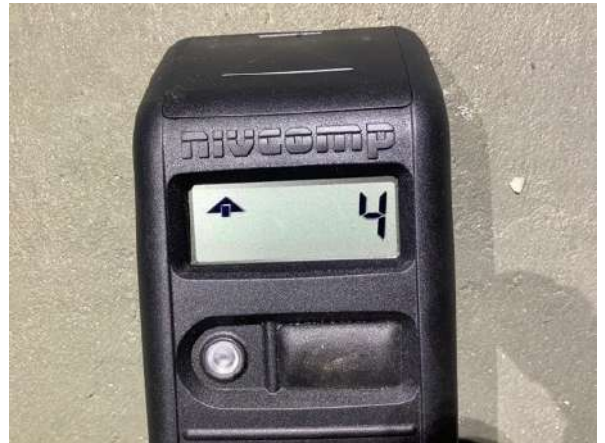
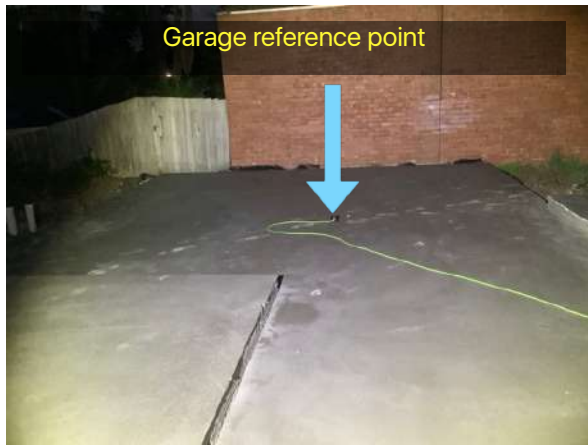
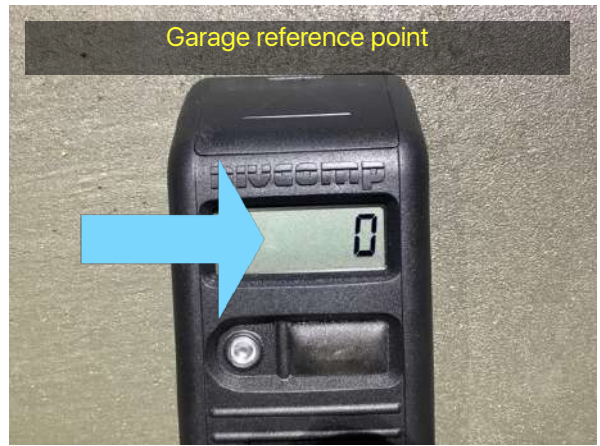
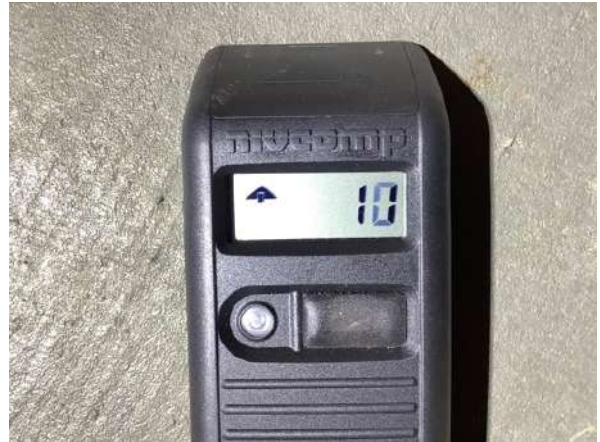
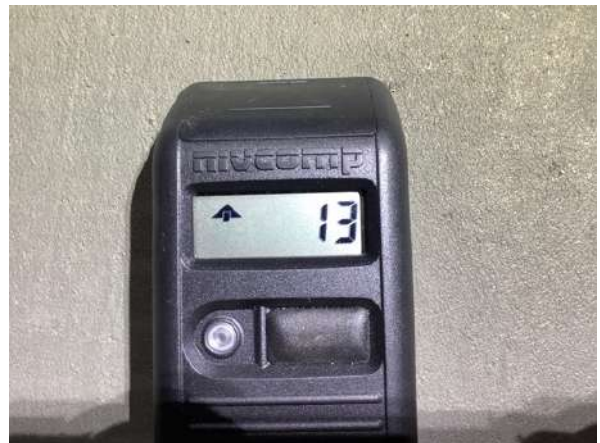
Whilst the concrete levels are within tolerance, it is important to note that there are levels that are out of level and/or close to out of tolerance.
 The concrete slab does appear to have a dish surface affect and I do recommend the builder take this into consideration when continuing the build process
