Pre-Concrete Pour Slab Report

Inspection Date: 9 Jul 2021

Property Address: Niddrie area

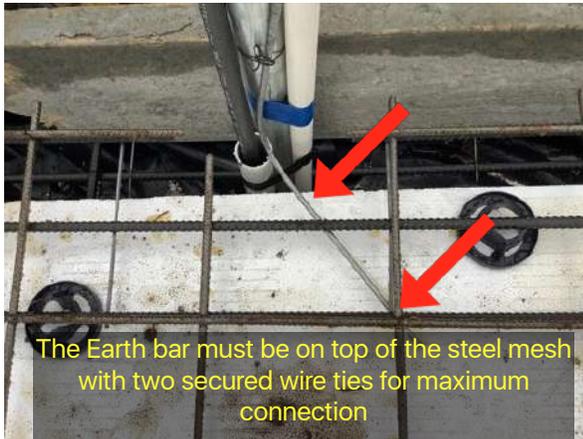
Safety Hazard 1.01

Location: Meter box
Finding: Earthing To Steel Mesh-NOT SECURED TIGHT / LIMITED TIES

The earthing facility installed to the dwellings slab steel as required in AS 3000 has not been SECURED TIGHT / LIMITED TIES to the top of the steel mesh, To maximise the connection.

I refer the builder to AS 3000, clause 5.6.2.5 that states "Any conductive reinforcing within a concrete floor or wall forming part of a shower or bathroom shall be bonded to the earthing system".

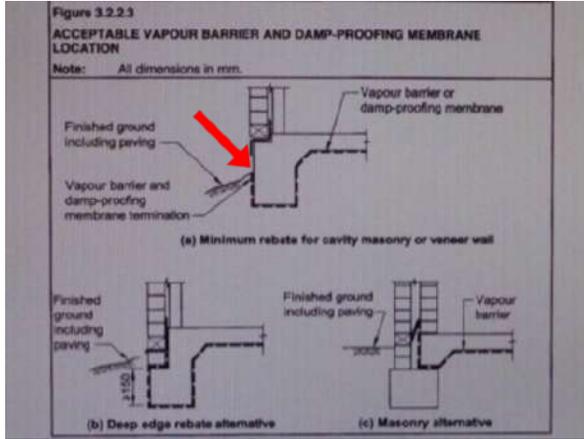
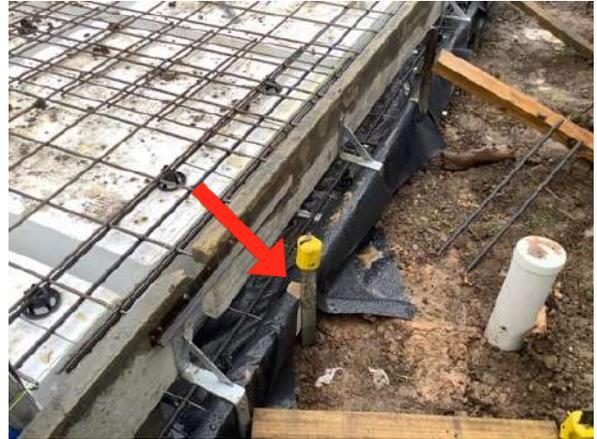
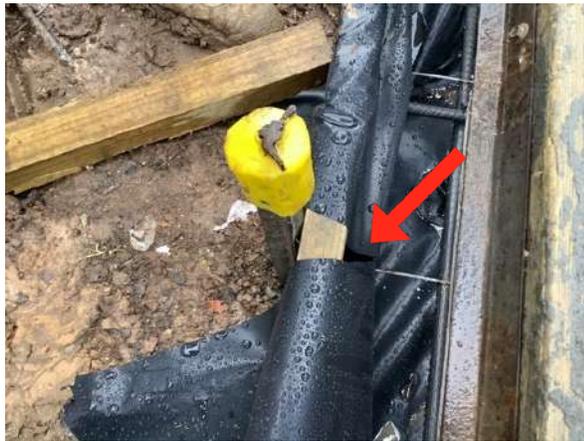
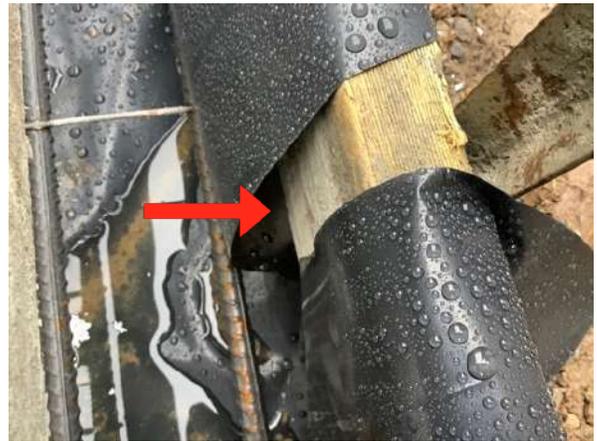
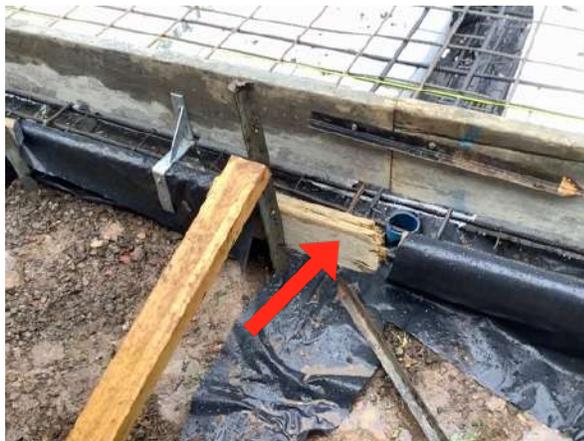
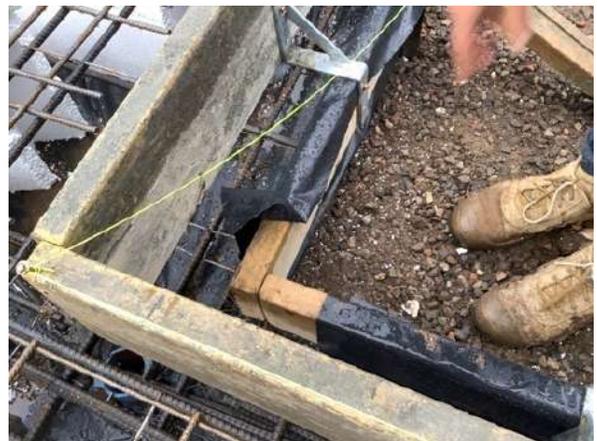
Non Compliant 2.01

Location: All Areas

Finding: Polyethylene (plastic) vapour barrier not installed as per BCA - Part 3.2.2.6

We have added some photos as examples however the vapour barrier is quite compromised and non-compliant throughout the perimeter, including the back separate concrete slab as well.

Defective Vapour Barrier Installation - Damaged/Punctured and/or overlapping Defective.

It was noted at the time of inspection that a vapour barrier had not be installed in accordance with AS2870 and BCA Part 3.2.2.6.

The polyethylene vapour barrier from beneath the concrete floor slab must be turned up the external side faces of its edge beams. Failing to install the vapour barrier correctly will allow moisture ingress via slab edge dampness into the internal timber wall skins and/or the floor coverings if not done.

Without a vapour barrier installed, these areas are non-compliant with Australian Standards and are susceptible to excessive moisture, which may create major secondary defects as the building ages. Rectification works are necessary as soon as possible to ensure all standards are met.

1/ All over laps are not taped as described below.

2/ All the rippes and/or damaged area needs to be taped.

3/ Some areas are not up to future ground and/or finished paving or concrete heights and must be extended with 200mm overlay and taped.

4/ Somes areas whilst listed above are Damaged / Ripped / Not Consistent And Sealed with 200mm Overlay And Taped / Not High Enough / Non Existent must ALL be repaired.

The polyethylene vapour barrier must properly extended up the external side faces of the edge beams to at least the height of future finished ground level or paving i.e. 75mm below the damp-proof course and bottoms of the weepholes, after which any termite barriers that are in place, if required, will also need to be properly instated.

All AREAS to the ENTIRE slab should be checked CAREFULLY to identify any further defects that are the same as this defect.

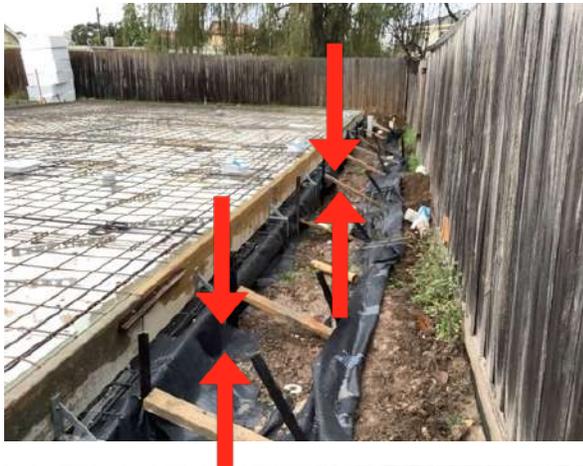
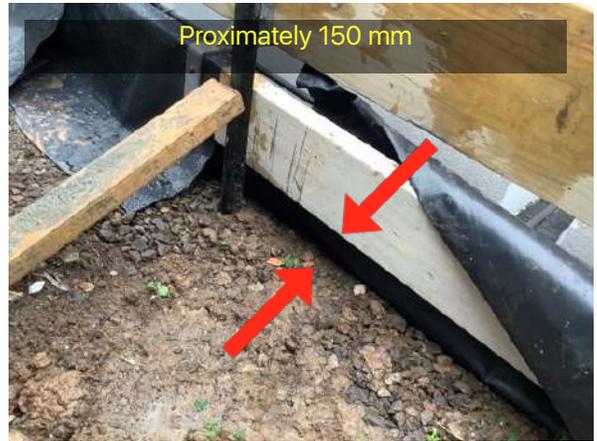
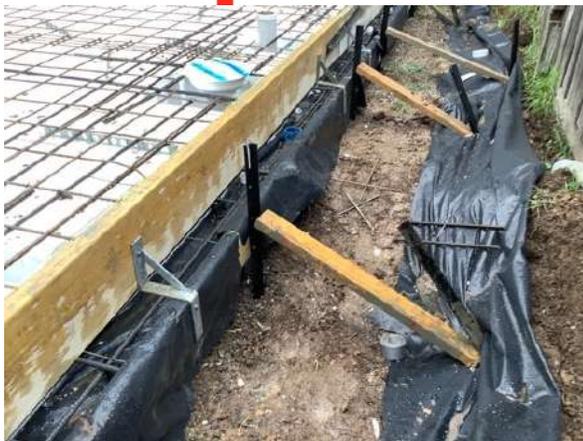
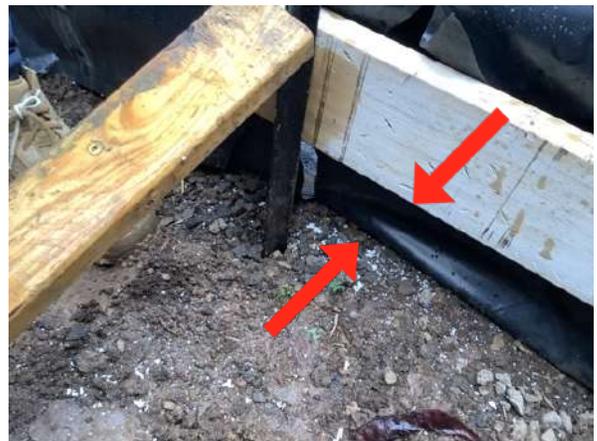
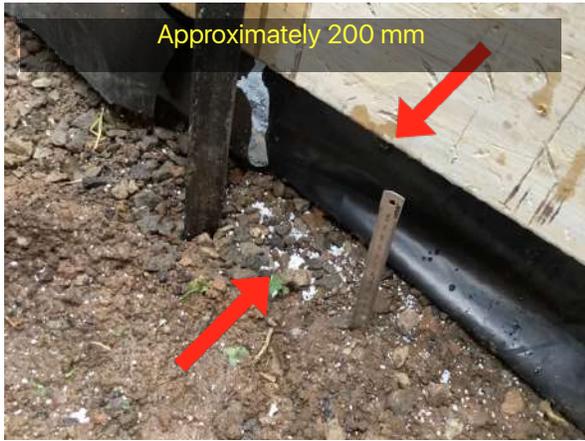
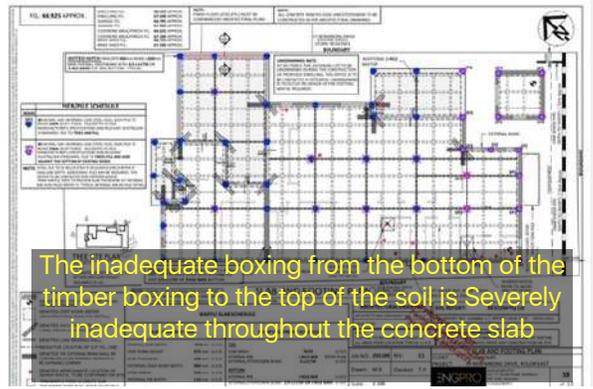
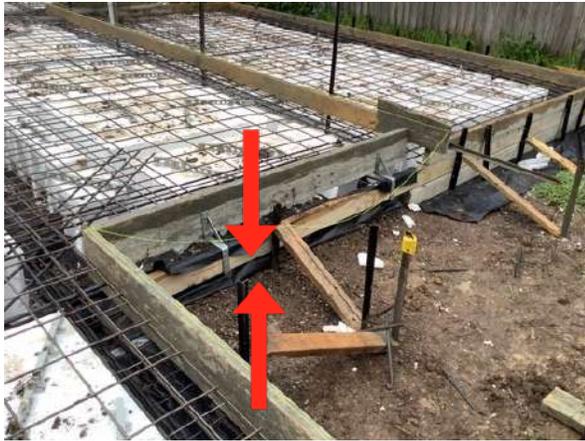
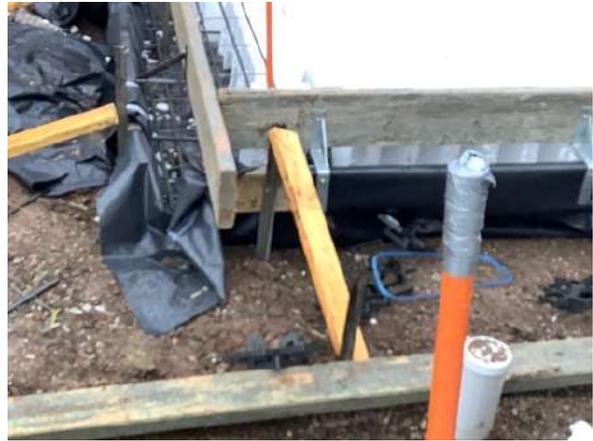
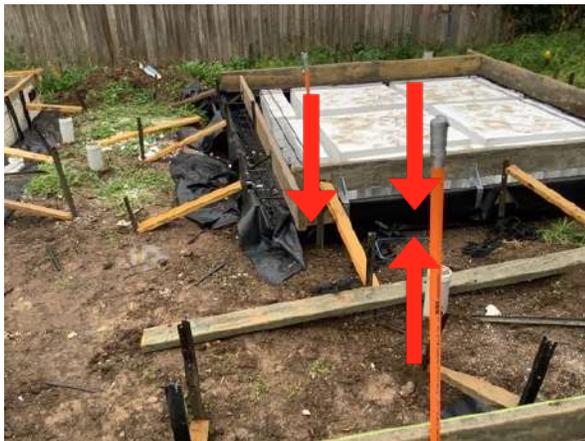
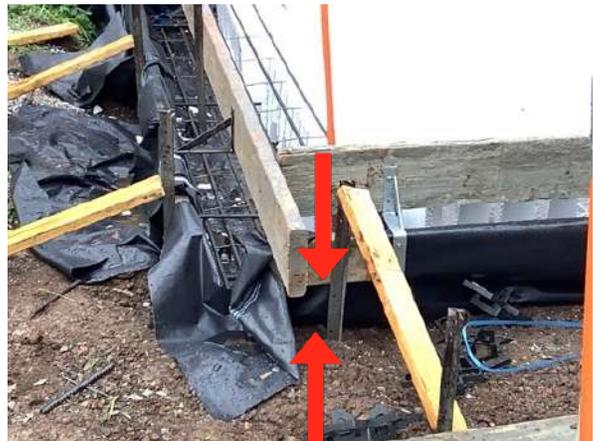
Non Compliant 2.02

Location: All Areas
Finding: Timber Boxing - Missing / Inadequate
Timber Boxing Missing

At the time of the inspection there are areas of timber boxing that is missing and inadequate where there will definitely be slab over pour. Additional timbers are required to secure the concrete in place and allow the vapour barrier not to become compromised and to allow the vapour barrier to come up the side of the concrete, vertically straight at 90 degrees in order to comply with the Australian standards

There is Timber Boxing Missing to MANY MANT AREAS and The severity of the missing timbers is quite bad where massive amount of concrete over Paul will occur.

◆ I highly recommend without compromise that all the timber boxing be completed and become compliant prior to the concrete pour, for the best outcome and to not compromise the vapour barrier system as well, Without complete repairs it will be impossible for the vapour barrier not to be compromised.

◆ I highly recommend without compromise that all the timber boxing be completed and become compliant prior to the concrete pour, for the best outcome and to not compromise the vapour barrier system as well. Again as the defect is so severe it's going to take quite some time to complete it to a compliant level.

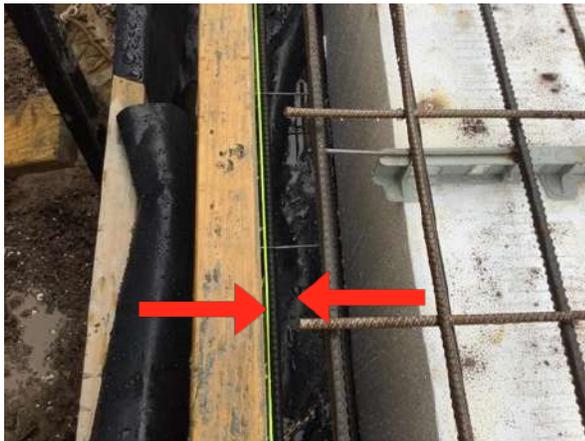
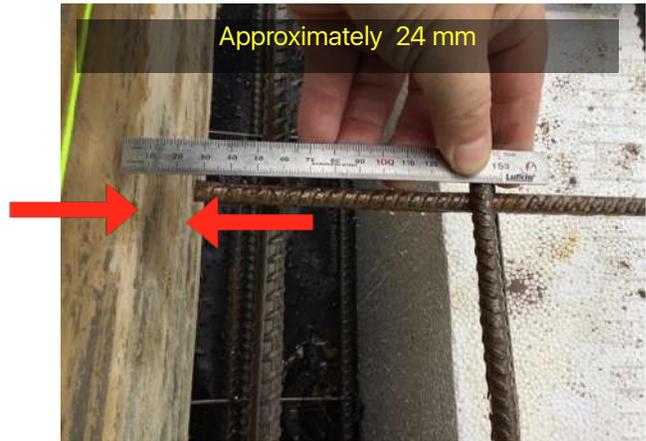
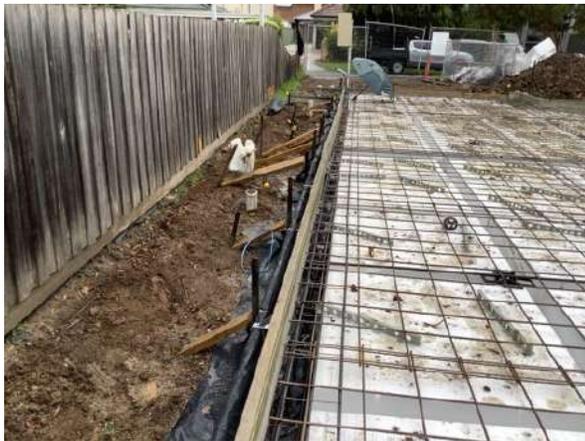
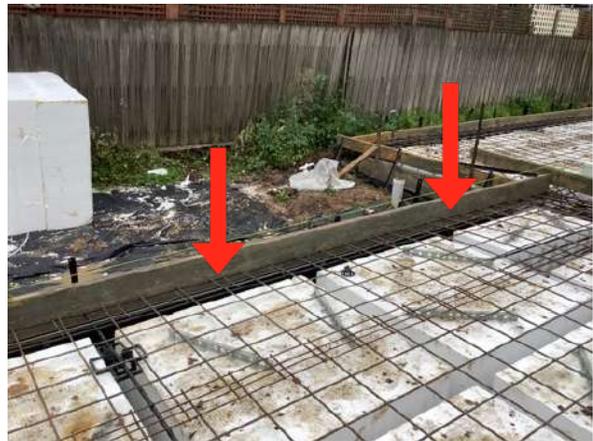
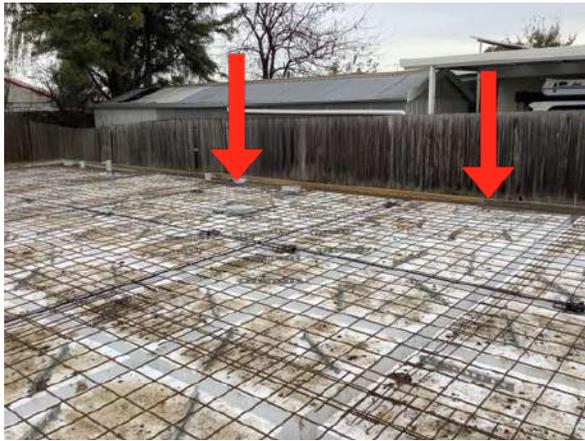
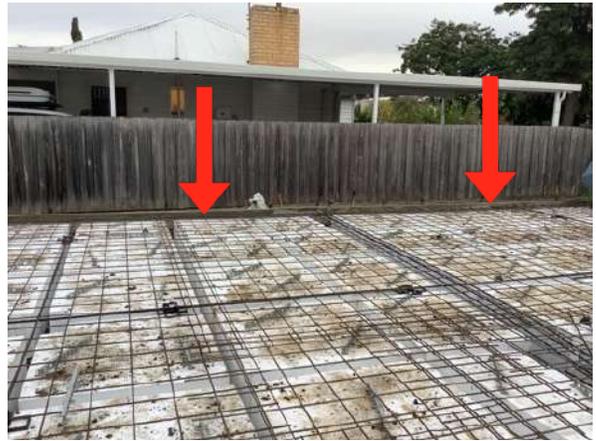
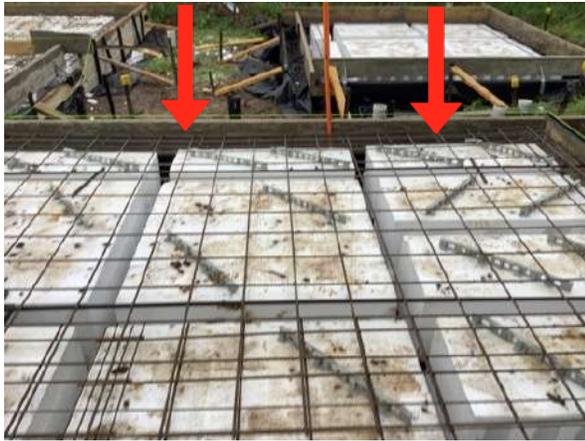
Non Compliant 2.03

Location: All Areas
Finding: Mesh Too Close To The Perimeter.

The reinforcement mesh is sitting too close to the perimeter boxing to sections of the dwelling. 40mm to external exposure, to the entire perimeter boxing is required.

This mesh will need to be cut back or repositioned before the slab is poured to provide sufficient concrete cover to the reinforced steel.

All AREAS to the ENTIRE slab should be checked CAREFULLY to identify any further defects that are the same as this defect.

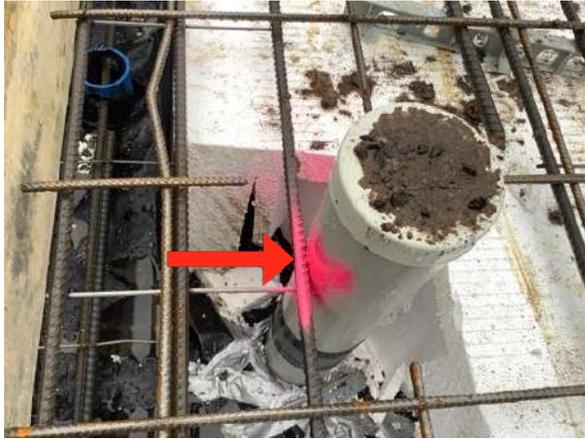
Non Compliant 2.04

Location: All Areas
Finding: Plumbing Pipe Clearance.

At the time of inspection it was found that distance between the plumbing pipes and the Mesh/Reo is NOT at a minimum clearance of 20mm.

It is advised that all the Mesh/Reo that is not 20mm clearance to any plumbing be rectified before the concrete is poured.
Note all repairs required are sprayed with pink paint.

All AREAS to the ENTIRE slab should be checked CAREFULLY to identify any further defects that are the same as this defect.

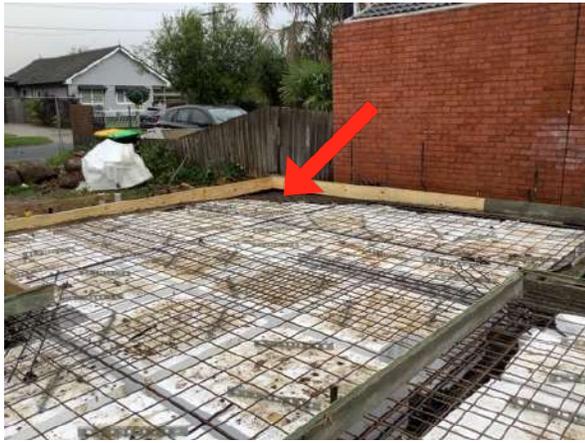
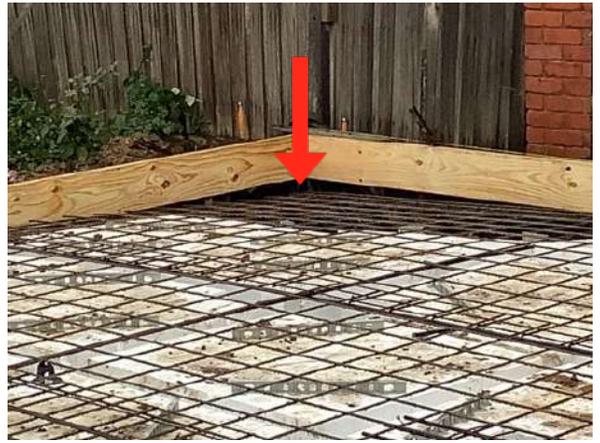
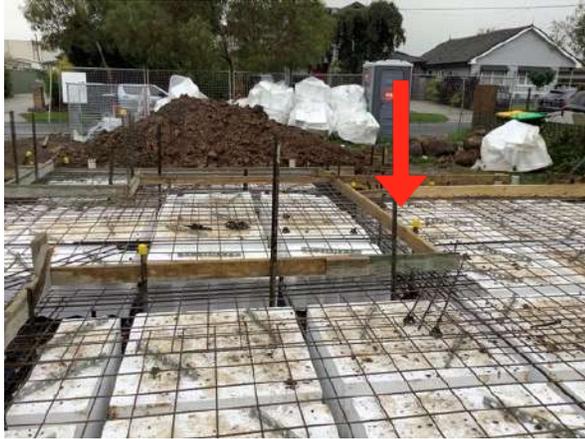
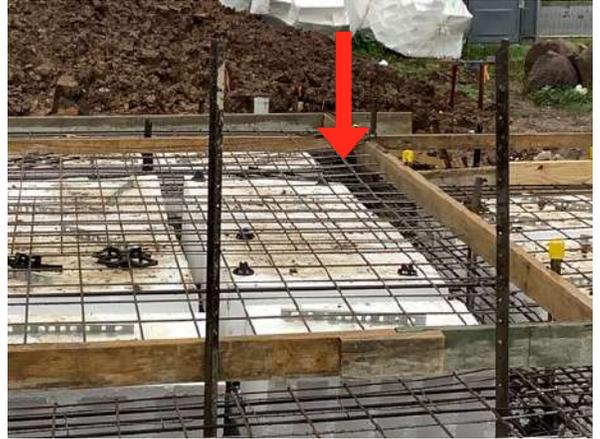
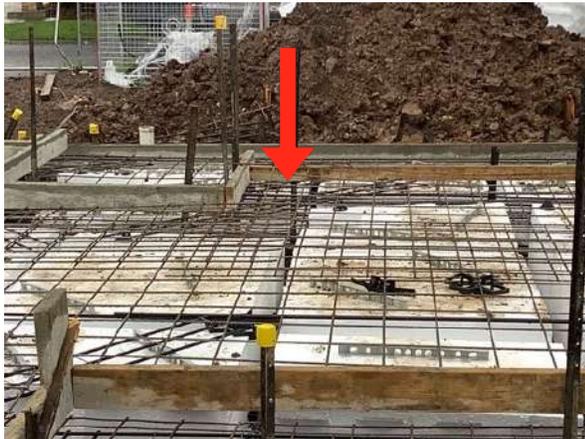
Non Compliant 2.05

Location: All Areas
 Finding: Steel Sagging - Requires To Be Tied / Secured Into Place

I noted various areas of reinforced steel that has not been secured (tie wire or that alike) in a manner to prevent the reinforcement to move during the concrete pour.
 There are areas of reinforcement mesh sagging below the top 1/3 section of the slab.

Ideally this mesh should be supported with timber diagonally across the boxing and wires to hold it up. At the very least the concretor needs to be vigilant on the day of pour to lift it up into position with a hook.

I strongly suggest the builder supply the owner with photographs that substantiate either before the slab pour or during the slab pour the mesh has been placed at the correct height.

These areas must comply with the NCC Volume 2 section 3.2.3.2 (f), (i) inserted below.

All AREAS to the ENTIRE slab should be checked CAREFULLY to identify any further defects that are the same as this defect.

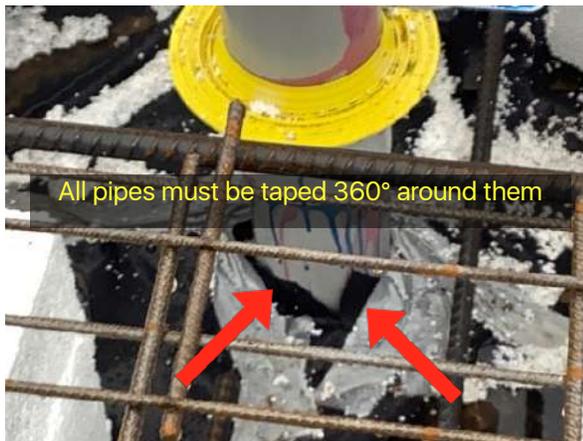
Non Compliant 2.06

Location: All Areas
Finding: Pipe penetrations through the vapour barrier.

The pipe penetrations through the vapour barrier have not been fully taped and require further works.
There are also numerous cuts and tears throughout the vapour barrier that have not been taped correctly.
These will need to be taped up and photographed before the pour is started.

All AREAS to the ENTIRE slab should be checked CAREFULLY to identify any further defects that are the same as this defect.

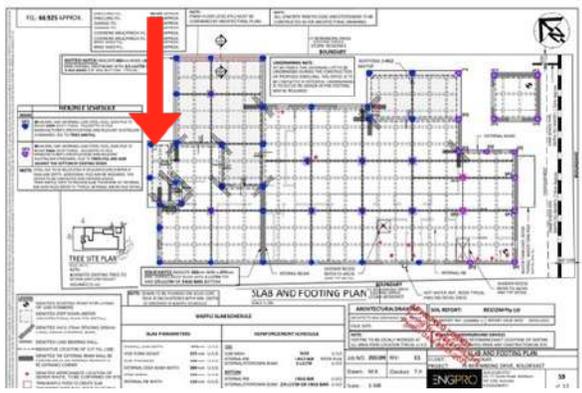
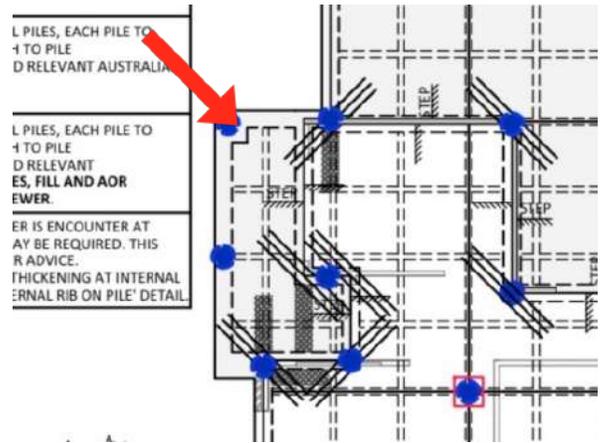
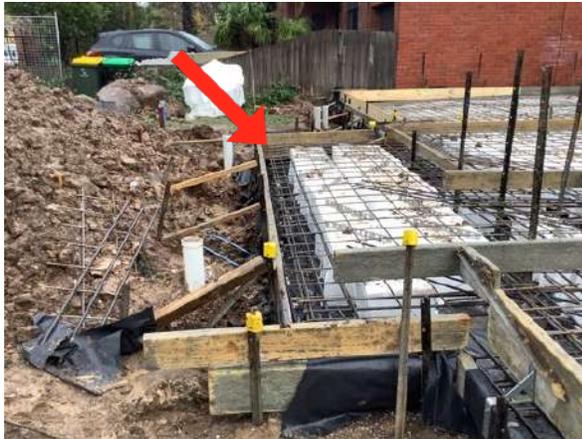
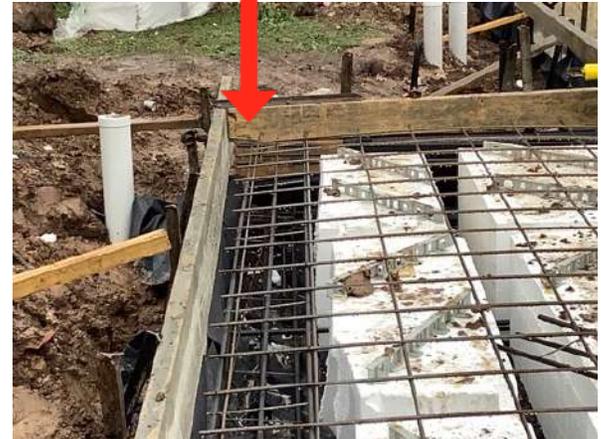
Non Compliant 2.07

Location: All Areas
Finding: Incorrect Boxing - To The Plans
The area identified is not coinciding with the report.

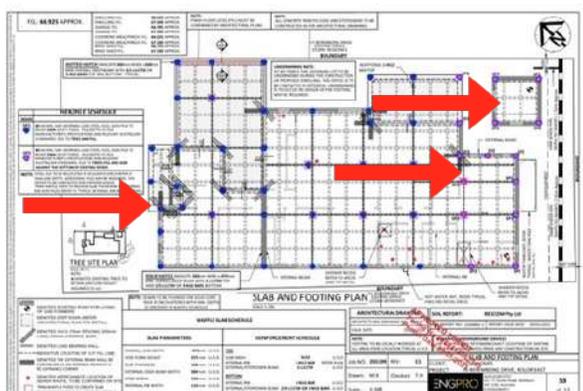
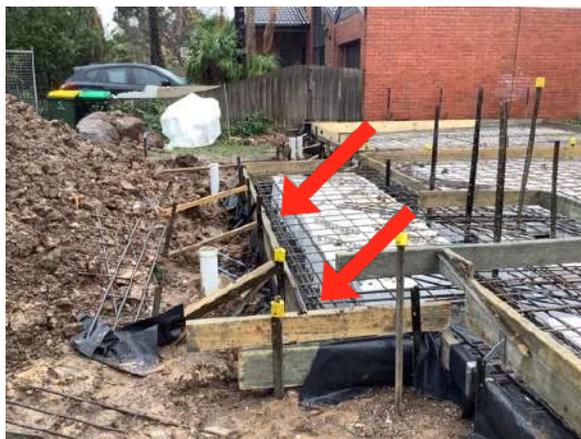
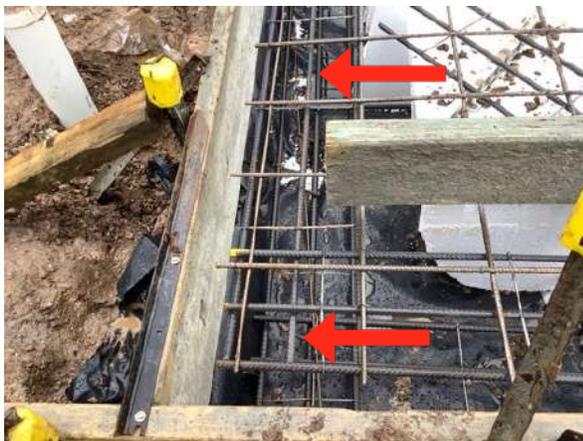
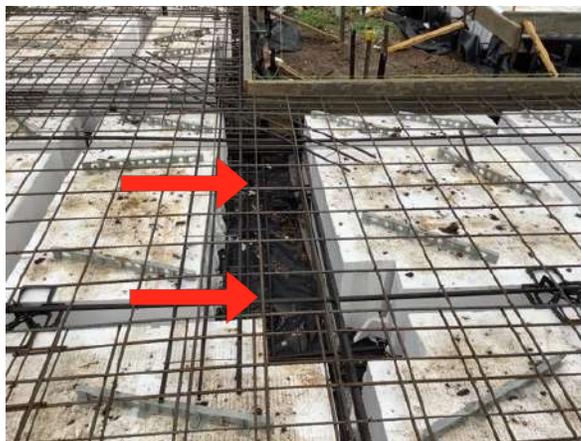
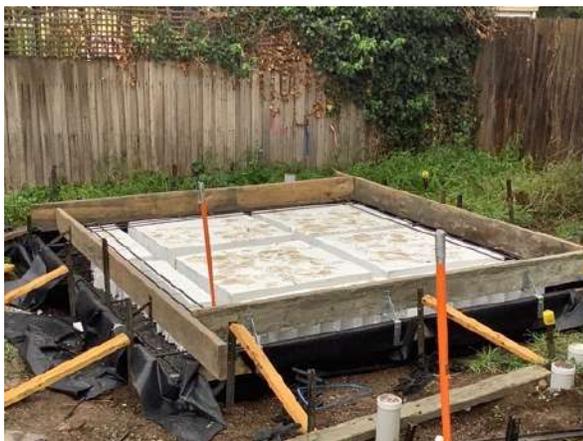
Incomplete 4.01

Location: All Areas

Finding: Double Three Bar Missing & Steel Mesh - Missing

This area/s were missing steel mesh in the trench and not completed as per the plans. Additional steel including bar chairs are required and in addition the additional steel is not to be touching the trench vapour barrier system.

The steel mesh is required to be tied and secured to the existing trench steel where required.
