# Pre-Paint (Plaster & Waterproofing ) Report

Inspection Date: 9 Jul 2021

Property Address: North Melbourne area

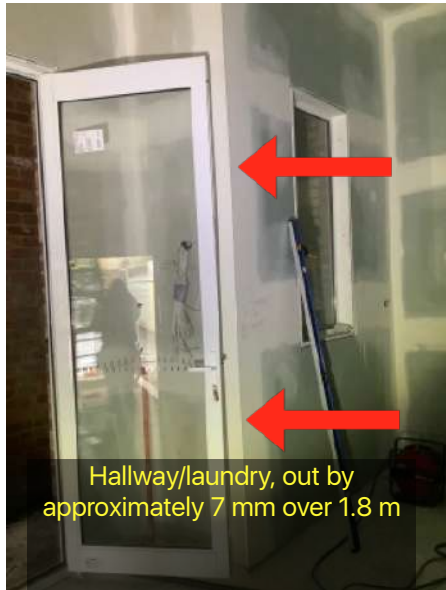
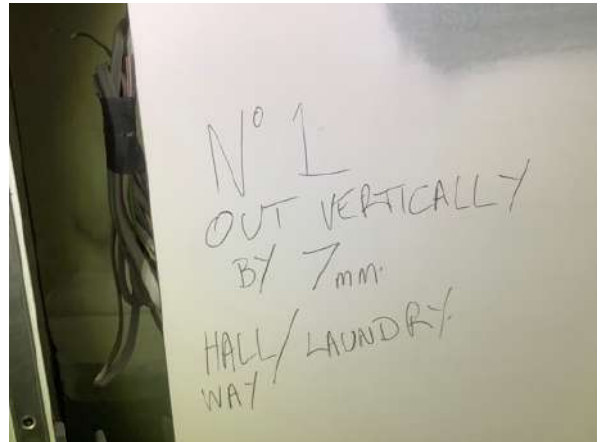
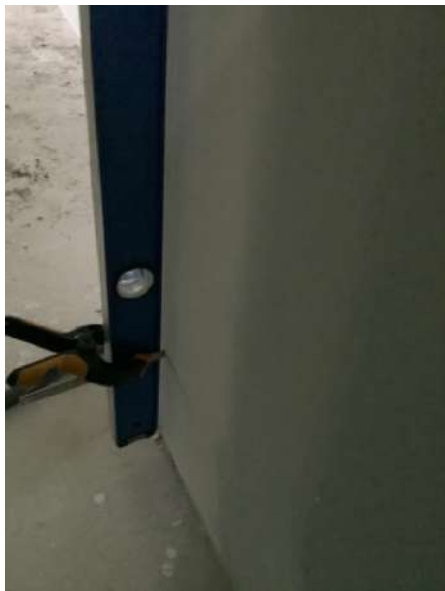
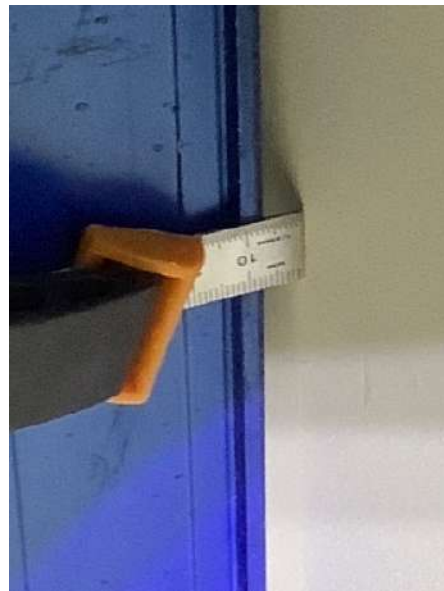
Finding: Plaster Walls / Frame - Vertical And/Or Horizontal Defective

A deviation ( large bow ) exceeding 4mm measured across a 2 mtr straight edge was identified in all the areas as per the photos attached & any gaps larger then 4mm is considered a defect and requires considerable re-working of the plaster and possible timber framing ( pending on how out of tolerance the frame is ) in all the areas to rectify the defects.

TV area, out by 12 mm over 1.8 m, vertically

Nº 2  
OUT VERTICALLY  
BY 12 mm  
TV AREA

A registered builder should be appointed to assess the defect and perform rectification works as necessary.

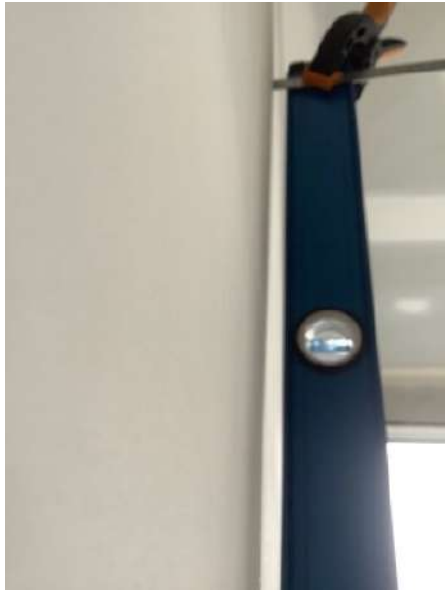
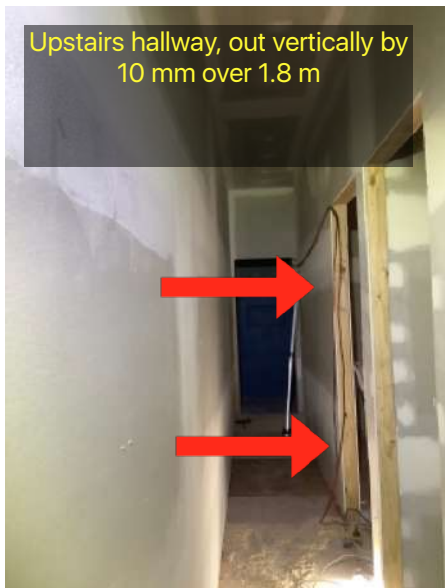
Nº 3  
UPSTAIRS HALL WAY  
OUT VERTICALLY  
BY 10 mm

Upstairs hallway, out vertically by 10 mm over 1.8 m

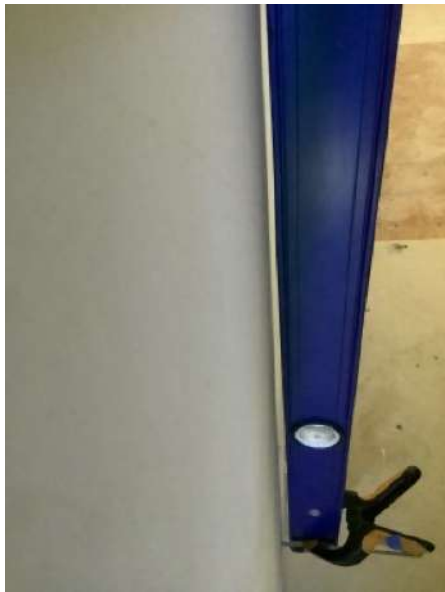
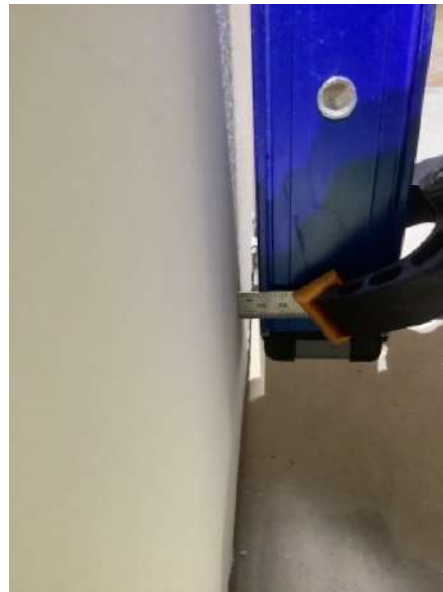
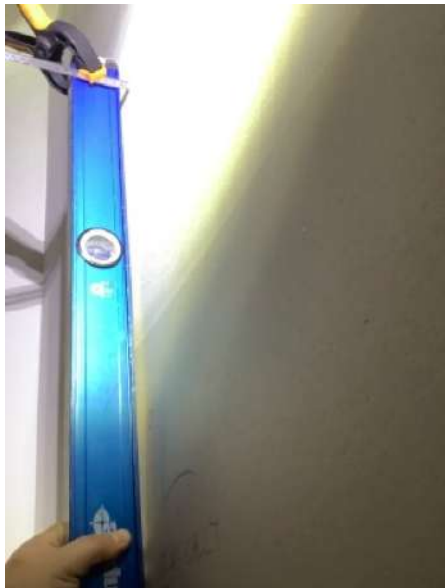
N<sup>o</sup> 4  
OUT VERTICALLY  
BY 12mm  
UPSTAIRS MIDDLE S/ROOM  
EAST WALL

Upstairs middle bedroom on the east wall. The wall is out 12 mm over 1.8 m

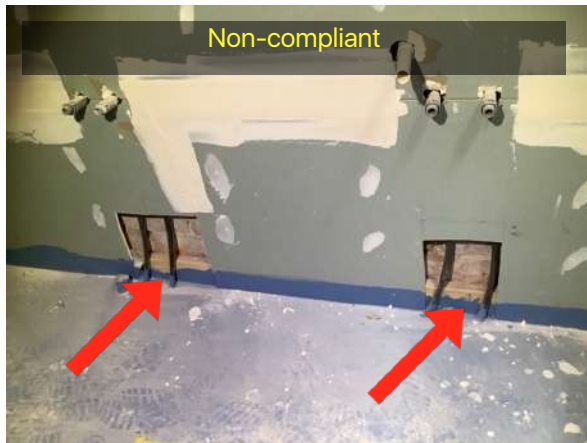
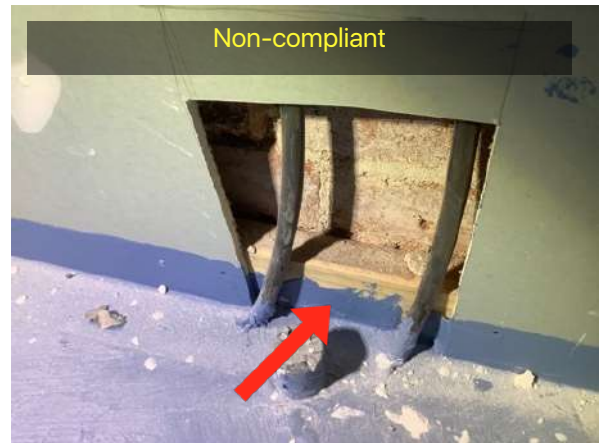
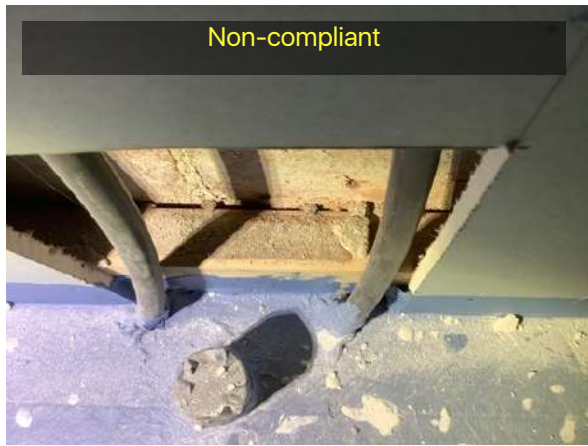
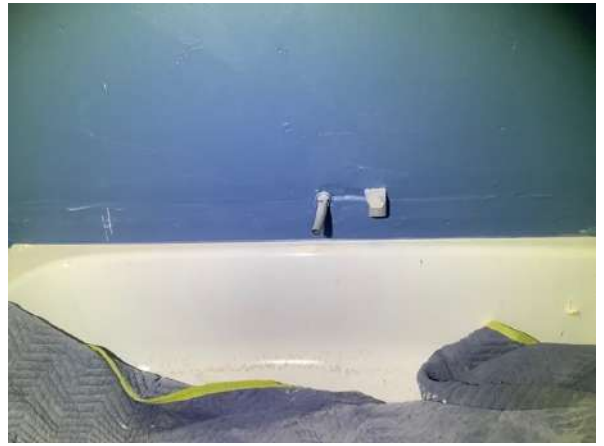
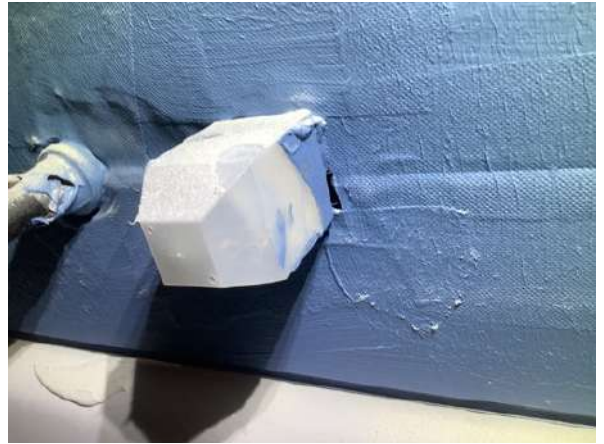
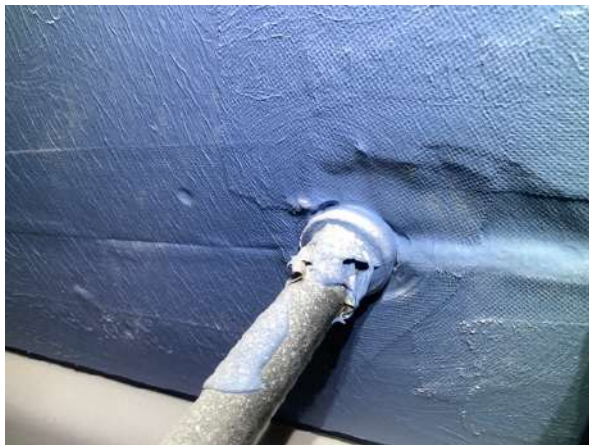
Finding: Water Proofing - Inadequate / Defective - Non Compliant

The photos are examples of the non-compliant and defective works. It is very difficult to inspect some areas of the waterproofing due to the lack of care to the waterproofing.

It appears that water proofing to the wet area/s has non-compliant areas and does not comply with Australian Standards and that the incorrect application of water proofing techniques has occurred in areas.

It is highly advised that adequate waterproofing materials be installed to all wet areas to comply with Australian Standards and protect all areas against water damage.

All repairs must be completed prior to the installation of the tiling and/or any other products used .

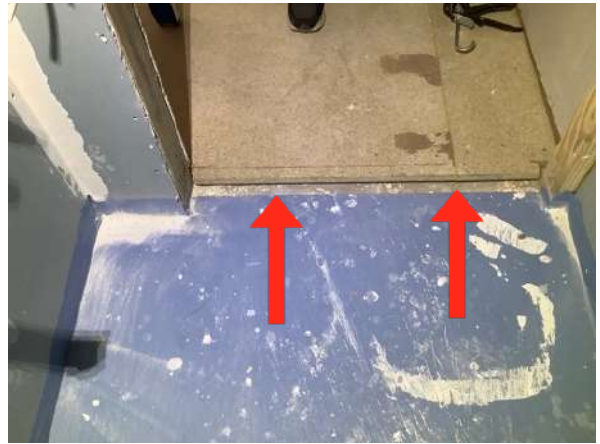
Finding: Wet Areas - Flashing At Floor Level Required.

The end of the tiles does not have the water stop at the end of the where the tiles will finish.

The builder must install this item and complete the waterproofing, before the tiles are installed.

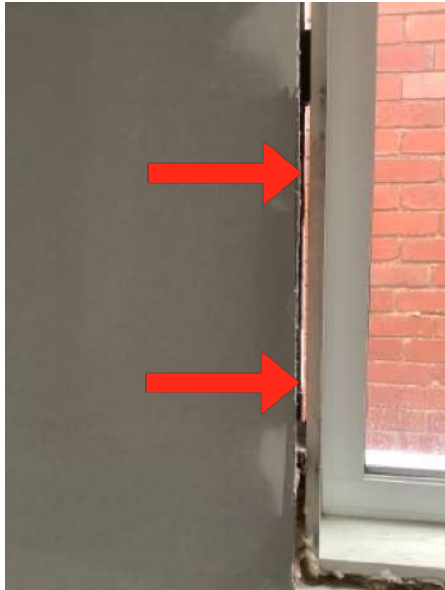
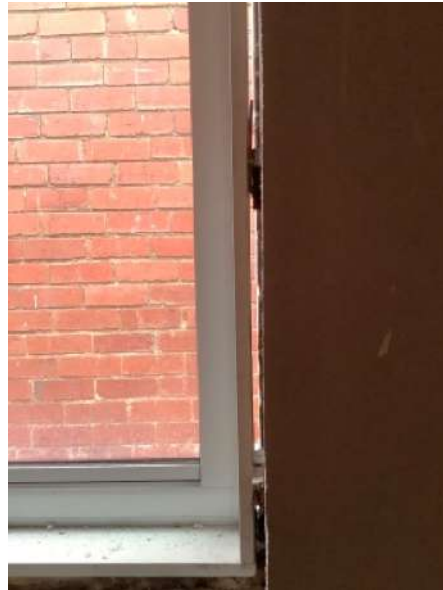
Finding: Missing Insulation

Please note that this was in the pre-plaster report, and it is obvious that it has not been completed. ALL surrounding windows and doors must be completed.

In this case the defect in discussion is the sides of the window and the bottom of the window DO NOT have a sufficient gap if any to allow for movement and compression of the frame.

ALL WINDOWS with no or insufficient gaps, also as per manufacturers standards is packing to the sides and bottom of the windows as well, must be reworked to allow a recommended of at least 15mm to 20mm of packing.

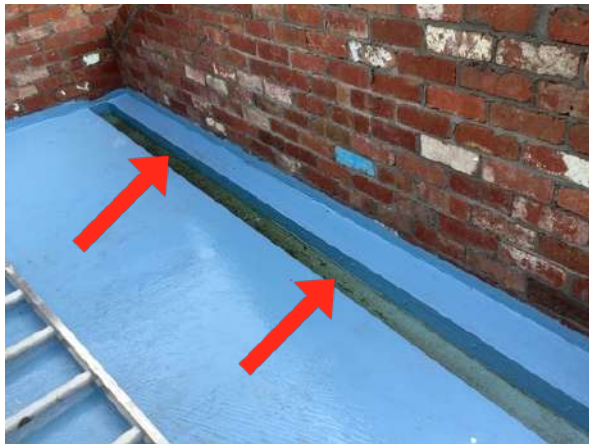
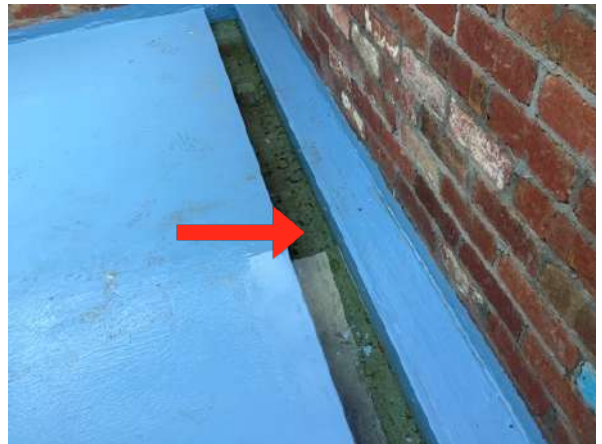
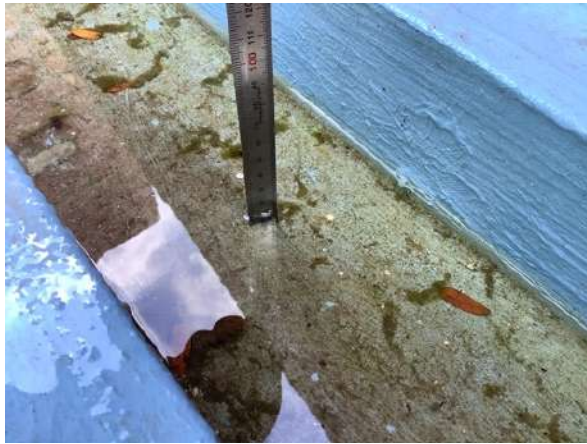
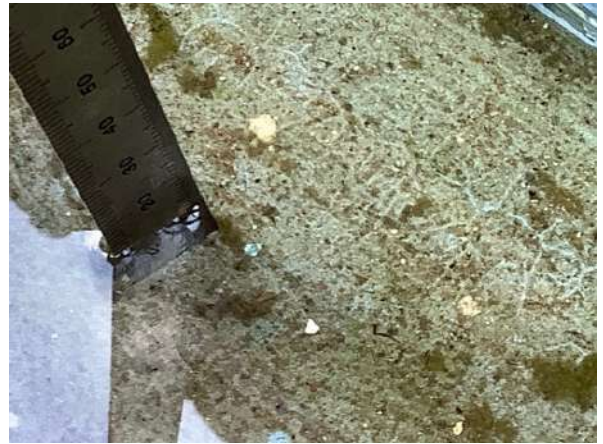
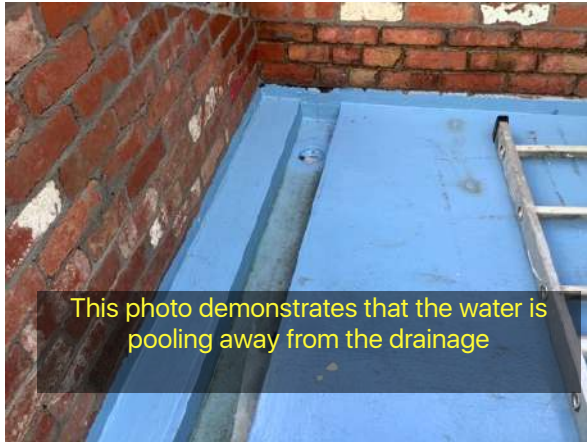
Finding: Balcony drainage – water pooling

The balcony drainage system is holding water, this is called water pooling and is classed as defective workmanship.

I do not see how this can be repaired other than to rework the drainage system and redo the waterproofing.

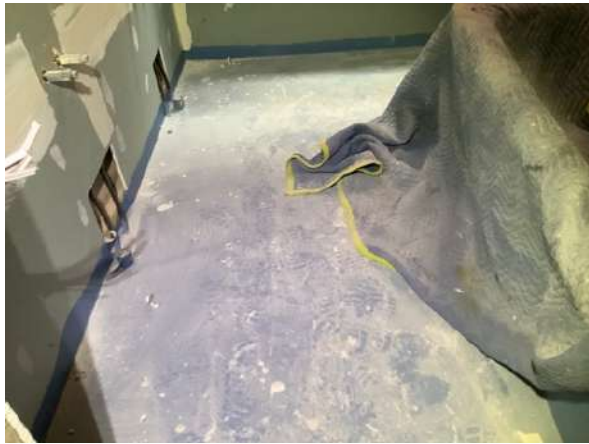
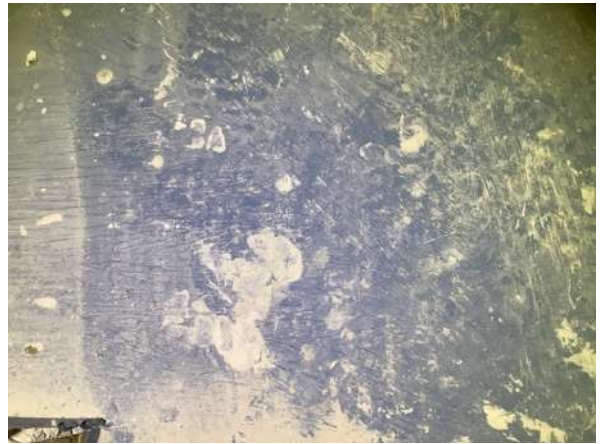
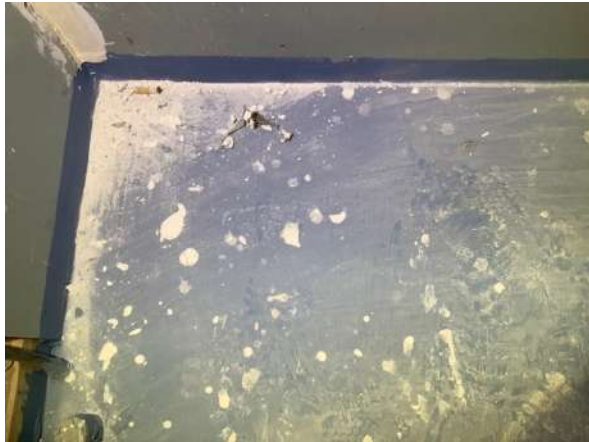
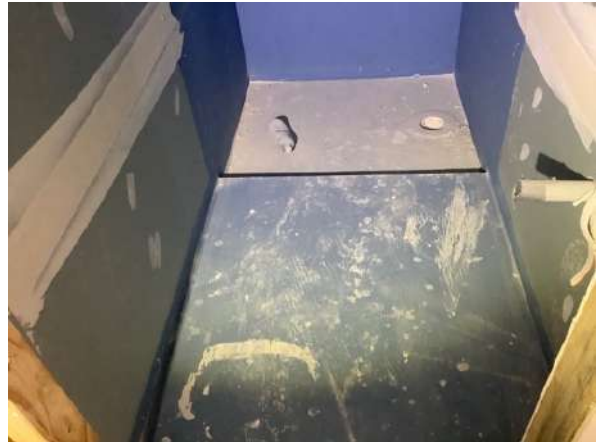
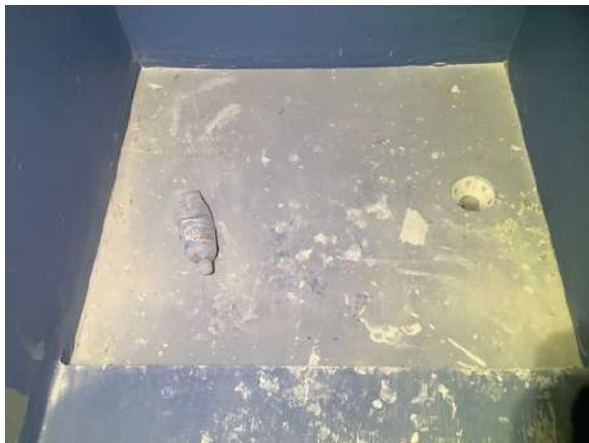
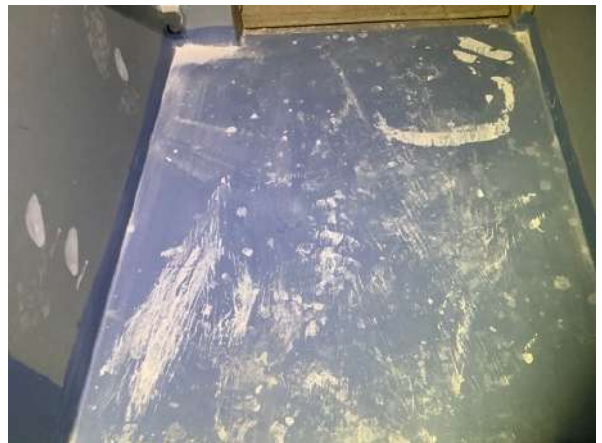
Finding: Water Proofing - Covered With Builders Debris

At the time of the inspection the waterproofing was not covered and protected. This has created excessive builders debris such as plaster, dust, etc onto the waterproofing. It is impossible to perform an inspection with the lack of respect to the waterproofing.

I highly recommend the builder provide to the client clean waterproofing services in order for us to perform an accurate inspection.

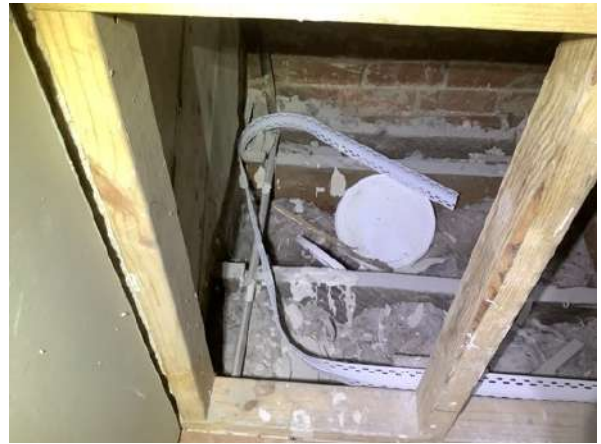
Location: Builders Debris  
Finding: Excessive Builders Debris

All areas should be cleaned from excessive builders debris regardless if the areas can be seen or not.

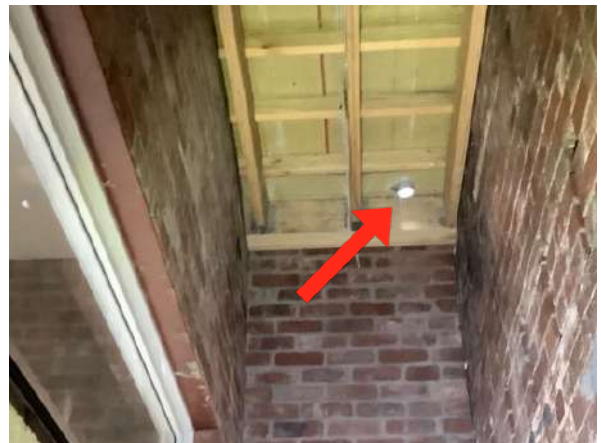
Finding: Plumbing – incomplete

At the time of the inspection the drainage for the balcony was not complete, this would be part of the reason the plaster would not be installed as yet.

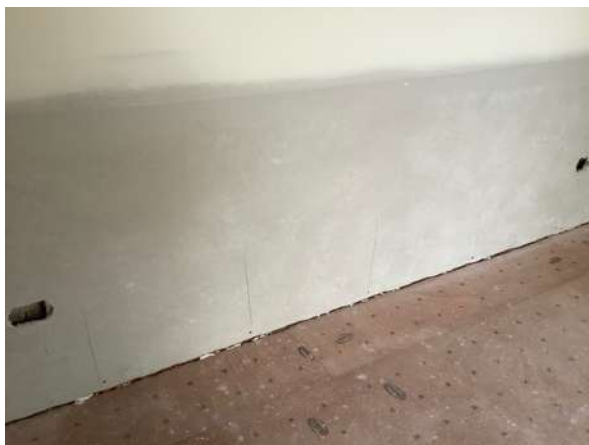
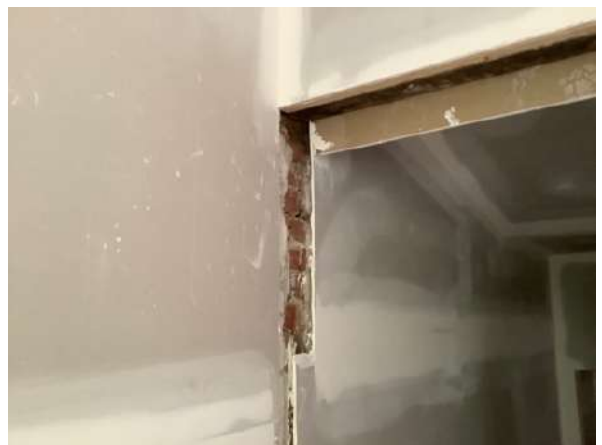
Finding: Skirting & Architrave Installations - Not Installed

At the time of the inspection the timber work, such as the timber skirting and architraves have not been installed as yet.

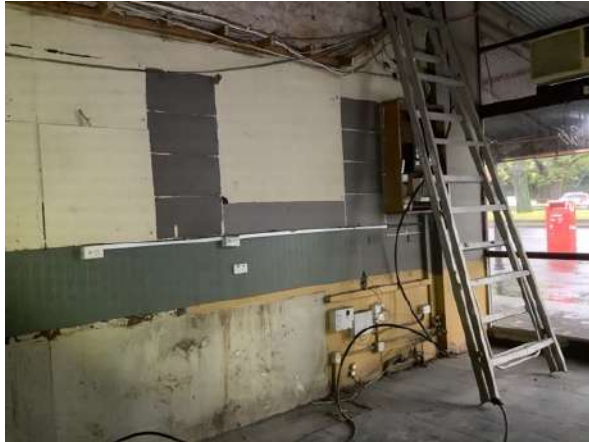
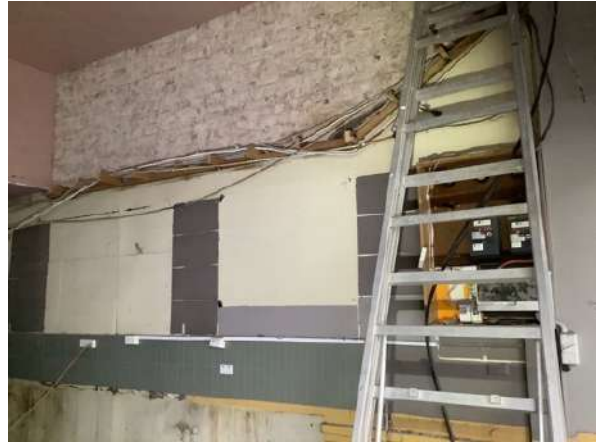
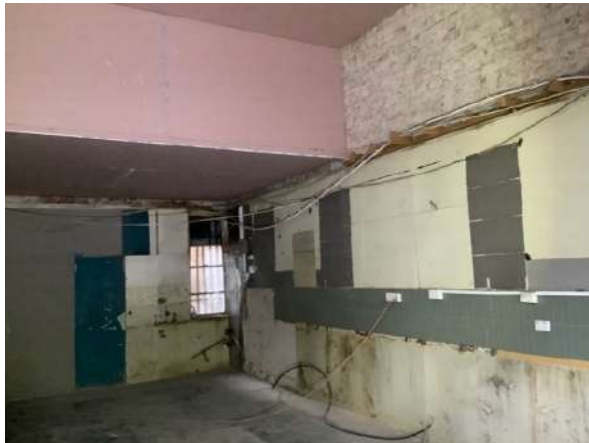
Location: Incomplete Areas  
 Finding: Electrical – Wiring Concerns

Whilst this may not be a defect, I feel it's important to raise my concerns. The builder is in the process of sorting out the supply mains for the residential area and the commercial area. However my assumption is that the sub mains from the new meter position at the rear of the property, to the downstairs commercial shop area and the upstairs residential area both require the mains to be installed. The sub mains wiring does not appear to be installed, I was of the assumption that the wiring of the sub mains would be installed prior to the plasterwork installation.

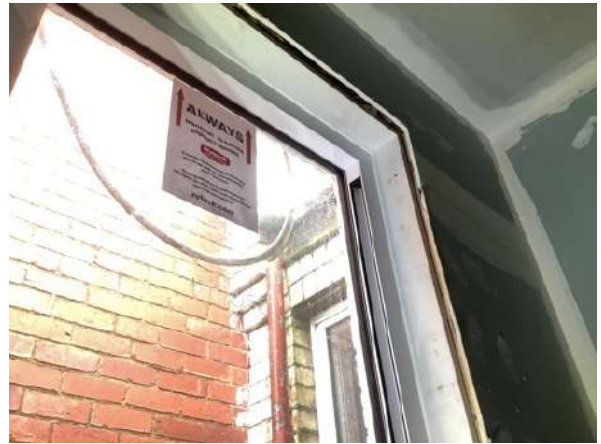
Location: Incomplete Areas  
 Finding: Areas Around Windows

It is important that the builder complete around the windows to a satisfactory level.
