Pre-Plaster Report

Inspection Date: 6 Jul 2021

Property Address: 3 Madel Avenue Strathmore, VIC, Australia

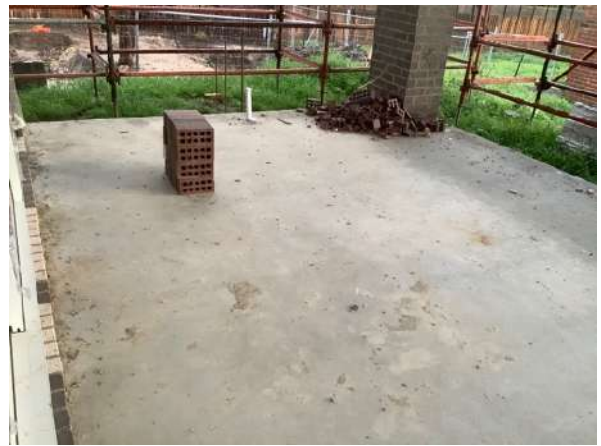
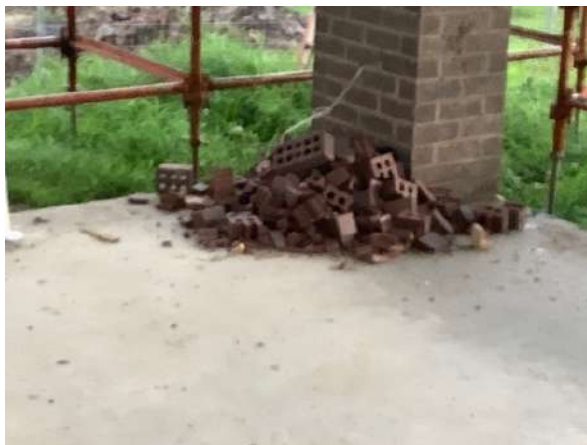
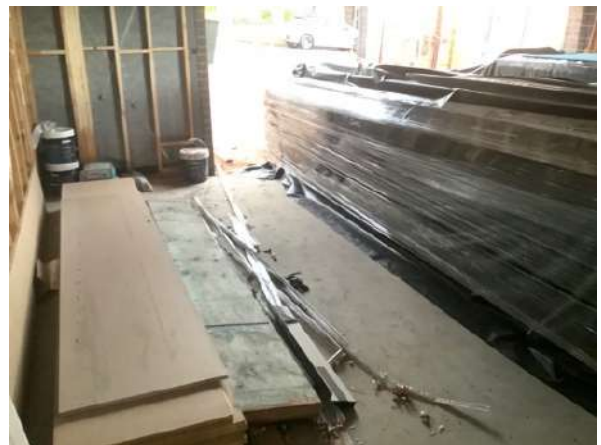
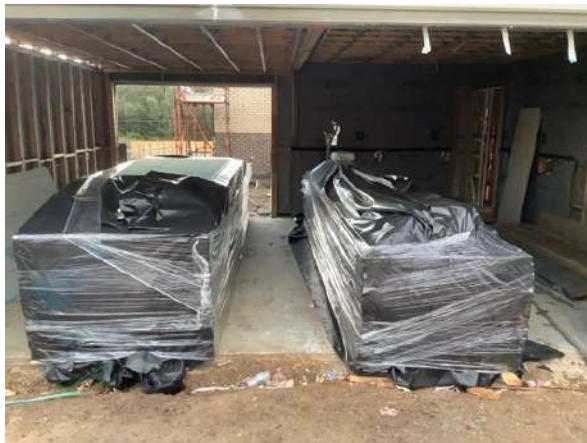
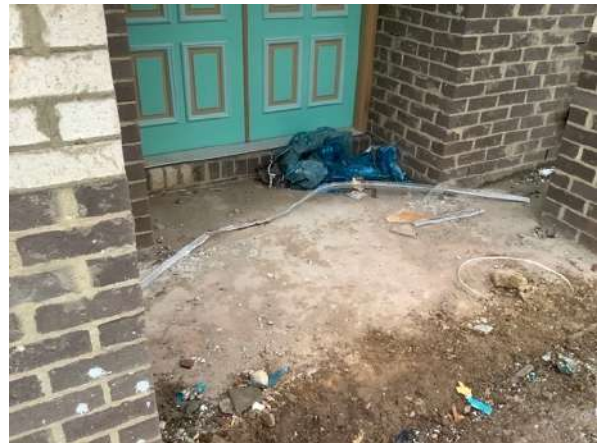
Non Compliant 2.01

Finding: Concrete Flooring, During Build Process

Please note that this defect has been in all previous reports as well.

It is very important that the builder take note that the concrete in the garage, front porch and the alfresco, ALL need to be handed to the client in as new condition. I highly recommend the builder take care with the concrete flooring in ALL these areas, by protecting/covering the concrete floor areas.

An acceptable finish consistent with AS 2870 Residential Slabs and Footing Construction requires the surface to be even and consistent in appearance.

The concrete flooring must be presented as new prior to handover.

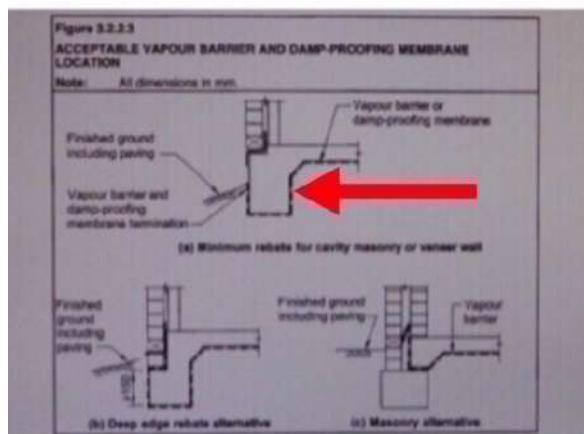
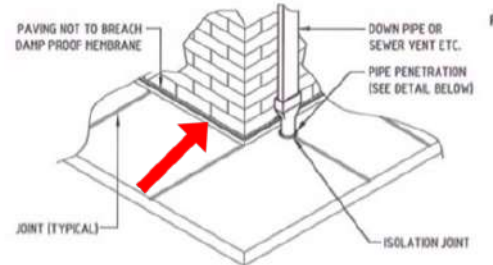
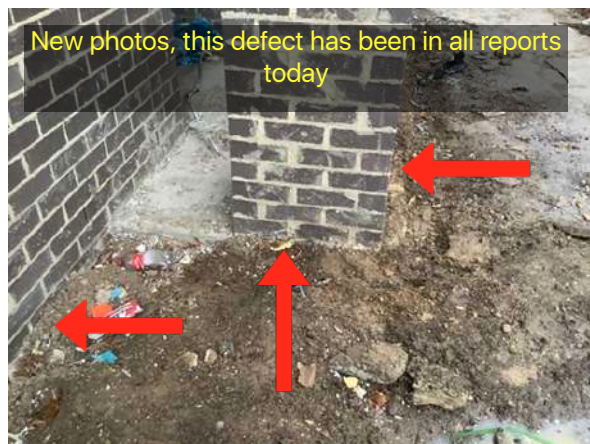
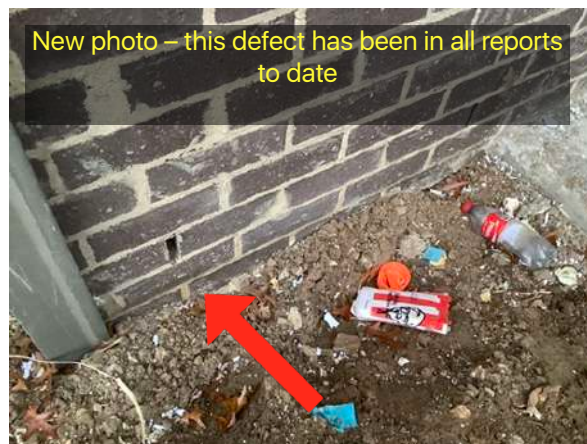
Non Compliant 2.02

Finding: Vapour barrier - Defective (AS2870- 2011)

Once again this defect has been in all previous reports.

The builder has not completed the vapour barrier system to the porch area and the alfresco area concrete perimeters.

The functionality of the vapour barrier to the entire perimeter of the building including, between the buildings each side of the house is being compromised due to poor workmanship during the installation/construction process.

It is a requirement of AS 2870-2011 5.3.3.4 that vapour barriers are turned up and terminated at ground level above pavement adjacent footing. The vapour barrier is defective if building materials and fill has been left on top of the membrane, as this prevents it from being pulled up against the slab when installing perimeter paving as it is intended to be.

I HIGHLY RECOMMEND that the builders dig the perimeter carefully,, sometimes the entire perimeter, pending of the severity of the vapour barrier (plastic) damage, pending on slab over pour, pending on excessive builders concrete (debris).

It is important to dig along the slab perimeter without damaging the plastic and to extend the vapour barrier plastic higher then the slab rebate as would have been in the post slab report if we performed one.

All over laps must be a minimum of 200mm and the correct tape must be used to seal the plastic.

This must be remedied immediately to prevent slab edge dampness.

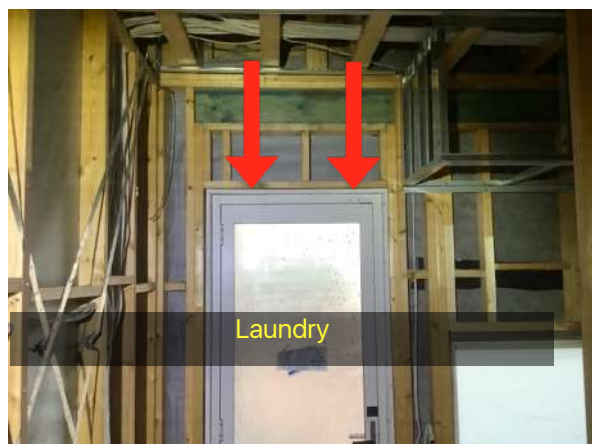
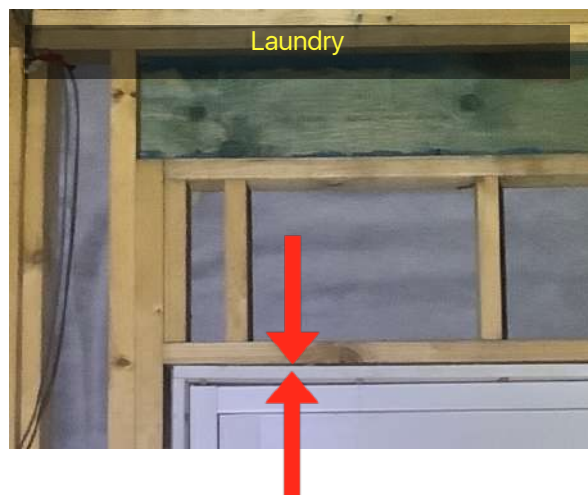
Non Compliant 2.03

Finding: Top Of Window - Undersized Gap.

There are areas where the top of the windows are currently tight or well under 15mm to the underside of the timber lintels.

It is a requirement of Australian Standard, A.S 1684 Residential Timber-Framed Construction, clause 6.2.3 Openings, that 'A minimum clearance of 15mm shall be provided between the underside of the lintel or lintel trimmer and the top of the window frame'.

This opening and/or ALL openings that are under 15mm must all be modified in compliance with the above.

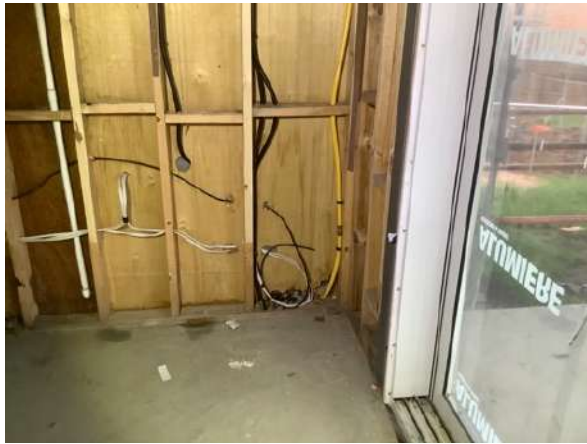
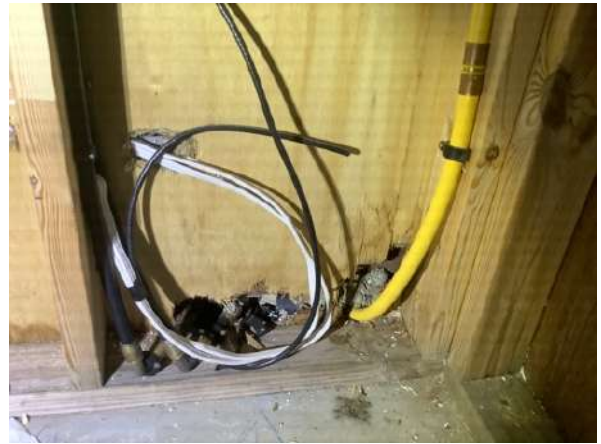
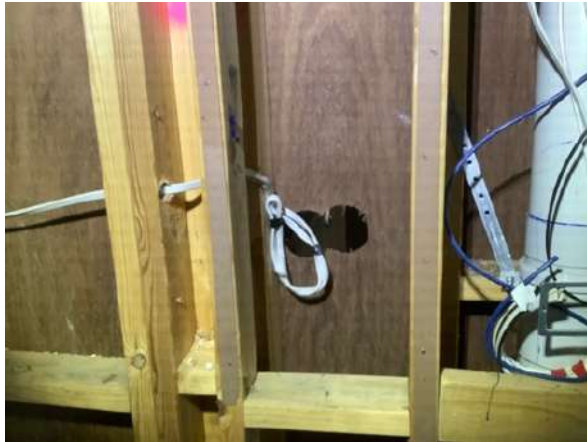
Non Compliant 2.04

Finding: Bracing Structurally Comprised - Cut Out or Damaged.

At the time of the inspection it was found that bracing has been cut out and structurally compromised.

Bracing boards are a critical structural element and should not be damaged in any way that may impede there long term performance.

Whilst trades need to cut out required holes, it is clear the hole cut out is oversized.

Repair of the bracing sheets is required by the builder in accordance with AS1684.2 before the plaster is installed, perhaps one of the repair methods would be to install a noggin top and bottom of cut out.

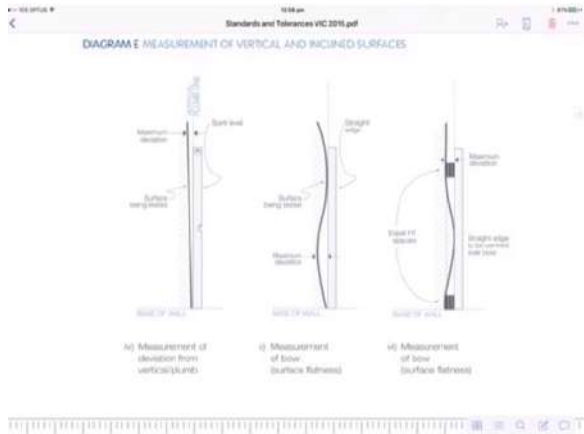
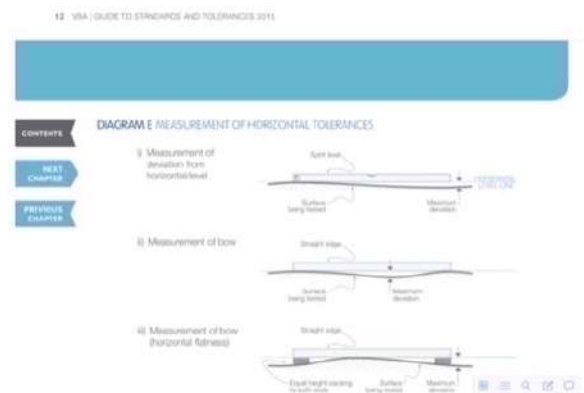
Non Compliant 2.05

Location: All Areas
 Finding: Frame / Posts - Not Square / Level Vertically (Max variation is 4mm over 2 mtrs).

It is observed that post/s and wall frame/s are defective as there is a deviation from a vertical or straight plumb line which exceeds 4mm within any 2m of height / length.
 This is a technical defect and may result in subsequent structural defects if left unmanaged.

Any deviation in excess of 4mm exceeds the allowable Standards and Tolerances and is considered a defect, in which the builder must attend to prior to the plaster installation.

This is commonly referred to as a bow in the frame material and/or defective workman.
 Any bow in excess of 4mm as identified exceeds the allowable Standards and Tolerances and is considered defective.

◆ Whilst we have identified this important defect item, it is the BUILDERS RESPONSIBILITY to identify any post/s and walls that are non-compliant to ALL AREAS of the frame, without compromise & complete rectification works before the plaster is installed, As I have found various locations which require further packing or straightening of walls.

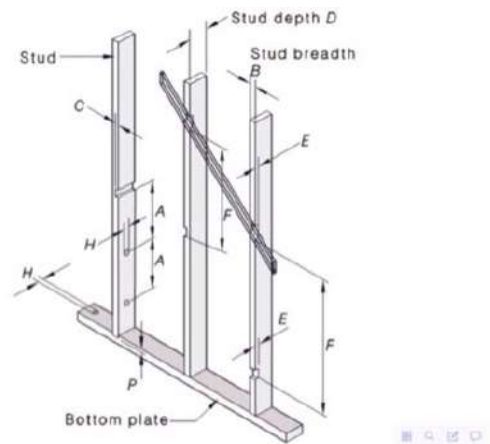
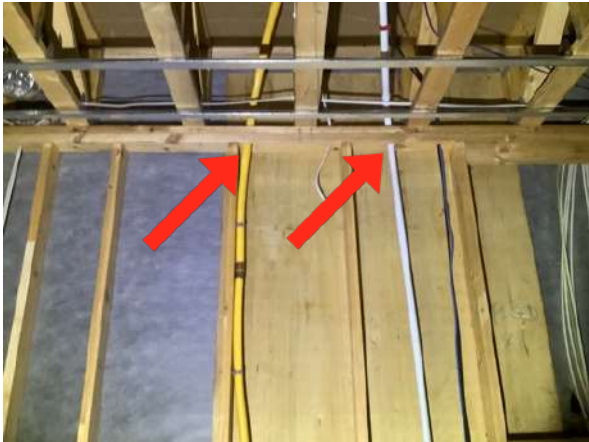
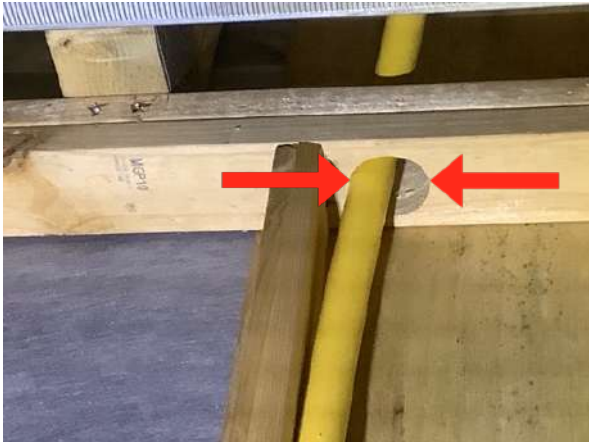
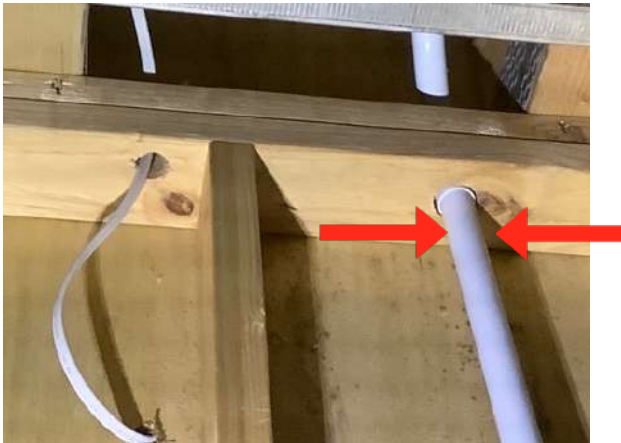
Non Compliant 2.06

It was observed during inspection that the diameter/size of holes and penetrations exceeded the maximum size allowable as defined in AS1684.

Generally with holes that exceed 25 mm in diameter a recommendation is just to install a noggin with two nails to each end into the studs and three nails into the top plate.

However where there are top plates, studs or timber beam structures that have been severely compromised Consultation with the building surveyor or certifier is recommended to establish the correct course of action to overcome the existing installation of services to comply with AS1684.

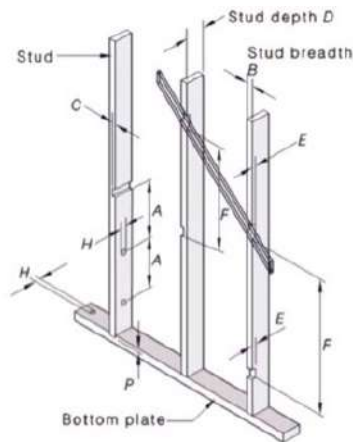
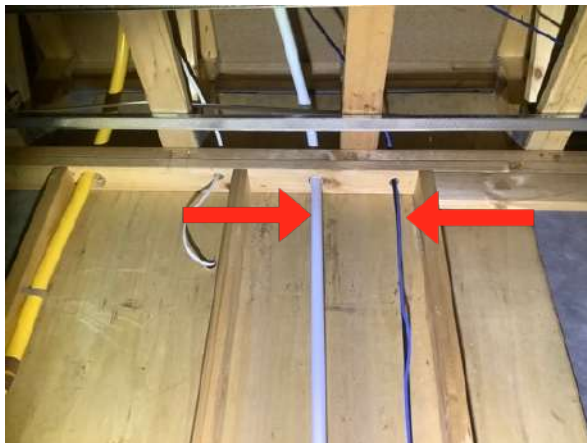
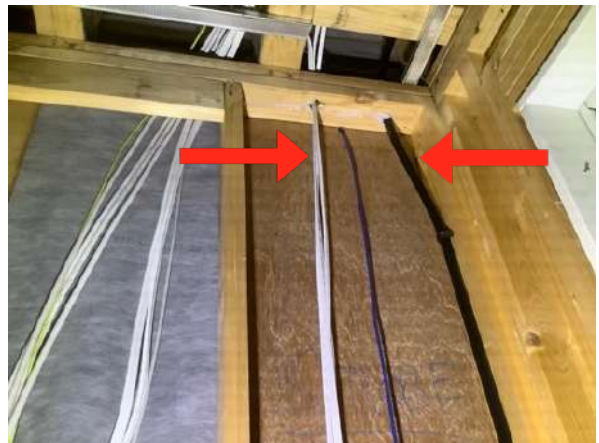
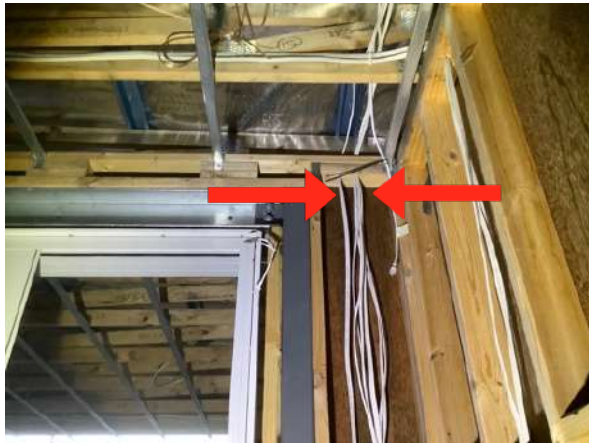
Non Compliant 2.07

It was observed during inspection that the minimum distance between holes for services (electrical and / or plumbing) and notching has not been maintained. The AS1684.2 2010, Page 60 and 61 requires a minimum distance between holes and notching in a 90mm stud and top plates is 270mm apart.

However where there are top plates, studs or timber beam structures that have been severely compromised Consultation with the building surveyor or certifier is recommended to establish the correct course of action to overcome the existing installation of services to comply with AS1684.

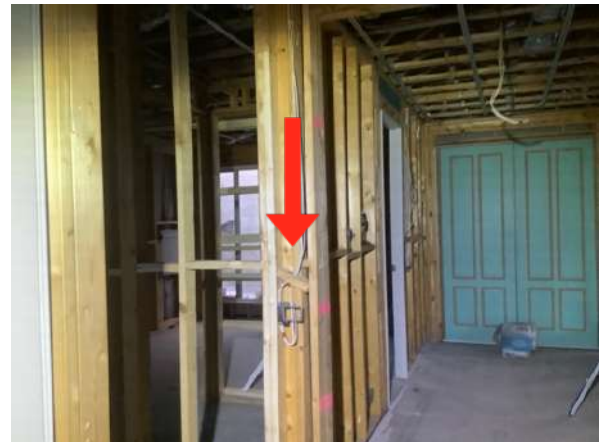
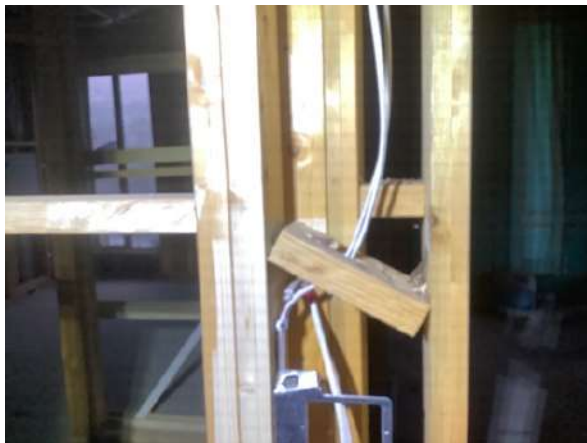
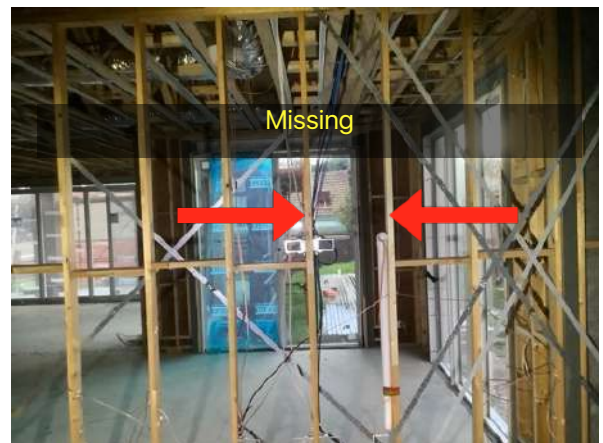
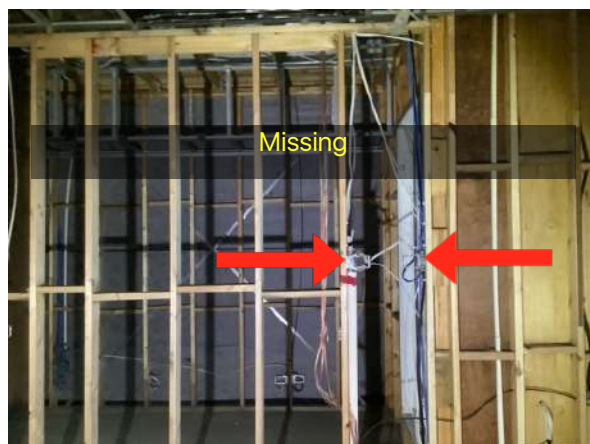
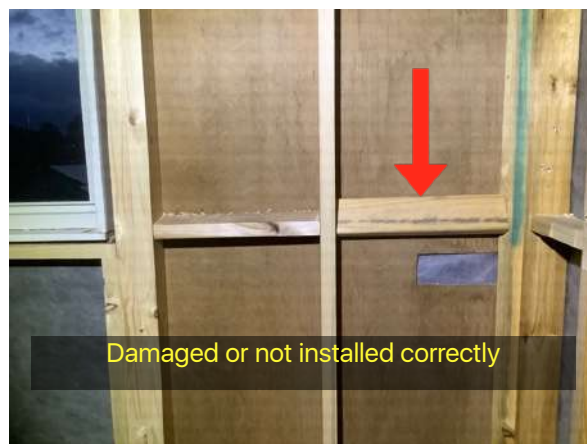
Non Compliant 2.08

Finding: Noggins - Defective Installation - Missing - Taken Out For Tradespersons Requirements.

All AREAS to the entire property should be checked CAREFULLY to identify any further defects that are the same as this defect.

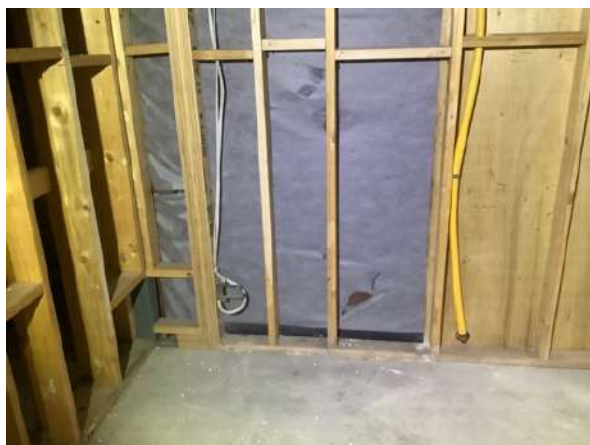
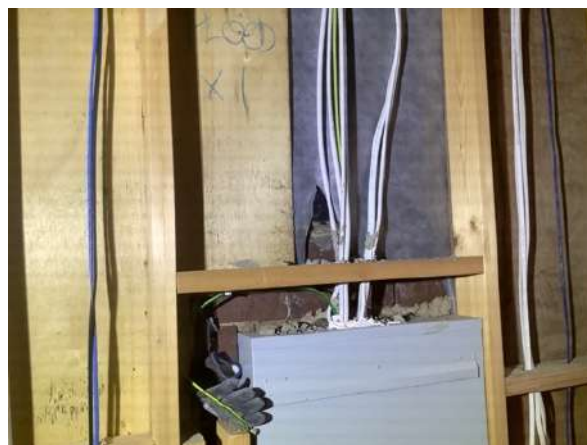
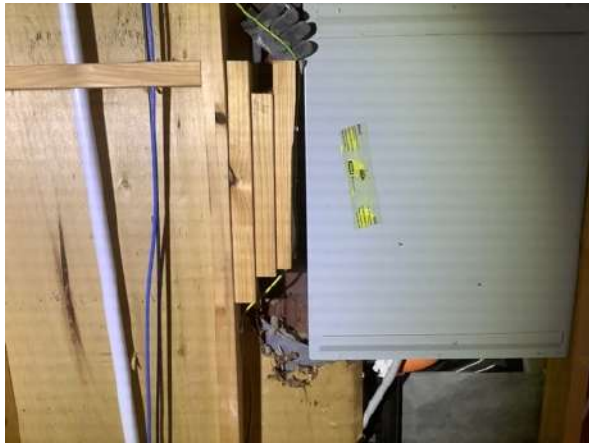
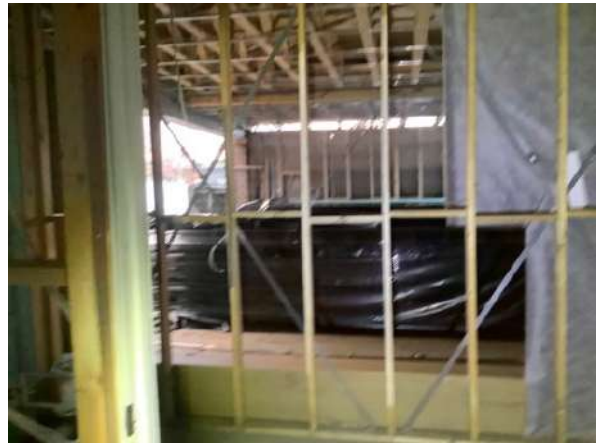
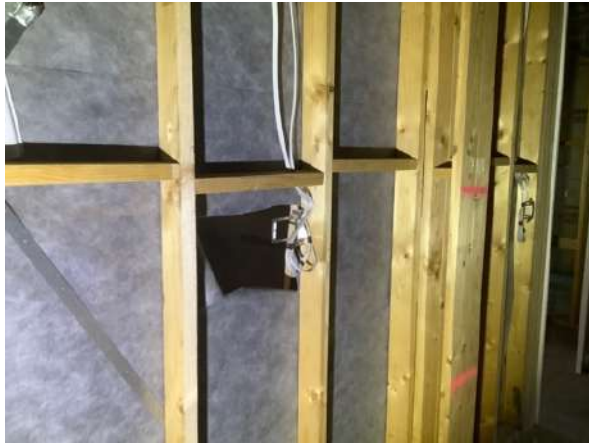
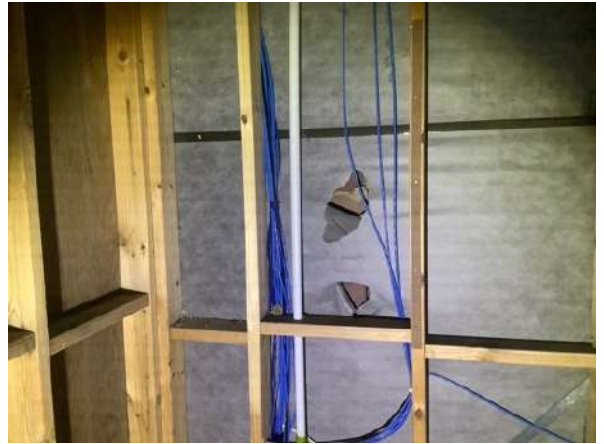
Non Compliant 2.09

Finding: Sisalation - not installed correctly, deterioration and damage.

It was observed that sisalation has not installed correctly, deterioration and damage. during construction. Poor or substandard installation combined with damage may result in secondary defects developing affecting weather tightness and environmental efficiency rating for the construction.

Additionally it was observed that the sisalation has not been installed as per the manufacturers specification and the AS which states that lapping of sheets must be 150mm.

All damaged or removed sections must be repaired prior to works continuing especially if a construction is a "reverse build".

Where sisalation is damaged and cannot be made as new. The damaged sections will need to be replaced with new prior to proceeding with the build. I refer the builder to the section of the contract on this topic.

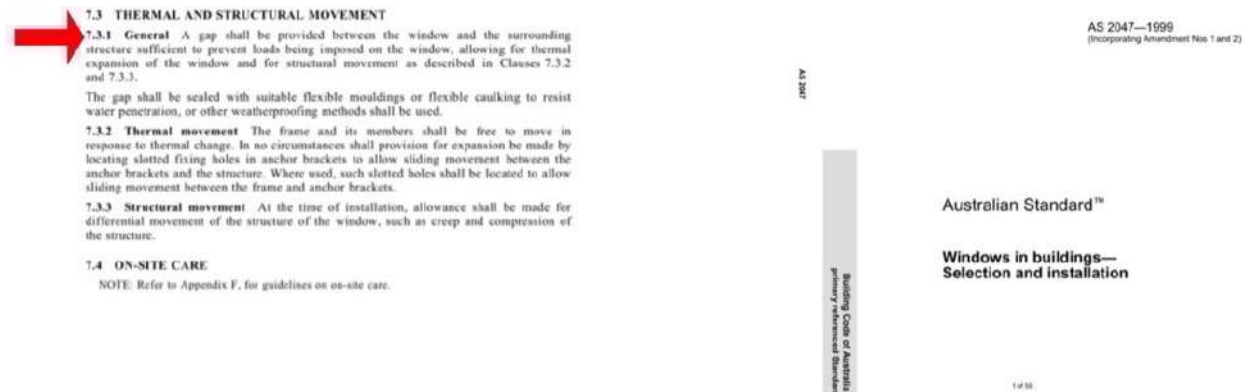
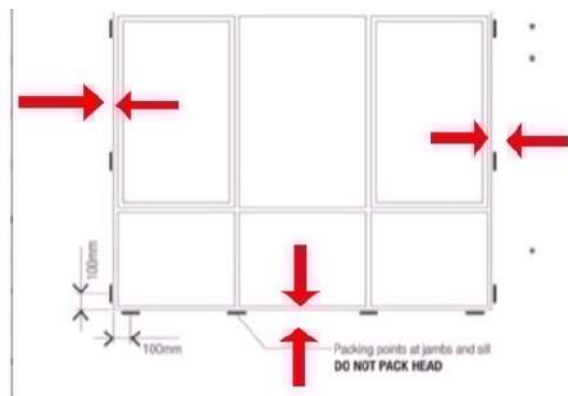
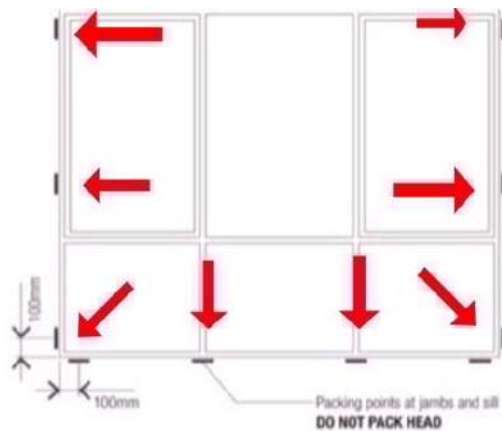
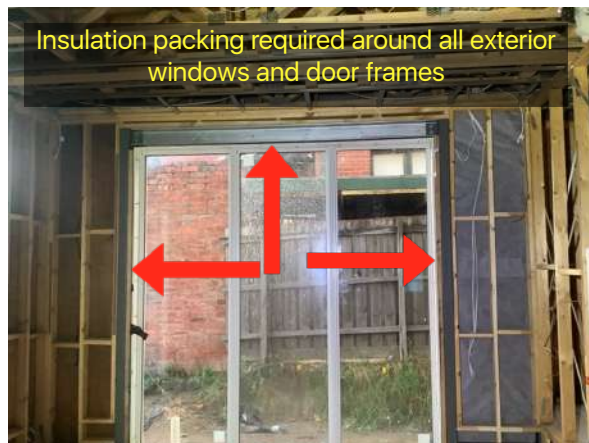
Non Compliant 2.11

Finding: Window Installation - Gaps To Perimeter Of Windows Defective.

In this case the defect in discussion is the sides of the window and the bottom of the window DO NOT have a sufficient gap if any to allow for movement and compression of the frame.

ALL WINDOWS with no or insufficient gaps, also as per manufacturers standards is packing to the sides and bottom of the windows as well, must be reworked to allow a recommended of at least 15mm to 20mm of packing.

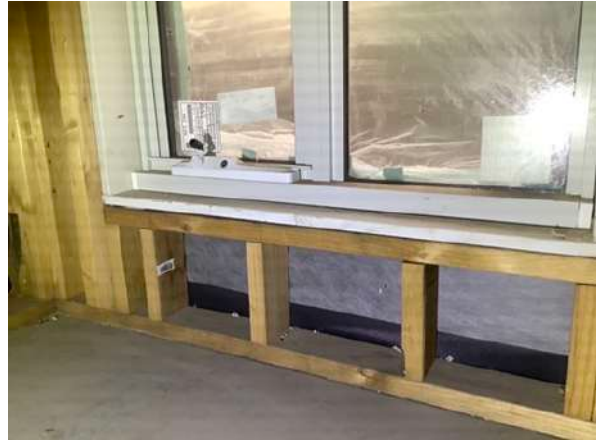
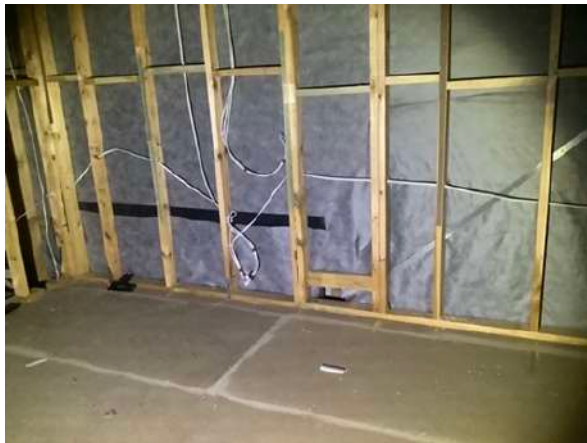
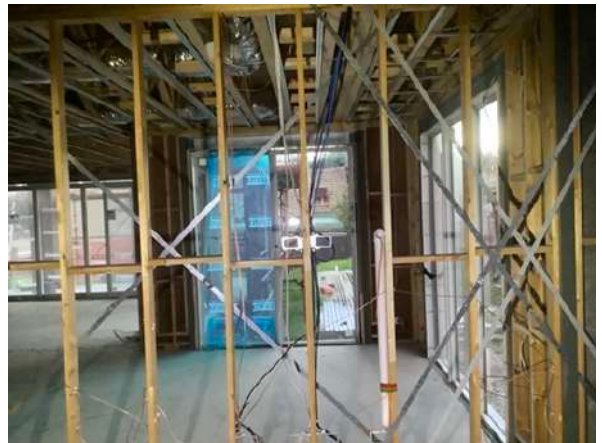
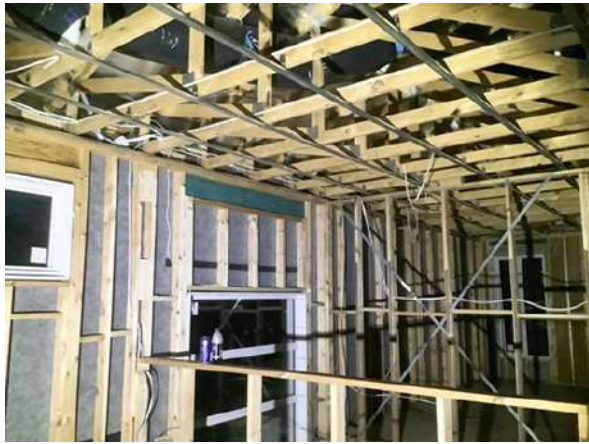
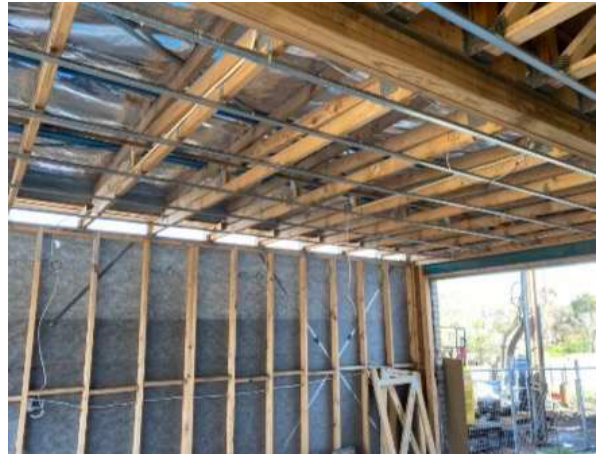
At the time of the pre-plaster inspection the insulation to the roof upstairs and the walls upstairs was not installed and in addition the insulation to downstairs all areas was not installed. In addition any other areas as required in the contract.

Normally for a pre-plaster inspection and report as mentioned above these items are normally 100% complete ready for the clients private building consultant to inspect as that is part of the pre-plaster report.
