Property Condition Report

Inspection Date: 7 Jul 2021

Property Address: Glenroy Area

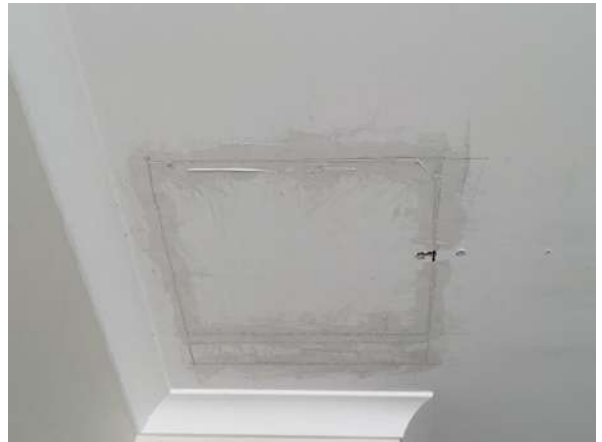
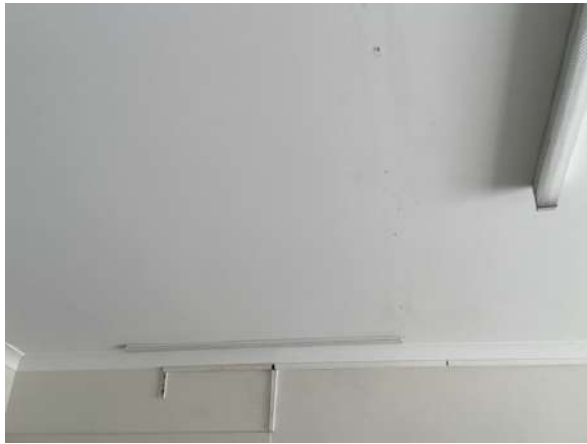
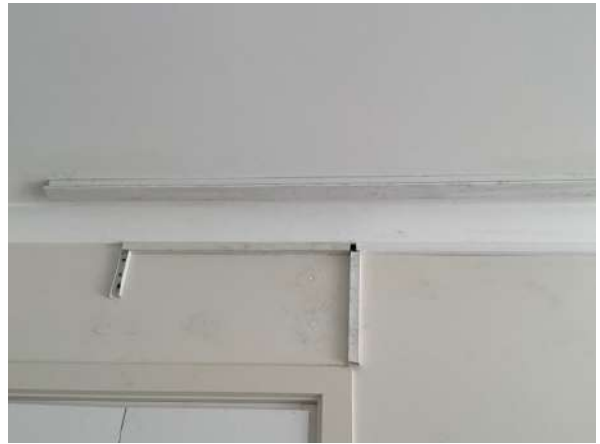
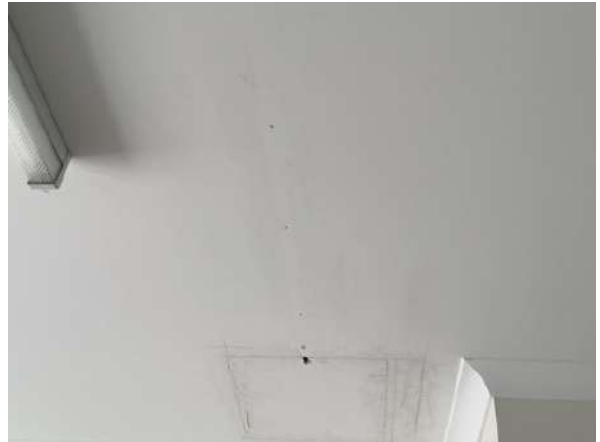
Safety Hazard 1.01

Location: Plaster Damage & Old Camera/Alarm

Finding: Garage - Plaster & Duct Damage

Due to the electrical works, alarm installation and camera installation, also the disassembly in part of the electrical, alarm and camera installation, there is now various damage taken place to the plasterwork and paint work.

There has been very crude and substandard workmanship repair done, however certainly not satisfactory for a property of 7 to 8 months old.

A qualified electrician, plasterer and painter is required, but due to the illegal electrical work that can be seen, we do not know the severity of the damage in the ceiling space area of electrical work that may be a fire risk and safety hazard and I highly recommend further invasive works to the plaster in order to visually see the ceiling space areas to identify any illegal wiring that is a fire risk or a safety hazard. All electrical is to be inspected by a qualified electrician. Once the electrical is all repaired and safe the plasterwork repairs and painting can then be finished.

A registered builder should take control of this job so that all the appropriate works are done in the appropriate orders.

It is important that the building become completely compliant to the building codes and the wiring is all safe, otherwise the builders warranty may not apply to this building.

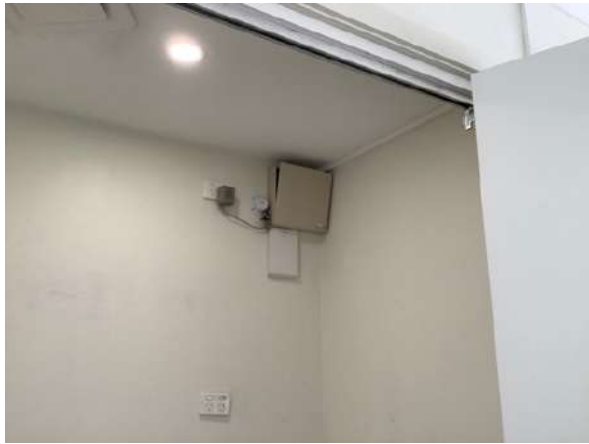
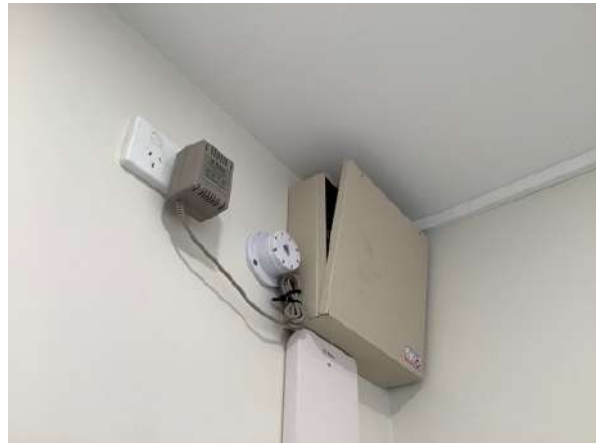
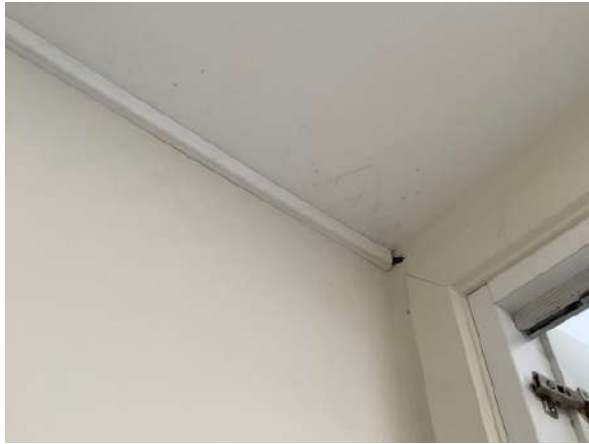
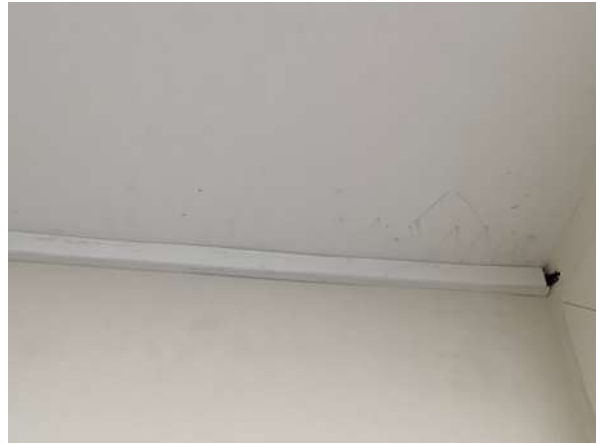
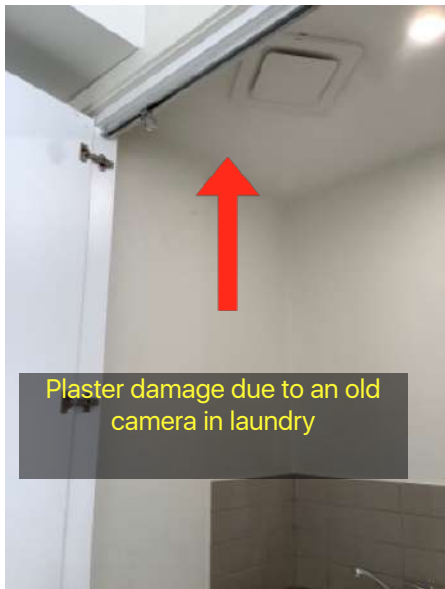
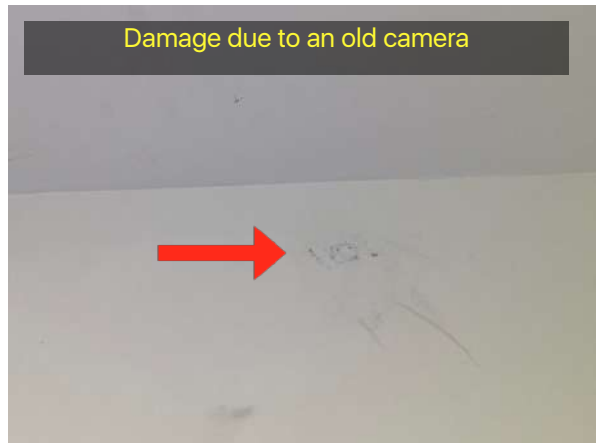
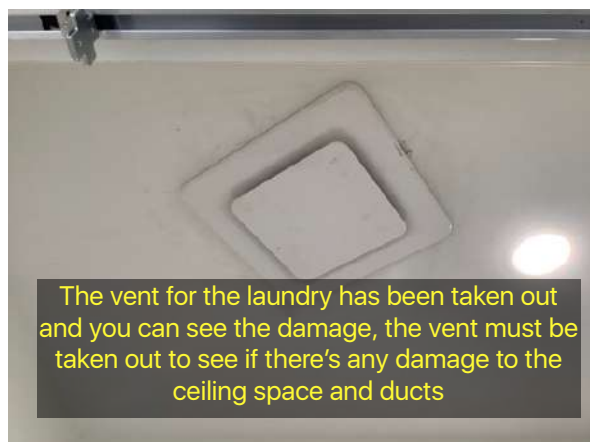
Safety Hazard 1.02

Location: Plaster Damage & Old Camera/Alarm

Finding: Laundry - Plaster & Duct Damage

Due to the electrical works, alarm installation and camera installation, also the disassembly in part of the electrical, alarm and camera installation, there is now various damage taken place to the plasterwork and paint work.

There has been very crude and substandard workmanship repair done, however certainly not satisfactory for a property of 7 to 8 months old.

You can identify that the exhaust fan vent has been taken out by the damaged painted ceiling, This is how some of the the electrical wiring has been performed between the floor levels and ceilings spaces.

A qualified electrician, plasterer and painter is required, but due to the illegal electrical work that can be seen, we do not know the severity of the damage in the ceiling space area of electrical work that may be a fire risk and safety hazard and I highly recommend further invasive works to the plaster in order to visually see the ceiling space areas to identify any illegal wiring that is a fire risk or a safety hazard.

All electrical is to be inspected by a qualified electrician. Once the electrical is all repaired and safe the plasterwork repairs and painting can then be finished.

A registered builder should take control of this job so that all the appropriate works are done in the appropriate orders.

It is important that the building become completely compliant to the building codes and the wiring is all safe, otherwise the builders warranty may not apply to this building.

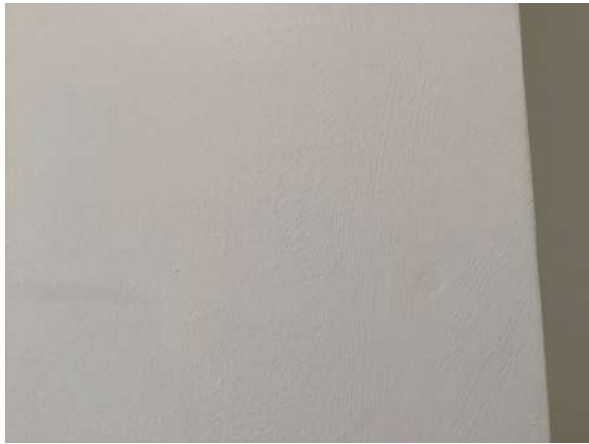
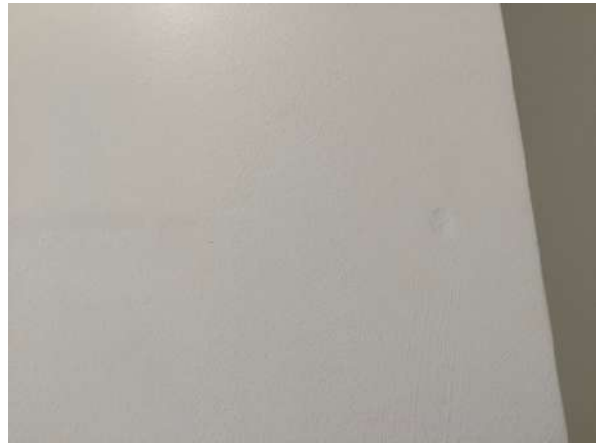
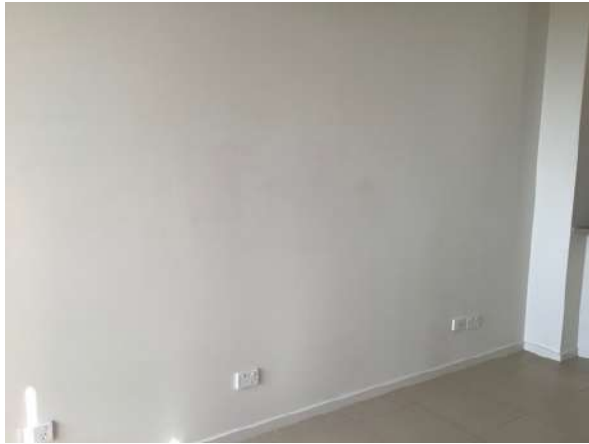
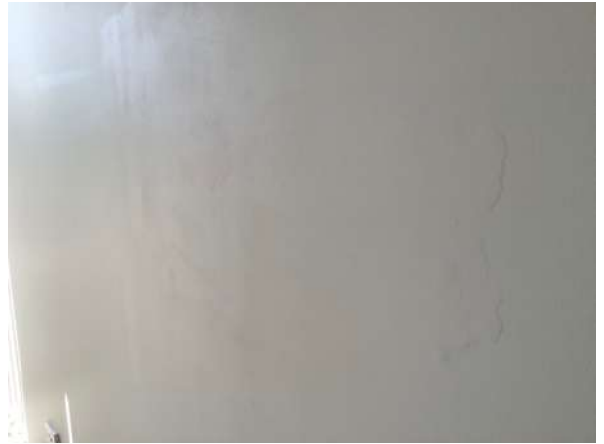
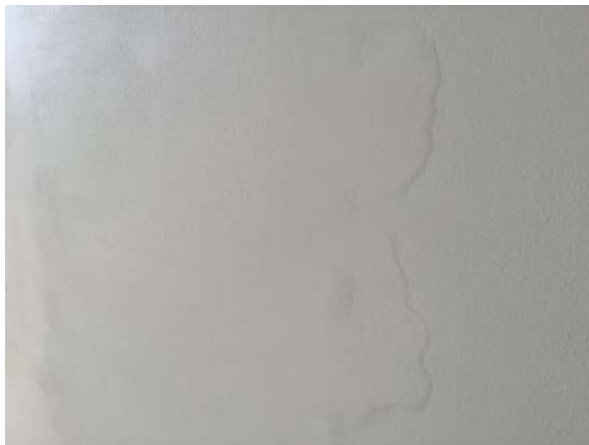
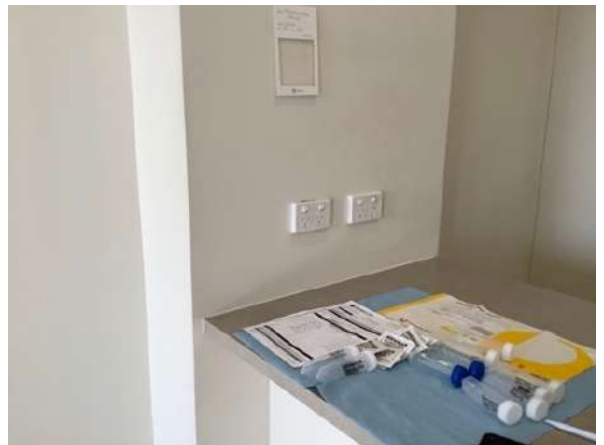
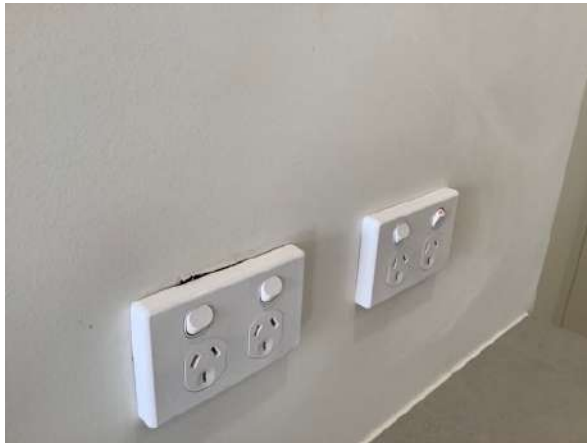
Safety Hazard 1.03

Location: Plaster Damage & Old Camera/Alarm

Finding: Kitchen and family room

There was some type of shelf installed above the kitchen bench and additional PowerPoints installed, more than likely this was installed for the camera system and/or other illegal activity.

Also there appears to be what may have been a TV bracket on the wall and the crude plasterwork and patchwork is well below acceptable tradesmen like qualities including all other plaster and paint repairs are all well below try to like quality.

A qualified electrician, plasterer and painter is required.

The extra PowerPoint that has been installed needs to be taken out in the wiring placed back to safe practices again.

A registered builder should take control of this job so that all the appropriate works are done in the appropriate orders.

It is important that the building become completely compliant to the building codes and the wiring is all safe, otherwise the builders warranty may not apply to this building.

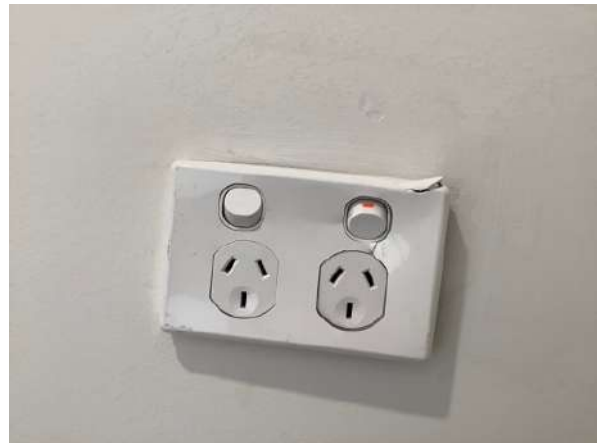
Safety Hazard 1.04

Location: Laundry

Finding: Damaged Power Point

The PowerPoint is structurally compromised and very much a safety hazard. This PowerPoint should not be used until it is replaced and the electrical wiring is inspected to this location and all locations.

It is unknown as to how this type of damage can occur in this location.

There is the strong possibility that this PowerPoint is compromised due to excessive power load caused by illegal activity and this PowerPoint could have something to do with the illegal wiring outside as well.

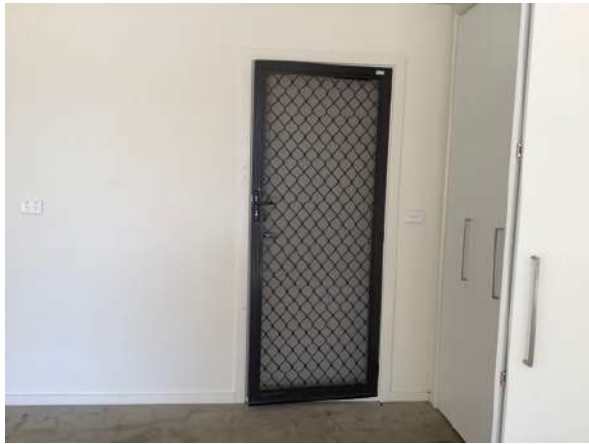
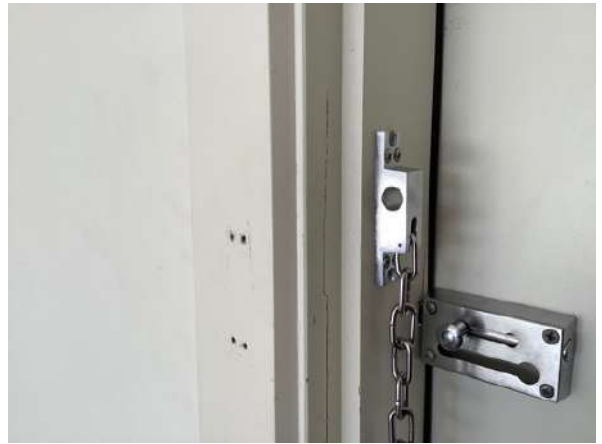
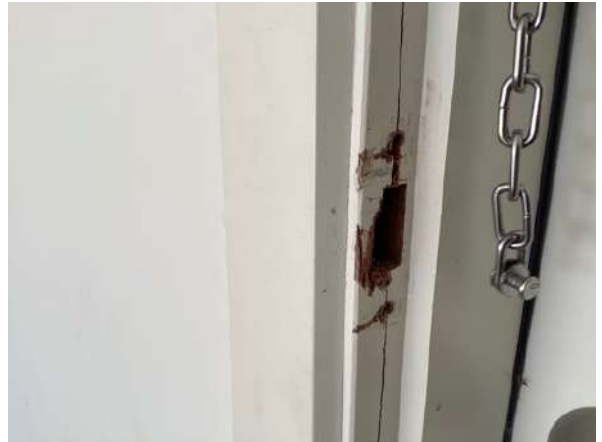
Safety Hazard 1.05

Location: Garage

Finding: Garage Back Door Damaged

The door frame, door and security door are all damaged

Garage backdoor severely damaged , Due to somebody trying to break in, once again this would certainly be related to the illegal activity that was being performed in this property. You can also identify that the tenant has added additional security locks as well three in fact. It is certainly not typical to have three different locks on one door.

A carpenter and security door expert are required to complete all the repairs, followed by a painter.

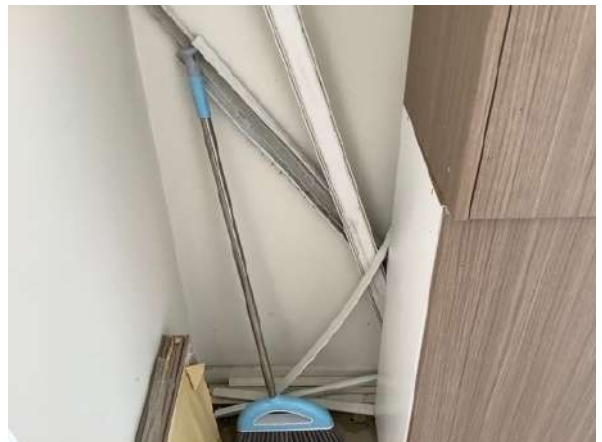
Safety Hazard 1.06

Location: Garage

Finding: The old camera ducts and cupboards

These cupboards are not from this property, and in addition all this ductwork is part of the electrical, camera and alarm systems that have been partially taken out.

All this material needs to be taken away for rubbish. It is very important as the place is contaminated with methamphetamine that this product be treated as contaminated as well.

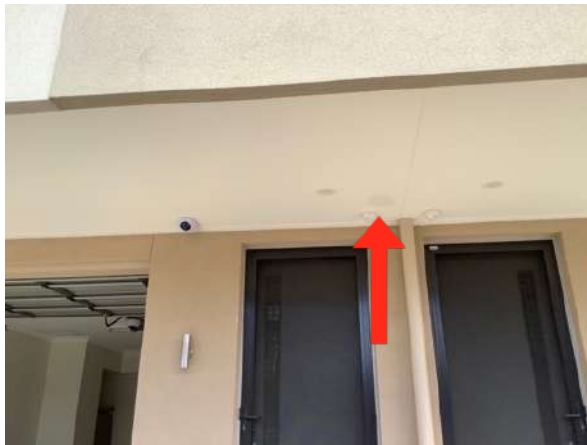
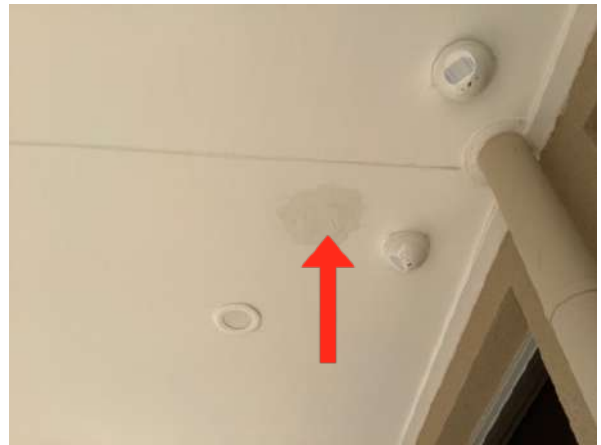
Safety Hazard 1.07

Location: Front exterior

Finding: Damage due to old cameras and alarms

The front exterior ceiling area is damaged by the camera system that has been taken out and there has been crude workmanship taken place that is certainly not acceptable.

Once the alarm system gets taken out there will be damage as well, not just at this location there will be varied locations damaged inside the property and outside the property as well from the alarm system to the plaster, timber work, brickwork, exterior render , door switches etc.

Due to the crude workmanship no work that has been performed by this tenant can stay on this property as it may affect the builders warranty and also be a fire risk.

Varied trades are required and once again all should be overlooked by a registered builder.

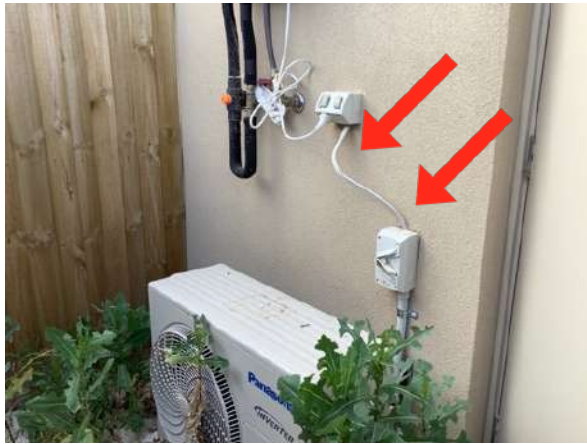
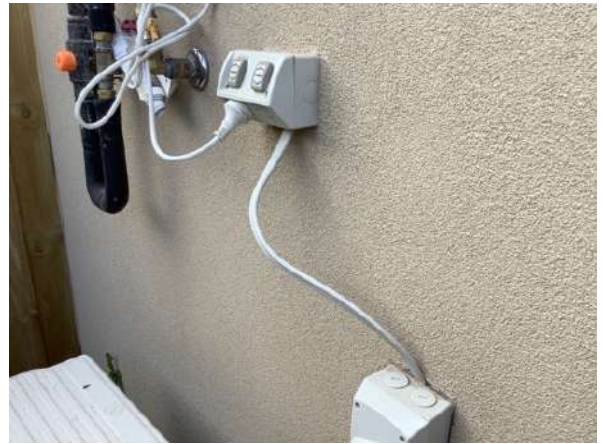
Safety Hazard 1.08

Location: Back Yard

Finding: Illegal wiring performed

The tenant stated to the managing agent that this wiring was like this at the time of signing her contract. This is an absurd comment to make and once again the managing agent has all her photos to identify this property was brand-new and this illegal electrical work is only one location of many that needs to be taken out and once again a qualified electrician needs to check all locations are safe and put back to normal, so that the builders warranty is not compromised and also people's lives will not be at risk.

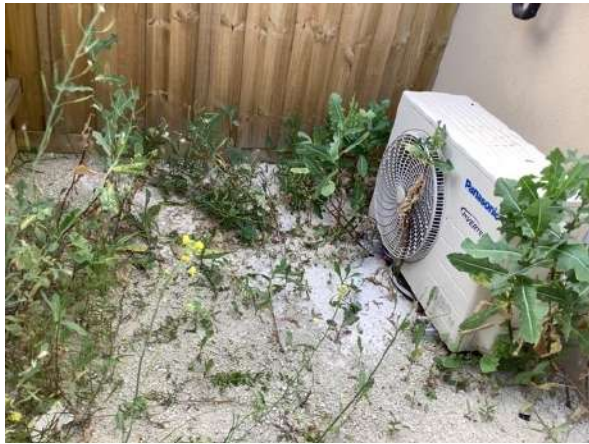
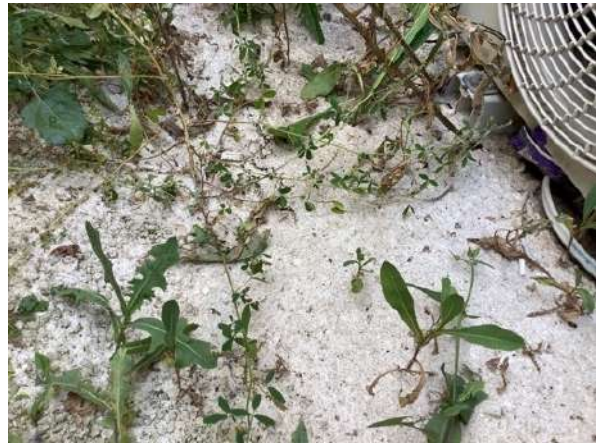
Safety Hazard 1.09

Location: Back Yard

Finding: Paper type material on ground - Evidence of suspected methamphetamine use

All paper on the ground, possibly linked to methamphetamine manufacturer or use, This product has also put a terrible smell through the backyard and inside the house.

Evidence of suspected methamphetamine use, or potentially its manufacture, was found during the inspection.

However the more significant issue is that there may be residual environmental contamination throughout the property if Methamphetamine has been used or manufactured in the property. Residual environmental contamination caused by Methamphetamine use can have serious health implications and effects on occupants. Consequently we have listed this as a Safety Hazard.

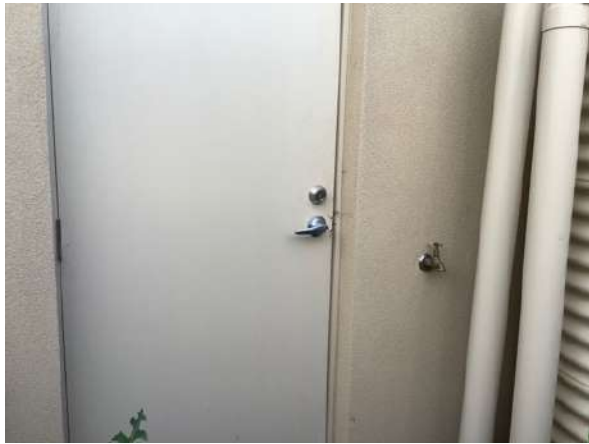
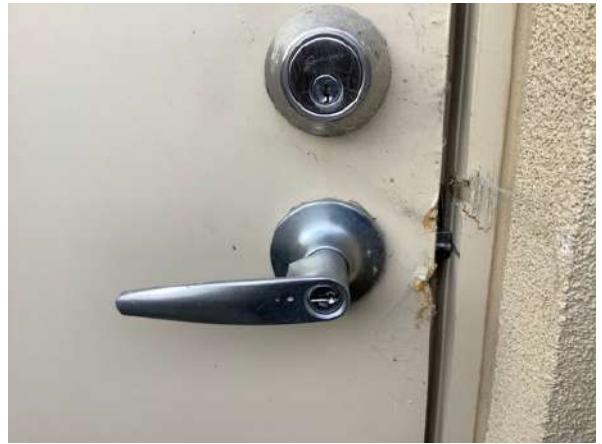
Safety Hazard 1.10

Location: Back Yard
Finding: Back door damaged

It appears someone has tried to break in, as there is the high possibility of a illegal activity, well we certainly do know for certain that the property is contaminated with methamphetamine and we do know the high levels of security with the additional locks, camera system and alarm system in which the tenant had no authority to install particularly since the tenant has left so much damage, of course it was related, that's why the tenant never notified us and added additional locks, cameras and alarm systems with all the damage left.

A carpenter is required for all the repairs to install new doors and timber work including locks, followed by a painter.

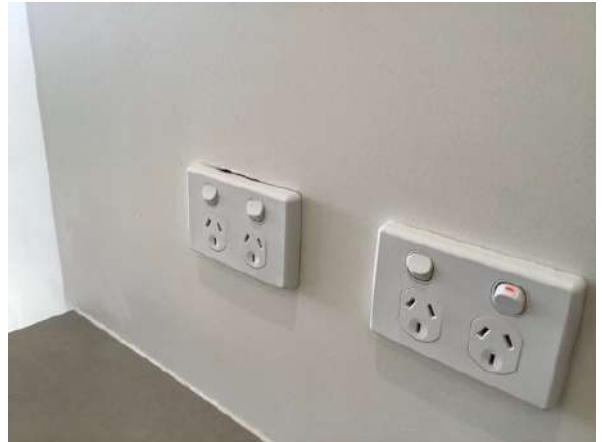
Safety Hazard 1.11

Location: Kitchen

Finding: PowerPoint Installed in kitchen.

There was already a PowerPoint above the bench in the kitchen. A PowerPoint in this location is more than enough, however this tenant had installed camera system and you can see the crude workmanship repair of the shelf in this location and now an additional PowerPoint has been installed a legally and once again this PowerPoint needs to be removed the electrical wiring place back to its original state and the plasterwork and paintwork repaired.

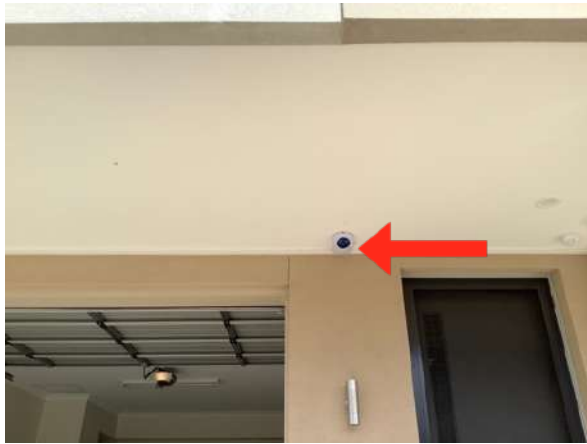
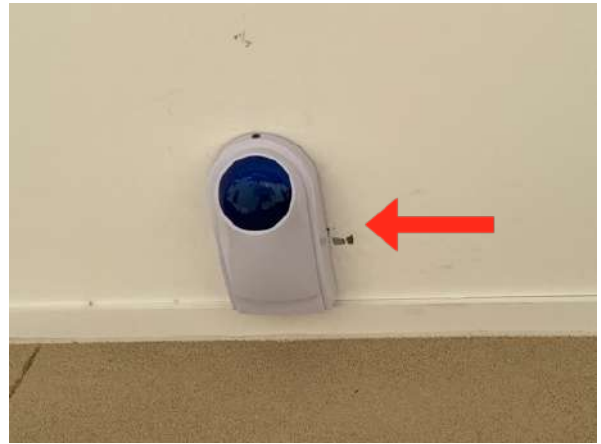
For Your Information 5.02

Location: Alarm Installed
 Finding: Alarm - Damage
 An alarm has been installed to this property without the consent of the vendors, there is various damages to the property due to the alarm system, however this is just to show indication that an alarm has being installed and damage to this area has taken place.

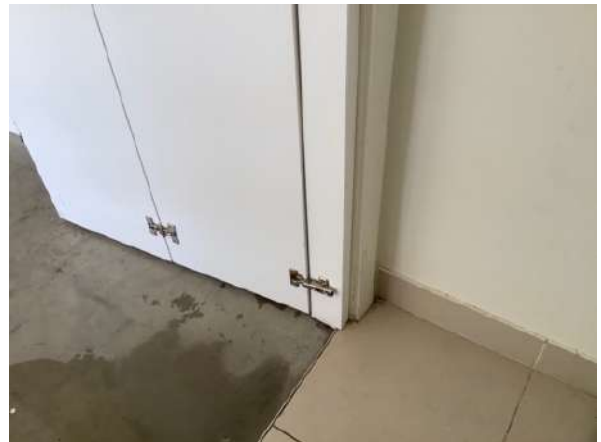
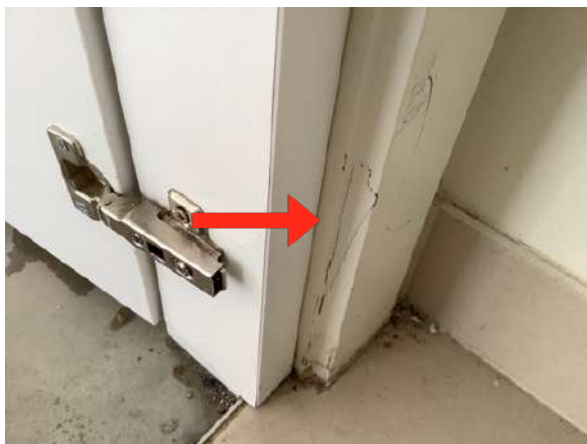
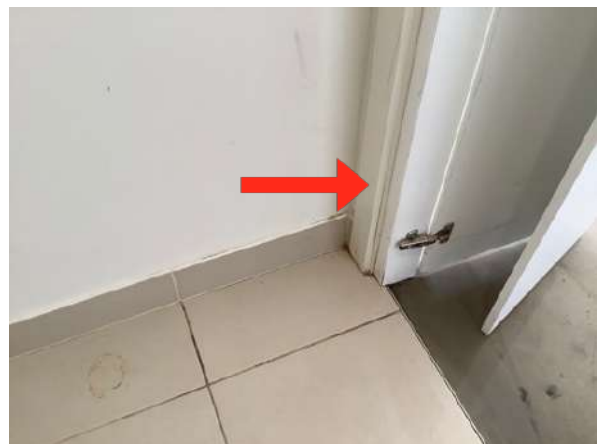
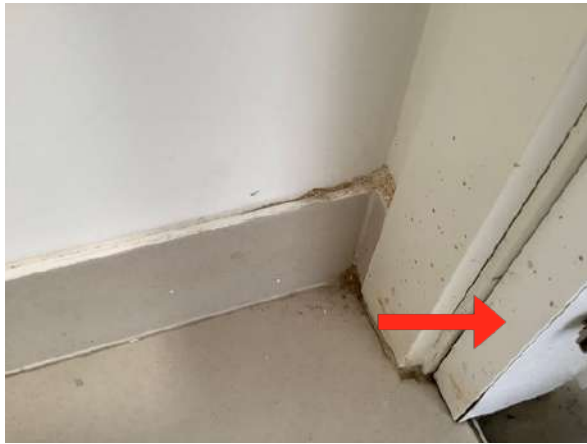
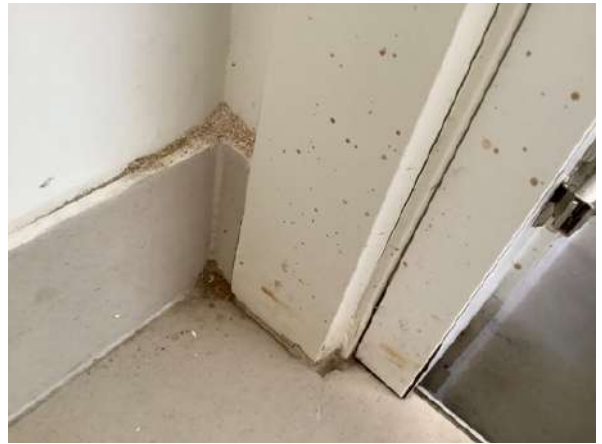
For Your Information 5.03

Location: Laundry

Finding: Timber Damage

The timber work has wood rot, this is due to excessive water on the ground caused by carelessness . Once again this was a brand-new property under eight months ago.

A qualified carpenter is required to do all the timber repairs following a painter.

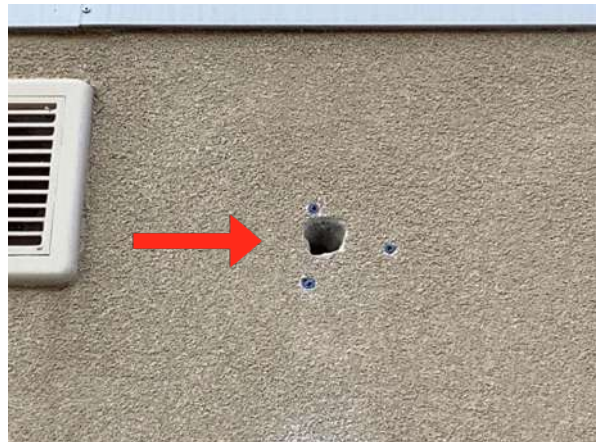
For Your Information 5.04

Location: Back Yard

Finding: Damage to the exterior wall

This appears to be damage from the old camera system the brickwork needs to be repaired and the render needs to be repaired and also the electrician needs to check the ceiling space areas that there are no fire hazards or any legal wiring left.

Once again this should all be overseen by a registered builder.

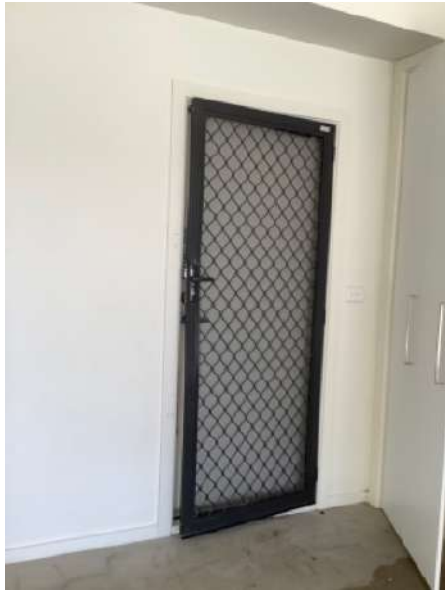
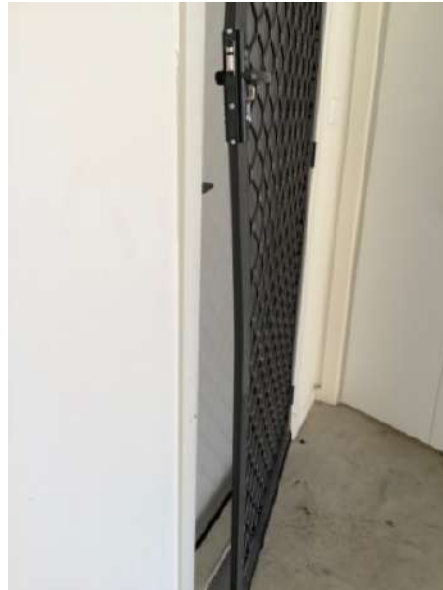
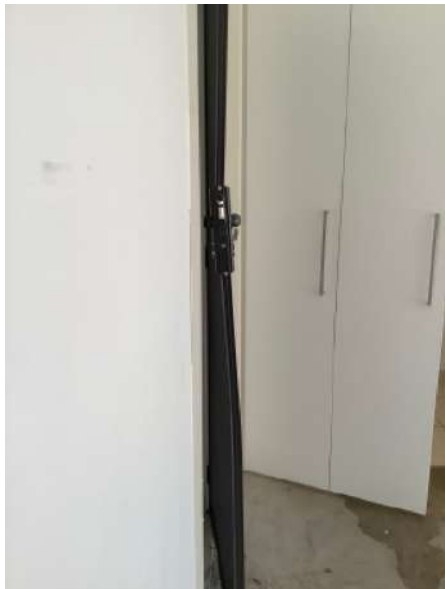
For Your Information 5.05

Location: Back Yard

Finding: Garage security door damaged

The garage security door is completely damaged and requires replacement.

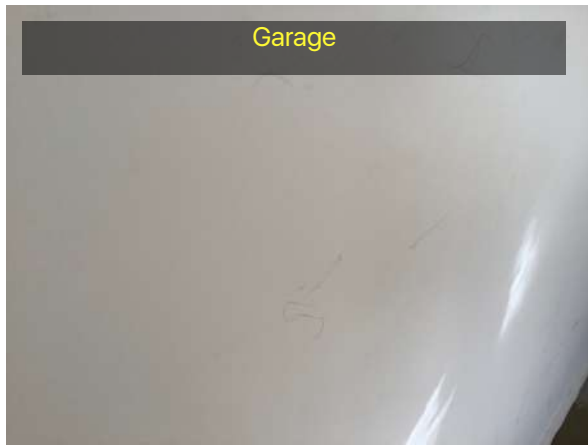
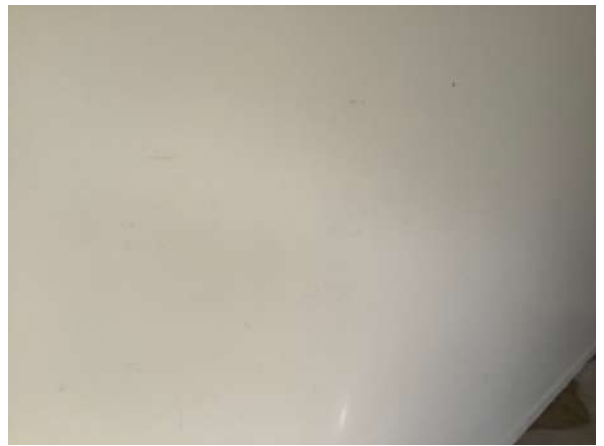
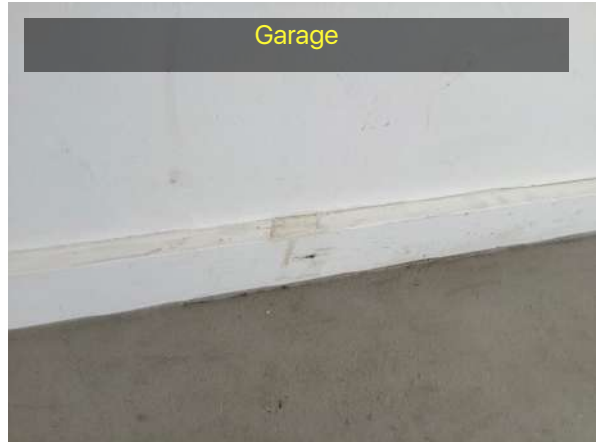
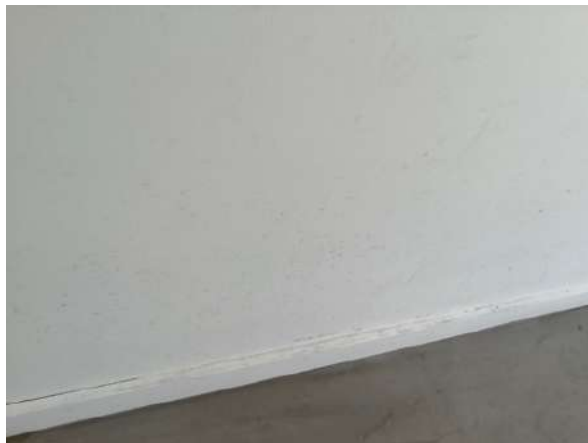
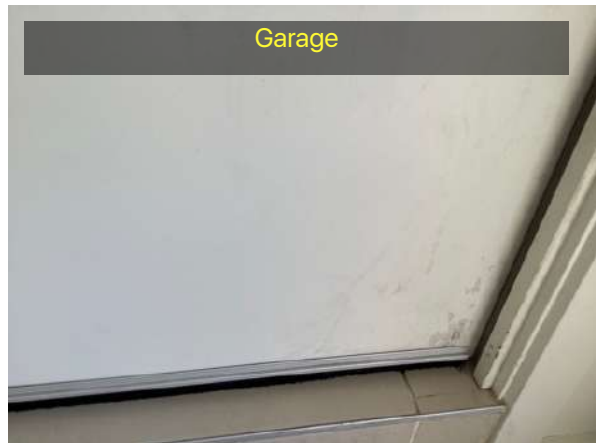
For Your Information 5.06

Location: Paint And Plaster Damage Throughout The Property

Finding: There is paint and plaster damage throughout the property.

There is paint and plaster damage throughout the property, some of it related to the tenant installing ilegal electrical works, the alarm system and cameras and due to their ilegal activity and some of it is through the general carelessness.

I would like to remind the reader that this property was brand-new and never been lived in, Only under eight months ago.

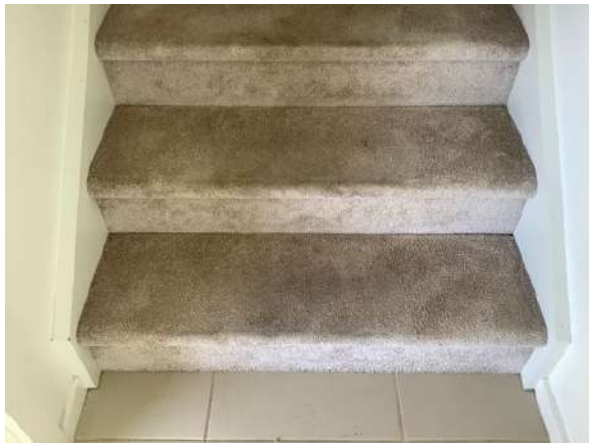
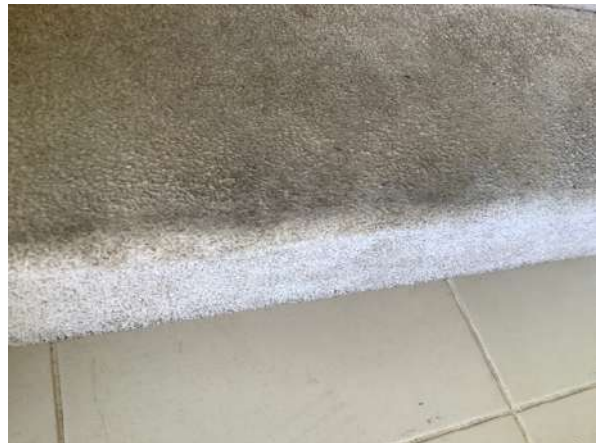
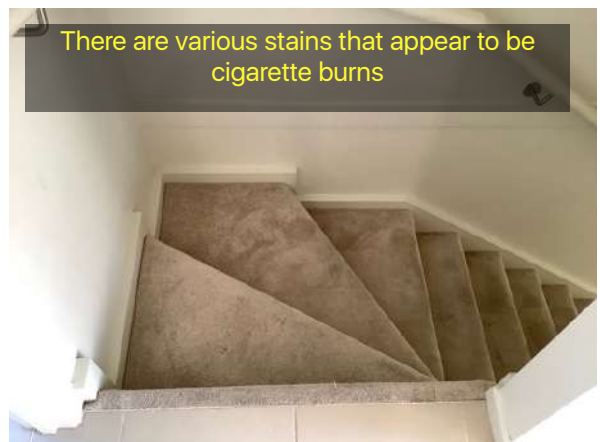
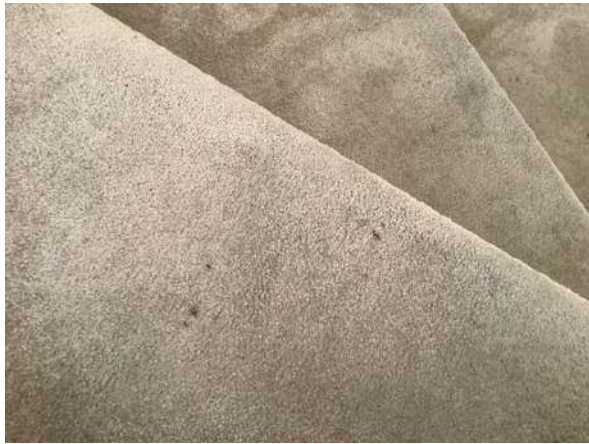
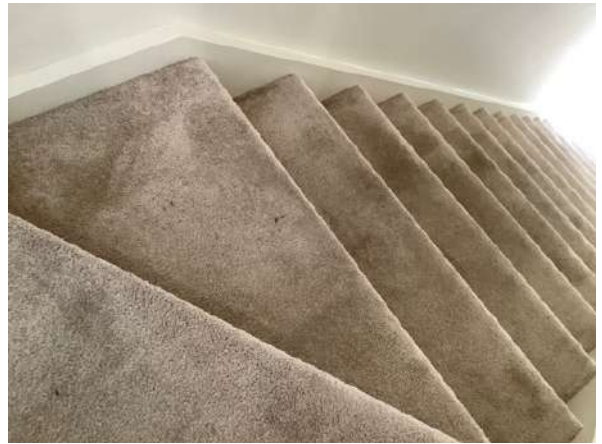
For Your Information 5.07

Location: Carpet On The Staircase

Finding: Carpet on staircase is well worn

The carpet on the staircase is well worn and stained, please note that this property has only been rented For under eight months and the damage is not just wear and tear, it has stains and marks and once again due to the activity of this property, in which the activity what type of activity has added to the damage.

The carpet requires replacement.

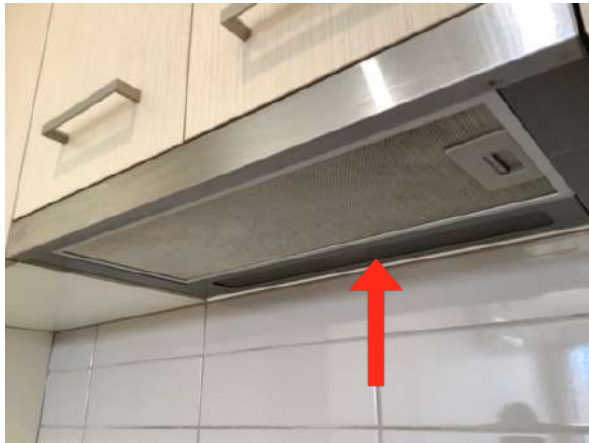
For Your Information 5.08

Location: Rangehood
Finding: Rangehood
Rangehood light not working

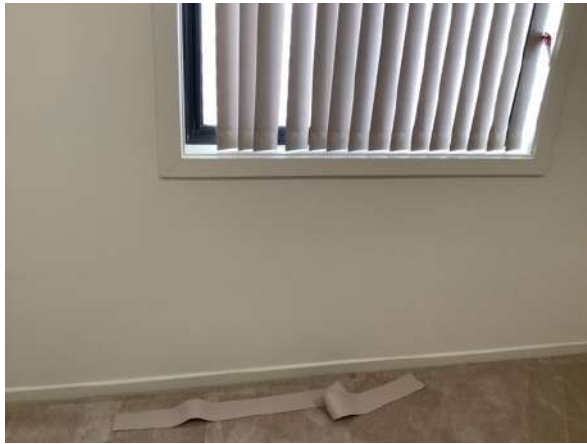
For Your Information 5.09

Location: Upstairs Bedroom
Finding: Broken blind
The blind appears to be broken

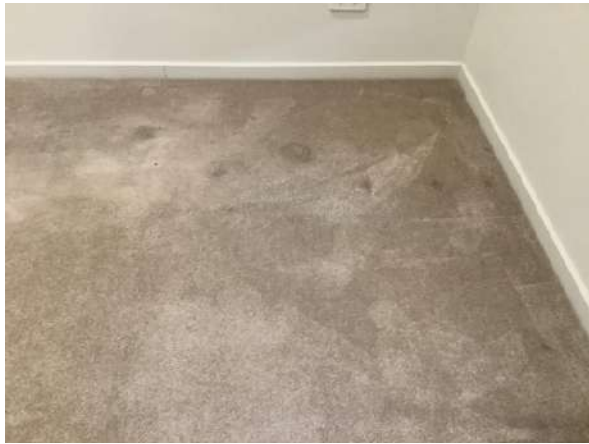
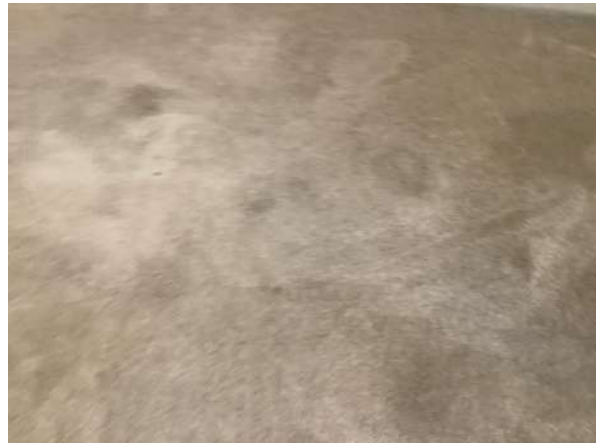
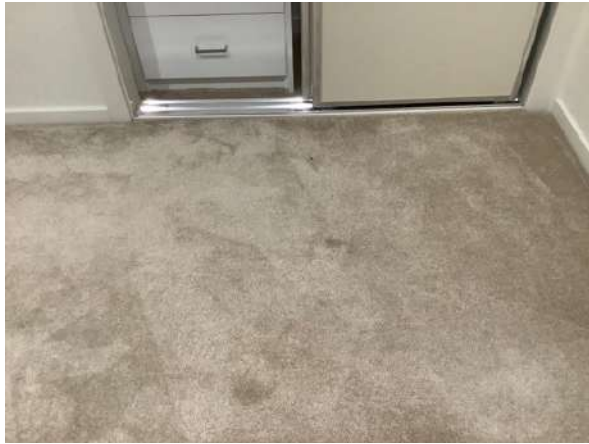
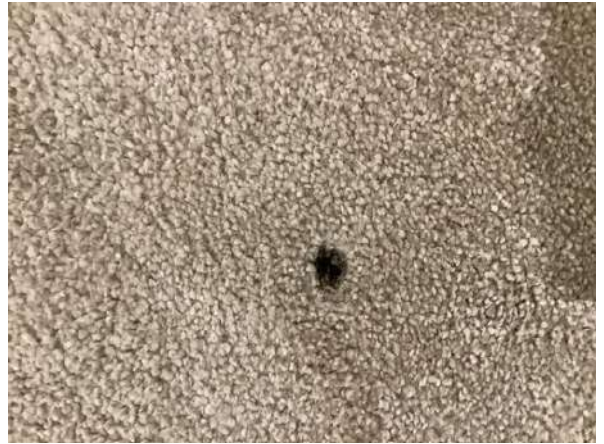
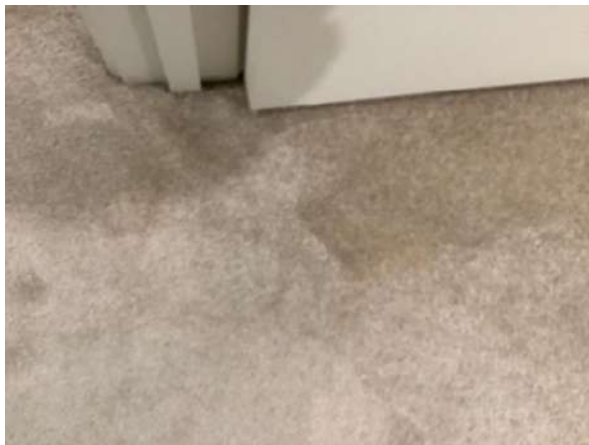
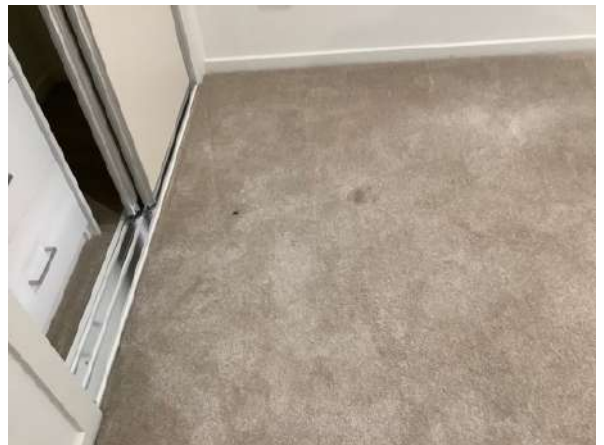
For Your Information 5.10

Location: Upstairs Bedroom

Finding: Suspicious burn marks in the carpet

Evidence of suspected methamphetamine use, or potentially its manufacture, was found during the inspection.

The evidence identified was staining and marking of surfaces that could be consistent with use or manufacture of methamphetamine. Evidence of suspected methamphetamine use

The evidence identified was staining of surfaces consistent with use of particular chemicals that are present in meth and can be used in its Manufacture.

However the more significant issue is that there may be residual environmental contamination throughout the property if Methamphetamine has been used or manufactured in the property. Residual environmental contamination caused by Methamphetamine use can have serious health implications and effects on occupants. Consequently we have listed this as a Safety Hazard.

Methamphetamine - Suspected Methamphetamine Use - Staining / Smoke Damage and Burns

We recommend a Methamphetamine Screening Assessment which includes Sampling to make an initial determination as to the presence of methamphetamine or to rule out its presence.

It is strongly recommended that this be completed prior to acquisition and certainly prior to occupation.

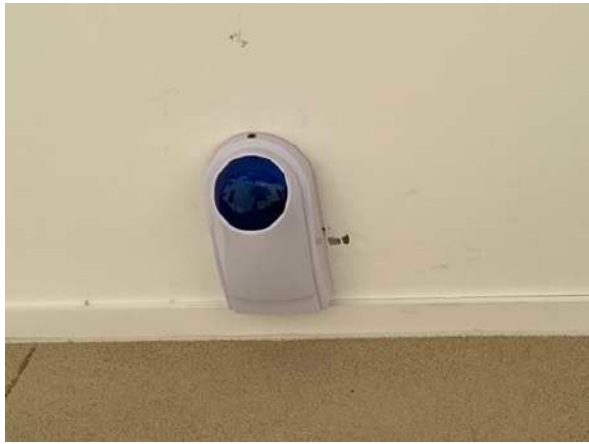
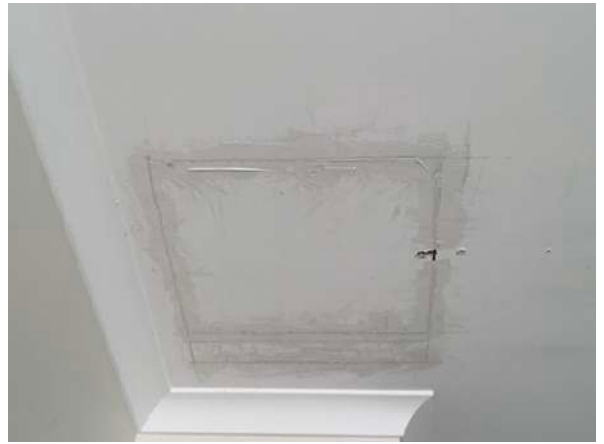
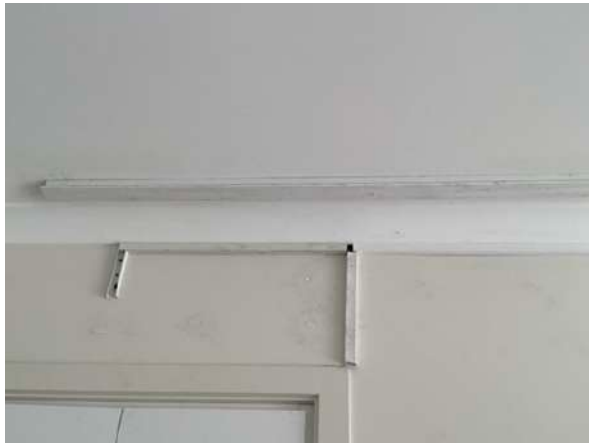
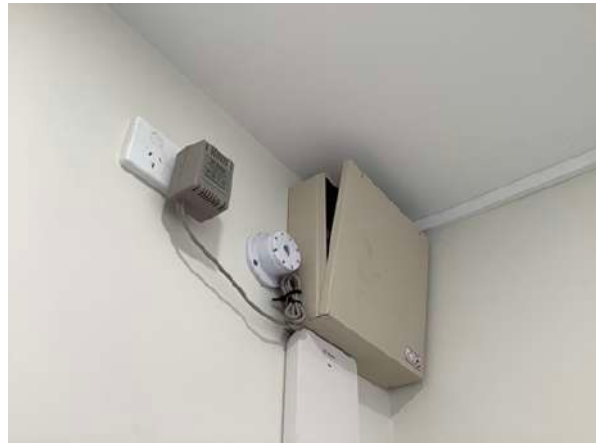
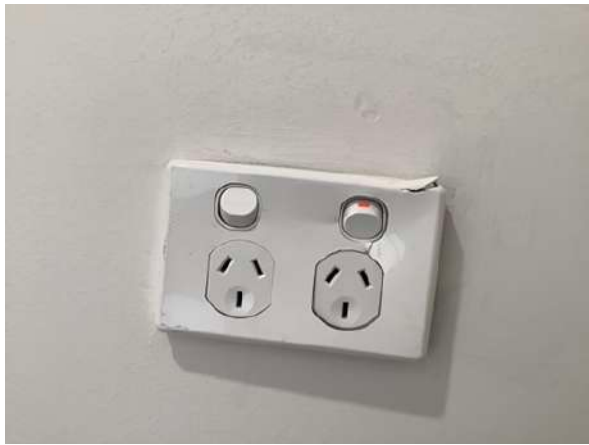
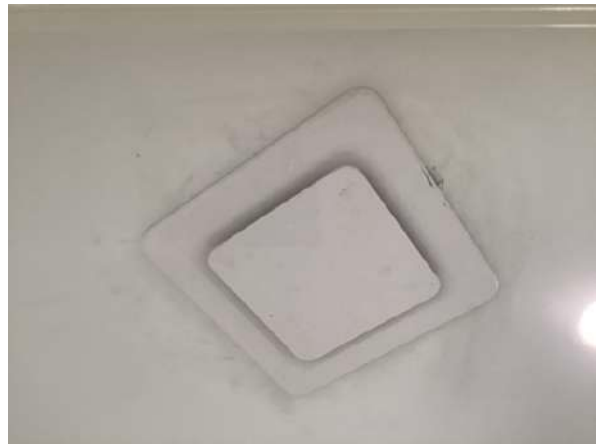
For Your Information 5.11

Location: Suspicious Activity

Finding: Suspicious activity

There is various suspicious building material activity in this property, various cameras spread throughout, alarm system installed, additional back locks, additional power points put in the kitchen, illegal wiring, upstairs suspicious staining on the walls and carpet, burn marks in carpet, Suspicious stains on the ceilings, Various stains to the ceilings as down-lights, vents have been taken out .

Once again the tenant had no right to do such extensive works to the property as this has now impacted the builders warranty insurance and all the ceiling spaces, to all three levels need to be fully inspected by a qualified electrician and registered builder and sign off that the building is as per it was built as without this we may have a compromise builders warranty.
