Rental Safety Report

Inspection Date: 7 Jul 2021

Property Address: Glenroy area

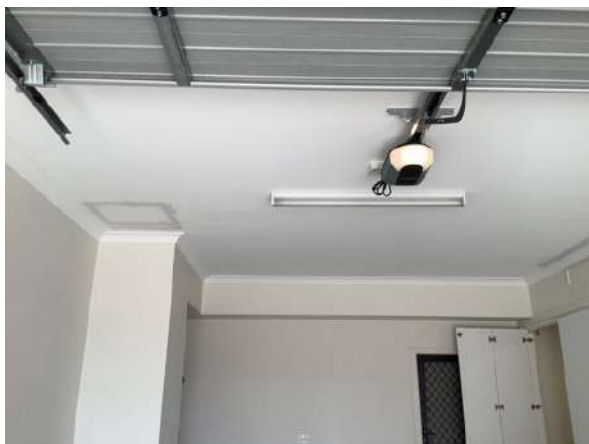
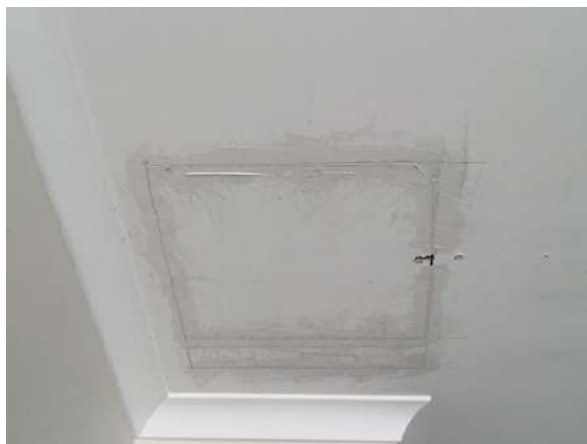
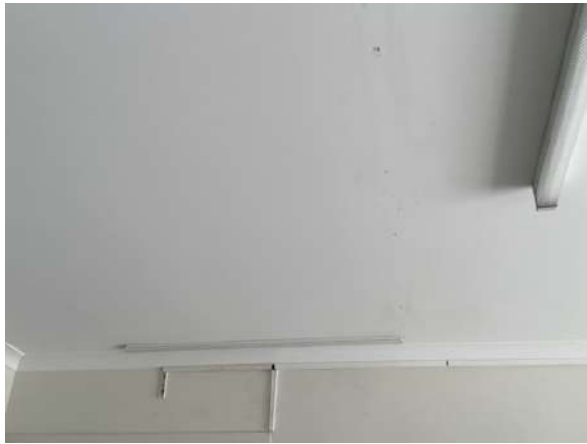
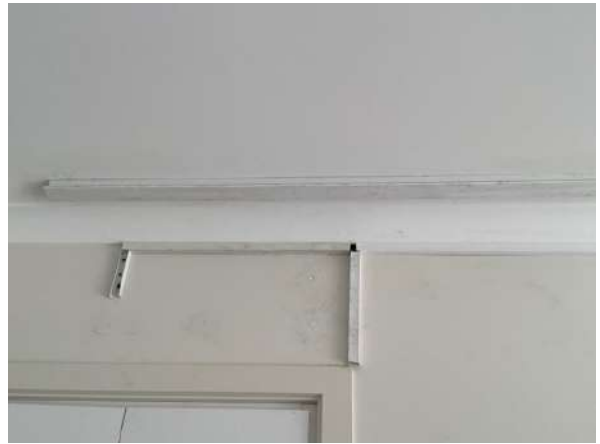
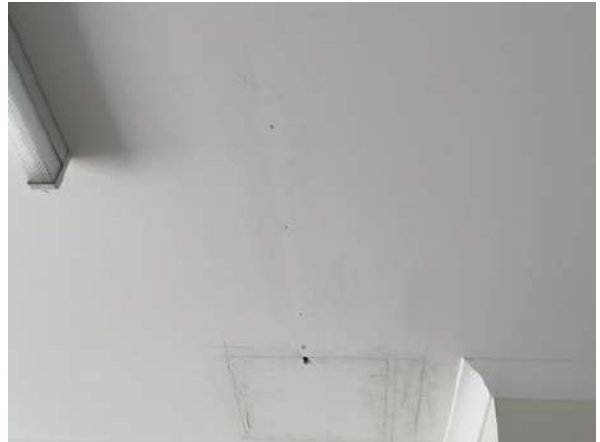
Safety Hazard 1.01

Location: Plaster Damage & Old Camera/Alarm

Finding: Garage - Plaster & Duct Damage

Due to the electrical works, alarm installation and camera installation, also the disassembly in part of the electrical, alarm and camera installation, there is now various damage taken place to the plasterwork and paint work.

There has been very crude and substandard workmanship repair done, however certainly not satisfactory for a property of 7 to 8 months old.

A qualified electrician, plasterer and painter is required, but due to the illegal electrical work that can be seen, we do not know the severity of the damage in the ceiling space area of electrical work that may be a fire risk and safety hazard and I highly recommend further invasive works to the plaster in order to visually see the ceiling space areas to identify any illegal wiring that is a fire risk or a safety hazard. All electrical is to be inspected by a qualified electrician. Once the electrical is all repaired and safe the plasterwork repairs and painting can then be finished.

A registered builder should take control of this job so that all the appropriate works are done in the appropriate orders.

It is important that the building become completely compliant to the building codes and the wiring is all safe, otherwise the builders warranty may not apply to this building.

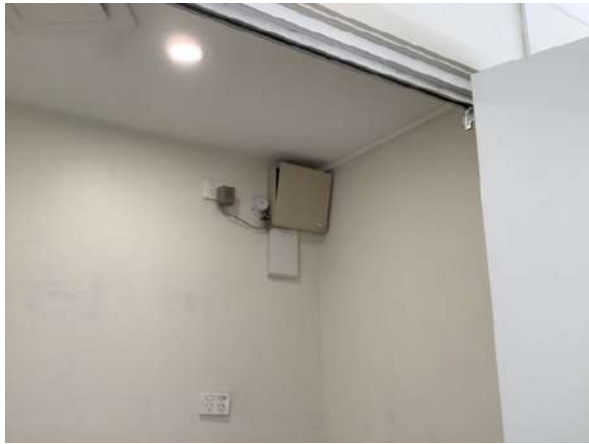
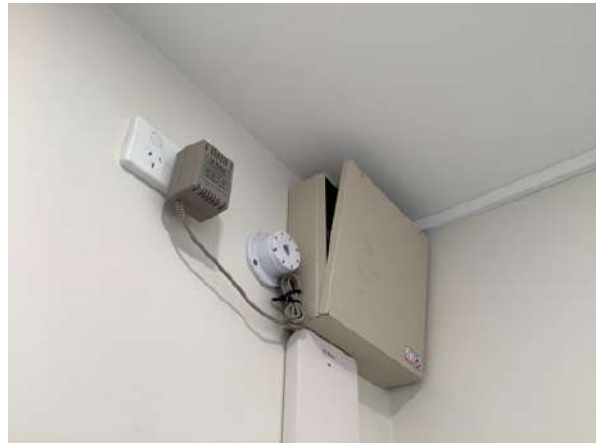
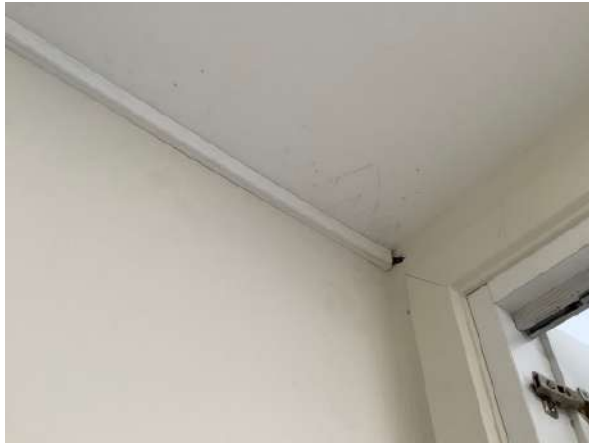
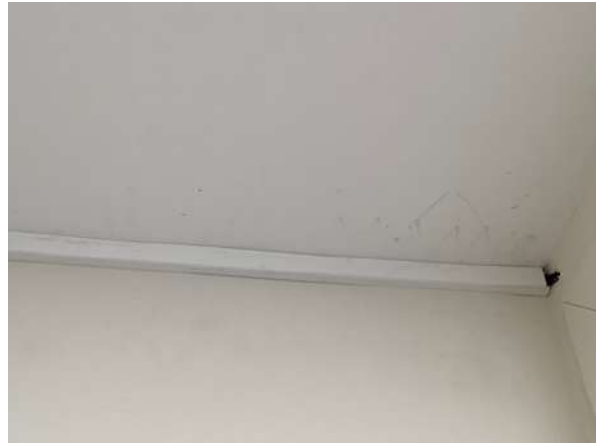
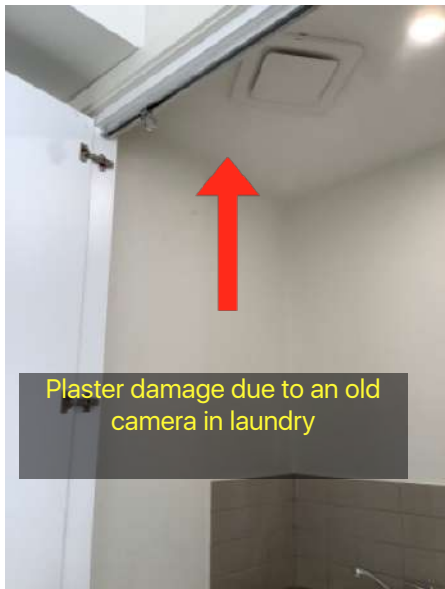
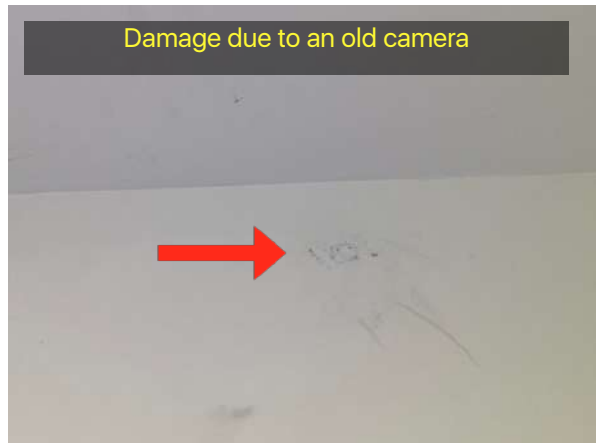
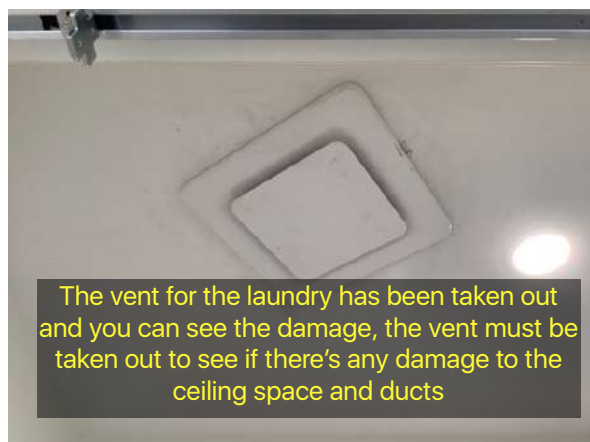
Safety Hazard 1.02

Location: Plaster Damage & Old Camera/Alarm

Finding: Laundry - Plaster & Duct Damage

Due to the electrical works, alarm installation and camera installation, also the disassembly in part of the electrical, alarm and camera installation, there is now various damage taken place to the plasterwork and paint work.

There has been very crude and substandard workmanship repair done, however certainly not satisfactory for a property of 7 to 8 months old.

You can identify that the exhaust fan vent has been taken out by the damaged painted ceiling, This is how some of the the electrical wiring has been performed between the floor levels and ceilings spaces.

A qualified electrician, plasterer and painter is required, but due to the illegal electrical work that can be seen, we do not know the severity of the damage in the ceiling space area of electrical work that may be a fire risk and safety hazard and I highly recommend further invasive works to the plaster in order to visually see the ceiling space areas to identify any illegal wiring that is a fire risk or a safety hazard.

All electrical is to be inspected by a qualified electrician. Once the electrical is all repaired and safe the plasterwork repairs and painting can then be finished.

A registered builder should take control of this job so that all the appropriate works are done in the appropriate orders.

It is important that the building become completely compliant to the building codes and the wiring is all safe, otherwise the builders warranty may not apply to this building.

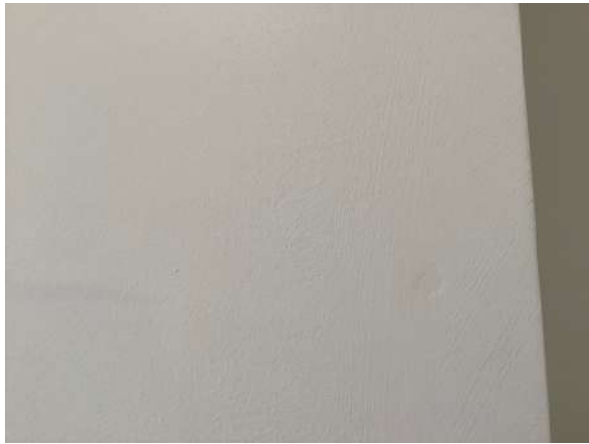
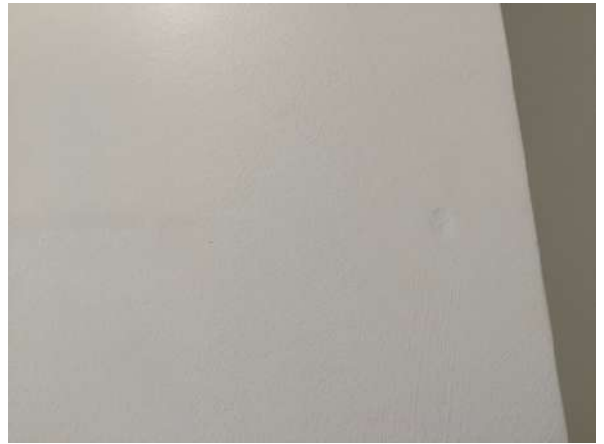
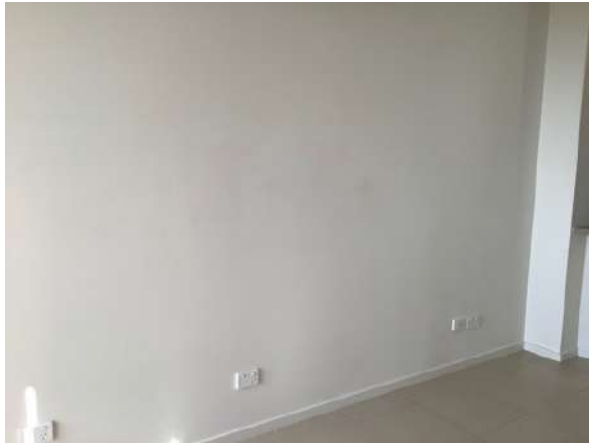
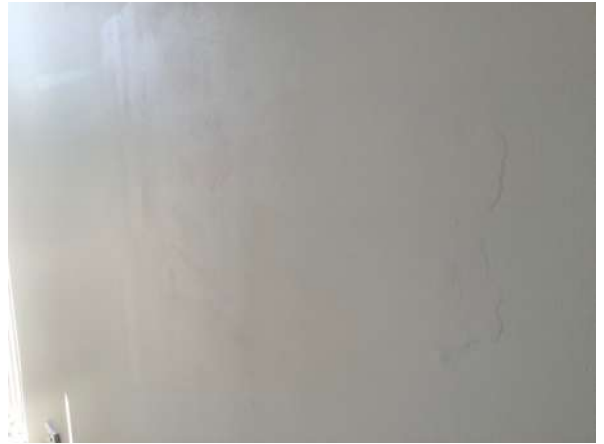
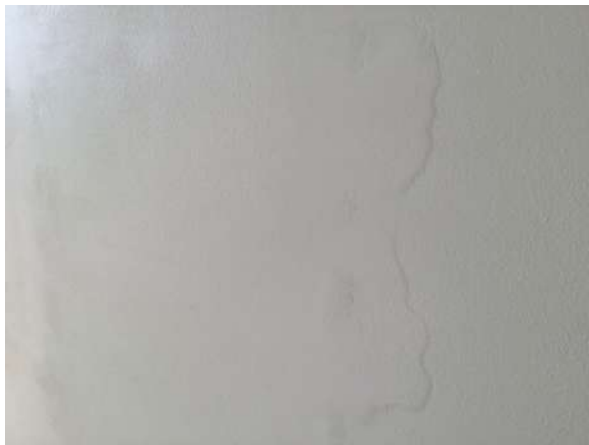
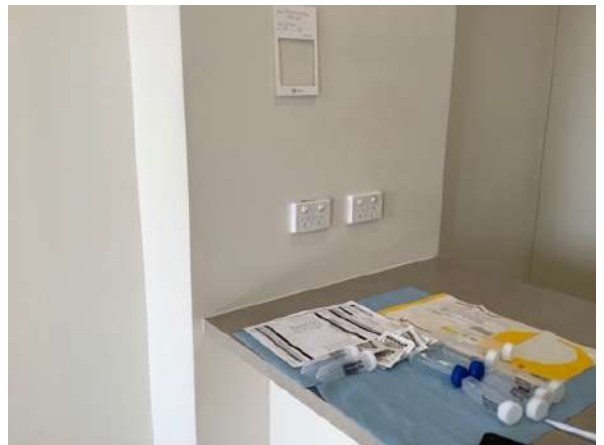
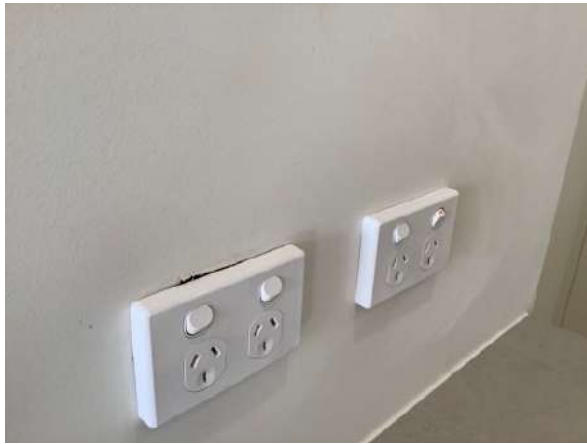
Safety Hazard 1.03

Location: Plaster Damage & Old Camera/Alarm

Finding: Kitchen and family room

There was some type of shelf installed above the kitchen bench and additional PowerPoints installed, more than likely this was installed for the camera system and/or other illegal activity.

Also there appears to be what may have been a TV bracket on the wall and the crude plasterwork and patchwork is well below acceptable tradesmen like qualities including all other plaster and paint repairs are all well below try to like quality.

A qualified electrician, plasterer and painter is required.

The extra PowerPoint that has been installed needs to be taken out in the wiring placed back to safe practices again.

A registered builder should take control of this job so that all the appropriate works are done in the appropriate orders.

It is important that the building become completely compliant to the building codes and the wiring is all safe, otherwise the builders warranty may not apply to this building.

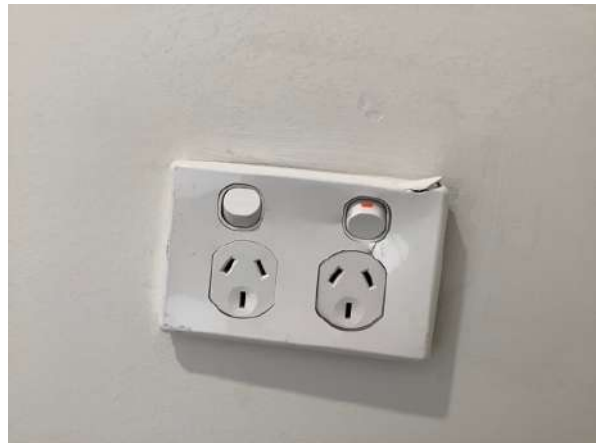
Safety Hazard 1.04

Location: Laundry

Finding: Damaged Power Point

The PowerPoint is structurally compromised and very much a safety hazard. This PowerPoint should not be used until it is replaced and the electrical wiring is inspected to this location and all locations.

It is unknown as to how this type of damage can occur in this location.

There is the strong possibility that this PowerPoint is compromised due to excessive power load caused by illegal activity and this PowerPoint could have something to do with the illegal wiring outside as well.

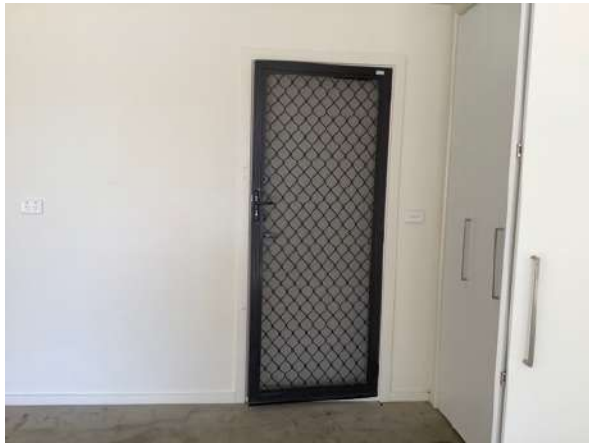
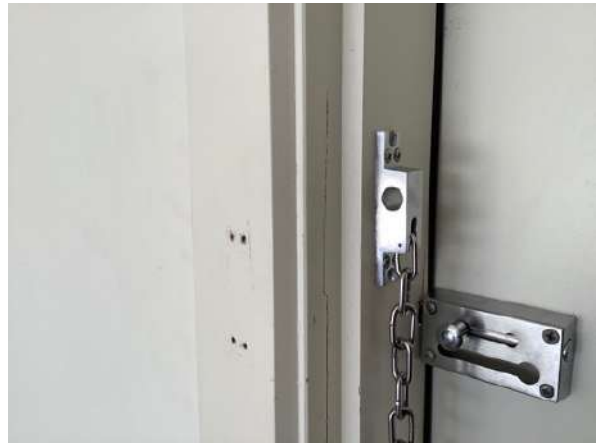
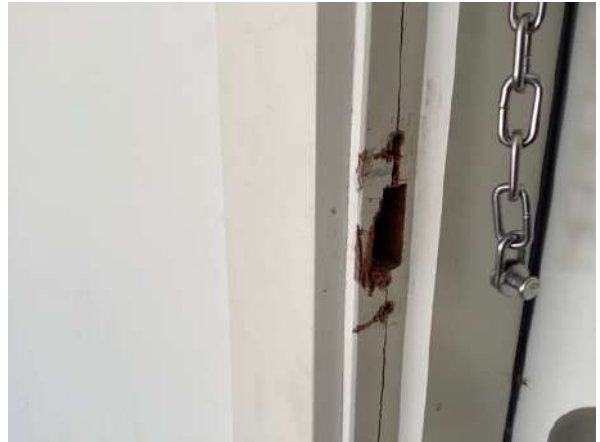
Safety Hazard 1.05

Location: Garage

Finding: Garage Back Door Damaged

The door frame, door and security door are all damaged

Garage backdoor severely damaged , Due to somebody trying to break in, once again this would certainly be related to the illegal activity that was being performed in this property. You can also identify that the tenant has added additional security locks as well three in fact. It is certainly not typical to have three different locks on one door.

A carpenter and security door expert are required to complete all the repairs, followed by a painter.

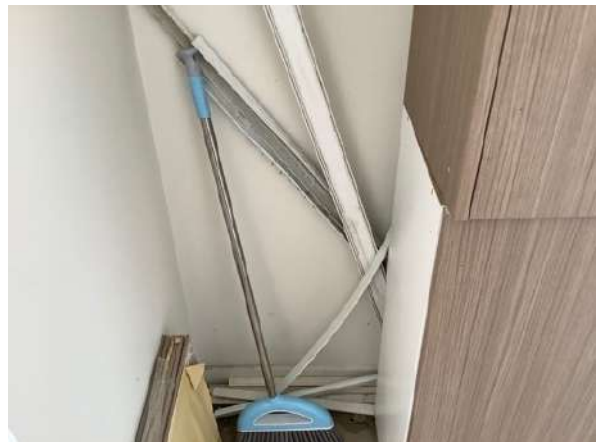
Safety Hazard 1.06

Location: Garage

Finding: The old camera ducts and cupboards

These cupboards are not from this property, and in addition all this ductwork is part of the electrical, camera and alarm systems that have been partially taken out.

All this material needs to be taken away for rubbish. It is very important as the place is contaminated with methamphetamine that this product be treated as contaminated as well.

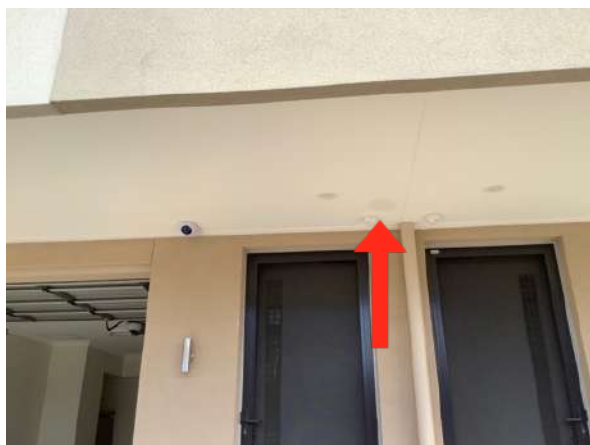
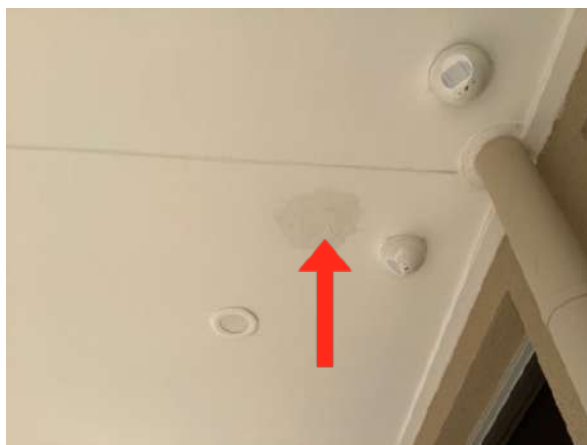
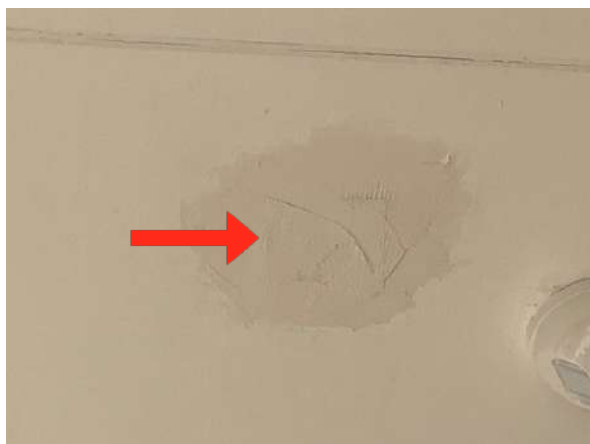
Safety Hazard 1.07

Location: Front exterior

Finding: Damage due to old cameras and alarms

The front exterior ceiling area is damaged by the camera system that has been taken out and there has been crude workmanship taken place that is certainly not acceptable.

Once the alarm system gets taken out there will be damage as well, not just at this location there will be varied locations damaged inside the property and outside the property as well from the alarm system to the plaster, timber work, brickwork, exterior render, door switches etc.

Due to the crude workmanship no work that has been performed by this tenant can stay on this property as it may affect the builders warranty and also be a fire risk.

Varied trades are required and once again all should be overlooked by a registered builder.

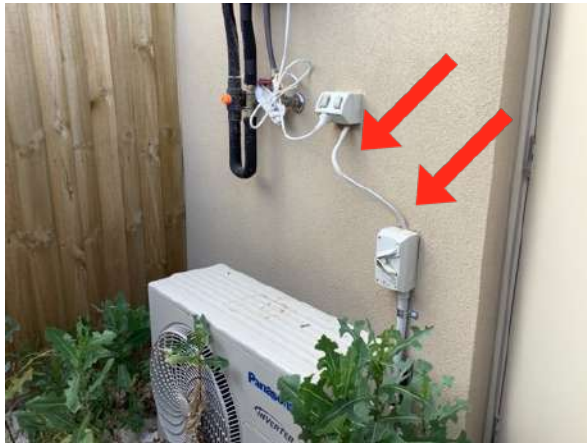
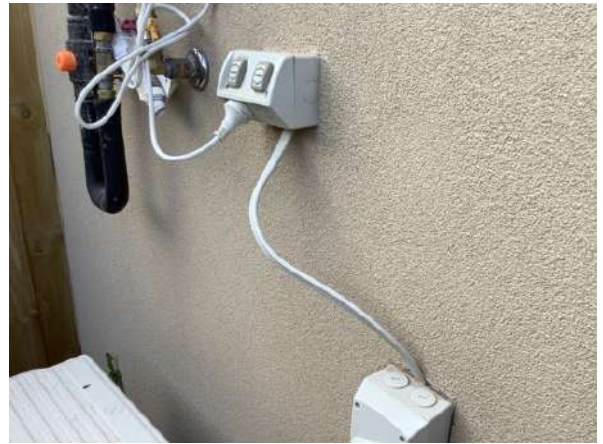
Safety Hazard 1.08

Location: Back Yard

Finding: Illegal wiring performed

The tenant stated to the managing agent that this wiring was like this at the time of signing her contract. This is an absurd comment to make and once again the managing agent has all her photos to identify this property was brand-new and this illegal electrical work is only one location of many that needs to be taken out and once again a qualified electrician needs to check all locations are safe and put back to normal, so that the builders warranty is not compromised and also people's lives will not be at risk.

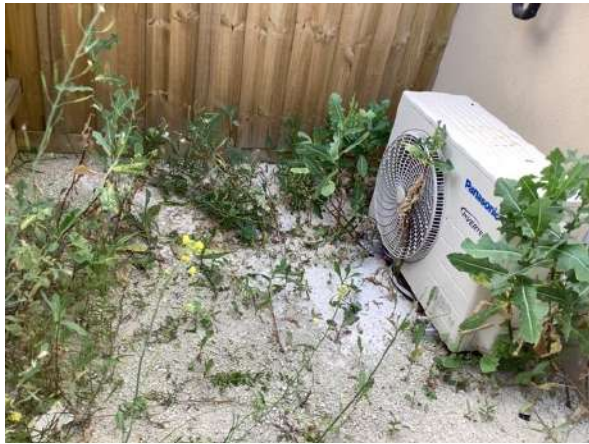
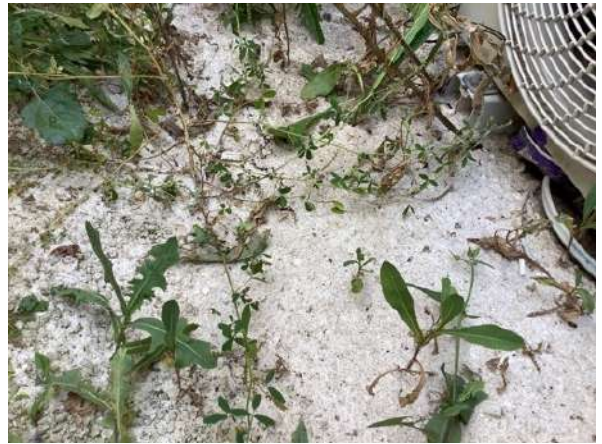
Safety Hazard 1.09

Location: Back Yard

Finding: Paper type material on ground - Evidence of suspected methamphetamine use

All paper on the ground, possibly linked to methamphetamine manufacturer or use, This product has also put a terrible smell through the backyard and inside the house.

Evidence of suspected methamphetamine use, or potentially its manufacture, was found during the inspection.

However the more significant issue is that there may be residual environmental contamination throughout the property if Methamphetamine has been used or manufactured in the property. Residual environmental contamination caused by Methamphetamine use can have serious health implications and effects on occupants. Consequently we have listed this as a Safety Hazard.

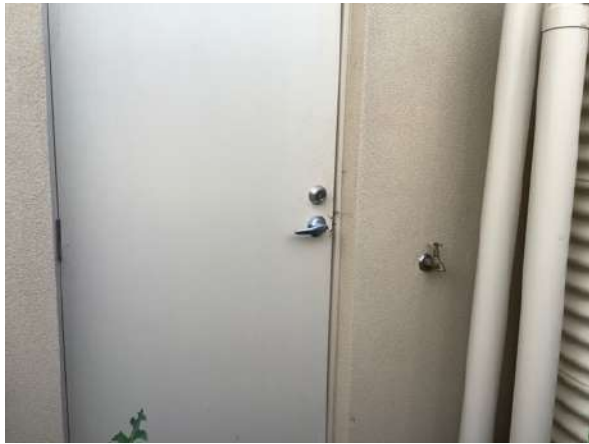
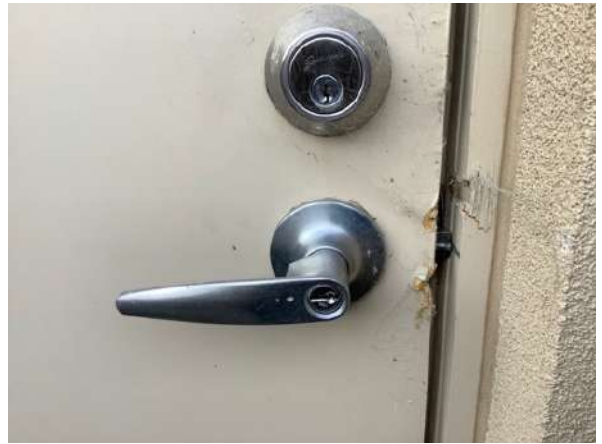
Safety Hazard 1.10

Location: Back Yard
Finding: Back door damaged

It appears someone has tried to break in, as there is the high possibility of a illegal activity, well we certainly do know for certain that the property is contaminated with methamphetamine and we do know the high levels of security with the additional locks, camera system and alarm system in which the tenant had no authority to install particularly since the tenant has left so much damage, of course it was related, that's why the tenant never notified us and added additional locks, cameras and alarm systems with all the damage left.

A carpenter is required for all the repairs to install new doors and timber work including locks, followed by a painter.

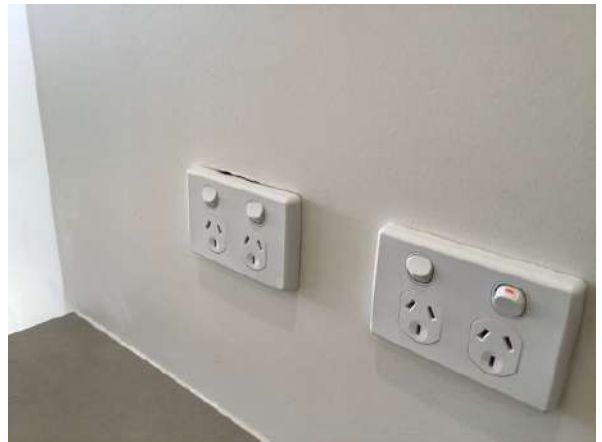
Safety Hazard 1.11

Location: Kitchen

Finding: PowerPoint Installed in kitchen.

There was already a PowerPoint above the bench in the kitchen. A PowerPoint in this location is more than enough, however this tenant had installed camera system and you can see the crude workmanship repair of the shelf in this location and now an additional PowerPoint has been installed a legally and once again this PowerPoint needs to be removed the electrical wiring place back to its original state and the plasterwork and paintwork repaired.

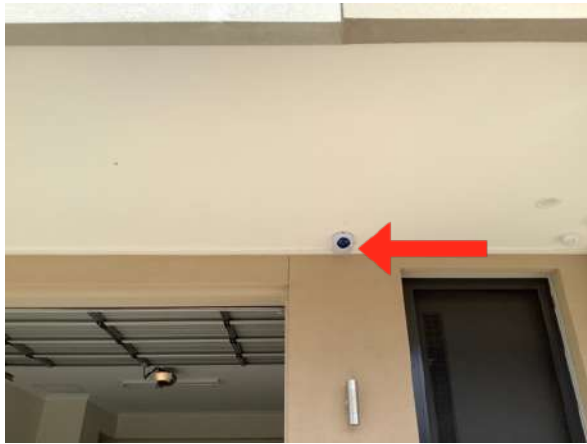
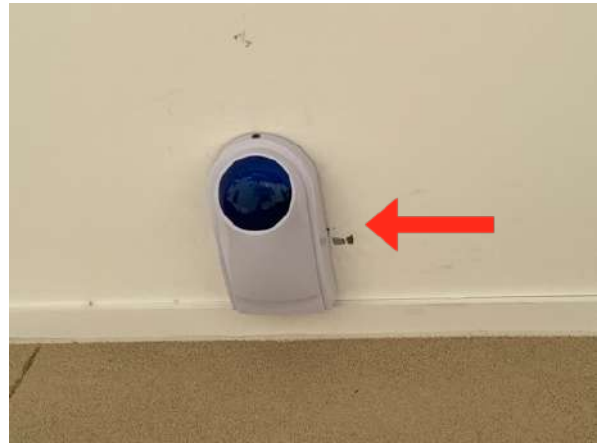
For Your Information 5.02

Location: Alarm Installed
 Finding: Alarm - Damage

An alarm has been installed to this property without the consent of the vendors, there is various damages to the property due to the alarm system, however this is just to show indication that an alarm has being installed and damage to this area has taken place.

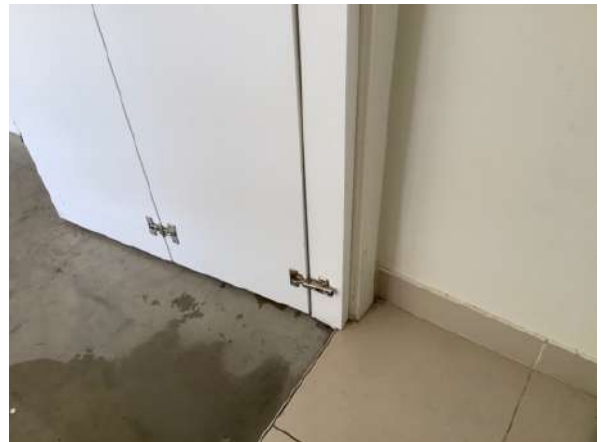
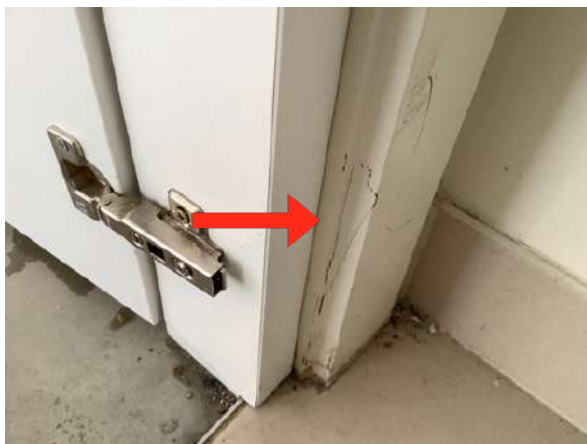
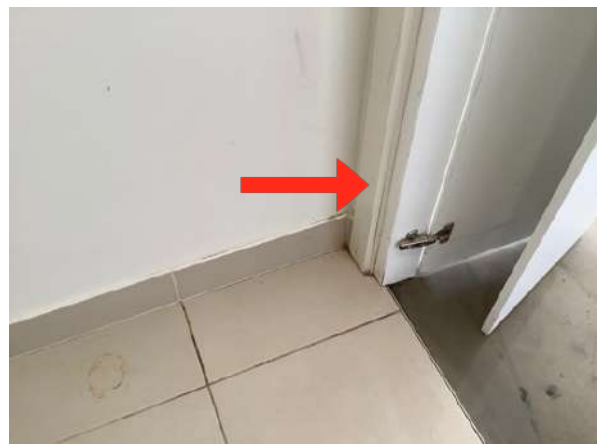
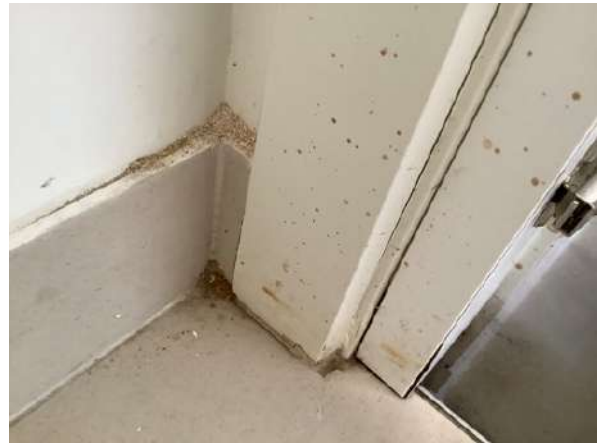
For Your Information 5.03

Location: Laundry

Finding: Timber Damage

The timber work has wood rot, this is due to excessive water on the ground caused by carelessness . Once again this was a brand-new property under eight months ago.

A qualified carpenter is required to do all the timber repairs following a painter.

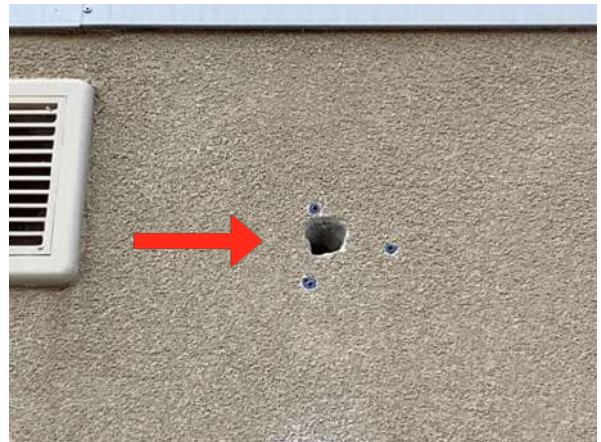
For Your Information 5.04

Location: Back Yard

Finding: Damage to the exterior wall

This appears to be damage from the old camera system the brickwork needs to be repaired and the render needs to be repaired and also the electrician needs to check the ceiling space areas that there are no fire hazards or any legal wiring left.

Once again this should all be overseen by a registered builder.

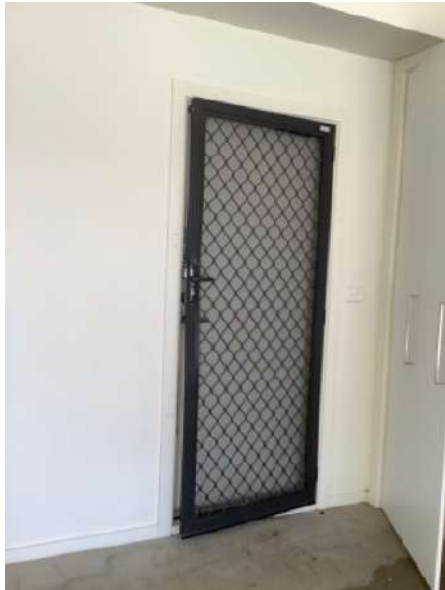
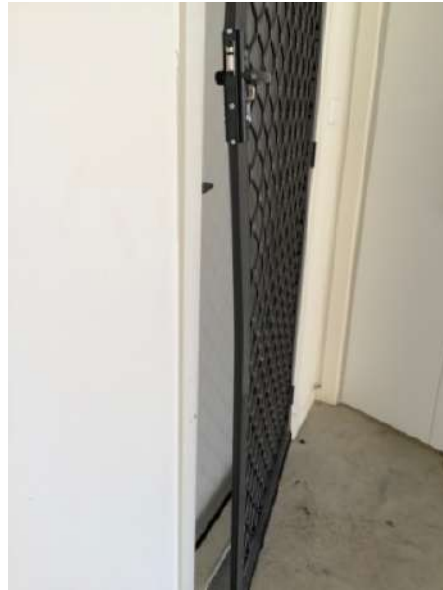
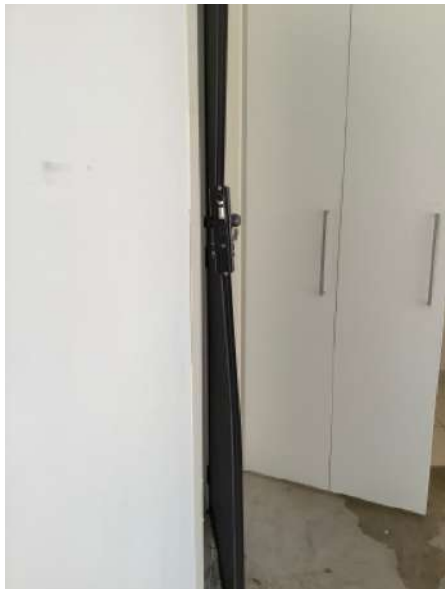
For Your Information 5.05

Location: Back Yard

Finding: Garage security door damaged

The garage security door is completely damaged and requires replacement.

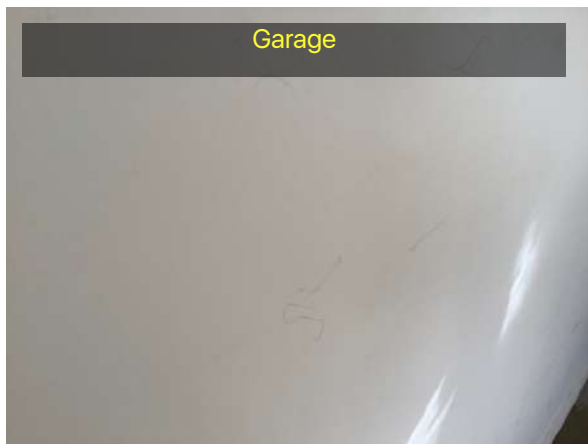
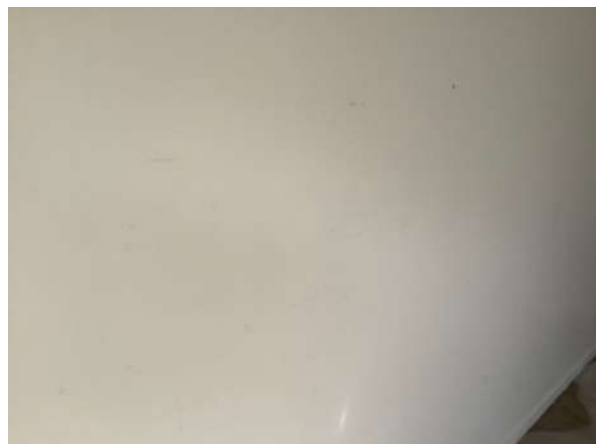
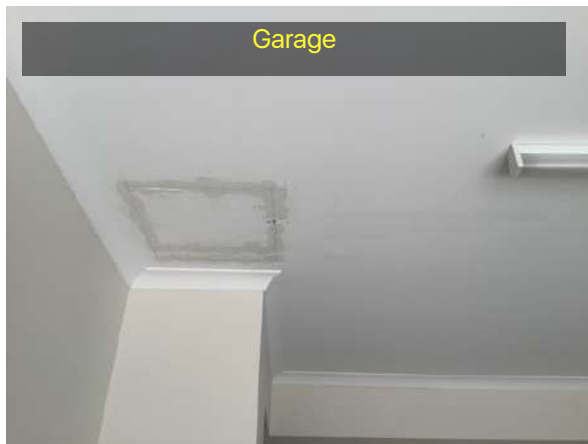
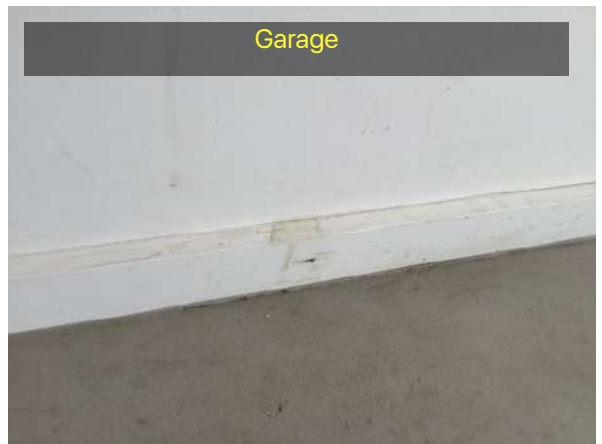
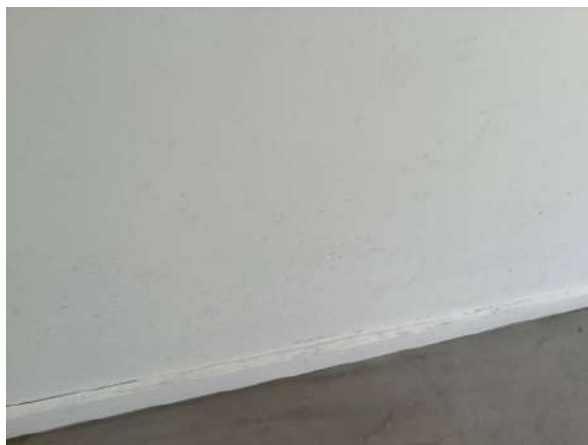
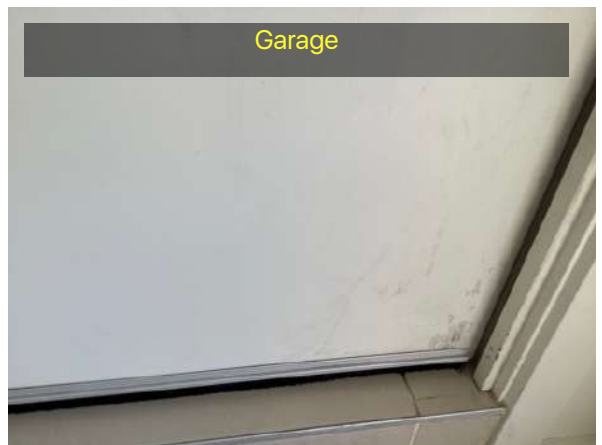
For Your Information 5.06

Location: Paint And Plaster Damage Throughout The Property

Finding: There is paint and plaster damage throughout the property.

There is paint and plaster damage throughout the property, some of it related to the tenant installing ilegal electrical works, the alarm system and cameras and due to their ilegal activity and some of it is through the general carelessness.

I would like to remind the reader that this property was brand-new and never been lived in, Only under eight months ago.

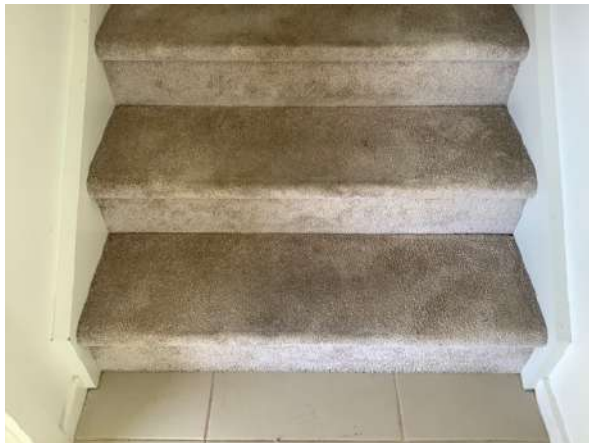
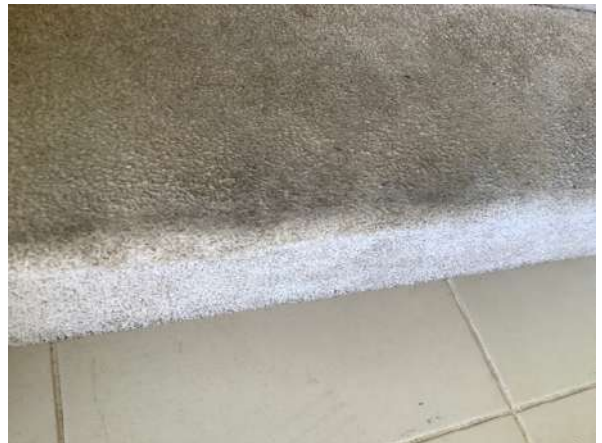
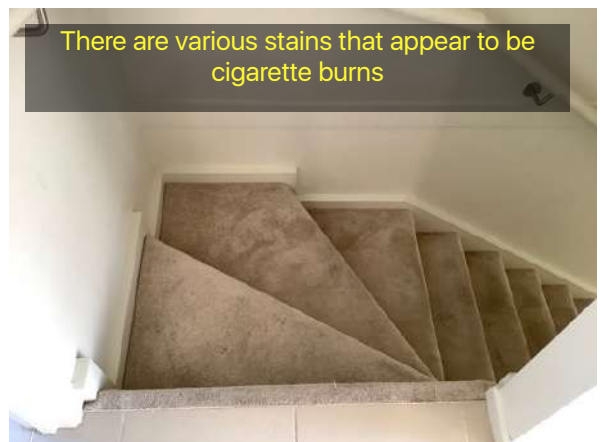
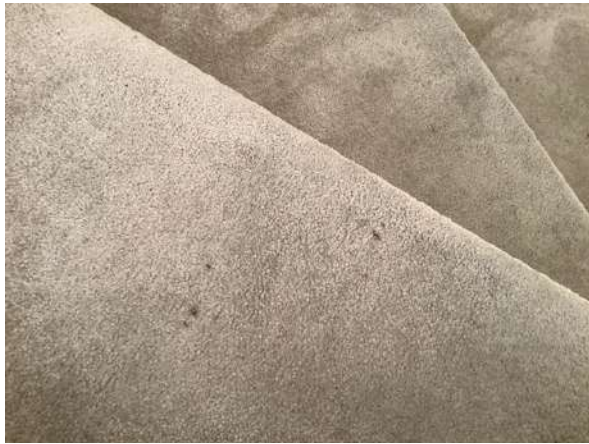
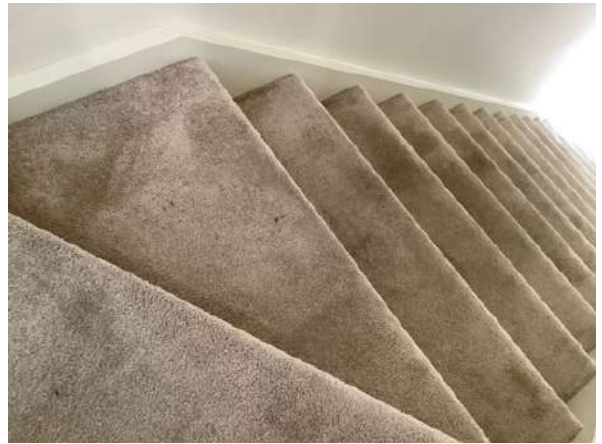
For Your Information 5.07

Location: Carpet On The Staircase

Finding: Carpet on staircase is well worn

The carpet on the staircase is well worn and stained, please note that this property has only been rented For under eight months and the damage is not just wear and tear, it has stains and marks and once again due to the activity of this property, in which the activity what type of activity has added to the damage.

The carpet requires replacement.

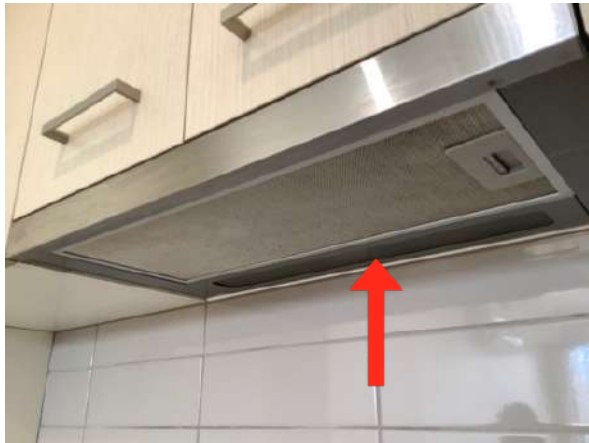
For Your Information 5.08

Location: Rangehood
Finding: Rangehood
Rangehood light not working

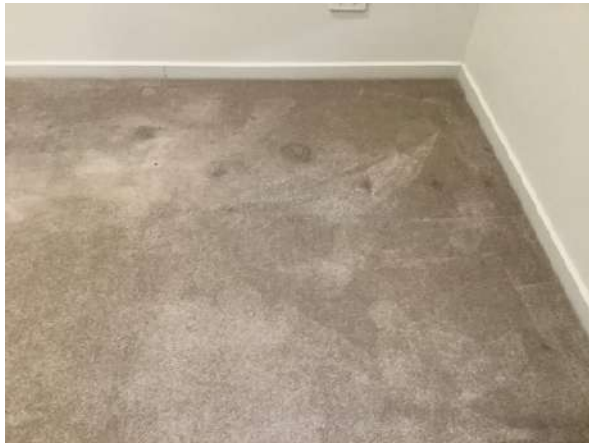
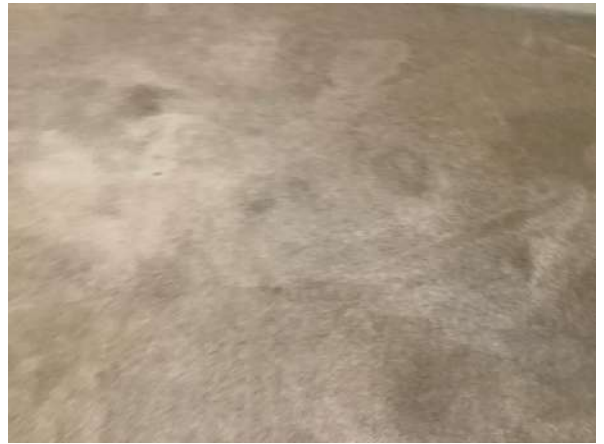
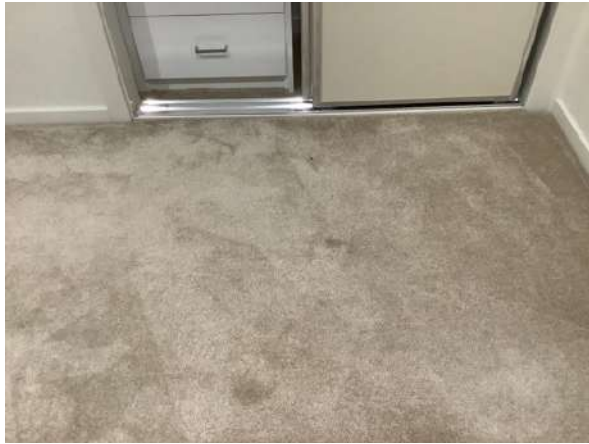
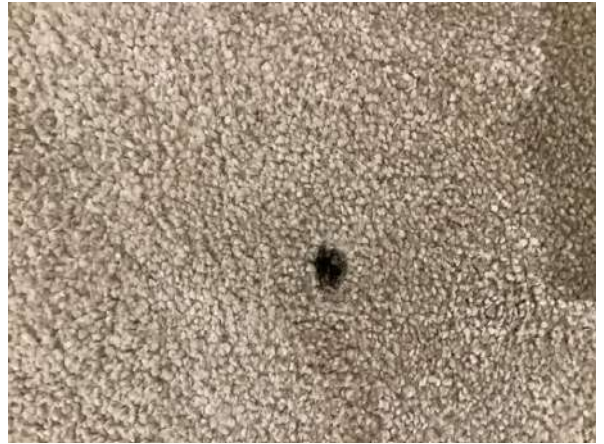
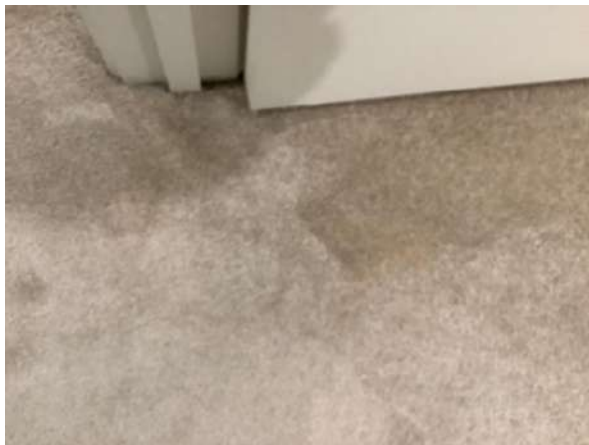
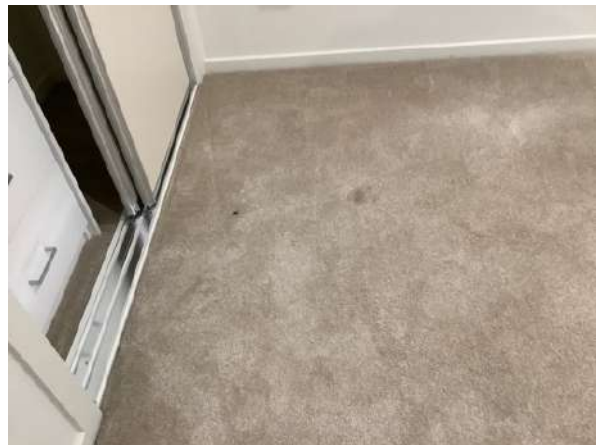
For Your Information 5.10

Location: Upstairs Bedroom

Finding: Suspicious burn marks in the carpet

Evidence of suspected methamphetamine use, or potentially its manufacture, was found during the inspection.

The evidence identified was staining and marking of surfaces that could be consistent with use or manufacture of methamphetamine. Evidence of suspected methamphetamine use

The evidence identified was staining of surfaces consistent with use of particular chemicals that are present in meth and can be used in its Manufacture.

However the more significant issue is that there may be residual environmental contamination throughout the property if Methamphetamine has been used or manufactured in the property. Residual environmental contamination caused by Methamphetamine use can have serious health implications and effects on occupants. Consequently we have listed this as a Safety Hazard.

Methamphetamine - Suspected Methamphetamine Use - Staining / Smoke Damage and Burns

We recommend a Methamphetamine Screening Assessment which includes Sampling to make an initial determination as to the presence of methamphetamine or to rule out its presence.

It is strongly recommended that this be completed prior to acquisition and certainly prior to occupation.

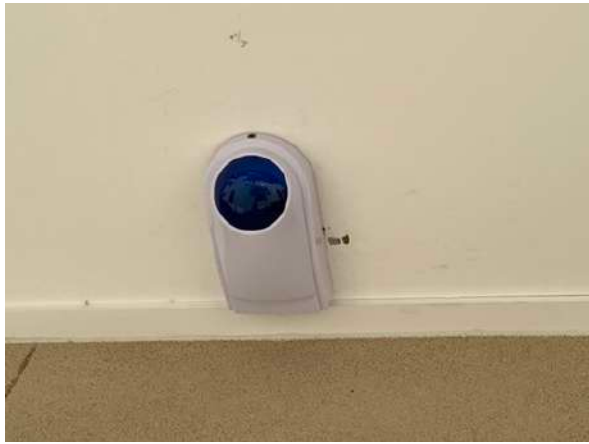
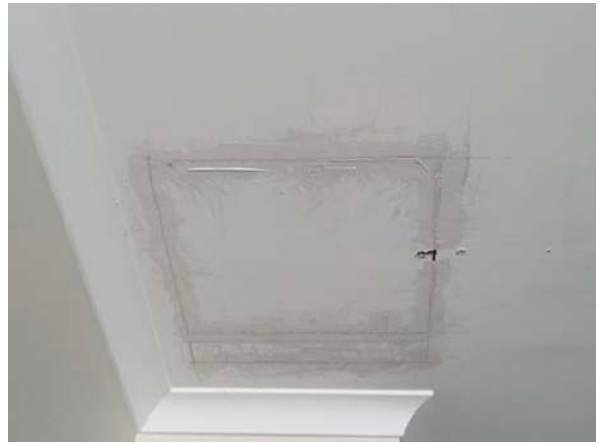
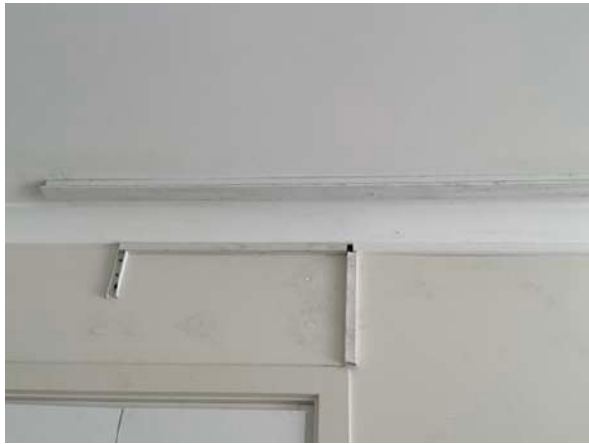
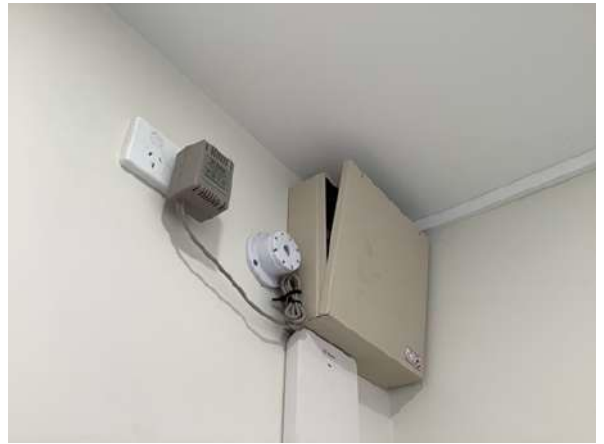
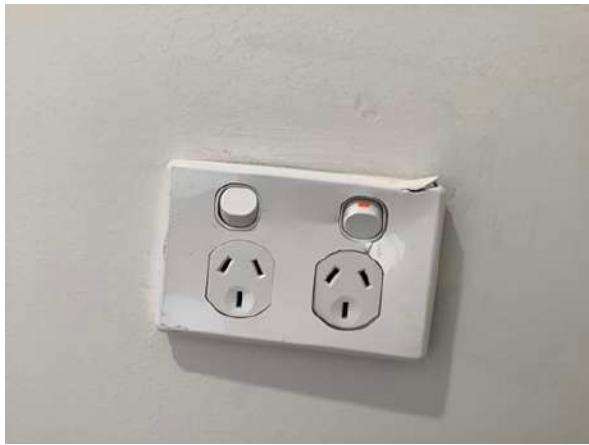
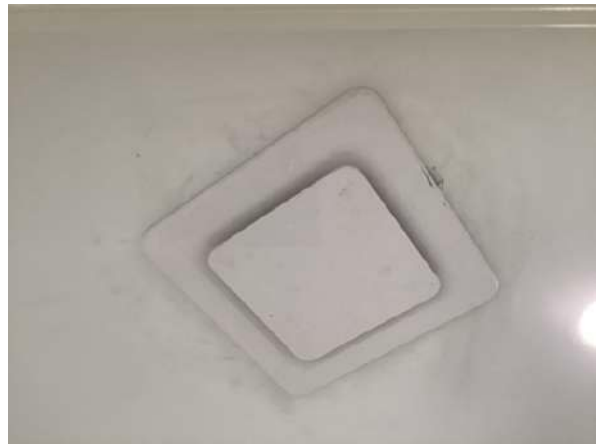
For Your Information 5.11

Location: Suspicious Activity

Finding: Suspicious activity

There is various suspicious building material activity in this property, various cameras spread throughout, alarm system installed, additional back locks, additional power points put in the kitchen, illegal wiring, upstairs suspicious staining on the walls and carpet, burn marks in carpet, Suspicious stains on the ceilings, Various stains to the ceilings as down-lights, vents have been taken out .

Once again the tenant had no right to do such extensive works to the property as this has now impacted the builders warranty insurance and all the ceiling spaces, to all three levels need to be fully inspected by a qualified electrician and registered builder and sign off that the building is as per it was built as without this we may have a compromise builders warranty.
