Termite/Timber Pest Report (includes Termatrac Radar Detection)

Inspection Date: 1 Jul 2021

Property Address: Kinglake area

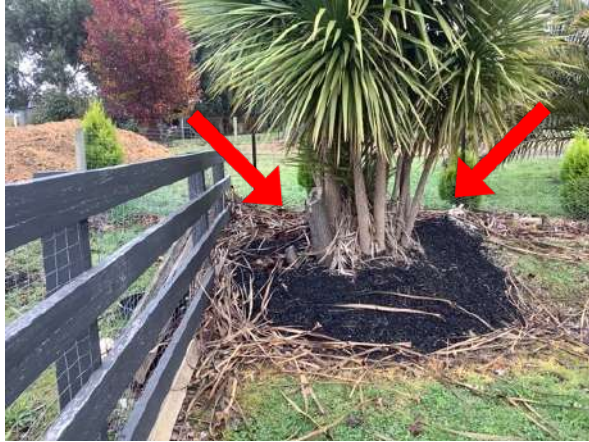
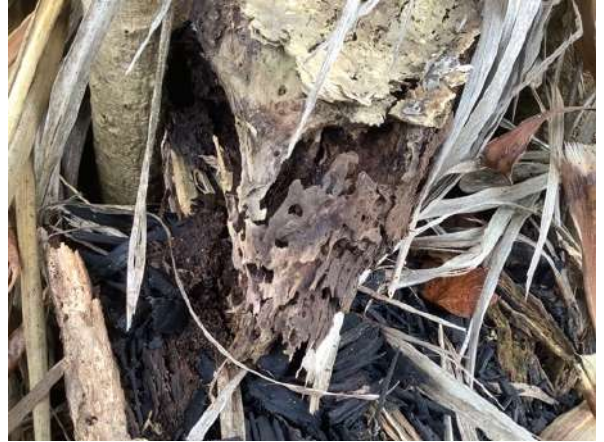
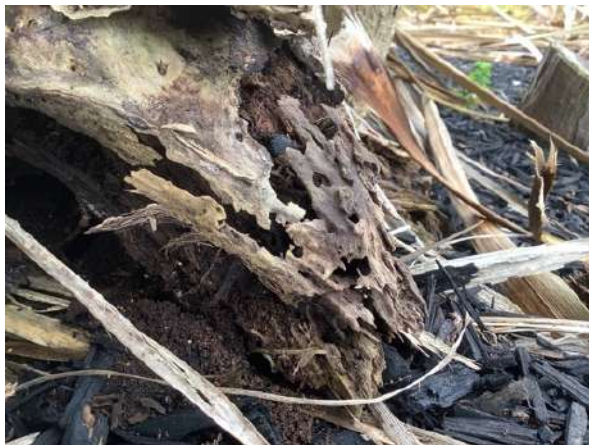
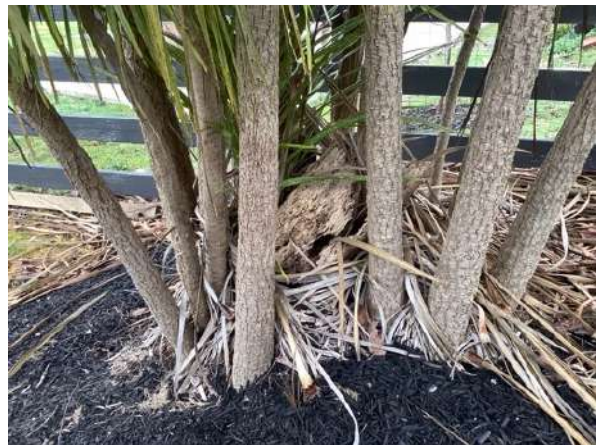
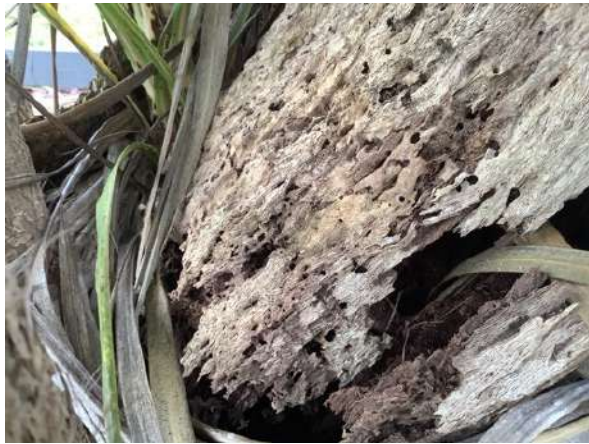
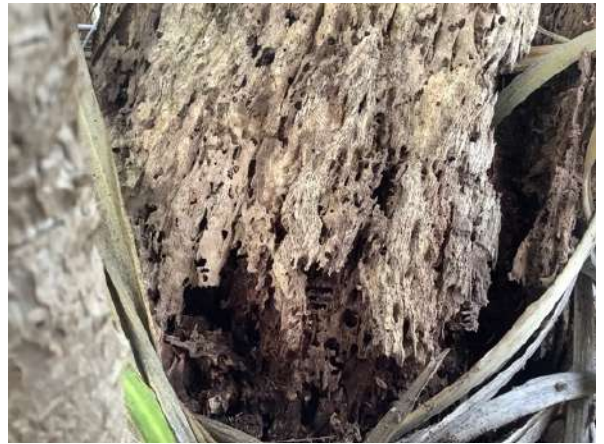
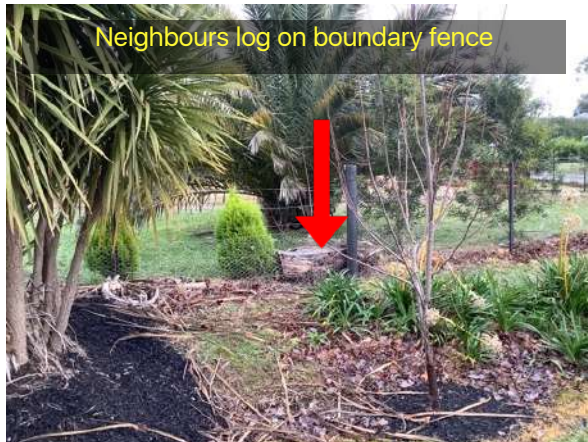
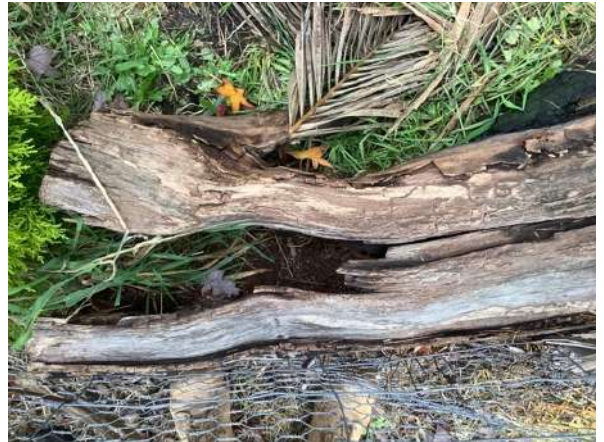
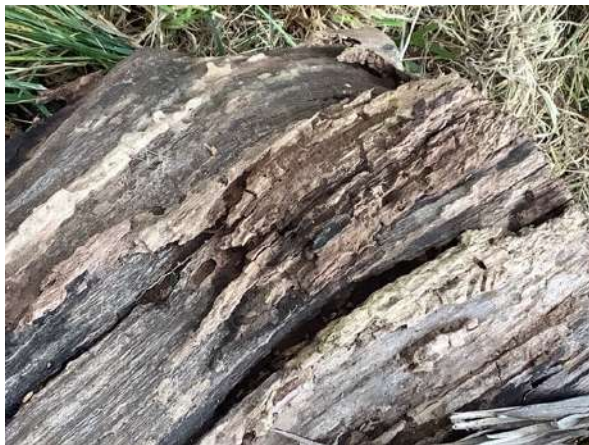
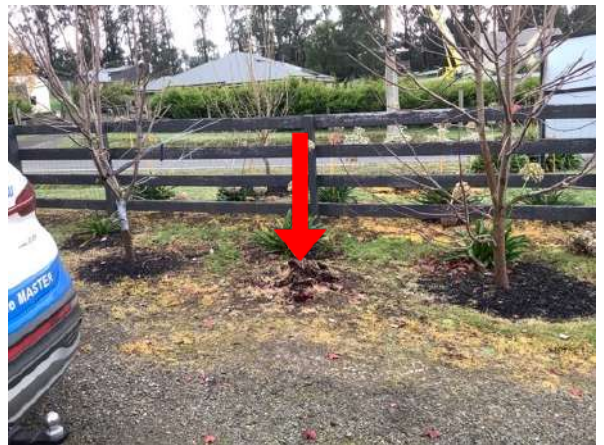
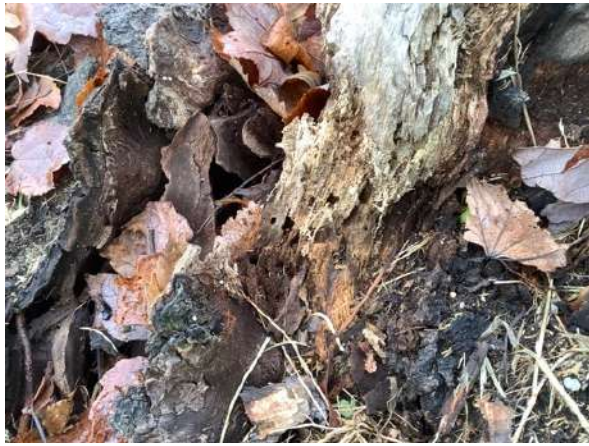
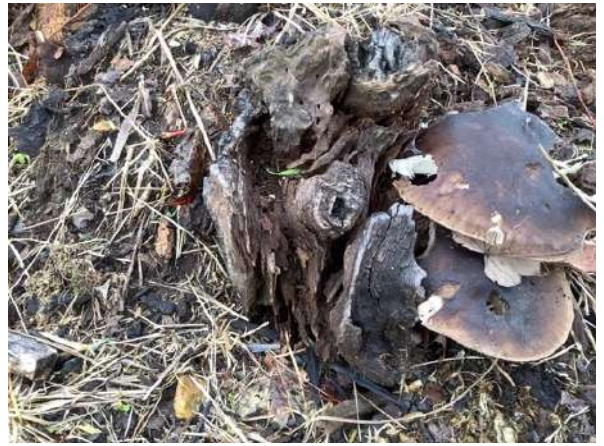
Finding: Termite - Damage Identified.

It is suspected that termite activity is occurring or has occurred as there is evidence of termite damage.

Such damage creates a potential safety hazard, and is likely to worsen and cause further damage to adjoining building materials.

If left unattended, this damage creates an unsafe environment and is likely to lead to the need for major structural works.

A building contractor should be appointed immediately to advise on options to prevent further damage and repair on all affected building materials, if any areas of damage are noticeable.

The client IS HIGHLY RECOMMEND gaining further advice from a licensed pest controller as to the costs and procedures involved with application of a termite management system and/or eradication, which should be treated as HIGH PRIORITY.

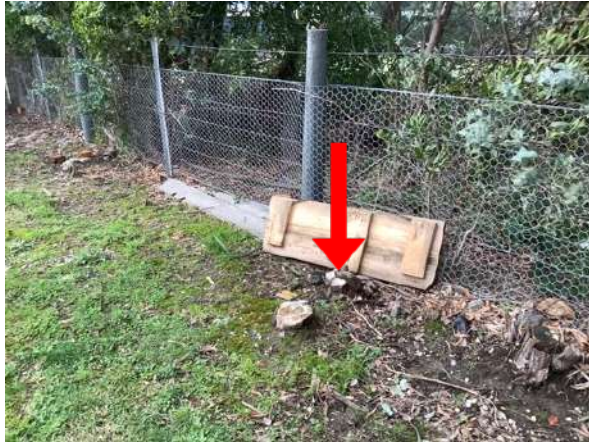
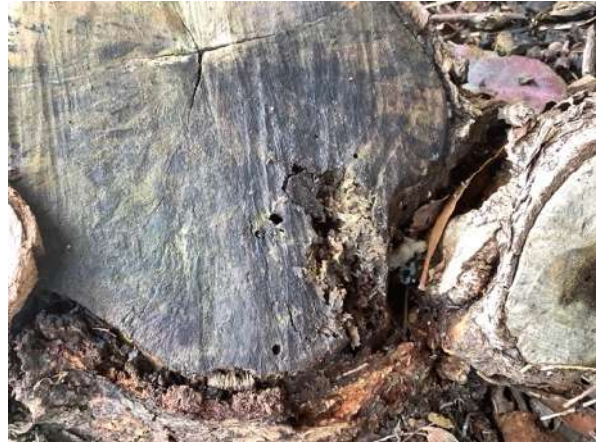
Finding: Timber Pest - Damage Identified.

It is suspected that timber pest activity is occurring or has occurred as there appears to be evidence of timber pest damage.

Despite no live termite or timber pest activity being identified, previous timber pest damage was found in these areas.

Such damage creates a potential safety hazard, and is likely to worsen and cause further damage to adjoining building materials.

A building contractor should be appointed immediately to advise on options to prevent further damage and repair all affected building materials. Until such time, caution should be taken by all people coming into contact with these building elements and this area.

The client IS HIGHLY RECOMMEND gaining further advice from a licensed pest controller as to the costs and procedures involved with application of a termite management system and/or eradication, which should be treated as HIGH PRIORITY.

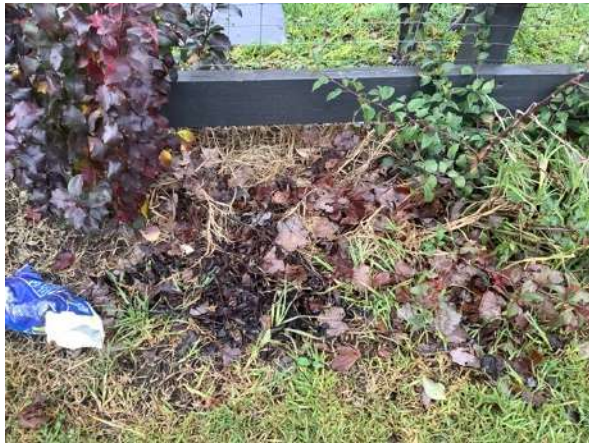
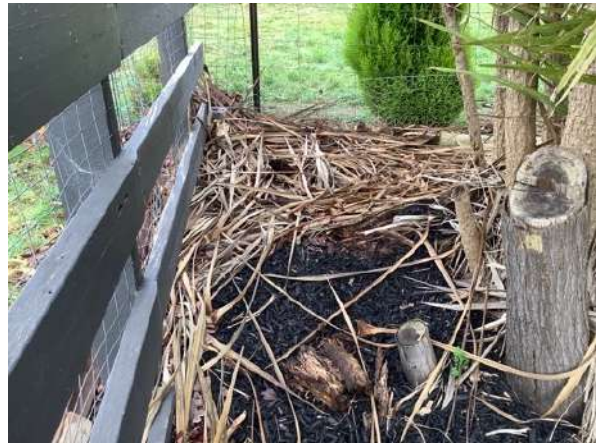
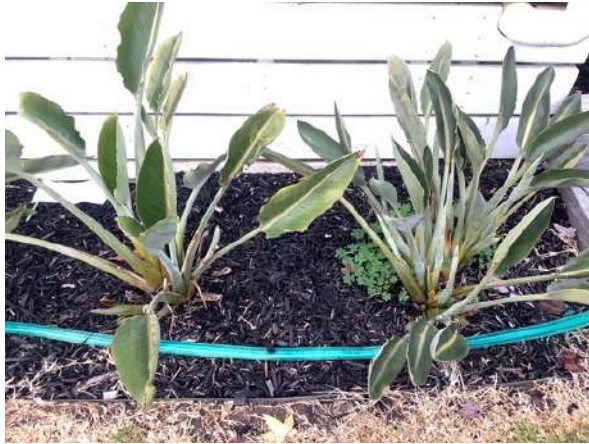
Conditions conducive to timber pest attack 1.03

Finding: Garden Beds - Conditions Conducive to Termites

Garden beds were found to be evident in areas of garden areas.

These garden beds can include untreated timber, bark, excessive old vegetation and with a combination of moisture from watering hosing can make conditions very conducive to termite activity and termite ingress.

It is always important to keep the garden beds as clean as possible and take out excess old bark from the trees, leaves and keep bark mulch to a minimum or better introduce rocks or some item that does not create an conducive environment for termites and hold excess moisture.

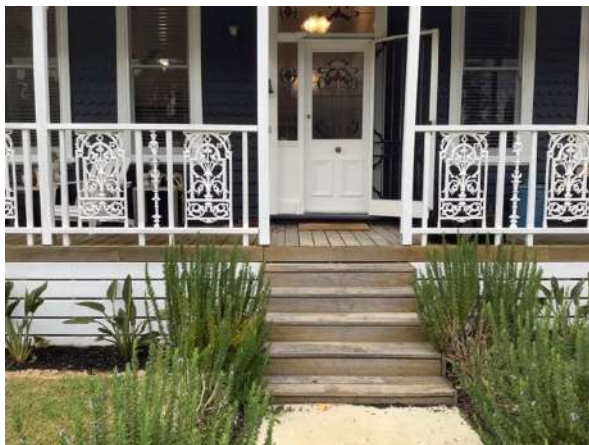
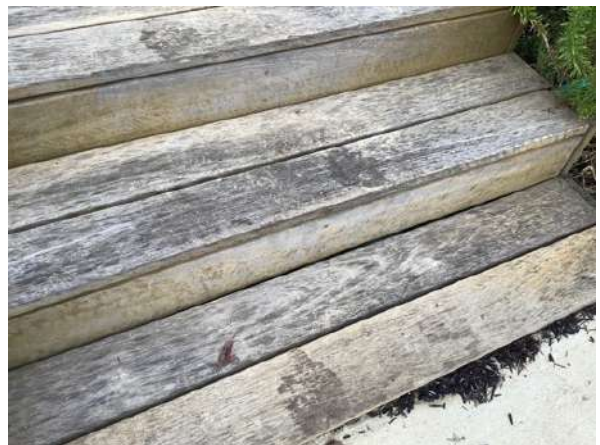
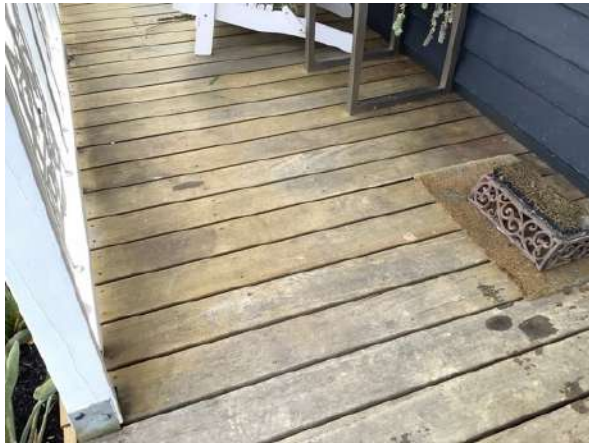
Conditions conducive to timber pest attack 1.04

Location: Timber Work - All External Areas

Finding: Timber, exposed to weather / External painting deteriorated

External timbers that are frequently exposed to harsh weather conditions require adequate protection (paint) in order to maintain their condition. Where timbers have not been painted or treated adequately, general deterioration is likely to occur at an accelerated rate.

Incomplete or missing paint finish NOT ONLY an appearance defect, it can in most cases lead to the development of secondary building defects over time. Incomplete areas of paint finish exposes the area to moisture, potentially accelerating the deterioration of underlying building materials.

Degraded paint finishes should be sanded back, filled, leveled and painted, as applicable. Where inadequate or missing paint protection has led to the deterioration of the associated building elements, meaning WOOD ROT (Decay) repair and/or replacement of this building element may be required, As if the wood rot is too severe repair of decayed timbers is generally too late.

If left unattended, replacement of these timbers is likely to be necessary in the short-term future. Adequate treatment of these timbers is required as soon as possible by a painting contractor should be appointed as soon as possible to perform necessary works to aid the appearance of the affected area and to ensure the area is protected against further deterioration. Alternatively, the homeowner following manufacturer instructions may perform these works.

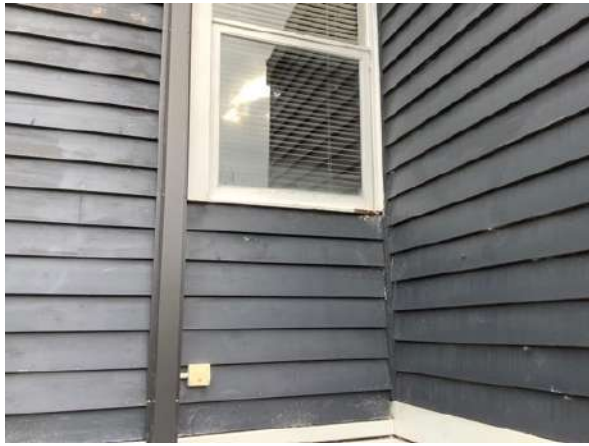
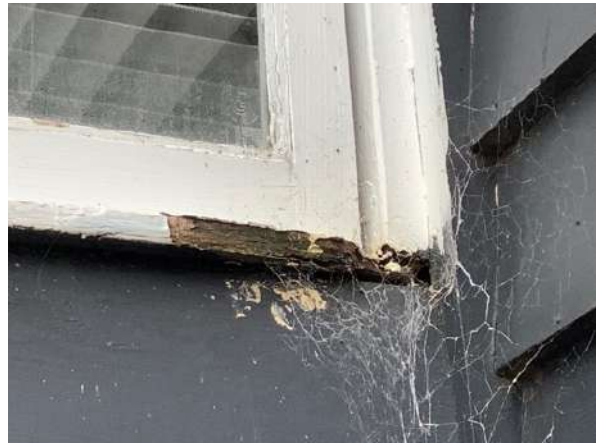
Conditions conducive to timber pest attack 1.05

Location: Timber Work - All External Areas

Finding: Wood Rot

This building element shows evidence of wood rot. Wood rot, also known as Fungal Decay, occurs when timbers and other cellulose building materials are exposed to damp conditions on an ongoing basis. This could be the result of exposure to weathering over a prolonged period of time, or the attraction of excessive moisture from other abutting building materials. Contributing factors also include poor air ventilation in the area.

Early intervention and regular maintenance, particularly of exterior timbers, will prolong the useful life of these building elements. Prior to any works being performed, the cause of the moisture that has created the visible wood rot should be identified and addressed in a suitable manner. Replacement of affected timbers may then be a necessary step in protecting surrounding building elements from such deterioration.

A qualified plumber / builder may be appointed to assess the cause of excessive moisture and to provide advice on any remedial works as required.

A qualified carpenter and/or registered builder may also be required to replace affected building materials.

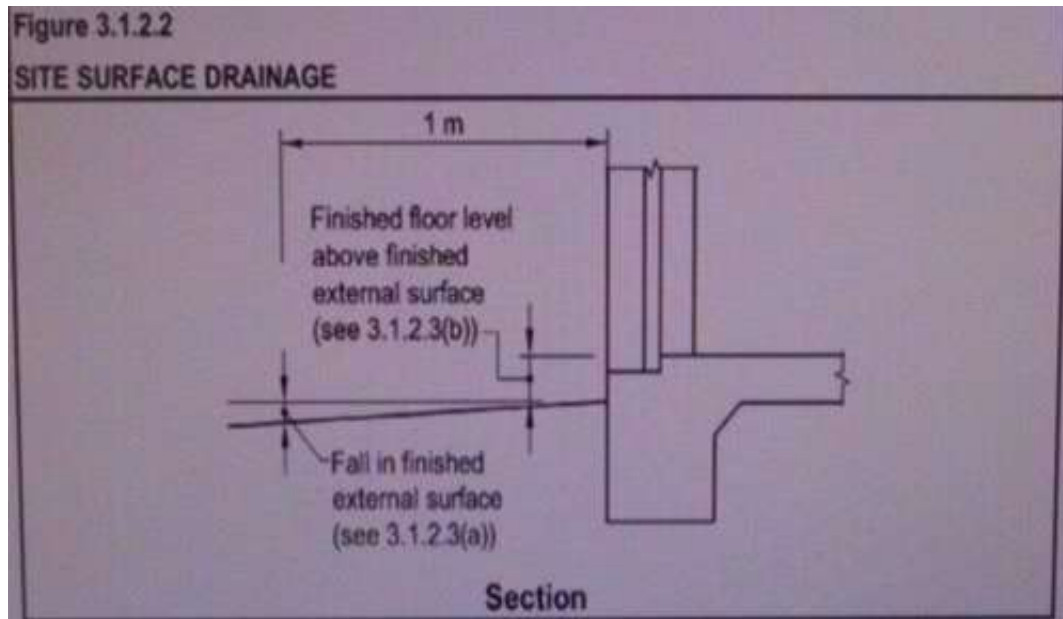
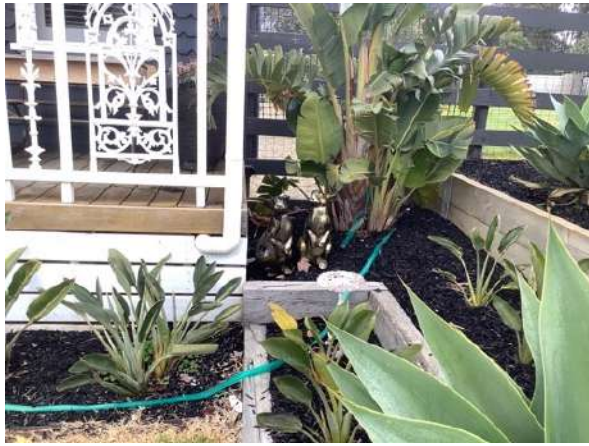
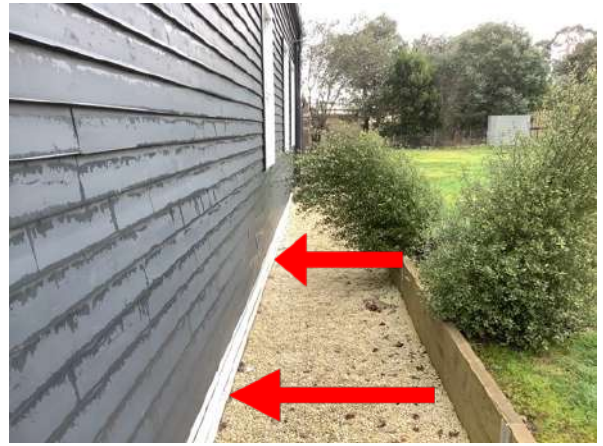
Conditions conducive to timber pest attack 1.06

Location: Perimeter Of Building - Exterior

Finding: Drainage - Inadequate

We have stated the drainage as defective and as a major structural defect is because we have found Excessive Dampness to the sub floor area.

Water pooling near foundations and footings is a serious concern with the potential to adversely impact on the longevity of the dwelling. The Building Code of Australia (BCA) outlines that the soil or concrete must be graded away from the dwelling at a minimum of 50mm over 1m (1:50 fall).

The site drainage in this report was found to be inadequate at the time of inspection, creating potential for subsequent water damage to associated building elements, such as foundation subsidence, brickwork cracking, windows and doors moving, concrete paths cracking, etc.

Where site drainage is inadequate, another option can be installation of an Agricultural (Aggie) Drain may be required or more serious remedial works.

It is highly recommended that a plumber and/or builder and then pending on the outcome, other forms of professionals be appointed to further inspect the area and to install / repair adequate drainage equipment where necessary.

If secondary damages have ALREADY accrued we highly recommend that you engage a structural engineer, geotechnical engineer to start with then engage a registered builder, qualified plumber to further inspect the property and perform any remedial works as necessary. Note, this is only if there is any building damages that have occurred.

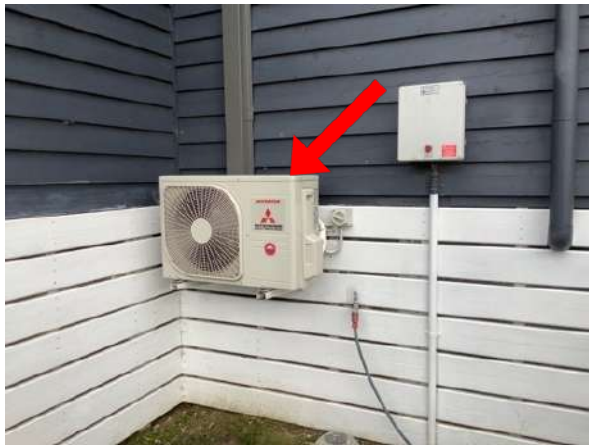
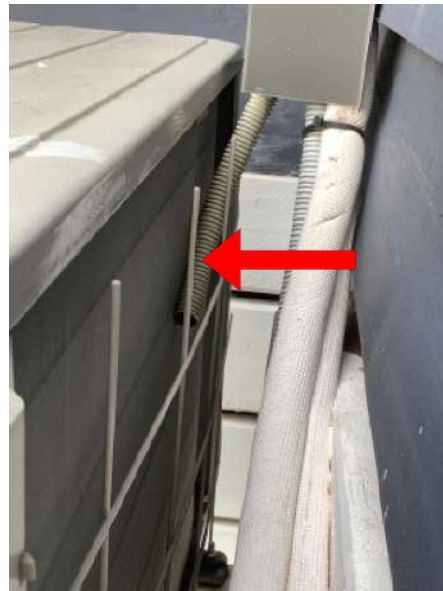
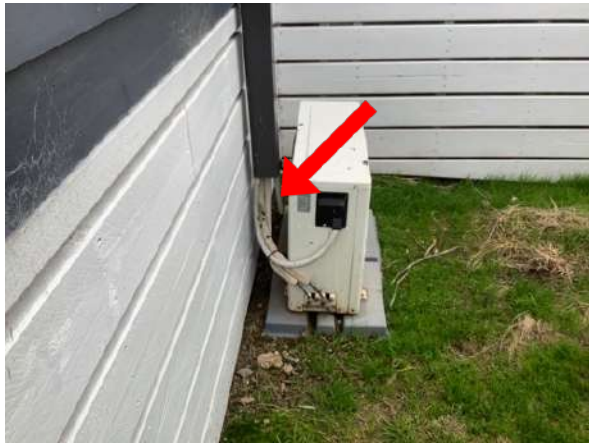
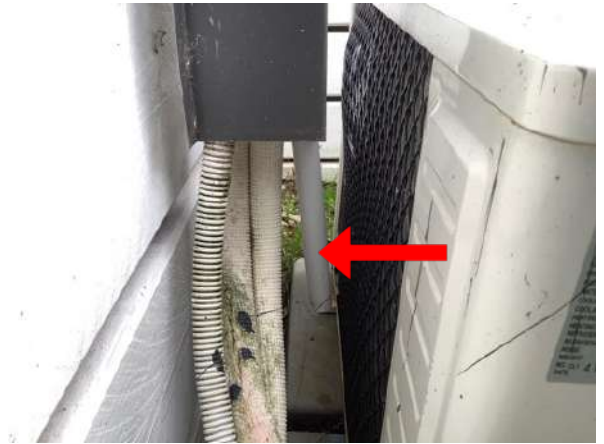
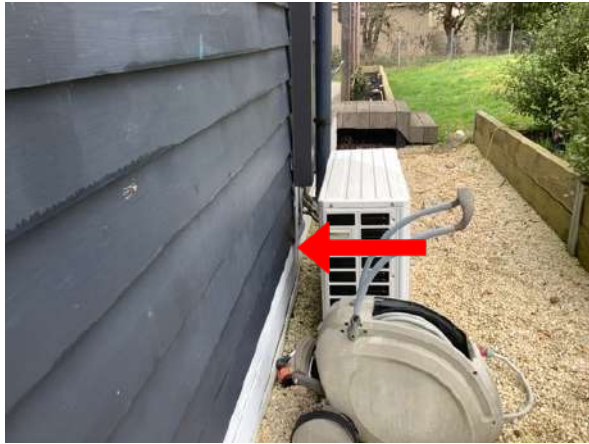
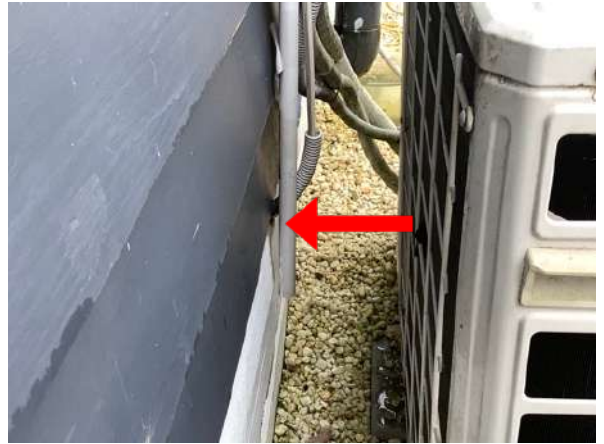
Conditions conducive to timber pest attack 1.07

Location: Perimeter Of Building - Exterior

Finding: Air conditioner - Disconnected overflow

The Air Conditioner (A/C) overflow was found to be disconnected from storm water draining and is creating excessive moisture in the surrounding area.

Such leaking creates an environment which is conducive to an array of defects, including water damage to associated building elements and the attraction of termite or timber pest infestation.

It is highly recommended that a licensed plumber be appointed to connect the A/C overflow in order to prevent such an environment from being created.

These minor works should be carried out as soon as possible.

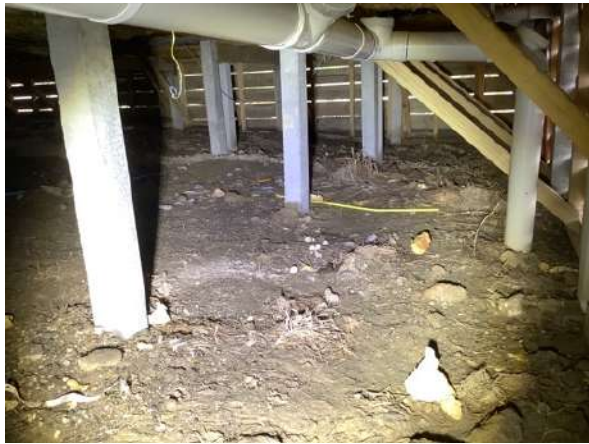
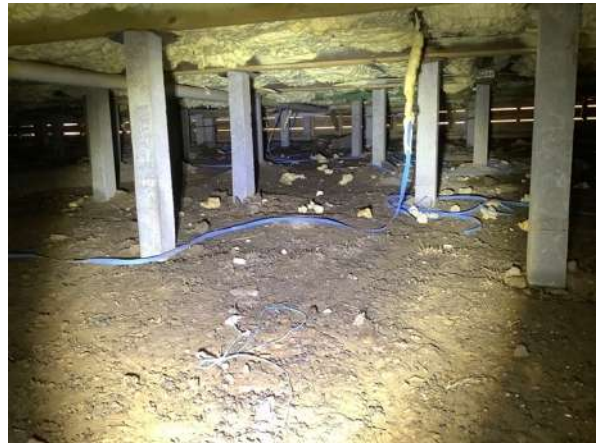
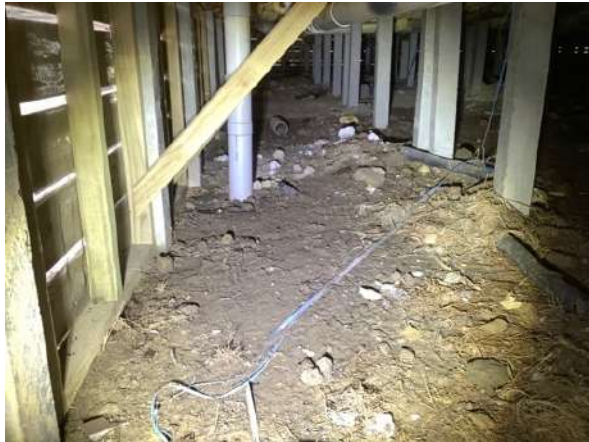
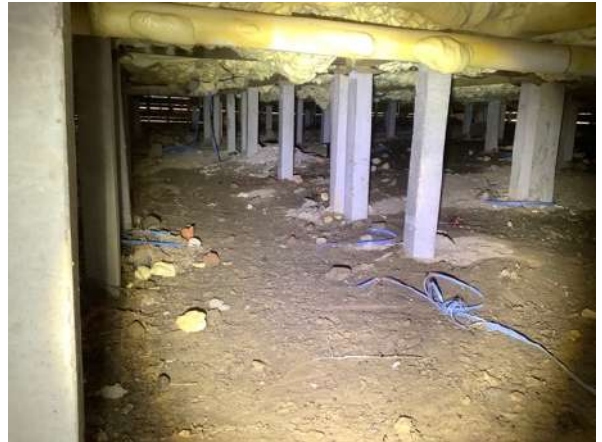
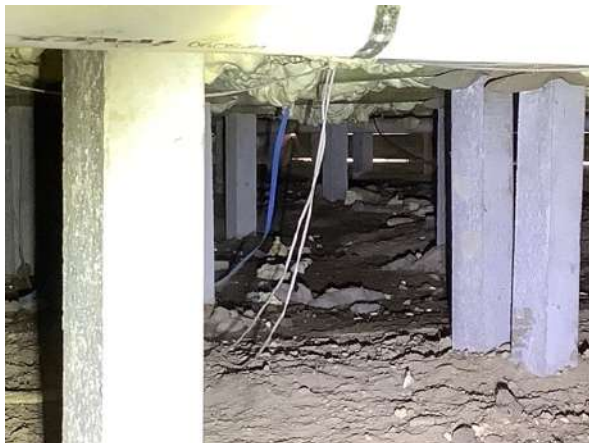
Conditions conducive to timber pest attack 1.08

Location: Subfloor

Finding: DAMP & WET LEAK

Damp (or structural damp) refers to the presence of unwanted moisture in the structure of a building, either as the result of intrusion from outside, or condensation from within the structure. Generally, structural damp is caused by rain penetration, rising damp, and leaks from plumbing pipes.

Unmanaged damp facilitates the formation and development of mould, fungi growth and wood rot, decaying associated building materials and compromising their structural integrity. Damage to finishes is also likely to occur, including lifting, bubbling, peeling and staining of paint, plaster and wallpaper.

Once the cause is rectified further determinations may be required by a BUILDER AND OR STRUCTURAL ENGINEER AND SOMETIMES A GEOTECHNICAL ENGINEER.

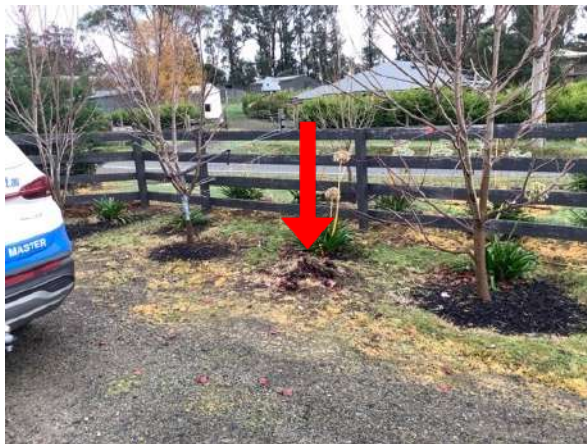
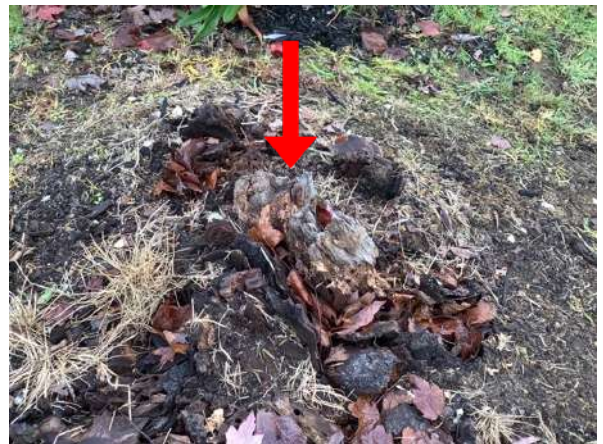
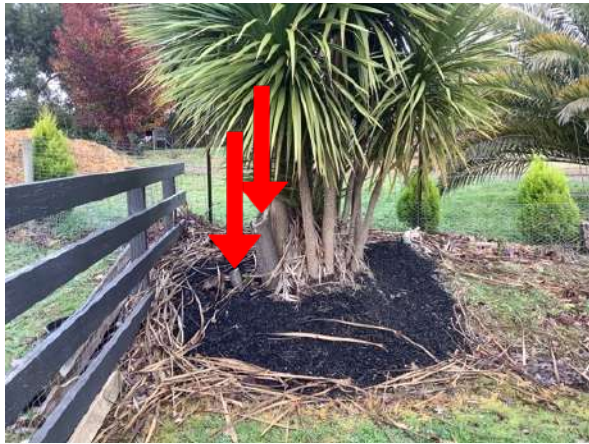
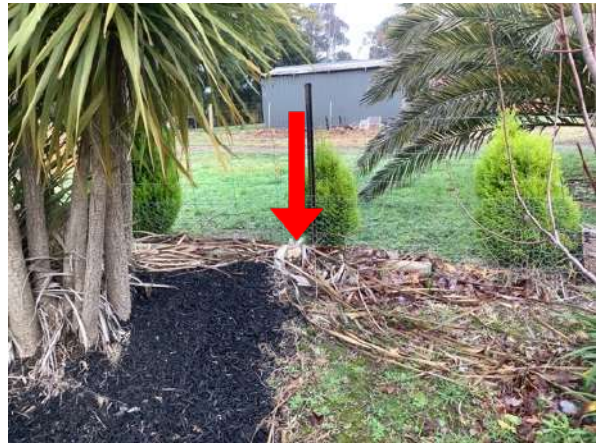
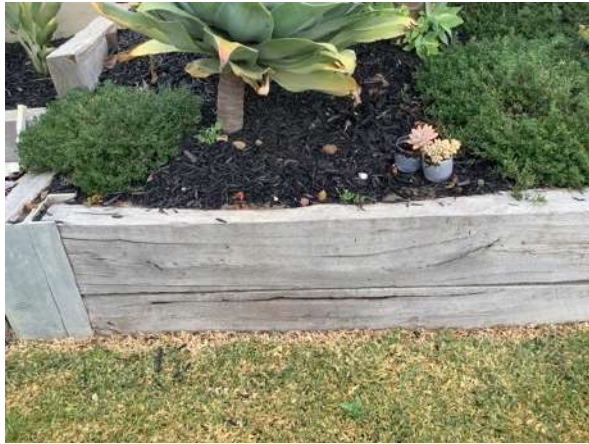
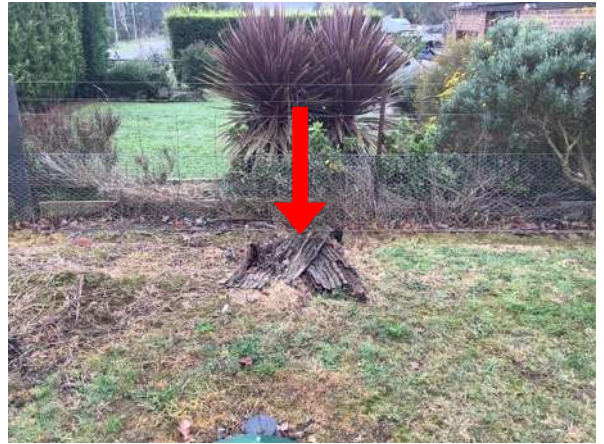
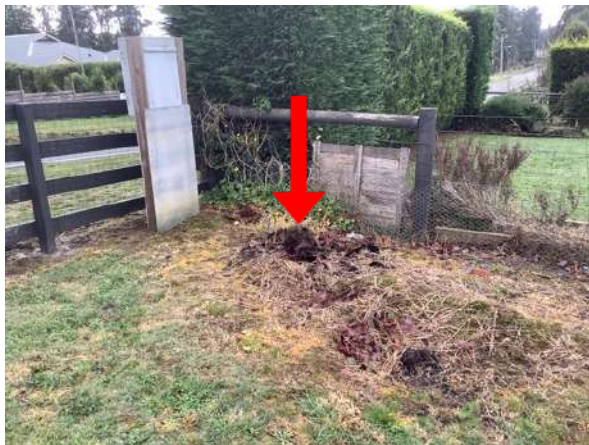
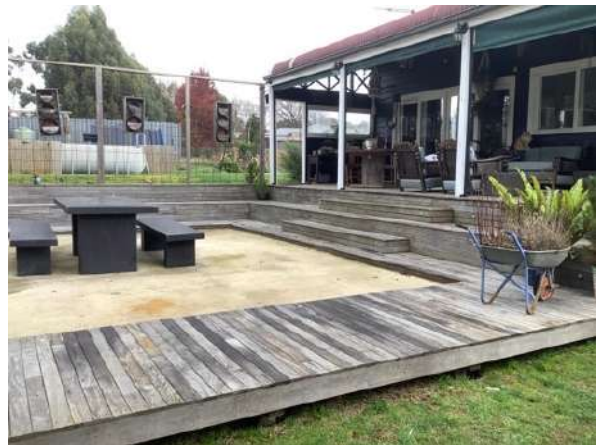
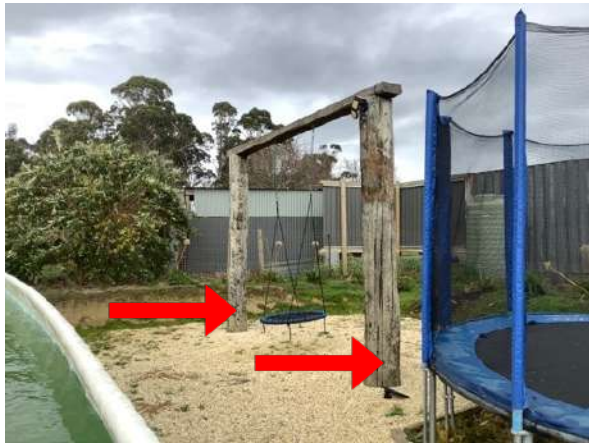
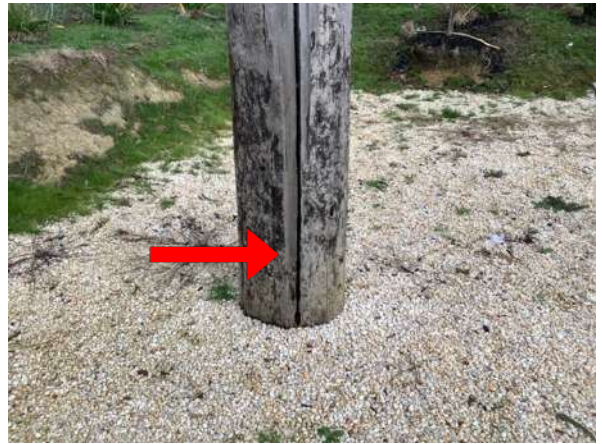
Tree stumps by far in my career has been the highest location, where I have found live termite activity or termite damage in a property, without any doubt whatsoever.

I highly recommend you seek further professional advice from a licensed pest controller and termite management system controller in relation to any trees that have been cut on the property and what can be done overall from just the typical termite management systems to a property.

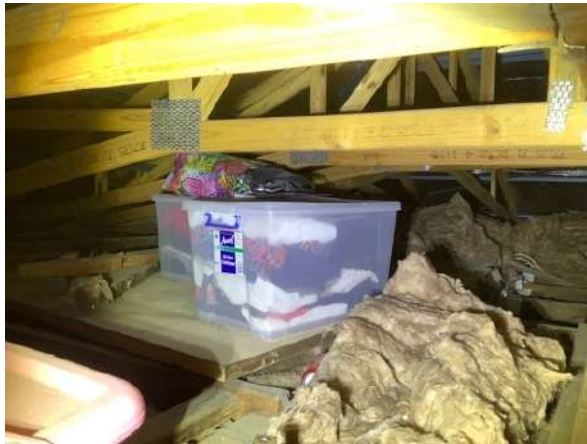
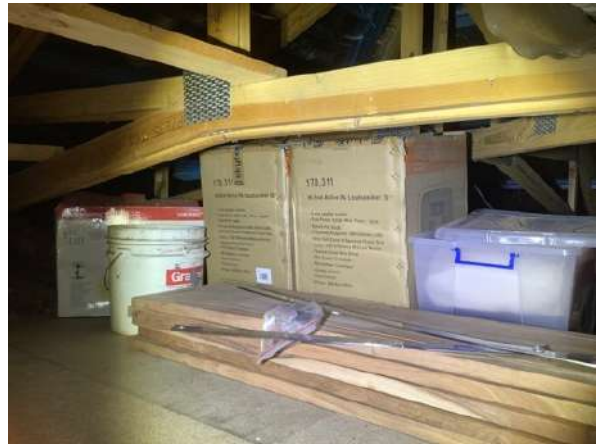
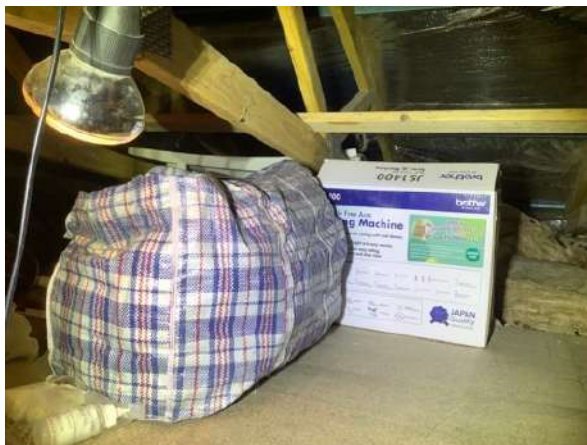
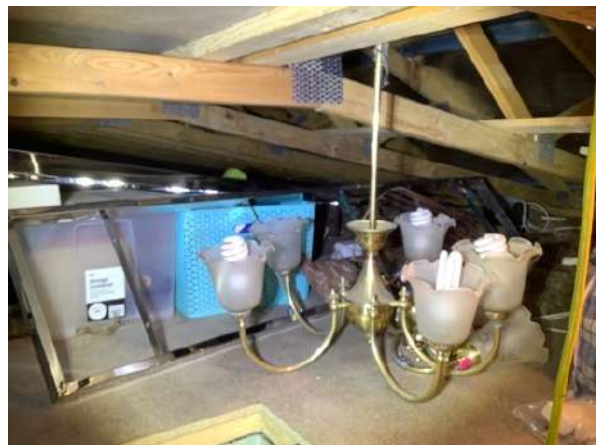
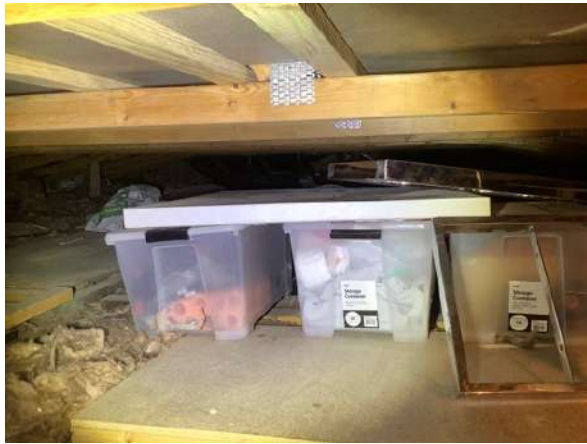
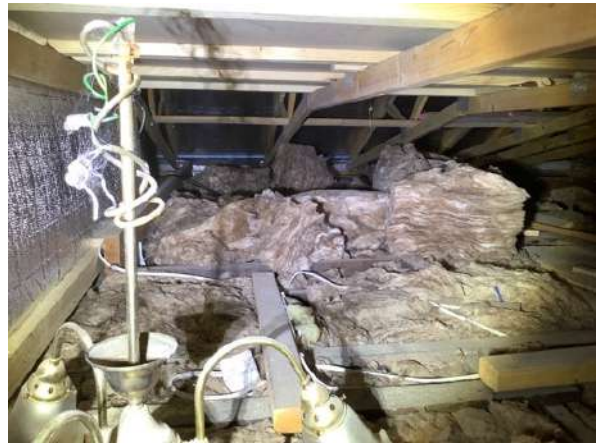
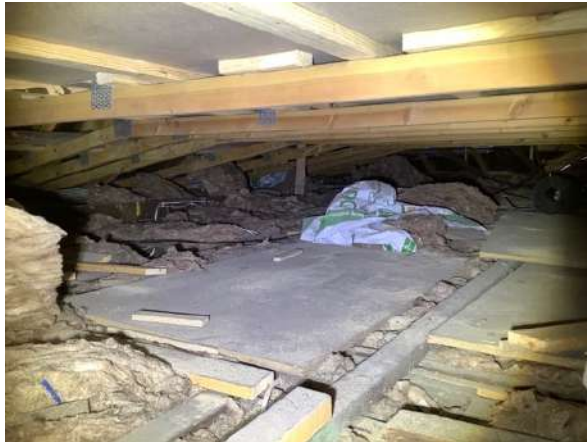
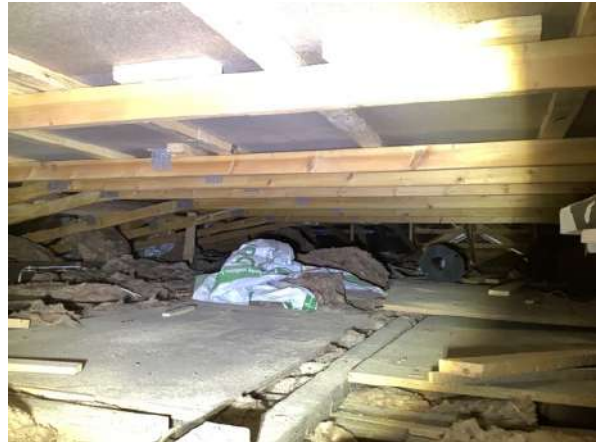
For your information 1.15

Location: Roof Space

The property is a very high risk for termites as the environments to the property are very conducive with many susceptible areas.

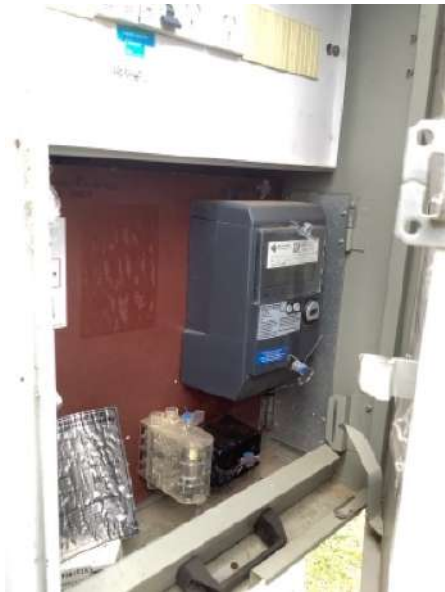
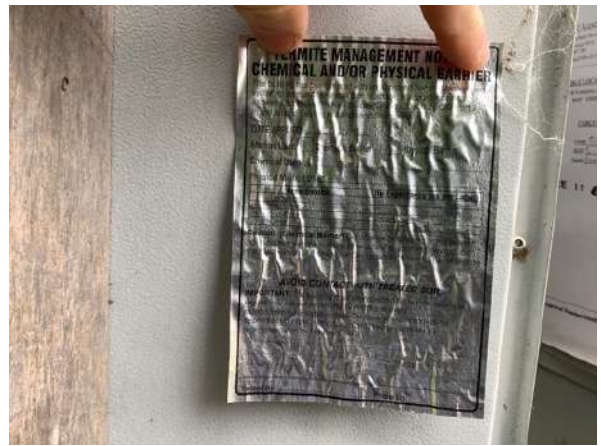
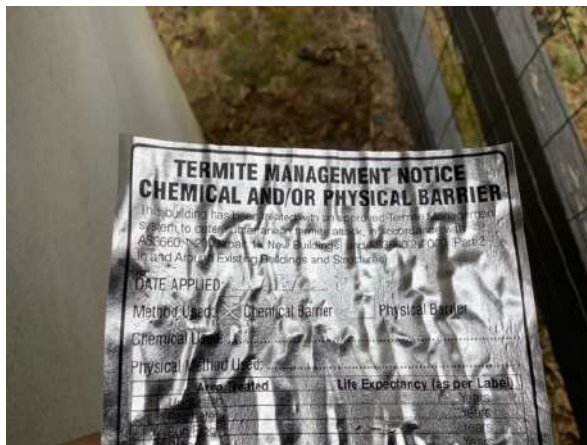
For your information 1.16

At the time of inspection, it appeared as though there is a termite management system that has been installed, with evidence to suggest that it is still dated to be in service.

I highly recommend that you contact the company who has performed the termite treatment and/or management system, so that you are 100% sure it is up-to-date and no further management maintenance is required & to also determine the systems limitations if any and if there should be some type of upgrade required.
