Termite/Timber Pest Report

Inspection Date: 1 Jul 2021

Property Address: King Lake area

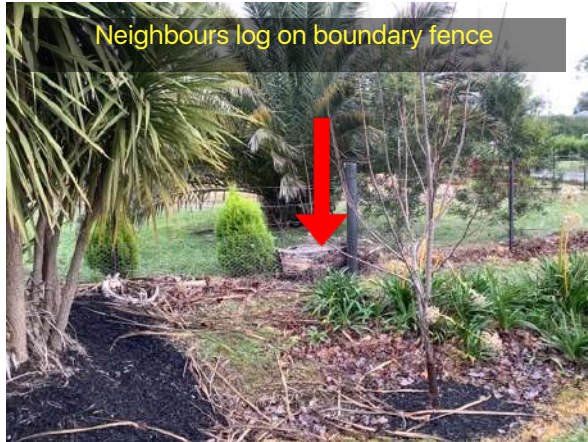
Finding: Termite - Damage Identified.

It is suspected that termite activity is occurring or has occurred as there is evidence of termite damage.

Such damage creates a potential safety hazard, and is likely to worsen and cause further damage to adjoining building materials.

If left unattended, this damage creates an unsafe environment and is likely to lead to the need for major structural works.

A building contractor should be appointed immediately to advise on options to prevent further damage and repair on all affected building materials, if any areas of damage are noticeable.

We HIGHLY RECOMMEND the client may consider gaining further advice from a pest controller as to the costs and procedures involved with this application.

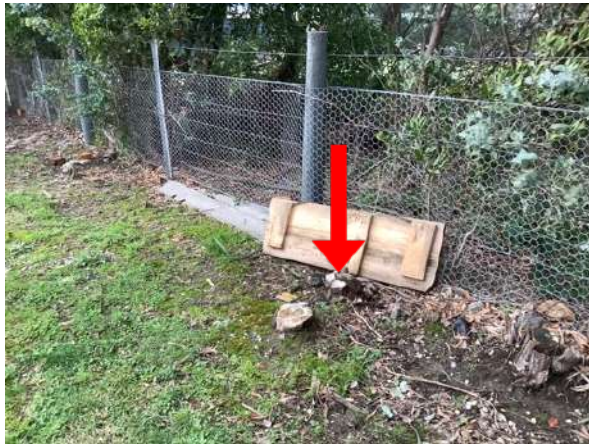
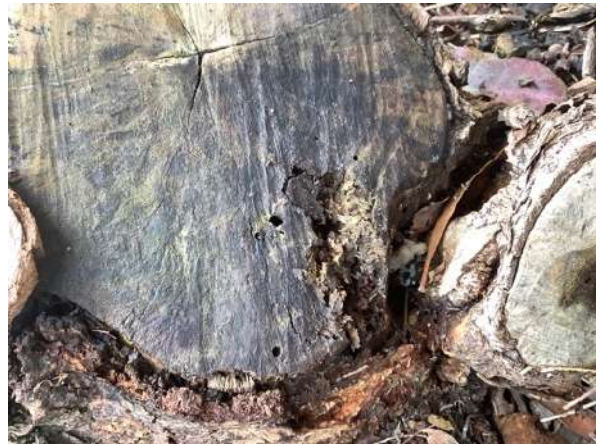
Finding: Timber Pest - Damage Identified.

It is suspected that timber pest activity is occurring or has occurred as there appears to be evidence of timber pest damage.

Despite no live termite or timber pest activity being identified, previous timber pest damage was found in these areas.

A building contractor should be appointed immediately to advise on options to prevent further damage and repair all affected building materials. Until such time, caution should be taken by all people coming into contact with these building elements and this area.

We HIGHLY RECOMMEND the client may consider gaining further advice from a pest controller as to the costs and procedures involved with this application.

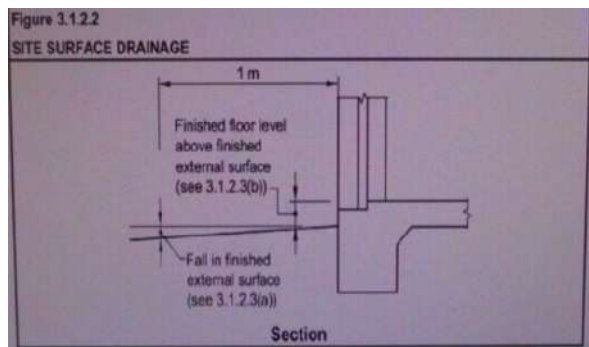
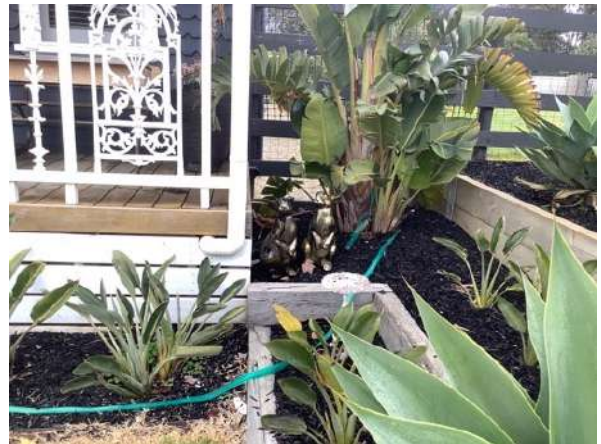
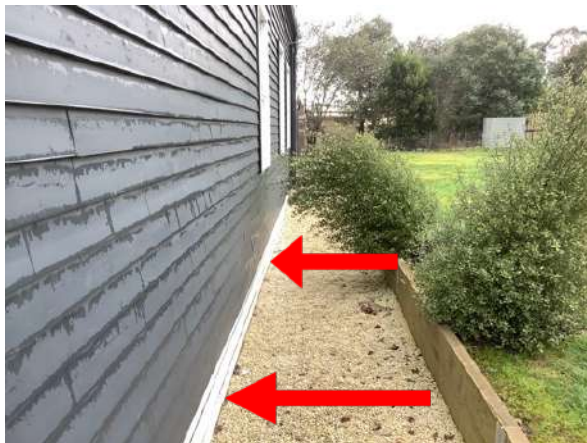
Conditions conducive to timber pest attack 1.06

Location: Perimeter Of Building - Exterior

Finding: Drainage - Inadequate

We have stated the drainage as defective and as a major structural defect is because we have found Excessive Dampness to the sub floor area.

Water pooling near foundations and footings is a serious concern with the potential to adversely impact on the longevity of the dwelling. The Building Code of Australia (BCA) outlines that the soil or concrete must be graded away from the dwelling at a minimum of 50mm over 1m (1:50 fall).

The site drainage in this report was found to be inadequate at the time of inspection, creating potential for subsequent water damage to associated building elements, such as foundation subsidence, brickwork cracking, windows and doors moving, concrete paths cracking, etc.

Where site drainage is inadequate, another option can be installation of an Agricultural (Aggie) Drain may be required or more serious remedial works.

It is highly recommended that a plumber and/or builder and then pending on the outcome, other forms of professionals be appointed to further inspect the area and to install / repair adequate drainage equipment where necessary.

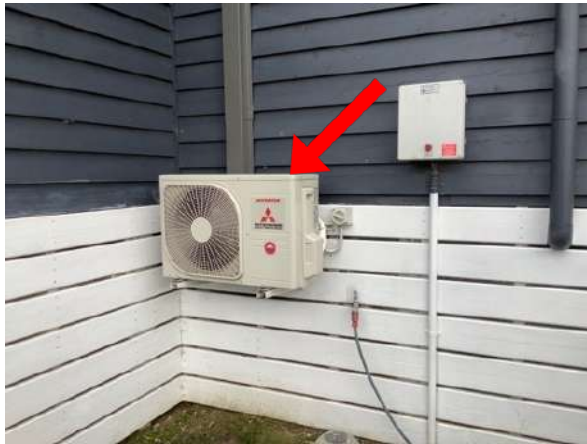
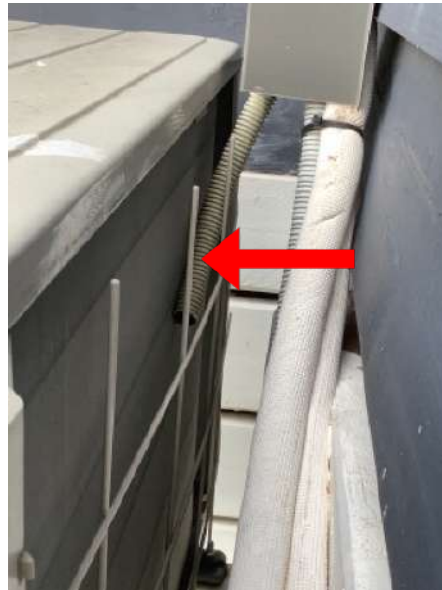
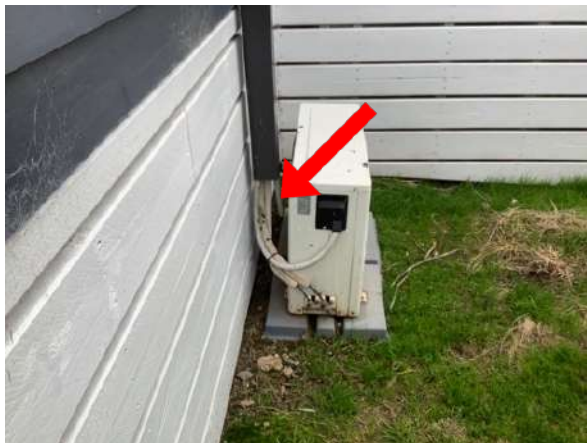
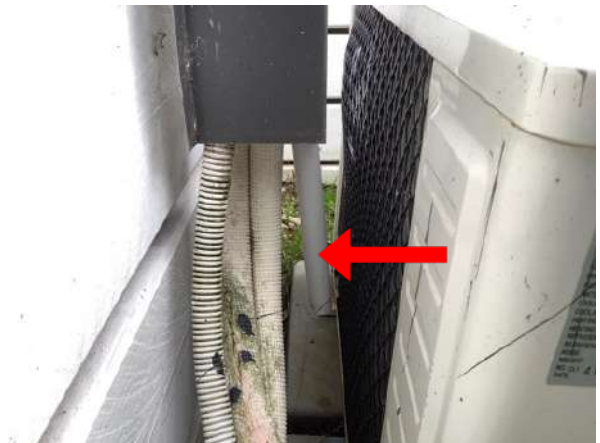
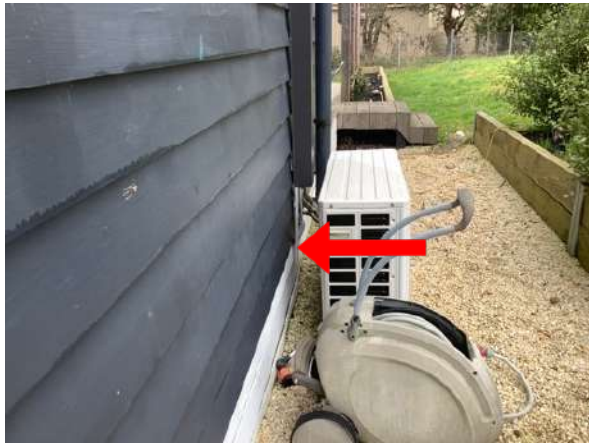
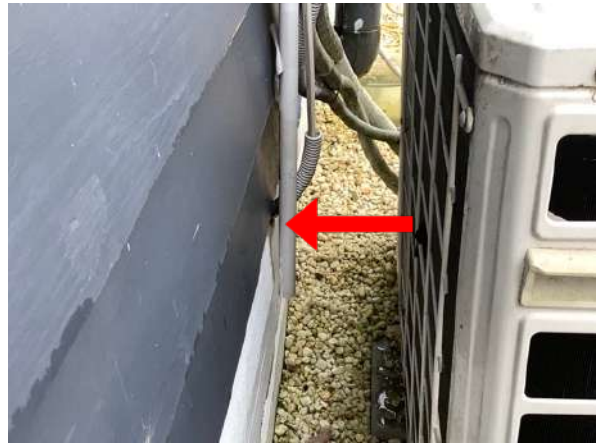
Conditions conducive to timber pest attack 1.07

Location: Perimeter Of Building - Exterior

Finding: Air conditioner - Disconnected overflow

The Air Conditioner (A/C) overflow was found to be disconnected from storm water draining and is creating excessive moisture in the surrounding area.

Such leaking creates an environment which is conducive to an array of defects, including water damage to associated building elements and the attraction of termite or timber pest infestation.

It is highly recommended that a licensed plumber be appointed to connect the A/C overflow in order to prevent such an environment from being created.

These minor works should be carried out as soon as possible.

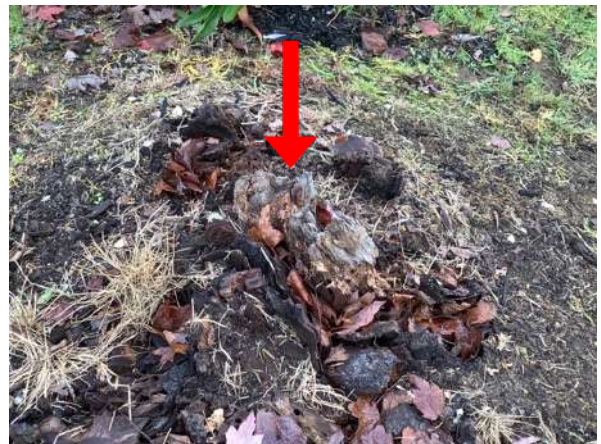
Tree stumps by far in my career has been the highest location, where I have found live termite activity or termite damage in a property, without any doubt whatsoever.

I highly recommend you seek further professional advice from a licensed pest controller and termite management system controller in relation to any trees that have been cut on the property and what can be done overall from just the typical termite management systems to a property.

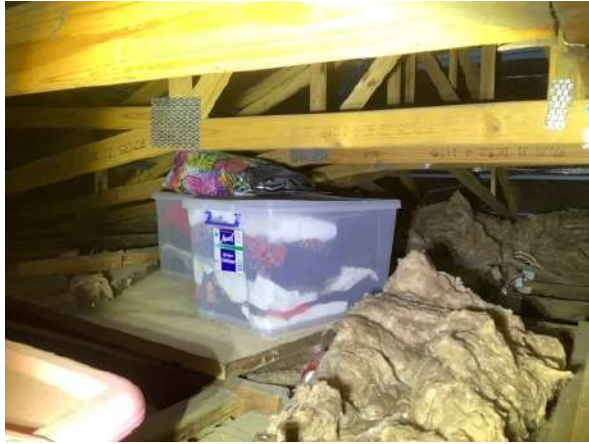
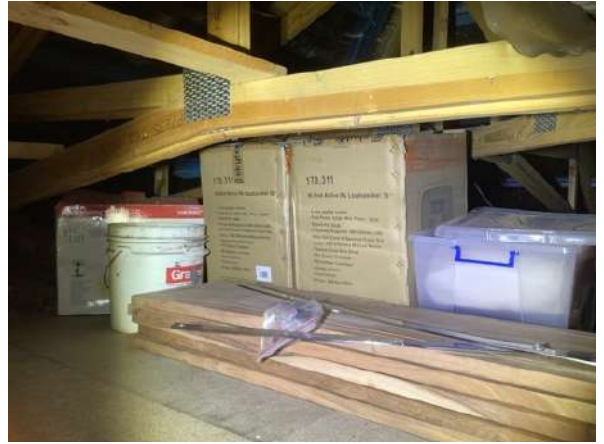
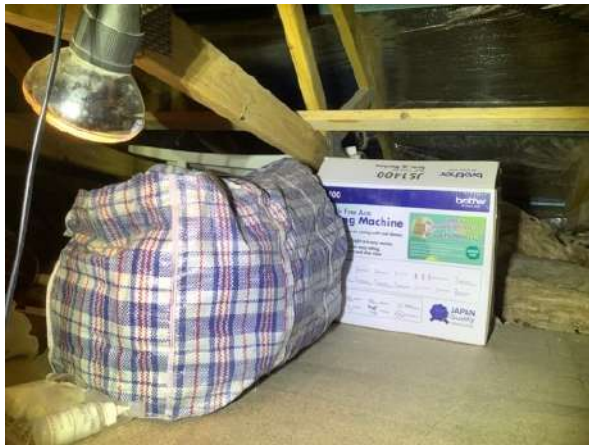
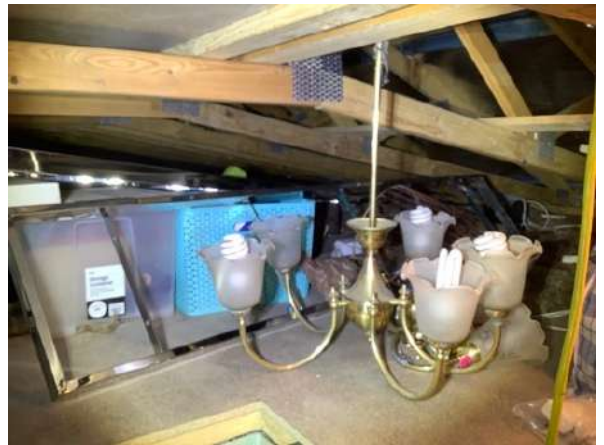
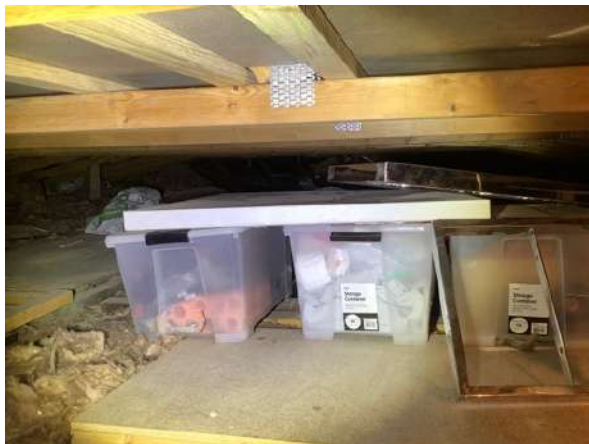
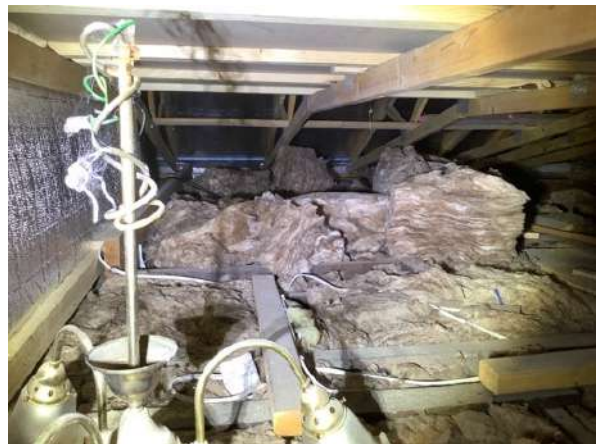
For your information 1.15

Location: Roof Space

The property is a very high risk for termites as the environments to the property are very conducive with many susceptible areas.

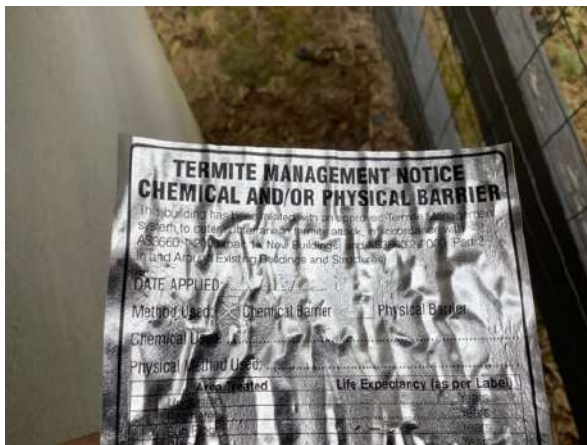
For your information 1.16

At the time of inspection, it appeared as though there is a termite management system that has been installed, with evidence to suggest that it is still dated to be in service.

I highly recommend that you contact the company who has performed the termite treatment and/or management system, so that you are 100% sure it is up-to-date and no further management maintenance is required & to also determine the systems limitations if any and if there should be some type of upgrade required.
