Building Specific Inspection Report

Inspection Date: 25 Aug 2020

Property Address: 3 Sample street Melbourne

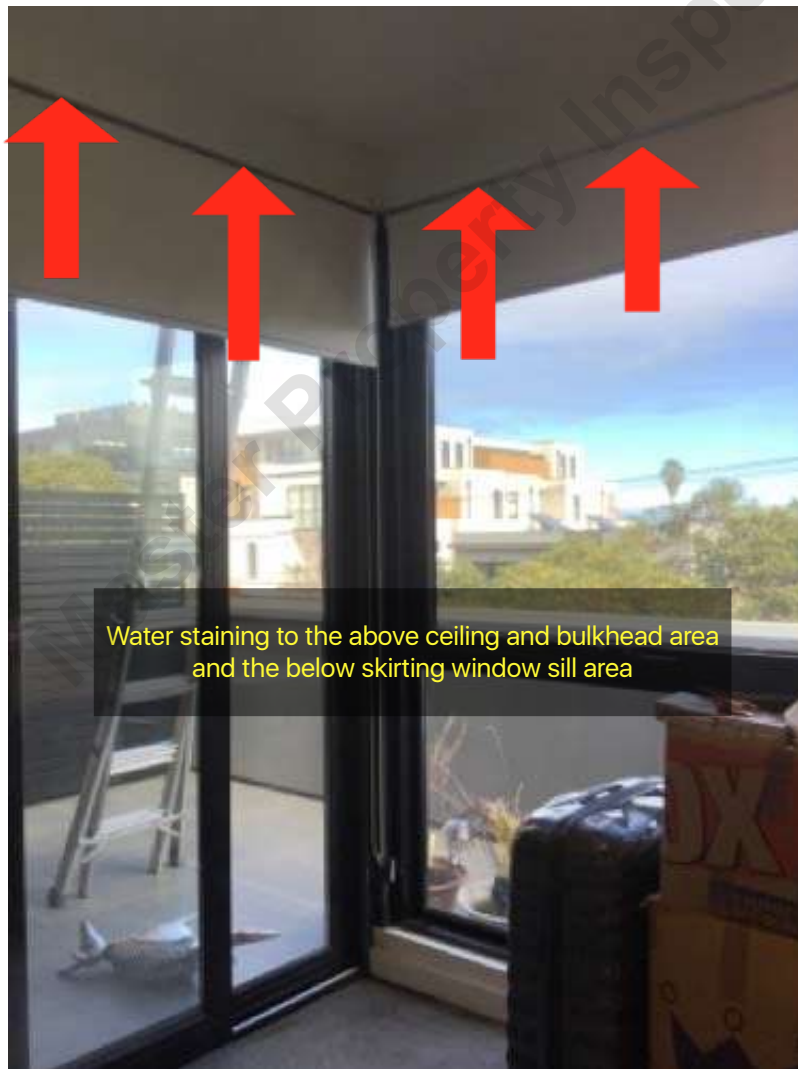
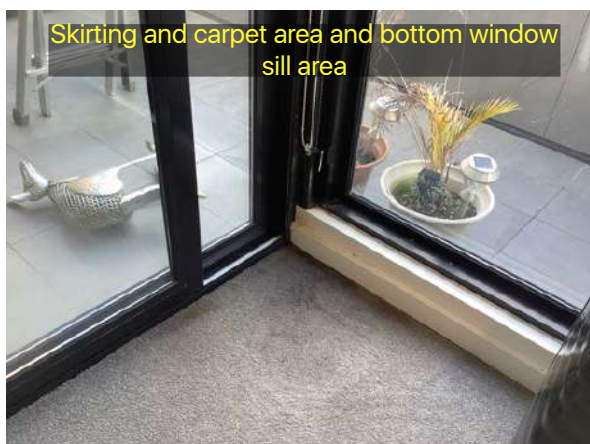
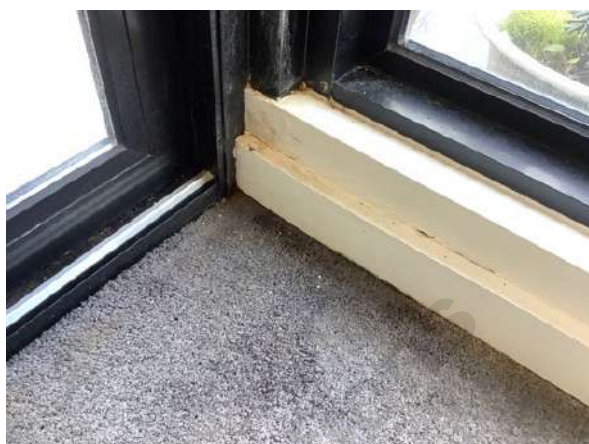
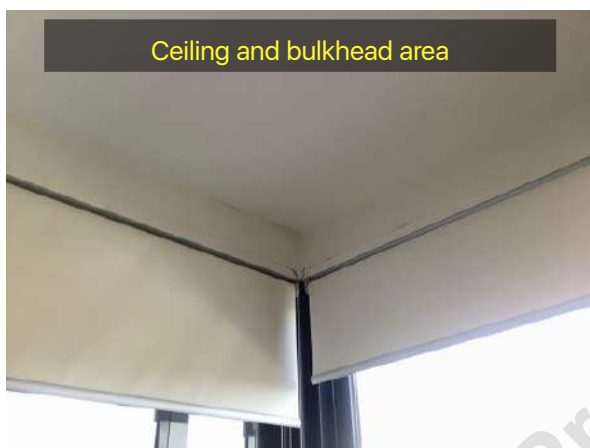
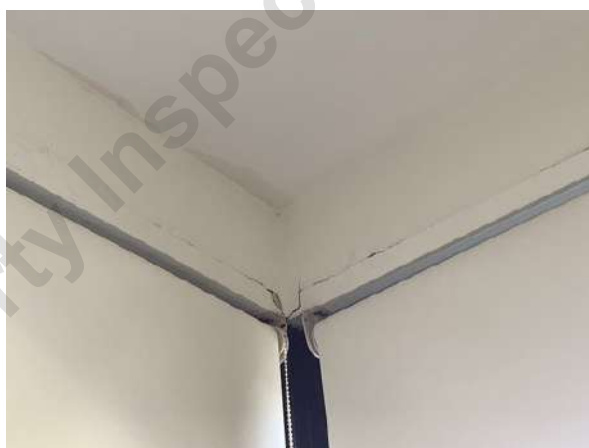
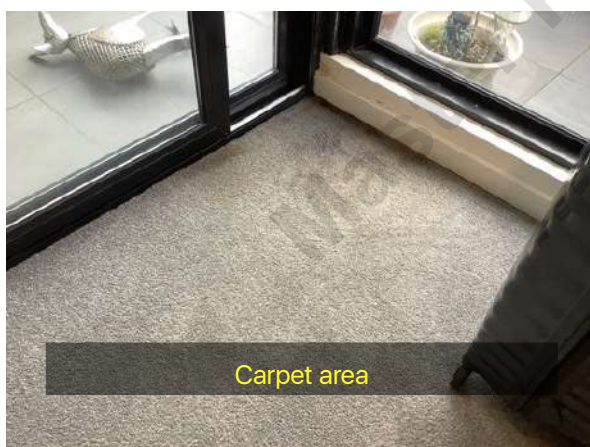
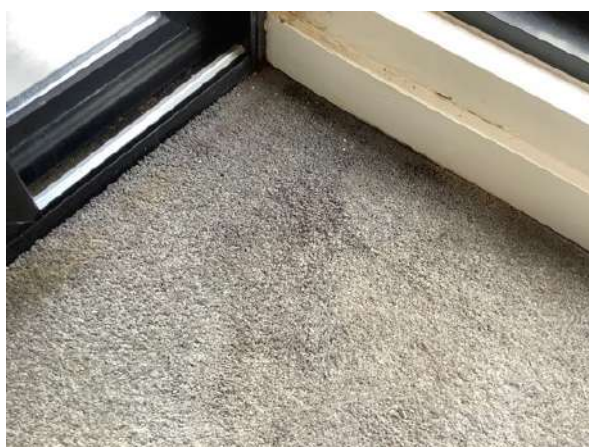
Defect 1.01

- / The ceiling was water stained and water damaged.
- / The bulkhead timber area had water stains and wood rott.
- / There was water stains running vertically down the window and door frames in various areas over approximately a 2.5 metre area.
- / There was actual areas of wetness and dampness running vertically down the window and door frames in various areas over approximately a 2.5 metre area.
- / The timber architraves to the window and door areas, including the timber skirting boards were water stained and contained wood rott.
- / The carpet was wet .

Finding: Addendum 'B' - DEFECT - 1 - Damp Wetness Location
Water is staining the ceiling, bulkhead, timber skirting and window sill areas

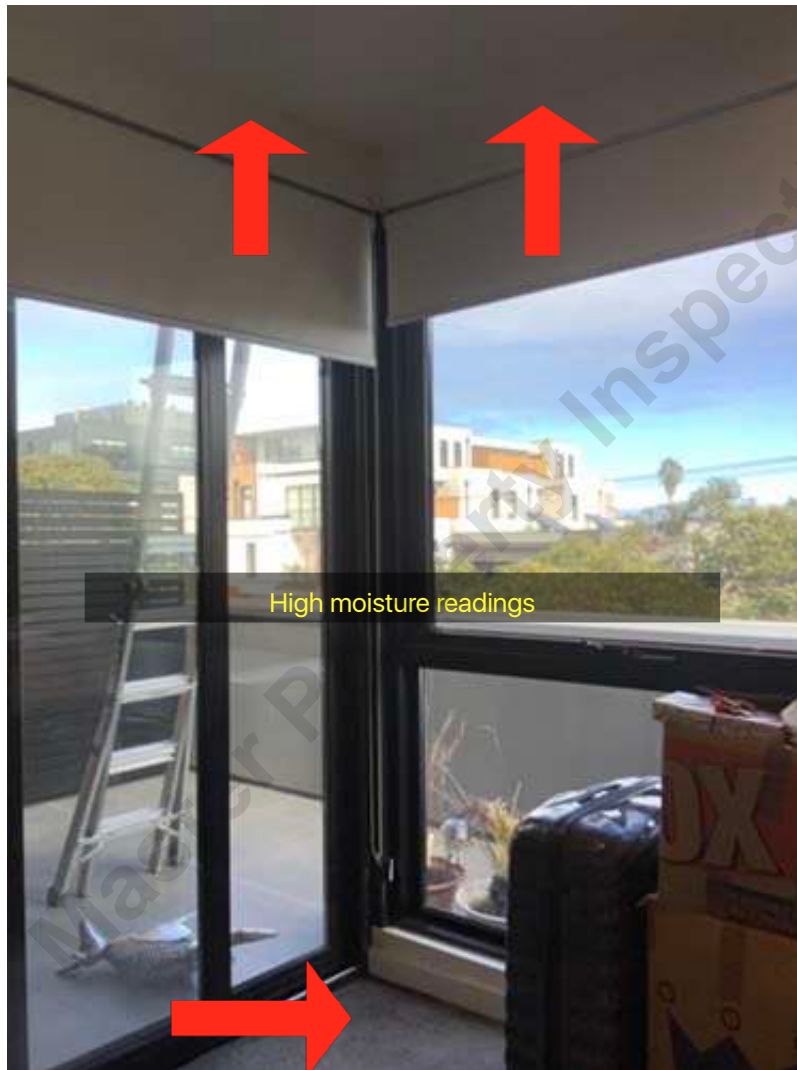
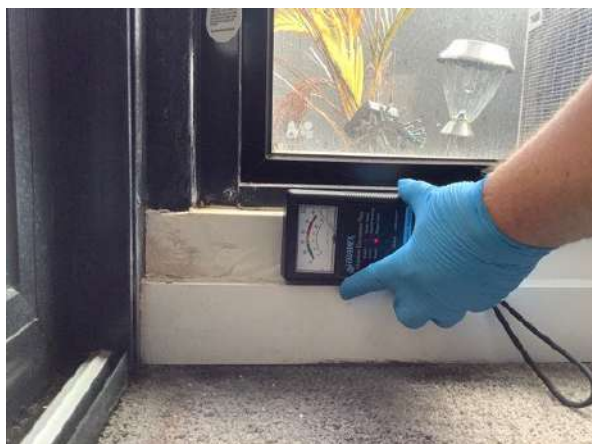
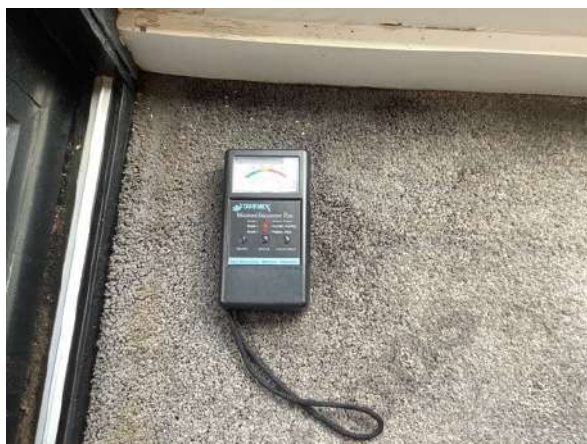
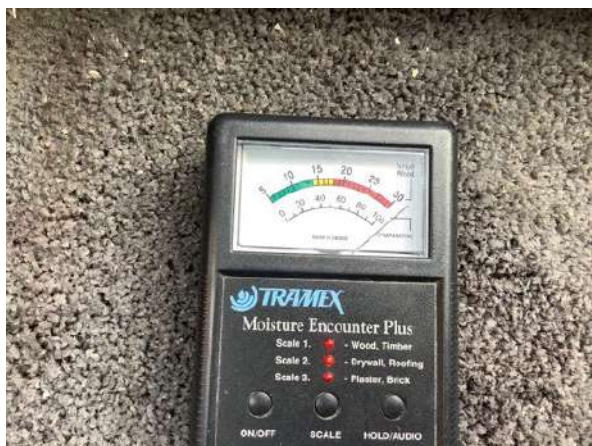
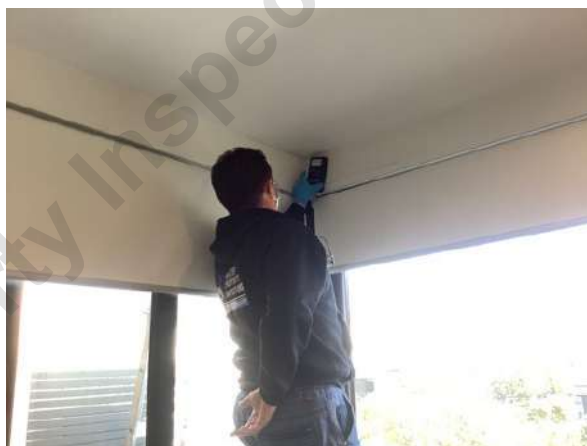
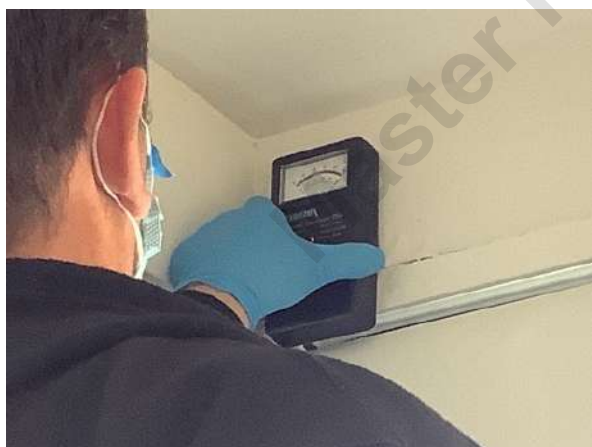
Defect 1.02

Finding: Addendum 'B' - DEFECT - 2 - High Moisture Levels
As per the photo's in this defect statement, we show and indicate high readings of moisture.

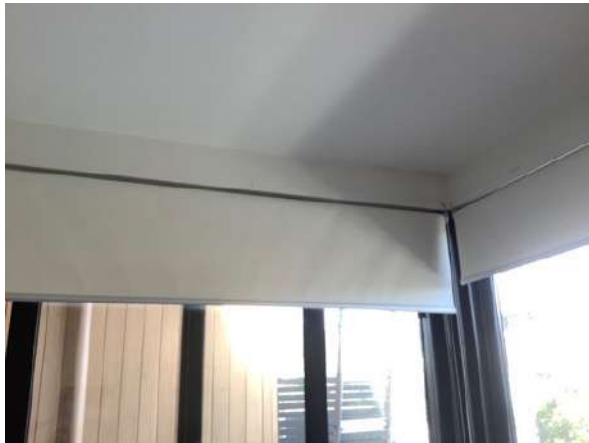
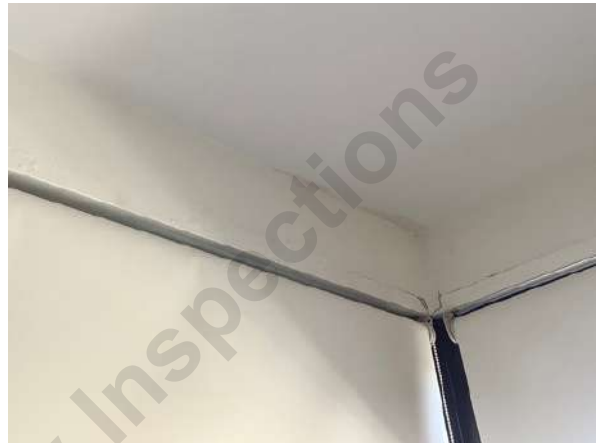
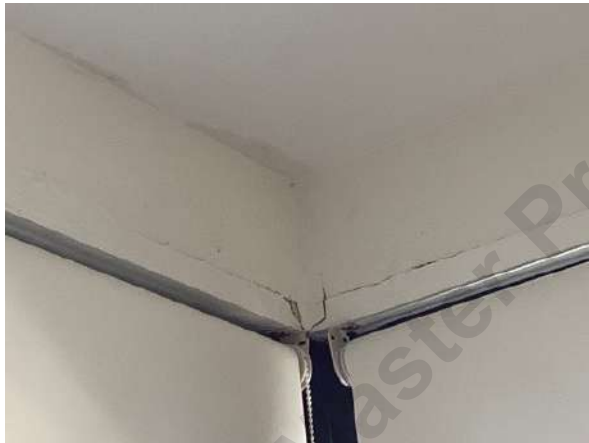
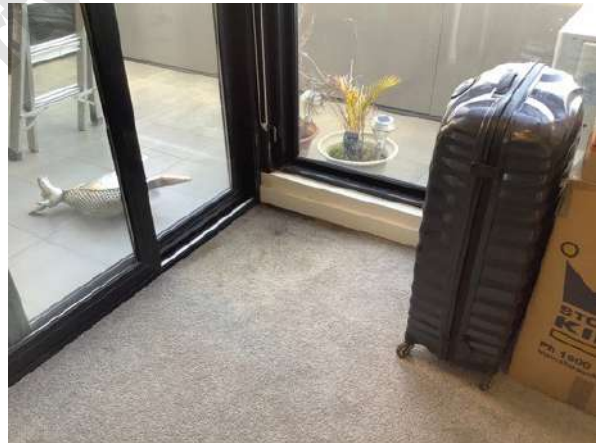
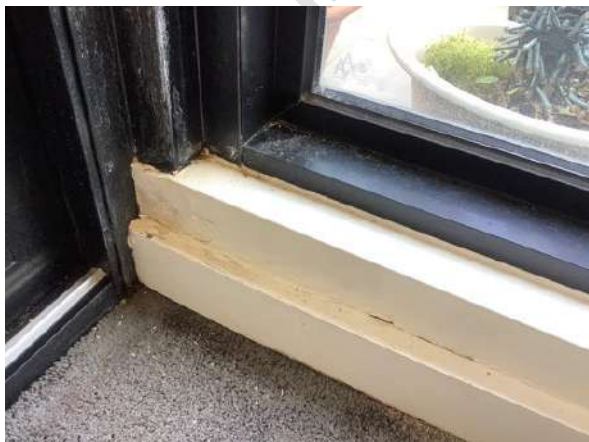
Defect 1.03

Finding: Addendum 'B' - DEFECT - 3 - Plaster & Timber Work
These photos show the plaster and timber work, water staining damage.

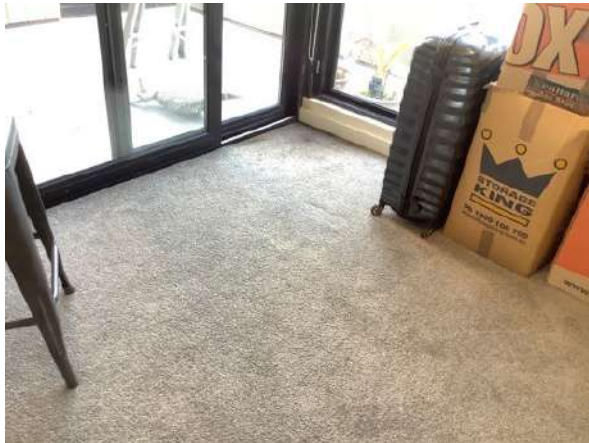
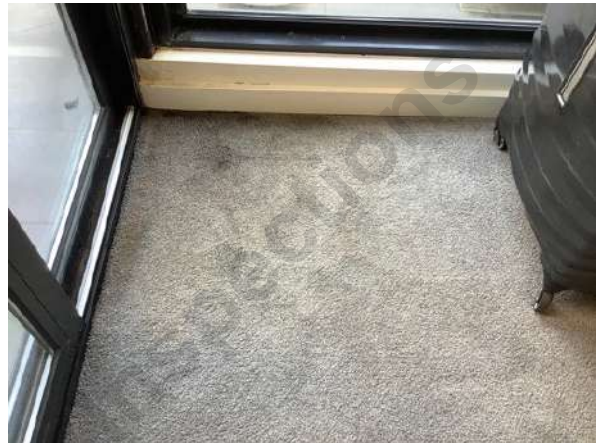
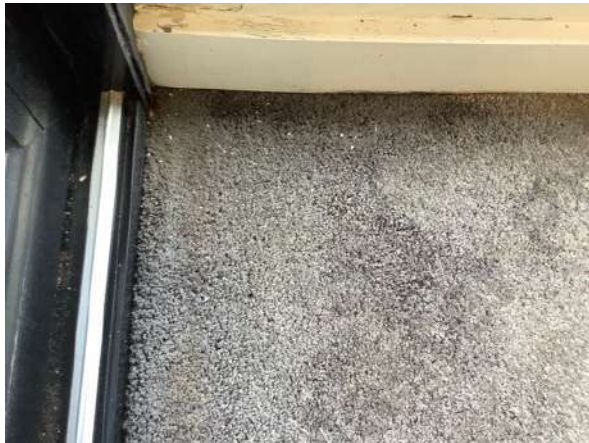
Defect 1.04

Location: Addendum 'B' - Defects List
Finding: Addendum 'B' - DEFECT - 4 - Wet Carpet
Wet carpet area.

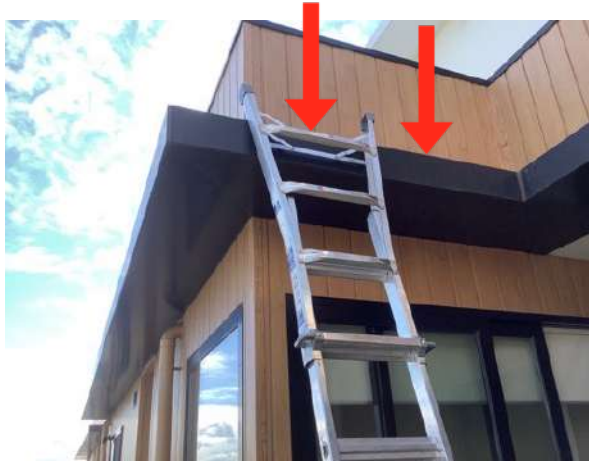
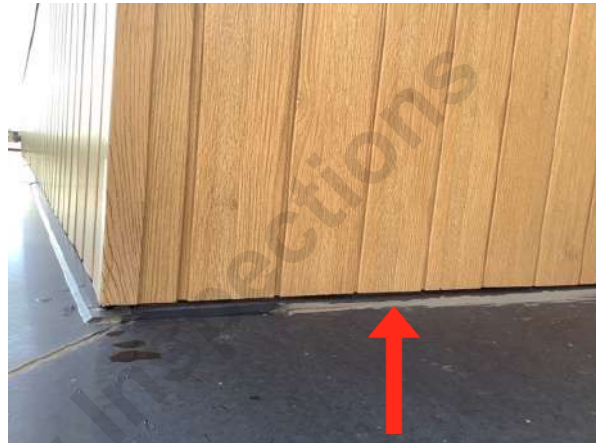
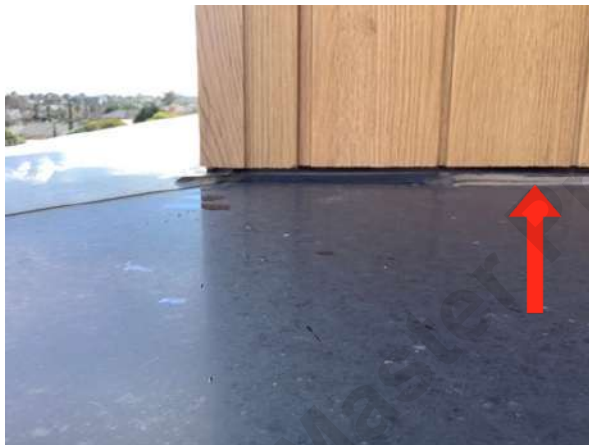
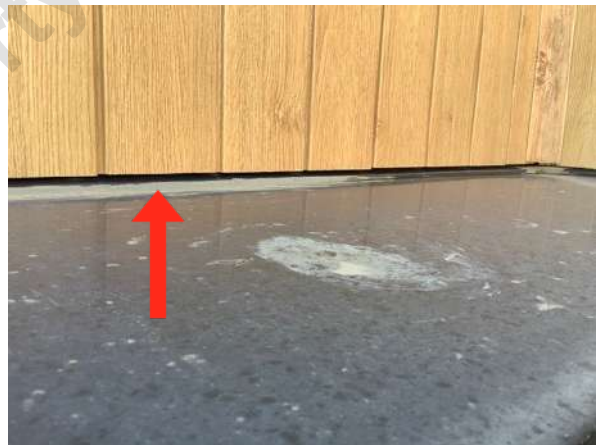
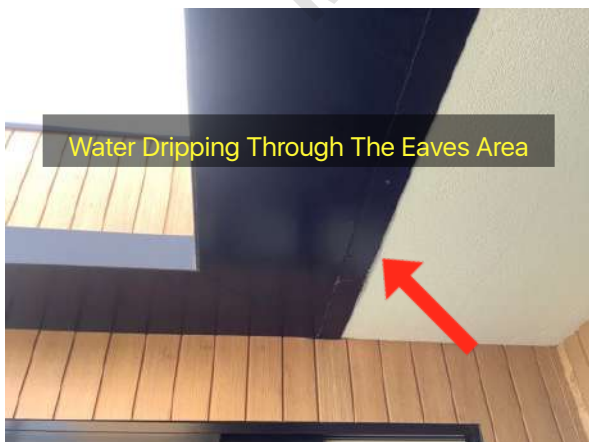
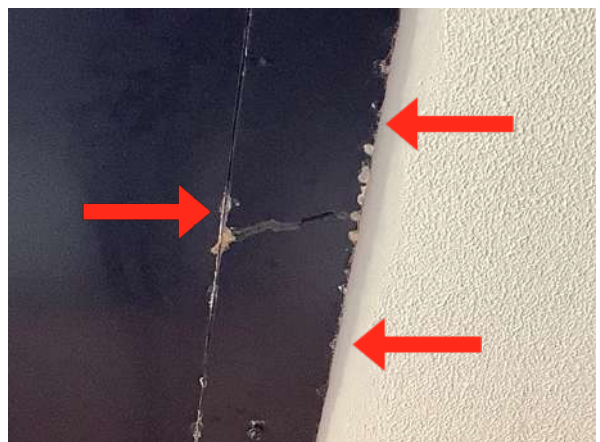
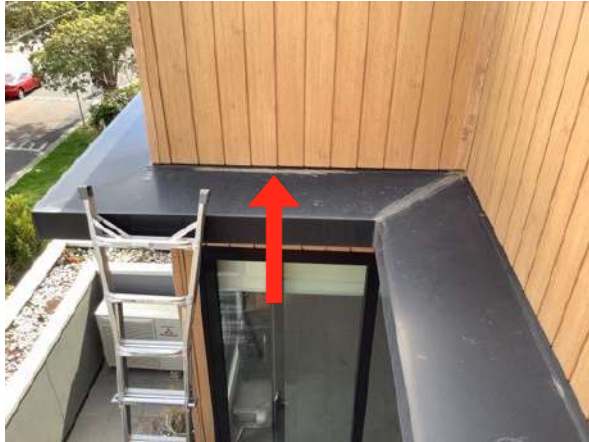
Defect 1.05

that there was some sealant installed along one of the metal flashings that would not have been installed at the time of the construction build as the area that had the sealant was not an area that normally requires sealant and it was clear that only this particular area has this added type sealant, this to me suggested that some person has attempted to stop the water ingress into the apartment.

Finding: Addendum 'B' - DEFECT - 5
Photo's indicate the minor repair attempt of sealant to the flashing area.

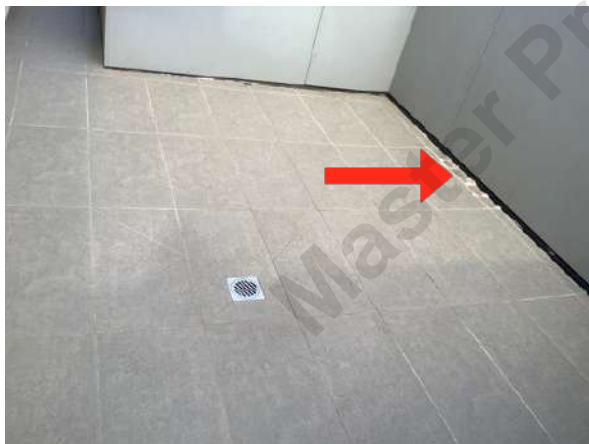
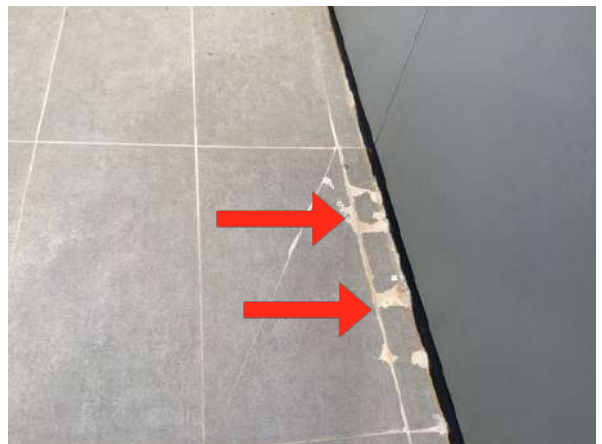
Defect 1.06

Finding: Addendum 'B' - DEFECT - 6, Upper Apartment 306 - Tile Efflorescence
There is evidence of calcification or efflorescence to Upper Apartment 306, affecting the tiled balcony area.
Where calcification or efflorescence is caused by water coming from the deck or balcony .
This is considered a defect.

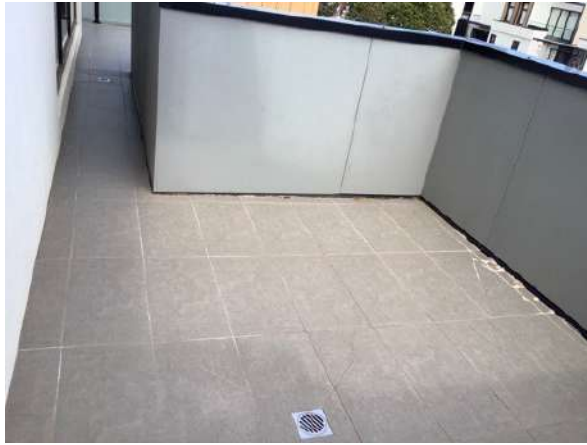
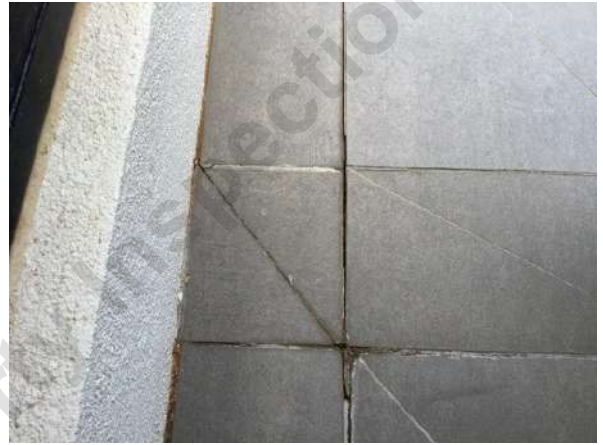
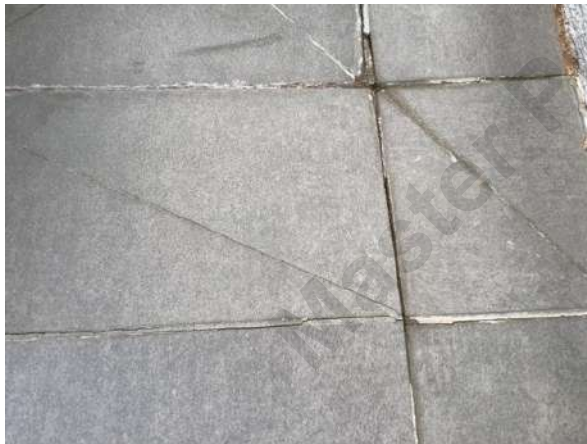
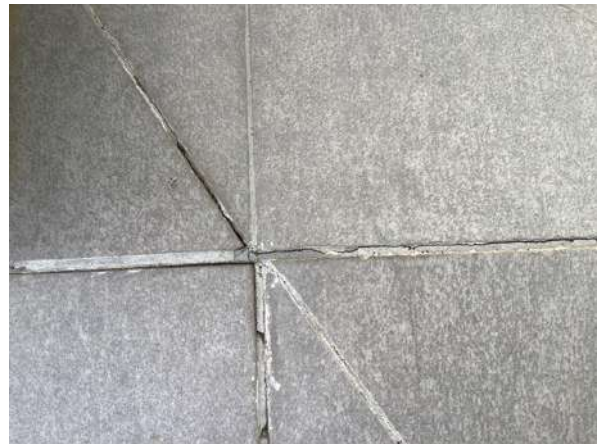
Defect 1.07

Finding: Addendum 'B' - DEFECT - 7, Upper Apartment 306 - Drummy Tiles
Drummy tiled areas were identified in Upper Apartment 306 at the time of inspection. The term 'drummy' refers to tiles that have become detached from their fixing.

Such defects are generally caused by physical or moisture damage to the area. Drummy tiled areas may also be a direct result of poor workmanship during the construction process.

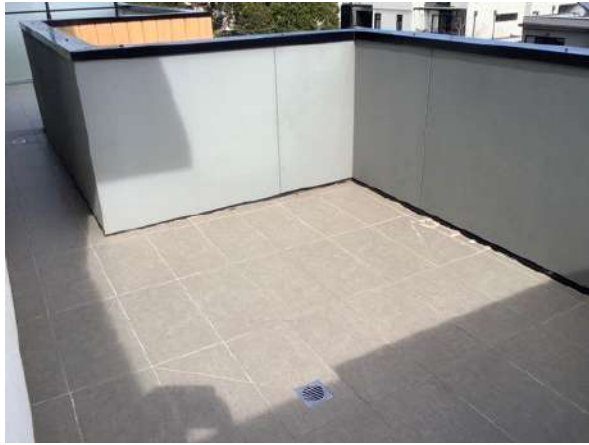
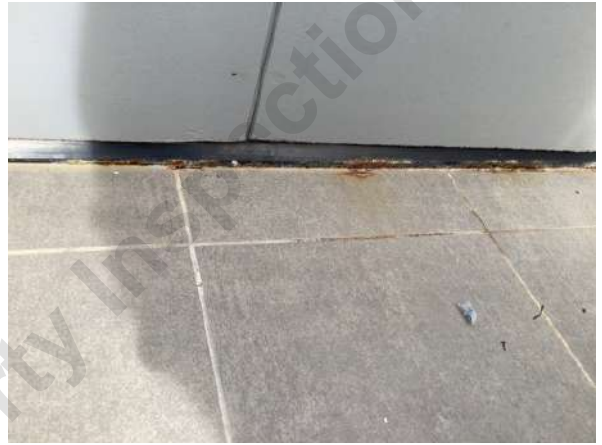
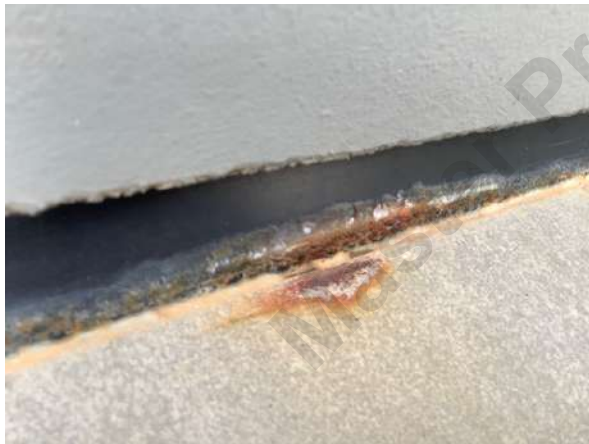
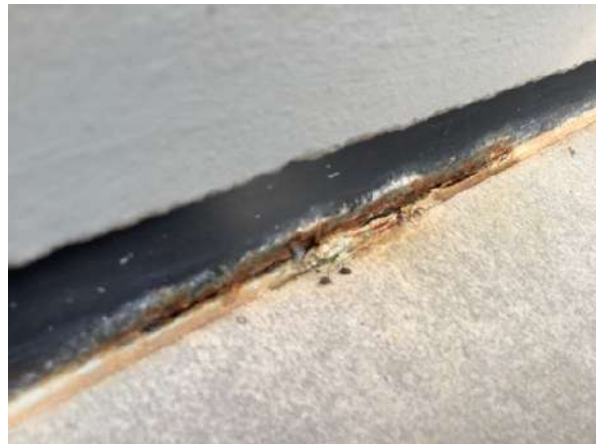
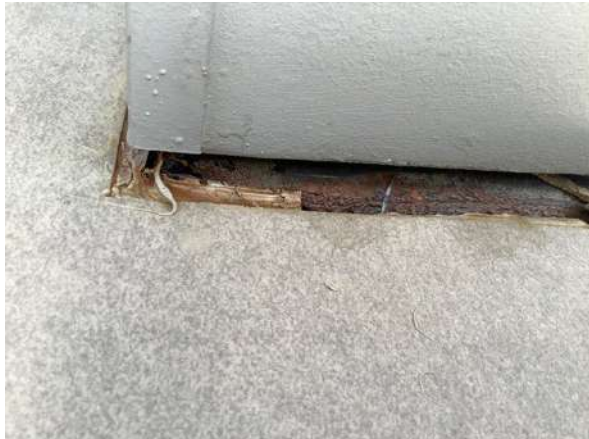
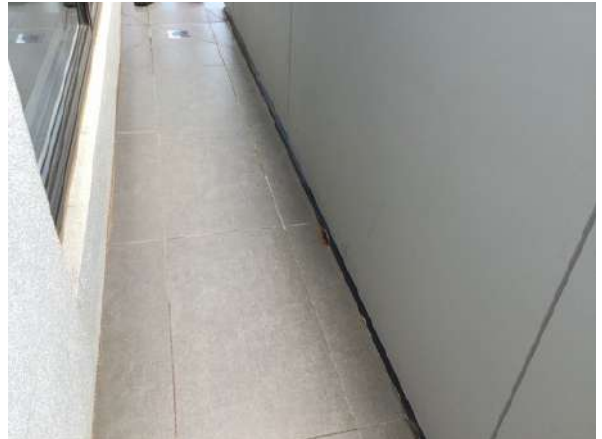
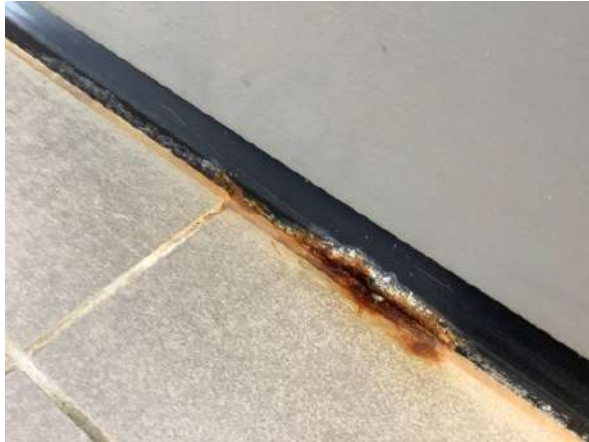
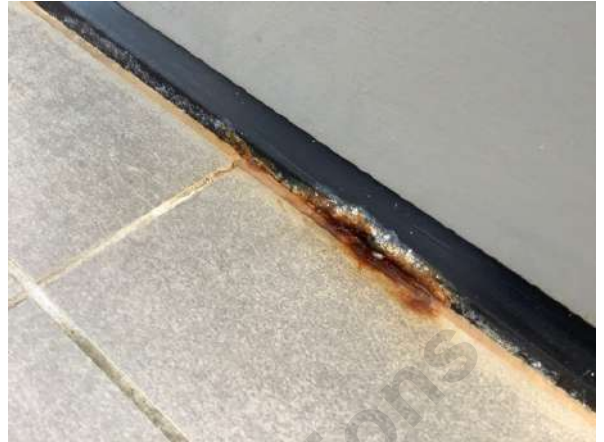
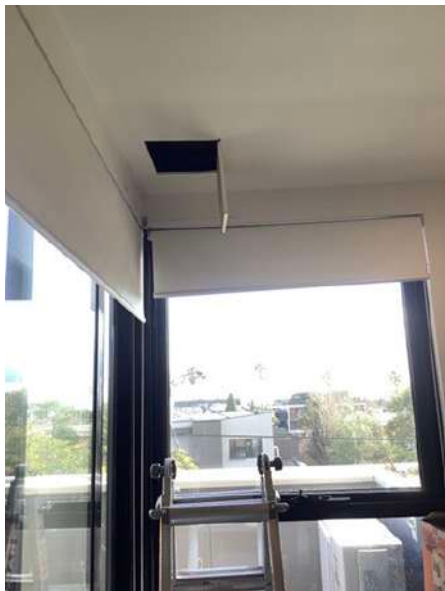
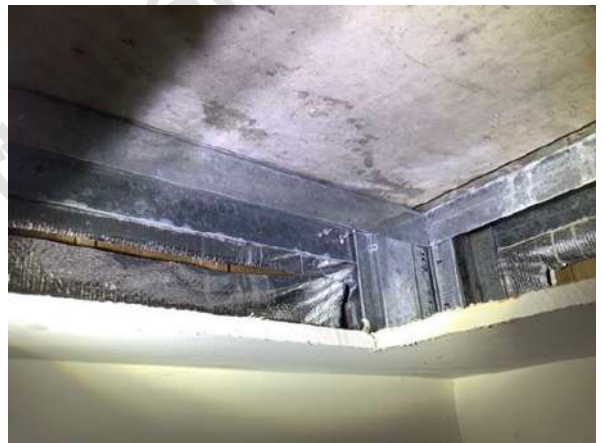
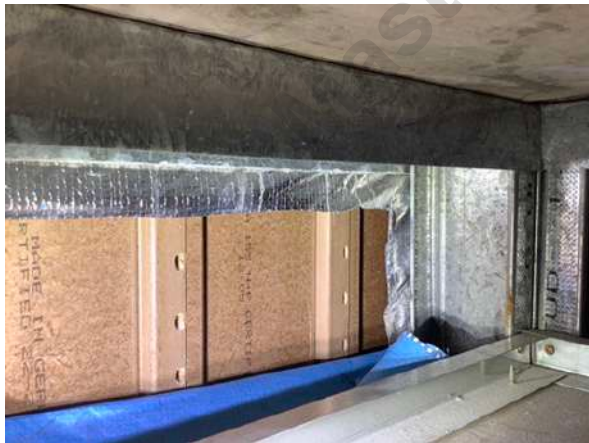
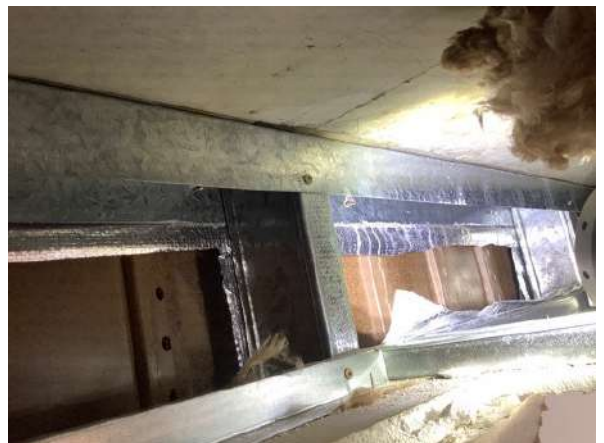
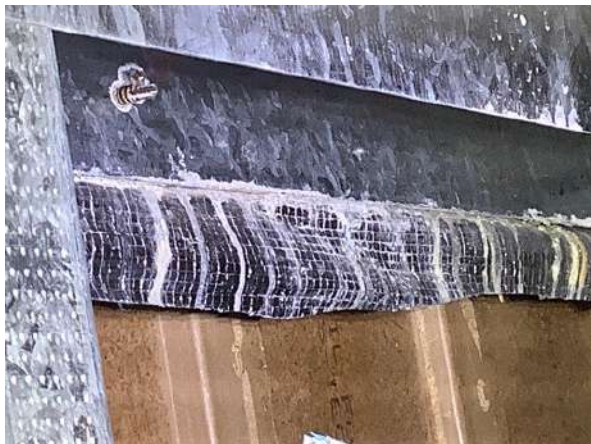
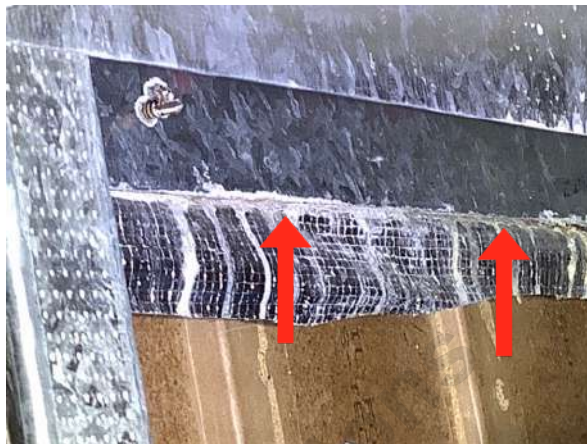
Defect 1.08

Finding: Addendum 'B' - DEFECT - 8, Upper Apartment 306 Material Corrosion / Rusting
There is severe corrosion and rusting in Upper Apartment 306 to the balcony perimeter. This indicates that the materials used are not as the manufacturer has intended the material to be used for.
This damage also will not allow the very important sealant to adhere to the rusting metal areas.

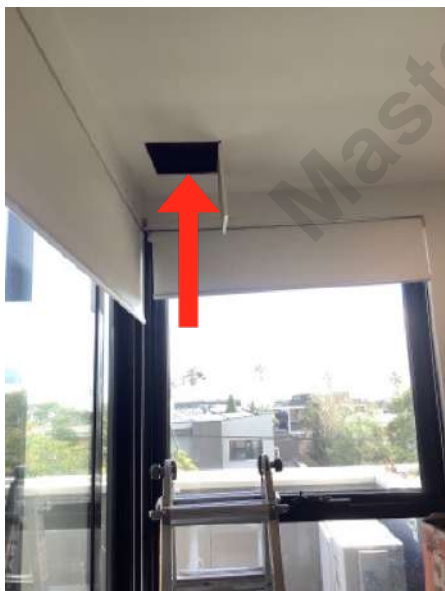
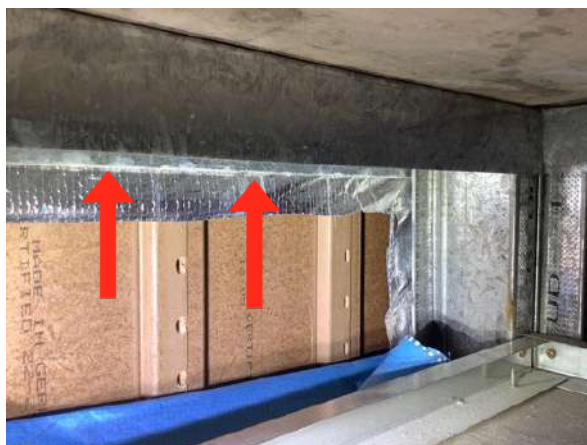
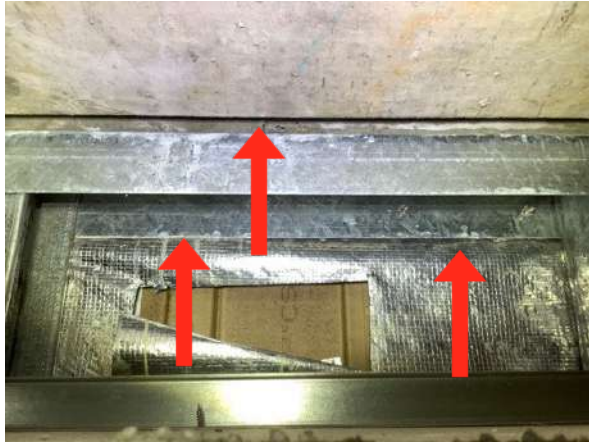
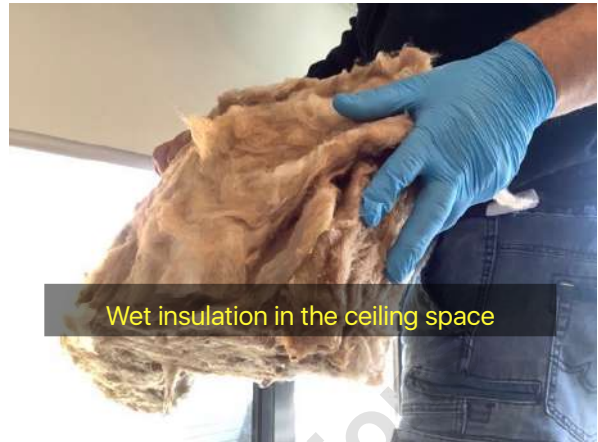
Defect 1.09

Due to our limited inspection in the ceiling space we have determined that water is ingressing from upstairs, via the front of the sisalation wrapping, which highly suggests that the water is coming from the defective and damaged upstairs balcony installation as water appears to be ingressing the balcony upstairs and running along the concrete floor in between the two buildings, then running in front of the sisalation wrapping to the exterior perimeter wall and at this point now in the ceiling space of our client which then is finding various ways to spread in the ceiling and down the walls, window and door frames, finally ending up on the carpet floor.

Finding: Addendum 'B' - DEFECT - 9, Ceiling Space Water Traveling
 We have cut 2 squares in the plaster ceiling at approximately 330mm x 330mm to identify the water ingress and also the water travel.
 At the time of the inspection we did identify that the water appears to be coming from the front of the sisalation wrapping. This would appear to indicate that the water would be travelling from the upstairs balcony area as the exterior cladding is on the other side of the sisalation wrapping, so if the water ingress was coming from the exterior roofing or cladding the other side of the sisalation wrapping area should be wet.

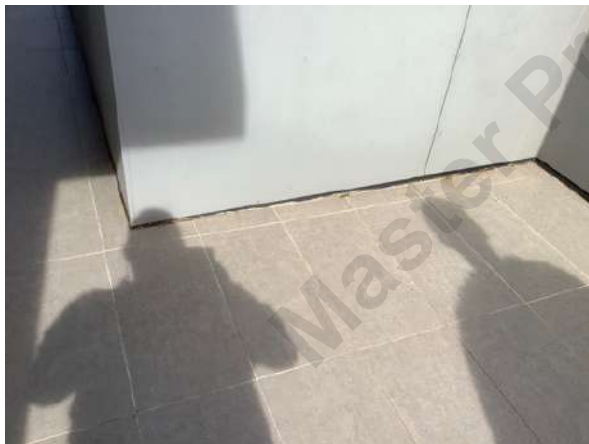
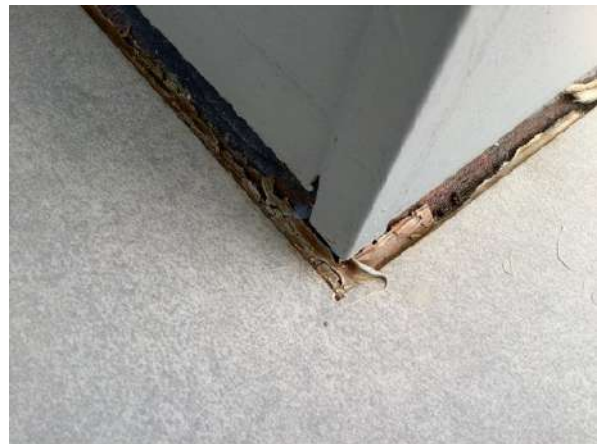
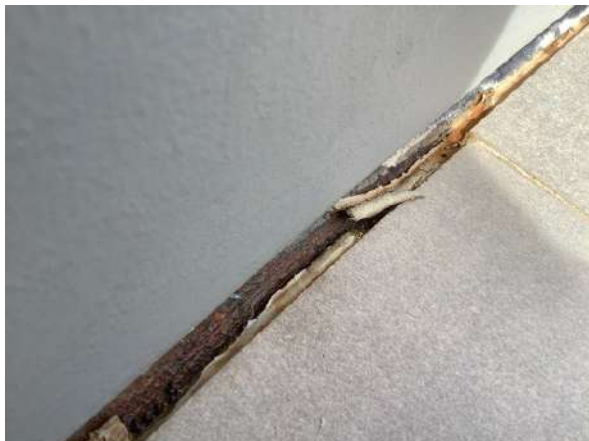
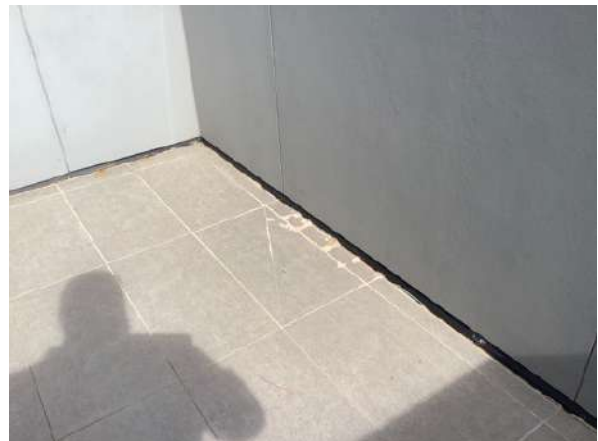
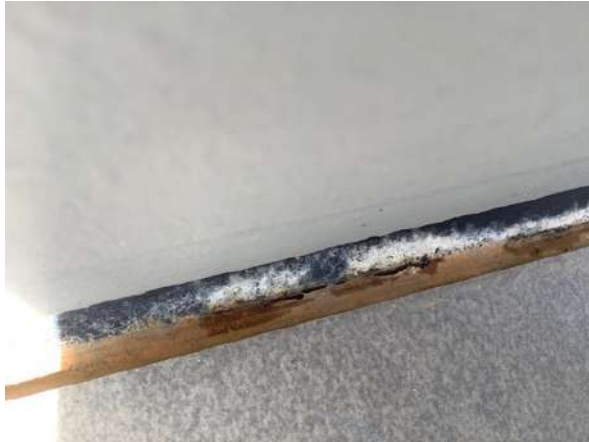
Defect 1.10

Finding: Addendum 'B' - DEFECT - 10, Upper Apartment 306 - Defective Caulking & Materials
The sealant is non-existent and severely compromised to the balcony in Upper Apartment 306. The sealant is an extremely important and integral part of a balcony area. Due to the corrosive and damaged metal surround, it is impossible for a sealant to adhere to the metal.
