Vendors Report - Building & Termite/Timber Pest

Inspection Date: 7 Jul 2021

Property Address: Glenroy area

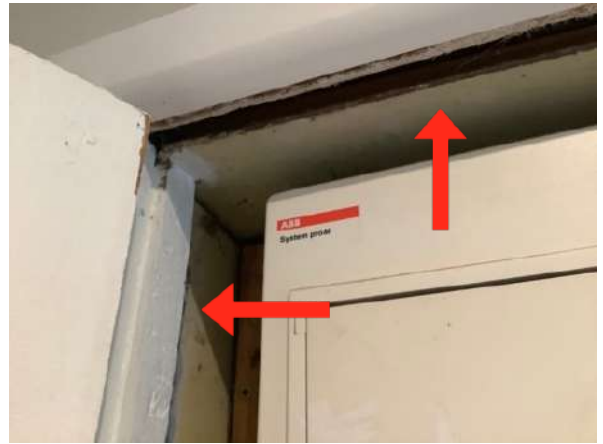
In the interim, the client is advised to act with caution, especially when considering any damage to building materials general wear and tear renovations extensions demolition and general maintenance activities due to the suspected presence of Asbestos.

◆ PLEASE NOTE : We are able to perform an Asbestos Inspection and Condition Audit, which can include the taking of samples for definitive confirmation of the presence of Asbestos. This inspection as noted above is outside the scope of this inspection but at request of the client we can perform the necessary inspection and take the samples to the laboratory to give you a comprehensive and definitive inspection report, with laboratory results.

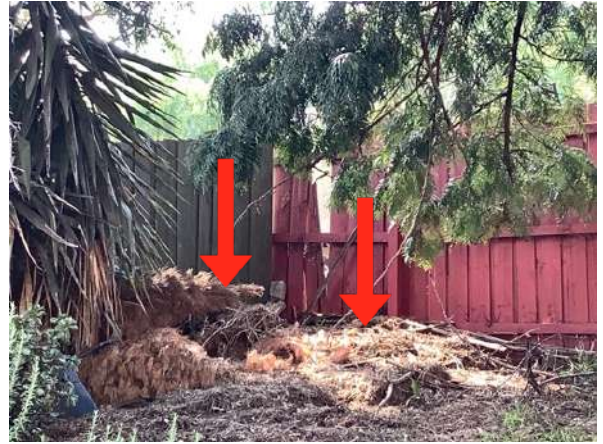
Location: Garden Areas - All Areas

This type of environment also creates a very conducive environment for termites as well.

I highly recommend as a matter of urgency the entire area be cleaned up by a handyman, gardener or competent similar persons and in addition the possibility of Vermin/Rodents/Snakes/Etc maybe of high risk as these conditions would be perfect.

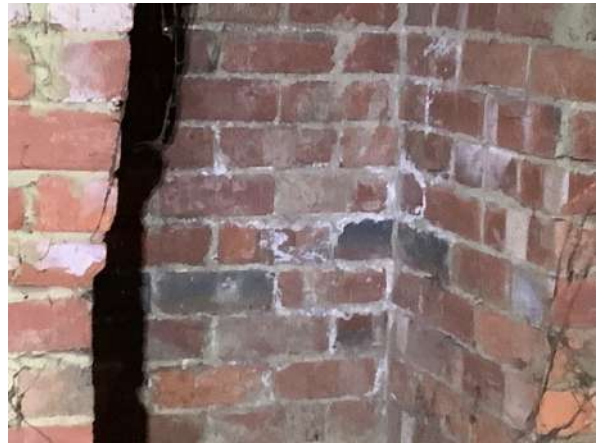
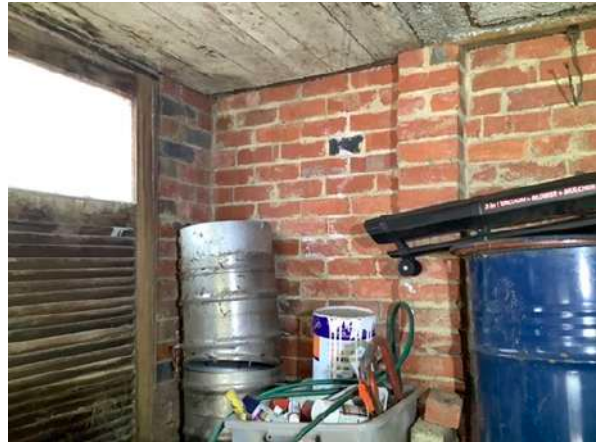
Location: Subfloor Area And Garage

Other damages that may co-exist with efflorescence, pending on where efflorescence is, such as subfloors, brick walls, inside garages in the concrete or brick walls, etc may be damp rising, dampness, concrete cancer and other such serious defects.

People can under estimate efflorescence, so we highly recommend further investigation, by a registered builder and/or a structural engineer as a starting point.

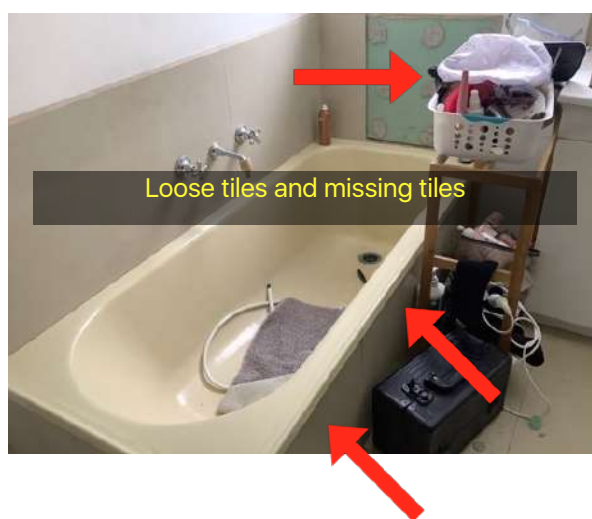
If left unmanaged, water penetration to these areas may lead to subsequent water damage, which is likely necessitate repair work to affected building elements.

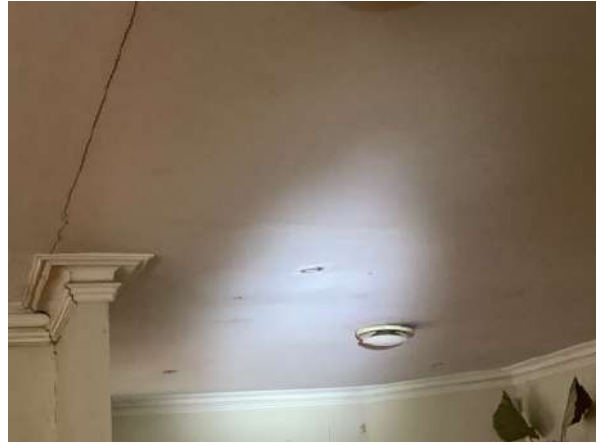
Location: Plaster-Variou Area's
 Finding: Plaster Ceiling - Drummy / Sagging

Houses that do not have insulation can sometimes contribute to drummy plaster as many times the drummy plaster is in garages where there is no insulation in the roof so the plaster is subjected to moisture as it is not protected by the insulation, so this may be the only reason the plaster has become damaged / drummy , meaning no insulation to the garage or house or sometimes this may only be a contributing factor along with defective workmanship and/or others defects to the home, such as leaking roofs, etc.

Ensure that the general environment is free of moisture and humidity to aid in the prevention of drummy plaster and plaster damage. Appointment of a qualified plasterer and/or builder is advised in order to complete remedial works as necessary.

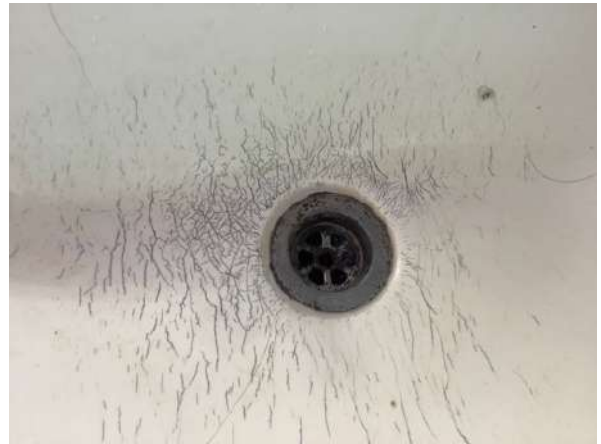
Location: Bathroom

As the cracking provides potential ingress for water, secondary water damage may occur to associated cabinetry, walls or flooring, if the cracking is left unmanaged.

Consultation with a plumber regarding basin repair or replacement is required. Remedial works may be required to protect against any further damage.

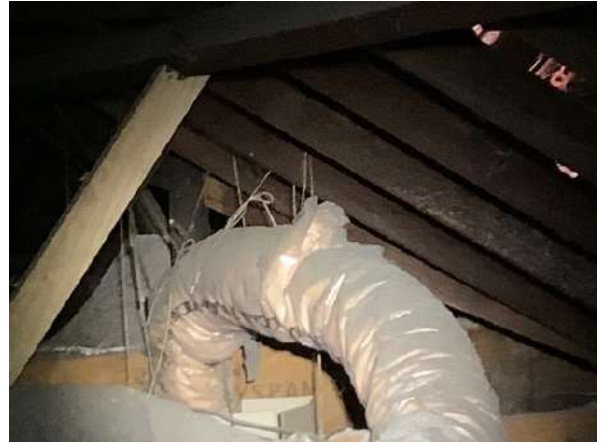
Location: Roof Space

The damage sustained by the ducts detracts from the energy efficiency of the property. The airflow within the property is likely to be restricted, particularly in areas where ducting shows signs of major damage.

A heating/cooling specialist should be appointed to provide further advice on remedial work options and to perform any works deemed necessary.

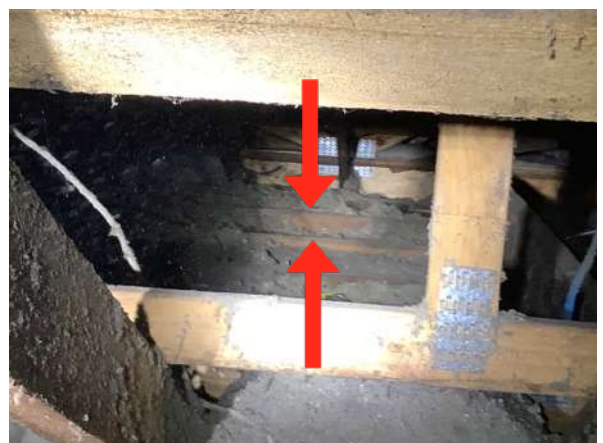
Location: Roof Space

This type of insulation is susceptible to settling and reducing in volume, detracting from its effectiveness and resulting in an overall loss of energy within the household. Additionally, the reduction in volume has led to an uneven distribution of insulation within the ceiling void, further detracting from its effectiveness.

It is highly advised that this insulation be removed and replaced with a more appropriate material. This will ensure that the property is adequately insulated and will promote an increase in energy efficiency within the property. An insulation contractor should be appointed to provide further advice on replacement options and to perform works as necessary.

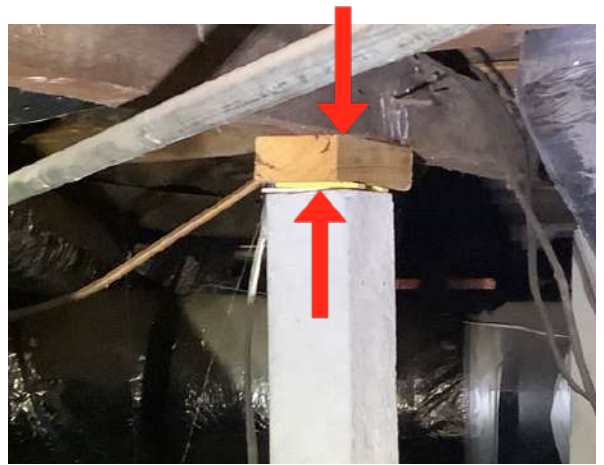
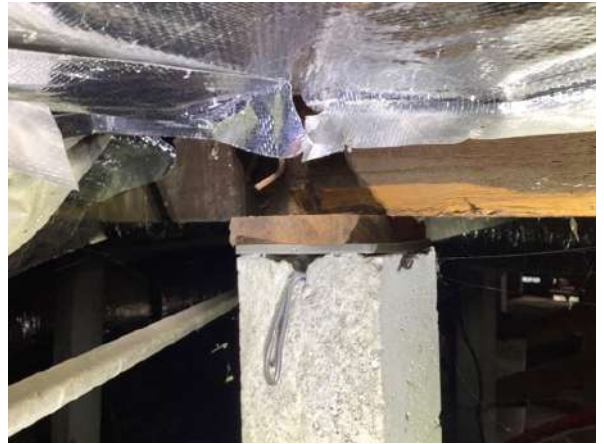
It is very important to note that packing a home does not fix the cause or the source of the problem and infact in most Cases installing Packers creates more pressure on the stumps creating more hydraulic force and causing the home to sink or subside further. The thick of the Packer the greater the issue.

Re-stumping is the ultimate repair method to level a home. Re-stumping is when the actual stumps are replaced and new stumps are installed and concreted in the ground, however it is very important to note that the source of the problem must be rectified first and in some cases the cause or the source can be water problems related to drainage, damaged plumbing, defective installation in the first place and various other reasons.
