# Dilapadation Report

Inspection Date: 4 Oct 2020

Property Address: Ascot vale area.

Report Type: Dilapidation Inspection Report

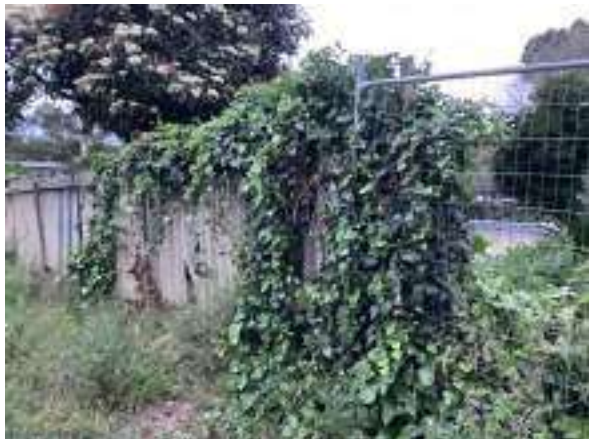
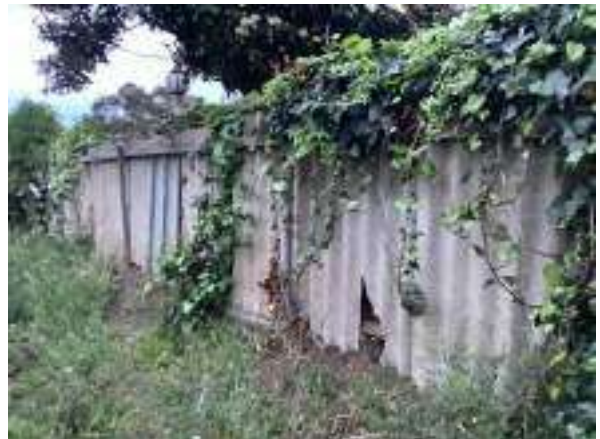
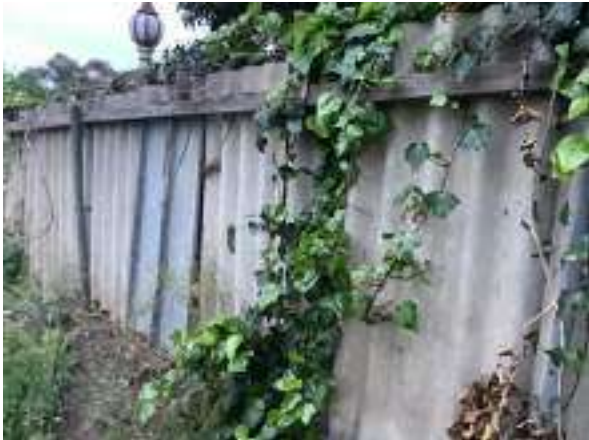
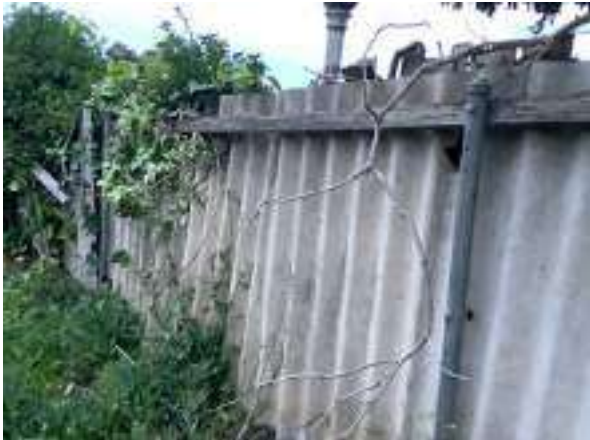
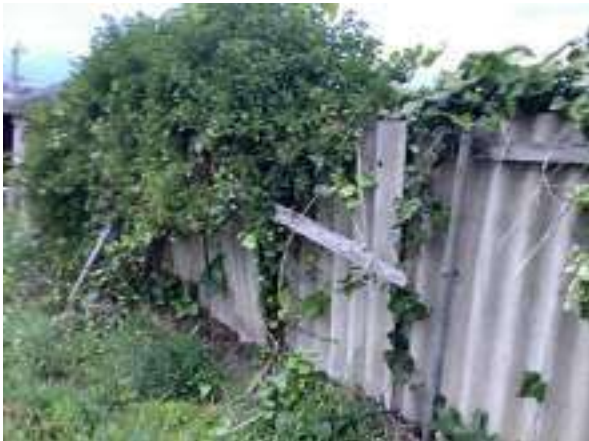
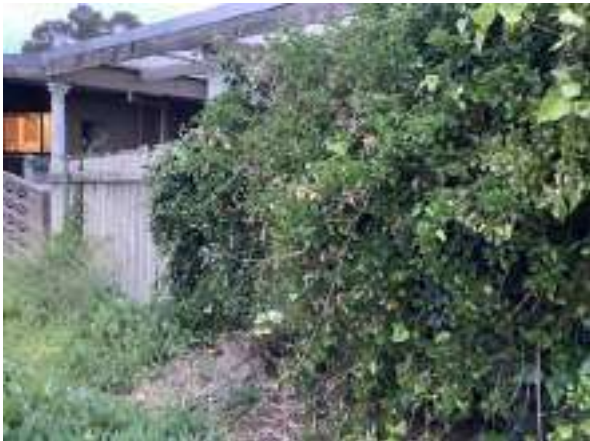
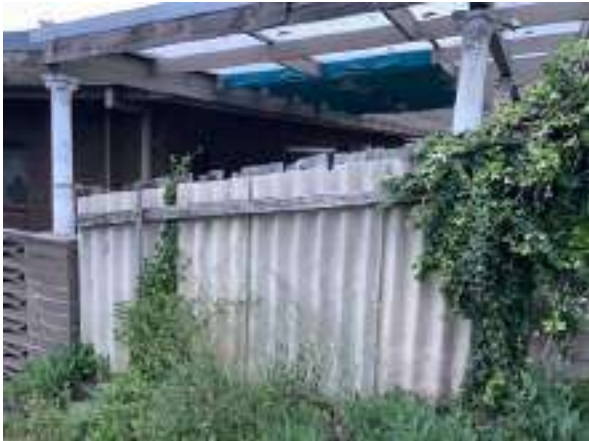
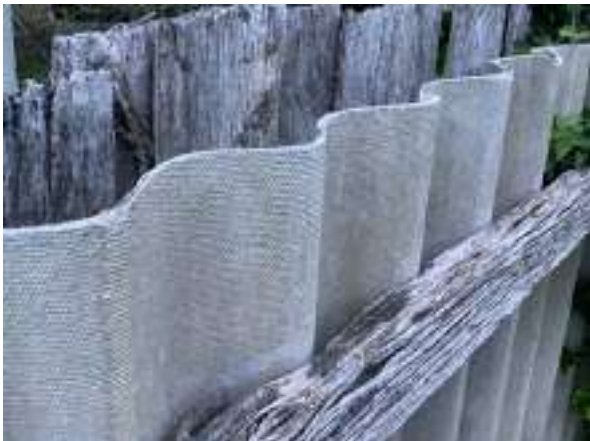
### Safety Hazard 1.01

Location: Fence From Proposed Site  
Finding: Fence - Suspected Asbestos-Suspected ACM Identified on Site.

Asbestos-Suspected ACM Identified on Site.

Reporting on Asbestos is outside the Scope of this Report. This suspected defect is highlighted as a caution only. We suspect, based on our experience in the building industry, that there is a higher risk of the identified building element containing asbestos ( ACM ).

As Asbestos Reporting is outside the scope of this report, we advise that you consider a separate Asbestos Inspection and Condition Audit, which can include the taking of samples for definitive confirmation of the presence of Asbestos.

In the interim, the client is advised to act with caution, especially when considering any damage to building materials general wear and tear renovations extensions demolition and general maintenance activities due to the suspected presence of Asbestos.

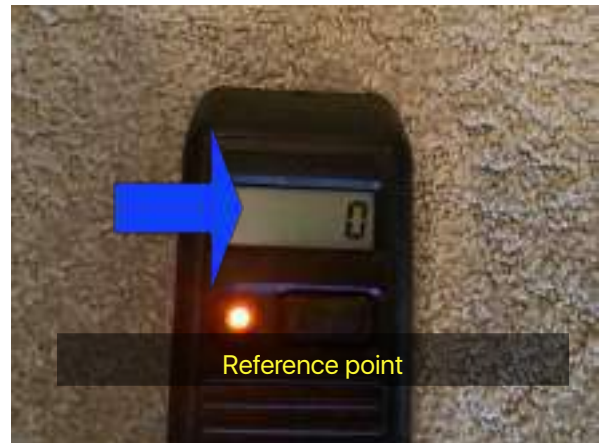
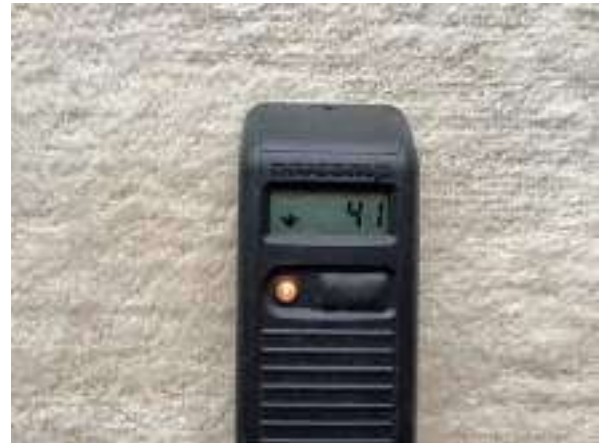
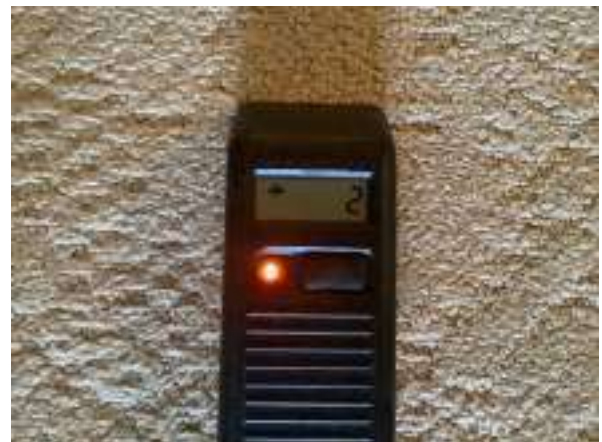
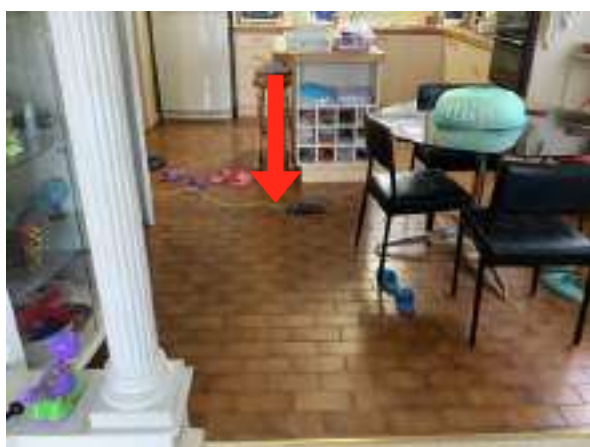
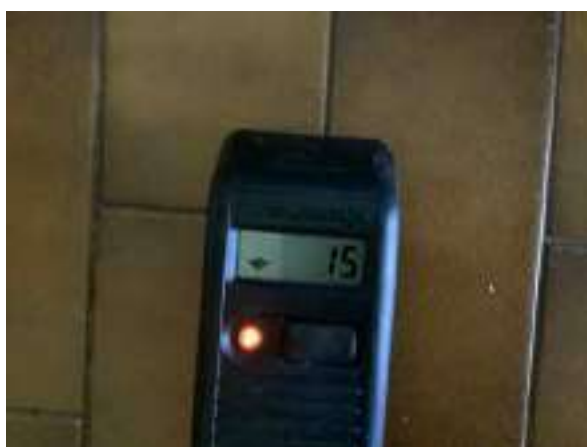
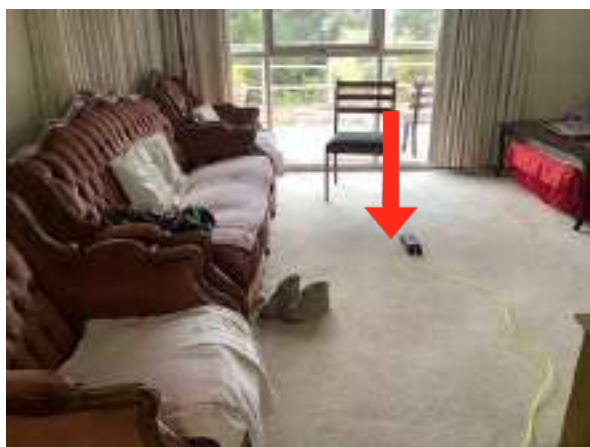
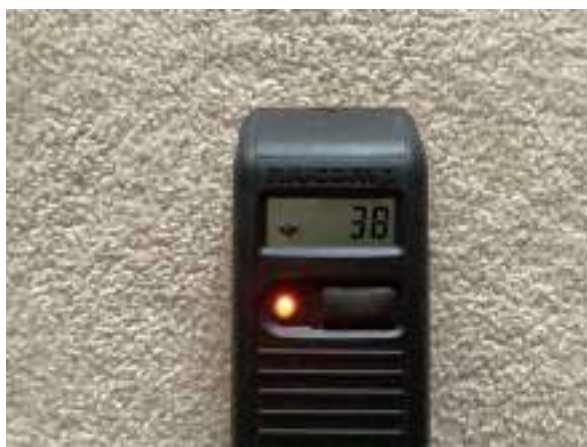
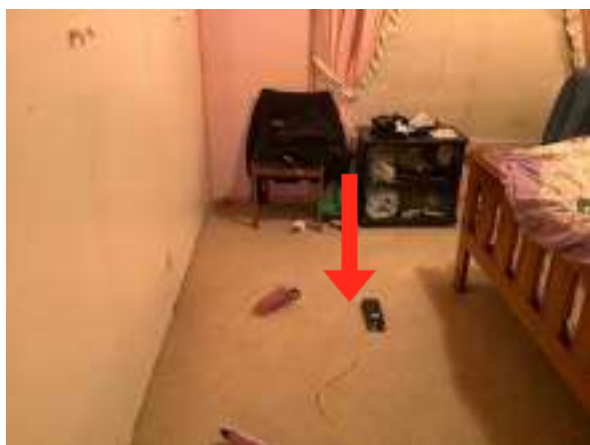
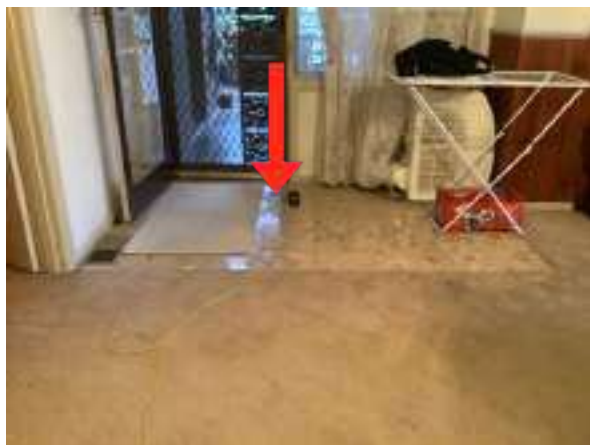
### For your information 4.03

Location: Internal Floor Levels

Finding: Floor Levels - Upper Level  
Attached are the floor levels in relation to a reference point to the upper level.

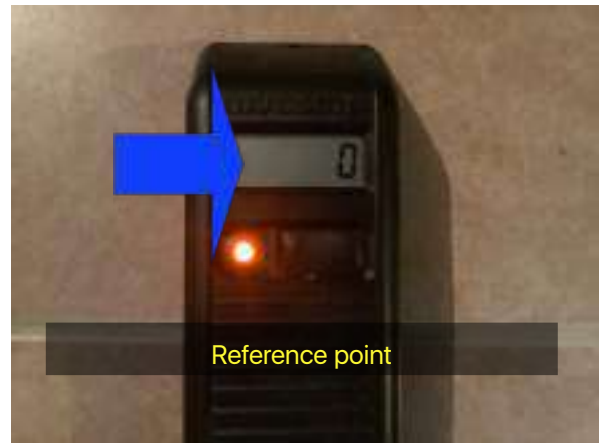
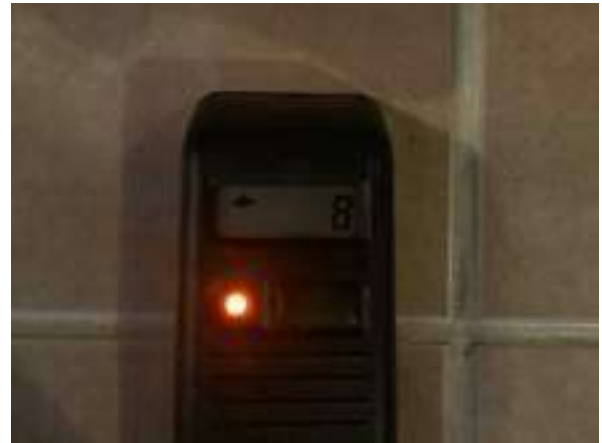
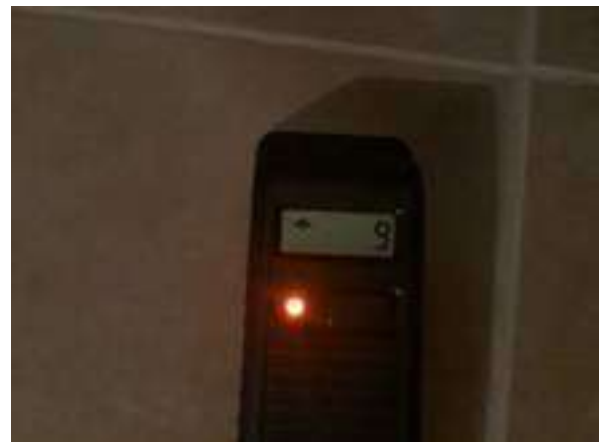
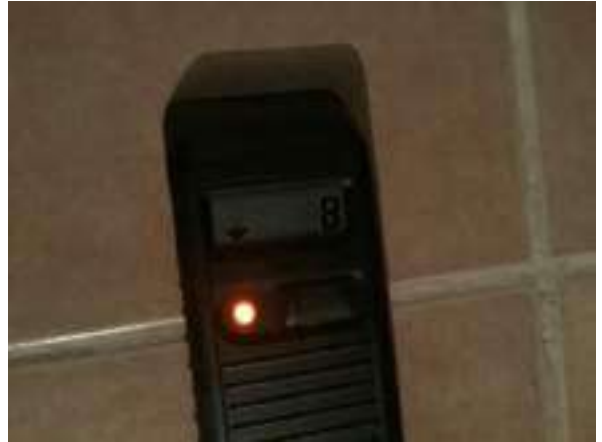
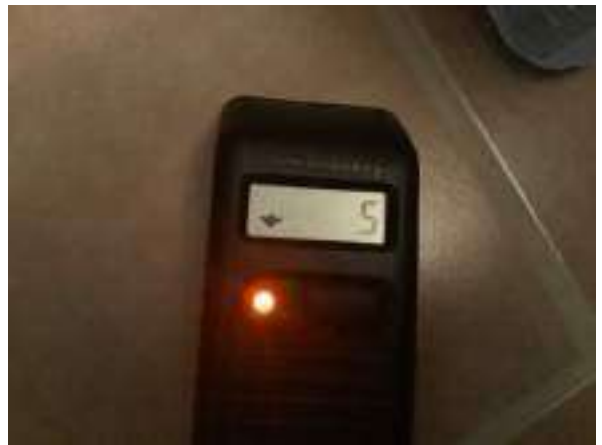
## For your information 4.04

Location: Internal Floor Levels

Finding: Floor Levels - Below Storage  
Attached are the floor levels in relation to a reference point to the lower level.

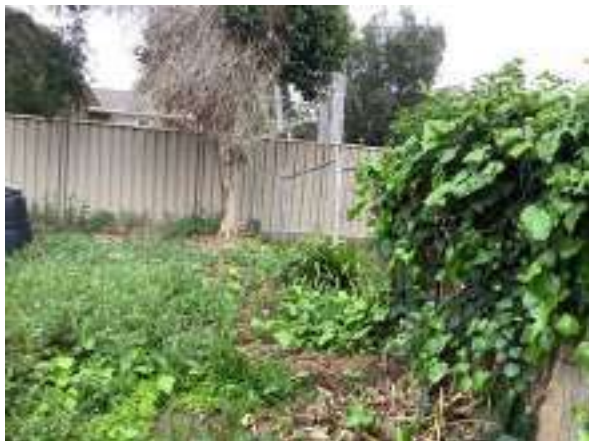
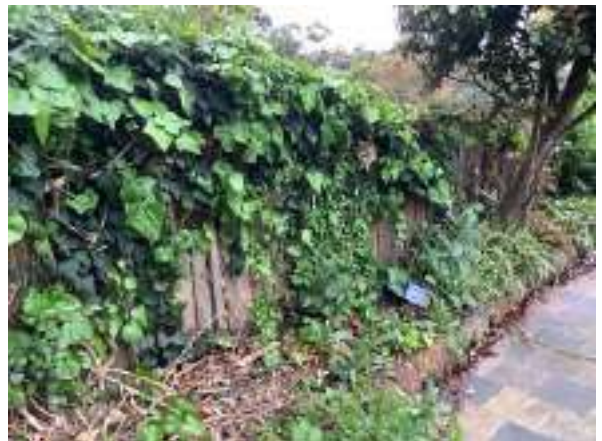
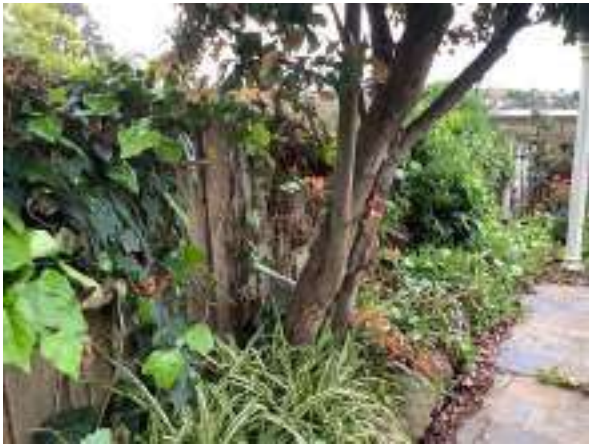
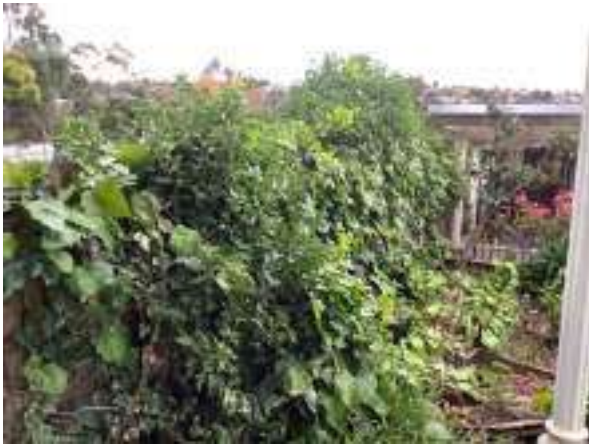
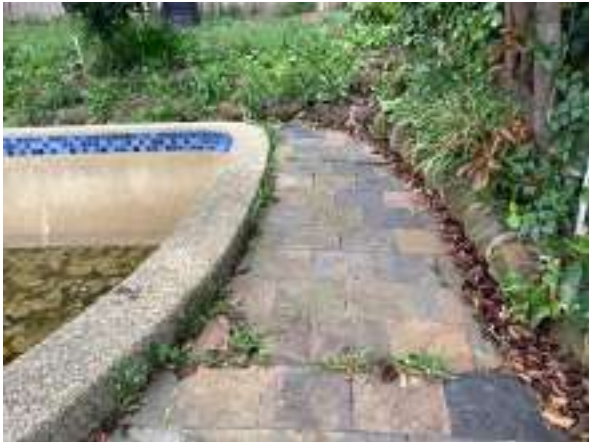
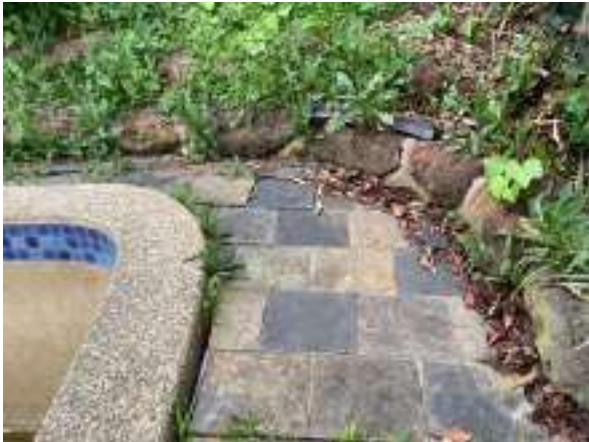
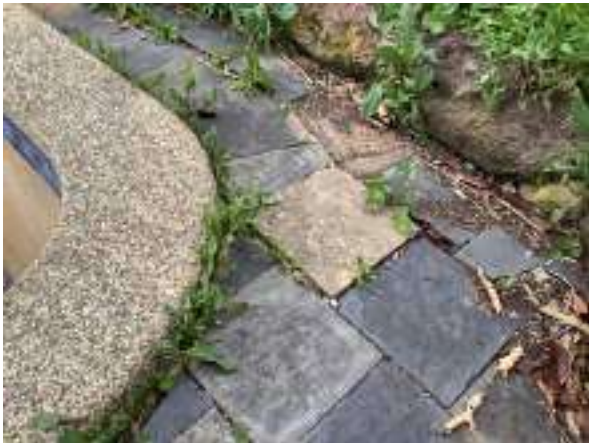
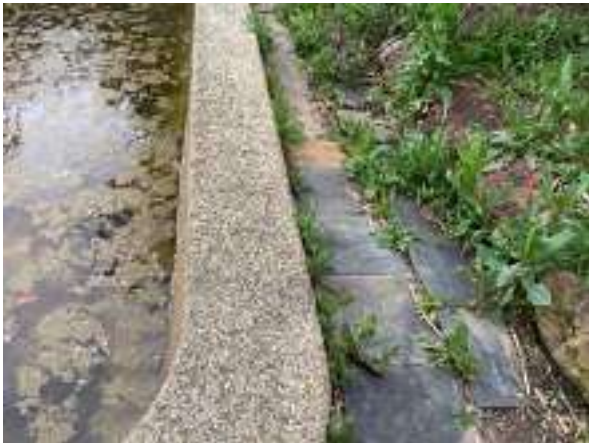
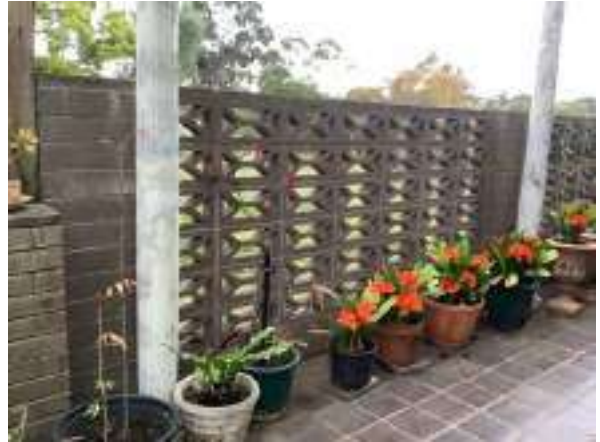
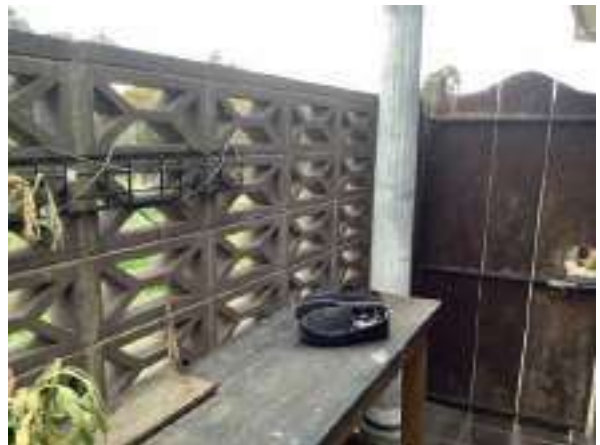
### For your information 4.05

Location: Exterior North Side

Finding: For your information – site photos ( back yard )  
Photos of interest and the condition for this location at the time of the inspection.  
In addition, various photos with a close up and/or arrows added to highlight the area of concern.

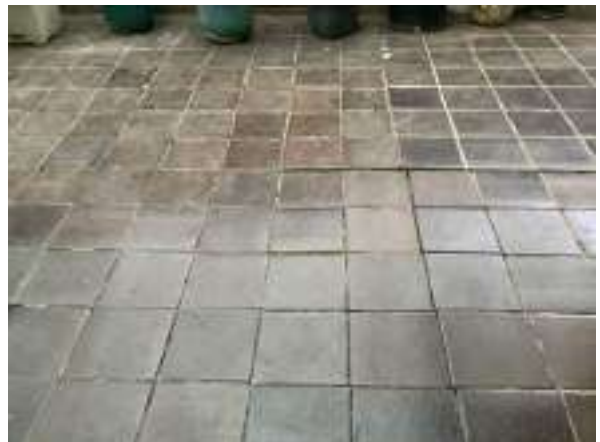
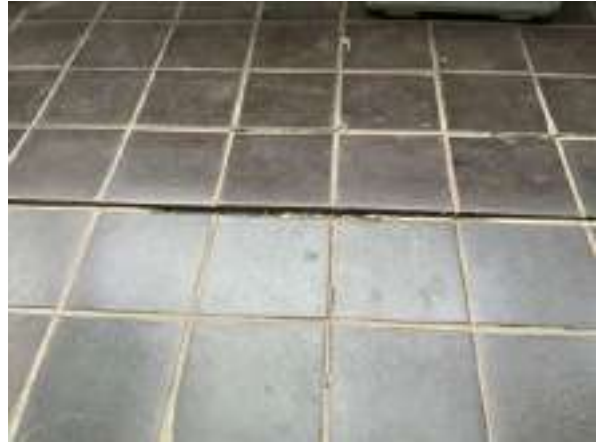
### For your information 4.06

Location: Exterior North Side

Finding: Tile Paving  
The tile paving is considerably compromised and drummy at the time of the inspection.

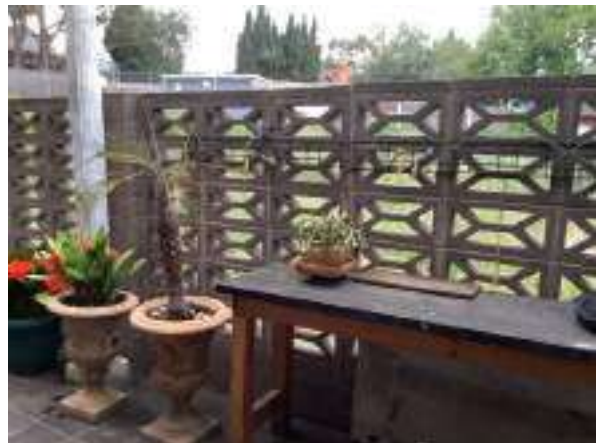
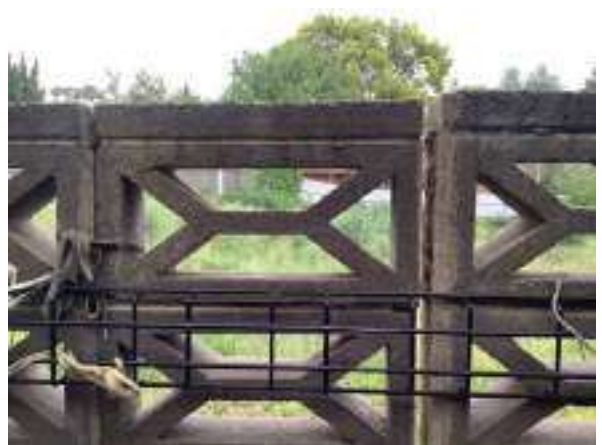
### For your information 4.07

Location: Exterior North Side

Finding: Block Fencing  
At the time of the inspection the block fencing has considerable movement.

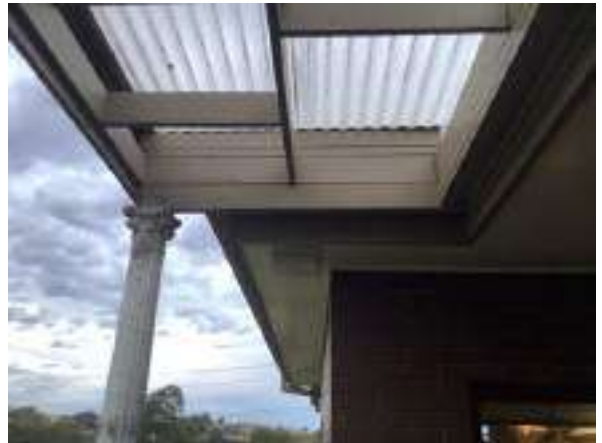
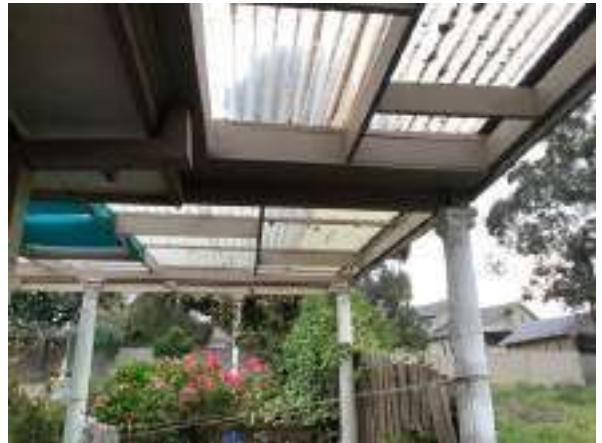
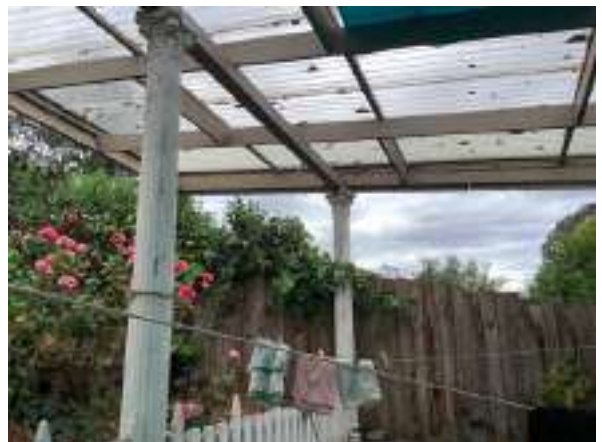
## For your information 4.08

Location: Exterior North Side

Finding: Pergola roofing area  
Photos of the pergola roofing at the time of the inspection.

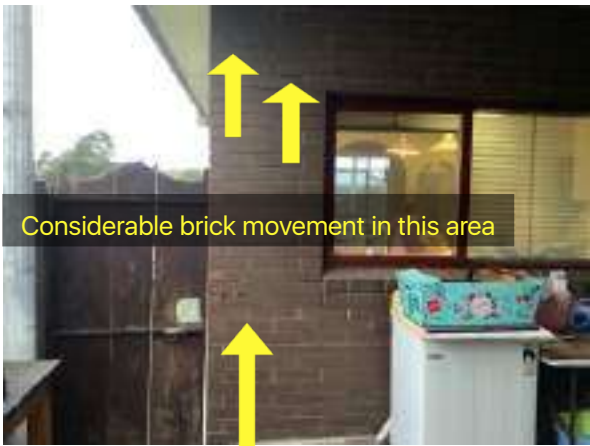
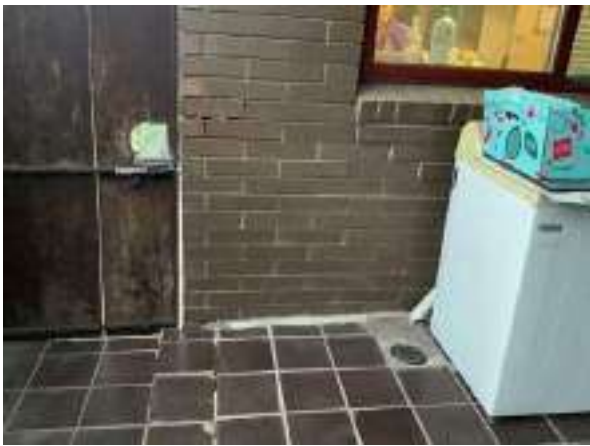
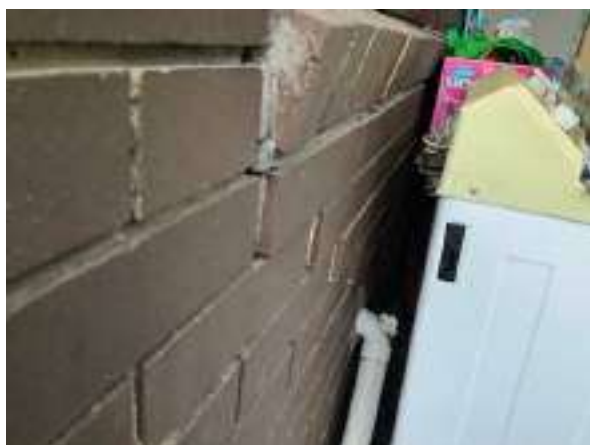
### For your information 4.09

Location: Exterior North Side

Finding: Brickwork - Backyard ( Behind Gate )  
The photos will demonstrate that the area has movement in relation to the brickwork.

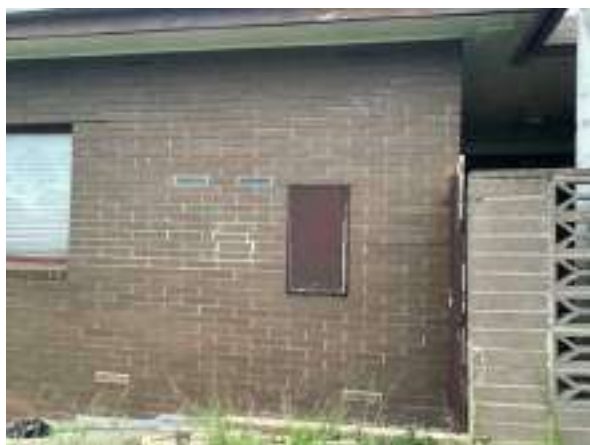
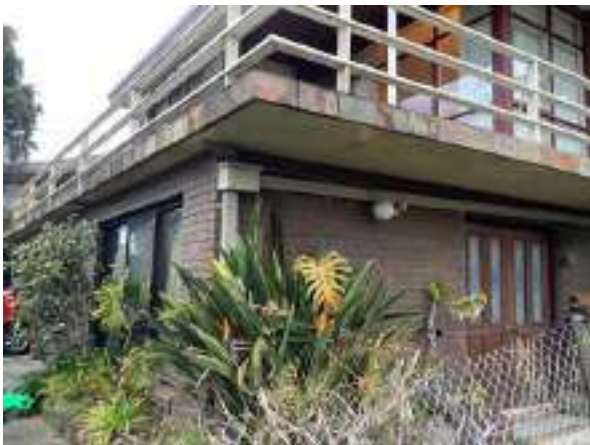
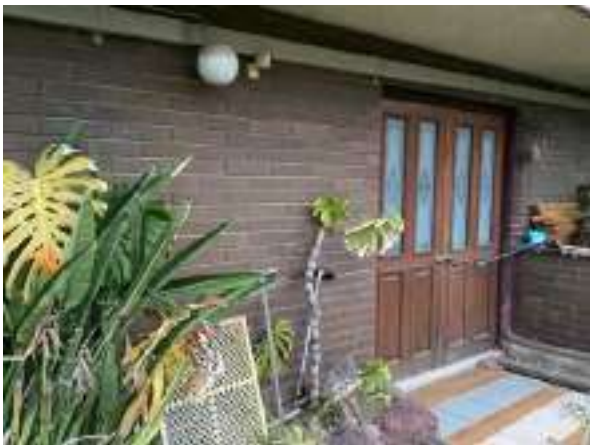
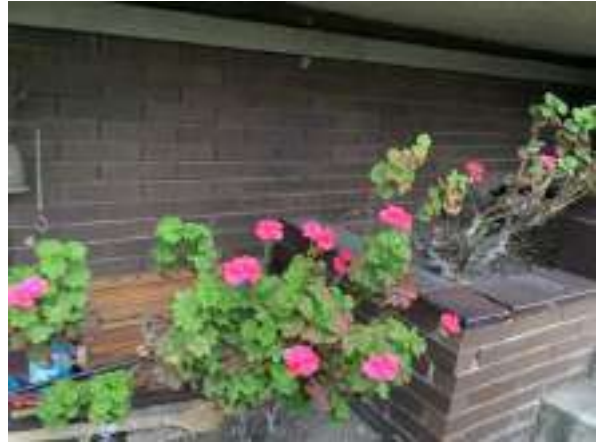
### For your information 4.10

Location: Exterior North Side  
Finding: Brickwork - In Front Of Gate  
Brick wall photos for your information.

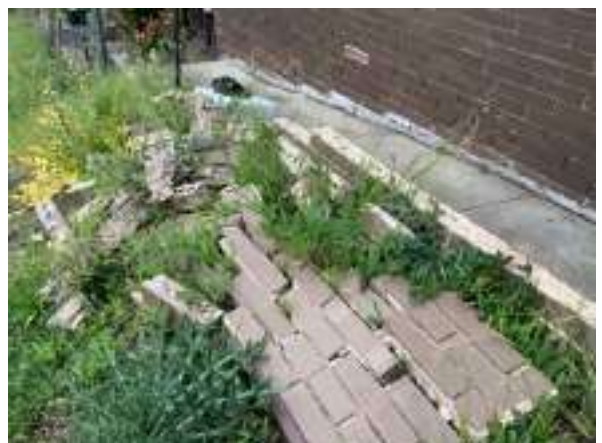
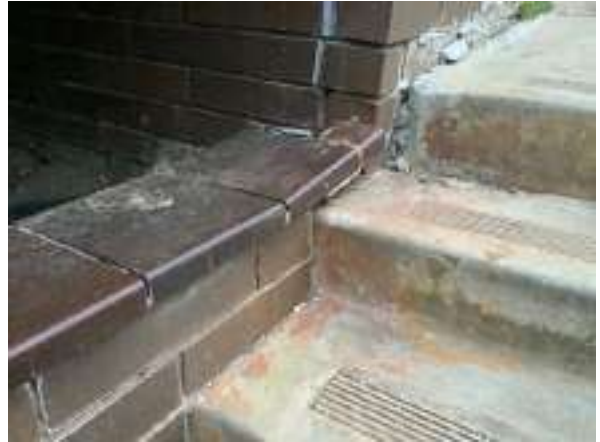
### For your information 4.11

Location: Exterior North Side

Finding: Brick - Movement & Dilapidated ( In Front Of Gate )  
The photos will demonstrate that the brick fence is severely compromised and in a state of dilapidated which requires removal.

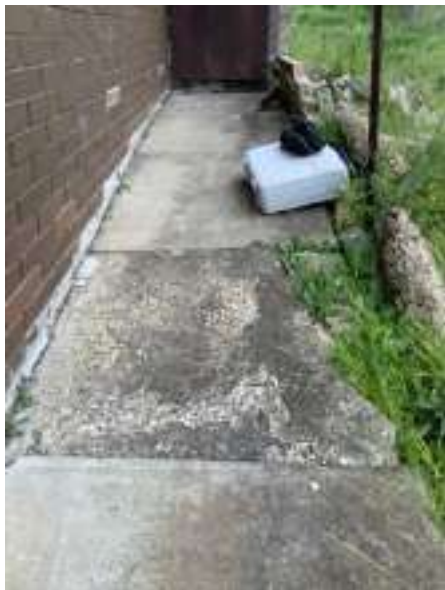
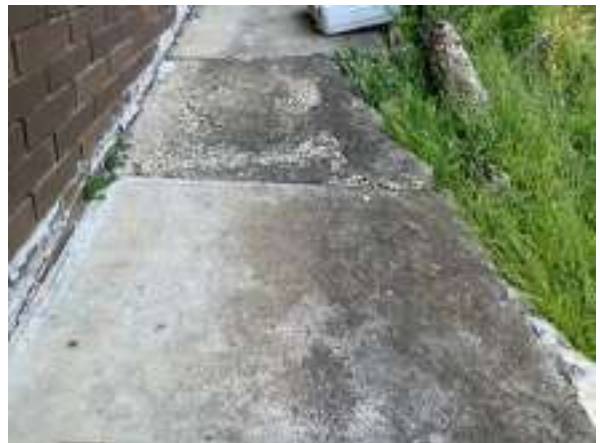
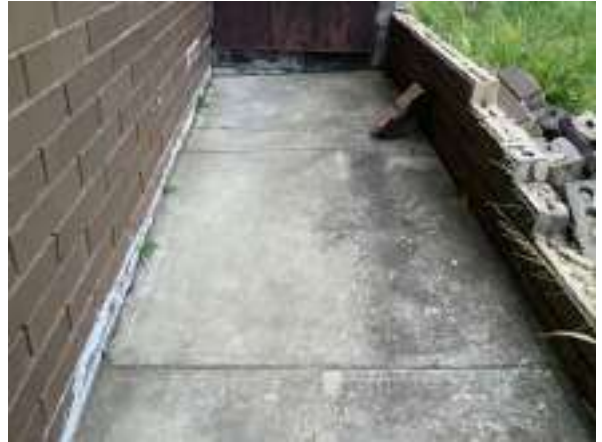
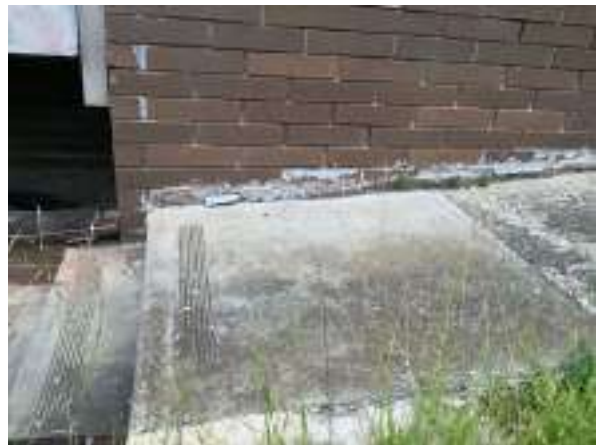
## For your information 4.12

Location: Exterior North Side

Finding: Concrete Path

The photos will demonstrate that the concrete path is severely compromised and in a state of dilapidated.

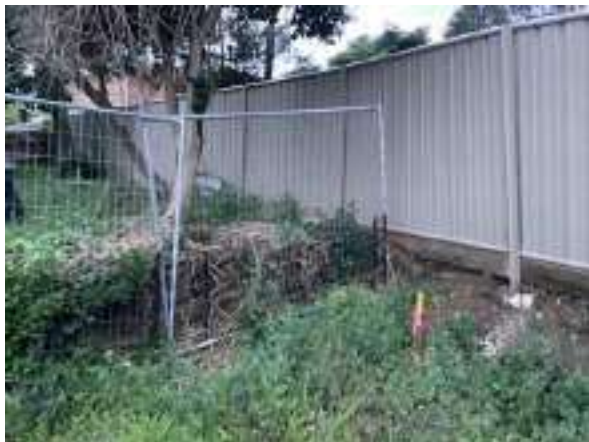
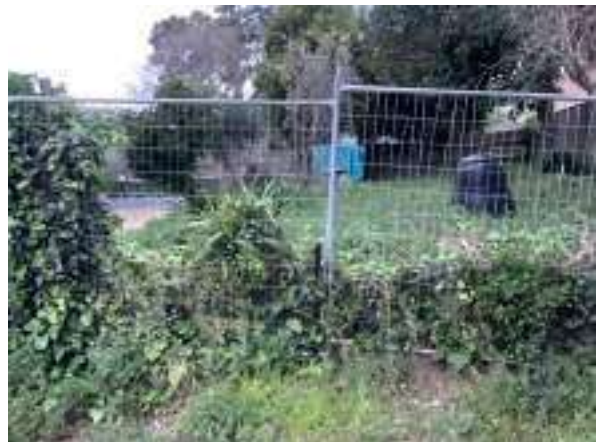
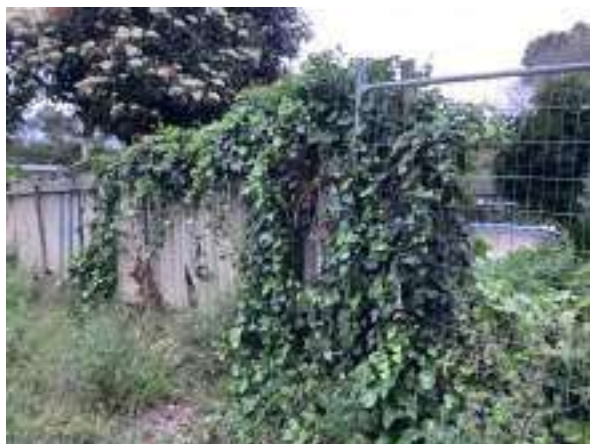
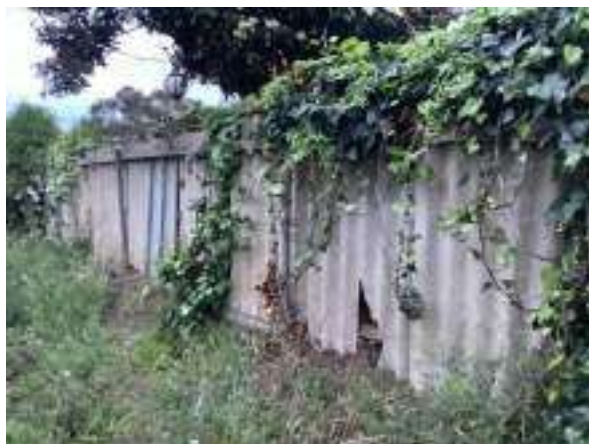
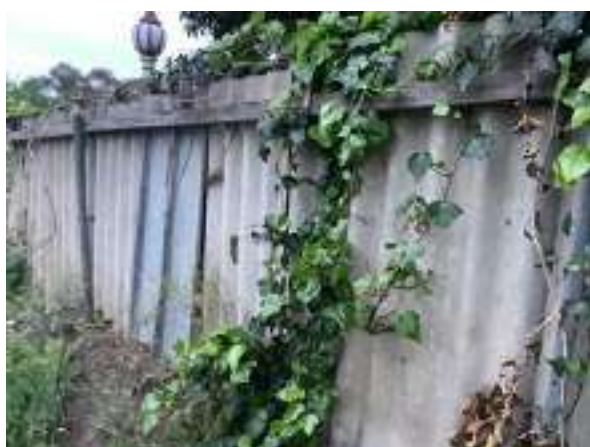
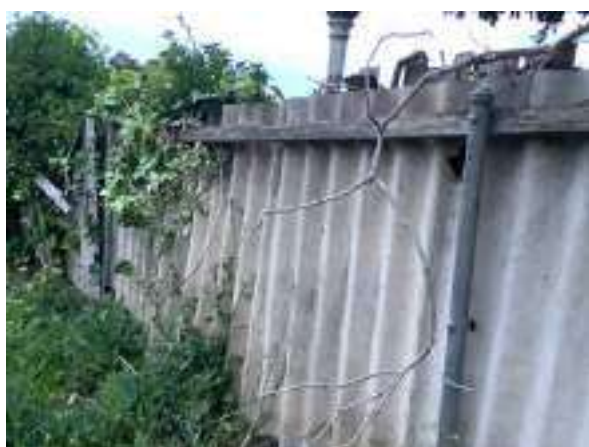
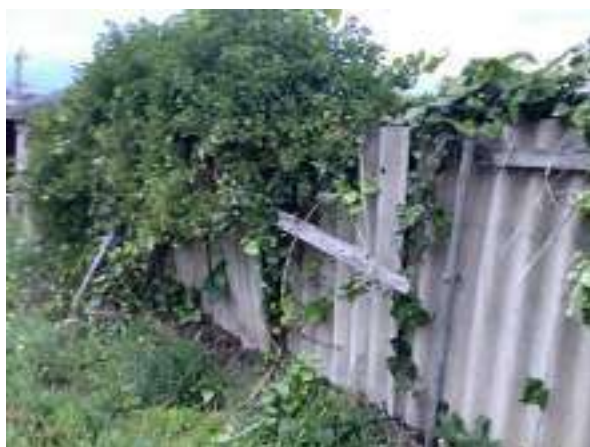
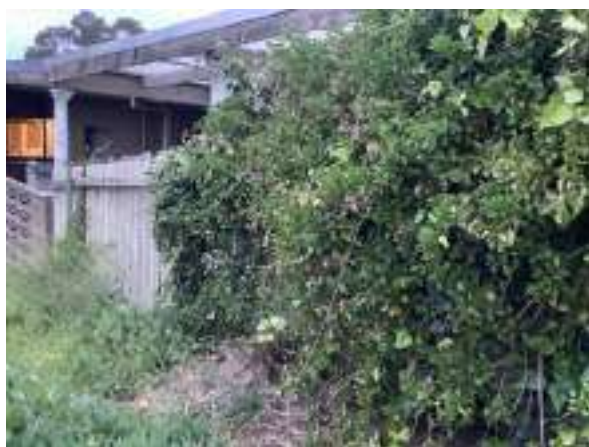
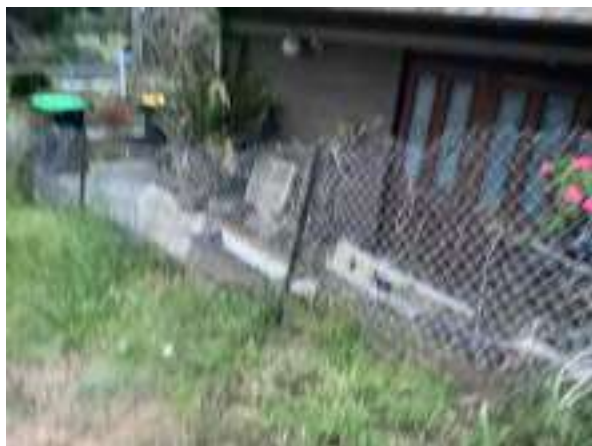
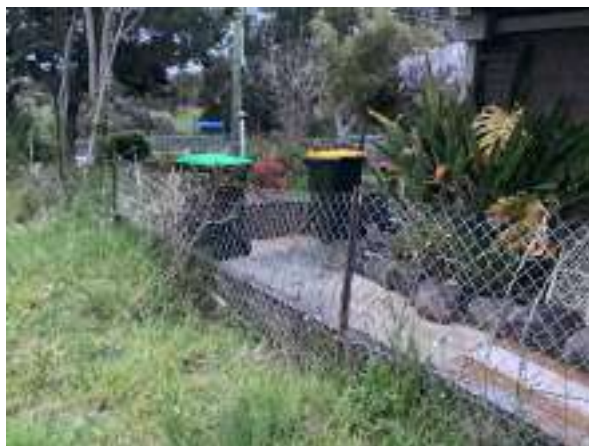
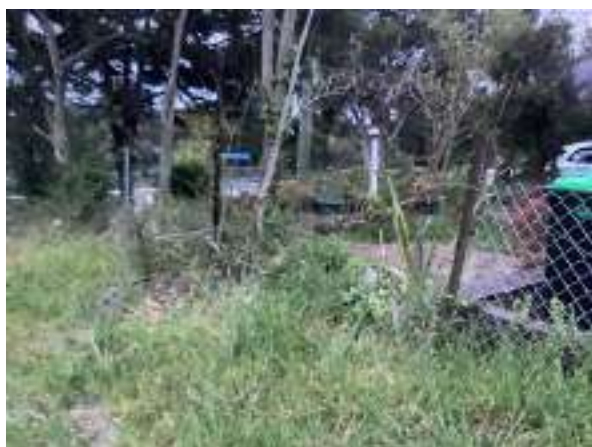
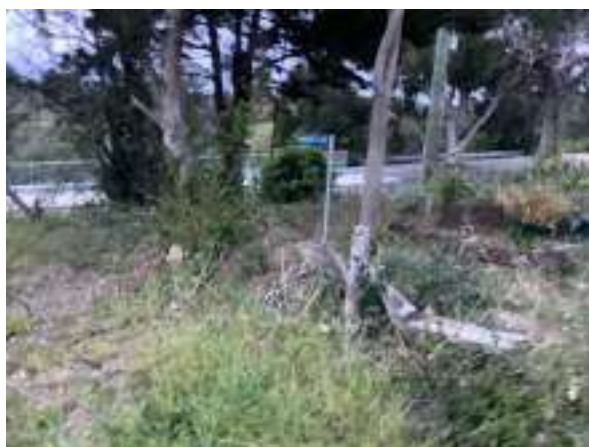
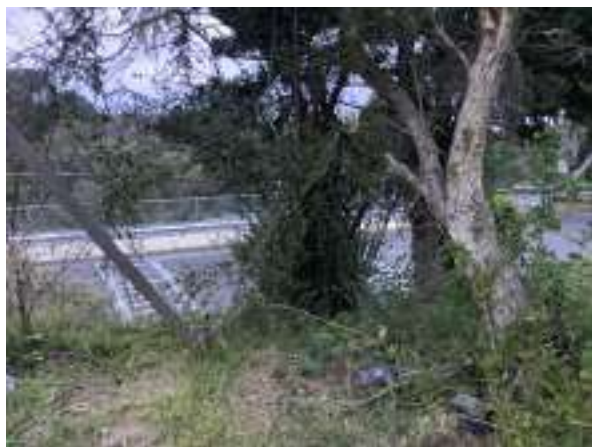
### For your information 4.13

Location: Fence From Proposed Site

Finding: Fencing from the proposed working site  
Photos of the fencing, various areas of damage and no fencing.
