Building Report - VCAT Compliant (Prepared For Court Proceedings)

Inspection Date: 29 Jul 2021

Property Address: (PRIVATE) Vic

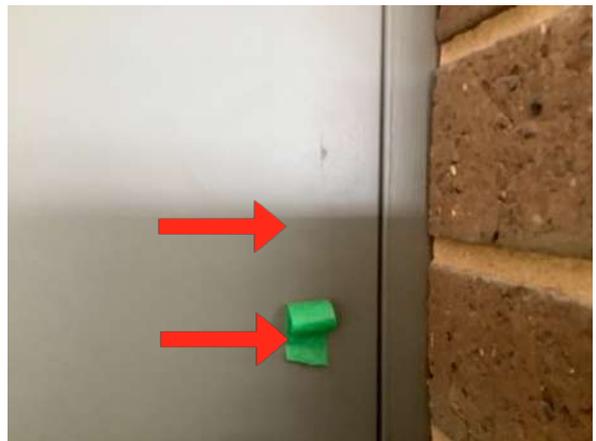
Defect 1.01

Damaged Garage Door.

The garage door is damaged with a split in the door face that has been painted over and can not be repaired in order for the door to be in as new condition.

Where this is due to the builder's workmanship or damage occurring during construction it is considered a defect.

The door must be replaced.

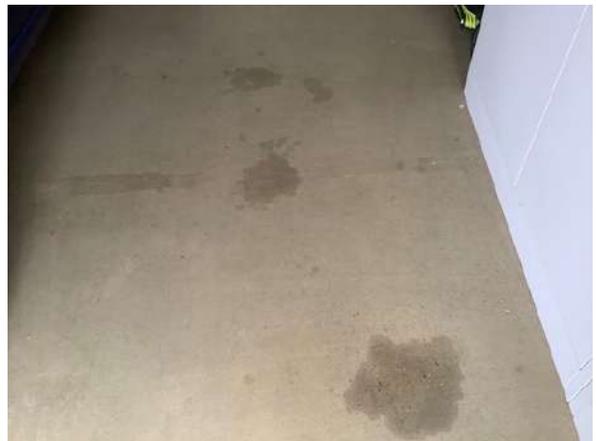
Defect 1.02

Garage flooring stained. Not in as new condition.

The garage flooring has staining to the concrete surface area. An acceptable finish consistent with AS 2870 Residential Slabs and Footing Construction requires the surface to be even and consistent in appearance.

It does appear that the owner has sealed the concrete, however, this should not matter as the flooring would need to be sanded back anyway.

To sand the concrete. Upon sanding the concrete, it must have a clear sealer as you can't leave it sanded without the clear sealer.

To acid clean the concrete and apply a high grade professional epoxy paint. However an epoxy paint must be of the highest quality level with a warranty and installed by a professional.

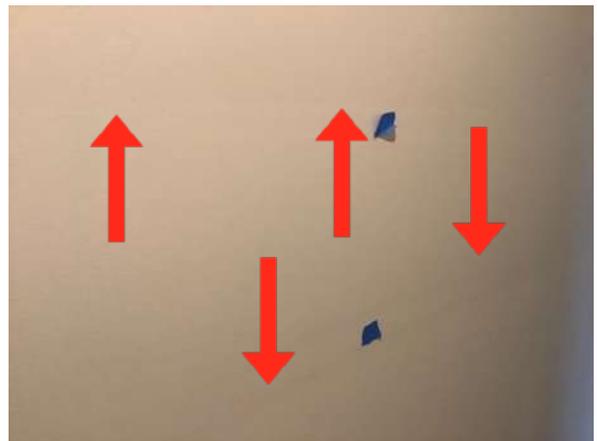
Defect 1.04

It was noted the plaster work / joints to the walls in these areas as per the photos attached are clearly visible.

Reworking of the plaster will need to take place and painting re-done to the areas within this report, but certainly not limited. It is the builders responsibility to make good all defective plaster work / joints within this property.

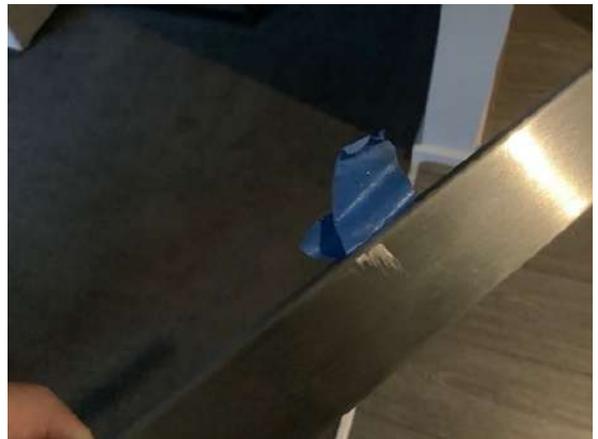
Defect 1.09

Front door handle will not stay in secured location and the owner is now leaving it off and in addition as per the second picture, the door handle is scratched and damaged.

As the handle is scratched, it is not in as new condition and should be replaced.

Re-installation of the door handle. Including replacement and supply and installation of new electronic locking system.

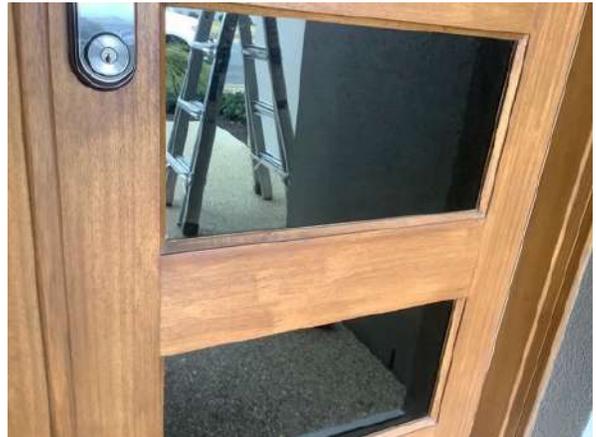
Defect 1.10

Defective paint staining and finish to the front door.

The front door has inconsistencies in the staining

Sand the door back to its original bare timber finish and apply the appropriate staining and sealing.

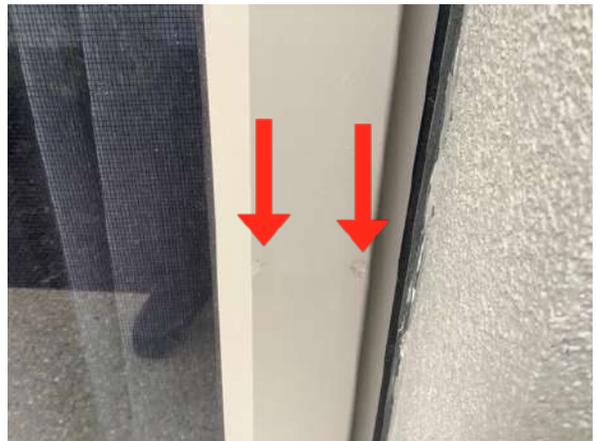
Defect 1.11

Bedroom 1 window frame damaged.

The colorbond / powder coat finish has had its prefinished painted coating scratched, exposing the base metal, which cannot be correctly repaired on site.

The affected damaged sections will need to be replaced.

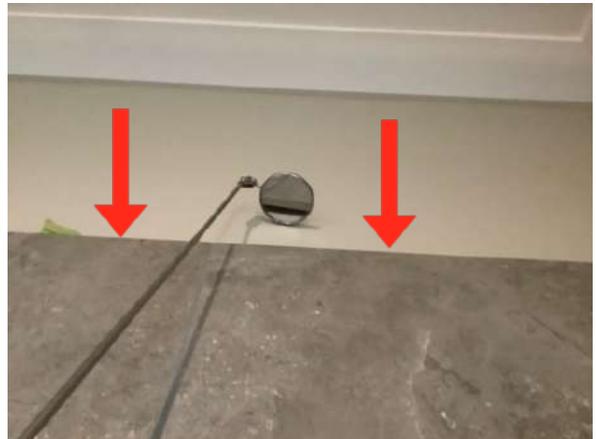
Defect 1.12

Technically the tiles are to be removed, which would consist of the tiles, the plaster work or cement sheet to all come out and be re-done.

This is a major re-working job to both bathrooms.

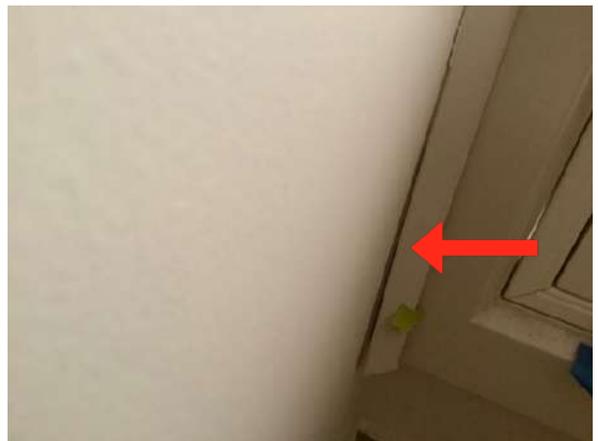
Defect 1.14

Minor repairs required.

Minor nailing and glue required. Finally repainted.

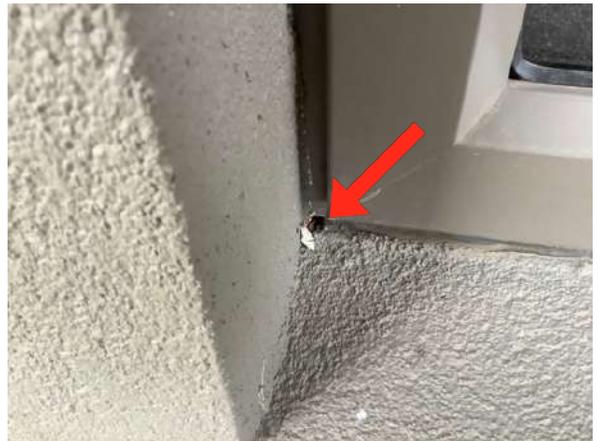
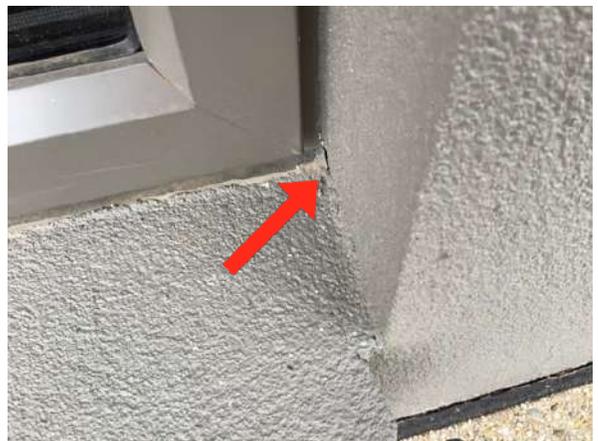
Defect 1.15

Damaged Render.

The render work to the front bedroom windows is damaged. My understanding is that the builder had to come back for maintenance issues to the windows and created this damage at the time of the repairs.

Marks caused by damage which is obvious from a normal viewing position is considered a defect with reference to Standards and Tolerances.

Render repairs required.

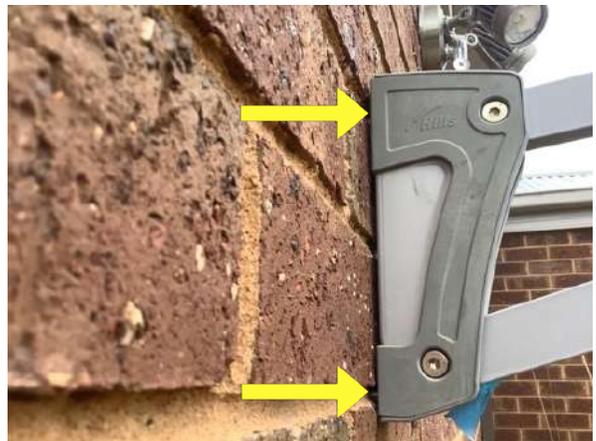
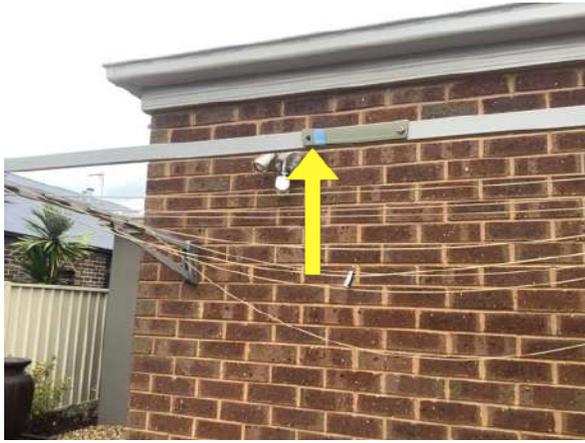
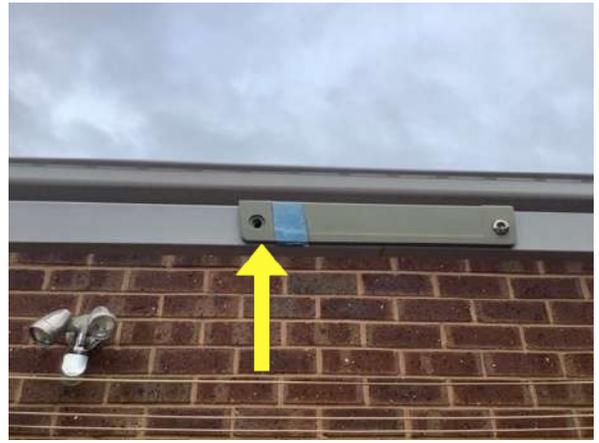
Defect 1.16

Clothesline loose and damaged.

The builder has installed the clothesline fixings directly into the brick mortar and it is clear that the brick mortar has given way and the clothesline is loose and swinging. This is a safety hazard and requires urgent attention for resecuring the clothesline appropriately to the brickwork. In addition the brick mortar will need to be repaired..

Due to the defective installation the front support bracket has lost one of its fixings and the clothesline wire has all become loose due to excessive movement.

Upon new installation into the brickwork (not brick mortar) I highly recommend a new Clothesline be supplied for installation as all items are to be in new condition.

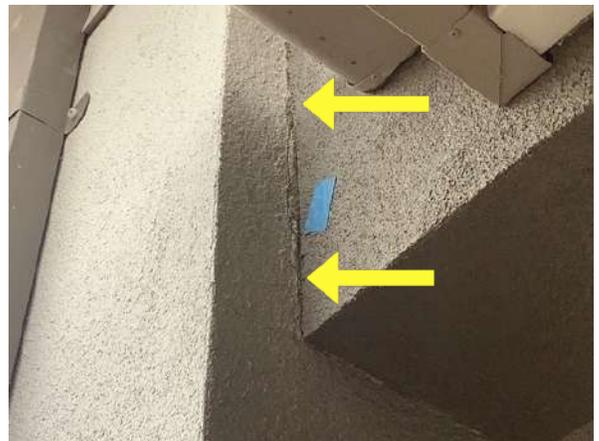
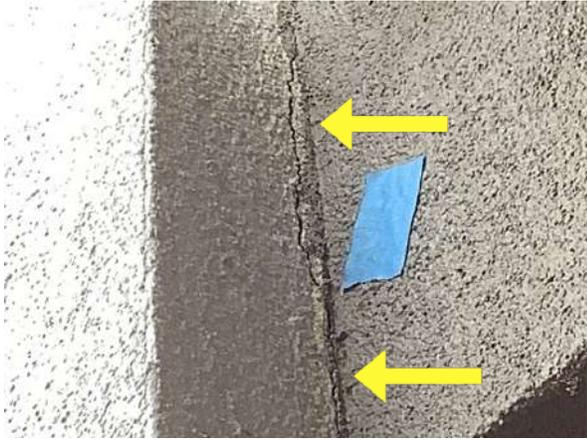
Defect 1.17

Render Movement and damage visible.

Render movement, which can be typical upon a house settling, however it is typical for a builder to come back and repair these type of items.

Repair and re-render required.

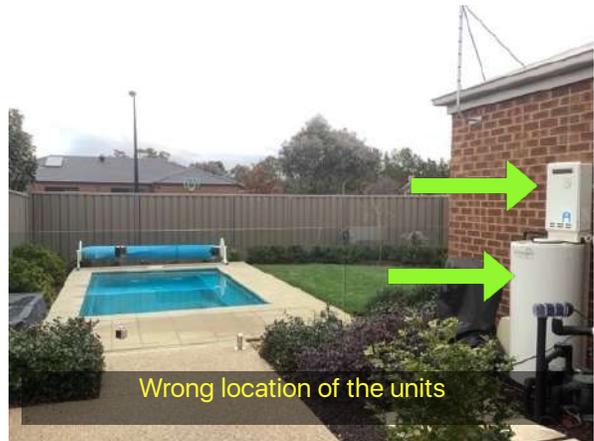
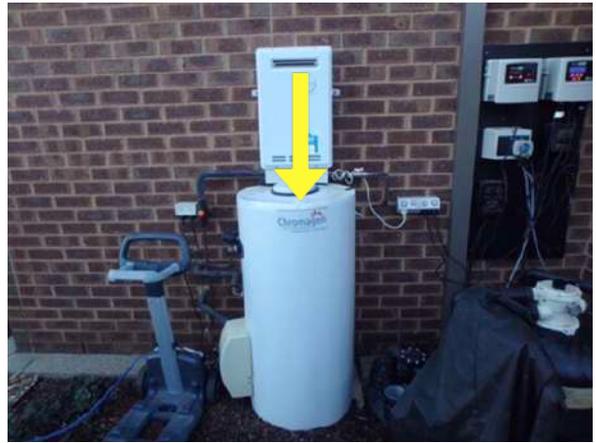
Defect 1.19

Hot water location, is not as per the plans and the unit is damaged.

In-addition the unit is damaged and must be in as new condition at handover.

Major re-plumbing works required, to relocate the Hot Water Unit to its correct location, so I would highly recommend that the solar panels be brought closer to the hot water service unit as this was discussed with the owner and she was happy for the solar panels to be closer to the hot water service instead of moving the hot water service itself. Whilst this is not the ideal situation, it is a practical situation and in addition I would recommend installing a fence around the hot water service to simply make that area near the swimming pool much more attractive.

Upon relocation of the Hot Water Unit, the unit is to be replaced or partially replaced, pending on how excessive the damage to the unit is.

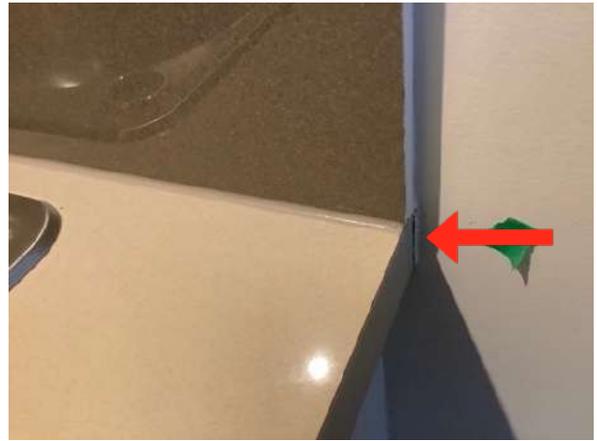
Defect 1.20

Minor area of sealant missing

It was noted on inspection that sealant is missing .
Water ingress into the bench top area creates secondary building damages.

Caulking to be installed.

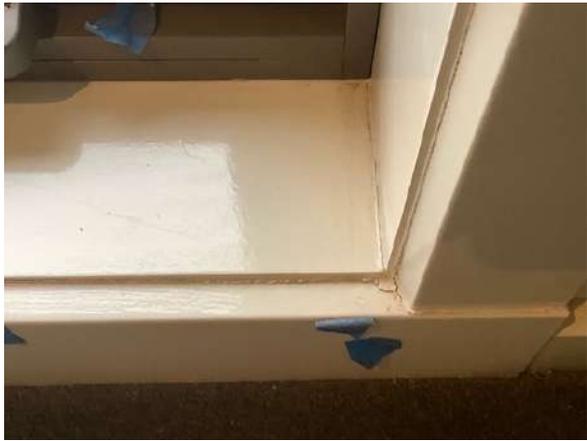
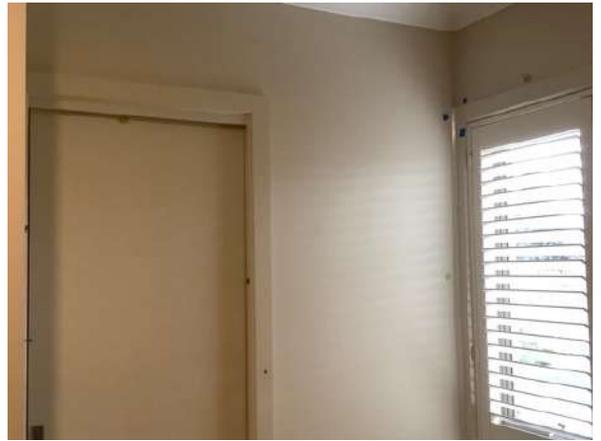
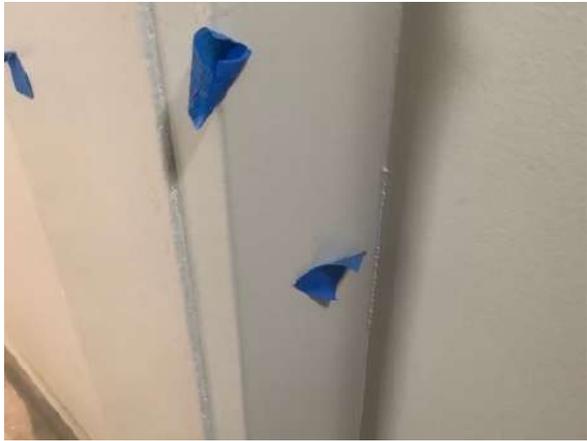
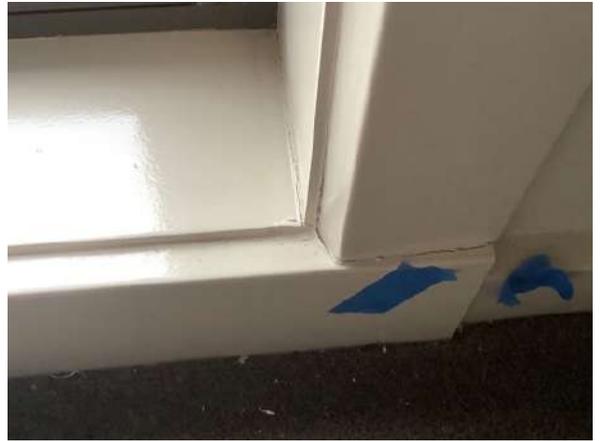
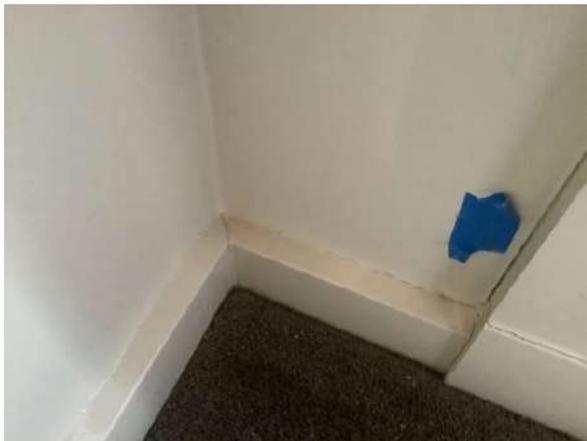
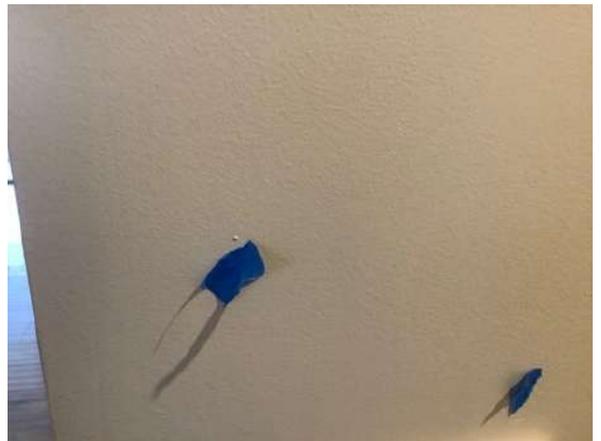
Defect 1.22

Painting - Defective (AS2311)

Areas were identified where the surface finish of the painting was found to be defective. This includes areas of minor blemishes, missing painting, over-painting, paint runs, sags, paint chips, scratches and general paint imperfections.

The builder will need to repair and sand the entire property, particularly to the plaster walls and timber fixings, including the architraves and skirtings .

I would recommend to repair, sand and apply 2 coats of paint to the defective areas and finally a complete coat of paint to the plaster walls and timber fixings, including the architraves and skirtings to the entire property, as a complete final coat of paint is the only way to provide the property a complete and consistent level 4 finish as per Standards and Tolerances 2015 and the Guide to the painting of buildings AS/NZS 2311:2000.

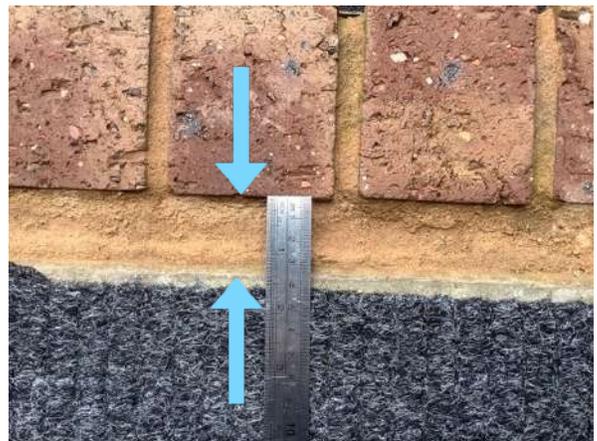
Defect 1.23

Defective mortar works to bottom of door step. The bottom of the door step should not have such excessive mortar width. Generally a maximum of 10 mm is acceptable of mortar width.

The builder is required to take out the existing bottom bricks and install the new bricks on there side so that the builder can cut the bricks with a maximum mortar width of 10mm or less. I would recommend only a 2mm gap, so that the gap may be caulked neat.

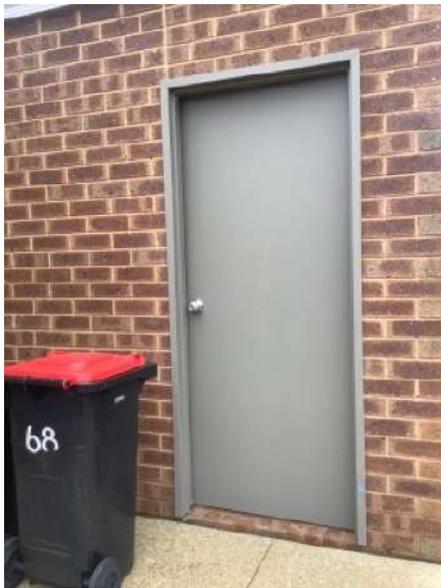
Defect 1.24

Garage Door operation - binding and jamming - defective

Binding and/or jamming of this door is evident during standard operation. This defect inhibits the functionality of the affected door as well as creating potential for secondary defects to associated building elements, such as damage to the floor covering.

The builder is required to re-fit the door and/or plain the edges of the door, including re-painting.

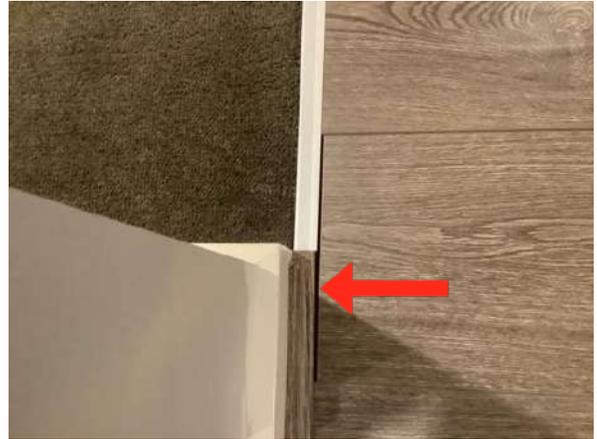
Defect 1.25

Floating Flooring - Defective Gaps

It was noted that the floating floor had gaps adjoining the skirting trim near the passage and a skirting trim was loose in the kitchen. Floor coverings/treatments should be installed as manufacturers specifications.

The builder will need to replace the short floating floor boards.

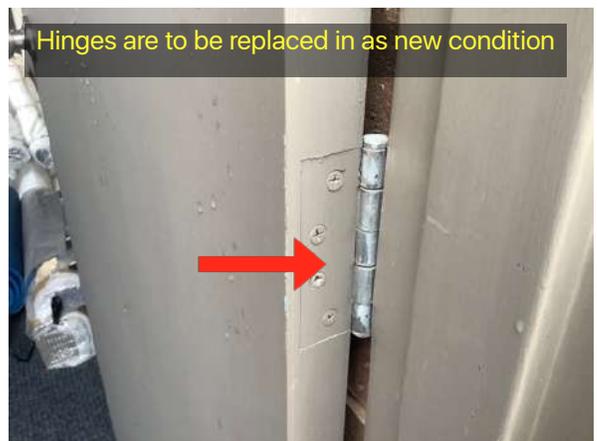
Defect 1.26

Paint finish excessive over painting - Defective and Damaged Materials

This area was identified where the surface finish of the door hinges is now damaged, due to excessive and defective painting.

The door hinges will need to be replaced.

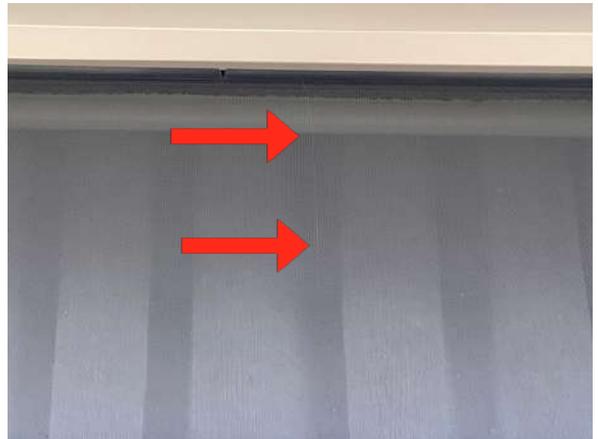
Defect 1.27

Windows are required to be presented in an `as new` condition during the final handover. Therefore, where minor rectification works are not adequate, affected windows must be replaced.

The Building Commission's, Guide to Standards and Tolerances clause 18.04 Glazing, states- 'Scratches, fractures, chips or blemishes on glazing and mirrors are defects if they are caused by the builder and can be seen from a normal viewing position. Minor scratches, fractures, chips or other blemishes that are not more than 10mm long and where there are not more than three blemishes per pane, are not defects'.

The glass panel needs to be replaced.

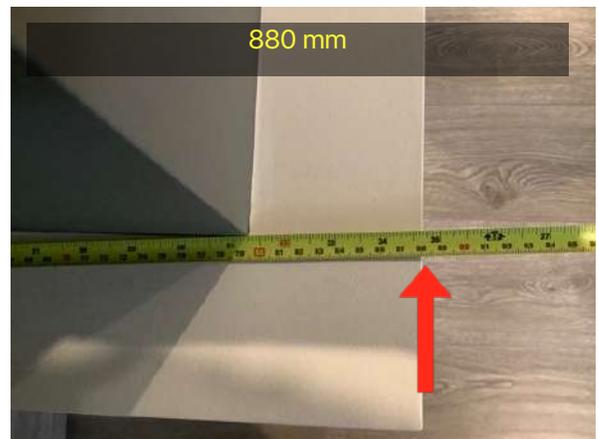
Defect 1.29

In addition to the defective design of the wall unit, I would like to bring to your attention "Addendum 'B' - DEFECT - 18" in this report with a SUGGESTED SOLUTION to completely dismantle and re-build the entire wall unit.

The wall heater needs to be dismantled for the wall unit to be TOTALLY RE-BUILT and finally the heater to re-installed to its correct height.

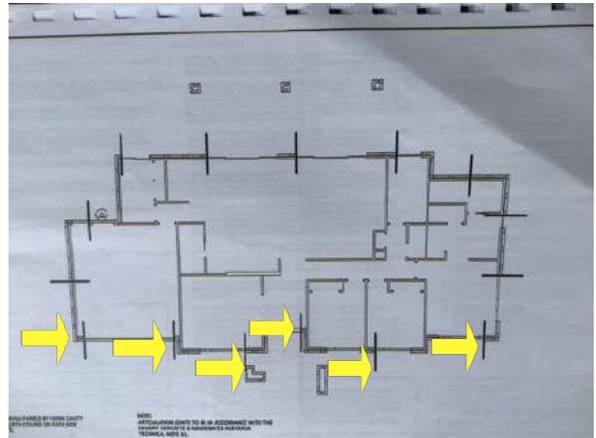
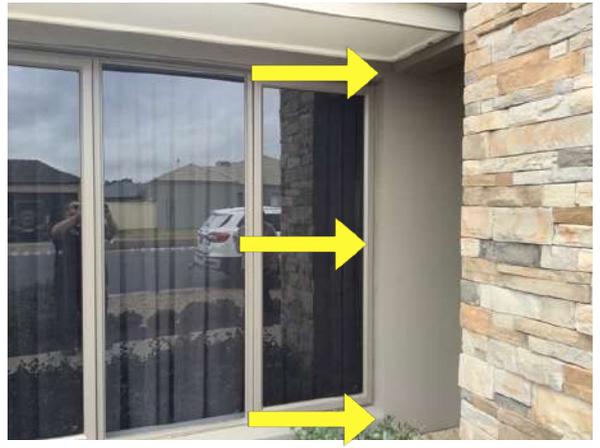
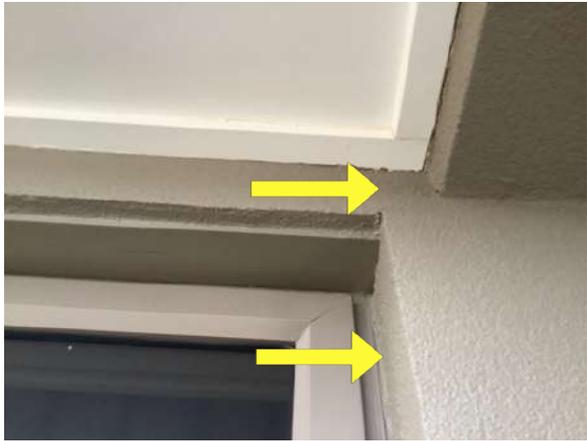
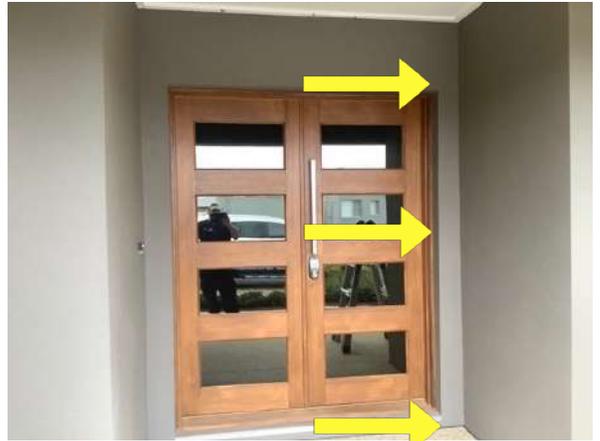
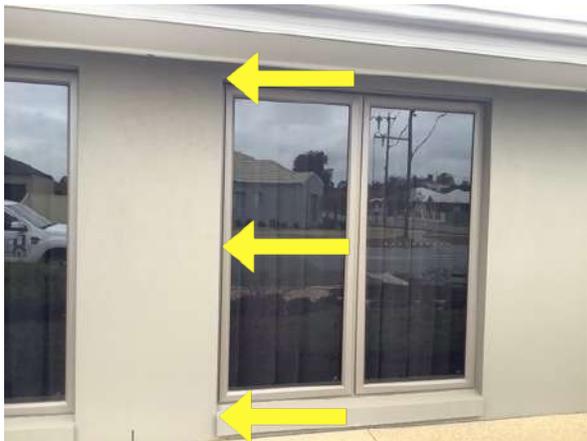
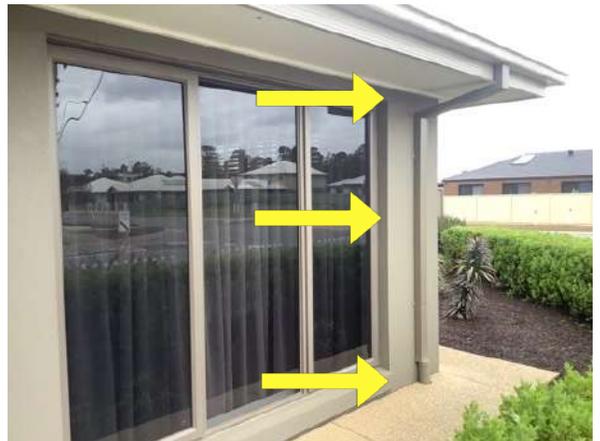
Defect 1.30

ARTICULATION JOINTS - Missing

If render is covering articulation and control joints this is considered a defect with reference to Standards and Tolerances.

If articulation joints are missing, which does appear to be the case, the structural engineer will need to make decisions, however my experience does tell me that normally the brickwork is dismantled and re-built.

The possibility of new plaster to the perimeter walls is highly likely as the brickwork's excessive brick mortar must be cleaned from the cavity walls.

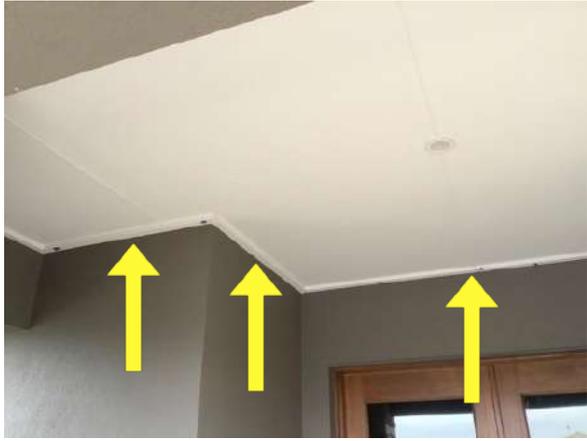
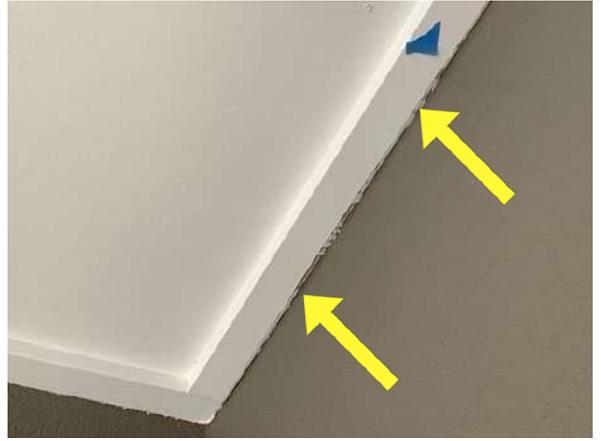
Defect 1.32

Defective timber/eaves and rendered wall junctions.

Caulking is required at the exterior eaves and render wall junctions to create a neat tidy finish, completed with paint work.

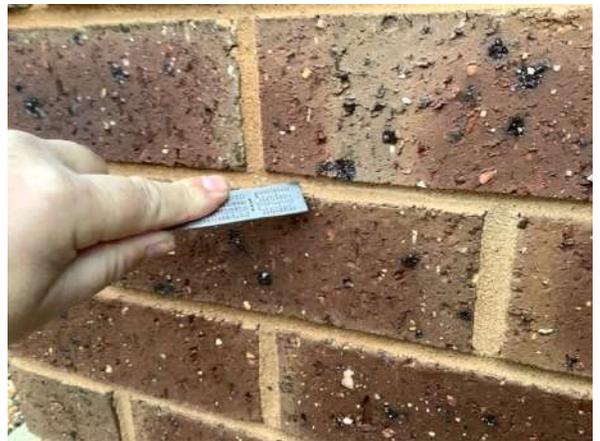
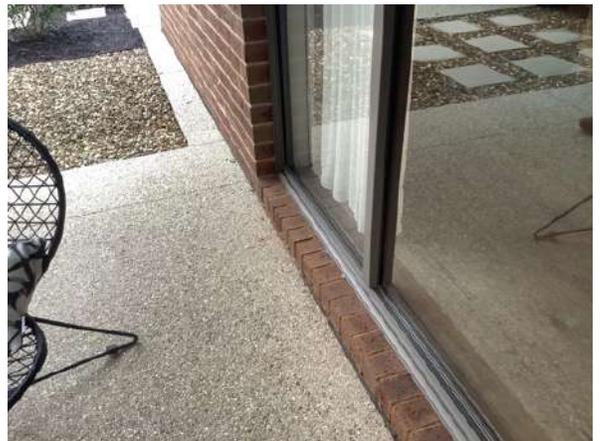
Defect 1.33

Defective and structurally compromised brick mortar.

Upon inspection of the brick mortar on site, it was quite evident that the brick mortar was soft as the mortar could be scraped quite easily with a metal rule or even my finger. My experience did tell me just feeling the brick mortar was enough to ring alarms bells, however the client has engaged two separate company's that have determined the brick mortar to be structurally compromised and defective. Now Sharp and Howells mentioned in there report to possibly grind the brick mortar and re-point, but Marshall Structures did not agree with this technique and request complete demolition of the brickwork. I do not feel I should elaborate on there findings, as it is better for the reader to read there reports direct.

As per Sharp and Howells Report Dated - 25th May 2021. Who performed laboratory testing and Marshall Structures Report Dated - 9th July 2021, which was performed by a structural engineer, which both reports state problems with the brick mortar, I highly recommend complete demolition of the entire perimeter brick veneer, including the rendered brick areas as well

Upon demolition of the brickwork, I highly recommend demolition of the perimeter plaster work to all the walls as in order for clean brick cavity's and compliance of clean brick cavity's and for the damp coarse and weep holes to perform, the brick cavity's must be cleaned once the bricks are installed.

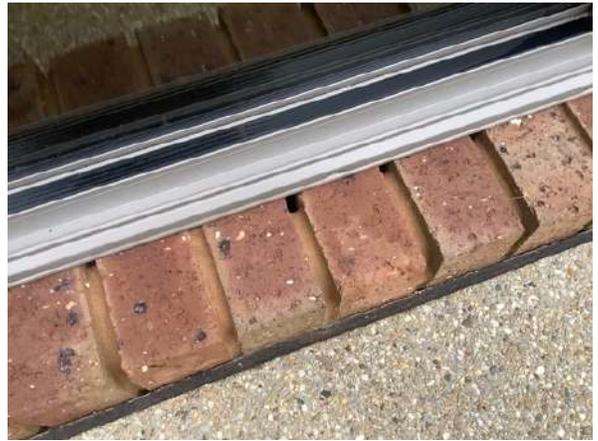
Defect 1.34

There are 2 Defects for consideration. One defect is brick mortar "holes and voids" and the other defect is "brick cleaning acid and pressure damage to the brick mortar.

I would like to make note that there are two major defects to this brickwork, one is the brick holes and brick voids in various locations to the brick mortar and the other is the damaged brick mortar due to excessive acid and pressure from the brick cleaner as the brick mortar is severely damaged in many areas.

As detailed in Addendum 'B' - DEFECT - 33, within this report, the brickwork is to be demolished/taken down .
