Asbestos Clearance Certificate Report

Inspection Date: 23 Jan 2020

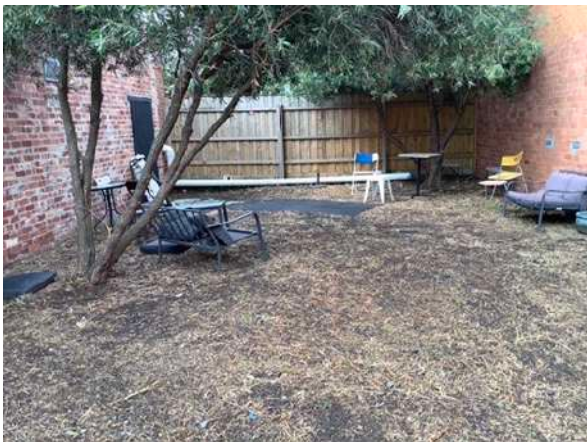
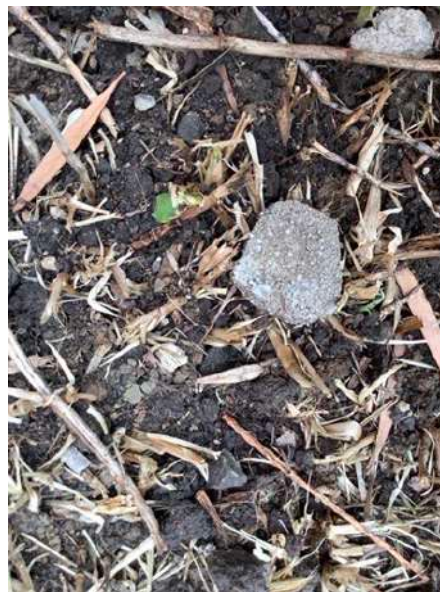
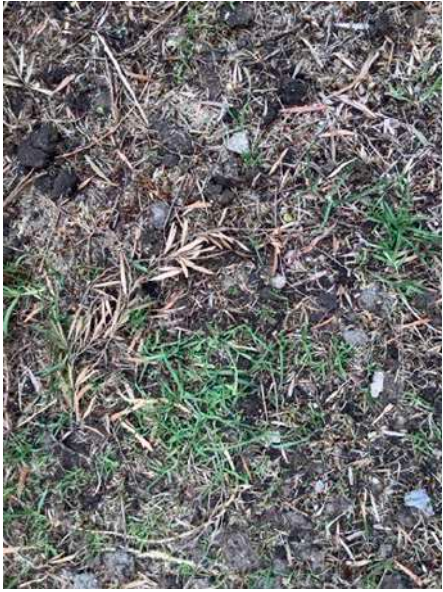
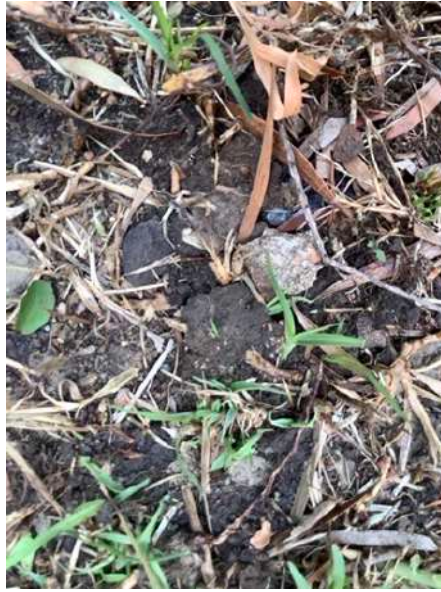
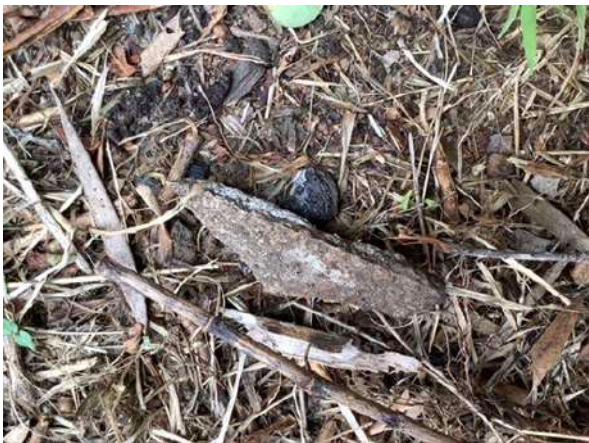
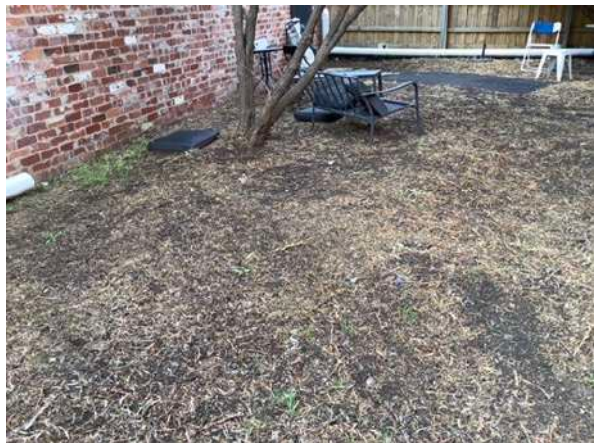
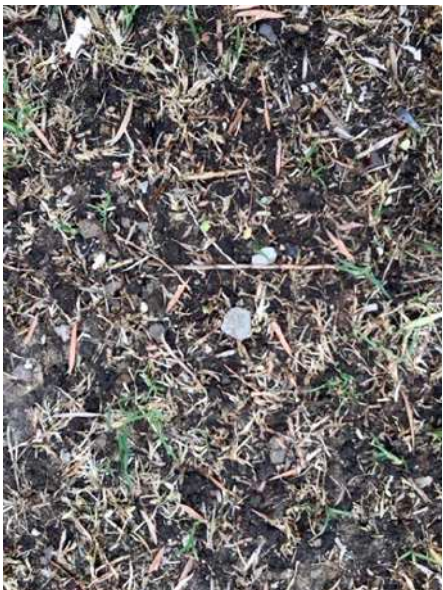
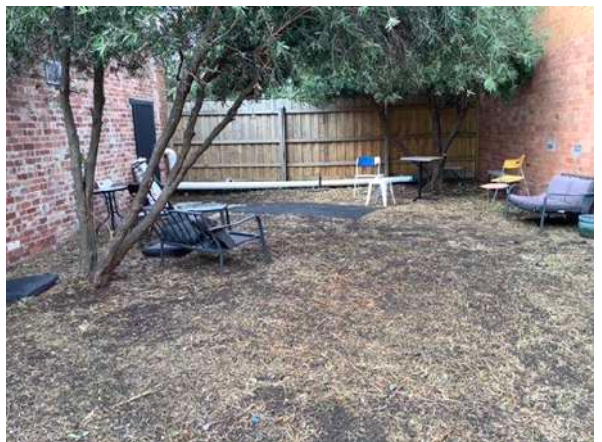
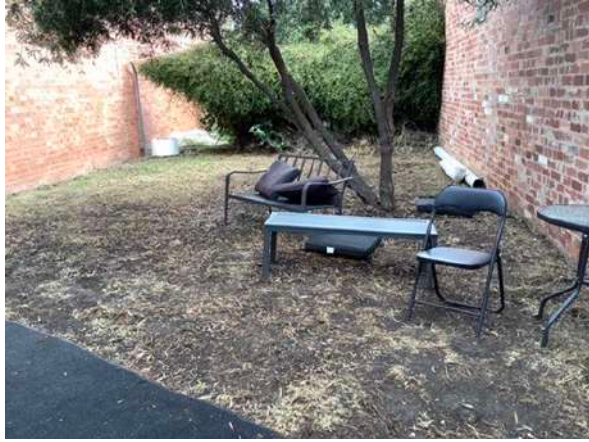
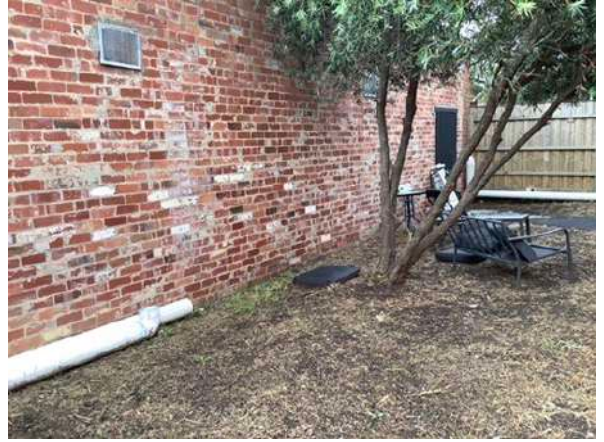
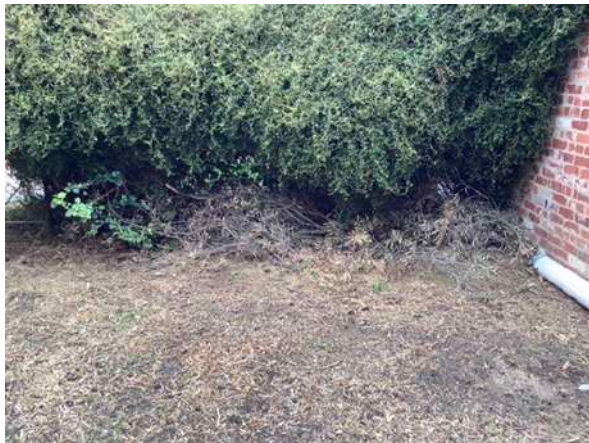
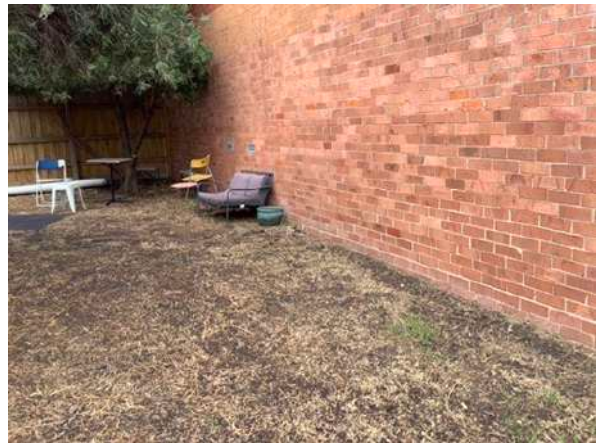
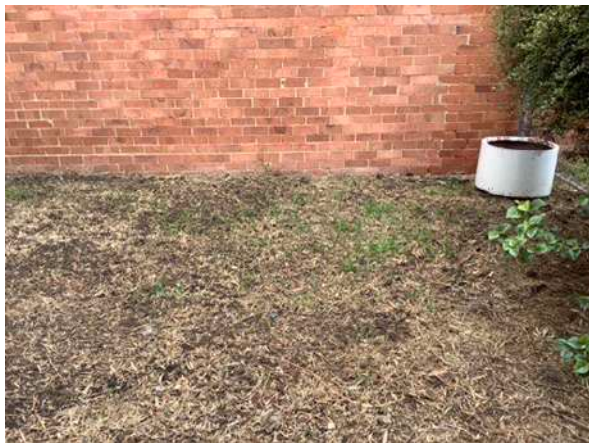
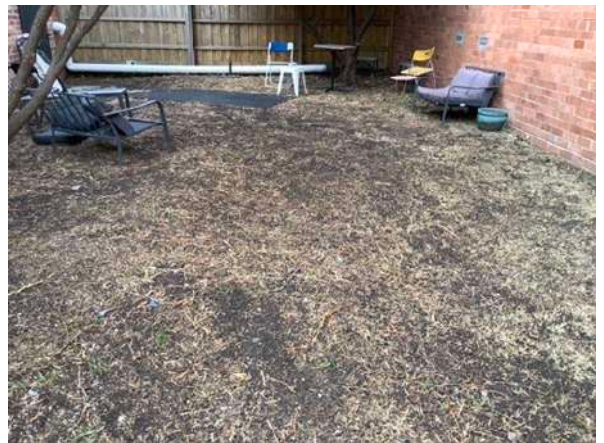
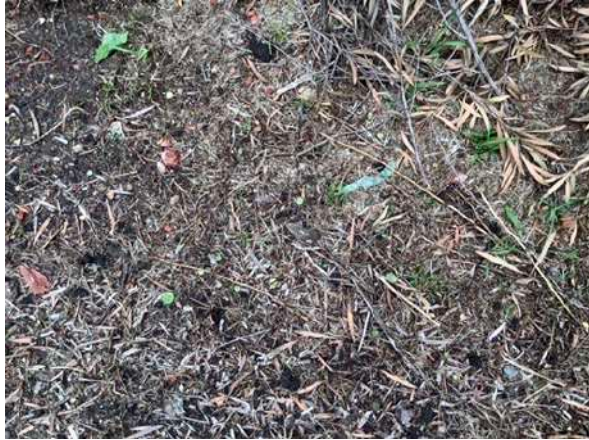
3.01

Location: Rear Back Side Yard

Finding: Asbestos Remaining

This asbestos clearance certificate was to determine if there was any further asbestos debris found on the ground at the rear backyard area, as Asbestos was found and tested at with laboratory results, so I recommended to the vendor to poison and clean up the entire backyard for a further asbestos clearance analogy.

Asbestos debris was found in the rear back yard.

Suspected Asbestos Containing Materials (ACMs) was identified in debris or rubbish found on the site. When discarded building materials which may contain Asbestos are treated as general rubbish, this constitutes improper disposal, representing a significant personal and environmental health risk.

A sample for lab analysis to confirm the presence of asbestos was taken from this location. The client is advised to assume that the affected area and construction material contains Asbestos until the lab analysis results are available.

As the materials are confirmed as Asbestos, the debris should be removed and the site cleaned by a Licensed Asbestos Removal firm. In the interim, appropriate risk reduction strategies should be undertaken, including isolating the area and ensuring the debris or rubbish is not further disturbed.

IMMEDIATE ACTION IS REQUIRED AND THE AREA MUST BE LOCKED SECURE SO THAT NO PERSONS CAN ENTER THE REAR BACKYARD AREA UNTILL A LICENSED ASBESTOS REMOVALIST HAS CLEANED UP THE AREA AND I HAVE GIVE A CLEARANCE CERTIFICATE.

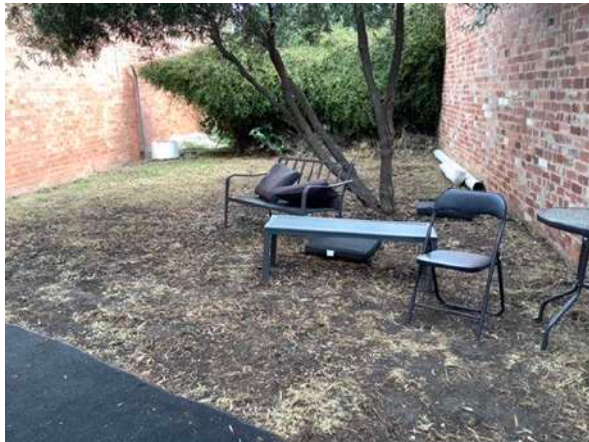
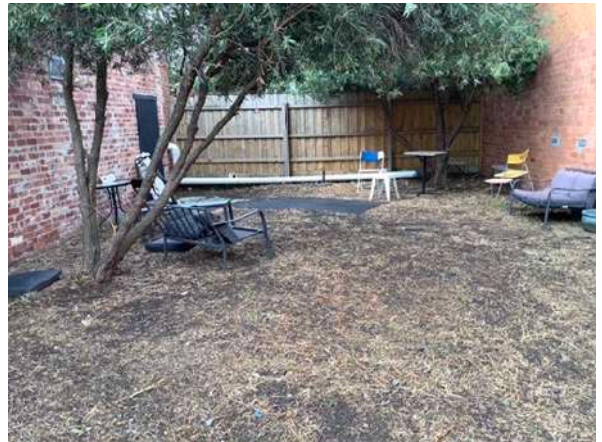
3.02

Location: The Site

Finding: Scope Of Works - Attached.

The scope of works was that the vendor cleaned the vegetation in the back yard and I was to determine if and asbestos is remaining in the ground area.

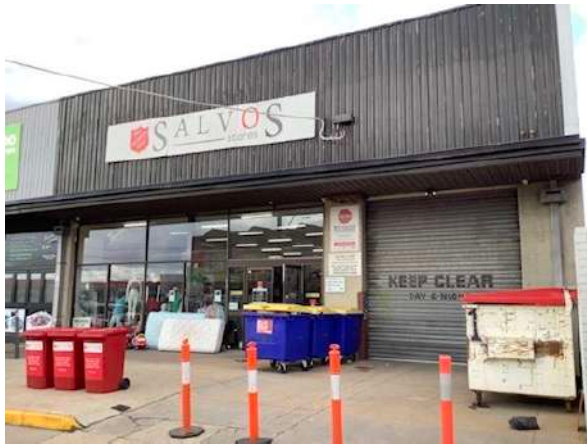
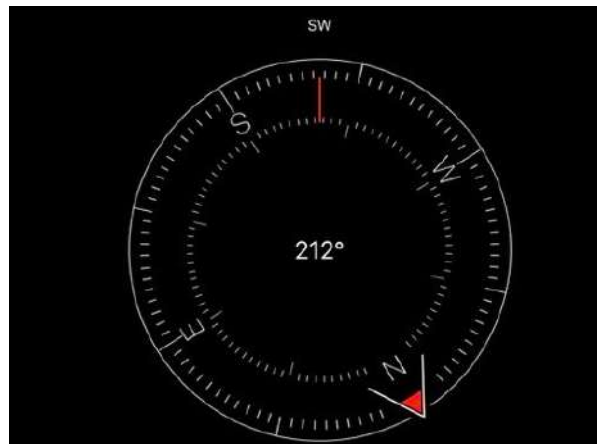
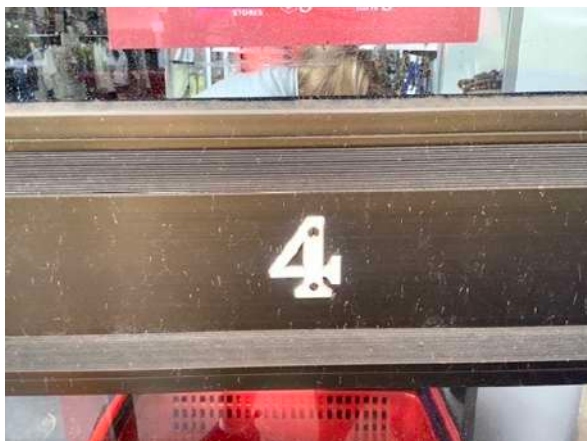
4.03

Location: The Site
Finding: Site Photos Added
Additional photos are provided for your general reference.
