Asbestos Visual Report

Inspection Date: 8 Apr 2020

Report Type: Asbestos Inspection and Condition Report

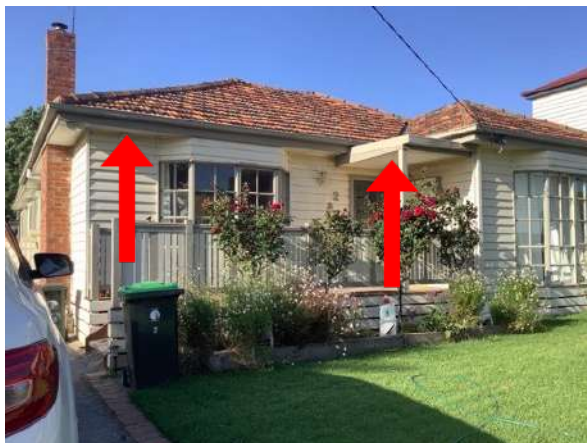
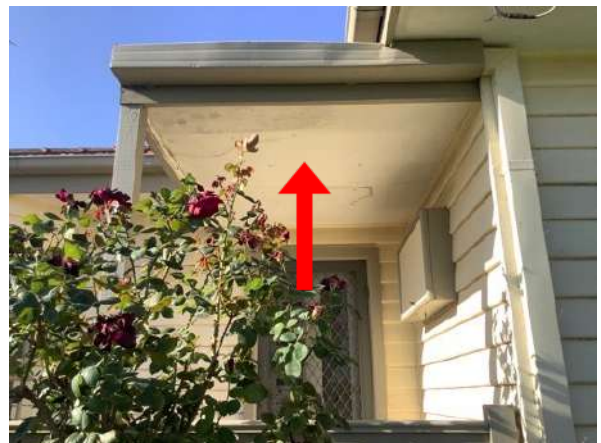
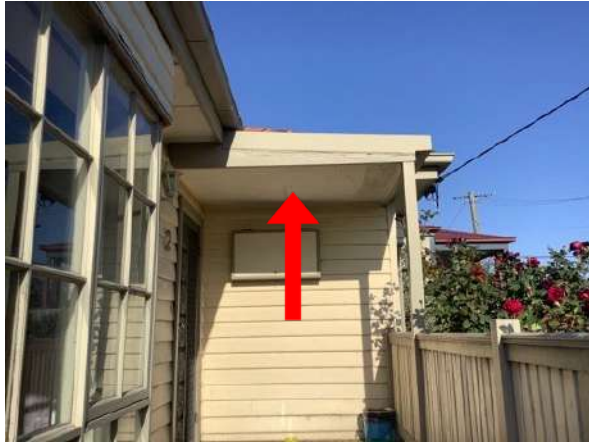
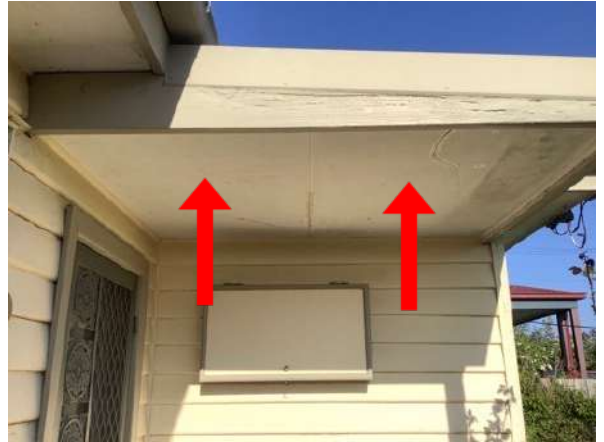
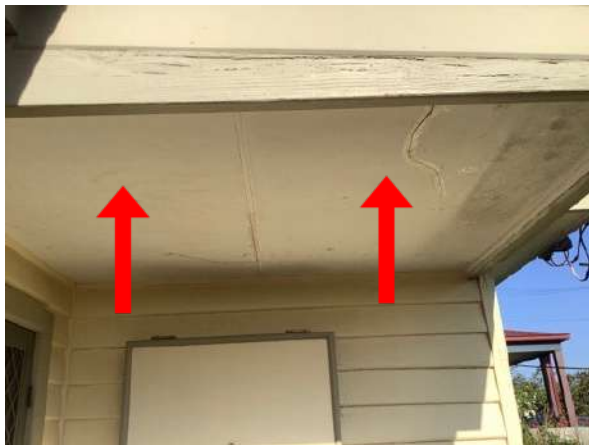
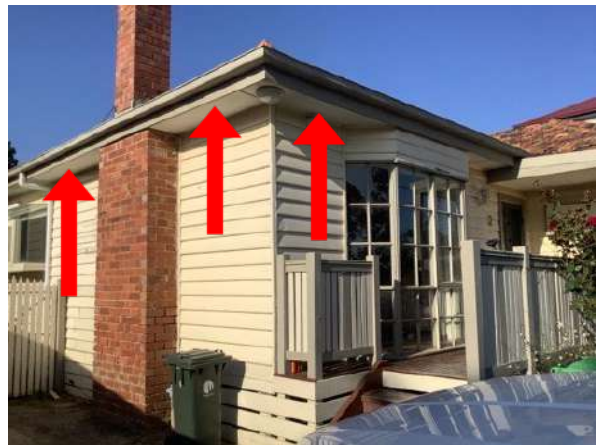
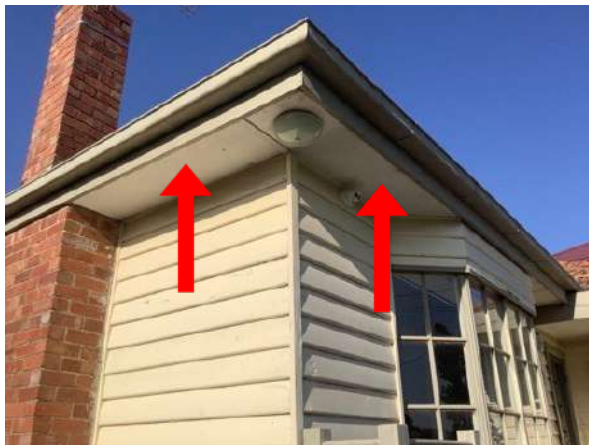
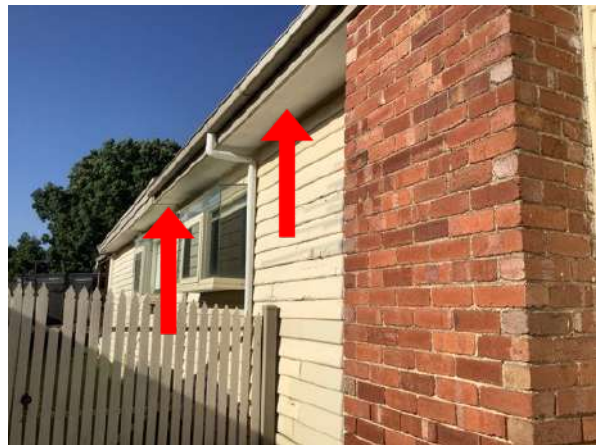
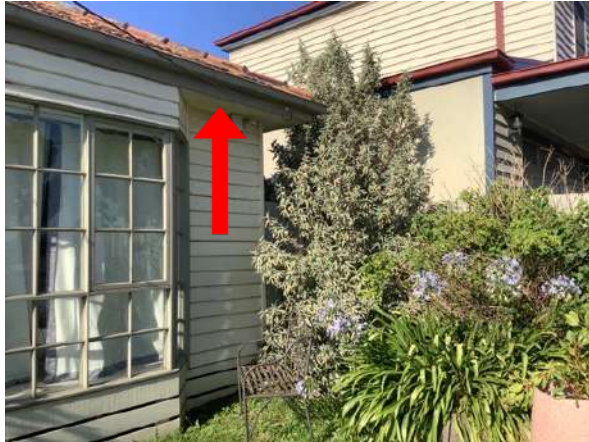
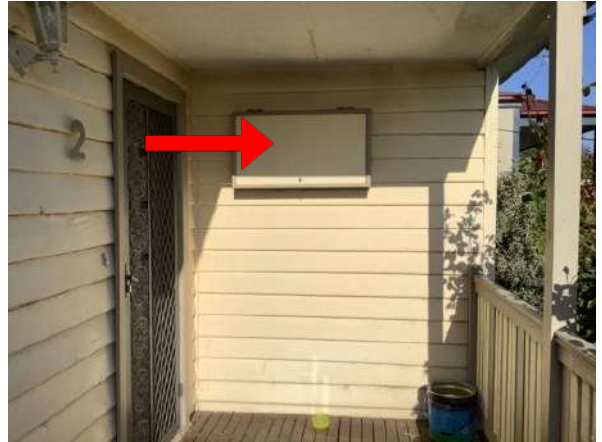
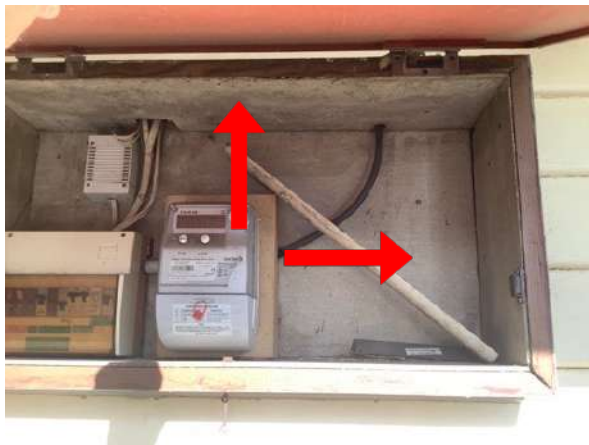
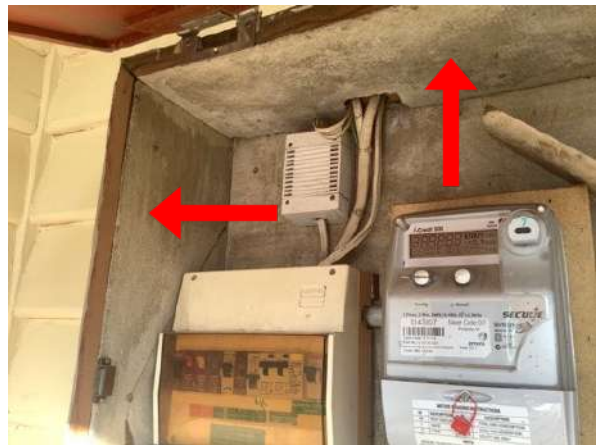
ACM - High Risk Condition 2.01

Location: External Asbestos Visual Inspection

Finding: Asbestos - Suspected ACM Identified on Site (Visual Assessment Only)
This statement and photos attached to this statement are areas that we believe will be asbestos and/or contain asbestos.
Are there is no need to take a sample of the asbestos in the porch area as I am certain it is asbestos so there would be no benefit to spend the additional money. Also I would like to comment that the eaves is Asbestos as well and inside the meter box is all lined with asbestos as well.

Based on our experience in the building industry, no further action is required from us for these areas and a asbestos removalist is required to remove the asbestos in the areas that you are working at a minimum.

It would be highly recommended that any holes and/or entry points in the ACM eaves be sealed or painted by a approved asbestos tradesperson.

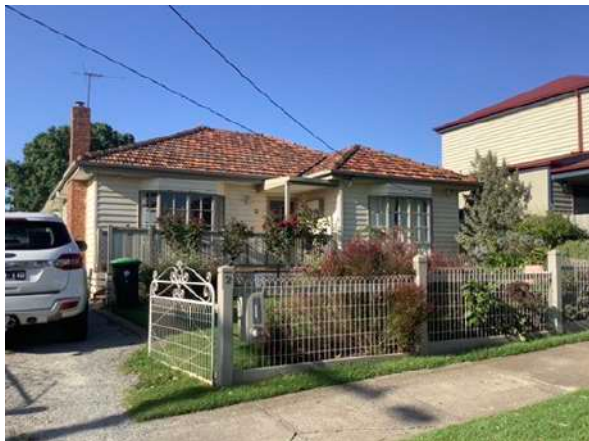
For your information 5.02

Finding: Asbestos Risk Factors - Age of Building
The building is believed to have been constructed well before 1980, up to 50 years before.

Any property constructed between 1945 and 1980 is considered highly likely to have Asbestos Containing Materials (ACM) in its construction.
