# Building & Electrical (Apartment) Report

Inspection Date: 25 Feb 2020

Property Address: St Kilda Area

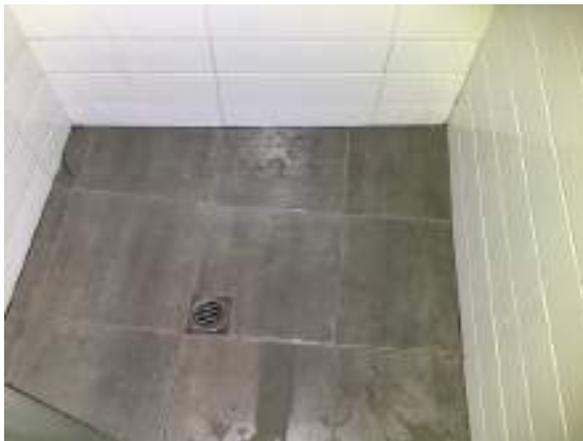
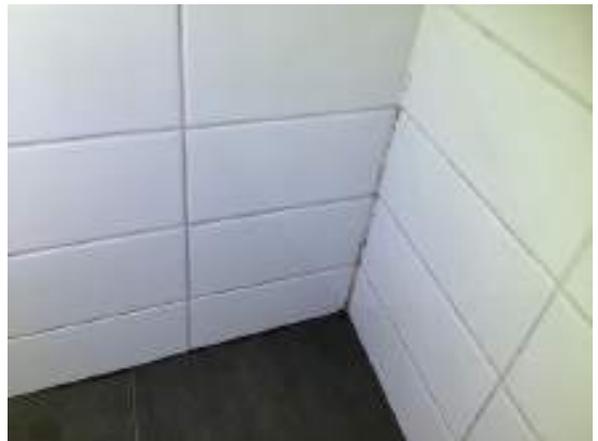
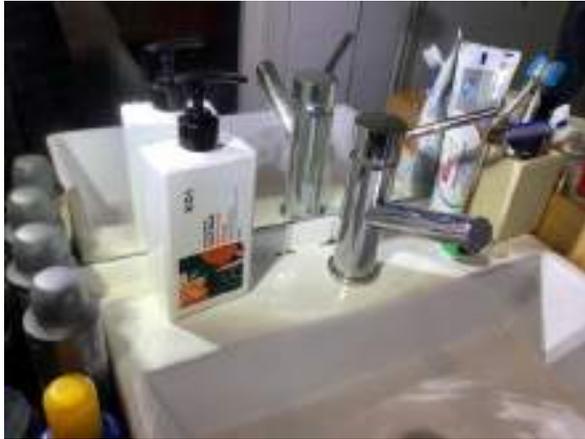
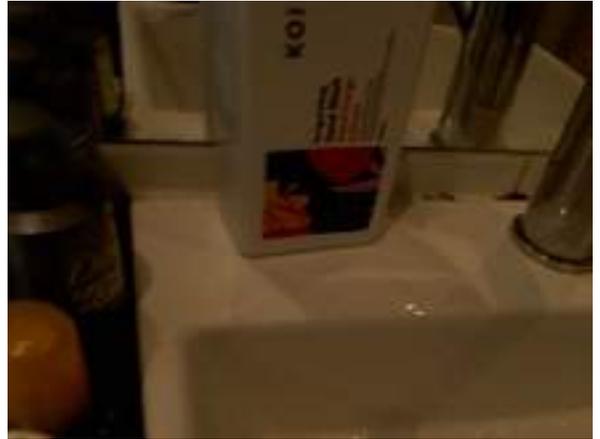
Where evidence of mould growth was noted, there may be environmental, biological or health issues associated with the report. A specialist inspection by a suitably qualified environmental health inspector may be warranted where mould is extensive or where any queries regarding air quality spores or other related issues apply.

Generally, the client is advised to ensure that the general environment is free of moisture and humidity to aid in the prevention of mould formation and development. Any mould found during the inspection should be cleaned immediately and/or taken out, particularly where the mould is in the silicon / caulking.

Please note that severely affected building elements may require replacement by a registered builder or qualified carpenter, however generally where mould is found in bathrooms benches, shower tile junctions, laundry sinks and all other wet area junctions you can get rid of the mould, once you take out the old caulking in most cases.

Heavy mould on walls, ceilings and under homes, generally will require professionals in this field, like hazardous material company's.

Finally the cause or source of the mould **MUST BE TAKEN CARE OF URGENTLY.**

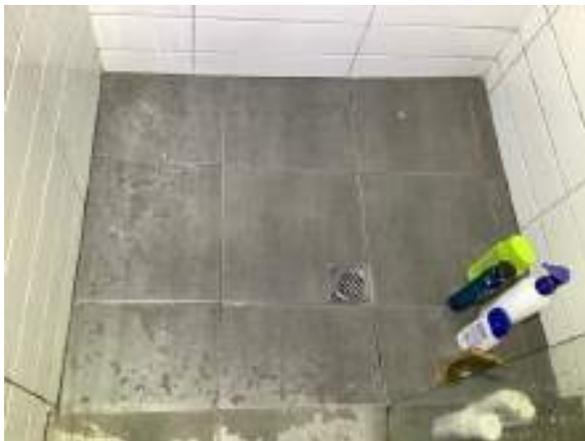
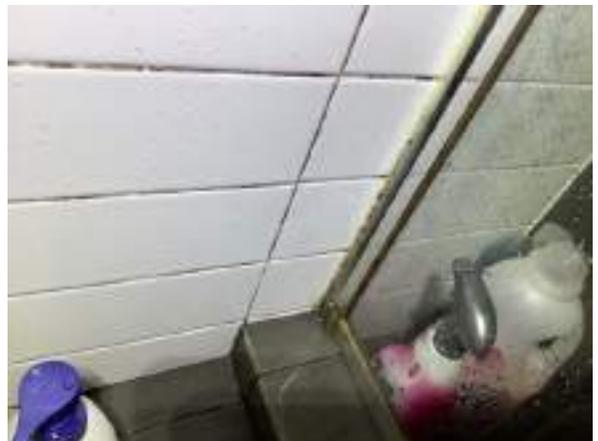
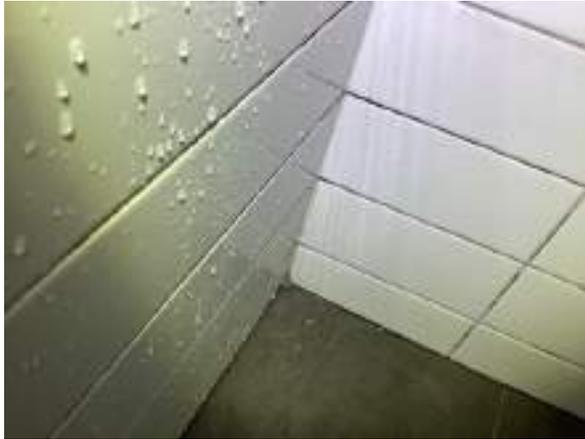
### 1.04

Location: En-suite Bedroom 2

Where evidence of mould growth was noted, there may be environmental, biological or health issues associated with the report. A specialist inspection by a suitably qualified environmental health inspector may be warranted where mould is extensive or where any queries regarding air quality spores or other related issues apply.

Please note that severely affected building elements may require replacement by a registered builder or qualified carpenter, however generally where mould is found in bathrooms benches, shower tile junctions, laundry sinks and all other wet area junctions you can get rid of the mould, once you take out the old caulking in most cases.

Heavy mould on walls, ceilings and under homes, generally will require professionals in this field, like hazardous material company's.

Finally the cause or source of the mould **MUST BE TAKEN CARE OF URGENTLY.**

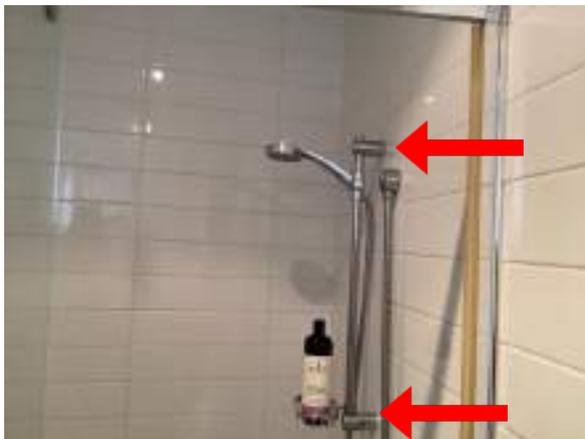
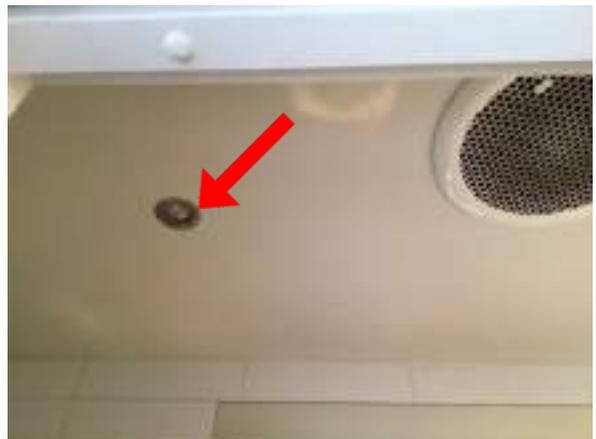
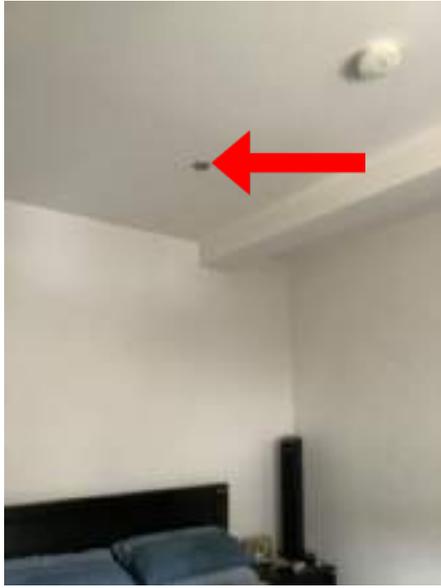
Finding: Building Materials & Hardware That Is Worn / Aged and/or Damaged .  
Building Materials & Hardware That Is Worn / Aged and/or Damaged .

This may have been caused by water damage, moisture and/or general wear and tear. Replacement or repair ( which ever is appropriate and cost effective ) is up to you of the items attached.

Items like cracked glass mirrors, cracked glass windows and windows not operation smoothly are defects that should be repaired by the appropriate trades.

It is IMPERATIVE that you engage registered and qualified trades and at the end of there works they must supply certificates, such as an electrical safety certificate, plumbing and gas certificate if the works are electrical or plumbing, but for items such as damaged door handles, painting an experienced carpenter or handyman can sometimes be engaged.

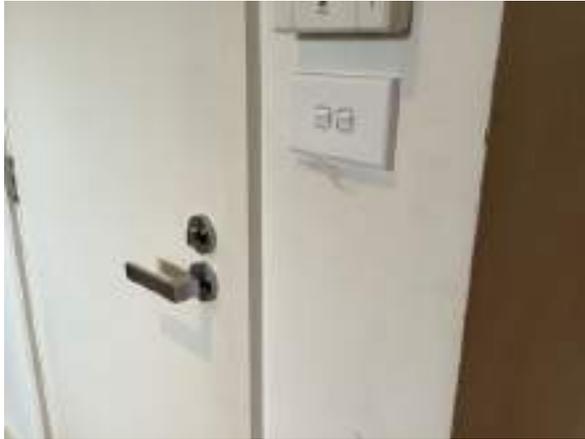
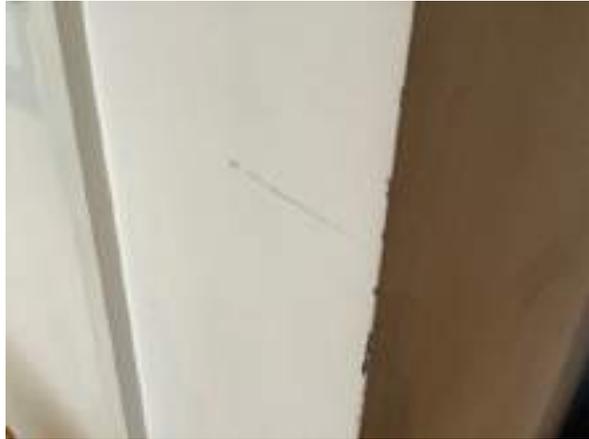
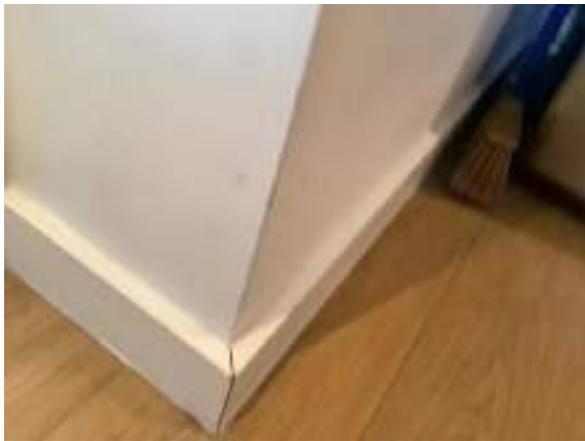
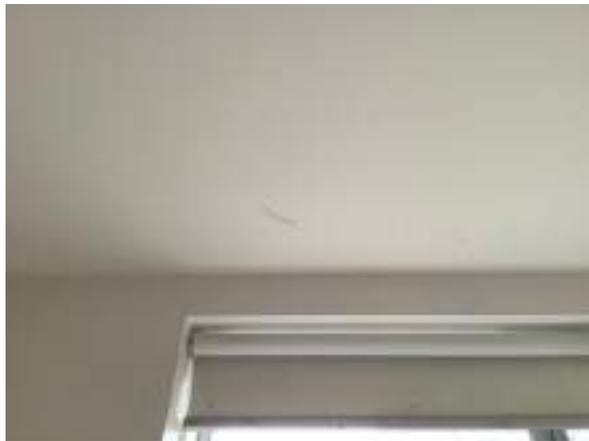
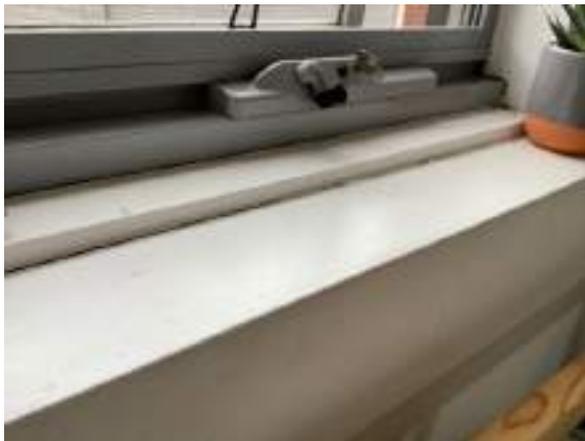
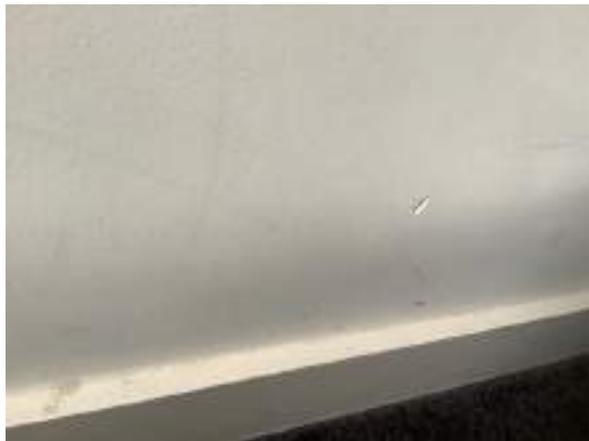
### 3.06

Location: Paint Internal Areas

Finding: Paint & Plaster Defects To Doors, Architraves, Walls & Ceilings, ETC.

Superficial scuff marks, damaged plaster, holes in walls,missing paint,sub-standard paint work were noted to the internal walls / ceilings and/or architraves as per the photos attached at the time of inspection.

While these minor defects are detracting from the overall appearance of the affected building element, they do not indicate any operational or structural damage. This degree of surface damage is consistent with general damage, accidents, movement and wear and tear.

A painting contractor,builder, plasterer and/or suitable handy person may be appointed to perform necessary works to aid the appearance of the affected area and to ensure the area is protected against further deterioration.

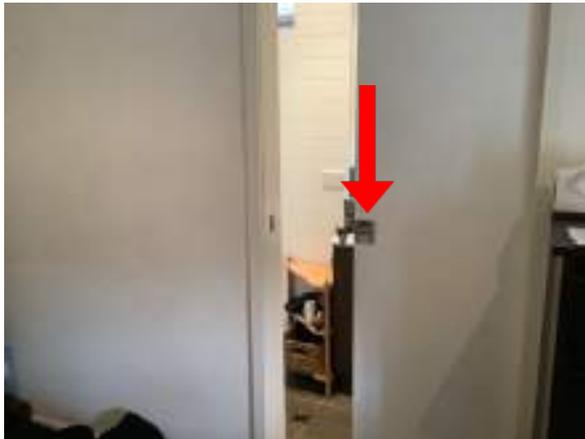
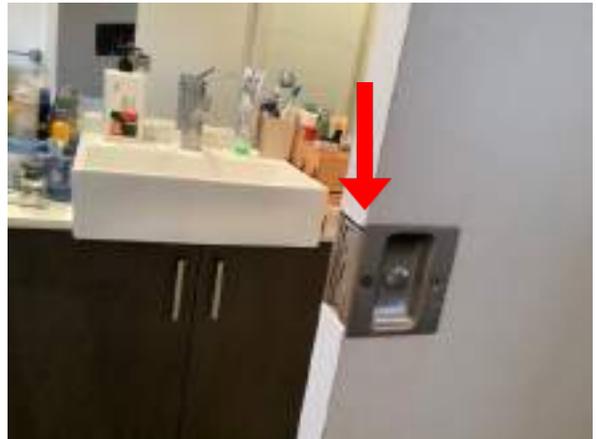
### 3.07

Location: En-suite Bed 1  
Finding: Door lock - Loose

Replacement of the handle /locks should be conducted as soon as possible. A general handy person, window manufacturer and/or service technician should be appointed to perform these works to improve the operational state of the affected window and improve the safety of the internal area.

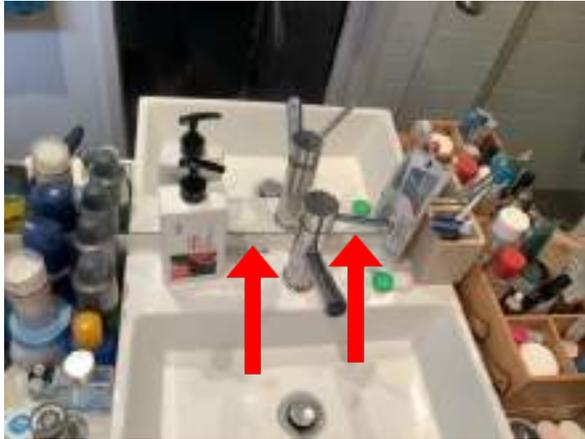
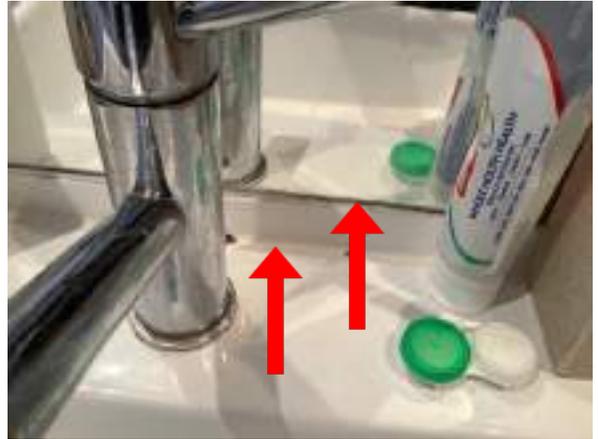
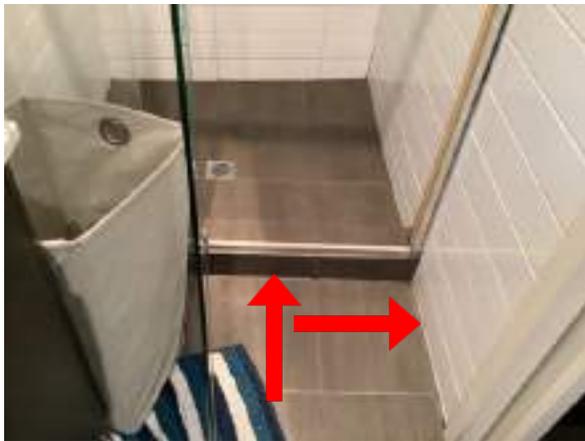
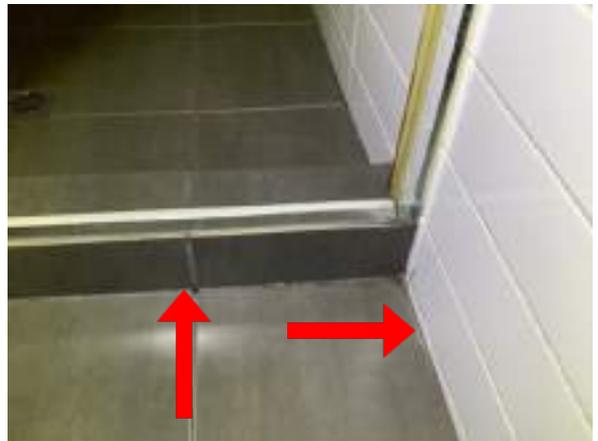
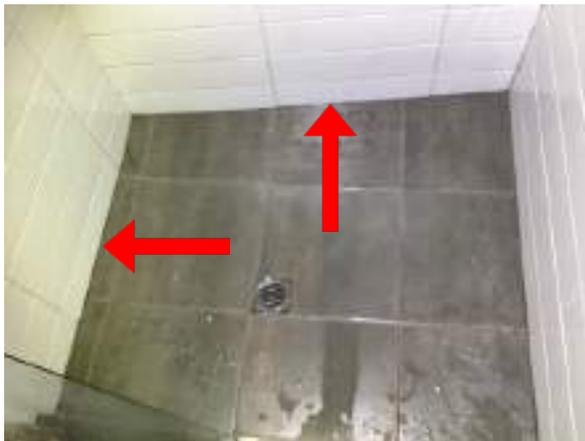
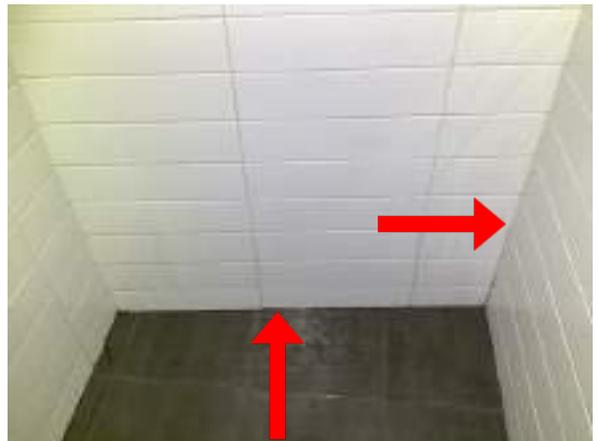
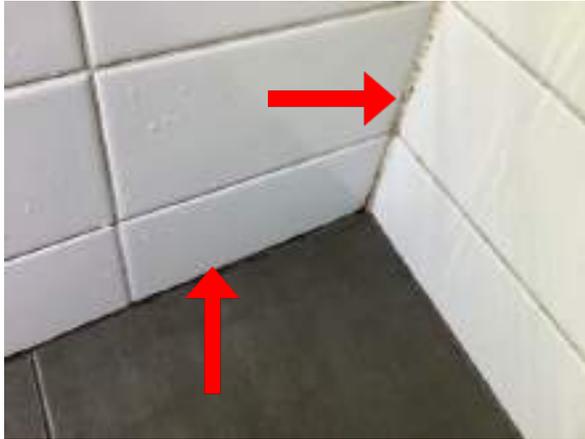
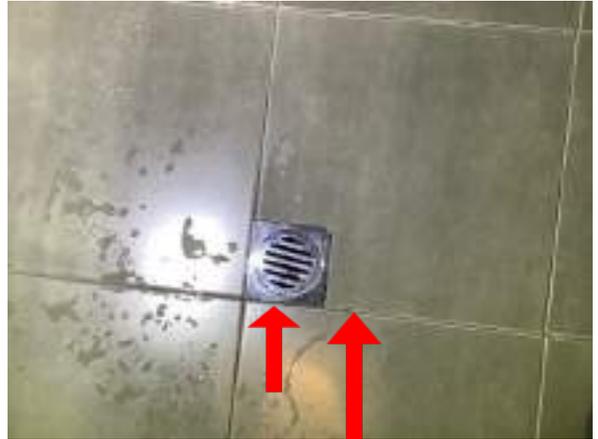
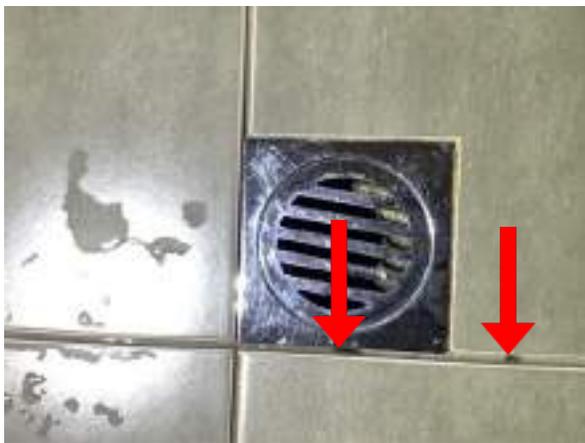
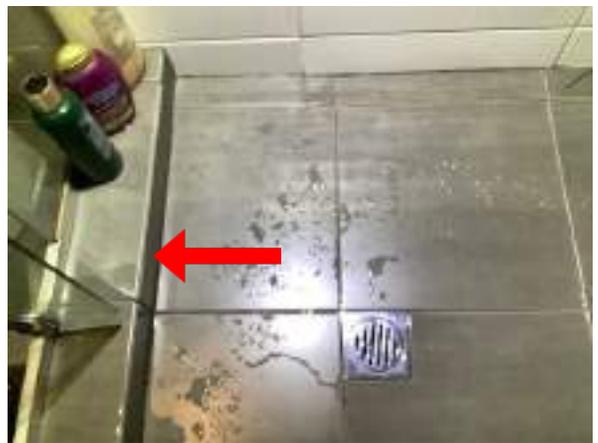
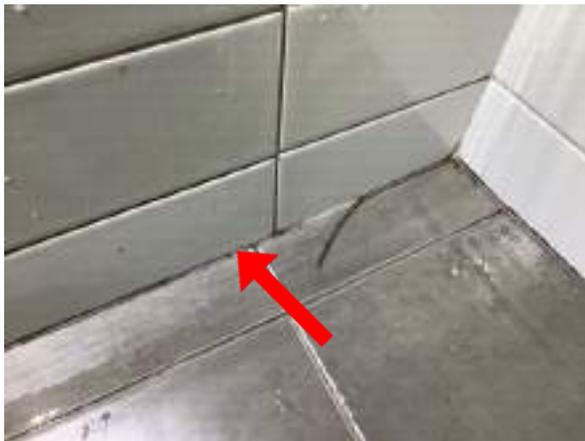
### 3.08

Location: En-suite Bed 1

A sealant specialist, tiling contractor and/or registered builder should be appointed to assess any damage caused by water to the entire internal, sub-floor, walls etc of the building and clean, take off old sealant and tile mortar, then re-seal and re-mortar these works as soon as possible.

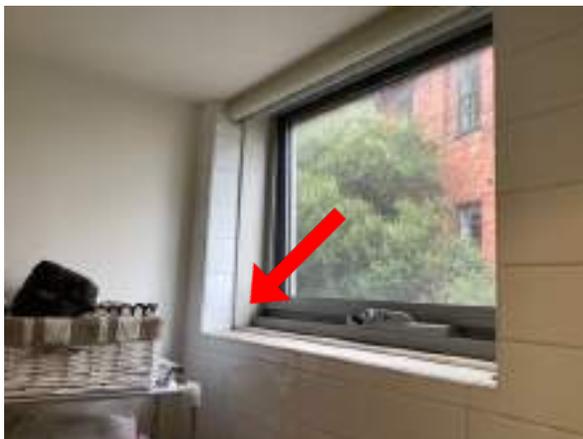
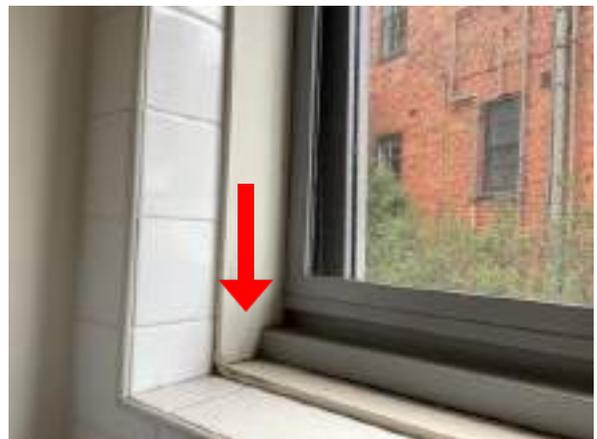
### 3.09

Location: En-suite Bed 1

Water Staining - Damaged Materials.

It is important to identify the correct professional to perform these works, pending on each situation on how minor or major it has become.

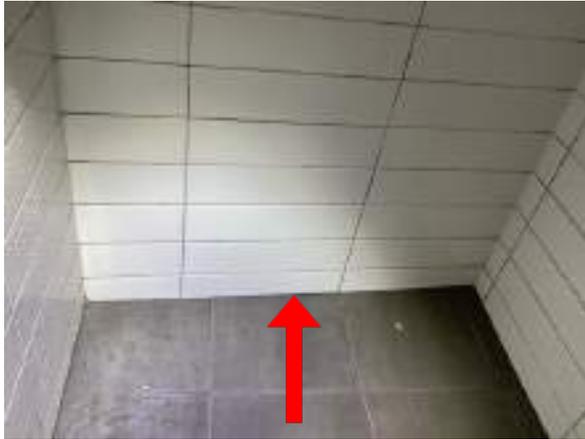
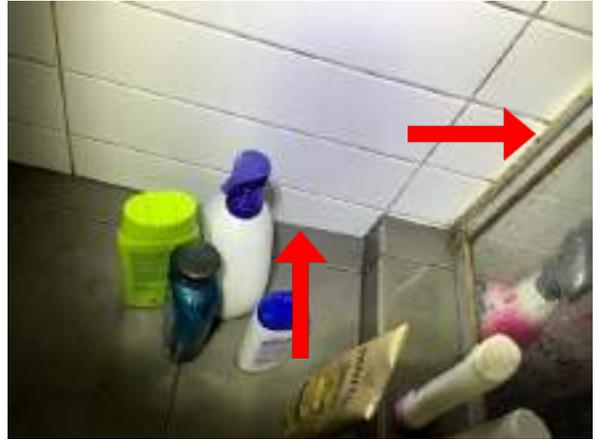
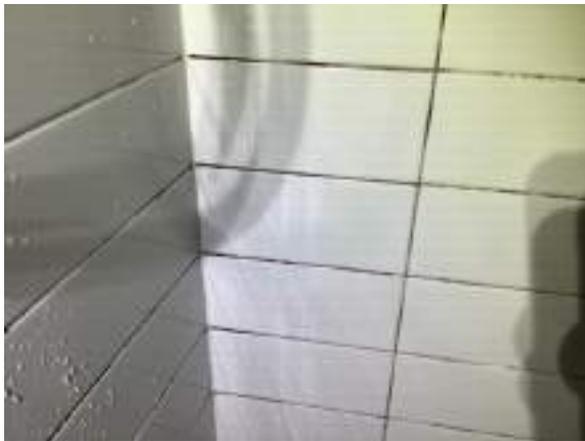
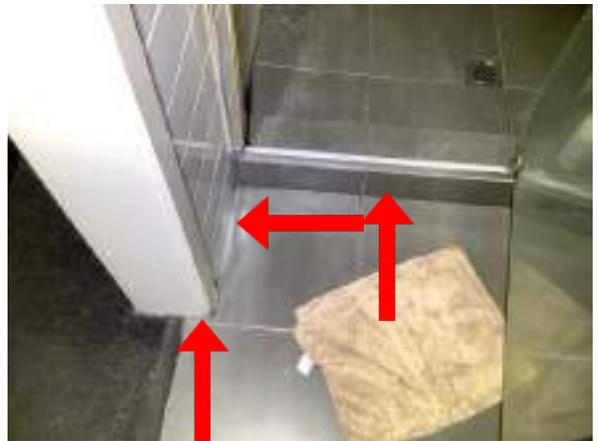
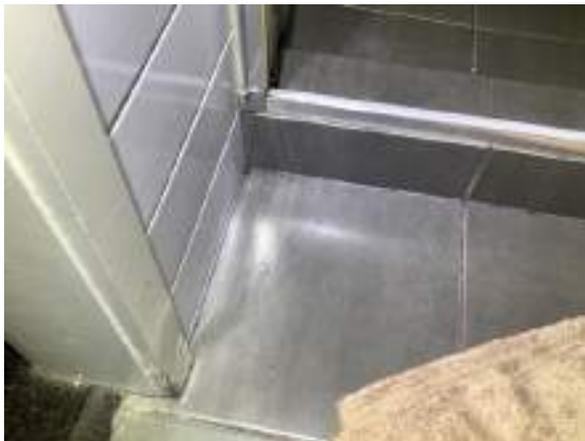
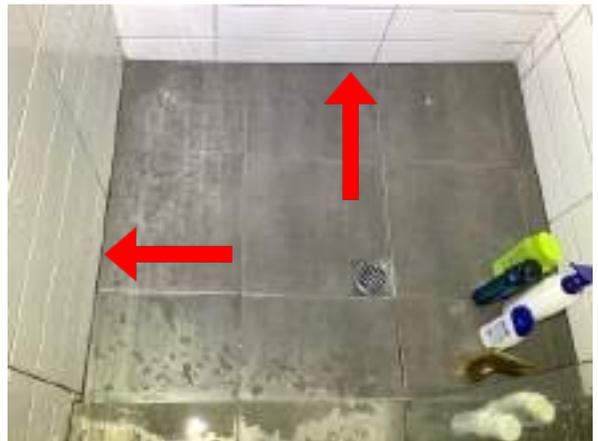
### 3.10

Location: En-suite Bedroom 2

A sealant specialist, tiling contractor and/or registered builder should be appointed to assess any damage caused by water to the entire internal, sub-floor, walls etc of the building and clean, take off old sealant and tile mortar, then re-seal and re-mortar these works as soon as possible.

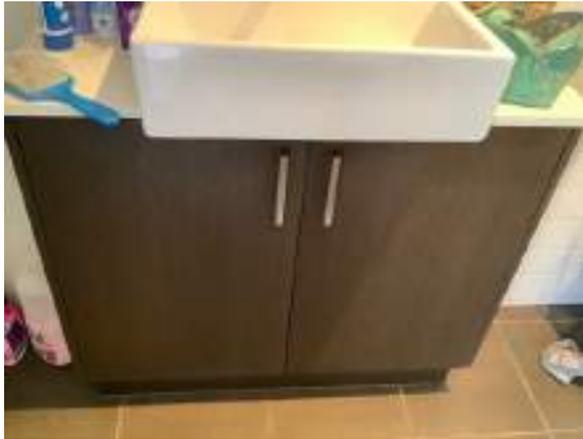
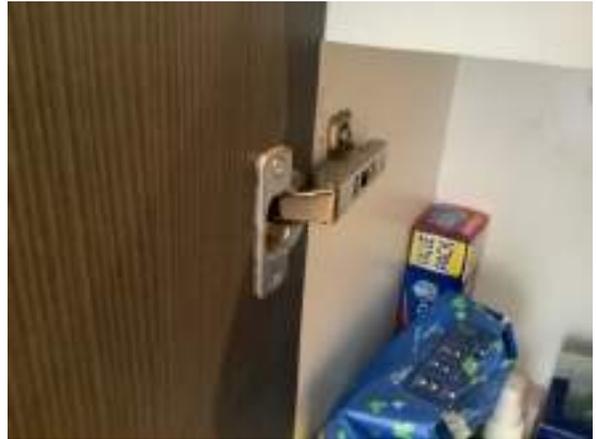
### 3.11

Location: En-suite Bedroom 2

To improve operation of the affected doors, a general handyman / cabinetmaker/ carpenter may be appointed to replace the faulty hinges and/or adjust .

Such works should be completed at the discretion of the client, but we do recommend repairs so that there is no further damages to the existing cabinets or cupboards.

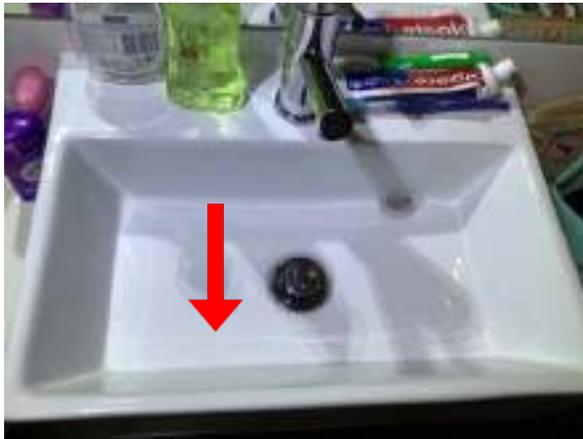
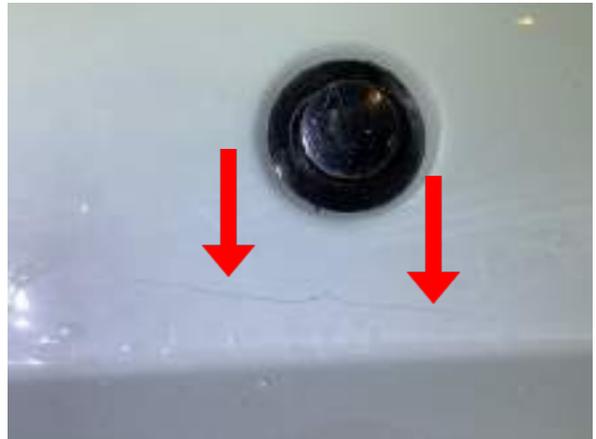
### 3.12

Location: En-suite Bedroom 2

Finding: Basin - Cracked / Damaged

As the cracking provides potential ingress for water, secondary water damage may occur to associated cabinetry, walls or flooring, if the cracking is left unmanaged.

Consultation with a plumber regarding basin repair or replacement is required. Remedial works may be required to protect against any further damage.

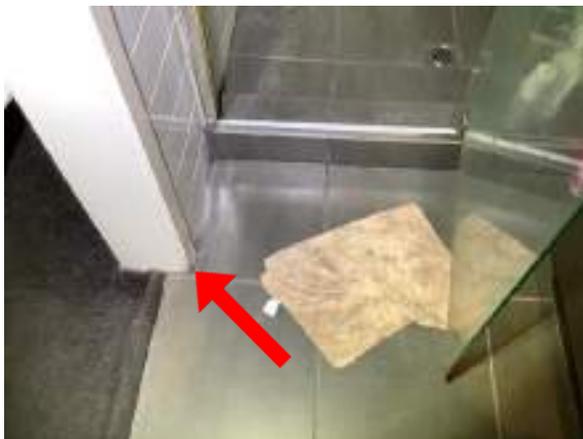
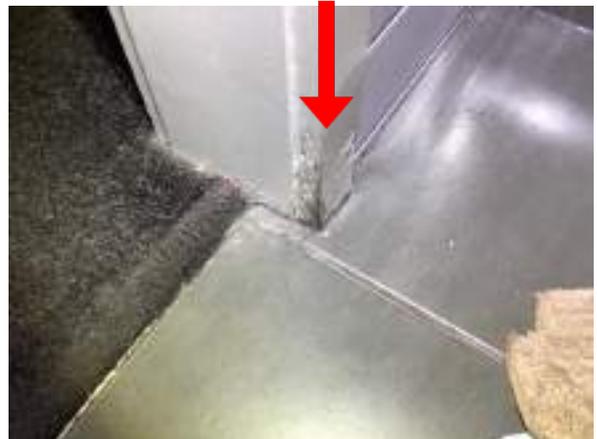
### 3.13

Location: En-suite Bedroom 2

Water Staining - Damaged Materials.

It is important to identify the correct professional to perform these works, pending on each situation on how minor or major it has become.

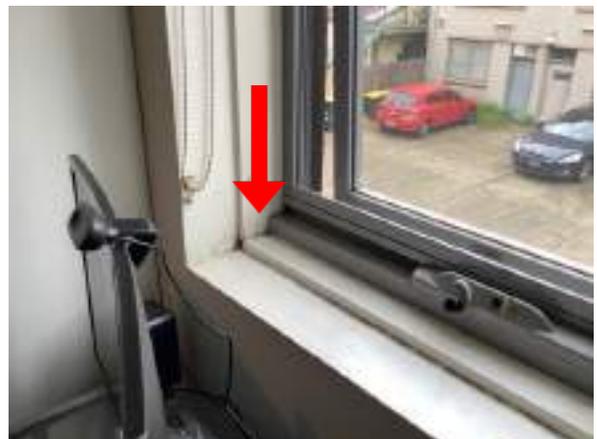
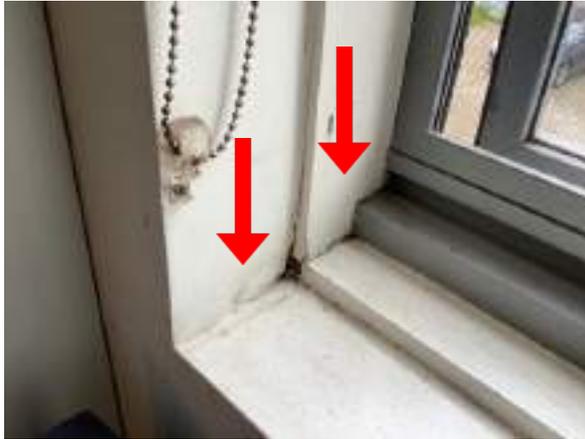
### 3.14

Location: Bedroom 1

Water Staining - Damaged Materials.

It is important to identify the correct professional to perform these works, pending on each situation on how minor or major it has become.

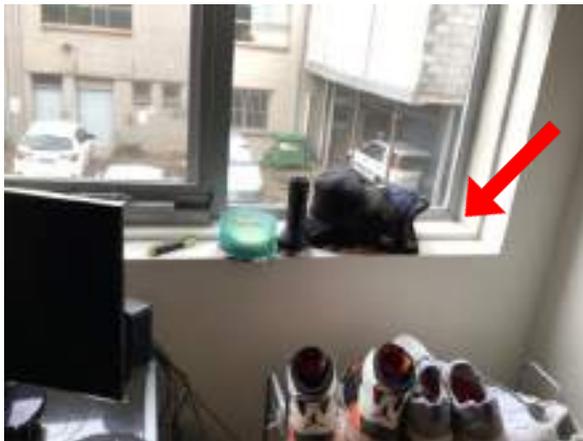
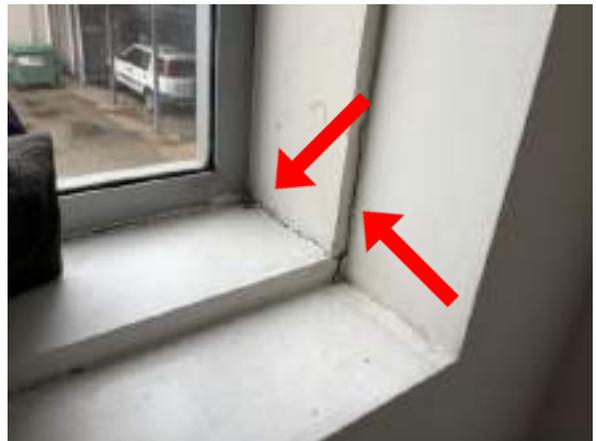
### 3.15

Location: Bedroom 1

Relevant tradespeople, such as carpenters, painters and plasterers, should be appointed to perform remedial works, as deemed necessary.

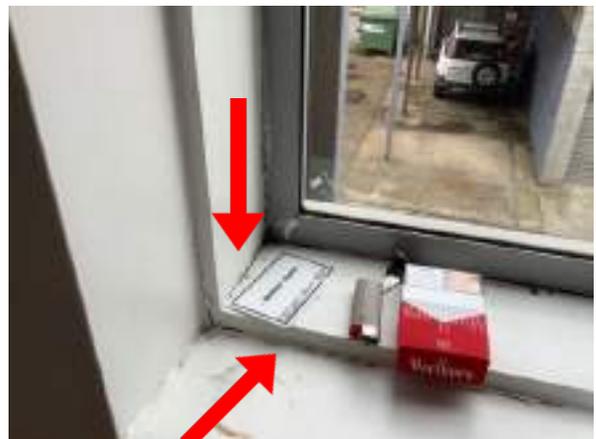
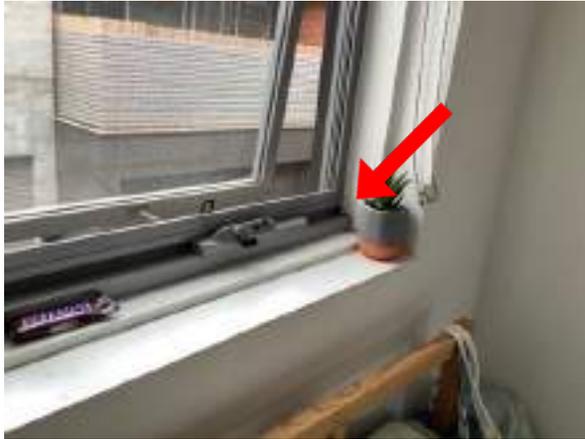
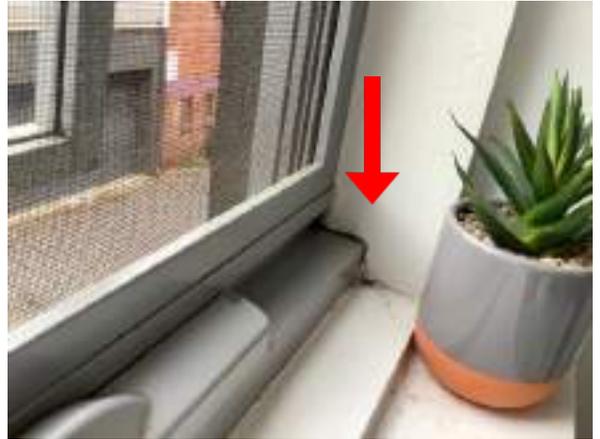
### 3.16

Location: Bedroom 2

Water Staining - Damaged Materials.

It is important to identify the correct professional to perform these works, pending on each situation on how minor or major it has become.

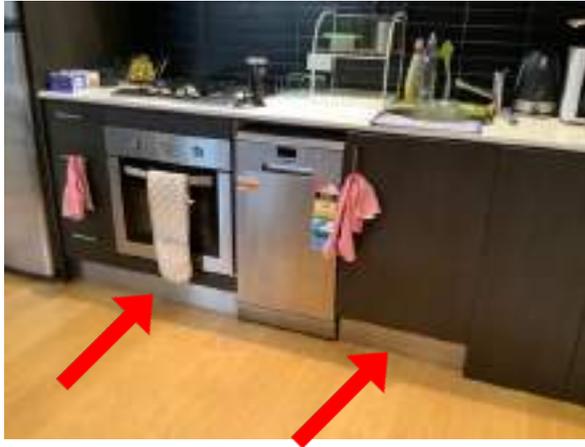
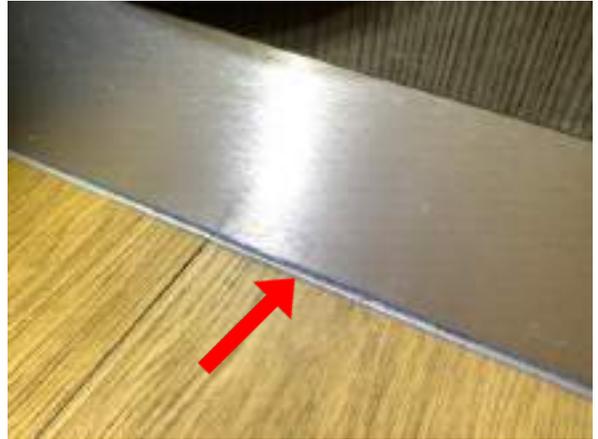
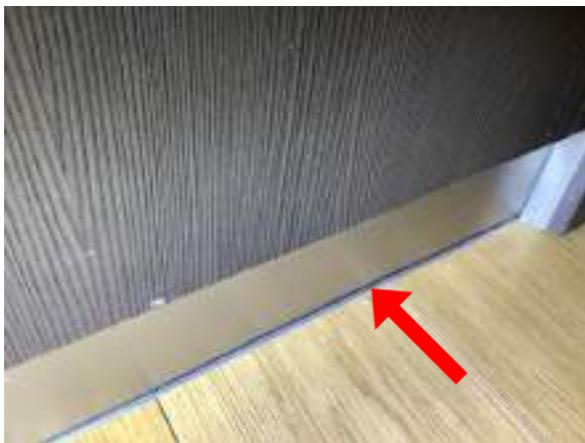
### 3.17

Location: Kitchen

A sealant specialist, tiling contractor and/or registered builder should be appointed to assess any damage caused by water to the entire internal, sub-floor, walls etc of the building and clean, take off old sealant and tile mortar, then re-seal and re-mortar these works as soon as possible.

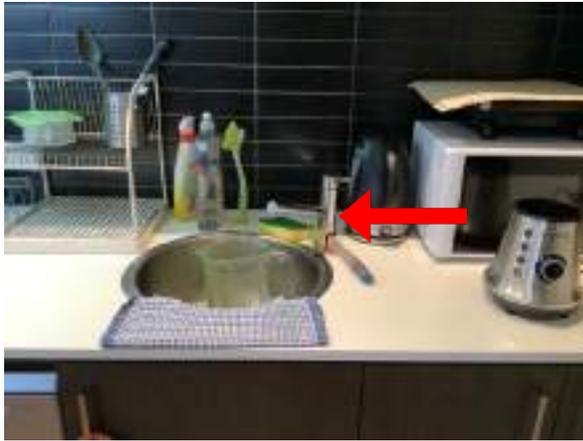
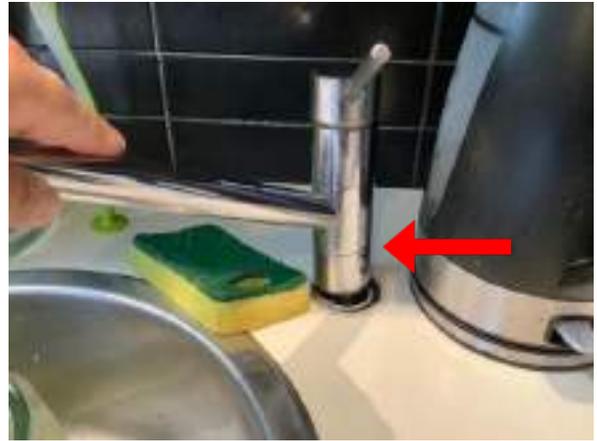
### 3.18

Location: Kitchen

Finding: Tap - Loose

The tap in this area has not been installed correctly, or has deteriorated with age, and is consequently loose. This tap being loose creates potential for water leaks and subsequent water damage to the surrounding area.

Where taps are loose, a qualified plumber should be appointed to re-fix the plumbing fitting to prevent further secondary damages that may not be seen, creating water damage unseen.

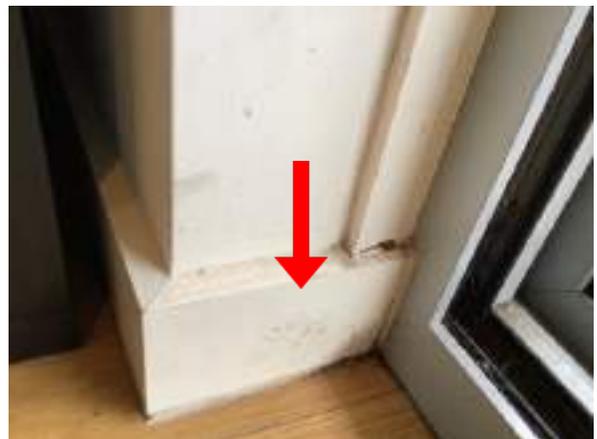
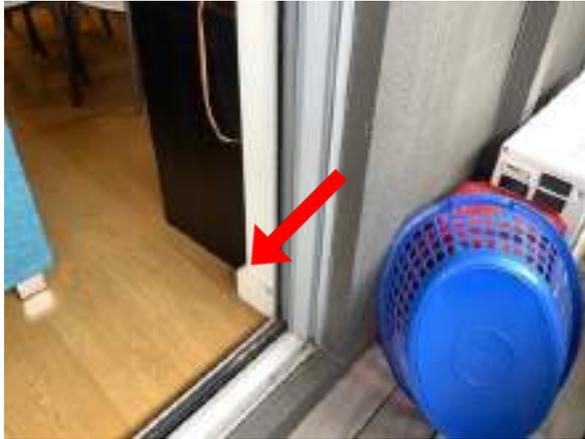
### 3.20

Location: Living Room

Water Staining - Damaged Materials.

It is important to identify the correct professional to perform these works, pending on each situation on how minor or major it has become.

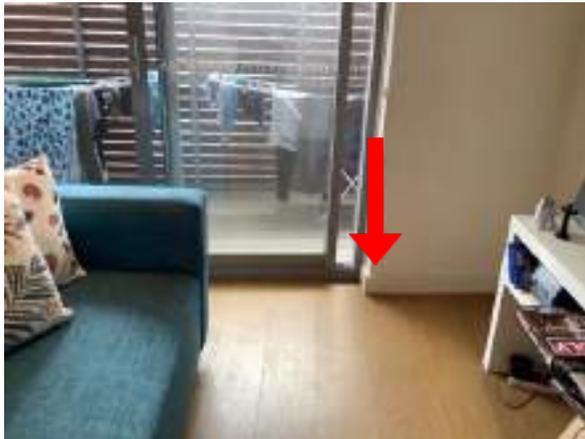
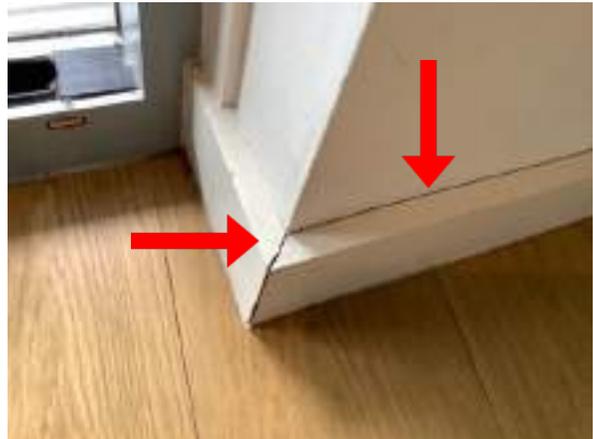
### 3.21

Location: Living Room

Relevant tradespeople, such as carpenters, painters and plasterers, should be appointed to perform remedial works, as deemed necessary.

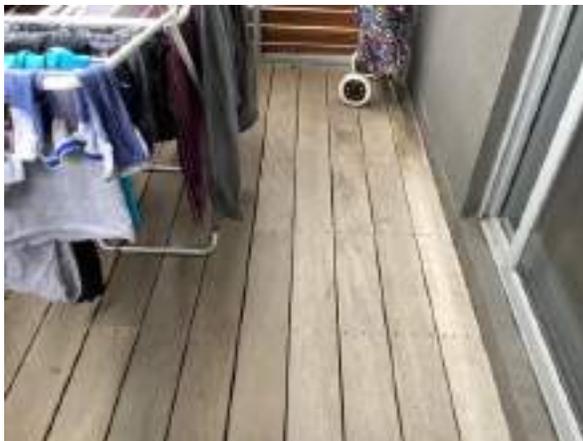
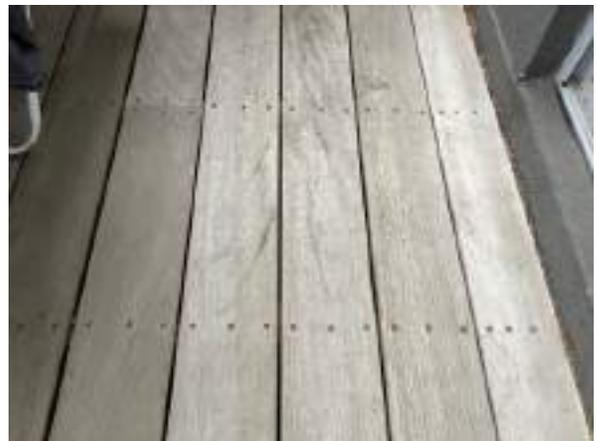
### 3.22

Location: Balcony

The property is a very high risk for termites as the environments to the property are very conducive with many susceptible areas.

Please read the report carefully and Maintenance to all susceptible and conducive areas is a MUST to minimise the risk of termite and timber pest existence and timber damage.

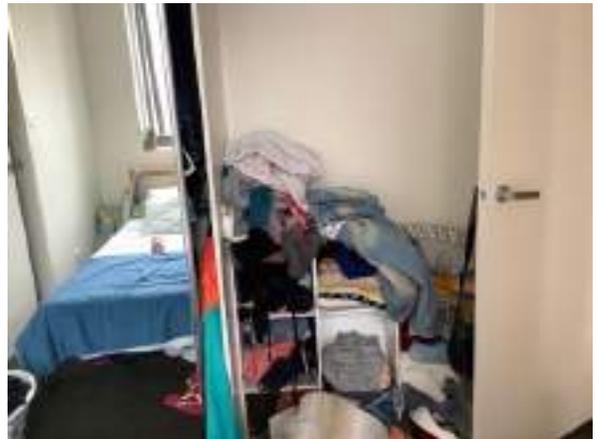
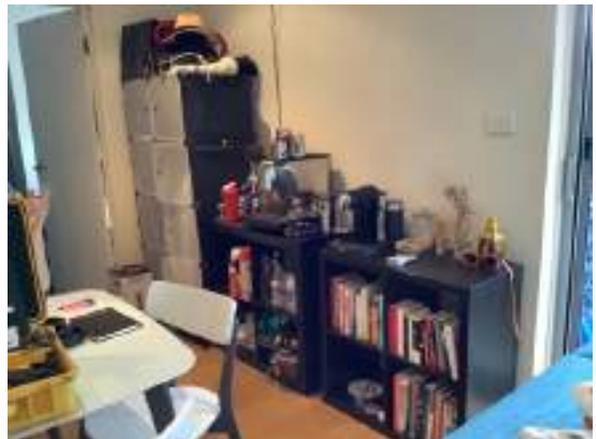
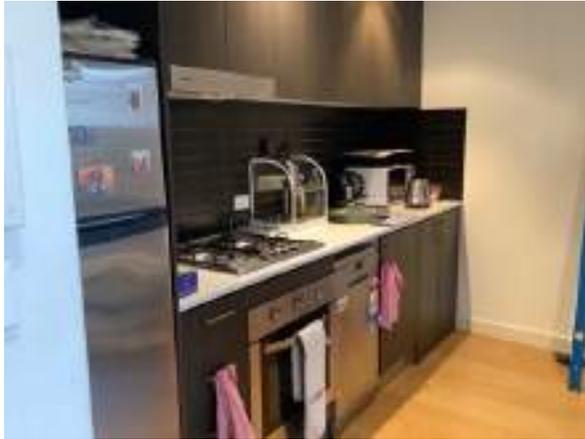
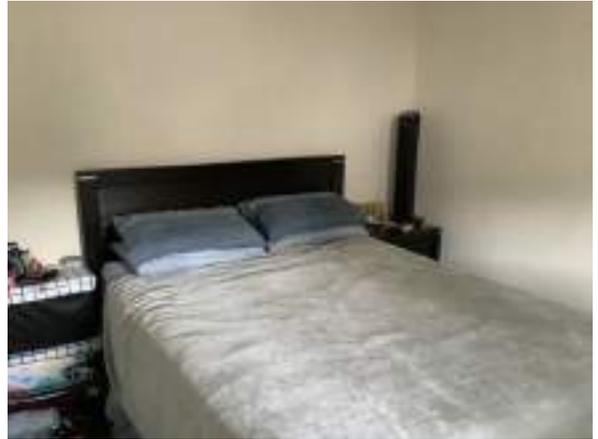
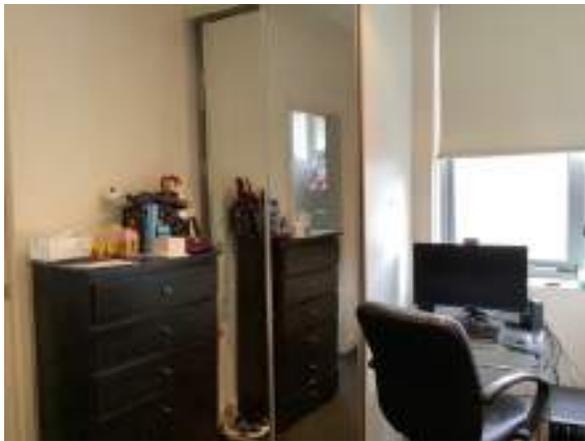
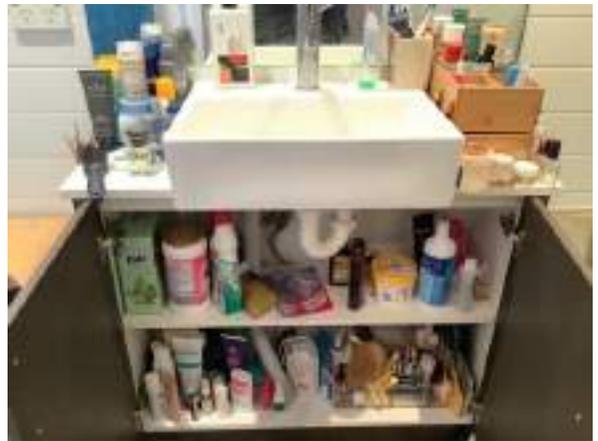
Whilst we have taken many photos of the home and surroundings of the obstructions and limitations , we have just added a few photos in the report for you to understand the type of obstructions and limitations .

A re-inspection is recommended once the areas are made accessible.
