Building-Termite-Electrical - Report - Previous Job

Inspection Date: 28 Jan 2020

Property Address: Building-Termite-Electrical Report

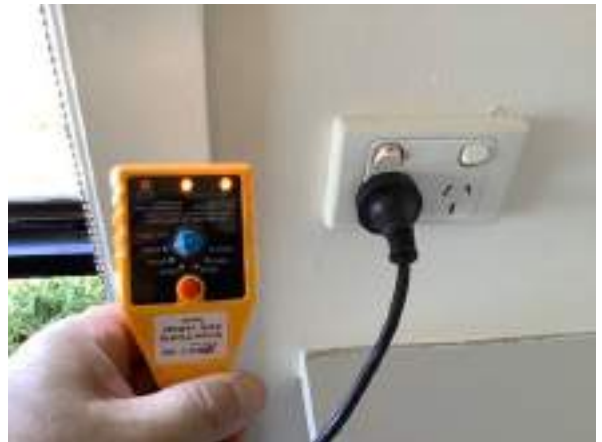
3/ Safety Switch test to trip the safety switch at less than 30 milli amps was performed and the initial tests to the safety switches DID NOT trip at 30 milli amps. I highly recommend that both safety switches be replaced by a qualified electrician as a matter of urgency.

These tests DID NOT all pass the AS 3000 requirement and acceptance level.

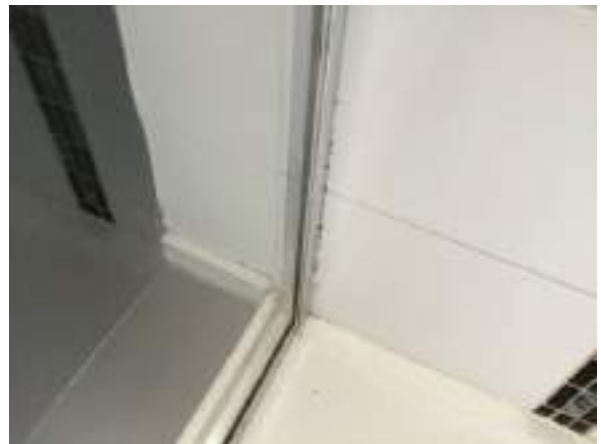
1.02

Location: Bathroom

Finally the cause or source of the mould MUST BE TAKEN CARE OF URGENTLY.

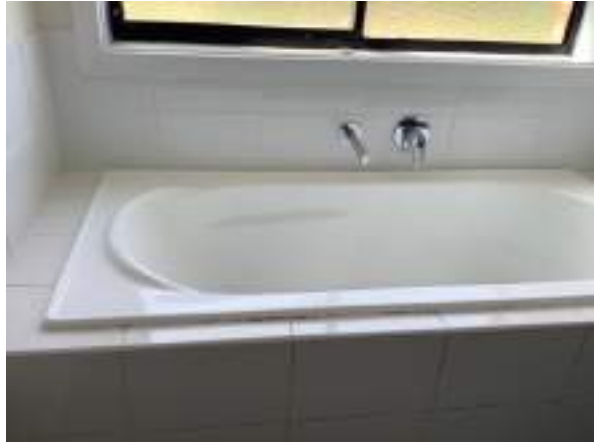
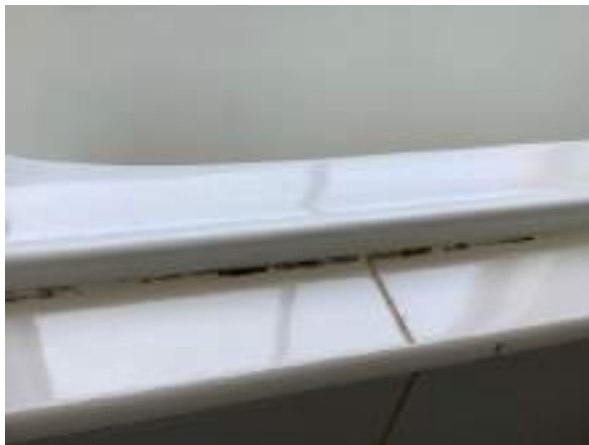
1.03

Location: Ensuite

Finally the cause or source of the mould MUST BE TAKEN CARE OF URGENTLY.

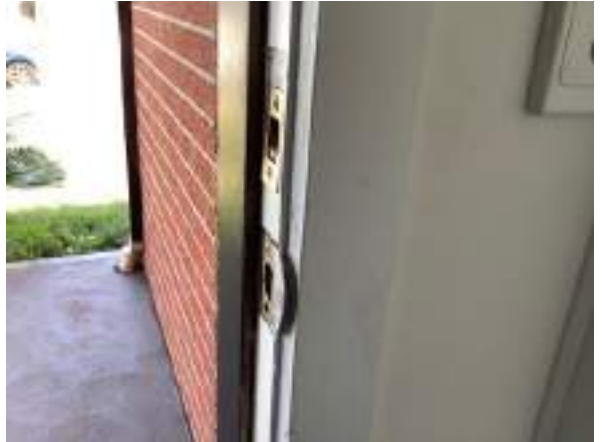
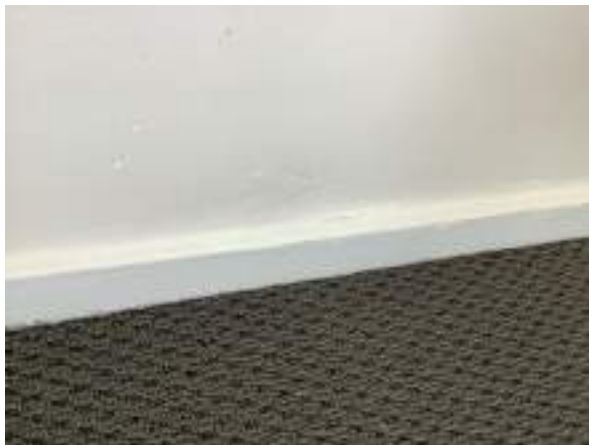
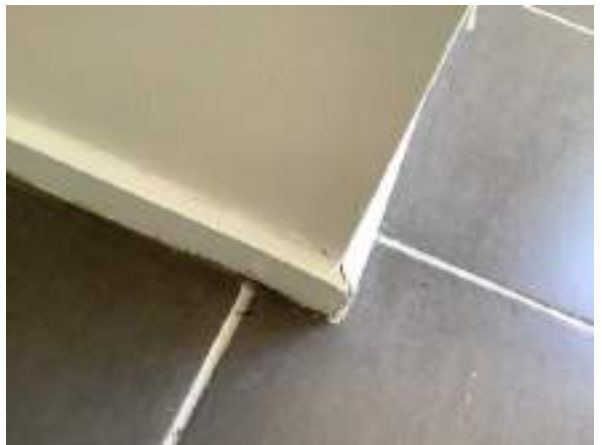
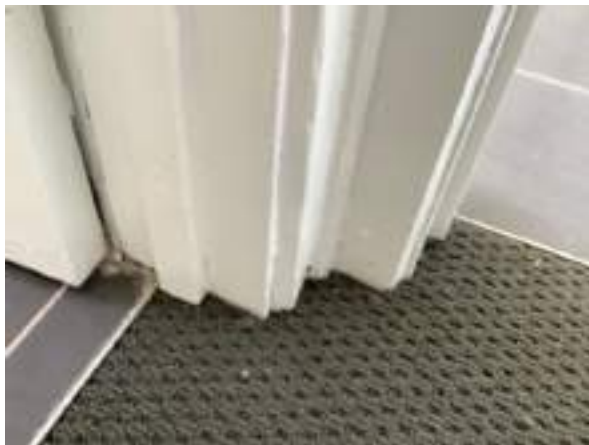
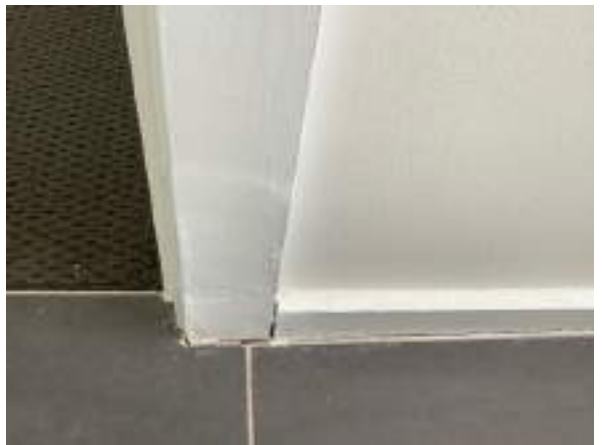
3.10

Location: All Paint Internal Areas

Wet areas are the main areas that MUST have SUFFICIENT paint coverage to the walls, ceilings and timber work as moisture can deteriorate the areas.

A painting contractor, builder, plasterer and/or suitable handy person may be appointed to perform necessary works to aid the appearance of the affected area and to ensure the area is protected against further deterioration.

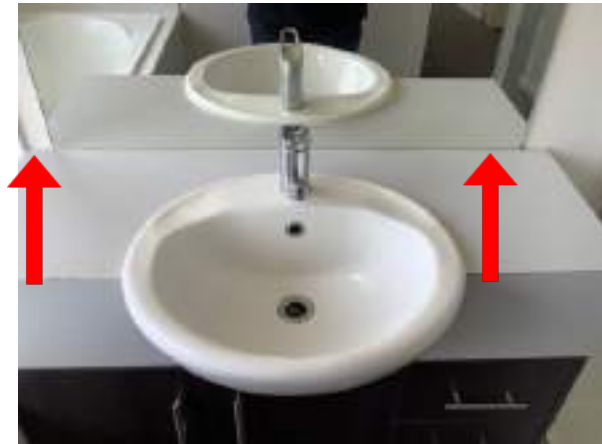
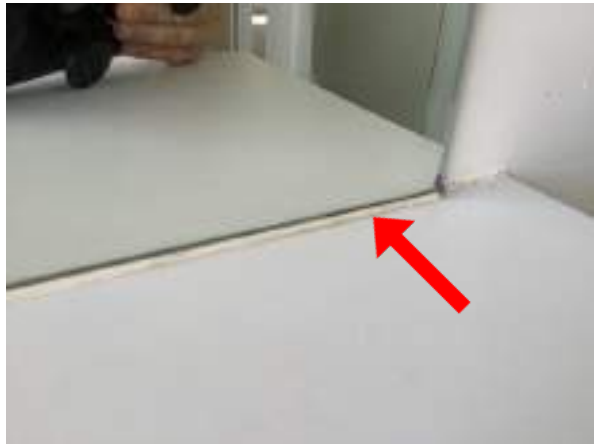
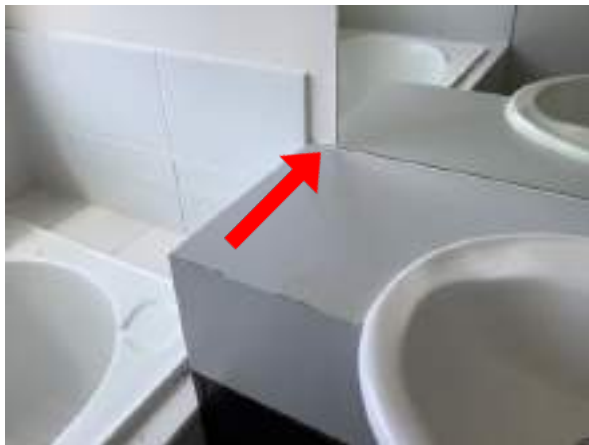
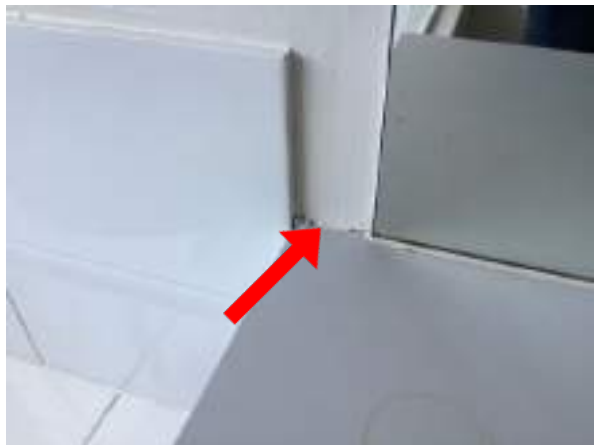
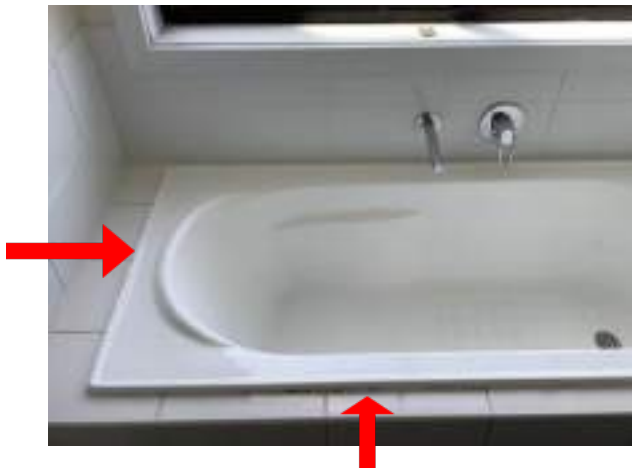
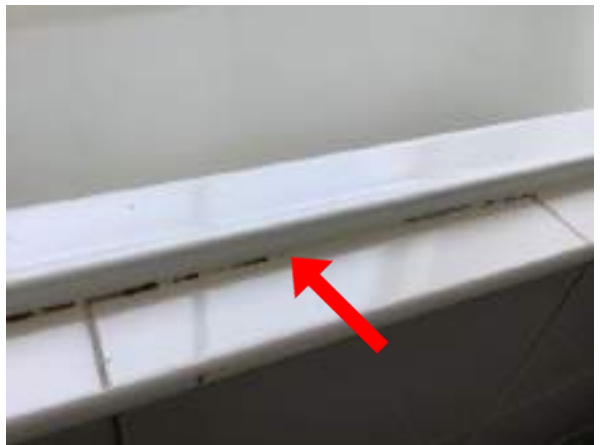
3.11

Location: Bathroom

A sealant specialist, tiling contractor and/or registered builder should be appointed to assess any damage caused by water to the entire internal, sub-floor, walls etc of the building and clean, take off old sealant and tile mortar, then re-seal and re-mortar these works as soon as possible.

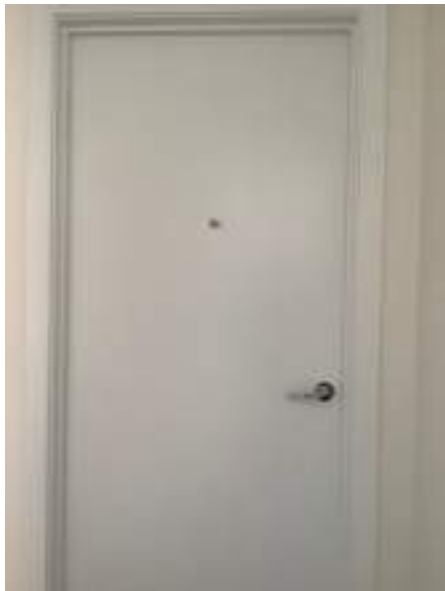
3.21

Location: Bedroom 1

For minor causes, a qualified carpenter or general handyperson should be appointed to perform minor rectification works at client discretion.

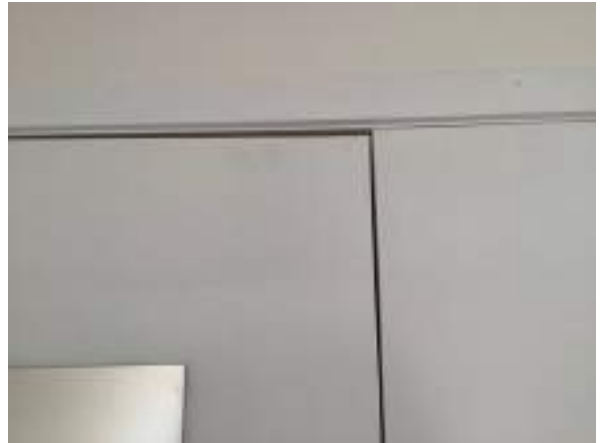
3.26

Location: Bedroom 4

To improve operation of the affected doors, a general handyman / cabinetmaker/ carpenter may be appointed to replace the faulty hinges and/or adjust .

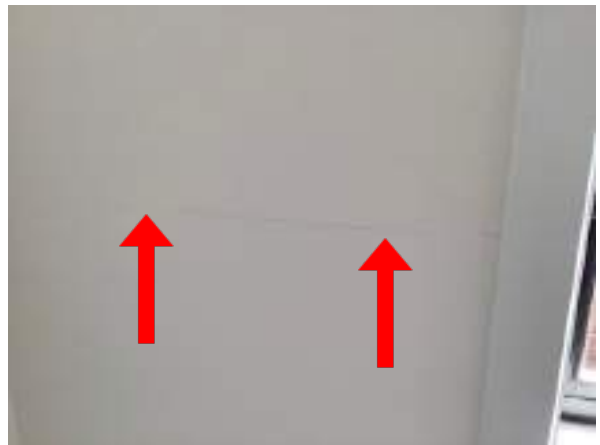
3.27

Location: Bedroom 4

Relevant tradespeople, such as carpenters, painters and plasterers, should be appointed to perform remedial works, as deemed necessary.

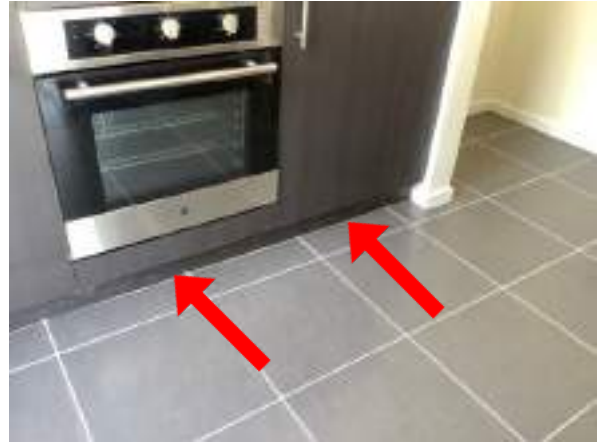
3.28

Location: Kitchen

A sealant specialist, tiling contractor and/or registered builder should be appointed to assess any damage caused by water to the entire internal, sub-floor, walls etc of the building and clean, take off old sealant and tile mortar, then re-seal and re-mortar these works as soon as possible.

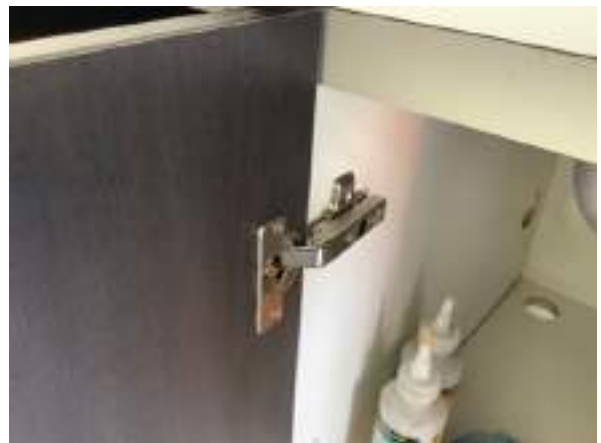
3.29

Location: Kitchen

To improve operation of the affected doors, a general handyman / cabinetmaker/ carpenter may be appointed to replace the faulty hinges and/or adjust .

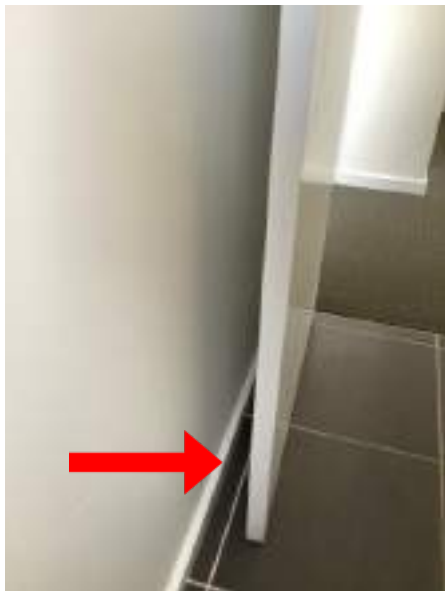
3.33

The door stop is missing or is inadequate to stop the door handle from damaging the wall. Although some building elements may seem irrelevant or unnecessary, all building elements play a key role in the operation and function of the overall structure and its performance.

Re-installation or replacement of the door stop is advised as soon as possible to prevent any subsequent damage to the door or associated structures. A general handyman may be appointed to perform these works at client discretion.

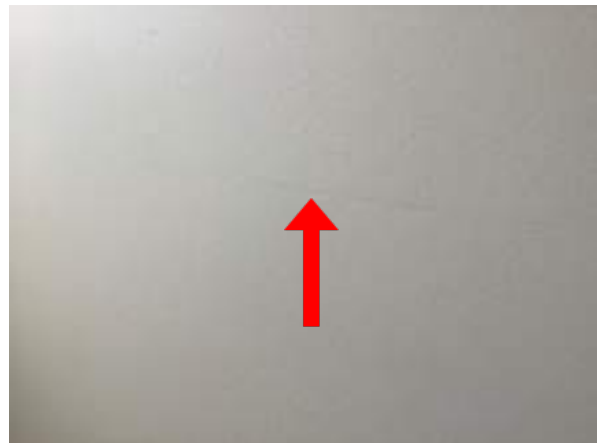
3.35

Location: Toilet

Relevant tradespeople, such as carpenters, painters and plasterers, should be appointed to perform remedial works, as deemed necessary.

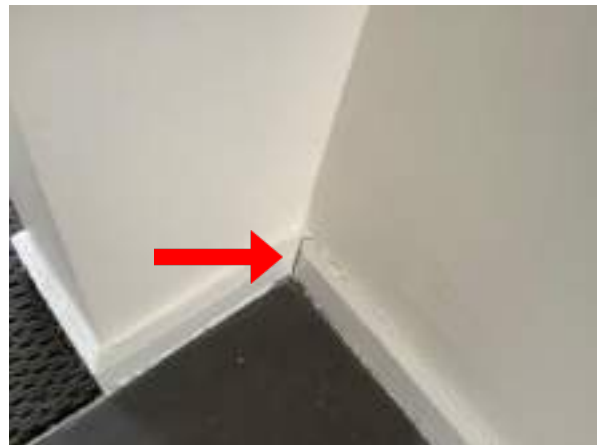
3.36

Location: Family Room

Relevant tradespeople, such as carpenters, painters and plasterers, should be appointed to perform remedial works, as deemed necessary.

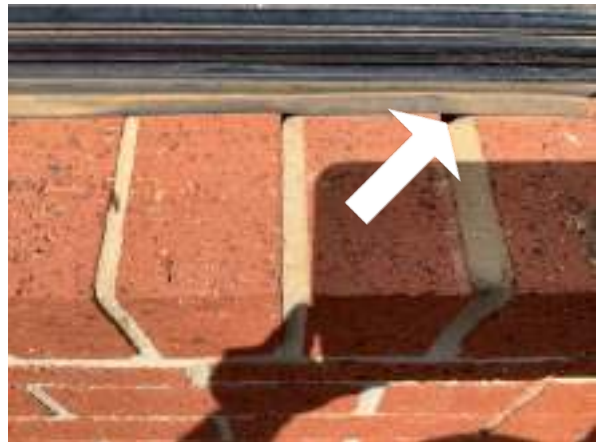
3.43

Location: Brickwork - All Areas

Mortar deterioration can be addressed by a bricklayer where areas of deterioration are localised and easily accessible. Alternatively, appointment of a registered builder is advised, to repoint large areas of decaying mortar. Where secondary structural defects have become evident, consultation with a structural engineer may be required.
