Building & Termite, Timber, Asbestos Pest Report

Inspection Date: 15 Feb 2020

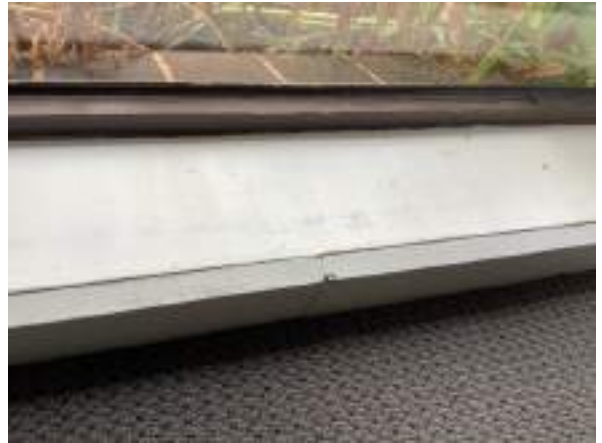
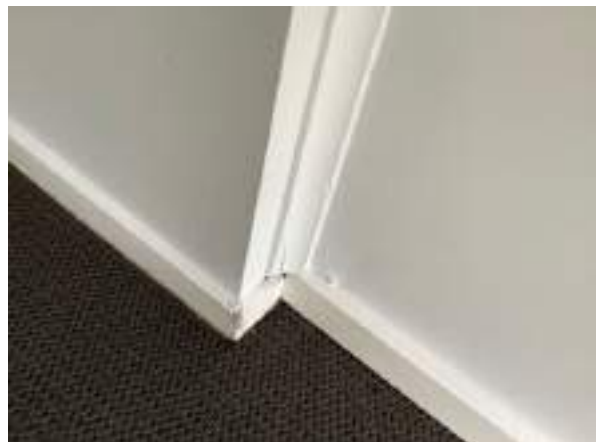
There are areas that have been repaired as for example in bedroom 4 and the laundry and the toilet adjacent to bedroom 4. These areas appear to have repaired for some reason and the workmanship is substandard including the plasterwork and timber work.

It is unknown as to why these repairs have taken place, and may require further investigation at your discretion, possibly by a registered builder.

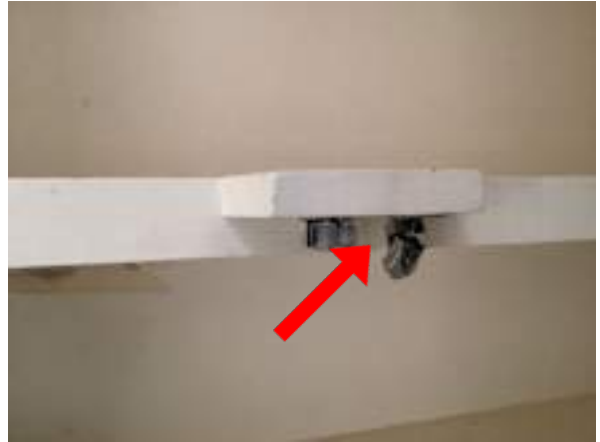
Finding: Door - Broken handle/latch

The door handle/latch in this area was found to be broken at the time of inspection. Replacement of the broken door handle is advised to improve the operational state of the associated door. A qualified carpenter or general handyman should be appointed to replace the door handle at the client's discretion.

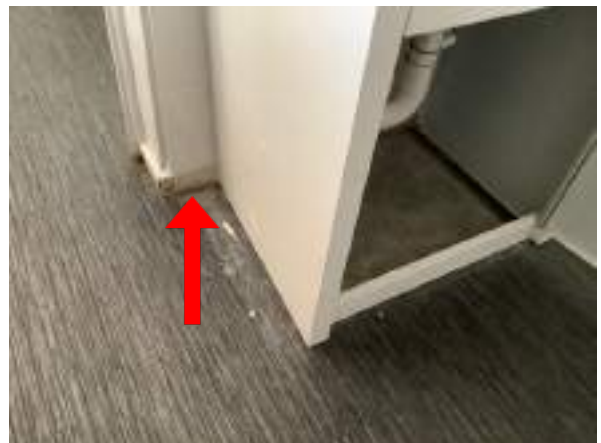
Location: Laundry

Conversely, where water staining is old and inactive, affected building materials may be repaired or replaced at client discretion only if the damage is cosmetic though.

It is important to identify the correct professional to perform these works, pending on each situation on how minor or major it has become.

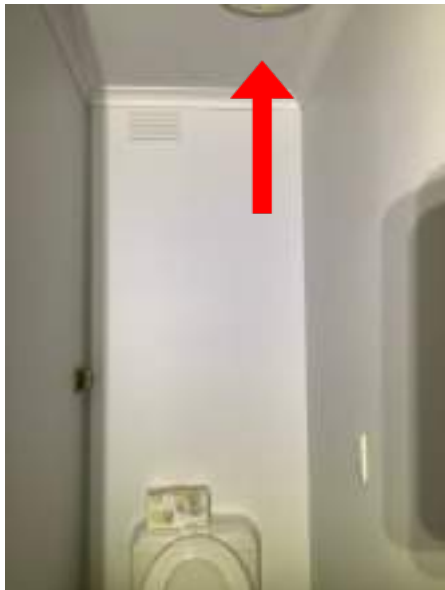
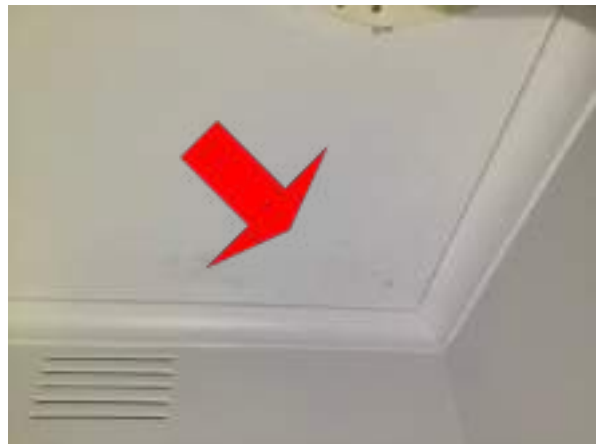
Location: Both Toilets

The presence of excessive moisture can have major implications on associated building elements if left unattended. While only seemingly minor at this stage, the damage cannot be determined due to the paint obstructing any further inspection of the damage.

It is highly advised that the affected paint be cleaned to allow a further, more invasive inspection by a licensed plumber. Failure to act on this defect may necessitate major works in the future.

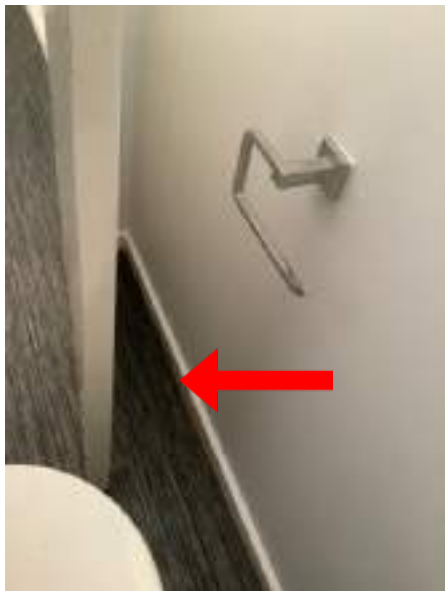
Location: Both Toilets

The door stop is missing or is inadequate to stop the door handle from damaging the wall. Although some building elements may seem irrelevant or unnecessary, all building elements play a key role in the operation and function of the overall structure and its performance.

Re-installation or replacement of the door stop is advised as soon as possible to prevent any subsequent damage to the door or associated structures. A general handyman may be appointed to perform these works at client discretion.

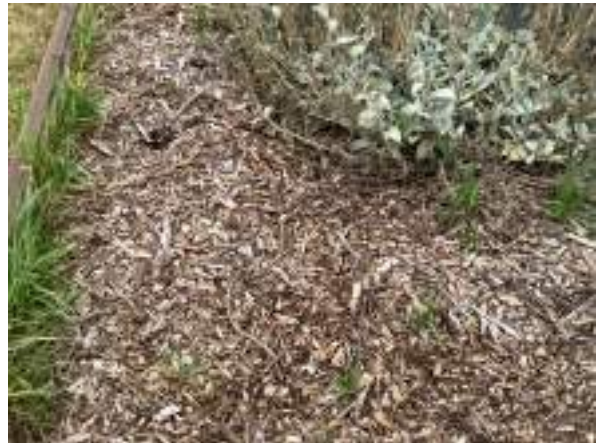
Finding: Garden Beds - Conditions Conducive to Termites
 Garden beds were found to be evident in areas of garden areas.
 These garden beds can include untreated timber, bark, excessive old vegetation and with a combination of moisture from watering hosing can make conditions very conducive to termite activity and termite ingress.
 It is always important to keep the garden beds as clean as possible and take out excess old bark from the trees, leaves and keep bark mulch to a minimum or better introduce rocks or some item that does not create an conducive environment for termites and hold excess moisture.

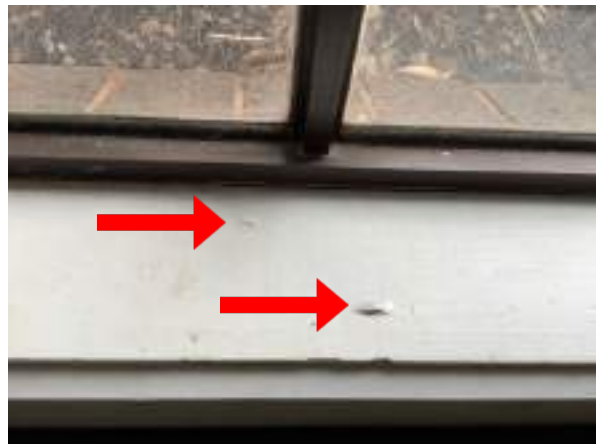
Location: Bedroom 2

Finding: Nail popping
Couple of nails are popping out in the window frame. This is generally due to timber shrinkage and is a minor repair. A handyman or carpenter can repair this item.
