# Building/Termite/Electrical/ Asbestos/Digital Flooring

Inspection Date: 21 Jan 2020

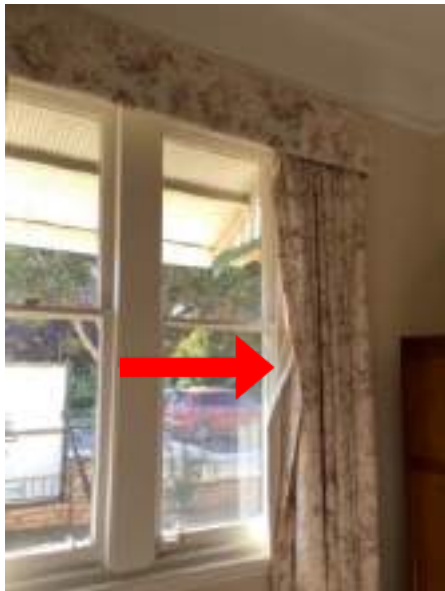
Replacement of the handle /locks should be conducted as soon as possible. A general handy person, window manufacturer and/or service technician should be appointed to perform these works to improve the operational state of the affected window and improve the safety of the internal area.

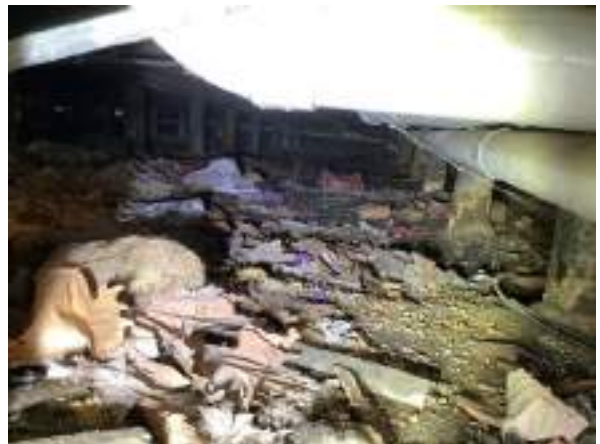
Finally the cause or source of the mould MUST BE TAKEN CARE OF URGENTLY.

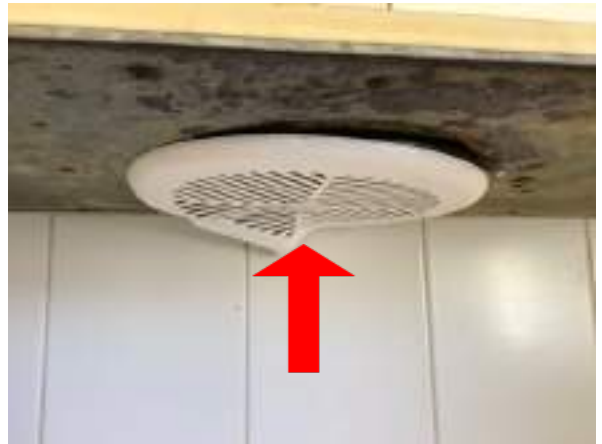
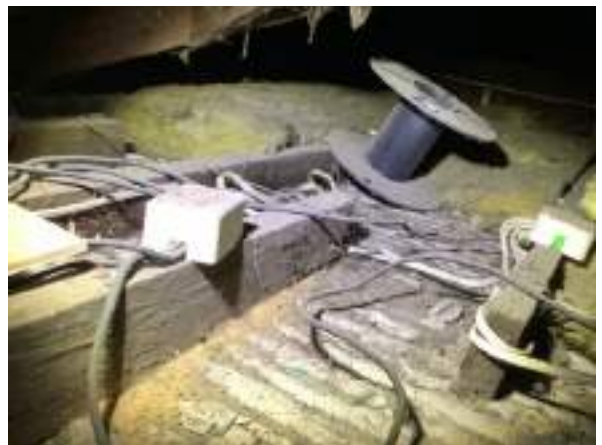
Location: Electrical - All Areas

-/// The kitchen make shift exhaust fan, does not comply with electrical safety standards and  
is a fire hazard.
