Dilapidation Inspection Report

Inspection Date: 24 Mar 2020

Property Address: Northern Area

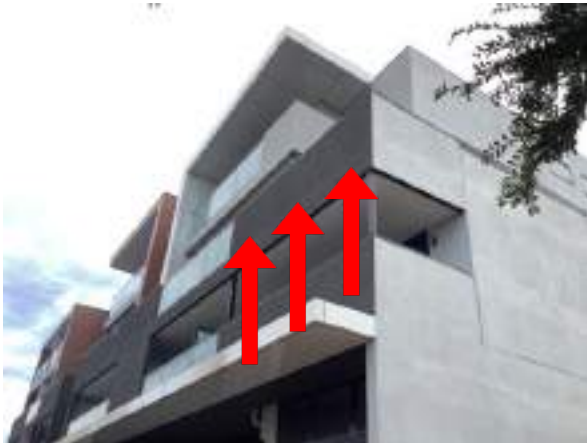
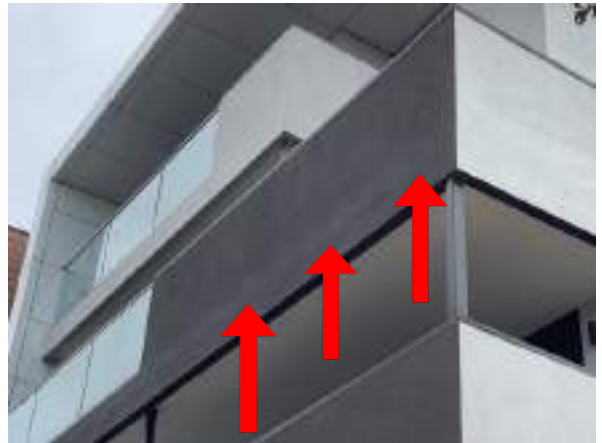
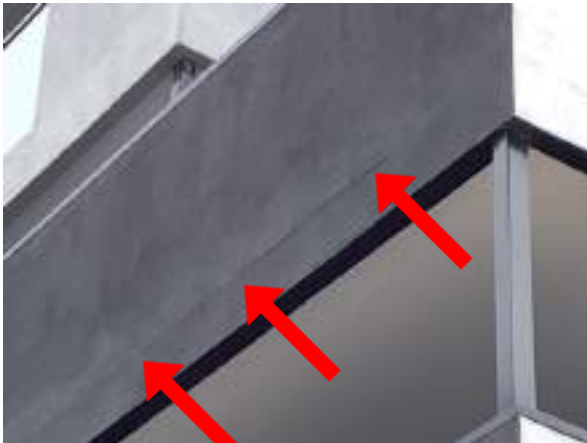
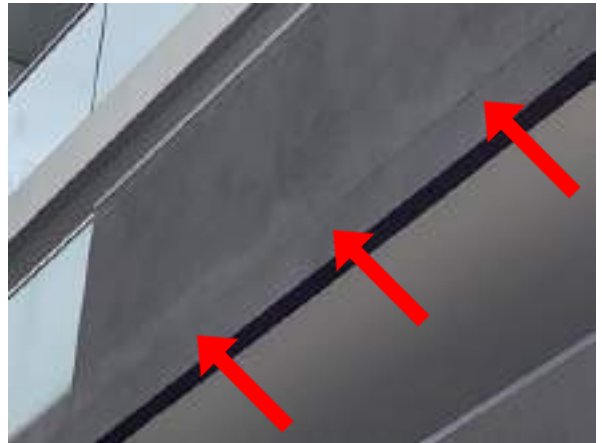
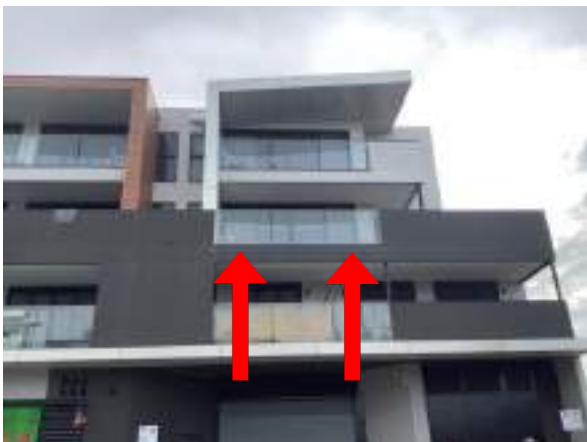
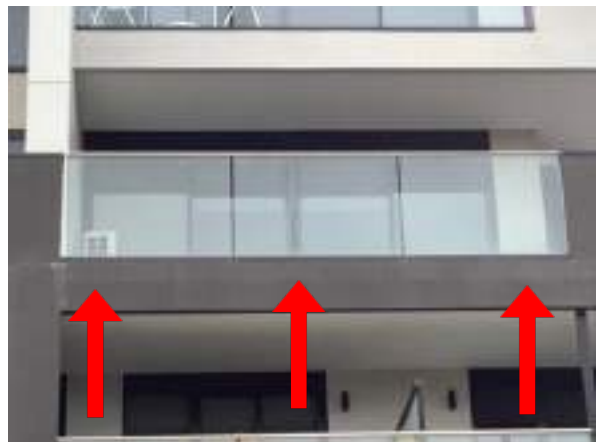
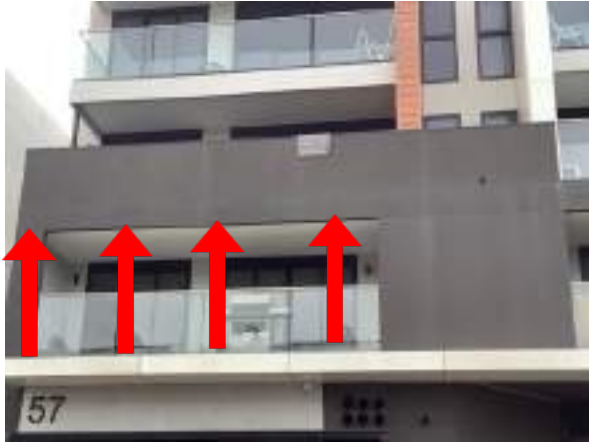
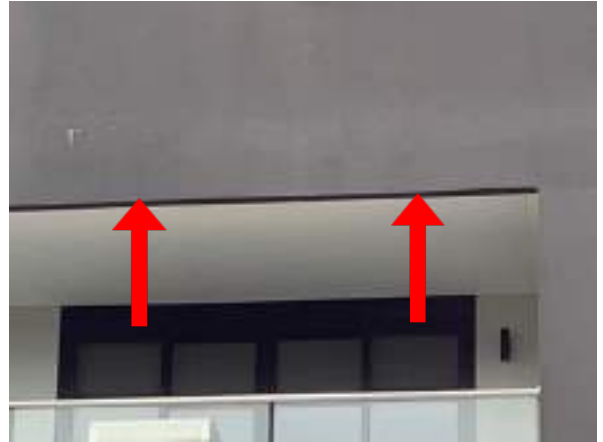
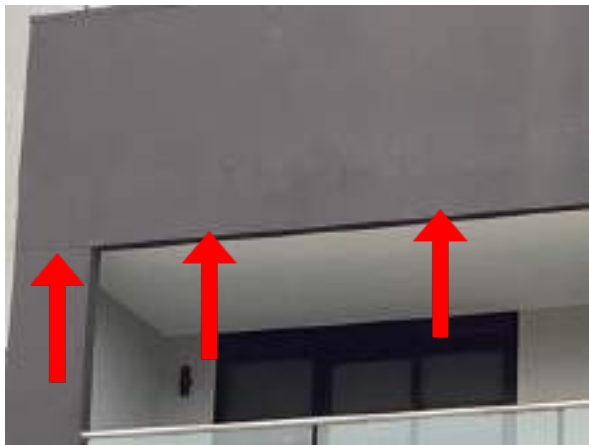
For your information 4.02

Location: Exterior East Side

Finding: Exterior East Side
Various Cracking

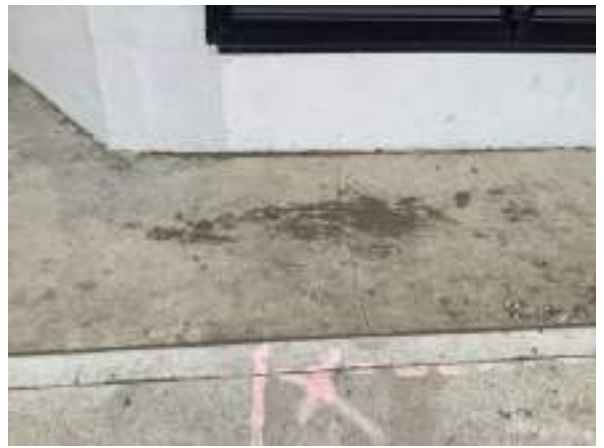
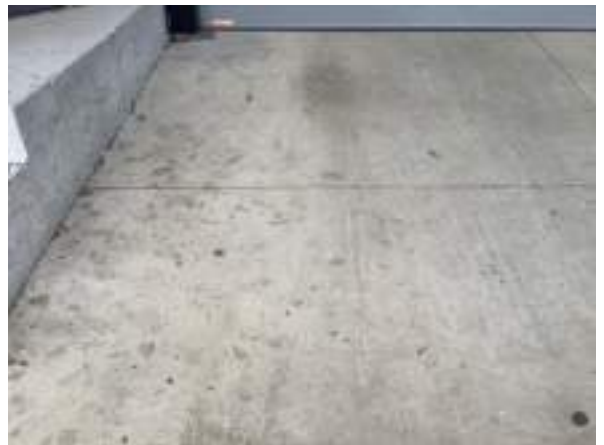
For your information 4.03

Location: Exterior East Side
Finding: For Your Information
Lower story, for your information.

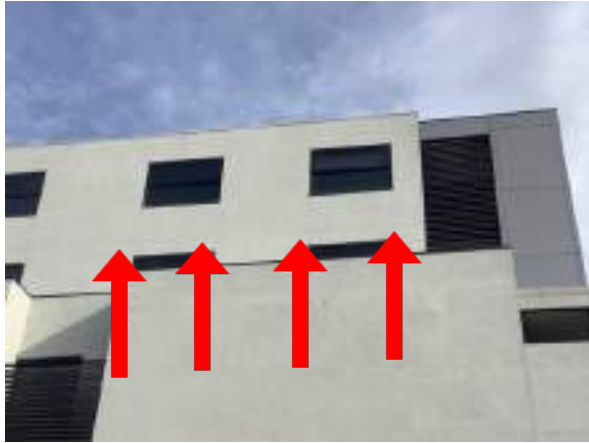
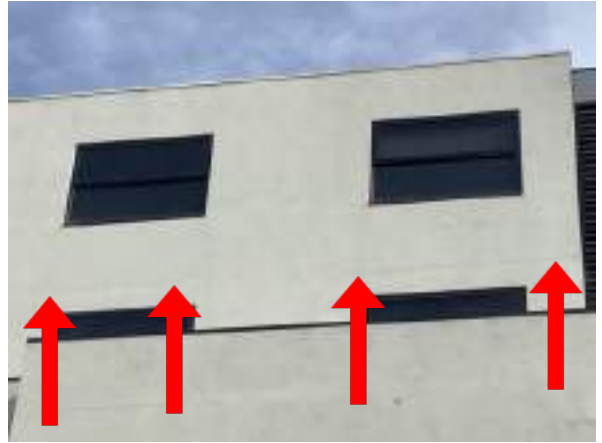
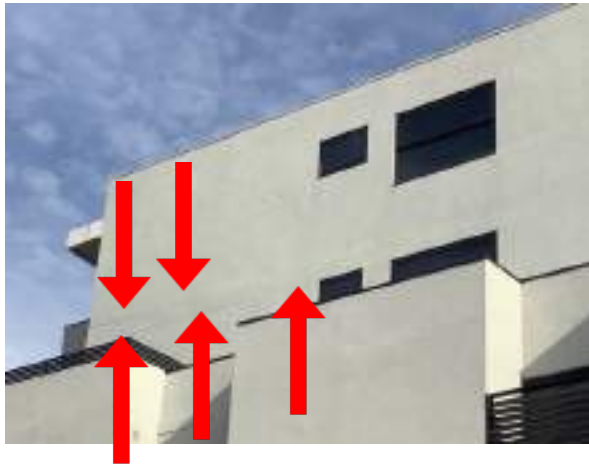
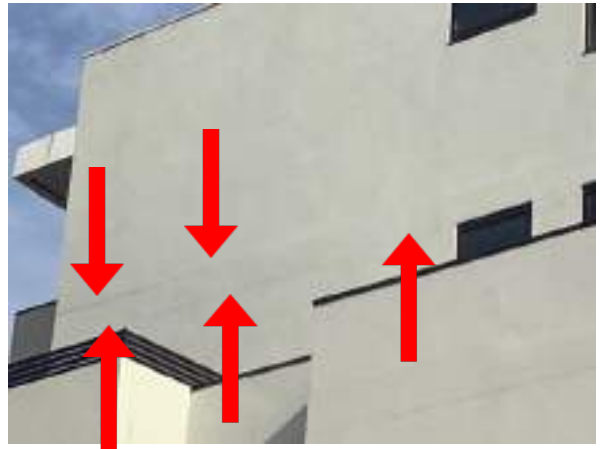
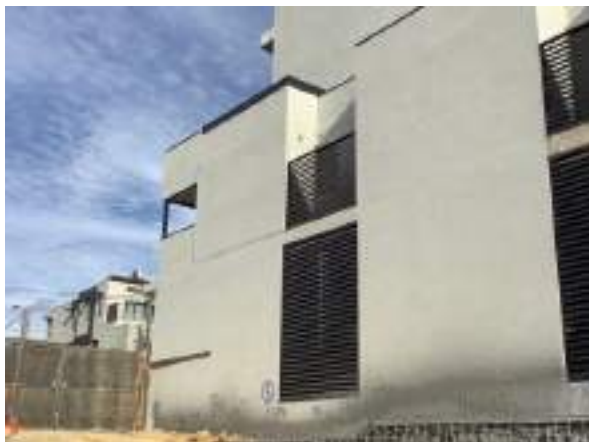
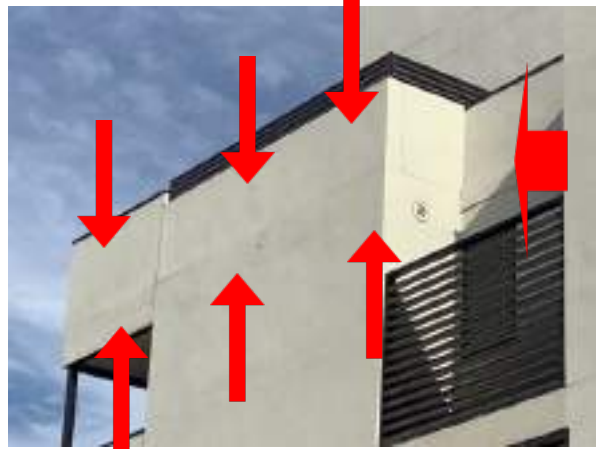
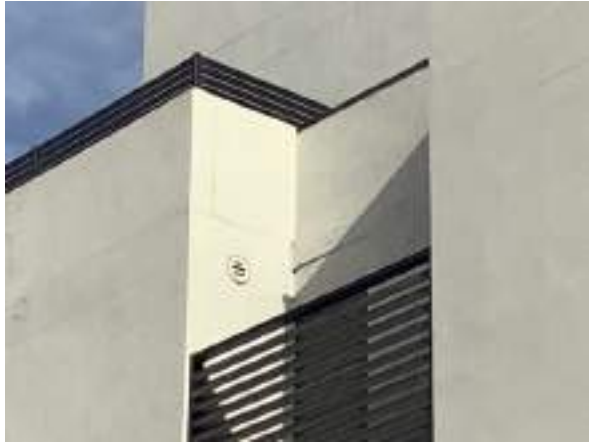
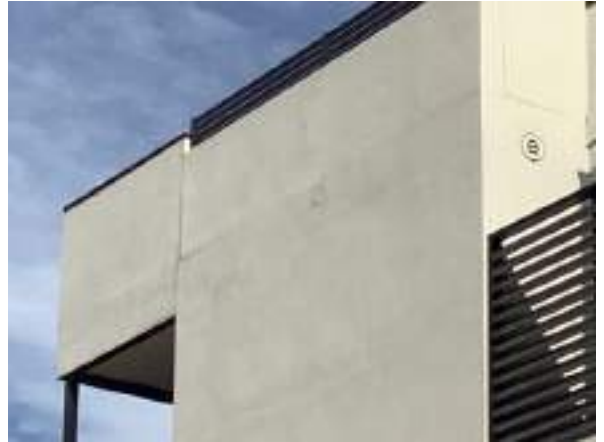
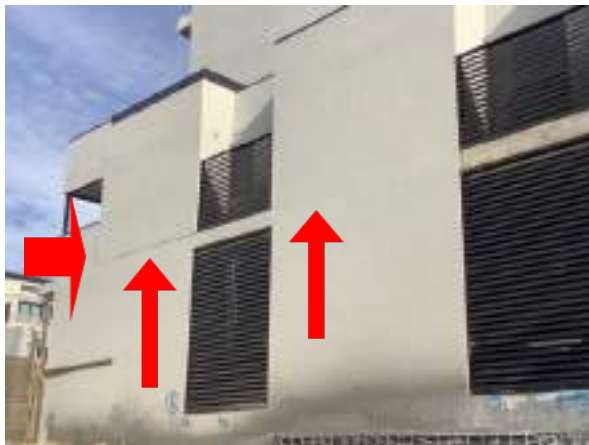
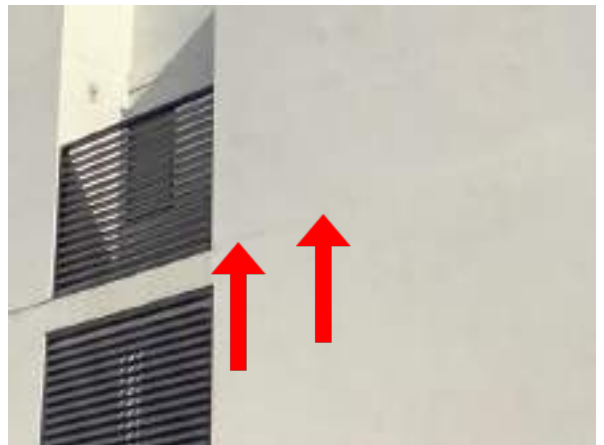
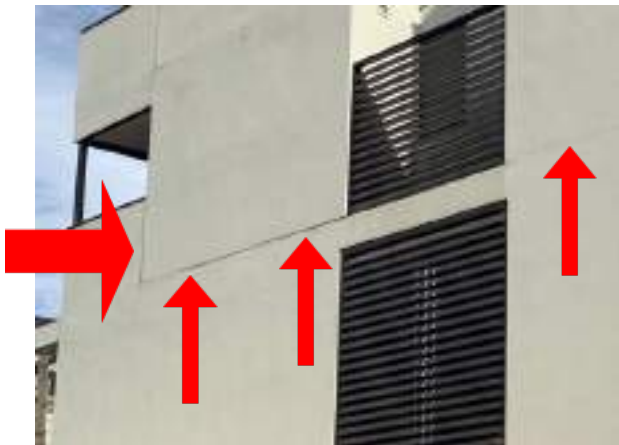
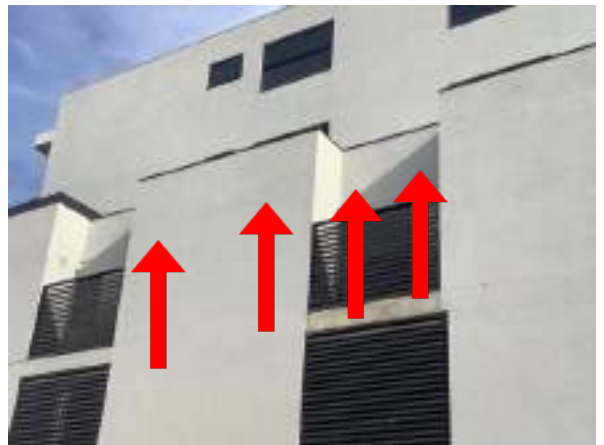
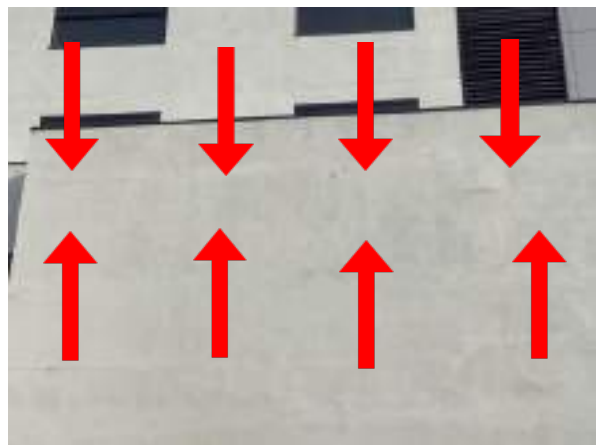
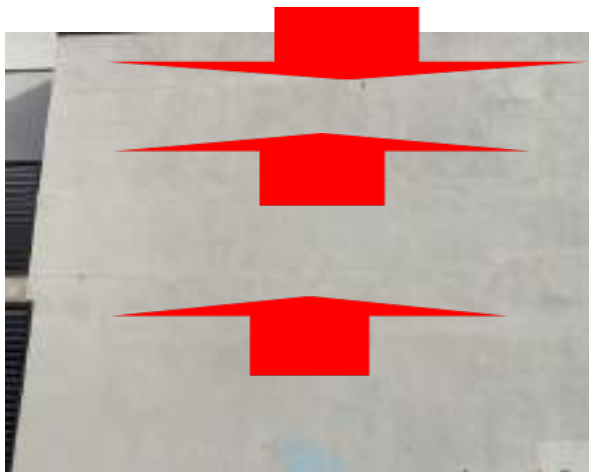
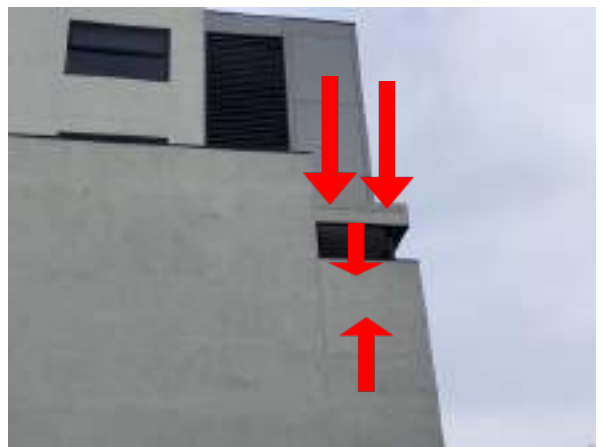
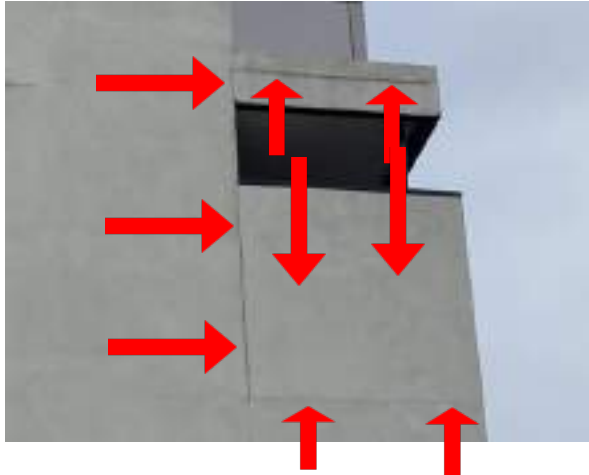
For your information 4.05

Location: Exterior North Side
Finding: Various Cracking
Various cracking to North Side

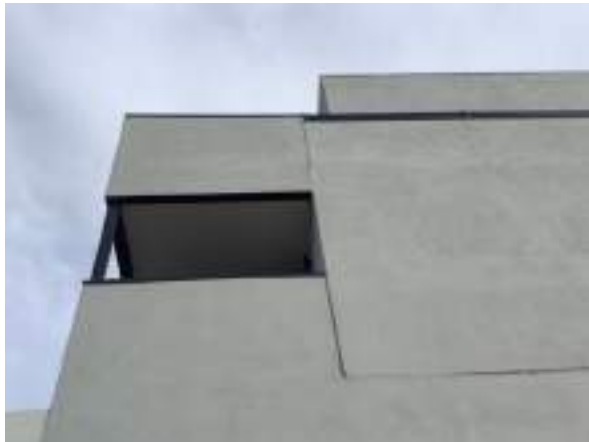
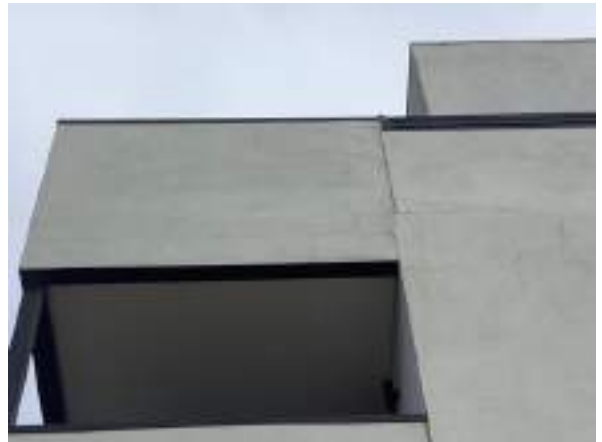
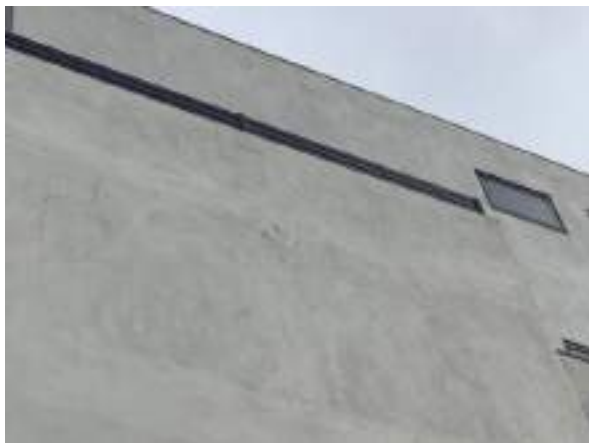
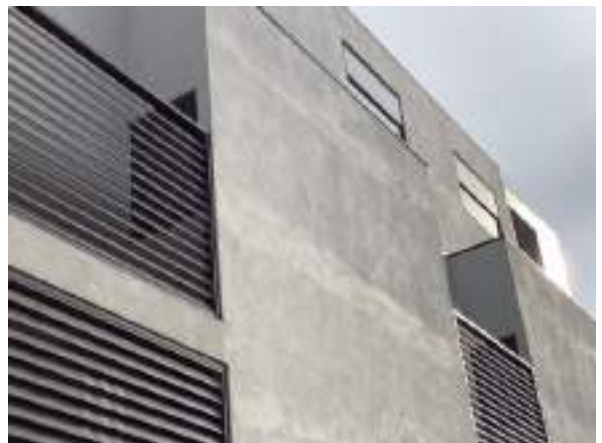
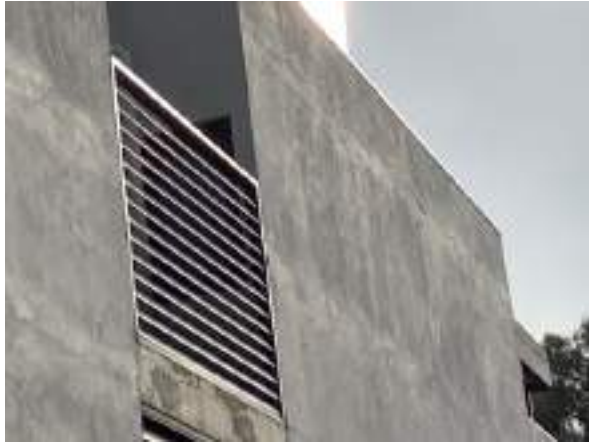
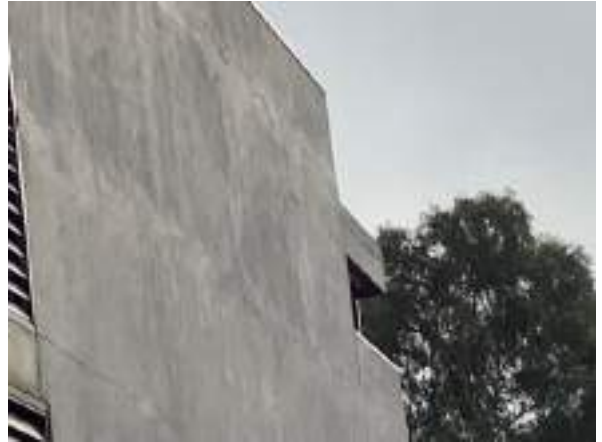
For your information 4.06

Location: Exterior North Side

Finding: For Your Information
Site Photos of cracks which have already been noted with arrows, These are just additional photos from a different angle.

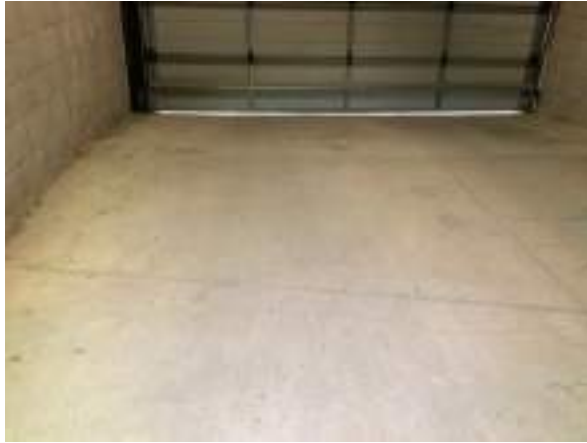
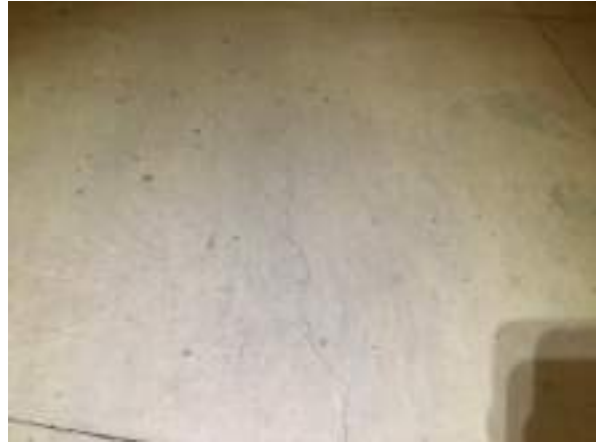
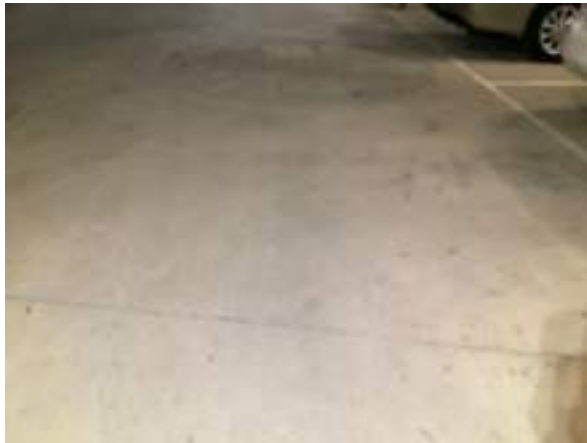
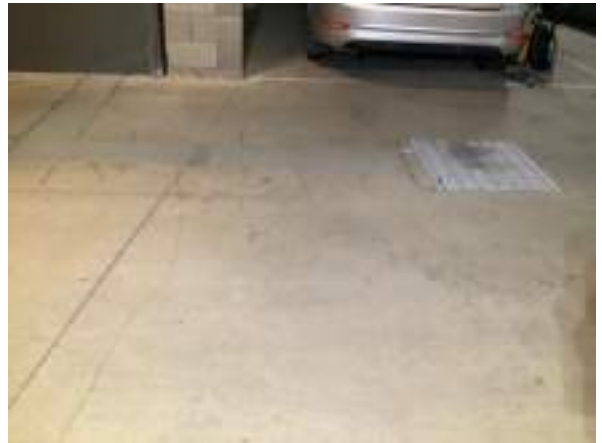
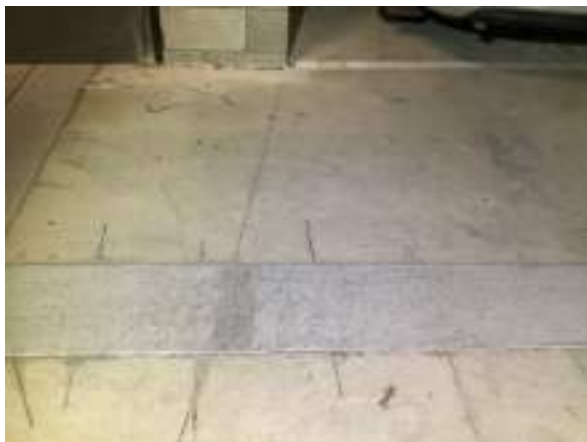
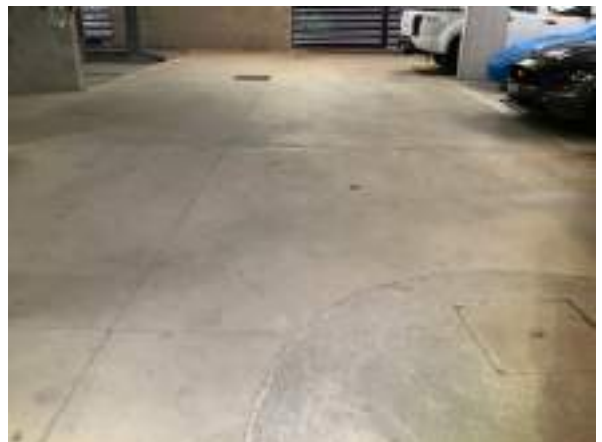
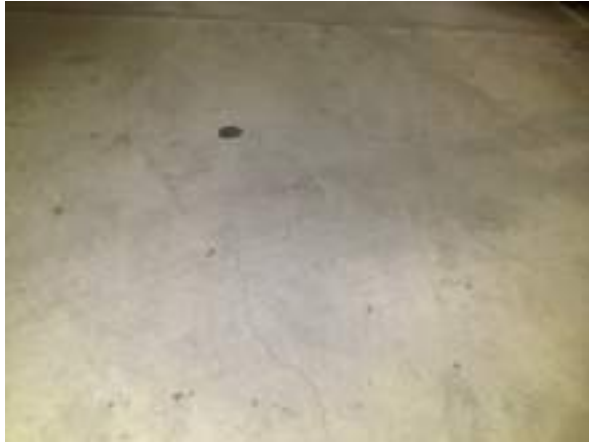
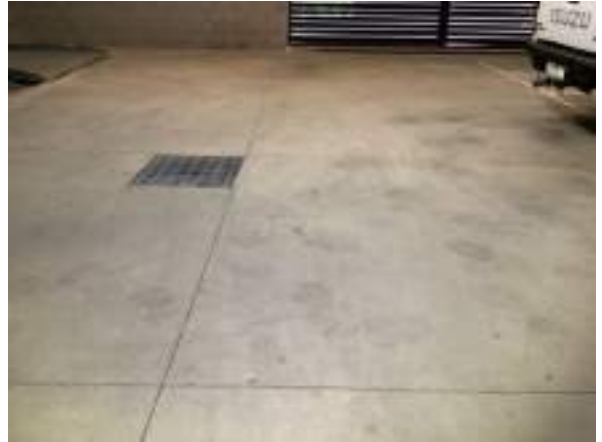
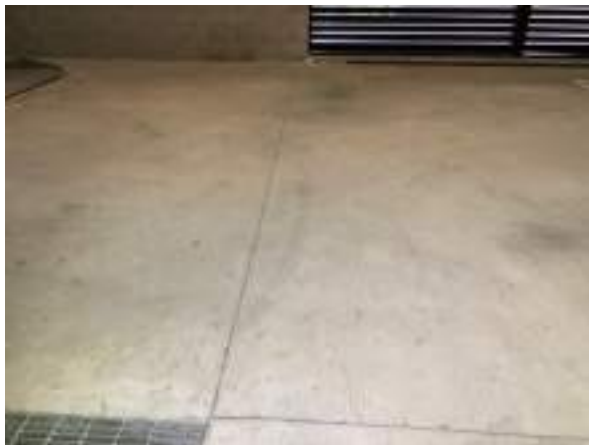
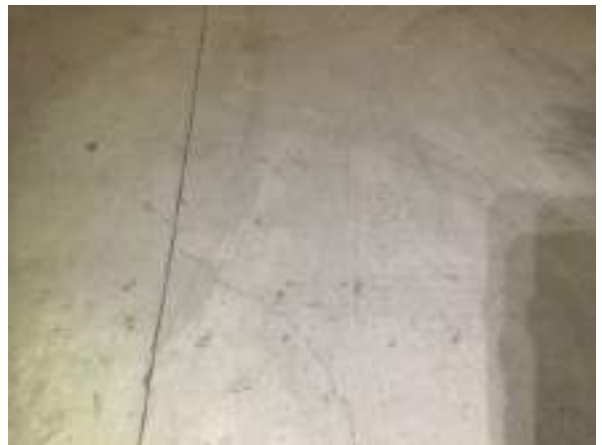
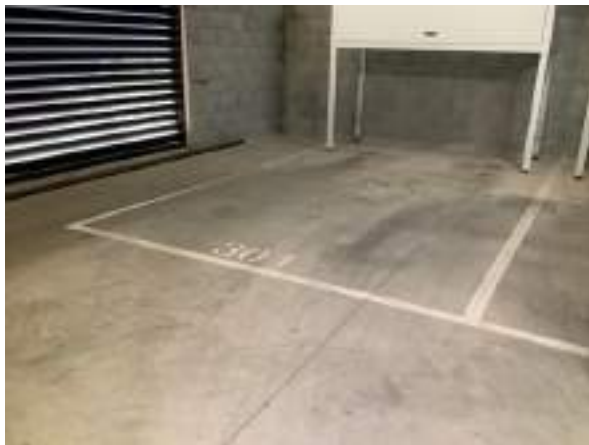
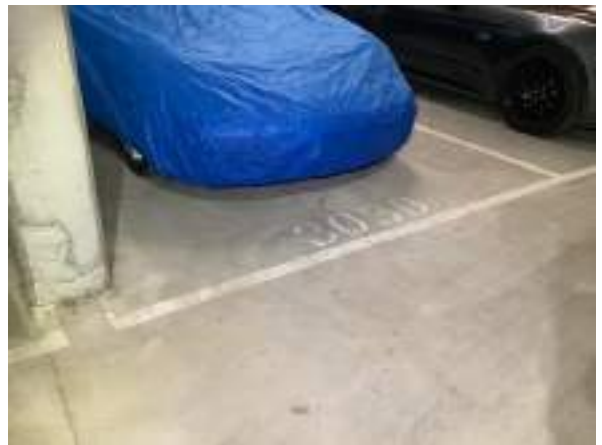
For your information 4.10

Location: Car Park
Finding: Concrete Flooring
For your information, minimum typical cracking.

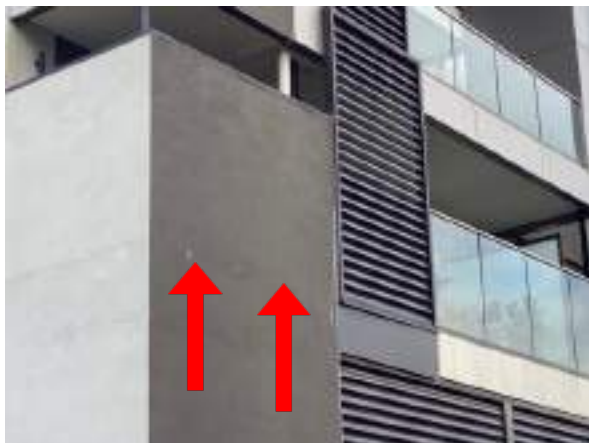
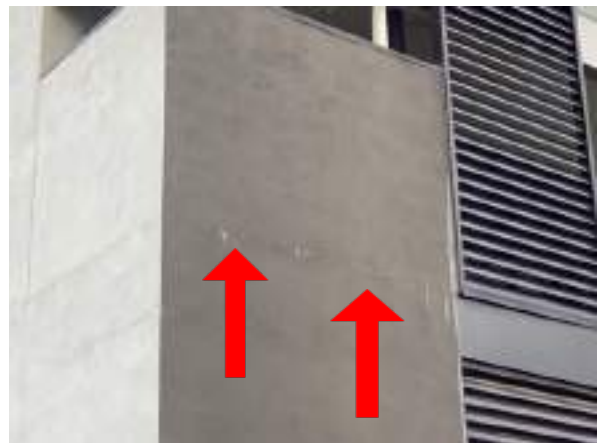
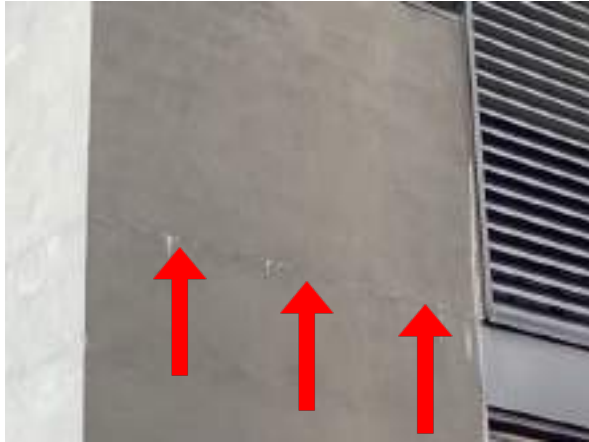
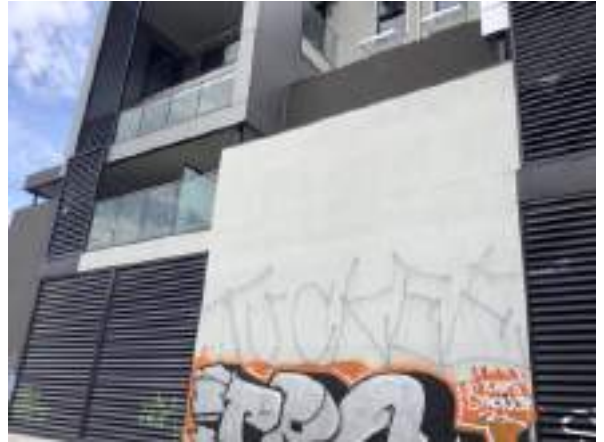
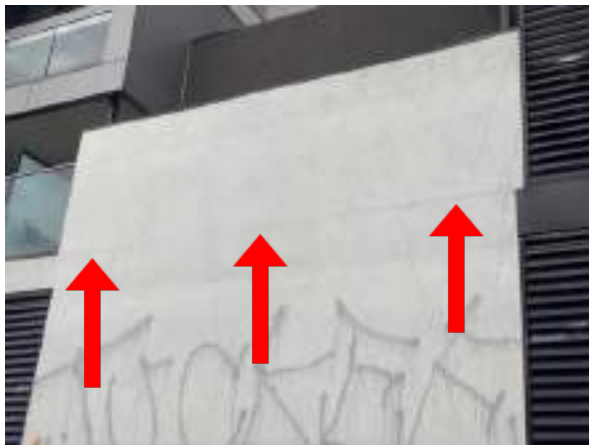
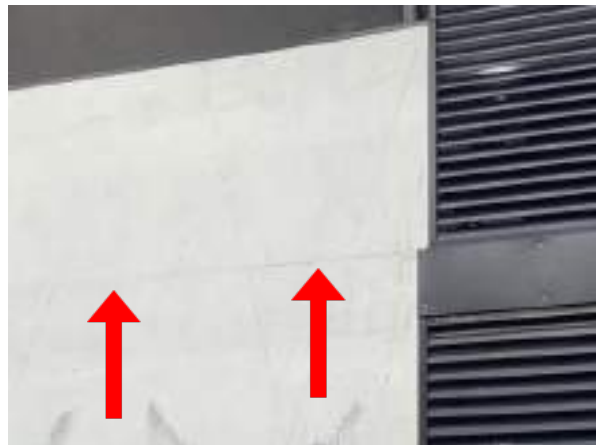
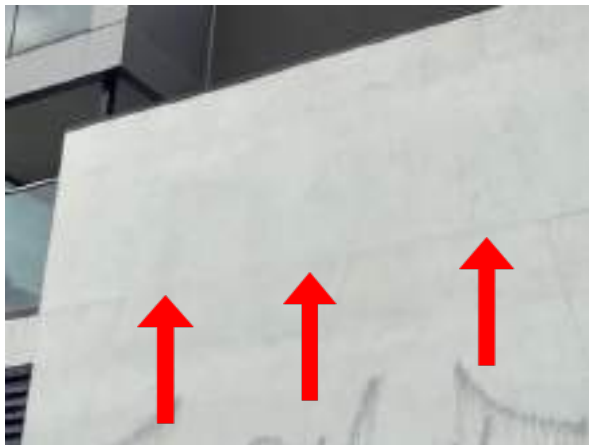
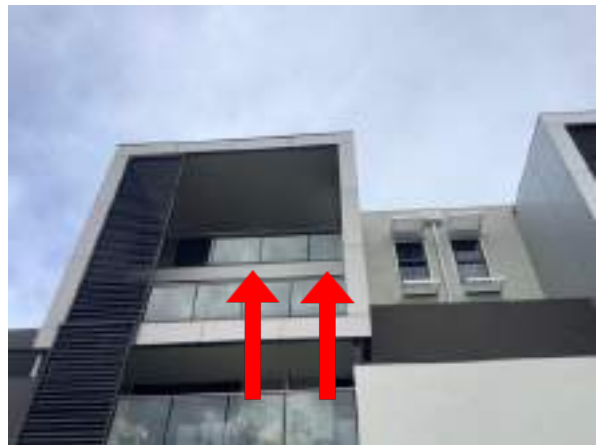
For your information 4.13

Location: Exterior West Side
Finding: Exterior Cracking
Exterior Cracking
