## **New Construction-Handover Report (Luxury Town House)**

Inspection Date: 26 Mar 2020

Property Address: CBD Area

Report Type: New Home Construction

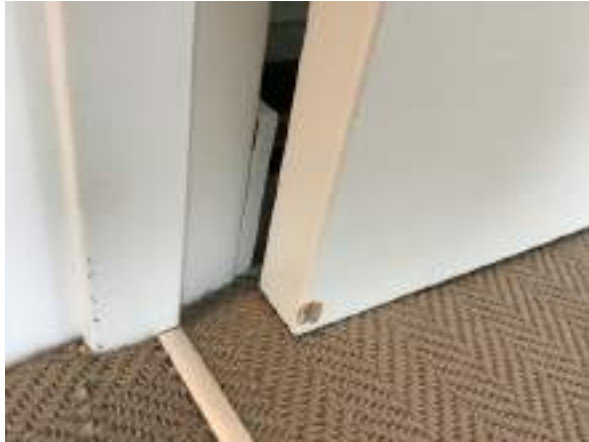
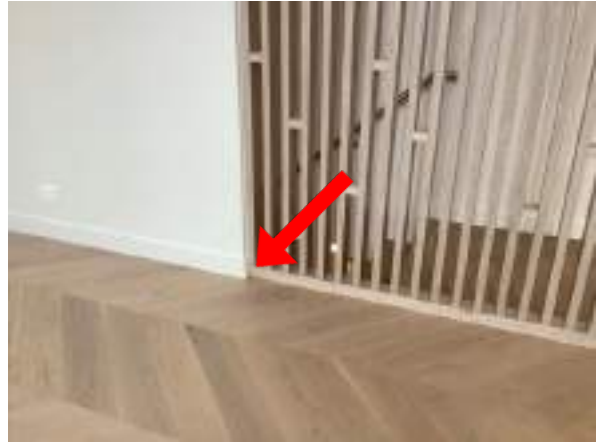
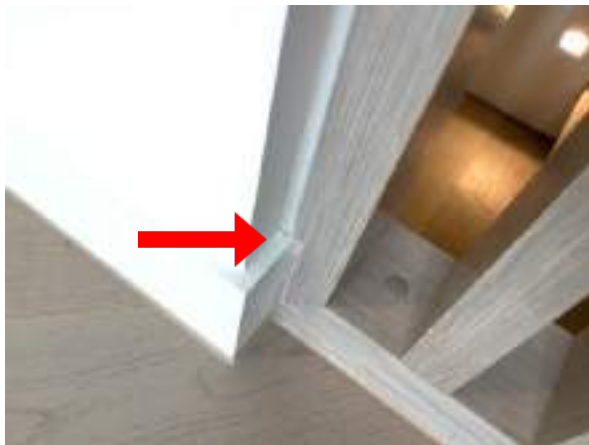
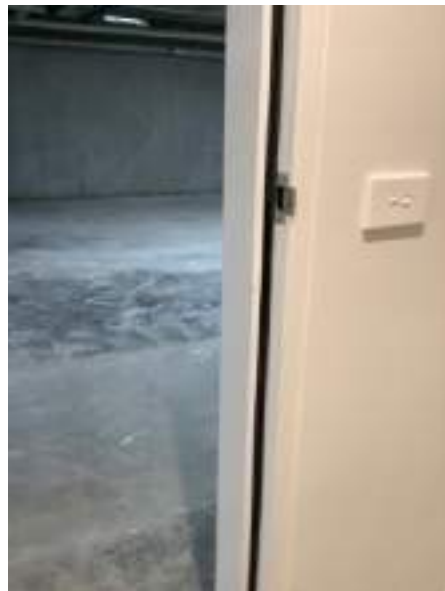
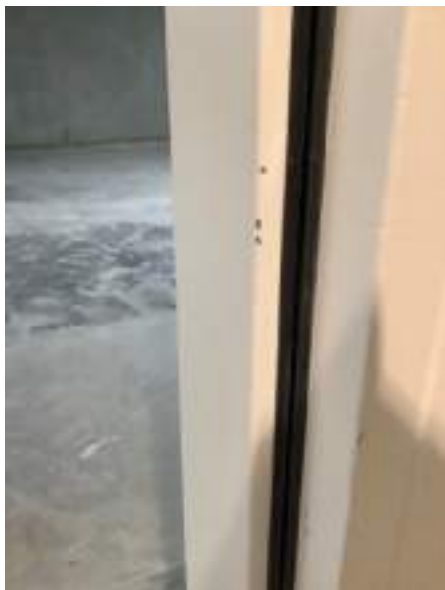
## Non Compliant 2.03

Finding: Painting - Defective (AS2311)

The paint work is inconsistent with orange peel in some areas and smooth in others or chips, scratches, runs and or imperfections.

Areas were identified where the surface finish of the painting was found to be defective. This includes areas of minor blemishes, missing painting, over-painting, paint runs, sags , lack of paint and/or wrinkling of paint finish.

These finishes should be sanded back, filled, levelled and painted as applicable. The painting contractor should be appointed to perform the necessary works prior to final handover.

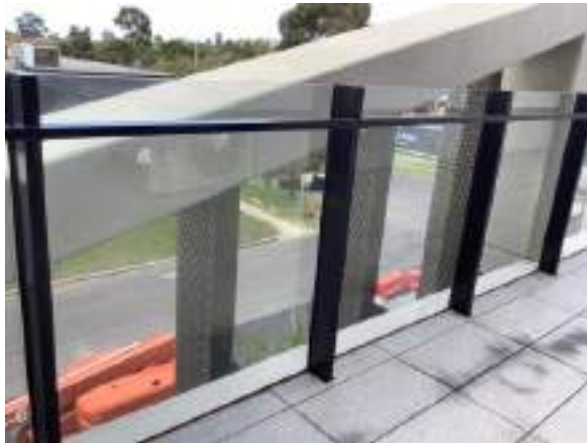
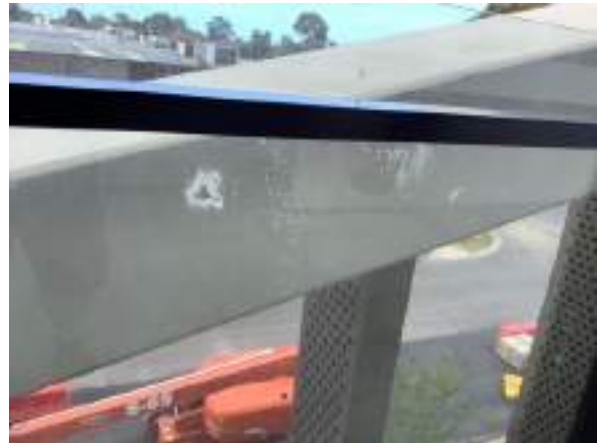
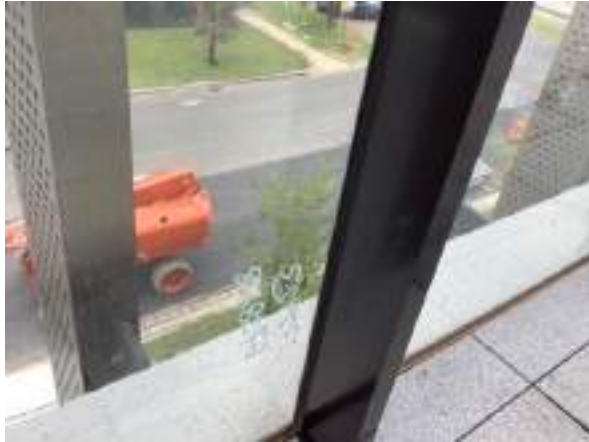
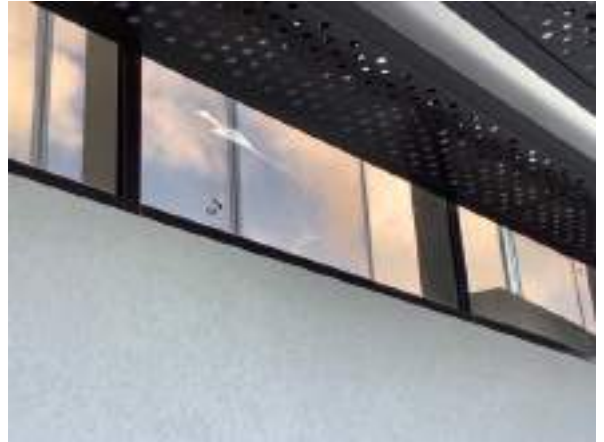
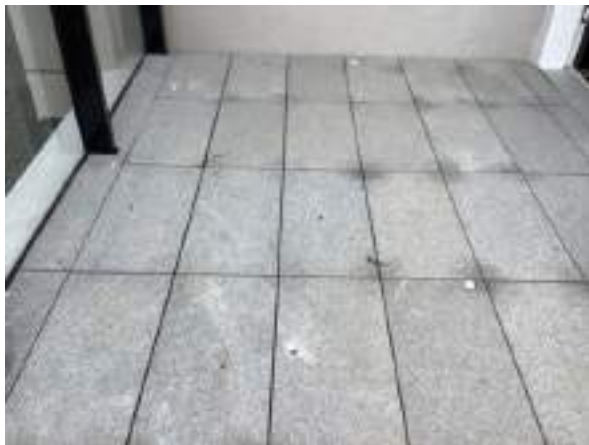
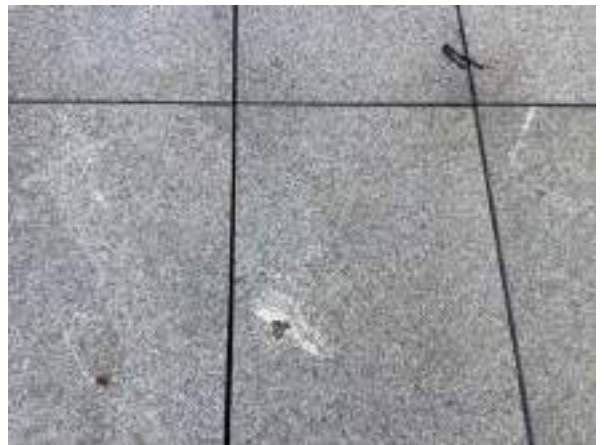
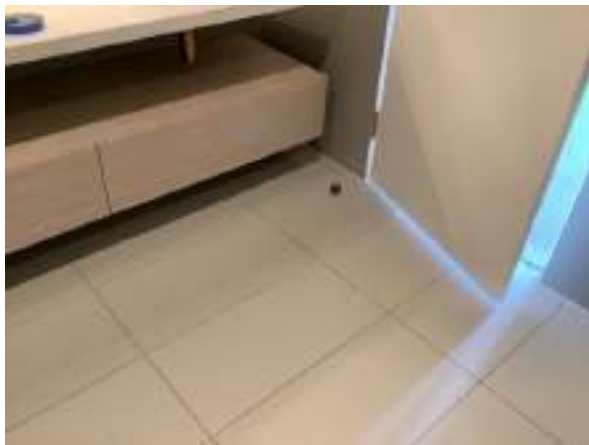
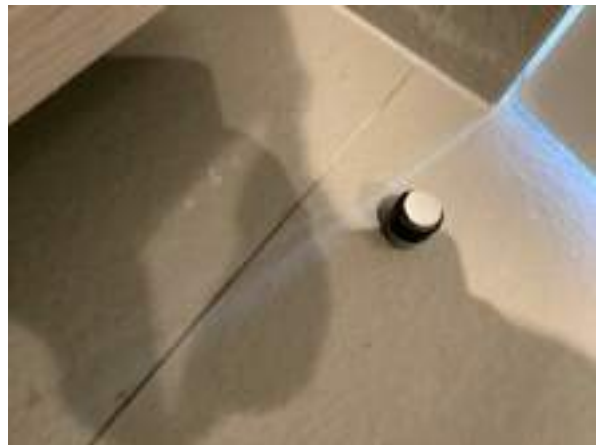
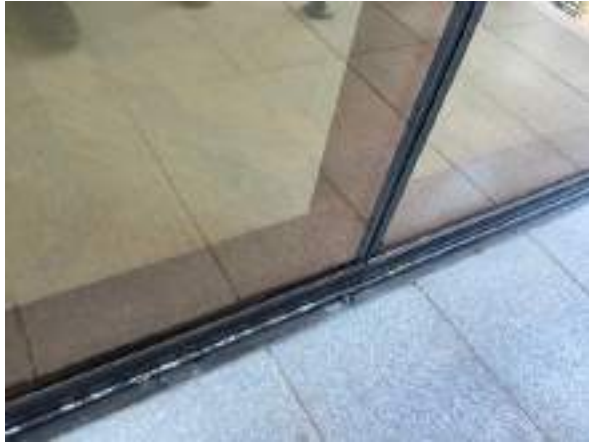
## Non Compliant 2.05

Finding: Cleaning Defective - Floors, Tiles, Glass, Bathroom fittings and fixtures, Etc  
I have ONLY taken LIMITED photos of this defect and attached are LIMITED photos of this defect in SOME AREAS ONLY.  
All AREAS to the entire property should be checked CAREFULLY to identify any further defects that are the same, as this defect is in other areas of the property.

It was identified that the cleanliness and degree of finish for fixtures and fittings is substandard. Fittings and fixtures including sinks and bathtubs are required to be as new prior to handover. Evidence of damage marks scuffs and dirt need to be removed where present.

Once the cleaners have properly completed all of this work, all of the glazing, mirrors, cupboards, baths, shower bases, shower screens, floor coverings, walls, stairs, garage floor, fixtures and fitting etc, should all be thoroughly checked again for any scratches and damage which may have occurred, prior to handover proceeding.

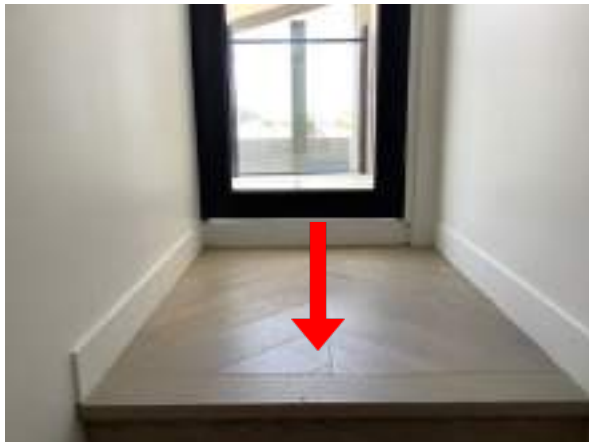
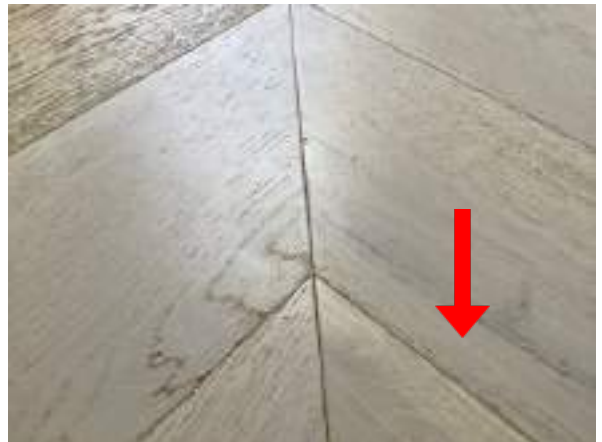
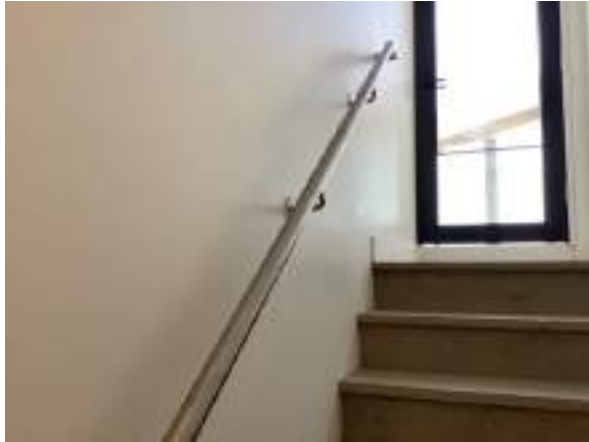
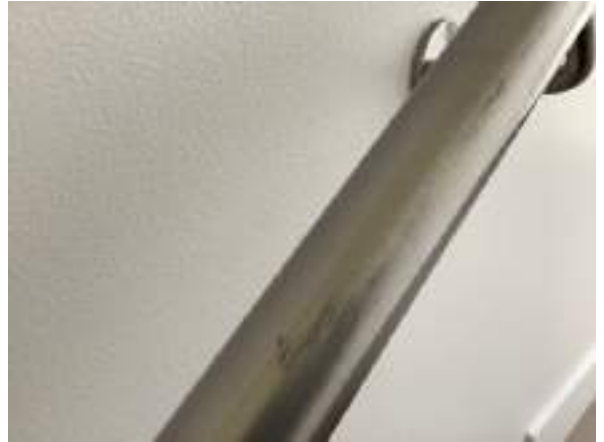
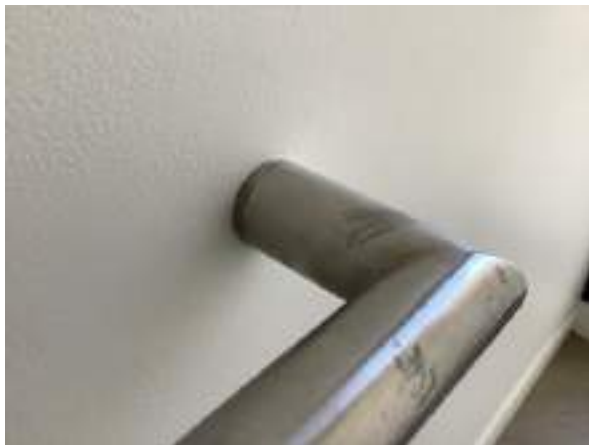
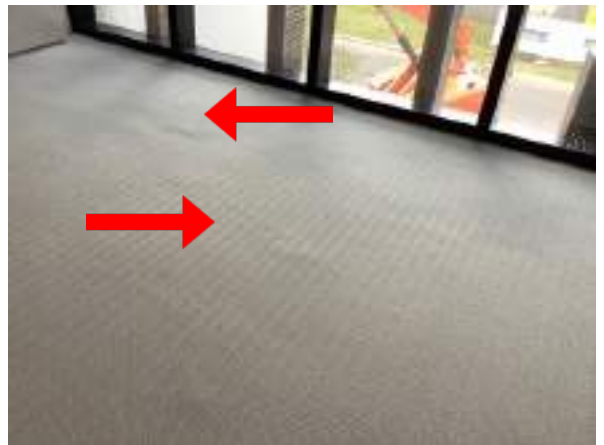
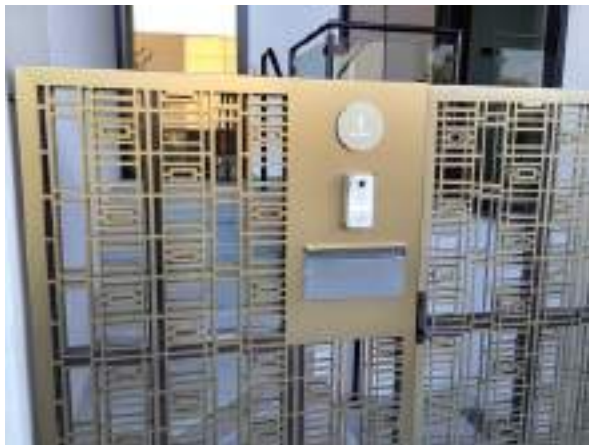
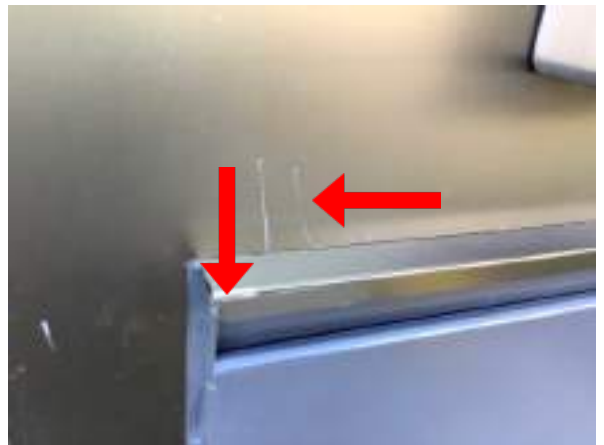
## Non Compliant 2.06

Finding: Damages/ Faults - Appliances / Fittings / Tiles, Etc  
All areas to the entire property should be checked carefully to identify any further defects of the same type.

It is identified that damage or faults affecting tiles, appliances and / or fittings supplied as part of the building contract have occurred. Where this is due to the builder's workmanship or damage occurring during construction it is considered a defect with respect to Standards and Tolerances - 18.02.

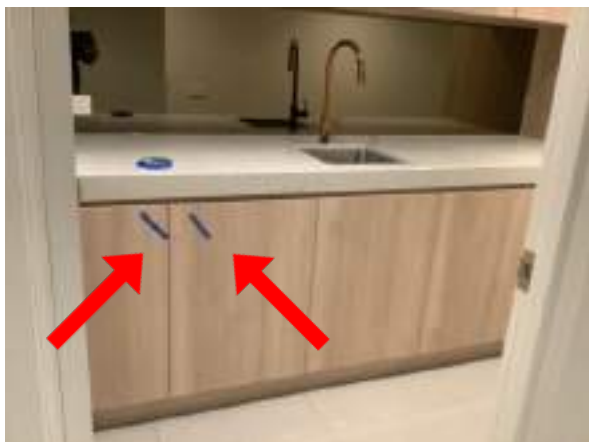
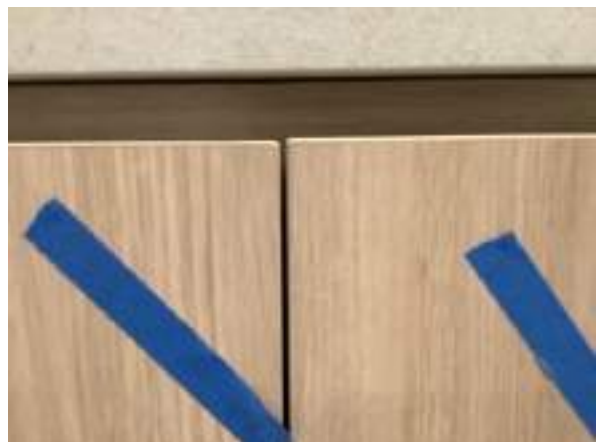
## Non Compliant 2.07

Finding: Cabinet doors - misaligned

It is observed that some of the cabinet doors are not aligned and / or have inconsistent gaps between the doors.

It is observed that some of the cabinet drawers are not aligned and / or have inconsistent gaps between the drawers.

The gaps around the door vary in their finished widths.

The gaps around these doors must be adjusted to comply with this tolerance.

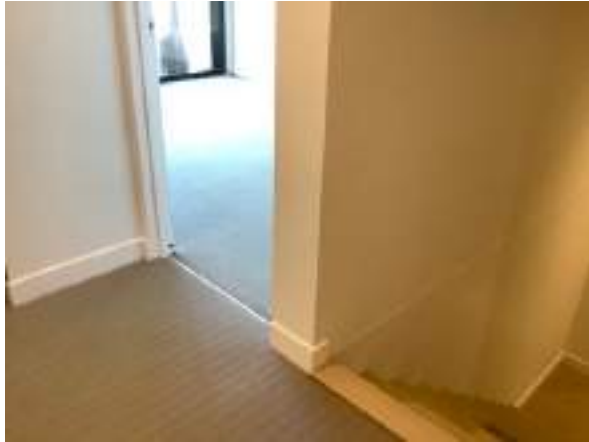
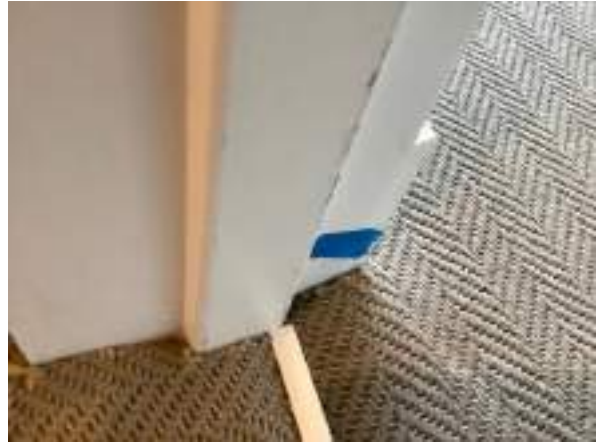
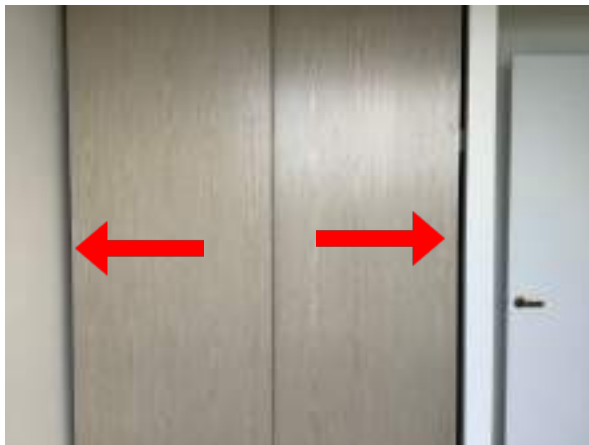
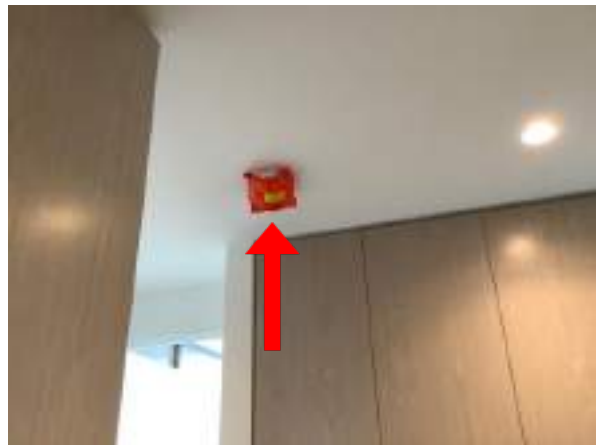
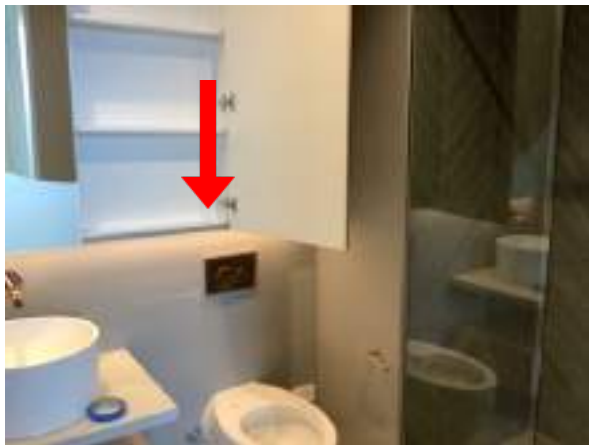
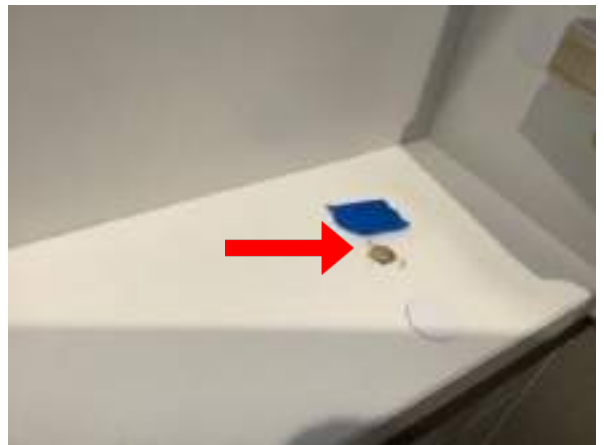
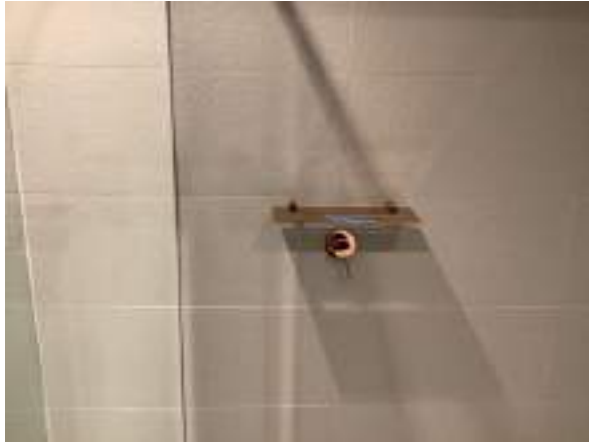
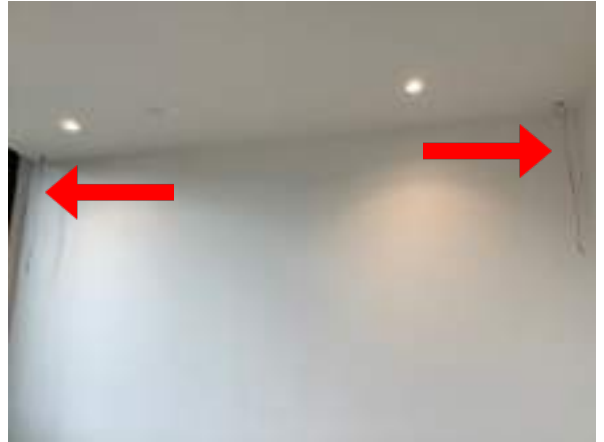
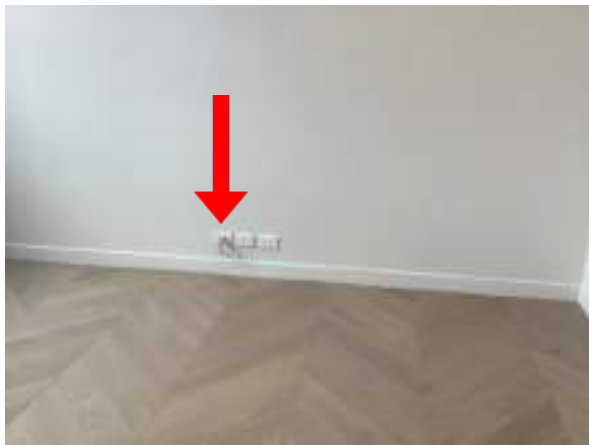
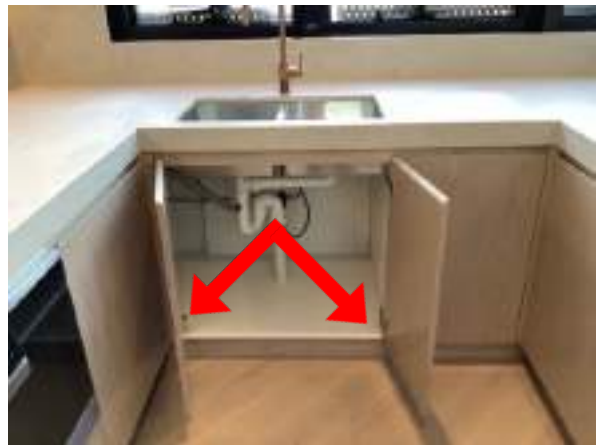
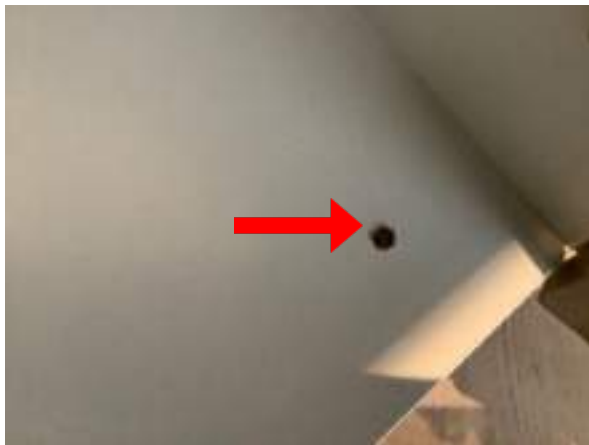
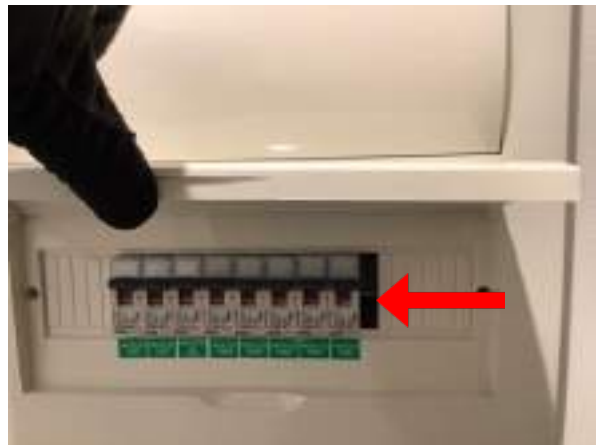
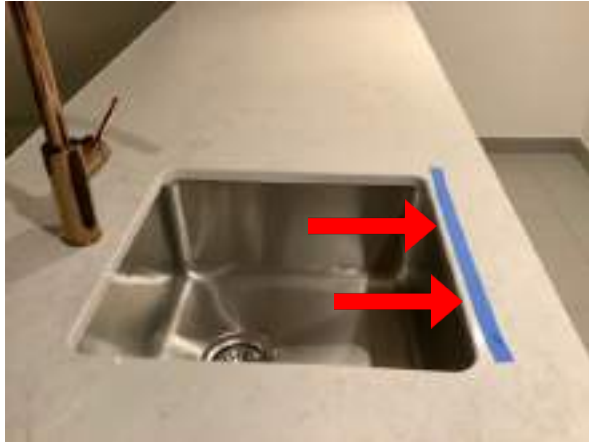
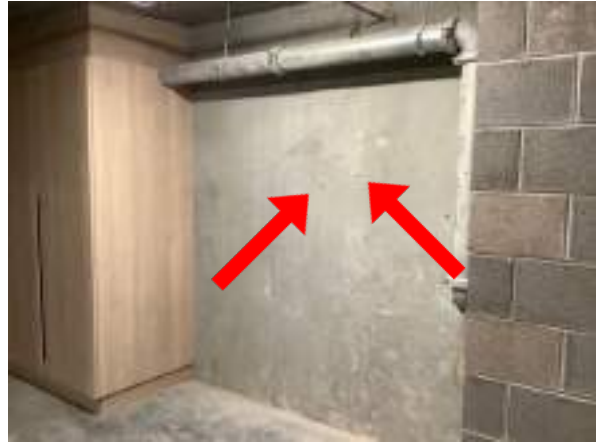
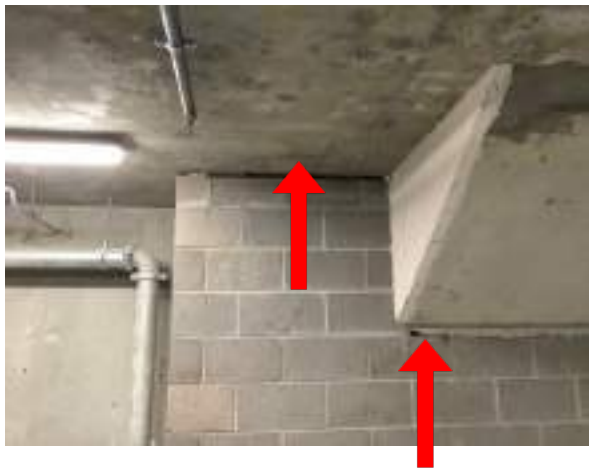
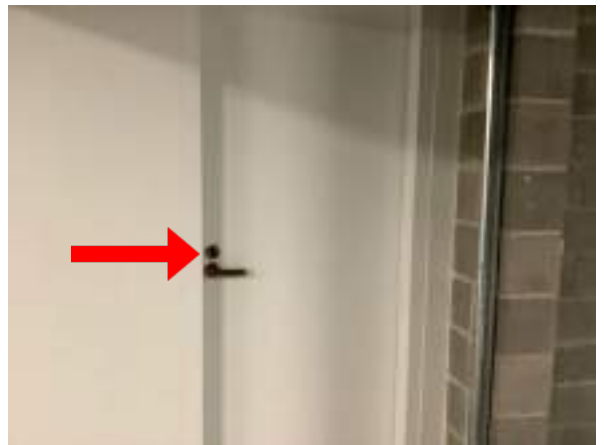
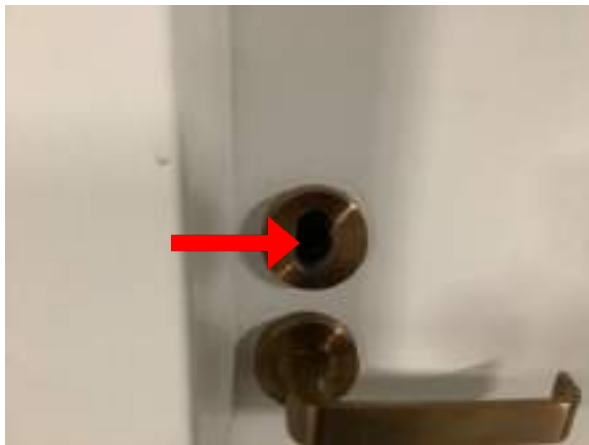
## Non Compliant 2.08

Finding: Internal - Unfinished/Defective Works - Additional Photos  
These items have been inspected in order from the top level working down towards the lower level.

All these photos are added in to demonstrate DEFECTIVE / SUB STANDARD and/or INCOMPLETE WORKS and they are all required to be rectified as they are ALL not satisfactory for Handover as per the DOMESTIC BUILDING CONTRACT ACT 1995 as stated above.

The following items will need to be completed or repaired in accordance with the Domestic Building Contracts Act 1995.

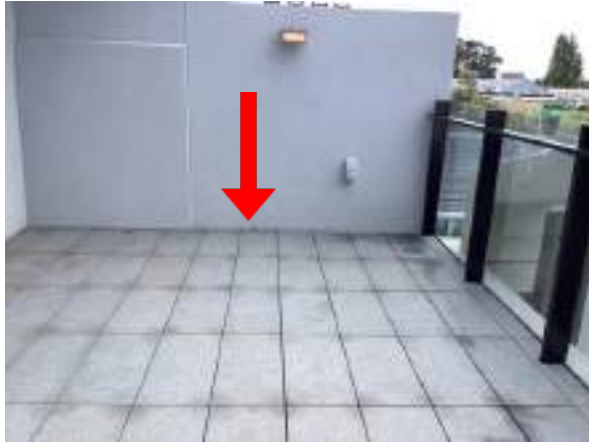
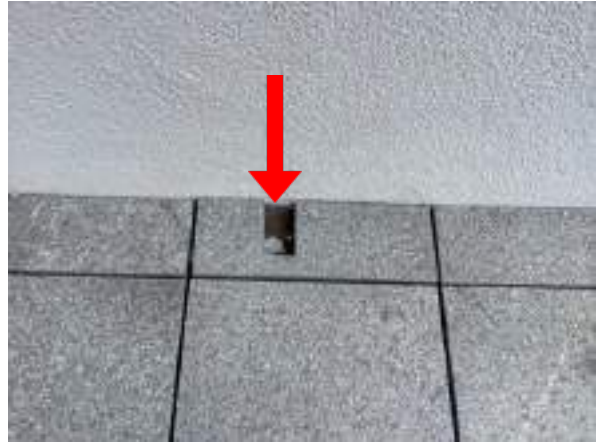
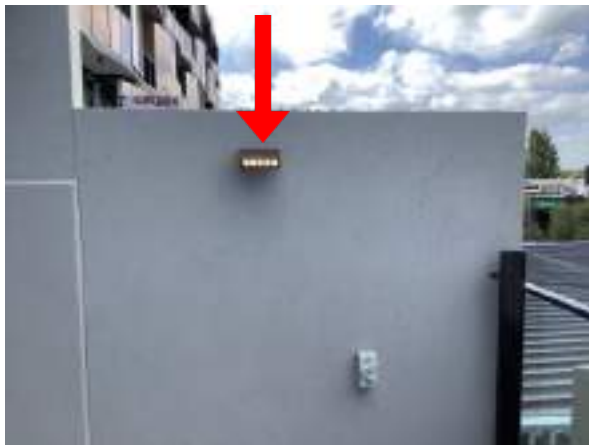
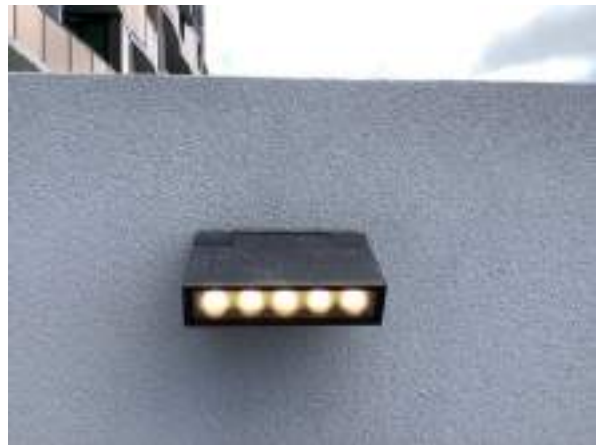
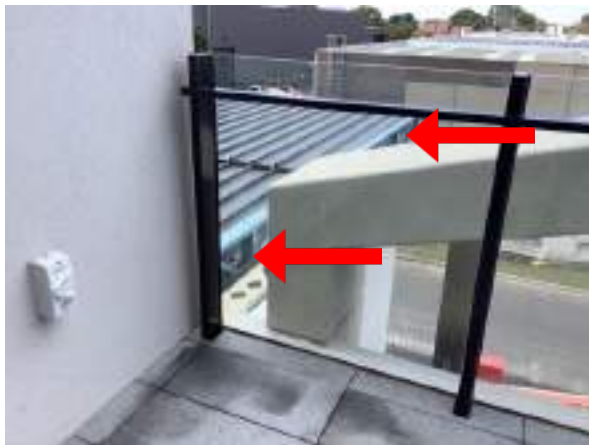
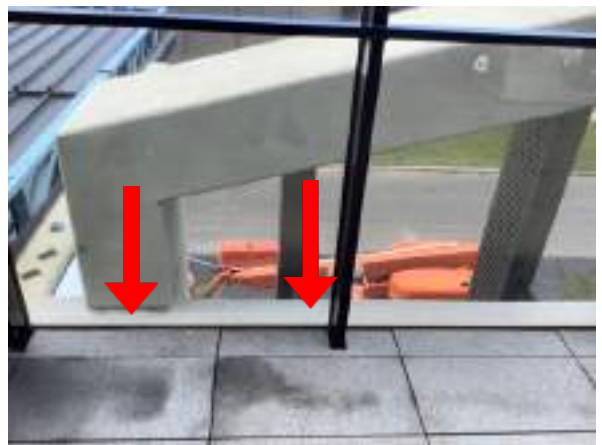
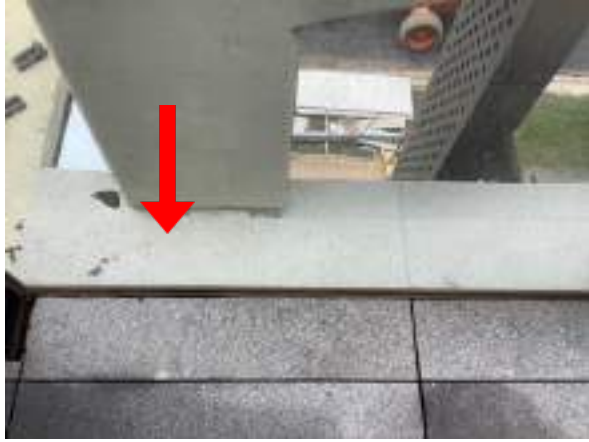
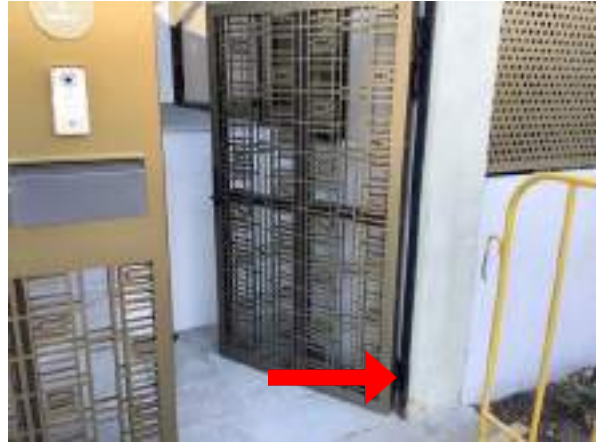
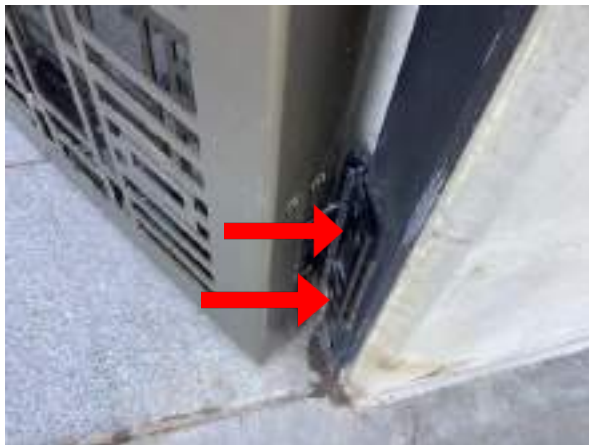
## Non Compliant 2.09

Finding: External - Unfinished/Defective Works - Additional Photos

All these photos are added in to demonstrate DEFECTIVE / SUB STANDARD and/or INCOMPLETE WORKS and they are all required to be rectified as they are ALL not satisfactory for Handover as per the DOMESTIC BUILDING CONTRACT ACT 1995 as stated above.

The following items will need to be completed or repaired in accordance with the Domestic Building Contracts Act 1995.

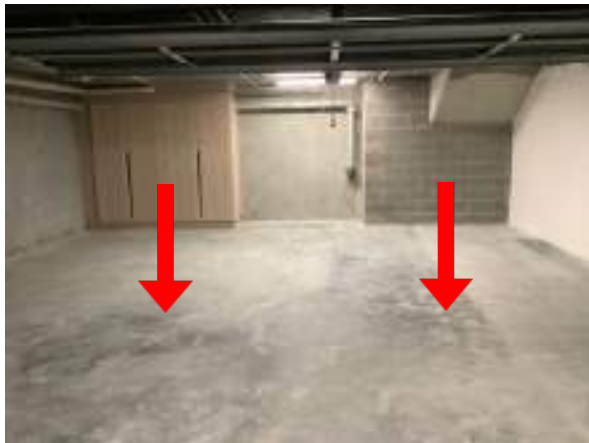
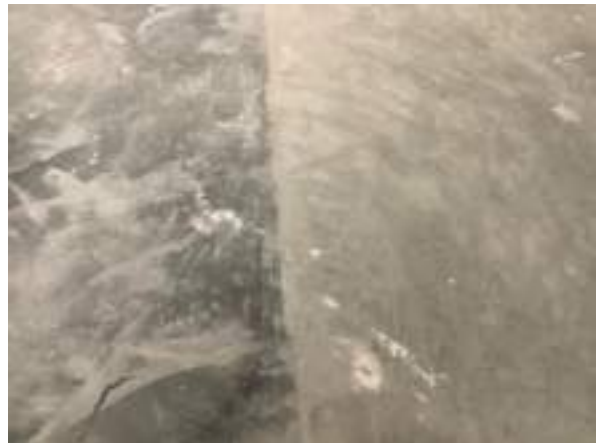
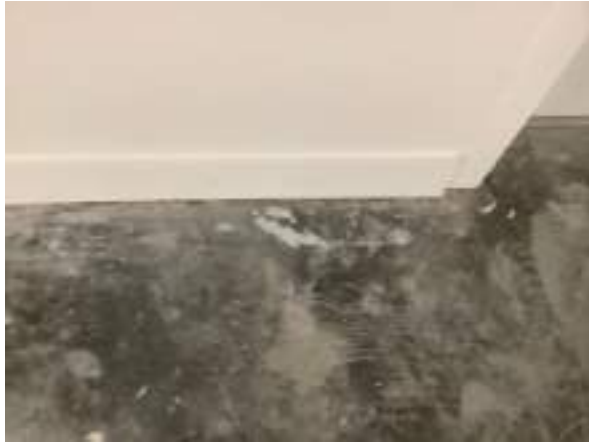
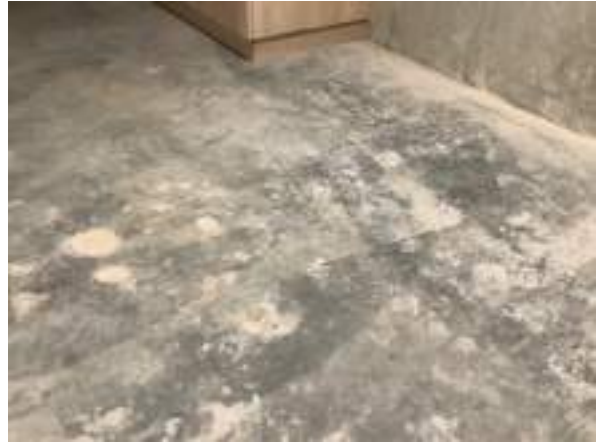
Location: Garage

Finding: Concrete Floors Damaged / Chipped / Marked / Paint, Etc - Non Compliant  
Areas where the concrete floor has been damaged were identified. The damage consists of deep gouges chips and scrape and associated marks.  
An acceptable finish consistent with AS 2870 Slabs and Footing Construction requires the surface to be even and consistent in appearance.  
The concrete floors must be presented as new prior to handover.

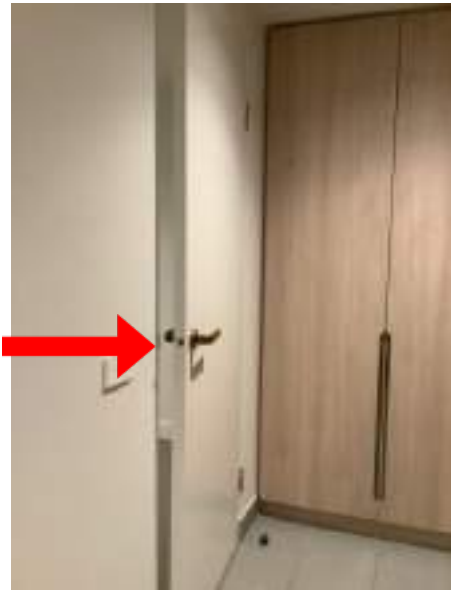
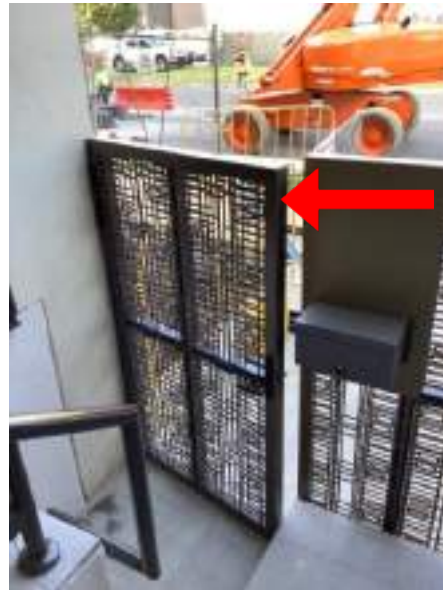
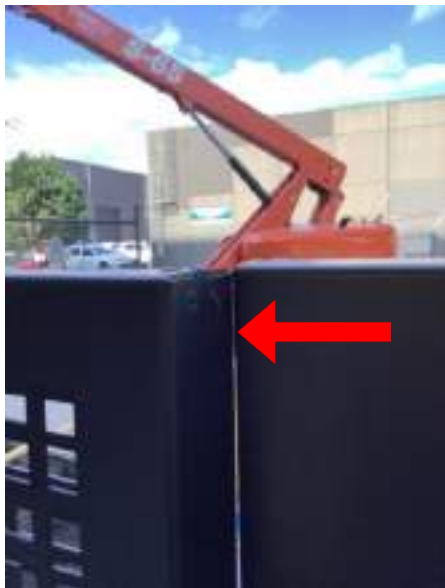
Finding: Door operation - binding and jamming - defective  
Binding and/or jamming of this door is evident during standard operation. This defect inhibits the functionality of the affected door as well as creating potential for secondary defects to associated building elements, such as damage to the floor covering.

A door that binds to flooring or to the associated door frame may have several causes, ranging from minor defects, such as poor installation of the door or deteriorated hinges, through to major structural issues, such as damage to subfloor structures.

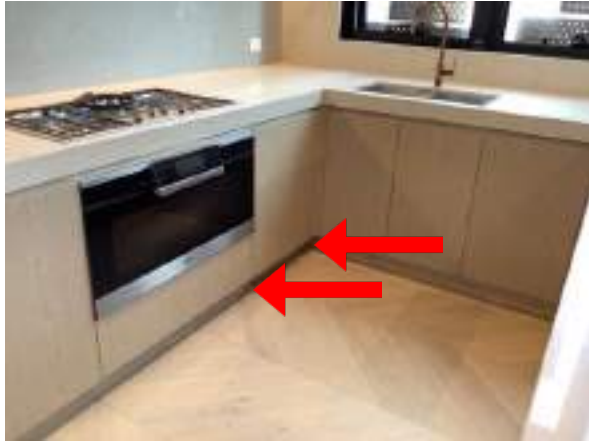
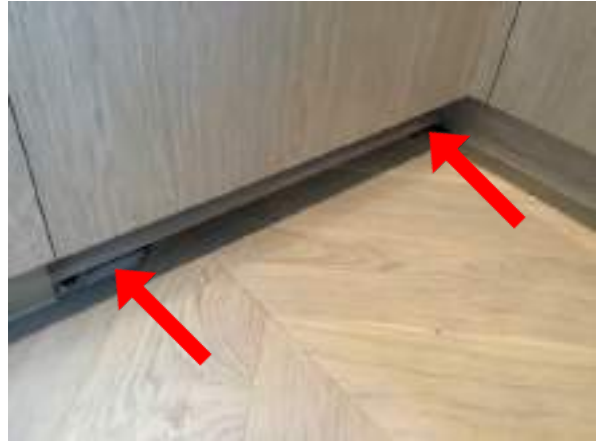
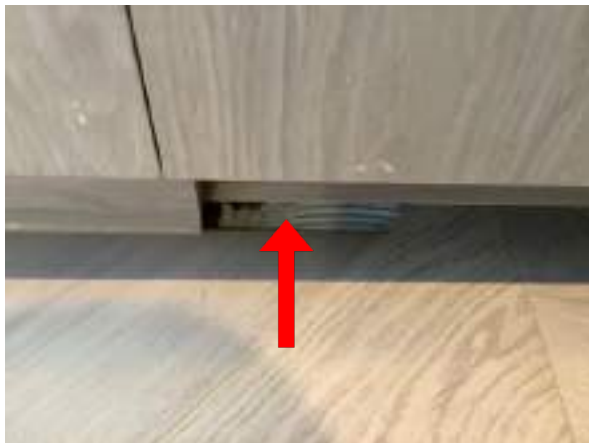
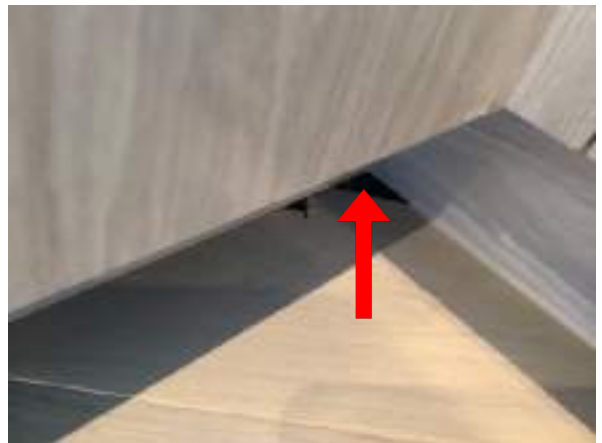
### Substandard Workmanship 3.14

Finding: Kitchen Flooring-Defective Finish

The kitchen flooring as indicated with the arrows is not complete

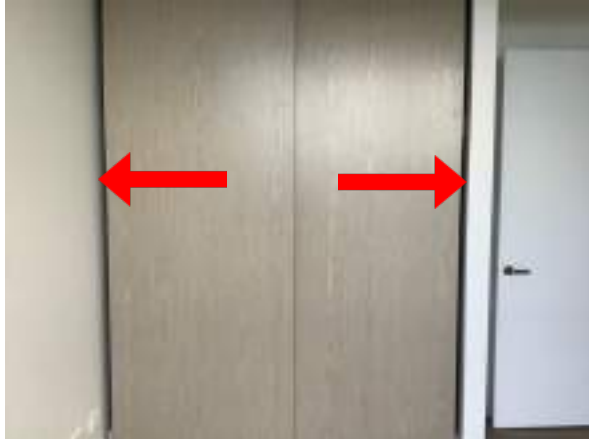
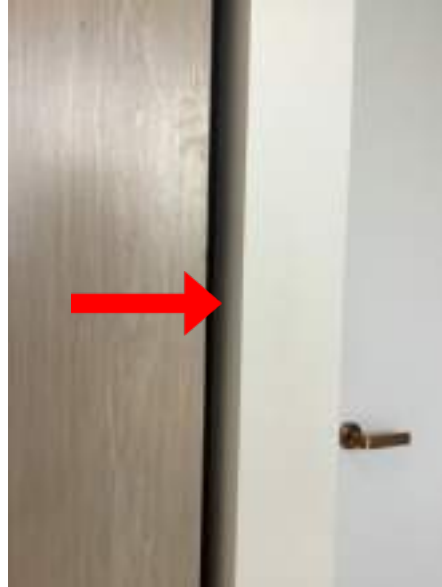
### Substandard Workmanship 3.15

Finding: Sliding doors – require rubber stoppers  
The sliding doors require rubber stoppers of some type, overtime this will damage the plaster and paint. This defect statement is for all areas with sliding doors.

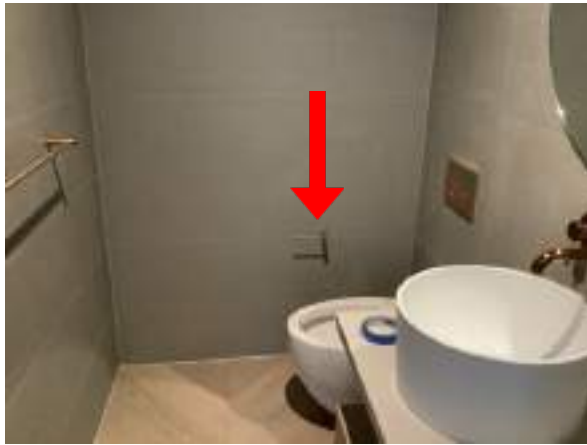
## Substandard Workmanship 3.16

Finding: Toilet roll holder - Loose

The toilet roll holder was found to be loose at the time of inspection. While not a major operational defect, function can deteriorate and cause further damage to the plaster/tiles if the problem is left unmanaged.

These items must be repaired prior to handover

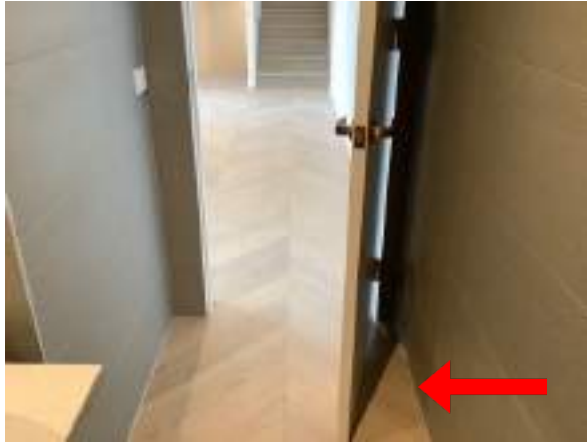
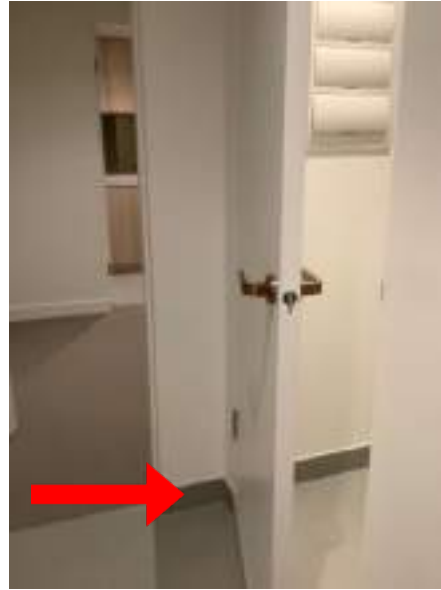
## Incomplete 4.17

Finding: Door Stop - Missing.

The is no door stop to the opening door, leaving the door to swing and hit the wall, or cupboard which will damage the area the door hits and the handle.  
An appropriate door stop is required prior to handover .
