Frame Report

Inspection Date: 8 Apr 2020

New Home Construction

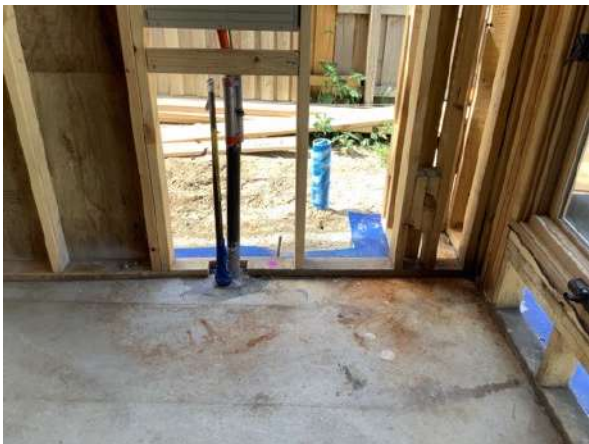
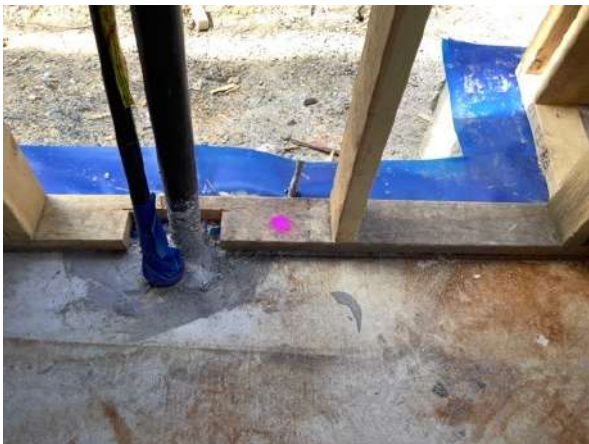
Non Compliant 2.01

Finding: Bottom plate - insufficient fixing to slab
Fixings must be placed at maximum 1200 centres and at the ends of wall plates.

It was identified that there are instances where the bottom plate is not sufficiently fixed to the slab. Depending on factors like the type of concrete nail / masonry anchor used the required pull out force and wind category the distance of the fixing from the edge of the slab must be between 50 to 70mm minimum for standard 20Mpa concrete. Taking into account these factors it is considered to not meet the AS1684 Residential Timber Framed Construction.

Taking into account these factors it is considered to not meet the AS1684 Residential Timber Framed Construction.

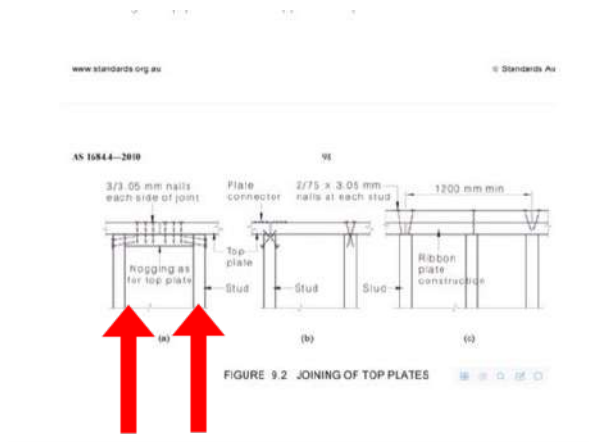
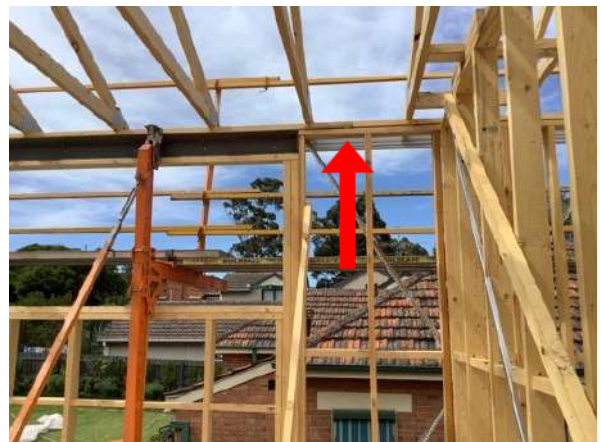
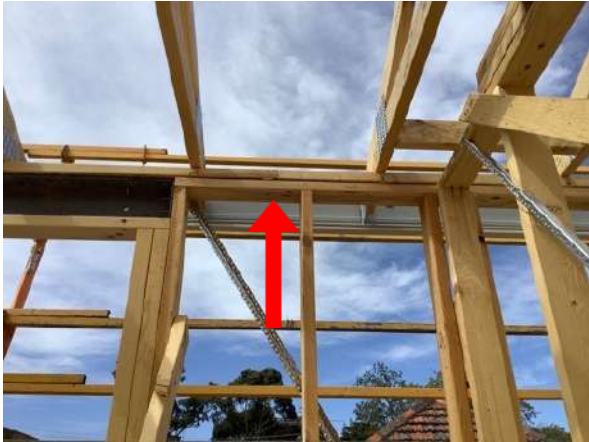
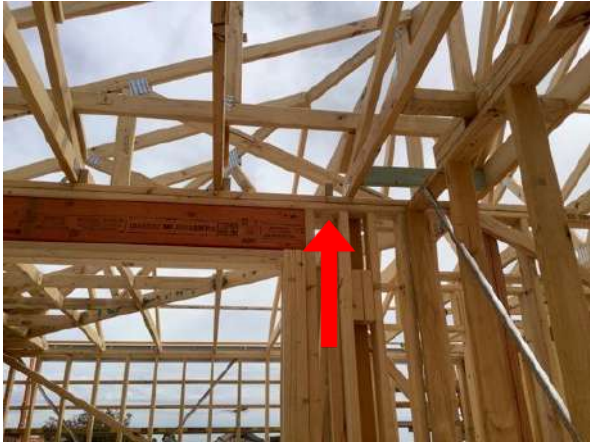
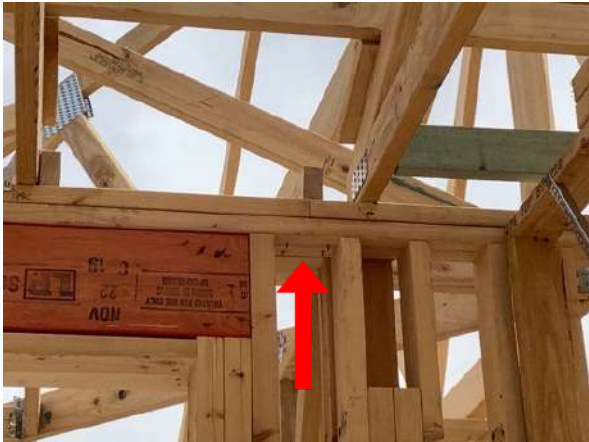
Non Compliant 2.02

Finding: Joining of top plates /. Unsupported Top Plate Join On Double Plates.
It is a requirement of Australian Standard, A.S 1684 Residential Timber-Framed Construction, clause 2.4 Stud/Plate Lamination, that 'where joints occur in either top plate between studs, and where rafters or trusses bears onto top plates, additional blocking shall be provided (see Figure 2.9).'

The connection between the top plates and the connections of the ribbon plates do not conform to As 1684.4 section 9.2.8 outlining the correct fixings and the distance between the joint of the top plate and the joint ribbon plate

The join in this top plate must be properly rectified in accordance with the above.

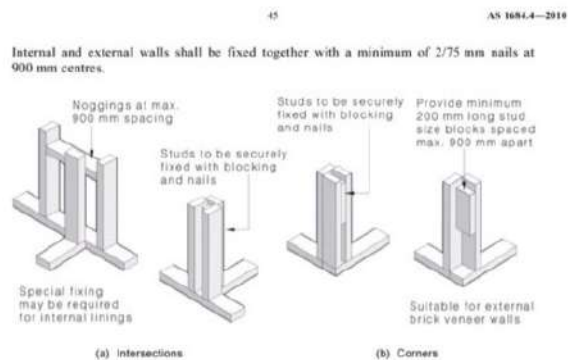
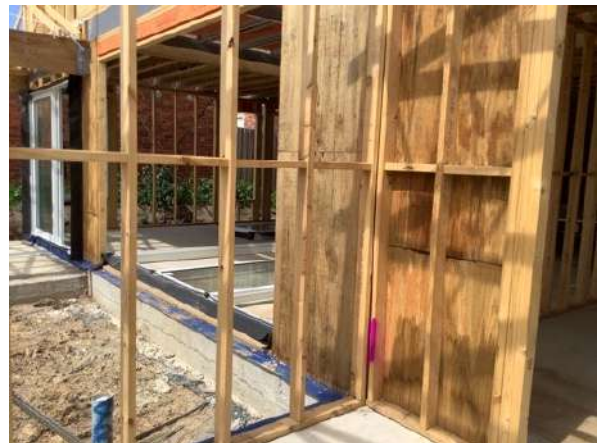
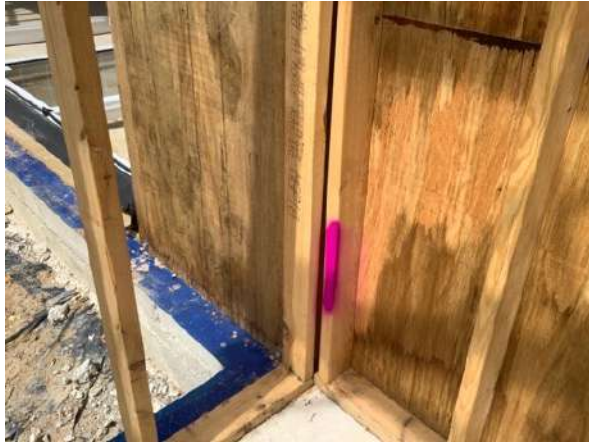
Non Compliant 2.03

Finding: Blocking at intersecting walls - insufficient / undersized
 It was observed that the blocking of intersecting walls are insufficient in the nominated locations throughout the Structure.
 The AS1684.2 indicates that three blocks are required at intersecting walls (minimum length 200mm)
 At spacings not exceeding 900mm and each stud must be fixed to the block with 2/75mm nails.
 Where wall junctions are within a deemed wet area, blocks must be installed at a maximum of 600mm centres .

In particular the standard notes that all walls must be installed with noggings at a spacing not exceeding 1350mm and wall intersections don't negate this requirement.

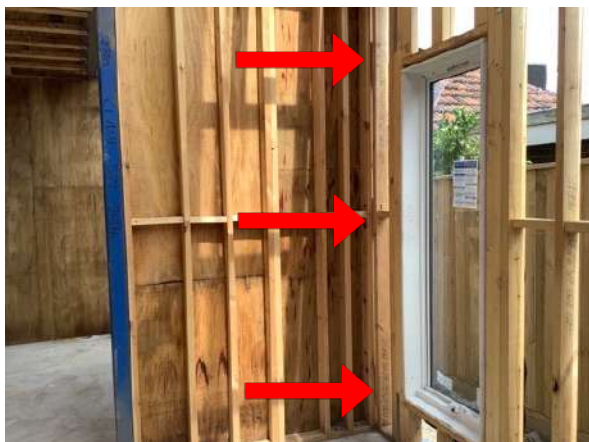
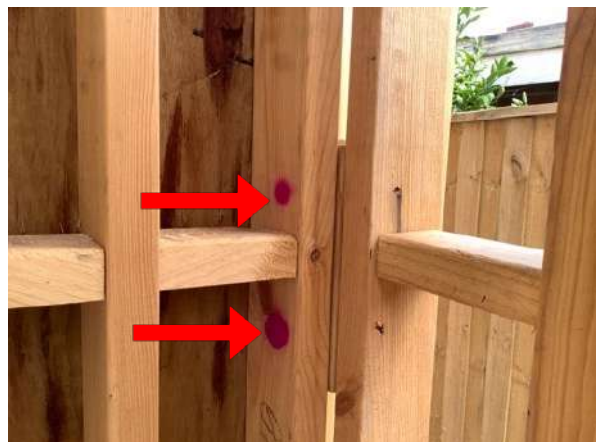
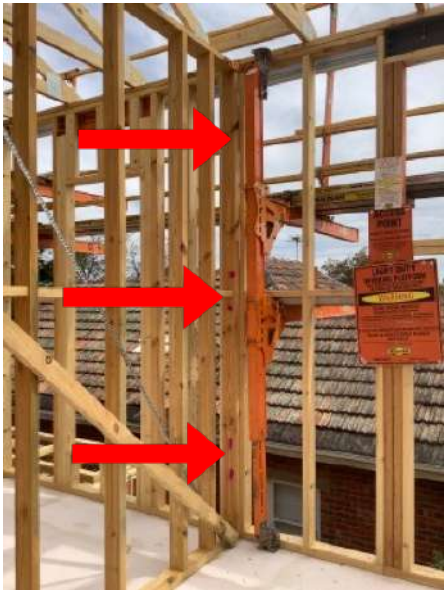
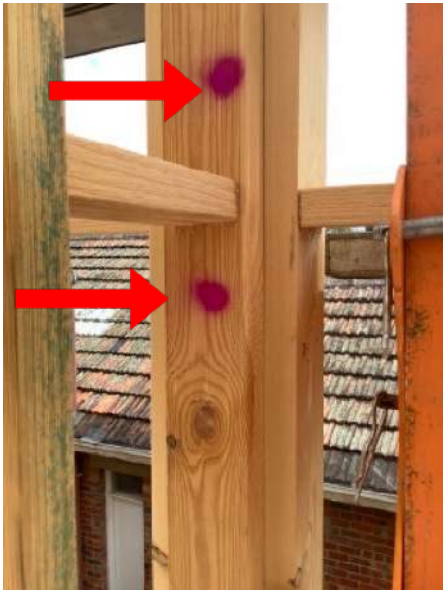
Non Compliant 2.04

Finding: Blocking at intersecting walls - External as a minimum.

It appears none of the external walls on the dwelling have been nailed off. Section 9.5 and table 9.4 of AS1684.2. and section 6.2.1.3 of the same document states all connecting walls must be secured and nailed in accordance with both clauses.

The frame pass should not have been approved without this element being installed.

As a minimum the builder must nail off the external walls to ensure that the dwelling can resist the racking forces that AS 1684.2 mandates.

The internal walls can then be finished off at lockup stage.

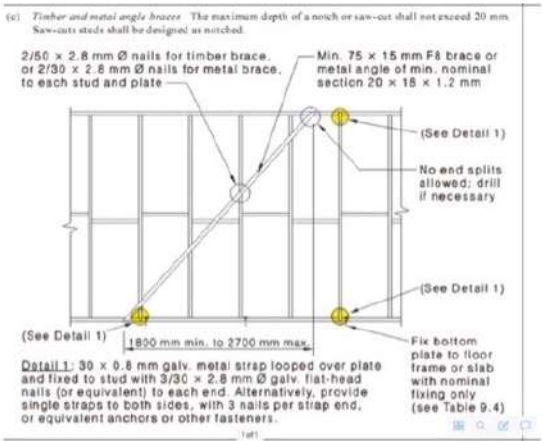
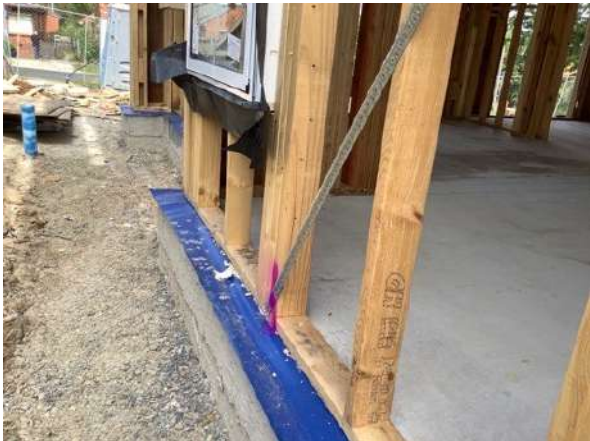
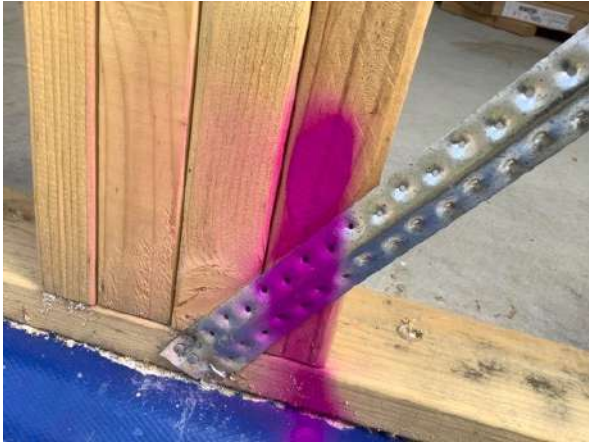
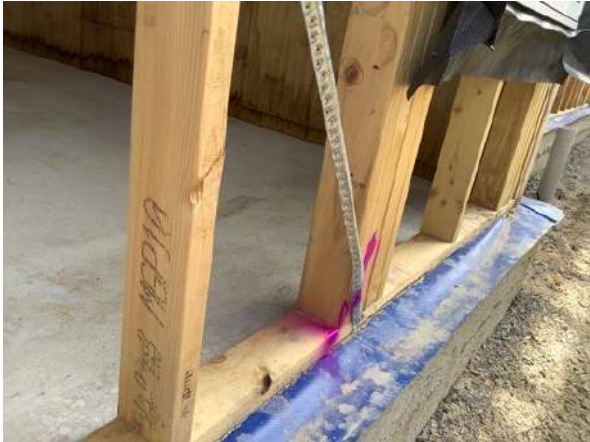
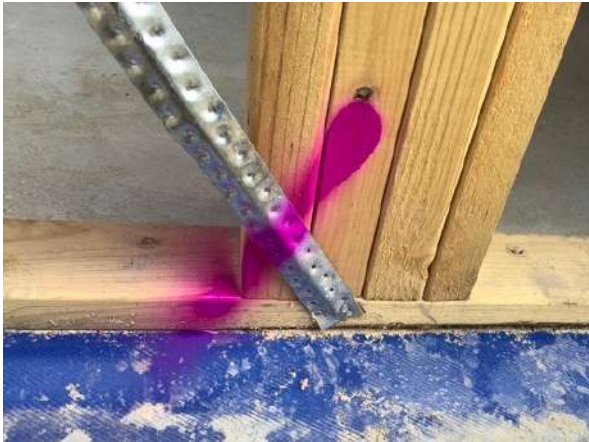
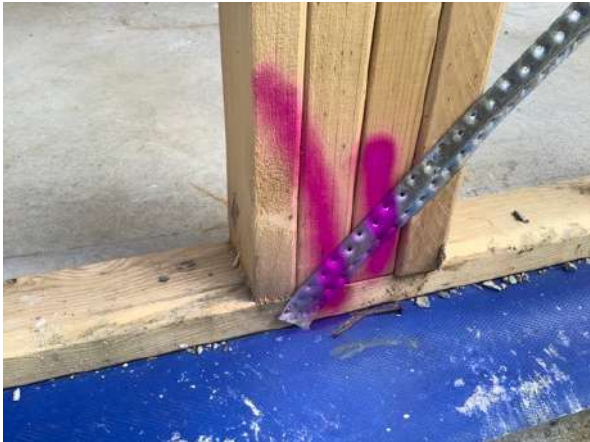
Non Compliant 2.05

Finding: Bracing straps - not secured
It was identified that some bracing straps have not been secured correctly. The bracing straps are required to be secured with two galvanised clouts (2 x 30mm) to each stud and plate.

1. At the time of the inspection there were several bracing straps that were not secured correctly. AS 1684.2 clause 8.3.6.3 Structural wall bracing – see table 8.18 below

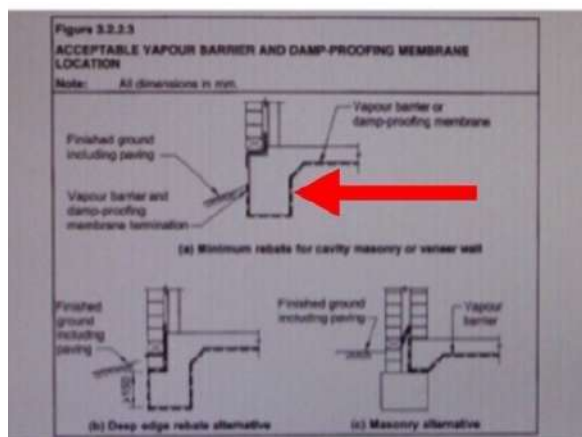
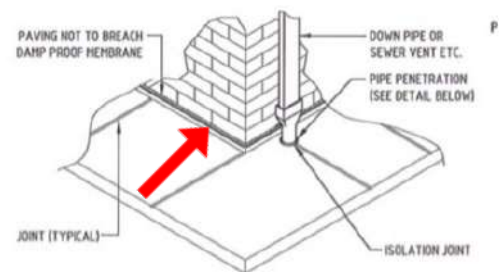
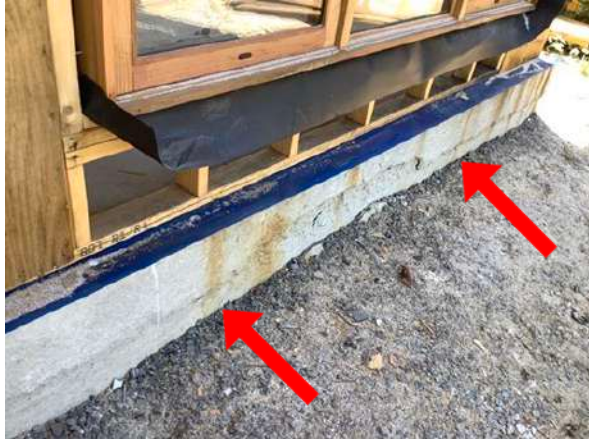
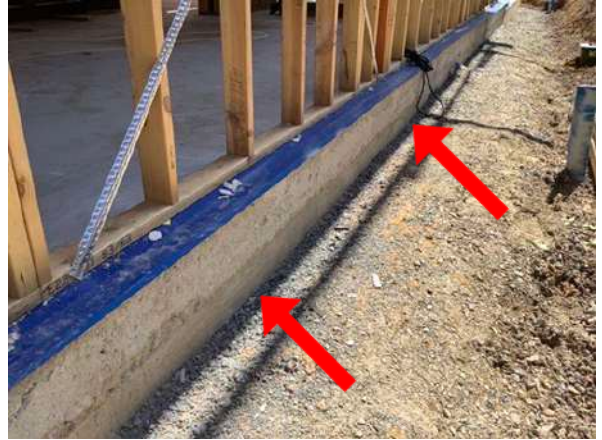
Non Compliant 2.07

Finding: Vapour barrier - Defective (AS2870- 2011)

The functionality of the vapour barrier to the entire perimeter of the building including, between the the buildings each side of the house is being compromised due to poor workmanship during the installation/construction process.

It is a requirement of AS 2870-2011 5.3.3.4 that vapour barriers are turned up and terminated at ground level above pavement adjacent footing. The vapour barrier is defective if building materials and fill has been left on top of the membrane, as this prevents it from being pulled up against the slab when installing perimeter paving as it is intended to be.

This must be remedied immediately to prevent slab edge dampness.

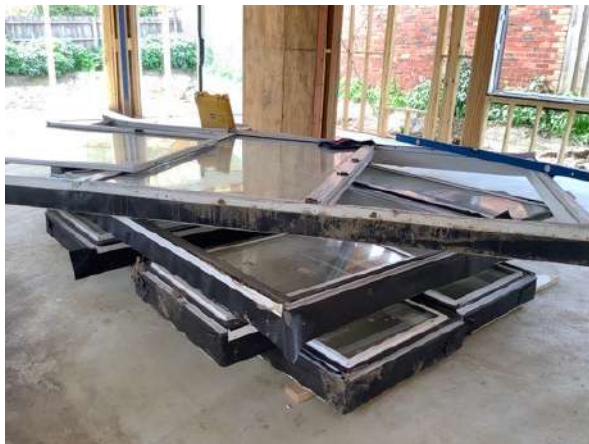
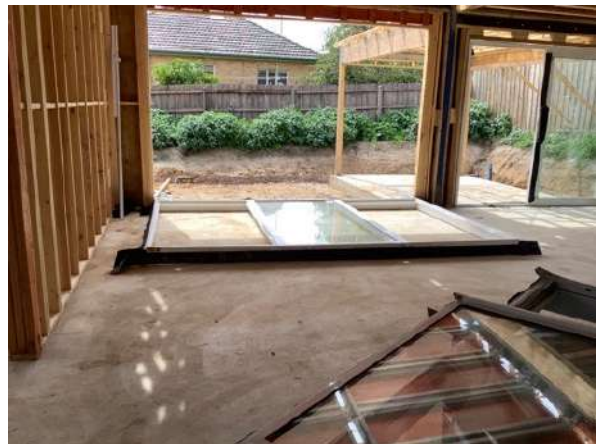
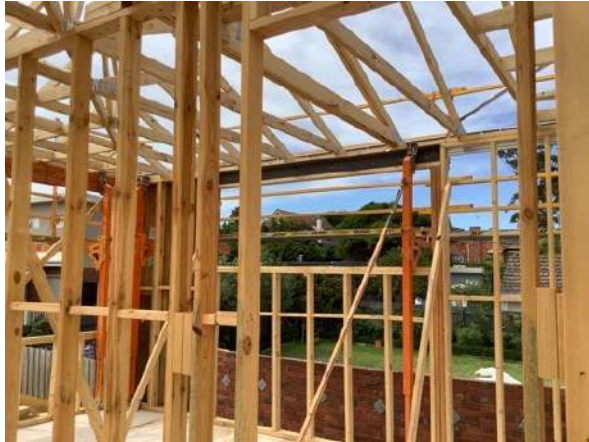
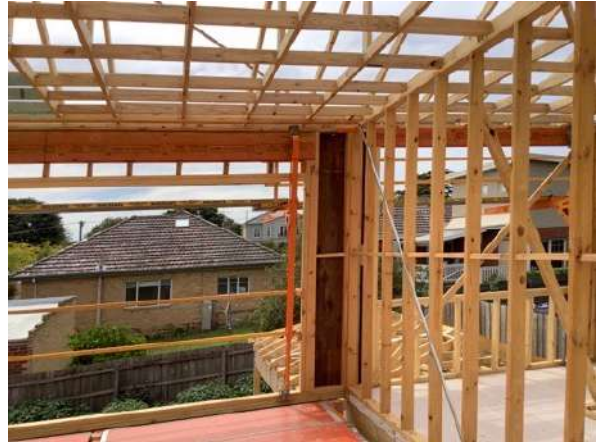
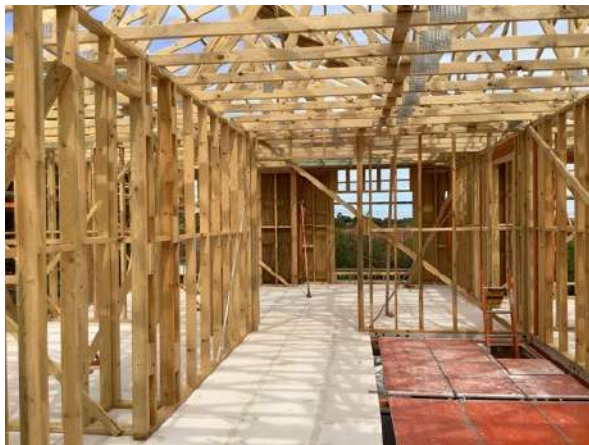
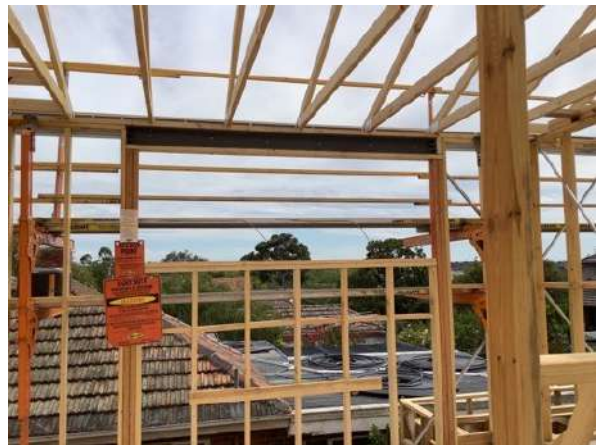
Incomplete 4.08

Finding: Windows - Not Installed
NOTE : The windows and/or not all the windows were not installed at the time of the inspection, so many defects related to window installations could not be inspected. A complete inspection was not achieved due to the above statement.

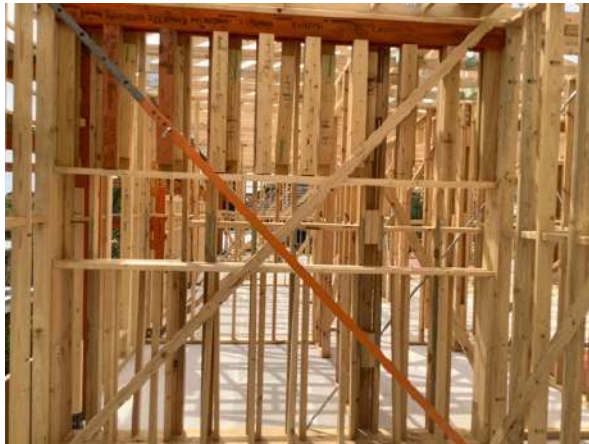
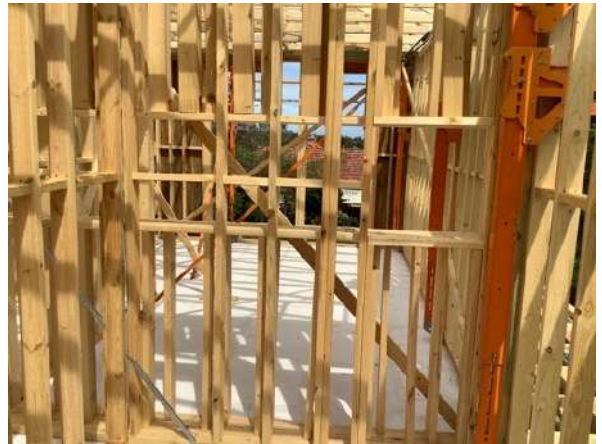
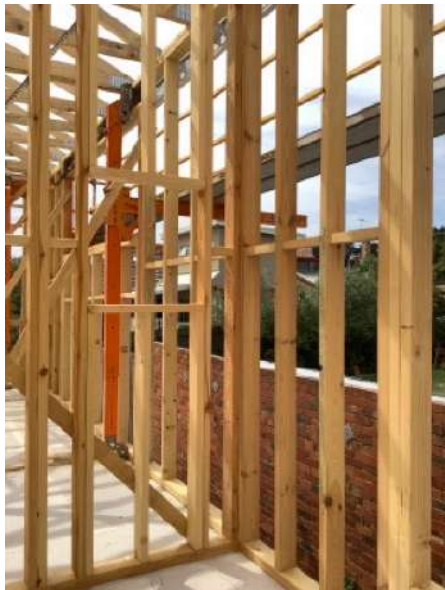
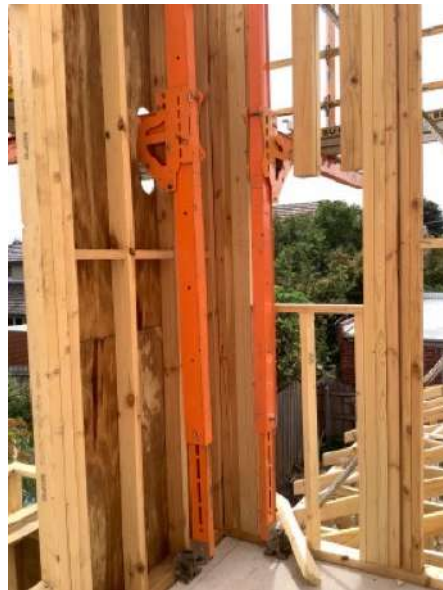
For Your Information 5.13

Finding: Shower Stud Width Acceptable
Additional photos are provided for your general reference.

Upon inspection of the shower areas, it appears that the stud width installation is at 300mm centres which is suspected to be adequate for shower areas as per BCA and the framing standard.

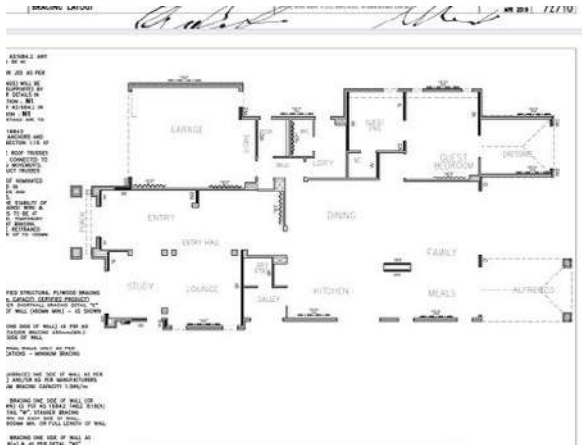
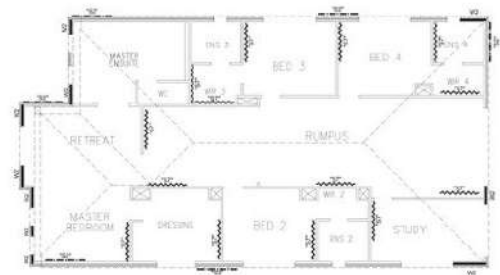
For Your Information 5.14

Finding: Bracing Sheets - Locations.
The bracing sheets are located as per plans supplied.
