Practical Completion Report (Final)

Inspection Date: 5 Feb 2020

Company Name: Master Property Inspections

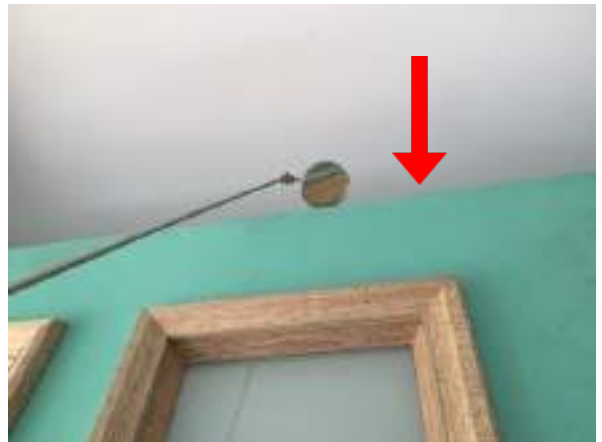
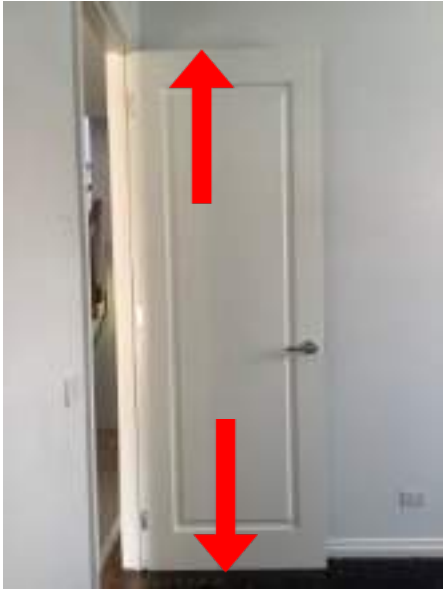
Finding: Doors Paint-Tops & Bottoms Not sealed (AS2688)
 I have ONLY taken LIMITED photos of this defect and attached are LIMITED photos of this defect in SOME AREAS ONLY.
 All AREAS to the entire property should be checked CAREFULLY to identify any further defects that are the same, as this defect is in other areas of the property.

The paint finish is missing to the tops and bottoms of the doors.

It was found at the time of inspection that the doors have not been adequately sealed.

Tops and bottoms of all external and internal doors must be sealed to uphold manufacturer warranty conditions and to comply with Section 8.06 of the Guide to Standards and Tolerances, 2015.

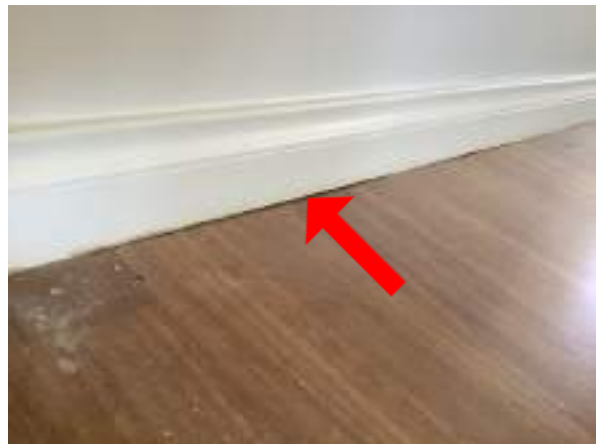
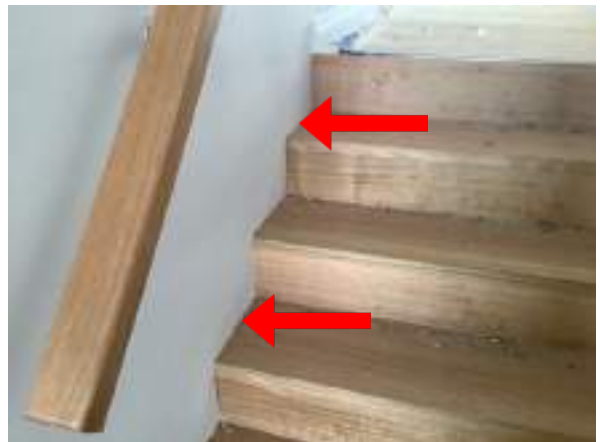
2.04

Finding: Sealant / Caulking - Missing Floor Areas.
Caulking / Silicon - Missing, Required To Bottom Of Skirtings, Door Frames, Entrances, Kitchens, Toilets, Garages or Similar To Protect Skirtings & Timbers From Moisture & Water Damage.

It was noted on inspection that sealant and/or caulking is not to the bottom of all the skirtings, where the skirting is on top of the timber flooring or floor tiles.

Garages in particular are subjected to sometimes high levels of incoming water through incoming rain and/or hosing and/or moisture, which is all very typical and it is very common to identify swollen skirtings in these type of areas.

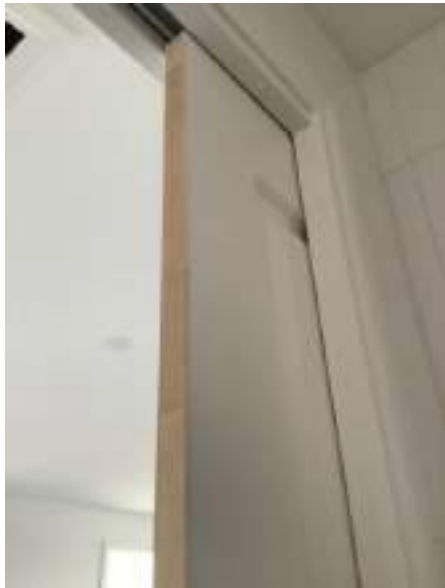
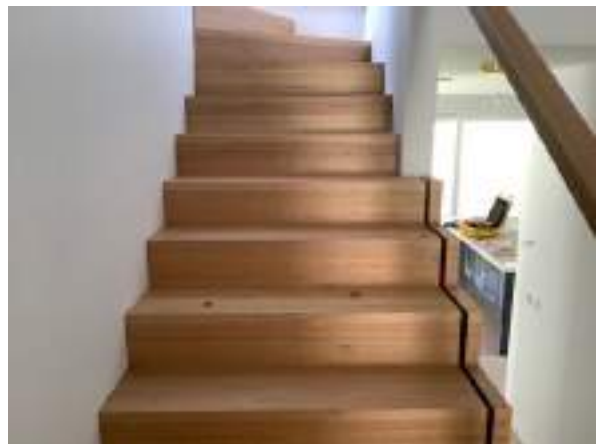
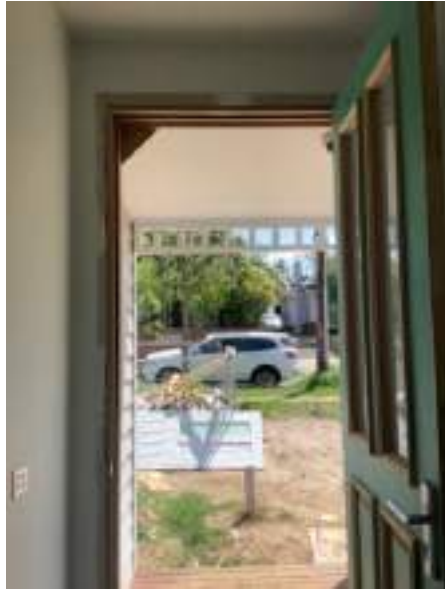
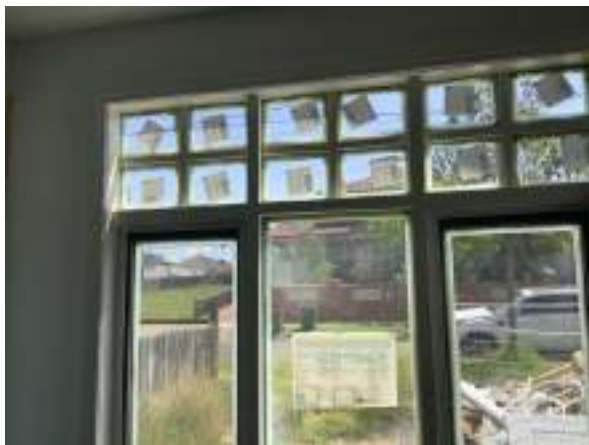
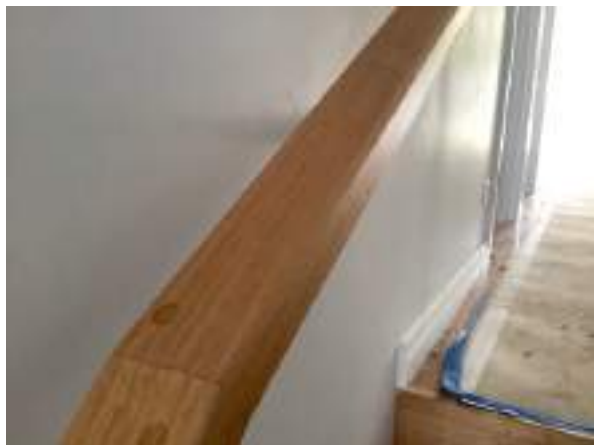
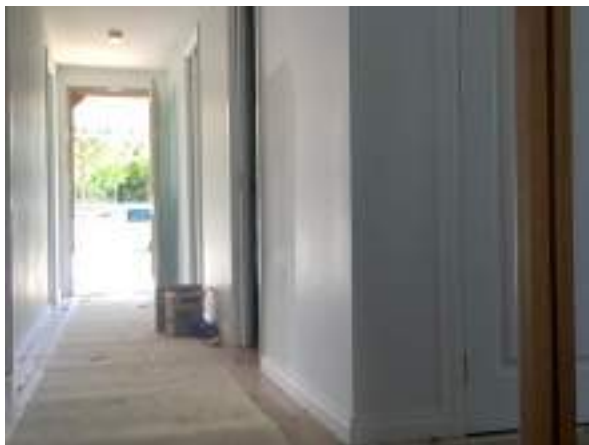
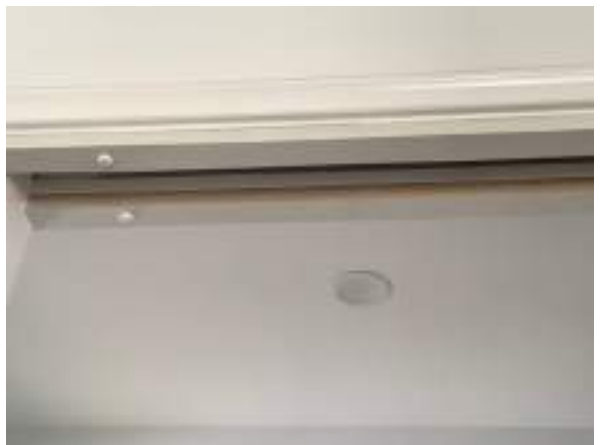
Finding: Paint Surface Finish - Incomplete/Starved/Defective.

The paint finish in these areas was identified as being incomplete/starved/defective.

Whilst incomplete or missing paint finish is generally an appearance defect, it can also lead to the development of secondary building defects over time. Incomplete areas of paint finish exposes the area to moisture, potentially accelerating the deterioration of underlying building materials.

Incomplete paint finishes should be sanded back, filled, levelled and painted as applicable. Where inadequate or missing paint protection has led to the deterioration of the associated building element, repair and/or replacement of this building element may be required.

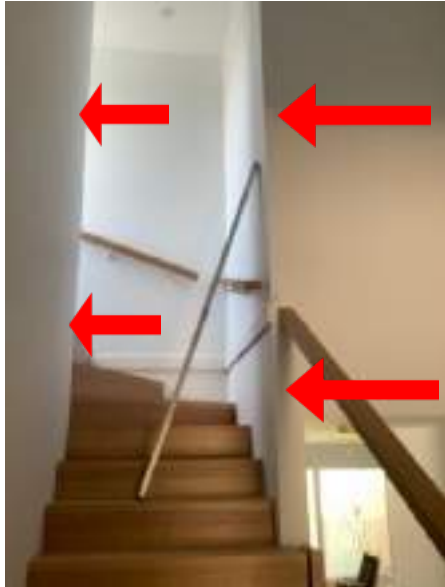
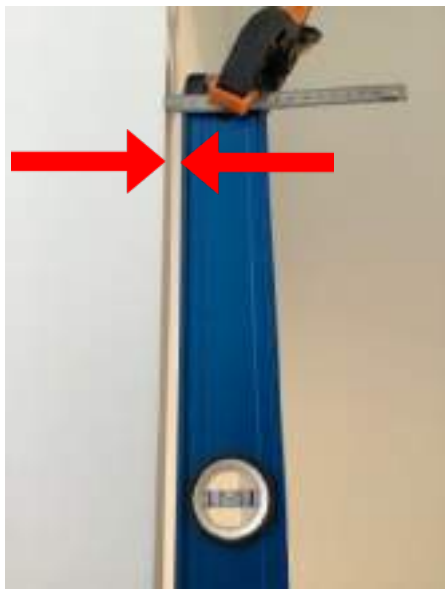
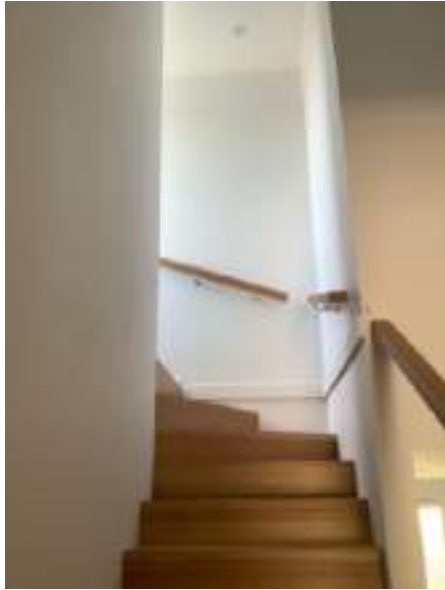
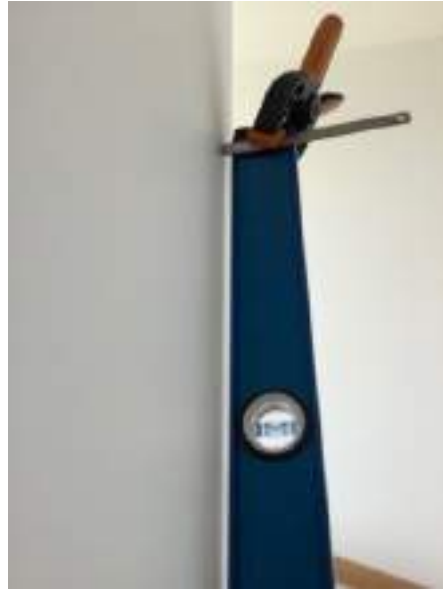
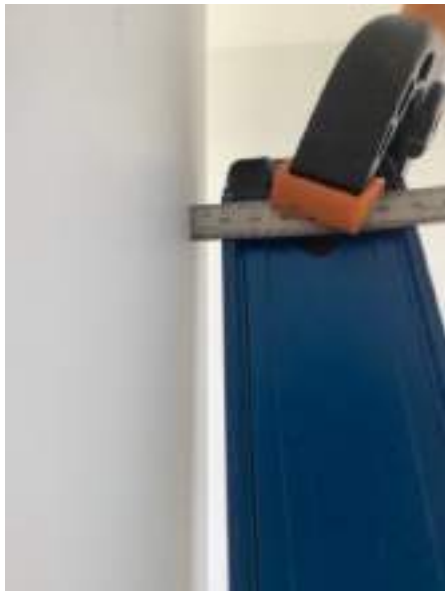
2.08

Finding: Plaster wall surfaces - Vertical / Horizontal Defective to plaster and/or framing.
It is important to mention, that this property had serious vertical and horizontal walls that were considerably out of level. I supplied my client a postcompletion pre-paint inspection report if you would like more information.
No re-inspection was performed at the clients request. It is obvious that not all the areas have been repaired as the staircase is still quite out of level and there is a possibility that other areas of the home are still out of level as well and I recommend further investigation into this matter to identify all walls that are vertically and horizontally out of level.

It is observed that the wall frame/s are defective as there is a deviation from a vertical or straight plumb line which exceeds 4mm within any 2m of height / length.

This is commonly referred to as a bow in the frame material and/or defective workman. Any bow in excess of 4mm as identified exceeds the allowable Standards and Tolerances and is considered defective.

This deviation from the verticality / horizontal or plumbness of the wall is a defect with reference to Standards and Tolerances 9.10.

A registered builder should be appointed to assess the defect and perform rectification works as necessary.

Considerable re working of the plaster to rectify this defect in the areas specified is required.

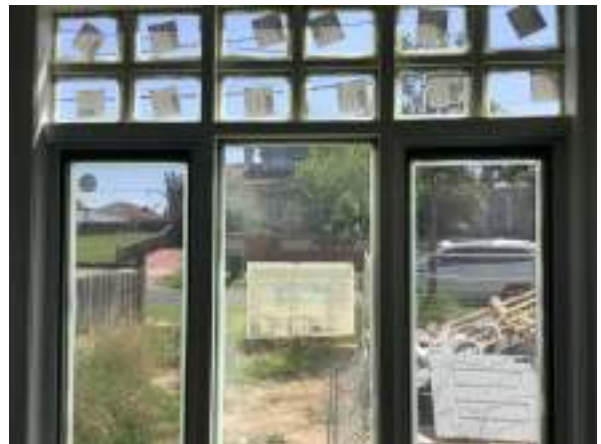
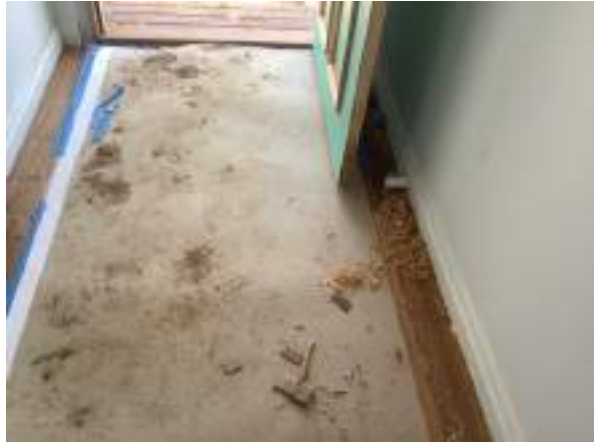
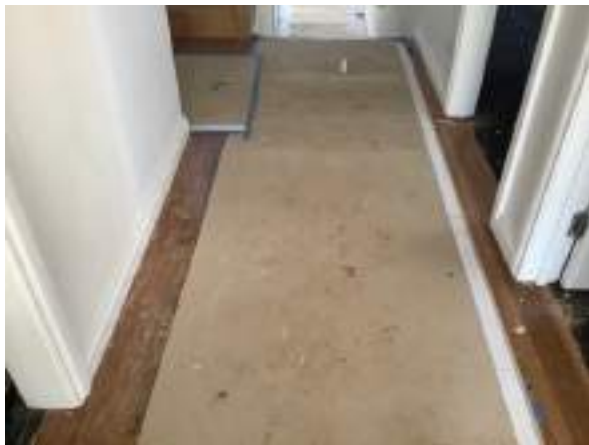
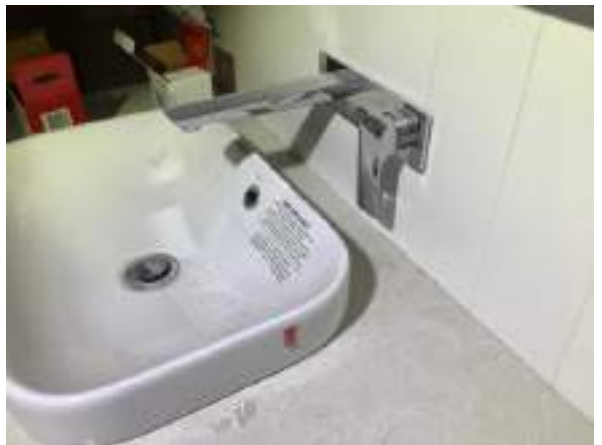
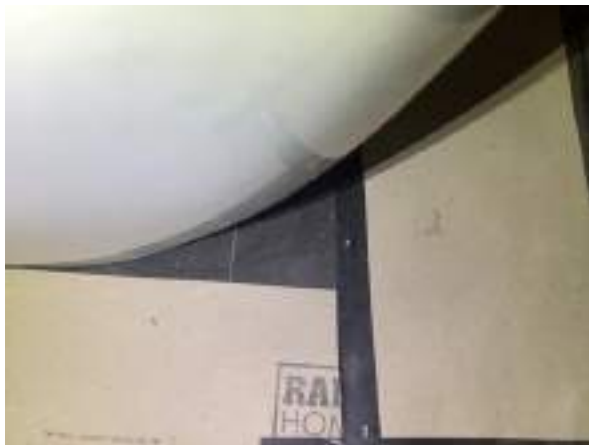
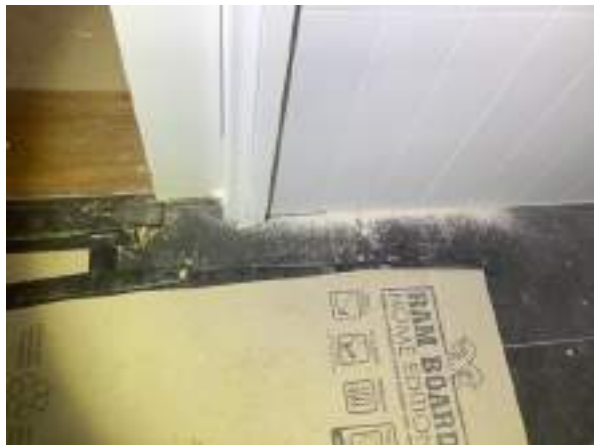
2.09

Finding: Cleaning Defective - Floors, Tiles, Glass, Bathroom fittings and fixtures, Etc
It is important to note that as the home is really in construction mode not completion mode there is a high possibility that many surfaces such as timber flooring, tiles, kitchen benches, cupboards, etc will be damaged and until the home is professionally cleaned and complete it is impossible to determine the damage. So it is important that special note be taken into consideration about this topic, As repairs can sometimes be a case of total re-sanding of timber floors and re-coating as an example. As the home must be presented to the client in as new condition and to a level for finish without compromise.

It was identified that the cleanliness and degree of finish for fixtures and fittings is substandard. Fittings and fixtures including sinks and bathtubs are required to be as new prior to handover. Evidence of damage marks scuffs and dirt need to be removed where present.

The Building Commission's, Guide to Standards and Tolerances clause 18.09 Cleaning, states- 'Owners are entitled to expect that the building site and works are clean and tidy on completion. Building works are defective where windows are not clean, floors are not swept, mopped or vacuumed as appropriate, tiles, sinks, basins, troughs, baths, etc. are not cleaned and shelving, drawers and cupboards ready for use.'

Once the cleaners have properly completed all of this work, all of the glazing, mirrors, cupboards, baths, shower bases, shower screens, floor coverings, walls, stairs, garage floor, fixtures and fitting etc, should all be thoroughly checked again for any scratches and damage which may have occurred, prior to handover proceeding.

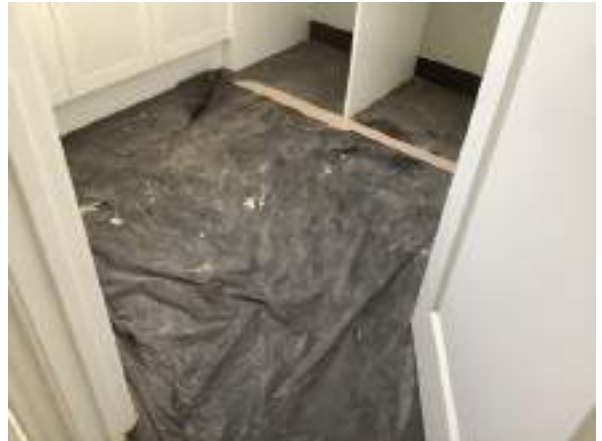
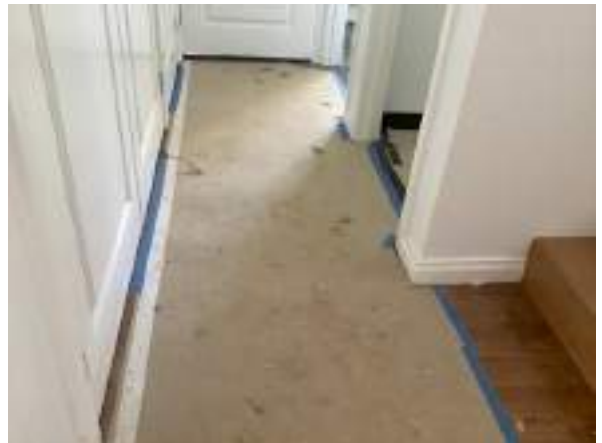
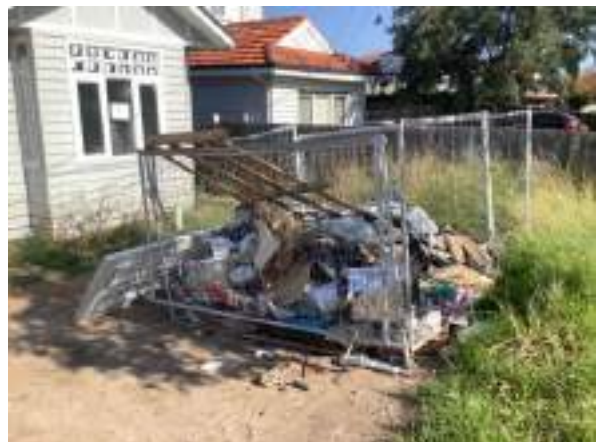
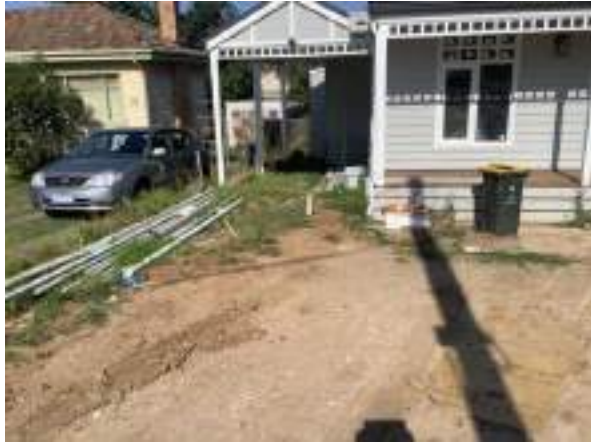
Finding: Cleaning - debris on site at handover
It was observed that builder's debris was present on site at handover. This is a defect with reference to Standards and Tolerances.

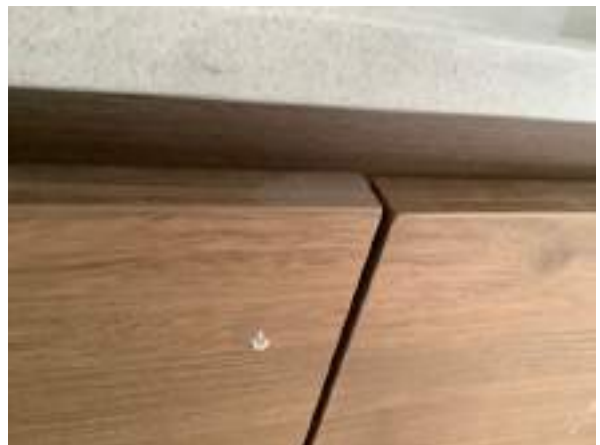
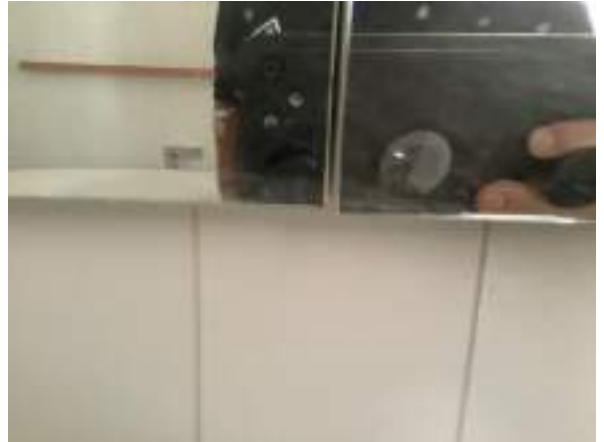
2.12

It is observed that some of the cabinet doors are not aligned and / or have inconsistent gaps between the doors.

It is observed that some of the cabinet drawers are not aligned and / or have inconsistent gaps between the drawers.

The Building Commissions, Guide to Standards and Tolerances clause 8.04 Internal Door Clearances, states- 'The installation of doors is defective if within three months of completion, clearances between door leaves and frames and between adjacent door leaves are not uniform and within 1mm. A clearance between door leaves or between a door leaf and the frame is defective if it is less than 2mm or greater than 5mm in width'

The gaps around these doors must be adjusted to comply with this tolerance.

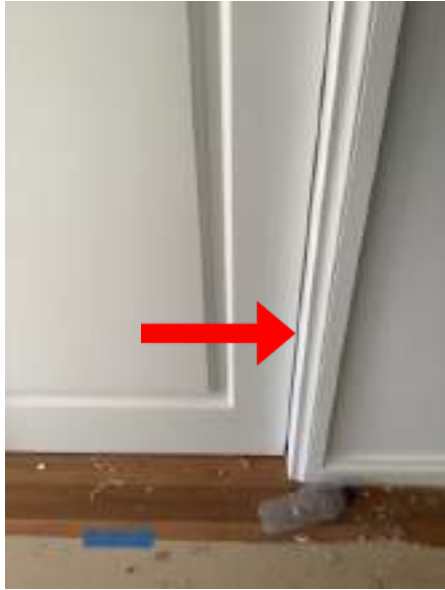
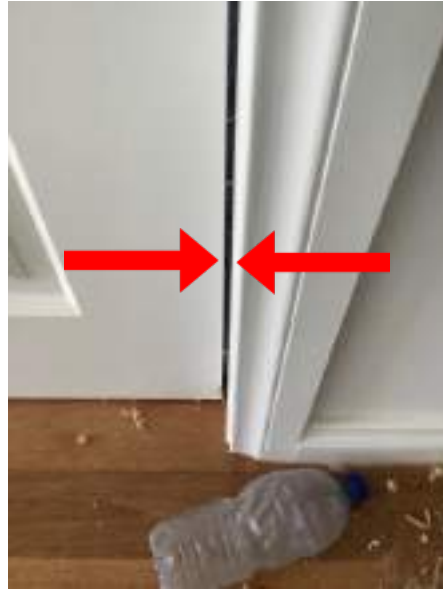
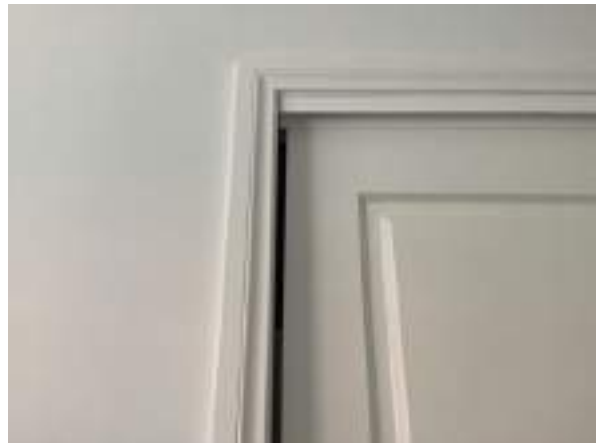
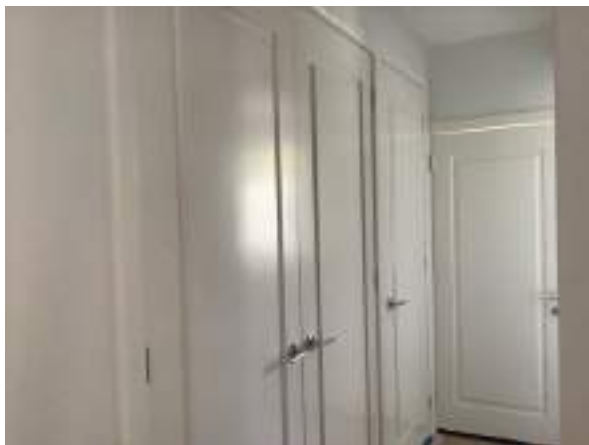
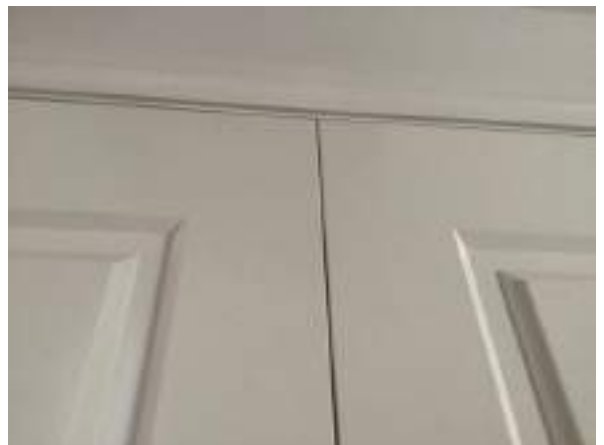
2.13

Finding: Door Clearances Defective.

Unless additional clearance is required for removable toilet doors or air ventilation, a clearance between the door and the floor finish is defective if it is greater than 20 mm after installation of the floor covering.

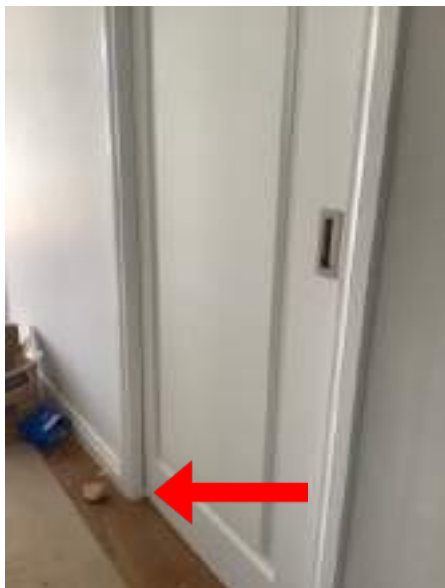
2.14

Finding: Door operation - binding and jamming - defective
Binding and/or jamming of this door is evident during standard operation. This defect inhibits the functionality of the affected door as well as creating potential for secondary defects to associated building elements, such as damage to the floor covering.

A door that binds to flooring or to the associated door frame may have several causes, ranging from minor defects, such as poor installation of the door or deteriorated hinges, through to major structural issues, such as damage to subfloor structures.

Where the operation of the door is not as intended by the manufacturer it is considered defective with reference to Standards and Tolerances

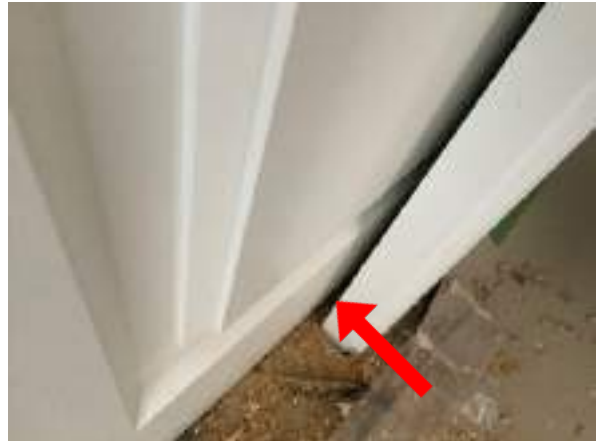
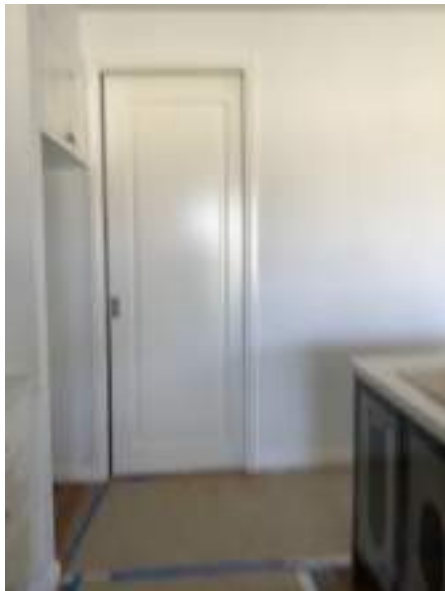
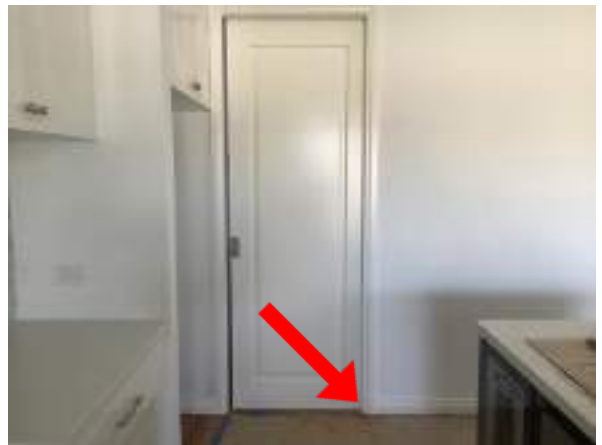
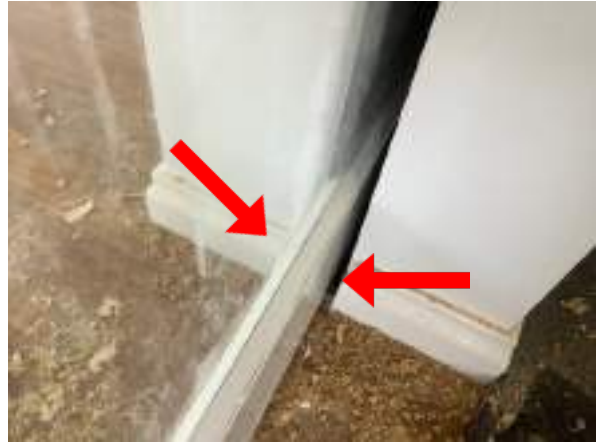
2.15

Finding: Cavity doors - missing guides
The cavity doors require the guides to be adjusted, also some guides are missing, All areas are to be checked for installation or repair and adjustment.

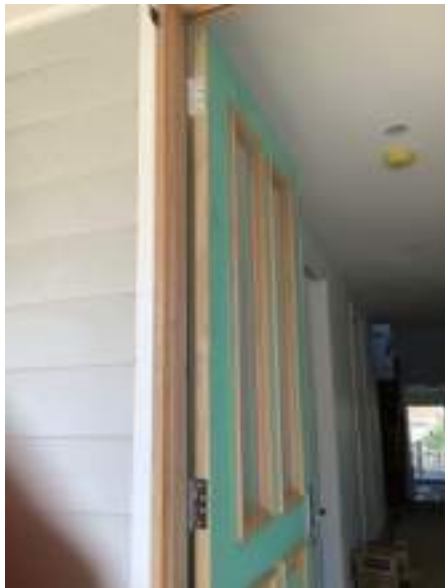
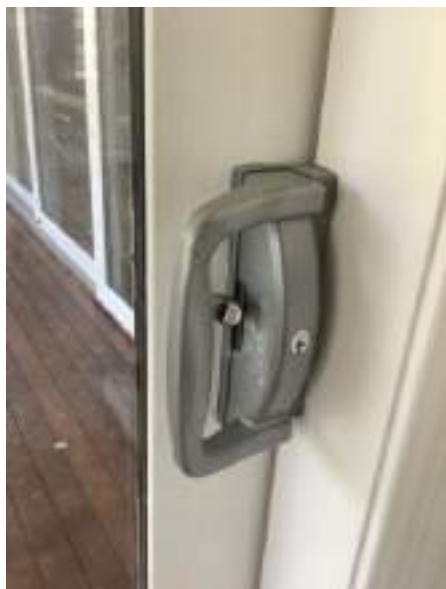
2.16

Finding: Damages/ Faults - Appliances / Fittings / Tiles, Etc
 All areas to the entire property should be checked carefully to identify any further defects of the same type.

It is identified that damage or faults affecting tiles, appliances and / or fittings supplied as part of the building contract have occurred. Where this is due to the builder's workmanship or damage occurring during construction it is considered a defect with respect to Standards and Tolerances - 18.02.

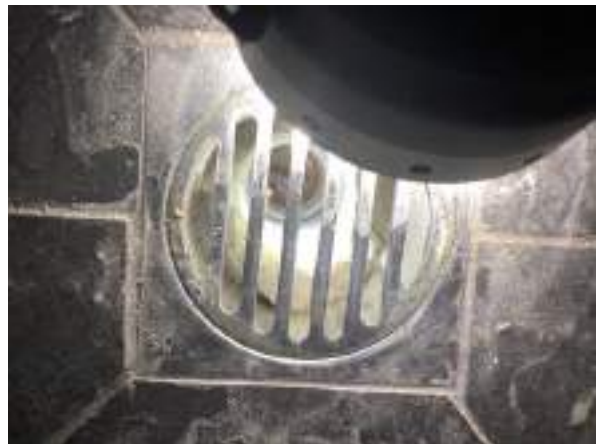
2.17

Finding: Drains Internal - Blockages (AS3500)
Floor drains throughout the property have accumulated excess glue and grout during the installation process. Floor drains are vital in removing excessive water in wet areas and should therefore be fully functional otherwise secondary defects can create larger problems.

The shower drain appeared to be blocked at the time of inspection. Blockages prevent building elements from operating as intended. If left unmanaged, a lack of general maintenance may lead to the development of more significant defects, such as water damage to surrounding building materials.

Minor blockages created by excessive glue and grouting impedes on this function, and creates potential for the development of moisture damage over time.

All floor drains should be assessed by the building contractor prior to final inspection and cleared where applicable. All drains must comply with AS3500.2 Plumbing and Drainage.

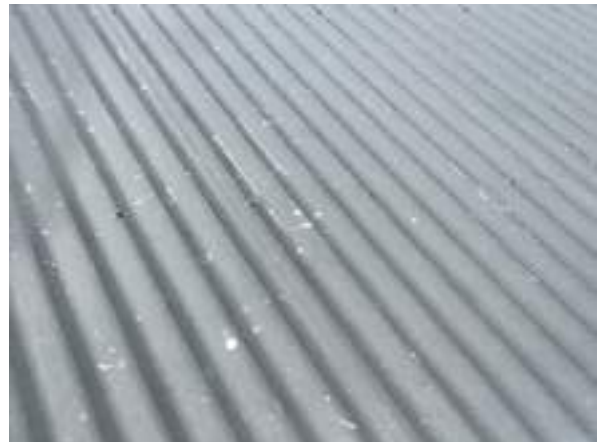
2.18

Finding: Colourbond Coating Scratched and/or Damaged. //. Powder coat finish - damaged
The colorbond / powder coat finish has had its prefinished painted coating scratched, exposing the base metal, which cannot be correctly repaired on site.

BlueScope Steel, the manufacturer of colorbond steel state on their web site that –‘BlueScope steel does not recommend the use of touch up paints on Colorbond steel’ and that ‘Our recommendation is not to touch up. Minor scratching will not affect the life of the sheet and is rarely obvious to a casual observer. Should damage be substantial, replace the sheet.

The affected damaged sections will need to be replaced.

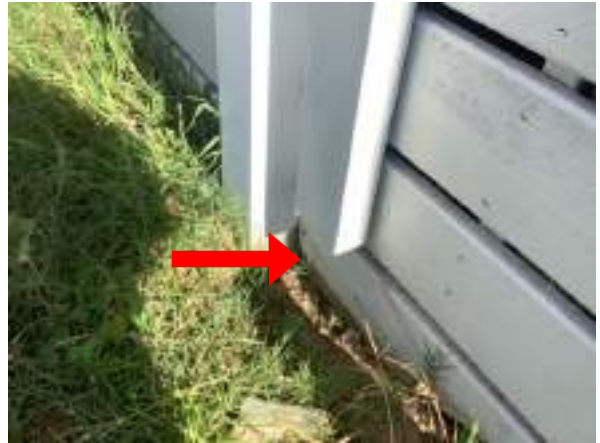
Finding: Plumbing work - Appears Defective

An instance of potentially defective plumbing work was identified. Whilst we are not licensed plumbers it appears that work which is not compliant with the relevant plumbing regulations and or the contract documents has occurred. The area of suspected non-compliance or poor workmanship should be referred to the builder and or the Building Surveyor or Certifier. The builder is required to provide a Certificate of Compliance when required by the relevant regulations.

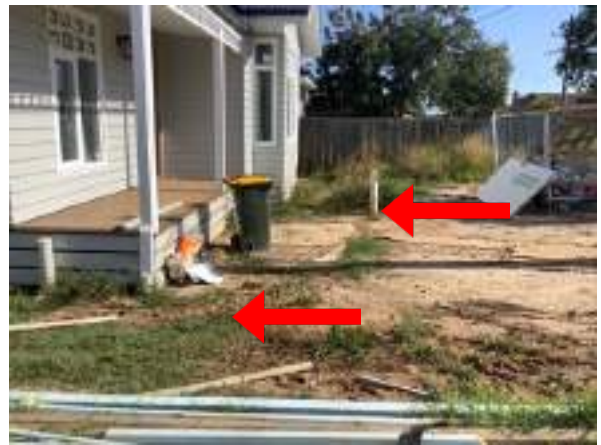
Finding: Drainage - Owners Responsibility - Foundation and Site Drainage Maintenance
Foundation movement caused by activities not documented at the time of the contract any variations or which have been undertaken by the owner have been identified.
This may include paving landscaping planting trees and drainage works after the site is handed over. The builder is not responsible for foundation movements caused by the owners failure to maintain drainage systems after the site is handed over to the owner.

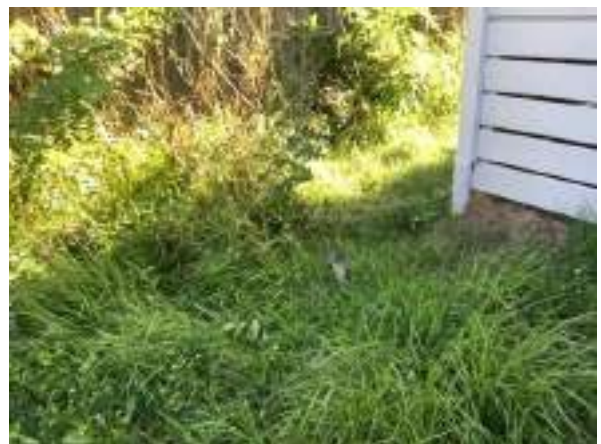
5.34

Finding: Holes - Safety Hazard
The exterior ground around the perimeter of the home has various paint holes and is quite a safety hazard
