Pre-Paint & Waterproofing Report.

Inspection Date: 28 Feb 2020

Property Address: Rockbank Area

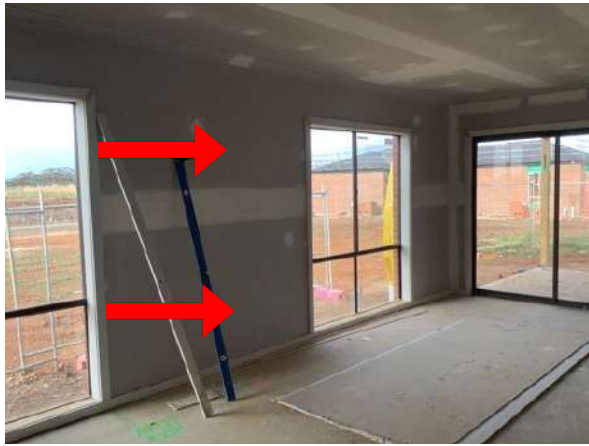
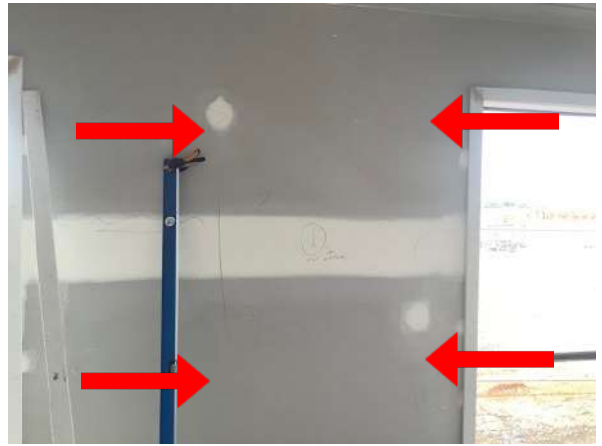
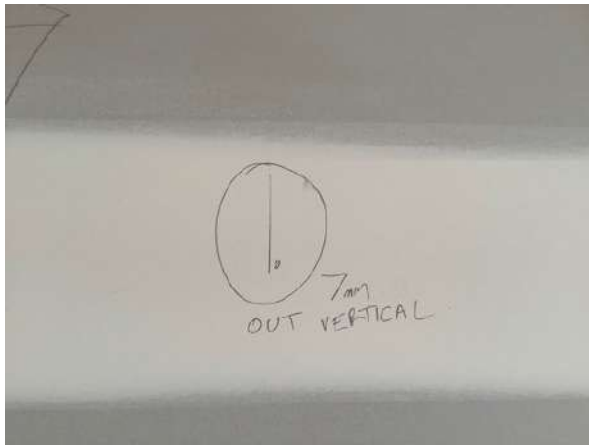
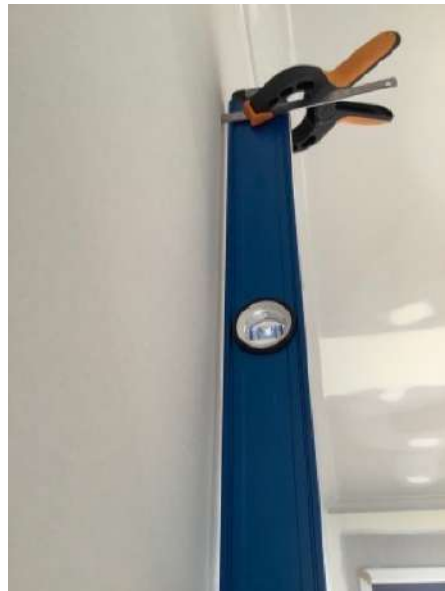
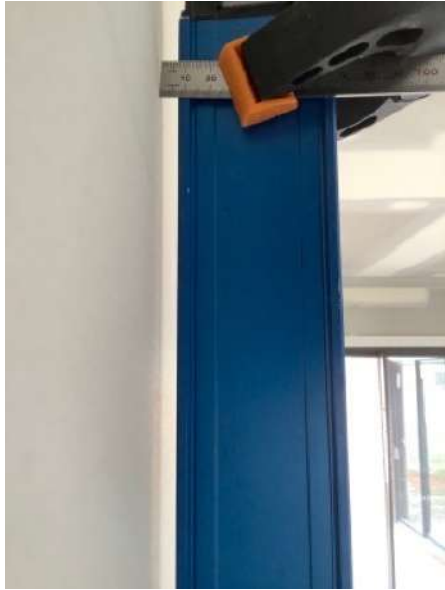
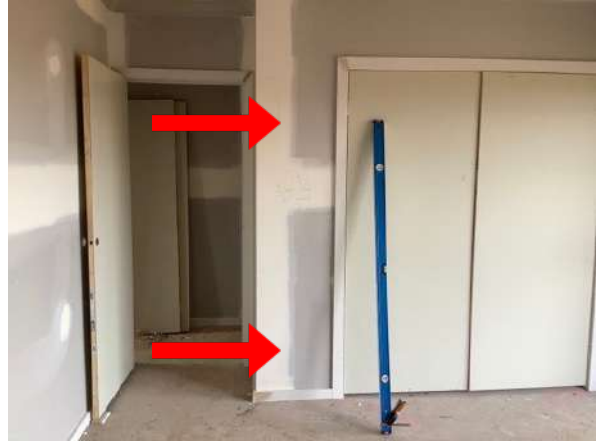
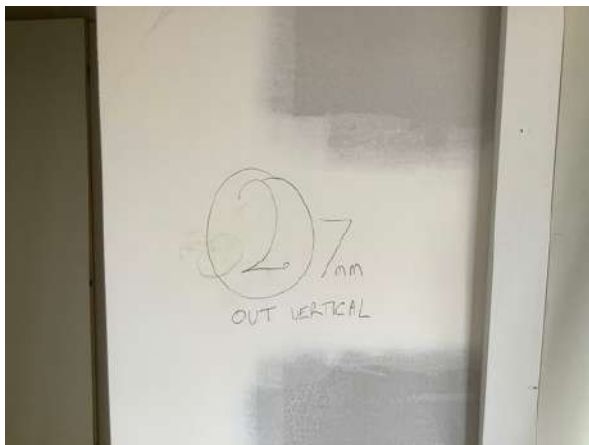
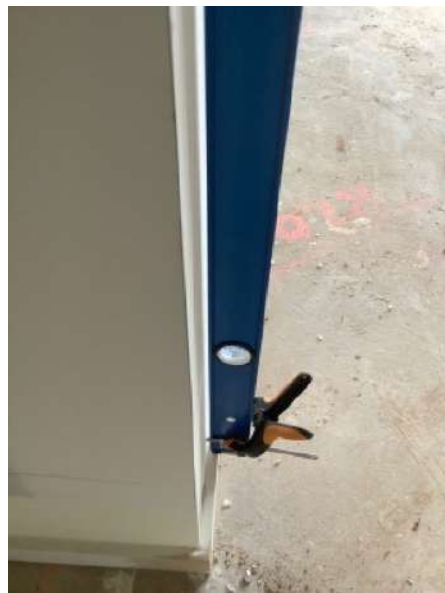
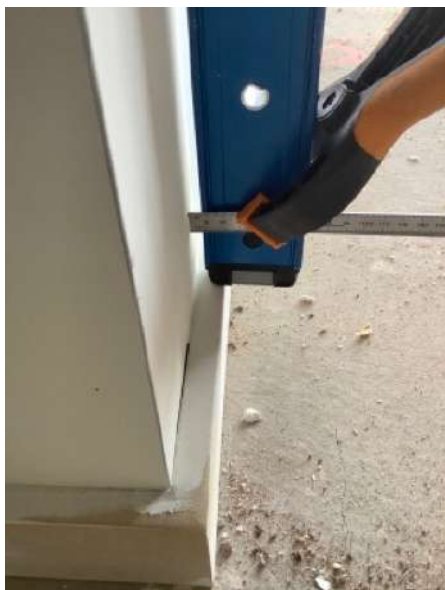
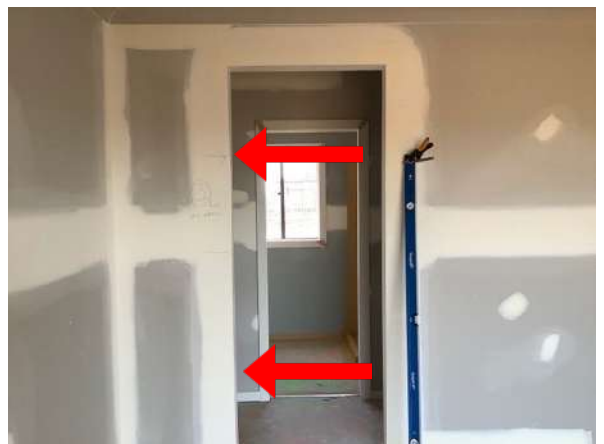
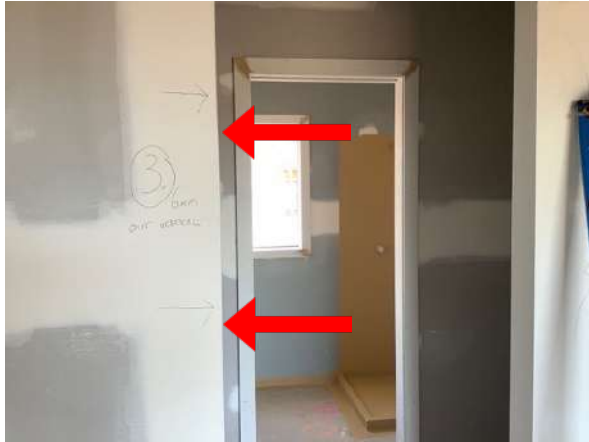
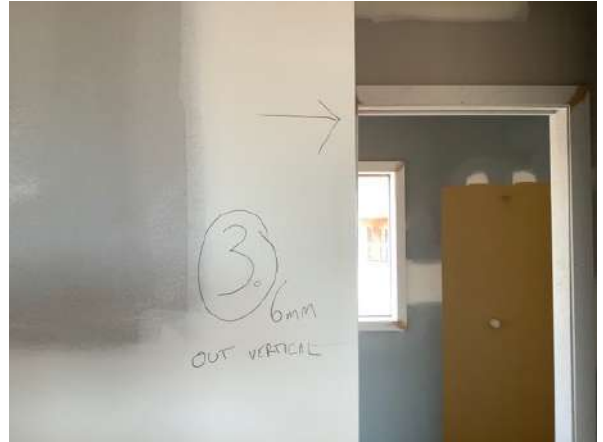
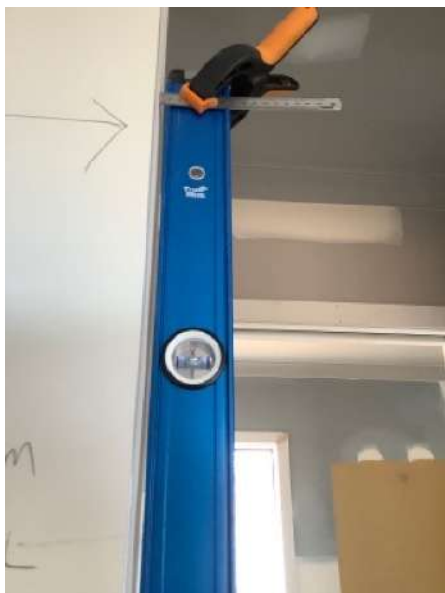
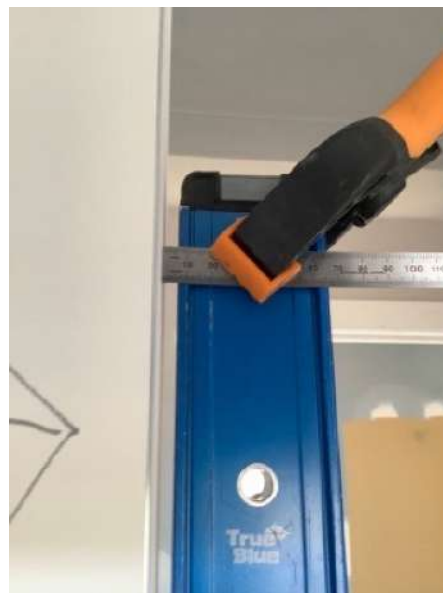
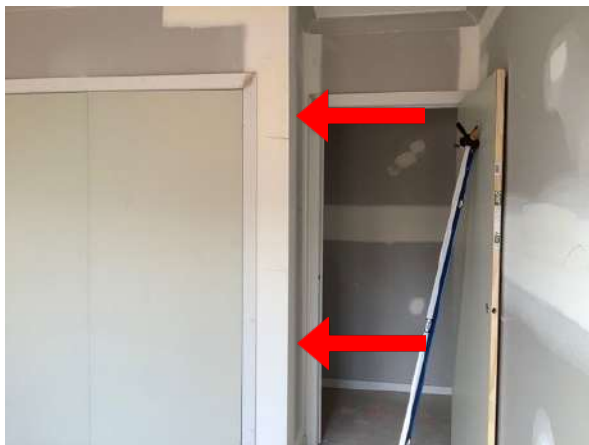
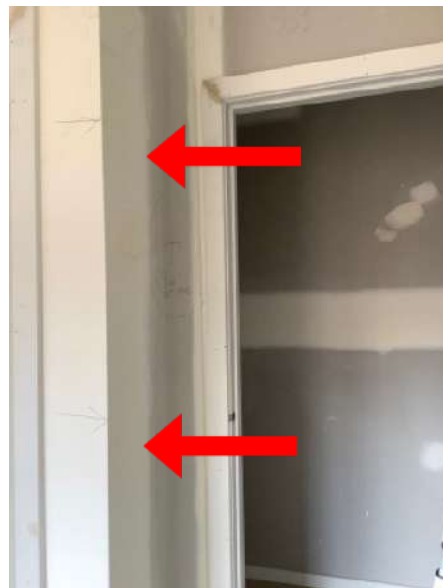
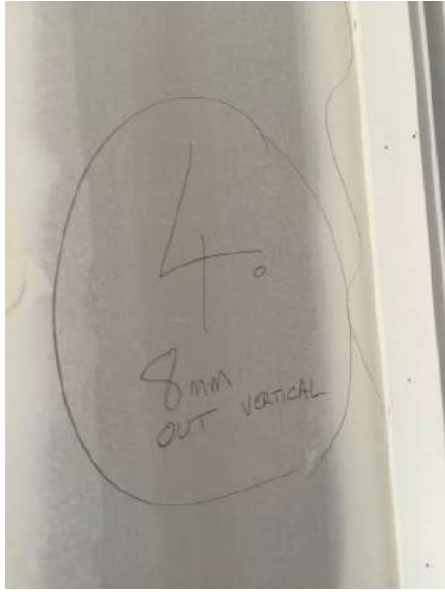
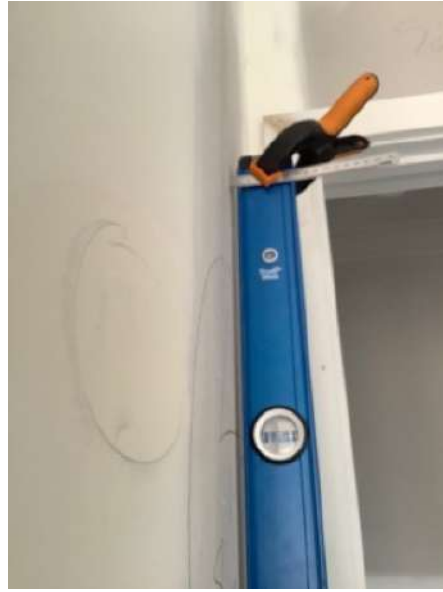
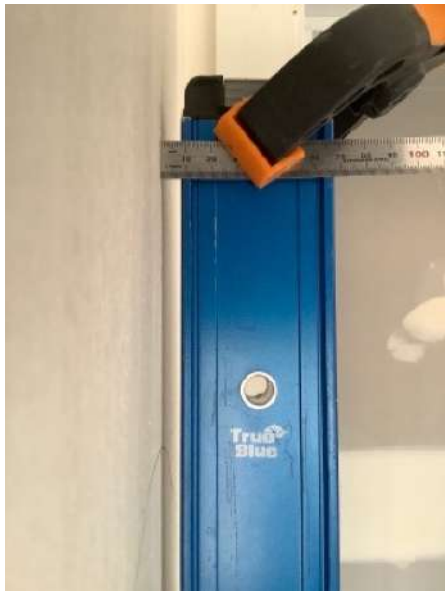
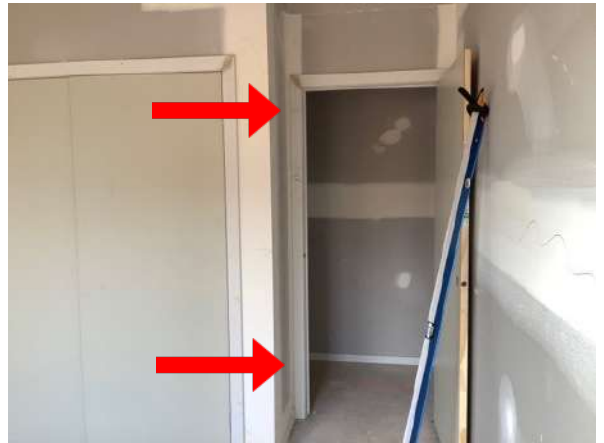
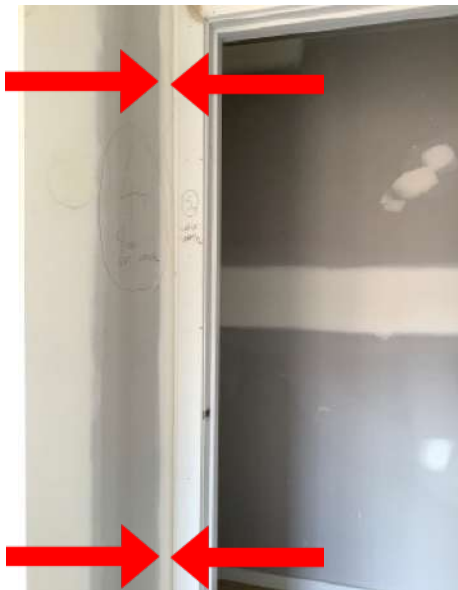
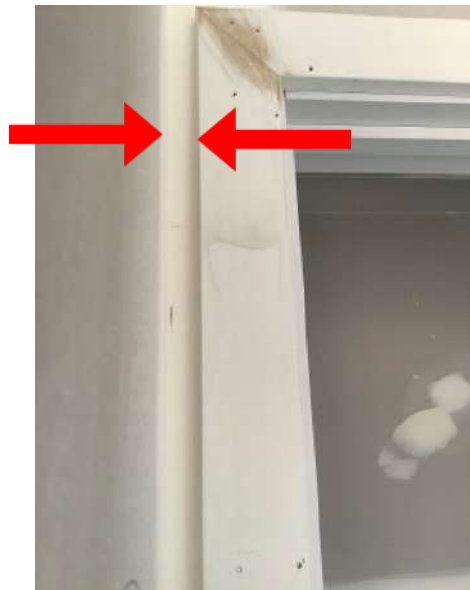
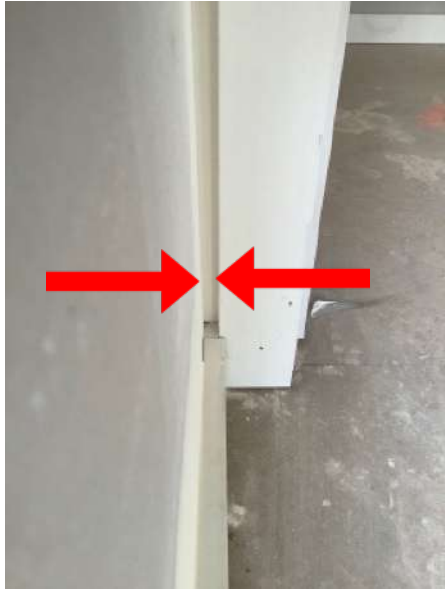
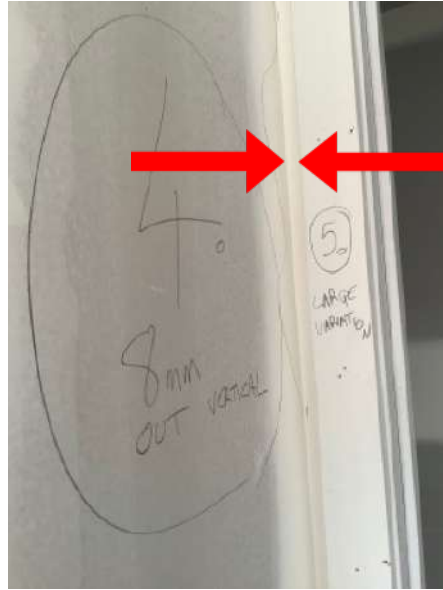
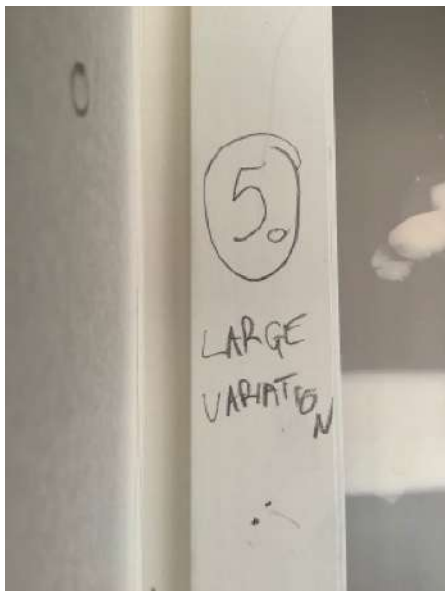
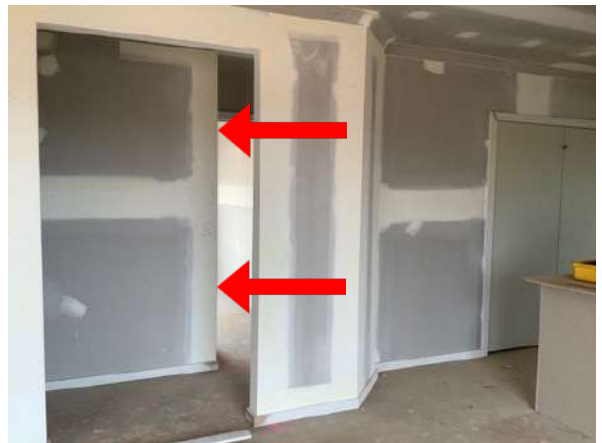
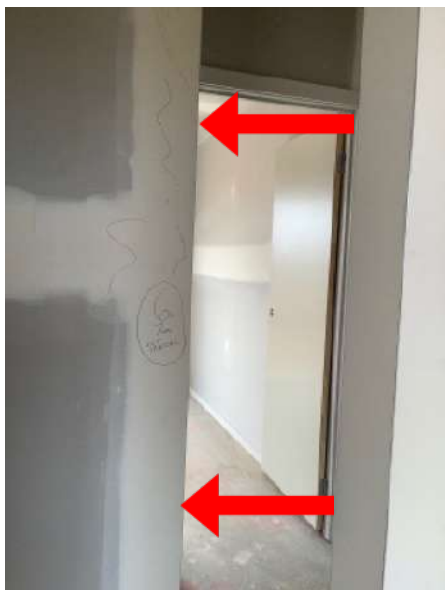
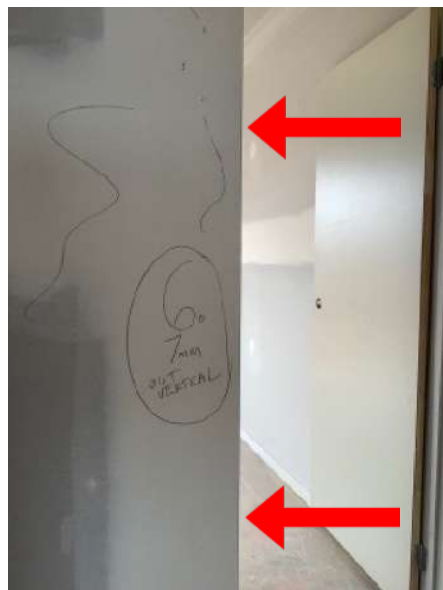
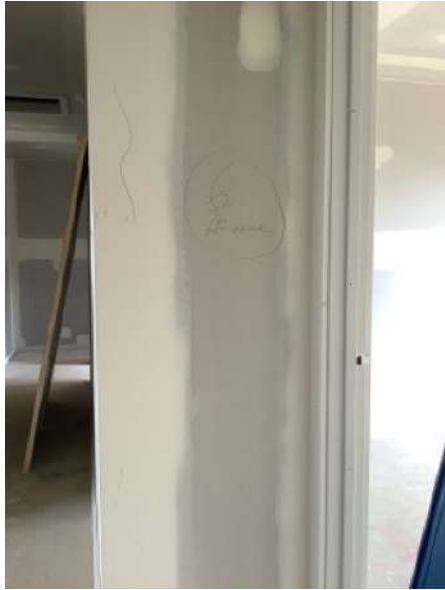
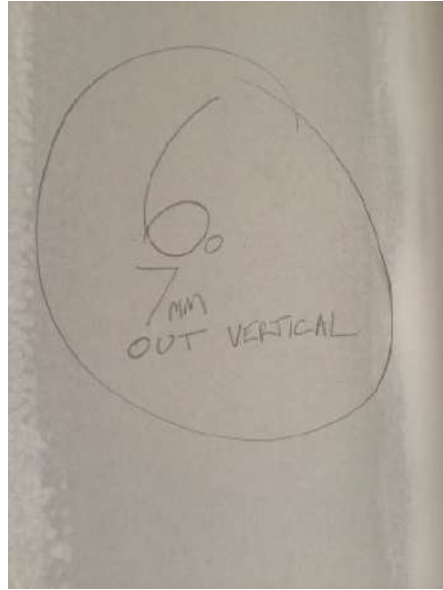
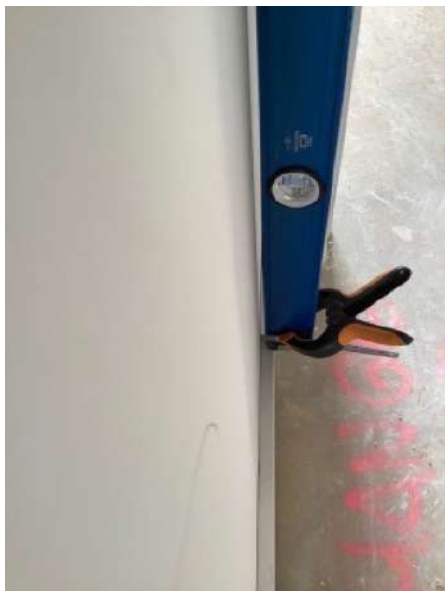
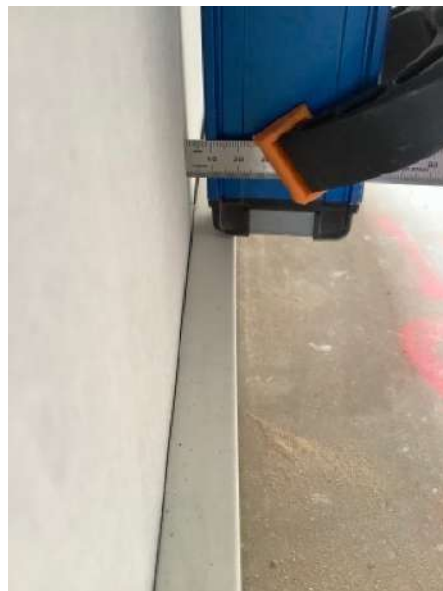
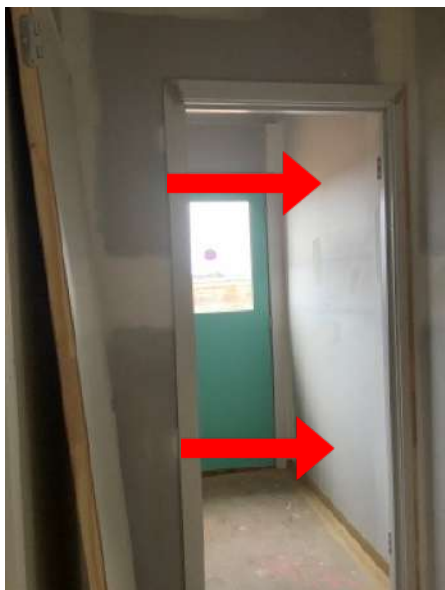
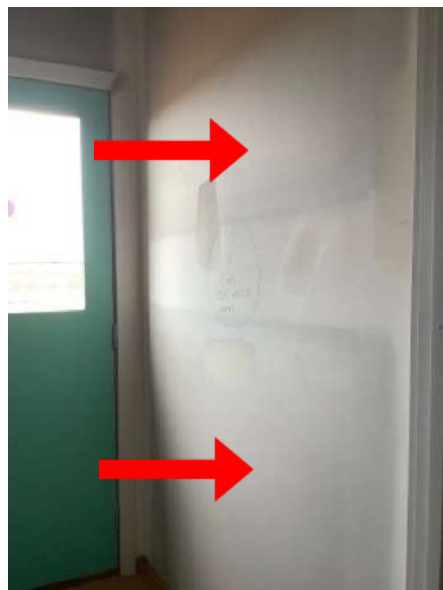
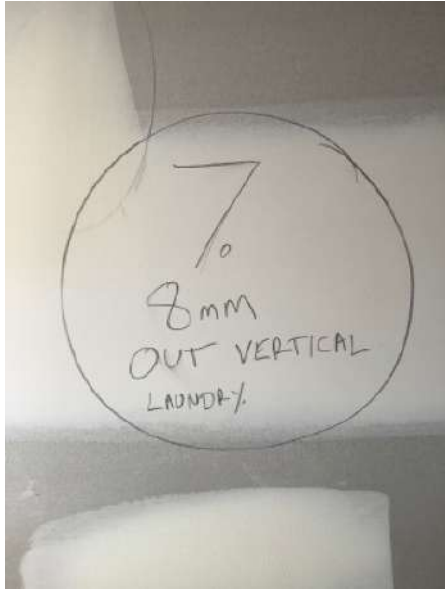
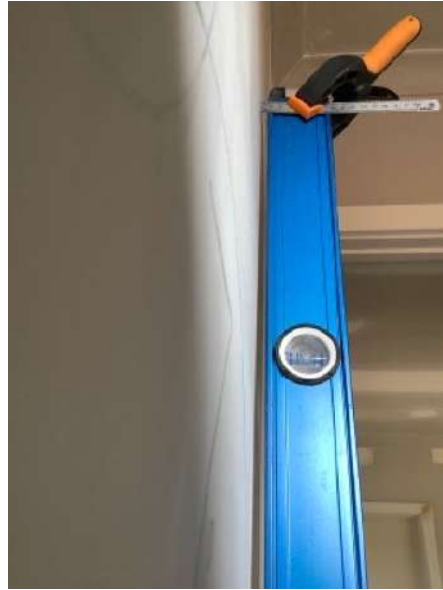
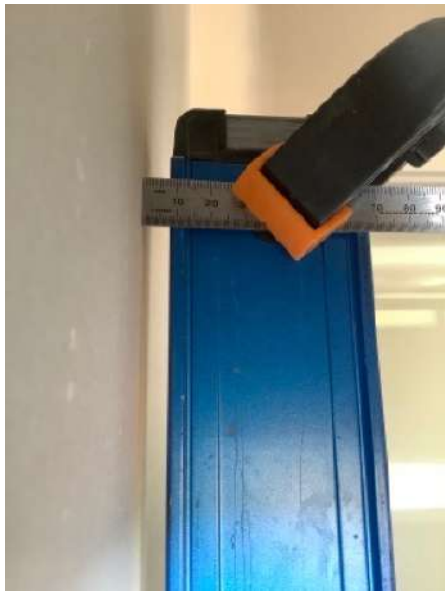
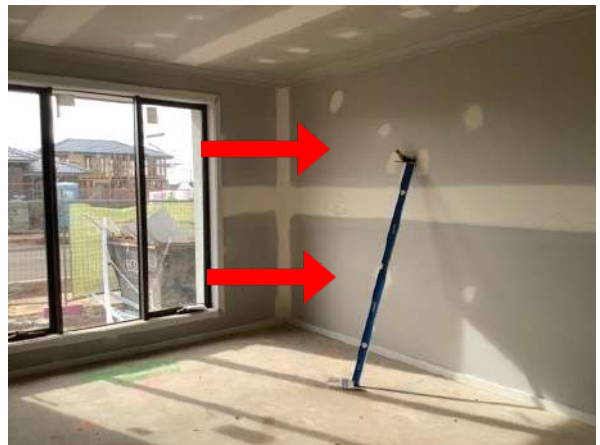
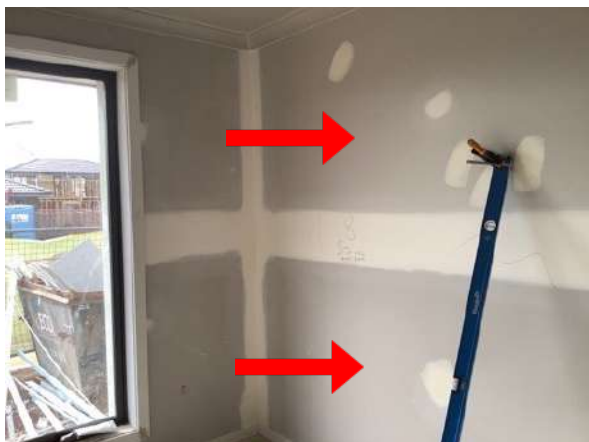
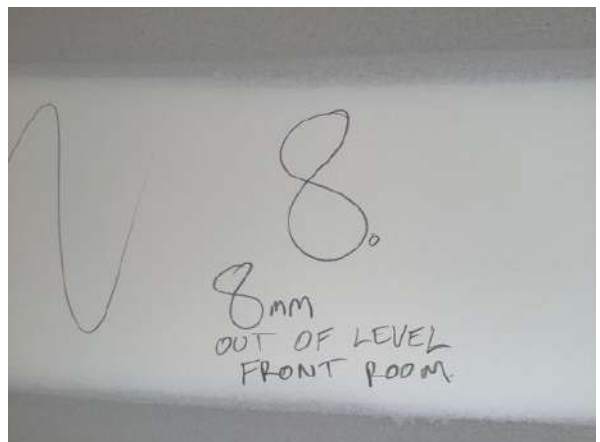
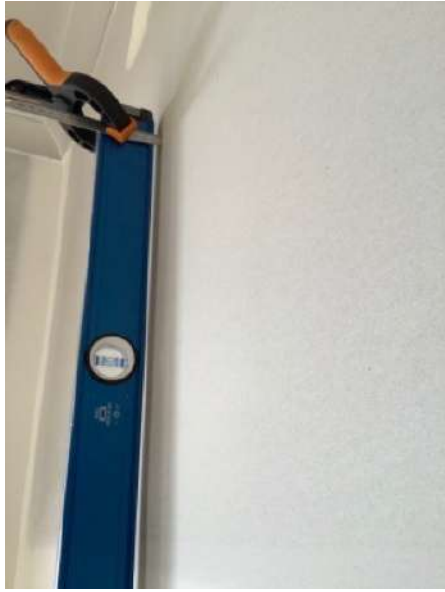
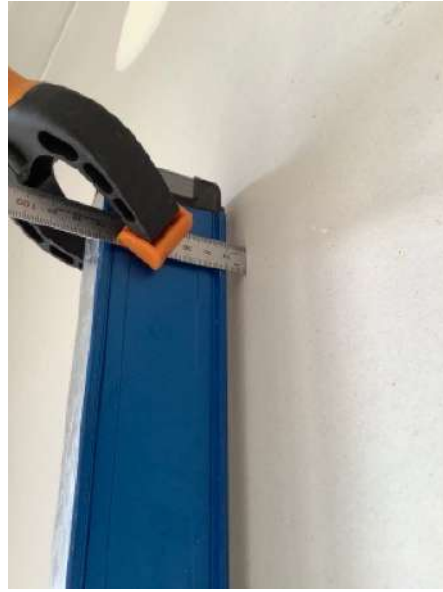
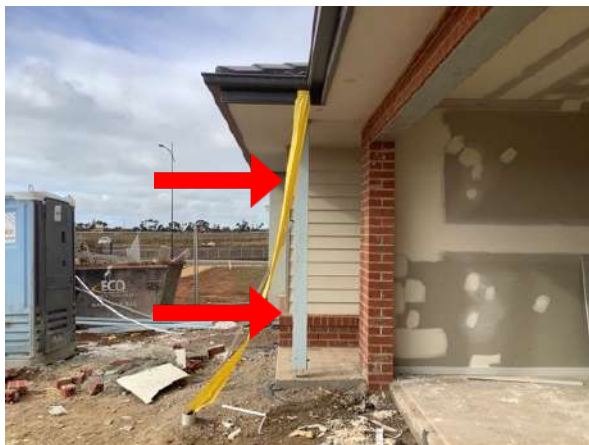
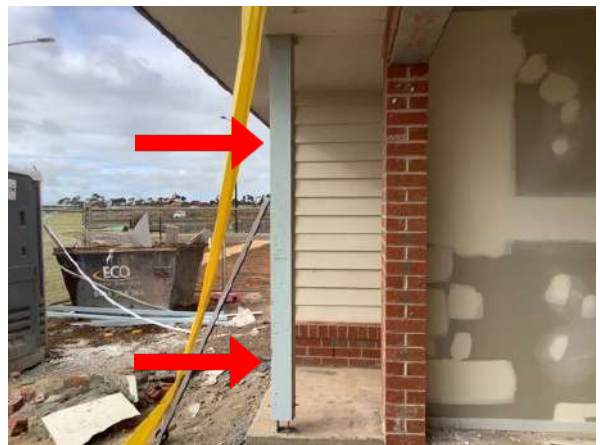
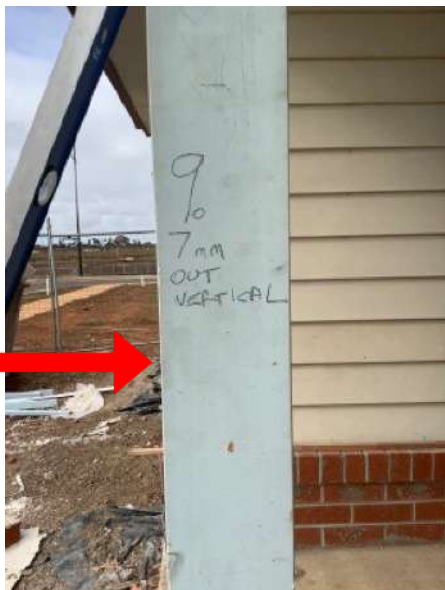
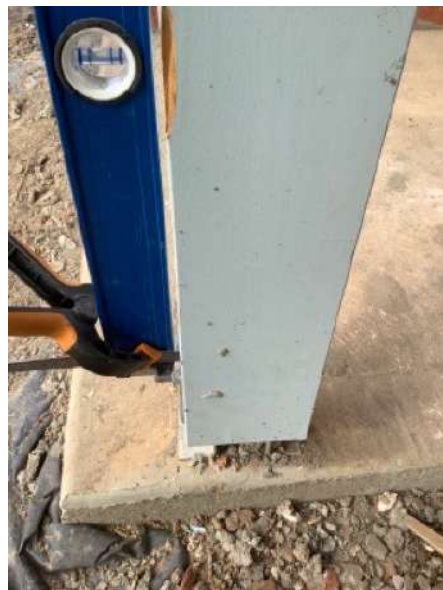
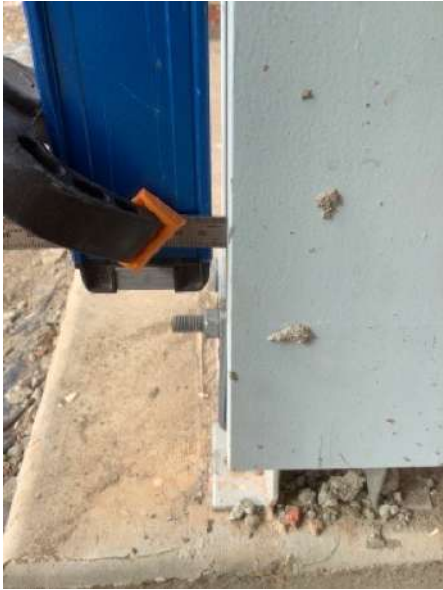
2.01

Location: Frame & Plaster - All Areas

Finding: Various Plaster Walls / Frame / Posts - Not Square Or Vertical Or Horizontal (Maximum Variation Is 4mm Over 2 mtrs)
 Procedure for checking the walls, cornices and timber fixing was performed.
 A deviation (large bow) exceeding 4mm measured across a 2 mtr straight edge was identified in all the areas as per the photos attached & any gaps larger then 4mm is considered a defect and requires considerable re-working of the plaster and possible timber framing in all the areas to rectify the defects.

It is observed that plaster walls / frames are defective as there is a deviation from a vertical or straight plumb line in any direction which exceeds 4mm within any 2m of height / length. This is a technical defect and may result in subsequent structural defects if left unmanaged.

This is commonly referred to as a bow in the frame material and/or defective workmanship. Any bow in excess of 4mm as identified exceeds the allowable Standards and Tolerances and is considered defective.

Any deviation in excess of 4mm exceeds the allowable Standards and Tolerances and is considered a defect.

Frames are defective if they deviate from plane (horizontal or vertical bow) by more than 4 mm in any 2 m length of wall.

This deviation from the verticality / horizontal or plumbness of the wall is a defect with reference to Standards and Tolerances 9.10.

A registered builder should be appointed to assess the defect and perform rectification works as necessary.

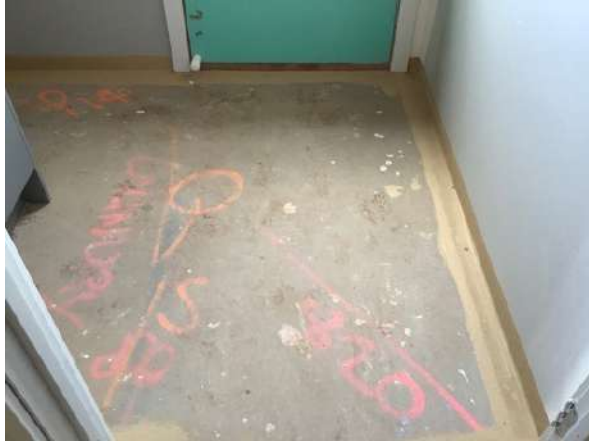
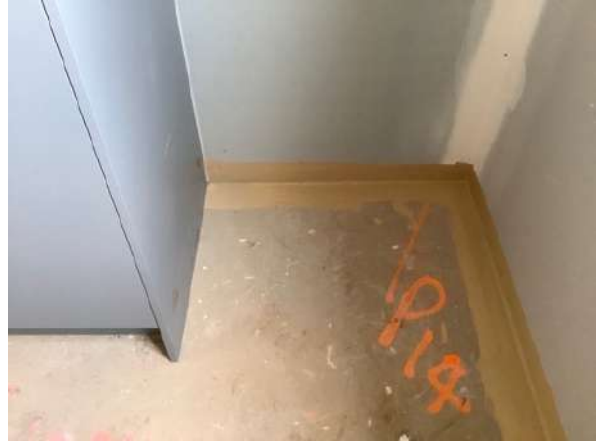
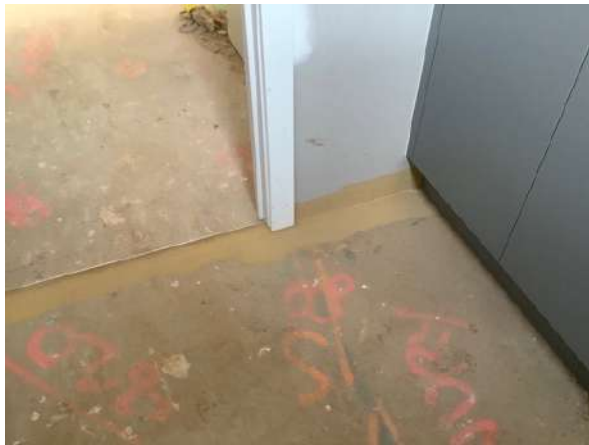
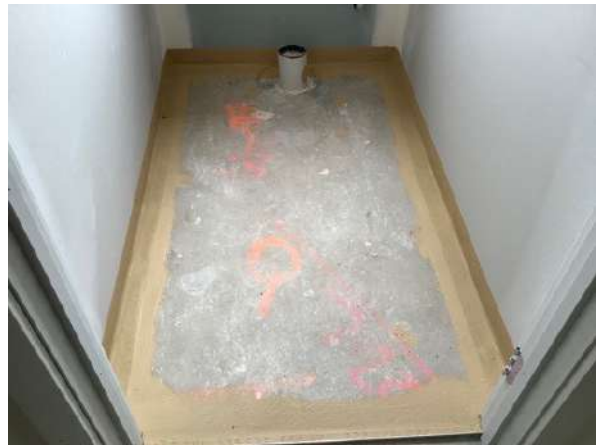
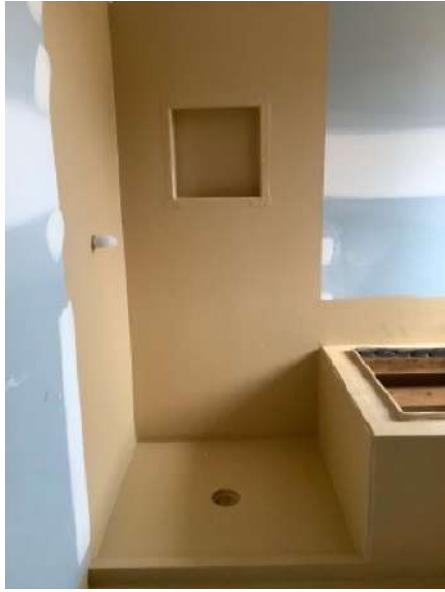
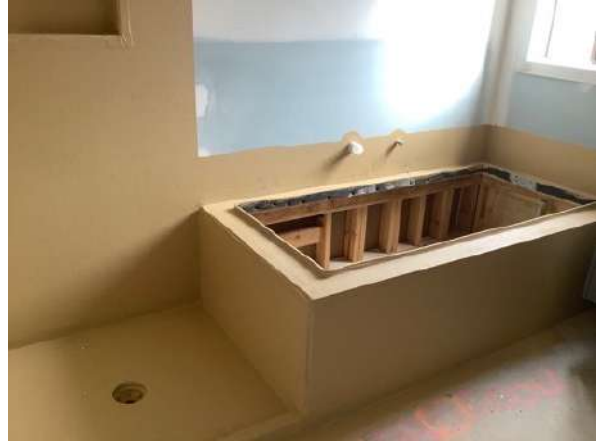
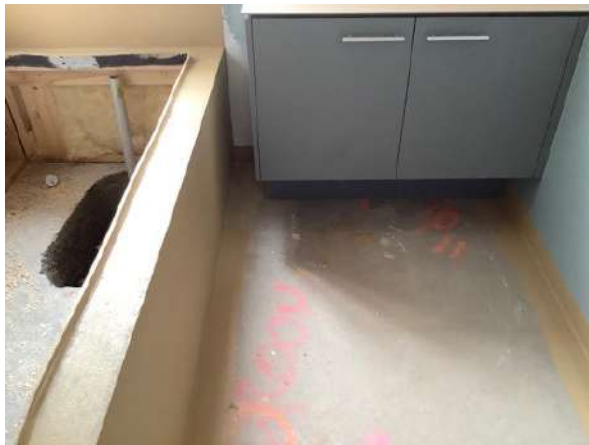
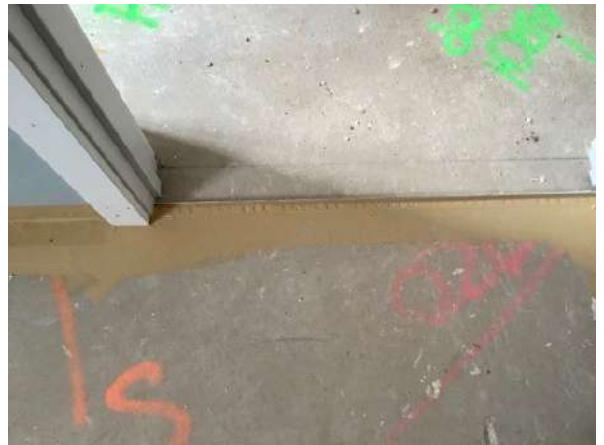
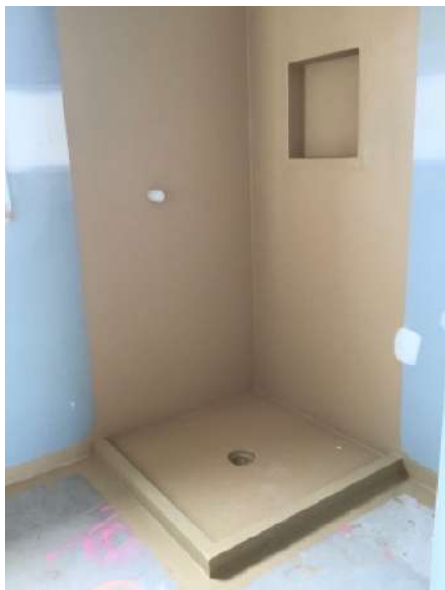
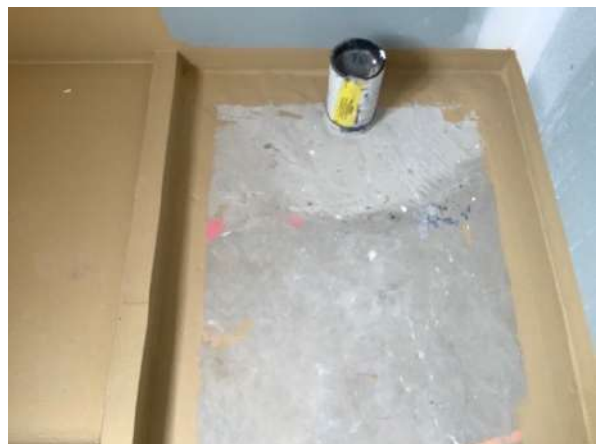
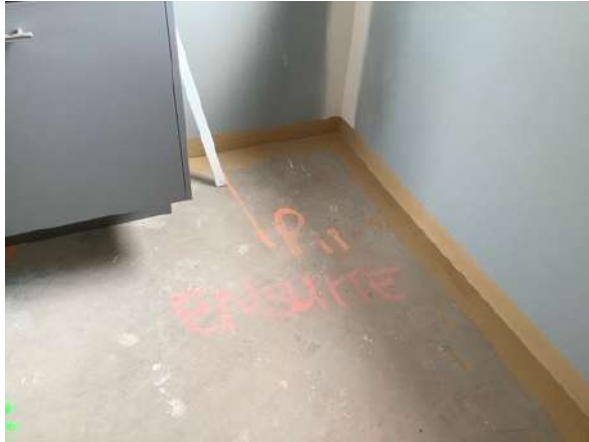
5.05

Location: Waterproofing - All Areas

Finding: Water proofing
At the time of the inspection all the waterproofing to all wet areas complied with the Australian standards and no further works are required in relation to any waterproofing.
