Pre-Plaster Report.

Inspection Date: 5 Feb 2020

Company Name: Master Property Inspections

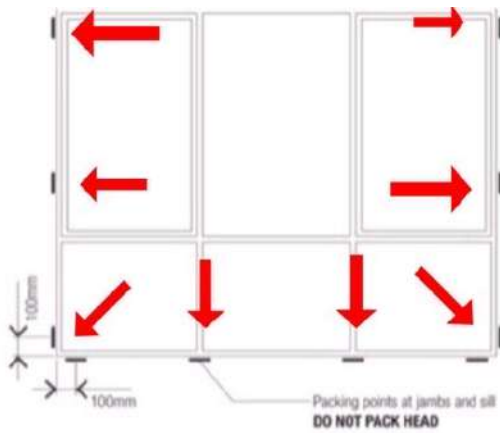
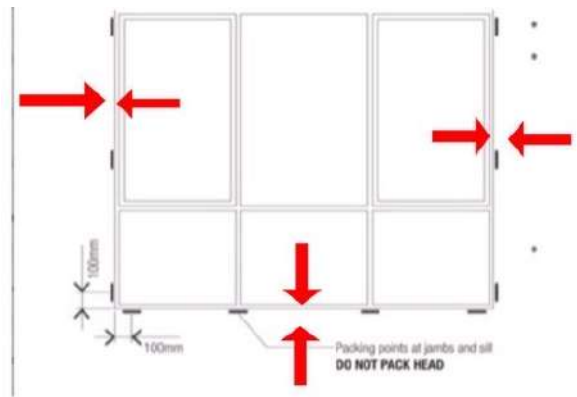
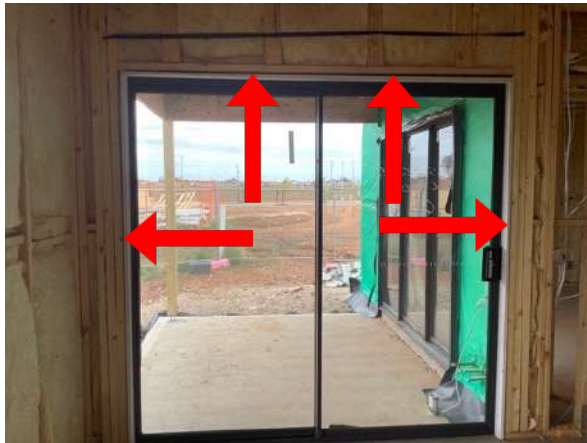
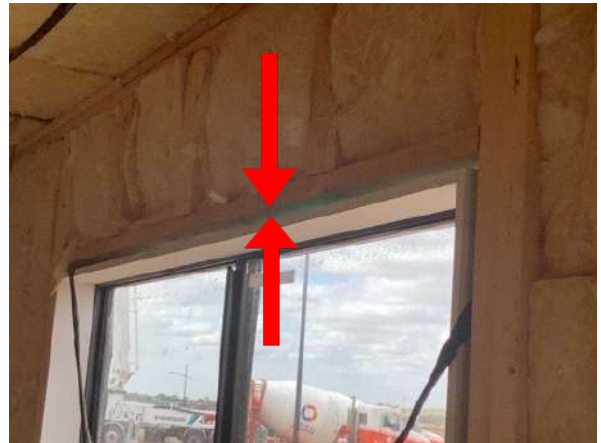
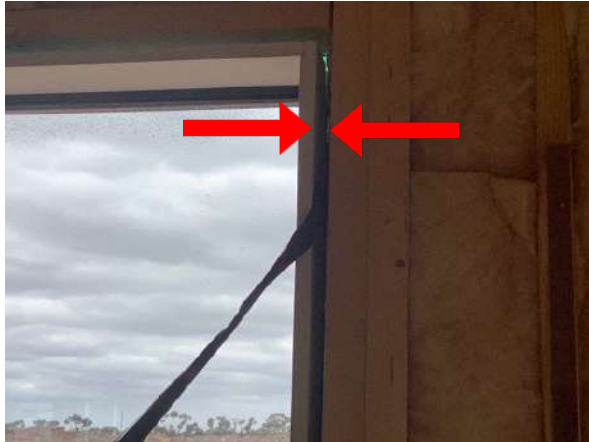
2.01

Finding: Window Installation - Gaps To Perimeter Of Windows Defective & Insulation Required As per AS-2047-1999 and the defect clause is below.
All windows must have sufficient gap around them with a minimum of 15mm at the top of the window to the underside of the timber frame.
In this case the defect in discussion is the sides of the window and the bottom of the window DO NOT have a sufficient gap if any to allow for movement and compression of the frame.

7.3.1 General A gap shall be provided between the window and the surrounding structure sufficient to prevent loads being imposed on the window, allowing for thermal expansion of the window and for structural movement as described in Clauses 7.3.2 and 7.3.3.

ALL WINDOWS with no or insufficient gaps, also as per manufacturers standards is packing to the sides and bottom of the windows as well, must be reworked to allow a recommended of at least 15mm to 20mm of packing.
The packers must be as the manufacturers specifications.

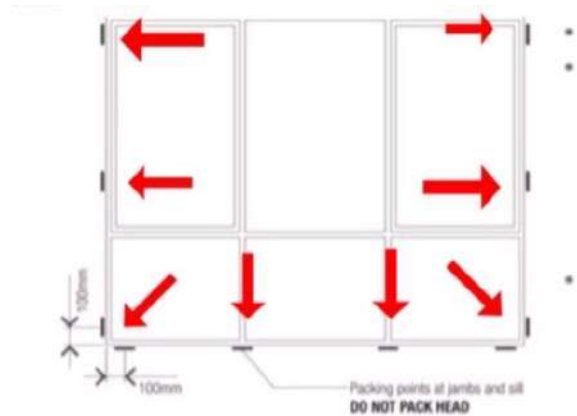
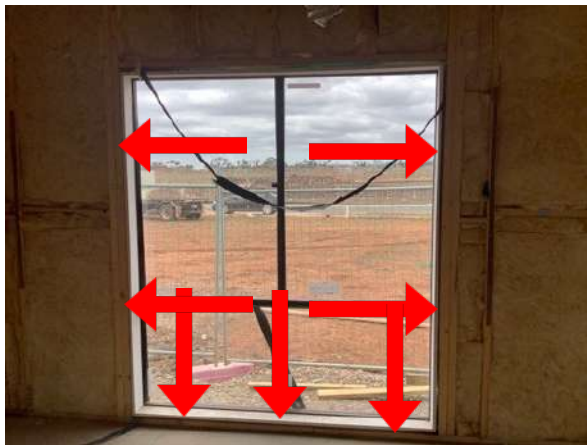
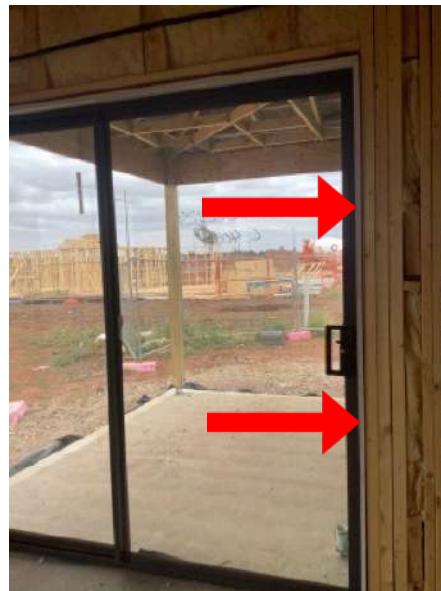
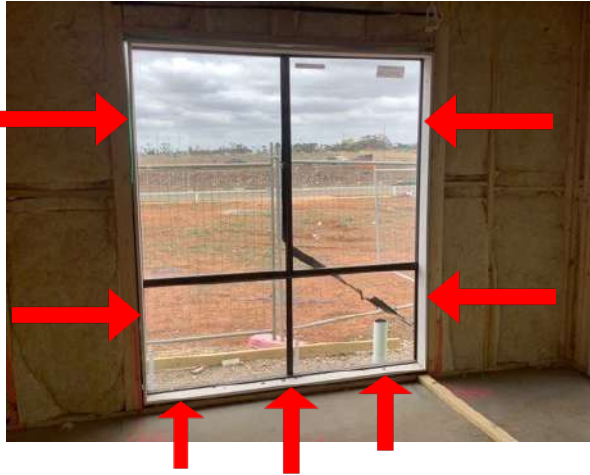
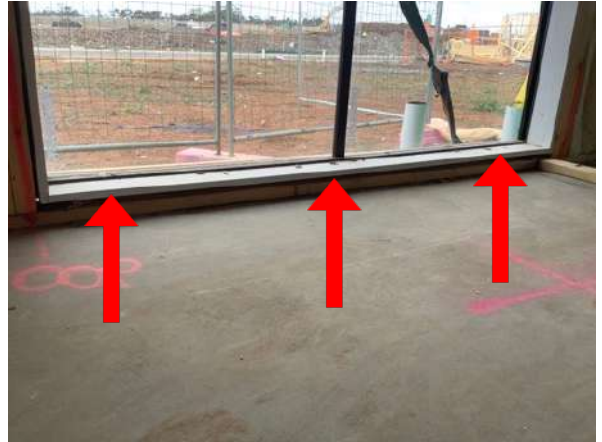
2.02

Finding: Windows - No Packing, As Per The Manufactures Specifications. (Or Packing Not Satisfactory)

Windows must be packed at the mullions as specified by the window manufacturers specifications.

In this case the defect in discussion is the sides of the window and the bottom of the window DO NOT have a sufficient gap if any to allow for movement and compression of the frame.

ALL WINDOWS with no or insufficient gaps, also as per manufacturers standards is packing to the sides and bottom of the windows as well, must be reworked to allow a recommended of at least 15mm to 20mm of packing.

The packers must be as the manufacturers specifications.

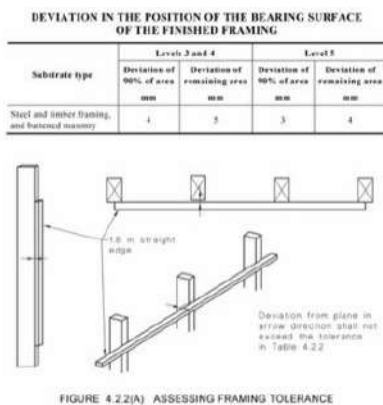
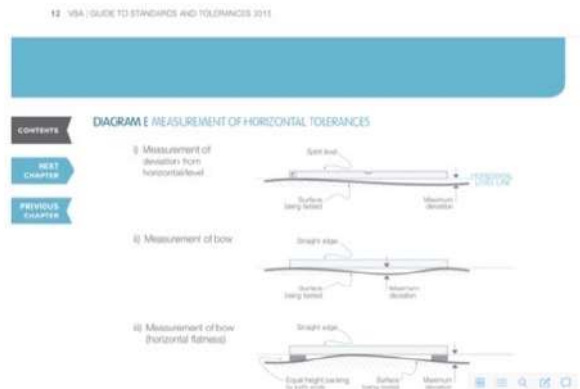
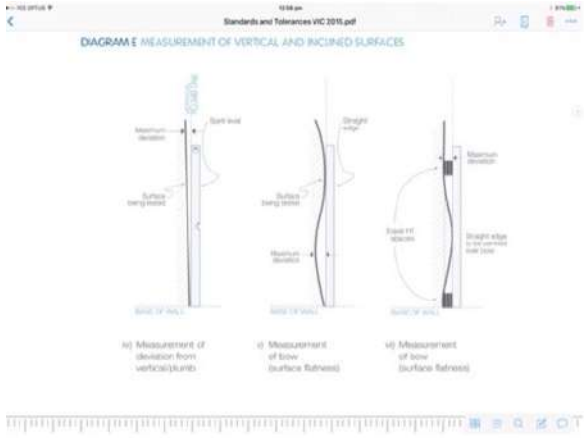
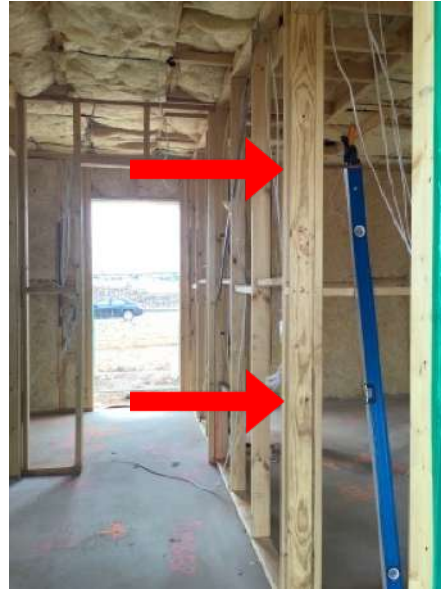
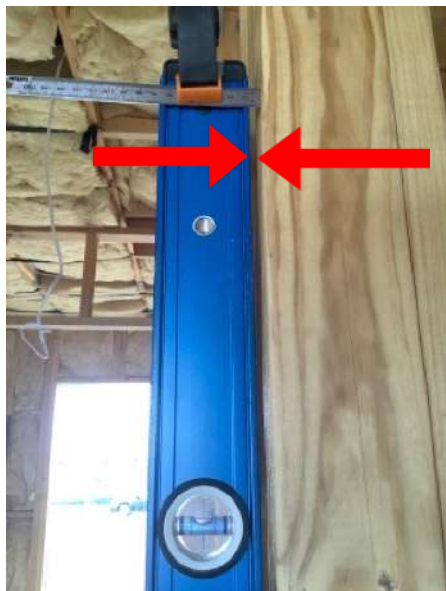
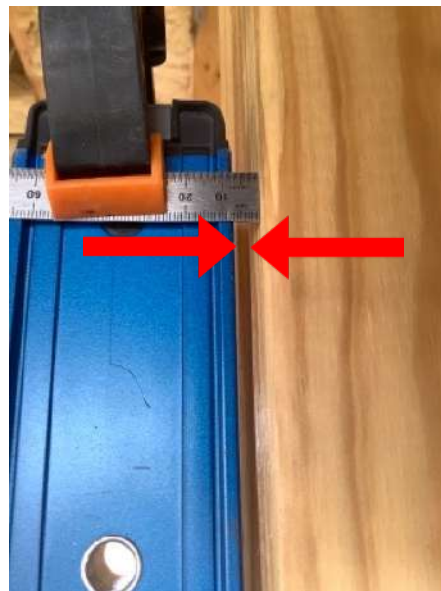
2.03

Finding: Frame / Walls - Not Square-Vertical Or Horizontal (max variation is 4mm over 2 mtrs)
It is observed that post/s and wall frame/s are defective as there is a deviation from a vertical or straight plumb line which exceeds 4mm within any 2m of height / length.

This is a technical defect and may result in subsequent structural defects if left unmanaged.

This is commonly referred to as a bow in the frame material and/or defective workman. Any bow in excess of 4mm as identified exceeds the allowable Standards and Tolerances and is considered defective.

Frames are defective if they deviate from plane (horizontal or vertical bow) by more than 4 mm in any 2 m length of wall.

A registered builder should be appointed to assess the defect and perform rectification works as necessary.

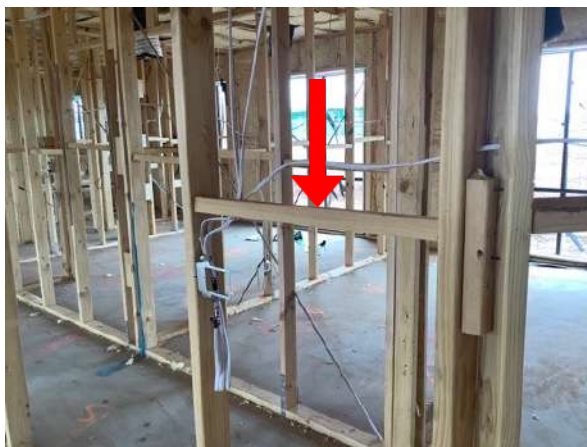
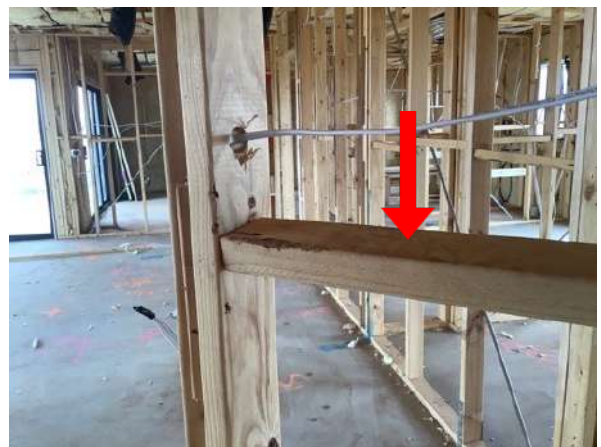
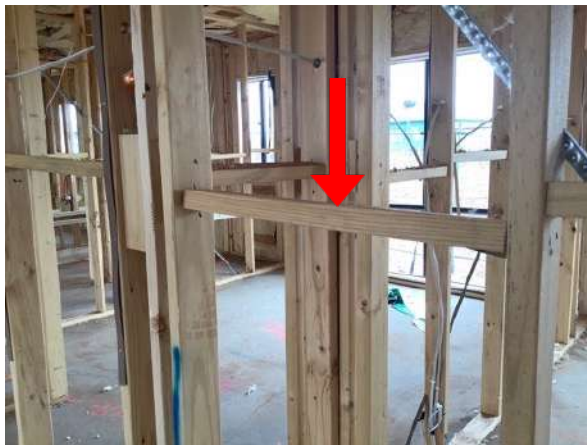
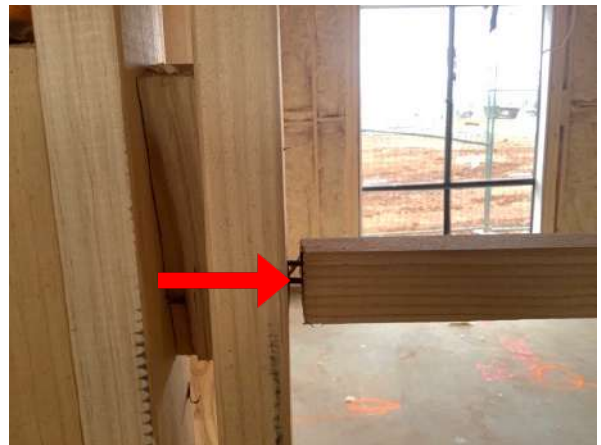
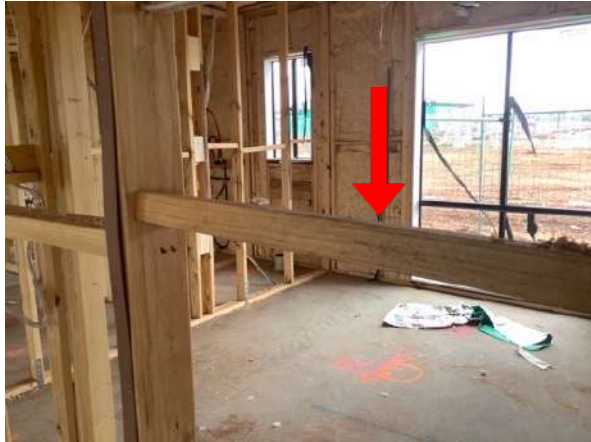
2.04

Finding: Noggings - Defective Installation - Missing - Taken Out For Tradespersons Requirements. We refer the builder to AS 1684.2, clause 6.2.1.5 which calls for all noggings to be installed to comply with the Australian Standards. That is into all stud openings, staggered no greater than 150 mm with no opening exceeding 1350 mm in total.

All walls must be installed with noggings no greater that 1350 mm spacing. The intersecting wall connection does not negate this requirement.

As such the continuation of noggings through the intersecting wall area must be installed. This means that one block has to be set at the noggling level. I refer the builder to clause 6.2.1.5.

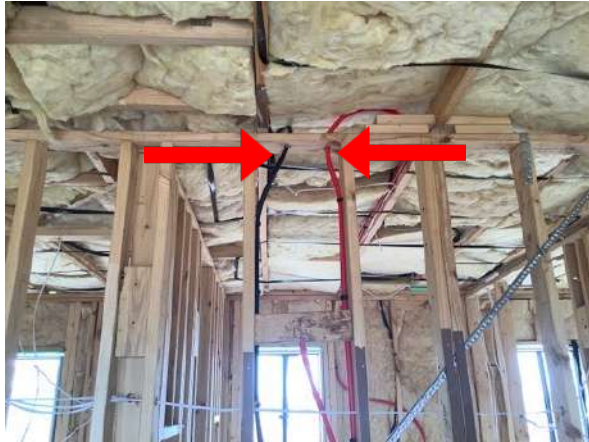
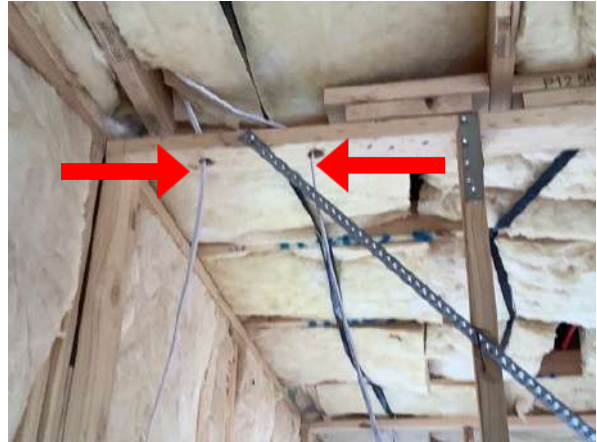
2.05

Finding: Holes and notching - insufficient distance and oversized holes.
 It was observed during inspection that the minimum distance between holes for services (electrical and / or plumbing) and notching has not been maintained. The AS1684.2 2010, Page 60 and 61 requires a minimum distance between holes and notching in a 90mm stud and top plates is 270mm apart.
 The standard (table 6.1) states that the distance between holes and other holes or holes to notches in studs can be no closer than 3 x D. This is calculated as 3 x the depth of the material used. In this case 3 x D is 3 x 90mm or 270mm minimum distance apart.

Install a noggin on edge hard up against the top plate..Install two nails to each side of the studs and nail two nails into the top plate and into the noggin on edge.

The timber must be replaced and the rough in reinstalled at 270mm separation or the area beside the rough in cleated to add additional support to the stud.

Consultation with the building surveyor or certifier is recommended to establish the correct course of action to overcome the existing installation of services to comply with AS1684.

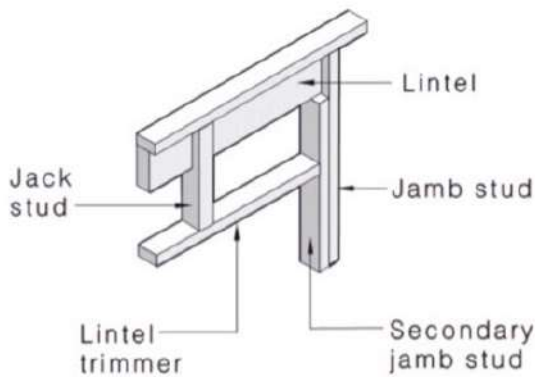
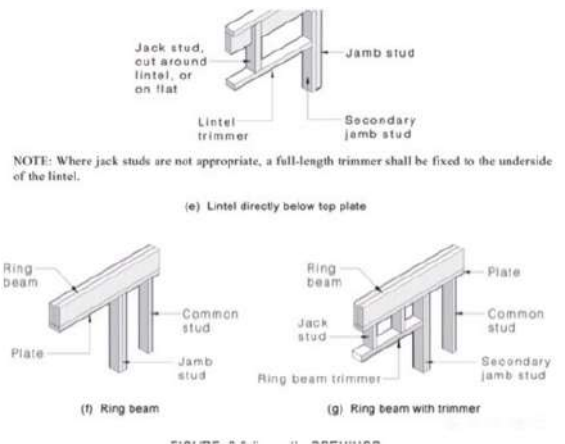
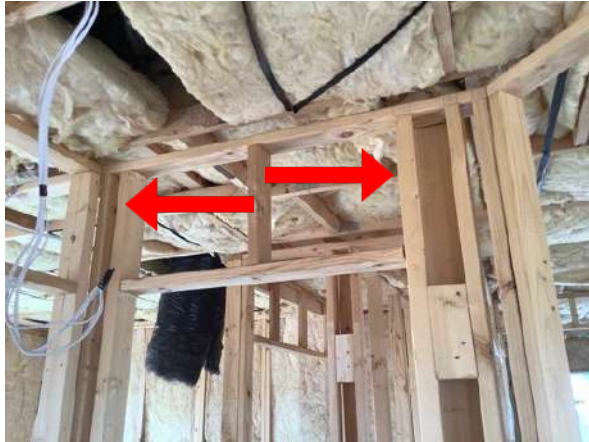
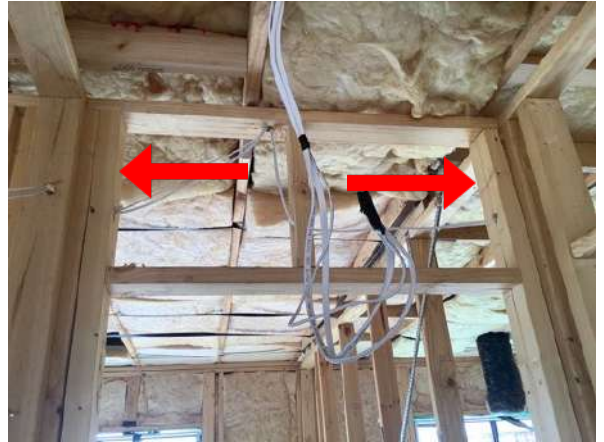
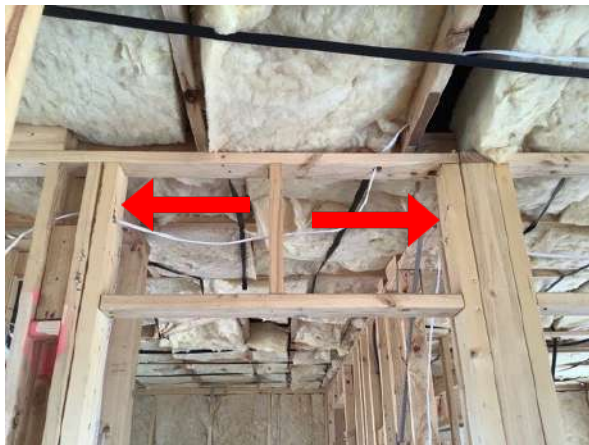
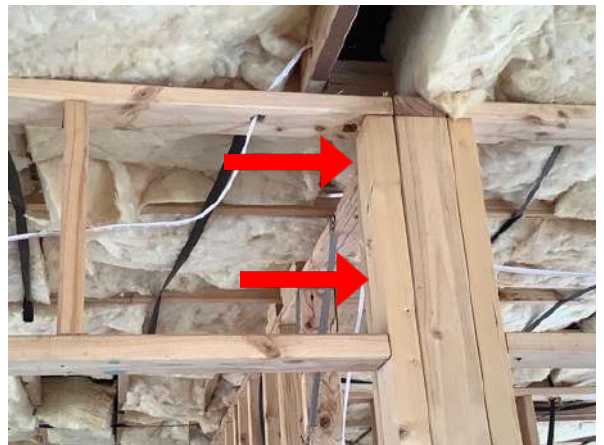
2.06

Finding: Door heads Defective (Jamb Studs Defective)
 The door openings have not been constructed in accordance with 1684.4 section 6.2.3 detailing the framing method for openings.
 These areas should be replaced to conform with the above section

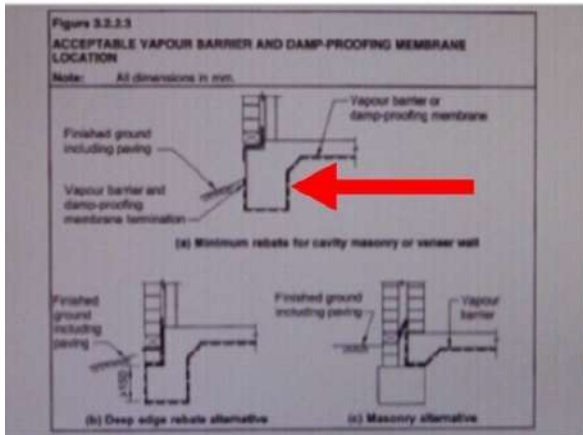
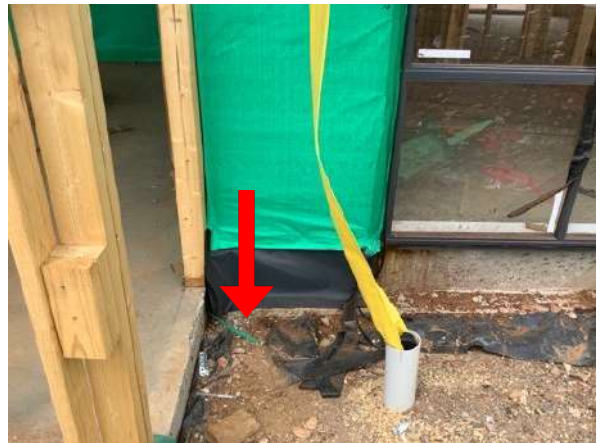
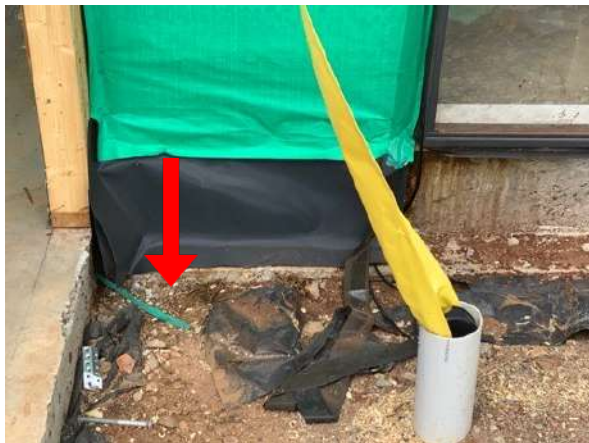
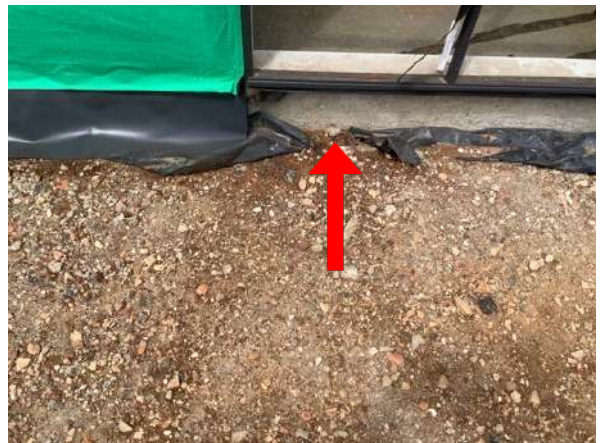
2.07

Finding: Vapour barrier - Defective (AS2870- 2011)
The functionality of the vapour barrier to the entire perimeter of the building including, between the the buildings each side of the house is being compromised due to poor workmanship during the installation/construction process.

It is a requirement of AS 2870-2011 5.3.3.4 that vapour barriers are turned up and terminated at ground level above pavement adjacent footing. The vapour barrier is defective if building materials and fill has been left on top of the membrane, as this prevents it from being pulled up against the slab when installing perimeter paving as it is intended to be.

This must be remedied immediately to prevent slab edge
It is a requirement of AS 2870-2011 5.3.3.4 that vapour barriers are turned up and terminated at ground level above paving adjacent footing. The vapour barrier is defective is building material and fill has been left on top of the membrane as this prevents it from being pulled up against the slab when doing perimeter paving as it is intended to be.

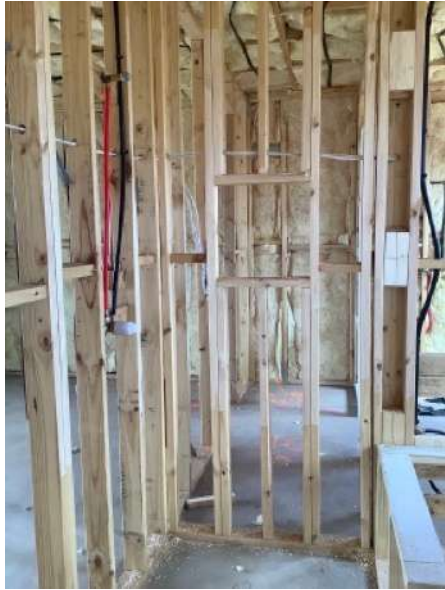
5.11

Finding: Shower Stud Width Acceptable

Upon inspection of the shower areas, it appears that the stud width installation is at 300mm centres which is suspected to be adequate for shower areas as per BCA and the framing standard.
