## Pre-Pour Concrete Slab Report

Inspection Date: 25 Mar 2020

Property Address: Greenvale Area, Vic

Report Type: New Home Construction

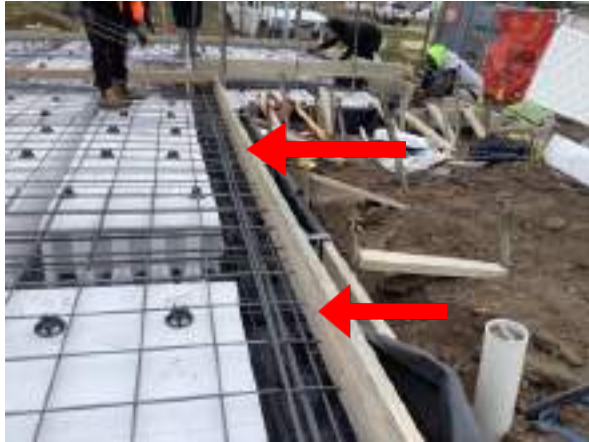
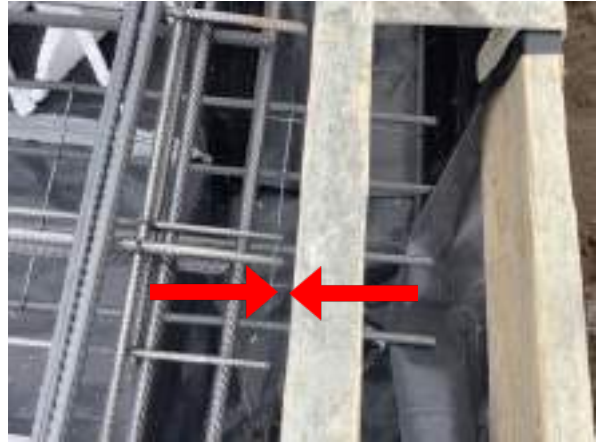
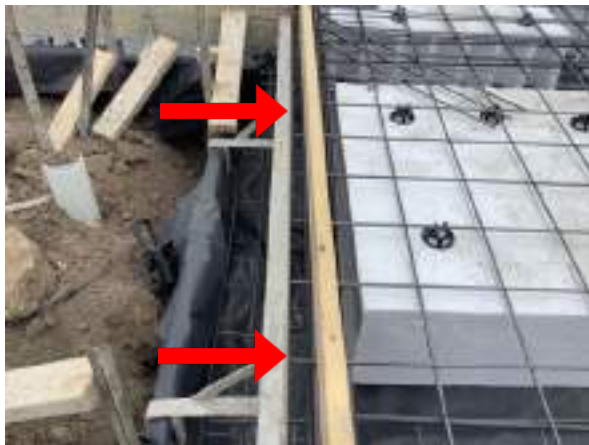
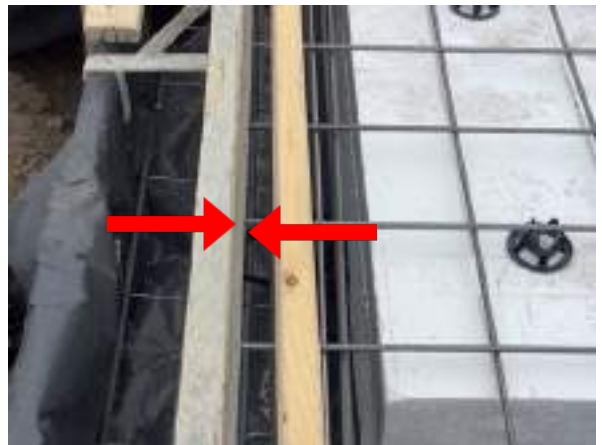
### Non Compliant 2.01

Location: Post-Pour Slab - All Areas

Finding: Mesh Too Close To The Perimeter.

1. The reinforcement mesh is sitting too close to the perimeter boxing to sections of the dwelling. 40mm to external exposure, to the entire perimeter boxing is required.

(D). Footings and slabs on ground must have concrete cover between the outermost edge of the reinforcement ( including ligatures, tie wire Etc. ) and the surface of the concrete of not less than :

- ( i ). 40mm to unprotected ground.
- ( ii ) 30mm to a membrane in contact with the ground.
- ( iii ) 20mm to an internal surface.

( iv ) 40mm to external exposure.

This mesh will need to be cut back or repositioned before the slab is poured to provide sufficient concrete cover to the reinforced steel.

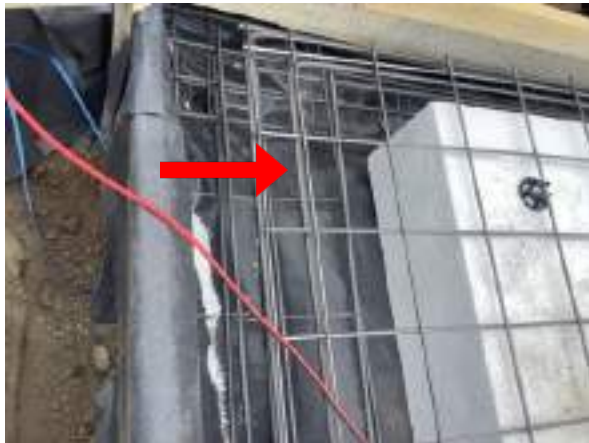
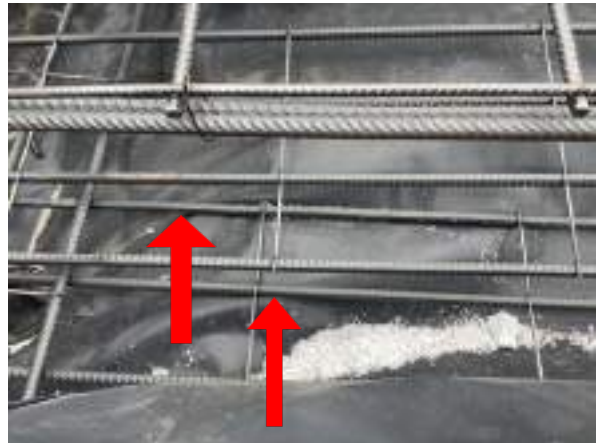
## Non Compliant 2.02

Location: Post-Pour Slab - All Areas

Finding: Trench Mesh or Steel Bars Sitting On Or Touching The Vapour Barrier Membrane.  
2. There are numerous areas where the reinforcement trench mesh or steel bars are sitting on or touching the vapour barrier (membrane).

The reinforcement fabric is designed to be located on bar chairs. The current installation puts the mesh touching the bottom of the trench or waffle beam. Other areas of mesh are in contact with the sides of the beams.

( ii ). 30mm to a membrane in contact with the ground.

These sections must be repositioned to provide 30mm of concrete cover to comply with the NCC volume 2 section 3.2.3.2 d) (ii).

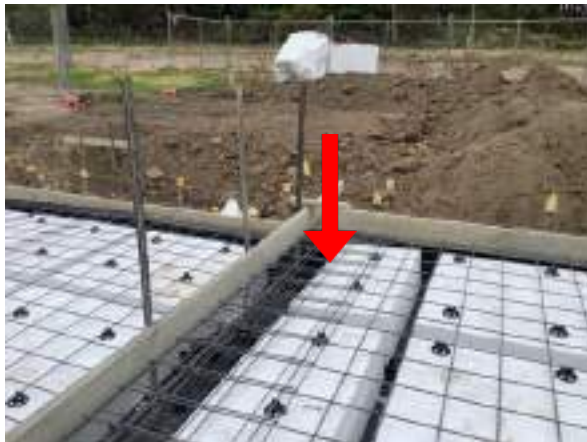
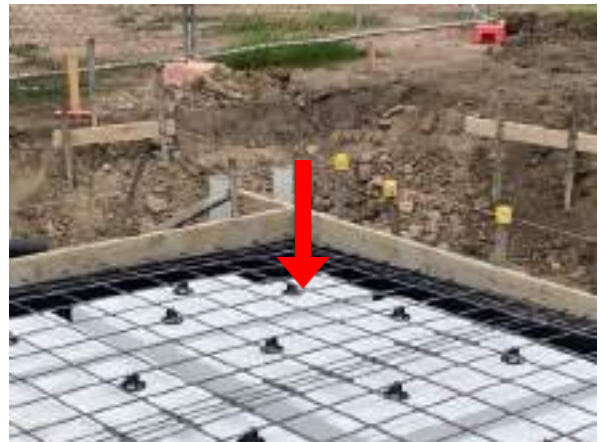
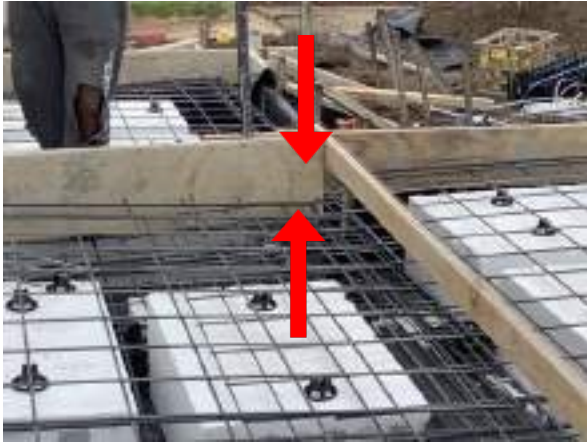
## Non Compliant 2.03

Location: Post-Pour Slab - All Areas

Finding: various areas of reinforced steel that has not been secured.

4. I noted various areas of reinforced steel that has not been secured (tie wire or that alike) in a manner to prevent the reinforcement to move during the concrete pour.

( i ) All reinforcement must be firmly fixed in place to prevent it moving during concreting operations .

( ii ) reinforcement must be supported off the ground or the forms by bar chairs made from wire, concrete or plastic.

These areas must comply with the NCC Volume 2 section 3.2.3.2 (f), (i) inserted below.

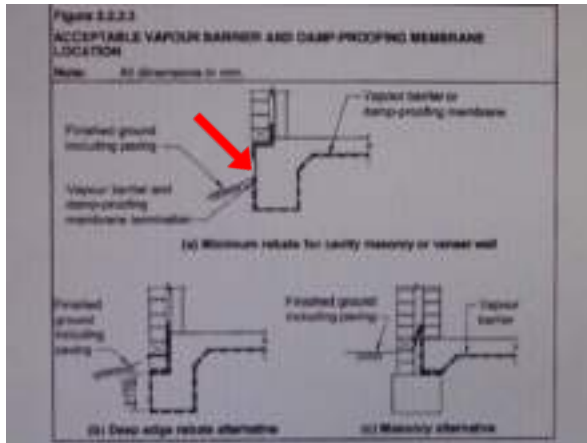
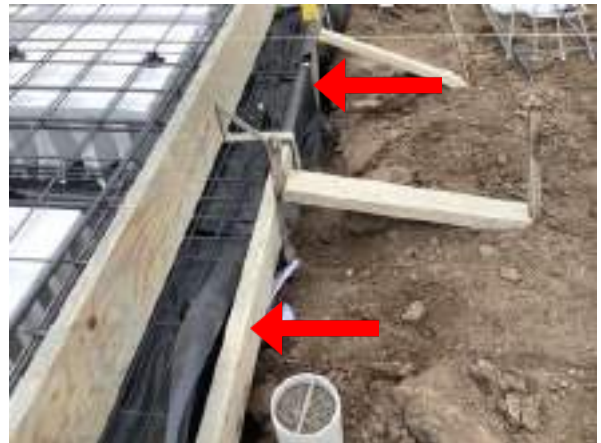
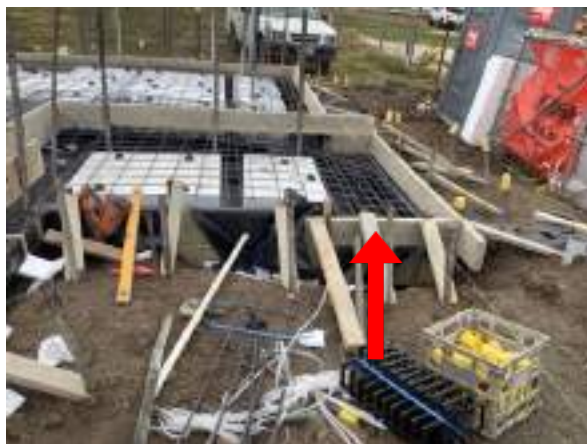
## Non Compliant 2.04

Location: Post-Pour Slab - All Areas

Finding: polyethylene vapour barrier not installed as per BCA - Part 3.2.2.6  
Defective Vapour Barrier Installation - Damaged/Punctured and/or overlapping Defective.

It was noted at the time of inspection that a vapour barrier had not be installed in accordance with AS2870 and BCA Part 3.2.2.6.

Whilst the majority of the vapour barrier system has been done correctly there are minor areas of non compliance to repair.

The polyethylene vapour barrier from beneath the concrete floor slab must be turned up the external side faces of its edge beams. Failing to install the vapour barrier correctly will allow moisture ingress via slab edge dampness into the internal timber wall skins and/or the floor coverings if not done.

Without a vapour barrier installed, these areas are non-compliant with Australian Standards and are susceptible to excessive moisture, which may create major secondary defects as the building ages. Rectification works are necessary as soon as possible to ensure all standards are met.

- 1/ All over laps are not taped as described below.
- 2/ All the rips and/or damaged area needs to be taped.
- 3/ Some areas are not up to future ground and/or finished paving or concrete heights and must be extended with 200mm overlay and taped.
- 4/ Somes areas whilst listed above are Damaged / Ripped / Not Consistent And Sealed with 200mm Overlay And Taped / Not High Enough / Non Existent must ALL be repaired.

The polyethylene vapour barrier must properly extended up the external side faces of the edge beams to at least the height of future finished ground level or paving i.e. 75mm below the damp-proof course and bottoms of the weepholes, after which any termite barriers that are in place, if required, will also need to be properly instated.

**The vapour barrier system was incomplete, however the Concretor's have informed me that they will do all the repairs to the vapour barrier once they take the timber boxing off as the concrete starts to set and I can re-inspect this defect at post slab inspection.**

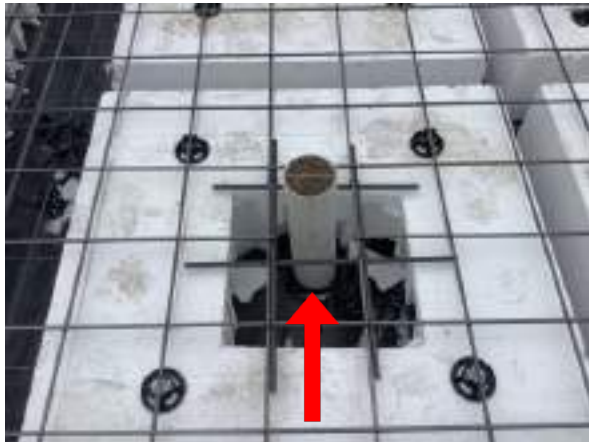
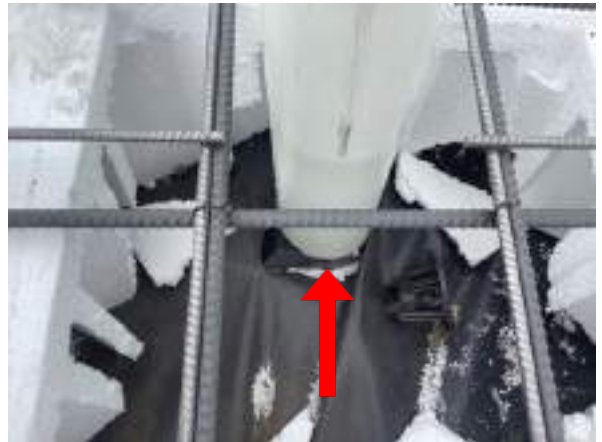
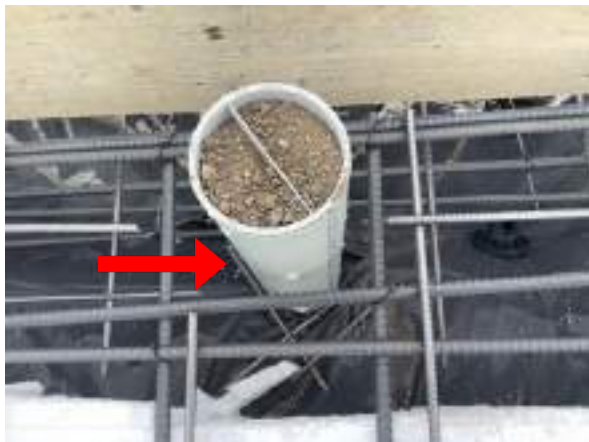
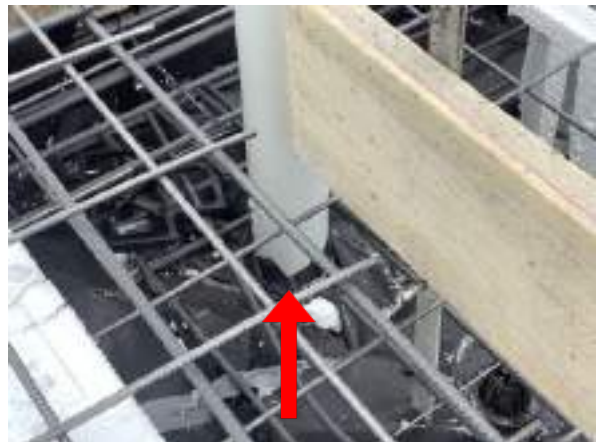
## Non Compliant 2.05

Location: Post-Pour Slab - All Areas

Finding: Pipe penetrations through the vapour barrier.  
The pipe penetrations through the vapour barrier have not been fully taped and require further works.  
There are also numerous cuts and tears throughout the vapour barrier that have not been taped correctly.  
These will need to be taped up and photographed before the pour is started.

- ( i ) lap not less then 200 mm at all joins. And
- ( ii ) tape or seal with a close fitting sleeve around all service penetrations.

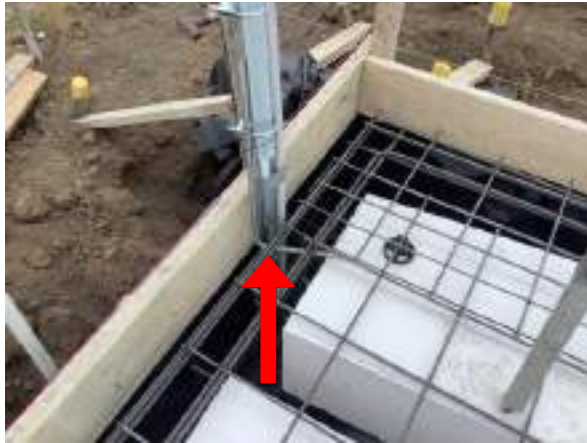
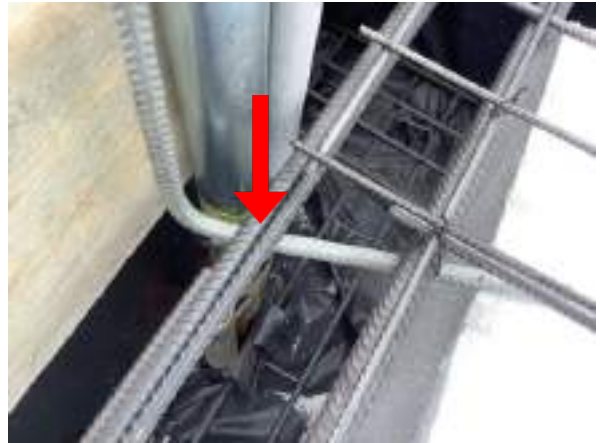
## Non Compliant 2.06

Location: Post-Pour Slab - All Areas

Finding: Defective Earthing To Steel Mesh.

The earthing facility installed to the dwellings slab steel as required in AS 3000 Requires additional wire tie.

I refer the builder to AS 3000, clause 5.6.2.5 that states "Any conductive reinforcing within a concrete floor or wall forming part of a shower or bathroom shall be bonded to the earthing system".

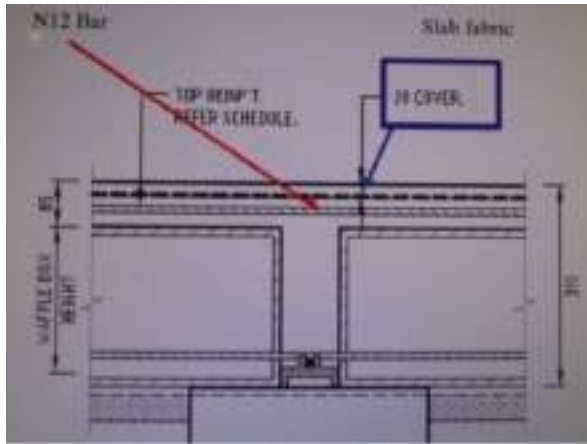
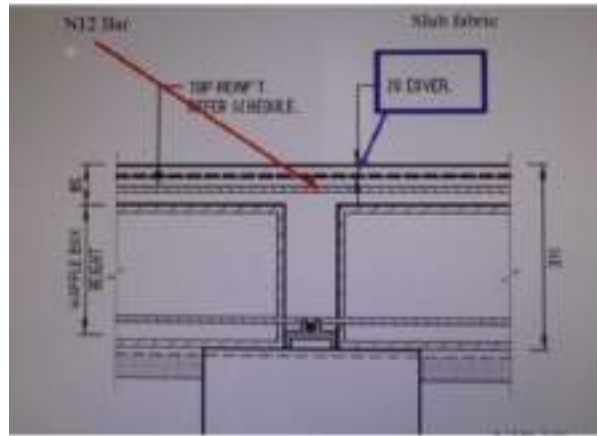
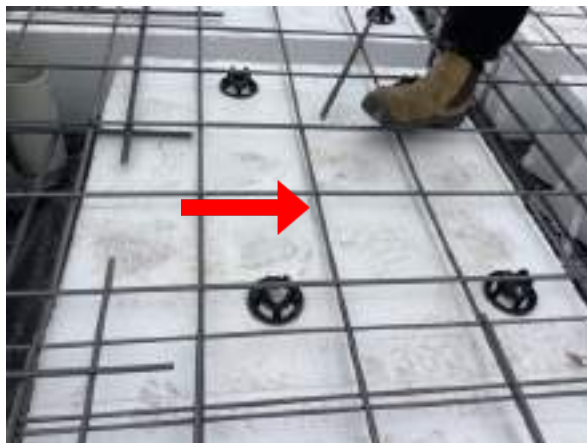
## Non Compliant 2.07

Location: Post-Pour Slab - All Areas

Finding: Min 20mm Slab Fabric For Steel Mesh  
Several N12 bars have been installed to the top of slab fabric. The engineering details calls for such bars to be installed below slab fabric to ensure sufficient concrete cover is provided. The steel must be re-worked below slab fabric.

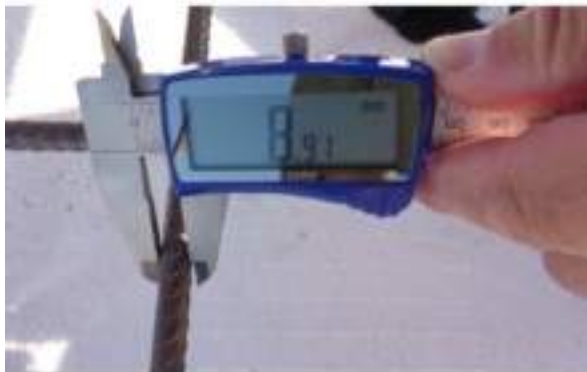
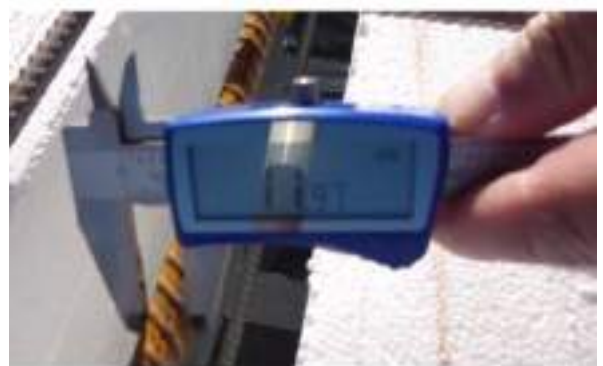
### For Your Information 5.12

Location: Post-Pour Slab - All Areas  
Finding: Thickness Of Steel Mesh.  
Additional photos are provided for your general reference.
