## Specific ( Wheel Chair Ramp ) Report

Inspection Date: 8 Apr 2020

Report Type: Property Inspection Report

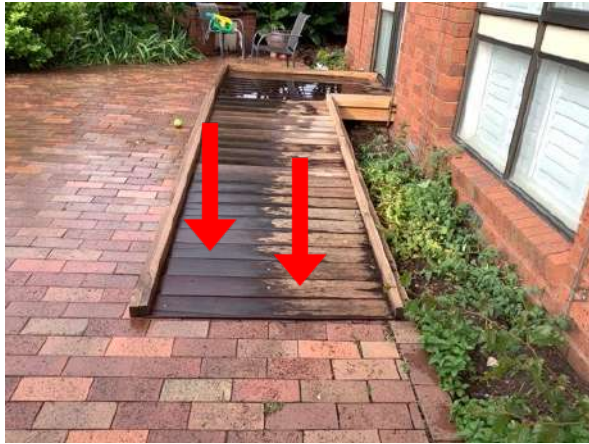
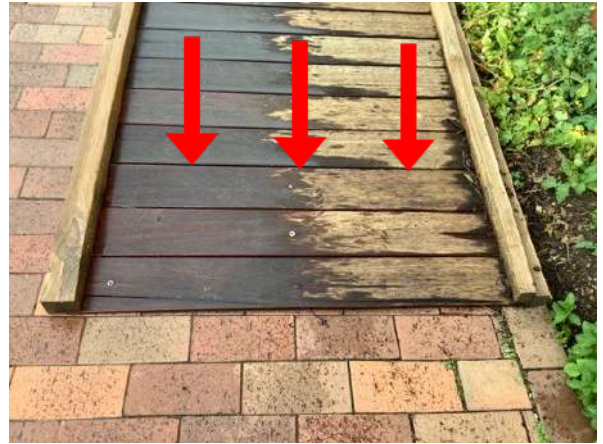
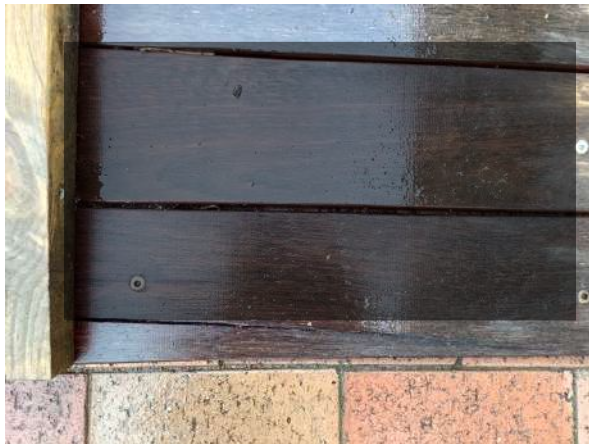
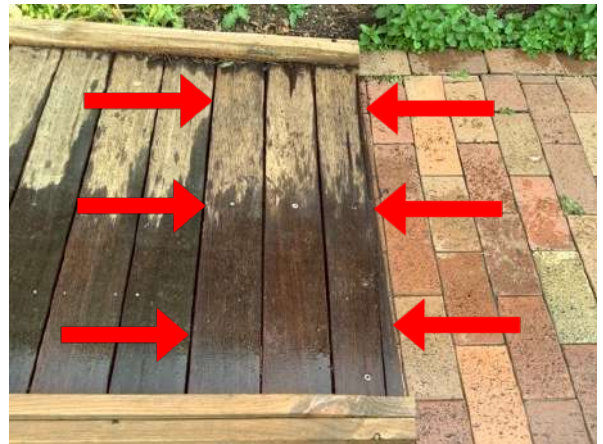
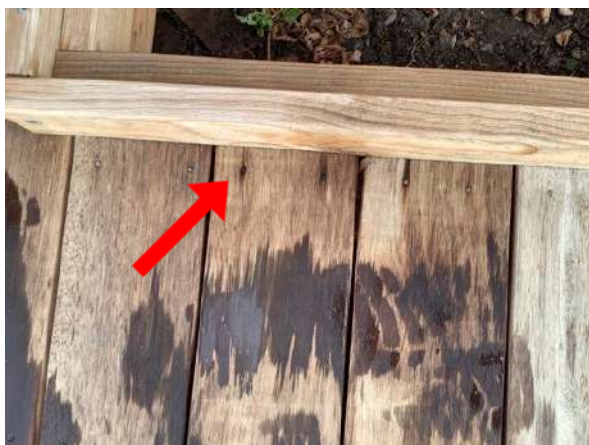
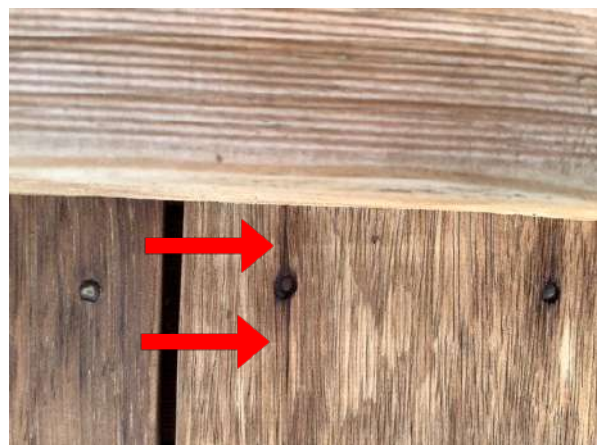
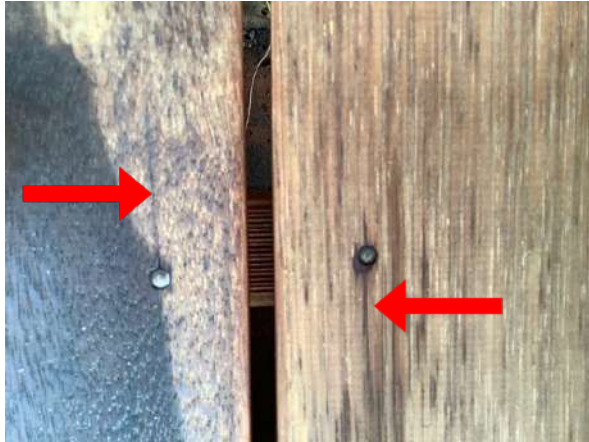
## Safety Hazard 1.01

Finding: Sub Standard Workmanship or Incomplete.

The installation of these building elements appear to have been completed to a substandard level of workmanship or is incomplete.

Unfinished and substandard building works are likely to degrade more quickly and may create potential for secondary defects to associated building elements and surrounding structures, As unfortunately it is clear that the ramp is failing in areas and this may also become a safety hazard for the client who requires the ramp for access with the wheelchair.

It is clear that the last three platforms are not secured to the substructure.

Is also very clear that the last three platforms are bouncy, this is due to the in adequate support underneath. Due to the inadequate support the timbers are splitting and this can become a major safety hazard for the client and requires rectification as a matter of urgency.

It is clear that timber is splitting in areas, this normally occurs when the timber is not pre-drilled correctly.

Where installation is substandard and/or incomplete, the client should contact the responsible trade to undertake rectification works, which are advised as soon as possible.

I highly recommend that the last three platforms be taken out and the ramp be redesigned for manufacture and installation of a metal platform that is rust resistant at a minimum.

Replacement of timbers is highly recommended and in addition as the substructure is pine, I would suggest that non corrosive screws are used to replace the nails.

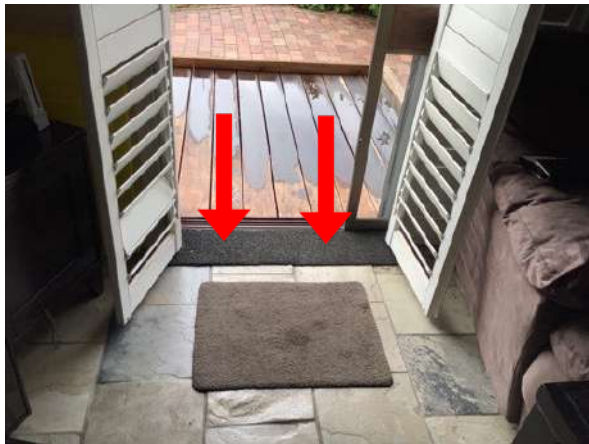
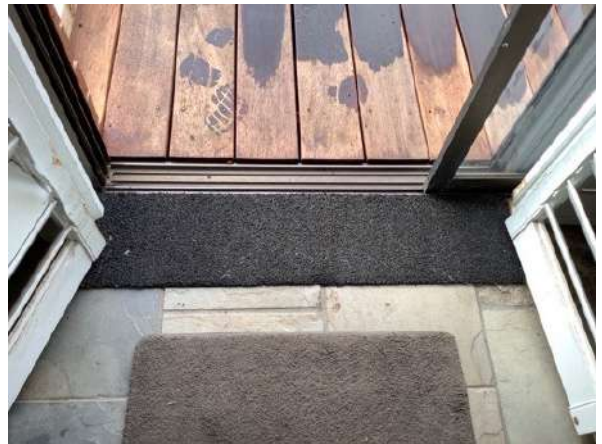
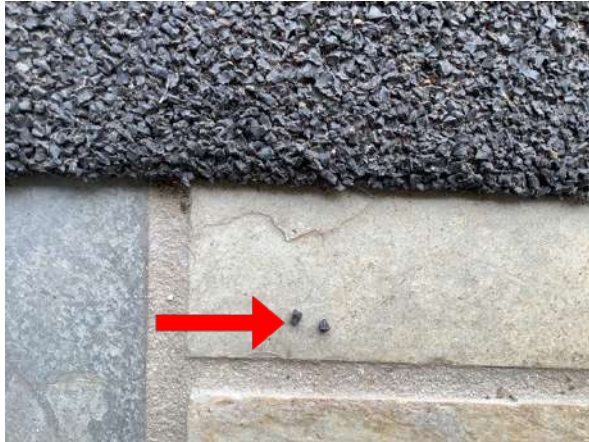
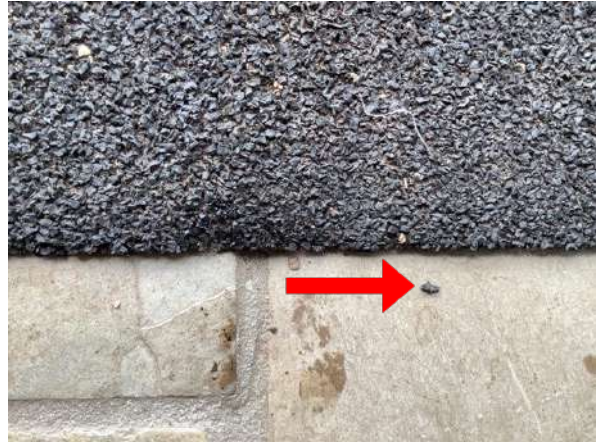
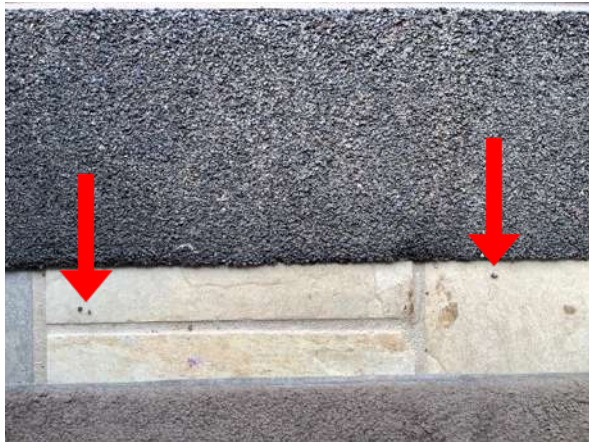
## Safety Hazard 1.02

Finding: Defective Internal Support Material & Installation

The material used does not appear to be appropriate for the requirements. It is clear that pieces of rubber are falling out as noted in the photos supplied.

this was part of the quotation and it is not meeting requirements. I highly recommend this piece of rubber be replaced with a firmer solid flat rubber that will not be compromised by the wheelchair goes over this area and will sustain wear and tear for a substantial amount of time.

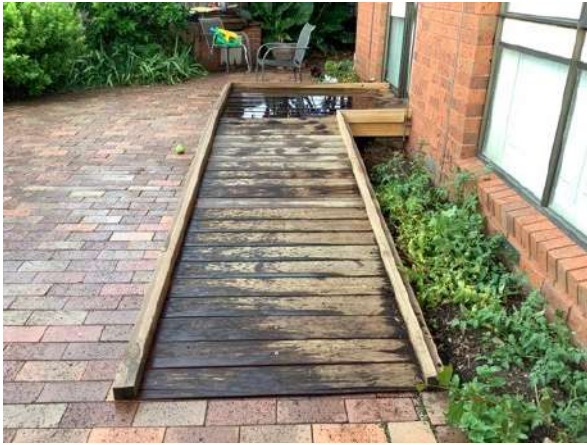
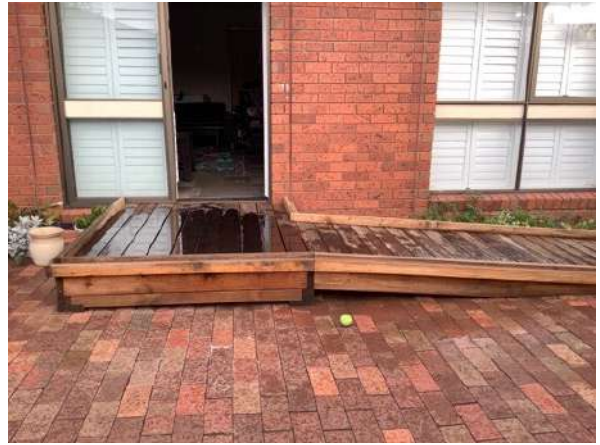
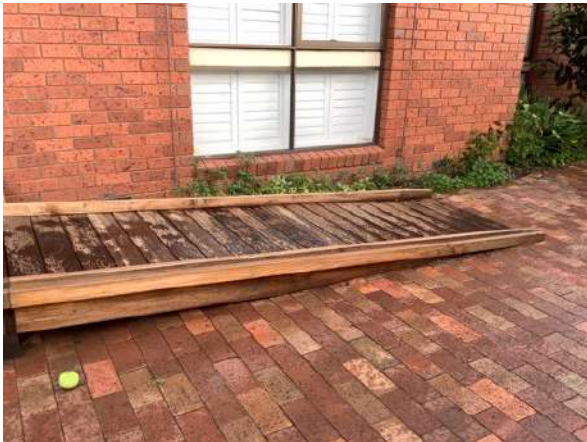
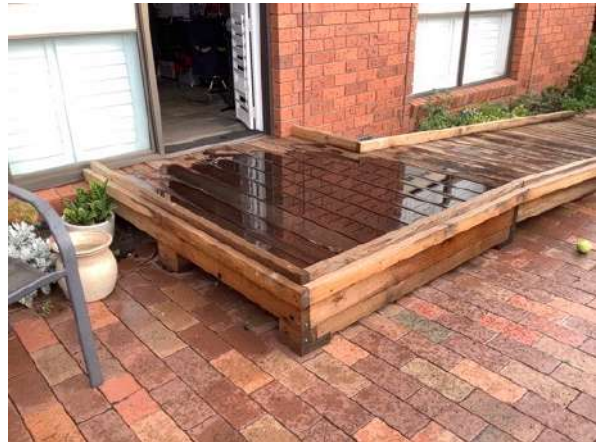
## Observation 4.06

Finding: Additional Photos - Obstructions and Limitations  
These photographs are an indication of the obstructions and limitations which impeded full inspection of the ramp at the time of inspection.  
These obstructions can hide an array of defects.

I cannot inspect the construction underneath the platforms so I can only now inspect what is visually noticeable.
