Termite, Timber Pest Report.

Inspection Date: 15 Feb 2020

Property Address: Northern Rural Area, Vic

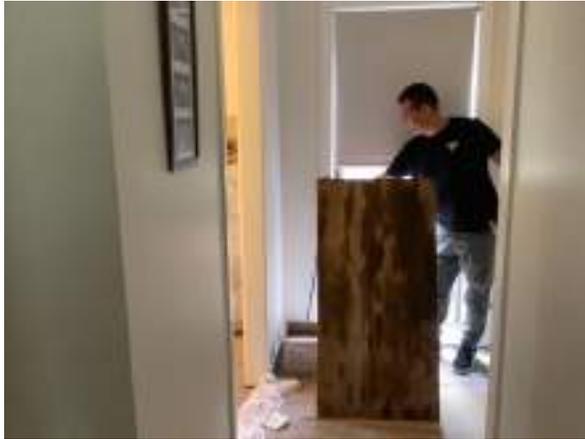
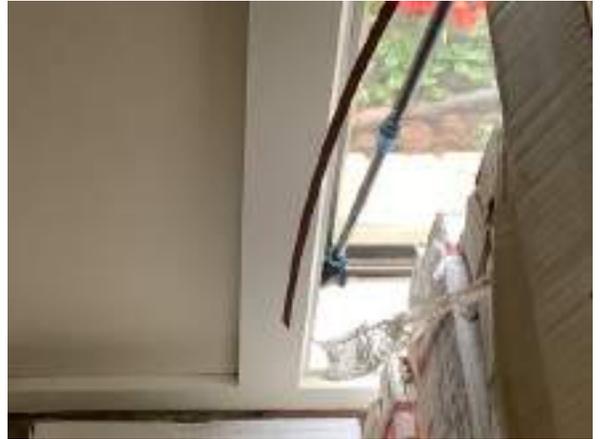
1.02

Location: Laundry
 Finding: Termite - Damage Identified.
 Termite damage to laundry

At this time the builder recognised that there could be some sort of pest damage and stopped the job.

It is evident that this is termite damage and significant. It is unknown as to how extensive the damages are.

Unfortunately the possibility of termite damage to other areas that are not visually accessible and/or exposed to the internal area of the property and the external area of the property , including all garden areas sheds etc are extremely HIGH.

I highly recommend that the plaster and timber areas around the laundry, including the room to the right and possibly the left and possibly ceiling areas will need to be taken down. The extent of the strip out will depend on where the termite damage stops as I highly recommend that until the timber damage stops the plaster will need to continue to come off at a very bare minimum.

My recommendation is there is a process of the order of works that need to take place. Prior to a builder starting any remediation and demolition works, it is important to get a professional licensed pest controller to assess the damage and make his recommendation on a pest management system for the property, whether it be chemical or bait stations .

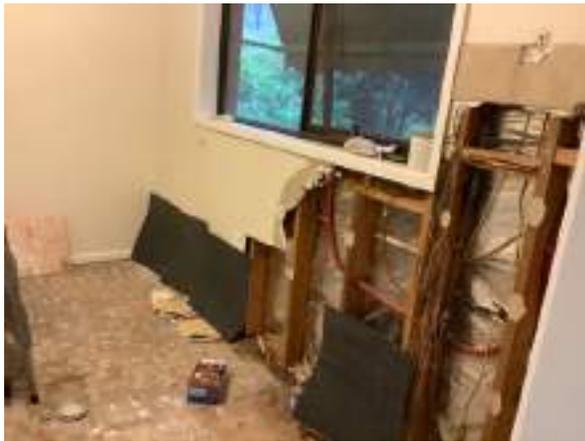
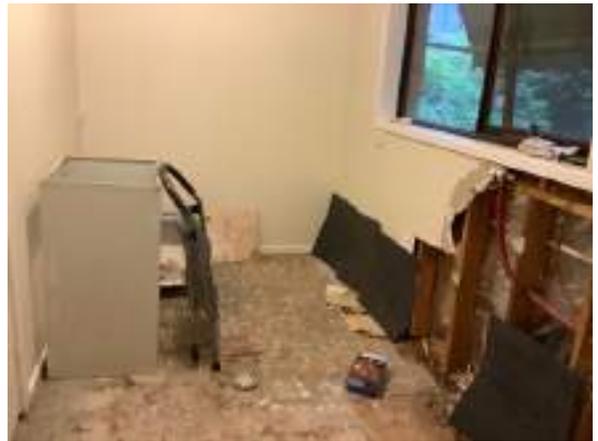
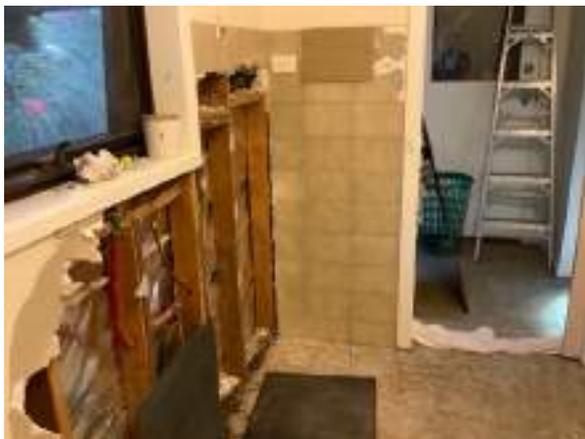
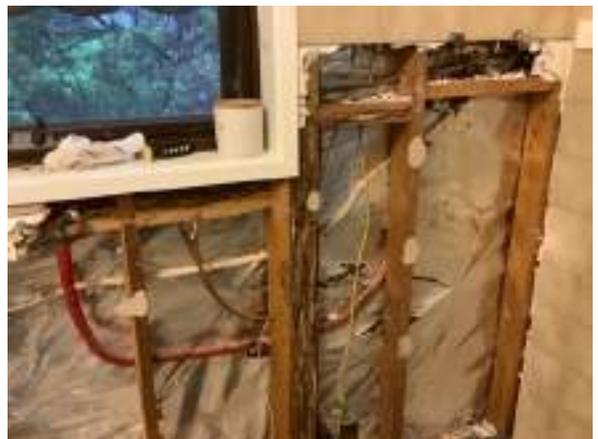
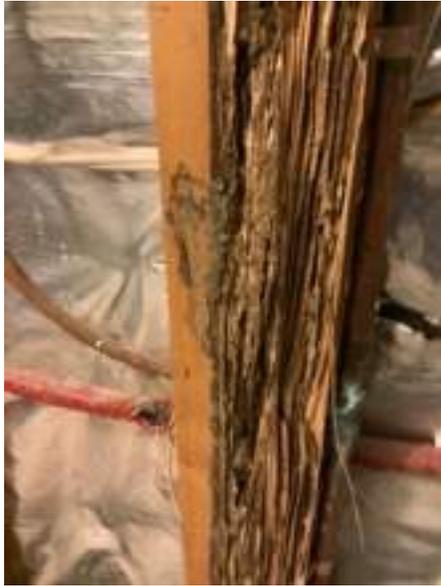
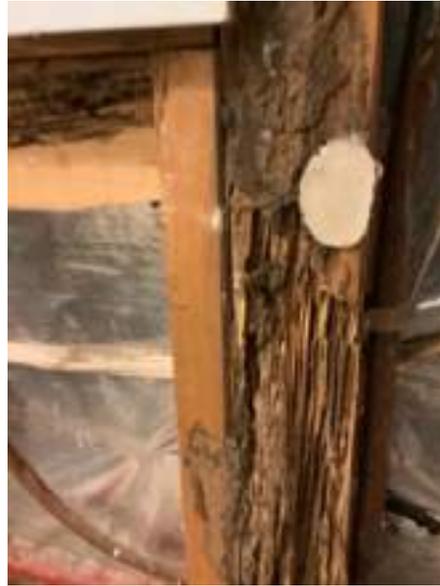
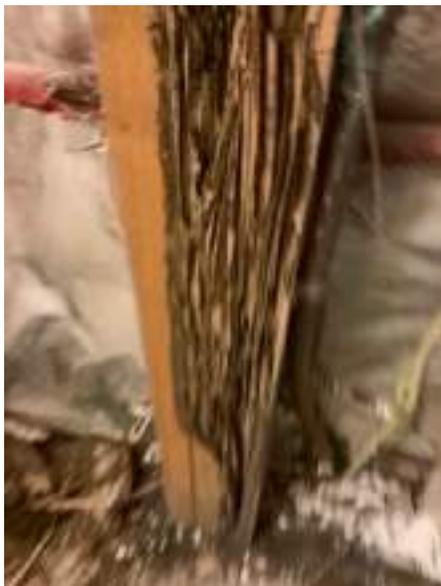
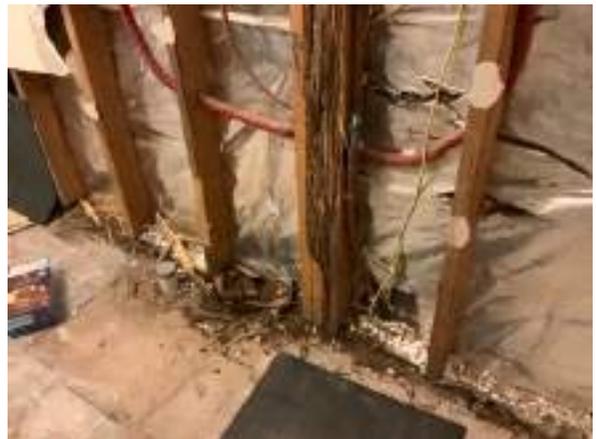
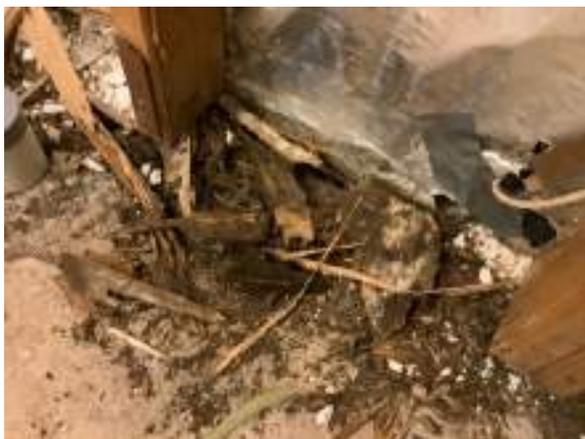
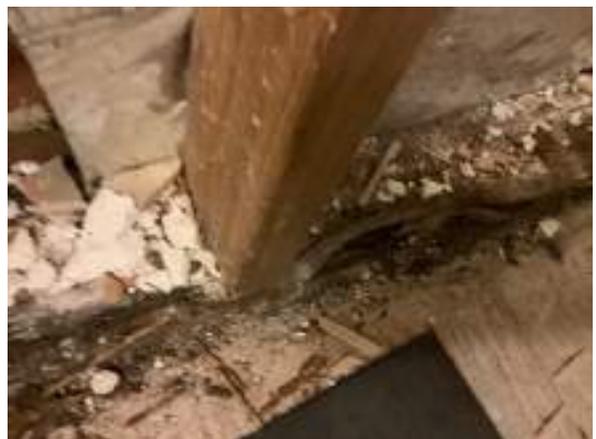
1.03

Finding: Termite - Damage Identified.
Prior to the statement below, Master Property Inspections could only inspect the roof space area around the man hole and as this property has termite damage, we HIGHLY RECOMMEND an invasive inspection to the roof space area and certainly NOT LIMITED TO THE ROOF SPACE AREA.

Despite no live termite or timber pest activity being identified, previous termite damage was found in this area.

A building contractor should be appointed immediately to advise on options to prevent further damage and repair all affected building materials. Until such time, caution should be taken by all people coming into contact with these building elements and this area.

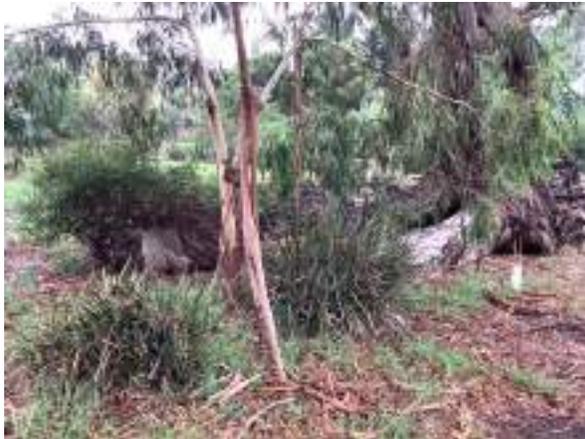
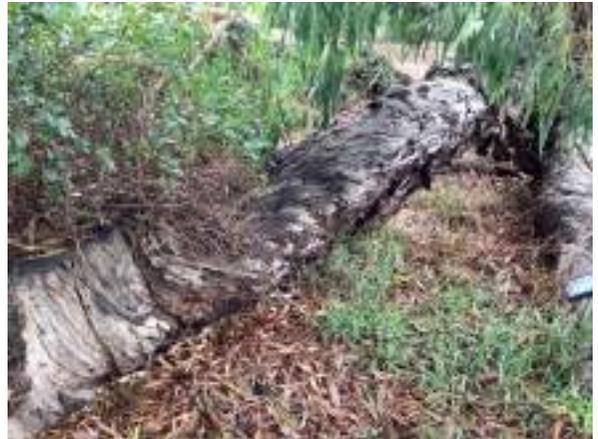
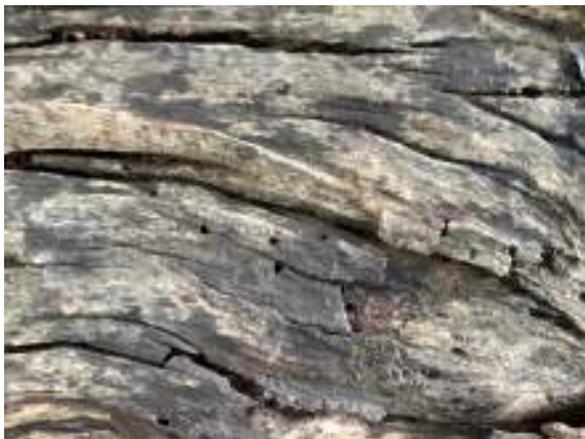
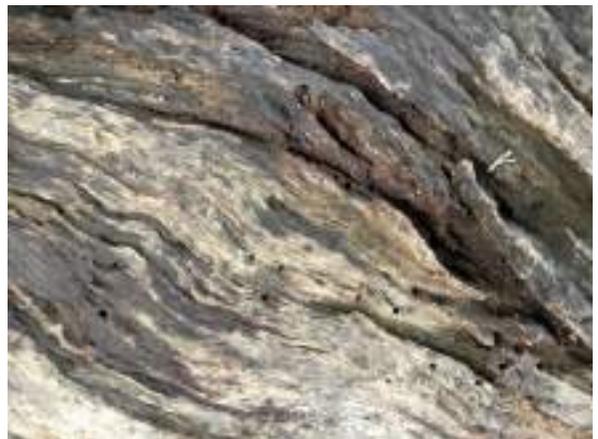
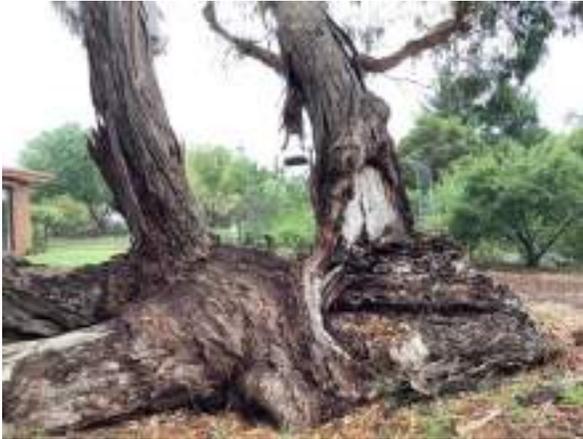
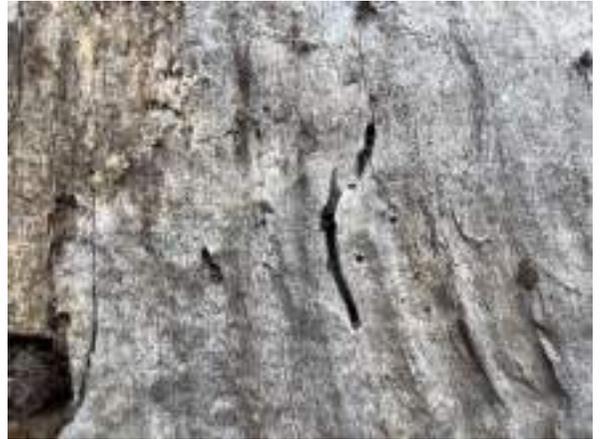
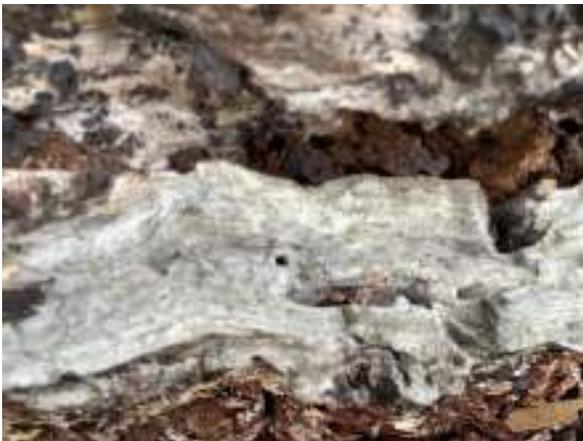
1.05

Location: Garden Areas - All Areas

Finding: Termite - Damage Identified.

It is recommended that obtaining such advice be a short-term priority.

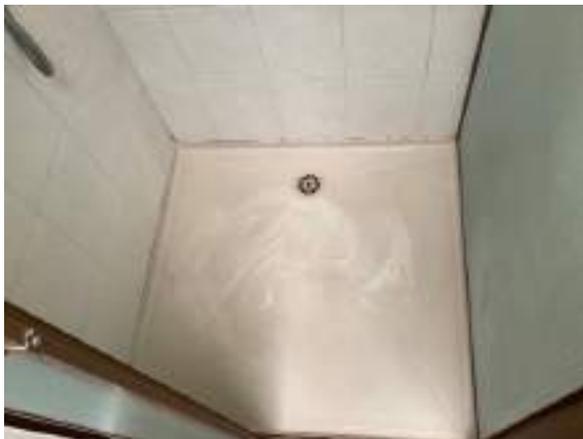
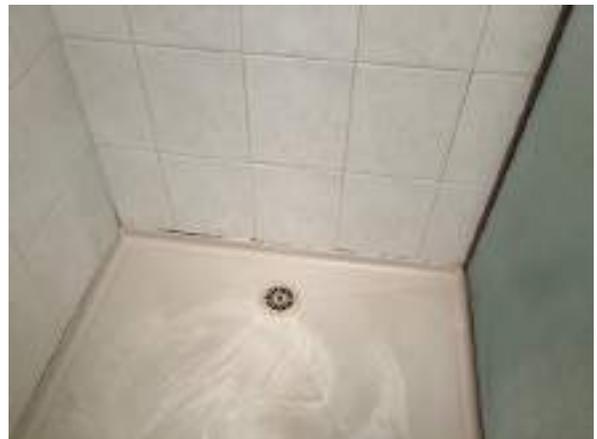
2.07

Location: Bathroom

Excessive moisture is generally caused by deteriorated inadequate or missing roof drainage leaking plumbing pipes or fixtures poorly plumbed HWS overflows or condenser units and poor site drainage.

It is highly recommended that all plumbing and drainage fixtures and fittings be maintained regularly in order to prevent excessive moisture being present in the external / internal property.

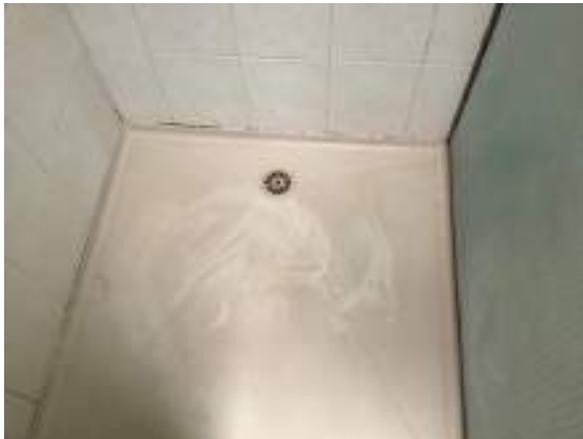
2.08

Location: Bathroom

A sealant specialist, tiling contractor and/or registered builder should be appointed to assess any damage caused by water to the entire internal, sub-floor, walls etc of the building and clean, take off old sealant and tile mortar, then re-seal and re-mortar these works as soon as possible.

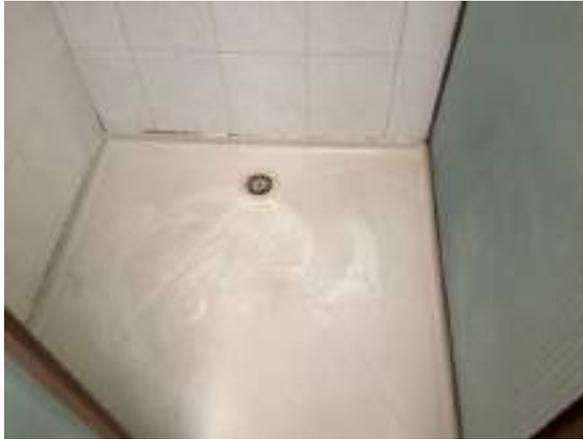
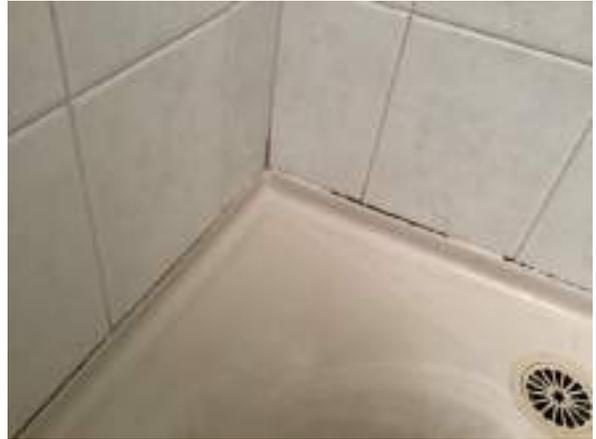
2.09

Location: Bathroom 2

A sealant specialist, tiling contractor and/or registered builder should be appointed to assess any damage caused by water to the entire internal, sub-floor, walls etc of the building and clean, take off old sealant and tile mortar, then re-seal and re-mortar these works as soon as possible.

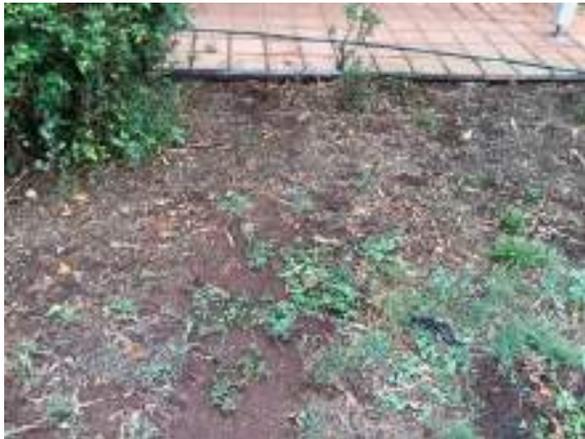
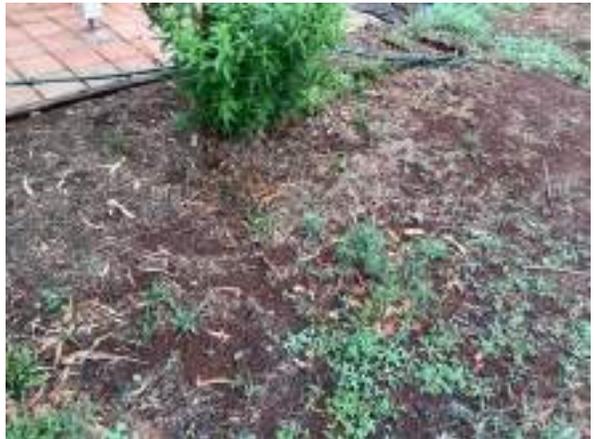
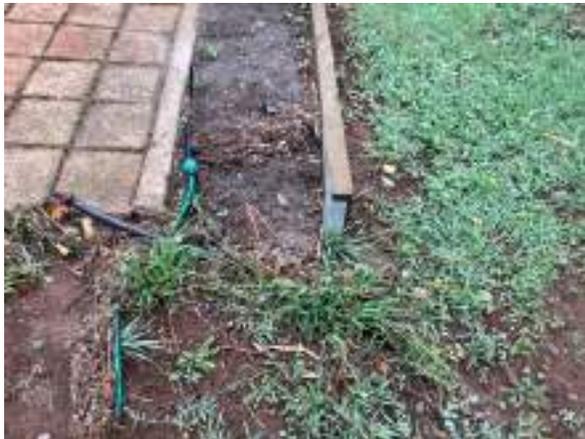
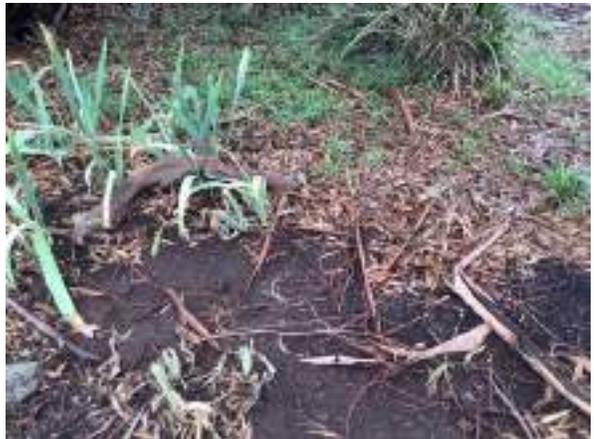
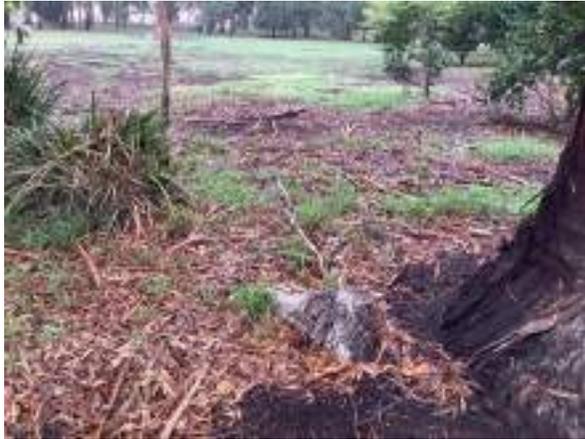
Finding: Garden Beds - Conditions Conducive to Termites
Garden beds were found to be evident in areas of garden areas. These garden beds can include untreated timber, bark, excessive old vegetation and with a combination of moisture from watering hosing can make conditions very conducive to termite activity and termite ingress. It is always important to keep the garden beds as clean as possible and take out excess old bark from the trees, leaves and keep bark mulch to a minimum or better introduce rocks or some item that does not create an conducive environment for termites and hold excess moisture.

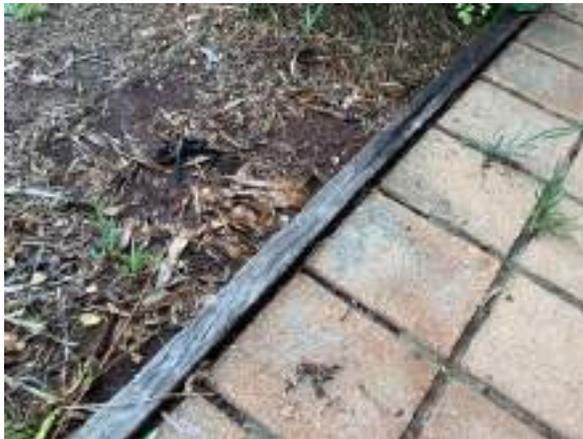
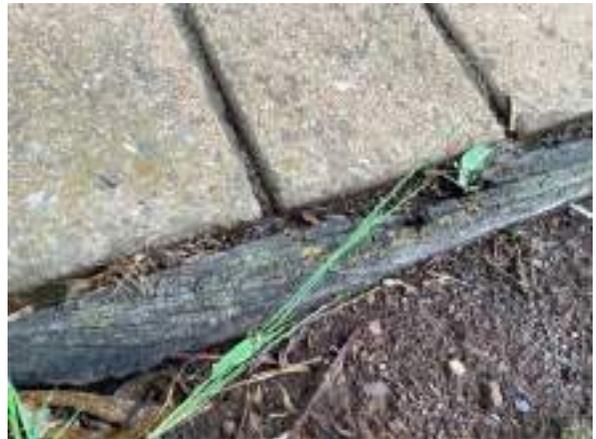
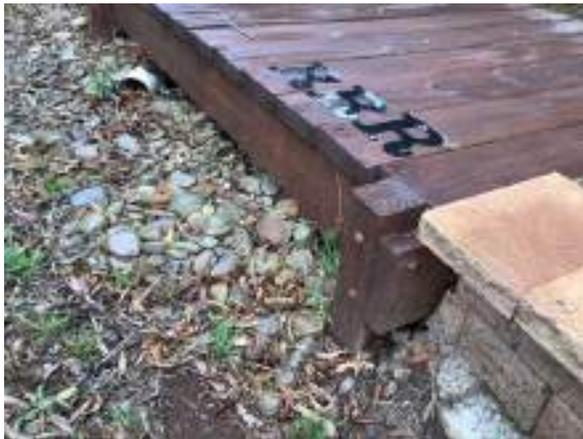
2.18

OTHER CONDITIONS CONDUCIVE TO TIMBER PEST ATTACK

It is highly recommended that any stored building materials or other materials be immediately removed from areas in which they may attract any termite / timber pest attack around the perimeter and/or sub floor areas of the dwelling and a re-inspection is carried out.

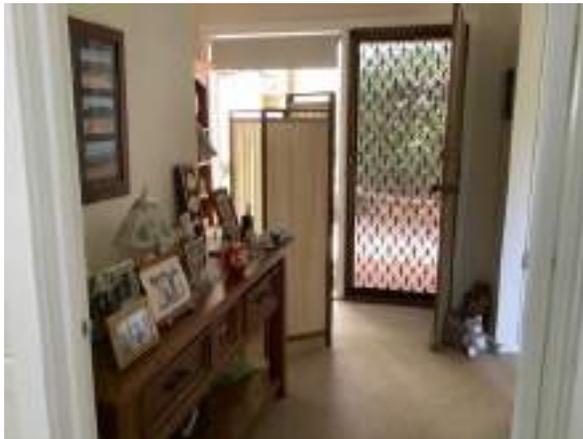
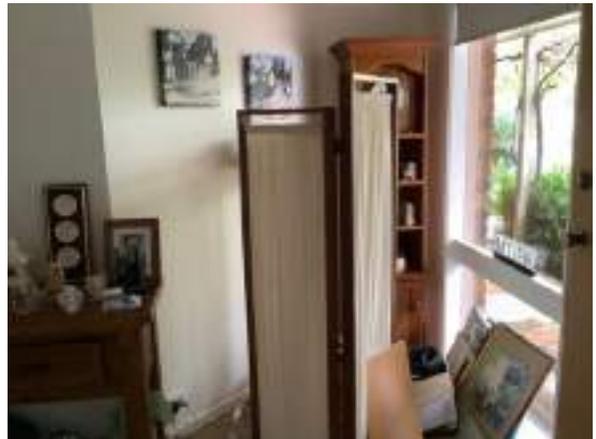
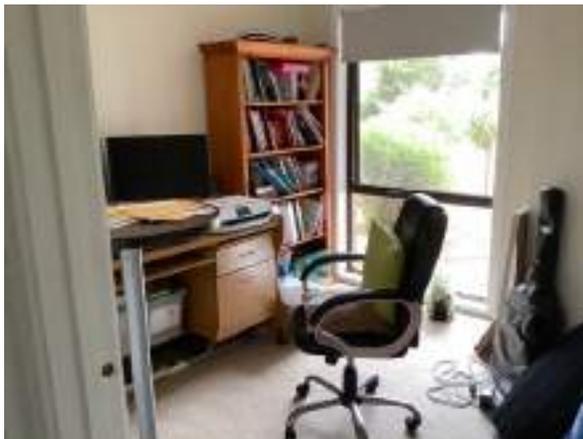
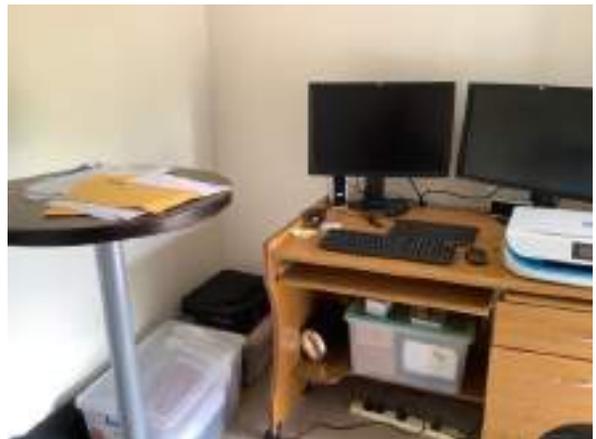
4.21

Location: The Site

Whilst we have taken many photos of the home and surroundings of the obstructions and limitations , we have just added a few photos in the report for you to understand the type of obstructions and limitations .

A re-inspection is recommended once the areas are made accessible.
